## DILAPIDATION REPORT

10 EASTERN CREEK DRIVE EASTERN CREEK, NSW, 2766

THURSDAY, 22 FEBRUARY 2024

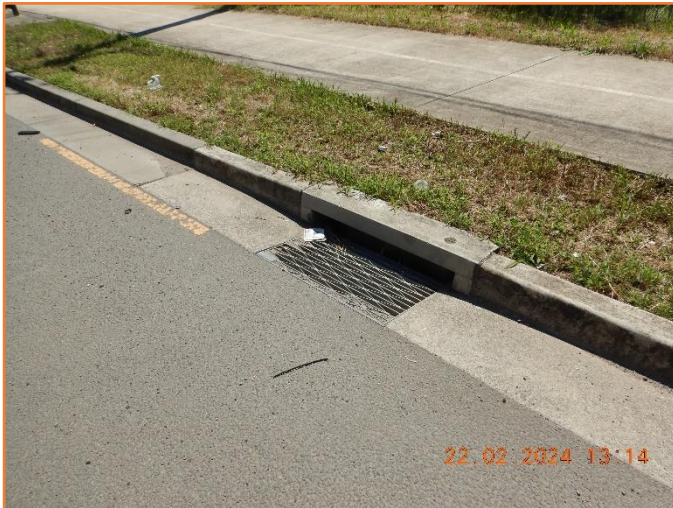
Figure 407: Reasonable - General condition of kerb inlet pit.

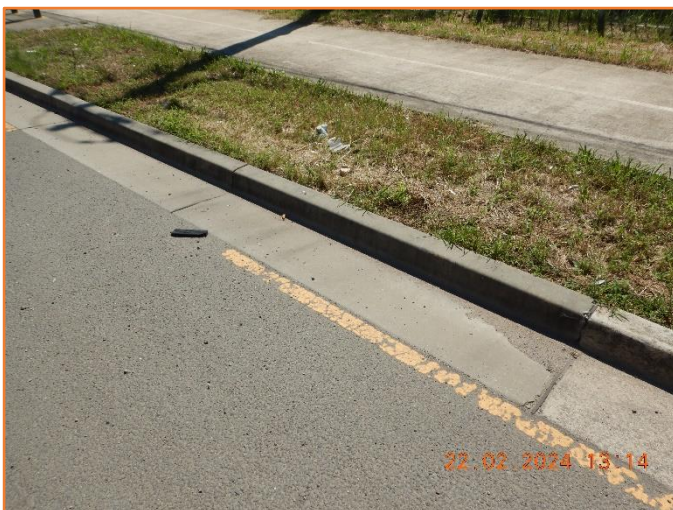
Figure 408: Reasonable - General condition of kerb and gutter.

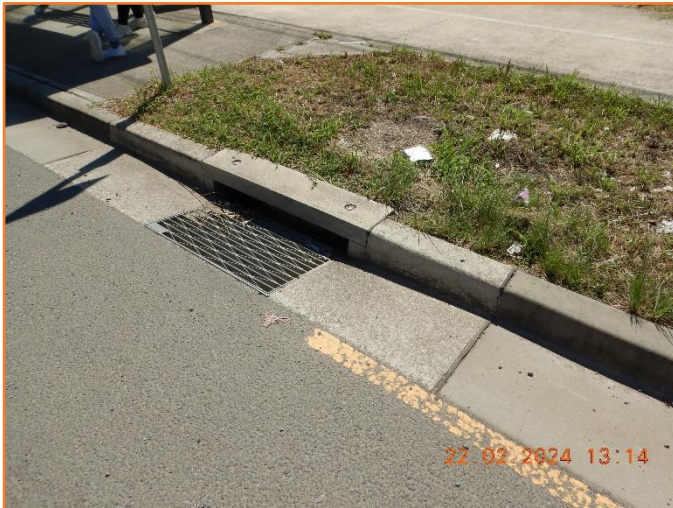
Figure 410: Reasonable - General condition of kerb inlet pit.

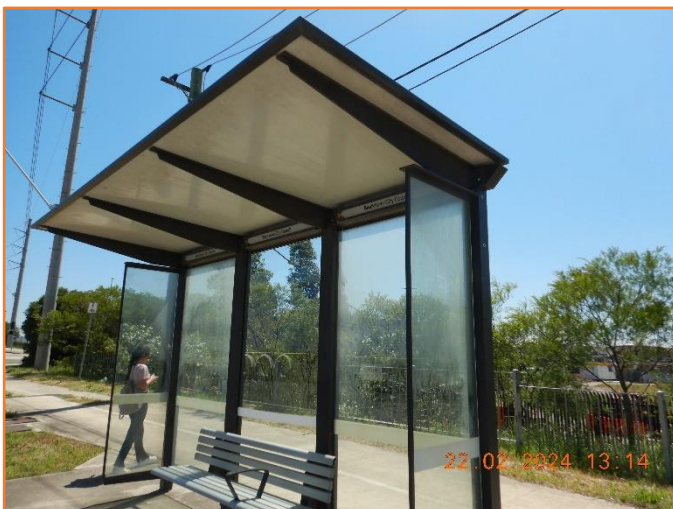
Figure 412: Reasonable - General condition of bus shelter.

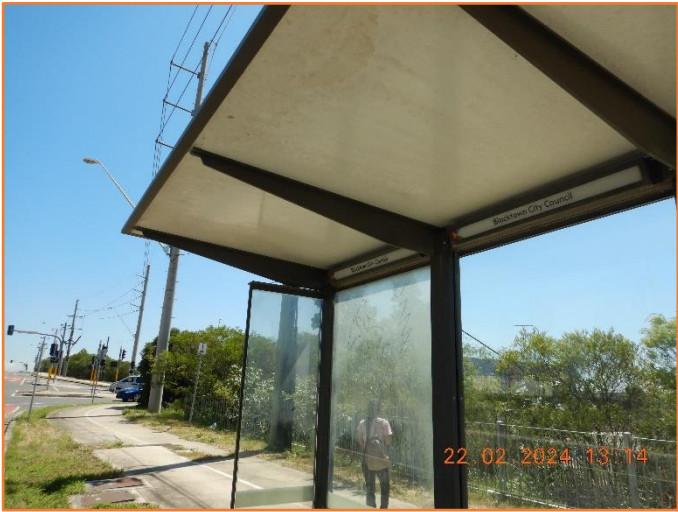
Figure 413: Reasonable - General condition of bus shelter.

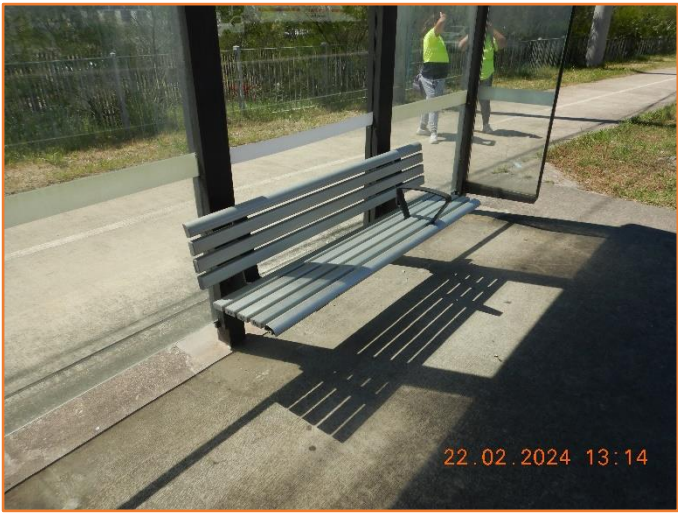
Figure 414: Reasonable - General condition of bus shelter.

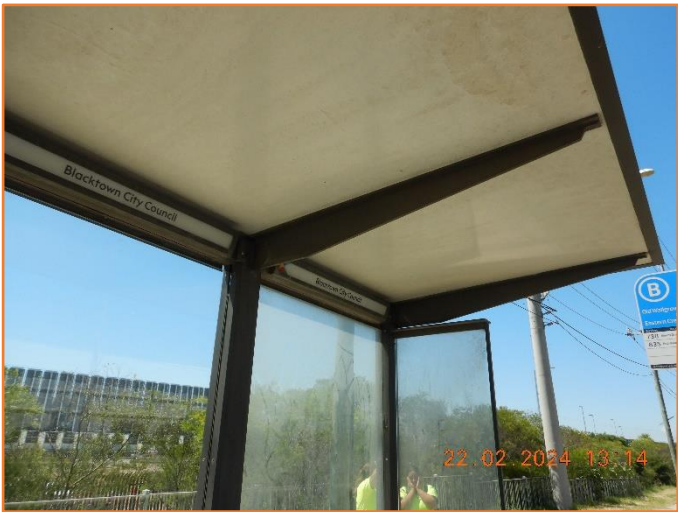
Figure 415: Reasonable - General condition of bus shelter.

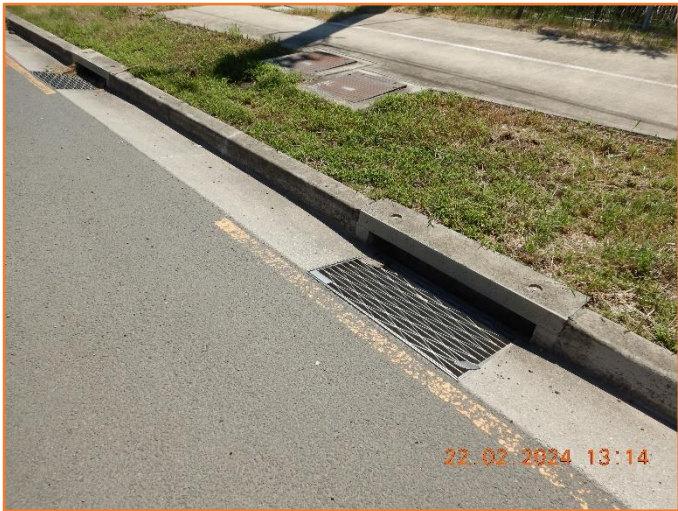
Figure 417: Reasonable - General condition of kerb inlet pit.

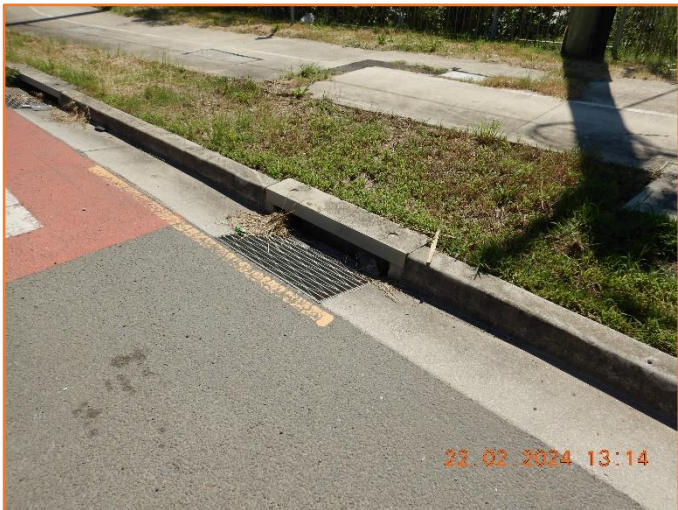
Figure 418: Reasonable - General condition of kerb inlet pit.

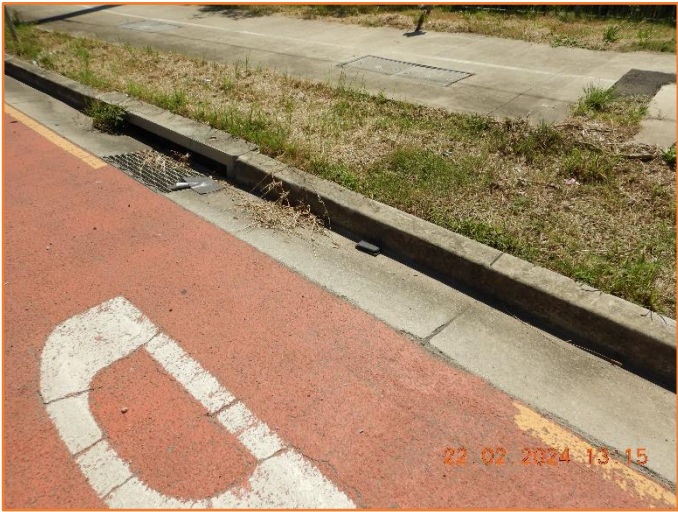
Figure 419: Reasonable - General condition of kerb and gutter.

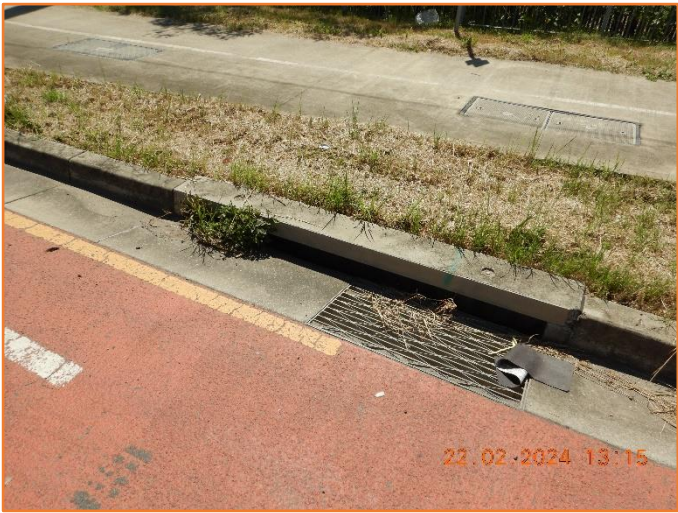
Figure 420: Reasonable - General condition of kerb inlet pit.

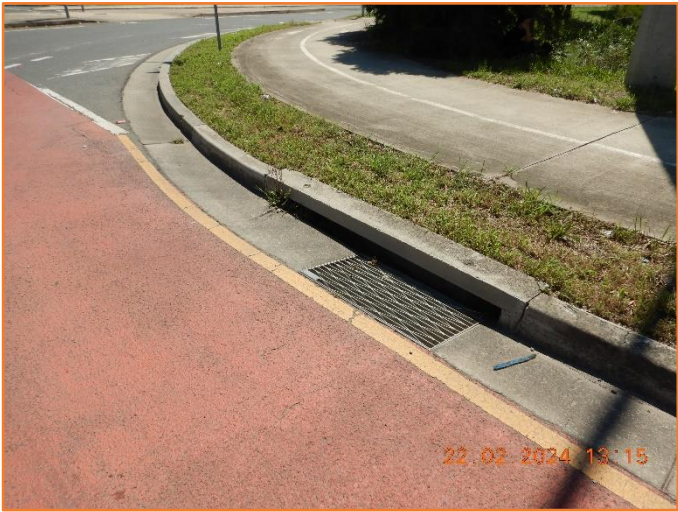
Figure 422: Reasonable - General condition of kerb inlet pit.

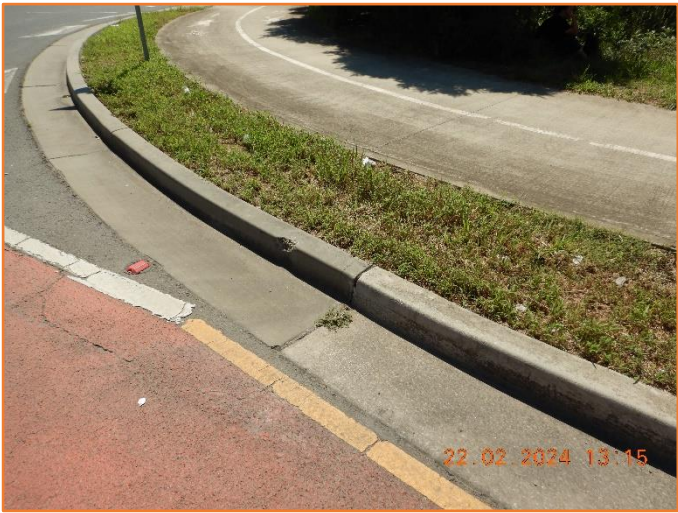
Figure 423: Reasonable - General condition of kerb and gutter. Moderate spalling observed.

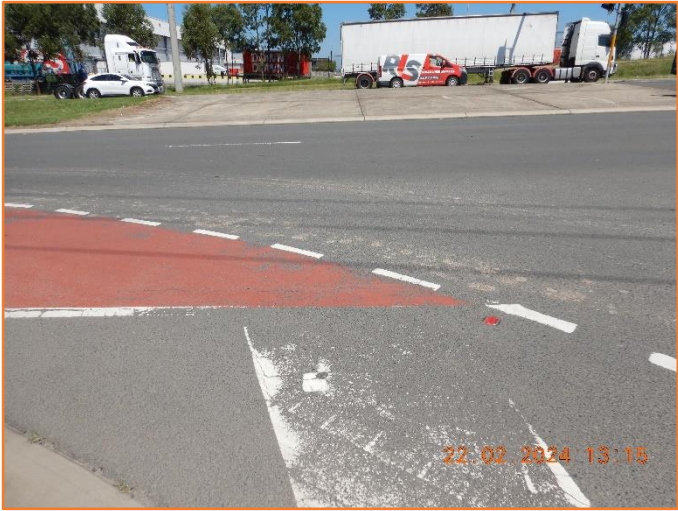
Figure 426: Reasonable - General condition of flexible pavement.

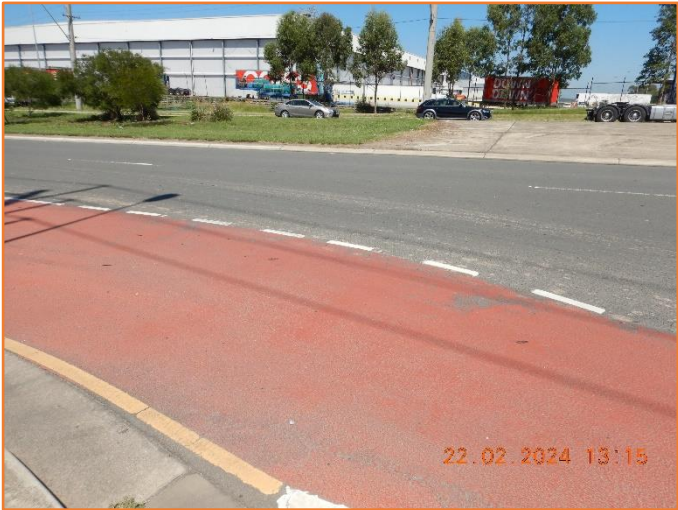
Figure 427: Reasonable - General condition of flexible pavement.

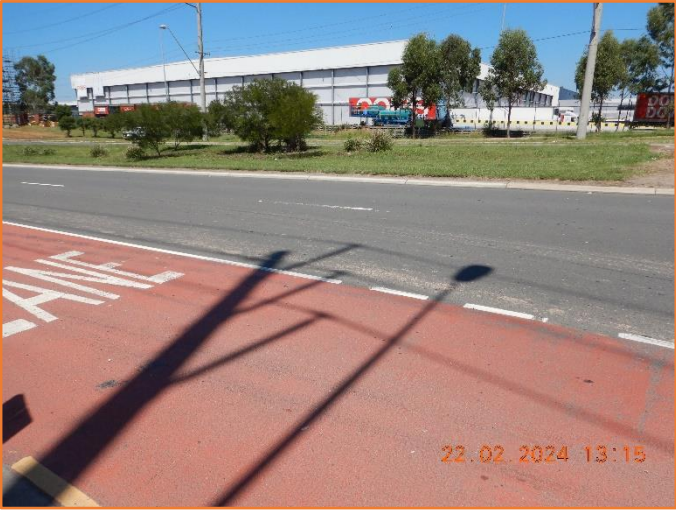
Figure 428: Reasonable - General condition of flexible pavement.

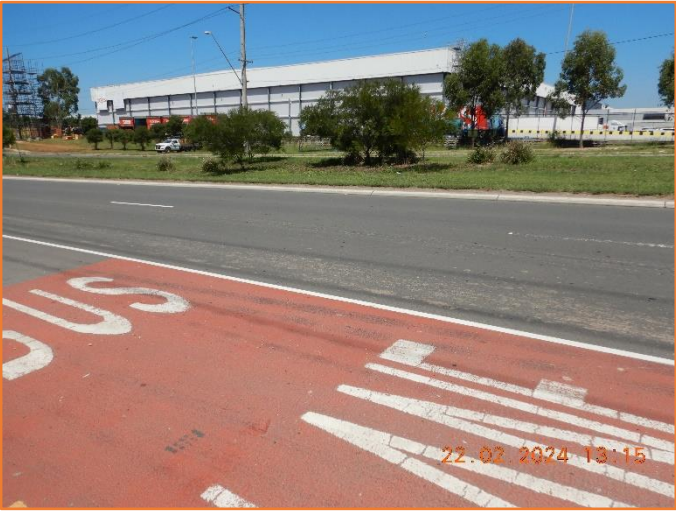
Figure 429: Reasonable - General condition of flexible pavement.

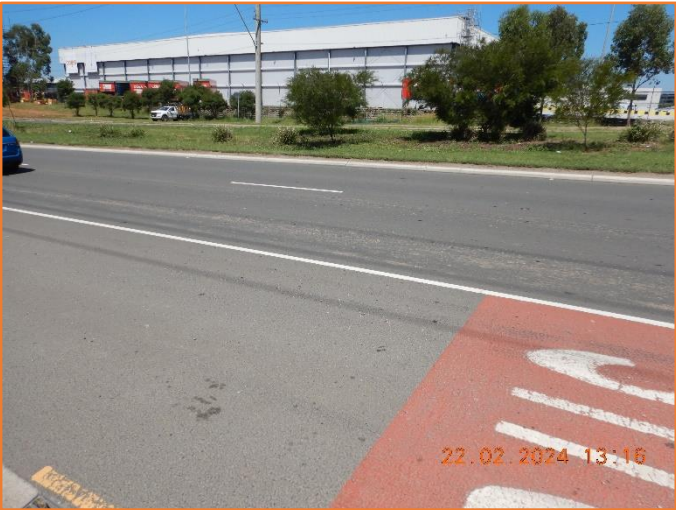
Figure 430: Reasonable - General condition of flexible pavement.

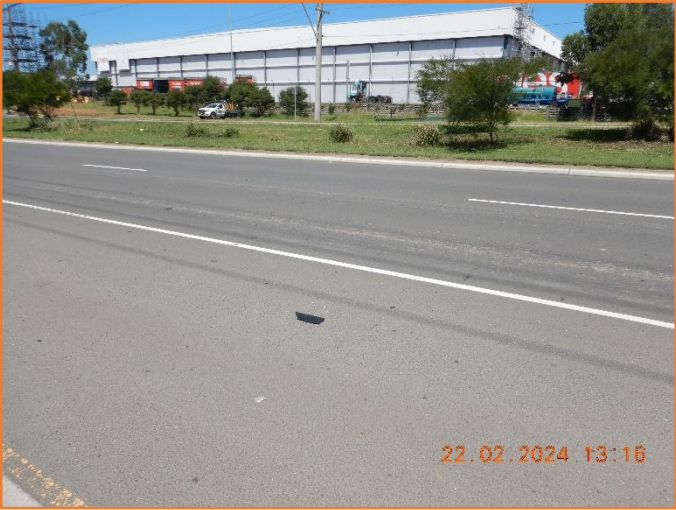
Figure 431: Reasonable - General condition of flexible pavement.

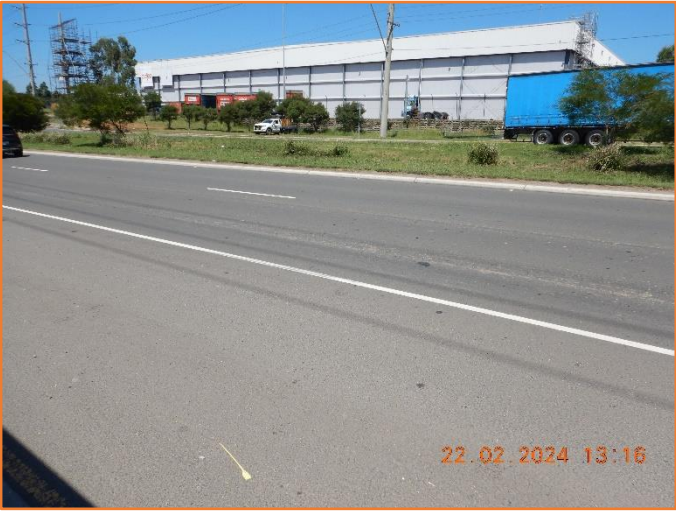
Figure 432: Reasonable - General condition of flexible pavement.

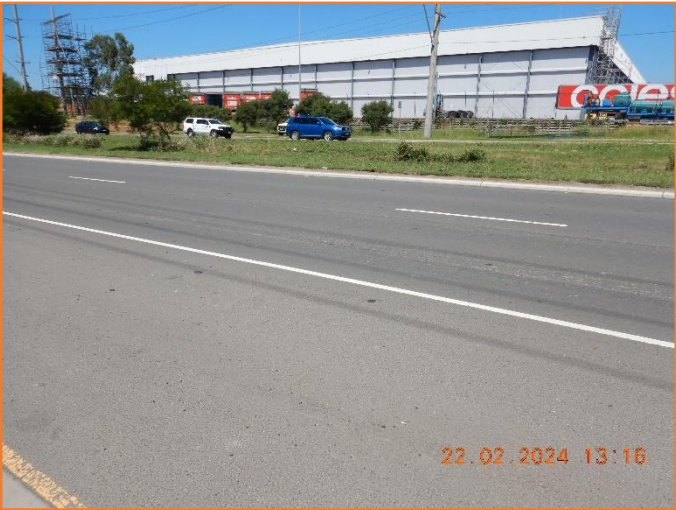
Figure 433: Reasonable - General condition of flexible pavement.

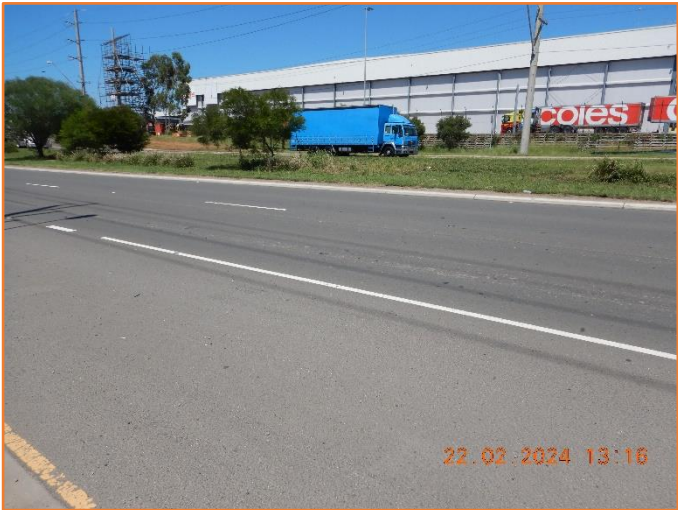
Figure 434: Reasonable - General condition of flexible pavement.

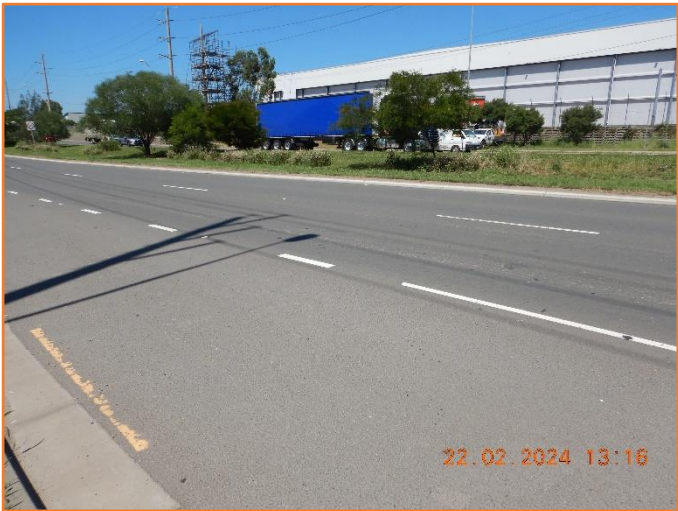
Figure 435: Reasonable - General condition of flexible pavement.

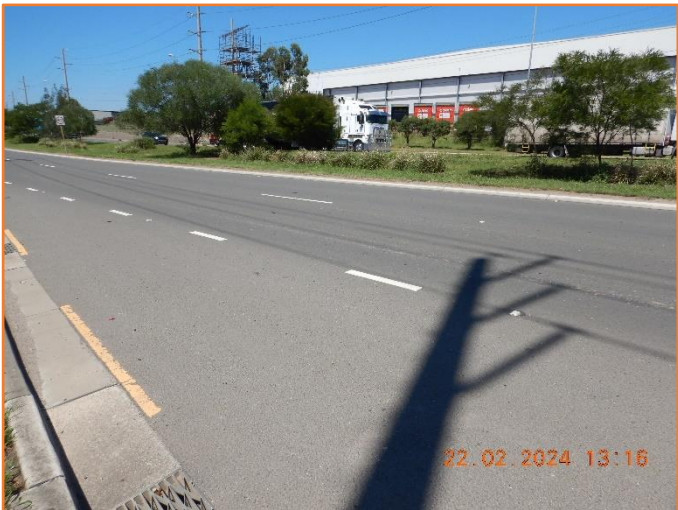
Figure 436: Reasonable - General condition of flexible pavement.

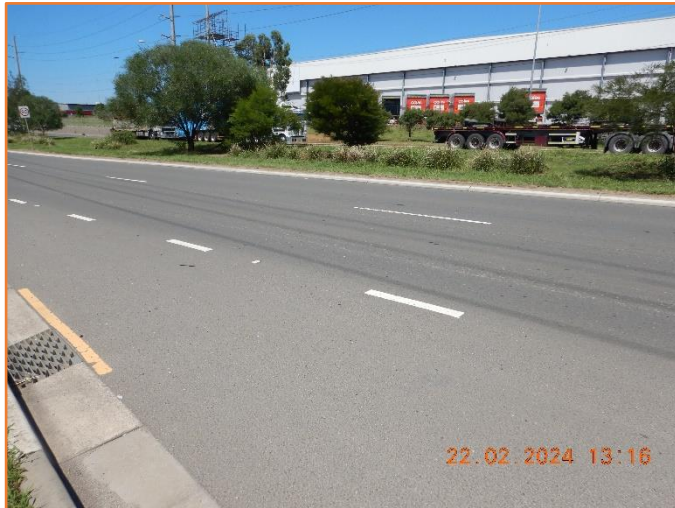
Figure 437: Reasonable - General condition of flexible pavement.

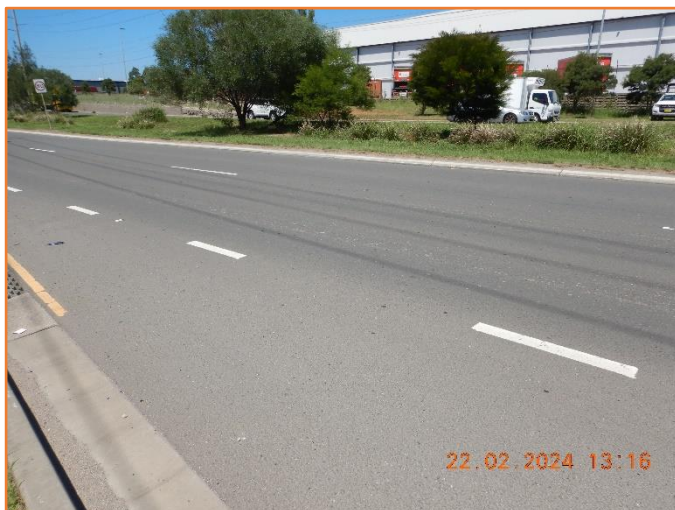
Figure 438: Reasonable - General condition of flexible pavement.

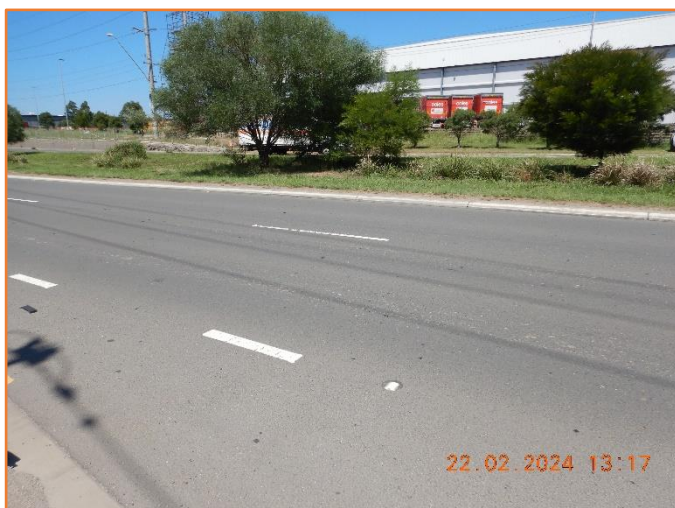
Figure 439: Reasonable - General condition of flexible pavement.

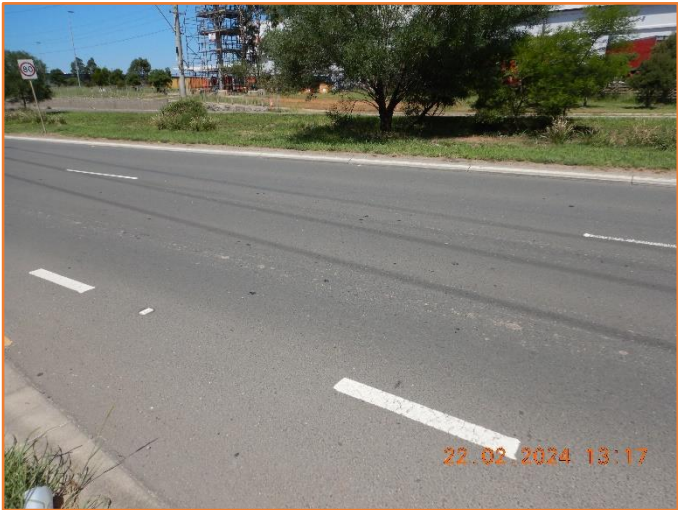
Figure 440: Reasonable - General condition of flexible pavement.

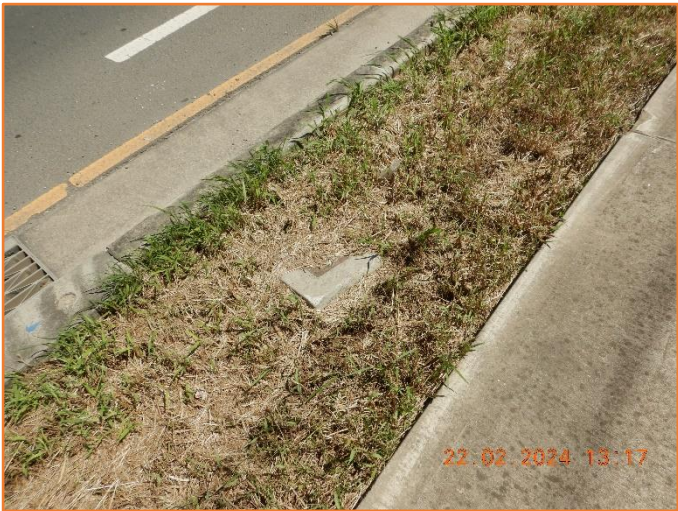
Figure 441: Defective - General condition of service pit.

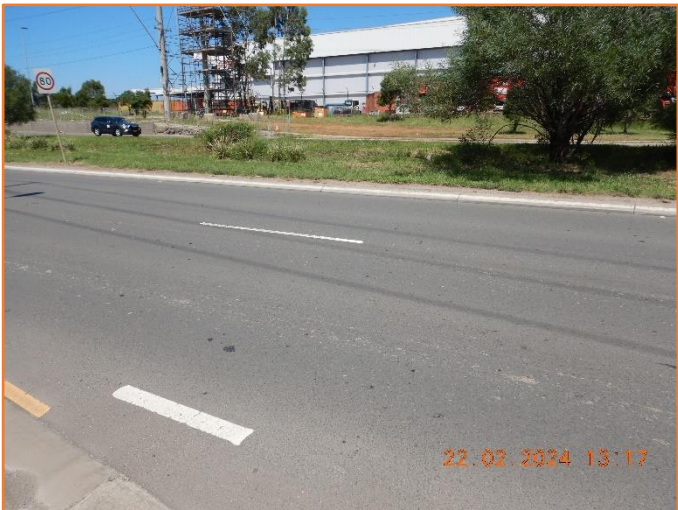
Figure 442: Reasonable - General condition of flexible pavement.

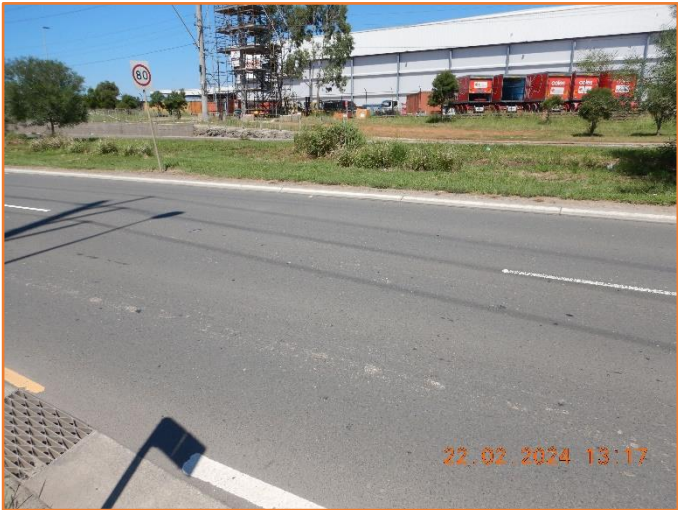
Figure 443: Reasonable - General condition of flexible pavement.

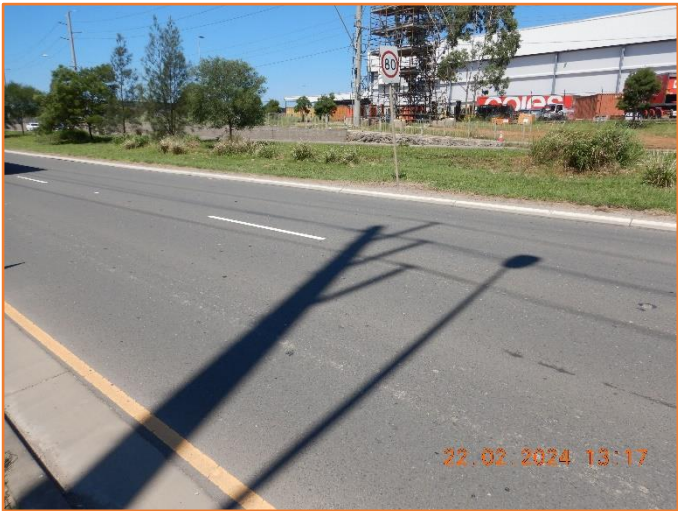
Figure 444: Reasonable - General condition of flexible pavement.

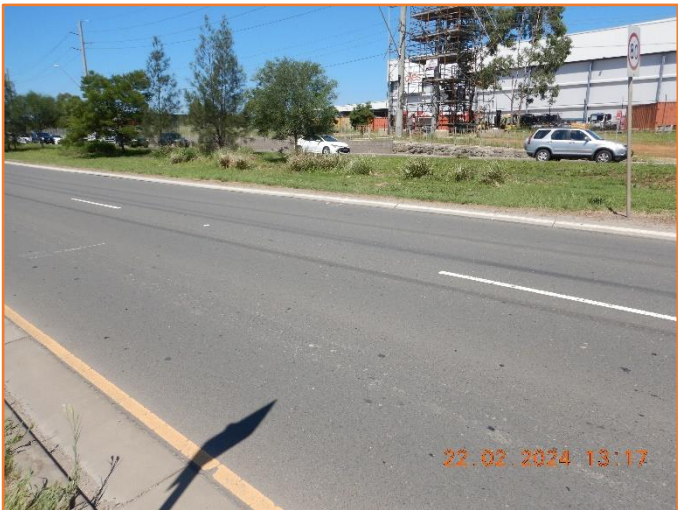
Figure 445: Reasonable - General condition of flexible pavement.

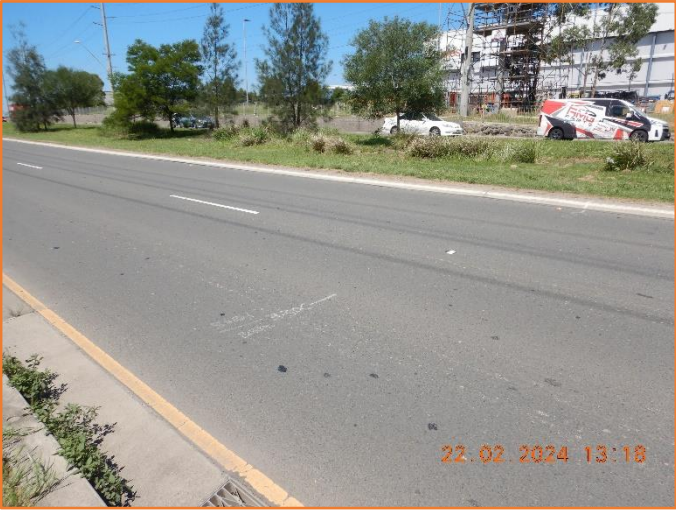
Figure 446: Reasonable - General condition of flexible pavement.

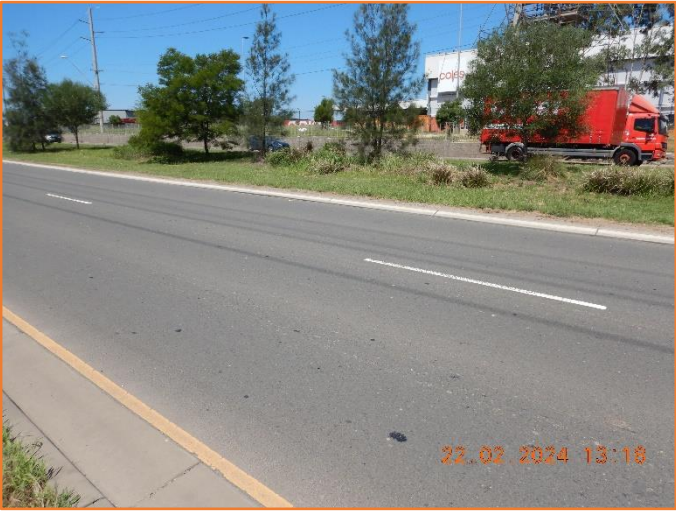
Figure 447: Reasonable - General condition of flexible pavement.

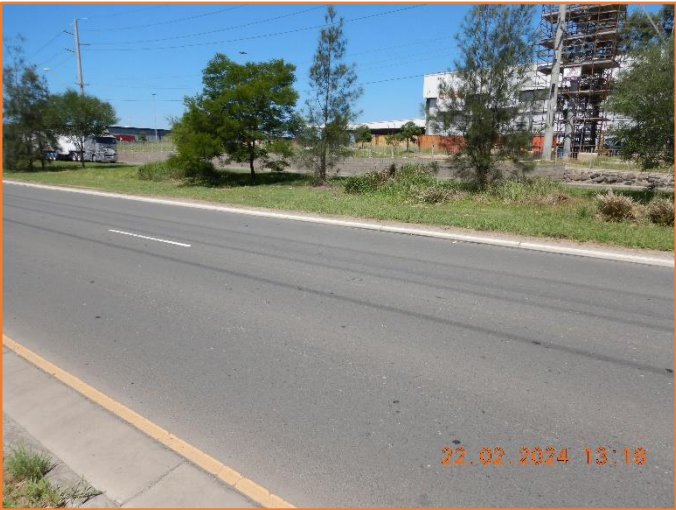
Figure 448: Reasonable - General condition of flexible pavement.

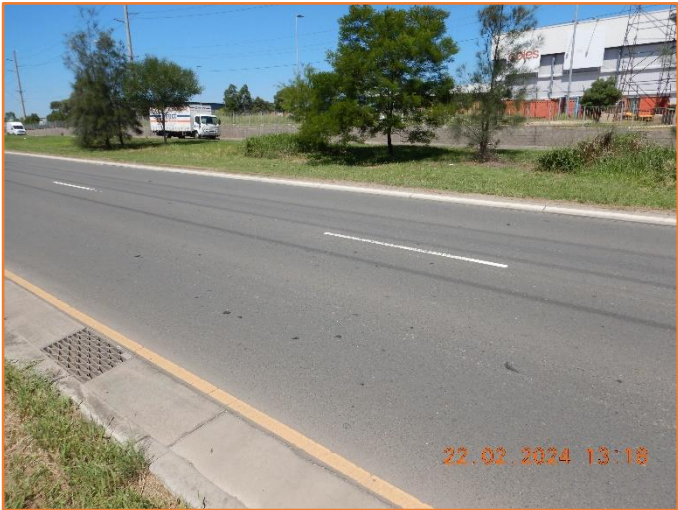
Figure 449: Reasonable - General condition of flexible pavement.

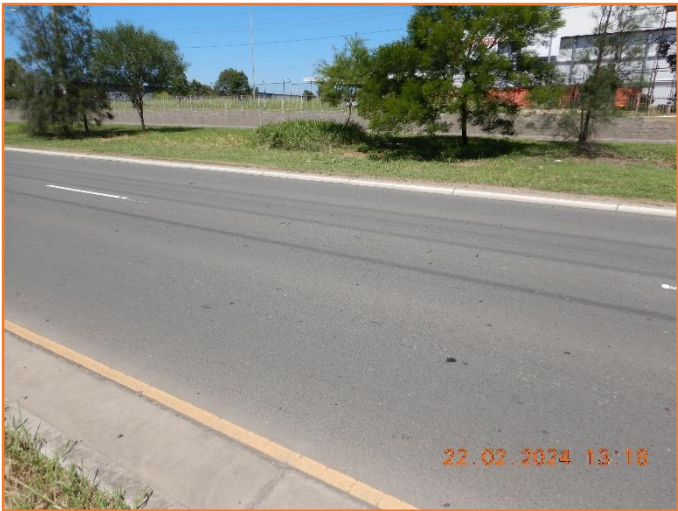
Figure 450: Reasonable - General condition of flexible pavement.

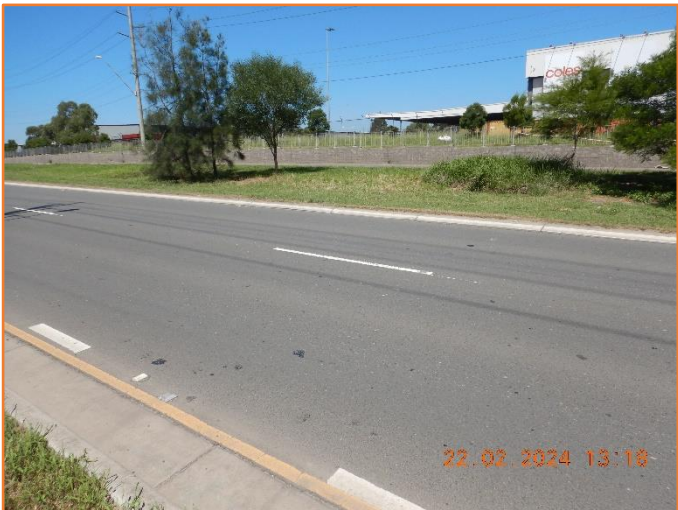
Figure 451: Reasonable - General condition of flexible pavement.

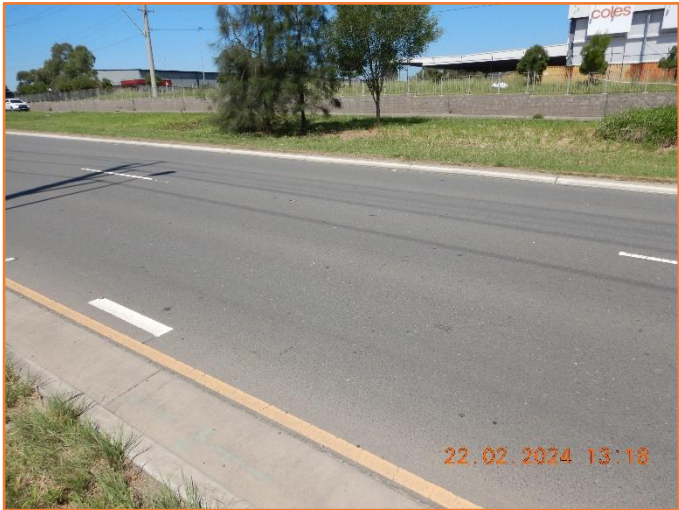
Figure 452: Reasonable - General condition of flexible pavement.

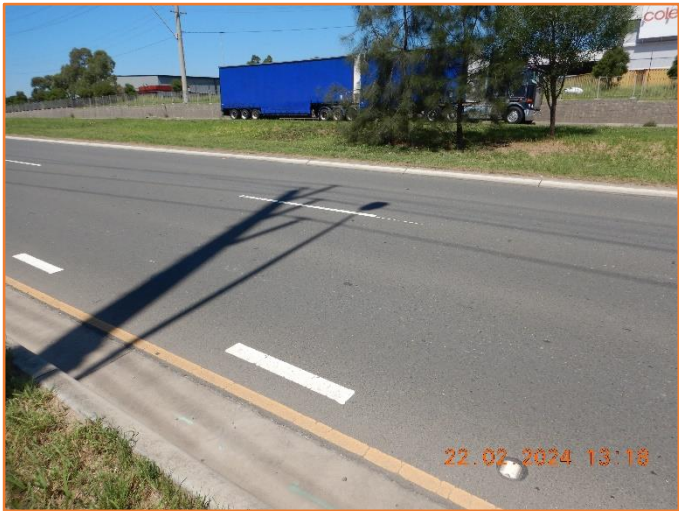
Figure 453: Reasonable - General condition of flexible pavement.

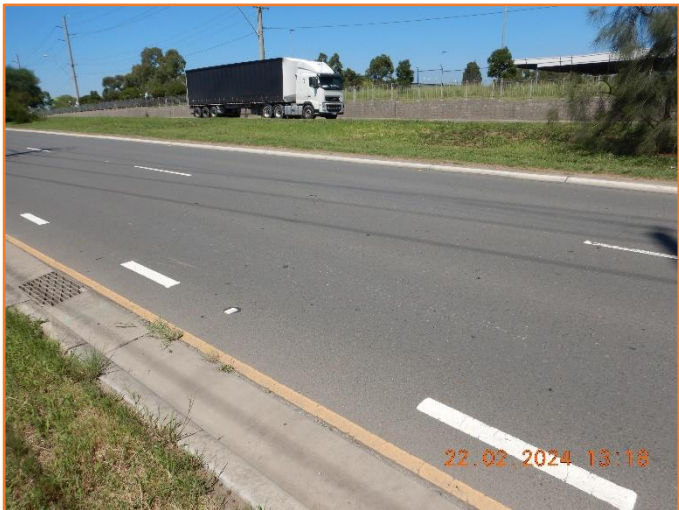
Figure 454: Reasonable - General condition of flexible pavement.

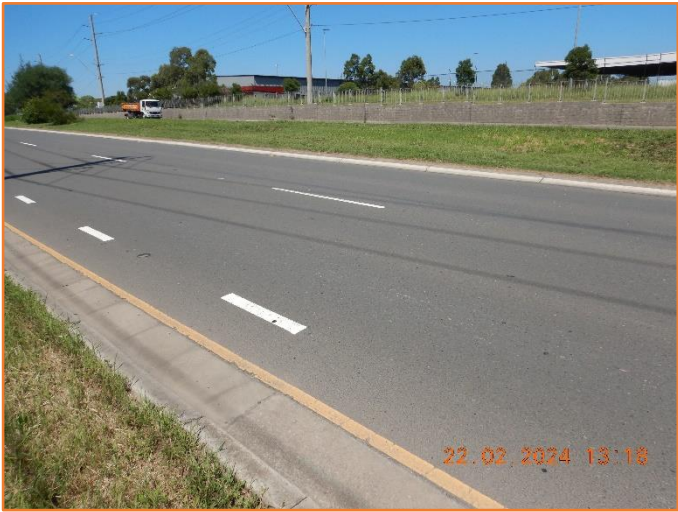
Figure 455: Reasonable - General condition of flexible pavement.

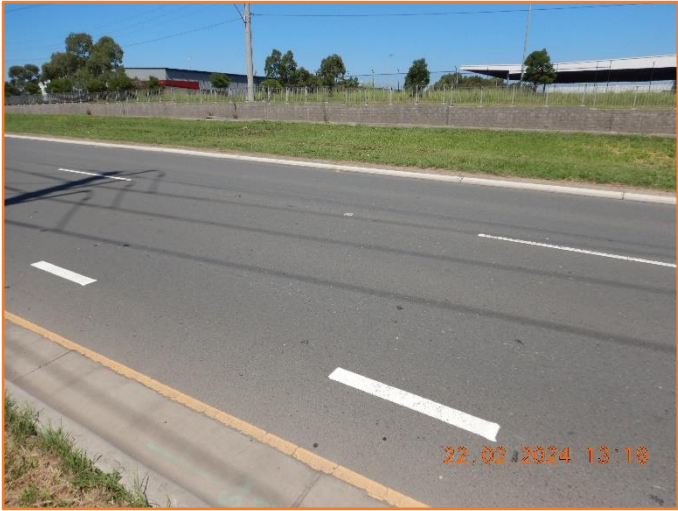
Figure 456: Reasonable - General condition of flexible pavement.

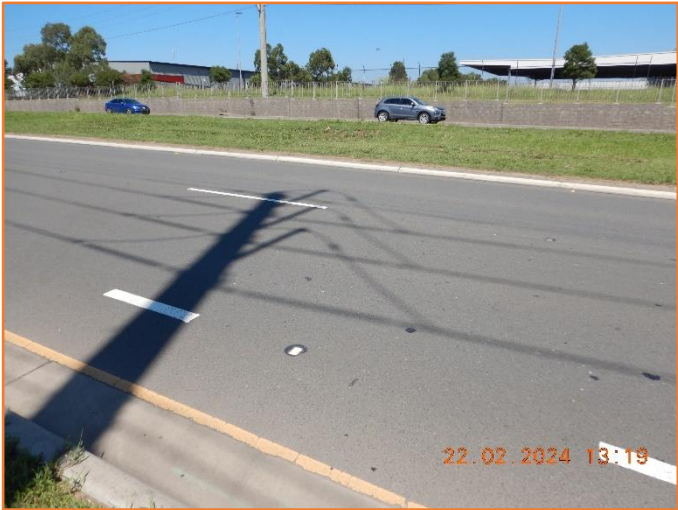
Figure 457: Reasonable - General condition of flexible pavement.

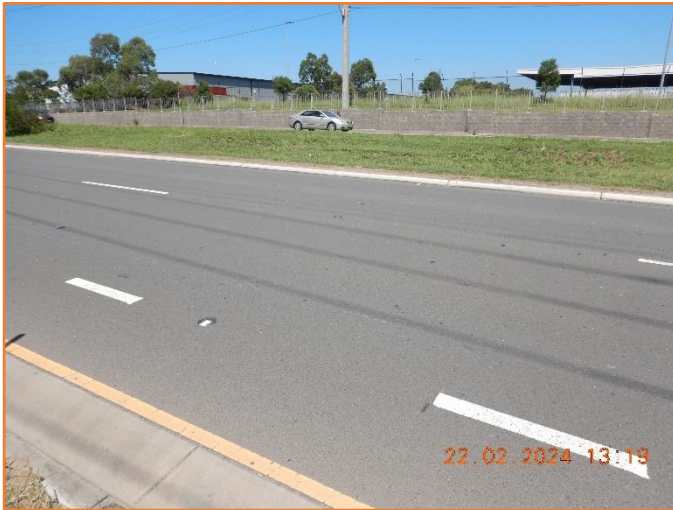
Figure 458: Reasonable - General condition of flexible pavement.
