**Proposed Development**

**157-163 Cleveland St**  
**Redfern**

**Arboricultural Assessment**

November 2011

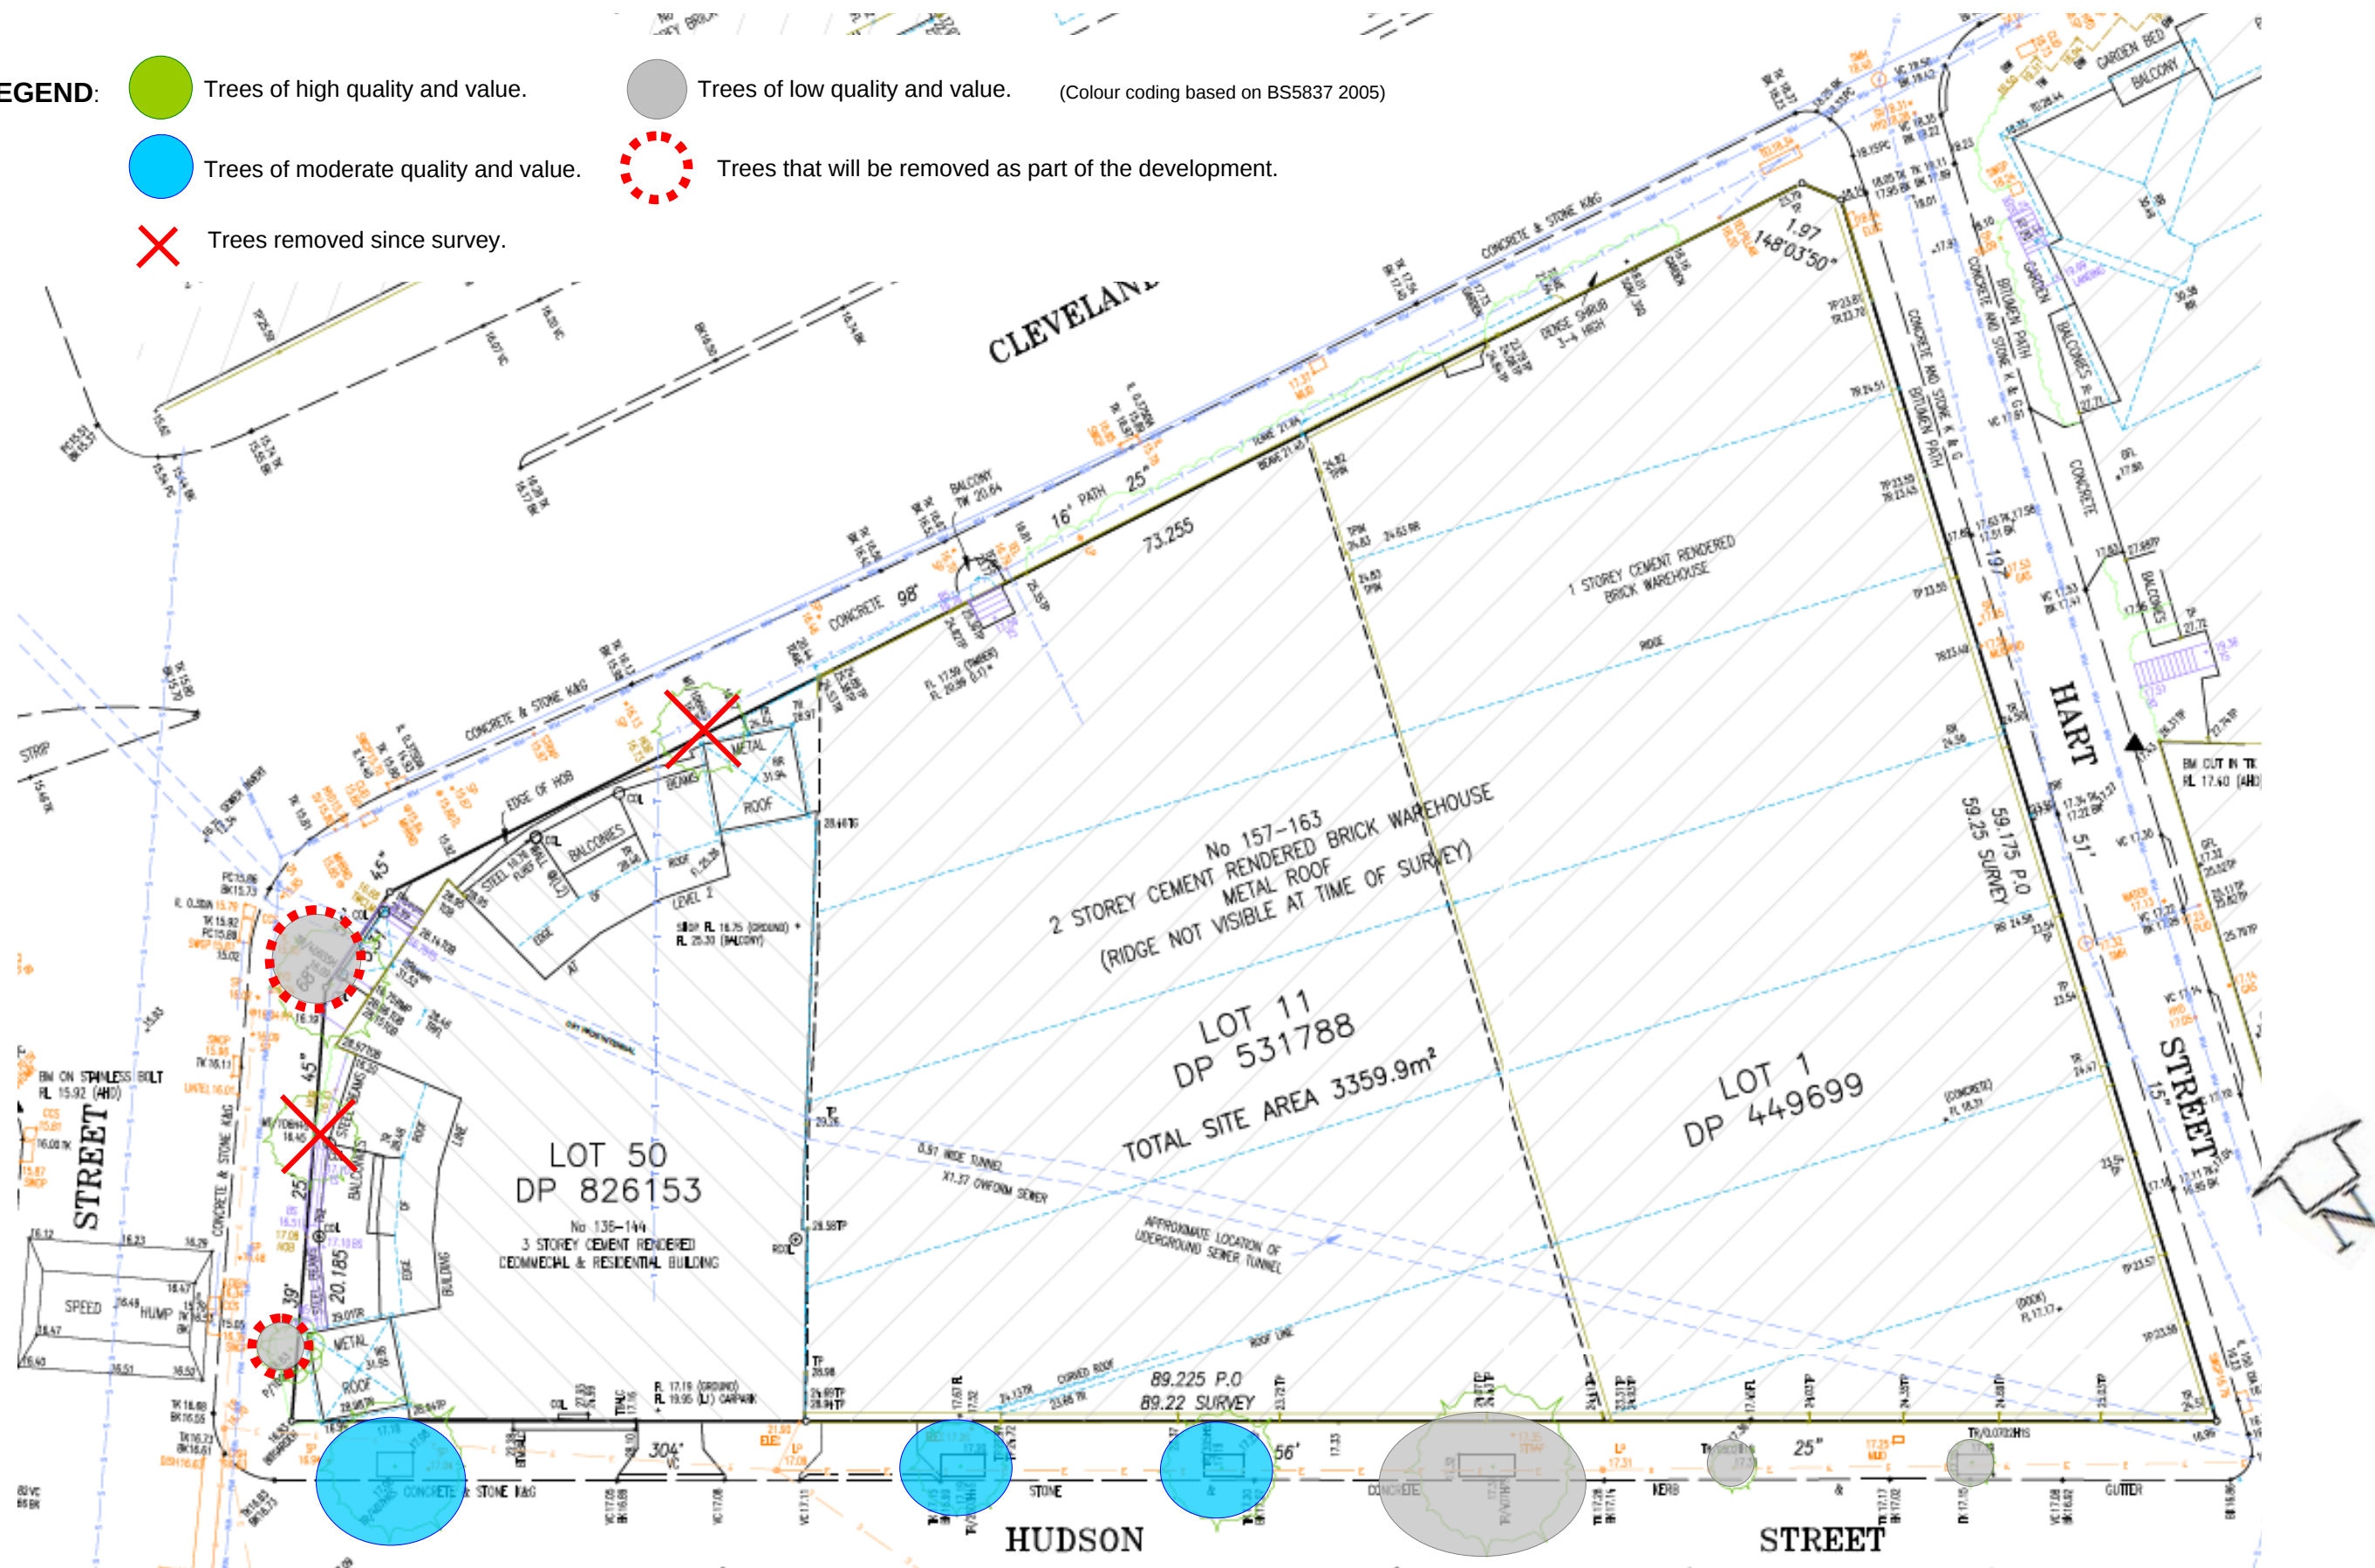
Diagram 1 – Tree Location Plan (n.t.s.) Note: refer to schedule for tree numbers.  
(Source: Adapted from Details and Levels Plan prepared by Denny Linker & Co. 20/05/2011)

Trees removed since survey.
