# **Extraction Plan**

## **Longwalls 25-31**

### **Six-Monthly Report**

#### **Mandalong Mine**

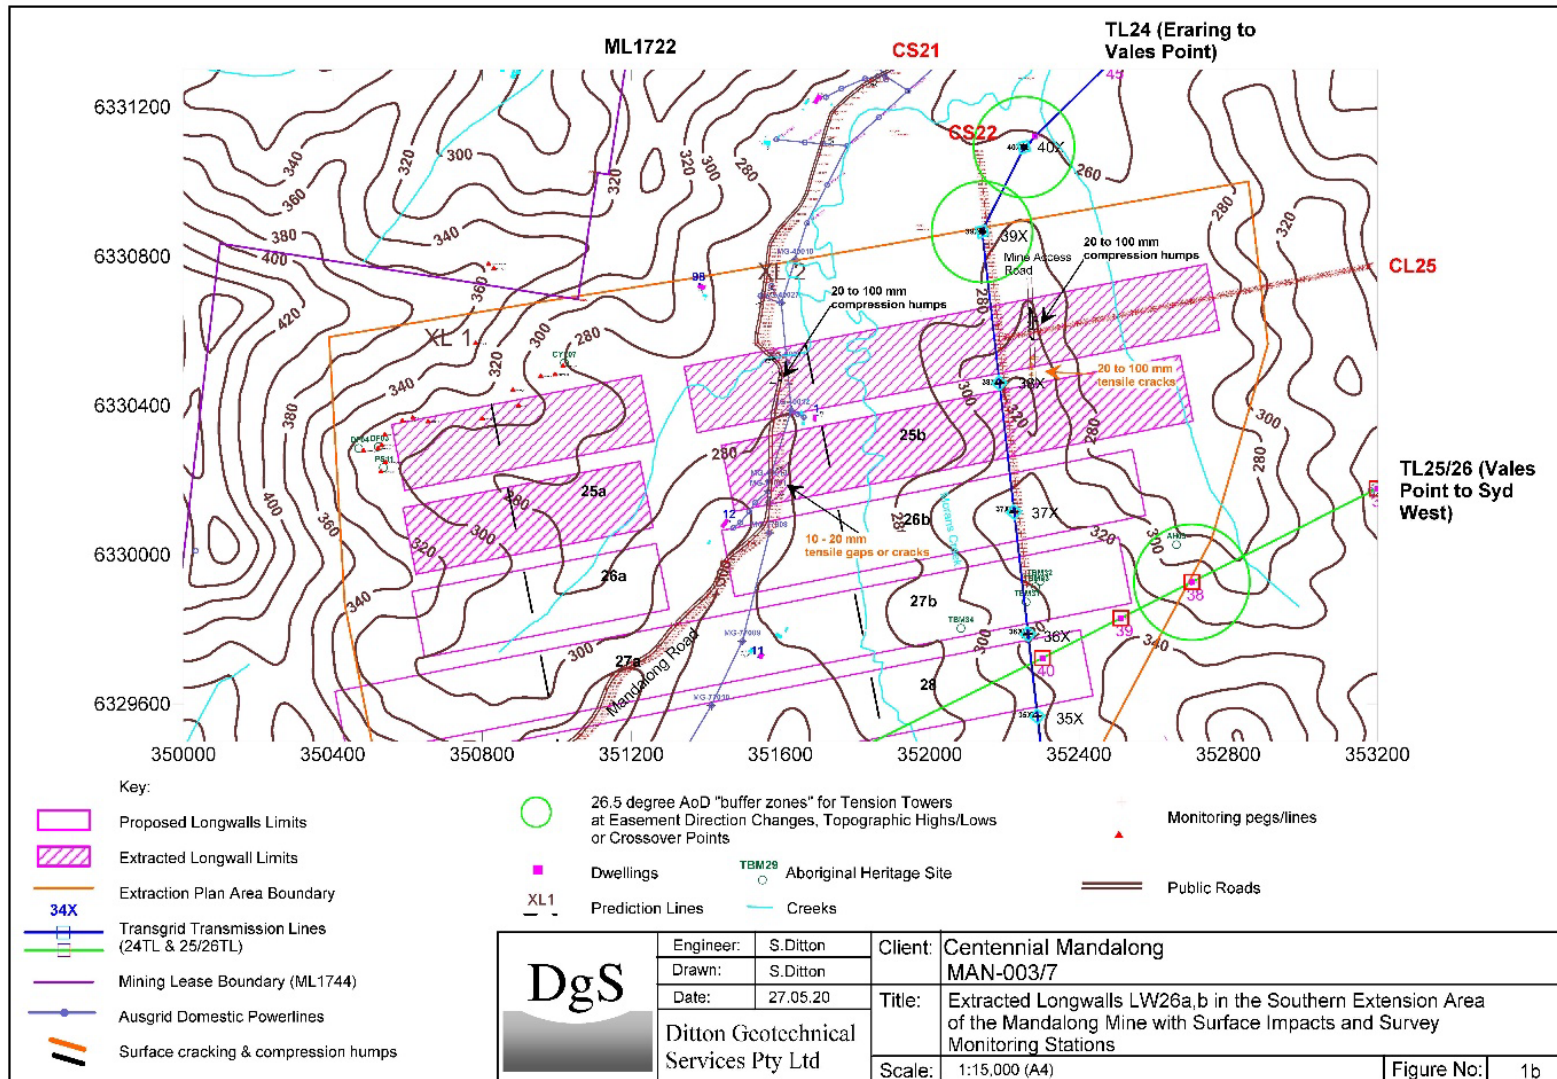
Figure 2 – Extracted Longwall 26 with Subsidence Lines and Depth of Cover

During the retreat and completion of Longwall 26B, subsidence monitoring was conducted along Crossline 21 (Mandalong Rd), Crossline 22 (TL24 transmission line easement), LW25 Centreline, TransGrid Transmission Line No. 24 Towers 38X and 39X and private dwelling. **Figure 2** shows the depth of cover and subsidence monitoring lines surveyed during and after the extraction of Longwall 25B.

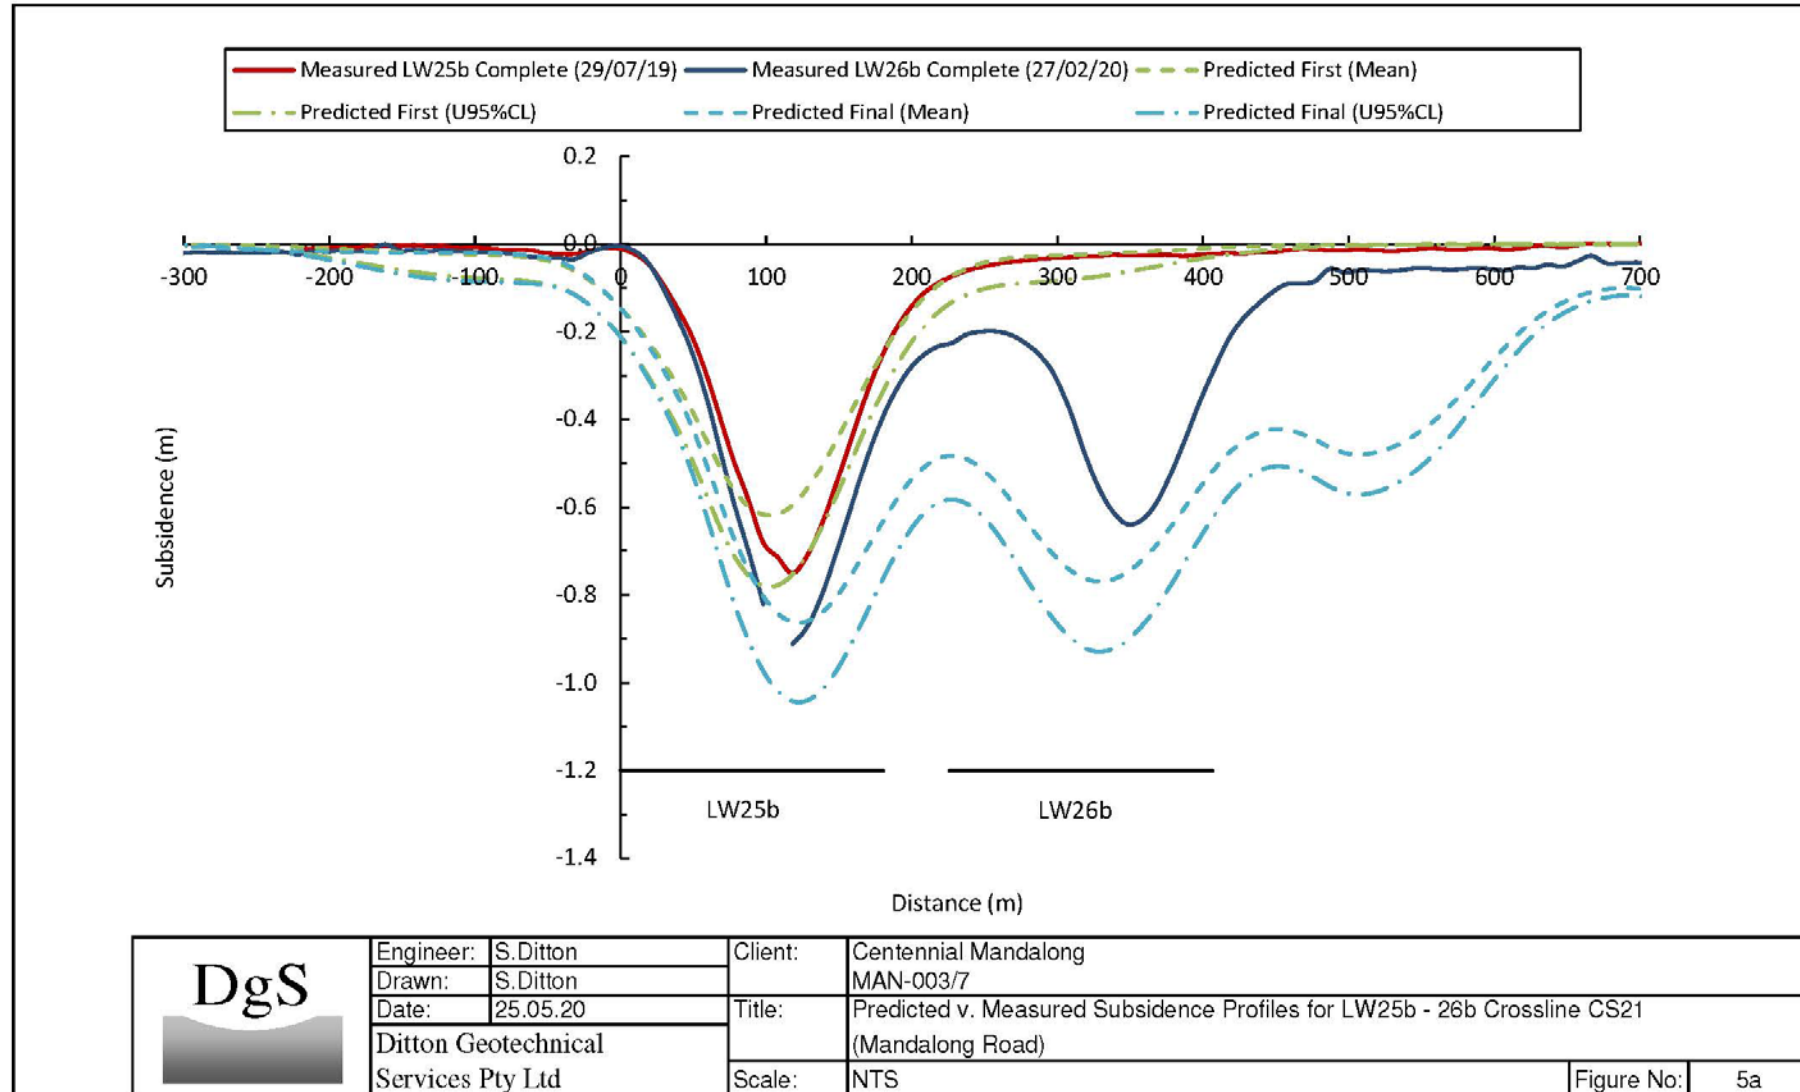
Figure 3 – Predicted v. Measured Vertical Subsidence Crossline 21

Overall, it is concluded the assumed SRP (i.e. Moderate) is still performing reasonably well. It is therefore not considered necessary to adjust the prediction model for subsequent longwalls at this stage. **Figure 3**, **Figure 4** and **Figure 5** show the subsidence profiles for Crossline 21 (Mandalong Road).

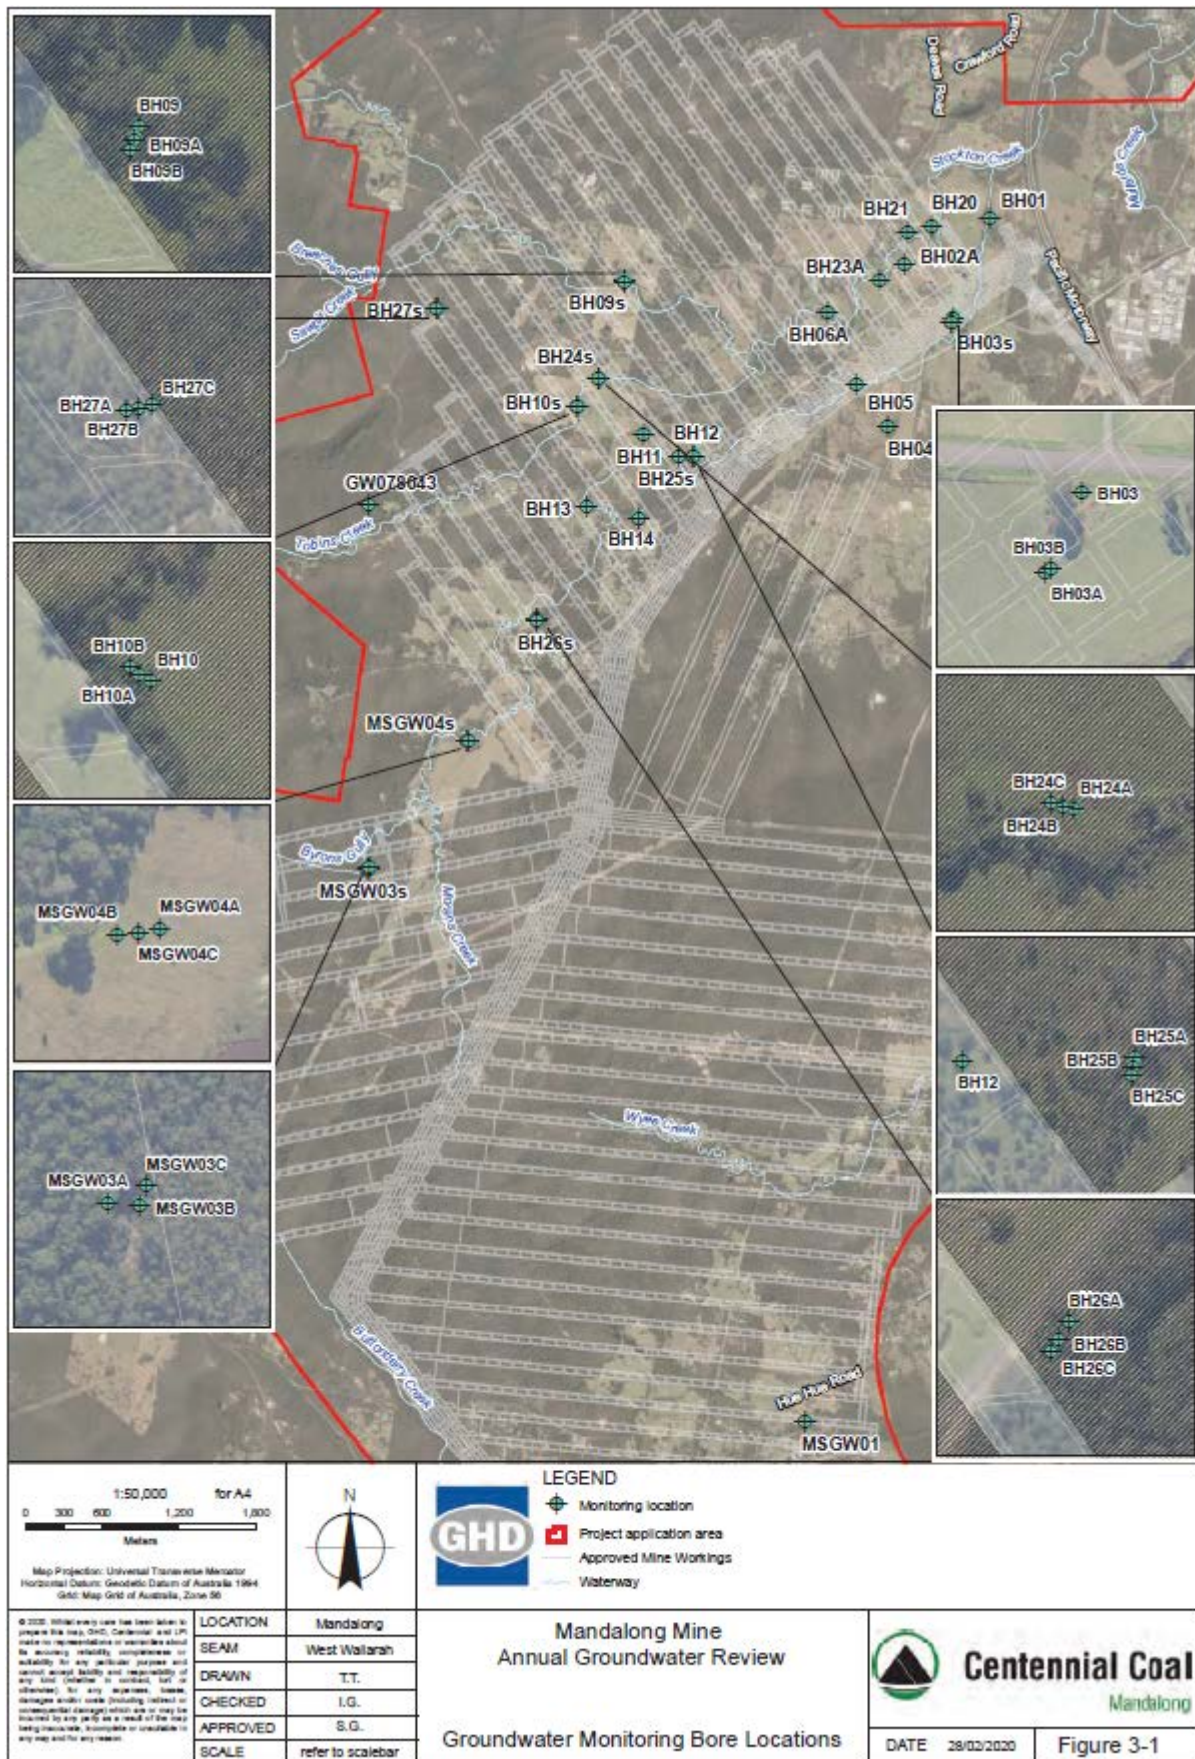
Figure 6 - Groundwater Monitoring Bores and Mine Plan

The current monitoring network consists of 57 bores (refer **Figure 6**); 26 alluvial monitoring bores, 29 overburden monitoring bores and 2 coal seam monitoring bores. The bores consist of 16 nests of 2 or 3 bores monitoring strata at increasing depth at the same site. The bores are monitored every month with the water level, EC and pH being measured.

No exceedances occurred in alluvial bores during 2019. Further, no complaints from adjacent landholders regarding groundwater quality were received in 2019.
