# BENGALLA MINE ANNUAL REVIEW 2024

**BENGALLA MINING COMPANY PTY LIMITED**  
LOCKED BAG 5  
MUSWELLBROOK NSW 2333

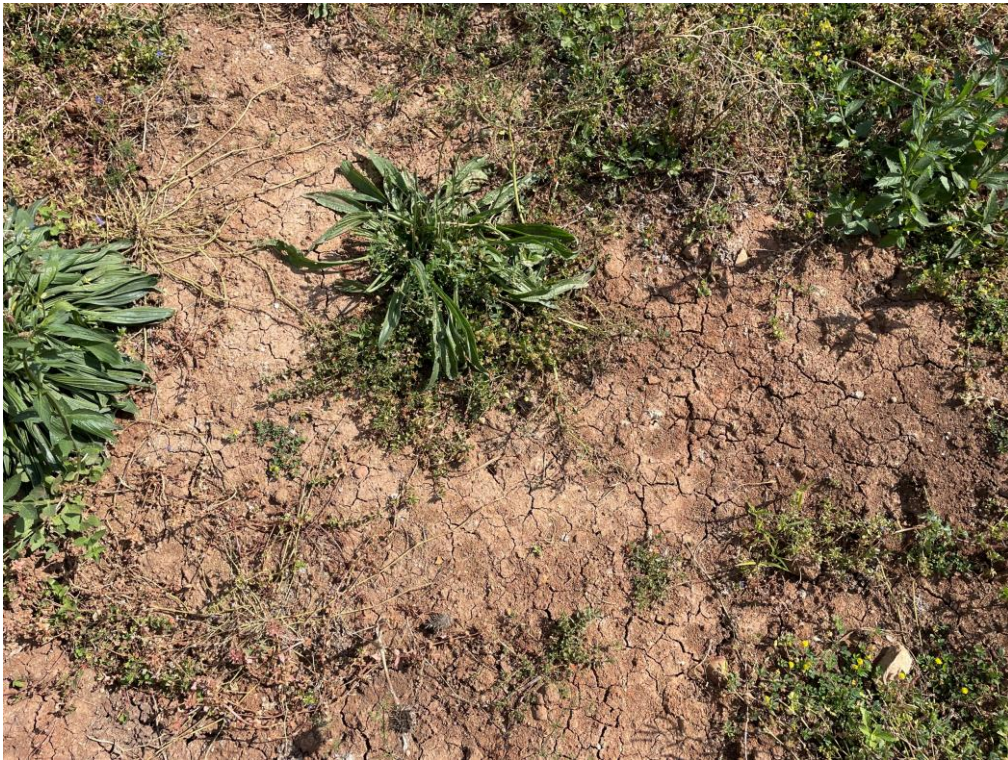
**Photo 1 – Poor ground cover establishment in Zone 8 Class IV/V pasture area**

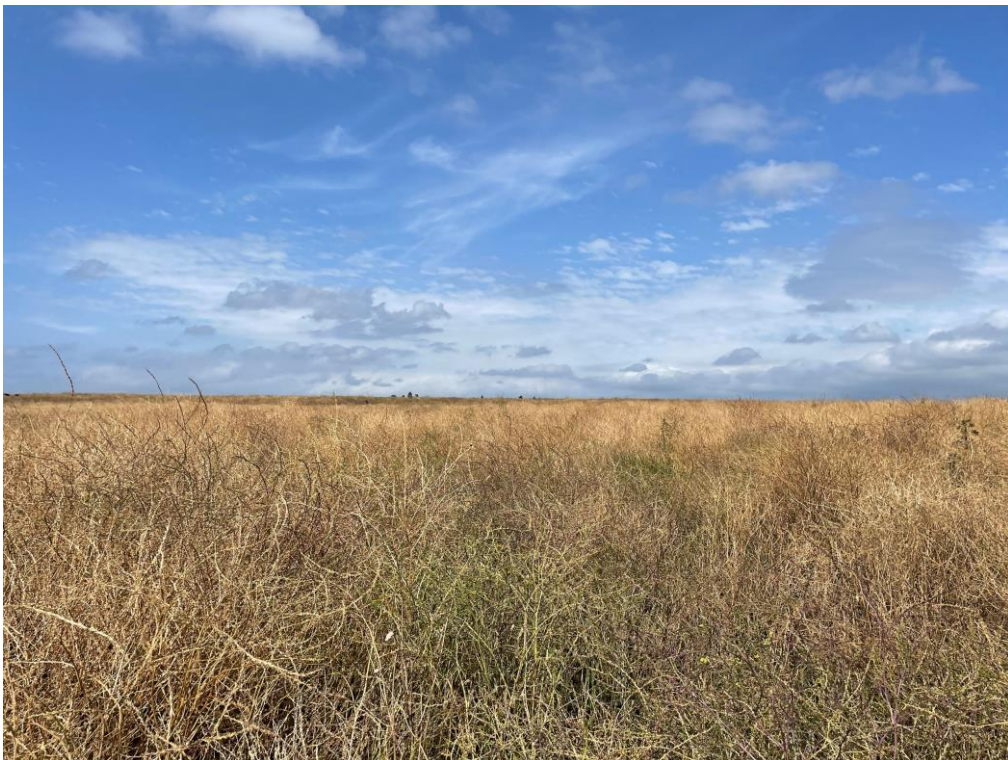
**Photo 2 – Severe Turnip Weed infestations in Zone 8 Class IV/V pasture area**

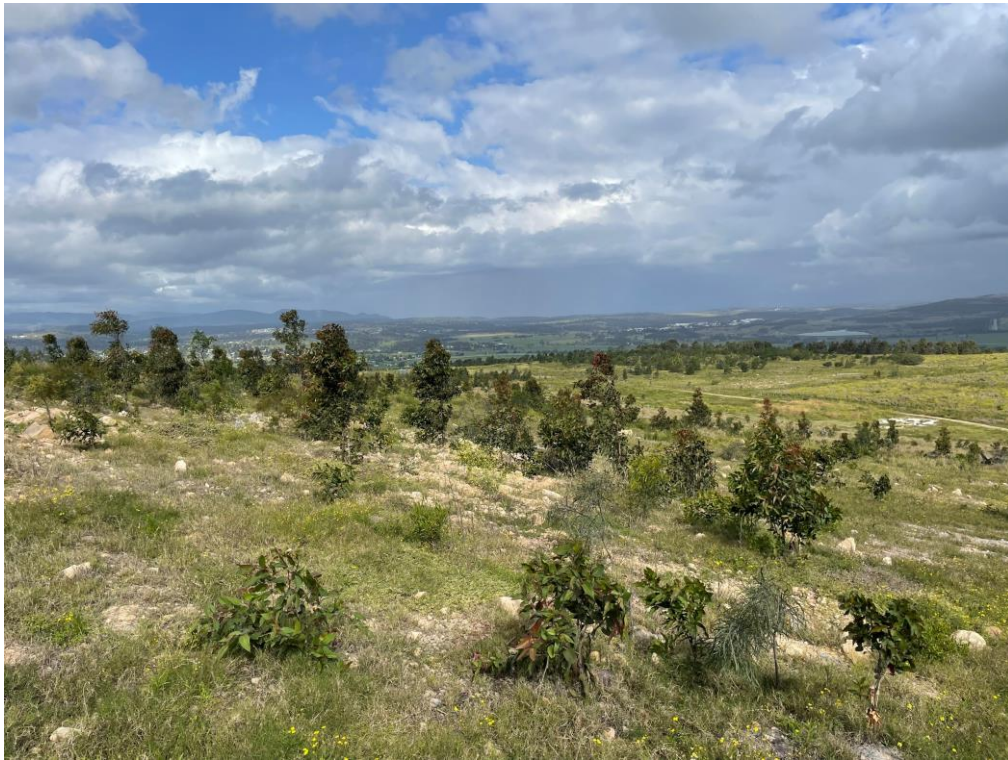
**Photo 3a – Example of good tree establishment in seeded area in Zone 7**

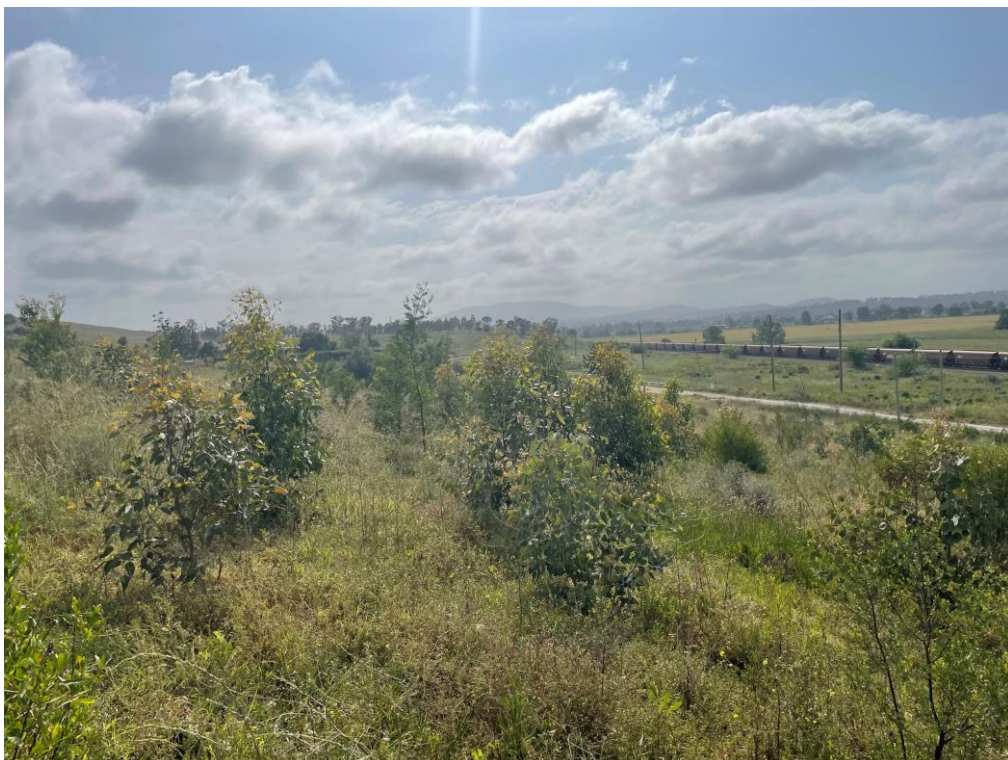
**Photo 3b – Example of good tubestock survival and growth rates in Zone 2**

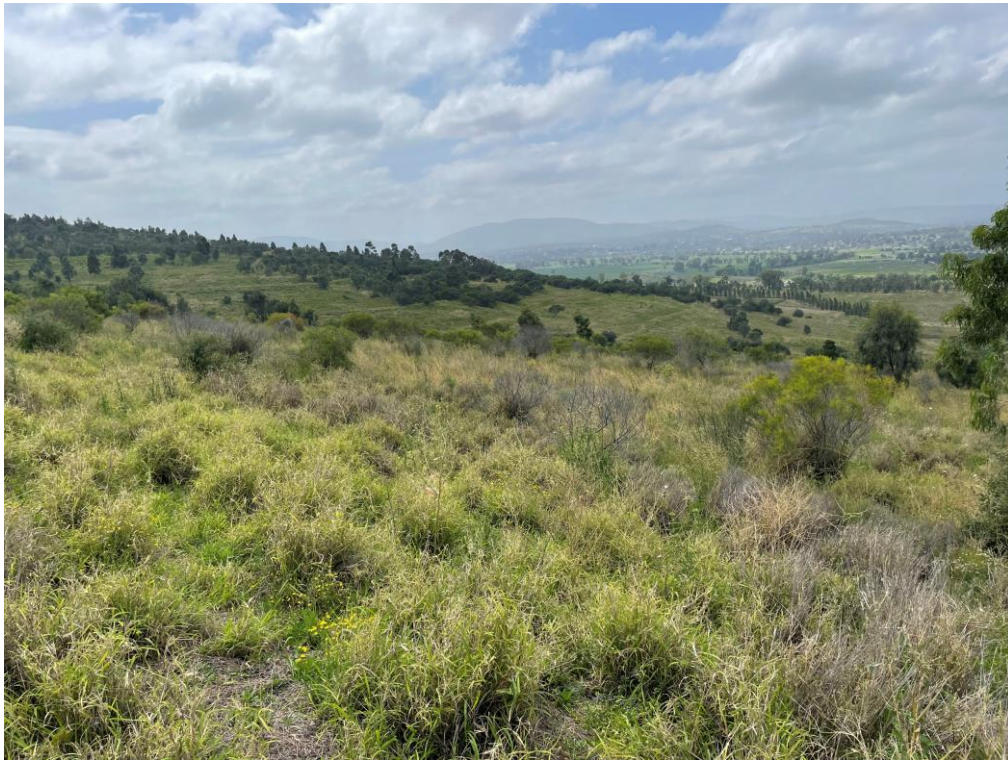
| Category | Details | Photo ref. | Priority |
|---|---|---|---|
| Poor tree establishment | Many areas recently established or re-worked under the FWP showed unsuccessful or insufficient tree establishment at the time of inspection, highlighting potentially ineffective revegetation efforts. Additional revegetation works may be needed if the areas are confirmed as insufficient in the next 1-2 monitoring events. | <b>Photo 4</b> | 3 |

**Photo 4 – Example of unsuccessful tree revegetation in Zone 2**

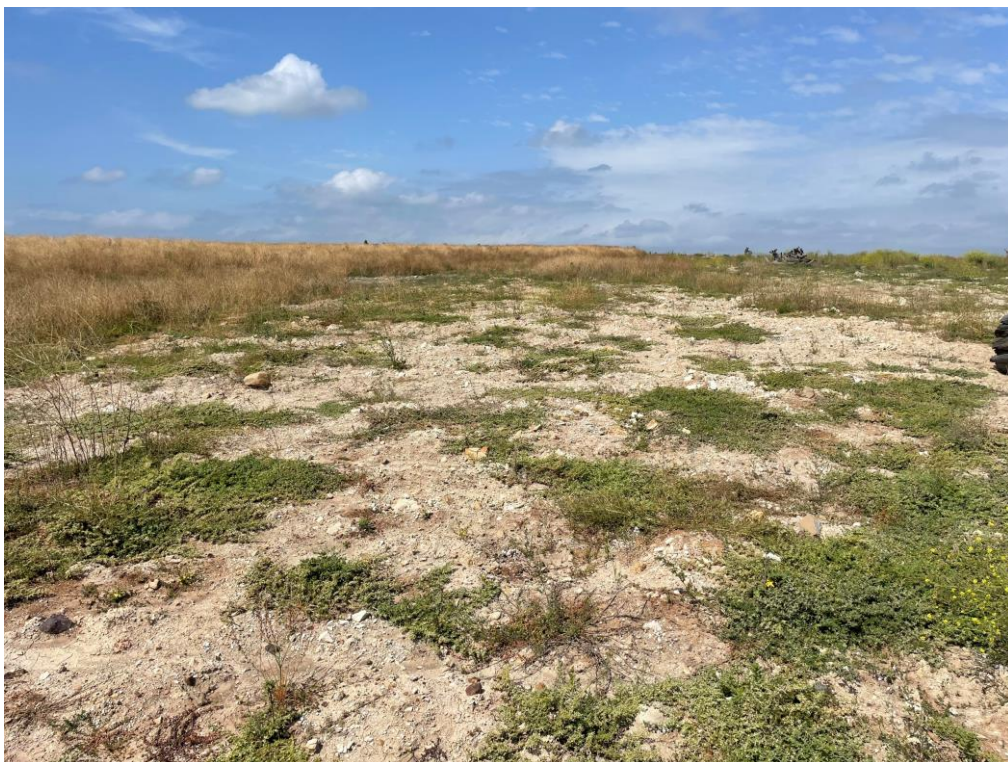
| Category | Details | Photo ref. | Priority |
|---|---|---|---|
| Bare ground | A localised patch of bare ground (~1,200 m <sup>2</sup> ) was noted in Zone 2 on the upper contour near the rock-lined drain. | <b>Photo 5</b> | 2 |

**Photo 5 – Localised bare patch in Zone 2**

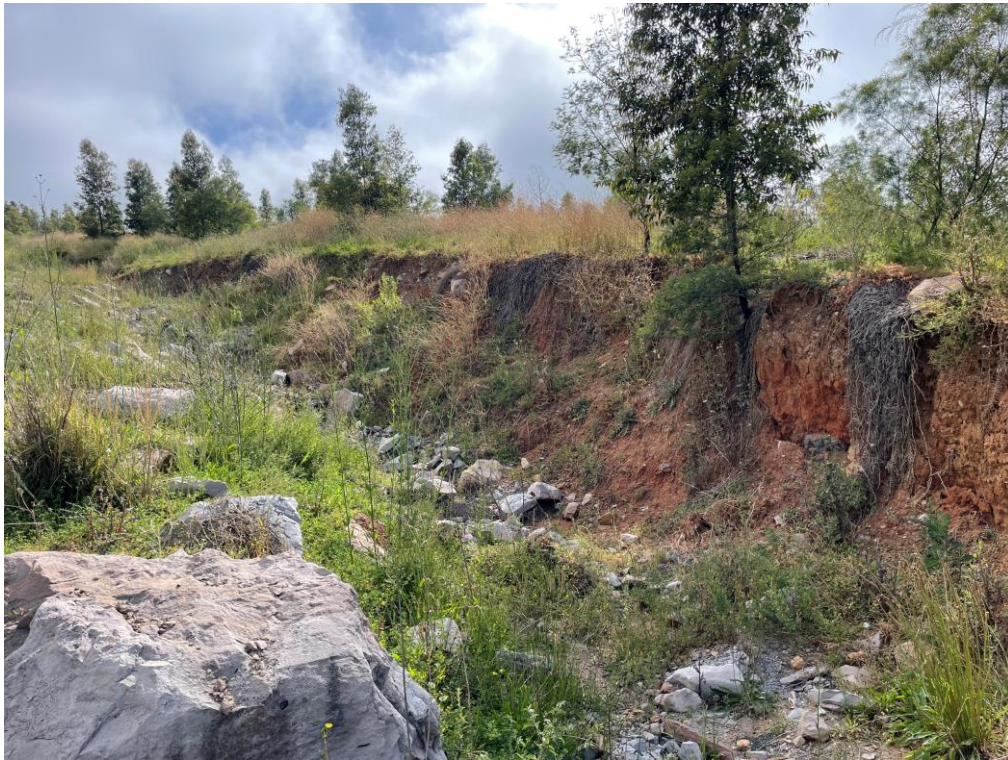
| Category | Details | Photo ref. | Priority |
|---|---|---|---|
| Scour in drainage structure – severe | Very severe scour erosion (to 2.5m deep in places) is impacting the sides of the main rock-lined drainage channel in the area of natural undulating landform in the southern OEA.<br><br>The drain structure is considered as failed and will require significant repairs. | <b>Photo 6</b> | 1 |

**Photo 6 – Severe scour erosion in drain in Zone 6**

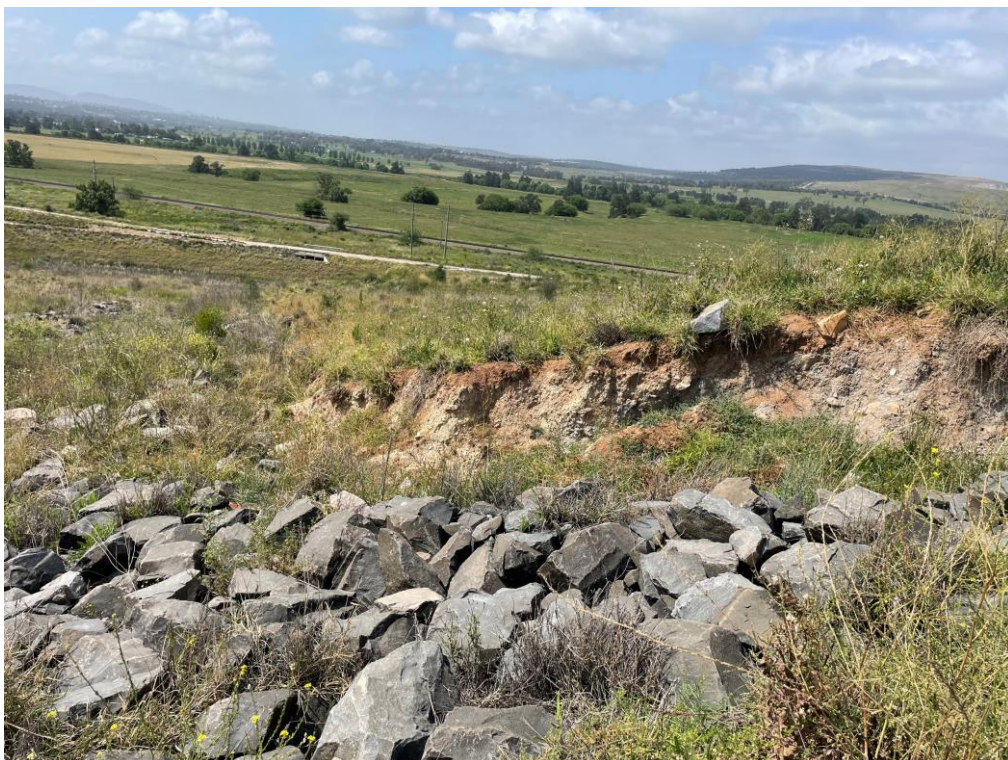
| Category | Details | Photo ref. | Priority |
|---|---|---|---|
| Scour in drainage structure – moderate | Two other locations of scour erosion impacts to rock drains of similar nature but milder severity were recorded including: <ul style="list-style-type: none"> <li>In Zone 6 (southern OEA) with scouring to ~75cm deep; and</li> <li>In Zone 2 (central OEA) with scouring to ~1.2m deep.</li> </ul> | <b>Photo 7</b> | 2 |

**Photo 7 – Moderate scour erosion in drain in Zone 2**

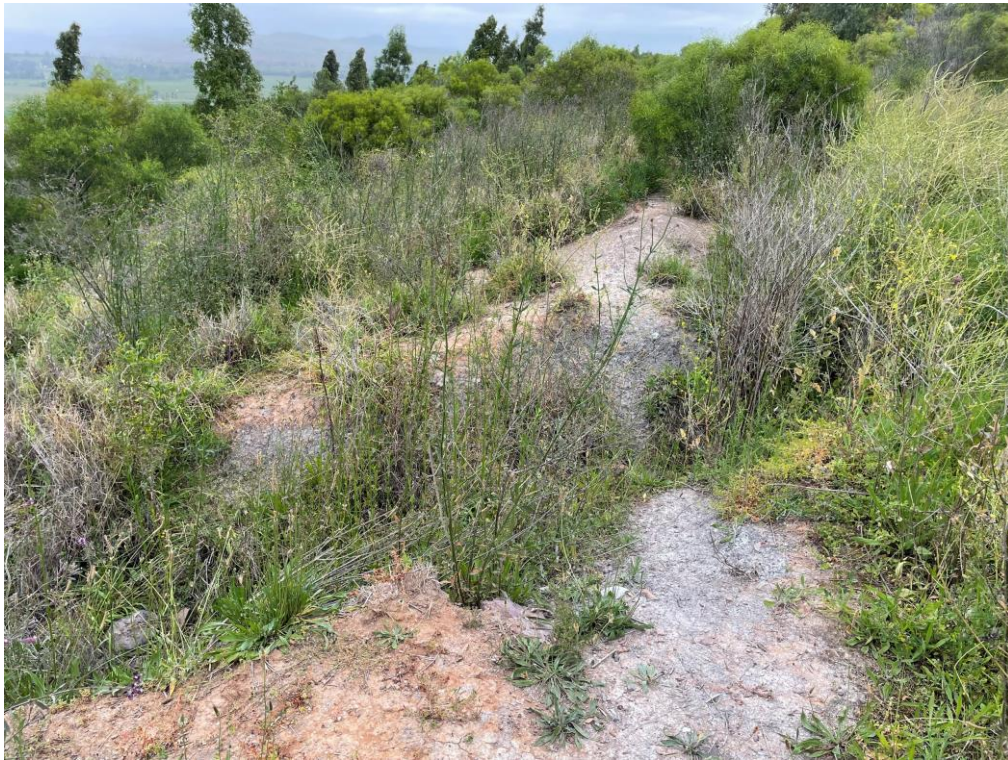
| Drainage structures – good performance | All other inspected drainage structures (contour banks and rock-lined drains) were assessed as stable and well-functioning. | <b>Photo 9</b> | 4 |

**Photo 9 – Example of stable and vegetated drop structure**

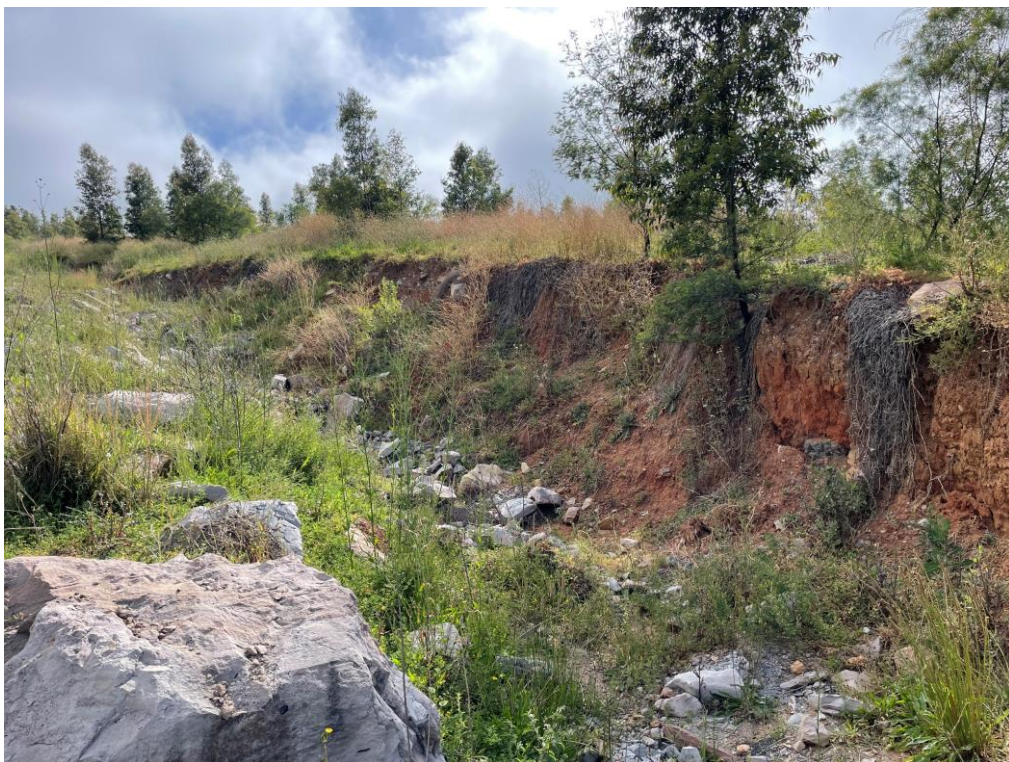
| Gully erosion on slope | Several gully channels were recorded during the inspection, including: <ul style="list-style-type: none"> <li>• 9 x channels of moderate severity 30-50 cm deep; and</li> <li>• 4 x channels of high severity 50-100cm deep.</li> </ul> All gullies of high severity should be repaired. Gullies of moderate severity should be closely monitored and remediation requirements considered on a case-by-case basis, i.e. repairs are unlikely to be justified in the channels fully stabilise in their current condition and are located in areas of good vegetation performance. | <b>Photo 12</b> | 2 |

**Photo 12 – example of gully erosion on slope in Zone 6**

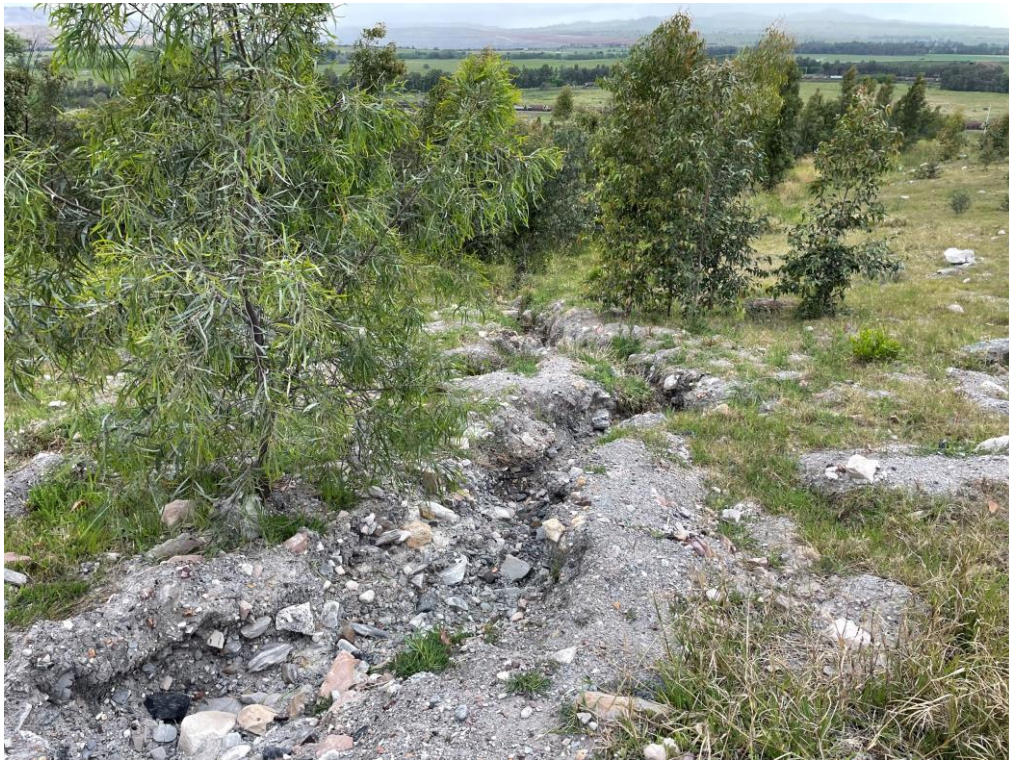
| Rill erosion on slope | Two localised sections of slope in Zone 2 and Zone 7 showed residual impacts from rill erosion processes with several channels defined to ~15-30cm deep. Both areas should be monitored but appeared largely stabilised, i.e. remediation works are unlikely to be needed. | <b>Photo 13</b> | 3 |

**Photo 13 – Example of superficial rill erosion in Zone 2**

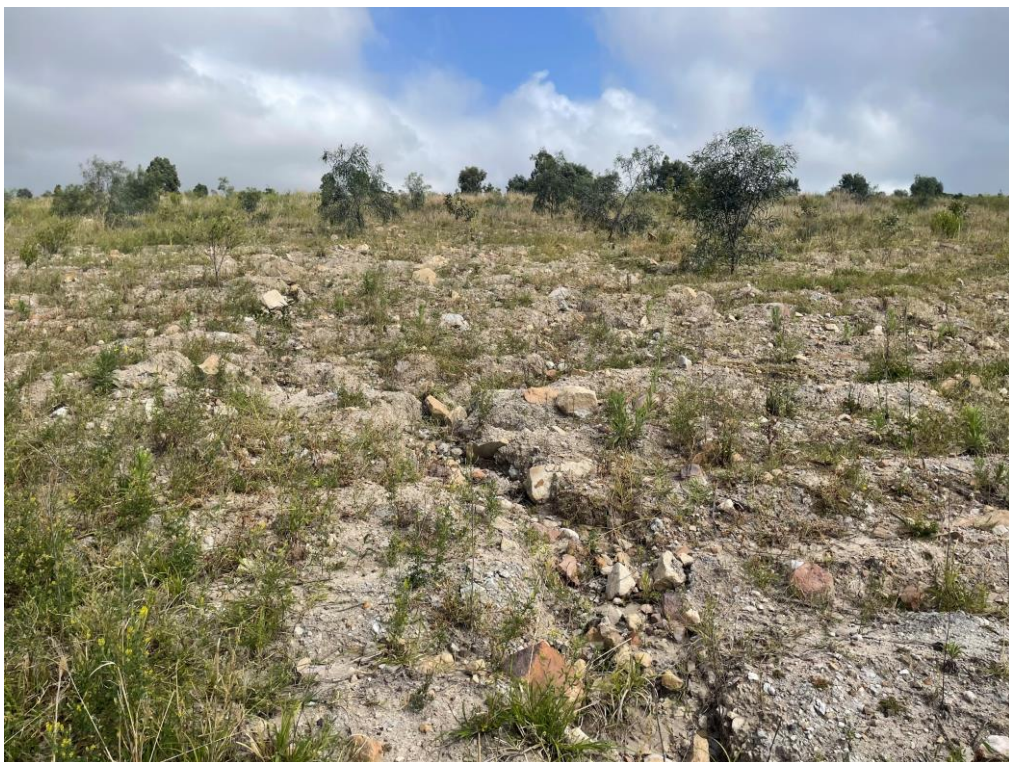
| Headcut erosion | One small (localised) erosion headcut was noted on the eastern slope in Zone 2. The feature is not very severe and currently of minimal concern but should be monitored to ensure it does not expand and develop into a gully. | <b>Photo 14</b> | 3 |

**Photo 14 – Slight head cut erosion in Zone 2 (visibility hindered by thick vegetation)**

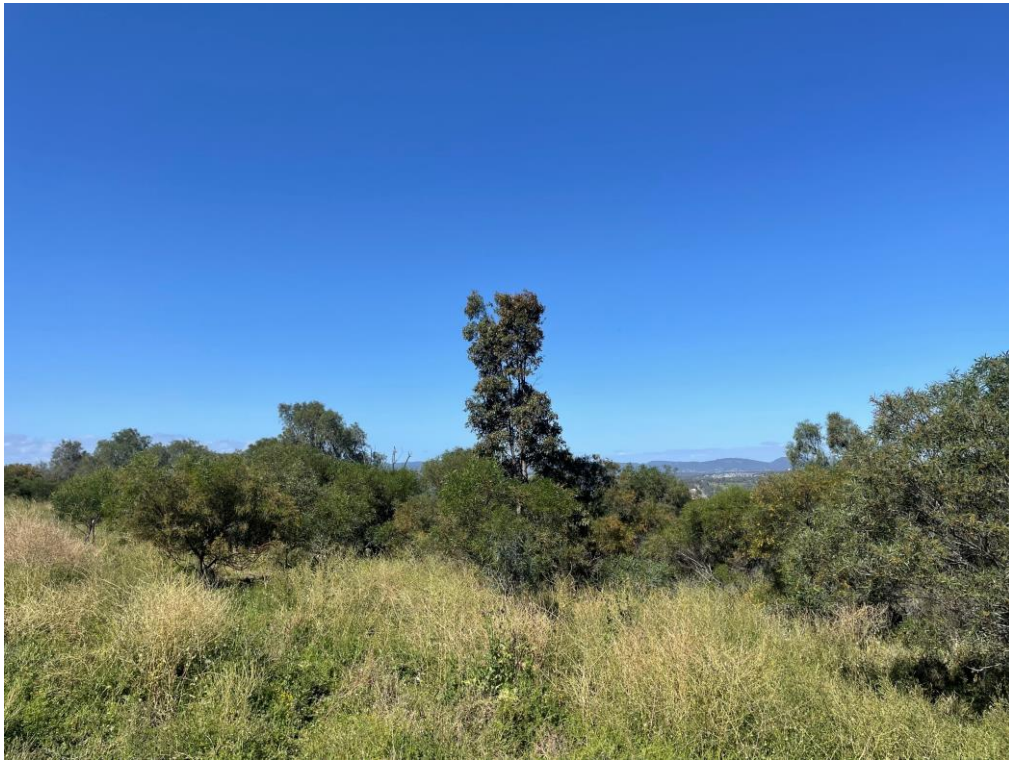
| Weeds – African Boxthorn | The species remains common across the site and keeps establishing from soil-borne seedbank. Localised infestations (particularly on contour banks) and scattered individuals occur throughout. | <b>Photo 17</b> | 2 |

**Photo 17 – High densities of African Boxthorns on contour bank in Zone 2**

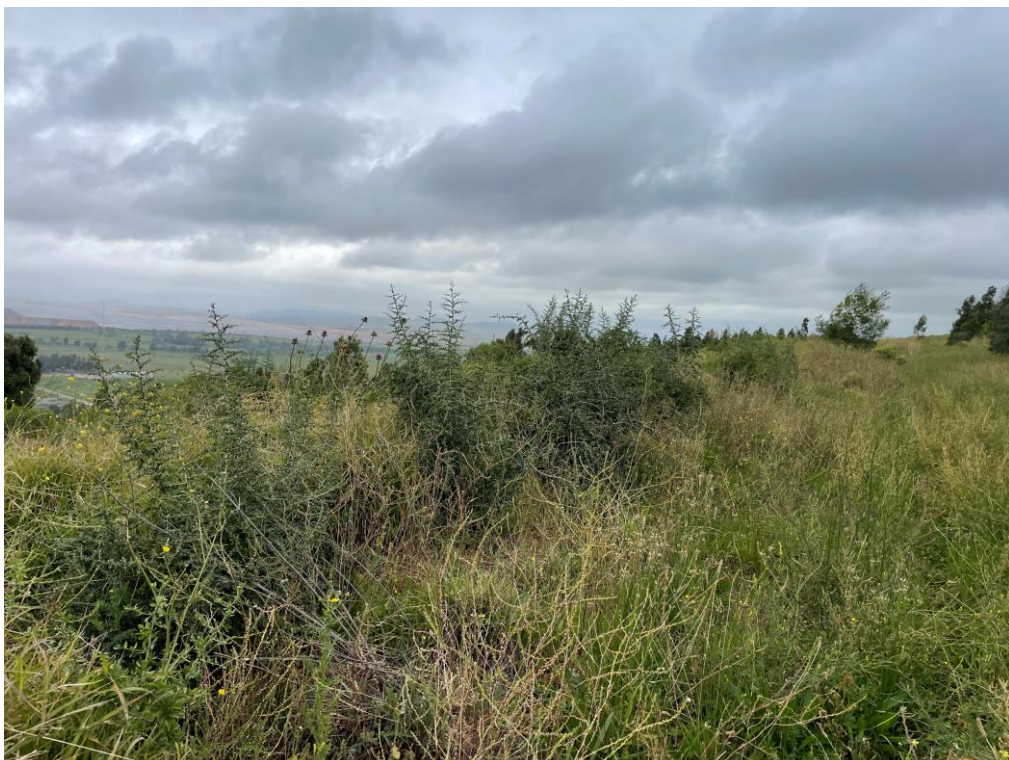
| Weeds – Galenia | <p>Galenia remains prevalent and widely distributed across the entire site, including localised infestations and small patches scattered throughout.</p> <p>The species is known to be problematic at the site and will require ongoing management as part of the routine weed control program.</p> | Photo 18 | 2 |

**Photo 18 – Example of Galenia infestation in Zone 5**

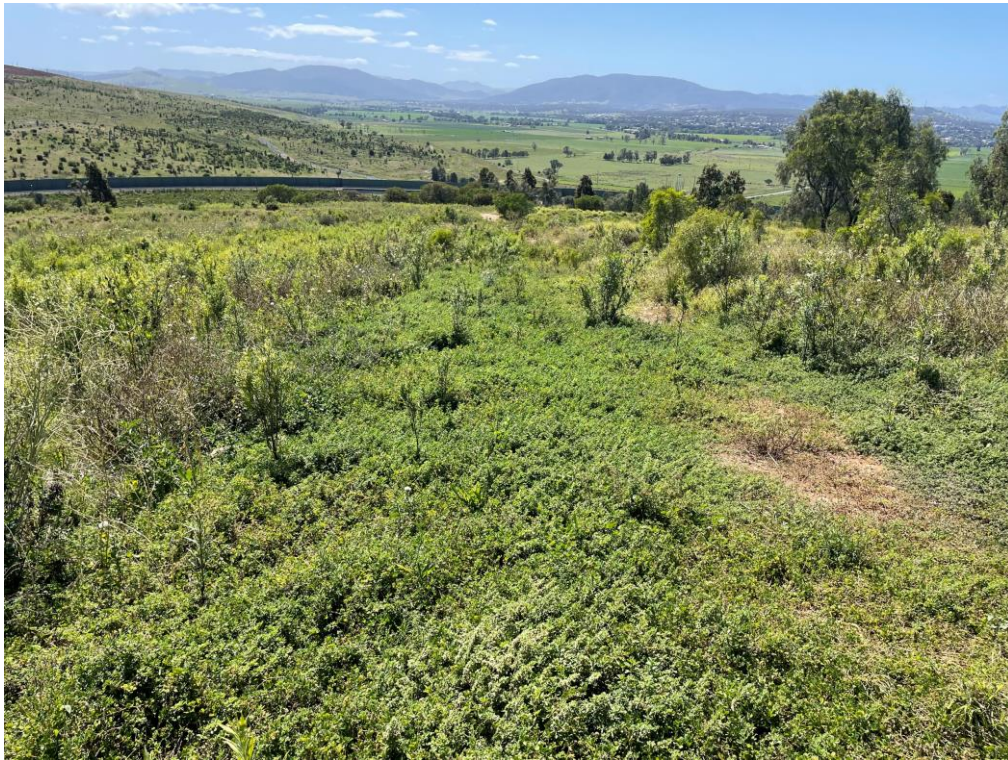
| Weed control – good practice | Some areas were noted with evidence of African Boxthorn control being undertaken. However, control activities appeared relatively haphazard and the treated areas very localised. | Photo 19 | 4 |

**Photo 19 – Localised control of African Boxthorns in Zone X**

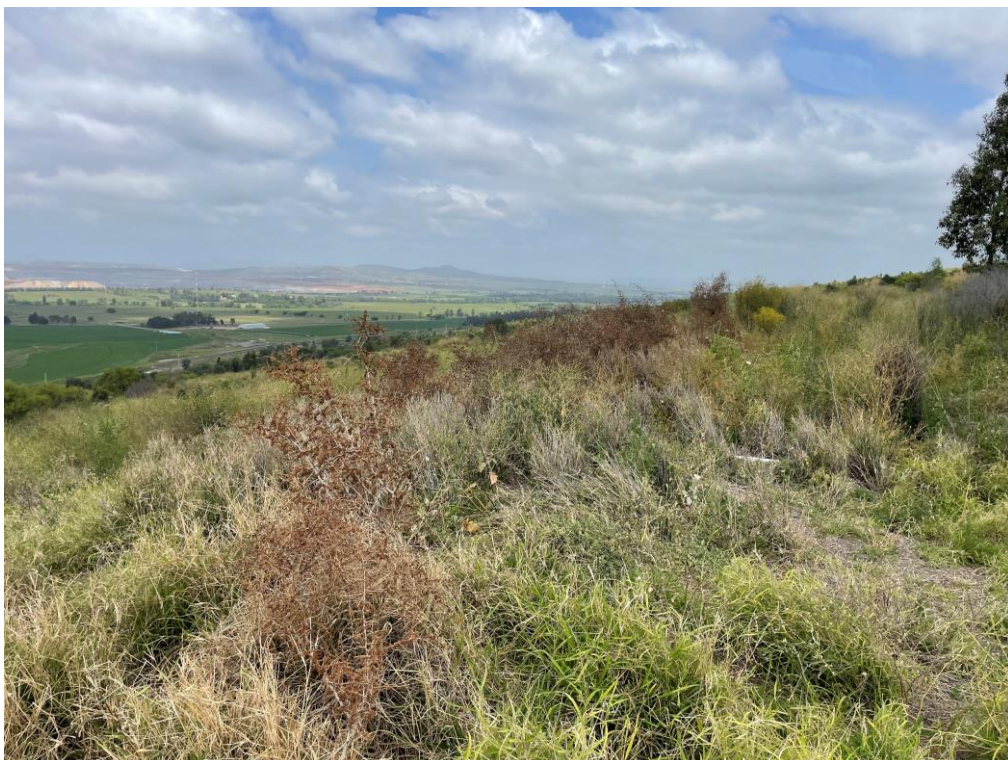
| Animal pests | <p>Rabbits and Feral Pigs were again sighted in the rehabilitation during the 2024 field works.</p> <p>Pig impacts were limited to scattered surface diggings / light soil churning. Although impacts are currently limited in extent and severity, their presence represents a risk to both ecological and pasture rehabilitation and ongoing control should continue.</p> <p>No rabbit warrens or significant soil disturbance from rabbits were detected, however localised impacts on establishing young seedlings were observed (ringbarking / browsing). Rabbits represent a significant threat especially in young rehabilitation or regenerating areas. Population levels at the site are unknown and regular population counts should be considered to understand and track rabbit abundance over time, which in turn would inform the need for management.</p> | Photo 20 | 3 |

**Photo 20 – Examples of impacts from hares on young seedling**
