# Desktop study of Hazardous Materials Surveys to WHS Regulations 2011

### Lismore Base Hospital (Targeted Buildings), Lismore NSW

July 2012

Our Ref: C107305: J111111

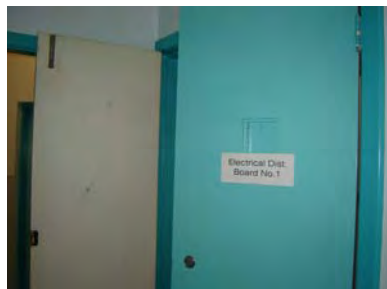
Photo 1. Asbestos containing fire door with exposed core

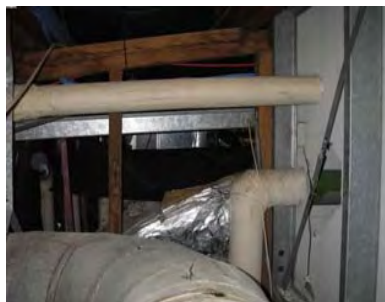
| Action Required | Location | Material | Condition | Works Completed by (Company) | Sign-Off | Date Completed |
|---|---|---|---|---|---|---|
| Removal of asbestos pipe lagging | NB306 Hewitt Block, Dining Room – ceiling space | Pipe Lagging | Poor | | | |
| Removal of asbestos pipe lagging | NB306 Hewitt Block, Air Conditioning Plantroom | Pipe Lagging | Poor | | | |

Photo 1. Asbestos containing pipe lagging within Hewitt Block

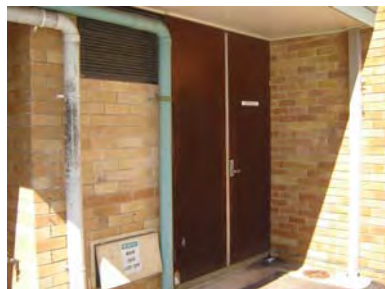
Photo 1. Asbestos containing fire doors at entrance of BB01 Operating Theatres

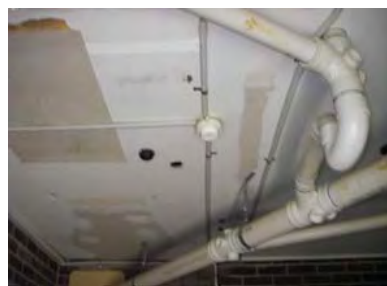
Photo 1. Asbestos soft board ceiling in Main Switchroom

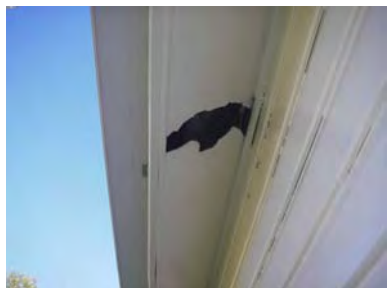
Photo 1. NB8002 Community Health Centre – Eaves

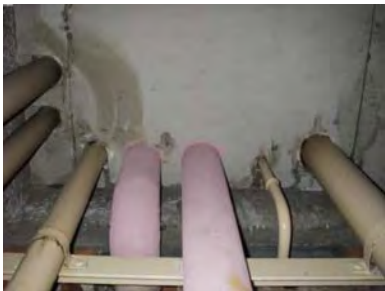
| <br><b>P2<br/>Priority<br/>Risks</b> | Action Required | Location | Material | Condition | Works Completed by (Company) | Sign-Off | Date Completed |
|---|---|---|---|---|---|---|---|
| | Remove damaged ceiling | GBN Accommodation Centre; Level 2, Electrical Cupboard 227 – Ceiling | Asbestos soft board ceiling | Poor | | | |

| Photo 1. GBN Accommodation Centre; Level 2, Electrical Cupboard 227 – Ceiling | Photo 2. GBS Conference Centre; GBS1013 Communication Cupboard, Ceiling joists debris | Photo 3. GBU Workshop and Boiler; Offices into Workshop – Ceiling | Photo 4. GBW West Wing; Level 1, Plantroom T39, South Wall Cavity |

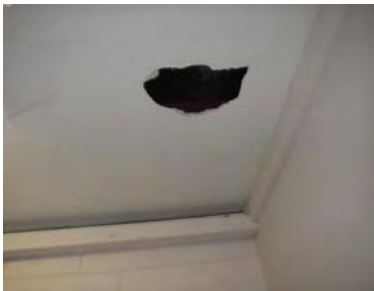
| <br><b>P2<br/>Priority<br/>Risks</b> | Action Required | Location | Material | Condition | Works Completed by (Company) | Sign-Off | Date Completed |
|---|---|---|---|---|---|---|---|
| | Repair damage to ceiling | GBU Workshop and Boiler; Offices into Workshop – Ceiling | Asbestos soft board ceiling | Poor | | | |

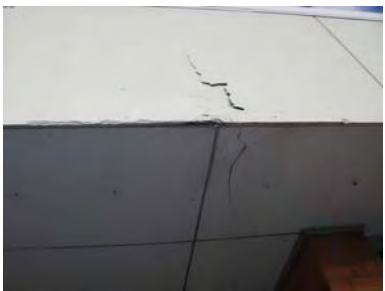
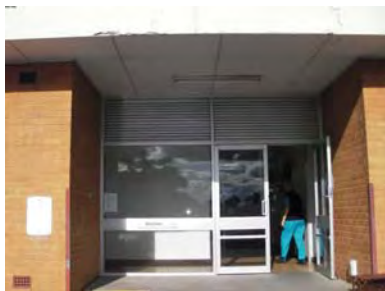
| Action Required | Location | Material | Condition | Works Completed by (Company) | Sign-Off | Date Completed |
|---|---|---|---|---|---|---|
| Repair damaged areas of ceiling | GBK Kitchen; Exterior, Surrounding – Fascia board panelling and canopy ceiling | Flat fibre cement sheet fascia and ceiling | Fair | | | |

| Photo 1. GBK Kitchen; Exterior, Surrounding – Fascia board panelling and canopy ceiling | Photo 2. GBK Kitchen; Exterior, Surrounding – Fascia board panelling and canopy ceiling | Photo 3. GBP Pathology; Electric cupboard – Ceiling |

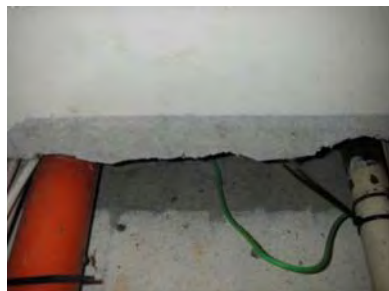
| Action Required | Location | Material | Condition | Works Completed by (Company) | Sign-Off | Date Completed |
|---|---|---|---|---|---|---|
| Remove damaged ceiling | GBP Pathology; Electric cupboard – Ceiling | Flat fibre cement sheet ceiling | Fair | | | |

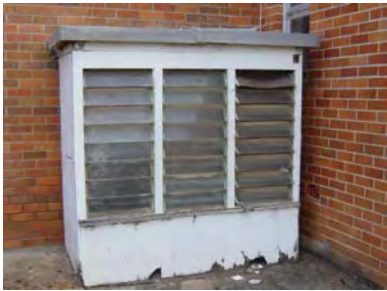
| Action Required | Location | Material | Condition | Works Completed by (Company) | Sign-Off | Date Completed |
|---|---|---|---|---|---|---|
| Remove asbestos cement debris from ground surface and repair damaged sections of wall | CBK013 Laundry, Boiler House, Workshop; Exterior, Small Shed attached to East Wall | Asbestos cement sheet wall and ground surface debris | Fair | | | |

| Photo 1. CBK013 Laundry, Boiler House, Workshop; Exterior, Small Shed attached to East Wall | Photo 2. CBK016 Doctor's Residence; Sub floor, Throughout |

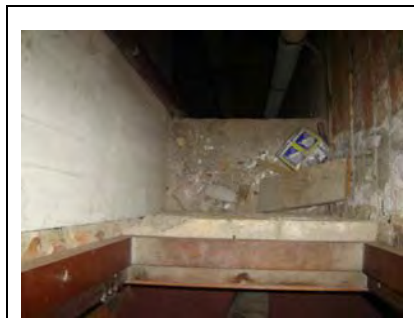
Photo 1. Asbestos containing pipe lagging debris within the pipe riser

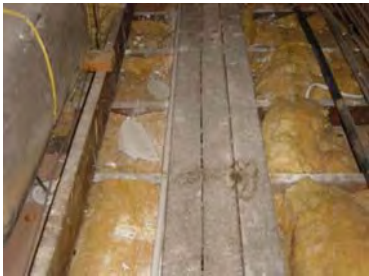
| Photo 1. NB601 Main Building, Health Campus; Level 2, Roof Space Throughout (concentrated beneath SMF lagged pipes) | Photo 2. NB601 Main Building, Health Campus; Ground Level, Hotel Services Coordinator Office, Ceiling Space | Photo 3. NB602 Agnes Grant Centre; Level 2, Service Riser Duct, Wash Room |

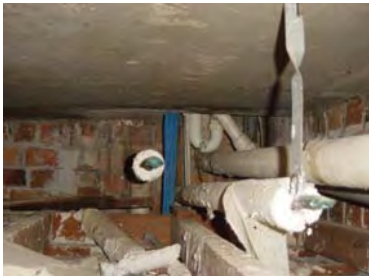
| Action Required | Location | Material | Condition | Works Completed by (Company) | Sign-Off | Date Completed |
|---|---|---|---|---|---|---|
| Remove pipe lagging debris | NB601 Main Building, Health Campus; Ground Level, Hotel Services Coordinator Office, Ceiling Space | Pipe Lagging Debris | Poor | | | |

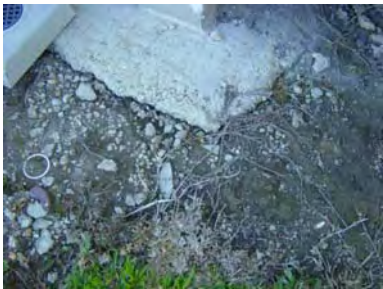
| Photo 1. ECN Early Childhood Nursing; Exterior, Rear of Building and Sub floor area | Photo 2. NB601 Main Building, Health Campus; Subfloor, East Wing below Staff Male Toilets | Photo 3. NB602 Agnes Grant Centre; Subfloor, Beneath Corridor |

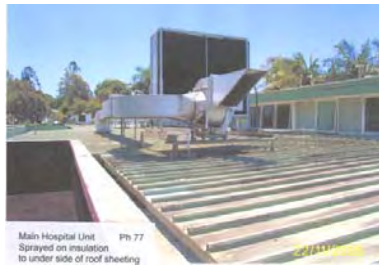
Photo 1. Asbestos sprayed insulation on underside of metal roof, Throughout ceiling space of Main Hospital (MU1)

- ☐ Restrict access to the ceiling spaces of the Main Hospital and the Community Health Centre. If contractors or personnel require access to the ceiling space, ensure the correct Personal Protective Equipment (PPE) is worn such as a P2 disposable half faced mask, disposable coveralls and disposable gloves;

- ☐ Review procedures, policies and management strategies on an annual basis; &
- ☐ Refer to the Emergency Procedures in the NAA's Management Plan if the sprayed asbestos insulation is disturbed.

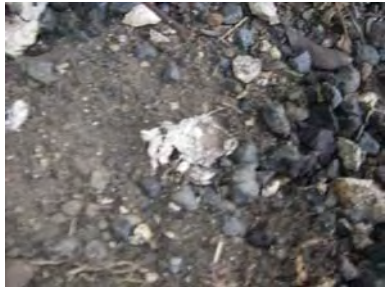
| Action Required | Location | Material | Condition | Works Completed by (Company) | Sign-Off | Date Completed |
|---|---|---|---|---|---|---|
| Removal of pipe lagging and debris | MW02 Main Hospital; Exterior, Pipe Work Duct Across Road to Kitchen | Pipe Lagging and debris | Poor | | | |

Photo 1. MW02 Main Hospital; Exterior, Pipe Work Duct Across Road to Kitchen

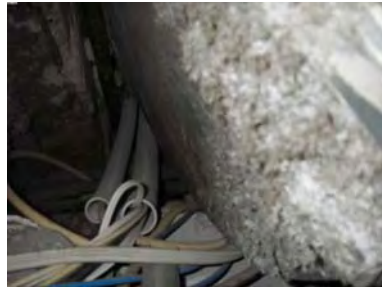
Photo 2. MW02 Main Hospital; Kitchen Lobby, Ceiling Space – Asbestos containing insulation

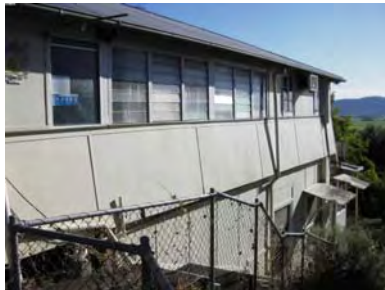
| Action Required | Location | Material | Condition | Works Completed by (Company) | Sign-Off | Date Completed |
|---|---|---|---|---|---|---|
| Repair damaged sections of panels | MW05 Cletus Smith Cottage; Exterior – Wall Panels | Flat fibre-cement sheet panels | Fair | | | |

Photo 1. MW05 Cletus Smith Cottage; Exterior – Wall Panels

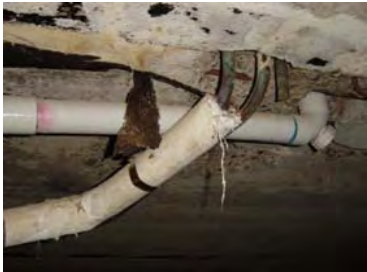
| Photo 1. CBH001 Port Macquarie Health Campus; Lower Ground Level, Throughout Service Tunnels | Photo 2. CBH001 Port Macquarie Health Campus; Ground Level, Rooms 53 and 54, Ceiling Space | Photo 3. CBH001 Port Macquarie Health Campus; Level 1, Unisex Toilets, Ceiling Space, North-east side | Photo 4. CBH001 Port Macquarie Health Campus; Level 3, Roof Space, Throughout |

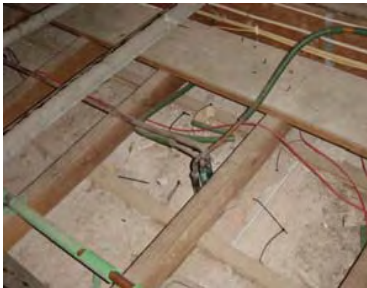
| Photo 1. CBH003 McLaren Building; Roof Space, West Section | Photo 2. CBH019 Kawara Cottage; Rear Shed, Exterior Walls |

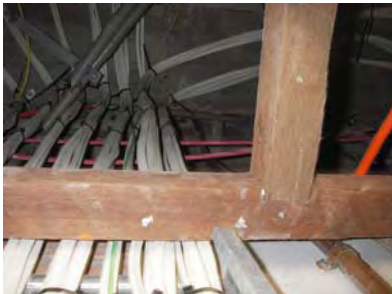
| Photo 1. TH02 Main Block; Level 3, Electrical Riser Cupboard (Physiotherapy) | Photo 2. TH02 Main Block; Level 2, Electrical Riser Cupboard (Community Health) |

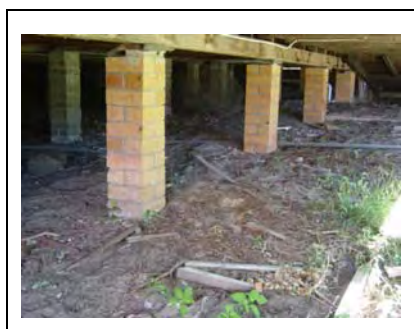
Photo 1. Urunga Community Seaboard Centre – Sub Floor Area

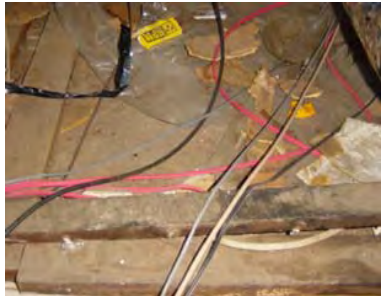
| <p>Photo 1. CBW001 Main Building; Ceiling Space, South-east area</p> | <p>Photo 2. CBW001 Main Building; Ceiling Space, South-east, Packing Material under Re-heat Unit</p> | <p>Photo 3. CBW001 Main Building; Sub floor area, Throughout</p> | <p>Photo 4. CBW001 Main Building; Exterior, West wall cladding</p> |

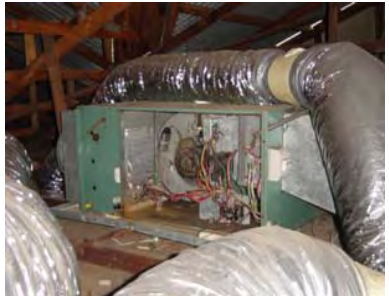
| | Action Required | Location | Material | Condition | Works Completed by (Company) | Sign-Off | Date Completed |
|---|---|---|---|---|---|---|---|
| | Remove fragments from beneath Re-heat Unit | CBW001 Main Building; Ceiling Space, South-east, Packing Material under Re-heat Unit | Fibre-cement sheet fragments | Fair | | | |

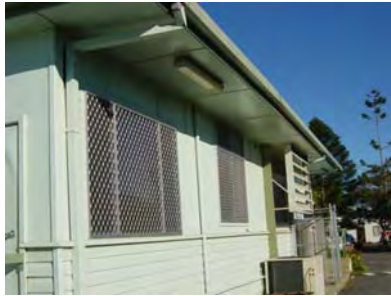
| | Action Required | Location | Material | Condition | Works Completed by (Company) | Sign-Off | Date Completed |
|---|---|---|---|---|---|---|---|
| | Repair exposed areas of sheeting | CBW001 Main Building; Exterior, West wall cladding | Flat fibre-cement sheeting | Fair | | | |
