Non-Destructive Hazardous Materials (HAZMAT) Assessment

28 – 32 Bourke Road, Alexandria, NSW 2015

EP2460.001_v1 | 22 December 2021

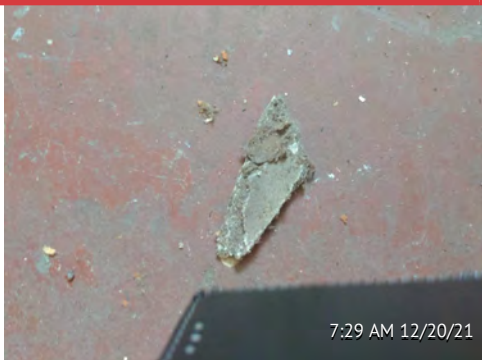
Assigned To West Warehouse, West Office Enclosed Western Alleyway, West Wall, EDB Fuses.

Assumed asbestos containing.

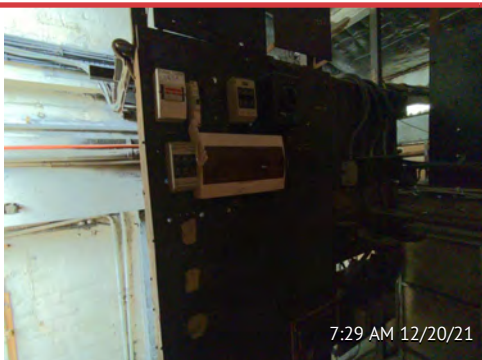
Assigned To West Warehouse, West West Office Enclosed Western Alleyway Mezzanine, Central Location, EDB, Resinous Board.

Assumed asbestos containing.

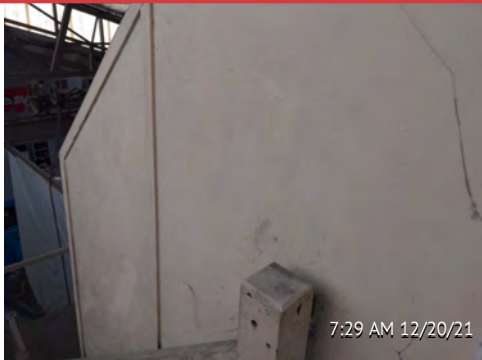
Assigned To West Warehouse, West Warehouse, South Mezzanine, Above Entry Door, Infill Panel Fibre Cement Sheeting.

Assumed asbestos containing.

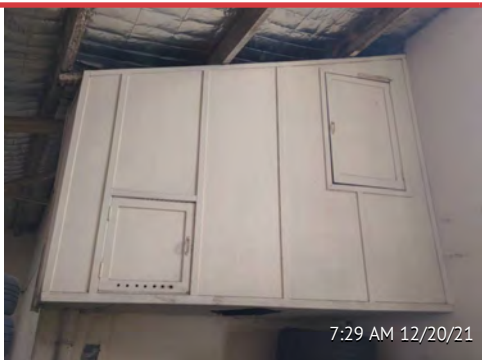
Assigned To West Warehouse, South Mezzanine, Main Room, Walls, Wall Lining, Fibre Cement Sheeting.

Assumed to containing asbestos.

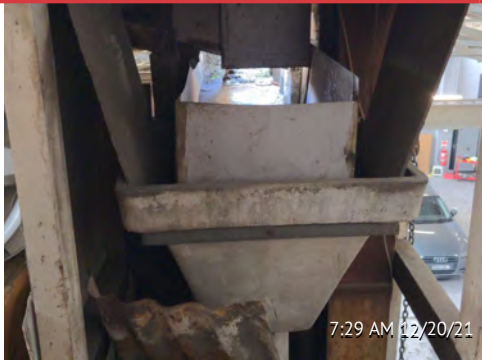
Assigned To West Warehouse, South Mezzanine, Main Room, West Wall, Downpipe And Gutter Box, Moulded Fibre Cement.

EP2640.003_ASB.005: Chrysotile and amosite asbestos detected.

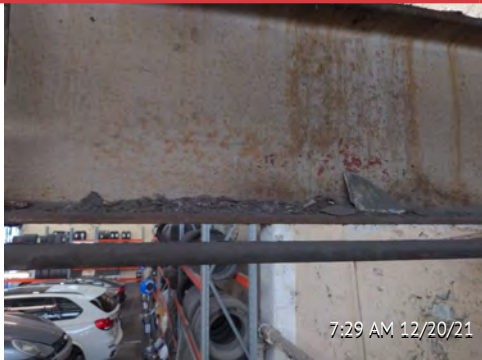
Assigned To Central Mezzanine, Wall Lining, Fibre Cement Sheeting.

EP2640.003_ASB.006: Chrysotile and amosite Asbestos detected.

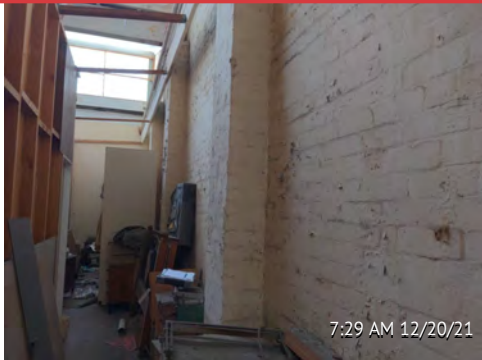
Assigned To West Warehouse, West Office Building, North Office Storage Room, Walls Throughout, White Paint.

EP2640.003_LCP.005: Lead containing paint.

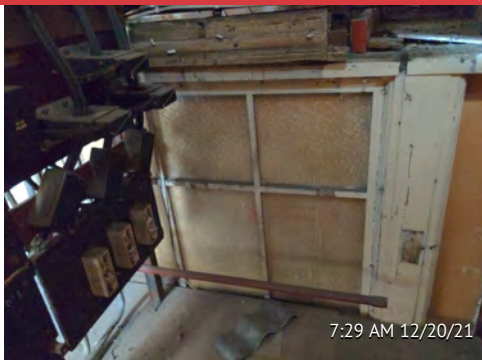
Assigned To West Warehouse, West Office, Enclosed Western Alleyway, Walls, Beige Paint.

EP2640.003_LCP.006: Lead containing paint.

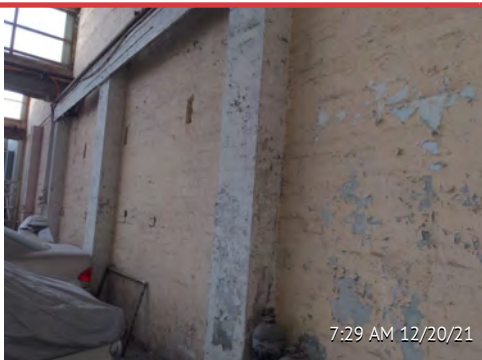
Assigned To West Warehouse, West Office, Enclosed Western Alleyway Mezzanine, North Wall, Redundant Window, Beige Paint.

Assumed lead containing paint.

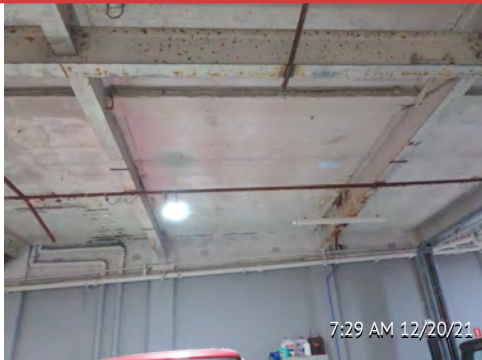
Assigned To West Warehouse, Throughout, Walls, White Paint.

EP2640.003_LCP.010: Lead containing paint.

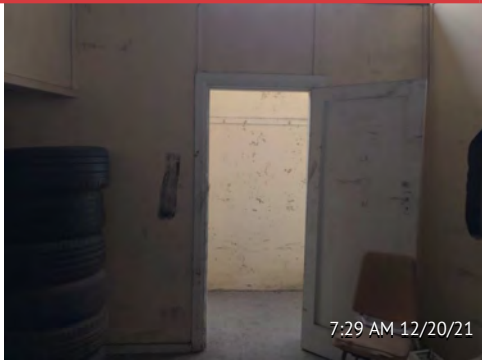
Assigned To West Warehouse, South Mezzanine Showers, Walls, Beige Paint.

Assumed lead containing paint.

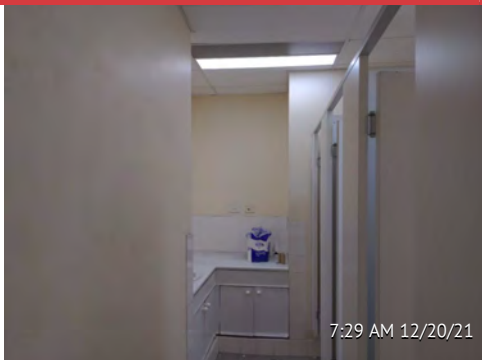
Assigned To West Warehouse, South Mezzanine Main Room, Walls, Beige Paint.

Assumed lead containing paint.

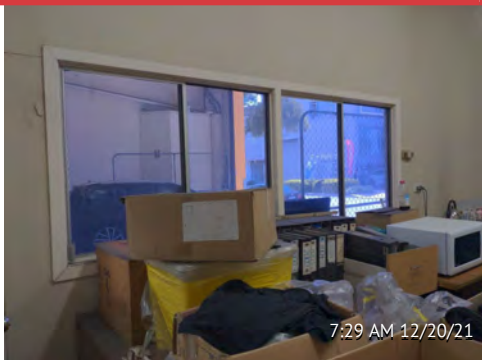
Assigned To West Warehouse, Central Mezzanine, Walls, Beige Paint

Assumed lead containing paint.

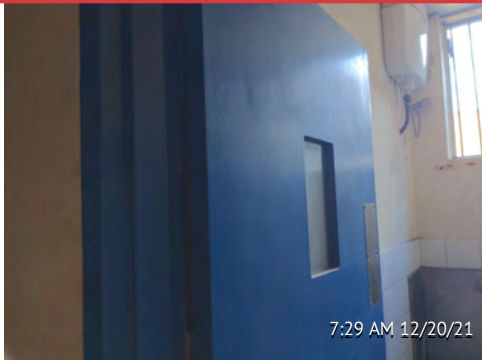
Assigned To East Warehouse, Male Bathroom Hallway,
Door And Door Frame, Blue Paint.

Assumed lead containing paint.

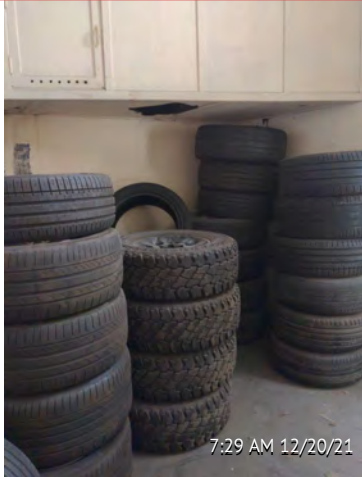
PHOTO 53

Assigned To West Warehouse, West Office Enclosed Western Alleyway Mezzanine, Floor, Accumulated Dust
Lead containing dust.

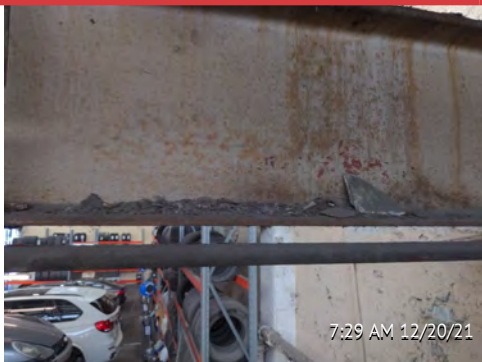
Assigned To Central Mezzanine, Wall Lining, Fibre Cement Sheeting.

EP2640.003_ASB.006: Chrysotile and amosite Asbestos detected.

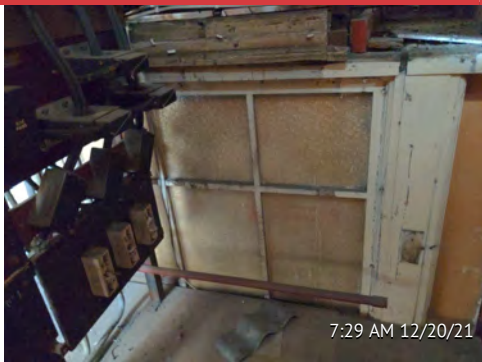
Assigned To West Warehouse, West Office, Enclosed Western Alleyway, Walls, Beige Paint.

EP2640.003_LCP.006: Lead containing paint.

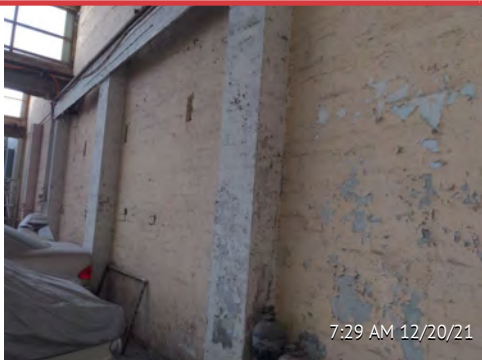
Assigned To West Warehouse, West Office, Enclosed Western Alleyway Mezzanine, North Wall, Redundant Window, Beige Paint.

Assumed lead containing paint.

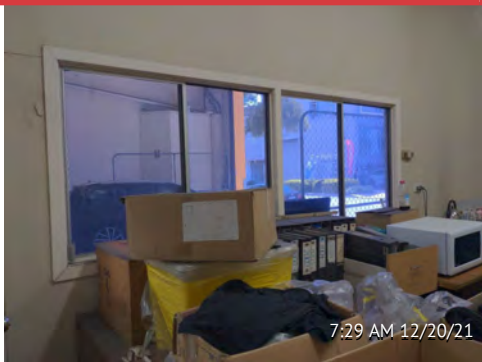
Assigned To West Warehouse, Central Mezzanine, Walls, Beige Paint

Assumed lead containing paint.

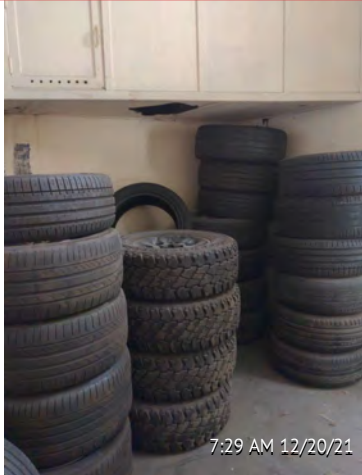
PHOTO 53

Assigned To West Warehouse, West Office Enclosed Western Alleyway Mezzanine, Floor, Accumulated Dust
Lead containing dust.

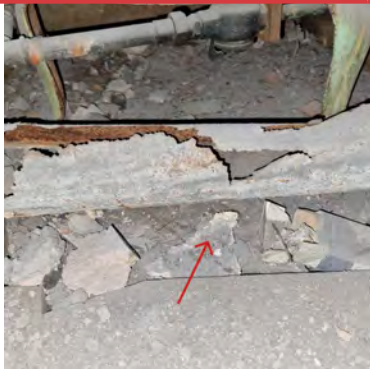
PHOTO 62

Sample ID: EP3072.001_ASB.001

Interior west warehouse, south mezzanine, main room, southeast wall, cupboard, adjacent to hot water heater - fibre cement sheeting fragment.

Chrysotile asbestos detected.

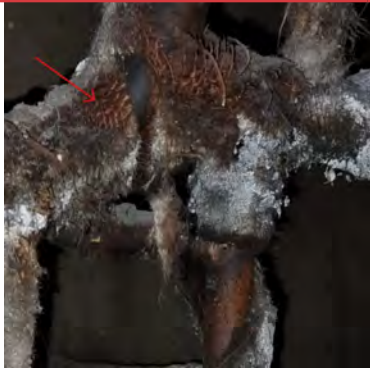
PHOTO 63

Sample ID: EP3072.001_ASB.002

Interior west warehouse, south mezzanine, main room, southeast wall, cupboard, to hot water heater pipework - hessian wrap.

Chrysotile asbestos detected.

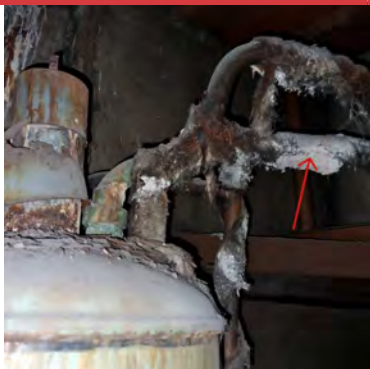
PHOTO 64

Sample ID: EP3072.001_ASB.003

Interior west warehouse, south mezzanine, main room, southeast wall, cupboard, to hot water heater pipework - lagging.

Chrysotile asbestos detected.

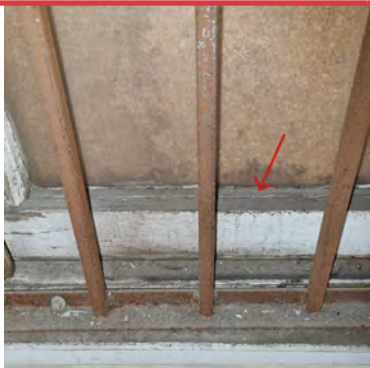
PHOTO 65

Sample ID: EP3072.001_ASB.004

Interior west warehouse, south mezzanine, main room, timber windows - window caulking.

No asbestos detected.

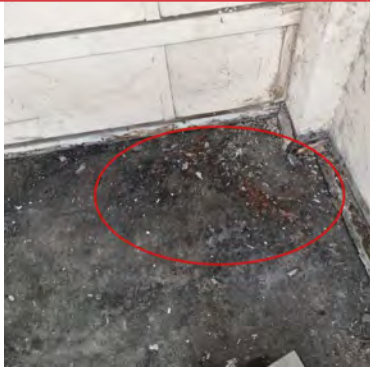
PHOTO 66

Sample ID: EP3072.001_ASB.005

Interior west warehouse, south mezzanine, main room, on floor, adjacent to door to enclosed balcony area - suspected fire damaged debris.

No asbestos detected.

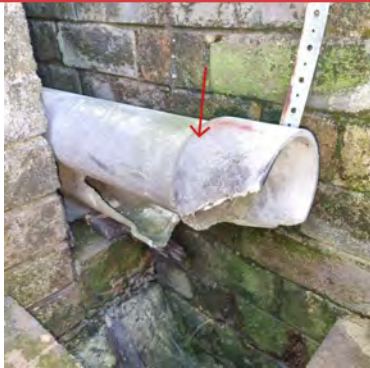
PHOTO 67

Sample ID: EP3072.001_ASB.009

Exterior east warehouse, courtyard, northeastern corner, redundant downpipes - moulded fibre cement conduits.

Chrysotile and amosite asbestos detected.

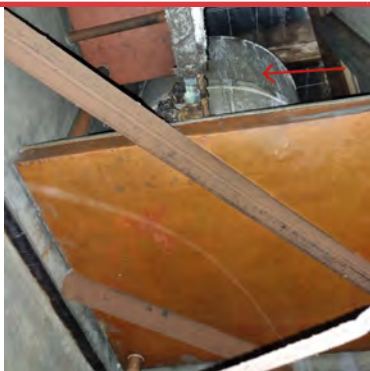
PHOTO 68

Interior west warehouse, south mezzanine, southeast wall, cupboard to hot water tank - hot water tank.

Not sampled due to access restrictions.

Suspected to contain asbestos.

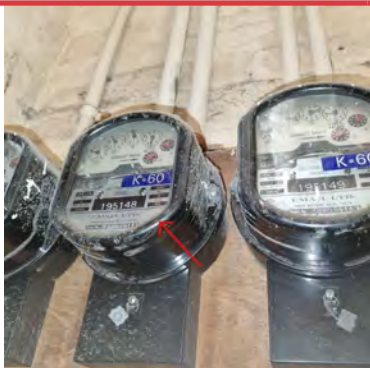
PHOTO 69

Interior west warehouse, west office building, enclosed western alleyway, west wall, EDB, EMAIL meters - window mastic.

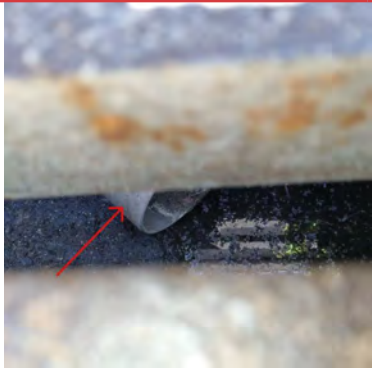
PHOTO 71

Exterior east warehouse, courtyard, stormwater drains, moulded fibre cement conduits

Not sampled due to access restrictions.

Suspected to contain asbestos.

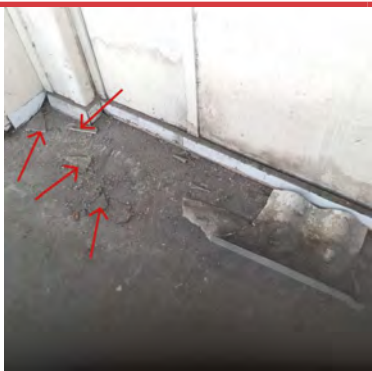
PHOTO 72

Interior west warehouse, south mezzanine, main room, on floor - fibre cement sheeting fragments.

Not sampled due to appearance.

Suspected to contain asbestos.

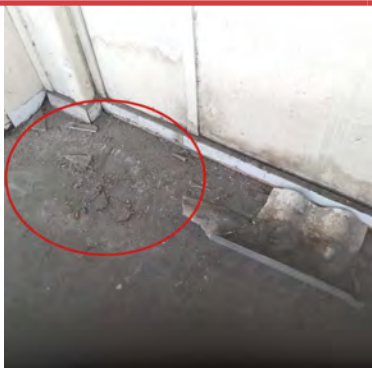
PHOTO 73

Sample ID: [EP3072.001_ASB.006](#)

Interior west warehouse, south mezzanine, main room, on floor, adjacent to fibre cement sheeting fragments - asbestos containing dust.

Chrysotile asbestos detected.

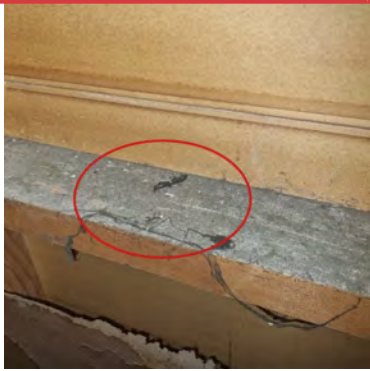
PHOTO 74

Sample ID: EP3072.001_ASB.007

Interior west warehouse, west office building, enclosed western alleyway, to exposed timber wall studs - asbestos containing dust.

Chrysotile asbestos detected.

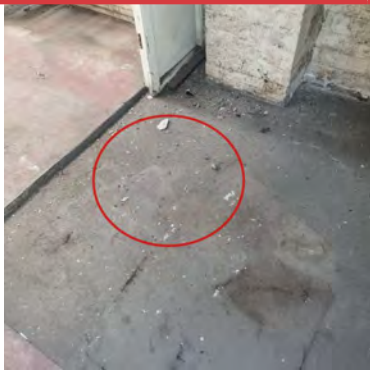
PHOTO 75

Sample ID: EP3072.001_ASB.008

Interior west warehouse, west office, enclosed western alleyway, below mezzanine, on floor adjacent to fibre cement sheeting fragments - asbestos containing dust.

Chrysotile asbestos detected.

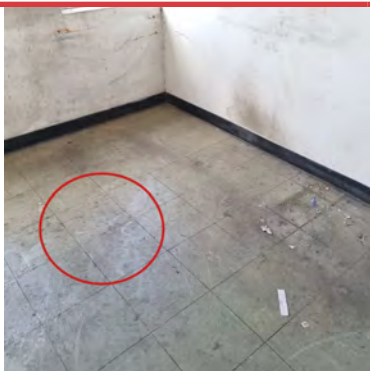
PHOTO 76

Sample ID: EP3072.001_ASB.010

Interior east warehouse, southeast mezzanine, lunchroom, on floor - asbestos containing dust.

Chrysotile asbestos detected.

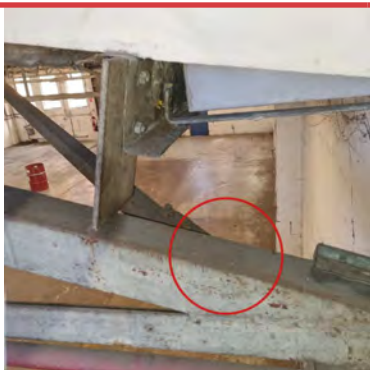
PHOTO 77

Sample ID: EP3072.001_ASB.011

Interior east warehouse, southeast mezzanine, north of stairway - asbestos containing dust.

Chrysotile and amosite asbestos detected.

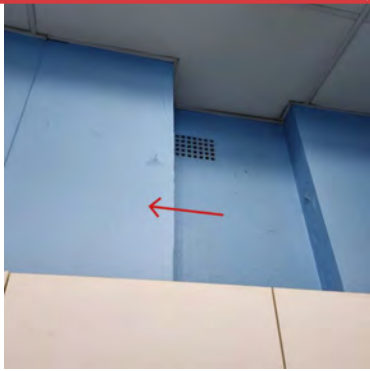
PHOTO 78

Sample ID: EP3072.001_LCP.001

Interior west warehouse, west office building, kitchen, walls (upper layer) - blue paint.

Lead-containing paint (13%w/w)

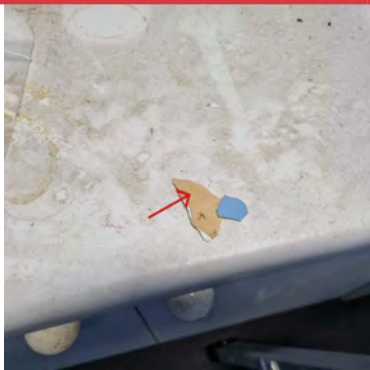
PHOTO 79

Sample ID: EP3072.001_LCP.002

Interior west warehouse, west office building, kitchen, walls (lower layer) - cream paint.

Lead-containing paint (14%w/w)

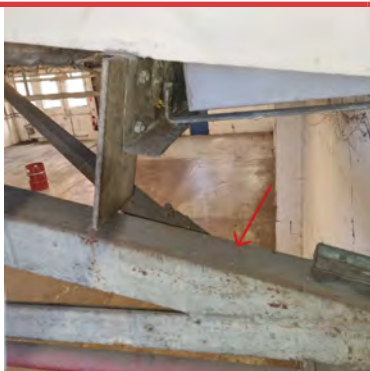
PHOTO 80

Sample ID: EP3072.001_LCP.003

Interior east warehouse, southeast mezzanine, metal beams - light green paint.

Lead-containing paint (19%w/w)

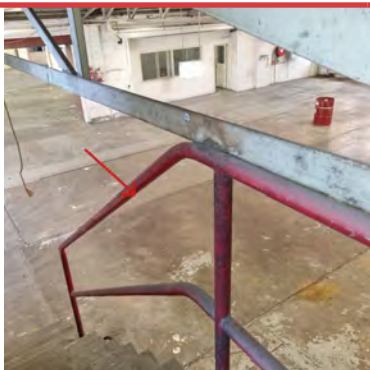
PHOTO 81

Sample ID: EP3072.001_LCP.004

Interior east warehouse, southeast mezzanine, stairway railing - red paint.

Insufficient sample - suspected lead-containing paint.

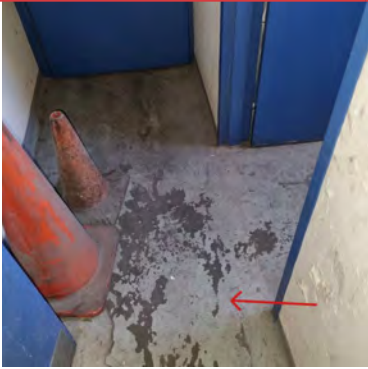
PHOTO 82

Sample ID: EP3072.001_LCP.005

Interior east warehouse, male bathrooms below southeast mezzanine, floor - grey paint.

Lead-containing paint (0.33%w/w)

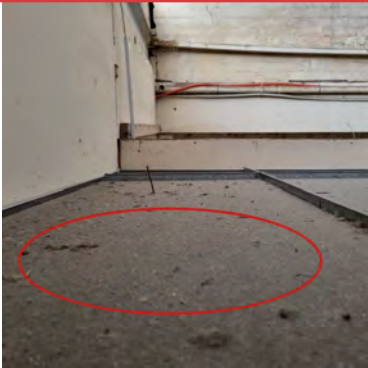
PHOTO 83

Sample ID: EP3072.001_LCD.001

Interior west warehouse, throughout, ceiling space - lead-containing dust.

Lead-containing dust (280 mg/m²)

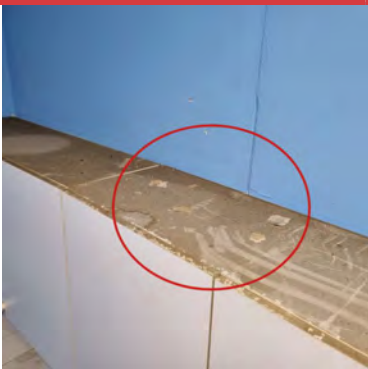
PHOTO 84

Sample ID: EP3072.001_LCD.002

Interior west warehouse, kitchen, above cabinets - lead-containing dust.

Non lead-containing dust (<0.1 mg/m²)

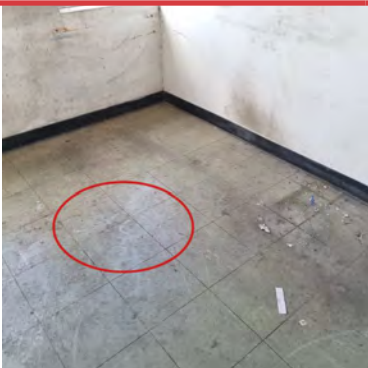
PHOTO 85

Sample ID: EP3072.001_LCD.003

Interior east warehouse, southeast mezzanine, lunchroom - lead-containing dust.

Lead-containing dust (16 mg/m²)

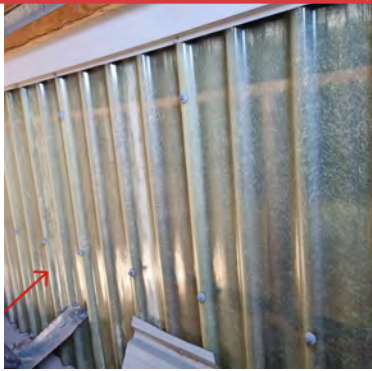
PHOTO 86

Interior west warehouse, south mezzanine, main room, skylights in enclosed balcony area - fibreglass.

Visually identified synthetic mineral fibres.

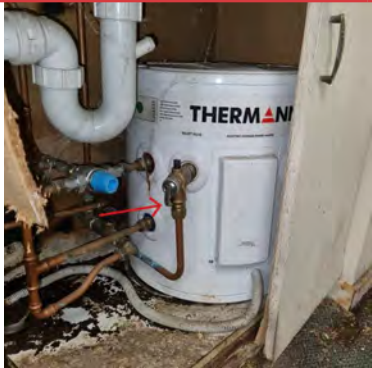
PHOTO 87

Interior west warehouse, east office building, main office, sink cupboard - hot water heater (internal insulation).
