UNIVERSITY HOUSE: ROOM DATA SHEETS

ROOM: 2.34,2.35,2.36,2.37,2.38,2.39	UNIVERSITY LEGAL CENTRE OFFICES
--	--

LOCATION: SECOND FLOOR NORTH EAST

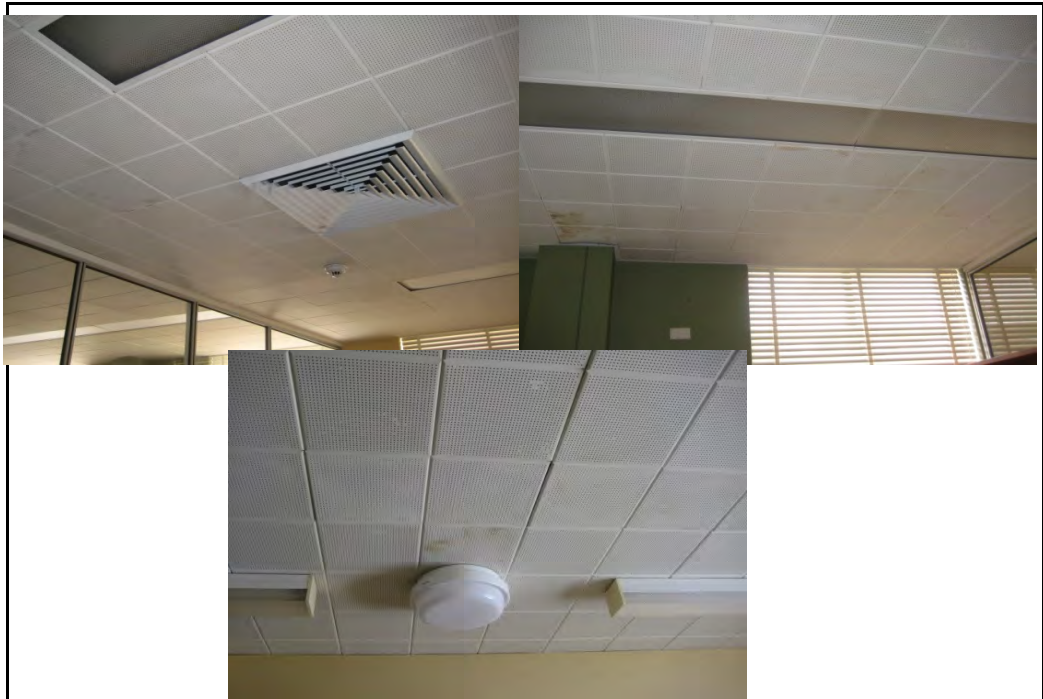
EXISTING CONDITION		
OVERVIEW	Suspended tile ceiling, fair condition, some misaligned tiles, some discoloured, possible moisture damage	
HERITAGE SIGNIFICANCE	Heritage Significance Value of the element	Moderate
FUNCTIONALITY	Functional, requiring repairs.	
ACTION REQUIRED		
OVERVIEW	Investigate and rectify source of moisture, replace / renew tiles as required

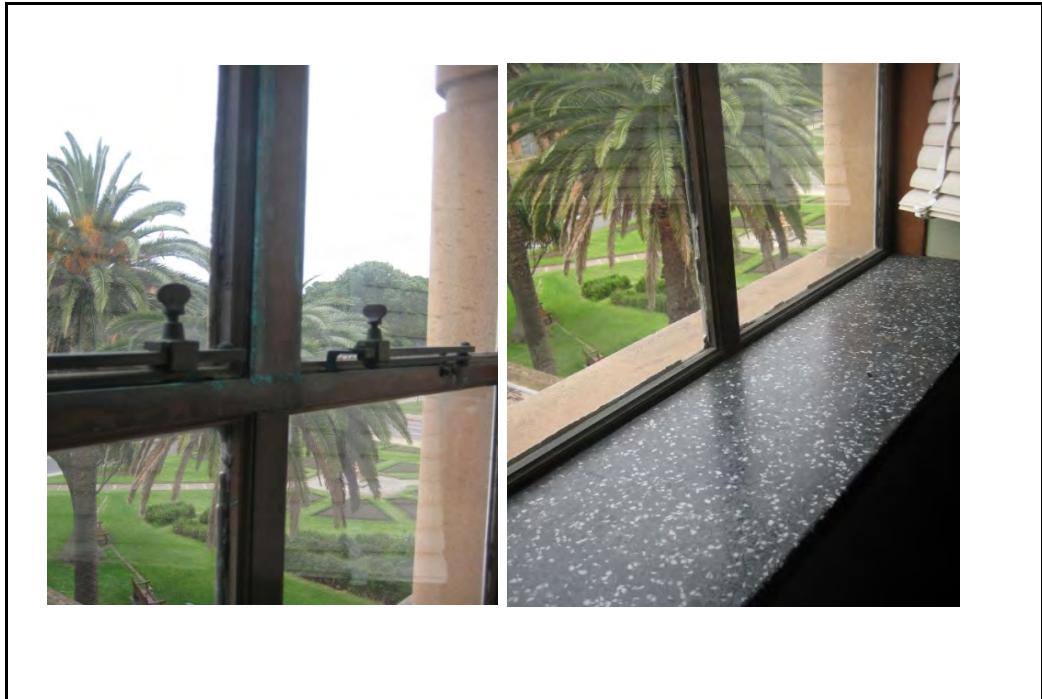
EXISTING CONDITION		
OVERVIEW	Steel / timber framed casement window to external walls of room 2.34, 2.35 and 2.36 - fair condition, some discolouration to frames, sealant perished, missing externally. Damaged control arm to window in room 2.35. Metal awning windows to rooms 2.37, 2.38 and 2.39. Black stone sills, some cracking and fading evident.	
HERITAGE SIGNIFICANCE	Heritage Significance Value of the element	High
FUNCTIONALITY	Functional	
ACTION REQUIRED		
OVERVIEW	Restore original glazing frames and sill as required.

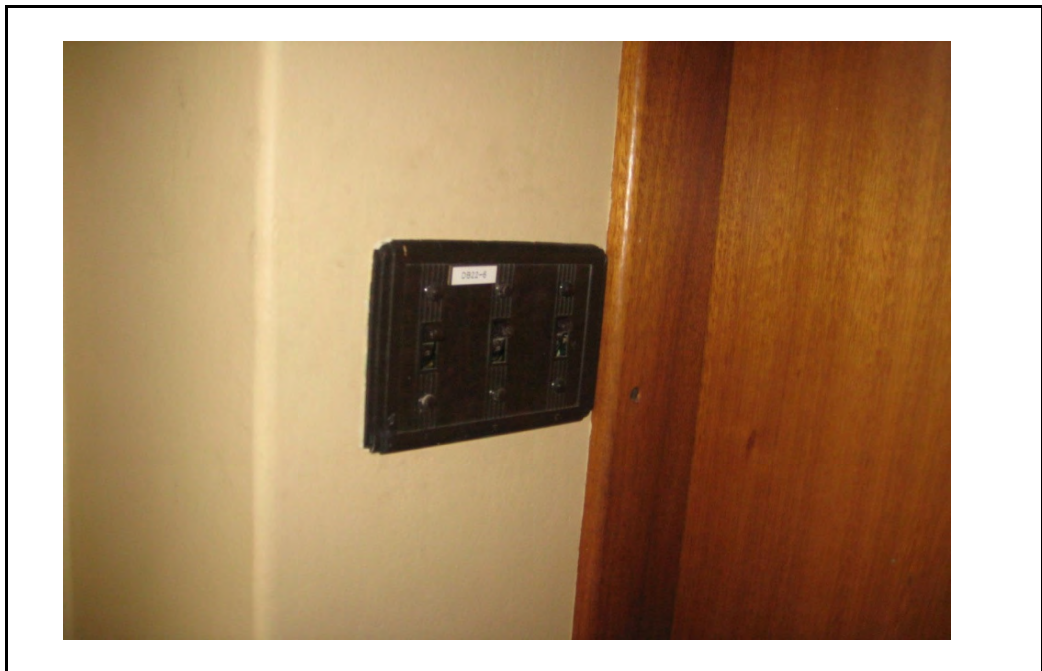
EXISTING CONDITION		
OVERVIEW	Original light switch in room 2.37	
HERITAGE SIGNIFICANCE	Heritage Significance Value of the element	Moderate
FUNCTIONALITY	Not assessed, assumed functional	
ACTION REQUIRED		
OVERVIEW

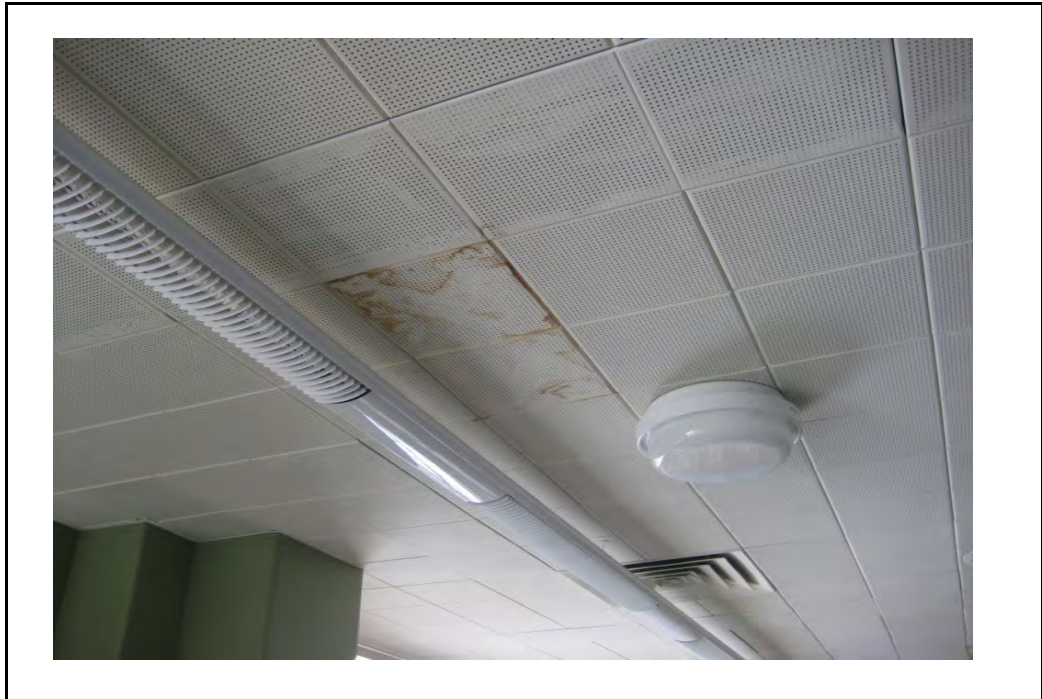
OVERVIEW	Suspended tile ceiling, fair condition, some misaligned tiles, some discoloured, possible moisture damage	
HERITAGE SIGNIFICANCE	Heritage Significance Value of the element	Moderate
FUNCTIONALITY	Functional, requiring repairs.

OVERVIEW	Investigate and rectify source of moisture, replace / renew tiles as required
-----------------	---

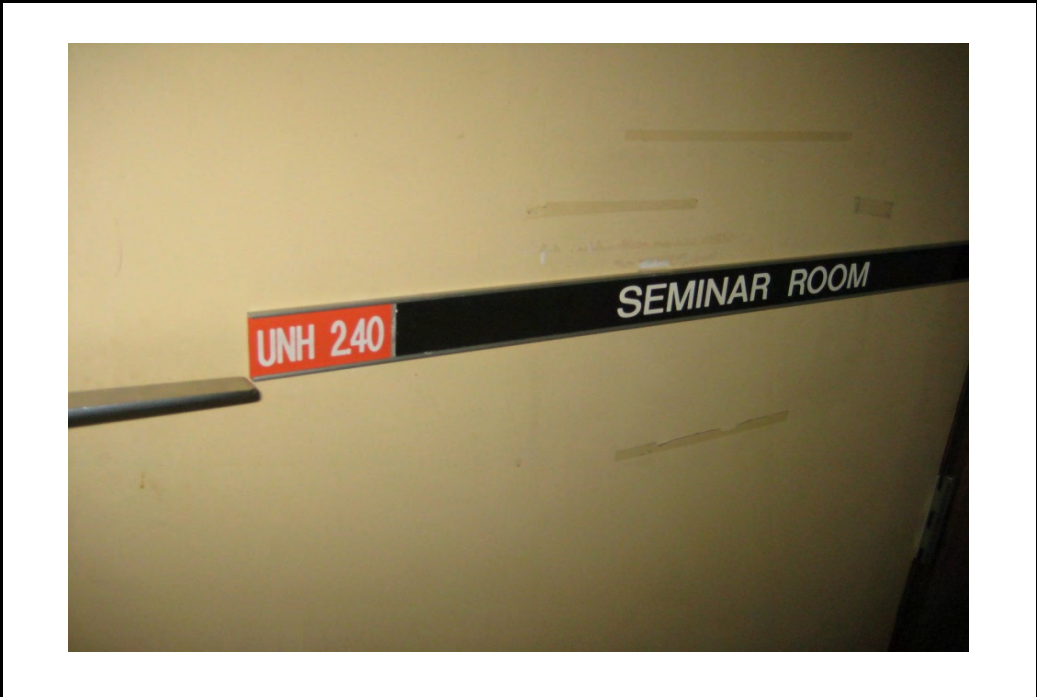
EXISTING CONDITION		
OVERVIEW	Painted timber doors, good condition. Some marks, etc.	
HERITAGE SIGNIFICANCE	Heritage Significance Value of the element	Low
FUNCTIONALITY	Functional	
ACTION REQUIRED		
OVERVIEW	Remove marks, repaint as required.

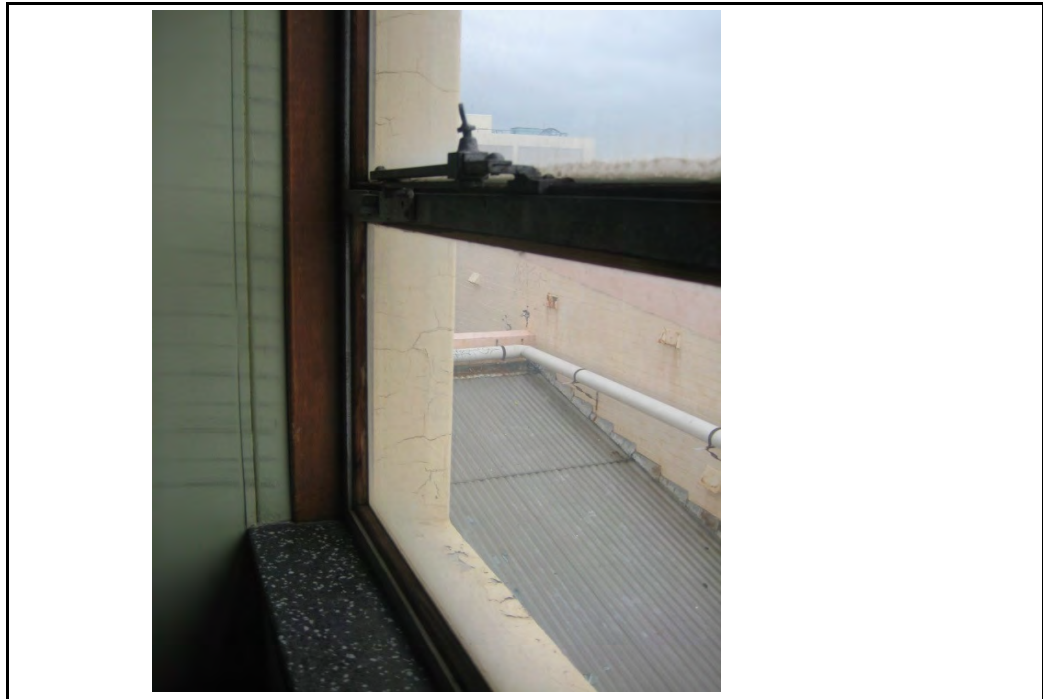
OVERVIEW	Steel / timber framed casement windows - fair condition, some discolouration to frames, sealant perished, missing externally. Black stone sills, some cracking and fading evident.	
HERITAGE SIGNIFICANCE	Heritage Significance Value of the element	High
FUNCTIONALITY	Functional

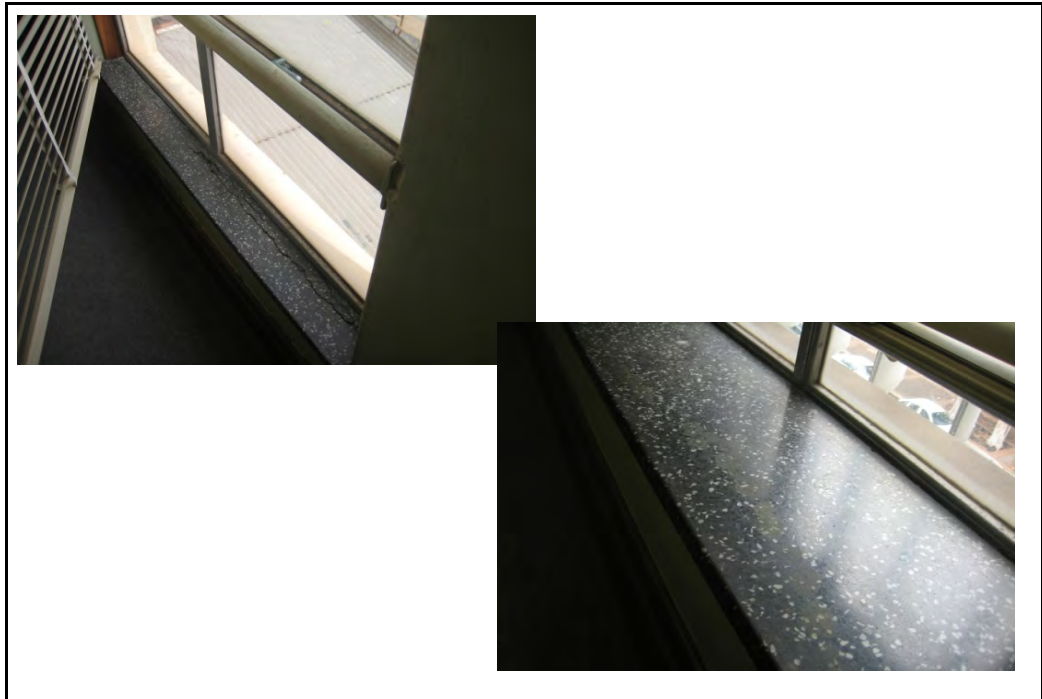
OVERVIEW	Metal framed windows - fair condition, some discolouration to frames. Black stone sills, some cracking and fading evident. Moisture spots on sill on western window	
HERITAGE SIGNIFICANCE	Heritage Significance Value of the element	High
FUNCTIONALITY	Functional

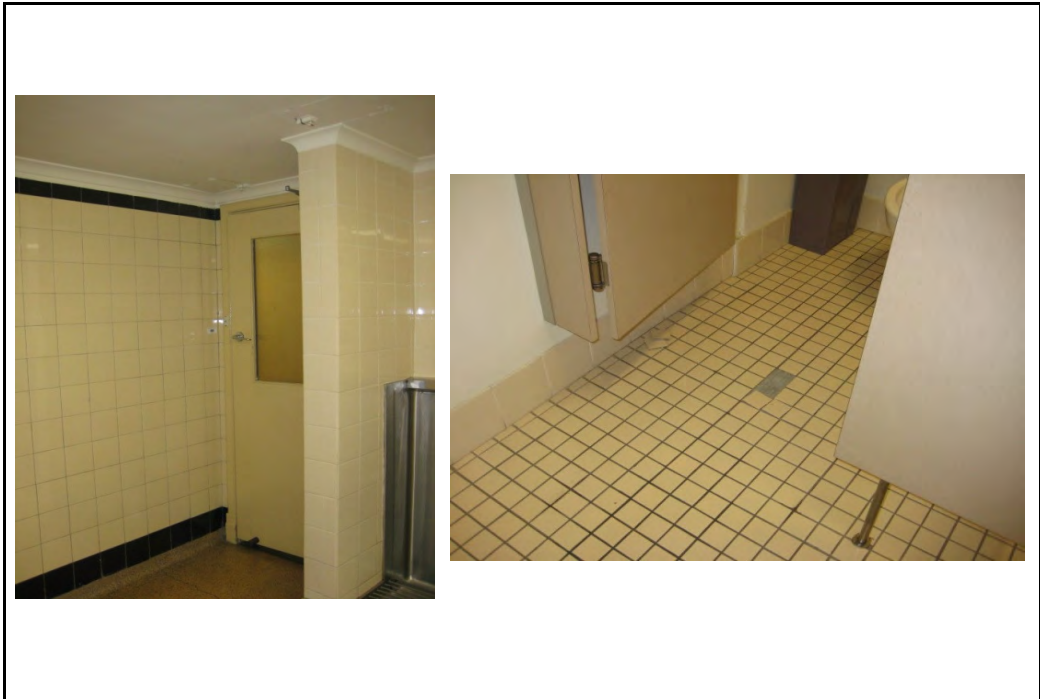
EXISTING CONDITION	
OVERVIEW	Terrazzo flooring, coved at walls in room 2.46. Generally fair condition, some cracks and discolouration present. Tiled floors to rooms 2.45, 2.47, 2.48, 2.49, generally good condition.
HERITAGE SIGNIFICANCE	Heritage Significance Value of the element
	Mixed
HERITAGE SIGNIFICANCE	HIGH Terrazzo flooring LOW Tiles
FUNCTIONALITY	Functional, requiring minor repair.
ACTION REQUIRED	
OVERVIEW	Repair and restore flooring as required

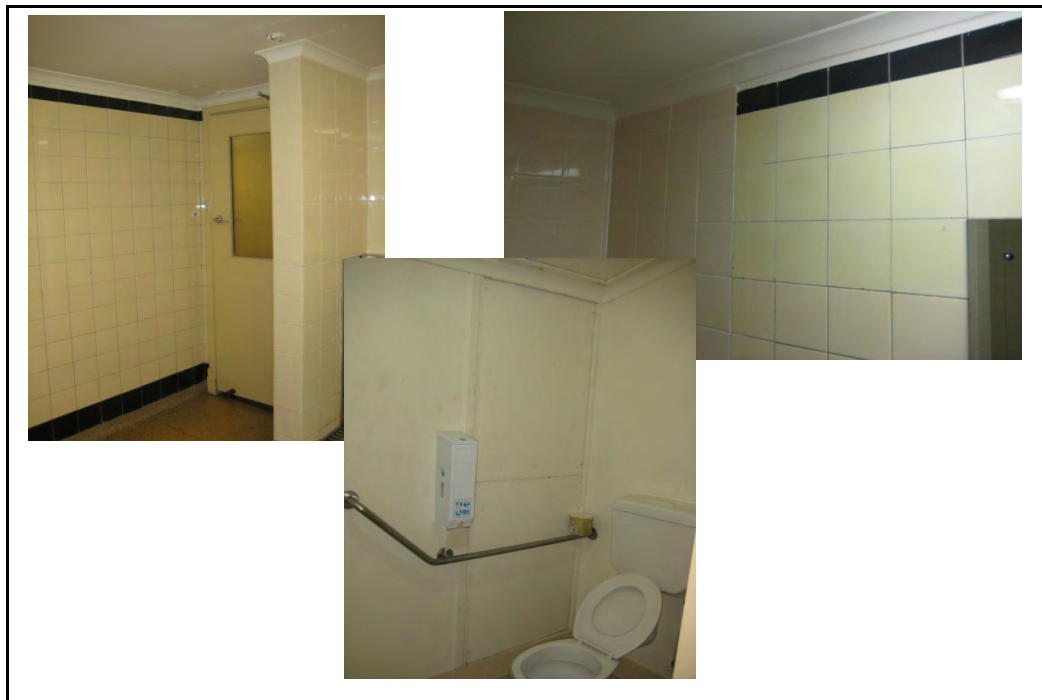
OVERVIEW	Full height tiles to room 2.46 - mainly original tiles with some replacement tiles evident. Painted walls with skirting tiles to 2.45, 2.47, 2.48, 2.49. Generally good condition, cracking at wall junction in S/W corner of room 2.49.	
HERITAGE SIGNIFICANCE	Heritage Significance Value of the element	
	Mixed	
FUNCTIONALITY	Functional, requiring minor repairs

OVERVIEW	Repair and restore wall finishes as required
-----------------	--

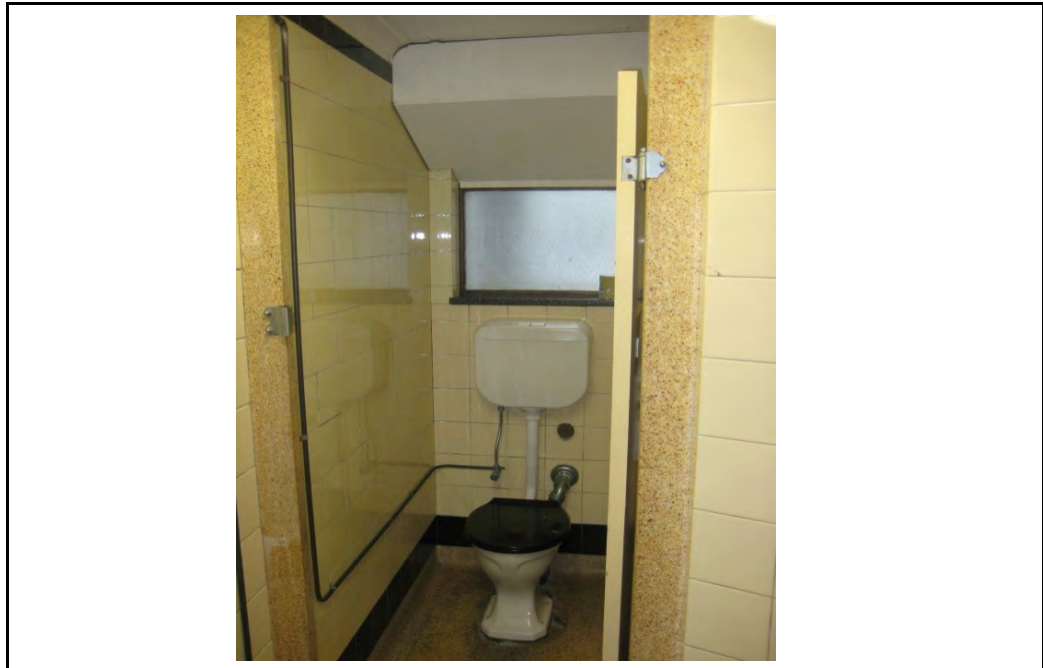
OVERVIEW	Original windows, fair condition. Black stone sill.	
HERITAGE SIGNIFICANCE	Heritage Significance Value of the element	
		Mixed
	HIGH Steel exterior type INTRUSIVE Vent	
FUNCTIONALITY	Functional.

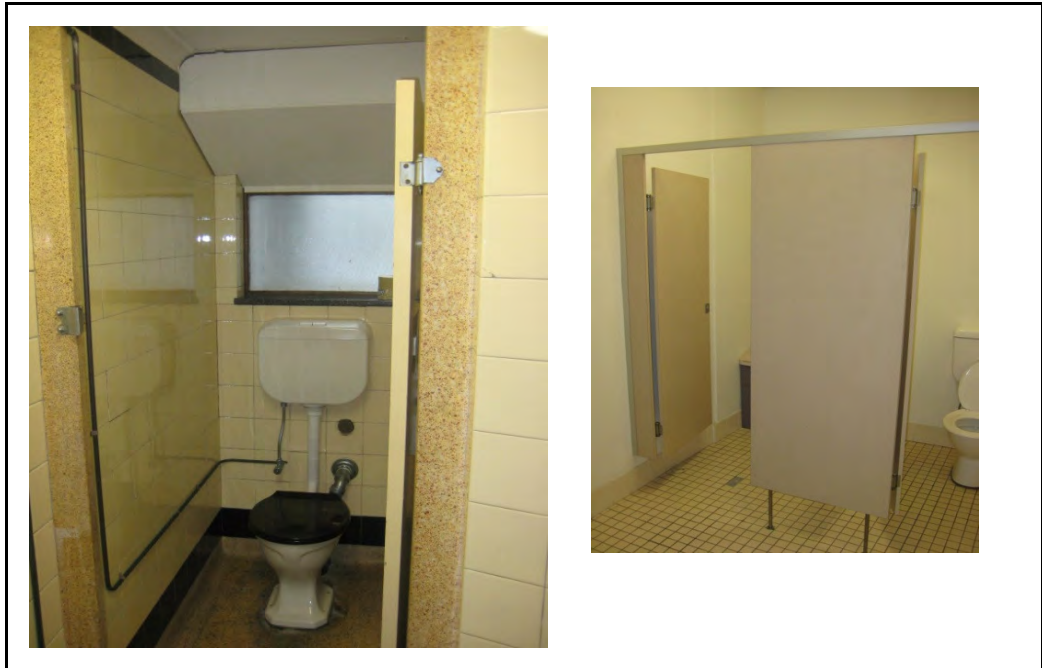
OVERVIEW	Terrazzo toilet partitions in fair condition, some discolouration particularly at base - room 2.46 only. Modern partitions to room 2.45.	
HERITAGE SIGNIFICANCE	Heritage Significance Value of the element	
		Mixed
	HIGH Terrazzo partitions and original sanitary fixtures LOW Modern partitions and non-original sanitary fixtures	
FUNCTIONALITY	Functional

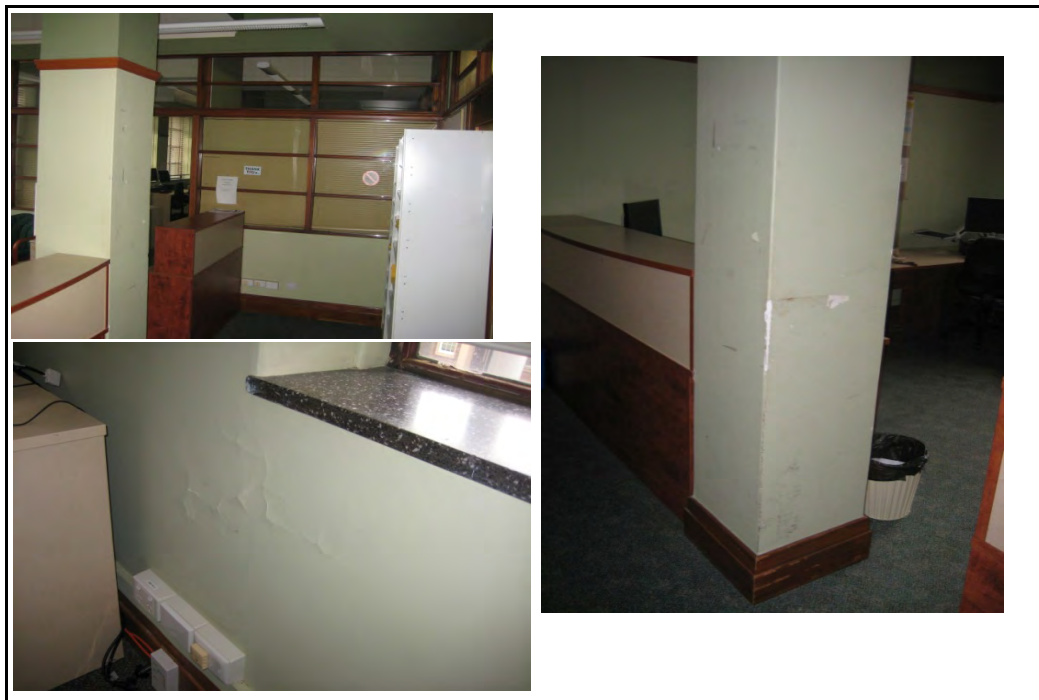
OVERVIEW	Render and paint finish to external wall of both rooms, fair - good condition. Areas of flaking, bubbling paint, possible moisture damage. Chips in corner of column in room 2.50. Painted masonite wall with timber framed glazing - common wall between the two rooms. Good condition.	
HERITAGE SIGNIFICANCE	Heritage Significance Value of the element	Mixed
	HIGH External wall and internal walls with timber framed window LOW All other walls	
FUNCTIONALITY	Functional but requiring repair.

OVERVIEW	Investigate and rectify source of moisture, repair and restore wall finishes as required.
-----------------	---

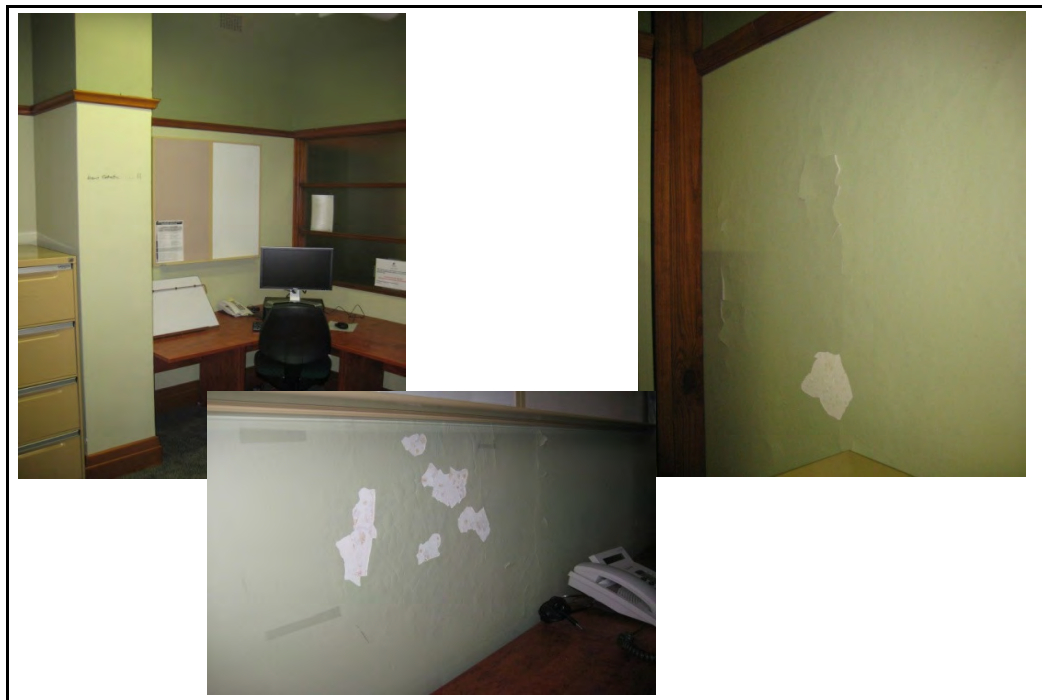
OVERVIEW	Render and paint finish to north wall of both rooms and west (external) wall of room 2.53. Painted plasterboard to remaining walls. Generally good condition, with exception of north wall to each room and west wall in 2.53 - moisture damage, paint bubbling, flaking, peeling.	
HERITAGE SIGNIFICANCE	Heritage Significance Value of the element	Mixed
	HIGH External, north walls LOW Other walls	
FUNCTIONALITY	Functional, requiring repair

OVERVIEW	Investigate and rectify source of moisture damage, repair and repaint walls as required.
-----------------	--

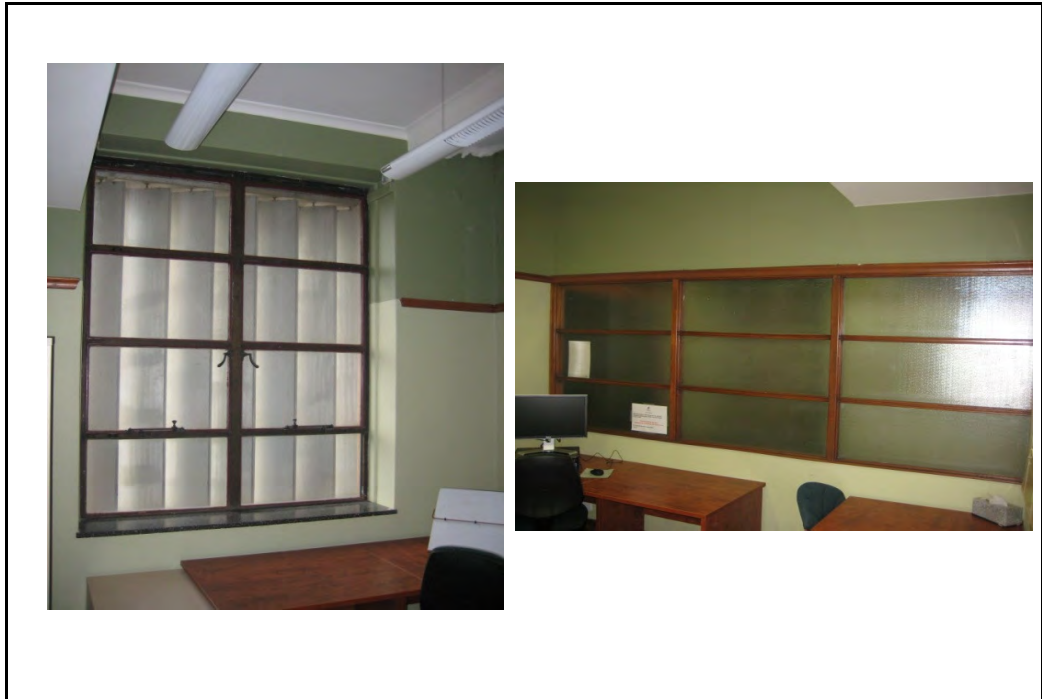
OVERVIEW	Metal framed window to external wall of 2.53, fair condition - frames discoloured, sealant perished and missing externally. Black stone sill cracked and faded. Timber framed glazing to east and south walls of room 2.52 and south wall of 2.53, good condition.	
HERITAGE SIGNIFICANCE	Heritage Significance Value of the element	Mixed
	EXCEPTIONAL External windows LOW Internal glazing (non-original)	
FUNCTIONALITY	Functional, requiring repairs.

OVERVIEW	Repair and restore original windows as required.
-----------------	--

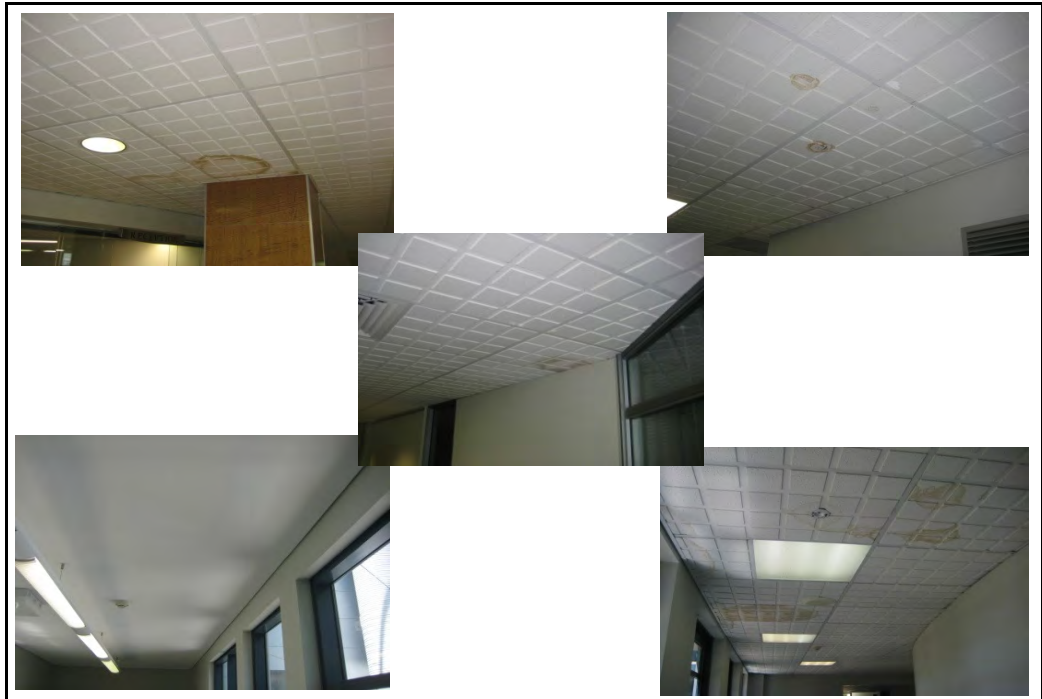
EXISTING CONDITION		
OVERVIEW	Painted plasterboard ceiling to bridge from foyer to north lobby, good condition. Suspended ceiling tiles to foyer and corridors, generally good condition, moisture stains at column in foyer, ceiling outside rooms 3.07, 3.22, 3.11, at south east corner of western corridor and area of access to terrace in eastern corridor. Cracked tiles in corridor near rooms 3.04, 3.07.	
HERITAGE SIGNIFICANCE	Heritage Significance Value of the element	Low
FUNCTIONALITY	Functional, requiring minor repair.	
ACTION REQUIRED		
OVERVIEW	Investigate and rectify source of moisture, replace tiles as required.

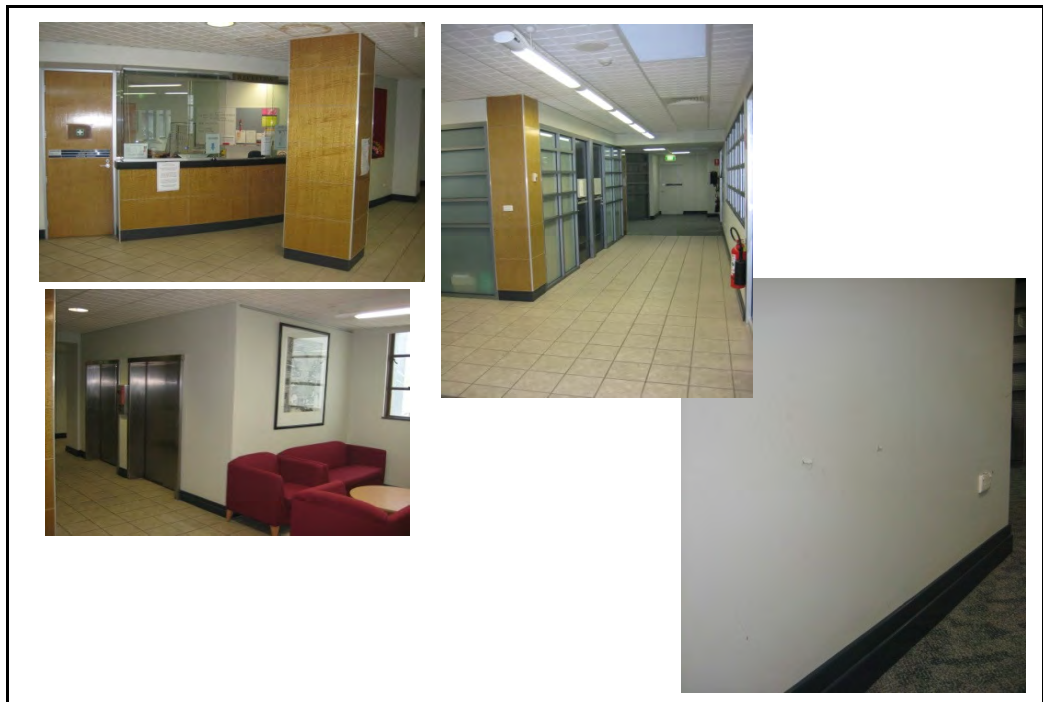
OVERVIEW	Render and paint finish to east and north walls of foyer, good condition. Plasterboard and paint finish generally, anodised aluminium framed glazed walls to parts of corridors / offices. Good condition. Cracked, peeling paint on wall near north end of east corridor (face of wall bounding room 3.30). Timber veneer to columns in foyer and north corridor, and to reception service wall.	
HERITAGE SIGNIFICANCE	Heritage Significance Value of the element	Low
FUNCTIONALITY	Functional but requiring repair.

OVERVIEW	Repair and restore wall finishes as required
-----------------	--

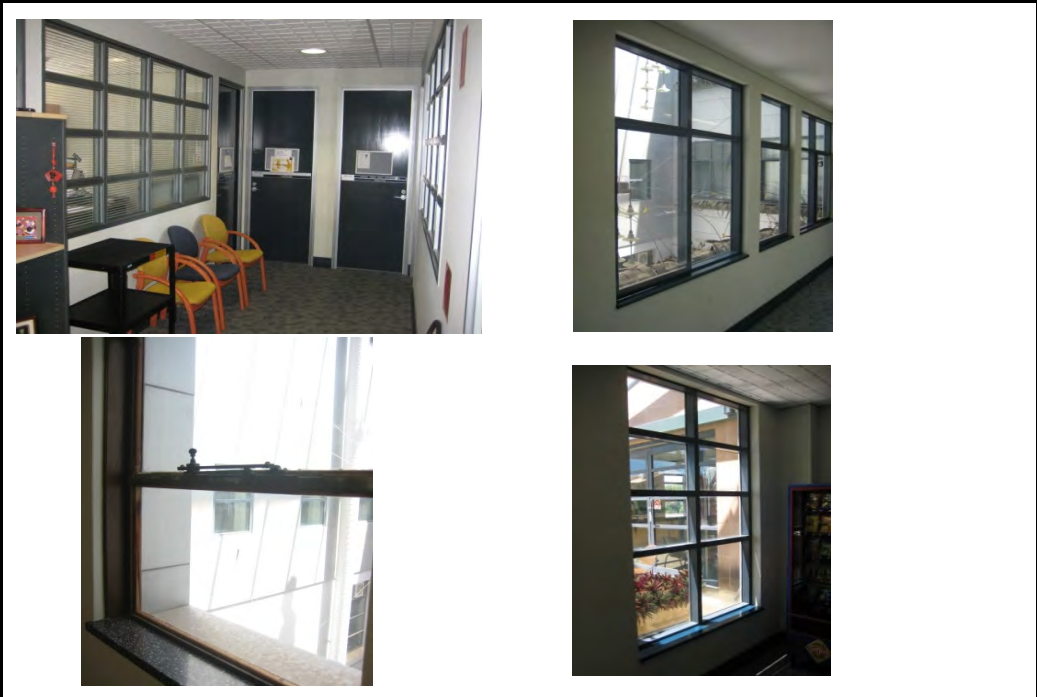
OVERVIEW	Steel / timber framed casement windows to external light well - fair condition, some discolouration to frame, timber beads in frame deteriorating, some sealant missing externally. Black stone sills, cracked. Anodised aluminium framed glazing to offices, powdercoated aluminium framed glazing to bridge, east side of western corridor and to eastern terrace. Good condition.	
HERITAGE SIGNIFICANCE	Heritage Significance Value of the element	Mixed
	HIGH Original steel type LOW Anodised and powdercoated glazing	
FUNCTIONALITY	Functional

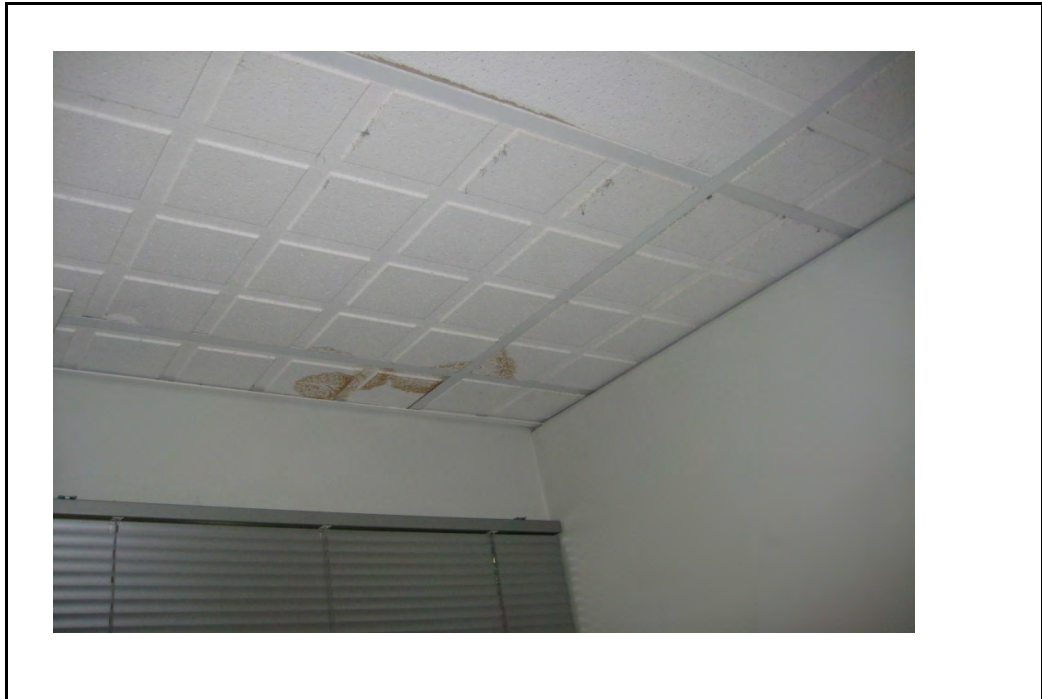
ASSET ELEMENT	CEILING
---------------	---------

EXISTING CONDITION		
OVERVIEW	Suspended ceiling tiles, generally good condition. Some moisture damage to tiles near north wall.	
HERITAGE SIGNIFICANCE	Heritage Significance Value of the element	Low
FUNCTIONALITY	Functional, requiring minor repair.	
ACTION REQUIRED		
OVERVIEW	Investigate and rectify source of moisture, replace tiles as required.

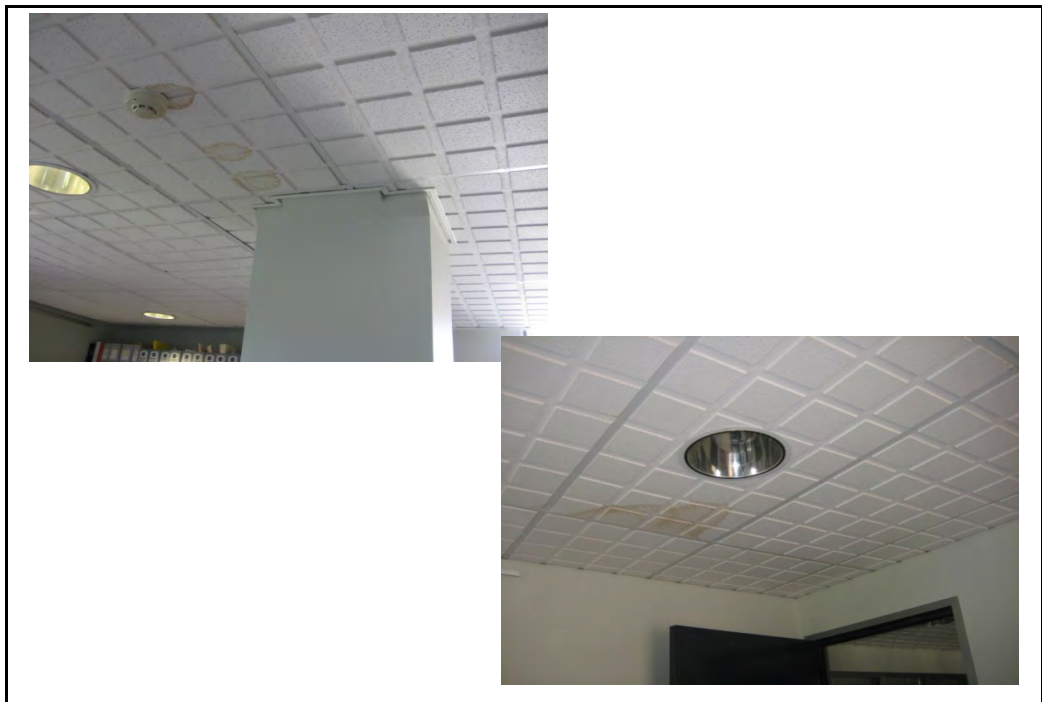
ASSET ELEMENT	CEILING
---------------	---------

OVERVIEW	Suspended ceiling tiles, generally good condition, areas of moisture damage in rooms 3.05 and 3.06.	
HERITAGE SIGNIFICANCE	Heritage Significance Value of the element	Low
FUNCTIONALITY	Functional, requiring repairs

OVERVIEW	Investigate and rectify source of moisture, replace ceiling tiles as required.
----------	--

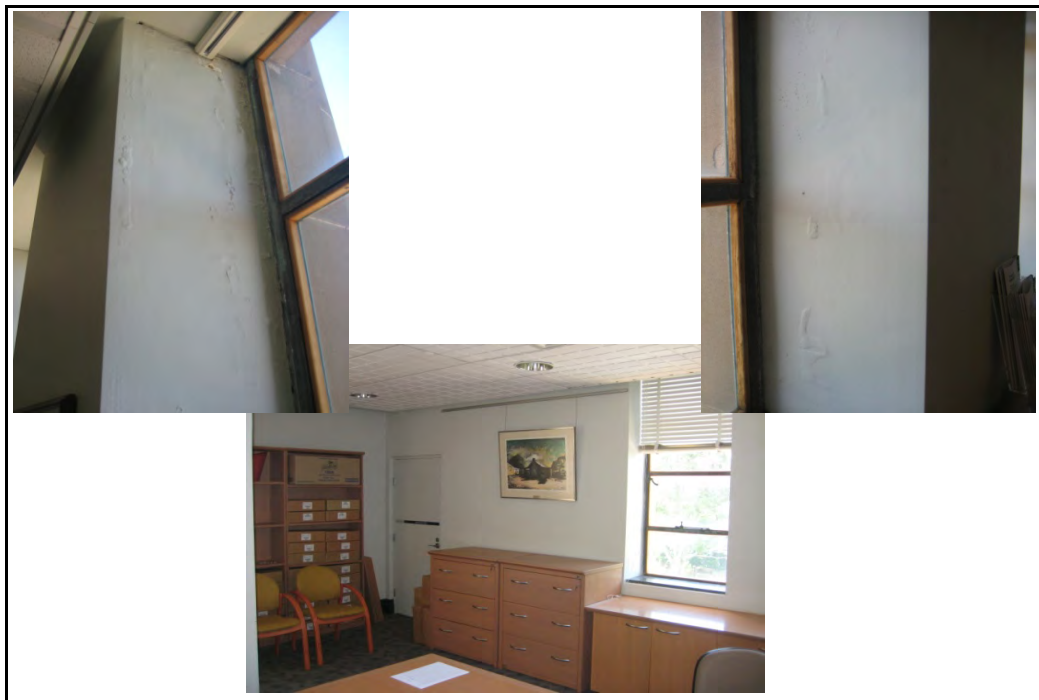
ASSET ELEMENT	WALLS
---------------	-------

OVERVIEW	Plasterboard and paint finish, generally good condition. Some paint bubbling, flaking on reveals of windows, particularly in south wall of rooms 3.05 and 3.06. Possible moisture damage.	
HERITAGE SIGNIFICANCE	Heritage Significance Value of the element	Mixed
	HIGH External walls LOW Internal walls	
FUNCTIONALITY	Functional but requiring repair.

OVERVIEW	Investigate and rectify source of moisture, repair and restore wall finishes as required
-----------------	--

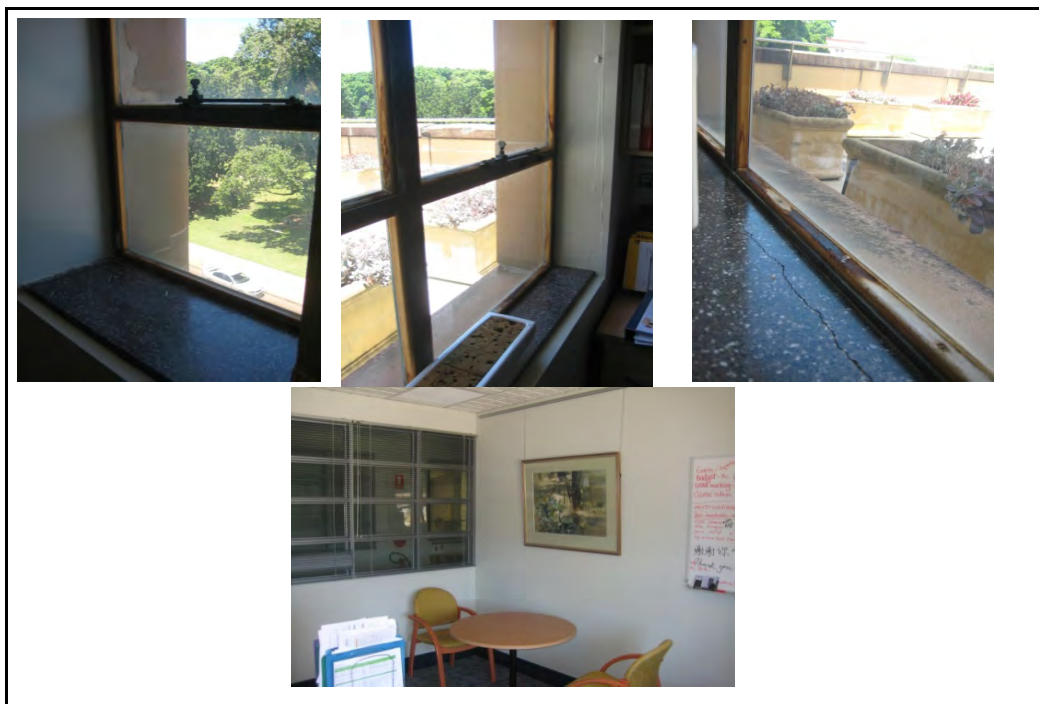
ASSET ELEMENT	WINDOWS
---------------	---------

OVERVIEW	Steel / timber framed casement window to external walls - fair condition, some discolouration to frames, timber beads appear relatively new, applied finish peeling on some beads. Black stone sills, some cracking evident. Anodised aluminium framed windows to corridor.	
HERITAGE SIGNIFICANCE	Heritage Significance Value of the element	Mixed
	EXCEPTIONAL Original steel window and timber framed windows LOW Aluminium framed glazing	
FUNCTIONALITY	Functional

OVERVIEW	Restore original glazing frames and sills as required.
-----------------	--

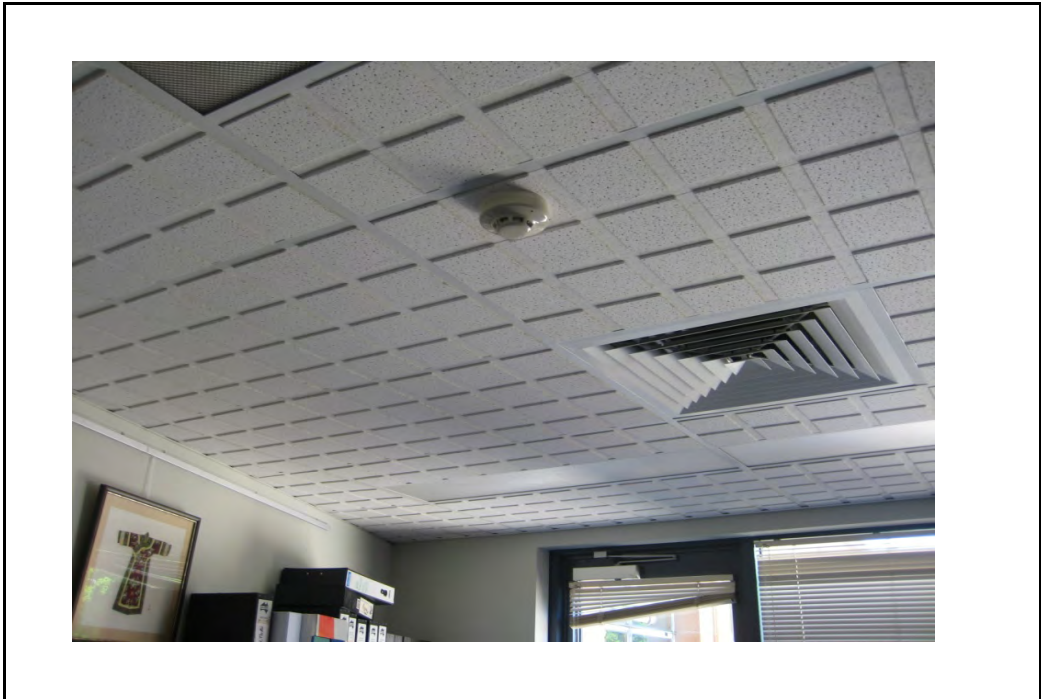
ASSET ELEMENT	CEILING
---------------	---------

EXISTING CONDITION		
OVERVIEW	Suspended ceiling tiles, generally good condition, small moisture stain at south wall.	
HERITAGE SIGNIFICANCE	Heritage Significance Value of the element	Low
FUNCTIONALITY	Functional, requiring repairs	
ACTION REQUIRED		
OVERVIEW	Investigate and rectify source of moisture, replace ceiling tiles as required.

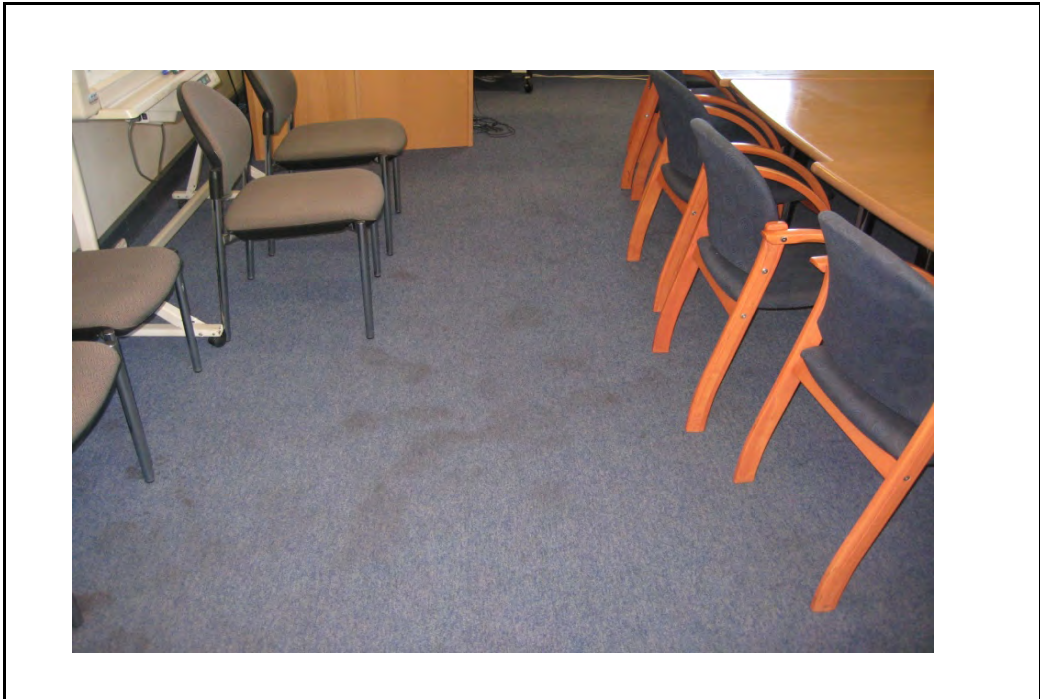
ASSET ELEMENT	FLOOR
---------------	-------

EXISTING CONDITION		
OVERVIEW	Carpet flooring, generally good condition, some staining and signs of wear.	
HERITAGE SIGNIFICANCE	Heritage Significance Value of the element	Low
FUNCTIONALITY	Functional.	
ACTION REQUIRED		
OVERVIEW

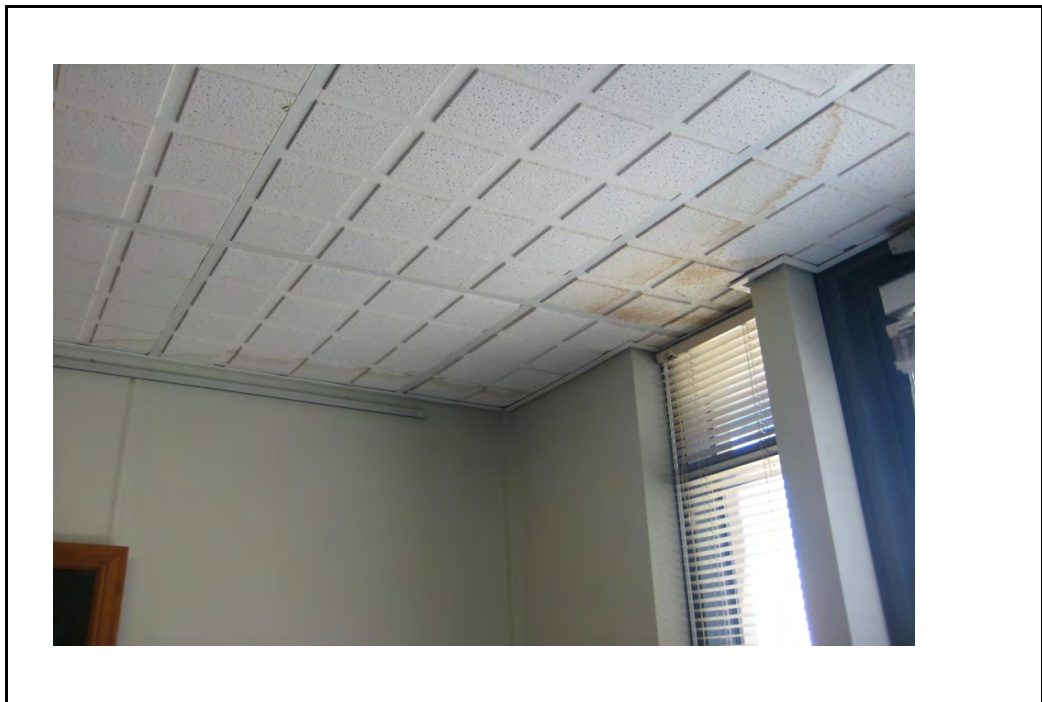
ASSET ELEMENT	CEILING
---------------	---------

OVERVIEW	Suspended ceiling tiles, generally good condition. Some moisture damage to tiles adjacent to north wall and north-west corner.	
HERITAGE SIGNIFICANCE	Heritage Significance Value of the element	Low
FUNCTIONALITY	Functional, requiring minor repair.

OVERVIEW	Investigate and rectify source of moisture, replace tiles as required.
----------	--

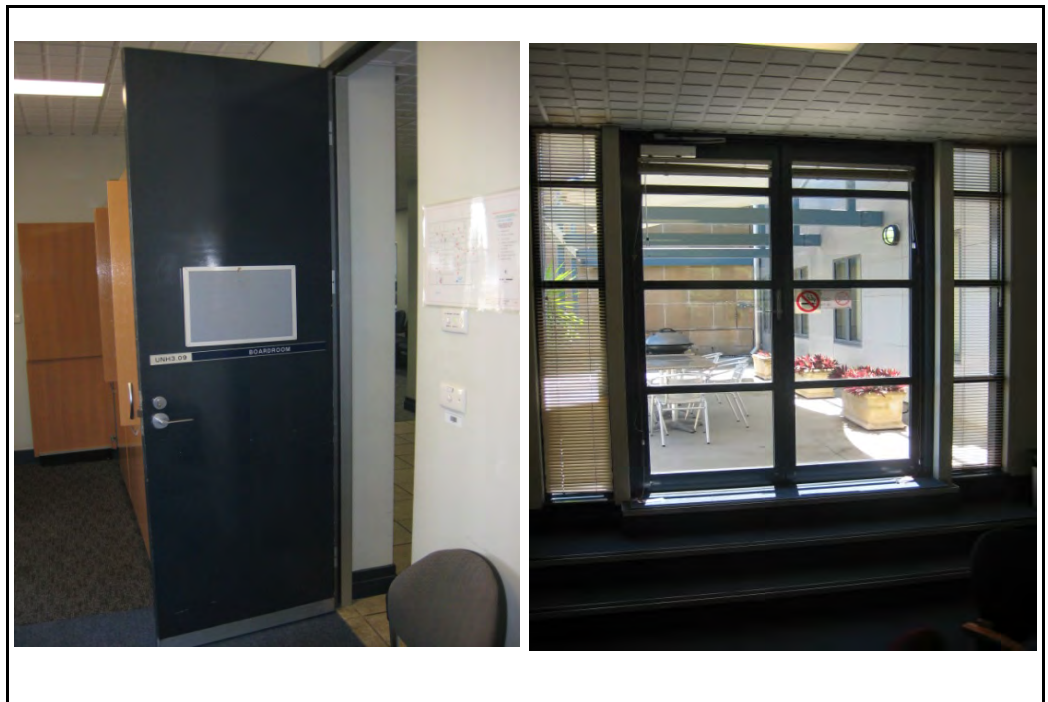
DOORS

OVERVIEW	Painted timber door with aluminium frame to foyer, powdercoated aluminium framed glazed door to terrace (north wall)	
HERITAGE SIGNIFICANCE	Heritage Significance Value of the element	Low
FUNCTIONALITY	Functional, terrace door sticking against sill, difficult to open.

OVERVIEW	Rectify operation of terrace doors.
----------	-------------------------------------

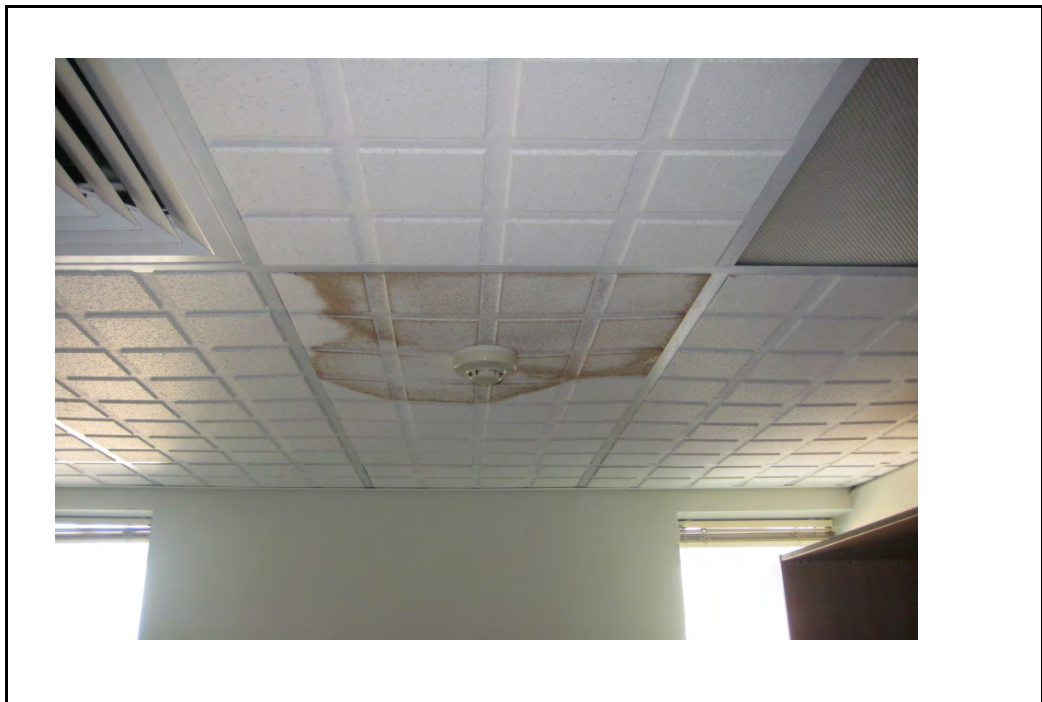
ASSET ELEMENT	CEILING
---------------	---------

OVERVIEW	Suspended ceiling tiles, generally good condition, moisture stain in middle of room 3.13.	
HERITAGE SIGNIFICANCE	Heritage Significance Value of the element	Low
FUNCTIONALITY	Functional, requiring repairs

OVERVIEW	Investigate and rectify source of moisture, replace ceiling tiles as required.
----------	--

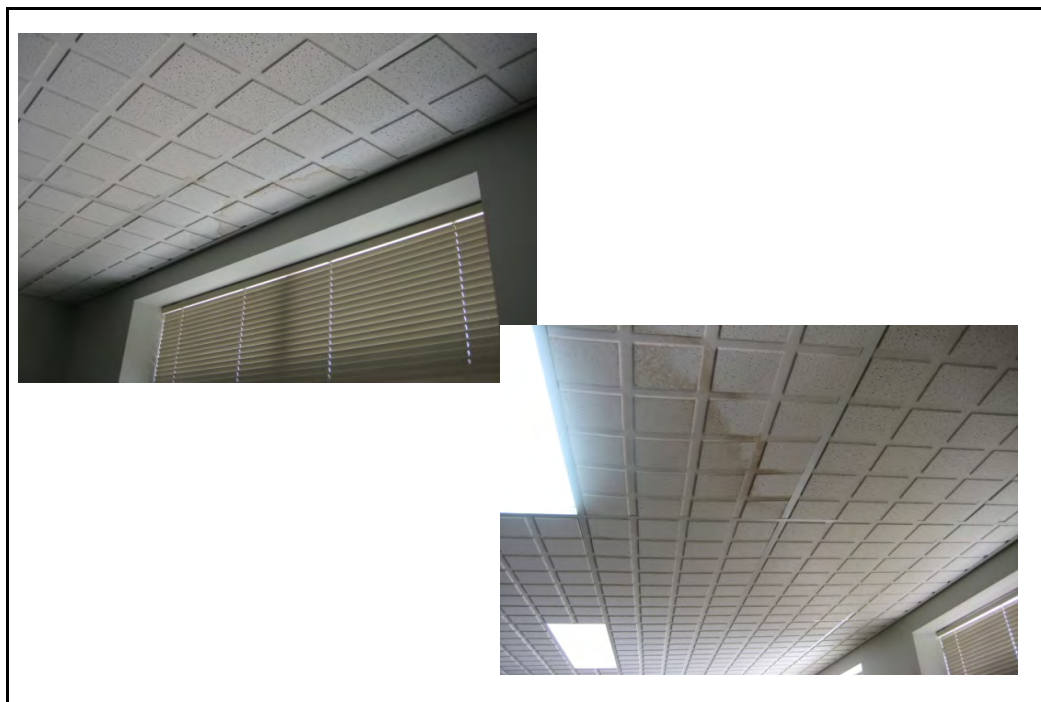
ASSET ELEMENT	CEILING
---------------	---------

OVERVIEW	Suspended ceiling tiles, generally good condition. Some moisture damage to tiles near north wall.	
HERITAGE SIGNIFICANCE	Heritage Significance Value of the element	Low
FUNCTIONALITY	Functional, requiring minor repair.

OVERVIEW	Investigate and rectify source of moisture, replace tiles as required.
----------	--
