UNIVERSITY HOUSE: ROOM DATA SHEETS

ROOM: 2.34,2.35,2.36,2.37,2.38,2.39	UNIVERSITY LEGAL CENTRE OFFICES
--	--

LOCATION: SECOND FLOOR NORTH EAST

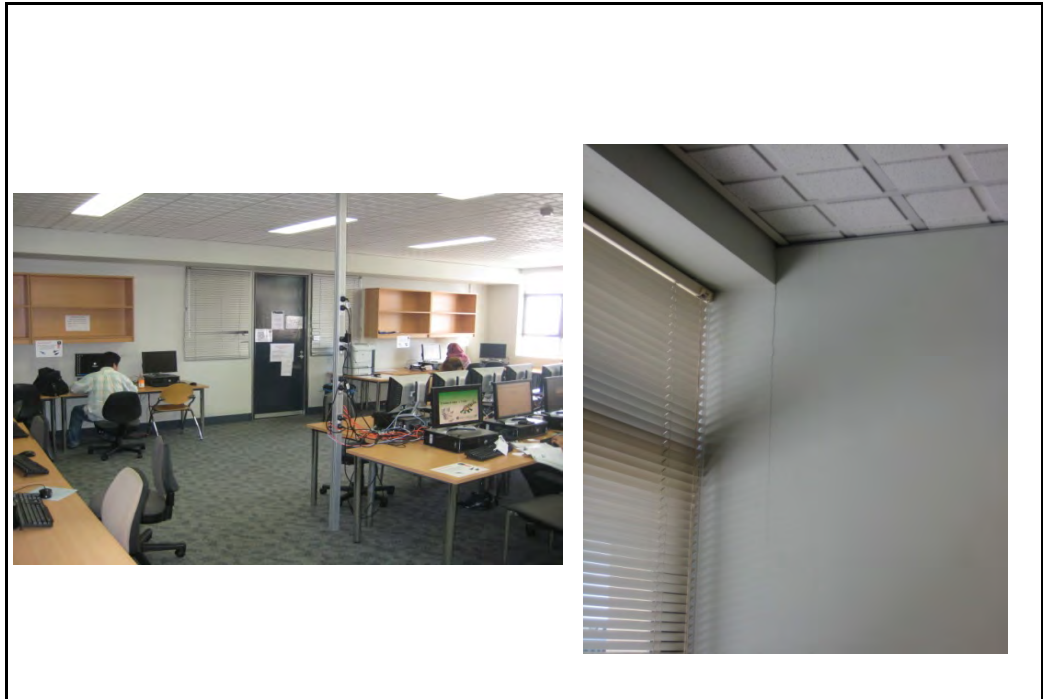
ASSET ELEMENT	WALLS
---------------	-------

EXISTING CONDITION		
OVERVIEW	Plasterboard and paint finish, generally good condition. Crack in wall near north east corner of room 3.19.	
HERITAGE SIGNIFICANCE	Heritage Significance Value of the element	Low
FUNCTIONALITY	Functional but requiring repair.	
ACTION REQUIRED		
OVERVIEW	Repair and restore wall finishes as required

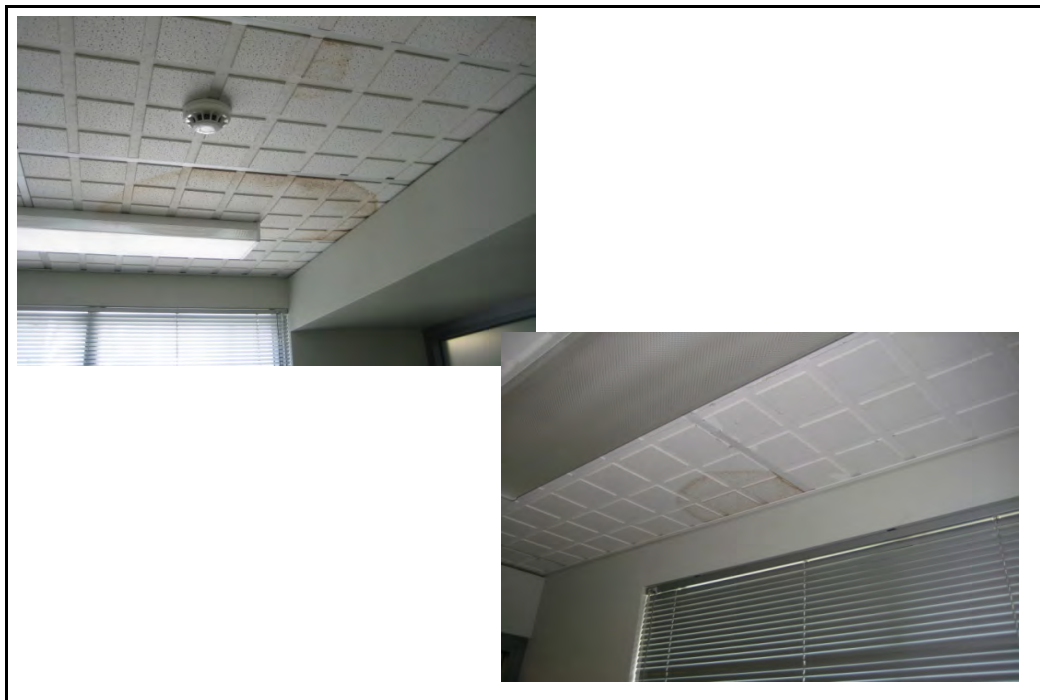
ASSET ELEMENT	CEILING
---------------	---------

OVERVIEW	Suspended ceiling tiles, painted plasterboard bulkhead along west wall of room 3.19b, generally good condition, moisture stain adjacent to bulkhead in 3.19b and at south wall in 3.19a.	
HERITAGE SIGNIFICANCE	Heritage Significance Value of the element	Low
FUNCTIONALITY	Functional, requiring repairs

OVERVIEW	Investigate and rectify source of moisture, replace ceiling tiles as required.
----------	--

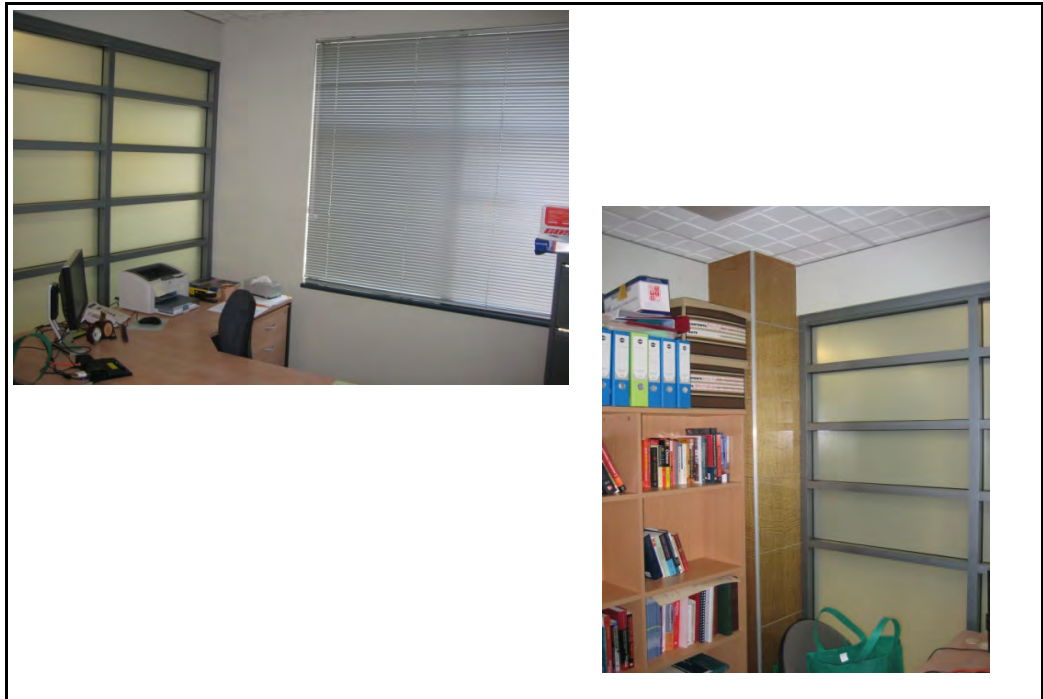
ASSET ELEMENT	WALLS
---------------	-------

OVERVIEW	Plasterboard and paint finish, anodised aluminium framed glazing to corridor and party walls, generally good condition. Timber veneer column at north east corner of room 3.19a and north west corner of 3.19b.	
HERITAGE SIGNIFICANCE	Heritage Significance Value of the element	Low
FUNCTIONALITY	Functional

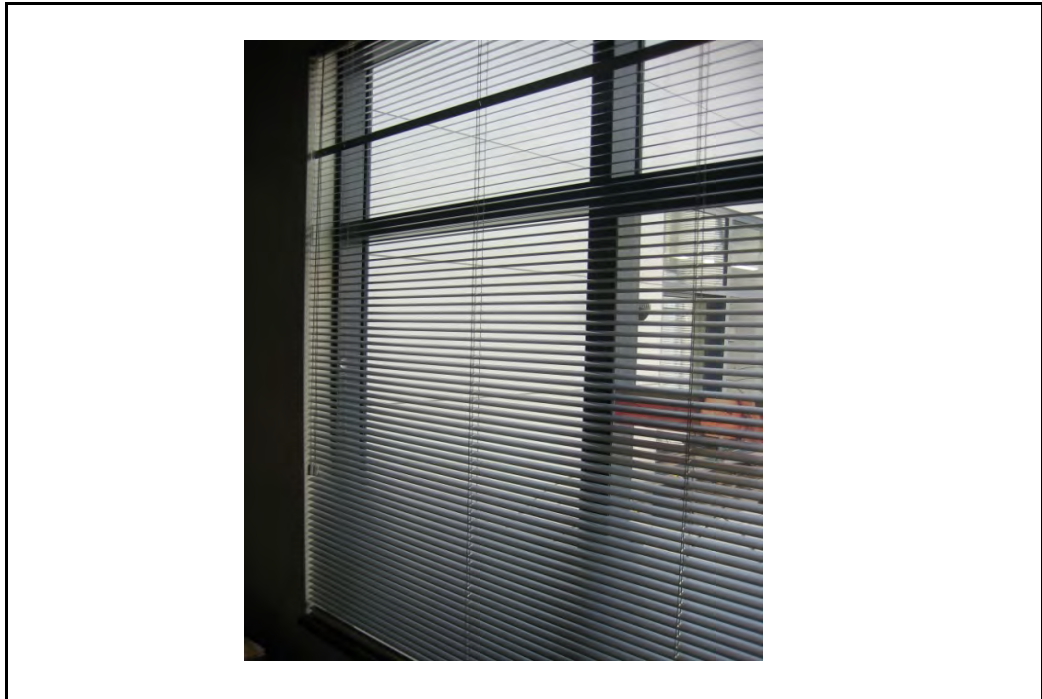
ASSET ELEMENT	WINDOWS
---------------	---------

OVERVIEW	Powdercoated aluminium framed window to south wall of each room, painted timber sill. Good condition.	
HERITAGE SIGNIFICANCE	Heritage Significance Value of the element	Low
FUNCTIONALITY	Functional

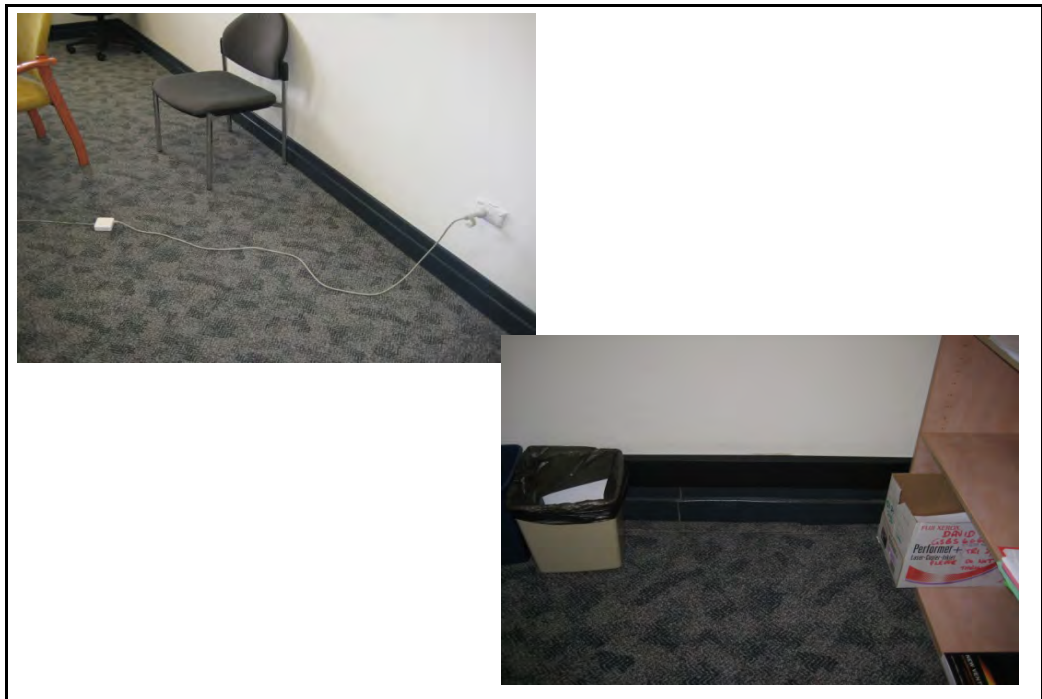
ASSET ELEMENT	FLOOR
---------------	-------

OVERVIEW	Carpet tile flooring, generally good condition, some loose tiles at south wall in room 3.28	
HERITAGE SIGNIFICANCE	Heritage Significance Value of the element	Low
FUNCTIONALITY	Functional

OVERVIEW	Refix tiles as required.
----------	--------------------------

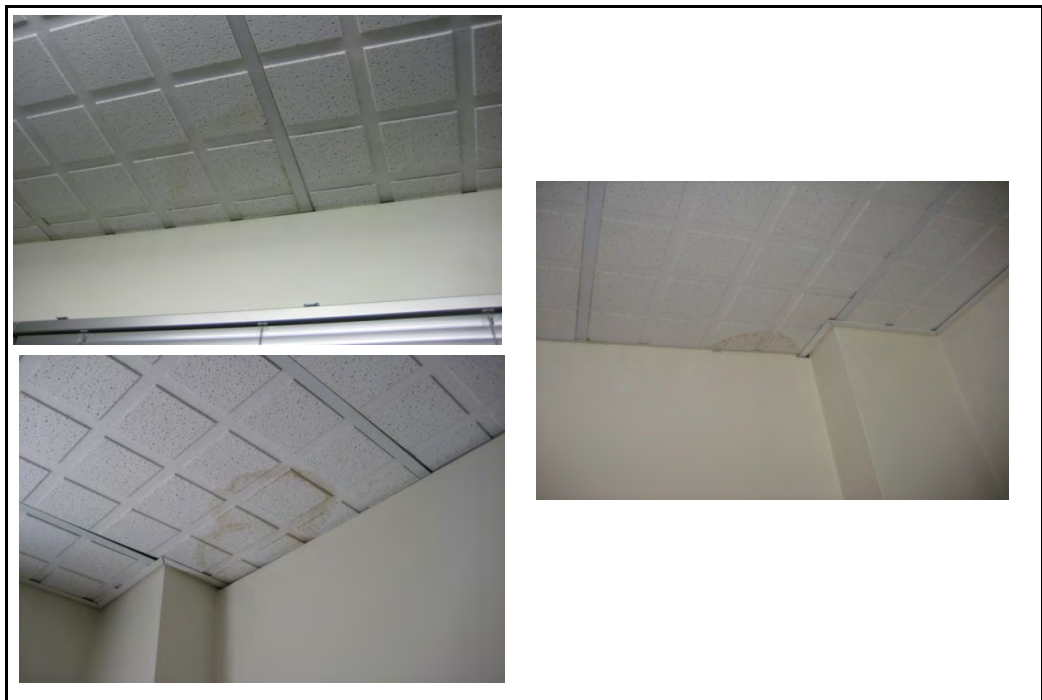
ASSET ELEMENT	CEILING
---------------	---------

EXISTING CONDITION		
OVERVIEW	Suspended ceiling tiles, generally good condition, moisture stains in rooms 3.24a, 3.25 and 3.26	
HERITAGE SIGNIFICANCE	Heritage Significance Value of the element	Low
FUNCTIONALITY	Functional, requiring repairs	
ACTION REQUIRED		
OVERVIEW	Investigate and rectify source of moisture, replace ceiling tiles as required.

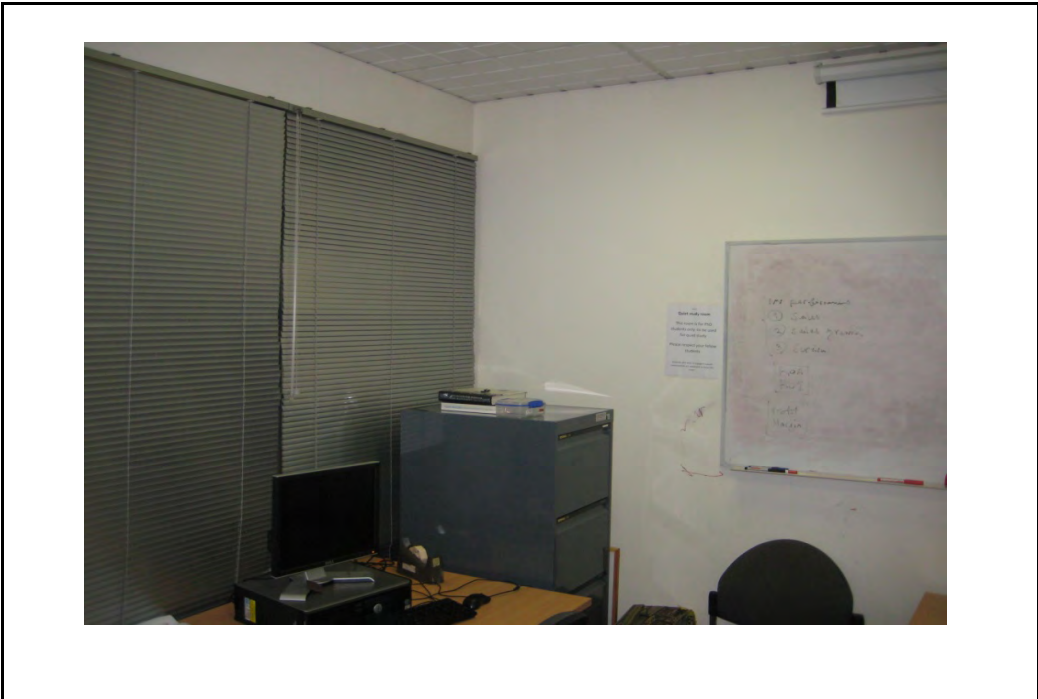
ASSET ELEMENT	WALLS
---------------	-------

OVERVIEW	Plasterboard and paint finish, anodised aluminium framed glazing to corridor walls, generally good condition.	
HERITAGE SIGNIFICANCE	Heritage Significance Value of the element	Low
FUNCTIONALITY	Functional

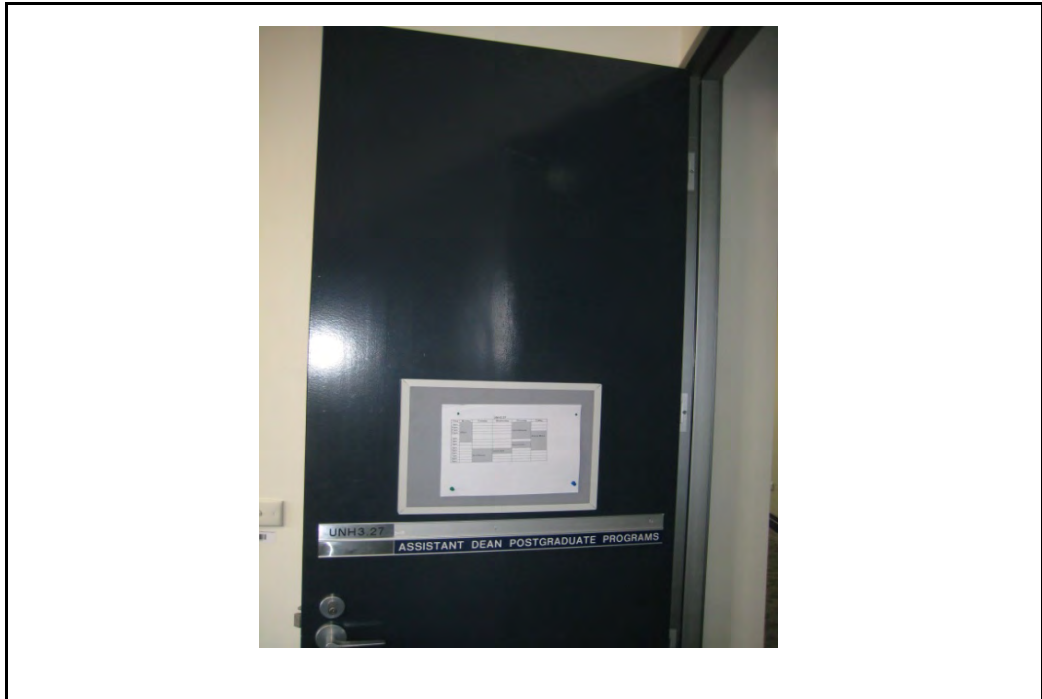
ASSET ELEMENT	DOORS
---------------	-------

OVERVIEW	Timber doors, paint finish, good condition.	
HERITAGE SIGNIFICANCE	Heritage Significance Value of the element	Low
FUNCTIONALITY	Functional

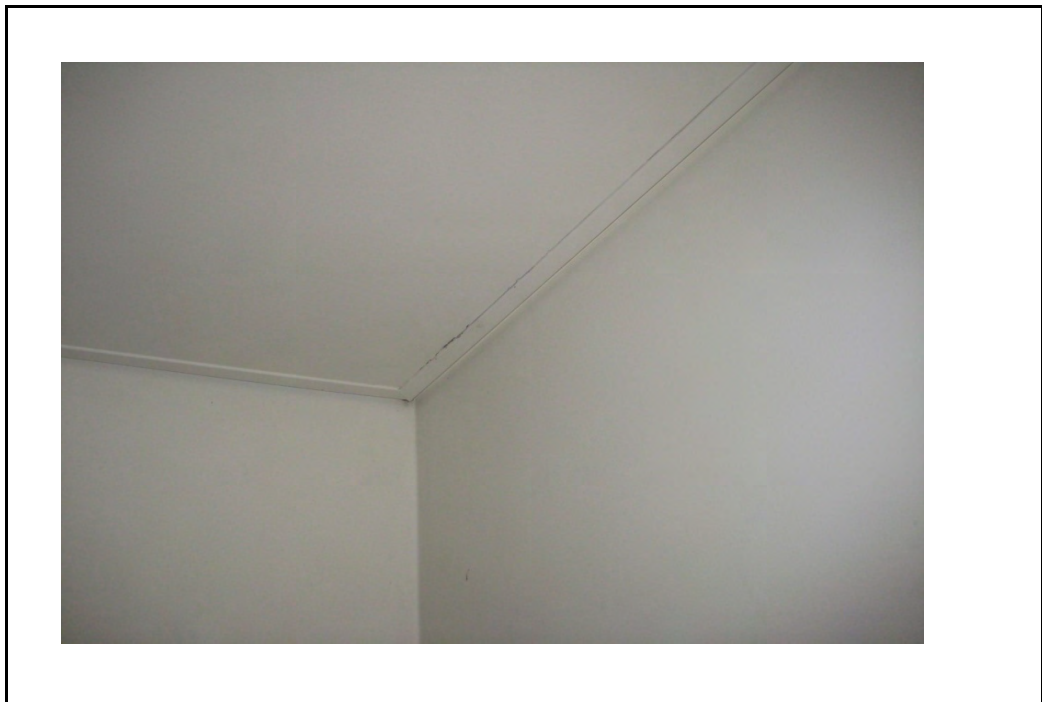
ASSET ELEMENT	CEILING
---------------	---------

OVERVIEW	Plasterboard and paint finish - generally good condition. Cracking at perimeter trim at south-east corner of room 3.32.	
HERITAGE SIGNIFICANCE	Heritage Significance Value of the element	Low
FUNCTIONALITY	Functional, requiring repair

OVERVIEW	Repair and repaint as required.
----------	---------------------------------

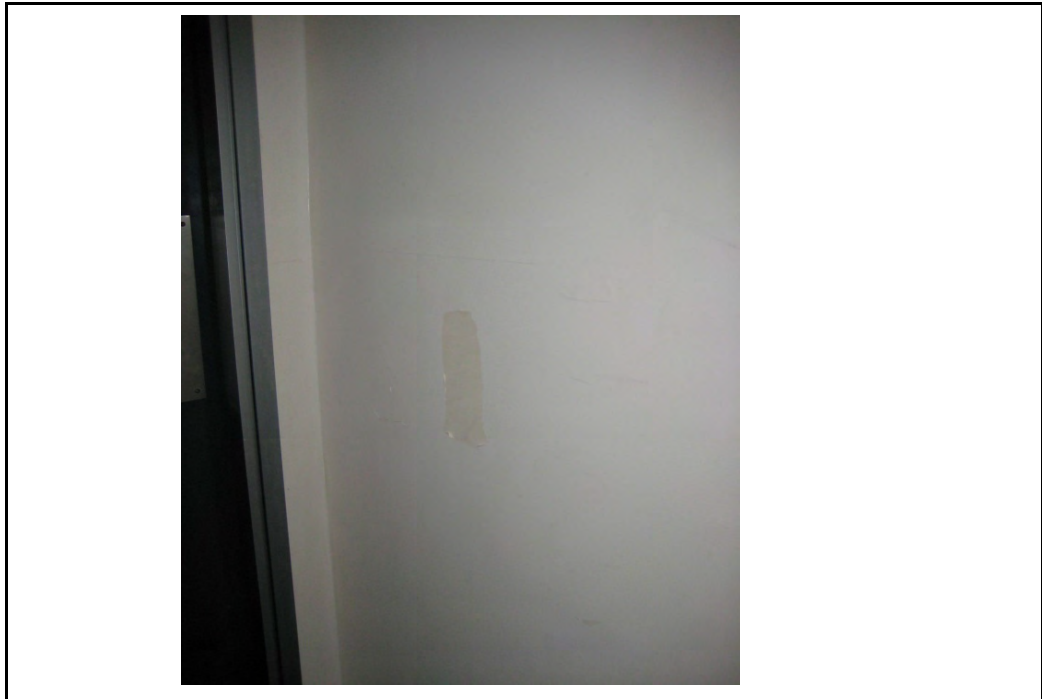
ASSET ELEMENT	WALLS
---------------	-------

OVERVIEW	Fibre cement sheeting, paint finish, with skirting tile. Wall tiles at urinals in room 3.32, splashback tiles at vanity in room 3.31. Generally good condition, some paint peeling on western wall of room 3.31, behind door.	
HERITAGE SIGNIFICANCE	Heritage Significance Value of the element	Low
FUNCTIONALITY	Functional, requiring minor repairs

OVERVIEW	Repair and restore wall finishes as required
----------	--

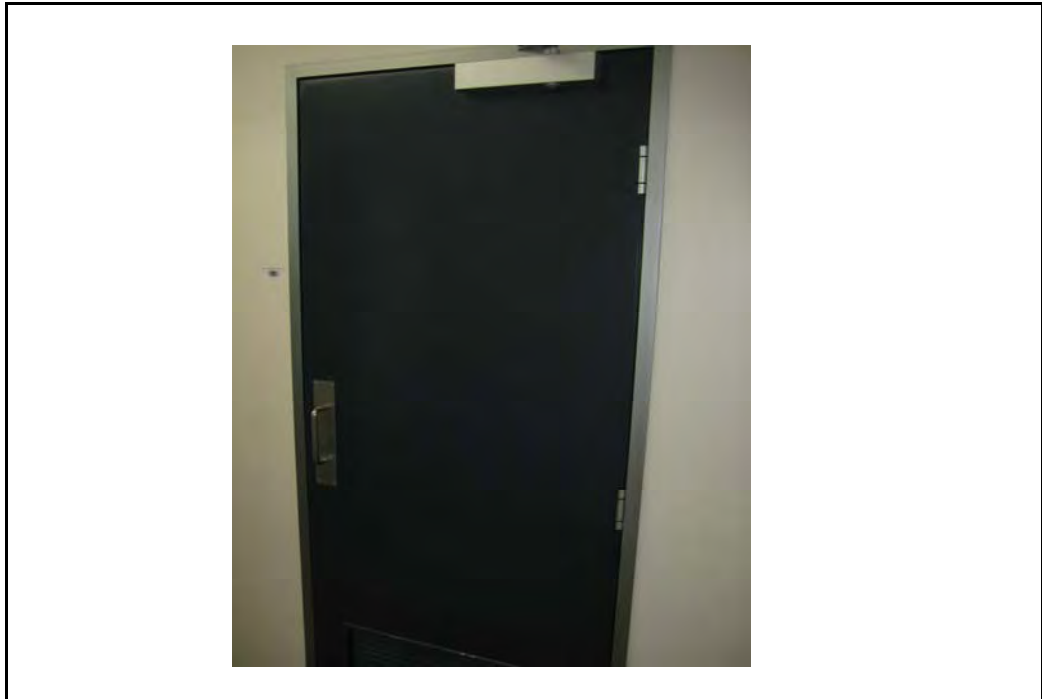
ASSET ELEMENT	DOORS
---------------	-------

OVERVIEW	Painted timber doors, good condition.	
HERITAGE SIGNIFICANCE	Heritage Significance Value of the element	Low
FUNCTIONALITY	Functional.

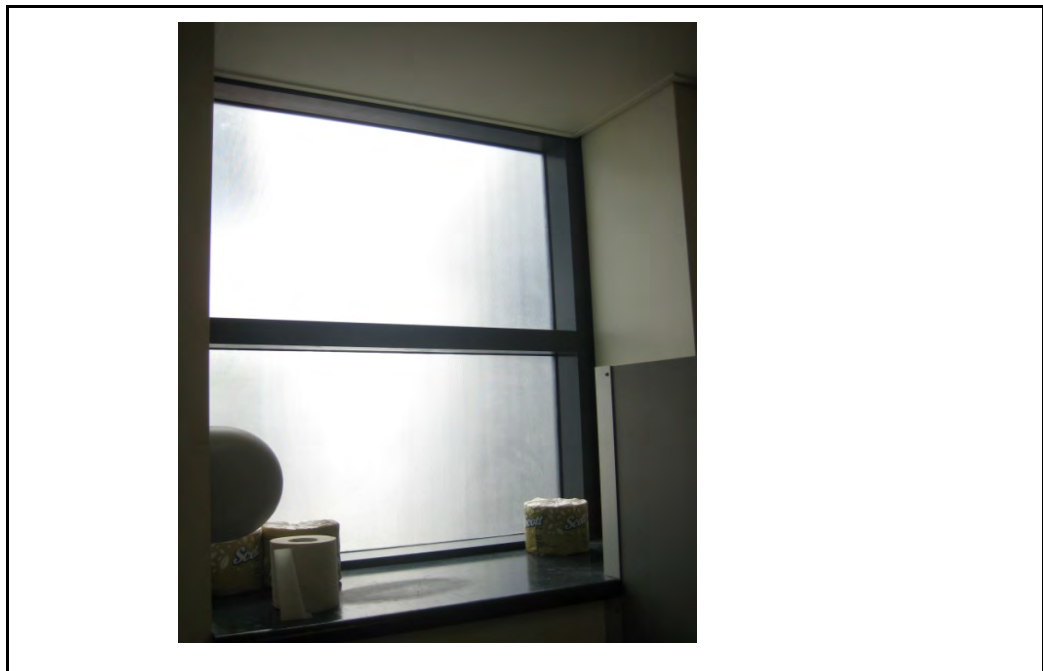
ASSET ELEMENT	WINDOWS
---------------	---------

EXISTING CONDITION		
OVERVIEW	Powdercoated aluminium framed window in room 3.32. Painted timber sill. Good condition, wear / discoloured patch on sill.	
HERITAGE SIGNIFICANCE	Heritage Significance Value of the element	Low
FUNCTIONALITY	Functional.	
ACTION REQUIRED		
OVERVIEW	Repair and repaint sill as required.

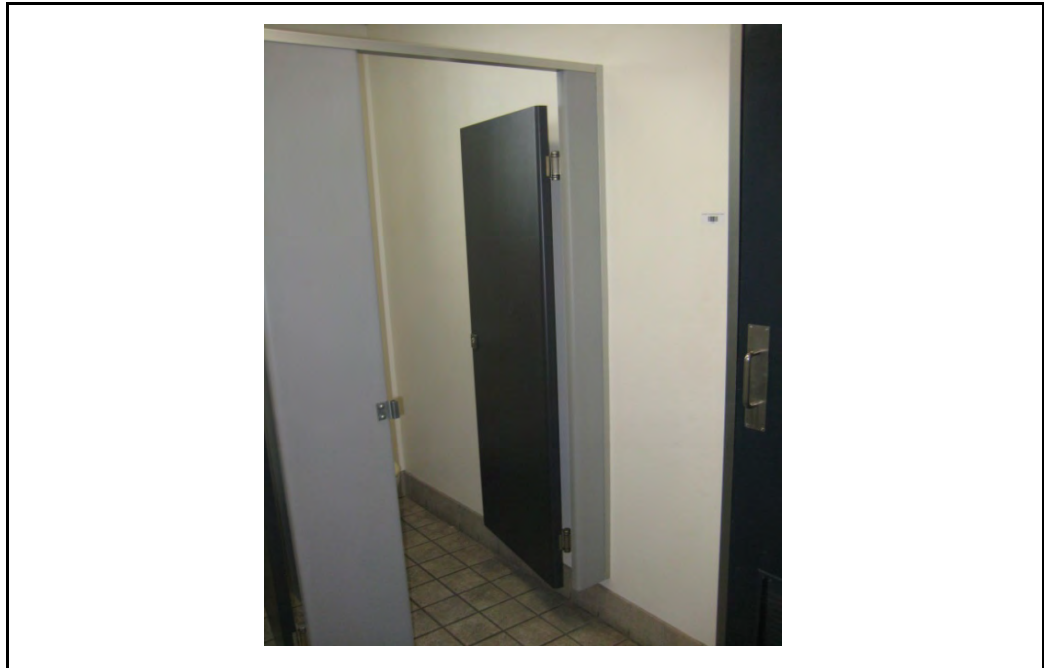
ASSET ELEMENT	FITTINGS
---------------	----------

OVERVIEW	Modern laminated toilet partitions, vanity bench and sanitary fittings. Good condition.	
HERITAGE SIGNIFICANCE	Heritage Significance Value of the element	Low
FUNCTIONALITY	Functional

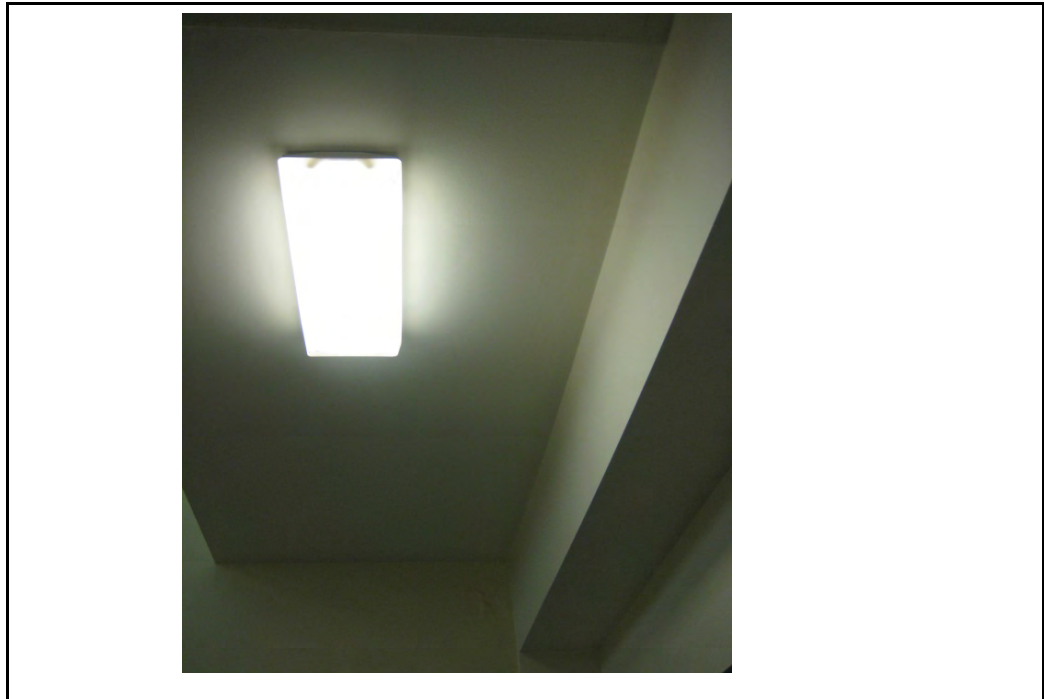
ASSET ELEMENT	CEILING
---------------	---------

OVERVIEW	Painted plasterboard ceiling to 3.35, painted soffit to stair over. Good condition.	
HERITAGE SIGNIFICANCE	Heritage Significance Value of the element	High
FUNCTIONALITY	Functional

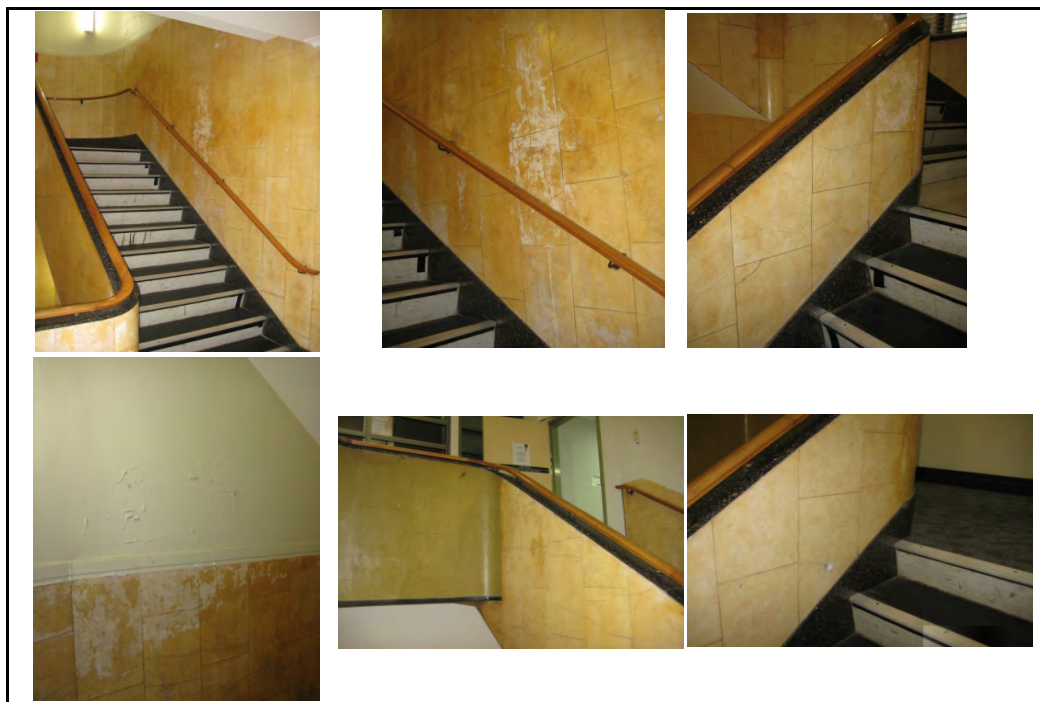
ASSET ELEMENT	WALLS
---------------	-------

OVERVIEW	Scagliola tiles with black stone skirting to stair wall and balustrade - fair condition, with fine cracks extensively across surface of scagliola tiles. Some tiles drummy, surface of some tiles deteriorating. Hole in scagliola tile on balustrade near top of stair. Scagliola tiles on outer wall of stair terminate at same level as floor of room 3.35. Render and paint finish above. Paintwork bubbling, flaking in area above first landing on stair. Chips in wall at window reveals. Black stone capping to balustrade. Painted plasterboard with painted timber skirting to room 3.35. Good condition. Balustrade material changes to vinyl tiles at room 3.35. Generally good condition.	
HERITAGE SIGNIFICANCE	Heritage Significance Value of the element	Mixed
	EXCEPTIONAL Scagliola tiles, skirtings, balustrade capping LOW Vinyl tiles and painted plasterboard	
FUNCTIONALITY	Functional but requiring repair.

OVERVIEW	Repair and restore wall finishes as required
-----------------	--

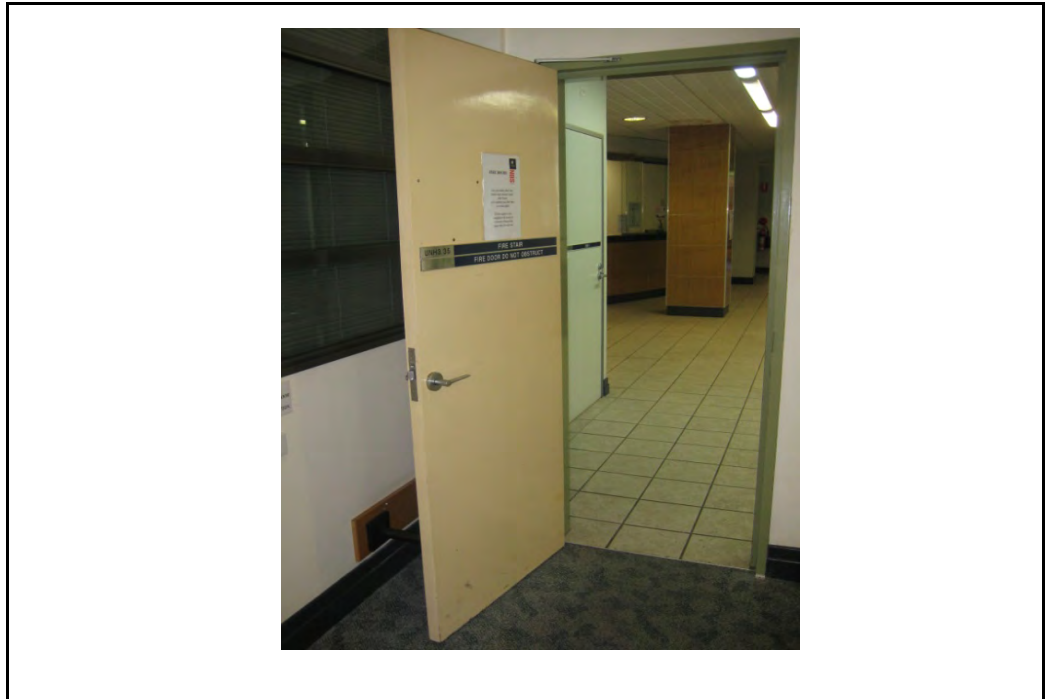
DOORS

OVERVIEW	Painted timber with painted steel frames. All good condition.	
HERITAGE SIGNIFICANCE	Heritage Significance Value of the element	Low
FUNCTIONALITY	Functional

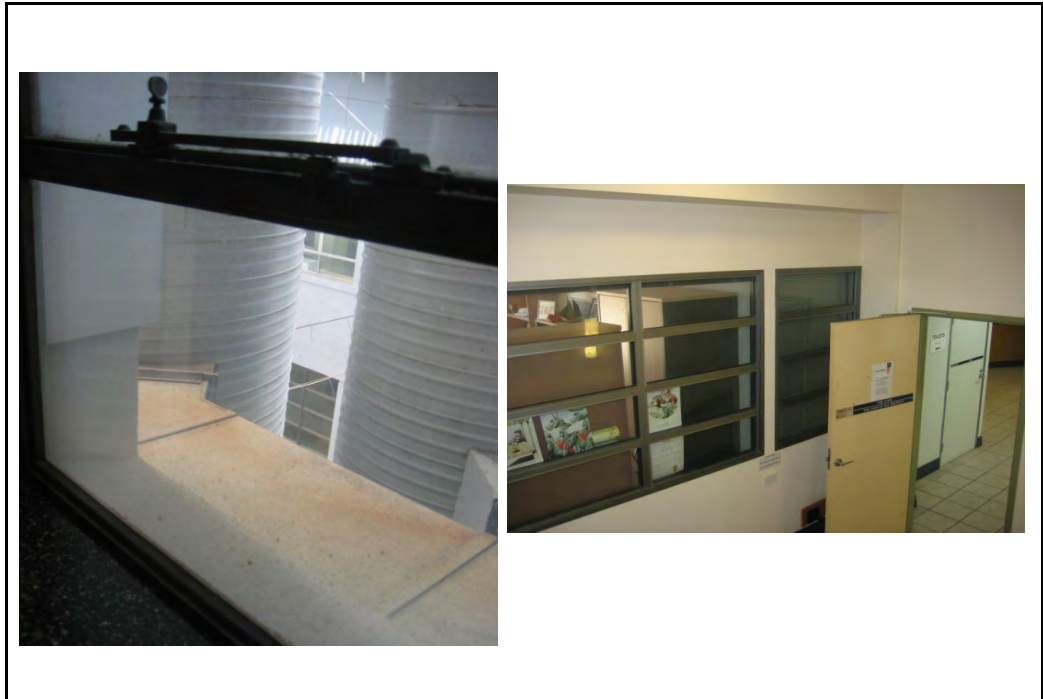
ASSET ELEMENT	WINDOWS
---------------	---------

OVERVIEW	Steel / timber framed casement window to external light well - fair condition, some discolouration to frame, some sealant missing externally. Black stone sill. Anodised aluminium framed glazing to south wall of room 3.35.	
HERITAGE SIGNIFICANCE	Heritage Significance Value of the element	Mixed
	HIGH Original steel window LOW Anodised glazing	
FUNCTIONALITY	Functional

OVERVIEW	Restore original glazing frames and sill as required.
-----------------	---

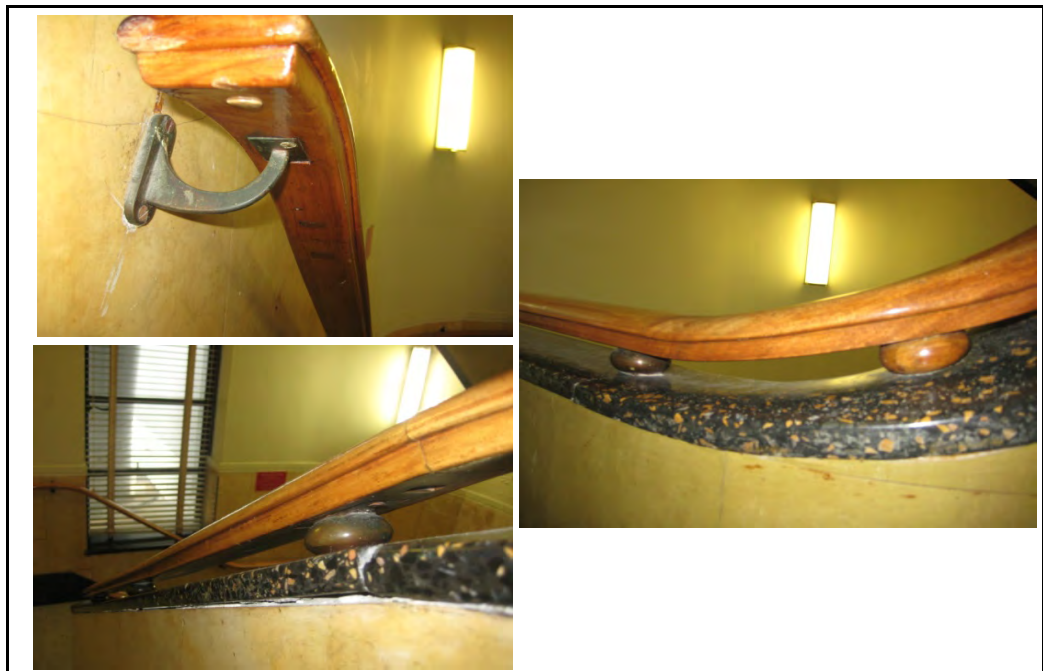
ASSET ELEMENT	FITTINGS
---------------	----------

OVERVIEW	Timber handrail fixed to walls with bronze brackets, fixed to balustrade top with bronze mountings. Good condition. Balustrade rail mountings change to timber at base of stair to level 4. Cracking at underside of stone on balustrade at top of stair / level 3 landing.	
HERITAGE SIGNIFICANCE	Heritage Significance Value of the element	High
FUNCTIONALITY	Functional

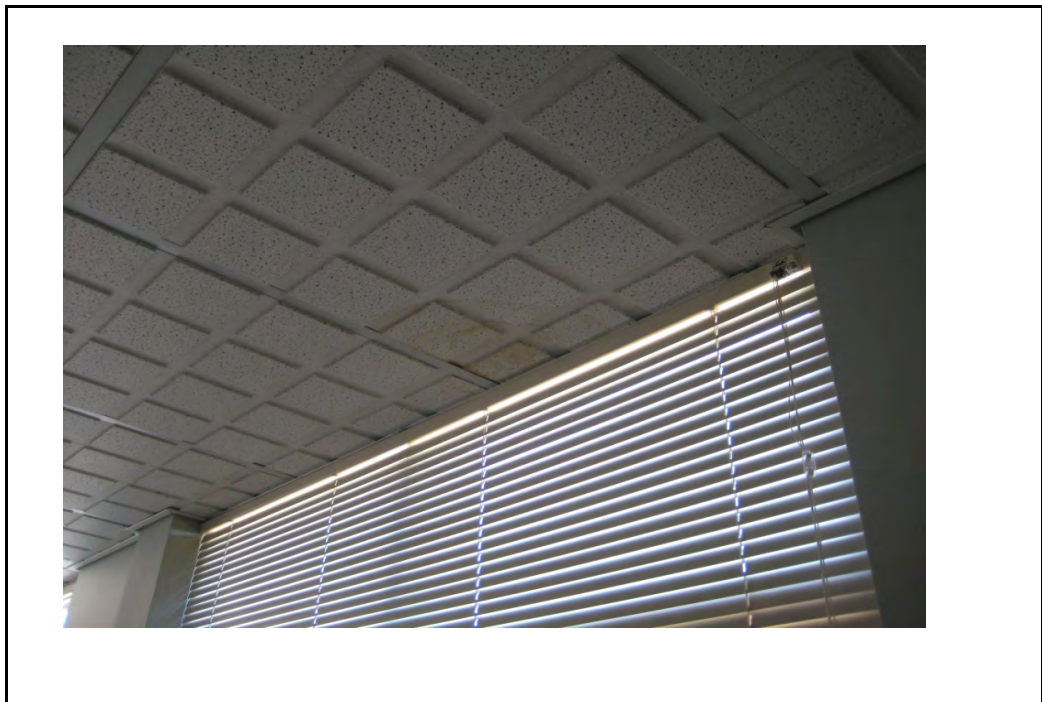
ASSET ELEMENT	CEILING
---------------	---------

OVERVIEW	Suspended ceiling tiles, generally good condition. Some moisture damage to tiles adjacent to window in east wall.	
HERITAGE SIGNIFICANCE	Heritage Significance Value of the element	Low
FUNCTIONALITY	Functional, requiring minor repair.

OVERVIEW	Investigate and rectify source of moisture, replace tiles as required.
----------	--

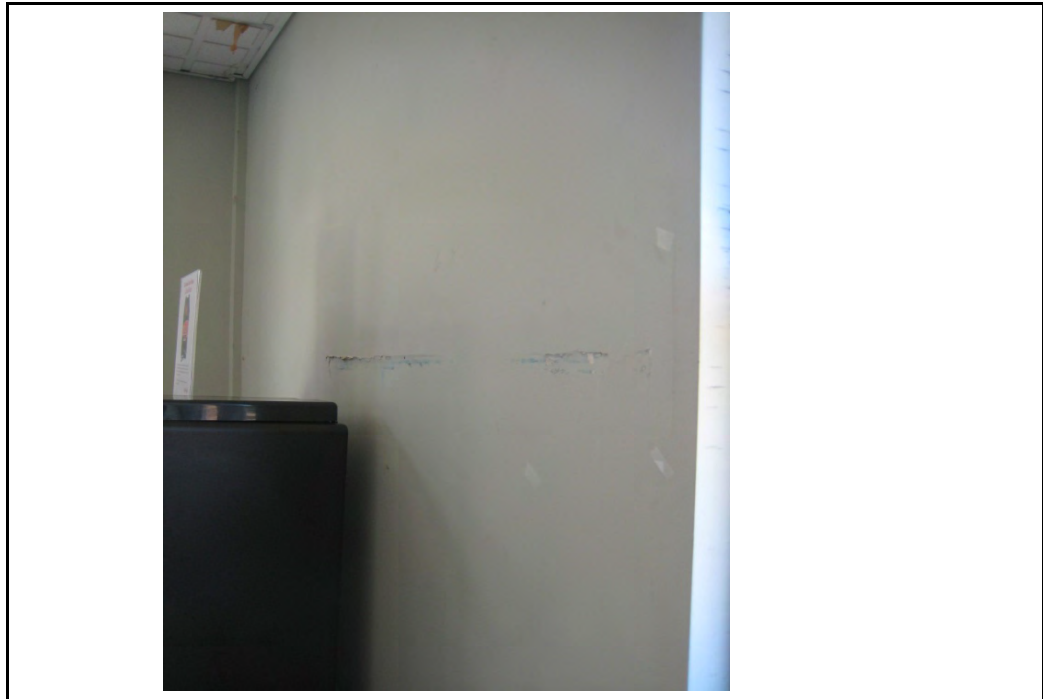
ASSET ELEMENT	WALLS
---------------	-------

OVERVIEW	Plasterboard and paint finish, generally good condition. Scrapes / damage to wall near north east corner of room.	
HERITAGE SIGNIFICANCE	Heritage Significance Value of the element	Low
FUNCTIONALITY	Functional but requiring repair.

OVERVIEW	Repair and restore wall finishes as required
----------	--

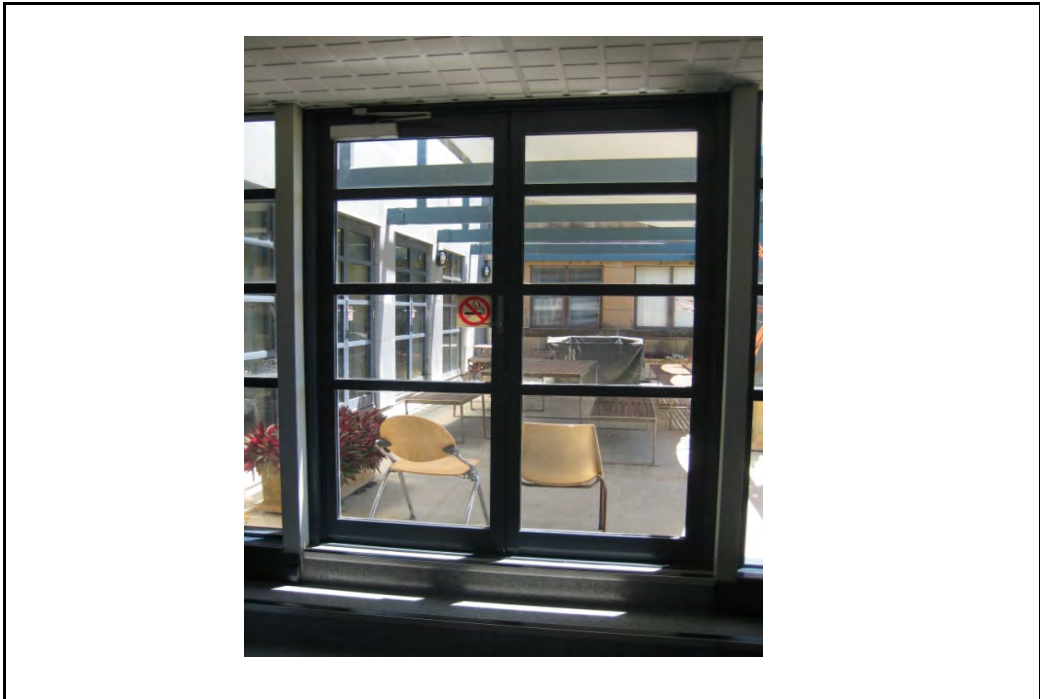
ASSET ELEMENT	DOORS
---------------	-------

EXISTING CONDITION		
OVERVIEW	Painted timber door with aluminium frame to corridor, powdercoated aluminium framed glazed door to terrace (north wall)	
HERITAGE SIGNIFICANCE	Heritage Significance Value of the element	Low
FUNCTIONALITY	Functional	
ACTION REQUIRED		
OVERVIEW

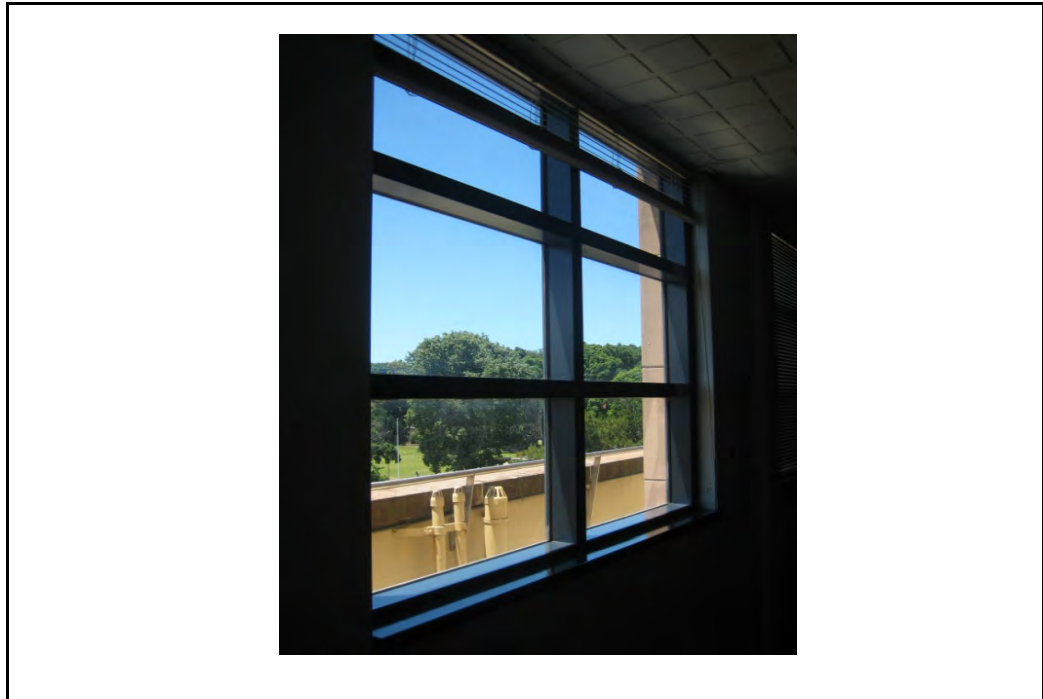
ASSET ELEMENT	WINDOWS
---------------	---------

EXISTING CONDITION		
OVERVIEW	Powdercoated aluminium framed windows, good condition. Painted timber sills.	
HERITAGE SIGNIFICANCE	Heritage Significance Value of the element	Low
FUNCTIONALITY	Functional	
ACTION REQUIRED		
OVERVIEW

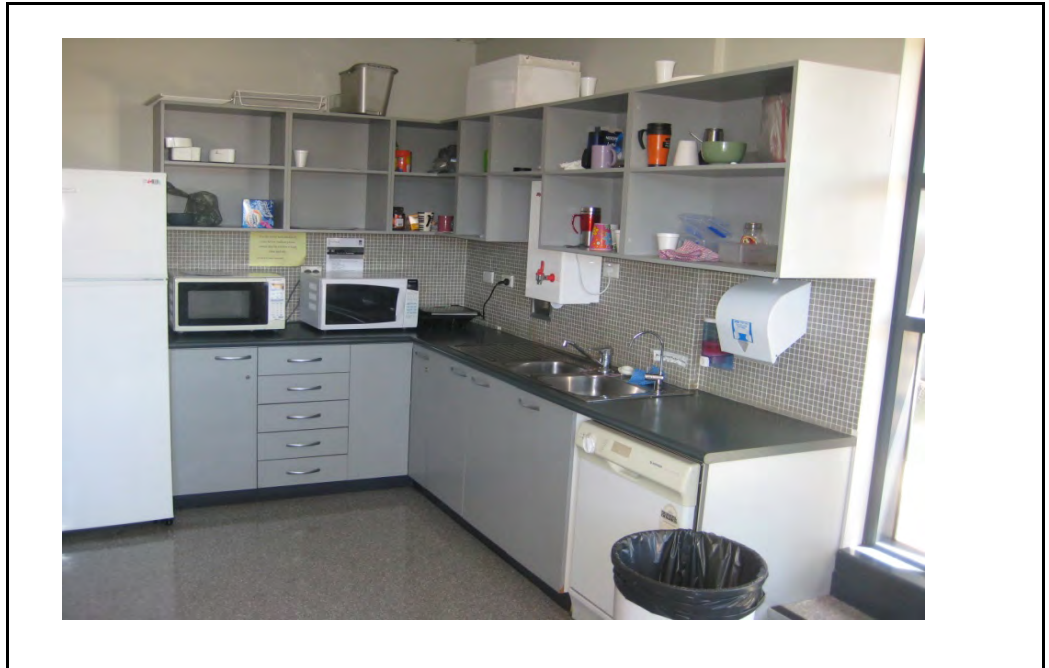
FITTINGS

OVERVIEW	Kitchen fitout, good condition, modern joinery.	
HERITAGE SIGNIFICANCE	Heritage Significance Value of the element	Low
FUNCTIONALITY	Functional

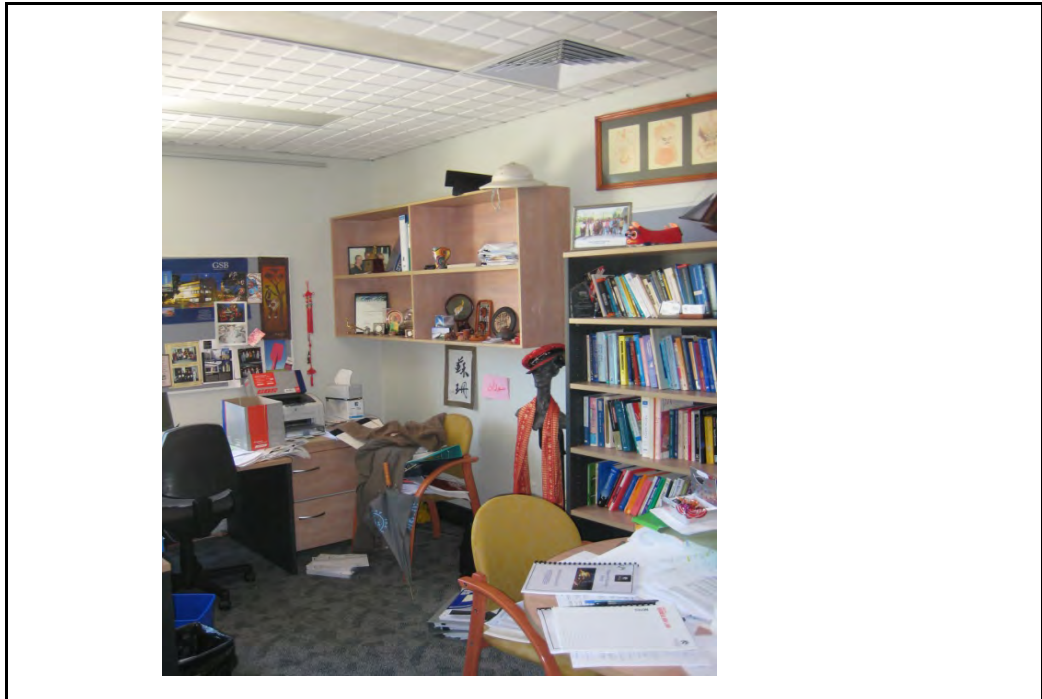
ASSET ELEMENT	FLOOR
---------------	-------

EXISTING CONDITION		
OVERVIEW	Carpet tile flooring, generally good condition.	
HERITAGE SIGNIFICANCE	Heritage Significance Value of the element	Low
	Refers to carpet tiles only, substrate may hold higher significance.	
FUNCTIONALITY	Functional	
ACTION REQUIRED		
OVERVIEW

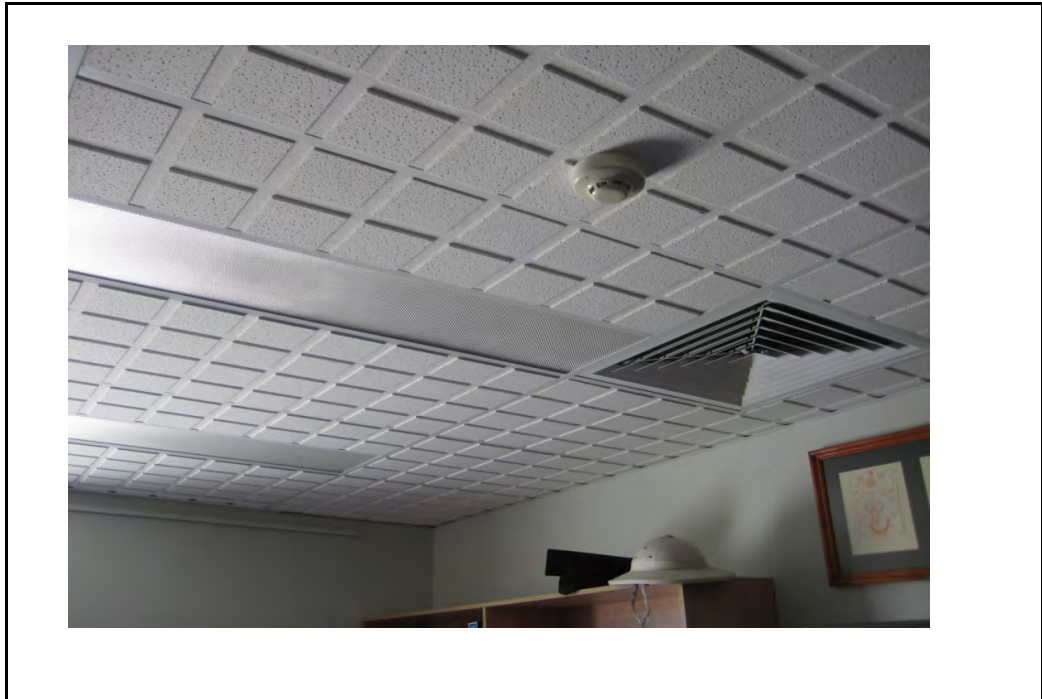
ASSET ELEMENT	CEILING
---------------	---------

OVERVIEW	Suspended ceiling tiles, generally good condition.	
HERITAGE SIGNIFICANCE	Heritage Significance Value of the element	Low
FUNCTIONALITY	Functional

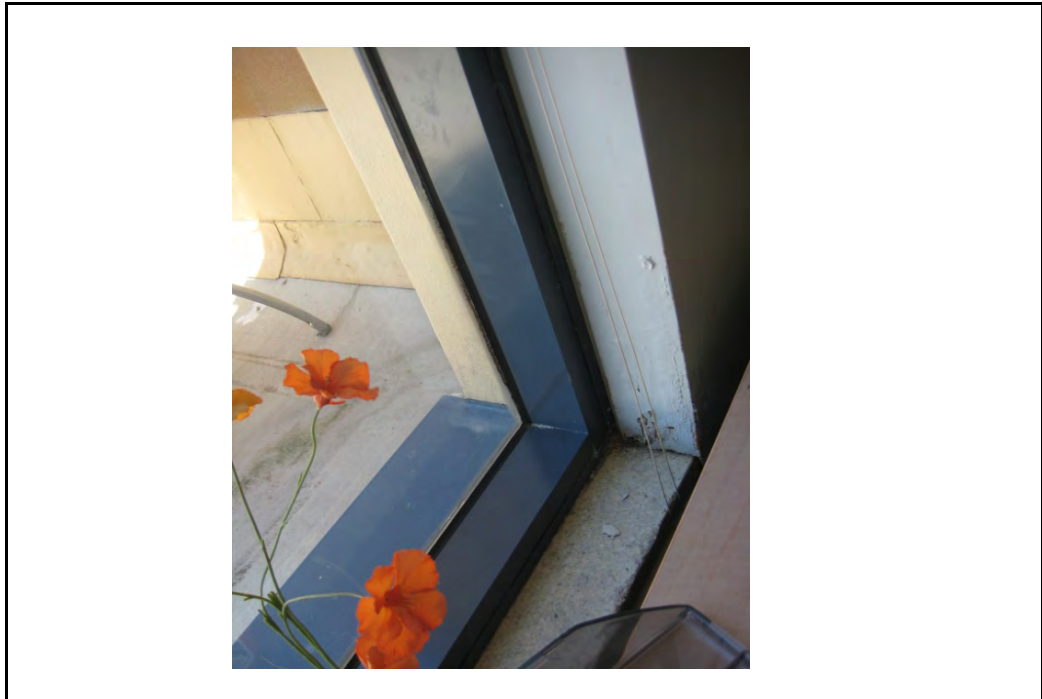
ASSET ELEMENT	WINDOWS
---------------	---------

EXISTING CONDITION		
OVERVIEW	Powdercoated aluminium framed window to south wall, reconstituted stone sill. Good condition. Anodised aluminium framed windows to stair lobby.	
HERITAGE SIGNIFICANCE	Heritage Significance Value of the element	Low
FUNCTIONALITY	Functional	
ACTION REQUIRED		
OVERVIEW

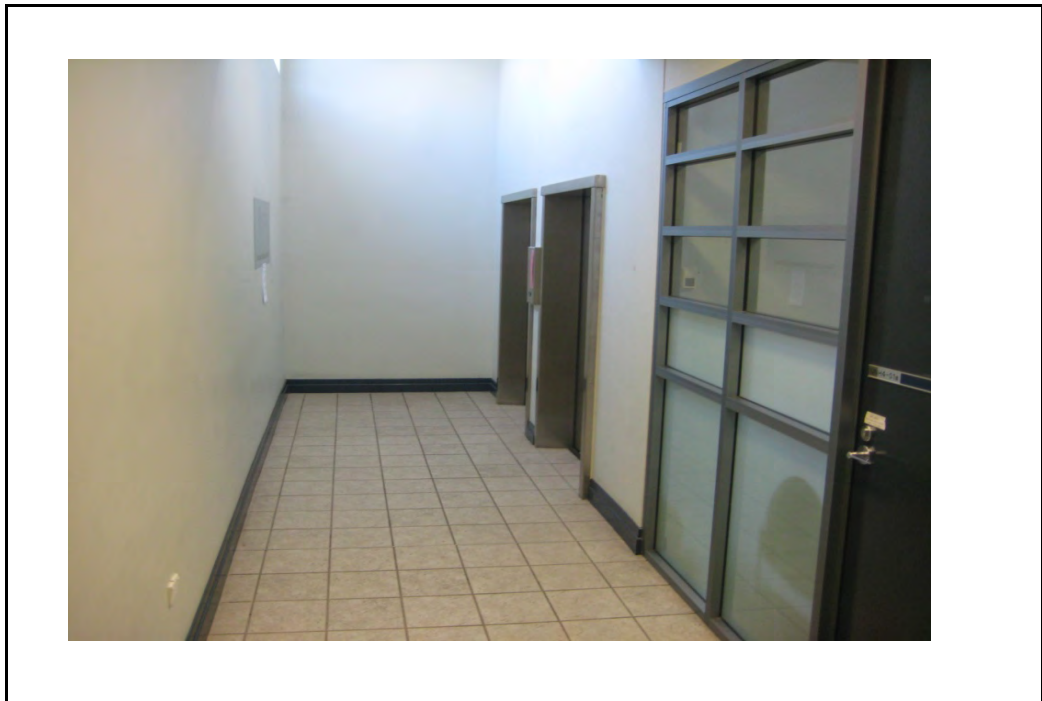
ASSET ELEMENT	FLOOR
---------------	-------

OVERVIEW	Tiles, good condition	
HERITAGE SIGNIFICANCE	Heritage Significance Value of the element	Low
FUNCTIONALITY	Functional.

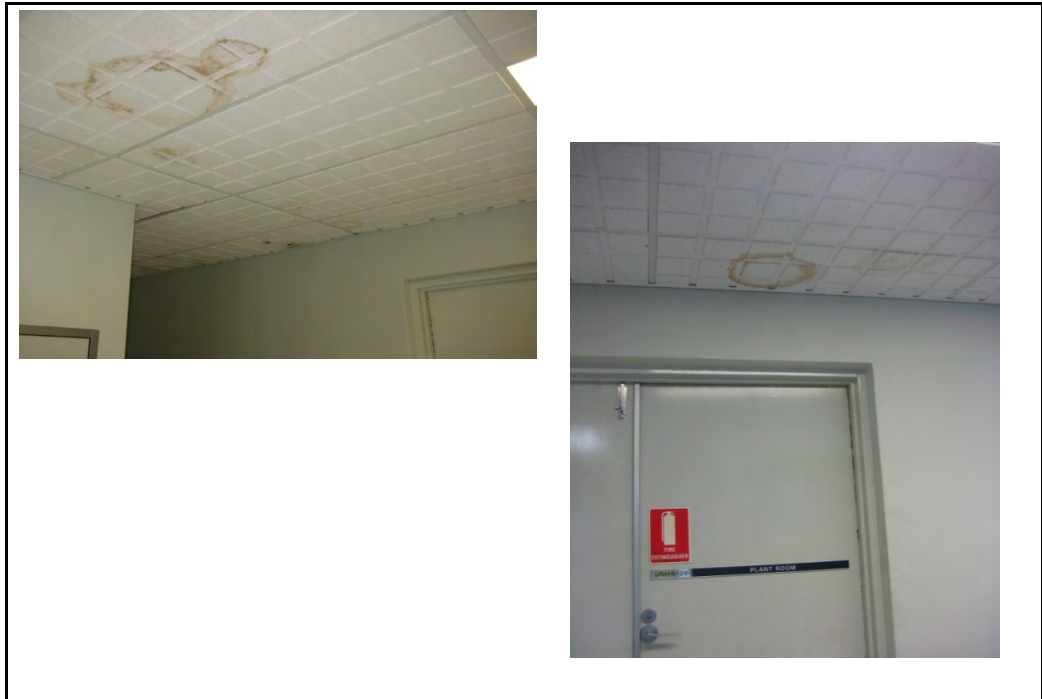
ASSET ELEMENT	CEILING
---------------	---------

EXISTING CONDITION		
OVERVIEW	Suspended ceiling tiles to eastern half of lobby, generally good condition, moisture stains. Plasterboard and paint finish to western end of lobby, good condition.	
HERITAGE SIGNIFICANCE	Heritage Significance Value of the element	Low
FUNCTIONALITY	Functional, requiring minor repair.	
ACTION REQUIRED		
OVERVIEW	Investigate and rectify source of moisture, replace tiles as required.
