UNIVERSITY HOUSE: ROOM DATA SHEETS

ROOM: 2.34,2.35,2.36,2.37,2.38,2.39	UNIVERSITY LEGAL CENTRE OFFICES
--	--

LOCATION: SECOND FLOOR NORTH EAST

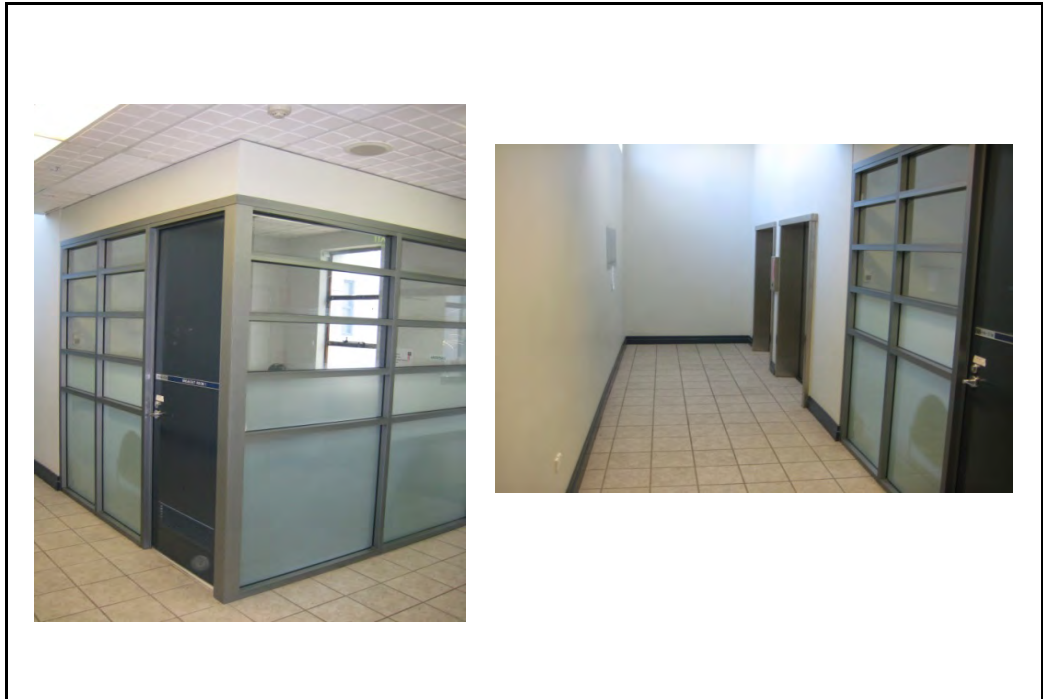
ASSET ELEMENT	WALLS
---------------	-------

OVERVIEW	Render and paint finish to south, west and front of lifts, good condition. Plasterboard and paint finish to eastern end of lobby, anodised aluminium framed glazed walls to room 4.01a. Good condition.	
HERITAGE SIGNIFICANCE	Heritage Significance Value of the element	
	Anodised aluminium framed glazed wall - low.	Low
FUNCTIONALITY	Functional

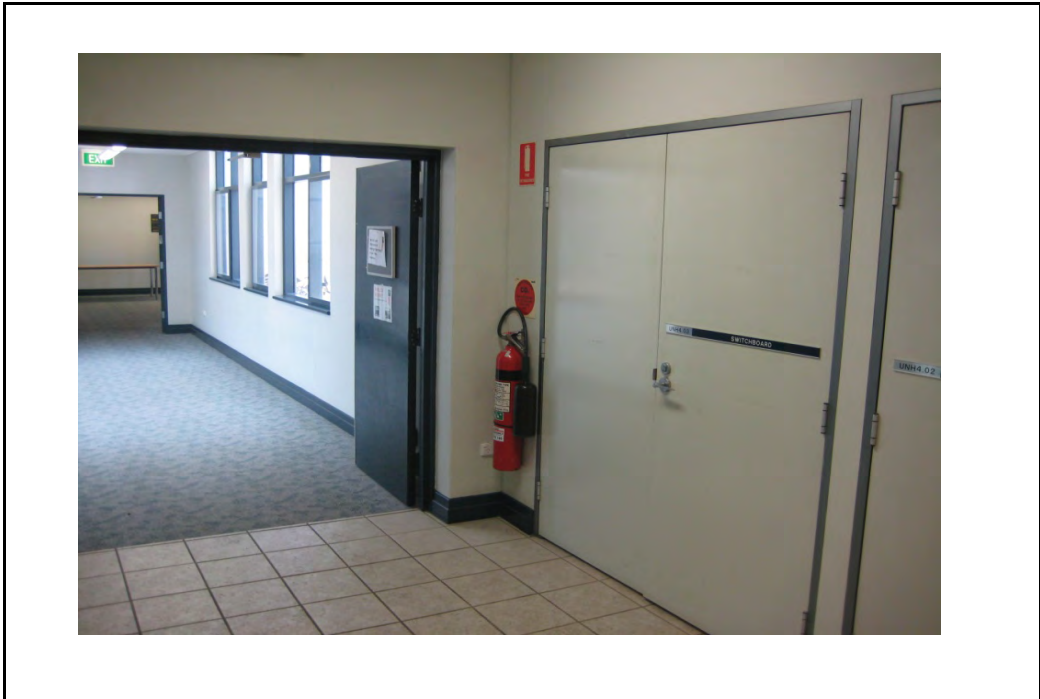
ASSET ELEMENT	DOORS
---------------	-------

EXISTING CONDITION		
OVERVIEW	Painted timber doors. Good condition.	
HERITAGE SIGNIFICANCE	Heritage Significance Value of the element	Low
FUNCTIONALITY	Functional	
ACTION REQUIRED		
OVERVIEW

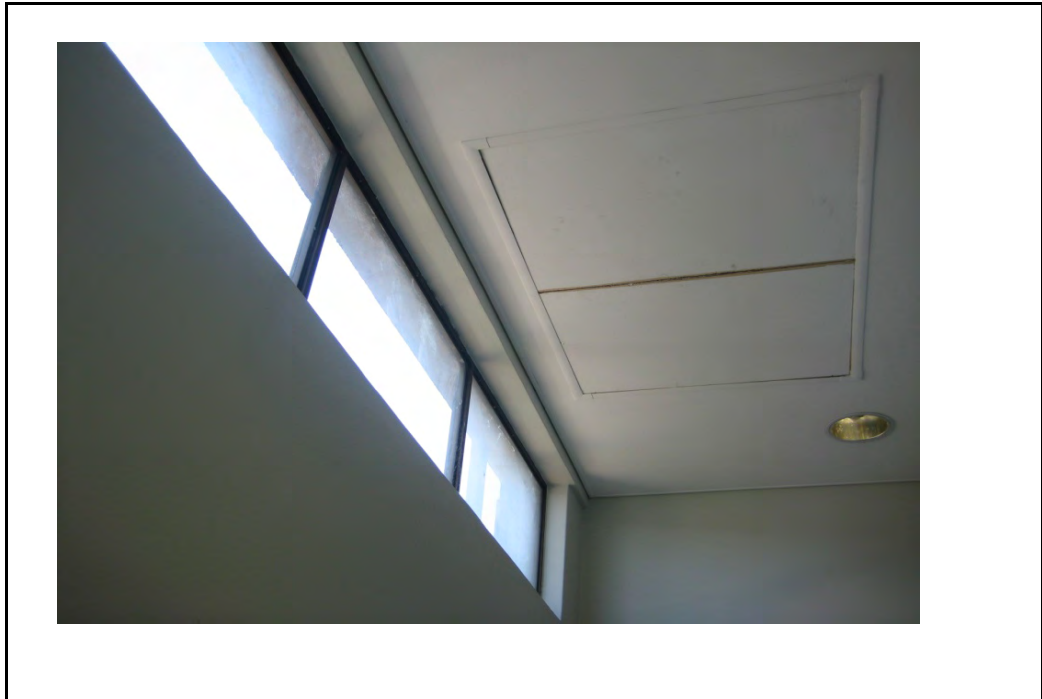
ASSET ELEMENT	WINDOWS
---------------	---------

EXISTING CONDITION		
OVERVIEW	Bronze anodised aluminium framed highlight window on south wall at west end of lobby. Good condition.	
HERITAGE SIGNIFICANCE	Heritage Significance Value of the element	Low
FUNCTIONALITY	Functional	
ACTION REQUIRED		
OVERVIEW

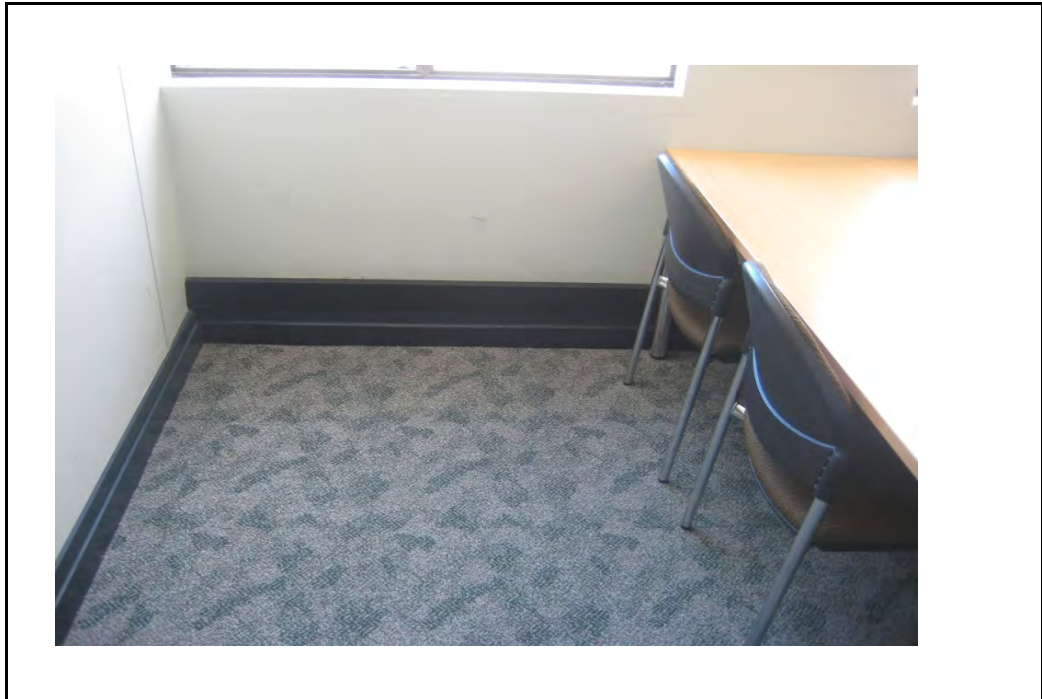
ASSET ELEMENT	FLOOR
---------------	-------

OVERVIEW	Carpet tile, good condition	
HERITAGE SIGNIFICANCE	Heritage Significance Value of the element	Low
	Refers to carpet tiles only, substrate may hold higher significance.	
FUNCTIONALITY	Functional.

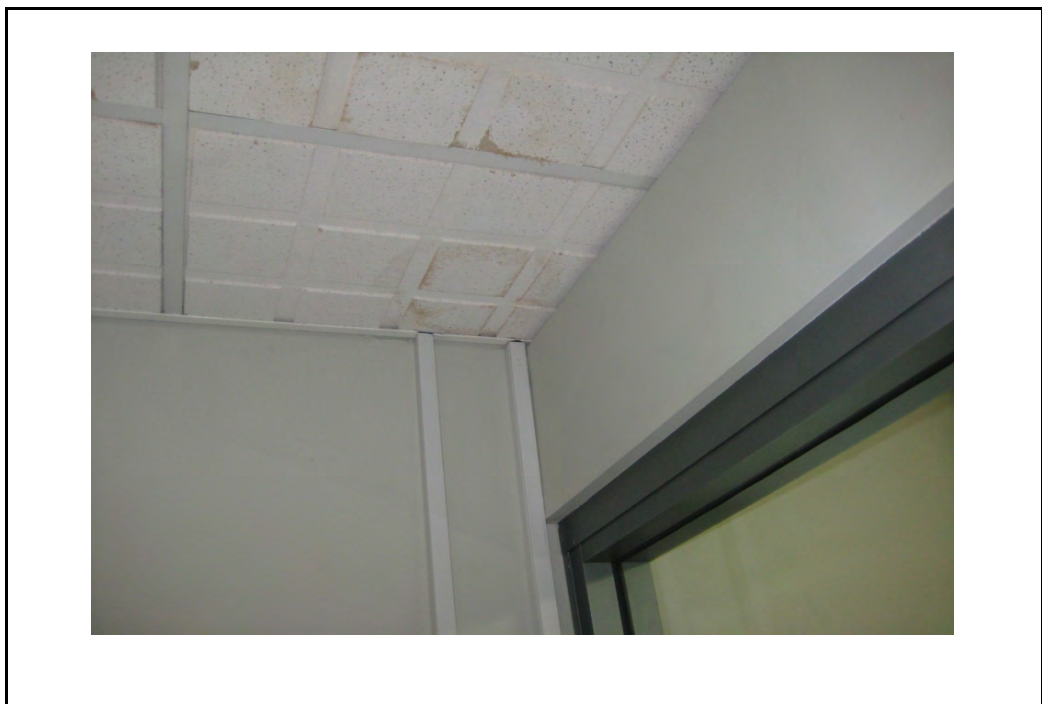
ASSET ELEMENT	CEILING
---------------	---------

OVERVIEW	Suspended ceiling tiles, generally good condition. Some moisture stains in north east corner of room	
HERITAGE SIGNIFICANCE	Heritage Significance Value of the element	Low
FUNCTIONALITY	Functional, requiring repair

OVERVIEW	Investigate and rectify source of moisture, replace tiles as required.
----------	--

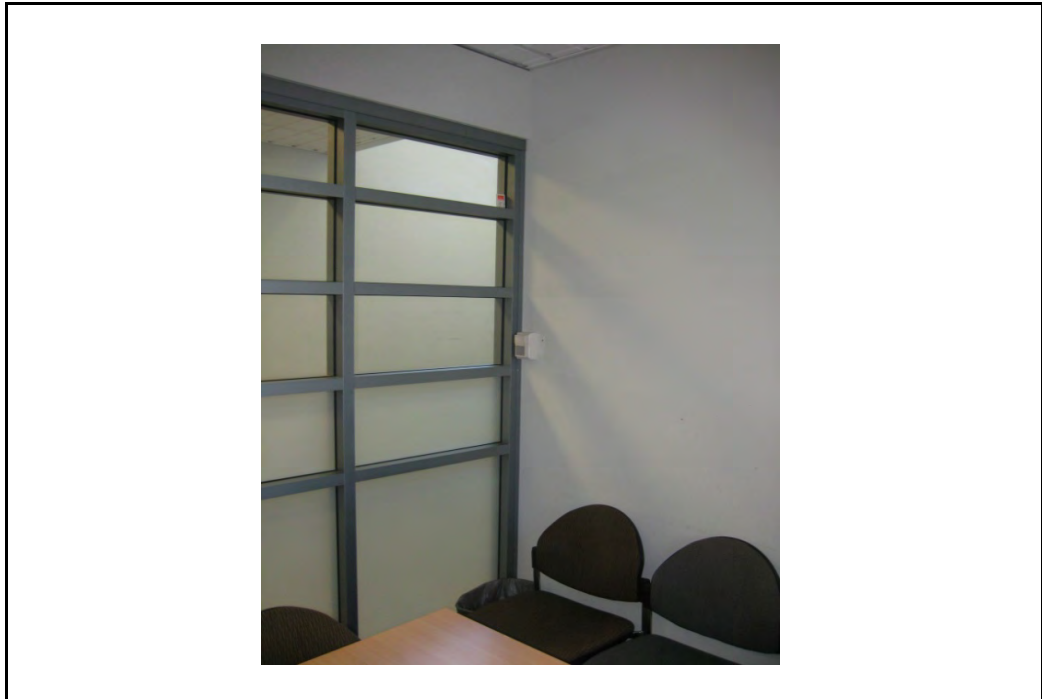
ASSET ELEMENT	WALLS
---------------	-------

OVERVIEW	Render and paint finish. Generally good condition, some scuff marks. Anodised aluminium framed glazed walls to east and south of room. Good condition.	
HERITAGE SIGNIFICANCE	Heritage Significance Value of the element	
	North, west walls only	High
FUNCTIONALITY	Functional

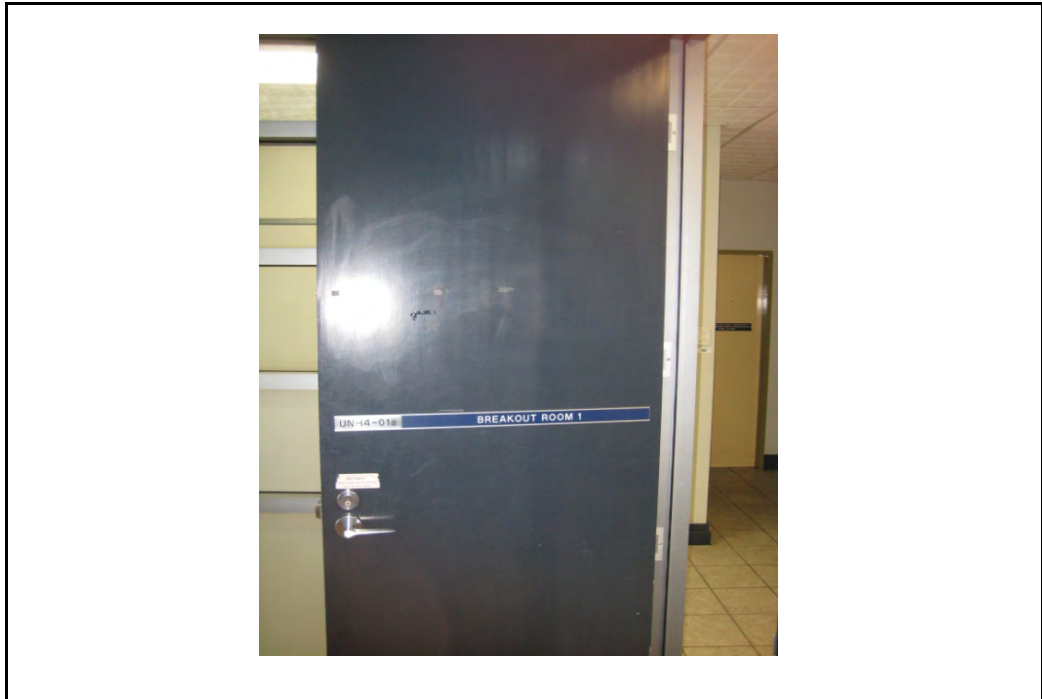
ASSET ELEMENT	DOORS
---------------	-------

EXISTING CONDITION		
OVERVIEW	Painted timber door. Good condition, some marks.	
HERITAGE SIGNIFICANCE	Heritage Significance Value of the element	Low
FUNCTIONALITY	Functional	
ACTION REQUIRED		
OVERVIEW

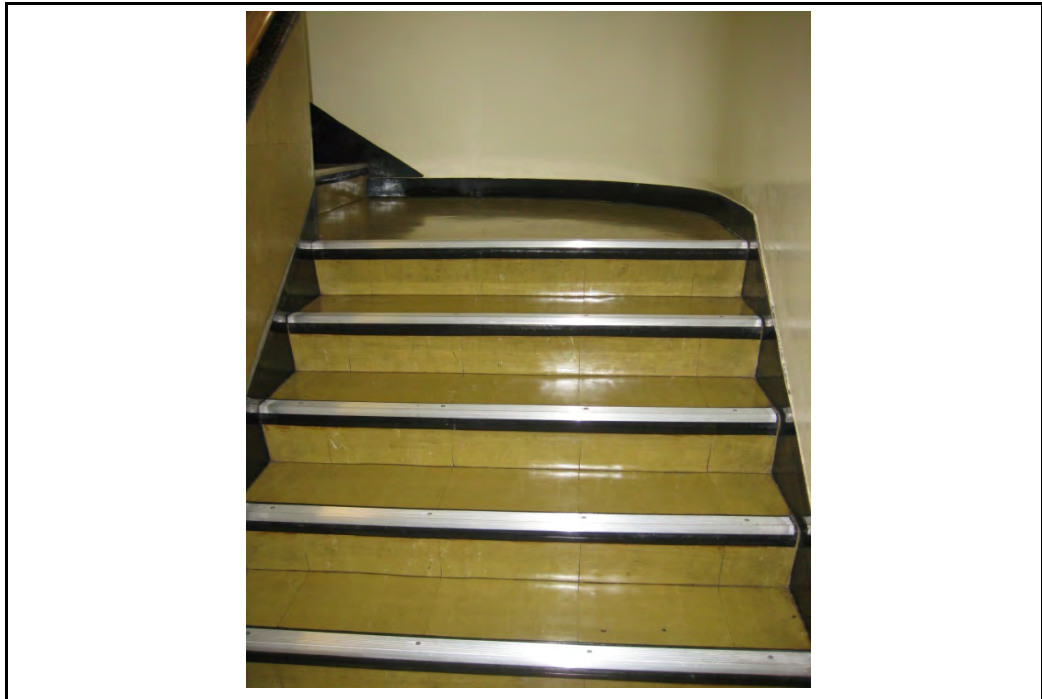
ASSET ELEMENT	FLOOR
---------------	-------

EXISTING CONDITION		
OVERVIEW	Vinyl flooring to treads, risers and intermediate and top landings. Generally good condition.	
HERITAGE SIGNIFICANCE	Heritage Significance Value of the element	High
FUNCTIONALITY	Functional.	
ACTION REQUIRED		
OVERVIEW

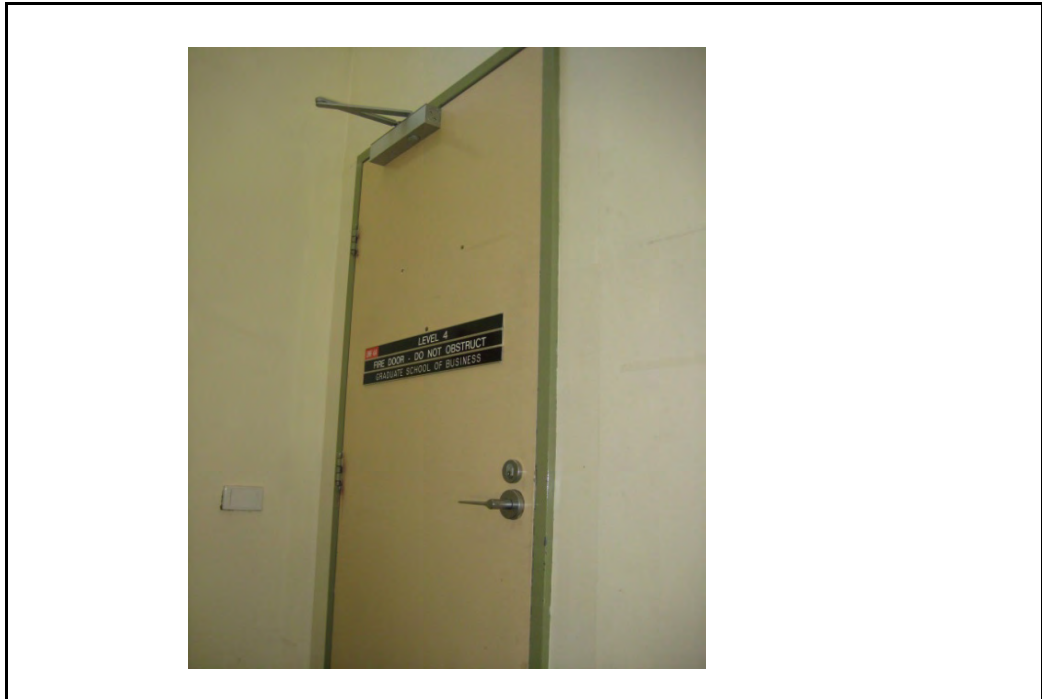
ASSET ELEMENT	DOORS
---------------	-------

EXISTING CONDITION		
OVERVIEW	Painted timber with painted steel frame. Good condition.	
HERITAGE SIGNIFICANCE	Heritage Significance Value of the element	Low
FUNCTIONALITY	Functional	
ACTION REQUIRED		
OVERVIEW

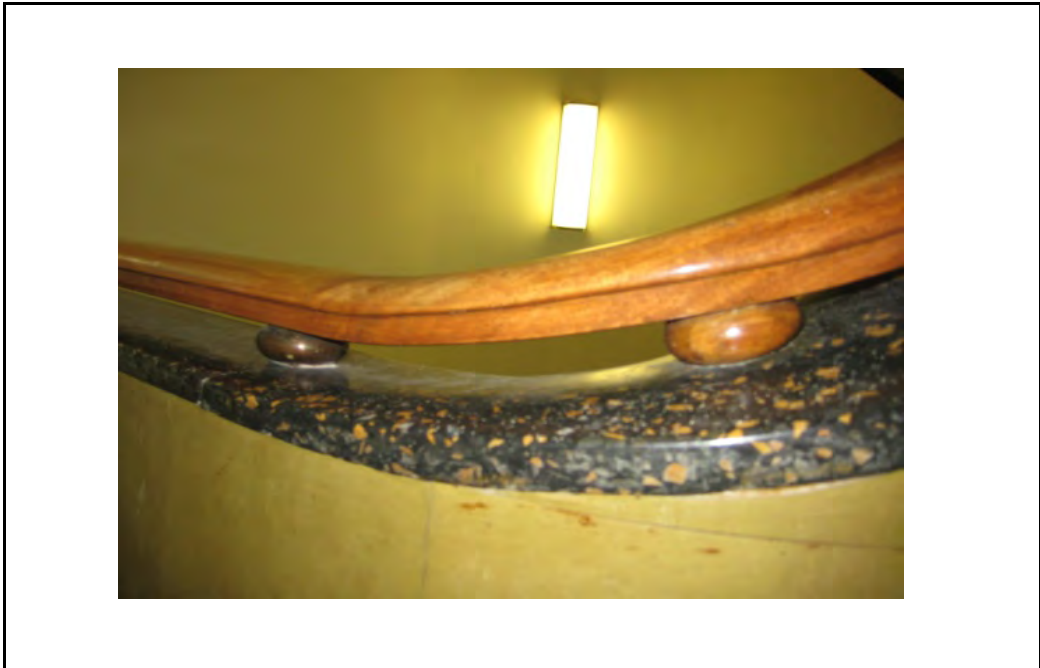
ASSET ELEMENT	FITTINGS
---------------	----------

OVERVIEW	Timber handrail fixed to balustrade top with timber mountings. Good condition.	
HERITAGE SIGNIFICANCE	Heritage Significance Value of the element	High
FUNCTIONALITY	Functional

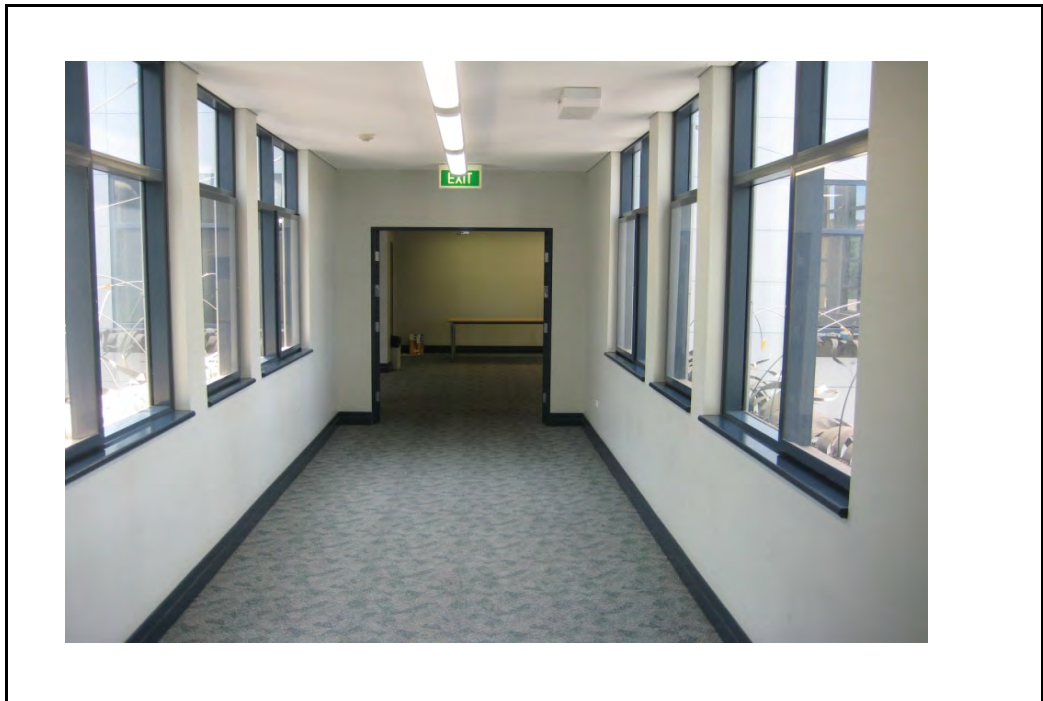
ASSET ELEMENT	FLOOR
---------------	-------

OVERVIEW	Carpet tile, good condition	
HERITAGE SIGNIFICANCE	Heritage Significance Value of the element	Low
FUNCTIONALITY	Functional.

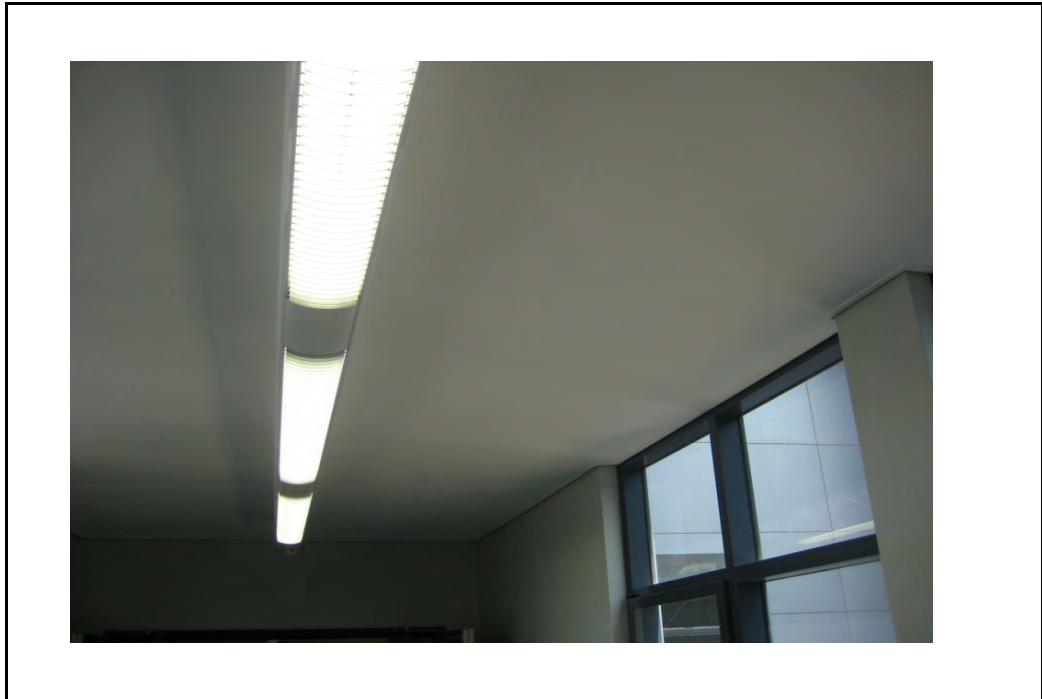
ASSET ELEMENT	CEILING
---------------	---------

OVERVIEW	Plasterboard and paint finish, good condition.	
HERITAGE SIGNIFICANCE	Heritage Significance Value of the element	Low
FUNCTIONALITY	Functional

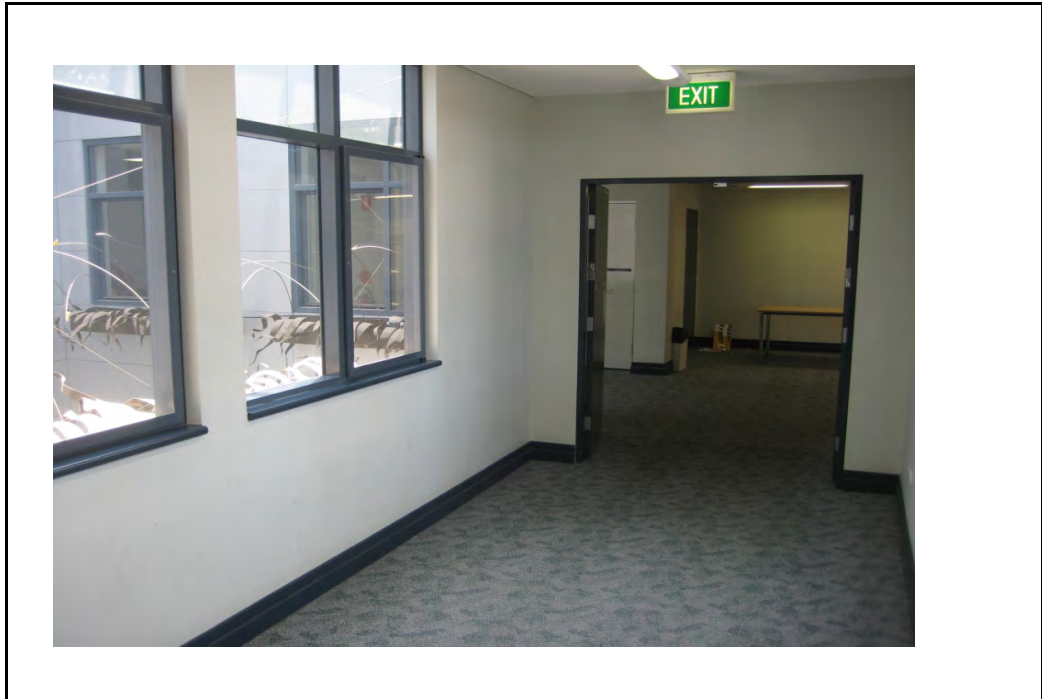
ASSET ELEMENT	WALLS
---------------	-------

OVERVIEW	Plasterboard and paint finish. Good condition.	
HERITAGE SIGNIFICANCE	Heritage Significance Value of the element	Low
FUNCTIONALITY	Functional

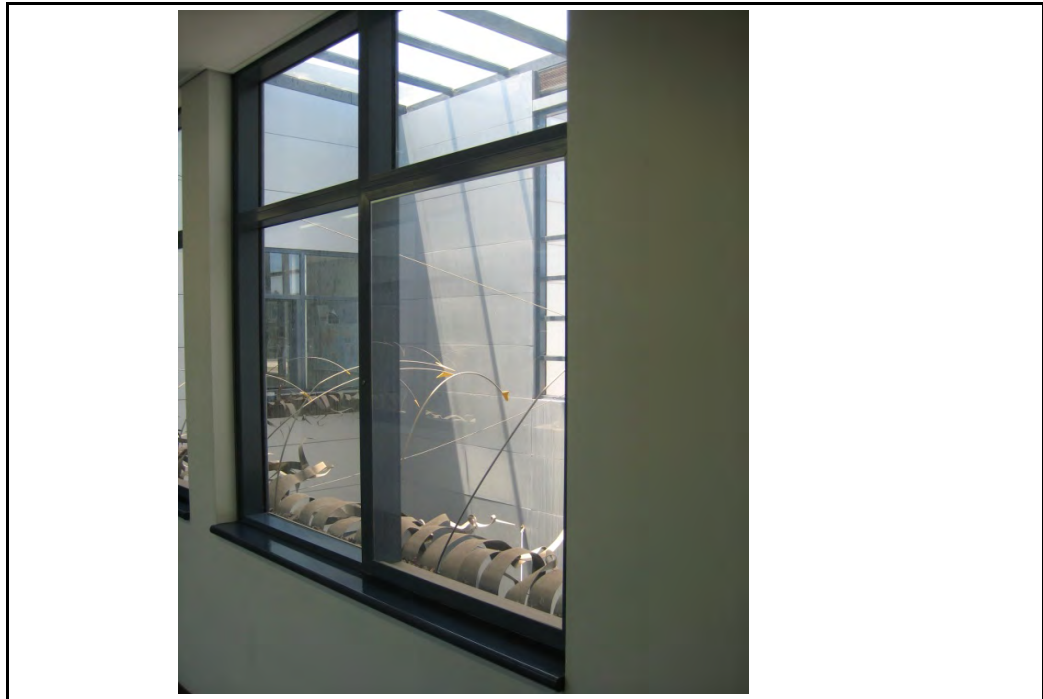
ASSET ELEMENT	WINDOWS
---------------	---------

EXISTING CONDITION		
OVERVIEW	Powdercoated aluminium framed windows each side of passageway. Good condition.	
HERITAGE SIGNIFICANCE	Heritage Significance Value of the element	Low
FUNCTIONALITY	Functional	
ACTION REQUIRED		
OVERVIEW

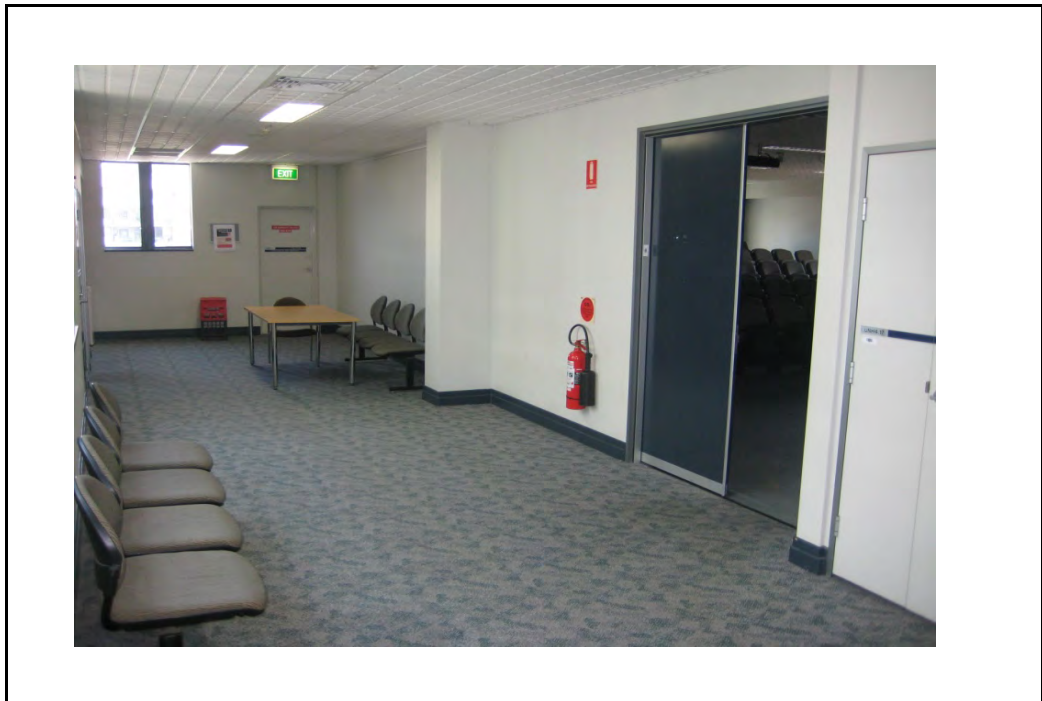
ASSET ELEMENT	FLOOR
---------------	-------

OVERVIEW	Carpet tile, good condition	
HERITAGE SIGNIFICANCE	Heritage Significance Value of the element	Low
FUNCTIONALITY	Functional.

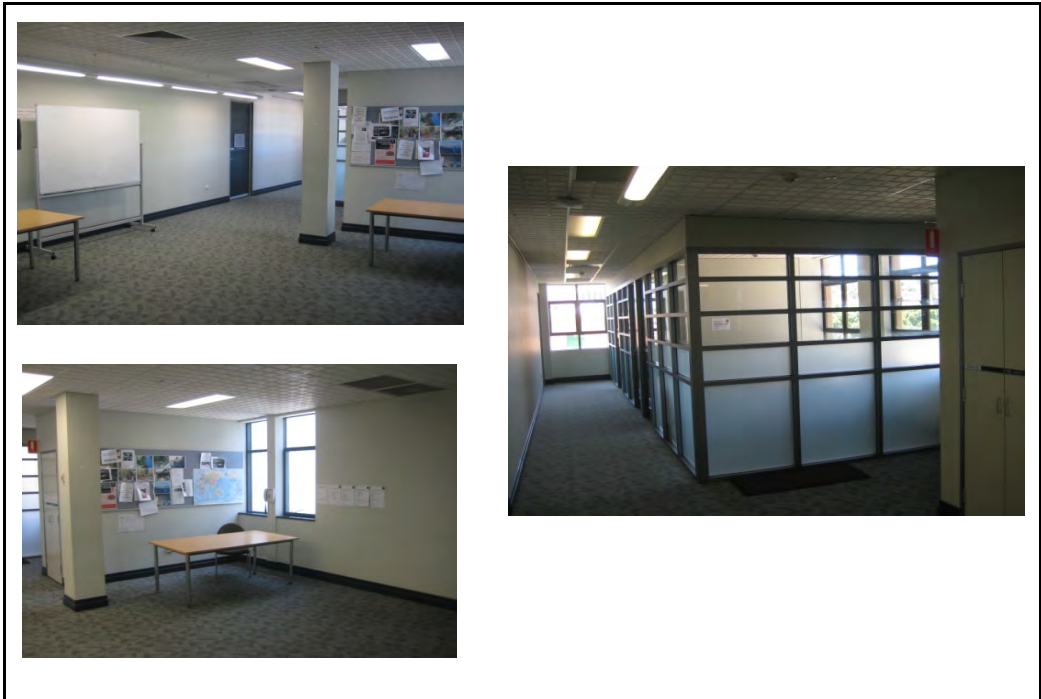
ASSET ELEMENT	WALLS
----------------------	--------------

EXISTING CONDITION		
OVERVIEW	Plasterboard and paint finish. Good condition. Anodised aluminium framed glazed walls to breakout rooms at eastern end. Good condition.	
HERITAGE SIGNIFICANCE	Heritage Significance Value of the element	Low
FUNCTIONALITY	Functional	
ACTION REQUIRED		
OVERVIEW

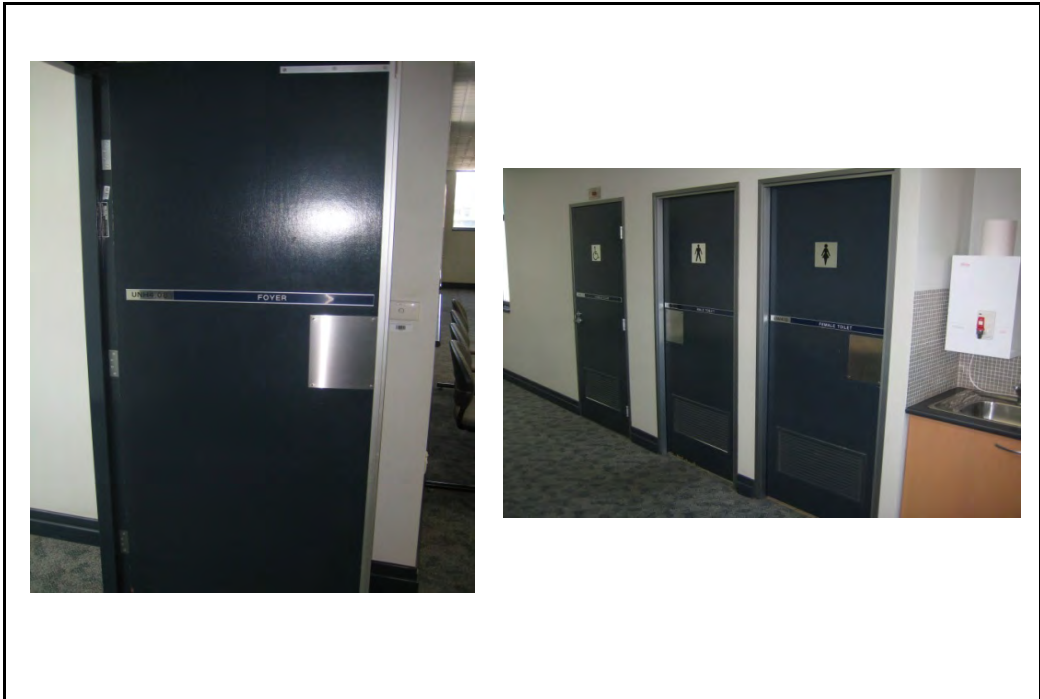
ASSET ELEMENT	DOORS
---------------	-------

EXISTING CONDITION		
OVERVIEW	Painted timber doors. Good condition.	
HERITAGE SIGNIFICANCE	Heritage Significance Value of the element	Low
FUNCTIONALITY	Functional	
ACTION REQUIRED		
OVERVIEW

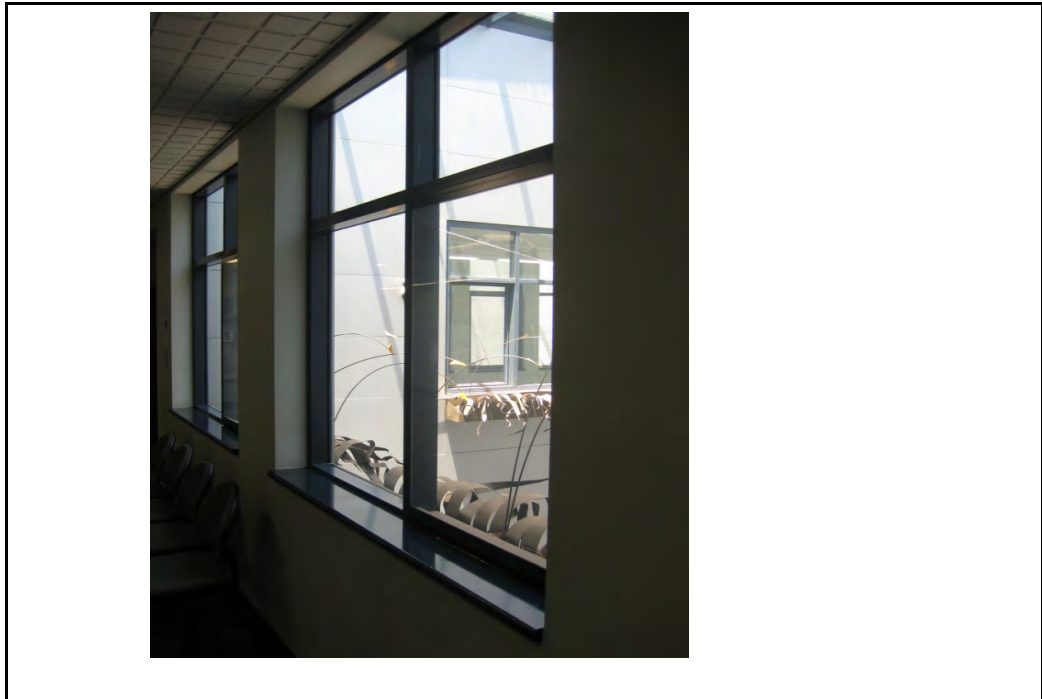
ASSET ELEMENT	WINDOWS
---------------	---------

EXISTING CONDITION		
OVERVIEW	Powdercoated aluminium framed windows with painted timber sills. Good condition. Bronze anodised aluminium framed window, painted plasterboard sill at eastern end. Good condition.	
HERITAGE SIGNIFICANCE	Heritage Significance Value of the element	Low
FUNCTIONALITY	Functional	
ACTION REQUIRED		
OVERVIEW

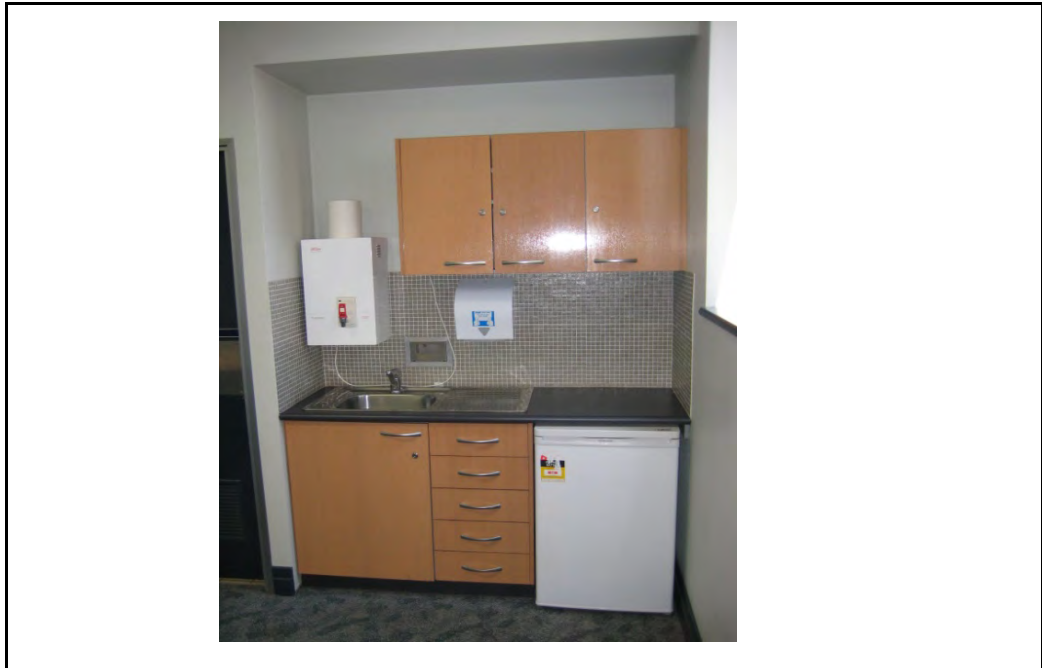
ASSET ELEMENT	FITTINGS
---------------	----------

EXISTING CONDITION		
OVERVIEW	Kitchenette fitout at western end of room. Good condition.	
HERITAGE SIGNIFICANCE	Heritage Significance Value of the element	Low
FUNCTIONALITY	Functional	
ACTION REQUIRED		
OVERVIEW

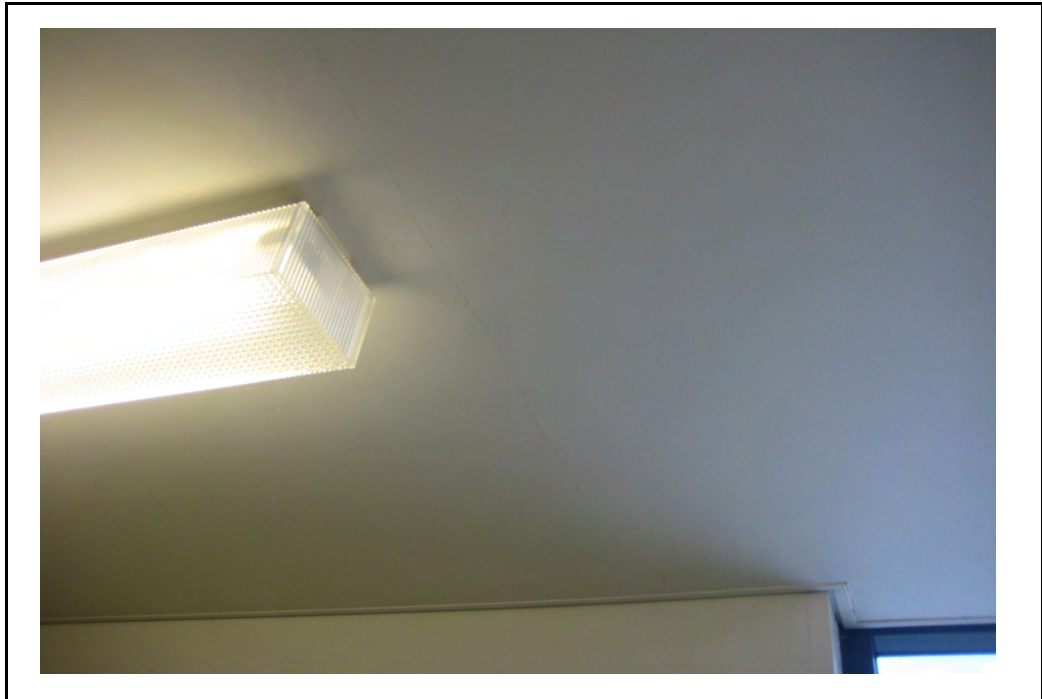
ASSET ELEMENT	CEILING
---------------	---------

OVERVIEW	Plasterboard and paint finish - generally good condition. Cracking perpendicular to western wall in room 4.13.	
HERITAGE SIGNIFICANCE	Heritage Significance Value of the element	Low
FUNCTIONALITY	Functional, requiring repair

OVERVIEW	Repair and repaint as required.
----------	---------------------------------

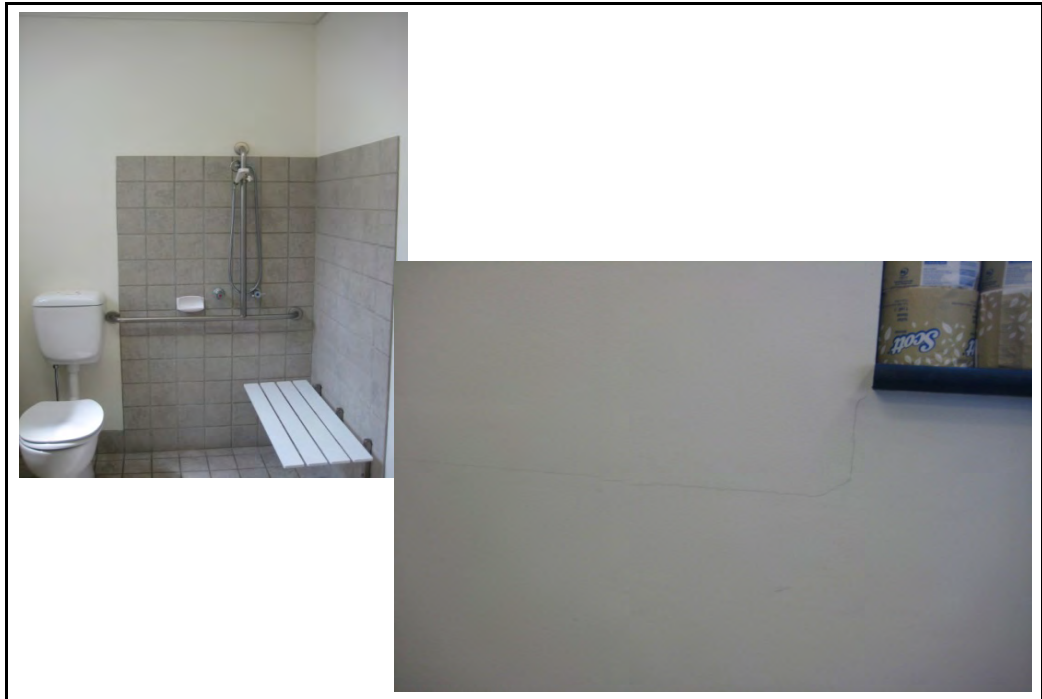
ASSET ELEMENT	WALLS
---------------	-------

EXISTING CONDITION		
OVERVIEW	Fibre cement sheeting, paint finish, with skirting tile. Wall tiles to approx. 1200 AFFL at urinals in room 4.11, tiles to approx 1800 AFFL for shower in room 4.09, splashback tiles at vanities. Generally good condition, narrow crack at lower left corner of window in room 4.13.	
HERITAGE SIGNIFICANCE	Heritage Significance Value of the element	Low
FUNCTIONALITY	Functional, requiring minor repairs	
ACTION REQUIRED		
OVERVIEW	Repair and restore wall finishes as required

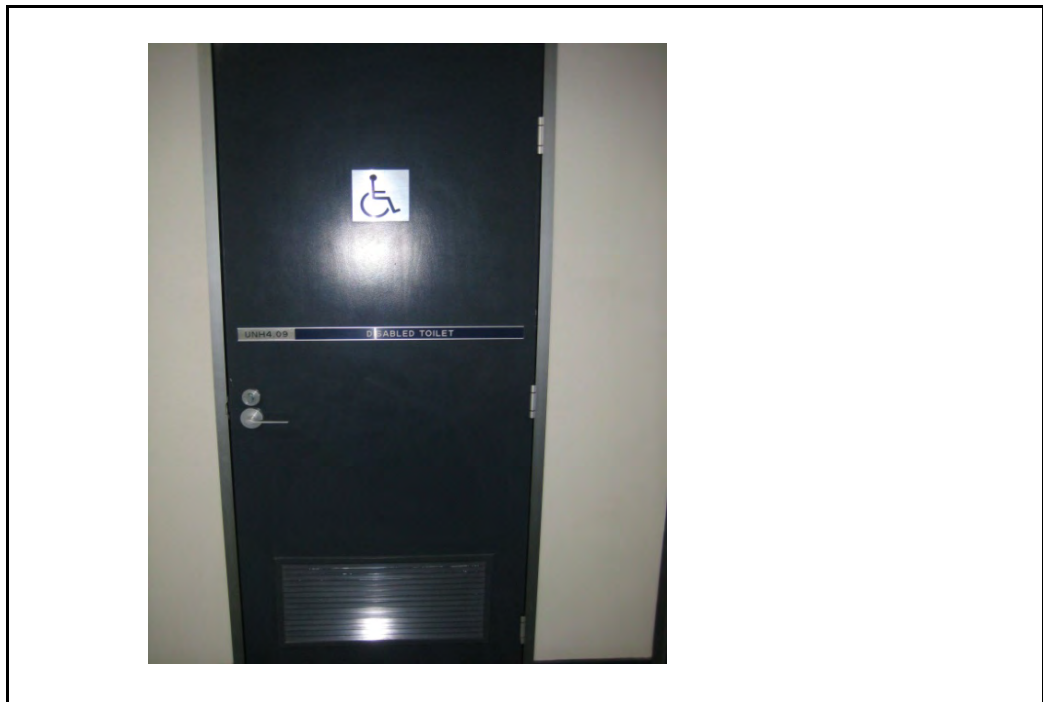
ASSET ELEMENT	DOORS
---------------	-------

OVERVIEW	Painted timber doors, good condition.	
HERITAGE SIGNIFICANCE	Heritage Significance Value of the element	Low
FUNCTIONALITY	Functional.

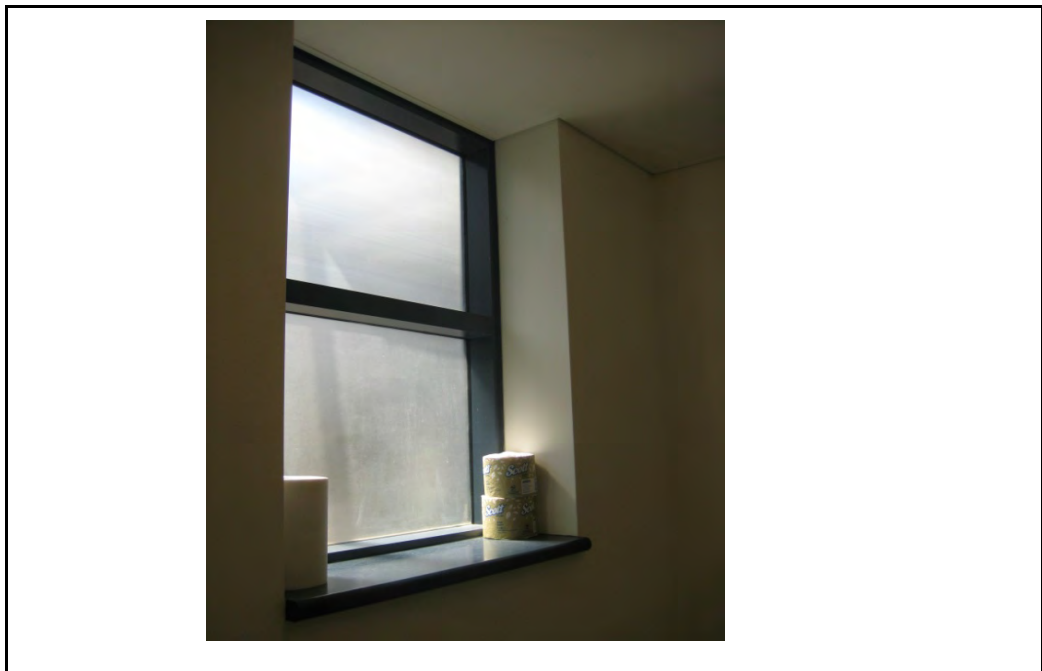
ASSET ELEMENT	WINDOWS
---------------	---------

OVERVIEW	Powdercoated aluminium framed windows to rooms 4.09, 4.11 and 4.13. Painted timber sills. Generally good condition.	
HERITAGE SIGNIFICANCE	Heritage Significance Value of the element	Low
FUNCTIONALITY	Functional.

OVERVIEW	Repair and repaint sill as required.
----------	--------------------------------------

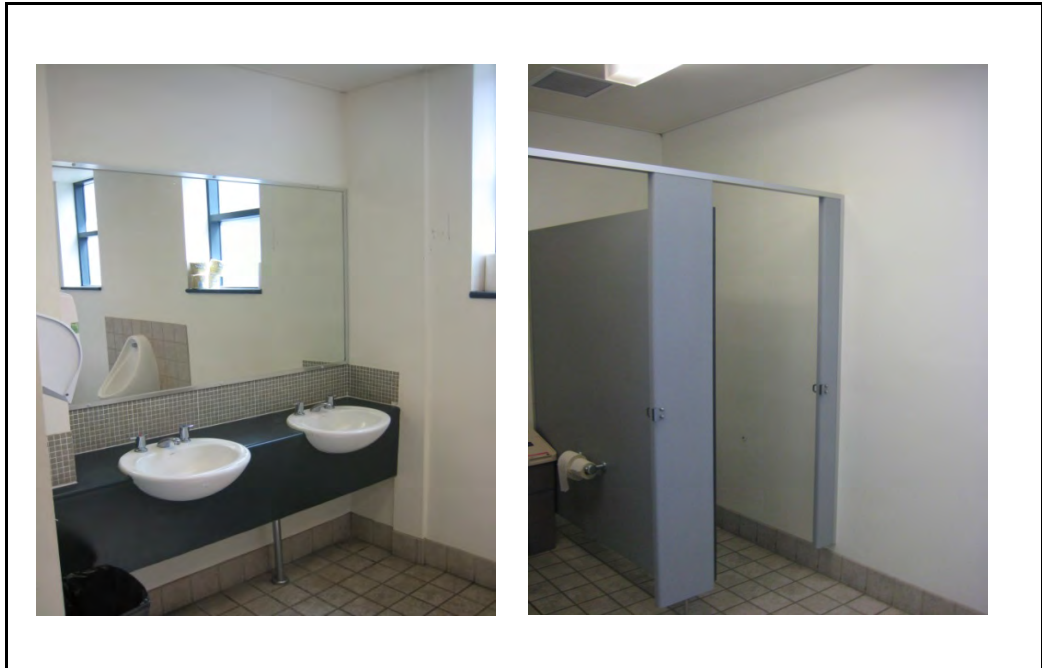
ASSET ELEMENT	FITTINGS
---------------	----------

EXISTING CONDITION		
OVERVIEW	Modern laminated toilet partitions, vanity bench and sanitary fittings. Good condition.	
HERITAGE SIGNIFICANCE	Heritage Significance Value of the element	Low
FUNCTIONALITY	Functional	
ACTION REQUIRED		
OVERVIEW

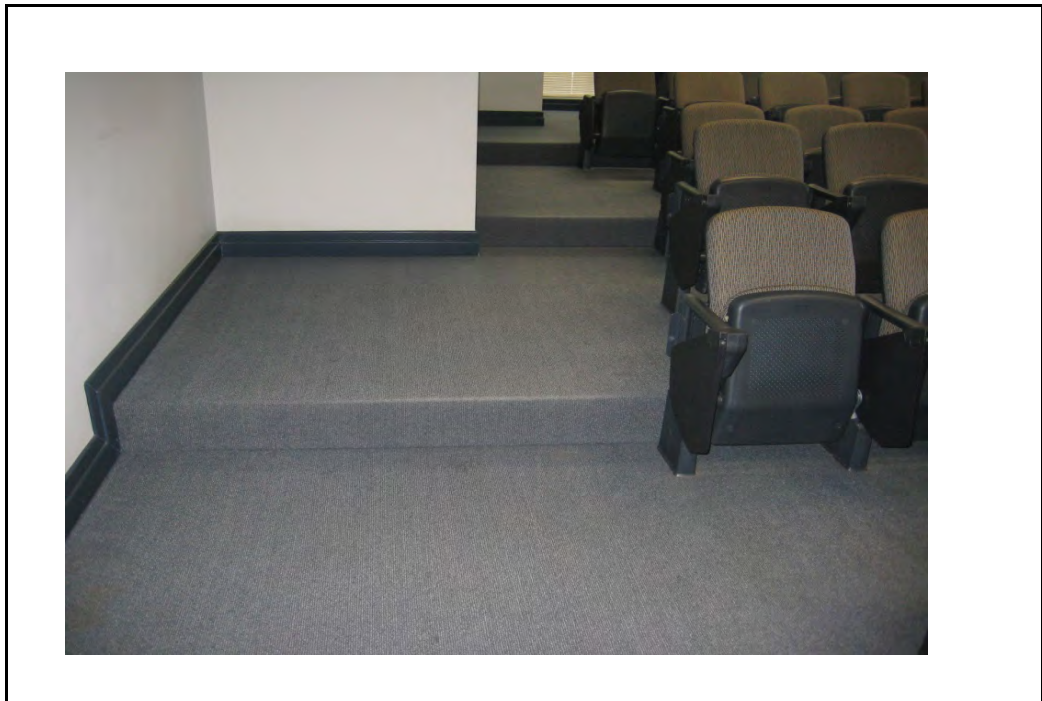
ASSET ELEMENT	FLOOR
---------------	-------

OVERVIEW	Carpet, generally good condition	
HERITAGE SIGNIFICANCE	Heritage Significance Value of the element	Low
FUNCTIONALITY	Functional.

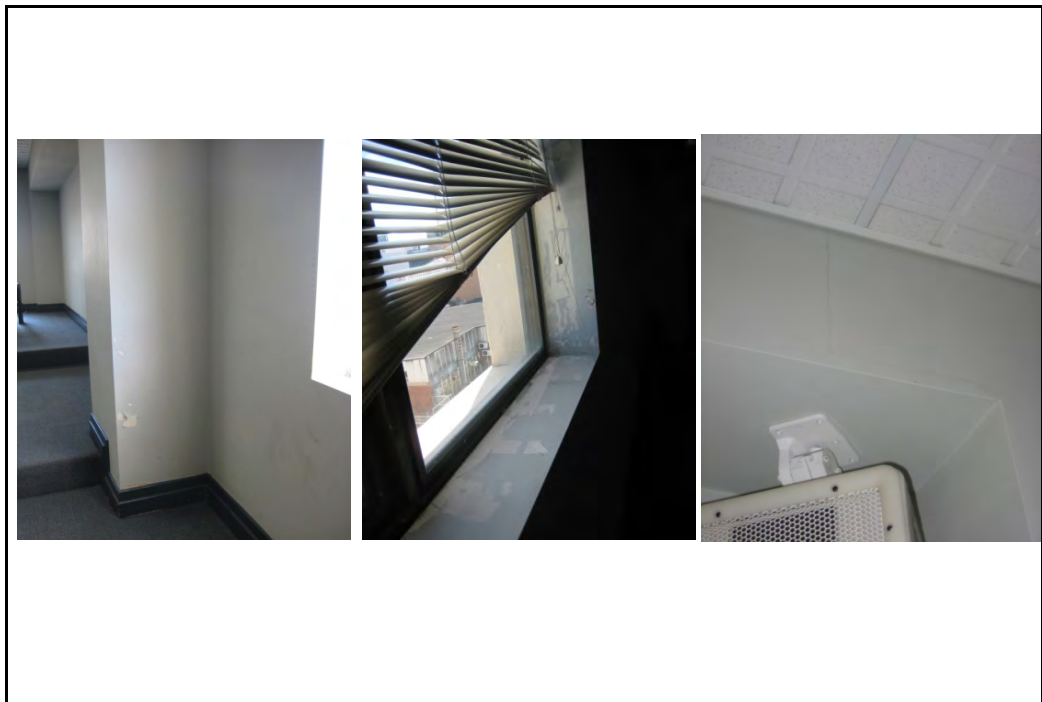
ASSET ELEMENT	WALLS
---------------	-------

OVERVIEW	Plasterboard and paint finish. Generally fair - good condition, some scuff marks, paint peeling on column on northern wall, paint peeling, missing at window reveals and sills. Minor cracking at bulkhead on north wall, toward eastern end.	
HERITAGE SIGNIFICANCE	Heritage Significance Value of the element	Low
FUNCTIONALITY	Functional, requiring minor repair

OVERVIEW	Repair wall finishes as required.
----------	-----------------------------------

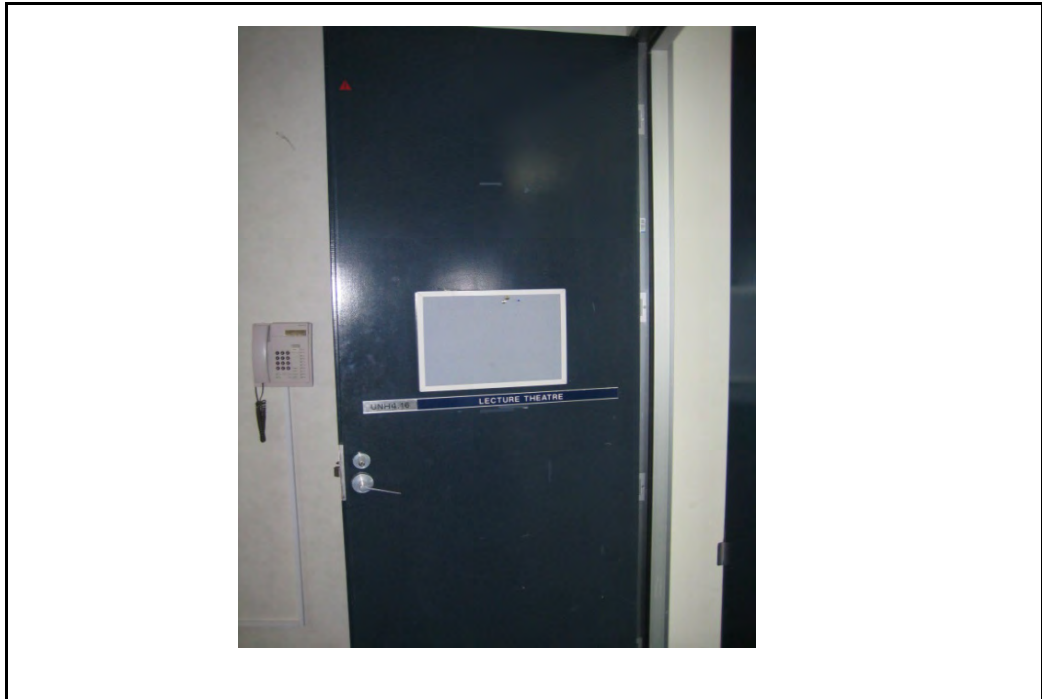
ASSET ELEMENT	DOORS
---------------	-------

OVERVIEW	Painted timber doors. Good condition, some marks, scratches, etc.	
HERITAGE SIGNIFICANCE	Heritage Significance Value of the element	Low
FUNCTIONALITY	Functional

OVERVIEW	Repaint as required.
----------	----------------------

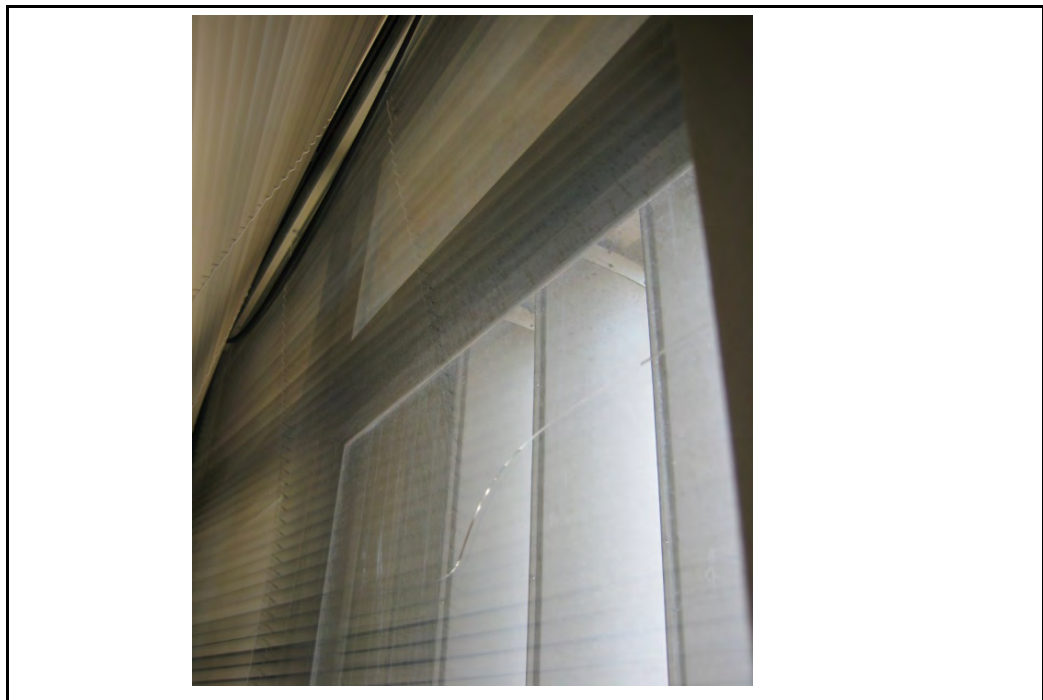
ASSET ELEMENT	WINDOWS
---------------	---------

OVERVIEW	Bronze anodised aluminium windows with painted plasterboard sills. Generally good condition. Additional (fixed) panel of glazing added to western windows, panel cracked and rubber seal separating on second window from the northern end of the western wall.	
HERITAGE SIGNIFICANCE	Heritage Significance Value of the element	Low
FUNCTIONALITY	Functional, requiring repair

OVERVIEW	Repair windows as required.
-----------------	-----------------------------
