UNIVERSITY HOUSE: ROOM DATA SHEETS

ROOM: 2.34,2.35,2.36,2.37,2.38,2.39	UNIVERSITY LEGAL CENTRE OFFICES
--	--

LOCATION: SECOND FLOOR NORTH EAST

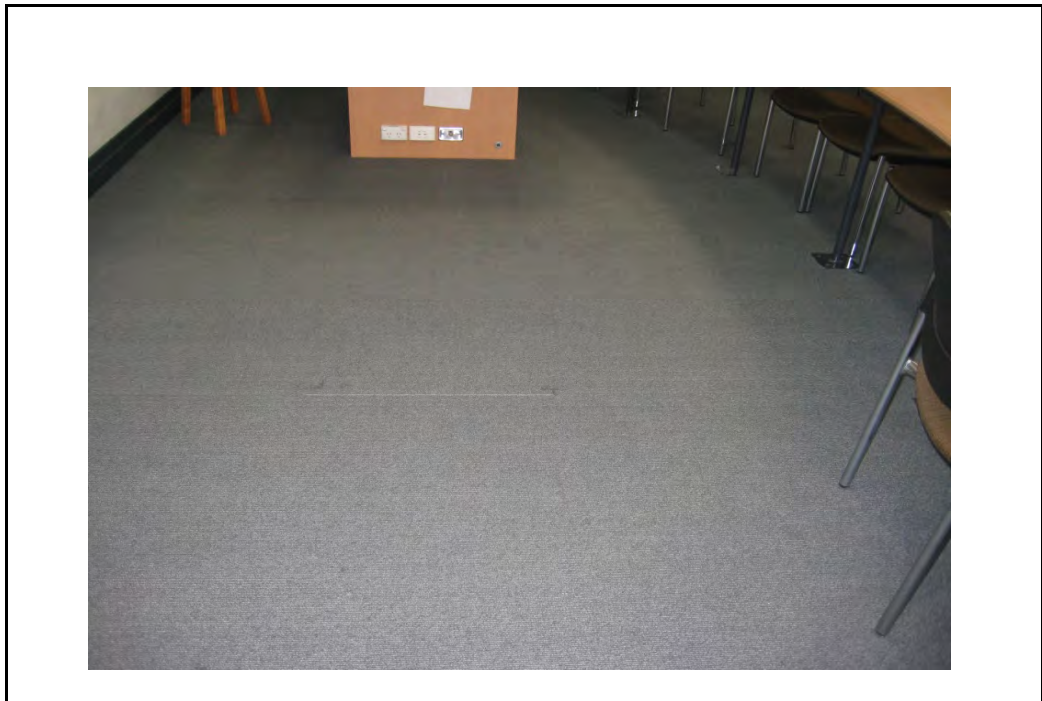
ASSET ELEMENT	FLOOR
---------------	-------

OVERVIEW	Carpet, generally good condition	
HERITAGE SIGNIFICANCE	Heritage Significance Value of the element	Low
FUNCTIONALITY	Functional.

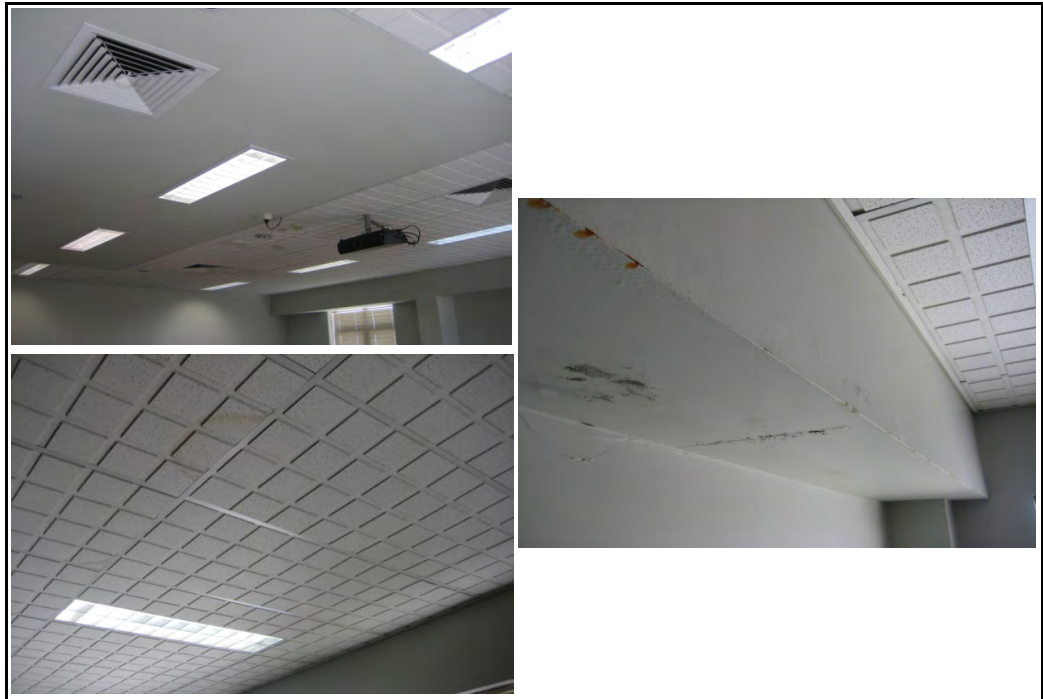
ASSET ELEMENT	CEILING
---------------	---------

OVERVIEW	Suspended ceiling tiles, with area of painted plasterboard at front of each room. Generally good condition, moisture stain on ceiling tiles in eastern part of room, moisture damage, rust marks, paint bubbling on plasterboard bulkhead in north-eastern part of room. Mould also present on underside of bulkhead.	
HERITAGE SIGNIFICANCE	Heritage Significance Value of the element	Low
FUNCTIONALITY	Functional, requiring repair

OVERVIEW	Investigate and rectify source of moisture, replace tiles, remove affected sections of plasterboard bulkhead, rebuild and repaint as required.
----------	--

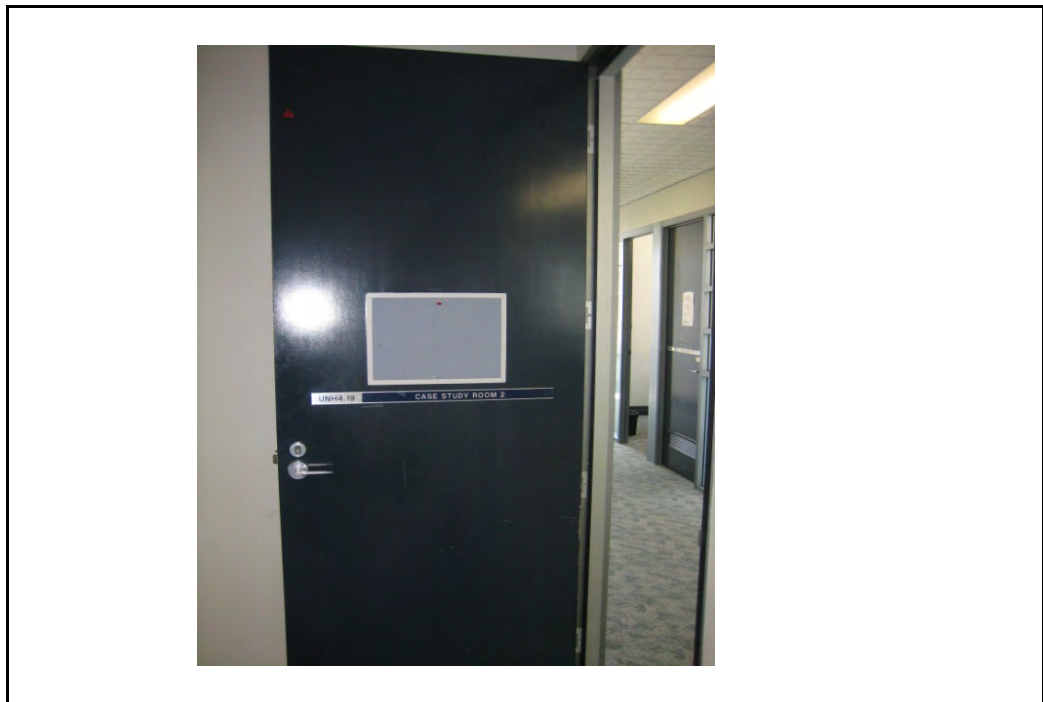
ASSET ELEMENT	DOORS
---------------	-------

OVERVIEW	Painted timber doors. Good condition.	
HERITAGE SIGNIFICANCE	Heritage Significance Value of the element	Low
FUNCTIONALITY	Functional

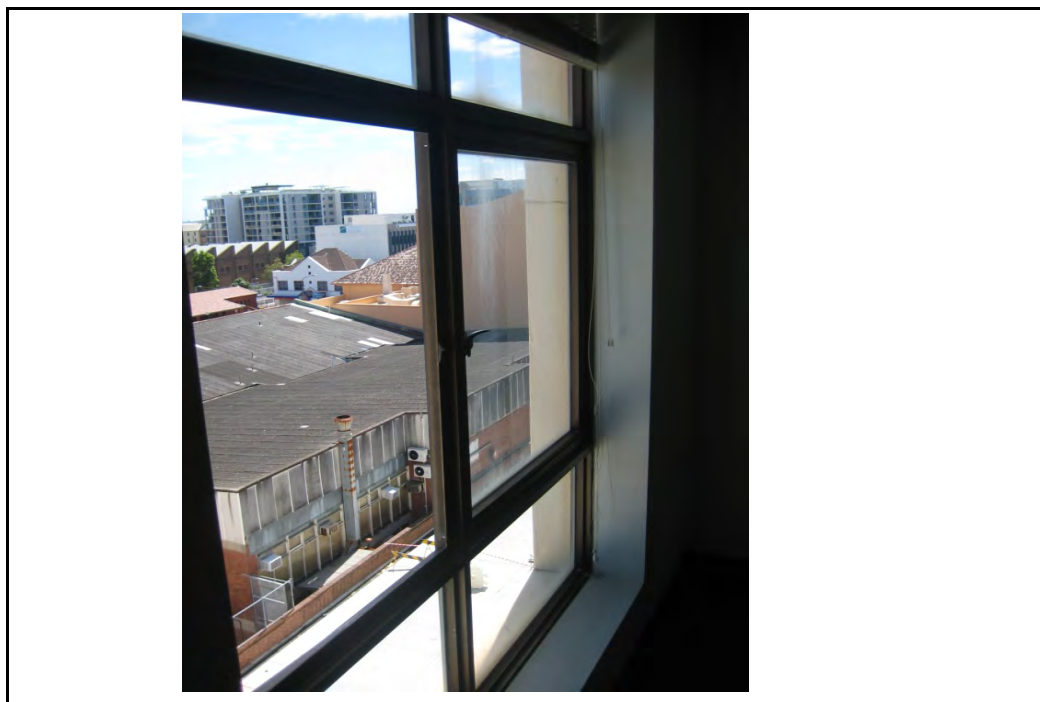
ASSET ELEMENT	WINDOWS
---------------	---------

OVERVIEW	Bronze anodised aluminium windows with painted plasterboard sills. Generally good condition. Pane missing from eastern-most window in room 4.19. (Issue of window pane discussed on site at time of inspection - 24.11.2010, was raised with maintenance on this date)	
HERITAGE SIGNIFICANCE	Heritage Significance Value of the element	Low
FUNCTIONALITY	Functional, requiring repair

OVERVIEW	Repair windows as required.
----------	-----------------------------

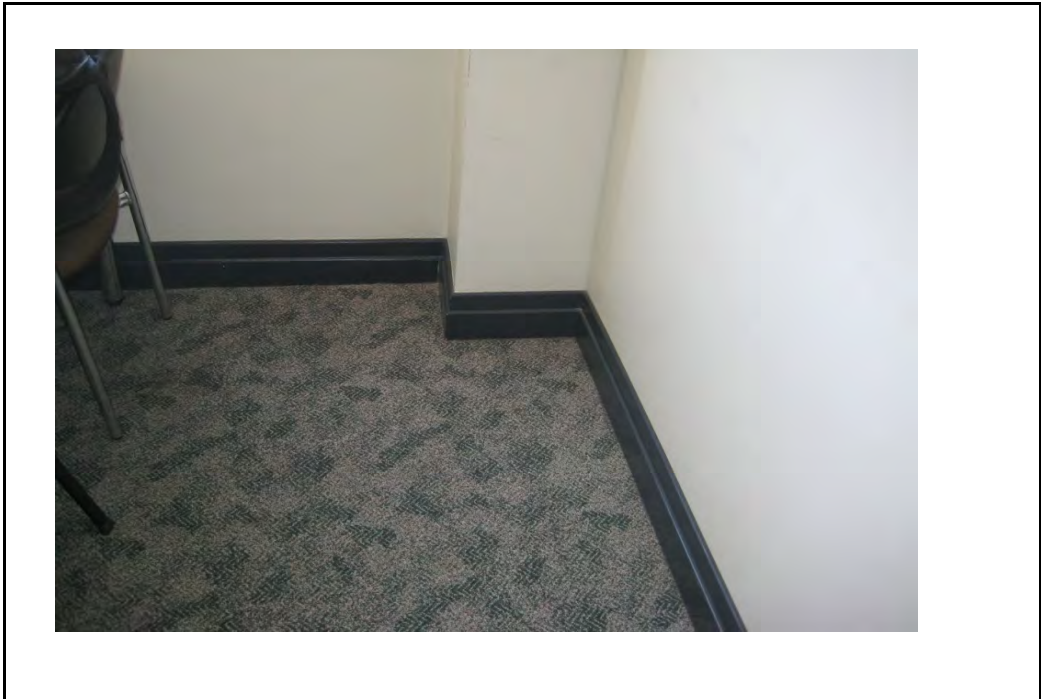
ASSET ELEMENT	FLOOR
---------------	-------

OVERVIEW	Carpet tile, good condition	
HERITAGE SIGNIFICANCE	Heritage Significance Value of the element	Low
FUNCTIONALITY	Functional.

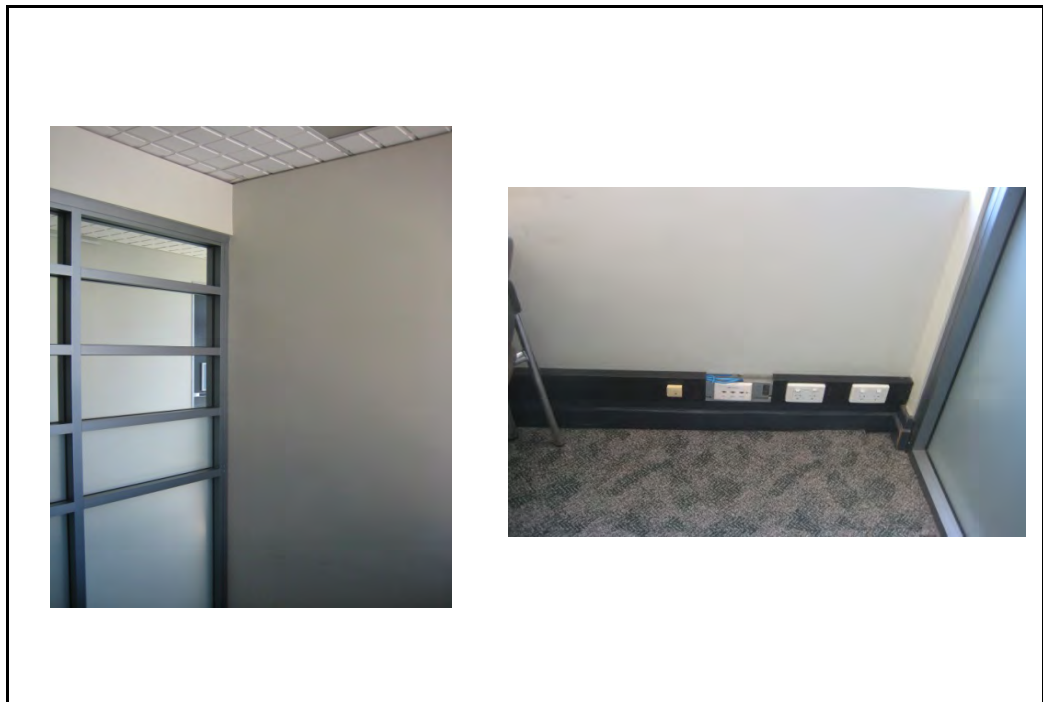
ASSET ELEMENT	WALLS
---------------	-------

OVERVIEW	Plasterboard and paint finish. Generally good condition, some scuff marks, crack in south west corner of room 4.25, section of ducted skirting missing in room 4.23. Anodised aluminium framed glazed walls to corridor. Good condition.	
HERITAGE SIGNIFICANCE	Heritage Significance Value of the element	Low
FUNCTIONALITY	Functional, requiring minor repair

OVERVIEW	Repair wall finishes as required.
-----------------	-----------------------------------
