CONSERVATION MANAGEMENT PLAN

UNIVERSITY HOUSE FORMERLY N.E.S.C.A HOUSE KING STREET NEWCASTLE

Prepared by EJE Heritage
MARCH 2011
Ref: 8836-CMP-UH-001

APPENDIX H: INVENTORY DATASHEETS

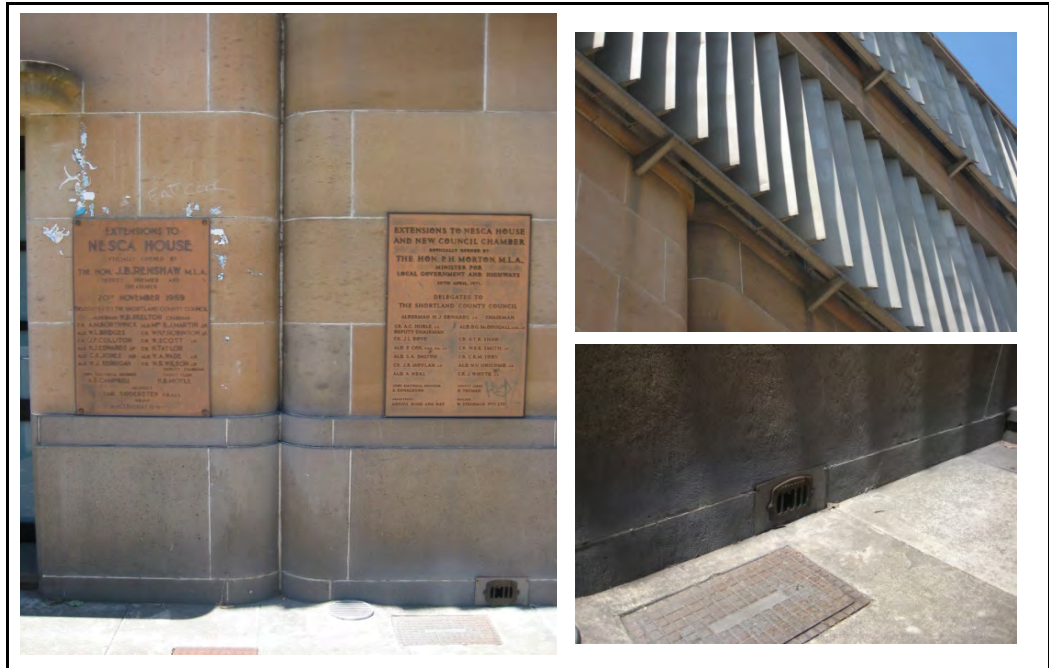
EXISTING CONDITION		
OVERVIEW	Memorial plaques commemorating opening of 1959 and 1971 extensions, vertical metal operable louvres to all windows above ground floor level, steel sub-floor ventilation grilles. Plaques and louvres showing signs of weathering. Vents corroded, some broken.	
HERITAGE SIGNIFICANCE	Heritage Significance Value of the element	Mixed
	<p>HIGH Plaques and Vents</p> <p>LOW Louvres</p>	
FUNCTIONALITY	Functional	
ACTION REQUIRED		
OVERVIEW	Nil

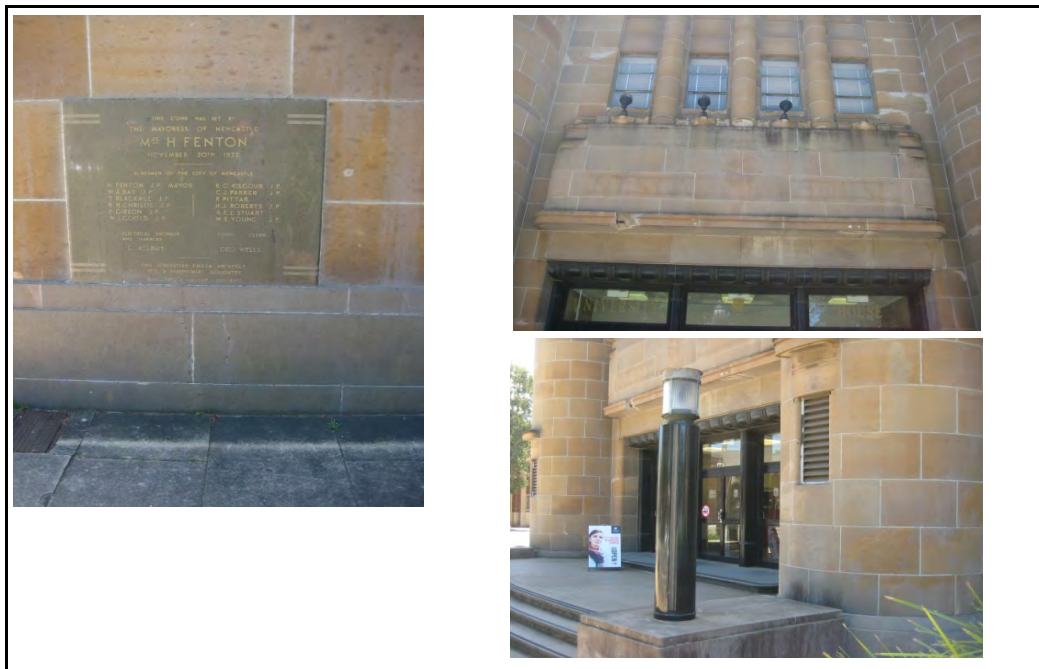
OVERVIEW	Memorial stones commemorating commencement and opening of original building, uplighting mounted to top of door spandrel (one fitting missing), metal and stone light pillars each side of entry landing, steel balustrades and painted flagpoles at top of building. Note silhouette of missing "Nesca House" signage above entry doors.	
HERITAGE SIGNIFICANCE	Heritage Significance Value of the element	Mixed
	<p>HIGH Memorial stones, lighting pillars, flag poles at top of central tower.</p> <p>LOW Steel balustrades at top of building.</p> <p>INTRUSIVE Flagpoles at corners of building on level 3.</p>	
FUNCTIONALITY	Functional but requiring repair / restoration

OVERVIEW	Restore light pillars to original condition, re-install uplight to match remaining fittings, restore balustrade and flagpoles at top of building.
----------	---

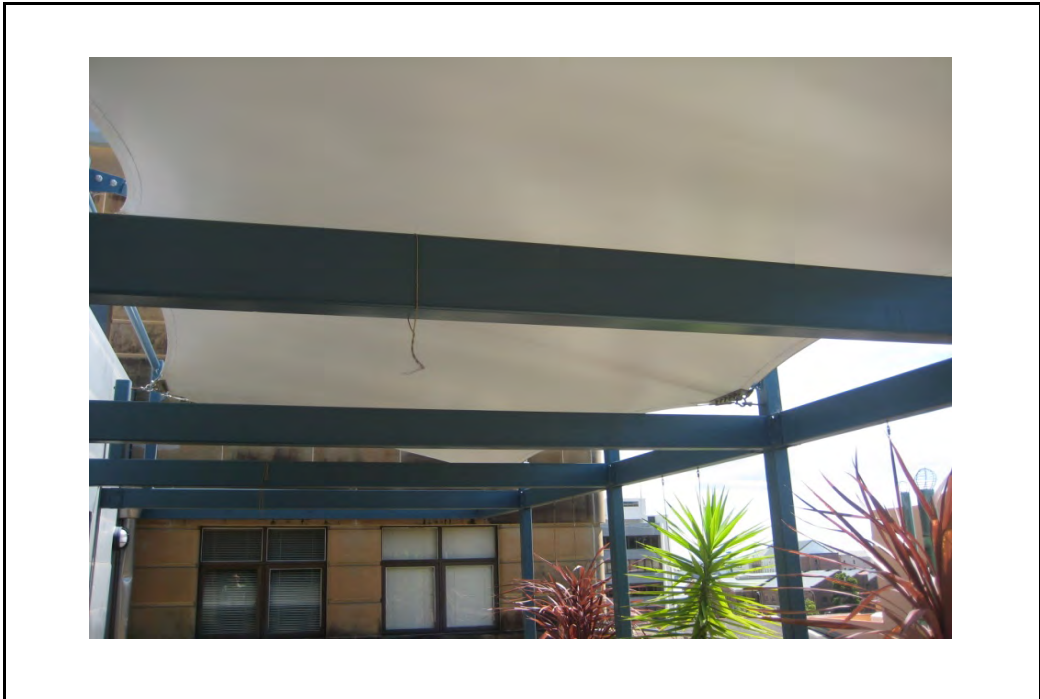
OVERVIEW	Steel framed tensile shade structure, good condition.	
HERITAGE SIGNIFICANCE	Heritage Significance Value of the element	Low
FUNCTIONALITY

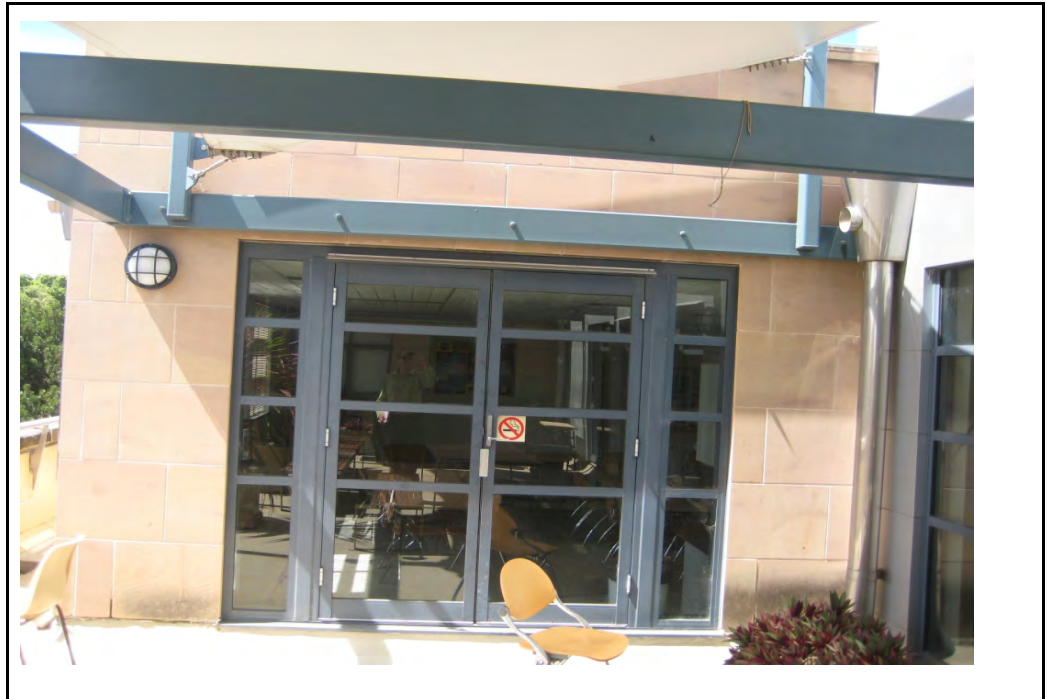
OVERVIEW	Powdercoated aluminium framed glazed doors, good condition.	
HERITAGE SIGNIFICANCE	Heritage Significance Value of the element	Low
FUNCTIONALITY	Functional

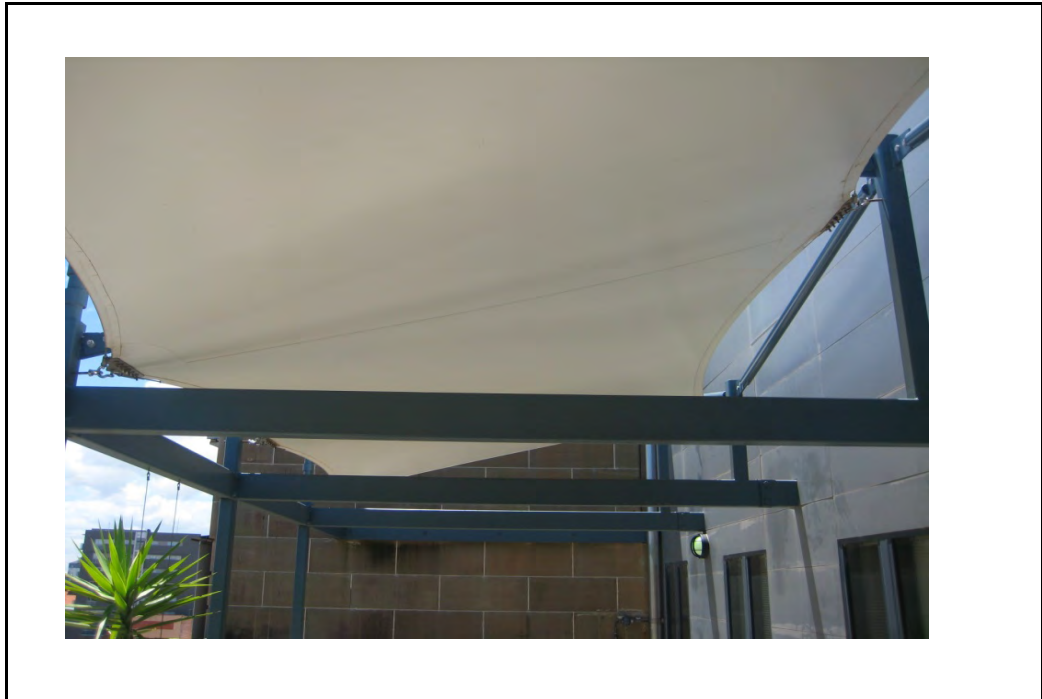
OVERVIEW	Steel framed tensile shade structure, good condition.	
HERITAGE SIGNIFICANCE	Heritage Significance Value of the element	Low
FUNCTIONALITY

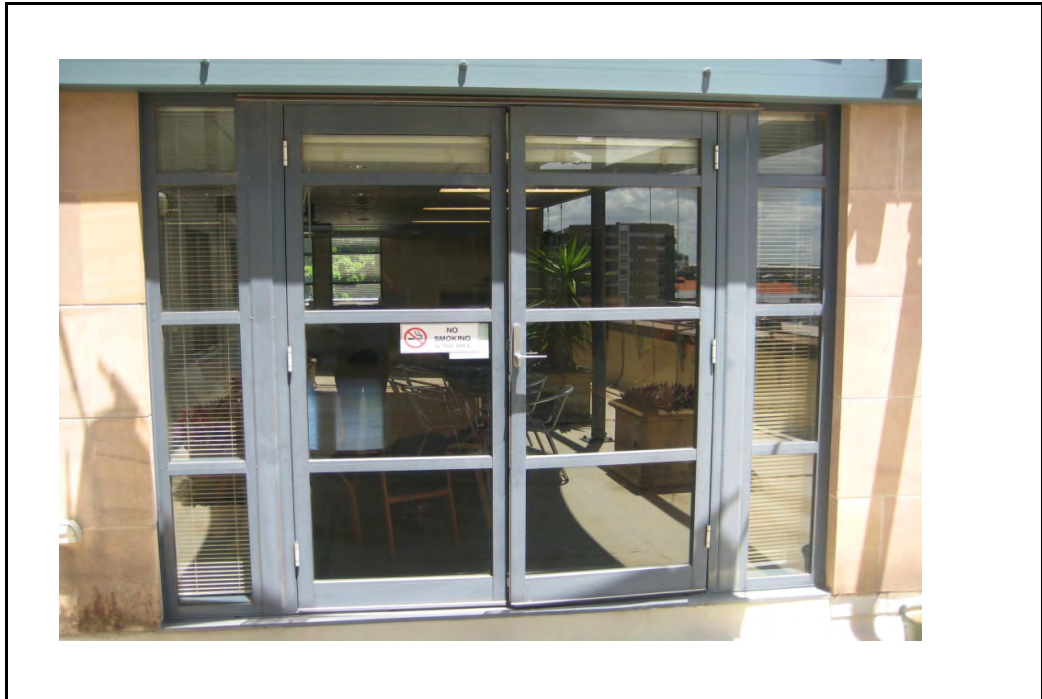
EXISTING CONDITION		
OVERVIEW	Powdercoated aluminium framed glazed doors, good condition.	
HERITAGE SIGNIFICANCE	Heritage Significance Value of the element	Low
FUNCTIONALITY	Functional	
ACTION REQUIRED		
OVERVIEW

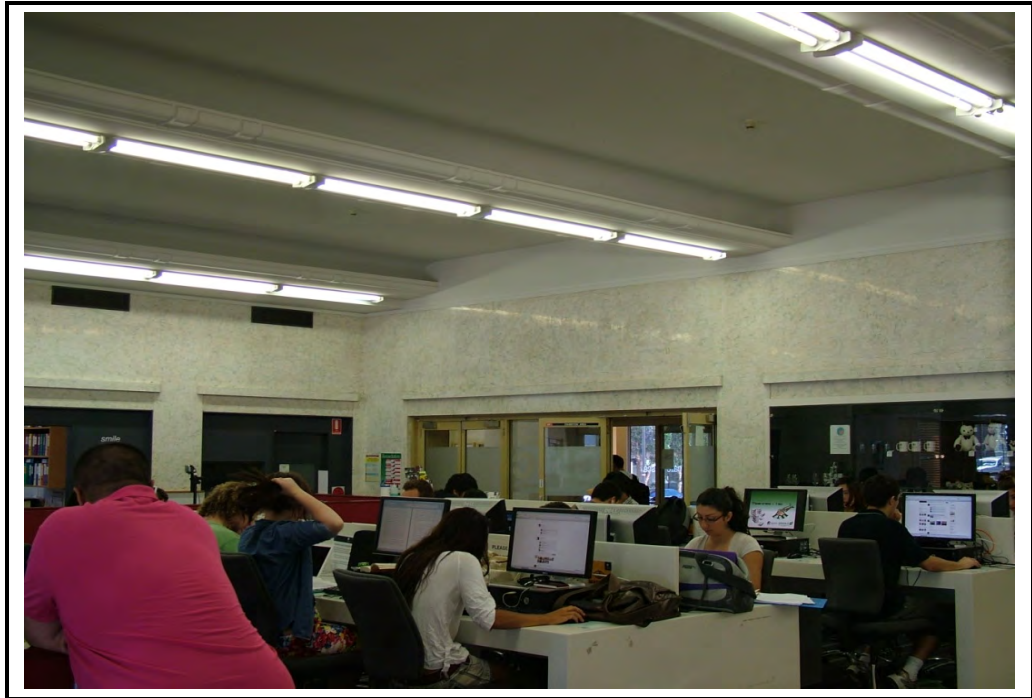
OVERVIEW	Painted plaster ceiling, feature spines with decorative covered edges. Suspended ceiling with shallow coffers at entry doors. Lower suspended plasterboard ceilings, paint finish, to southern bays of room. All in good condition.	
HERITAGE SIGNIFICANCE	Heritage Significance Value of the element	High
FUNCTIONALITY	Functional

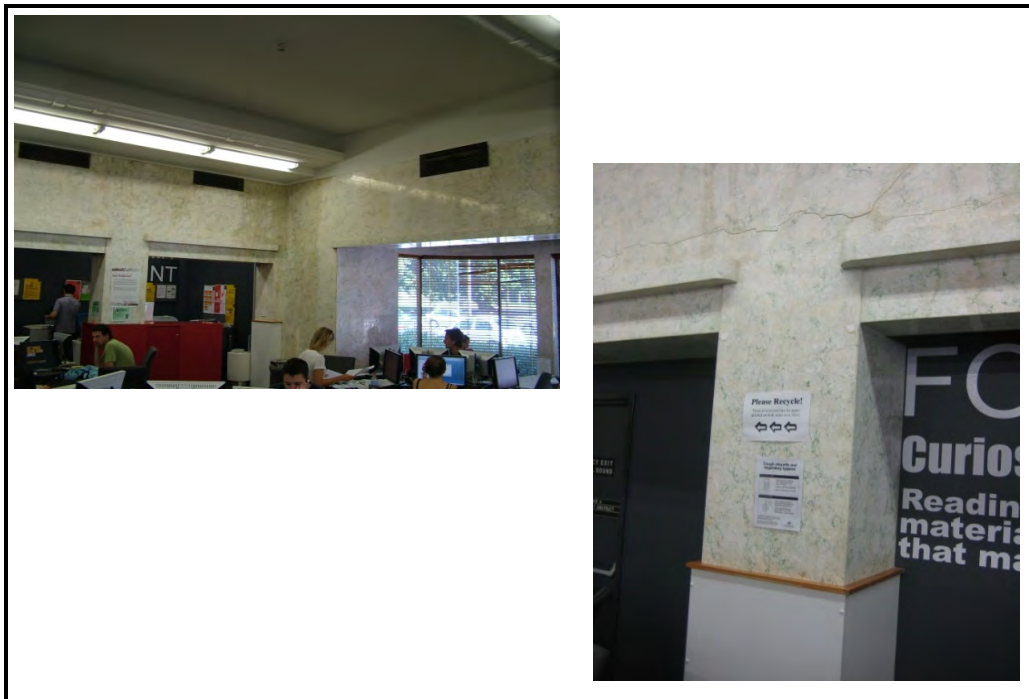
EXISTING CONDITION	
OVERVIEW	Scagliola with painted plaster at high level. Black stone skirting. Polished stone at sides of entry area. Painted plasterboard walls to eastern and western ends of room at newer works. Powdercoated aluminium framed glazing to corridor. Scagliola extensively covered with fine cracks and drummy areas. Some larger cracks evident at various points in the room, particularly over openings and adjacent to columns. Discolouration, possibly due to moisture, to scagliola at the eastern end of the room, particularly at north east and south east corners. Some areas where chips / fragments missing from finish, area of damage to door head at eastern most doors to corridor (Romm G6). Some cracking to polished stone at south doors, some repair attempted. Plasterboard walls good condition.
HERITAGE SIGNIFICANCE	Heritage Significance Value of the element
	Mixed
EXCEPTIONAL	Scagliola and polished stone

LOW	Plasterboard
FUNCTIONALITY	Functional but requiring some repair.
ACTION REQUIRED	
OVERVIEW	Repair and restore original wall finishes as required.

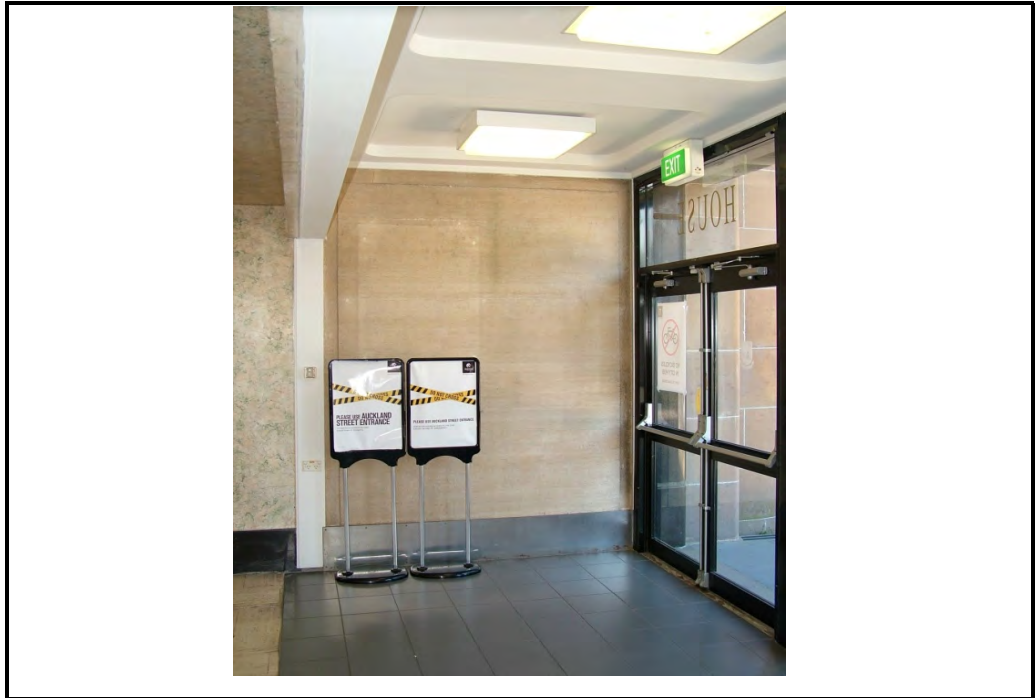
OVERVIEW	Powdercoated aluminium framed glazed doors to southern entry and to corridor (Room G6). Painted timber doors to offices at western end of room and fire exit at east end of room.	
HERITAGE SIGNIFICANCE	Heritage Significance Value of the element	Low
FUNCTIONALITY	Functional

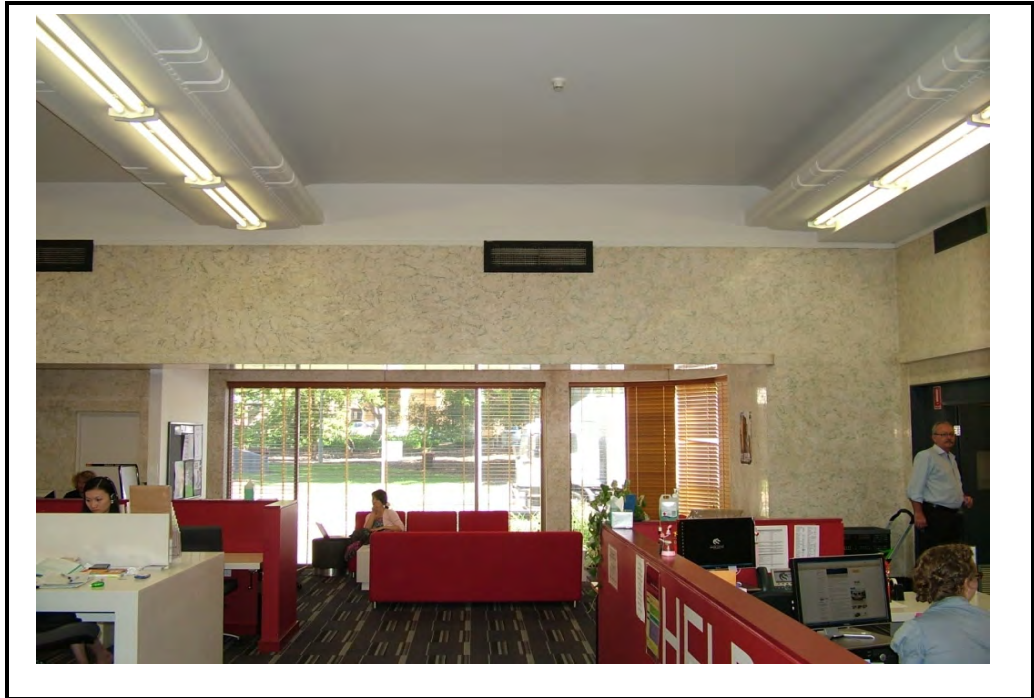
OVERVIEW	Non-original bronze anodised aluminium framed fixed glazing, good condition.	
HERITAGE SIGNIFICANCE	Heritage Significance Value of the element	Intrusive
	INTRUSIVE Facetted windows in curved walls	
FUNCTIONALITY	Functional

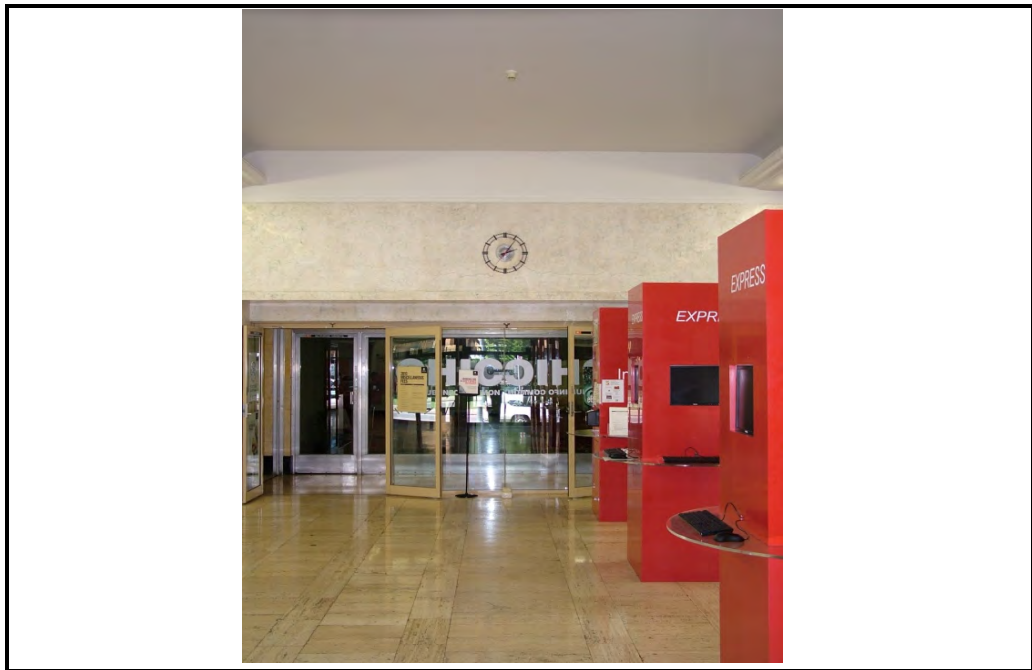
OVERVIEW	Wall mounted clock above doors to corridor, timber venetian blinds to windows. Red painted computer terminals to central area of room.	
HERITAGE SIGNIFICANCE	Heritage Significance Value of the element	Mixed
	HIGH Clock INTRUSIVE Venetians and computer terminals	
FUNCTIONALITY	Functional

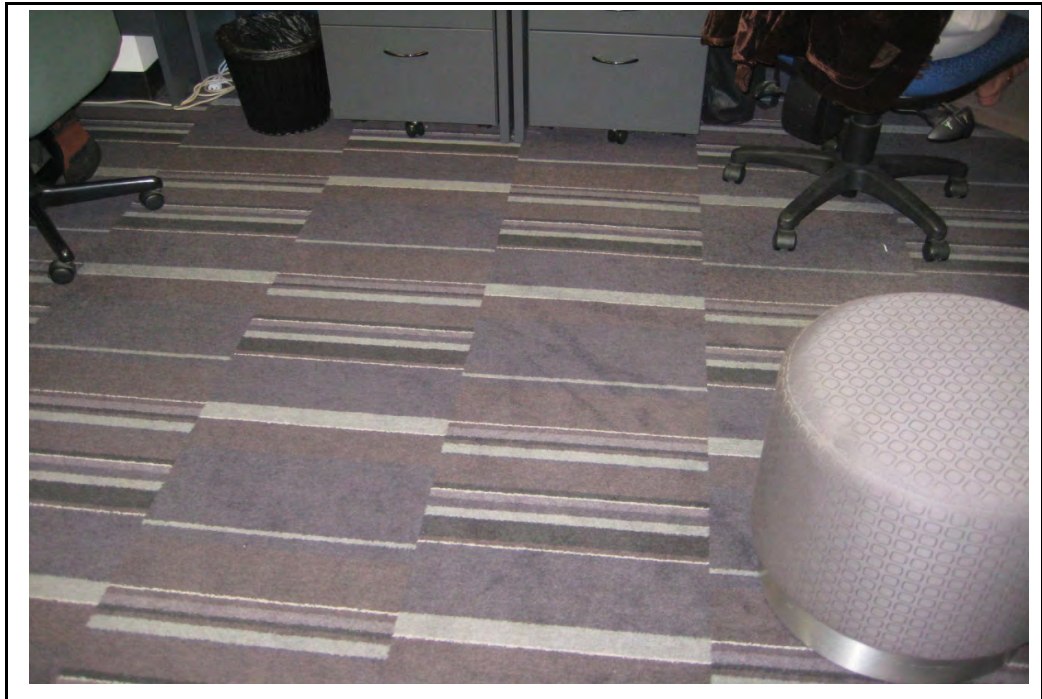
OVERVIEW	New carpet, possibly over existing travertine flooring. Good condition.	
HERITAGE SIGNIFICANCE	Heritage Significance Value of the element	Low
FUNCTIONALITY	Functional.

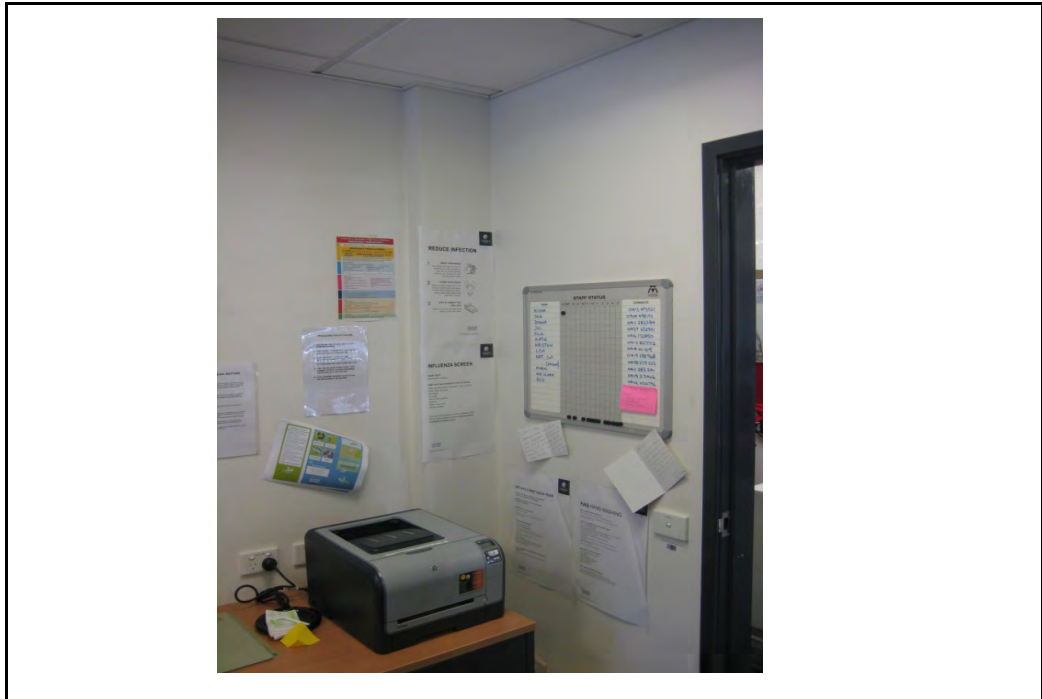
EXISTING CONDITION		
OVERVIEW	New plasterboard wall lining, paint finish. North wall of room G1A is render and paint finish. Vinyl skirtings to all.	
HERITAGE SIGNIFICANCE	Heritage Significance Value of the element	Low
FUNCTIONALITY	Functional	
ACTION REQUIRED		
OVERVIEW

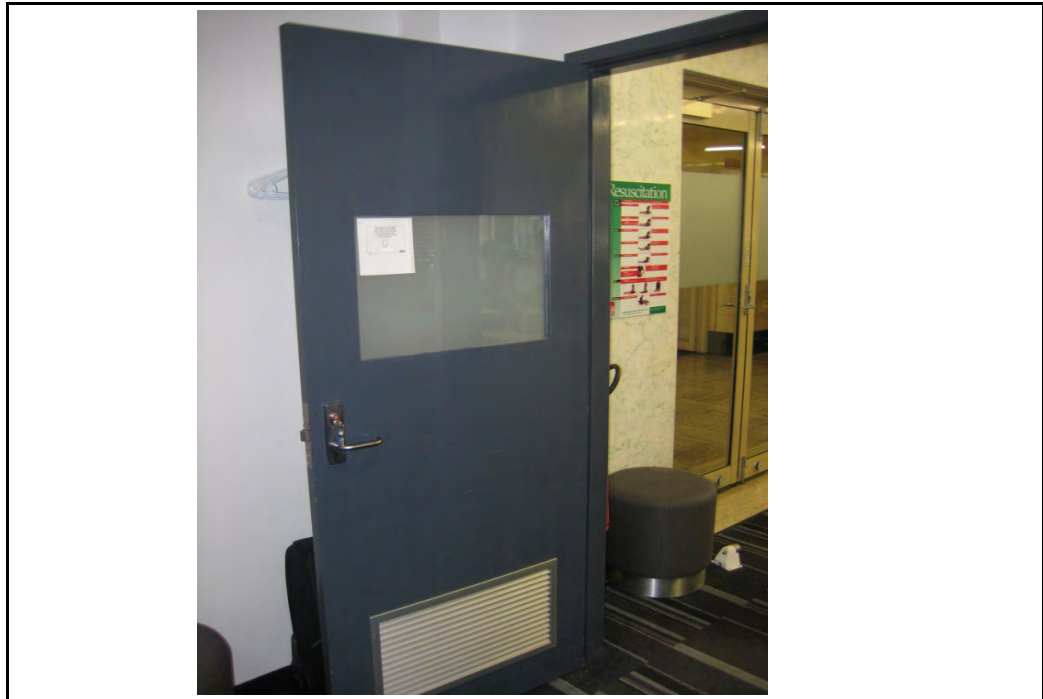
EXISTING CONDITION		
OVERVIEW	Painted timber doors with painted timber frames. Glass vision panel and aluminium ventilation grille. Good condition.	
HERITAGE SIGNIFICANCE	Heritage Significance Value of the element	Low
FUNCTIONALITY	Functional	
ACTION REQUIRED		
OVERVIEW

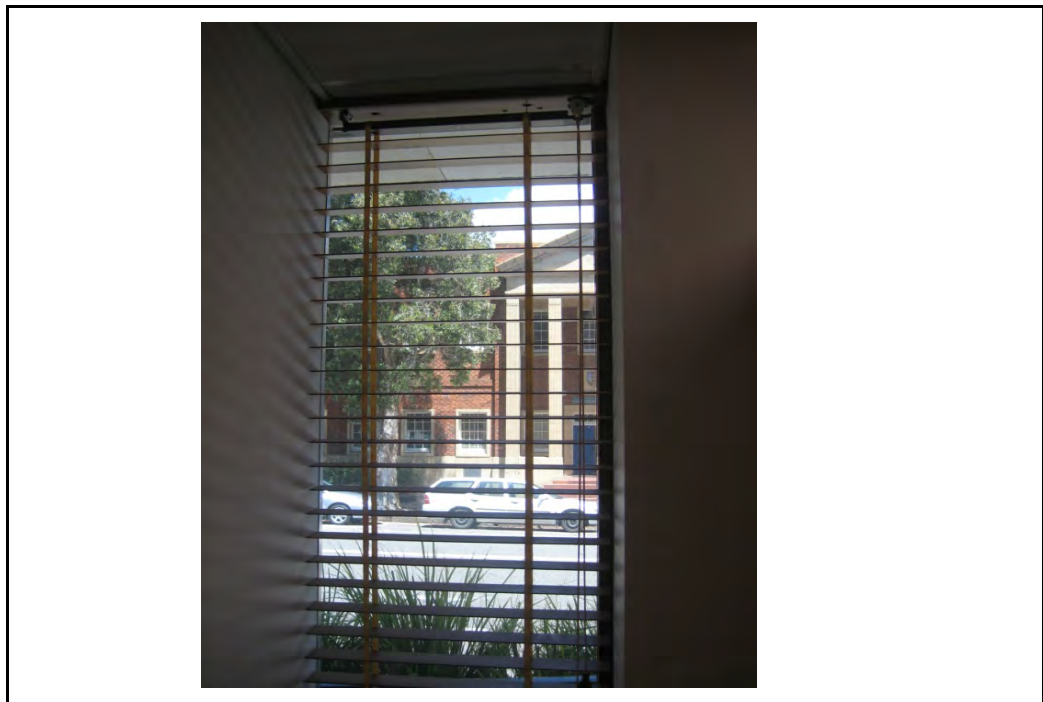
OVERVIEW	Bronze anodised aluminium framed aluminium framed glazing to external wall, powdercoated aluminium framed glazing to common walls with room G1.	
HERITAGE SIGNIFICANCE	Heritage Significance Value of the element	Low
FUNCTIONALITY	Functional

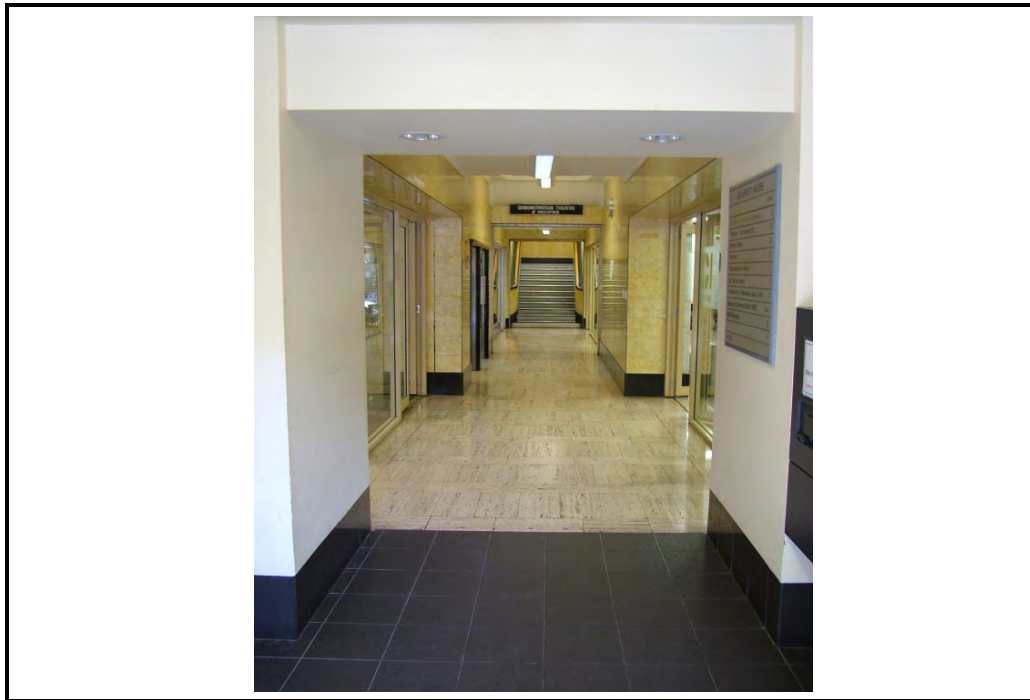
EXISTING CONDITION		
OVERVIEW	Black floor tiles at entry, good condition. Travertine flooring throughout corridor, generally good condition with some evidence of wear and cracking. Some pot marking of surface evidence, some of which appears to have been infilled with gold metallic material.	
HERITAGE SIGNIFICANCE	Heritage Significance Value of the element	Mixed
	HIGH Travertine LOW Tiles	
FUNCTIONALITY	Functional.	
ACTION REQUIRED		
OVERVIEW	Repair and restore flooring as required

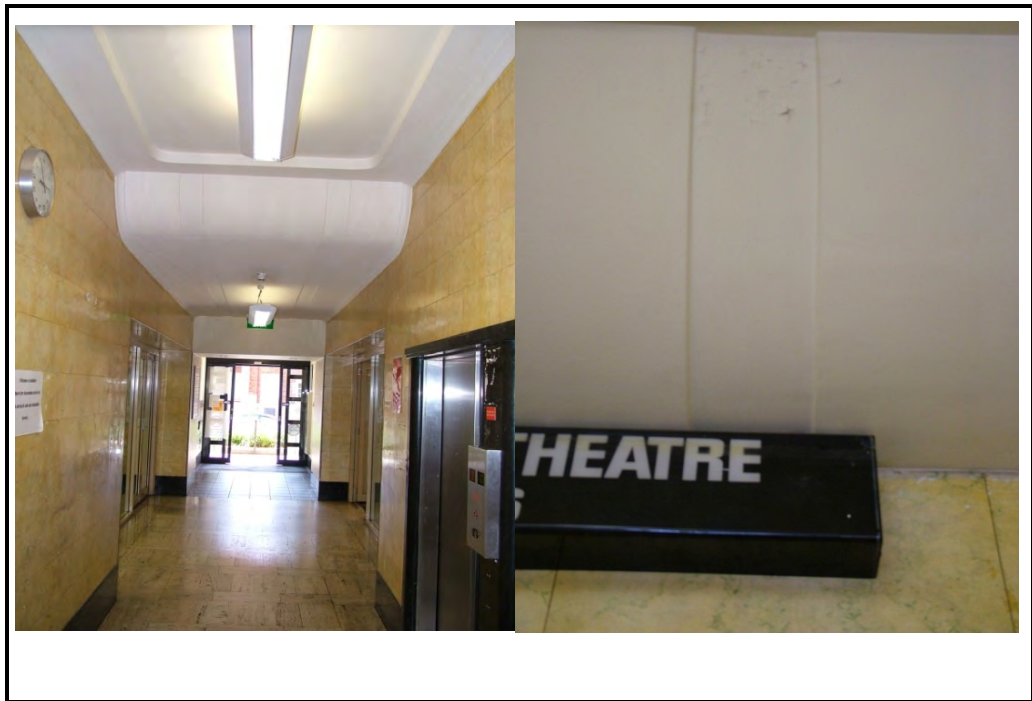
OVERVIEW	Painted plaster ceiling with curves and coffers and decorative relief. Generally good condition, some cracked and flaking paint	
HERITAGE SIGNIFICANCE	Heritage Significance Value of the element	High
FUNCTIONALITY	Functional, requiring minor repair

OVERVIEW	Repair areas of cracked / flaking paint and generally restore as required.
----------	--

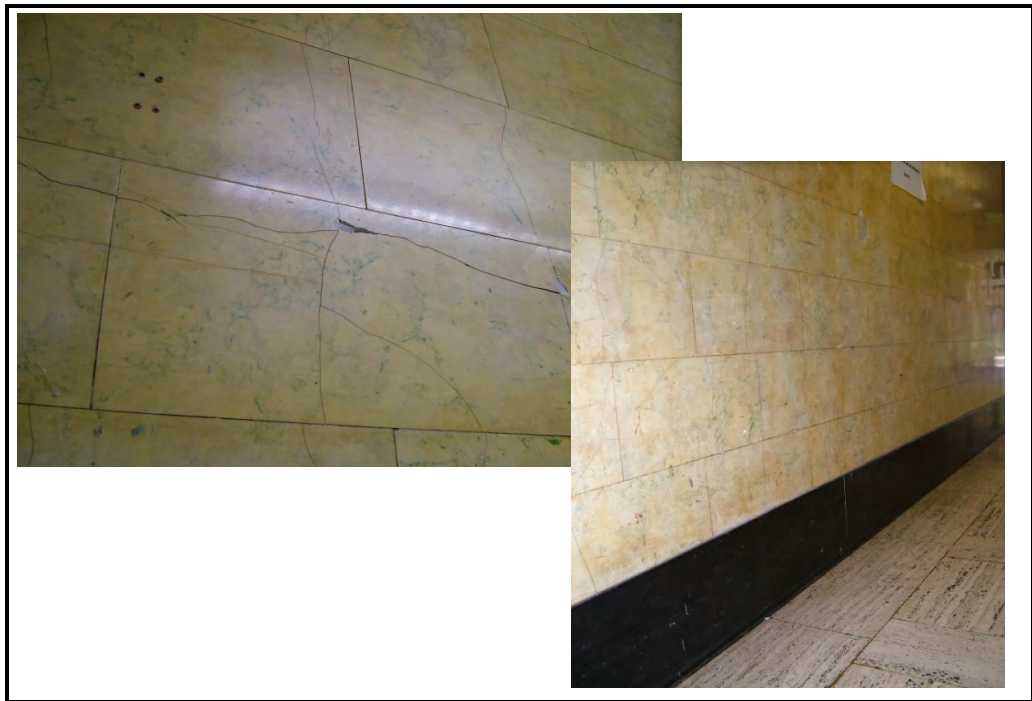
OVERVIEW	Scagliola tiles with black stone skirting to main part of corridor, plasterboard with paint finish at entry. Scagliola tiles extensively covered with fine cracks, some larger cracks and some chips missing. Some areas drummy. Evidence of attempted repair work opposite lift doors. Tile missing at door head at east end of glazed wall with room G1. Some areas of repair work on plasterboard walls require repainting.	
HERITAGE SIGNIFICANCE	Heritage Significance Value of the element	Mixed
	EXCEPTIONAL Scagliola tiles LOW Plasterboard lining	
FUNCTIONALITY	Functional but requiring repair.

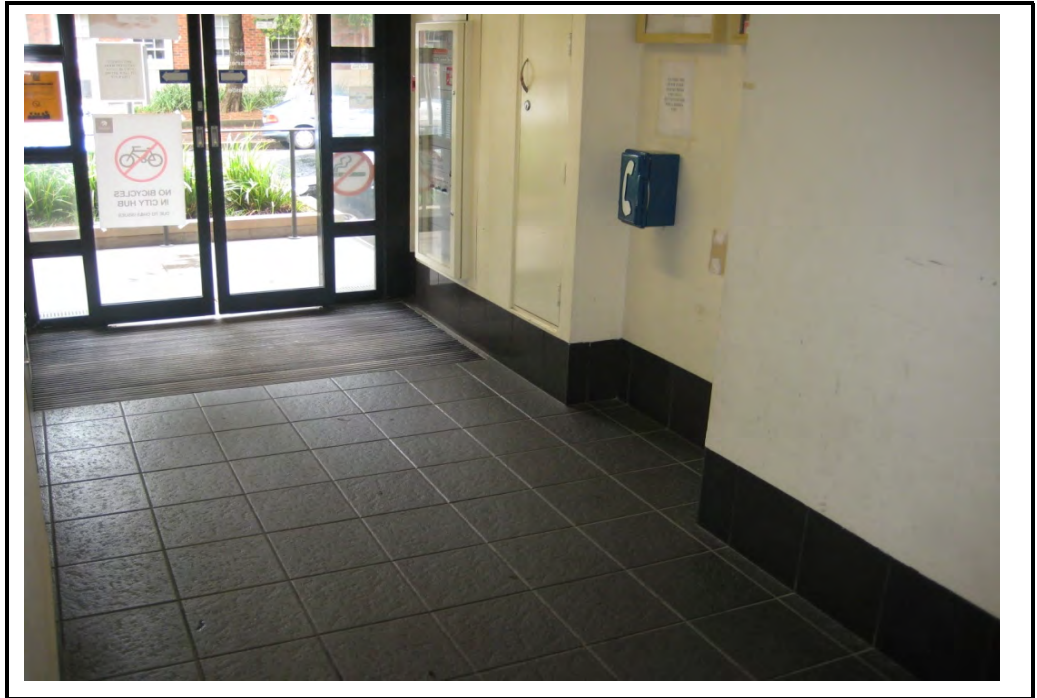
OVERVIEW	Powdercoated aluminium framed glazed doors to entry (automatic sliding doors) and rooms G1 and G7. Anodised framed glazed doors to room G9 appear original with decorative embellishments on frame. Metal sliding and vertical sliding doors at base of stair and adjacent to lift doors. All good condition.	
HERITAGE SIGNIFICANCE	Heritage Significance Value of the element	Mixed
	HIGH Anodised framed doors and concealed sliding doors to Demonstration Theatre LOW Powdercoated framed doors	
FUNCTIONALITY	Functional

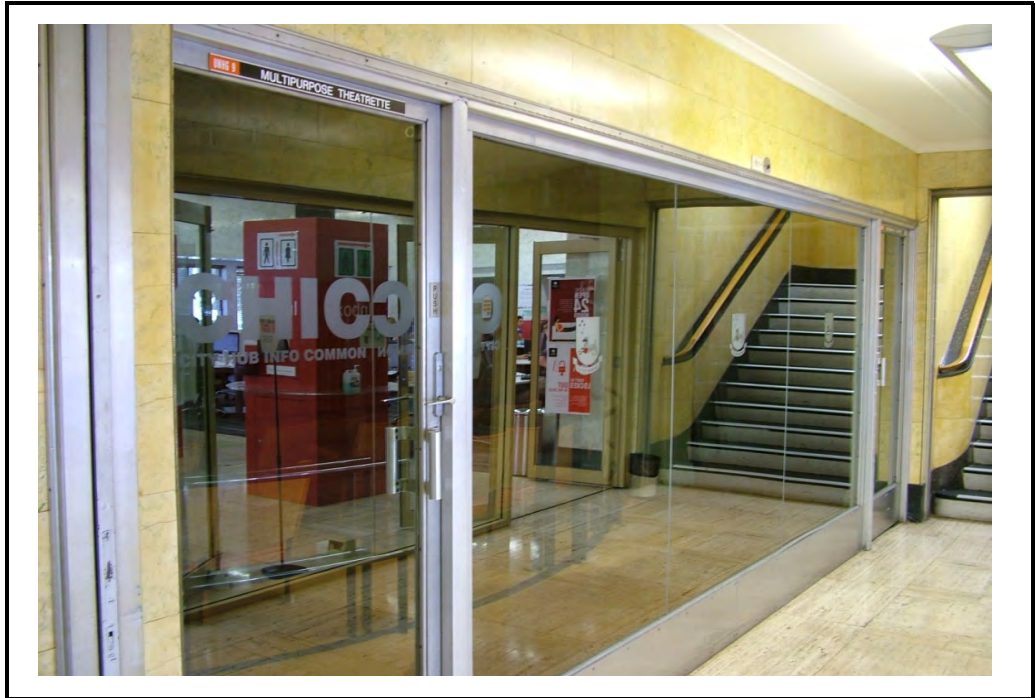
OVERVIEW	Powdercoated aluminium framed glazing to rooms G1 and G7. Anodised framed glazing to room G9 appears original with decorative embellishments on frame. All good condition.	
HERITAGE SIGNIFICANCE	Heritage Significance Value of the element	Mixed
	HIGH Anodised framed glazing LOW Powdercoated framed glazing	
FUNCTIONALITY	Functional

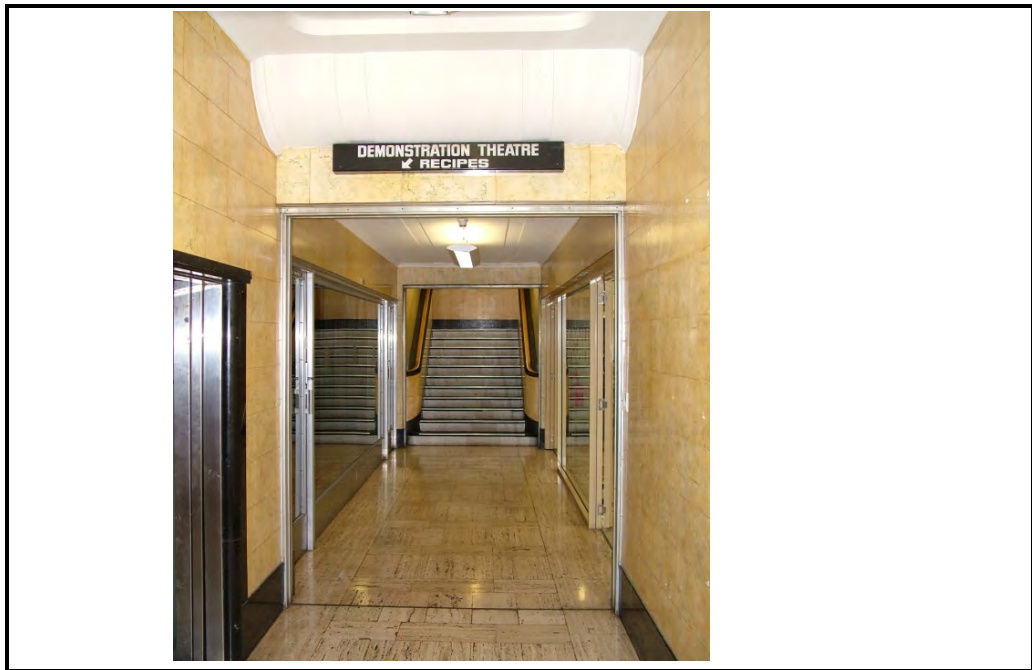
OVERVIEW	Signage for original demonstration theatre - good physical appearance, working assessment not done.	
HERITAGE SIGNIFICANCE	Heritage Significance Value of the element	High
FUNCTIONALITY	Assumed functional

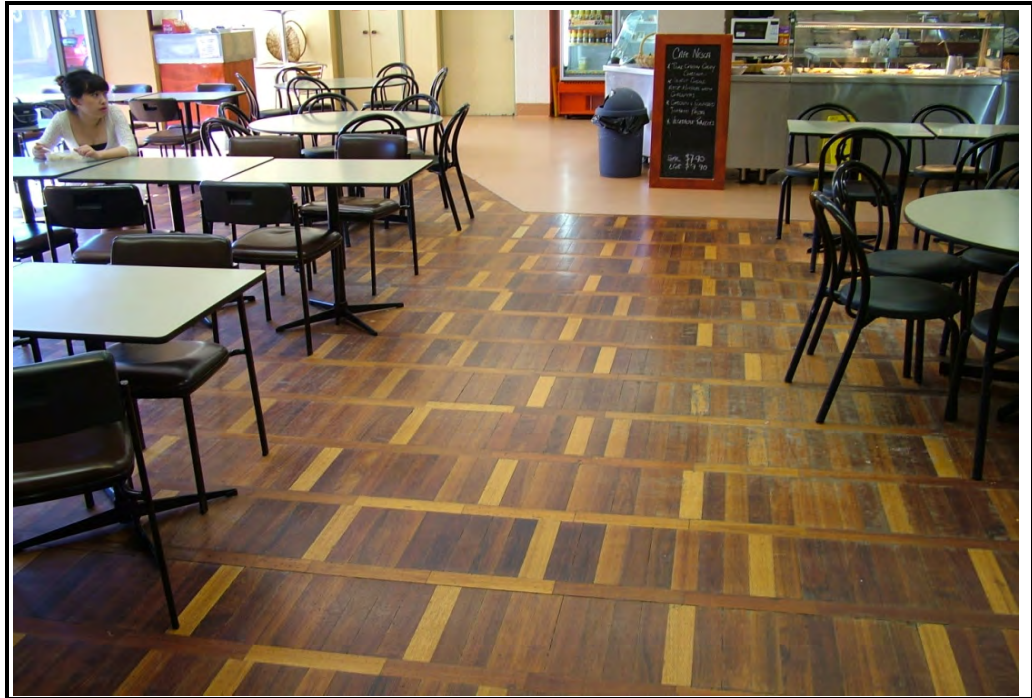
OVERVIEW	Timber parquet flooring, generally in good condition. Some gaps noted between boards. Sheet vinyl flooring at food service and preparation area, in good condition.	
HERITAGE SIGNIFICANCE	Heritage Significance Value of the element	Mixed
	HIGH Timber flooring LOW Vinyl flooring	
FUNCTIONALITY	Functional but requiring minor repair	
ACTION REQUIRED		
OVERVIEW	Repair and restore flooring as required

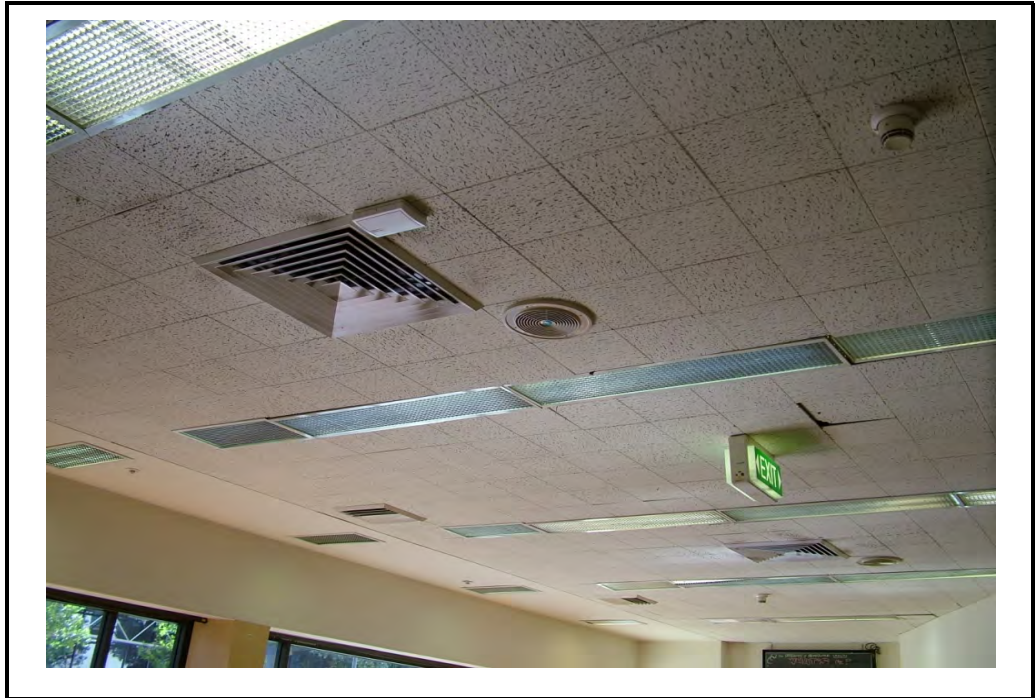
OVERVIEW	Fibrous tile ceiling with painted perimeter, set plasterboard with paint finish over food preparation area and in store room (G8). Generally good condition, some ceiling tile discoloured and / or cracked / chipped or misaligned. Some paint flaking on cornice of the north wall in the storeroom.	
HERITAGE SIGNIFICANCE	Heritage Significance Value of the element	Low
FUNCTIONALITY	Functional, requiring minor repair

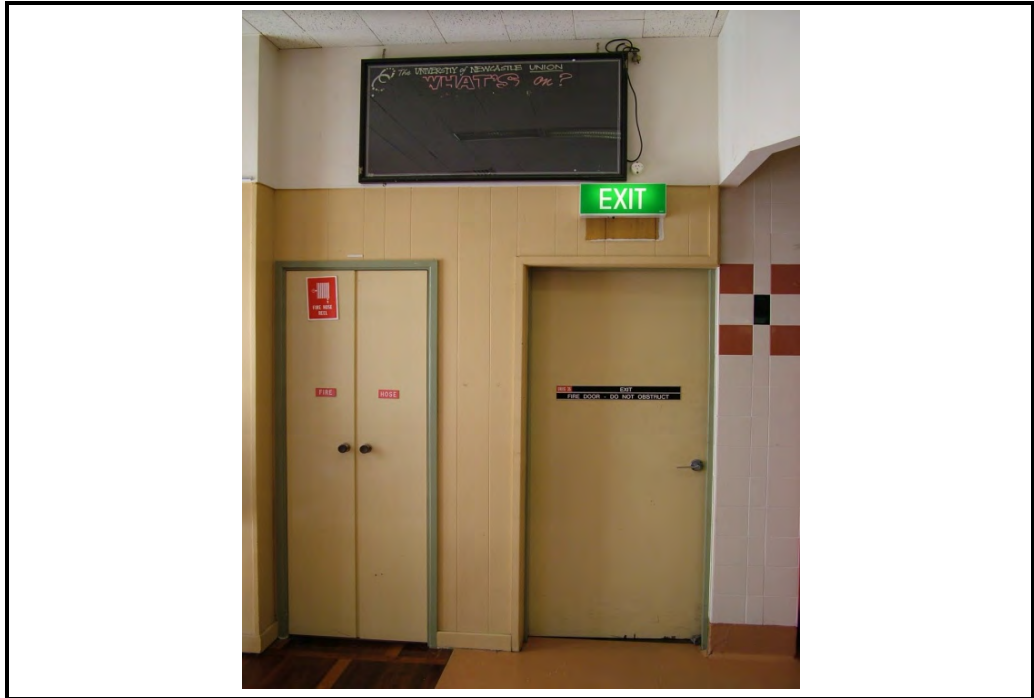
OVERVIEW	Grooved panelling with paint finish and timber skirting, with set lining over, paint finish. Wall tiles to food service / preparation area and storeroom. All generally good condition. Some paint missing at exit door.	
HERITAGE SIGNIFICANCE	Heritage Significance Value of the element	Low
FUNCTIONALITY	Functional but requiring minor repair.	
ACTION REQUIRED		
OVERVIEW	Repair wall finishes as required

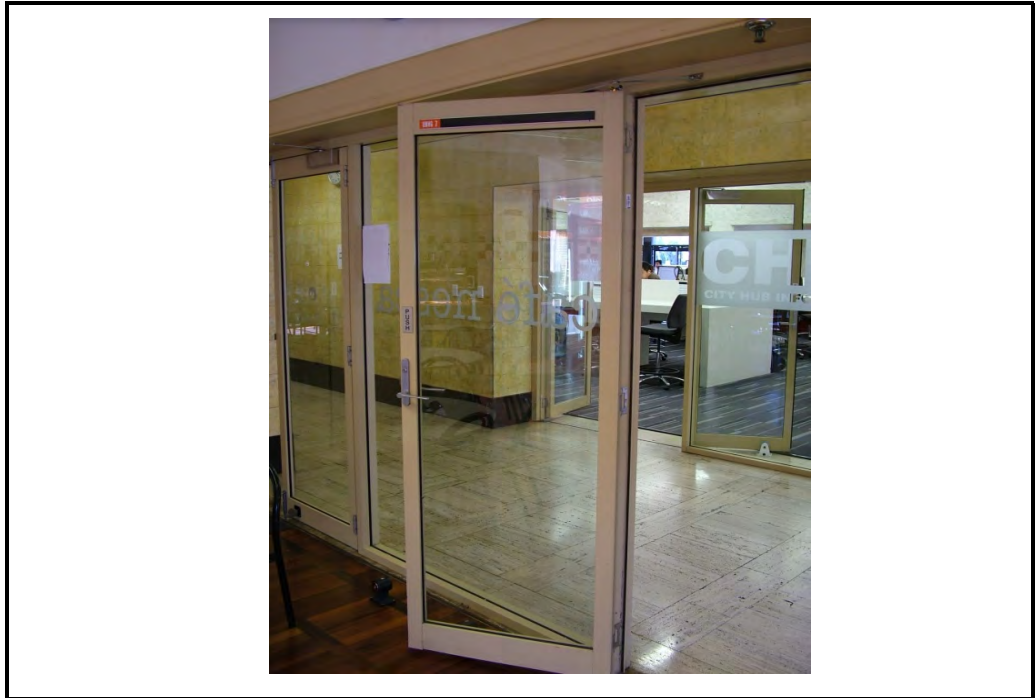
DOORS

OVERVIEW	Powdercoated aluminium framed glazed doors to corridor (room G6), painted timber doors to fire exit and hose reel cupboard. All good condition	
HERITAGE SIGNIFICANCE	Heritage Significance Value of the element	Low
FUNCTIONALITY	Functional

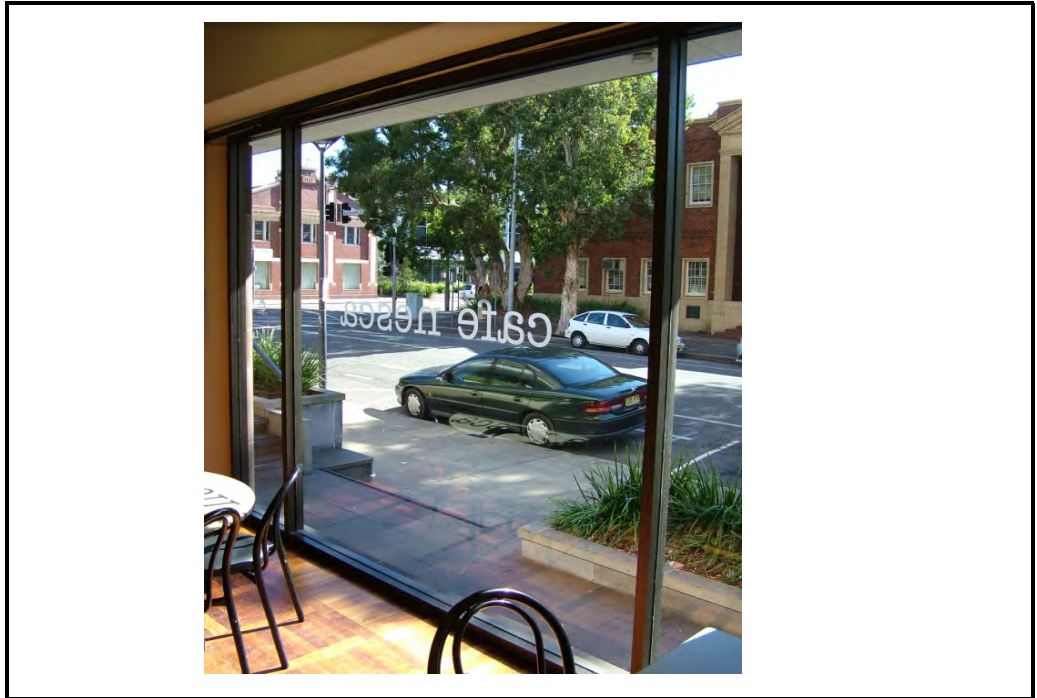
WINDOWS

OVERVIEW	Powdercoated aluminium framed glazing to corridor (room G6), bronze anodised aluminium framed glazing to external wall (non-original). All good condition.	
HERITAGE SIGNIFICANCE	Heritage Significance Value of the element	Mixed
	LOW Powdercoated type to Corridor G6 INTRUSIVE Annodised type in exterior wall	
FUNCTIONALITY	Functional

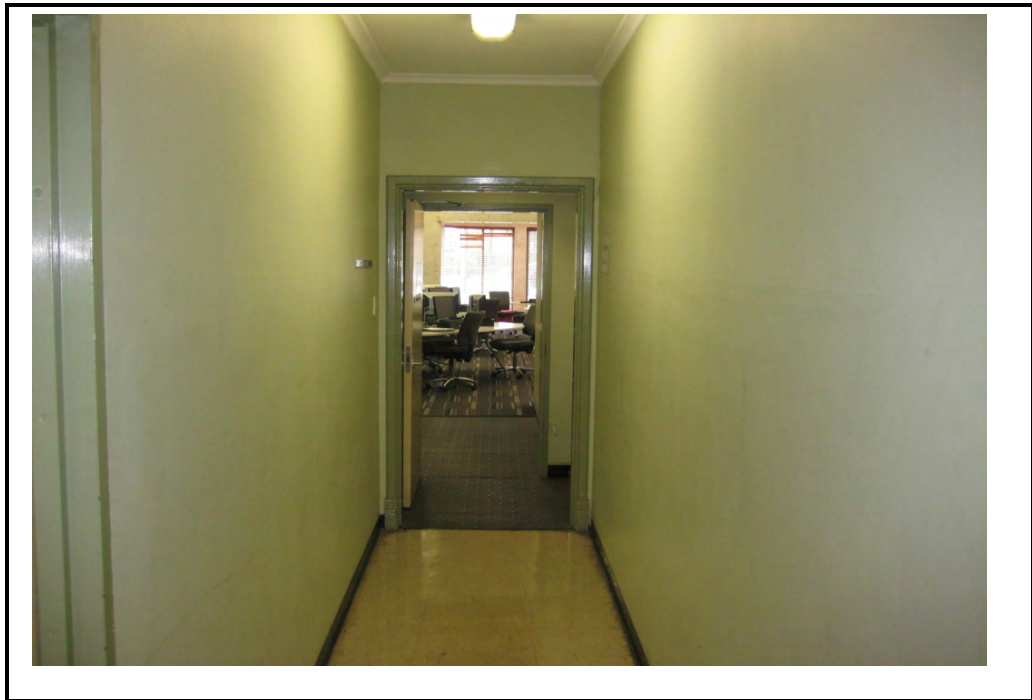
EXISTING CONDITION		
OVERVIEW	Vinyl to rooms G13, G11 and part of G20. Rubber flooring / matting to south end of room G13. Concrete to part of room G20 and all of G40. Room G40 has steel framed stair down to basement door. Vinyl in fair condition, with scuff marks, rubber matting in good condition, concrete in good condition with original linemarking in place.	
HERITAGE SIGNIFICANCE	Heritage Significance Value of the element	Mixed
	HIGH Rubber Flooring LOW Vinyl Flooring	
FUNCTIONALITY	Functional.	
ACTION REQUIRED		
OVERVIEW
