CONSERVATION MANAGEMENT PLAN

UNIVERSITY HOUSE FORMERLY N.E.S.C.A HOUSE KING STREET NEWCASTLE

Prepared by EJE Heritage
MARCH 2011
Ref: 8836-CMP-UH-001

APPENDIX H: INVENTORY DATASHEETS

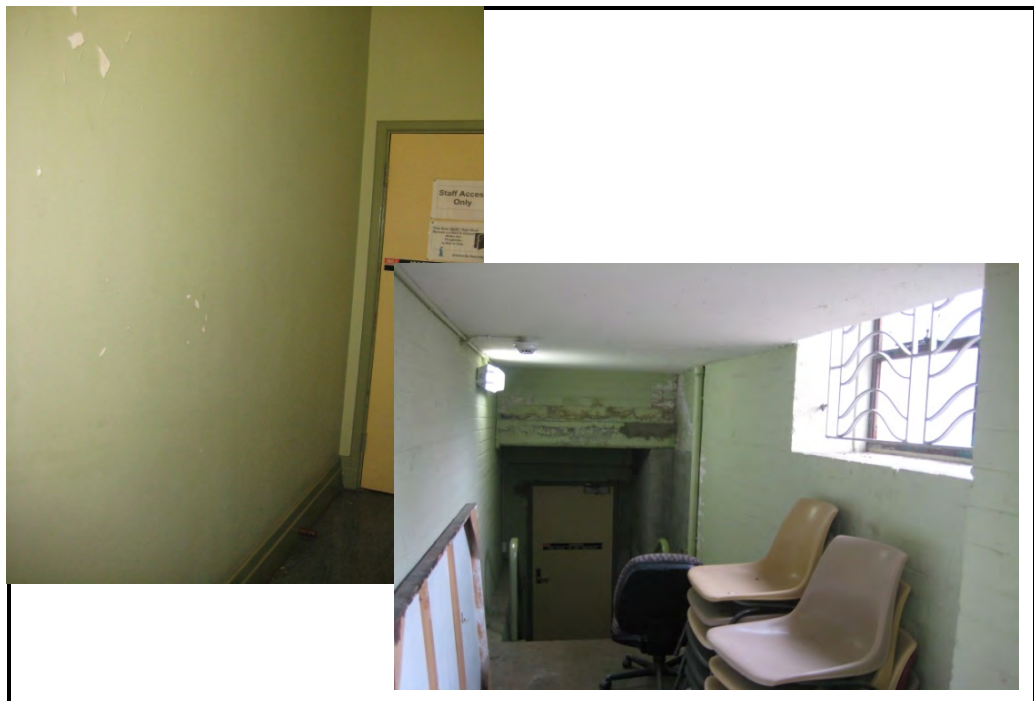
OVERVIEW	Render and paint finish to most walls, painted FC lining to south end of room G13, painted brickwork to part of room G20 and all of room G40. Generally good condition, peeling paint and chips at corner of room G11. Signs of moisture damage to north wall of room G40.	
HERITAGE SIGNIFICANCE	Heritage Significance Value of the element	Mixed
	HIGH Exterior Walls LOW Internal Walls	
FUNCTIONALITY	Functional

OVERVIEW	Investigate and rectify source of moisture to north wall of G40, repaint walls as required.
----------	---

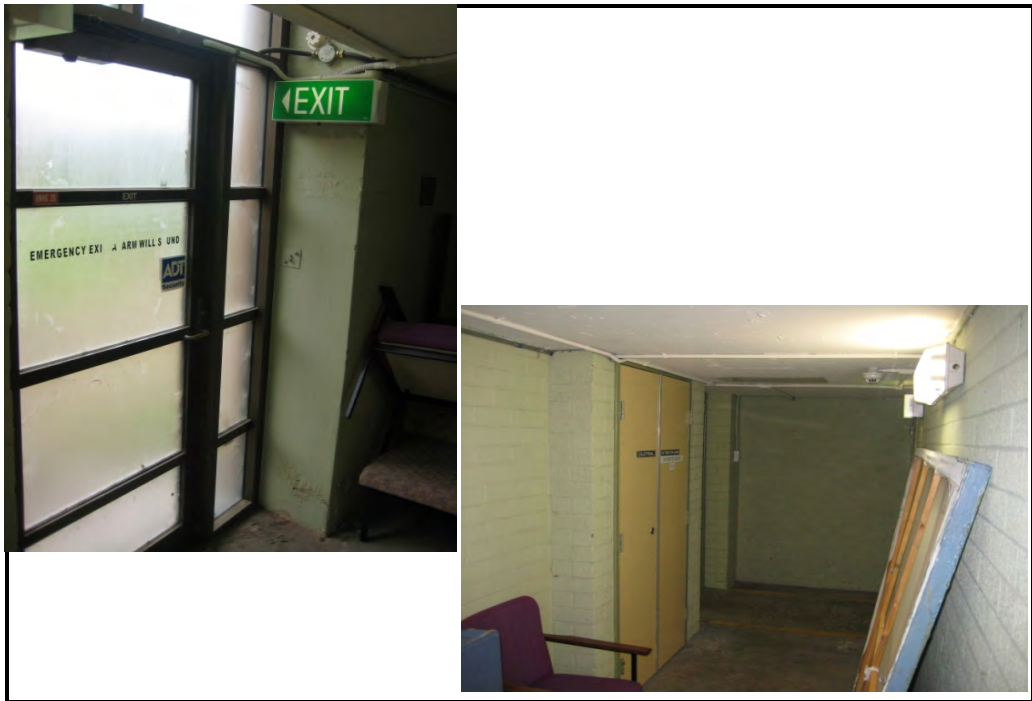
OVERVIEW	Generally painted timber doors. Good condition. Egress door from room G40 east wall is bronze anodised aluminium framed glass door with sidelight, good condition.	
HERITAGE SIGNIFICANCE	Heritage Significance Value of the element	Low
FUNCTIONALITY	Functional

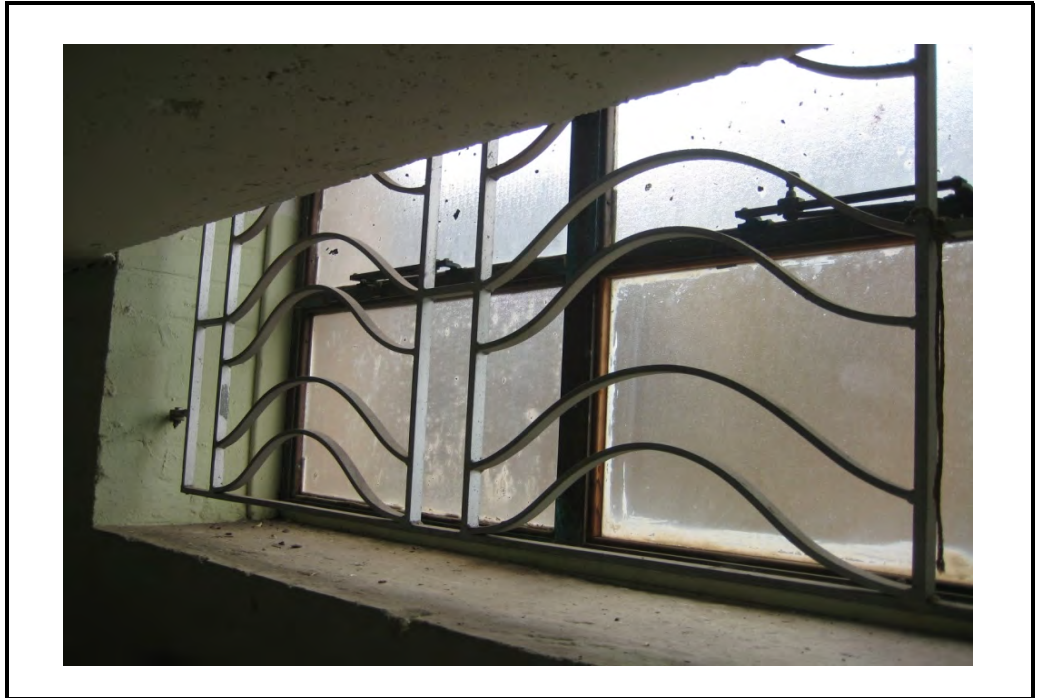
OVERVIEW	Original metal framed casement window - fair condition. Frames discoloured, some sealant missing. Steel grille internally.	
HERITAGE SIGNIFICANCE	Heritage Significance Value of the element	High
FUNCTIONALITY	Functional

OVERVIEW	Restore window frames and sealant to glazing as required.
----------	---

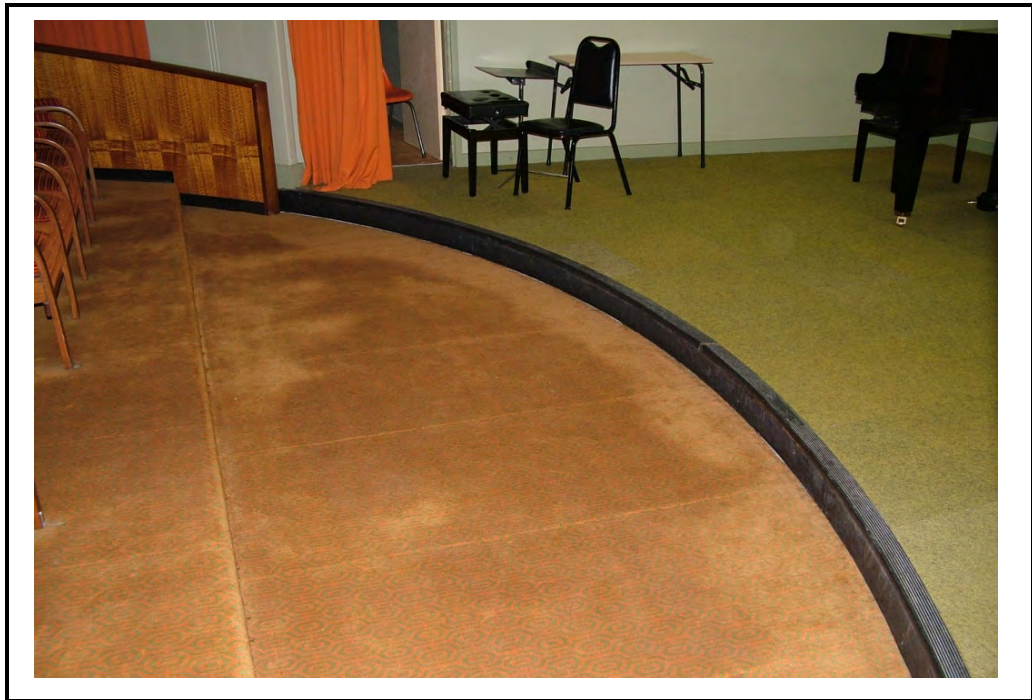
OVERVIEW	Carpet to stepped viewing area and rooms G10 and G25, carpet tiles to demonstration recesses. Rotating floor to main viewing area - functionality not assessed. All generally in good condition. Some carpet tiles missing in western demonstration area, at south wall.	
HERITAGE SIGNIFICANCE	Heritage Significance Value of the element	Mixed
	EXCEPTIONAL Rotating Floor LOW Carpet	
FUNCTIONALITY	Functional, requiring minor repair.

OVERVIEW	Repair and restore flooring as required
----------	---

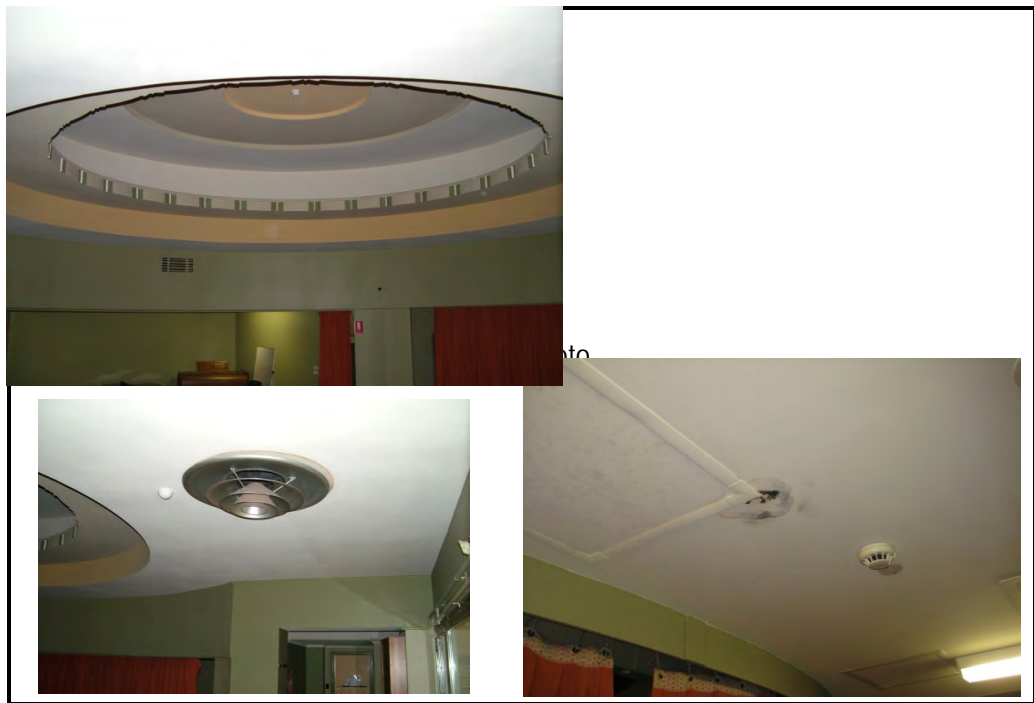
OVERVIEW	Painted plaster ceiling with curves in room G10, and large central feature with perimeter coving and decorative treatment in room G9. Some damage and possible mould to ceiling at corner of manhole - western demonstration recess. A/C vent at rear of room G9 has moved, revealing unpainted ceiling.	
HERITAGE SIGNIFICANCE	Heritage Significance Value of the element	High
FUNCTIONALITY	Functional, requiring minor repair

OVERVIEW	Investigate source of damage where required, rectify and restore ceilings as required.
----------	--

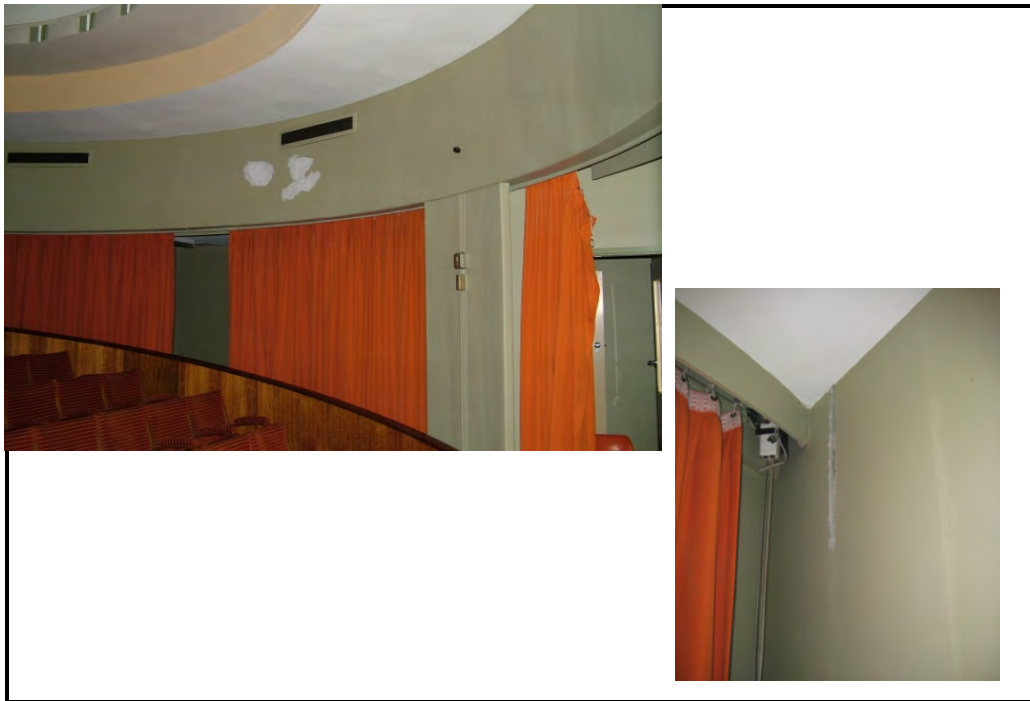
OVERVIEW	Generally good condition, some chipped render and paint at doorway to room G10. Some patchwork to main theatre area requires repainting. Large crack in southern wall of western demonstration recess.	
HERITAGE SIGNIFICANCE	Heritage Significance Value of the element	High
FUNCTIONALITY	Functional but requiring repair.

OVERVIEW	Repair and restore wall finishes as required
----------	--

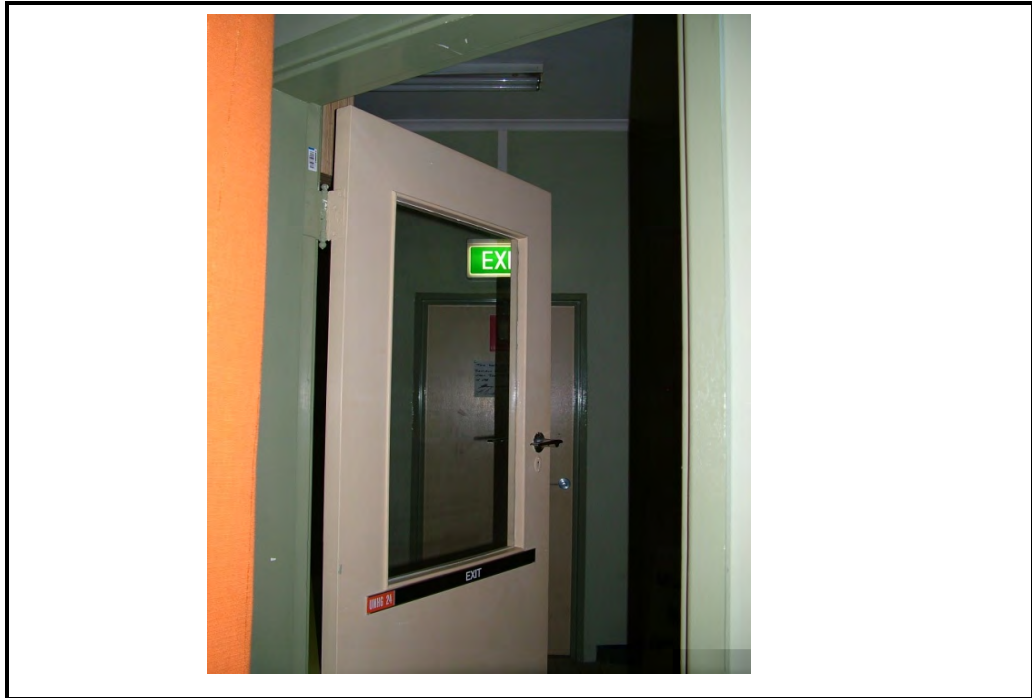
OVERVIEW	Anodised framed glazed doors to corridor (room G6) appear original with decorative embellishments on frame. Good condition. Painted timber and glass doors to rooms G25 and G24, painted timber door to room G10. Painted doors need repaint.	
HERITAGE SIGNIFICANCE	Heritage Significance Value of the element	High
FUNCTIONALITY	Functional, requiring minor repair.

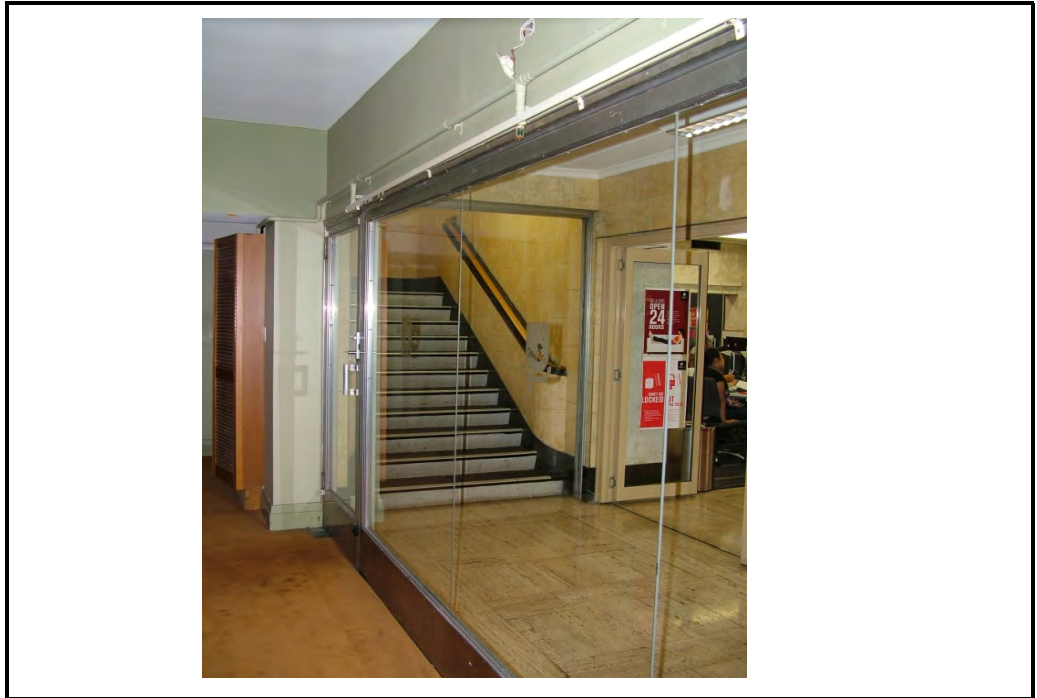
WINDOWS

OVERVIEW	Anodised framed glazing to corridor (room G6) appears original with decorative embellishments on frame. Good condition.	
HERITAGE SIGNIFICANCE	Heritage Significance Value of the element	High
FUNCTIONALITY	Functional

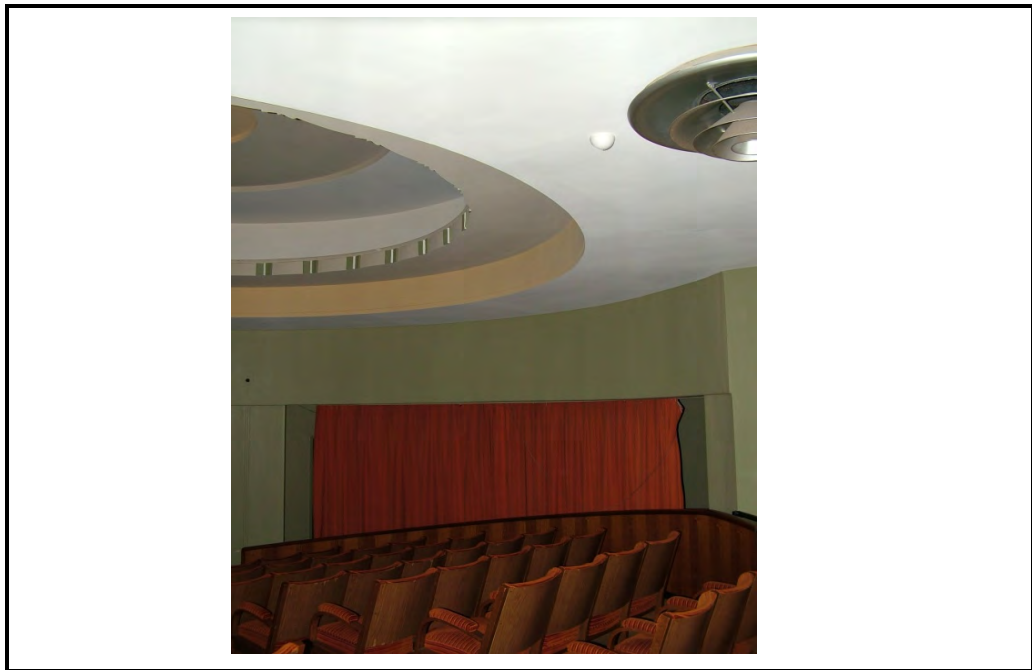
OVERVIEW	Large air conditioning vent in good condition - has shifted on ceiling revealing unpainted fabric. Fixed timber and upholstered seating, timber veneer and steel balustrade all in good condition.	
HERITAGE SIGNIFICANCE	Heritage Significance Value of the element	High
FUNCTIONALITY	Assumed functional

OVERVIEW	Re-centre air conditioning vent.	
----------	----------------------------------	--

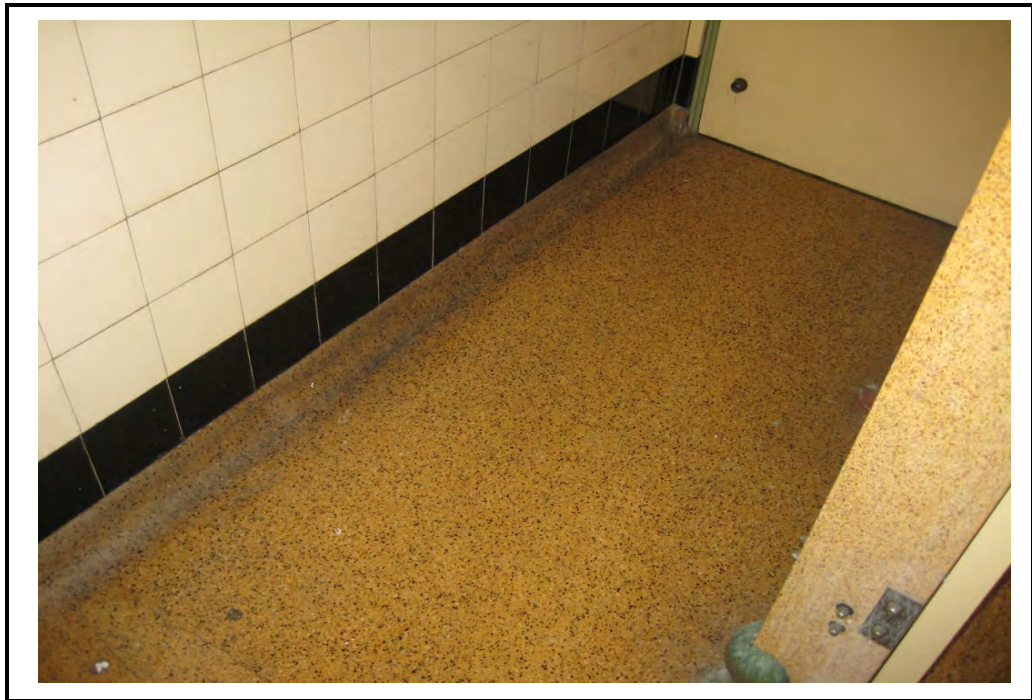
EXISTING CONDITION		
OVERVIEW	Terrazzo flooring to G12, G15, tile flooring to G19. Generally good condition, some cracks to terrazzo flooring.	
HERITAGE SIGNIFICANCE	Heritage Significance Value of the element	Mixed
	HIGH Terrazzo LOW Tile	
FUNCTIONALITY	Functional, requiring minor repair.	
ACTION REQUIRED		
OVERVIEW	Repair and restore flooring as required

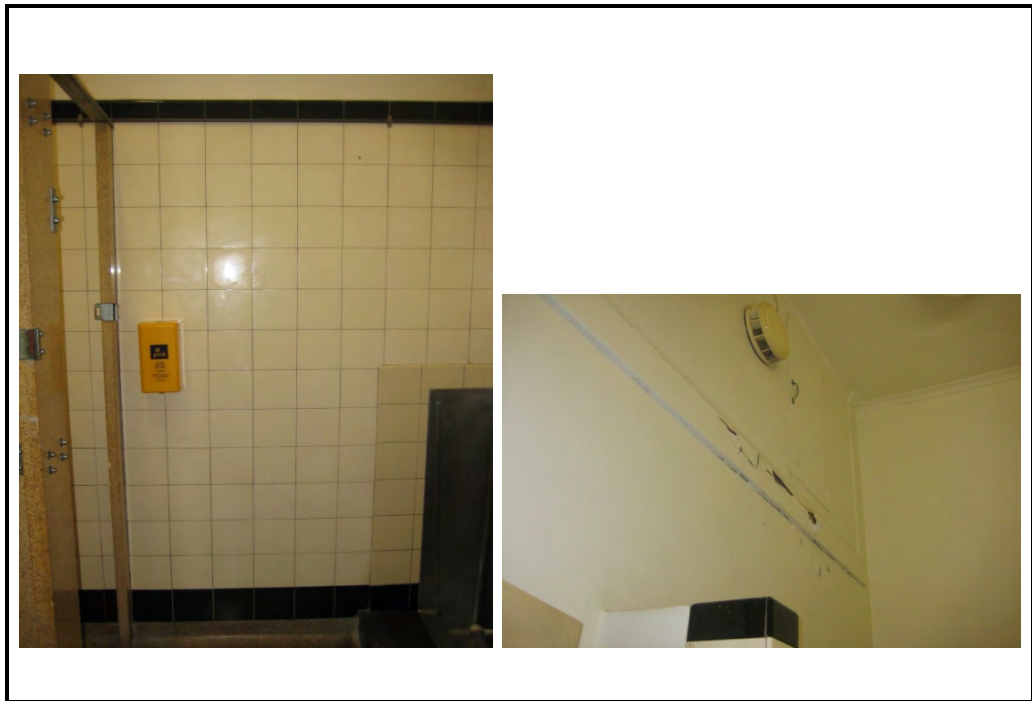
OVERVIEW	Rooms G12, G15 - wall tiles to approx. 2200 AFFL, appear to be original, in good condition. Paint finish over, paint peeling on part of G12. Room G19 - render / FC and paint finish, skirting tile with tiles to high level at shower recess. Generally good condition, some cracking at northern corners of room.	
HERITAGE SIGNIFICANCE	Heritage Significance Value of the element	Mixed
	HIGH Tiles in G12, G15 LOW Tiles and finishes in G19	
FUNCTIONALITY	Functional.

OVERVIEW	Repair and restore wall finishes as required
----------	--

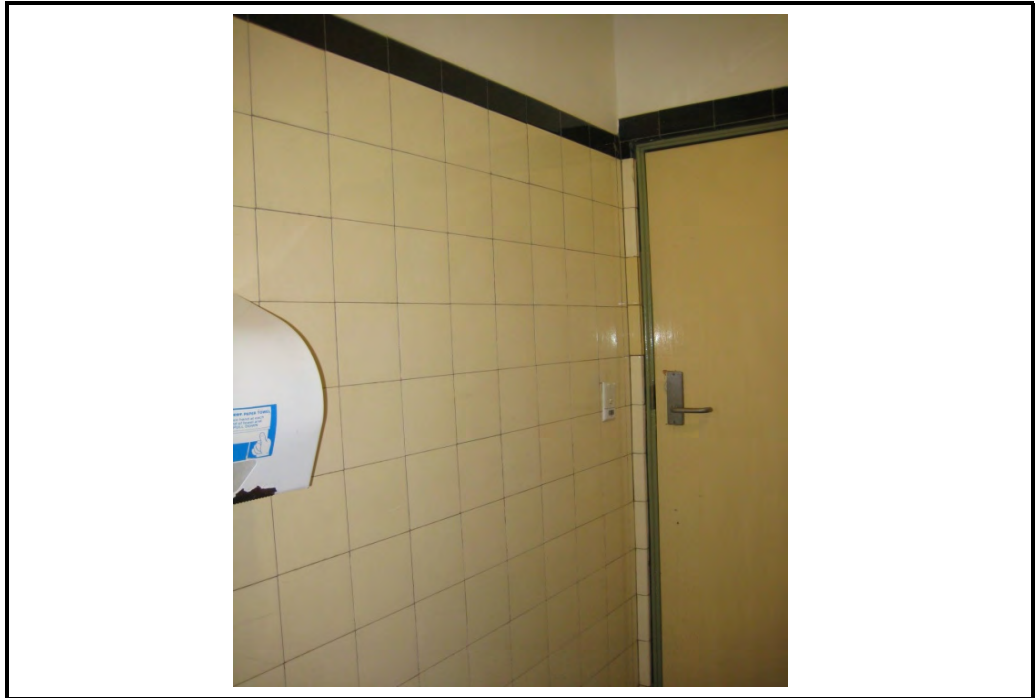
DOORS

OVERVIEW	Painted timber doors, generally good condition.	
HERITAGE SIGNIFICANCE	Heritage Significance Value of the element	Low
FUNCTIONALITY	Functional.

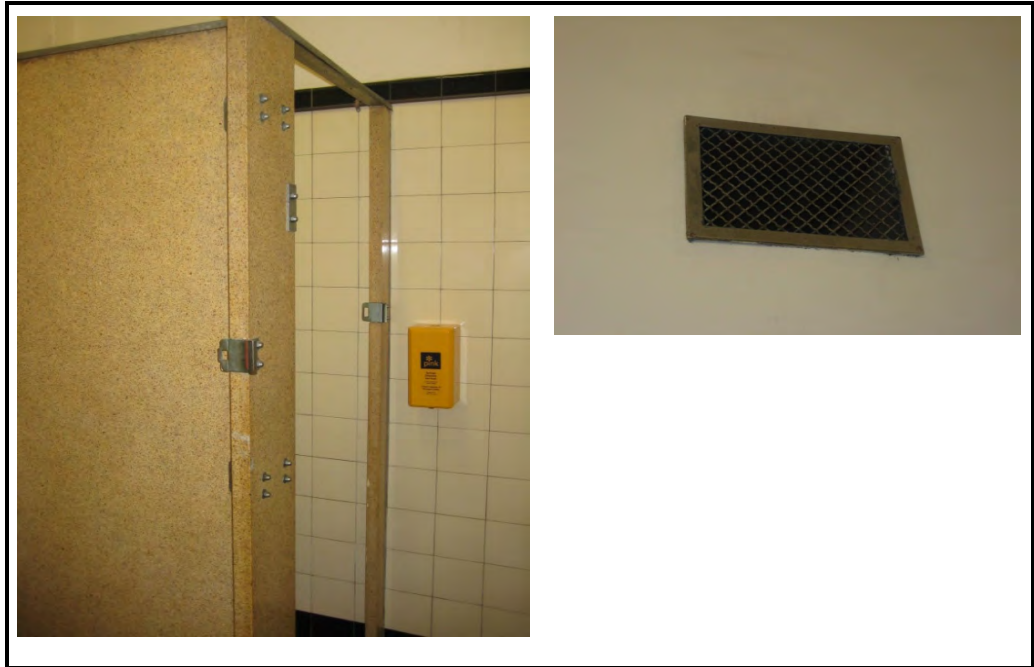
FITTINGS

OVERVIEW	Terazzo toilet partitions in good condition (G12, G15). Ventilation grille on walls of G12, G15.	
HERITAGE SIGNIFICANCE	Heritage Significance Value of the element	High
FUNCTIONALITY	Partitions functional, grille assumed functional

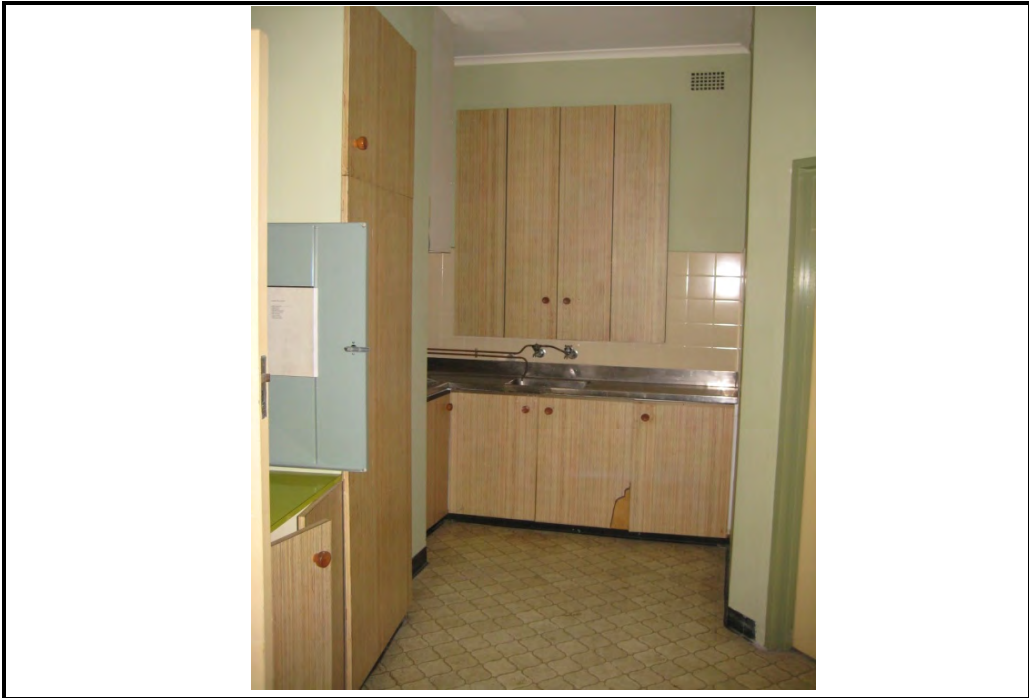
OVERVIEW	Vinyl flooring generally in good condition, some scuff marks. Part of room G23 bare concrete flooring.	
HERITAGE SIGNIFICANCE	Heritage Significance Value of the element	Low
FUNCTIONALITY	Functional, requiring minor repair.

OVERVIEW	Repair and restore flooring as required
----------	---

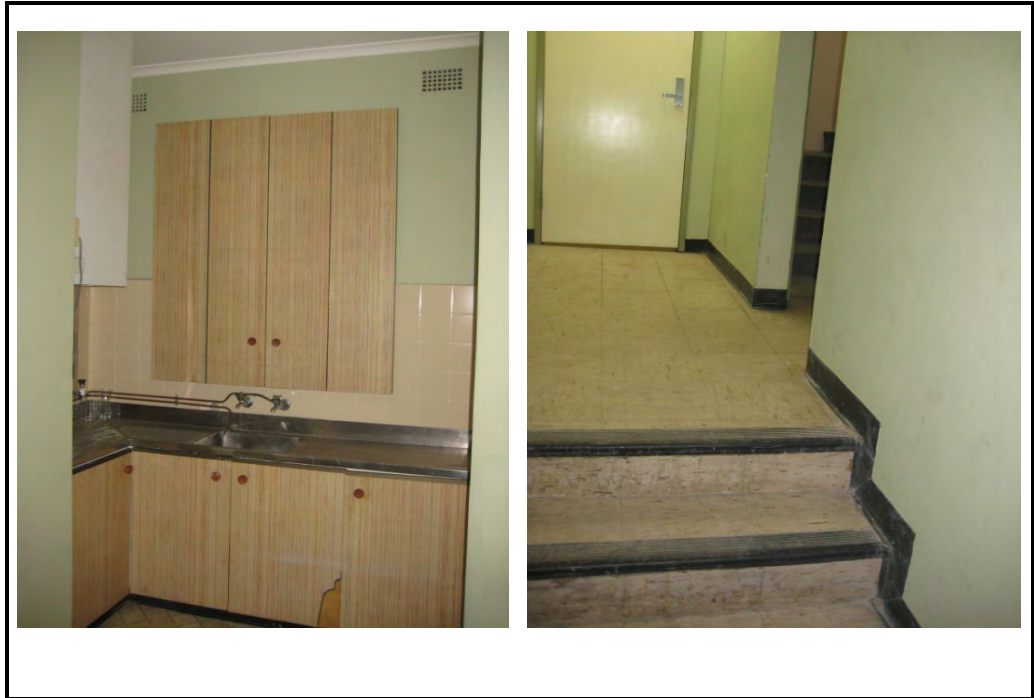
WALLS

OVERVIEW	Render and paint finish generally in good condition with some scuff marks. Tiles to kitchen in good condition.	
HERITAGE SIGNIFICANCE	Heritage Significance Value of the element	Low
FUNCTIONALITY	Functional.

OVERVIEW	Repair and restore wall finishes as required
----------	--

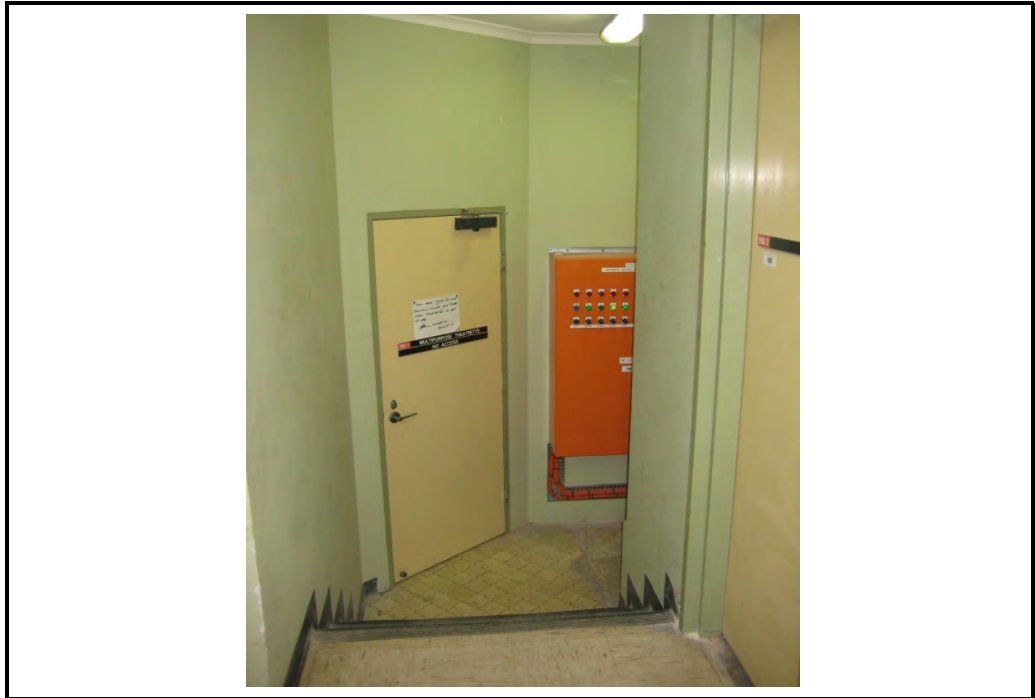
DOORS

OVERVIEW	Painted timber doors, 1 door in room G24 has glass panel, generally good condition. Door from room G20 to G23 squeaks.	
HERITAGE SIGNIFICANCE	Heritage Significance Value of the element	Low
FUNCTIONALITY	Functional.

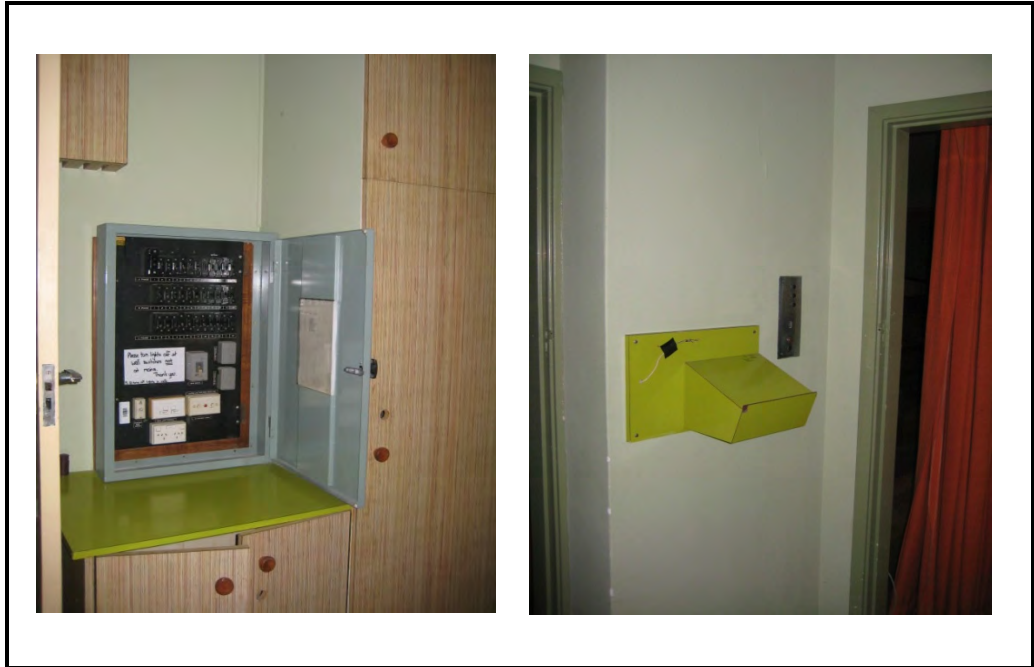
FITTINGS

OVERVIEW	Control panel for theatre floor in room G24, functionality not assessed. Switchboard in room G24, switchboards and control panels in room G23. Storage Joinery in G24.	
HERITAGE SIGNIFICANCE	Heritage Significance Value of the element	Mixed
	HIGH Control Panel for theatre LOW Joinery	
FUNCTIONALITY	Assumed functional	
ACTION REQUIRED		
OVERVIEW

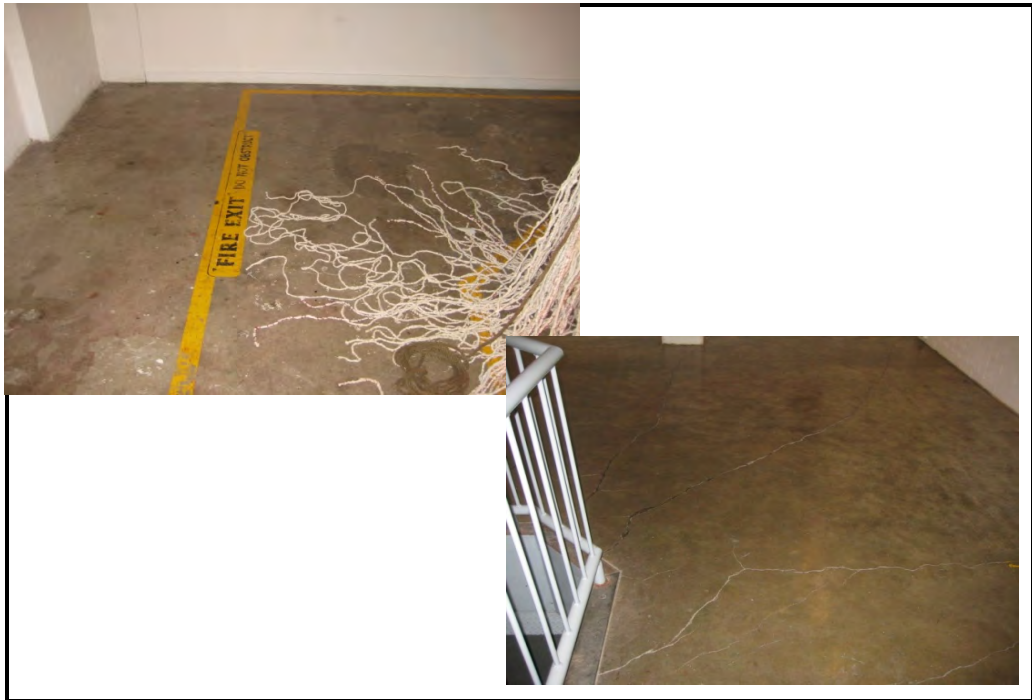
OVERVIEW	Polished concrete floors, vinyl flooring in room G33, generally in fair to good condition. Some cracking of concrete floors, ranging from light surface cracks to larger cracking. Original line marking to concrete floors in some rooms, partially painted over in room G34.	
HERITAGE SIGNIFICANCE	Heritage Significance Value of the element	Low
FUNCTIONALITY	Functional but requiring minor repair.

OVERVIEW	Repair and restore flooring as required
----------	---

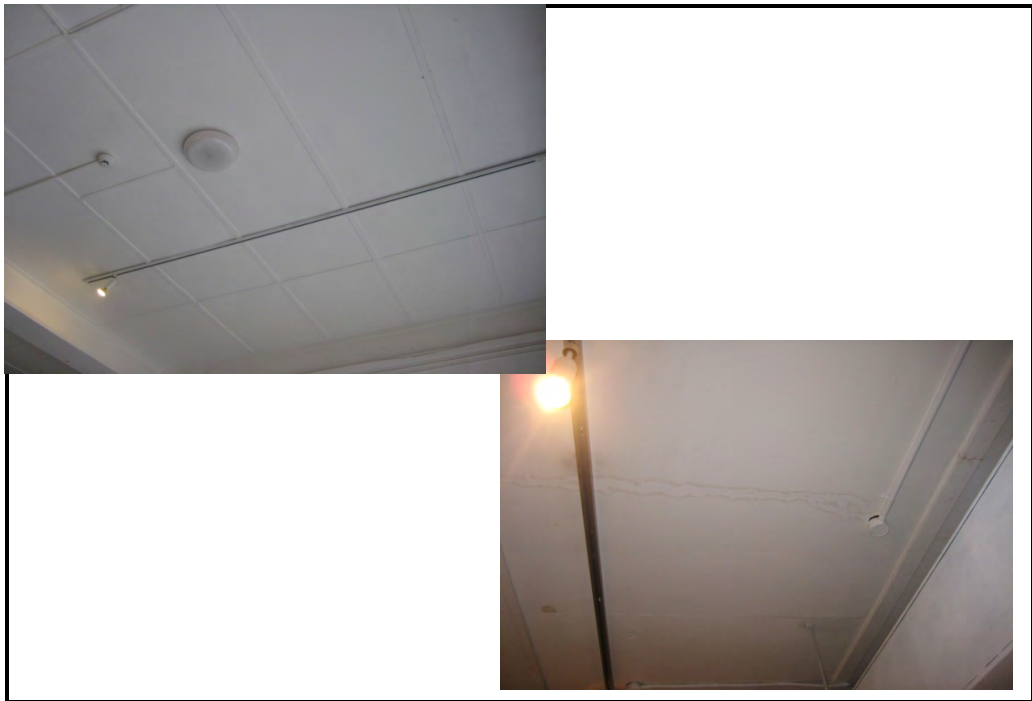
OVERVIEW	Mixture of FC and concrete soffits, all with paint finish and in good condition. Some moisture staining to concrete soffit in room G31.	
HERITAGE SIGNIFICANCE	Heritage Significance Value of the element	Low
FUNCTIONALITY	Functional, requiring minor repair

OVERVIEW	Investigate and rectify source of moisture in room G31, repaint ceiling as required.
----------	--

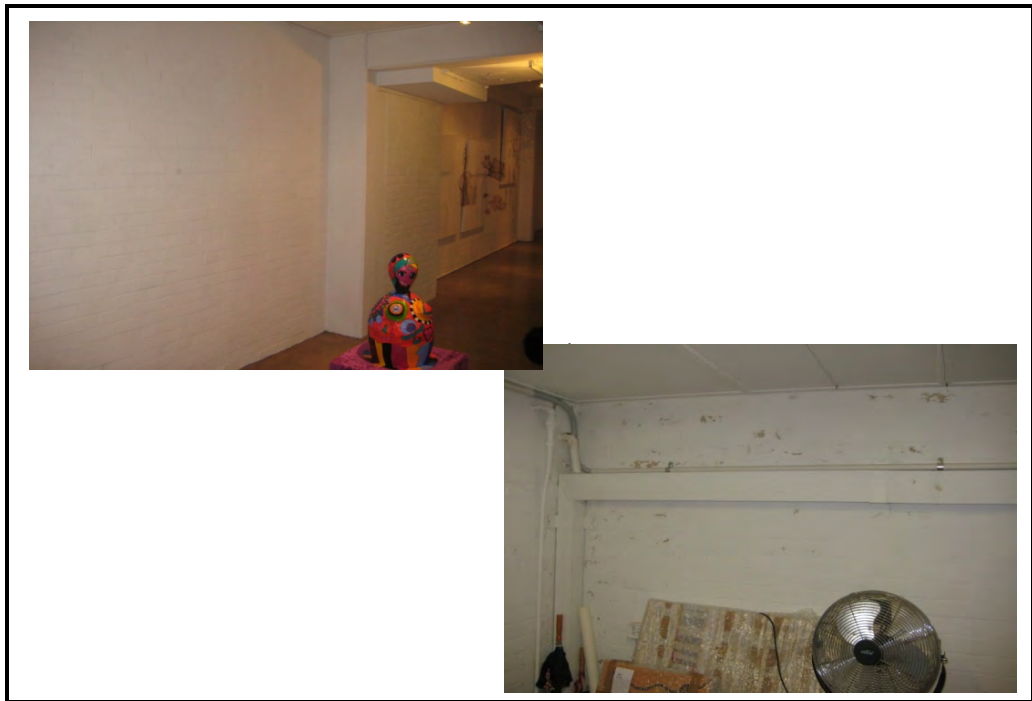
OVERVIEW	Generally painted brickwork or render or blockwork, some areas of plasterboard or FC and paint finish. Generally good condition, some paint cracked, peeling in room G35 - north wall. Wallpaper to north wall of G33, splashback tiles to kitchenette unit in G33.	
HERITAGE SIGNIFICANCE	Heritage Significance Value of the element	Mixed
	HIGH External Walls LOW Internal Walls	
FUNCTIONALITY	Functional but requiring repair.

OVERVIEW	Repair and restore wall finishes as required
----------	--

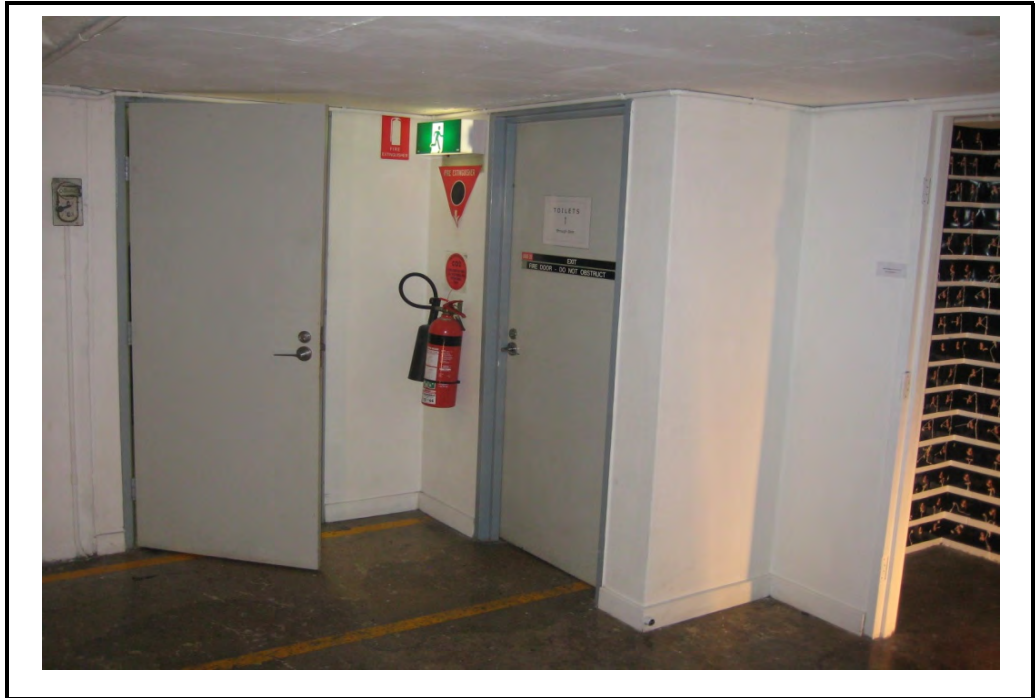
DOORS

OVERVIEW	Painted timber with either painted timber or painted steel frames. All good condition. Roller door to main entry.	
HERITAGE SIGNIFICANCE	Heritage Significance Value of the element	Low
FUNCTIONALITY	Functional

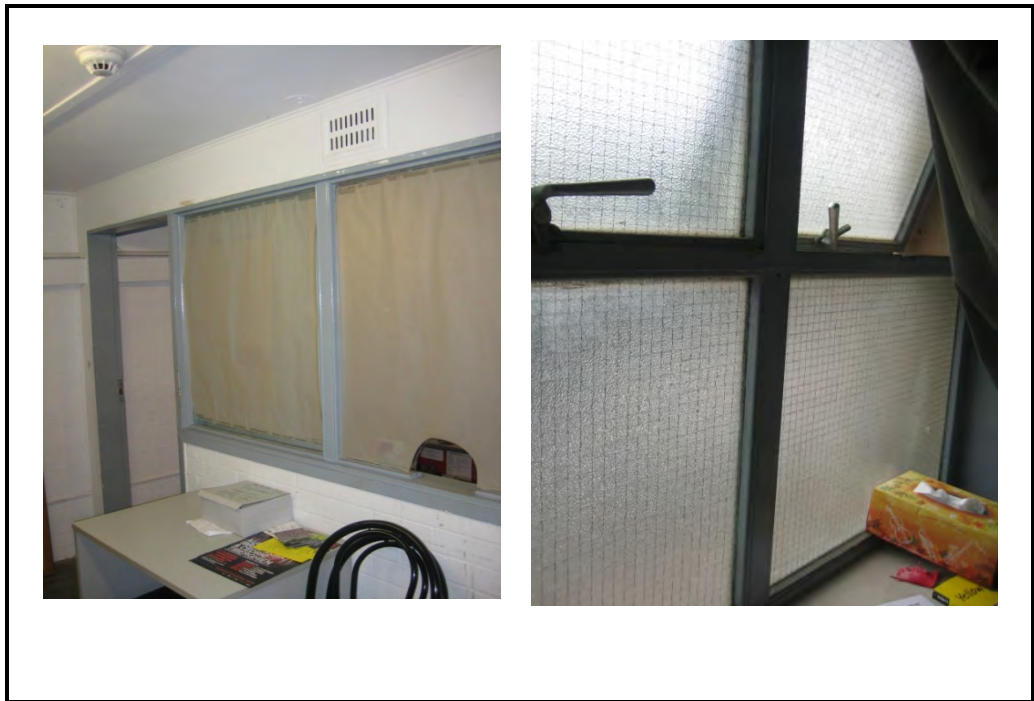
OVERVIEW	Painted timber framed glazing to internal (east) wall of room G35, painted steel framed awning window to western external wall of room G35. Both good condition.	
HERITAGE SIGNIFICANCE	Heritage Significance Value of the element	Mixed
	HIGH Exterior Bronze type LOW Internal Painted Timber type	
FUNCTIONALITY	Functional

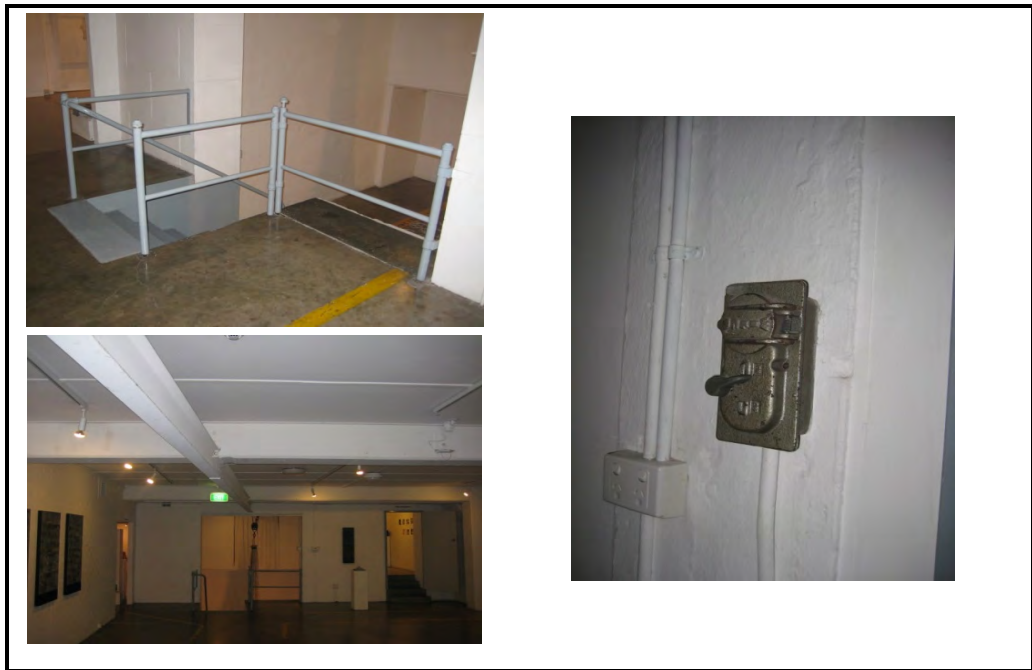
EXISTING CONDITION		
OVERVIEW	Painted steel balustrade to G30, steel crane gantry to G30, old switchgear to G30, G33, G34	
HERITAGE SIGNIFICANCE	Heritage Significance Value of the element	Moderate
FUNCTIONALITY	Functional	
ACTION REQUIRED		
OVERVIEW

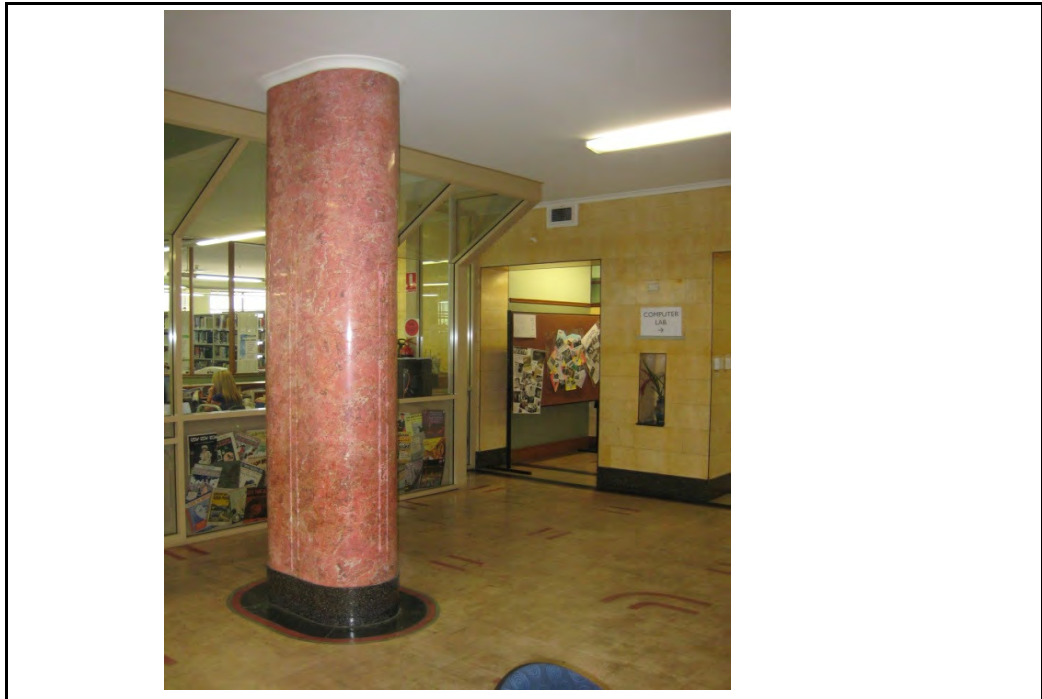
OVERVIEW	Painted plasterboard ceiling. Good condition.	
HERITAGE SIGNIFICANCE	Heritage Significance Value of the element	Moderate
FUNCTIONALITY	Functional

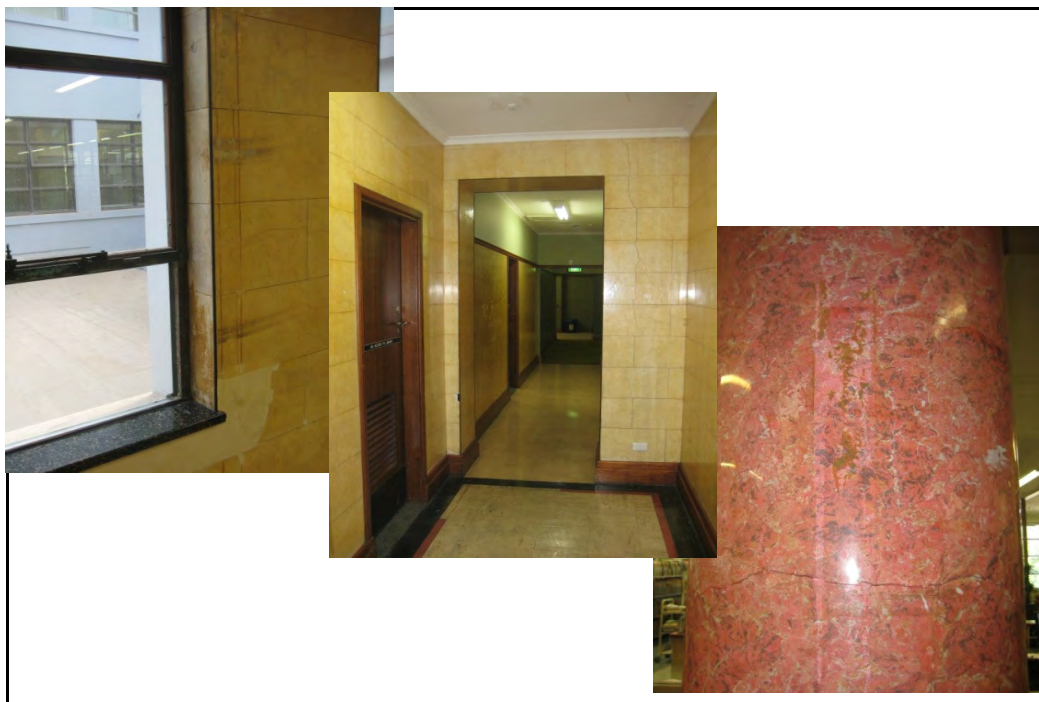
ASSET ELEMENT	WALLS
----------------------	--------------

OVERVIEW	Scagliola tiles with black stone skirting to lobby, scagliola tiles with stepped timber skirting to most of corridor - fair condition, with fine cracks extensively across surface of scagliola tiles. Some larger cracks and chips missing from tiles at doorway in corridor. Some tiles in corridor and lobby have surface colour deteriorating / falling off. Patchwork to tiles below window in lobby untidy. Pink scagliola with black stone skirting to columns in lobby. Cracking to scagliola, some scarring to facework on middle column in lobby. All scagliola / scagliola tiled walls drummy in some areas, particularly adjacent to larger crack locations. Decorative timber rail at 2100 AFFL along corridor, painted to match the painted plasterboard / render at north end of corridor. Painted plasterboard at door to 1.16, hole above door. Chips in reveal and head of doorway at north end of corridor.

HERITAGE SIGNIFICANCE	Heritage Significance Value of the element	Mixed
	EXCEPTIONAL Scagliola, scagliola tiles, skirtings LOW Painted plasterboard / render	
FUNCTIONALITY	Functional but requiring repair.

OVERVIEW	Repair and restore wall finishes as required
-----------------	--

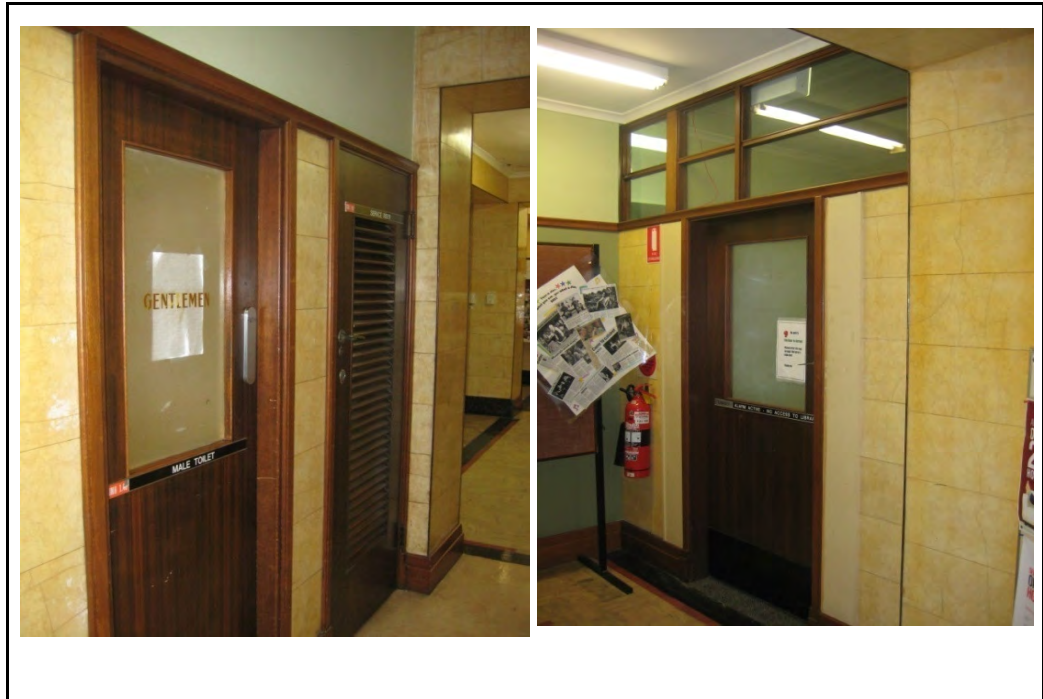
DOORS

<p>OVERVIEW</p>	<p>Timber veneer doors with timber frames. Doors to rooms 1.51 and 1.48 have glass panels. Door to service riser 1.49 has timber louvres. All good condition.</p>	
<p>HERITAGE SIGNIFICANCE</p>	<p>Heritage Significance Value of the element</p>	<p>High</p>
<p>FUNCTIONALITY</p>	<p>Functional</p>	
<p>ACTION REQUIRED</p>		
<p>OVERVIEW</p>

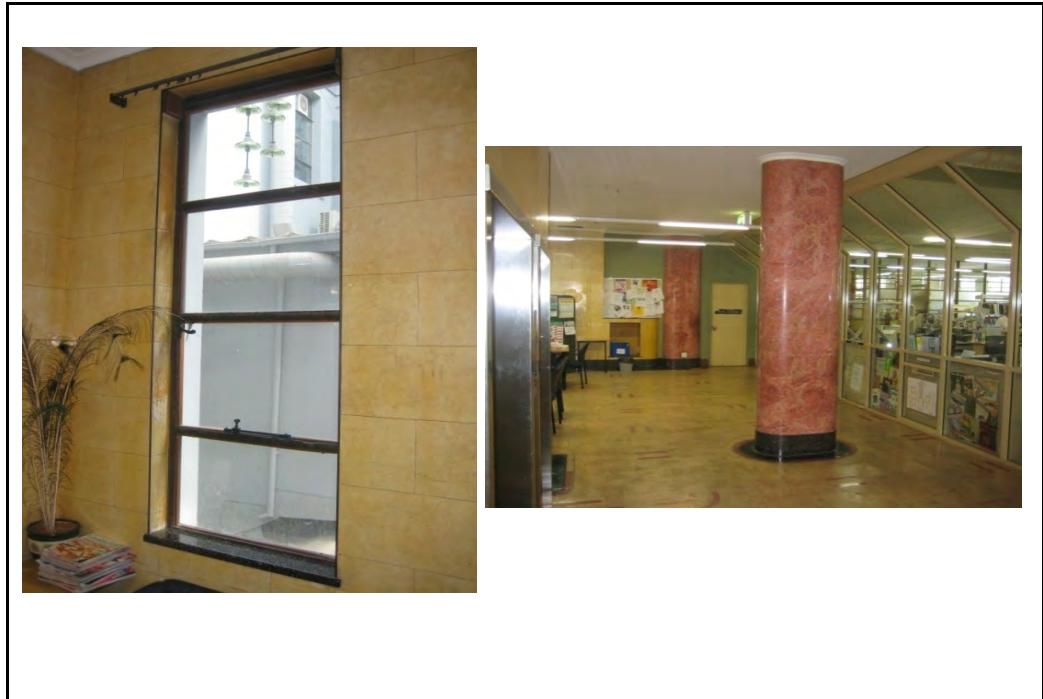
WINDOWS

OVERVIEW	Steel / timber framed casement window to external light well - fair condition, some discolouration to frame. Black stone sills, some minor cracking evident. Powdercoated aluminium framed glazing to south wall of room 1.16, good condition. Timber framed highlight glazing above door to room 1.51, good condition.	
HERITAGE SIGNIFICANCE	Heritage Significance Value of the element	Mixed
	HIGH Original metal windows and timber framed highlight windows LOW Powdercoated aluminium framed glazing	
FUNCTIONALITY	Functional	
ACTION REQUIRED		
OVERVIEW	Restore original glazing frames and sill as required.
