CONSERVATION MANAGEMENT PLAN

UNIVERSITY HOUSE FORMERLY N.E.S.C.A HOUSE KING STREET NEWCASTLE

Prepared by EJE Heritage
MARCH 2011
Ref: 8836-CMP-UH-001

APPENDIX H: INVENTORY DATASHEETS

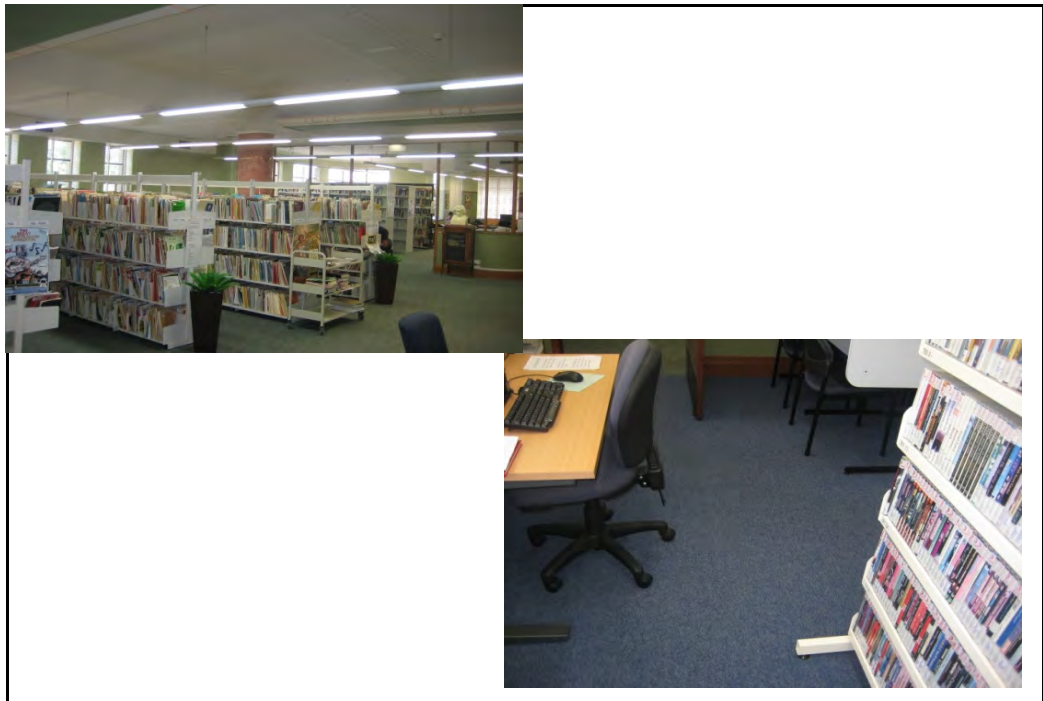
ASSET ELEMENT	FLOOR
----------------------	--------------

OVERVIEW	Carpet tile flooring to room 1.02, 1.04 and 1.05, good condition. Carpet flooring to room 1.09, good condition.	
HERITAGE SIGNIFICANCE	Heritage Significance Value of the element	
	Low	
FUNCTIONALITY	Functional

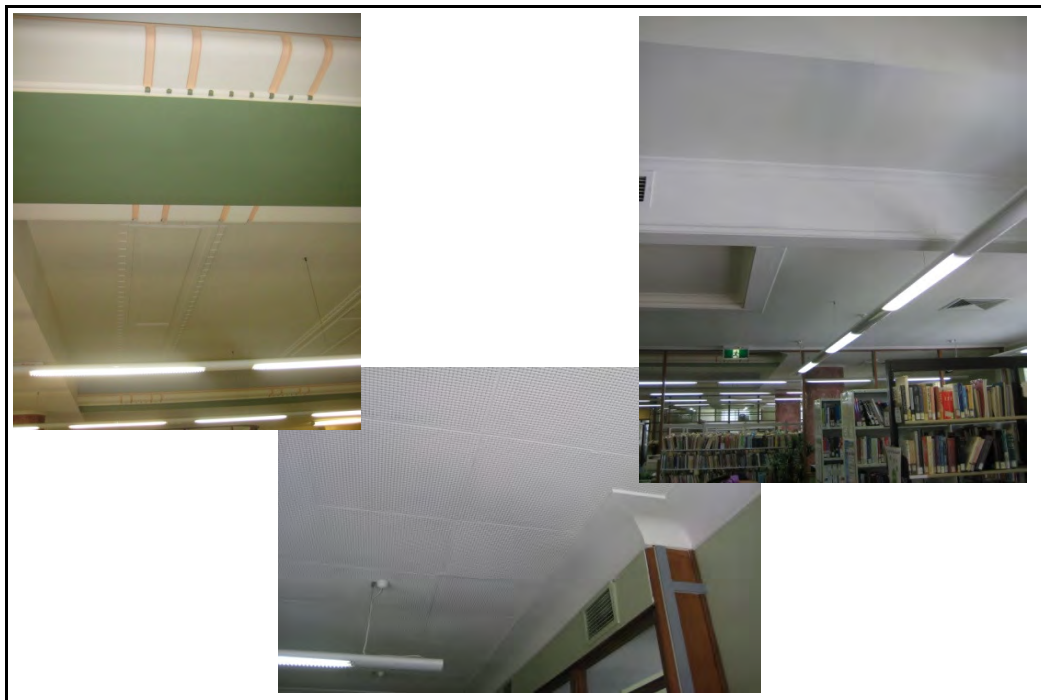
ASSET ELEMENT	CEILING
----------------------	----------------

OVERVIEW	Painted plasterboard ceiling with decorative coved spines and feature panels. Good condition. Painted plasterboard to room 1.04 and 1.05, paint flaking at underside of bulkheads in room 1.04, particularly in south west corner. Perforated plasterboard, paint finish in room 1.09, good condition.	
HERITAGE SIGNIFICANCE	Heritage Significance Value of the element	Mixed
	HIGH Decorative ceiling to room 1.02 LOW Other ceilings	
FUNCTIONALITY	Functional, requiring repairs to paintwork.

OVERVIEW	Remove damaged paintwork and repaint as required.
-----------------	---

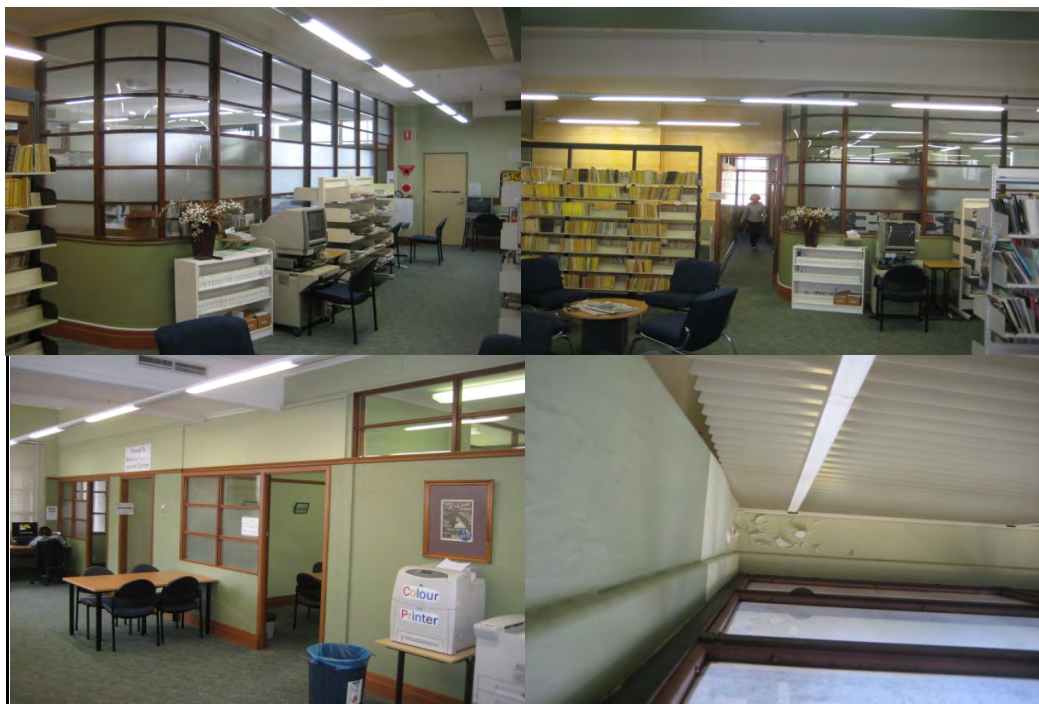
ASSET ELEMENT	WALLS
----------------------	--------------

OVERVIEW	Scagliola tiles with stepped timber skirting to room 1.05 and part of room 1.02 - fair condition, with fine cracks extensively across surface of scagliola tiles. Pink scagliola to columns. Cracking to scagliola. All scagliola / scagliola tiled walls drummy in some areas, particularly adjacent to larger crack locations. Render and paint finish to external walls in room 1.09, 1.04. Plasterboard and paint finish to common walls, southern wall to room 1.02. Generally good condition, paint finish bubbling, flaking adjacent to windows on rendered external walls in 1.04 and 1.09. Paint flaking at underside of window head in room 1.04. Common wall between room 1.02 and 1.09 timber framed glazing, curved at northern corner, with painted FC dado. Decorative timber rail at 2100 AFFL to rooms 1.04, 1.05 and 1.09.	
HERITAGE SIGNIFICANCE	Heritage Significance Value of the element	Mixed
	HIGH Scagliola, scagliola tiles, timber framed glazing LOW Painted plasterboard / render

FUNCTIONALITY	Functional but requiring repair.

OVERVIEW	Repair and restore wall finishes as required
-----------------	--

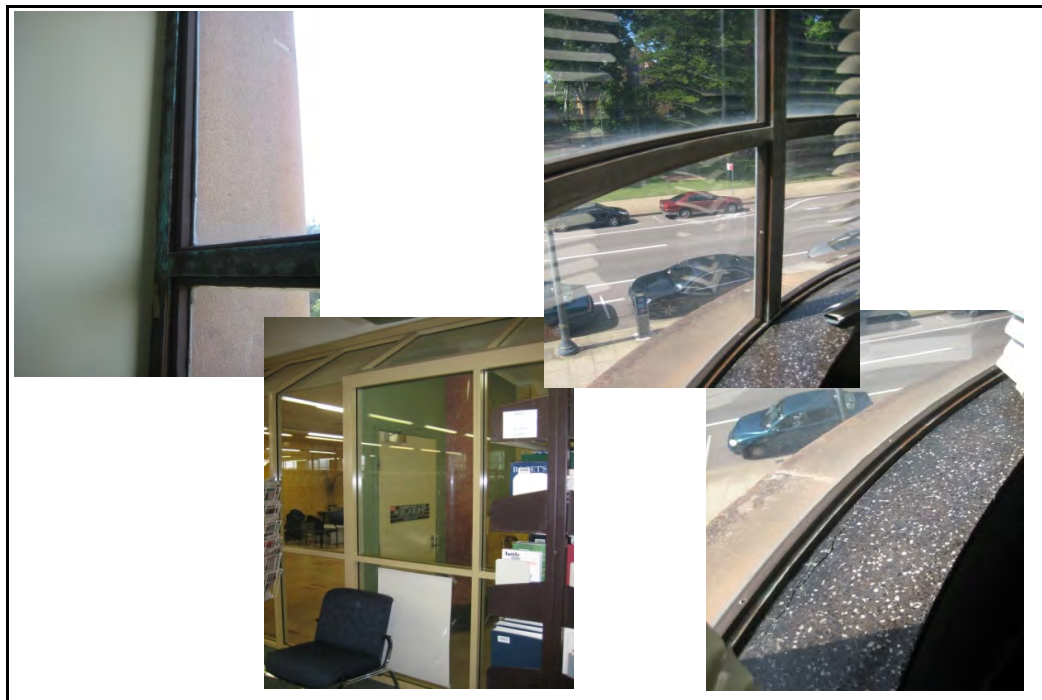
ASSET ELEMENT	WINDOWS
----------------------	----------------

OVERVIEW	Steel / timber framed casement window to external walls - fair condition, some discolouration to frames. Frames and glass curved to windows in rooms 1.04 and 1.09. Black stone sills, some cracking evident ranging from minor surface cracks to larger cracks. Powdercoated aluminium framed glazing to north wall of room 1.02, good condition. Timber framed glazing to internal windows, good condition. Crack in pane of curved glass in common wall between rooms 1.02 and 1.09.	
HERITAGE SIGNIFICANCE	Heritage Significance Value of the element	Mixed
	EXCEPTIONAL Original metal window and timber framed windows (particularly curved windows to room 1.04, 1.09) LOW Powdercoated aluminium framed glazing	
FUNCTIONALITY	Functional

OVERVIEW	Restore original glazing frames and sill as required. Replace cracked pane.
-----------------	---

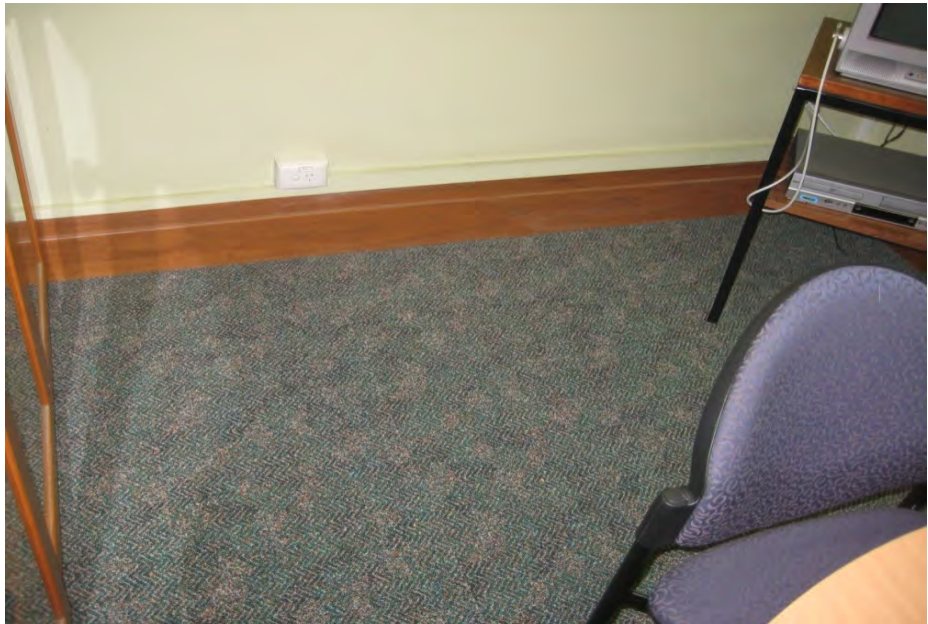
ASSET ELEMENT**FLOOR**

OVERVIEW	Carpet tile flooring, good condition.	
HERITAGE SIGNIFICANCE	Heritage Significance Value of the element	Low
	LOW Refers to carpet only - substrate may hold higher significance.	
FUNCTIONALITY	Functional

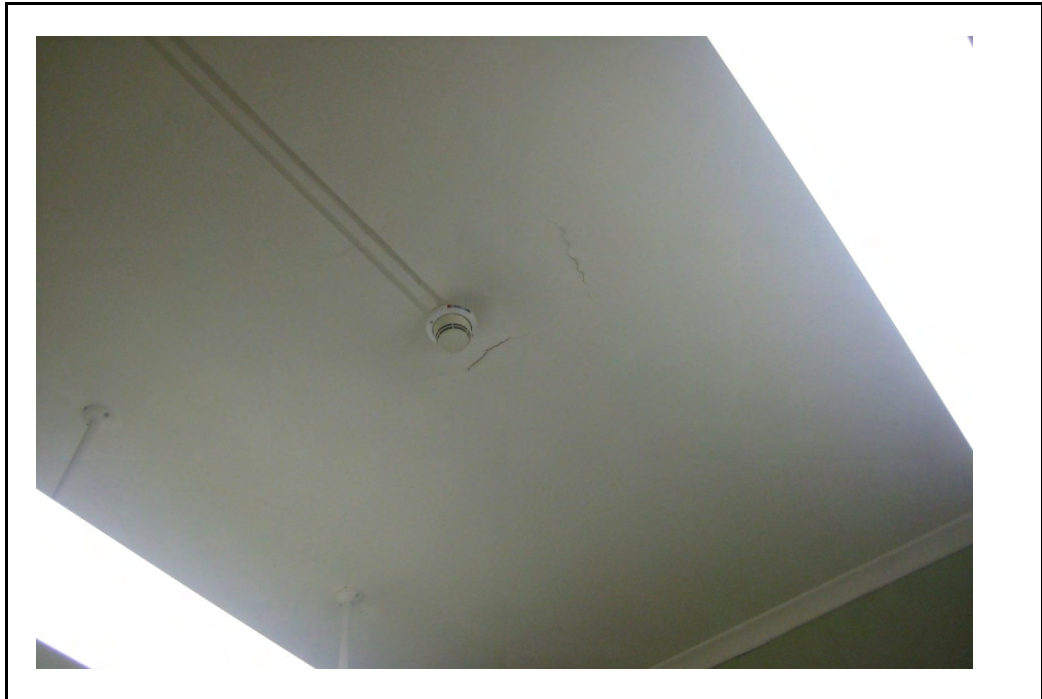
ASSET ELEMENT	CEILING
----------------------	----------------

OVERVIEW	Plasterboard ceiling, paint finish. Generally good condition, paint cracked, flaking in small area of room 1.06.	
HERITAGE SIGNIFICANCE	Heritage Significance Value of the element	Low
FUNCTIONALITY	Functional, requiring repairs to paintwork.

OVERVIEW	Remove damaged paintwork and repaint as required.
-----------------	---

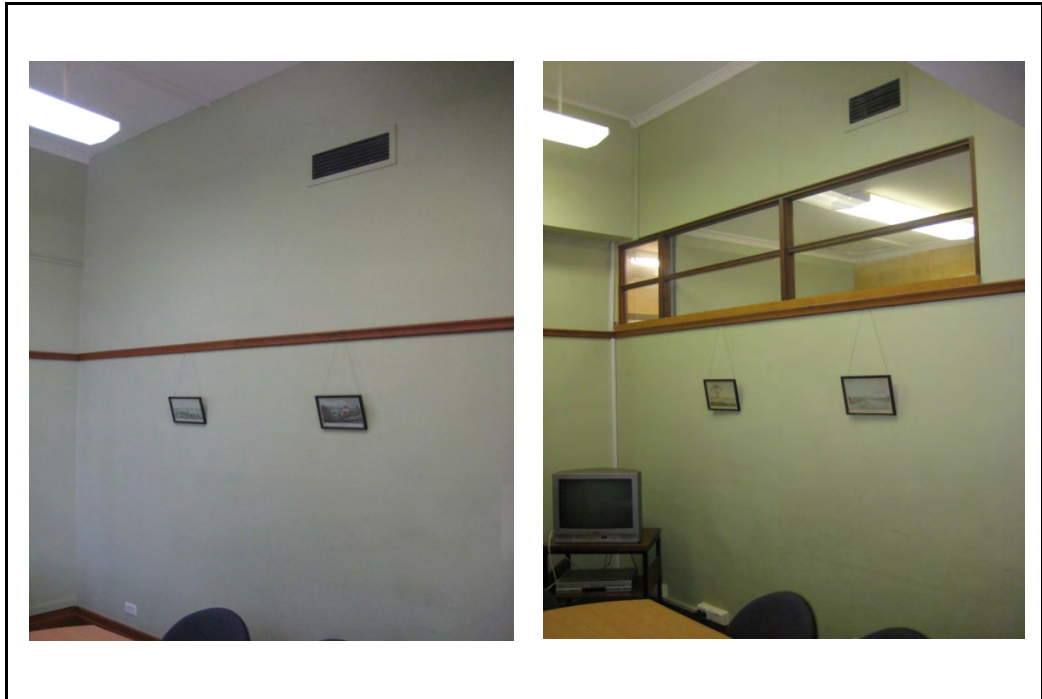
ASSET ELEMENT	WALLS
----------------------	--------------

OVERVIEW	Plasterboard and paint finish, render and paint finish to external wall of 1.08 and eastern wall of 1.06. Stepped timber skirtings and timber rail at 2100 AFFL. All good condition.	
HERITAGE SIGNIFICANCE	Heritage Significance Value of the element	Low
FUNCTIONALITY	Functional

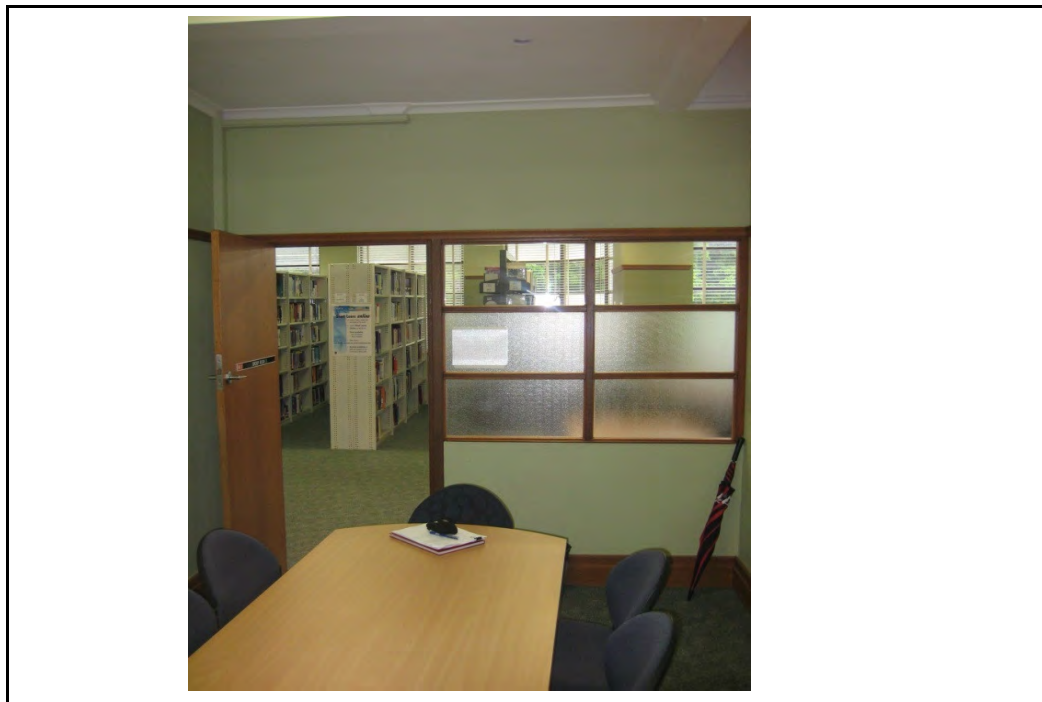
ASSET ELEMENT	DOORS
----------------------	--------------

OVERVIEW	Timber doors with timber frames. All good condition.	
HERITAGE SIGNIFICANCE	Heritage Significance Value of the element	Low
FUNCTIONALITY	Functional

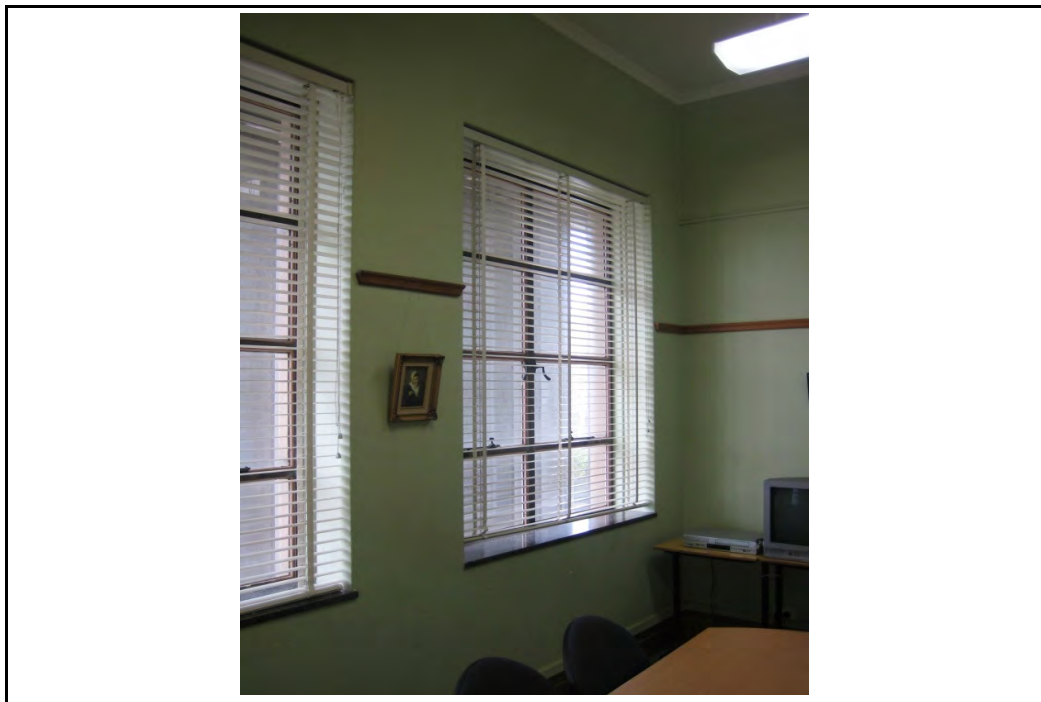
ASSET ELEMENT	WINDOWS
----------------------	----------------

OVERVIEW	Steel / timber framed casement window to external walls - fair condition, some discolouration to frames. Black stone sills, some cracking evident, colour faded. Timber framed glazing to south walls of rooms 1.06, 1.08, and timber framed highlight window to east wall of room 1.06.	
HERITAGE SIGNIFICANCE	Heritage Significance Value of the element	Mixed
	EXCEPTIONAL External windows exceptional HIGH Timber framed highlight glazing to room 1.06 LOW Timber framed glazing to south walls of rooms 1.06 and 1.08	
FUNCTIONALITY	Functional

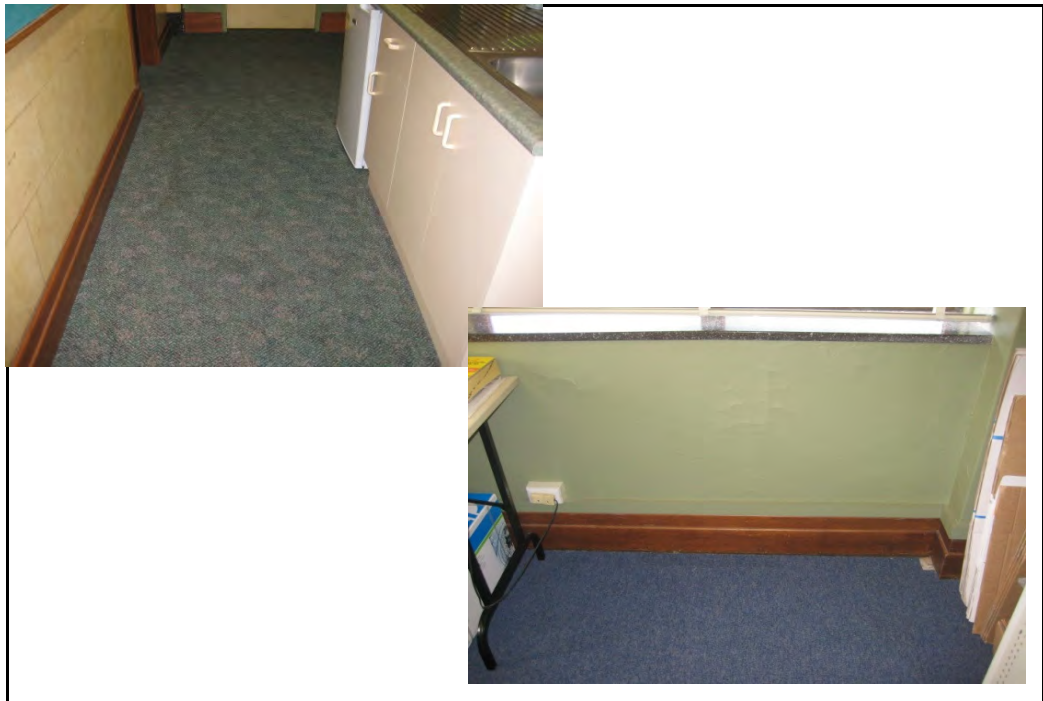
ASSET ELEMENT	FLOOR
---------------	-------

EXISTING CONDITION		
OVERVIEW	Carpet tile flooring to rooms 1.13, 1.17, good condition. Carpet to rooms 1.10, 1.11, good condition.	
HERITAGE SIGNIFICANCE	Heritage Significance Value of the element	Low
	LOW Refers to carpet / carpet tiles only, substrate may hold higher significance.	
FUNCTIONALITY	Functional	
ACTION REQUIRED		
OVERVIEW

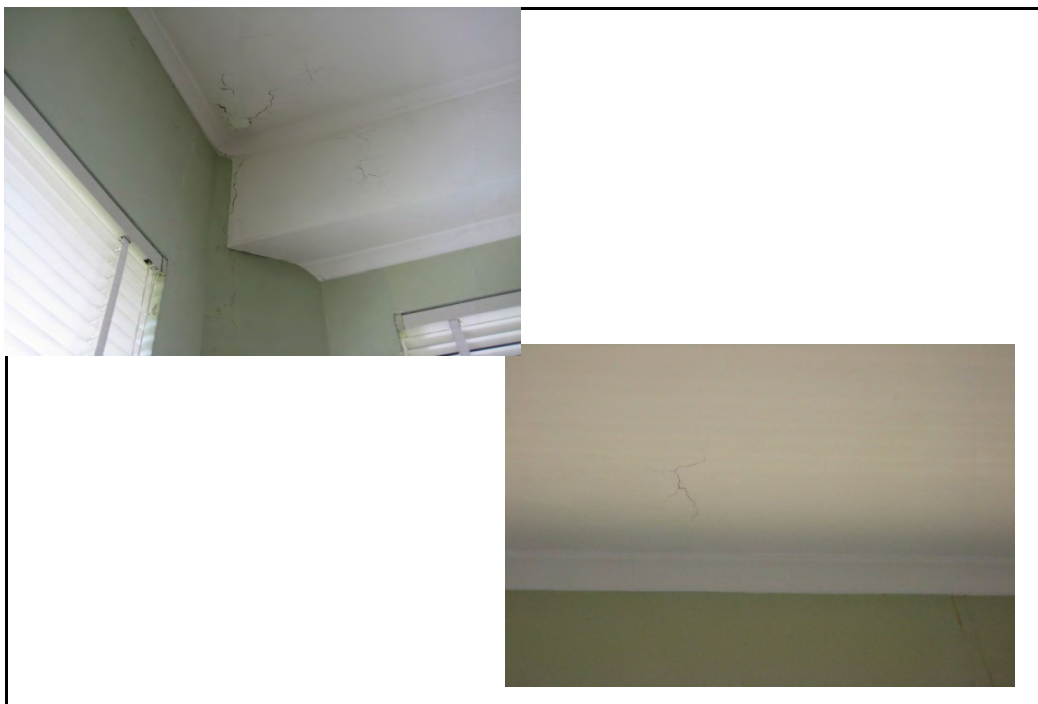
ASSET ELEMENT	CEILING
----------------------	----------------

OVERVIEW	Plasterboard ceiling, paint finish. Generally fair condition, poor condition in room 1.10 - paint flaking, peeling at corner of room. Paint flaking, peeling in smaller areas of rooms 1.11, 1.13 and 1.17	
HERITAGE SIGNIFICANCE	Heritage Significance Value of the element	Moderate
FUNCTIONALITY	Functional, requiring repairs to paintwork.

OVERVIEW	Remove damaged paintwork and repaint as required.
-----------------	---

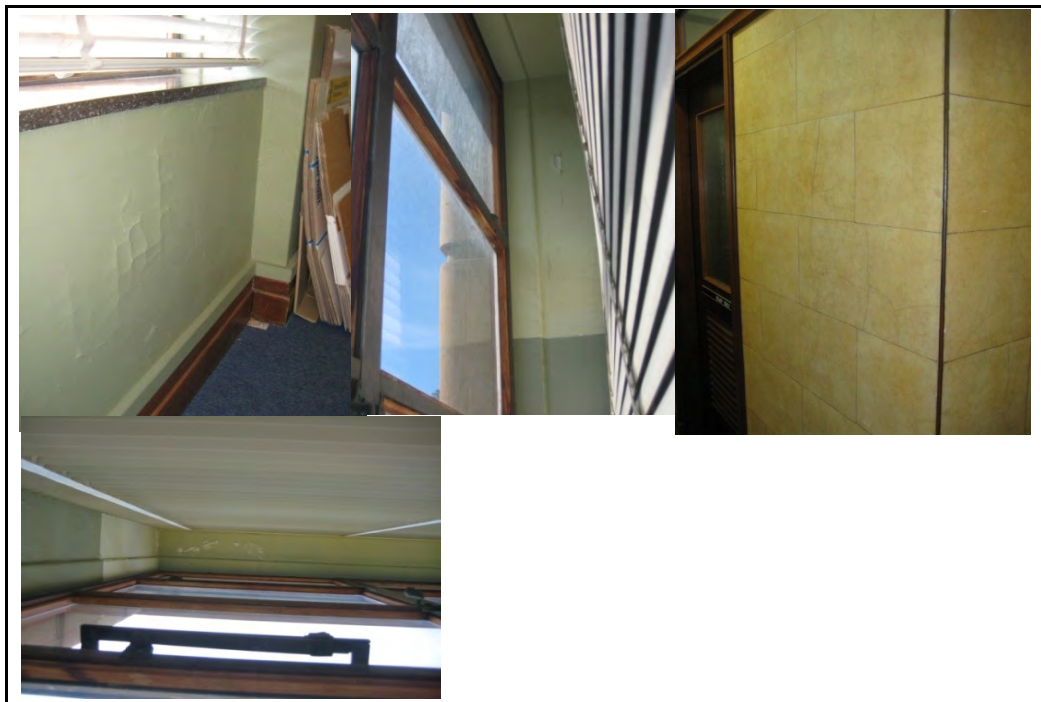
ASSET ELEMENT	WALLS
----------------------	--------------

OVERVIEW	Render and paint finish to all walls in 1.13, and external walls in 1.10 and 1.11. Generally good condition, some paint cracking, lifting on south wall of room 1.10, in addition to paint flaking on underside of window head and in reveals. FC and paint finish to internal walls of 1.10 and 1.11, good condition. Timber framed glazing to west wall of room 1.10. Scagliola tile to room 1.17 and corridor, fine cracks extensively across surface, some areas drummy.	
HERITAGE SIGNIFICANCE	Heritage Significance Value of the element	Mixed
	HIGH Scagliola tiles LOW Other finishes	
FUNCTIONALITY	Functional

OVERVIEW	Repair and restore wall finishes as required
-----------------	--

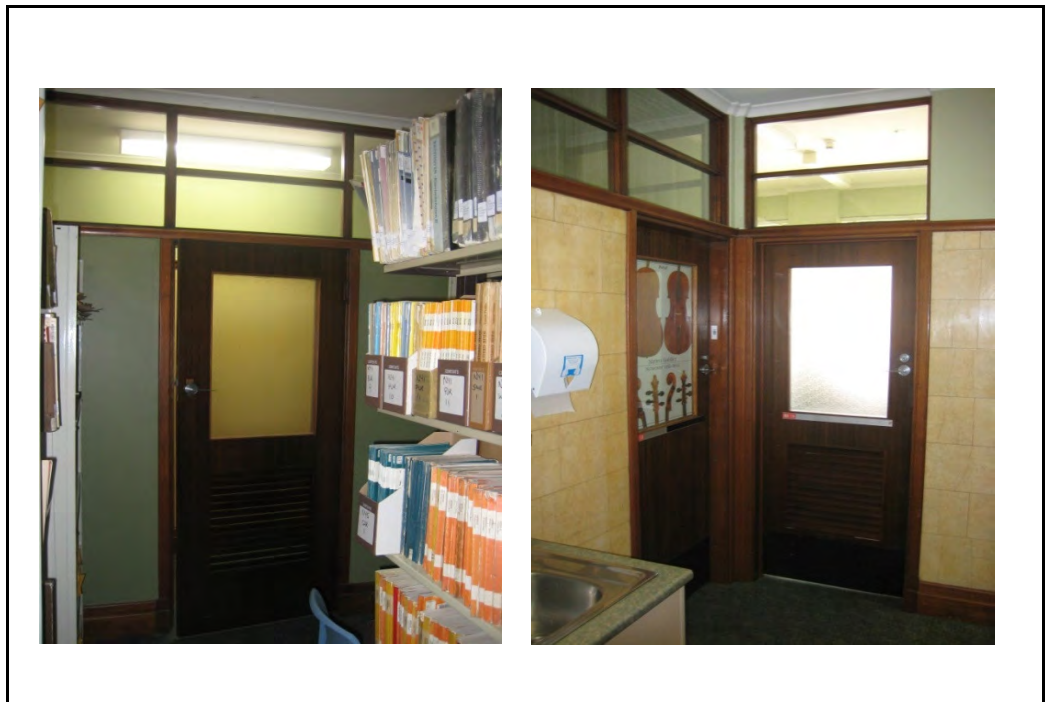
DOORS

<p>OVERVIEW</p>	<p>Timber veneer and glass doors with timber frames, good condition. Painted timber door with steel frame at access to 1.16. Good condition.</p>	
<p>HERITAGE SIGNIFICANCE</p>	<p>Heritage Significance Value of the element</p>	<p>Mixed</p>
	<p>HIGH Timber veneer and glass doors LOW Painted door</p>	
<p>FUNCTIONALITY</p>	<p>Functional</p>

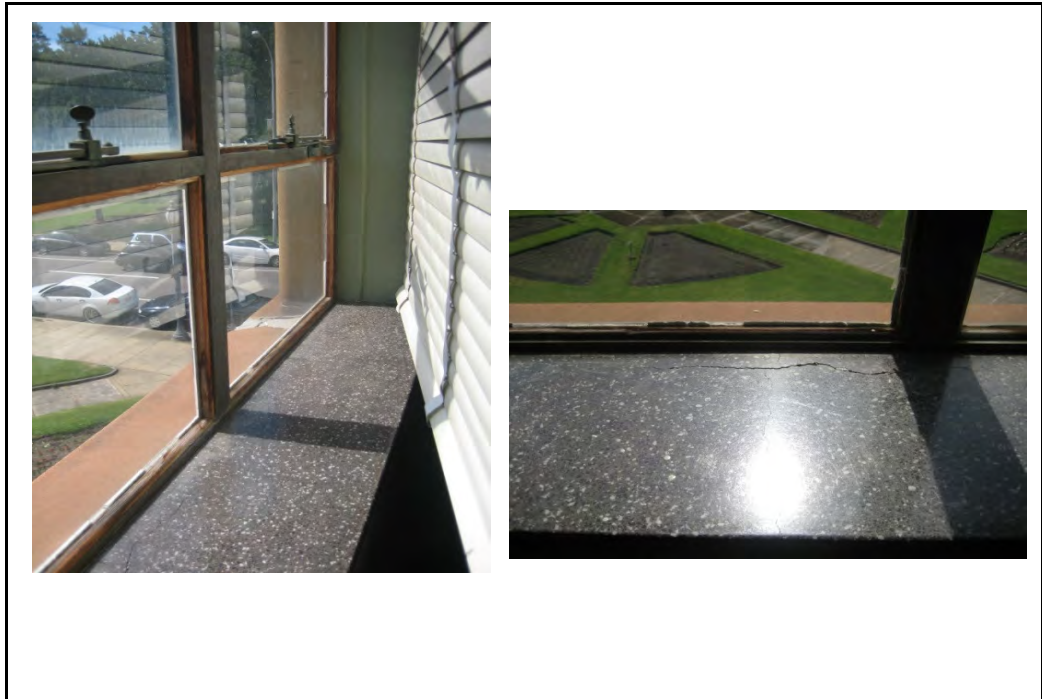
ASSET ELEMENT	WINDOWS
----------------------	----------------

OVERVIEW	Steel / timber framed casement window to external walls - fair condition, some discolouration to frames. Black stone sills, some cracking evident, colour faded. Timber framed highlight glazing to room 1.13 and 1.17, timber framed glazing to western wall of room 1.10	
HERITAGE SIGNIFICANCE	Heritage Significance Value of the element	Mixed
	EXCEPTIONAL Exterior windows HIGH Timber framed internal glazing	
FUNCTIONALITY	Functional

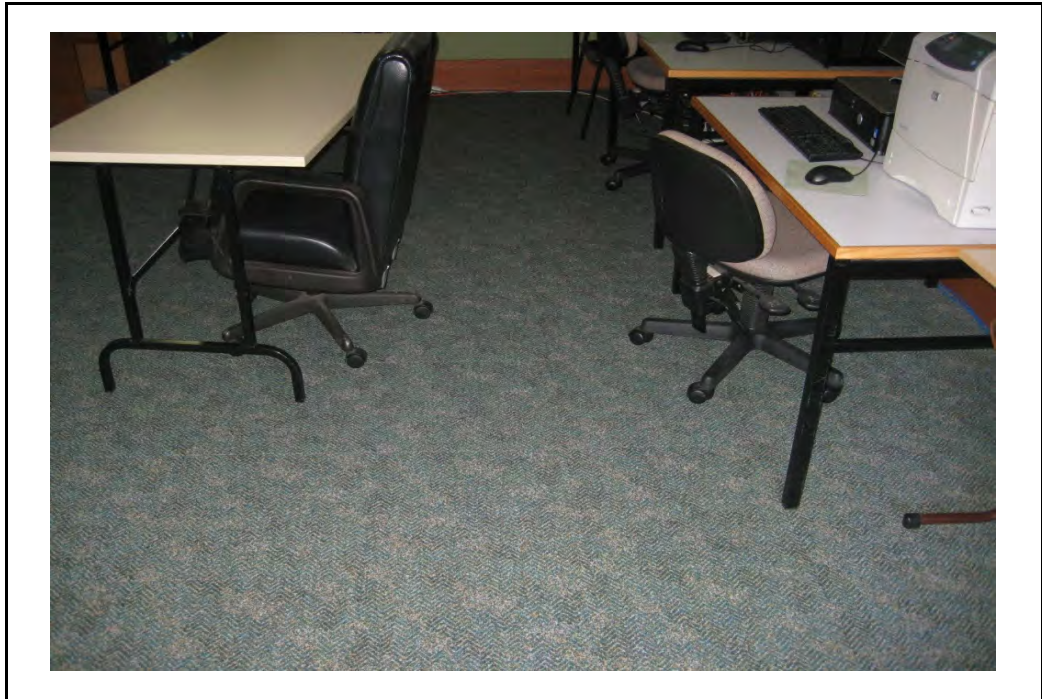
ASSET ELEMENT	FLOOR
----------------------	--------------

EXISTING CONDITION		
OVERVIEW	Carpet tile flooring, good condition.	
HERITAGE SIGNIFICANCE	Heritage Significance Value of the element	Low
	LOW Refers to carpet tiles only, substrate may hold higher significance.	
FUNCTIONALITY	Functional	
ACTION REQUIRED		
OVERVIEW

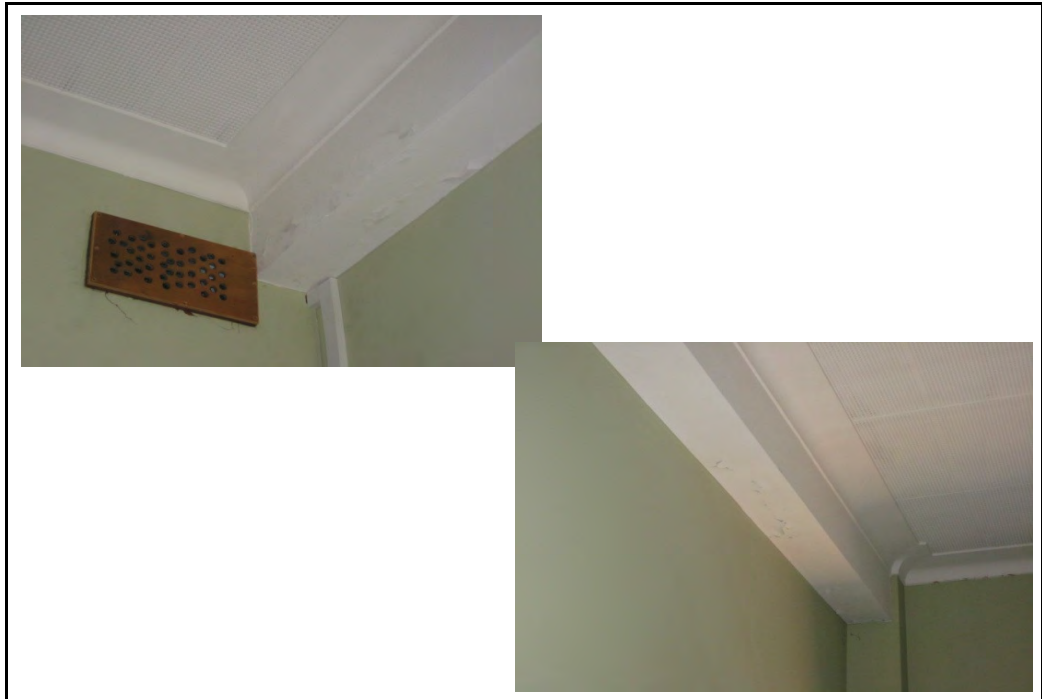
ASSET ELEMENT	CEILING
----------------------	----------------

OVERVIEW	Perforated plasterboard ceiling, paint finish, generally good condition. Some discolouration and paint bubbling on underside of cornice in north east corner of room. Painted plasterboard bulkhead along north wall, poor condition at each end - paint flaking, peeling.	
HERITAGE SIGNIFICANCE	Heritage Significance Value of the element	Low
FUNCTIONALITY	Functional, requiring repairs to paintwork.

OVERVIEW	Remove damaged paintwork and repaint as required.
-----------------	---

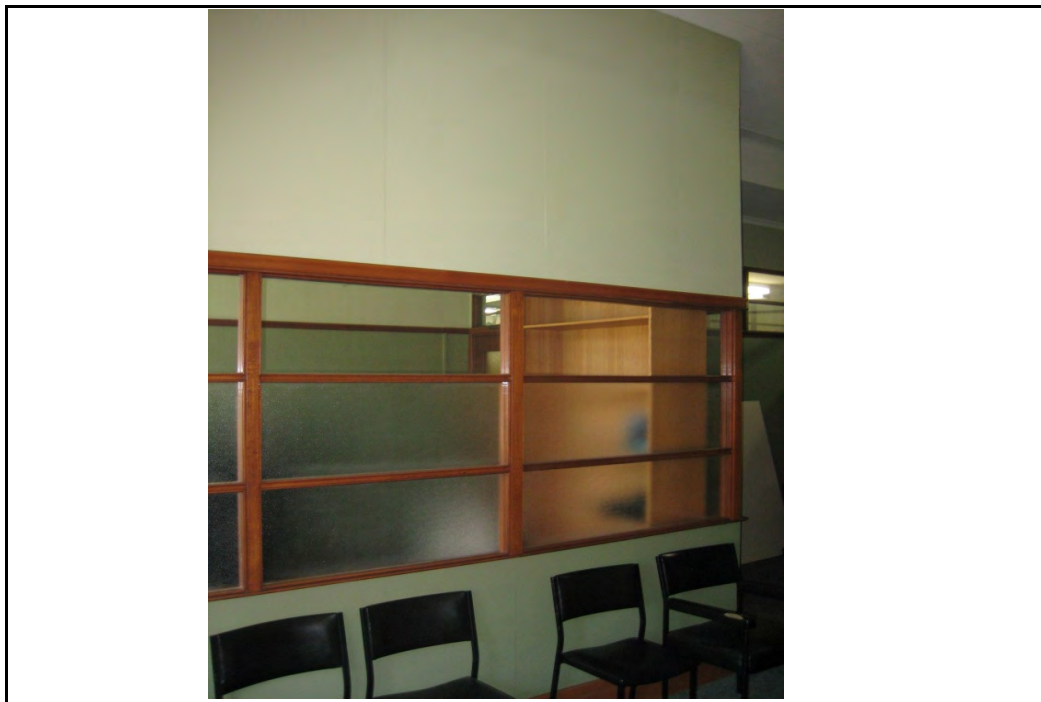
ASSET ELEMENT	WALLS
----------------------	--------------

OVERVIEW	Render and paint finish to external wall, in addition to western and southern walls. Generally good condition. Area of patchwork in area near door which needs repainting. Plasterboard lining, paint finish to north wall, good condition. Common wall with room 1.14 masonite lining, paint finish, with timber framed glazing. Good condition.	
HERITAGE SIGNIFICANCE	Heritage Significance Value of the element	Mixed
	HIGH Masonite and glazed wall LOW Other finishes	
FUNCTIONALITY	Functional

OVERVIEW	Repair and restore wall finishes as required
-----------------	--

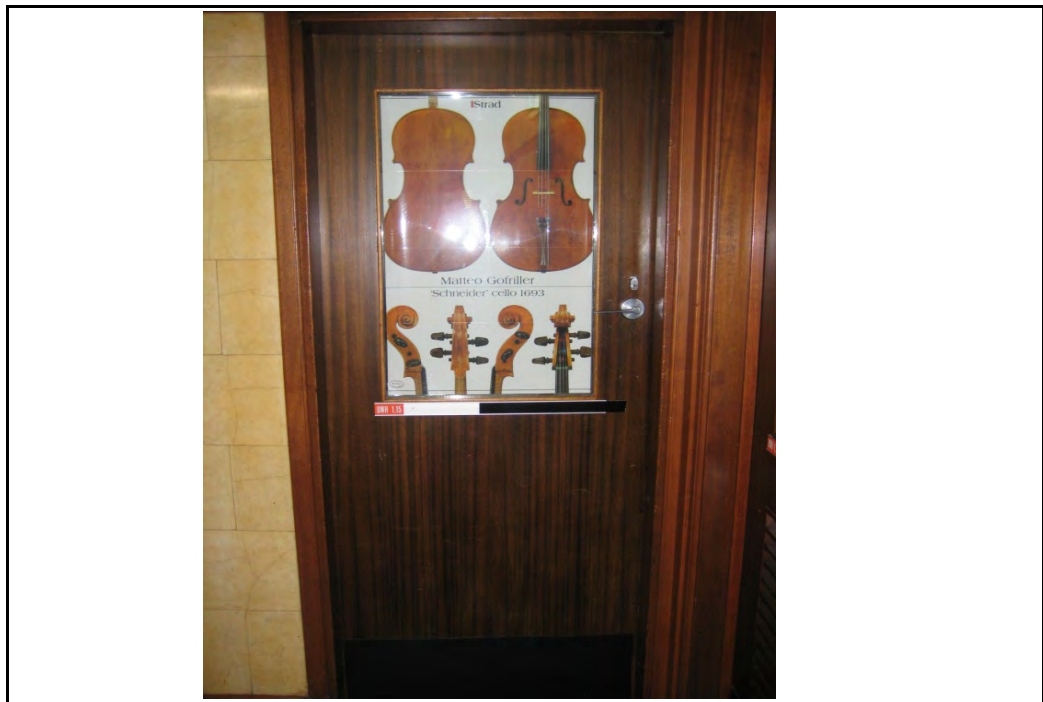
ASSET ELEMENT	DOORS
----------------------	--------------

EXISTING CONDITION		
OVERVIEW	Timber veneer and glass doors with timber frames, good condition.	
HERITAGE SIGNIFICANCE	Heritage Significance Value of the element	High
FUNCTIONALITY	Functional	
ACTION REQUIRED		
OVERVIEW

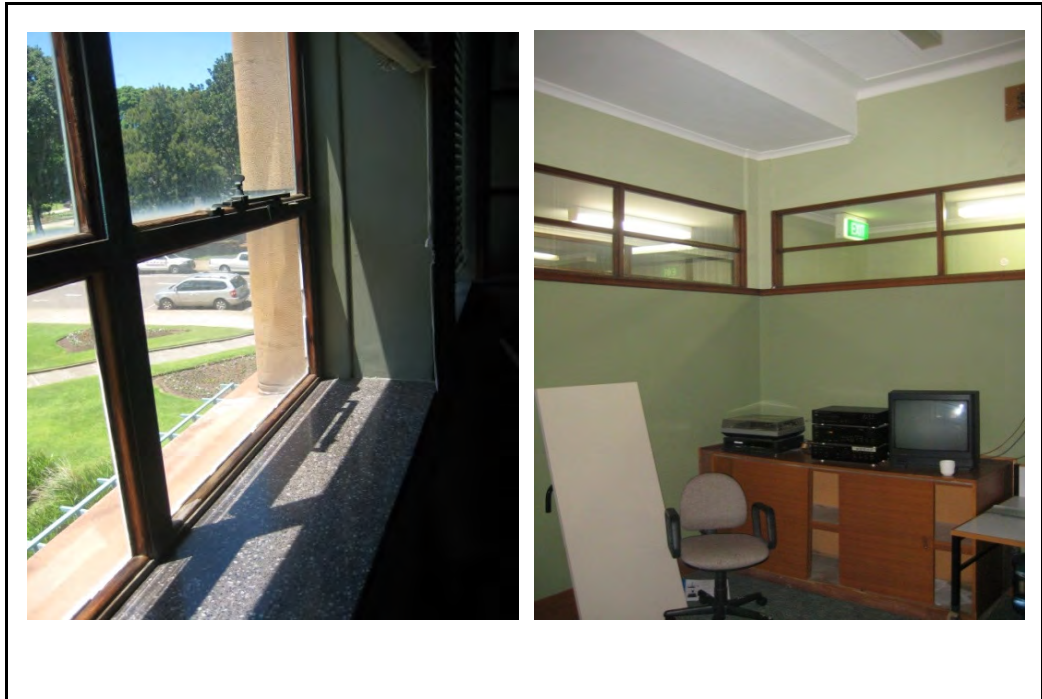
ASSET ELEMENT	WINDOWS
----------------------	----------------

OVERVIEW	Steel / timber framed casement windows to external wall - fair condition, some discolouration to frames, some sealant missing on exterior. Black stone sills, some cracking evident, colour faded. Timber framed highlight glazing to room 1.17 and corridor, timber framed glazing to common wall with room 1.14.	
HERITAGE SIGNIFICANCE	Heritage Significance Value of the element	Mixed
	EXCEPTIONAL Exterior windows HIGH Internal glazing	
FUNCTIONALITY	Functional

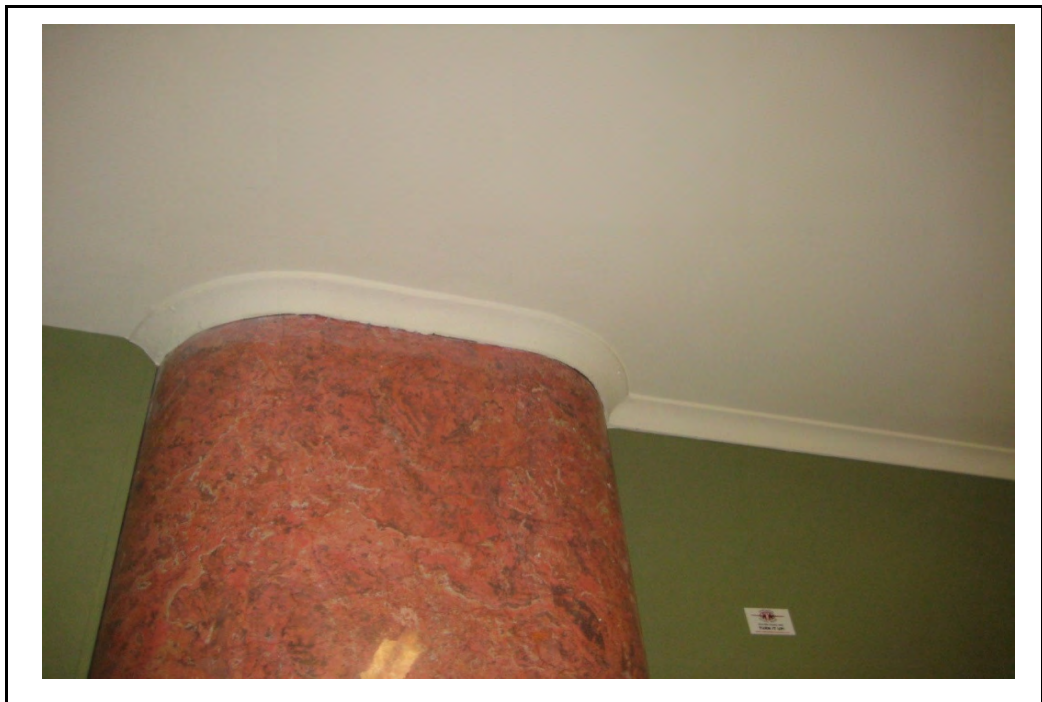
ASSET ELEMENT	CEILING
----------------------	----------------

OVERVIEW	Painted plasterboard ceiling to 1.16, painted soffit to stair over. Good condition.	
HERITAGE SIGNIFICANCE	Heritage Significance Value of the element	Moderate
FUNCTIONALITY	Functional

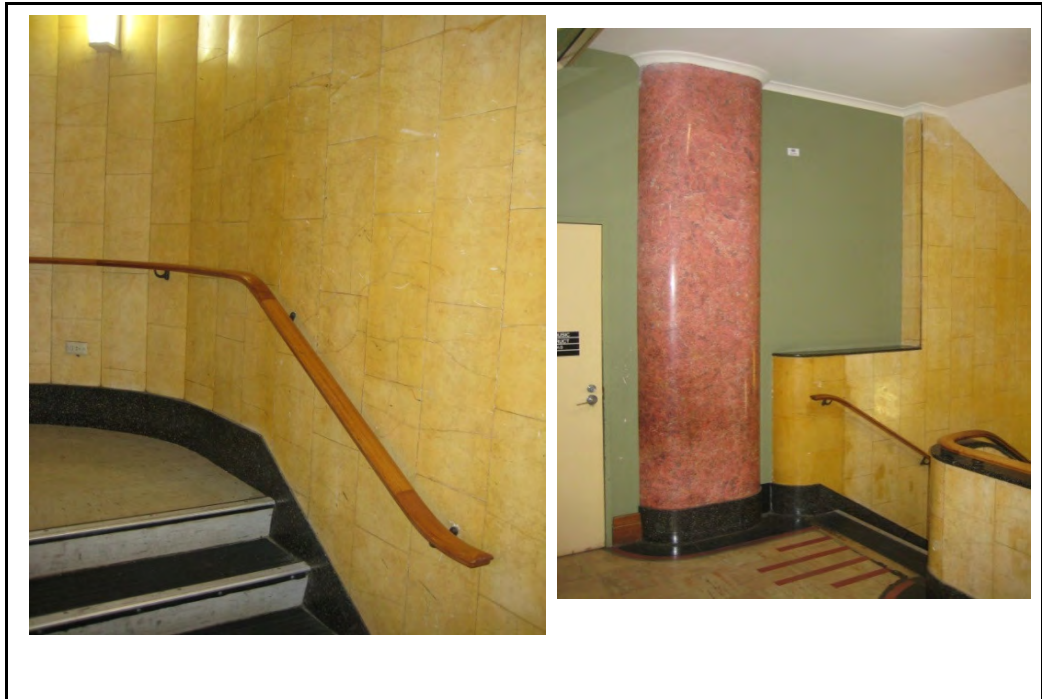
ASSET ELEMENT	WALLS
----------------------	--------------

OVERVIEW	Scagliola tiles with black stone skirting to stair wall and balustrade - fair condition, with fine cracks extensively across surface of scagliola tiles. Black stone capping to balustrade. Painted plasterboard with stepped timber skirting, scagliola tiles with black stone skirting to room 1.16. Pink scagliola with black stone skirting to columns in room 1.16. Similar condition to stair walls - fine cracking extensively across surface, all scagliola / scagliola tiled walls drummy in some areas, particularly adjacent to larger crack locations. Black stone skirting damaged at south east corner of room 1.16.	
HERITAGE SIGNIFICANCE	Heritage Significance Value of the element	Mixed
	EXCEPTIONAL Scagliola, scagliola tiles, skirtings LOW Painted plasterboard	
FUNCTIONALITY	Functional but requiring repair.

OVERVIEW	Repair and restore wall finishes as required
-----------------	--

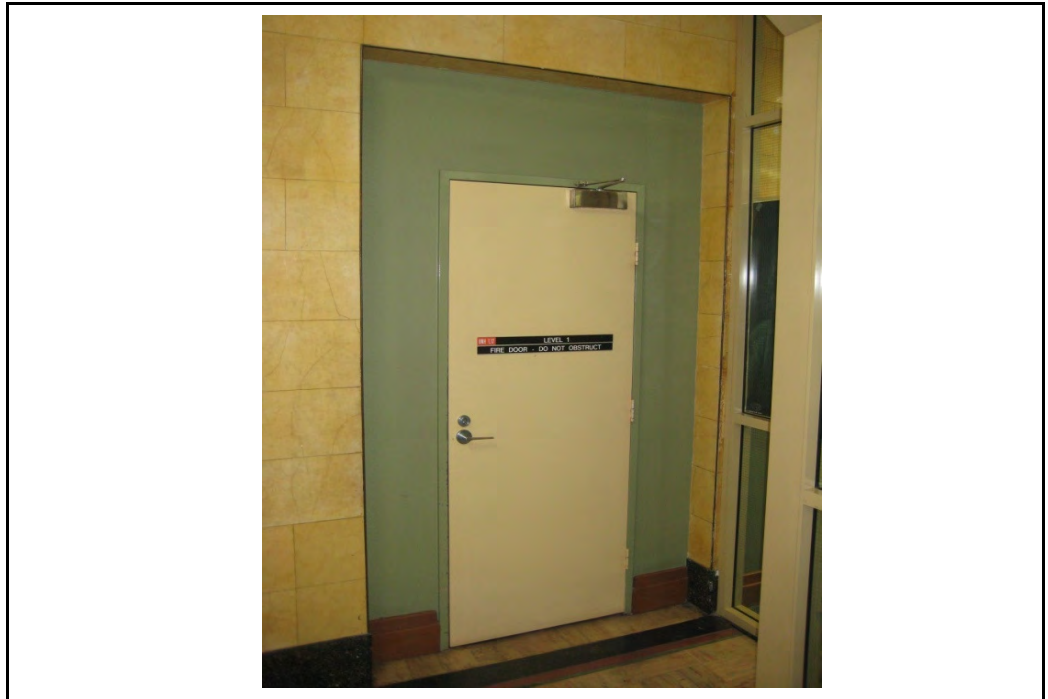
DOORS

OVERVIEW	Painted timber with painted steel frames. All good condition.	
HERITAGE SIGNIFICANCE	Heritage Significance Value of the element	Low
FUNCTIONALITY	Functional

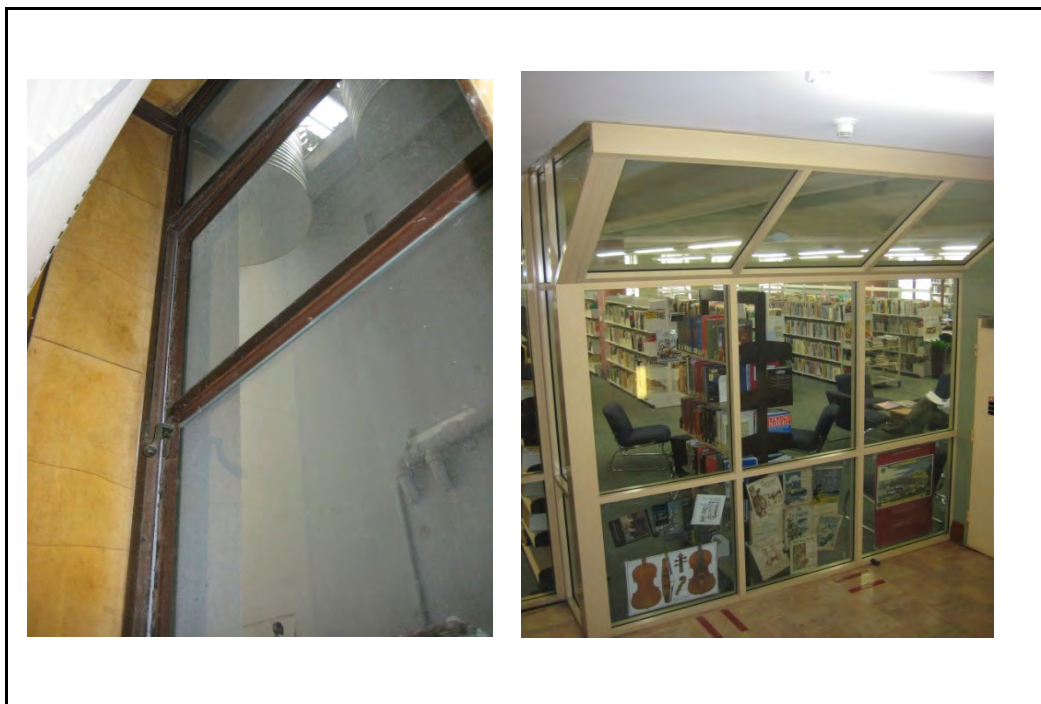
ASSET ELEMENT	WINDOWS
----------------------	----------------

OVERVIEW	Steel / timber framed casement window to external light well - fair condition, some discolouration to frame. Black stone sills, some minor cracking evident. Powdercoated aluminium framed glazing to south wall of room 1.16, good condition.	
HERITAGE SIGNIFICANCE	Heritage Significance Value of the element	Mixed
	HIGH Original metal window LOW Powdercoated aluminium framed glazing	
FUNCTIONALITY	Functional

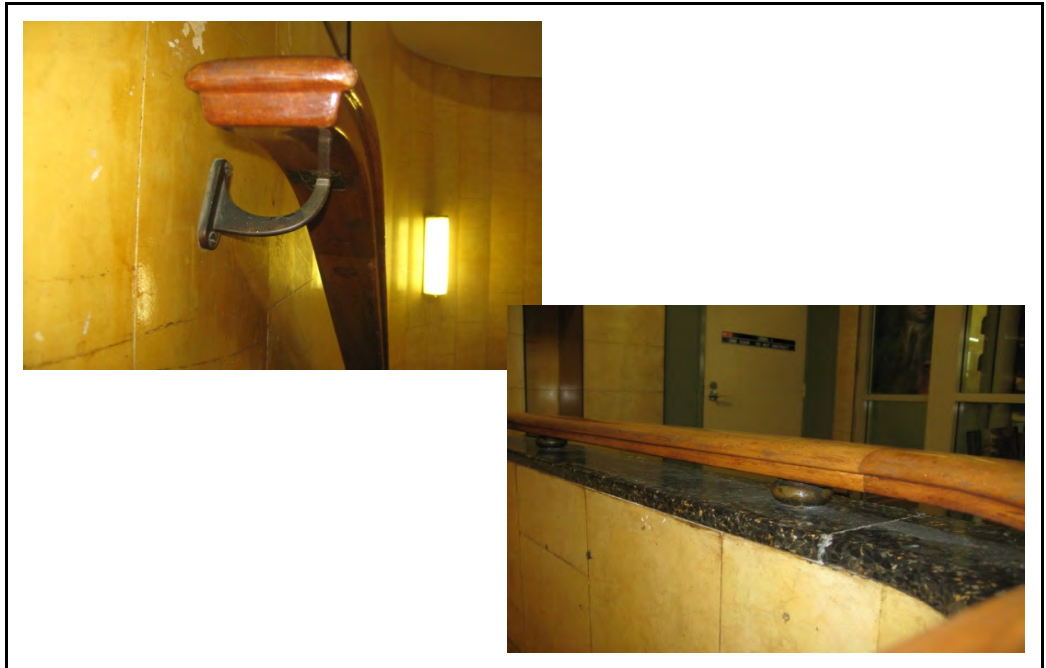
FITTINGS

OVERVIEW	Timber handrail fixed to walls with bronze brackets, fixed to balustrade top with bronze mountings. Good condition.	
HERITAGE SIGNIFICANCE	Heritage Significance Value of the element	High
FUNCTIONALITY	Functional
