CONSERVATION MANAGEMENT PLAN

VOLUME 3 OF 3

UNIVERSITY HOUSE FORMERLY N.E.S.C.A HOUSE KING STREET NEWCASTLE

Prepared by EJE Heritage
MARCH 2011
Ref: 8836-CMP-UH-001

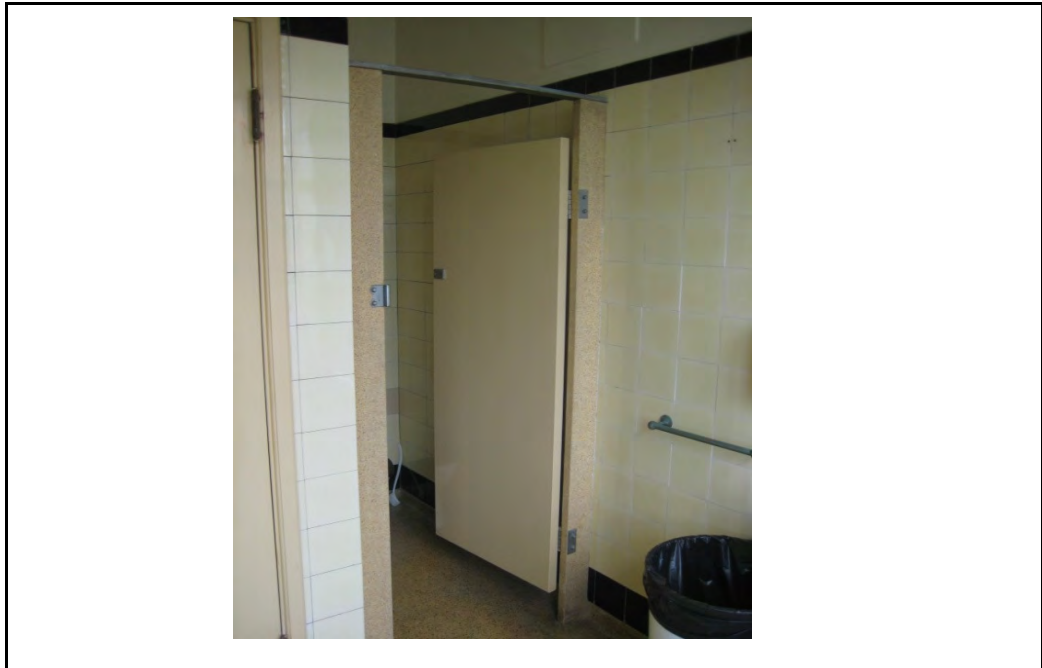
ASSET ELEMENT	FITTINGS
----------------------	-----------------

OVERVIEW	Terrazzo toilet partition in fair condition, some discolouration particularly at base.	
HERITAGE SIGNIFICANCE	Heritage Significance Value of the element	
		Mixed
	HIGH Terrazzo partitions LOW Non-original sanitary fittings	
FUNCTIONALITY	Functional

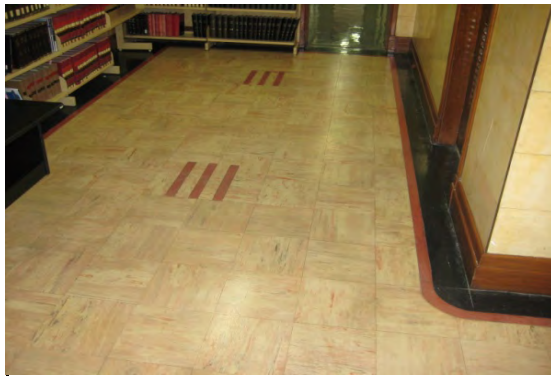
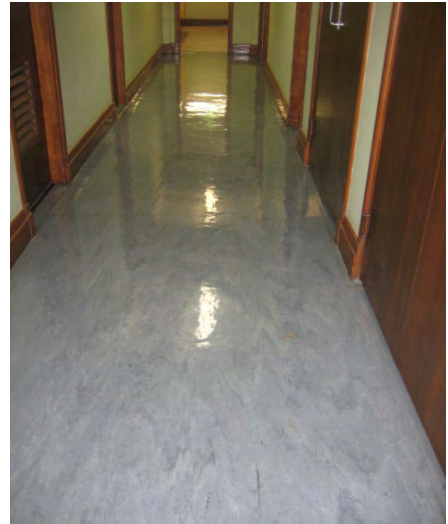
ASSET ELEMENT	FLOOR
---------------	-------

OVERVIEW	Inlaid vinyl flooring to lobby at south end, sheet vinyl flooring to corridor. All generally good condition, hole in vinyl near door to room 2.31.	
HERITAGE SIGNIFICANCE	Heritage Significance Value of the element	Mixed
	HIGH Inlaid vinyl flooring LOW Sheet vinyl	
FUNCTIONALITY	Functional

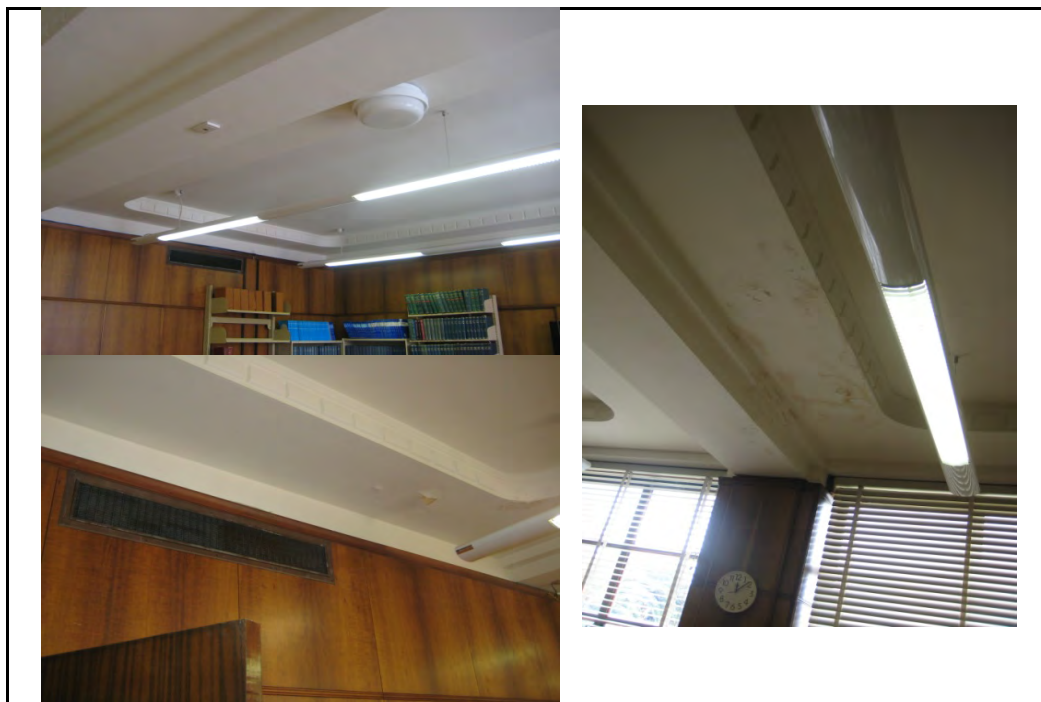
ASSET ELEMENT	CEILING
---------------	---------

OVERVIEW	Painted plasterboard ceiling, generally good condition, paint cracked, bubbling, flaking in south half of room. Moisture damage evident.	
HERITAGE SIGNIFICANCE	Heritage Significance Value of the element	High
FUNCTIONALITY	Functional, requiring repairs to paintwork.

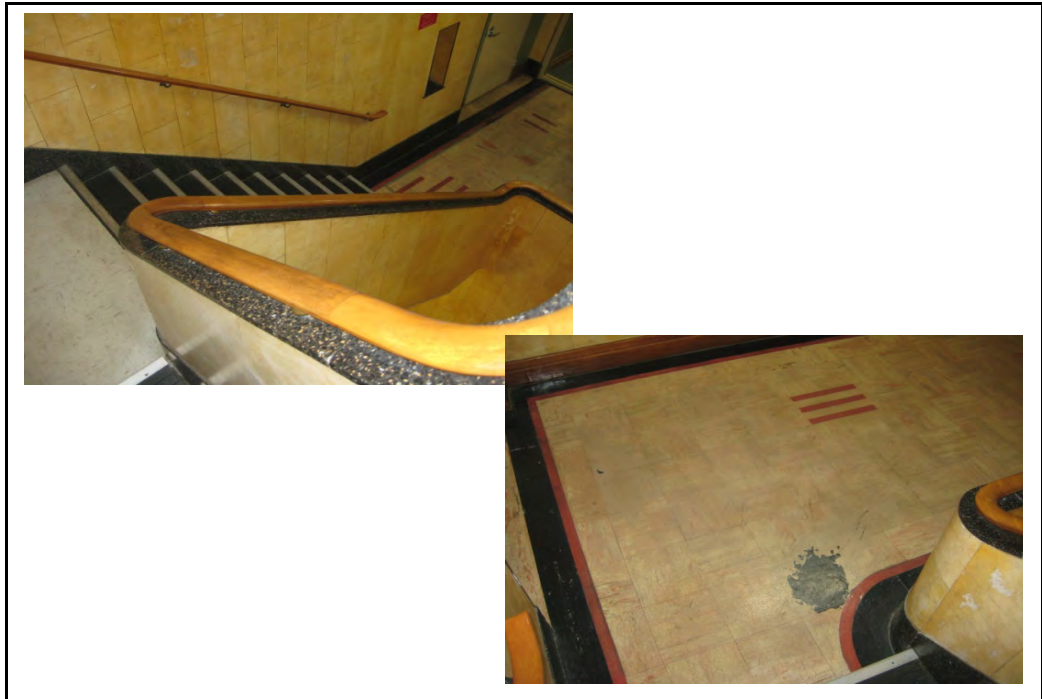
ASSET ELEMENT	FLOOR
---------------	-------

OVERVIEW	Rubber flooring to stair treads, vinyl flooring to intermediate landings, inlaid vinyl flooring to lobby 2.22. Generally good condition, some marks to flooring in lobby 2.22.	
HERITAGE SIGNIFICANCE	Heritage Significance Value of the element	High
FUNCTIONALITY	Functional.

OVERVIEW	Rectify marking to lobby floor
----------	--------------------------------

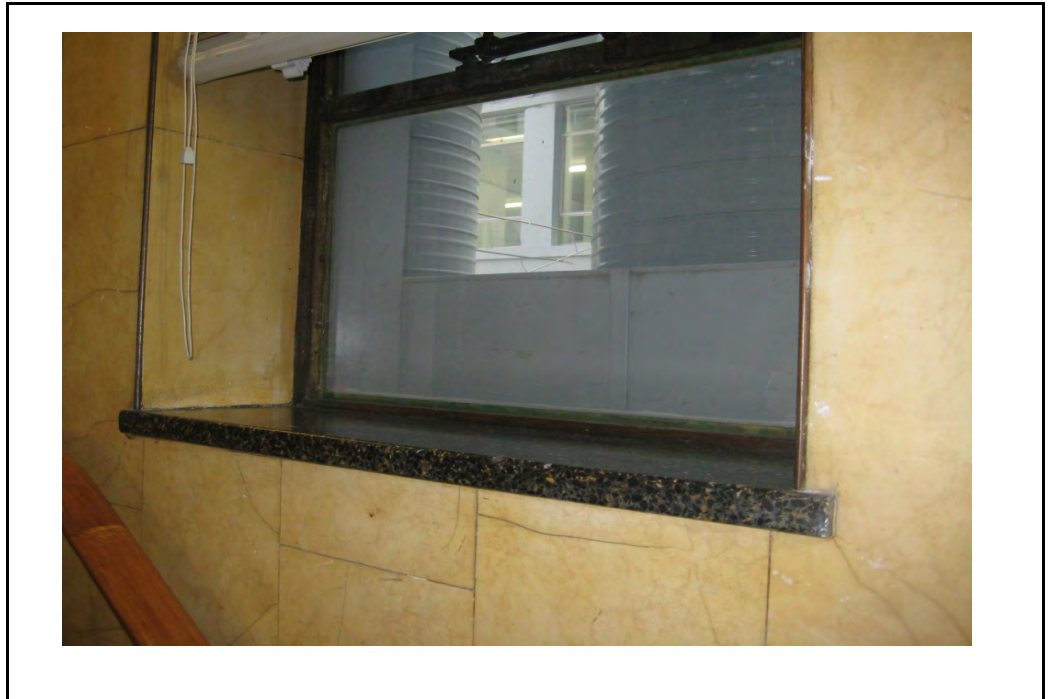
OVERVIEW	Steel / timber framed casement window to external light well - fair condition, some discolouration to frame. Black stone sills, some minor cracking evident.	
HERITAGE SIGNIFICANCE	Heritage Significance Value of the element	High
FUNCTIONALITY	Functional

OVERVIEW	Restore original glazing frames and sill as required.
----------	---

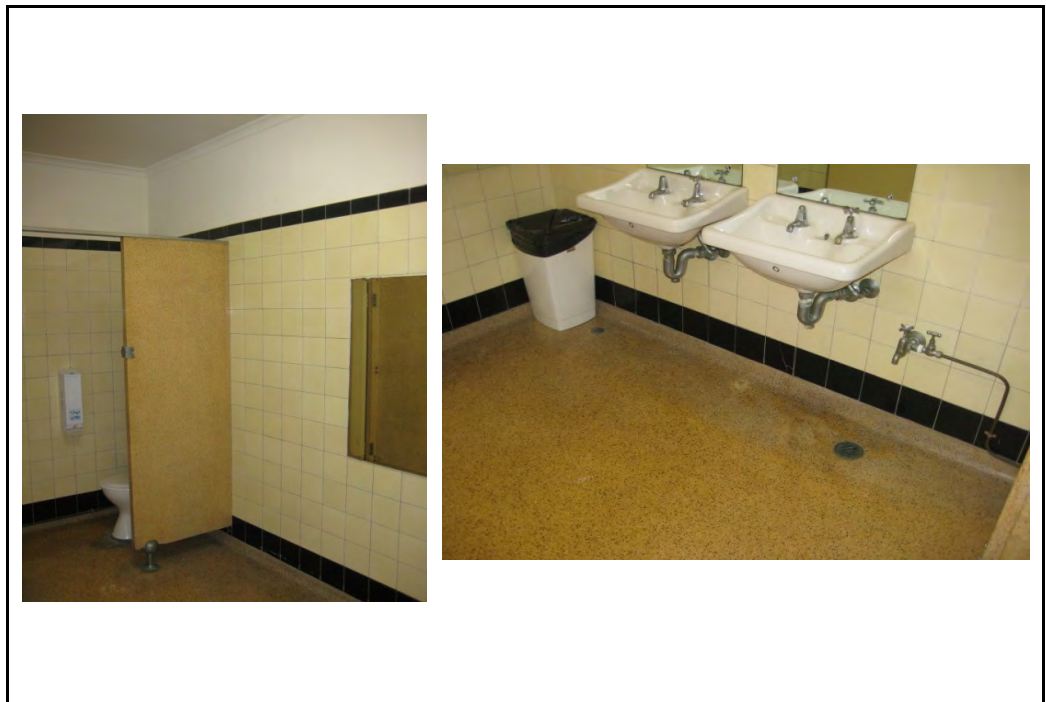
WALLS

OVERVIEW	Tiles to approx. 2200 AFFL, appear to be original and generally in good condition. Some cracked tiles. Paintwork above appears in good condition.	
HERITAGE SIGNIFICANCE	Heritage Significance Value of the element	High
FUNCTIONALITY	Functional, requiring minor repairs

OVERVIEW	Repair and restore wall finishes as required
-----------------	--

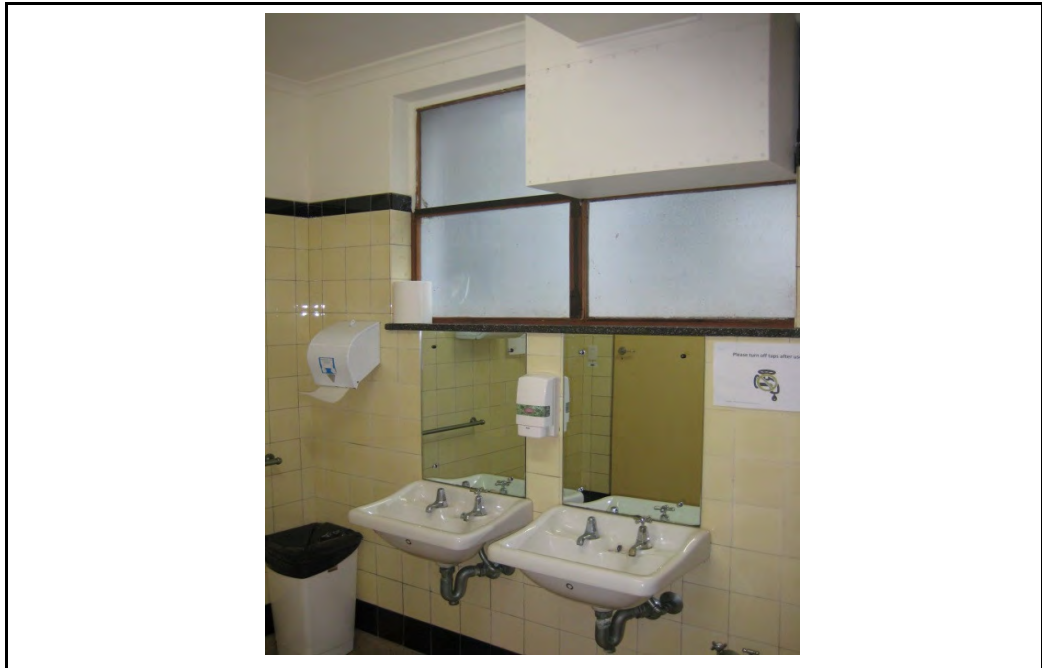
ASSET ELEMENT	WINDOWS
----------------------	----------------

EXISTING CONDITION		
OVERVIEW	Original windows, fair condition. Black stone sill.	
HERITAGE SIGNIFICANCE	Heritage Significance Value of the element	Mixed
	HIGH Window INTRUSIVE Louvre	
FUNCTIONALITY	Functional.	
ACTION REQUIRED		
OVERVIEW

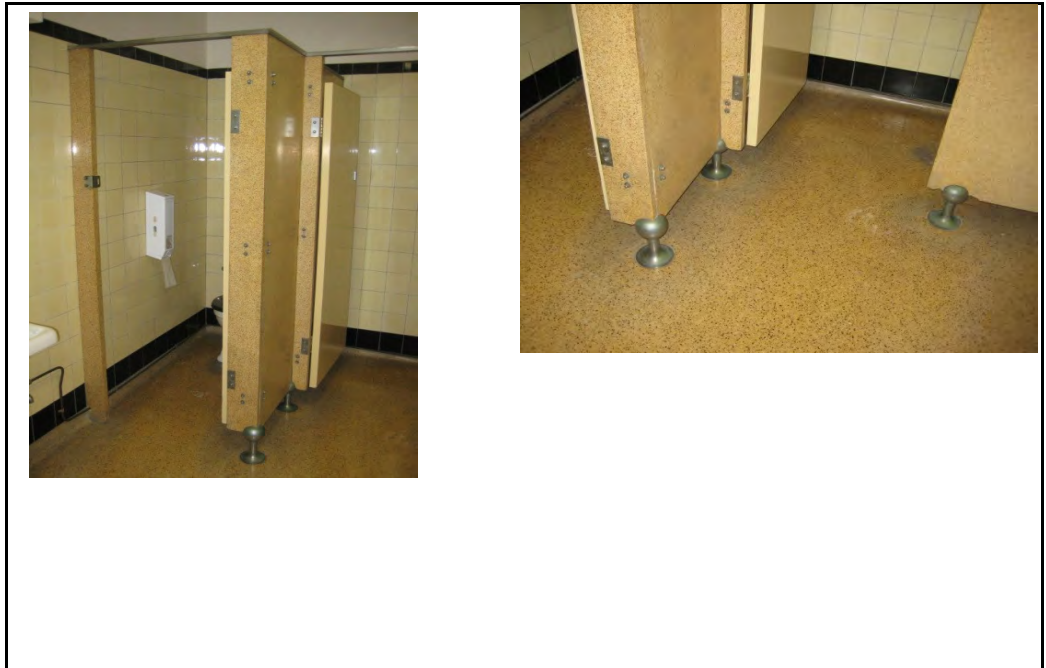
FITTINGS

OVERVIEW	Terrazzo toilet partitions in fair condition, some discolouration particularly at base, chips at base of one cubicle.	
HERITAGE SIGNIFICANCE	Heritage Significance Value of the element	Mixed
	HIGH Terrazzo partitions LOW Non-original sanitary fittings	
FUNCTIONALITY	Functional

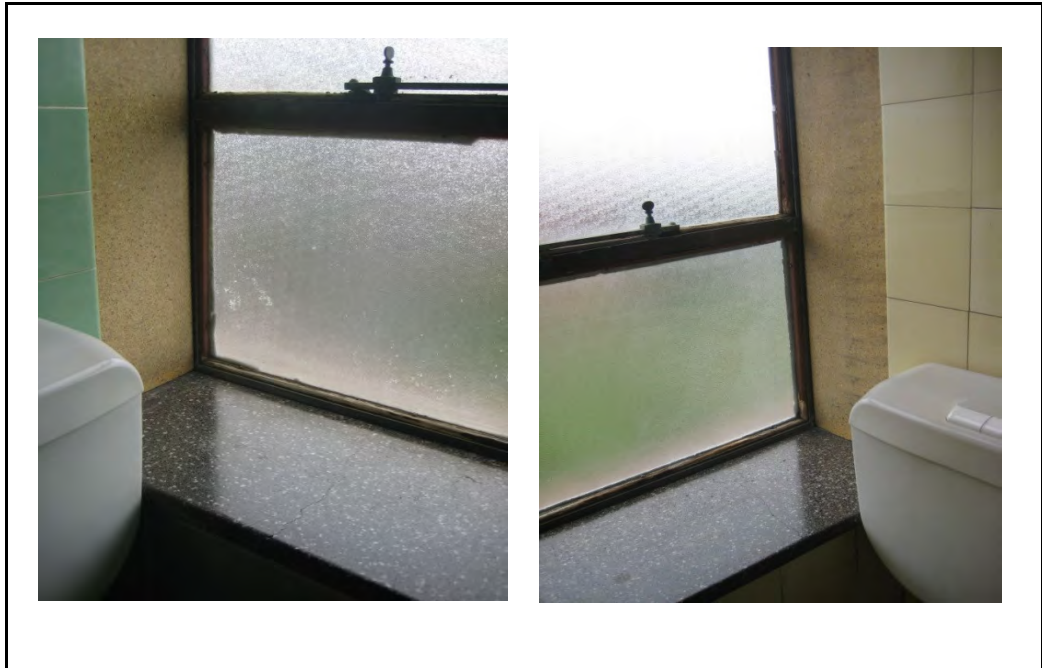
ASSET ELEMENT	WINDOWS
----------------------	----------------

OVERVIEW	Original metal framed windows - casement at base, louvres above, fair condition. Frame discoloured, timber beads in frame deteriorating, sealant perished, missing externally. Black stone sill - cracking and faded. Terrazzo reveal at common wall in each room.	
HERITAGE SIGNIFICANCE	Heritage Significance Value of the element	Exceptional
FUNCTIONALITY	Functional.

OVERVIEW	Restore window frames and sill as required.
-----------------	---

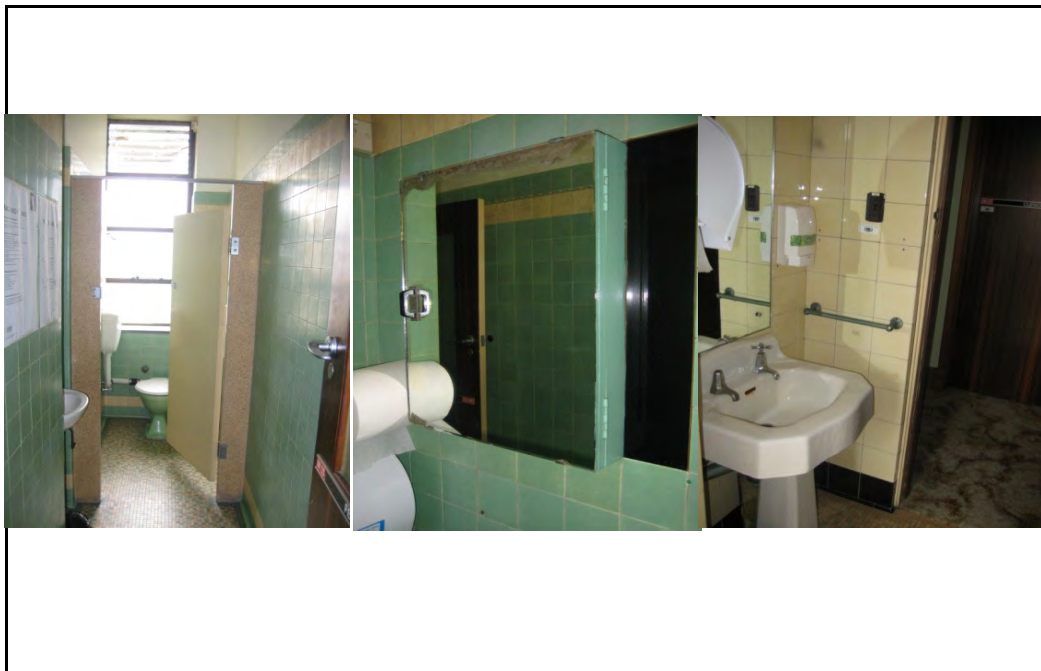
ASSET ELEMENT	FITTINGS
----------------------	-----------------

OVERVIEW	Terrazzo toilet partitions in fair condition, some discolouration particularly at base. Possibly original pedestal basin and towel rack in room 2.26, mirror cabinet in room 2.25.	
HERITAGE SIGNIFICANCE	Heritage Significance Value of the element	
		Mixed
	HIGH Terrazzo partition and original sanitary fittings LOW Non-original sanitary fittings	
FUNCTIONALITY	Functional

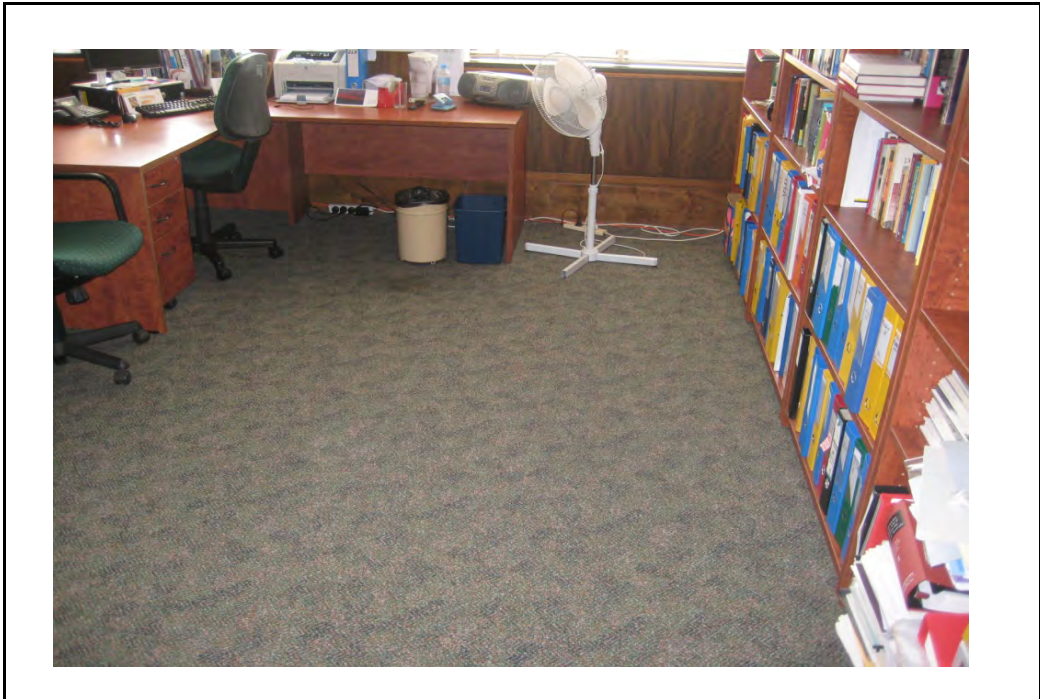
ASSET ELEMENT	FLOOR
---------------	-------

OVERVIEW	Carpet flooring, generally good condition, some staining and wear evident.	
HERITAGE SIGNIFICANCE	Heritage Significance Value of the element	Low
	Refers to carpet only, substrate may hold higher significance.	
FUNCTIONALITY	Functional

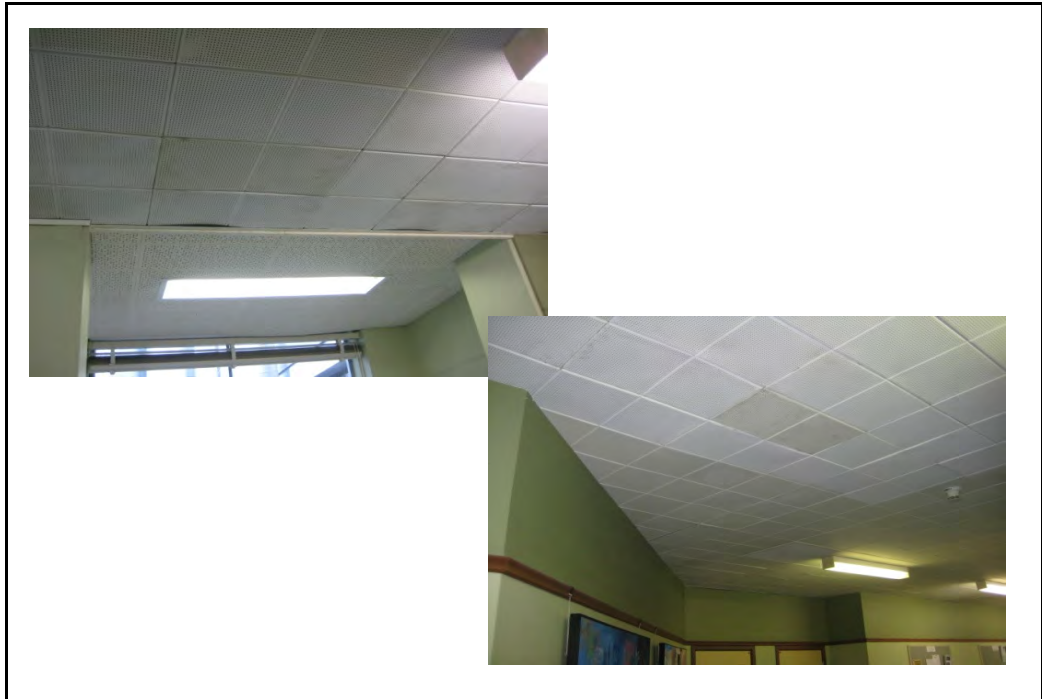
ASSET ELEMENT	CEILING
----------------------	----------------

OVERVIEW	Perforated metal suspended ceiling tiles, generally condition. Some tiles misaligned / loose, some tiles discoloured - possible moisture.	
HERITAGE SIGNIFICANCE	Heritage Significance Value of the element	Moderate
FUNCTIONALITY	Functional, requiring minor repair

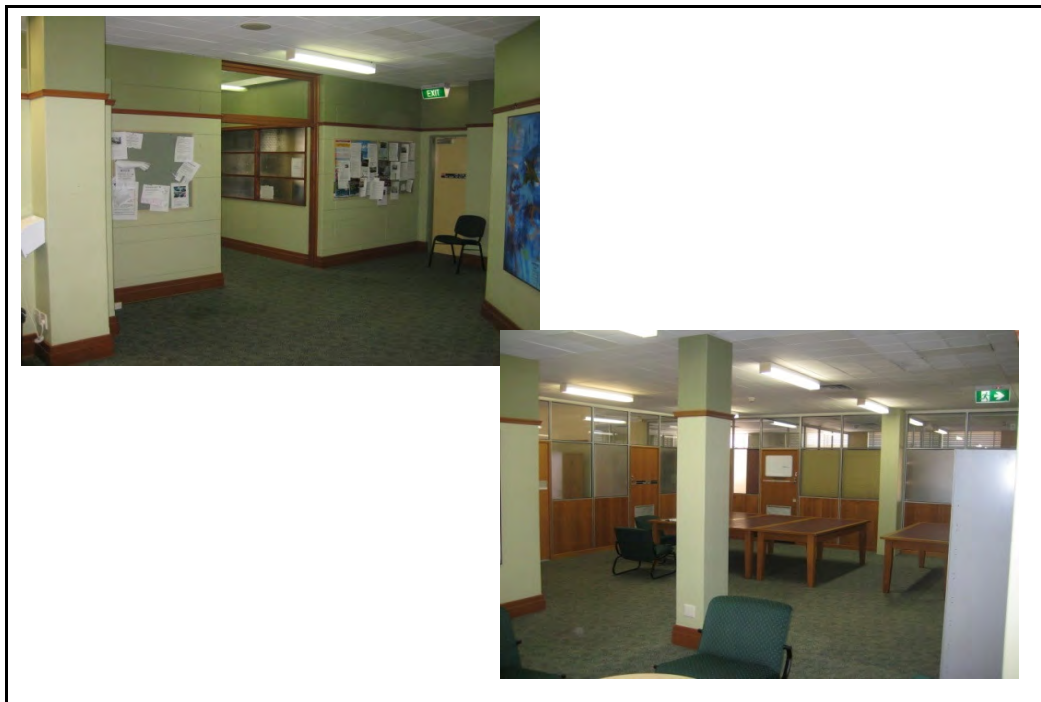
ASSET ELEMENT	WALLS
----------------------	--------------

OVERVIEW	Painted blockwork to south walls, painted plasterboard to north walls, aluminium framed timber veneer and glass walls to offices in north east part of room. Generally good condition, some scuffs and marks to painted walls.	
HERITAGE SIGNIFICANCE	Heritage Significance Value of the element	Mixed
	HIGH Rear wall of original building LOW Internal walls	
FUNCTIONALITY	Functional

OVERVIEW	Repair and restore wall finishes as required
-----------------	--
