# Mount Thorley Warkworth

## 2025 Annual Review

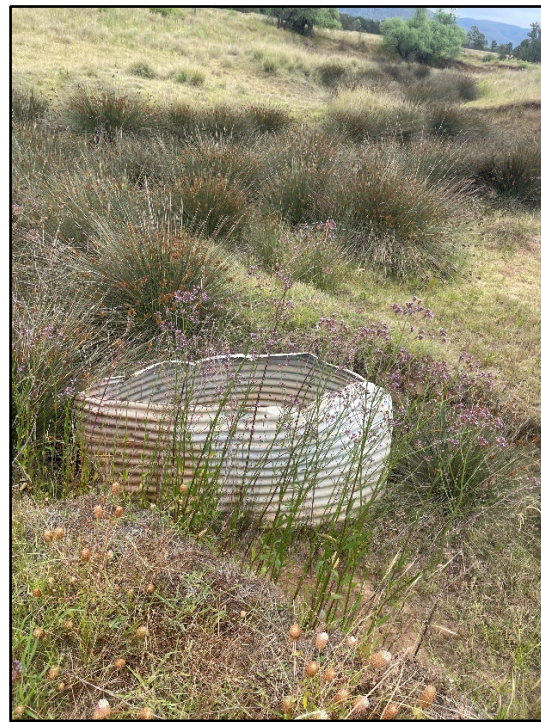
***Old water tank near MTW-176***

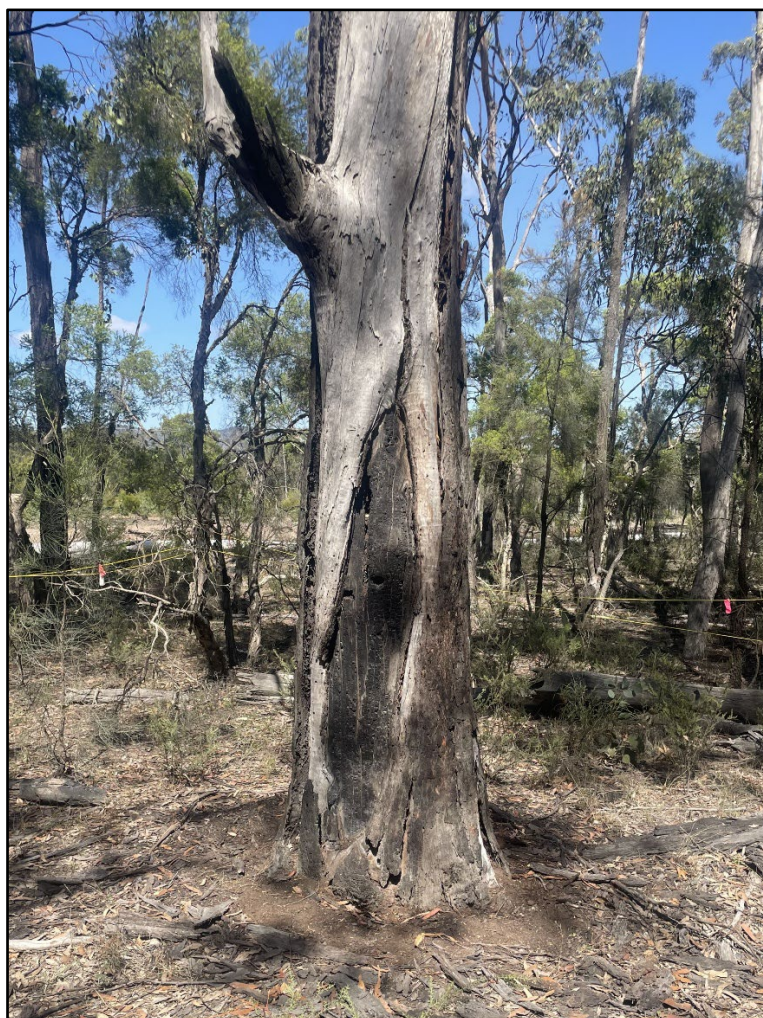
Site MTW-70 is a dead scarred tree located on the edge of the final mining boundary at Warkworth Mine. The tree is standing but is in a fragile state due to having been burnt, and is currently infested with termites. The site has been previously discussed with the MTW CHWG many times and is currently intended to be salvaged or re-assessed ahead of future mining disturbance. The current audit field team concurred with opinions offered by previous CHWG representatives that the scar did not appear to be of cultural origin. Until any reassessment occurs, the tree should be effectively barricaded and sign-posted for its protection as mining works continue to increase in the area.

The tree should be inspected annually until an ultimate decision is made as to its ability to be salvaged. Due to its fragile nature, a successful removal program is unlikely. Ongoing annual inspections will provide status information to the MTW CHWG and allow that group to make informed decisions on the tree's ongoing management. It should be noted that there were no obvious signs of deterioration evident compared to the 2024 compliance inspection.

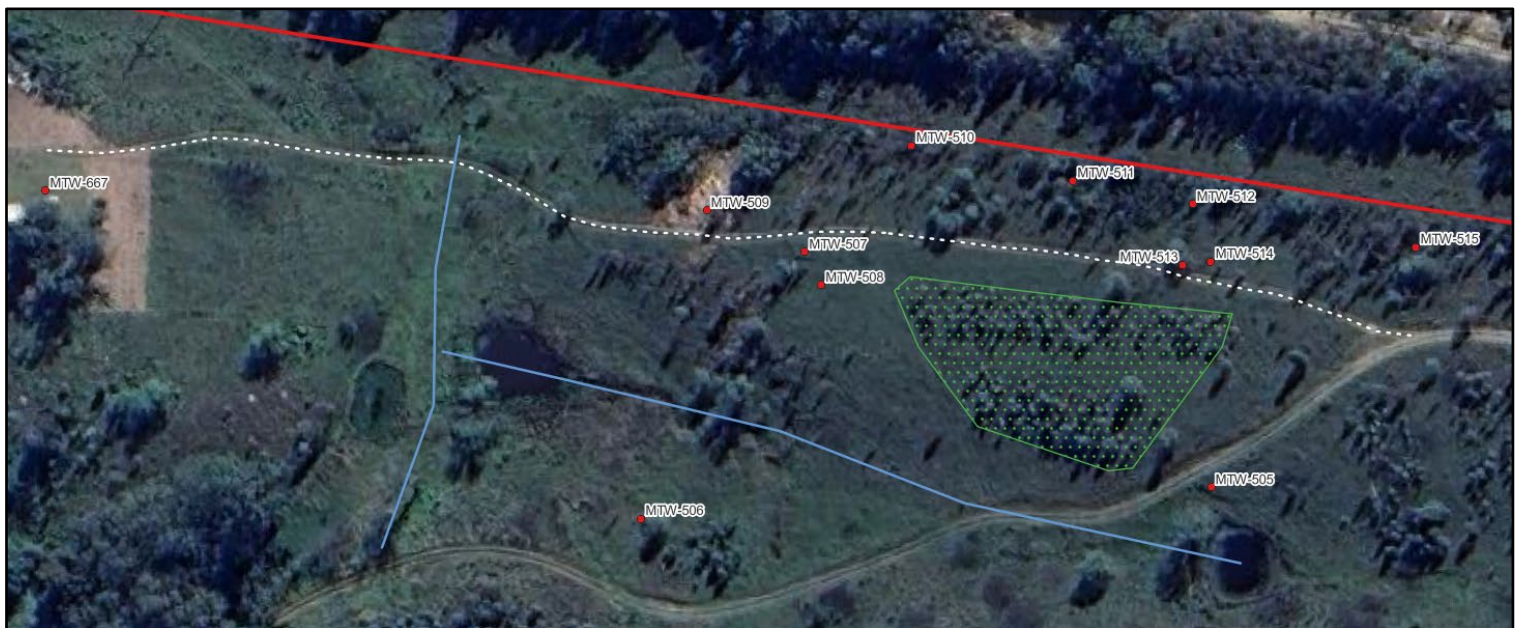
Site: MTW-507, 508, 509, 513, 514,

In order to avoid inadvertent disturbance to several ACH sites, the access track to Springwood Homestead has been re-routed. These sites are located immediately adjacent to, and occasionally intersecting with, the existing access track (white dashed line in image below) and it was recommended to re-route this track during the 2024 compliance audit, which has since occurred. It is further recommended that this redundant track be barricaded or banded to prevent inadvertent access and site disturbance. Logical positions for this bunding would be to the west of site MTW-509 and at the track intersection to the east of MTW-514.

### Barricade ends of redundant track

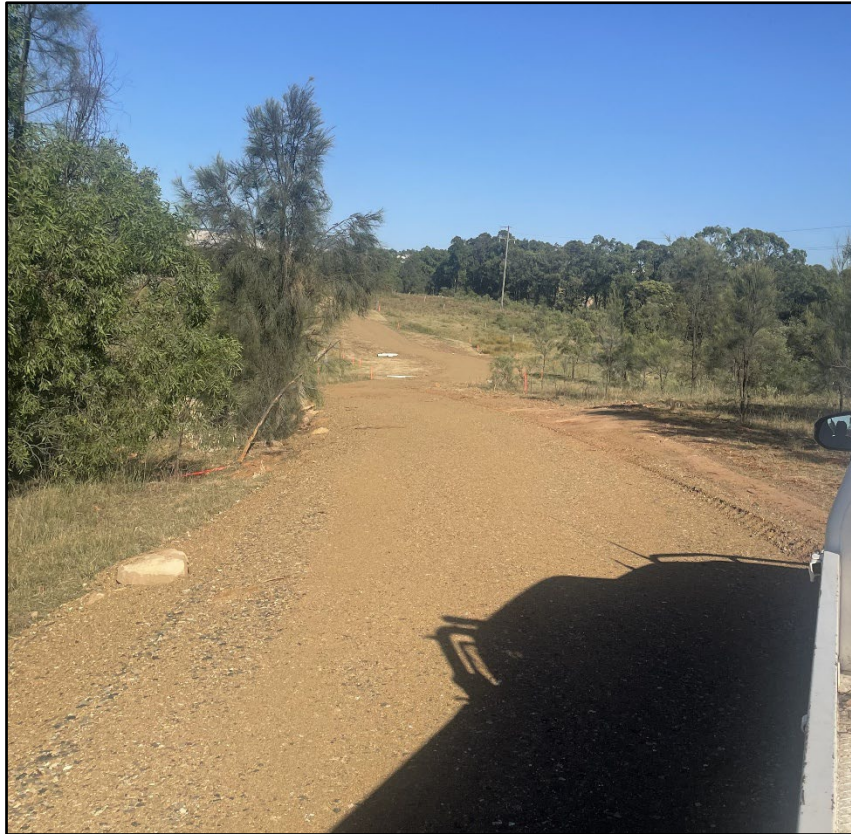
Aside from affording CHWG representatives with an opportunity to visit mining operations and monitor the condition of ACH sites, another intention of the compliance inspections is to provide the opportunity to inspect the operational compliance with AHMP provisions and GDP procedures. To this end an inspection was made of the re-routed Springwood Homestead access track. This new track is shown below, with the sites mentioned above in the vicinity of the now redundant track located within the scrub to the right of the picture.

The audit team confirmed that the construction of the new track had not disturbed any ACH sites or objects, and that it was an appropriate solution to prevent the disturbance of any sites adjacent to the now redundant track. This was reinforced by the identification of several stone artefacts on and adjacent to the redundant track, and outside of previously recorded site extents. These site extents will be modified to include these new finds, and the barricading/bunding recommended above will help ensure they are not further disturbed.

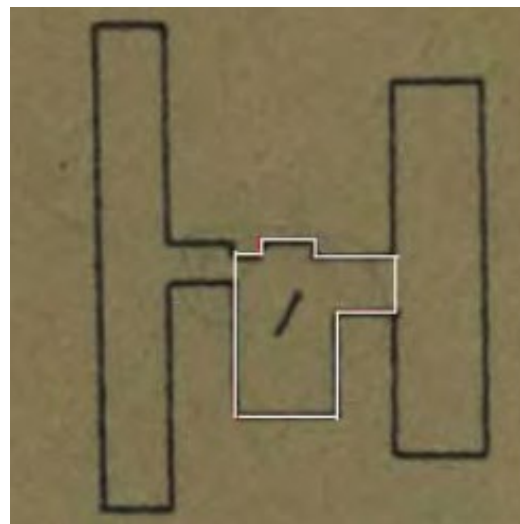
***Remaining structure***

The building is currently structurally unsound, with a number of timber elements either missing or in a deteriorated state. Corrugated asbestos roof sheeting is also missing in some places, and damaged and in poor condition where it remains. Much of the corrugated iron sheeting

is corroded. Brickwork is also cracking in a number of locations resulting in movement outward, loss of mortar and loss of bricks along the southern and eastern elevations.

As a result, a number of structural recommendations were outlined by ERM in the CMP developed for the site in 2012. These recommendations were not intended to return the building to a serviceable state, rather they sought to do the minimum required to allow safe access to the building to prevent significant damage, and also allow safe access for asbestos removal and internal inspection of the building in the short to medium term.

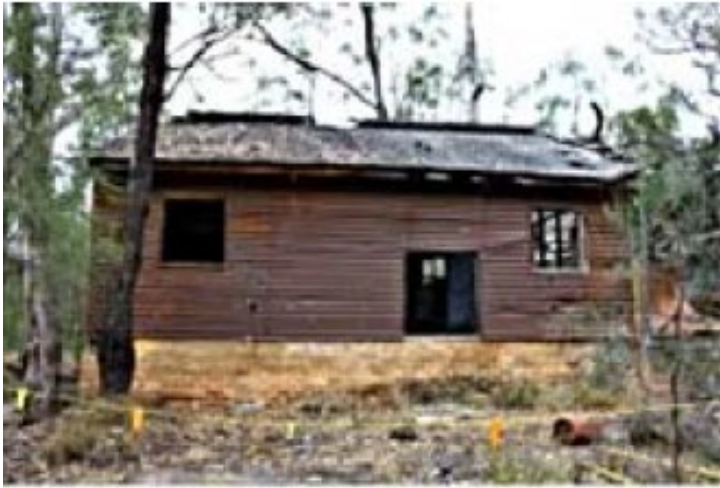
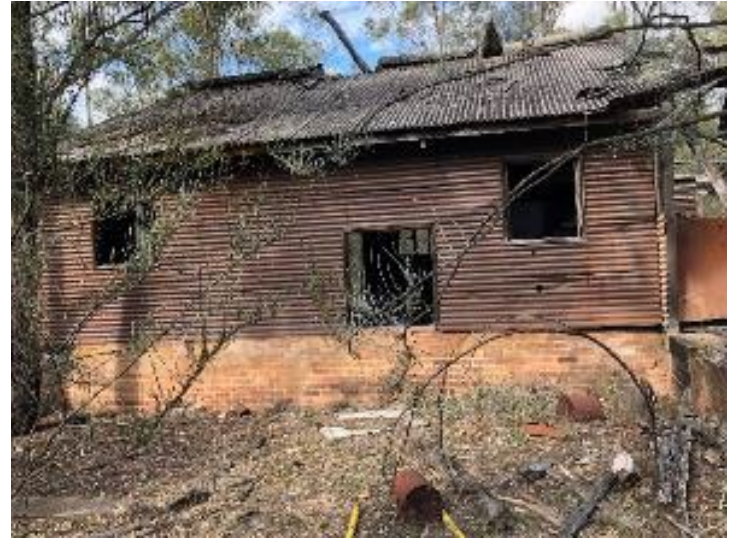
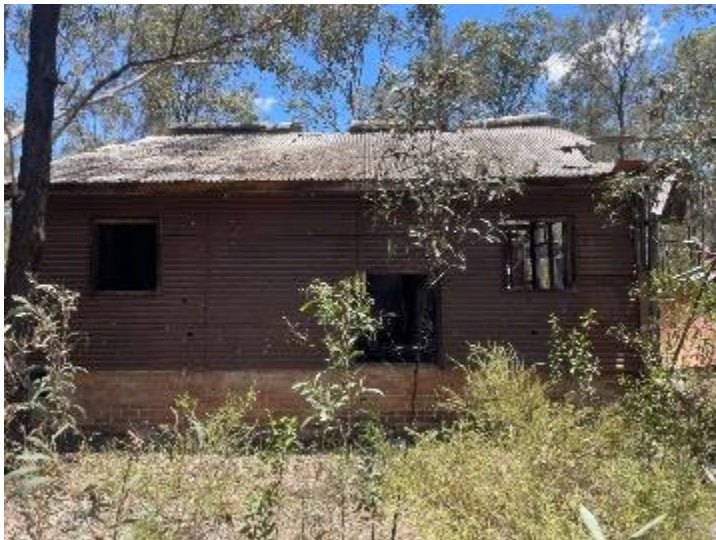
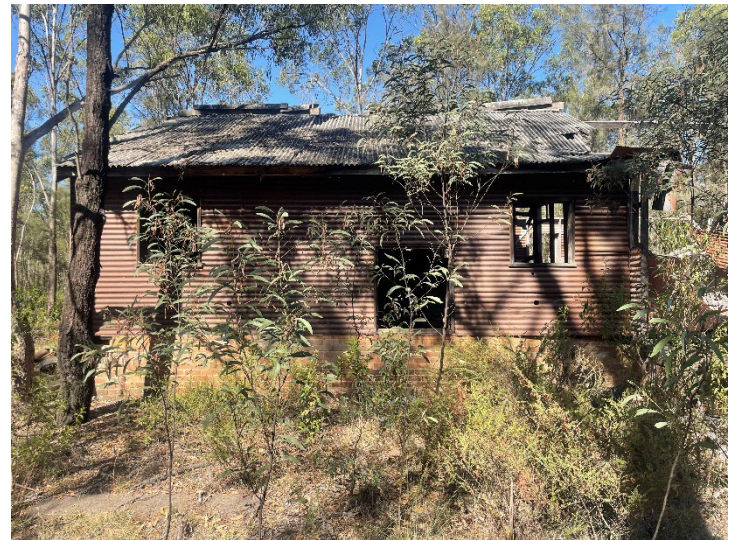
### **East elevation**

2012-18: no discernible change – note fallen branch from tree on western side.

2024-2025: no discernible change.

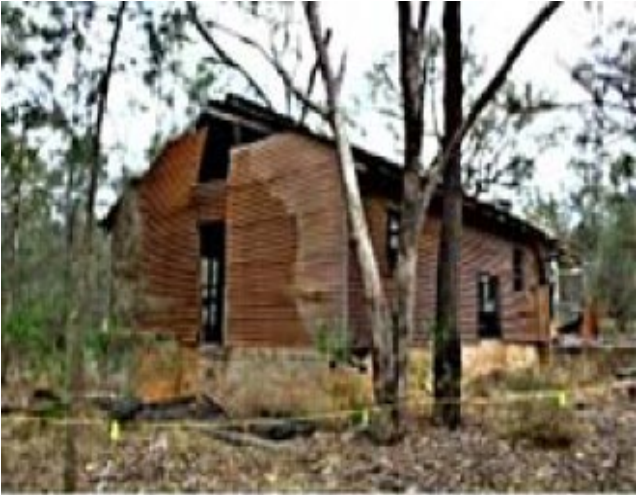
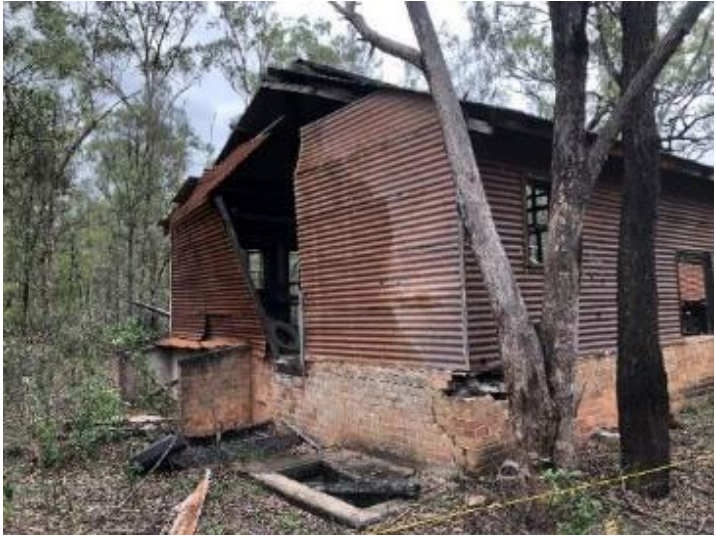
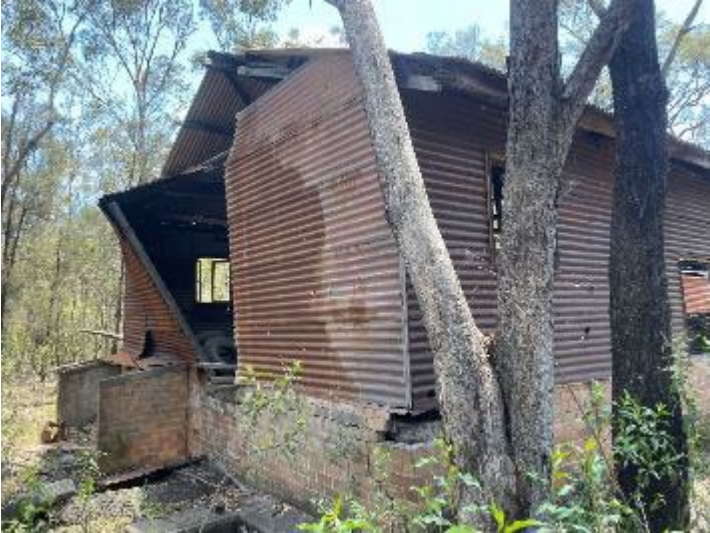
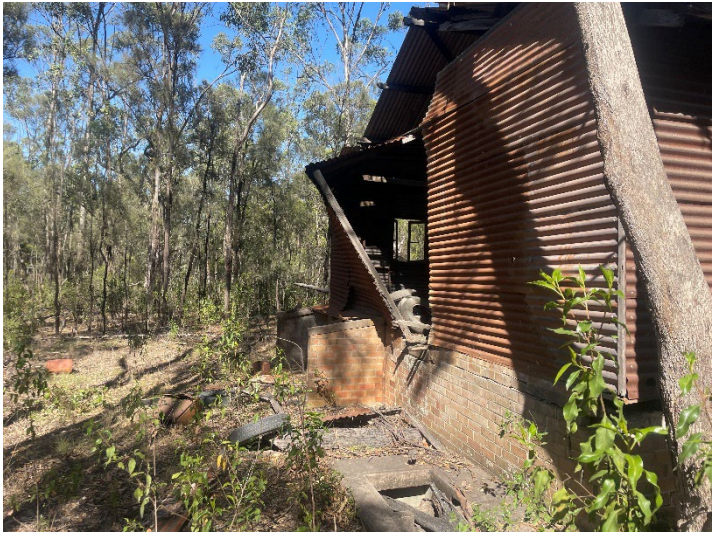
**South-east elevation**

- 2012-18: evidence of increased bow to southern wall.
- 2018-20 (Mar): bow in wall appears to have increased.
- Mar 2020 – Dec 2020: bow in wall continues to increase.
- Dec 2020 – 2021: gap in bowing has increased.
- 2021-2022: no discernible change.
- 2022-2023: bow in wall continues to increase
- 2023-2024: bow in wall increasing, with some collapse and slumping at near bottom corner
- 2024-2025: no discernible change.

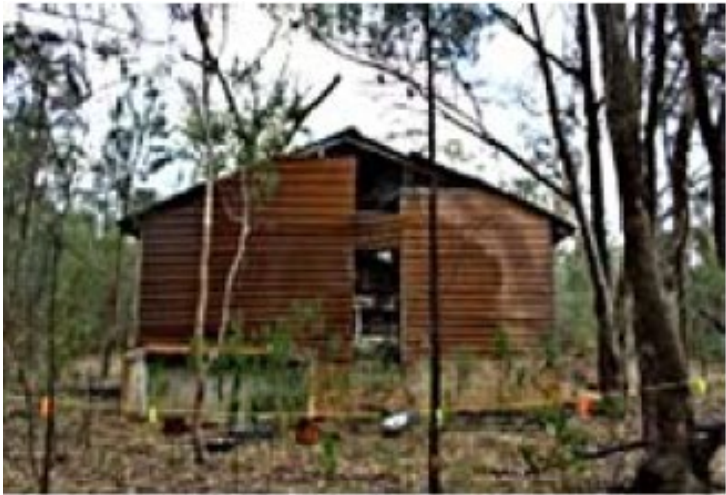
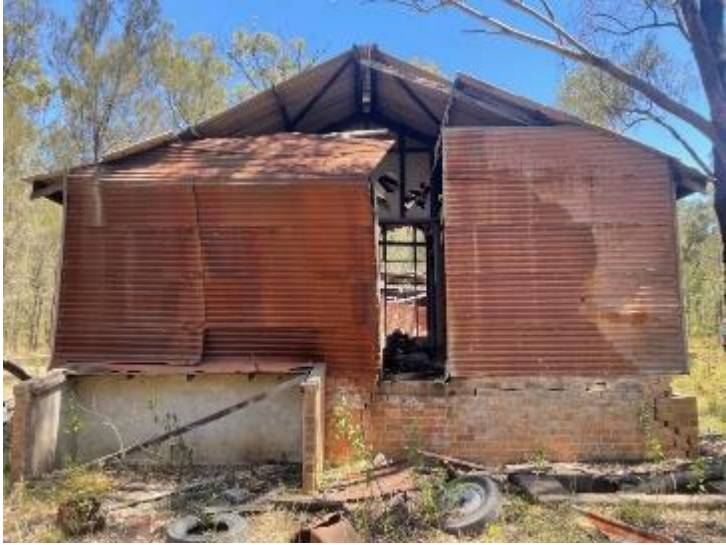
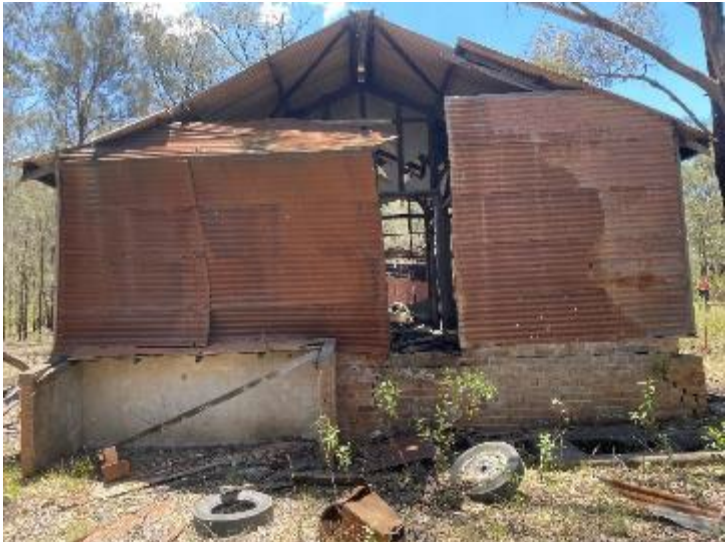
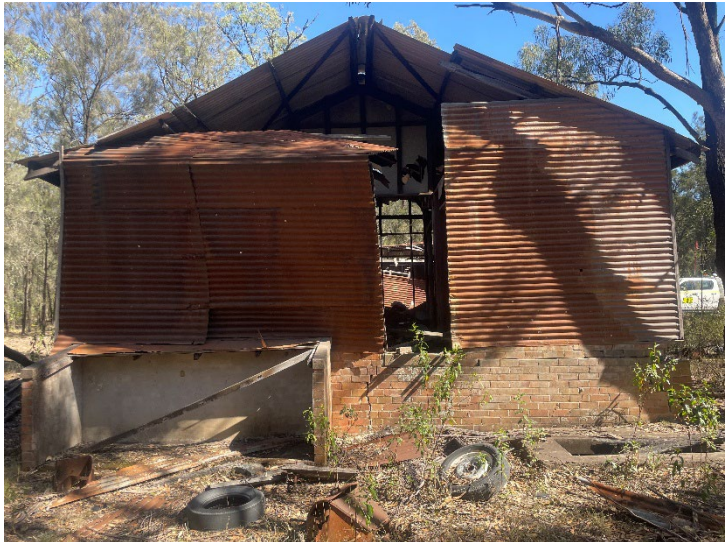
### South elevation

2012-18: evidence of increased bow to southern wall and missing panel above entry.

2024-2025: no discernible change.

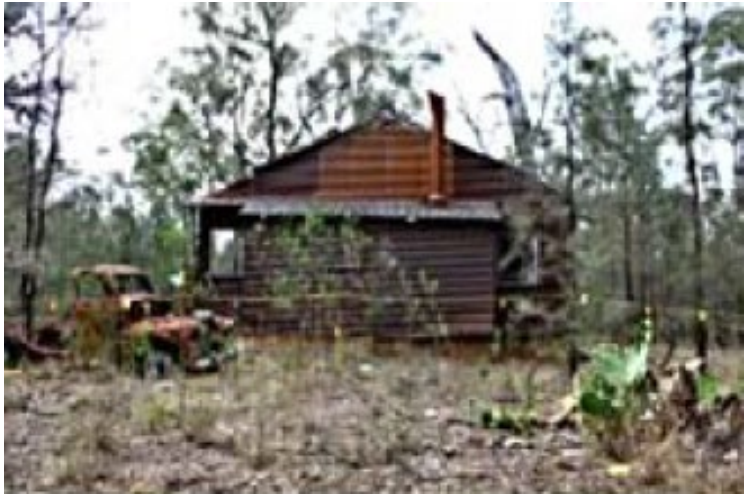
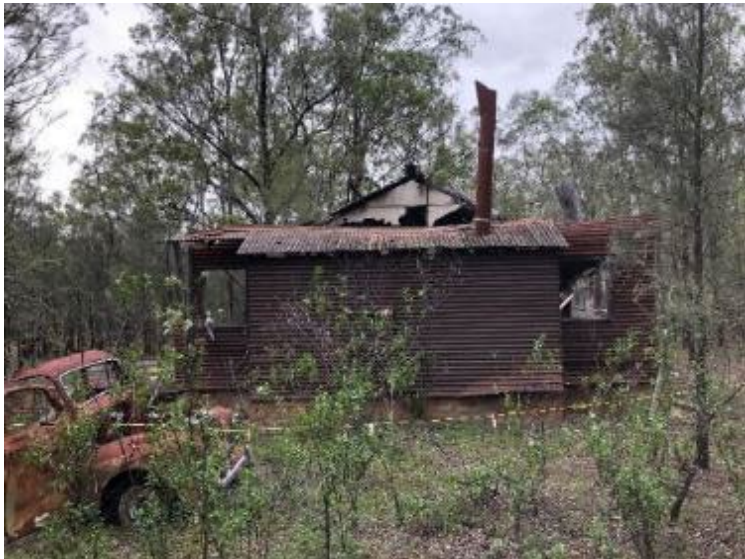
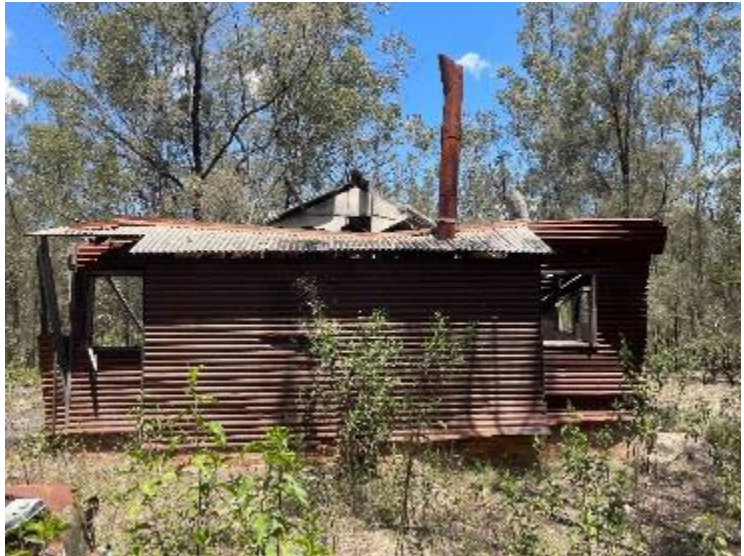
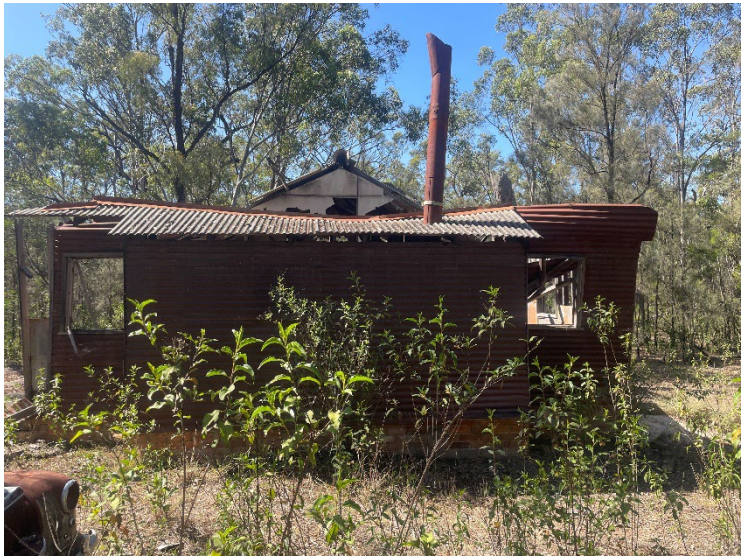
2012-18: shows deterioration of roofing members above open kitchen area and leaning north wall, and further collapse of asbestos roof due to fallen dead tree.

2018-20 (Mar): top of north wall now collapsed, further damage to roof with branch now fallen to ground.

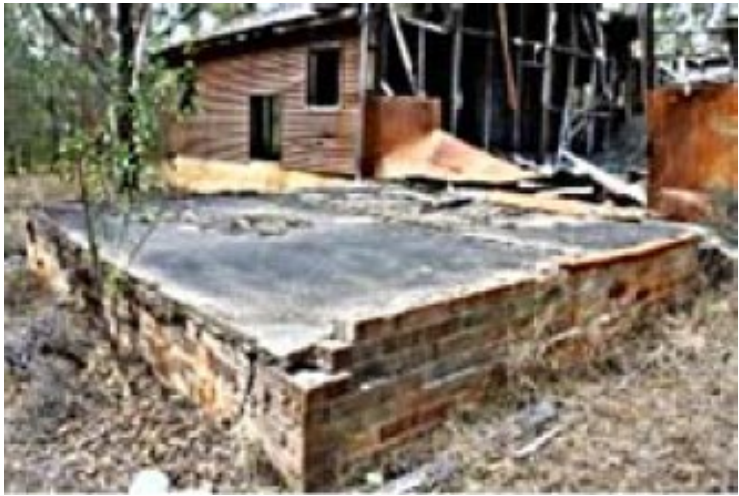
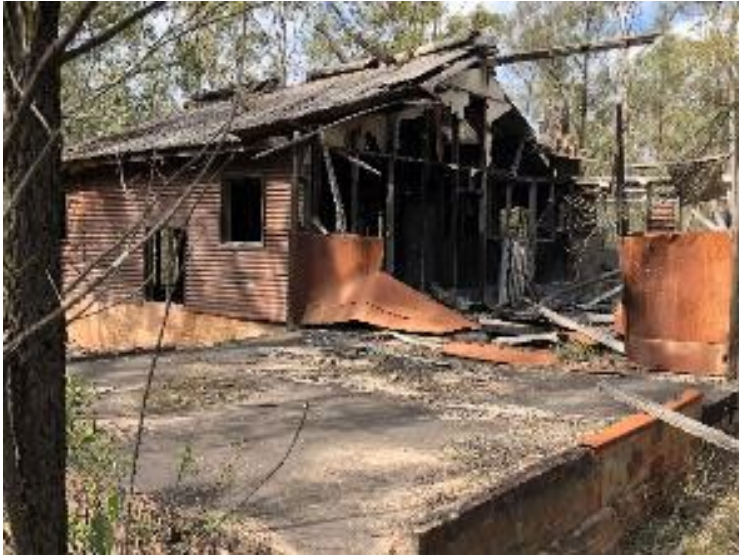
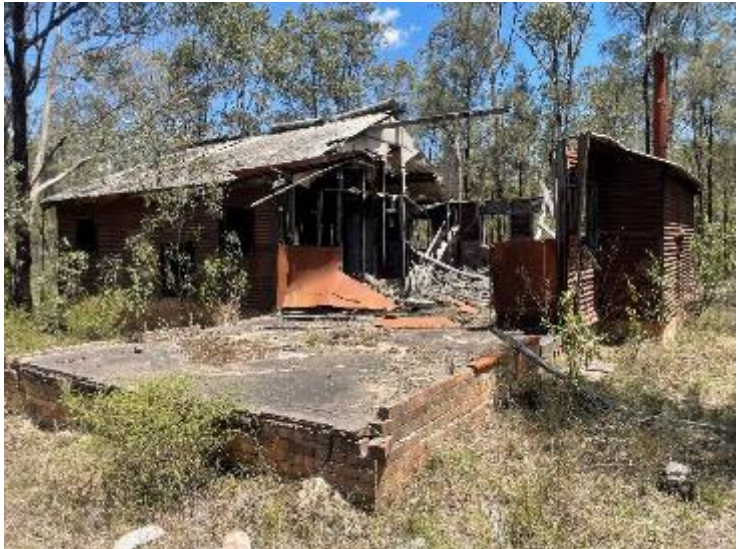
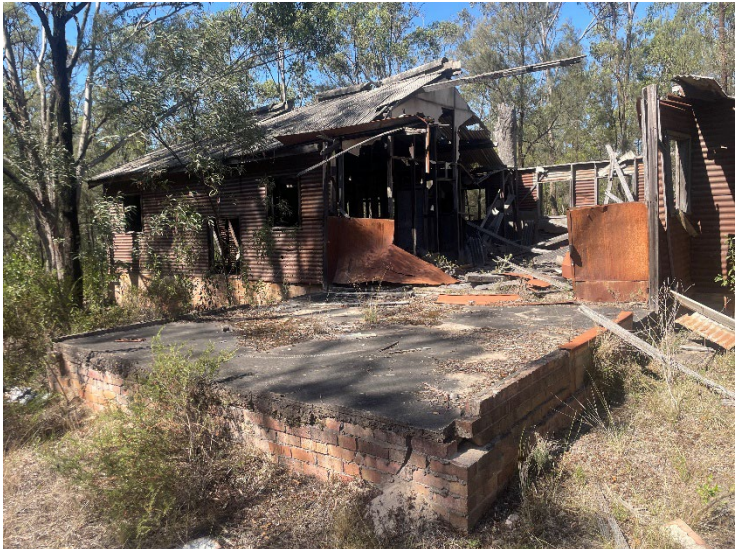
### North elevation

2012-18: no discernible change.

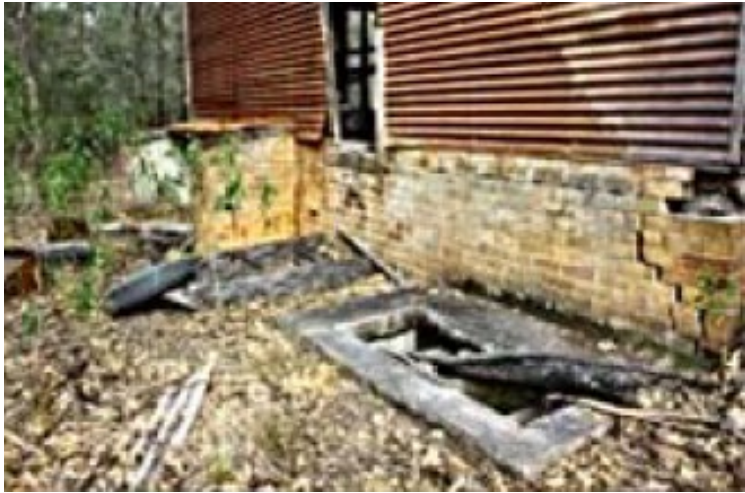
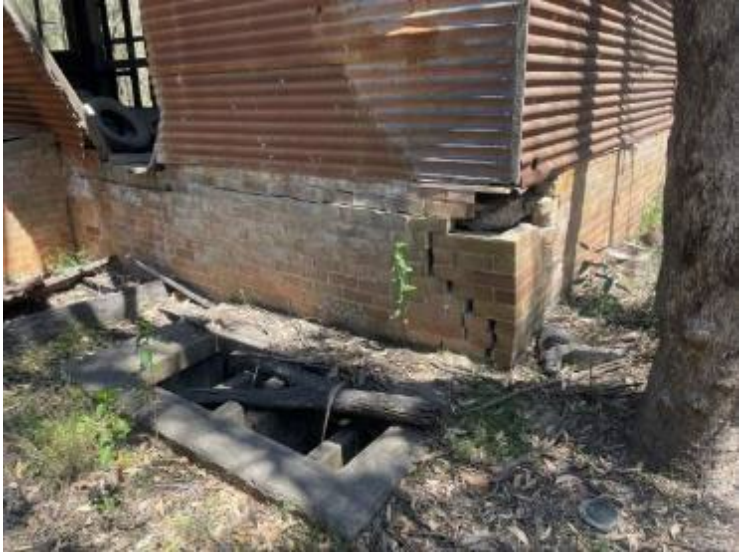
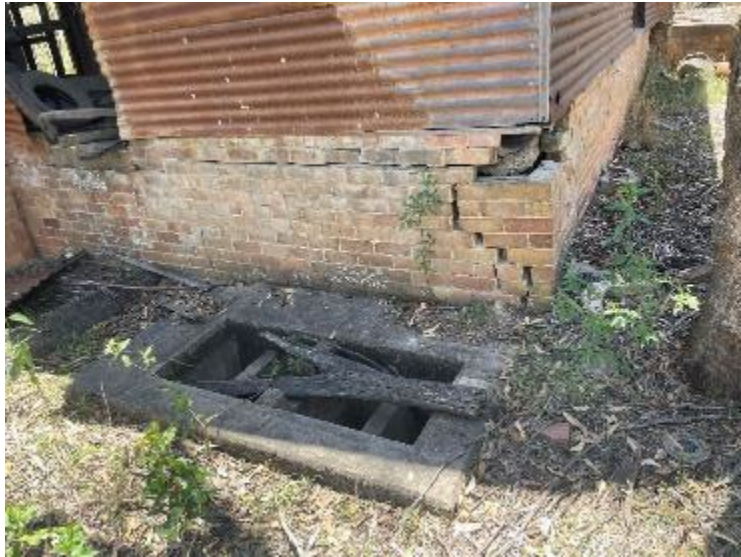
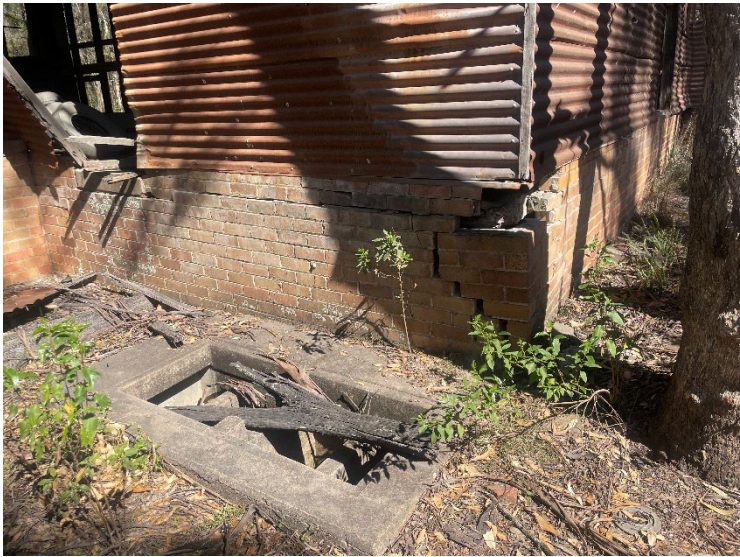
### Concrete and brick foundation at east side of building

2012-18: difficult to discern change.

2023-2024: [snapped timber on right hand side of foundation; motorcycle tracks on foundation surface](#)

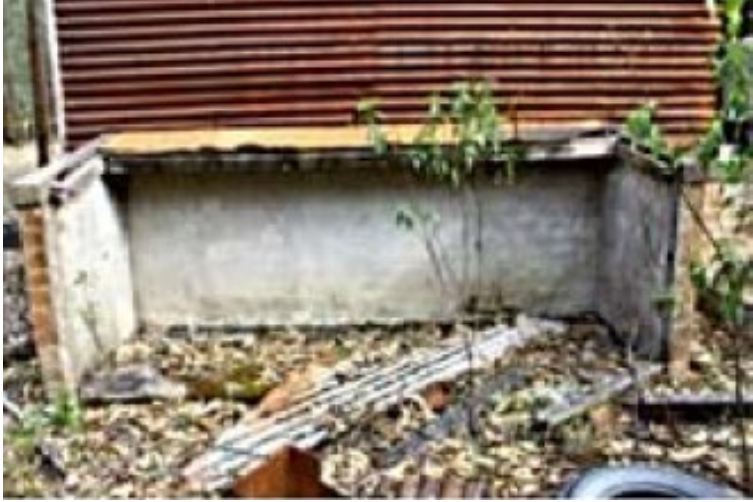
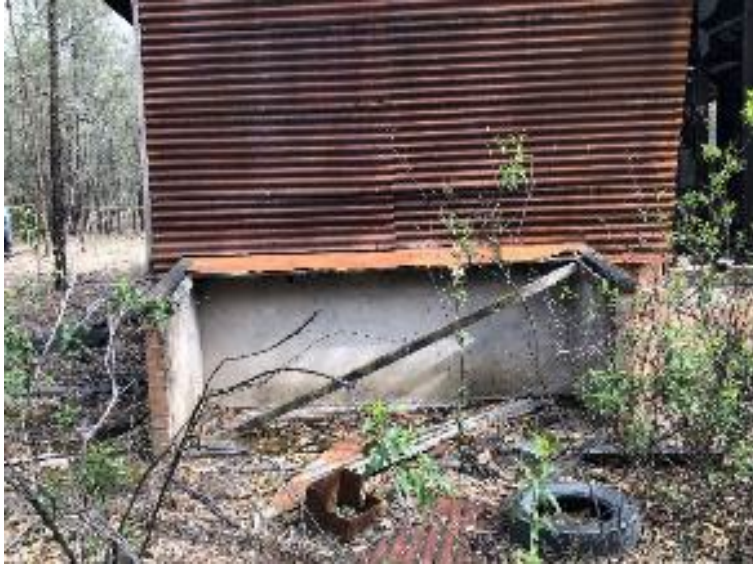
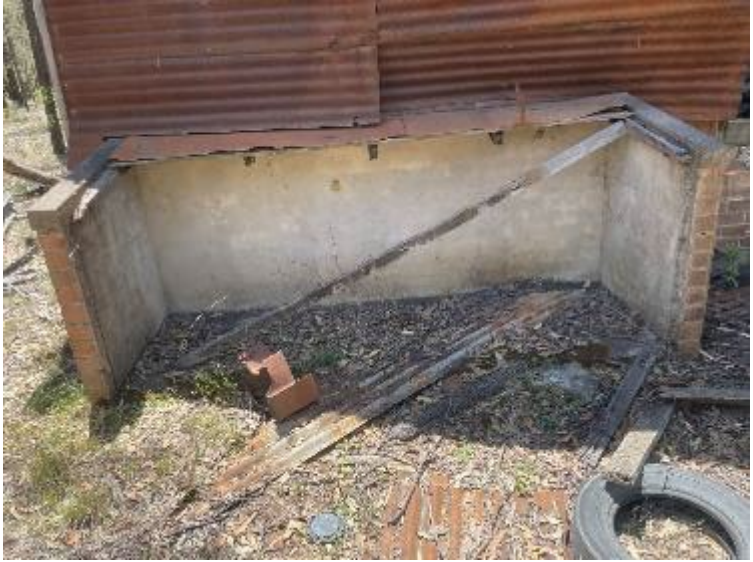
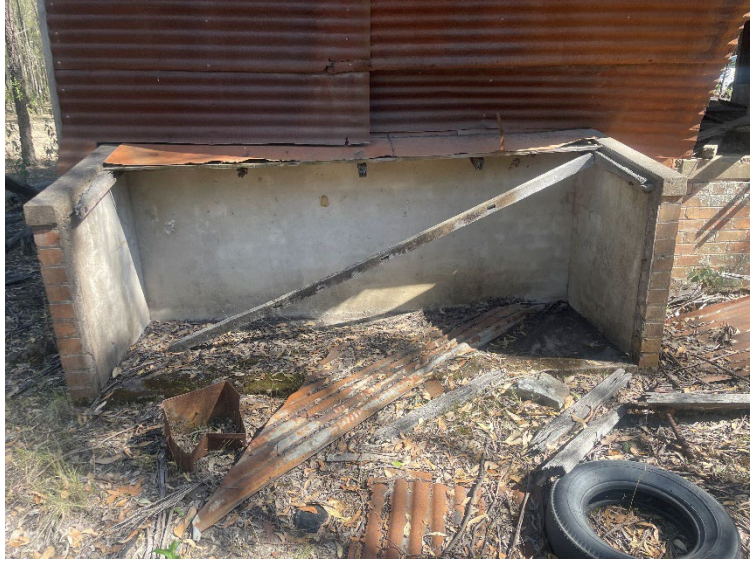
### Grease trap at south end of building

2012-18: shows bow to south wall.

2021-2022: potential subsidence at broken brick corner.

2022-2023: some increased movement at cracked corner

2023-2024: slumping brickwork at cracked corner.

2024-2025: no discernible change.

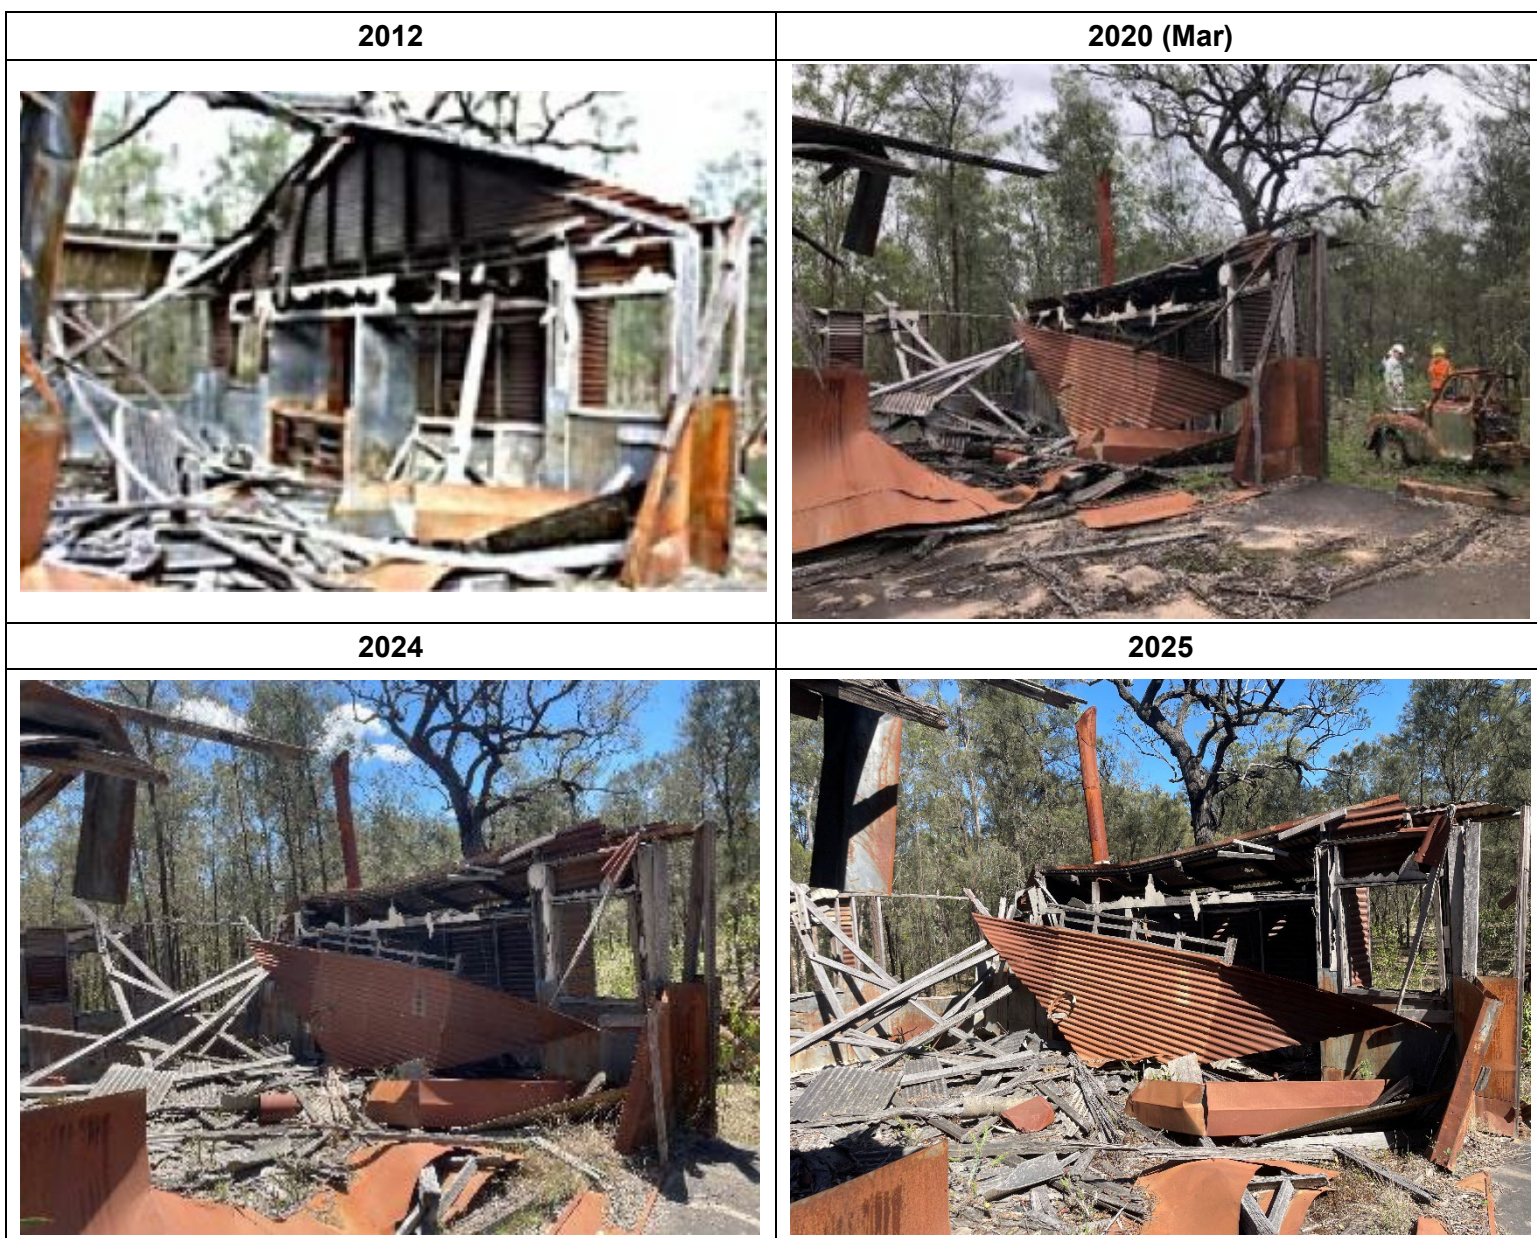
**Detail of north-west elevation**

- 2012-18: shows increased collapse over open kitchen area, as well as new damage to brick foundation at north-west corner.
- 2018-20 (Mar): shows fallen top of north wall plus increased (animal?) damage to brick foundation at north-western corner.
- Mar 2020 – Dec 2020: no discernible change.
- Dec 2020 – 2021: detachment of north wall from western beam.
- 2021-2022: no discernible change
- 2022-2023: some internal timbers have fallen further.
- 2023-2024: no discernible change.
- 2024-2025: further collapse of interior members; northern wall slumping out.

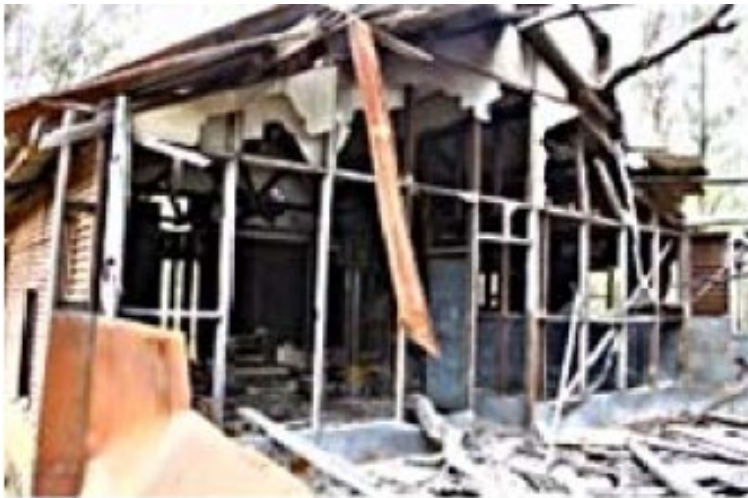
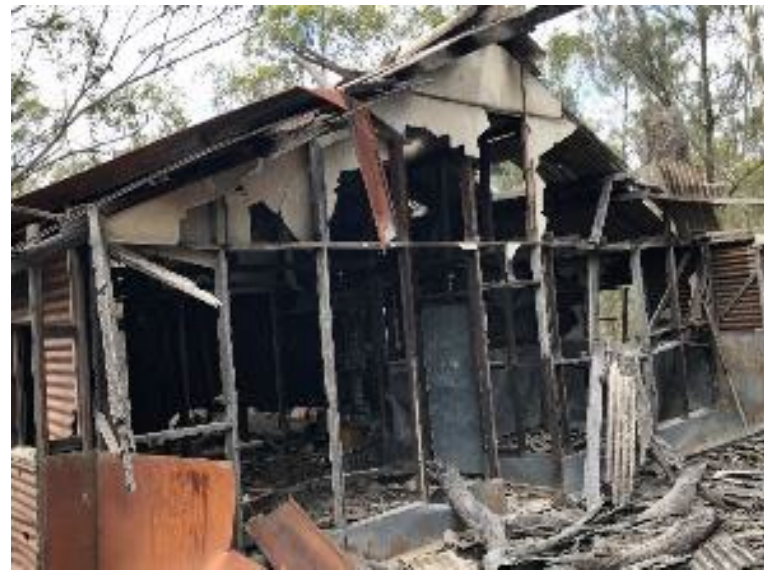
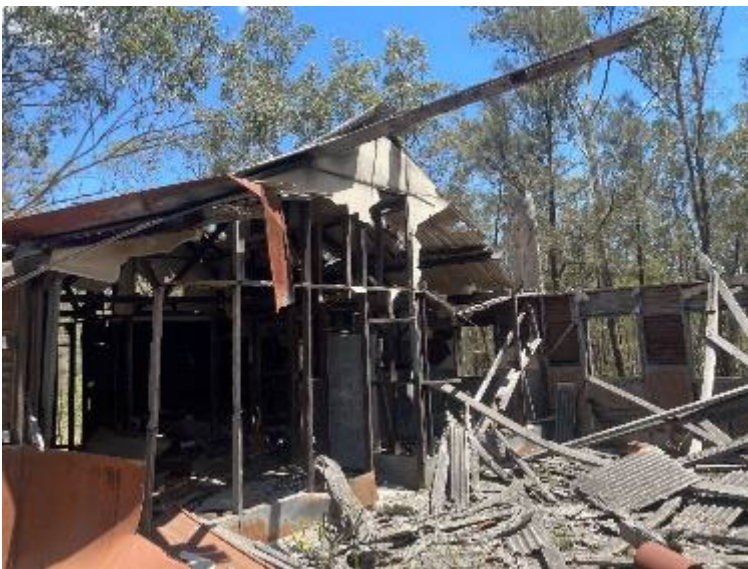
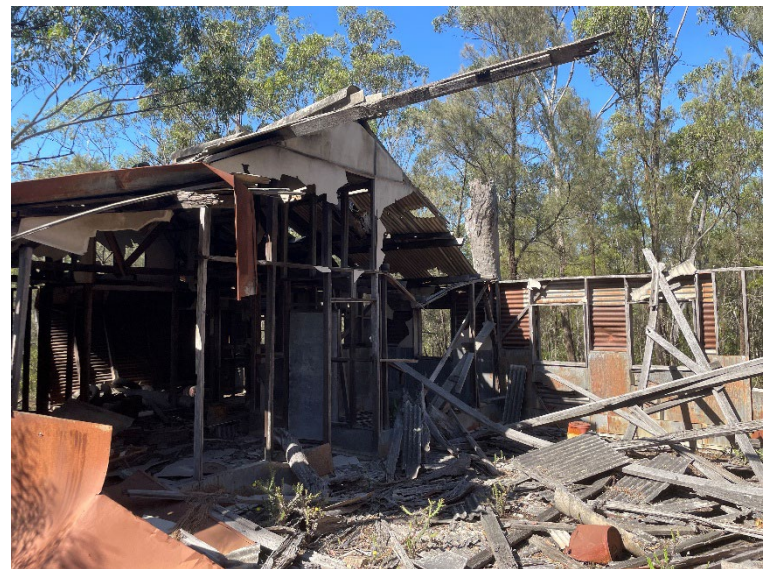
### Showing interior damage at kitchen at north end of building

2012-18: shows increased collapse over and accumulation of debris within open kitchen area. Note also severe lean to north wall. Stove doors have become unhinged.

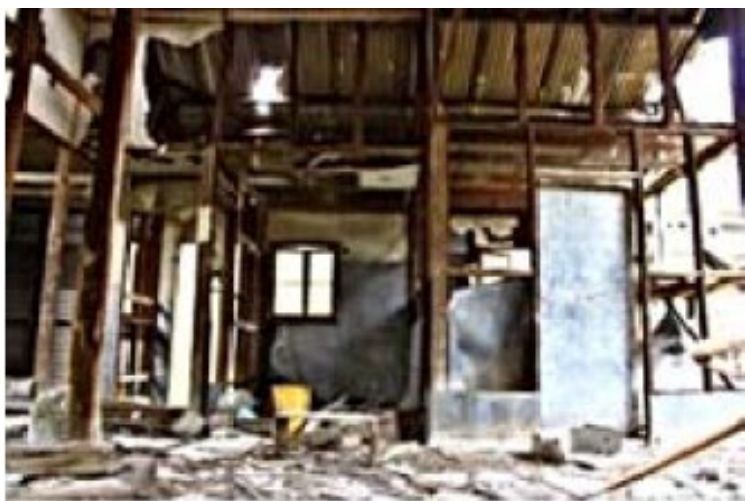
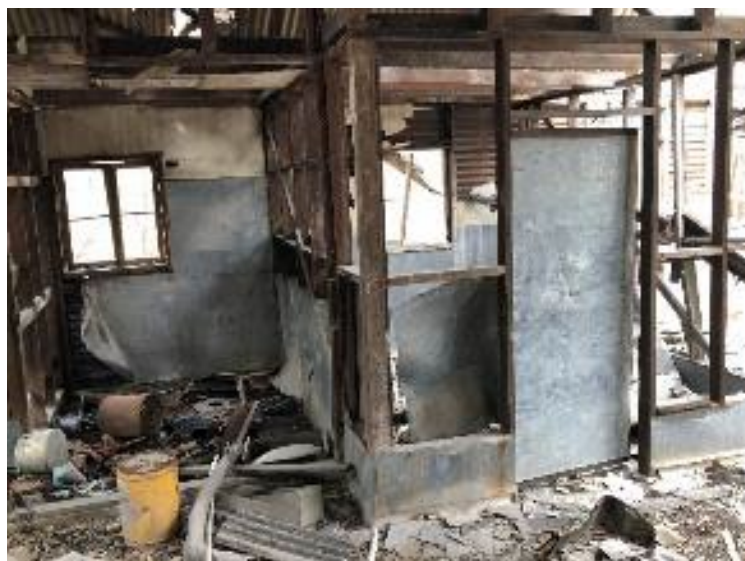
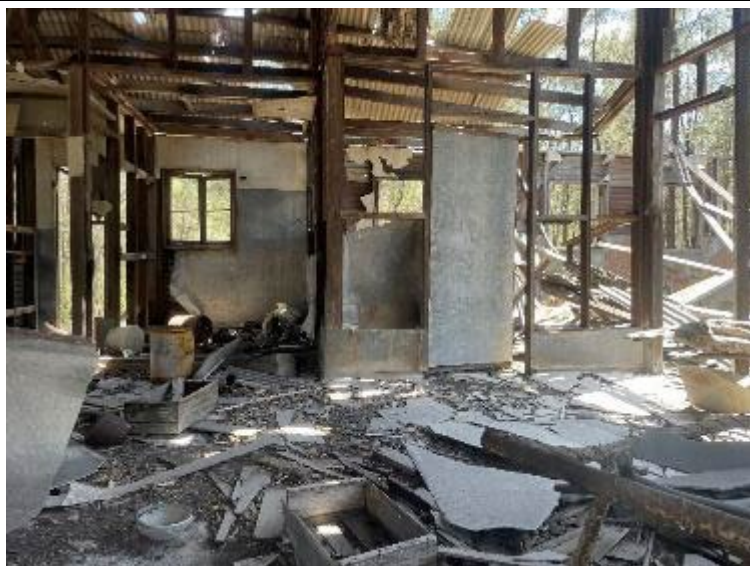
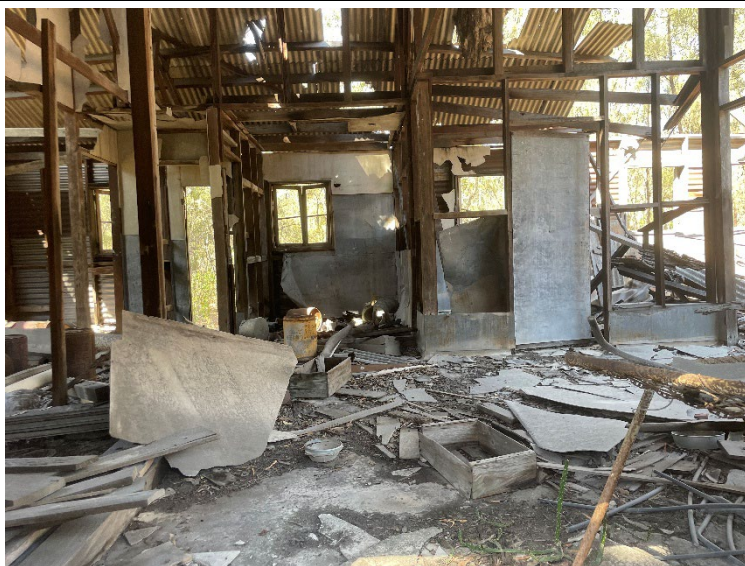
### View to interior of south end of building, view from east

2012-18: shows increased collapse over open kitchen area.

2018-20 (Mar): shows further minor deterioration of asbestos panelling.

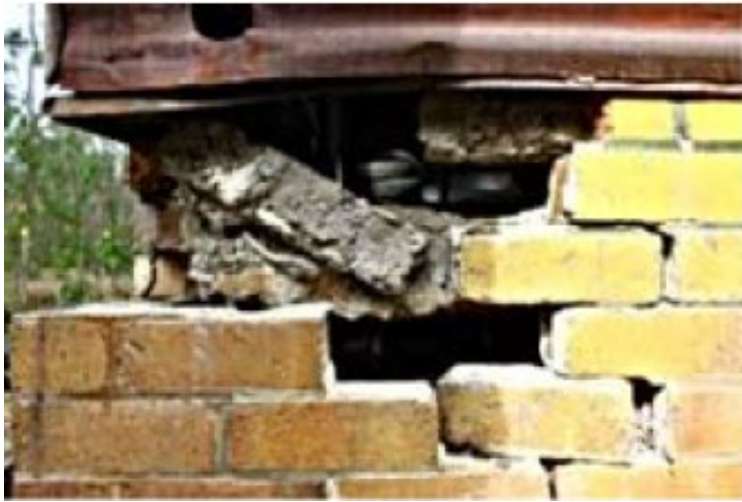
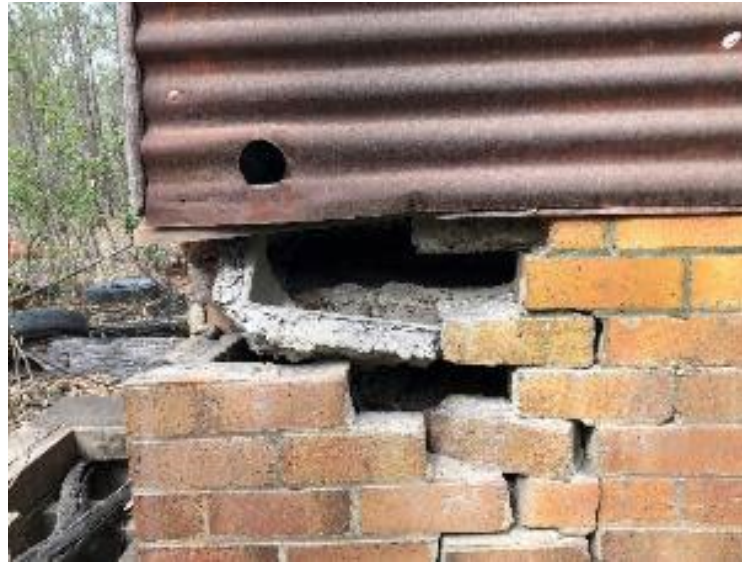
#### Detail of damaged brick foundation (east view)

2012-18: [some further collapse of concrete/cement above brick foundation.](#)

2018-20 (Mar): [some slumping outwards of corner brick foundation.](#)

2021-2022: [increased cracking along mortar lines.](#)

2024-2025: [some minor additional cracking along mortar lines.](#)
