# Mount Thorley Warkworth

## 2025 Annual Review

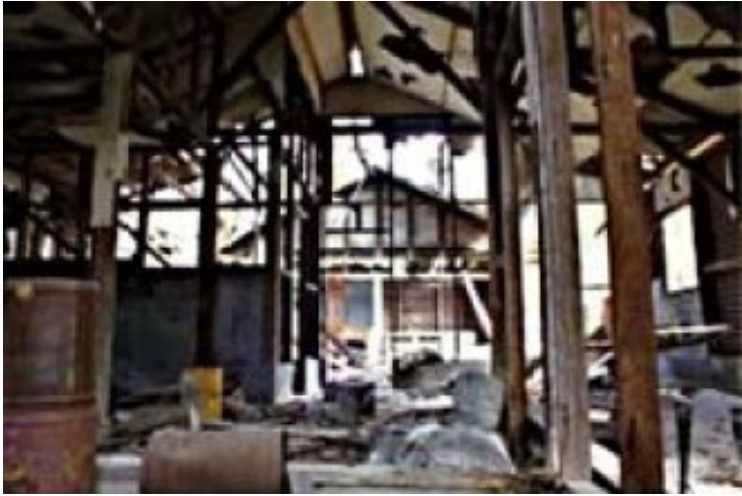
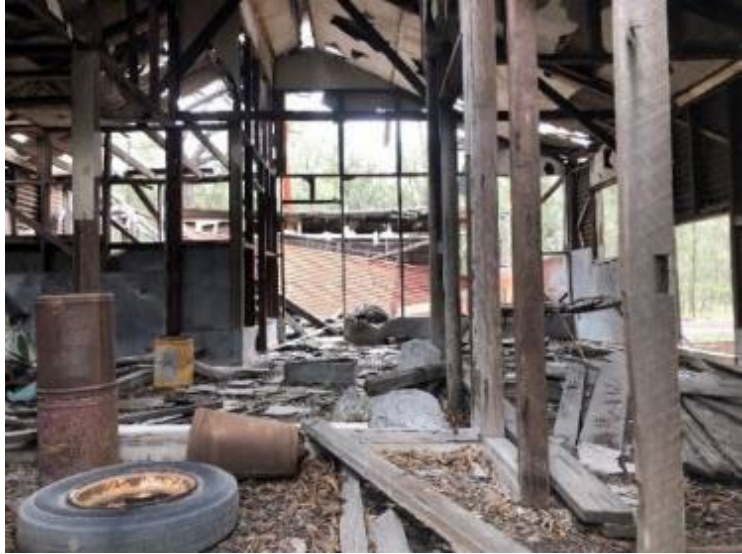
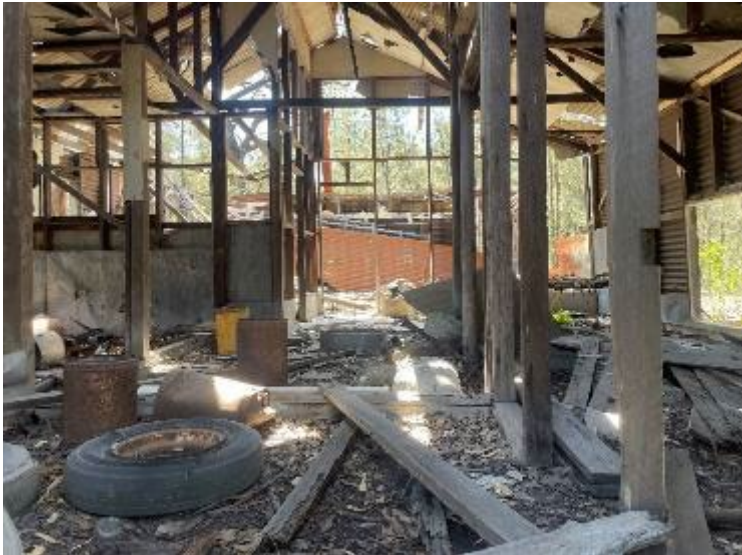
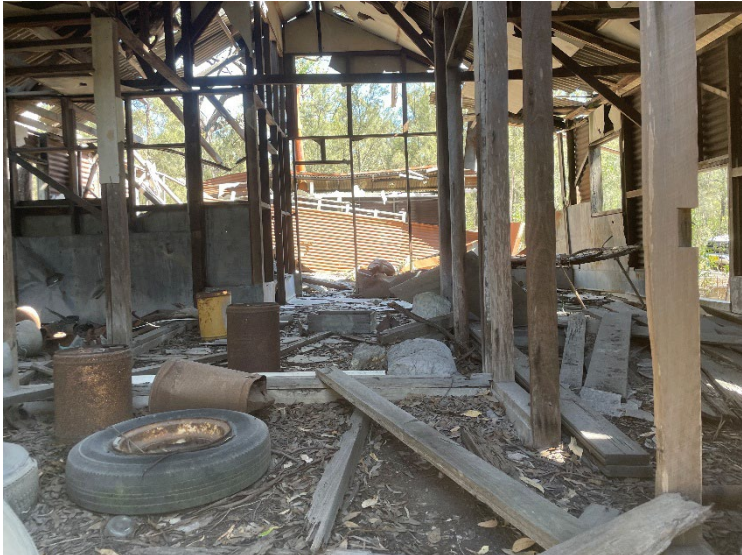
### View to interior of building, looking north from south entry

2012-18: no discernible change.

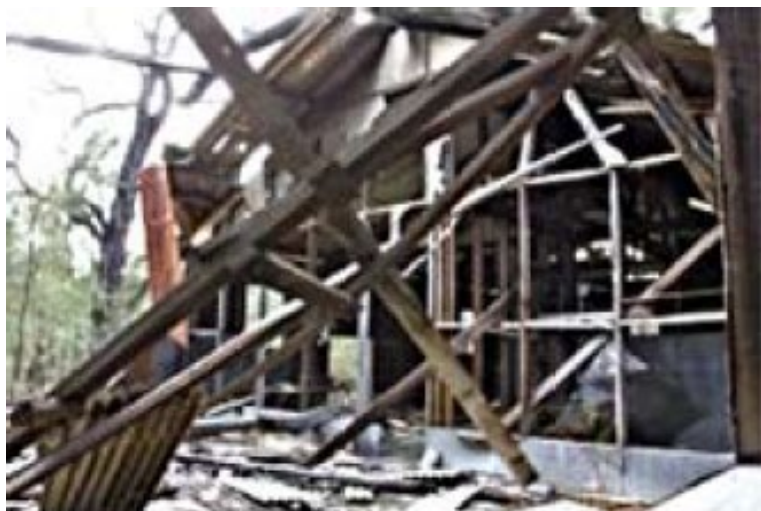
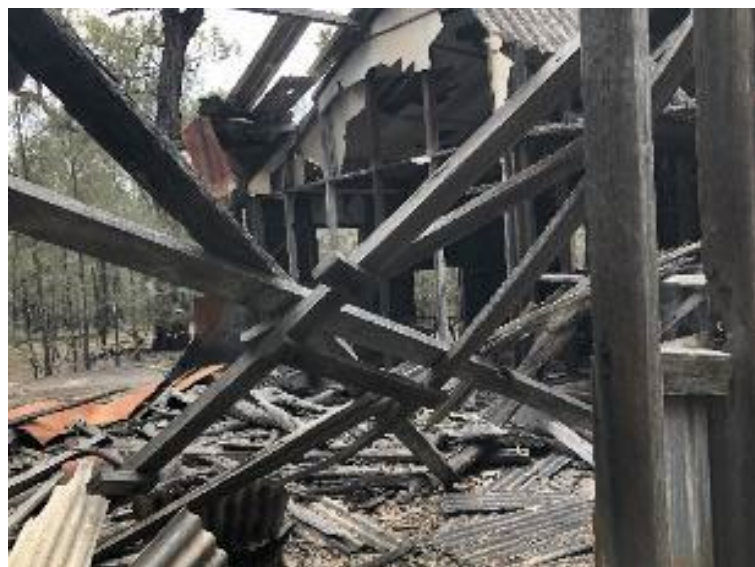
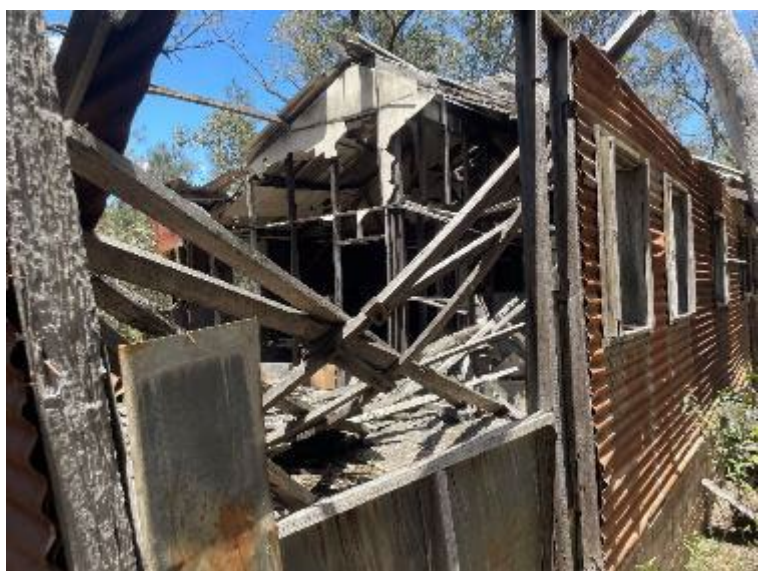
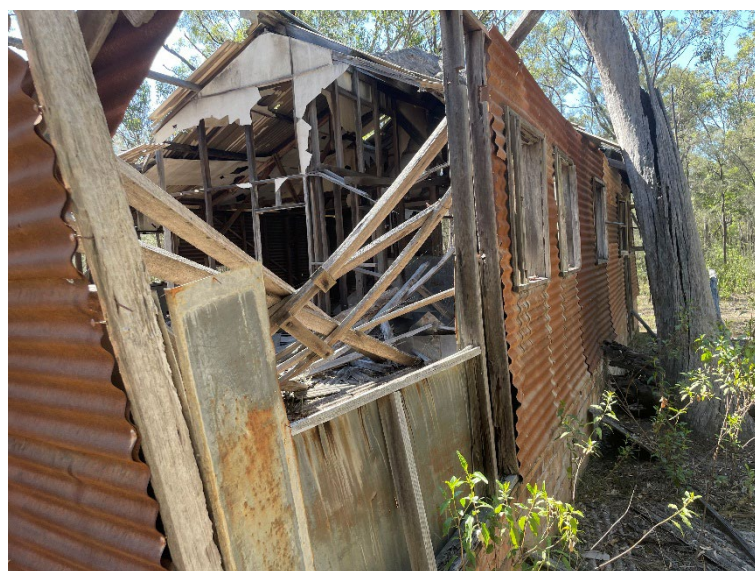
### Showing interior of building, viewed from north-west corner

2012-18: shows collapsed roofing members above open kitchen area and accumulation of debris.

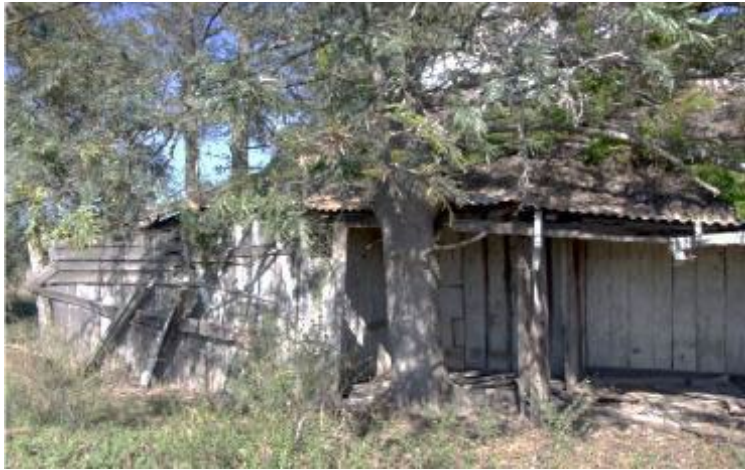
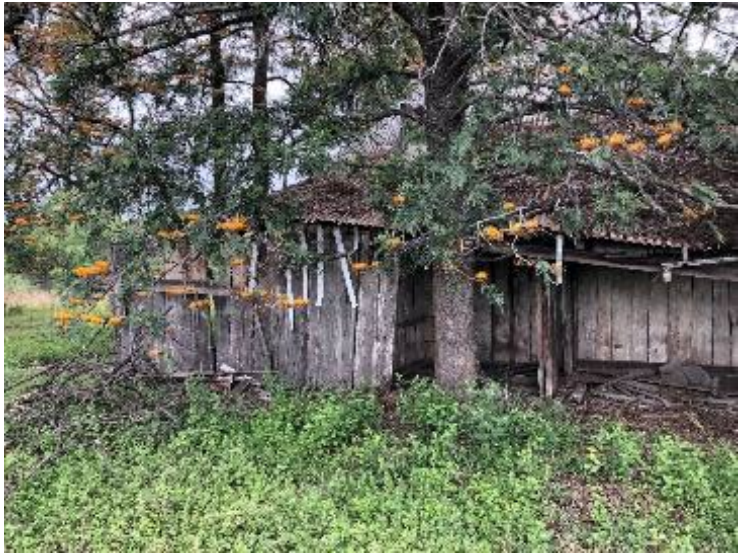
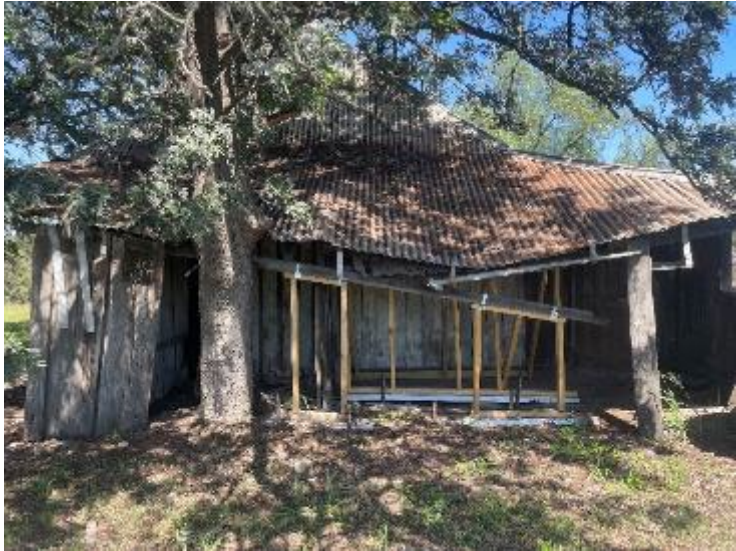
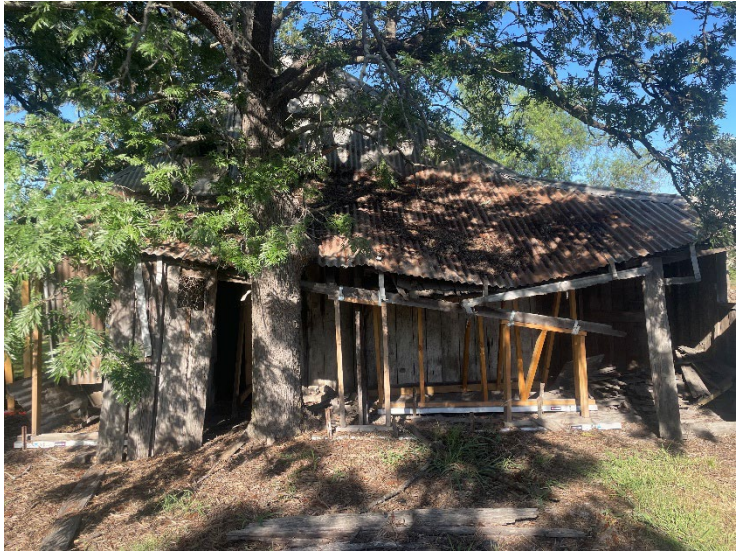
### Eastern elevation

**2014-8:** no discernible change.

**2021-2022:** tree growth increasing with associated deterioration of roof integrity.

**2023-2024:** tree has been pruned, fallen timbers and roof sheets have been cleared and stacked, broken edge beam strapped and propped, internal roof rafters propped.

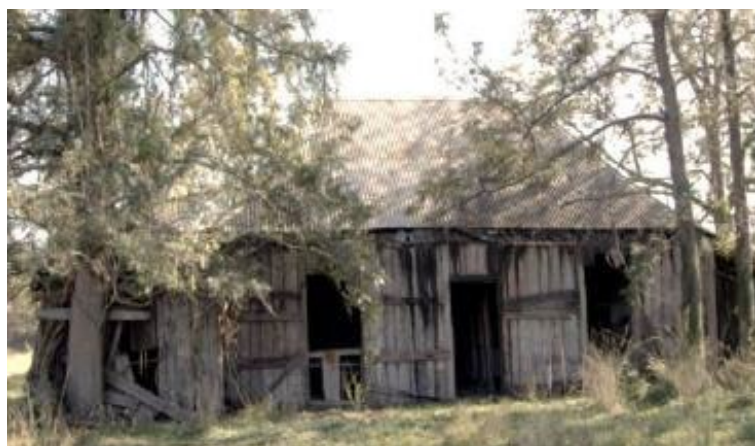
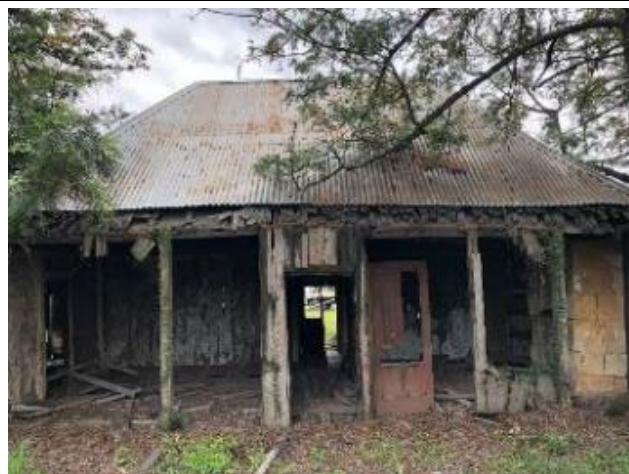
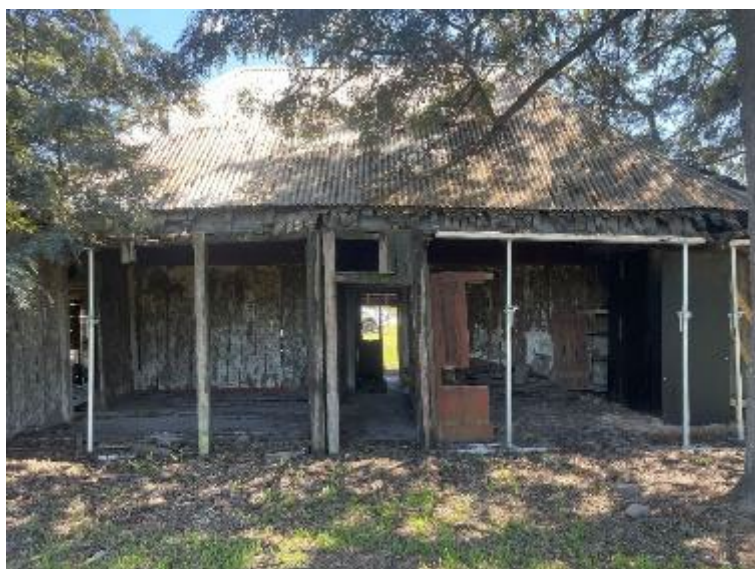
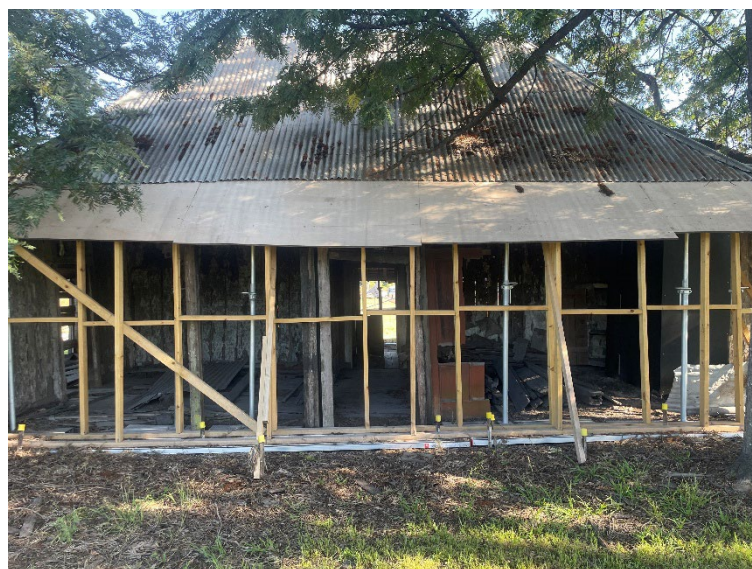
### Southern elevation

**2014-8:** vertical timber slabs have been removed from southern wall.

**2018-20 (Mar):** possible deterioration of shingles at roof edge, and missing panels from above back door.

**2022-2023:** part of door has broken off.

**2024-2025:** extensive new framing support installed; loose building materials and fabric stacked neatly inside; plywood sheeting installed to protect exposed shingles and direct roof runoff away from building.

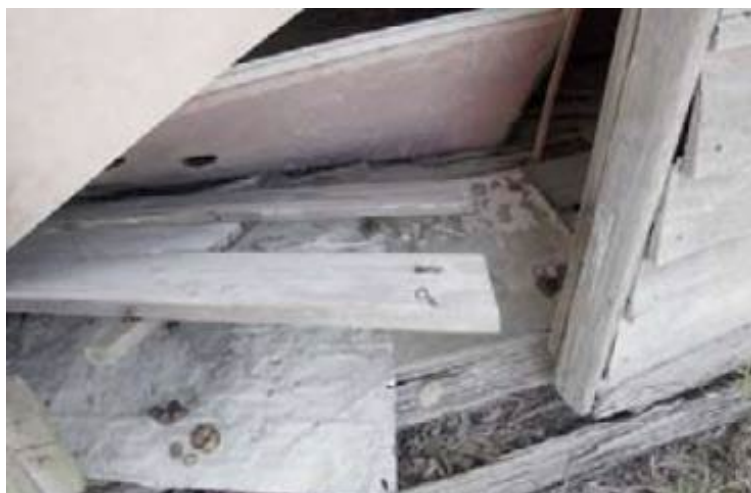
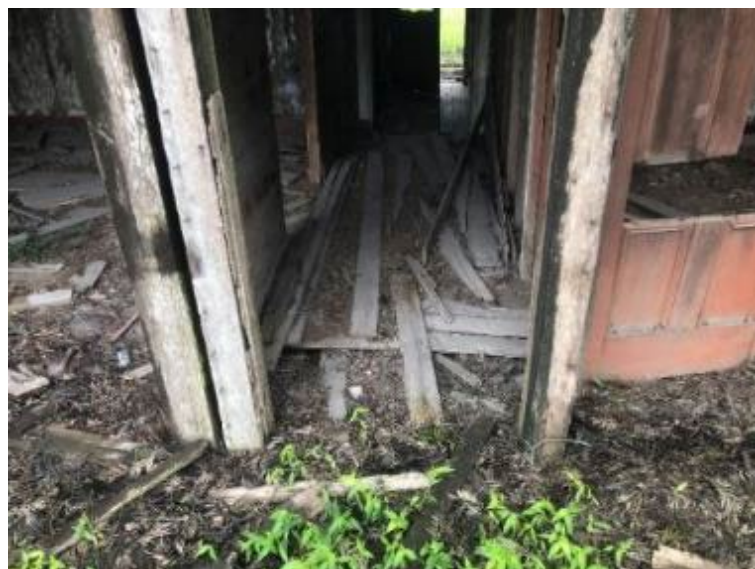
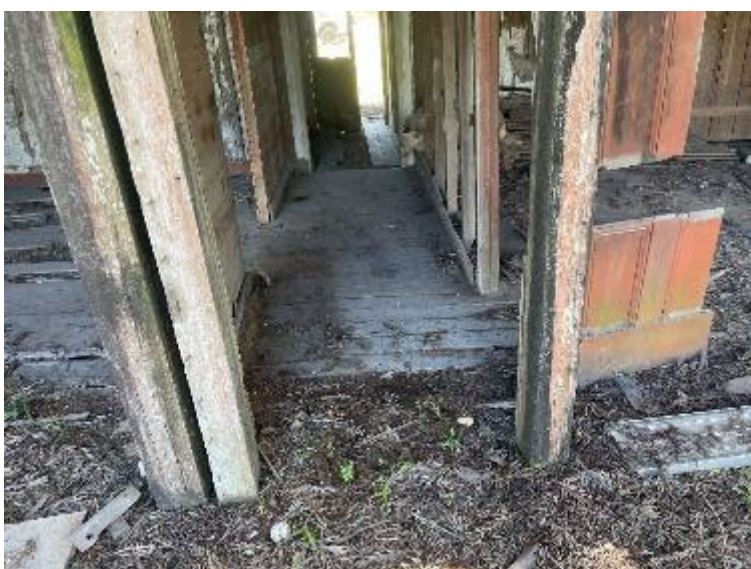
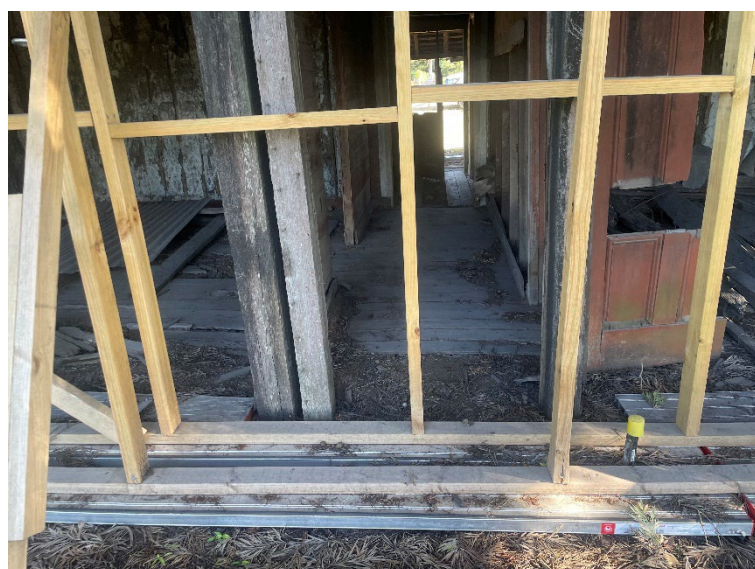
### Southern elevation doorway

2014-8: door has been removed.

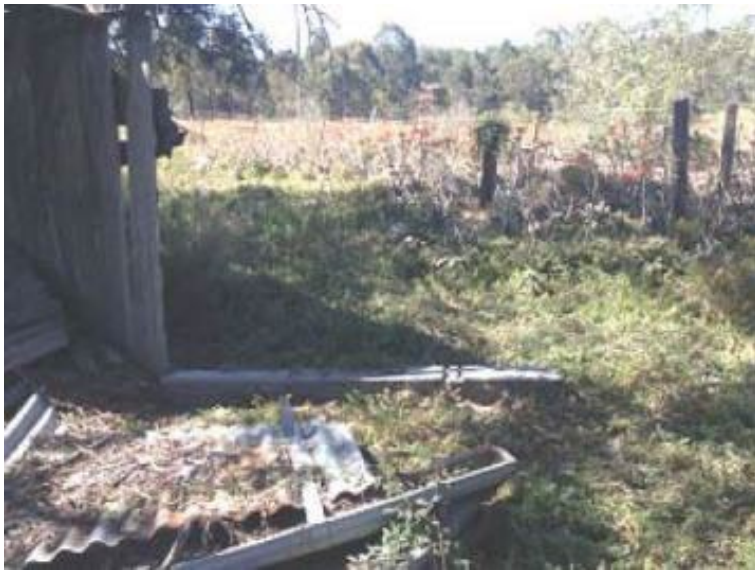
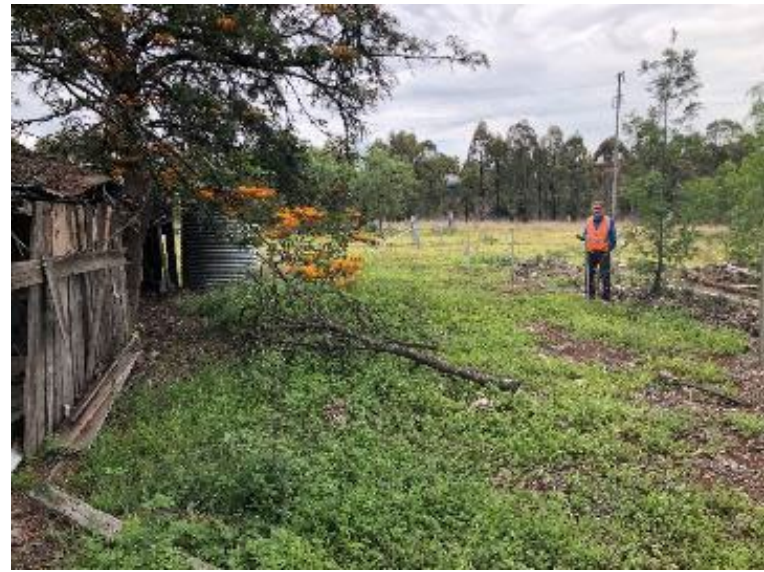
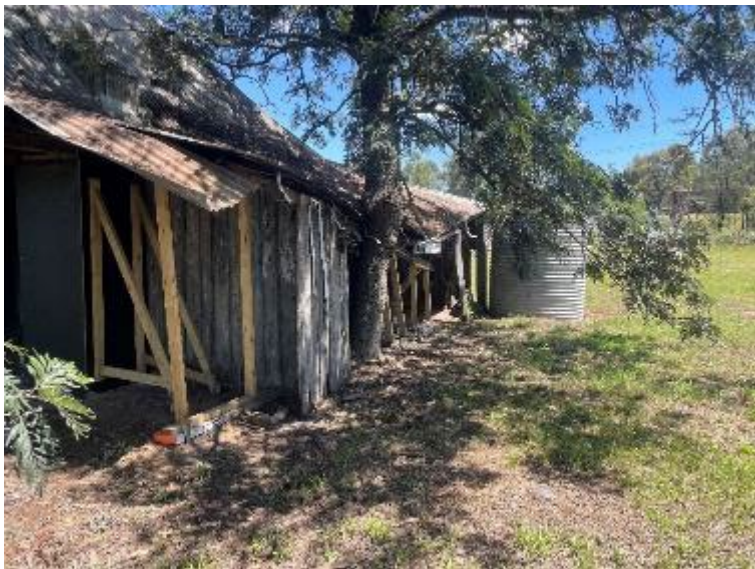
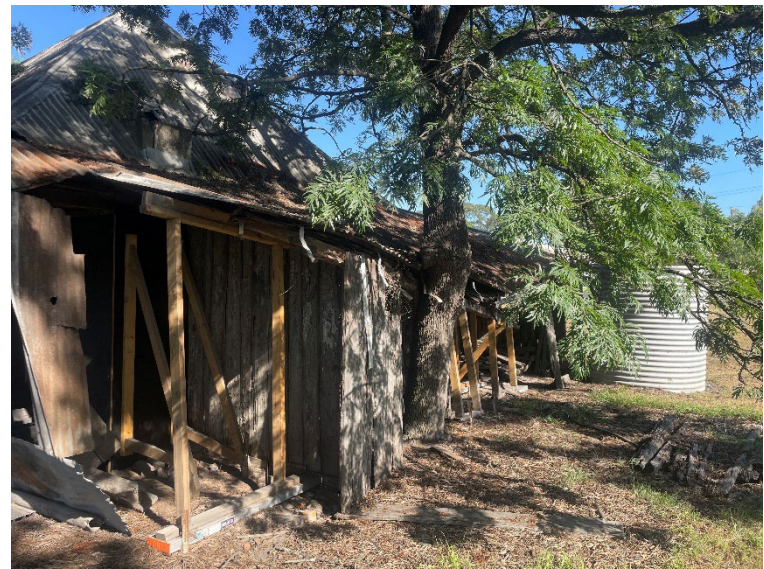
### Eastern side

**2014-8:** debris has been cleaned and stored and a weed removal program conducted. The house area has also been fenced.

**2018-20 (Mar):** further deterioration of eastern wall and regrowth of weeds.

**2023-2024:** tree has been pruned, fallen timbers and roof sheets have been cleared and stacked, fallen side wall and roof propped, chimney clad and propped.

**2024-2025:** some roof sheeting has detached and fallen.

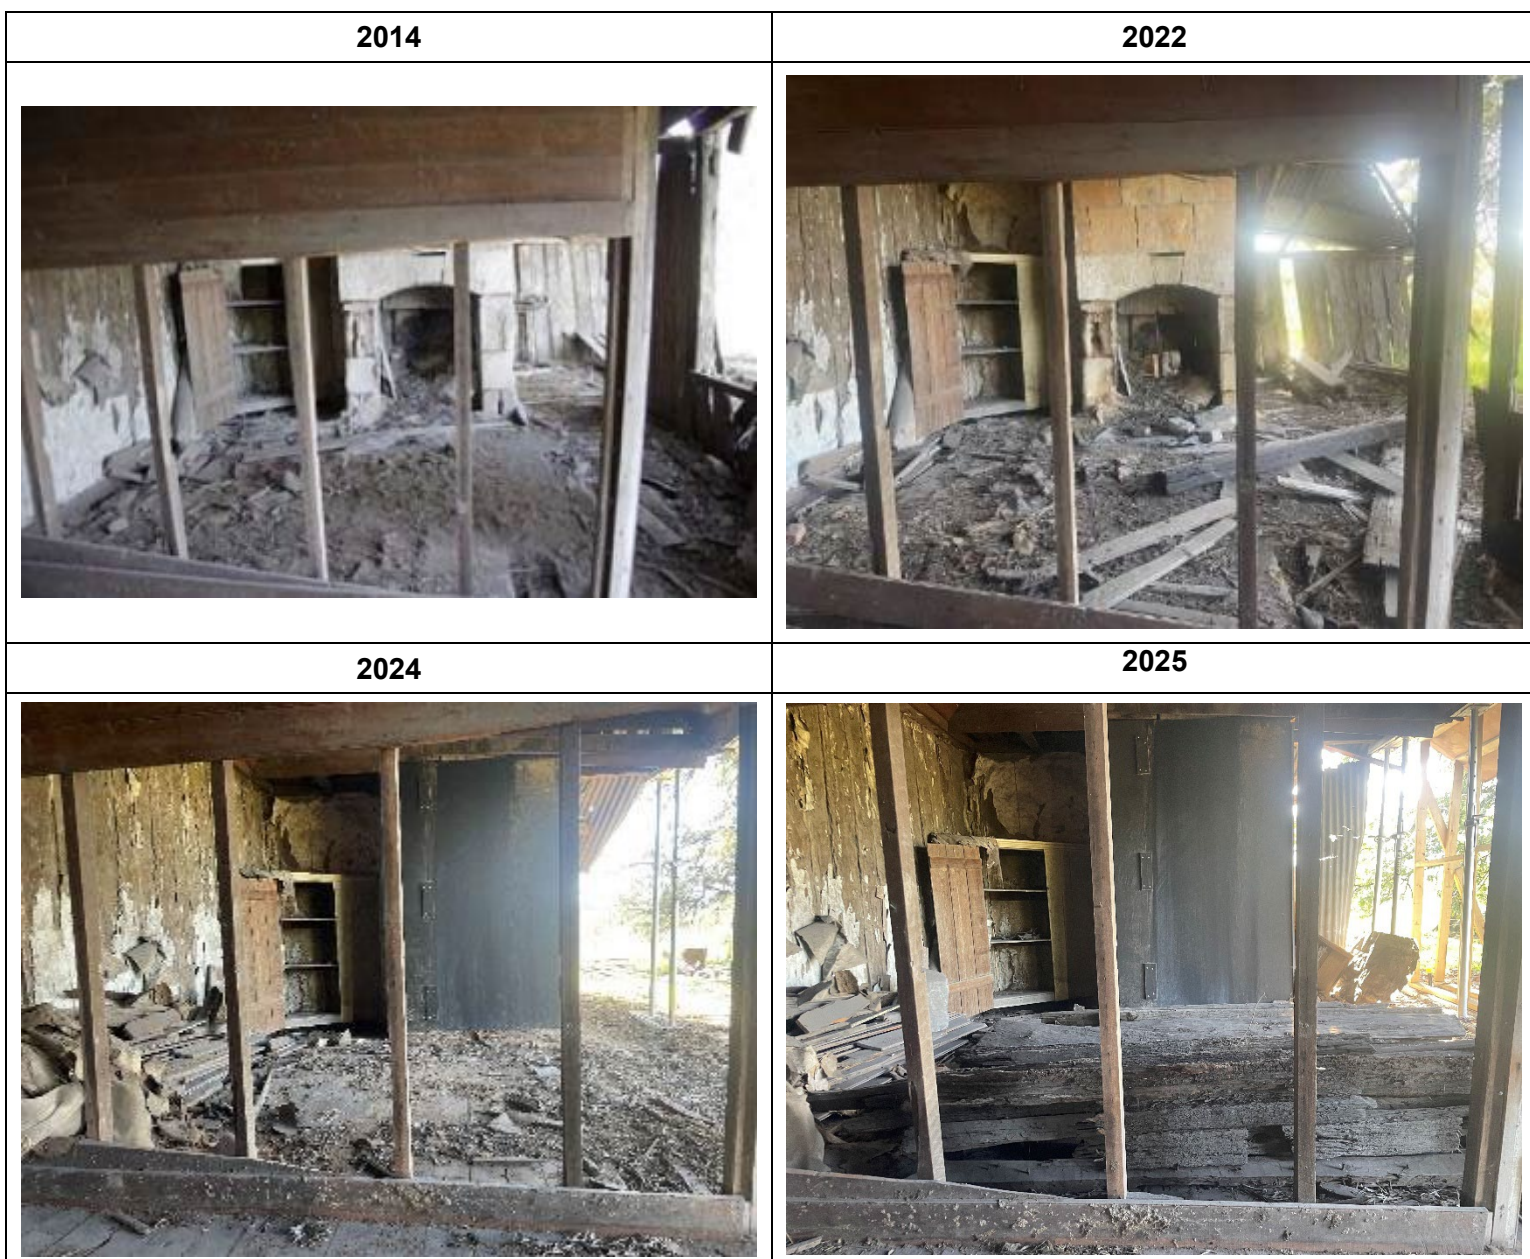
### Room 2 interior

**2014-8:** increased debris caused by removal of southern wall.

**2021-2022:** fallen timber upright; increased decay of chimney blocks.

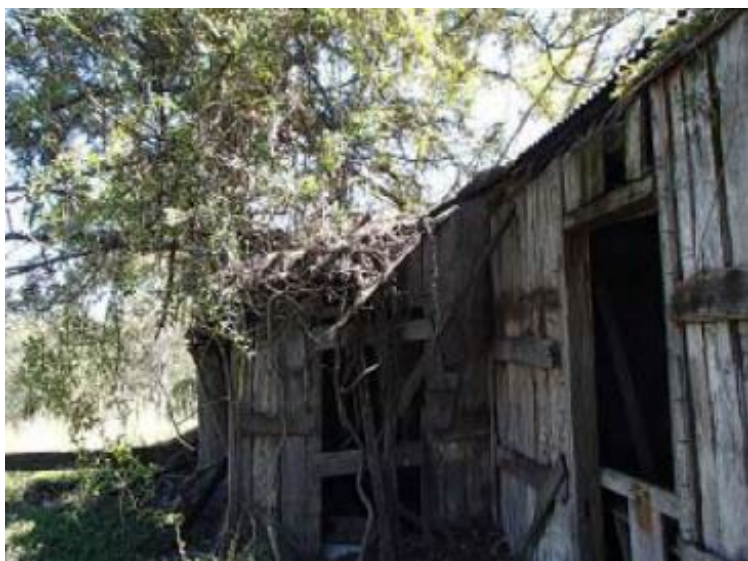
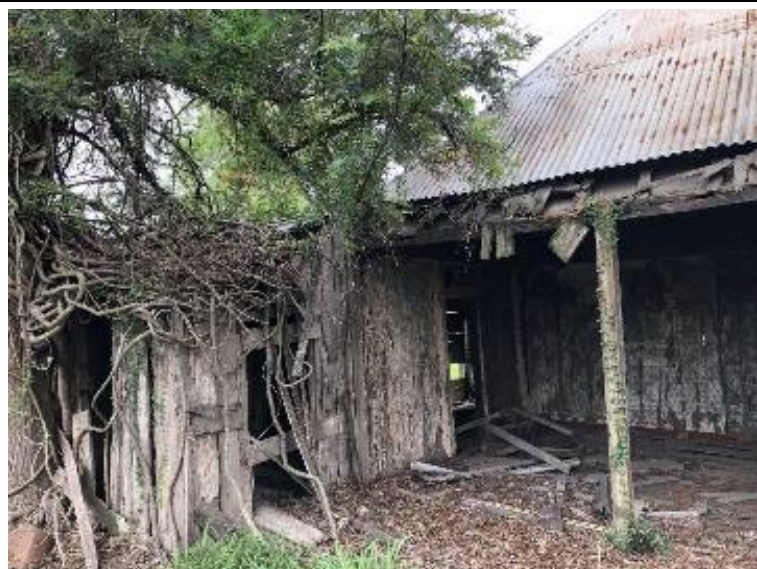
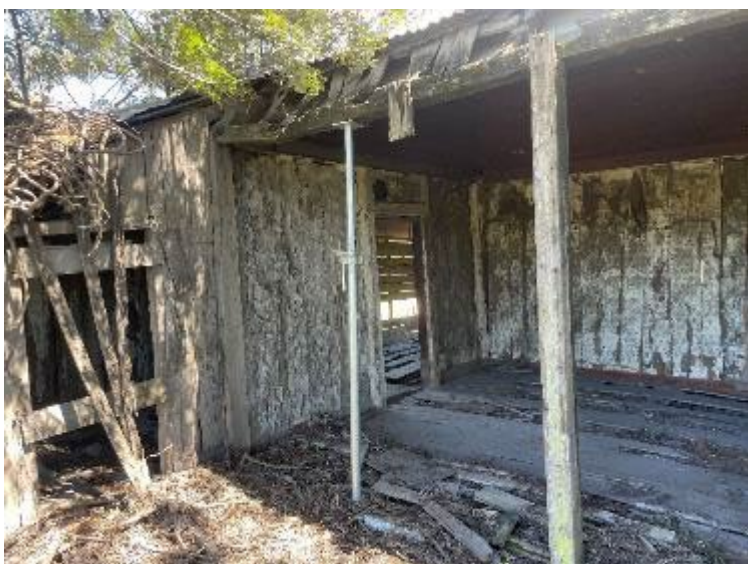
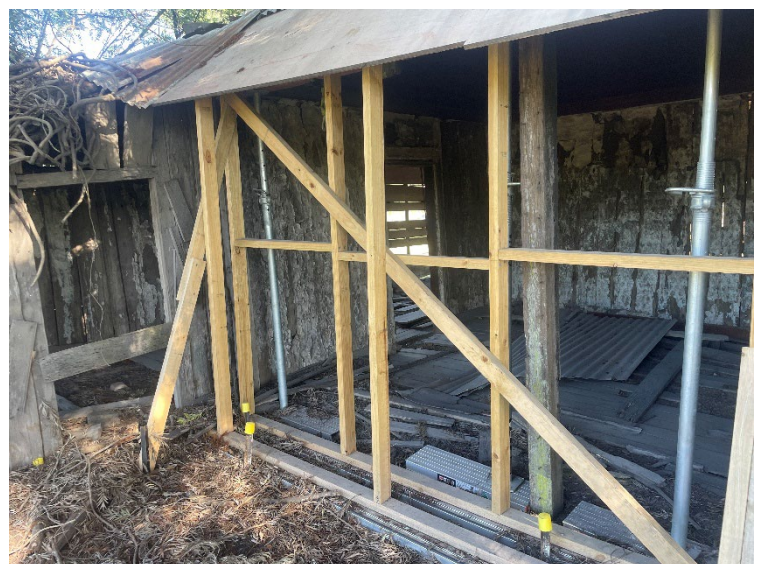
### South-west corner

**2014-8:** shows removal of vertical slabs from southern wall.

**2023-2024:** separation of wall at far left corner (up to 13cm), floor debris cleared and stacked, external missing wall propped.

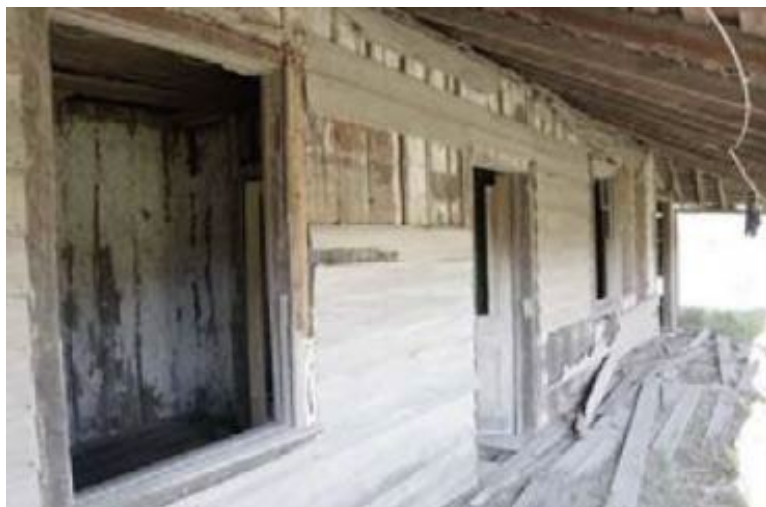
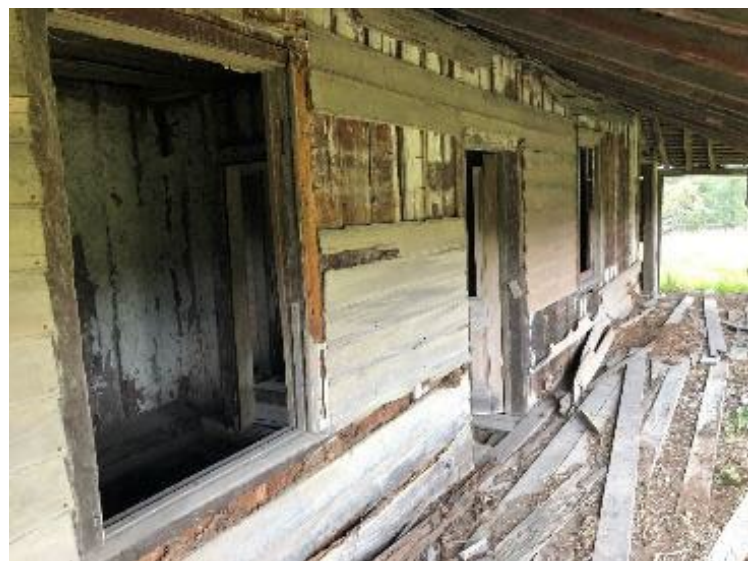
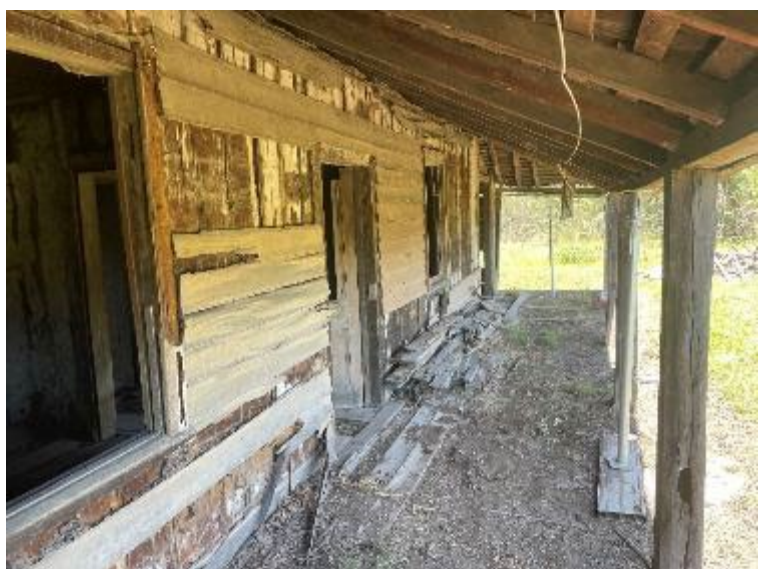
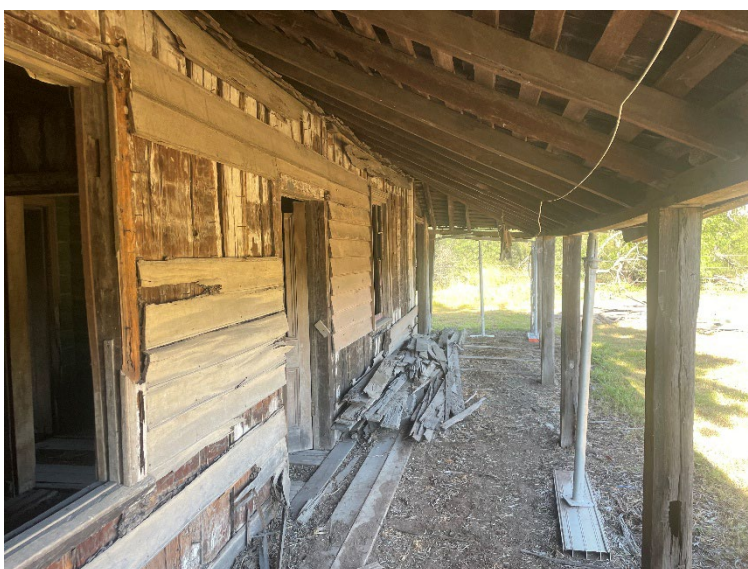
### Northern elevation

**2014-8:** further deterioration of weatherboard panelling.

**2024-2025:** no discernible change.

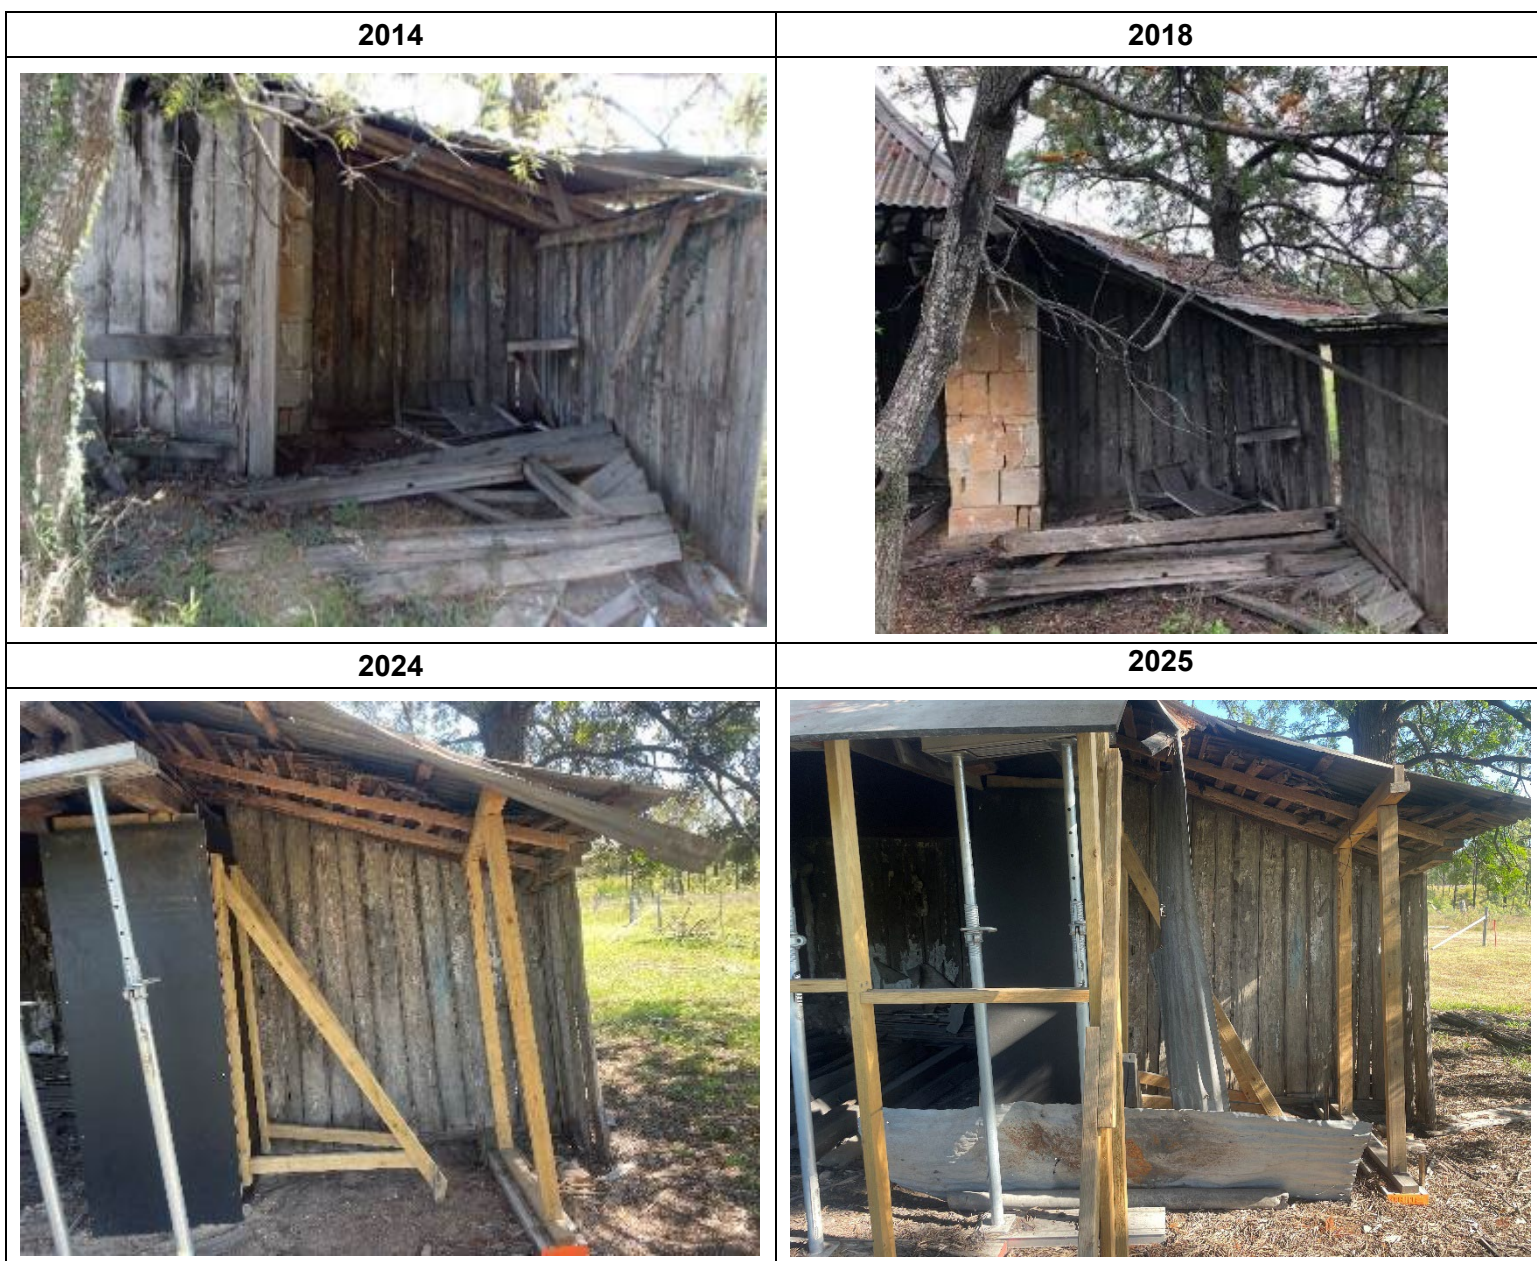
### South-east corner

**2014-8:** shows removal of vertical slabs from southern wall, and some from eastern wall, and further collapse of roof.

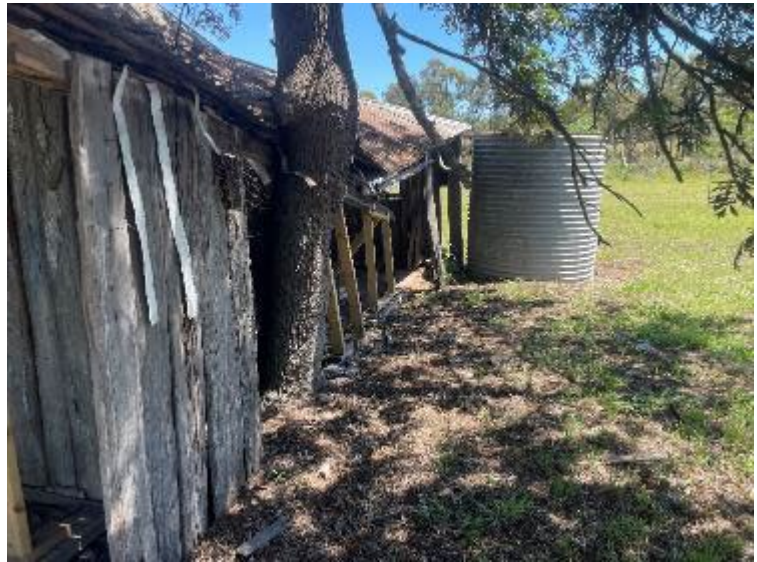
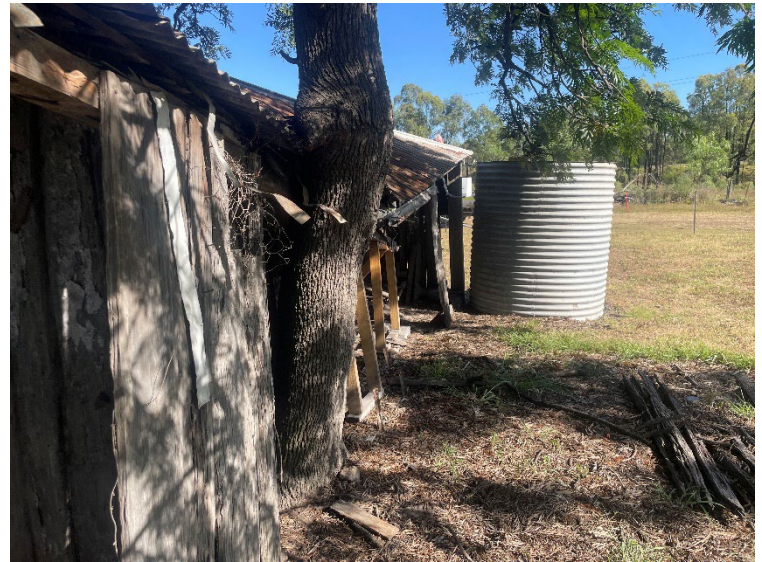
**2014-8:** possible further collapse of crossbeam and guttering.

**2023-2024:** tree has been pruned, broken edge beam strapped and propped.

**2024-2025:** no discernible change.

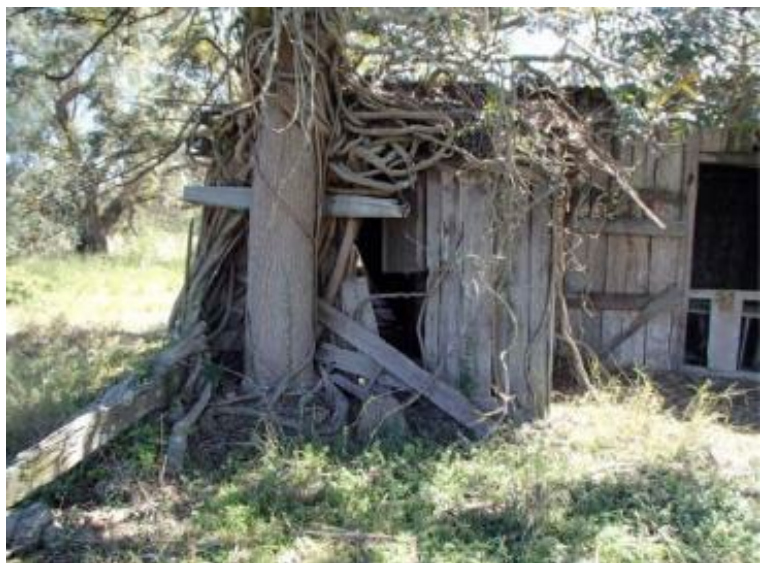
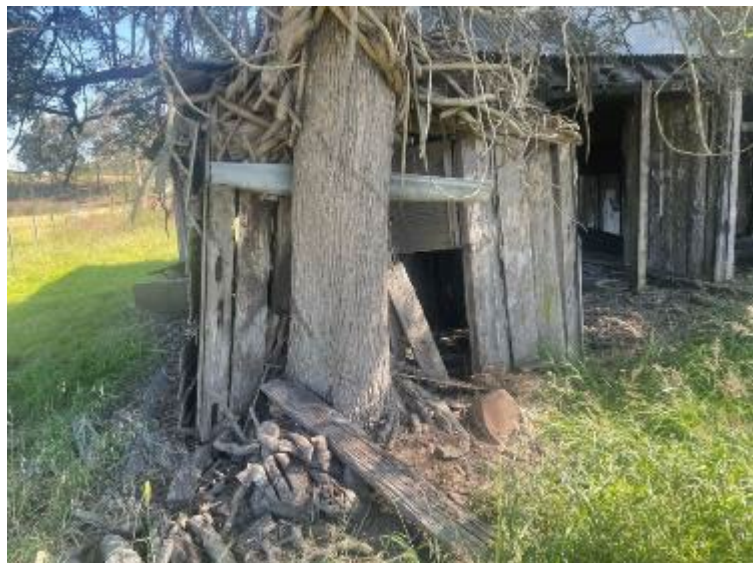
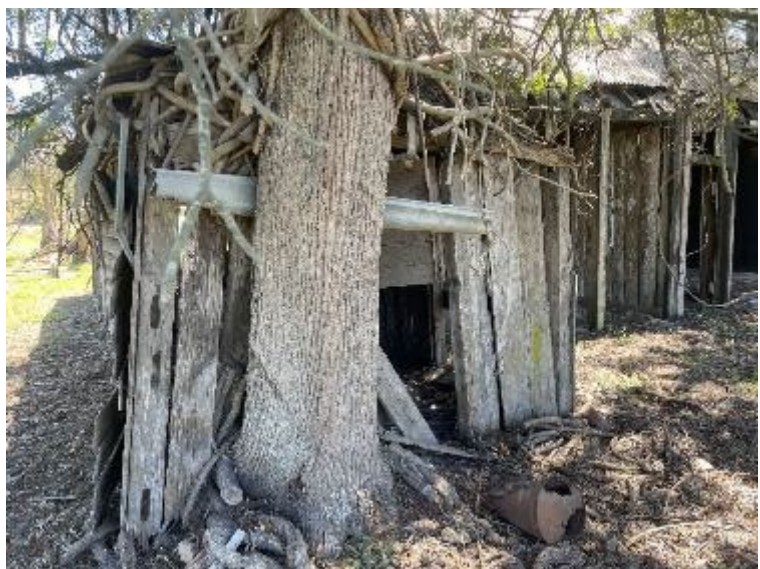
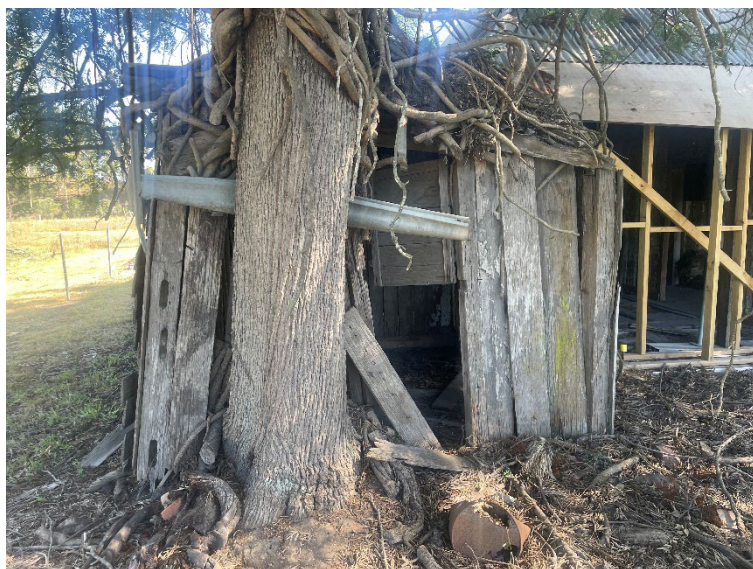
### Northern elevation

2014-8: slumping of veranda along edge beam.

2021-2022: peppercorn has been pruned; termite damage is increased within veranda uprights.

2023-2024: deterioration of third veranda post from right, props installed at centre of veranda and near corner, floor debris cleared and stacked.

2024-2025: strapping at corner loose; some cladding on western wall fallen.

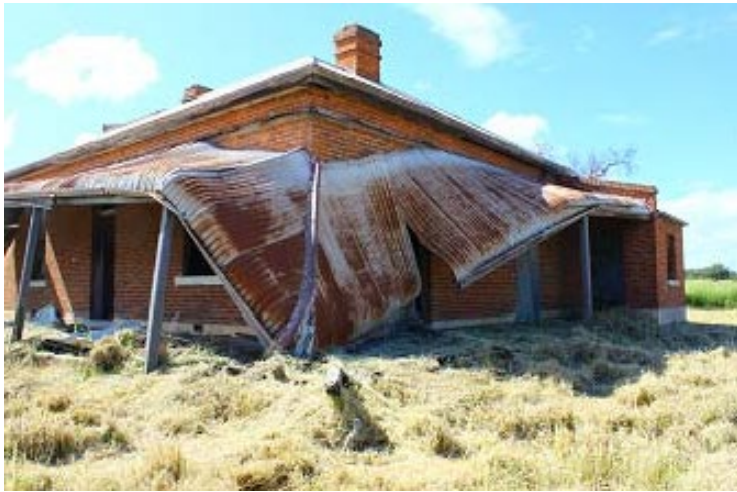
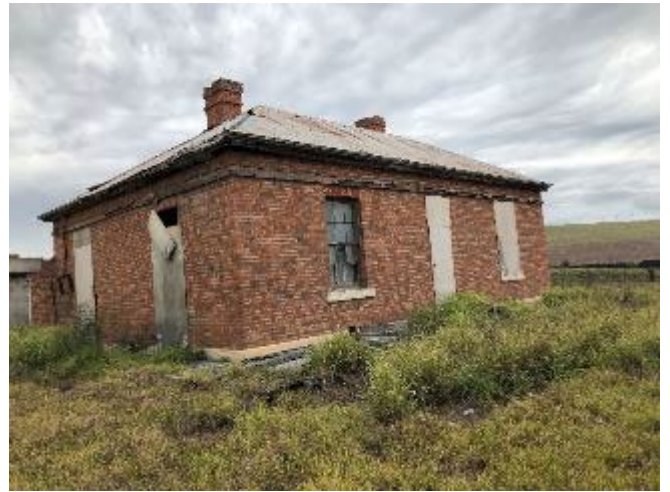
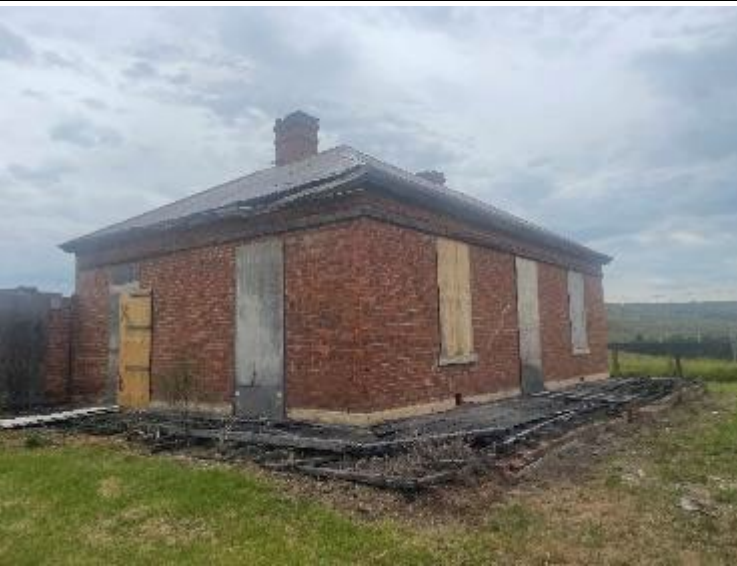
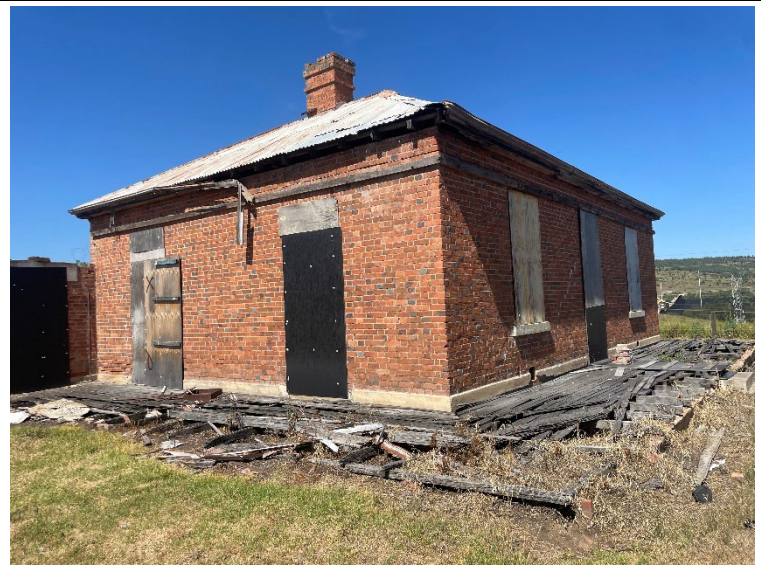
**View of north-west side**

**2015-8:** veranda removed and stored inside building, vegetation has been managed.

**Dec 2020 – 2021:** vegetation requires management and loose boards re-affixing.

**2022-2023:** recently mowed and left door barricading bolstered. Guttering deterioration and lifting of roof tin at near corner.

**2023-2024:** Damaged leftmost door opening repaired, guttering deterioration and lifting of roof tin at near corner

**2024-2025:** remnant guttering, fascia and soffit has collapsed along northern half; veranda boards have deteriorated noticeably. New board across door opening.

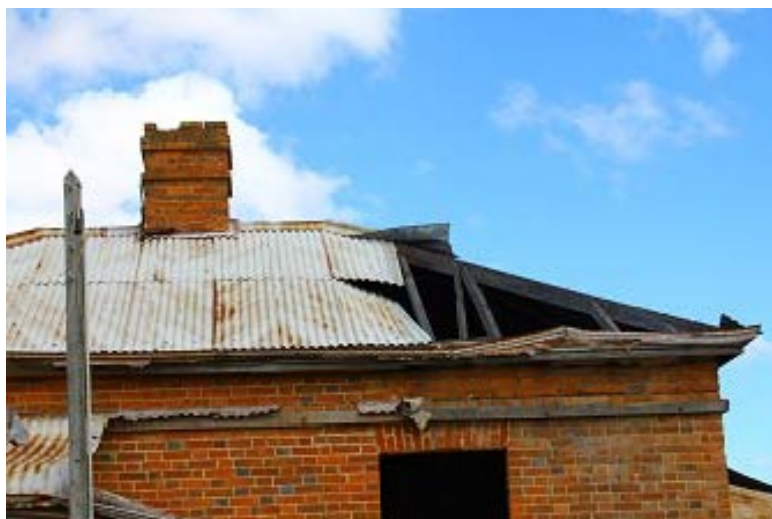
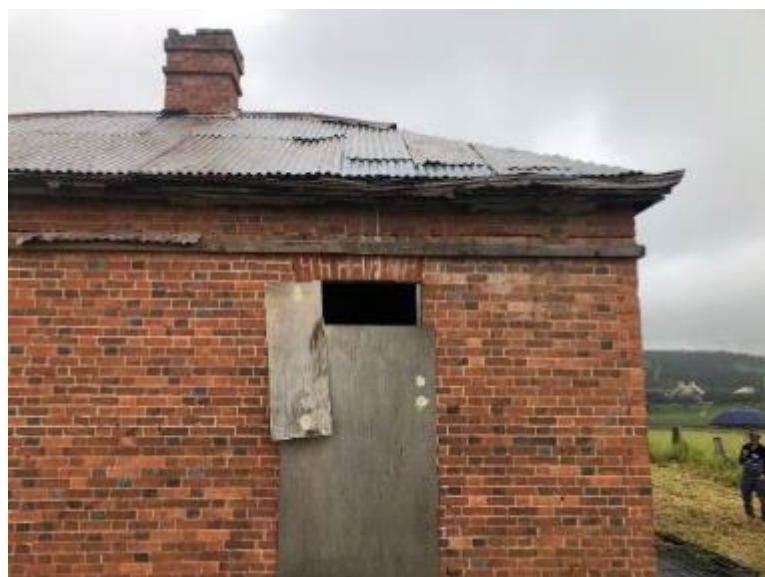
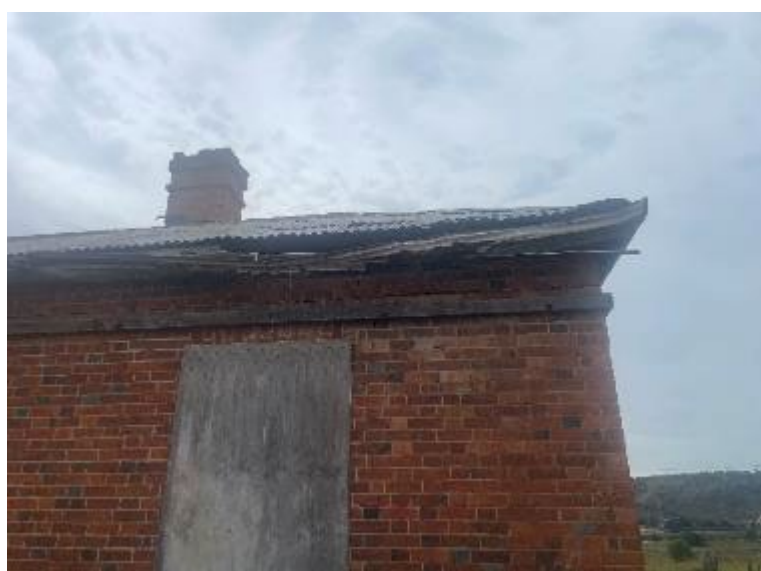
#### View of north-west roof corner (focus on damaged roof)

2015-8: roofing sheets have been replaced and holes patched.

2022-2023: Deterioration of guttering and roof edge.
