# Mount Thorley Warkworth

## 2025 Annual Review

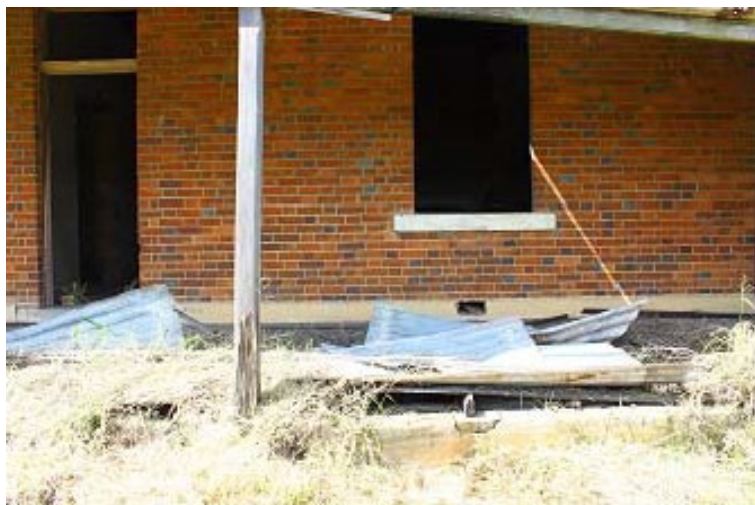
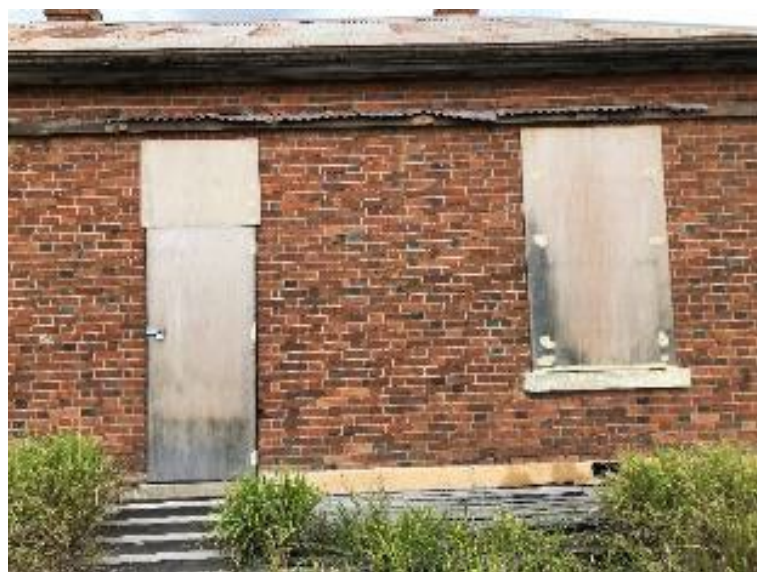
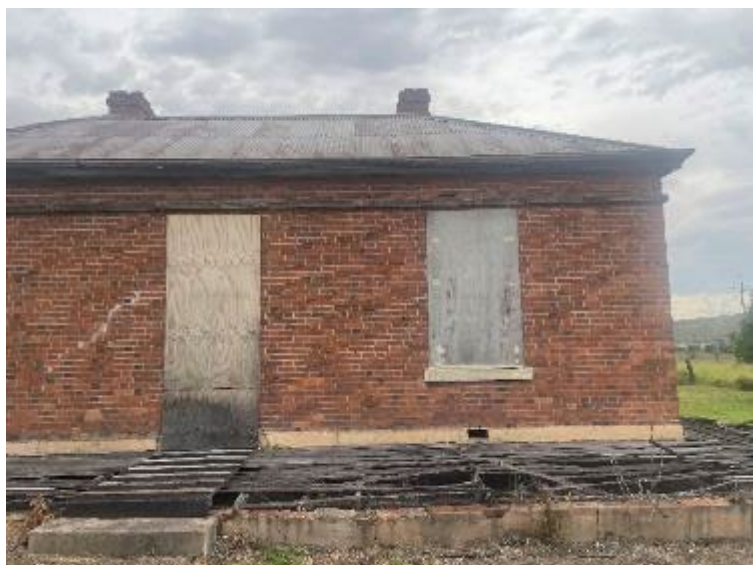
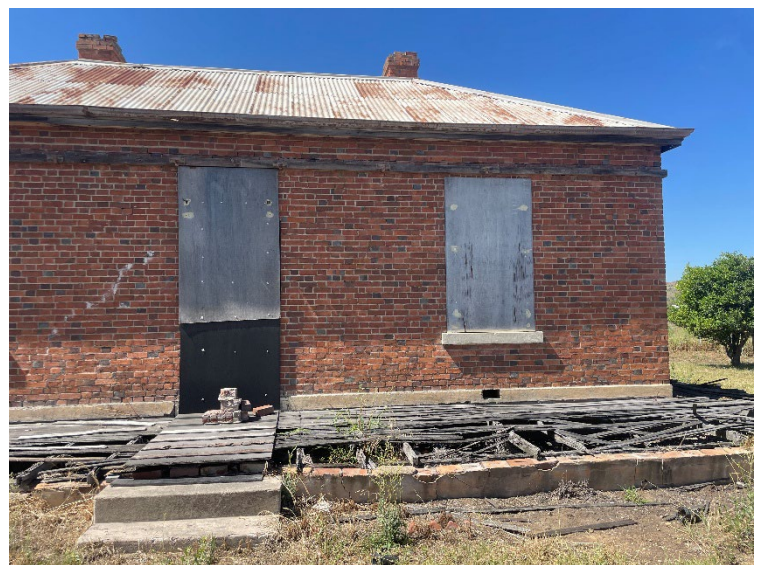
### View of door and window panelling

**2015-8:** sheeting installed on all openings, however some repair required.

**2024-2025:** new board across door; loose veranda dwarf wall bricks stacked on landing.

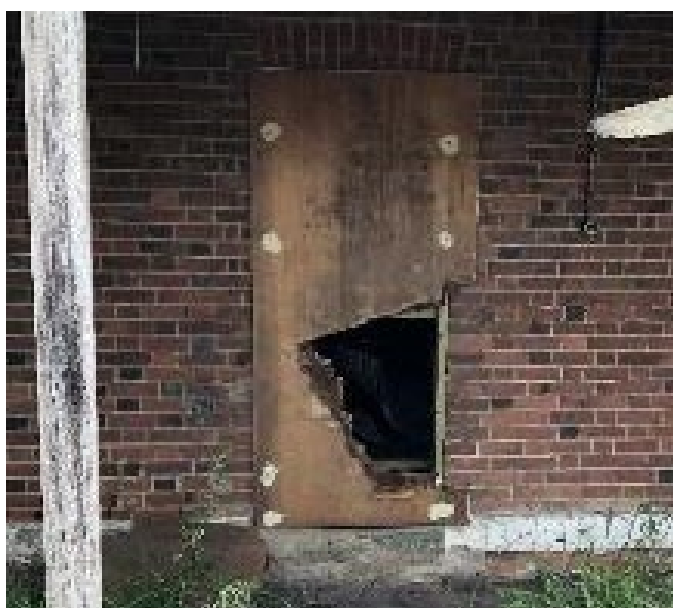
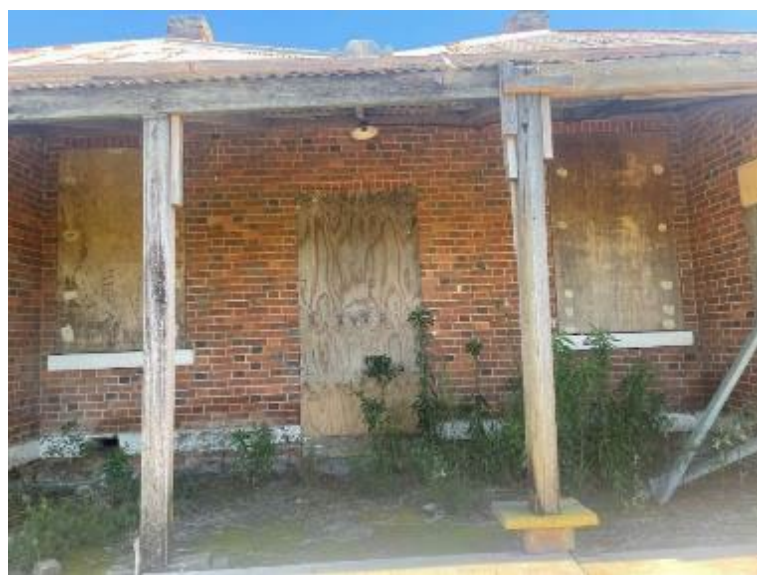
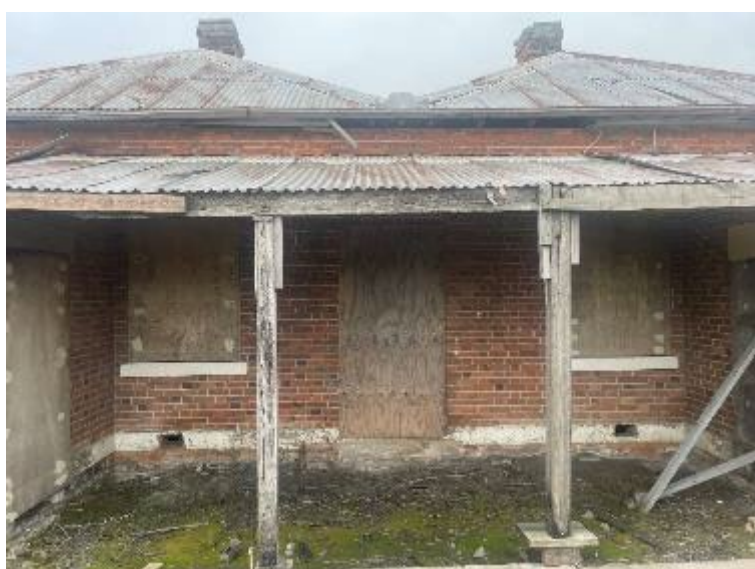
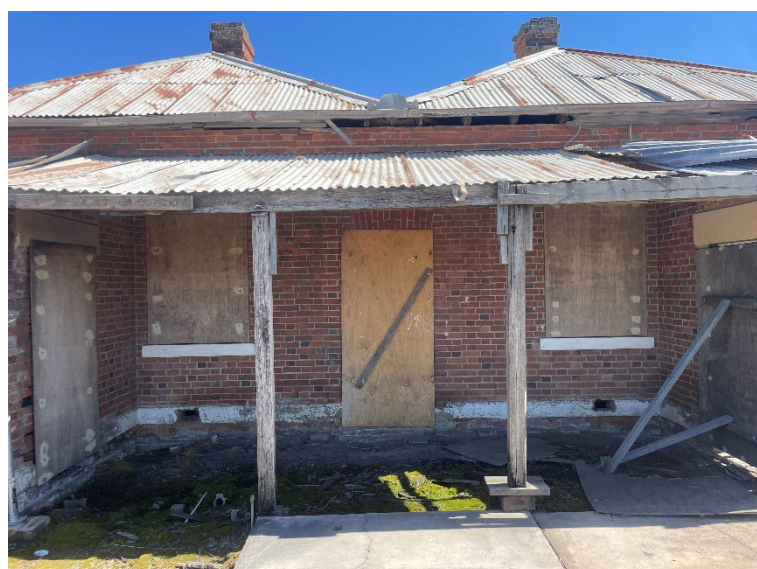
### View of door and window panelling

2015-8: **sheeting installed on all openings**, however some repair required.

2024-2025: **roof sheet lifting. Back door board strengthened.**

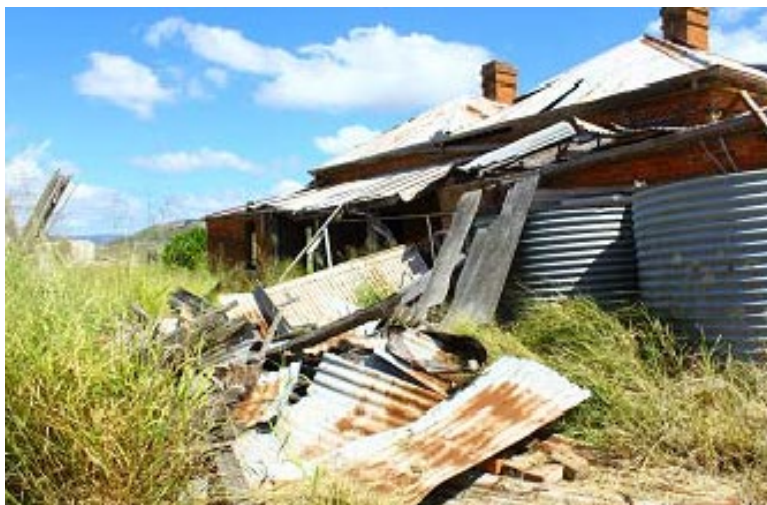
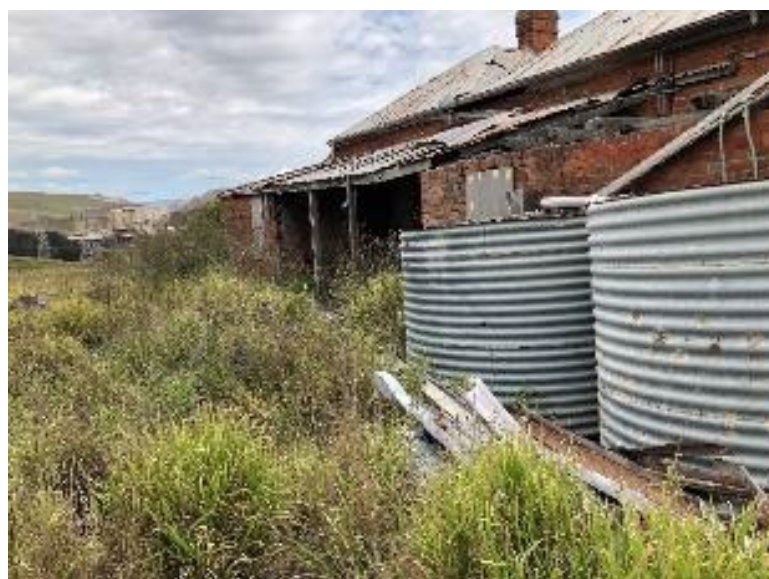
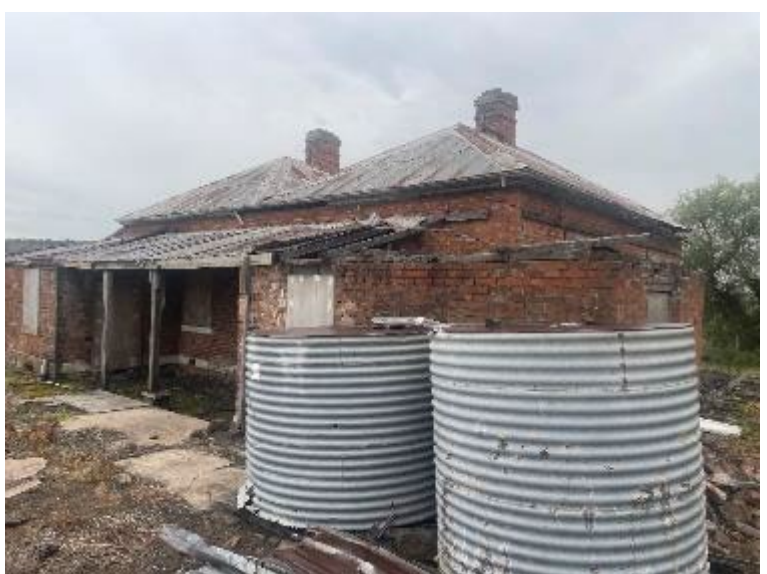
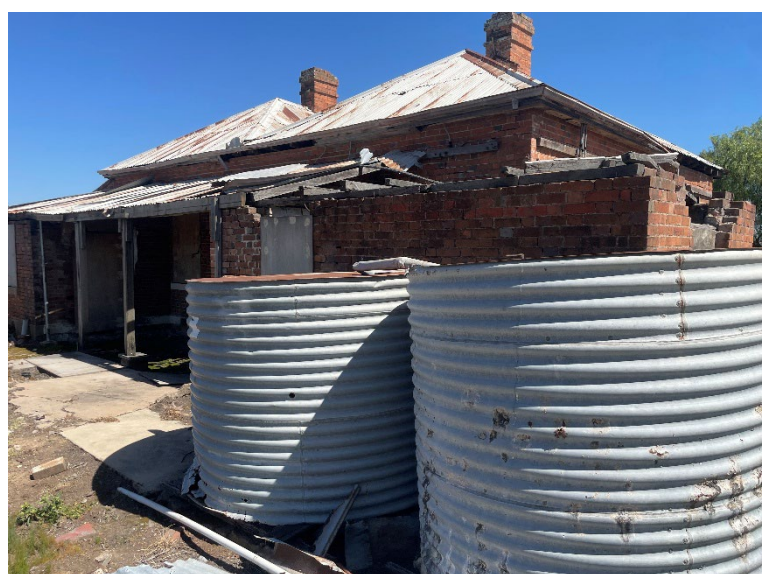
### View of rear of building (view south)

**2015-8:** debris has been cleared and stacked.

**2024-2025:** no discernible change.

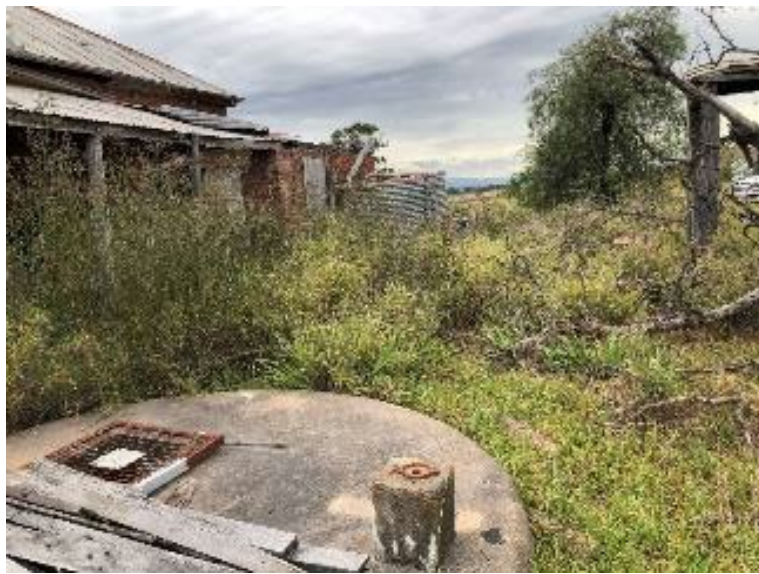
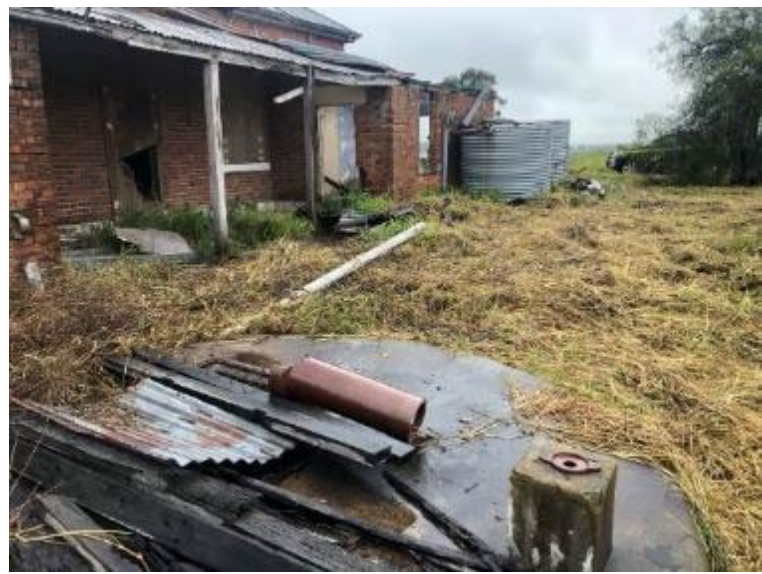
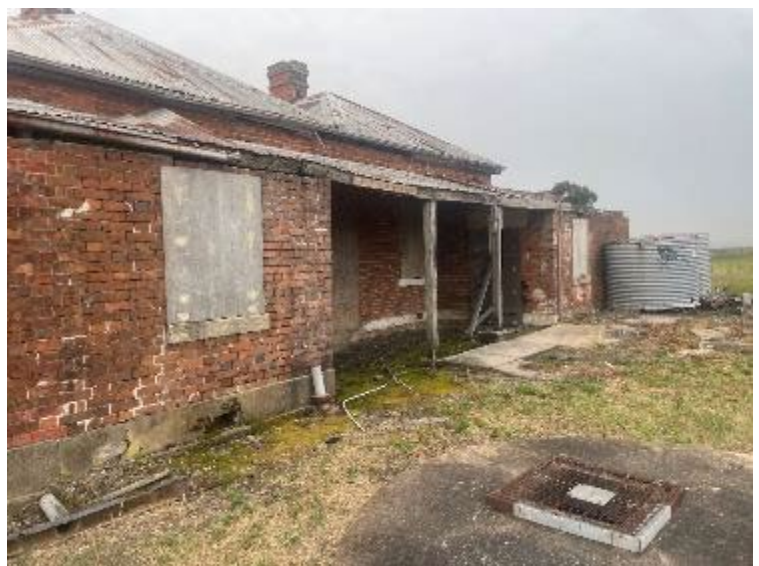
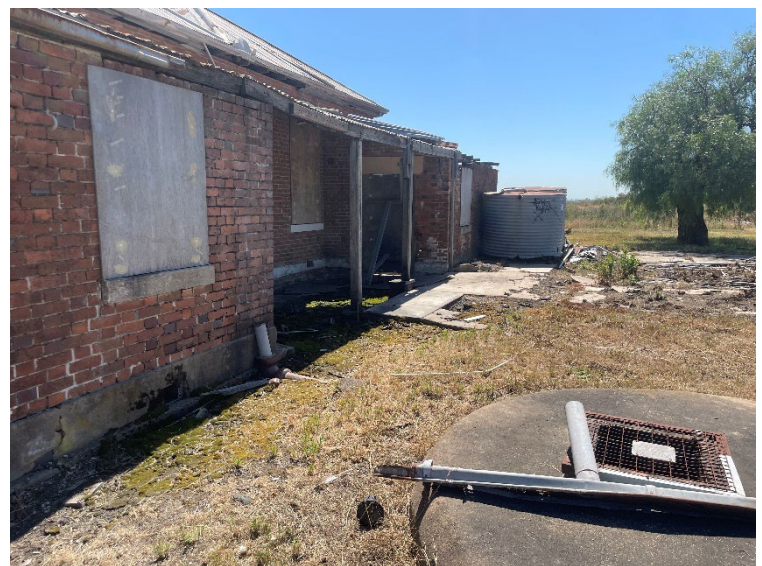
### View of rear of building (view north)

**2015-8:** debris has been cleared and stacked.

**2024-2025:** fallen gutter and down pipe moved to cistern.

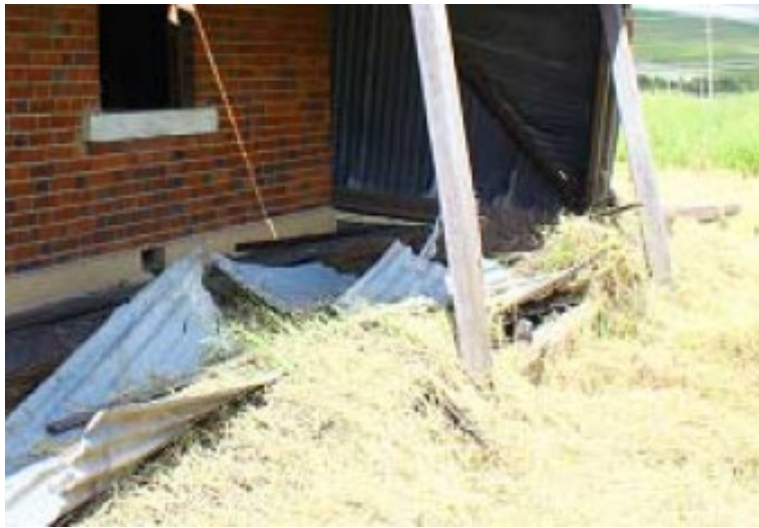
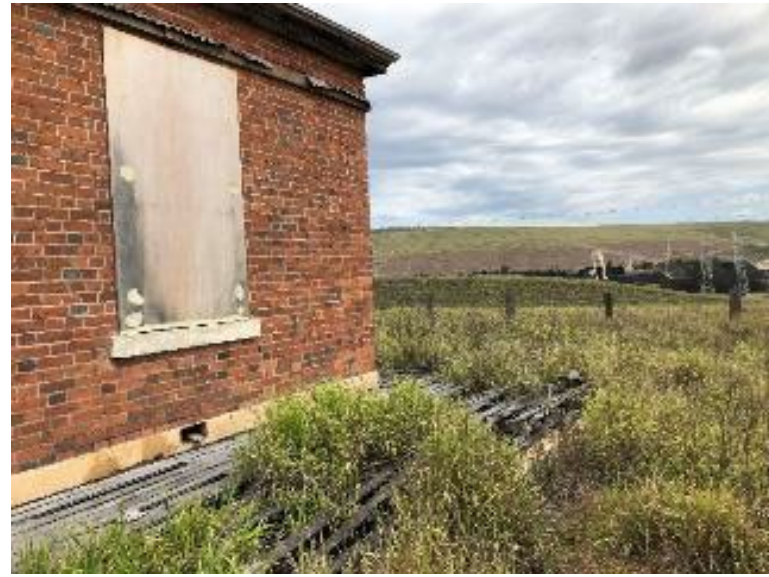
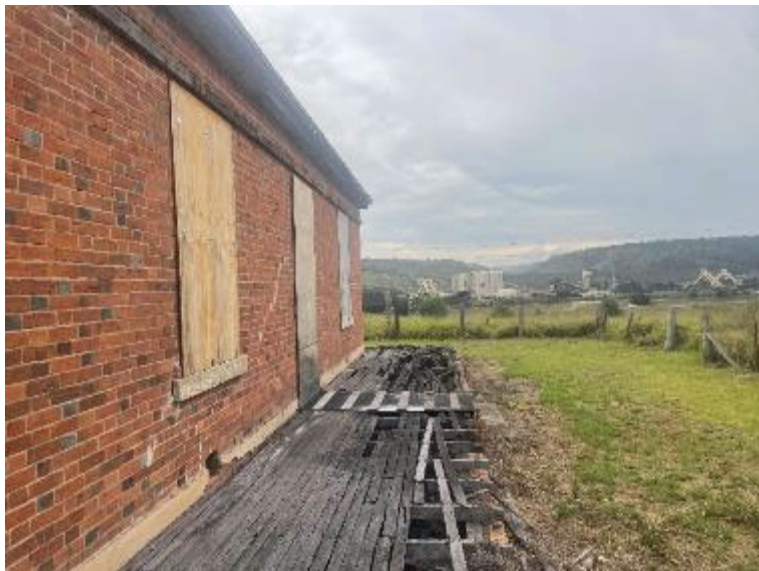
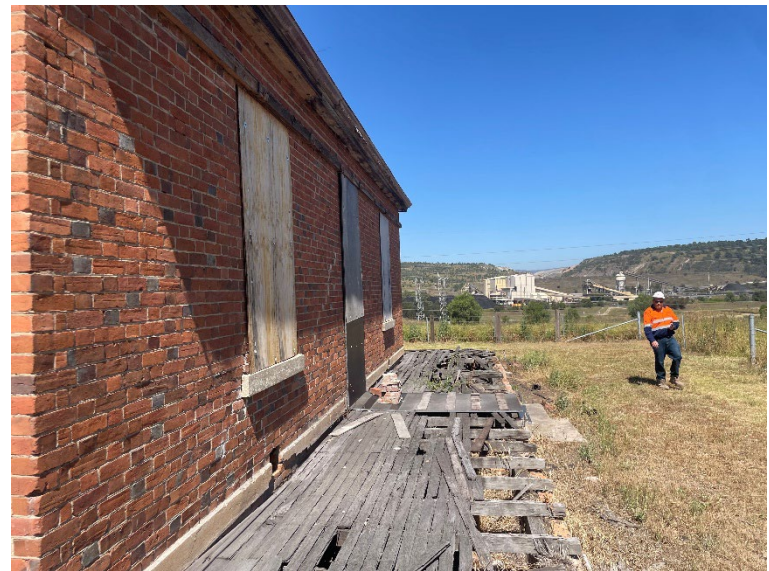
#### View of eastern veranda (focus on veranda floor)

**2015-8:** posts and sheeting removed, damaged boards remain exposed.

**2024-2025:** deterioration and movement of veranda boards.

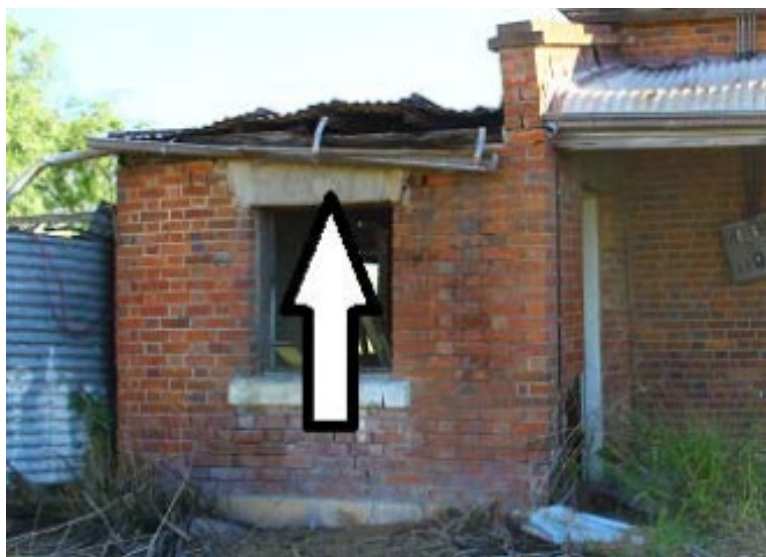
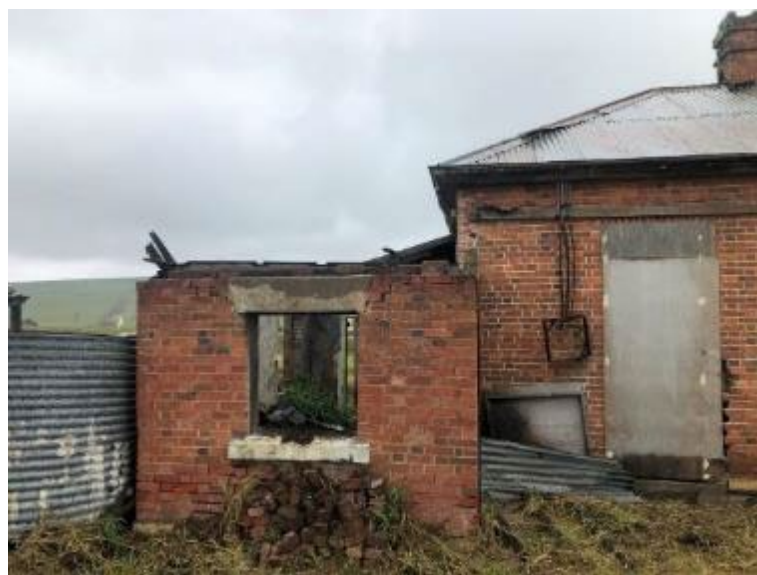
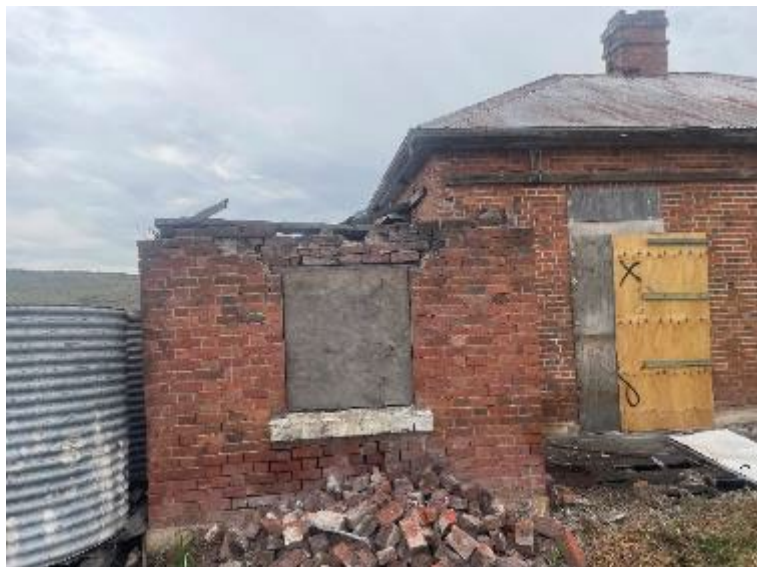
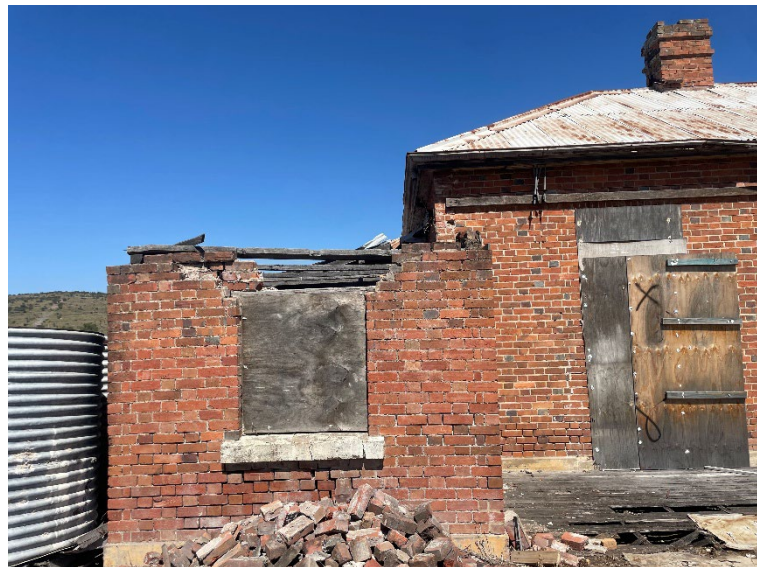
#### View of rear of building (focus on roof)

**2015-8:** skillion roof, guttering and rafters have collapsed; **main roof holes repaired.**

**Mar 2020-Dec 2020:** some minor holes in roofing require repair.

**2021-2022:** **veranda uprights propped, loose members tidied; roofing appears patched.**

**2024-2025:** **lifted roofing sheets. Prop installed under skillion roof edge.**

4. As the roof above Room 6 has collapsed, salvage any reusable masonry or timber and set aside within room. Engage a structural engineer to advise on feasibility of reconstructing the masonry and the roof. (NB. Recommendation M9 in the CMP conservation works schedule erroneously refers to this room as Room 5 rather than Room 6 as shown in the floor plan);

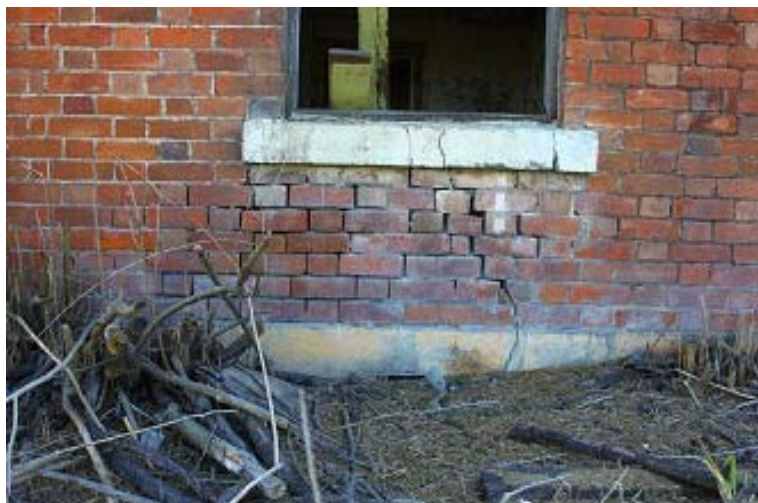
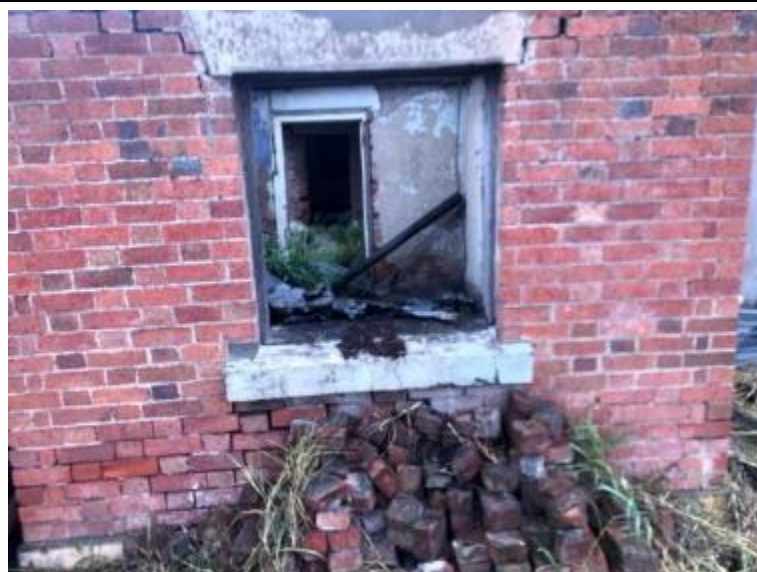
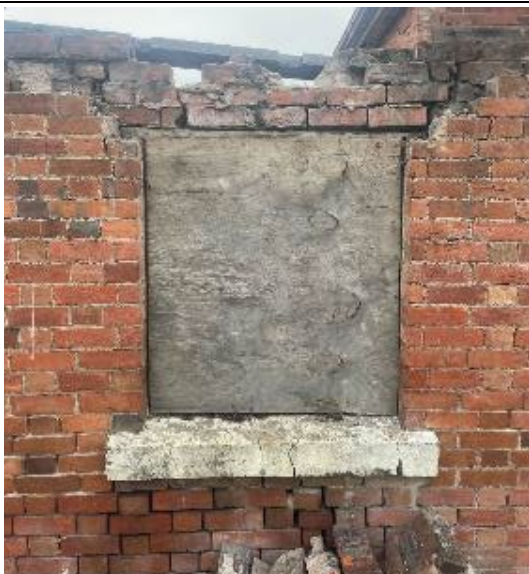
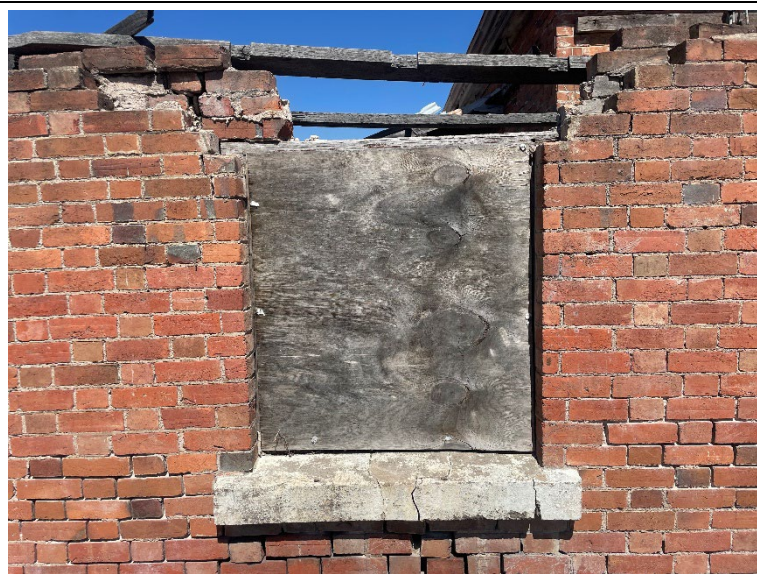
### View of north-east of building

**2015-8:** wall element has collapsed (bricks stacked under window); roof framing, sheeting and guttering has collapsed.

**2021-2022:** redundant electrical box fallen; increased vandal activity at doorway; roof capping repaired; redundant panel can be removed.

**2022-2023:** window opening cover replaced and door panel repaired.

**2024-2025:** lintel bricks collapsed and fallen.

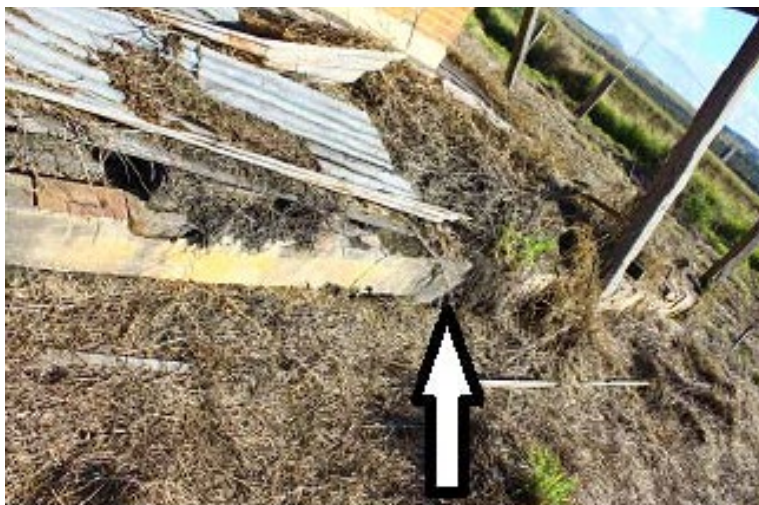
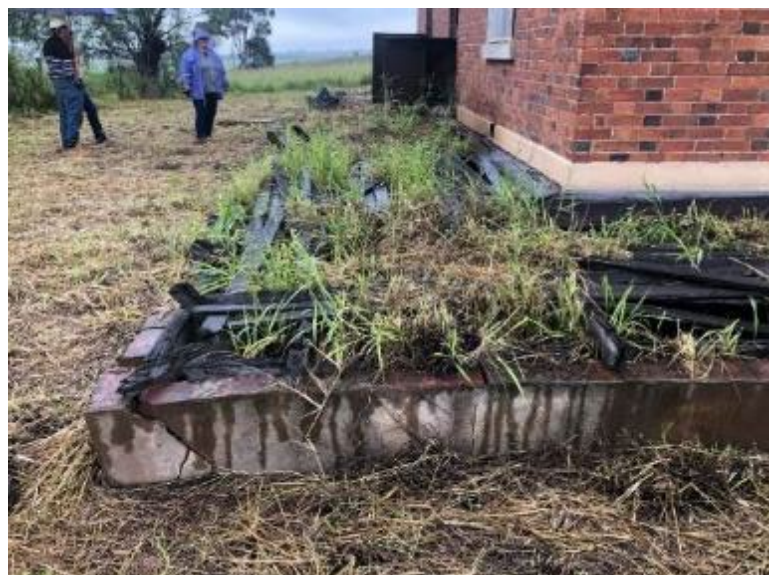
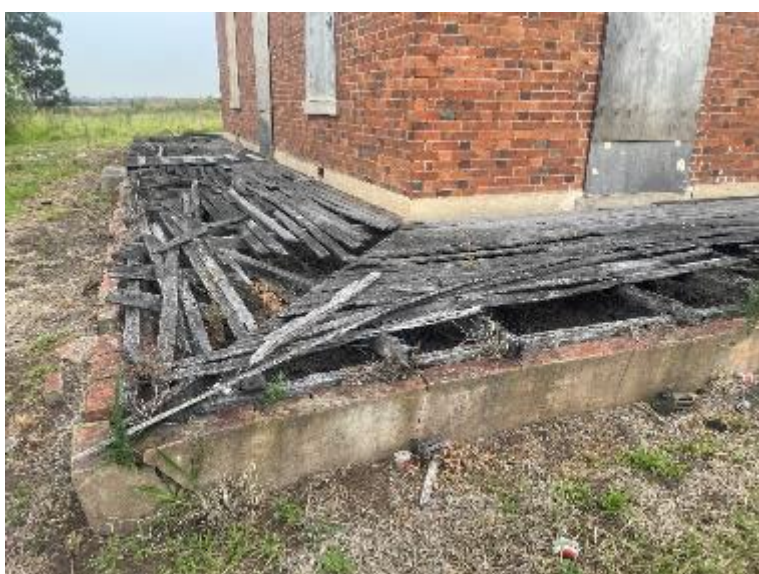
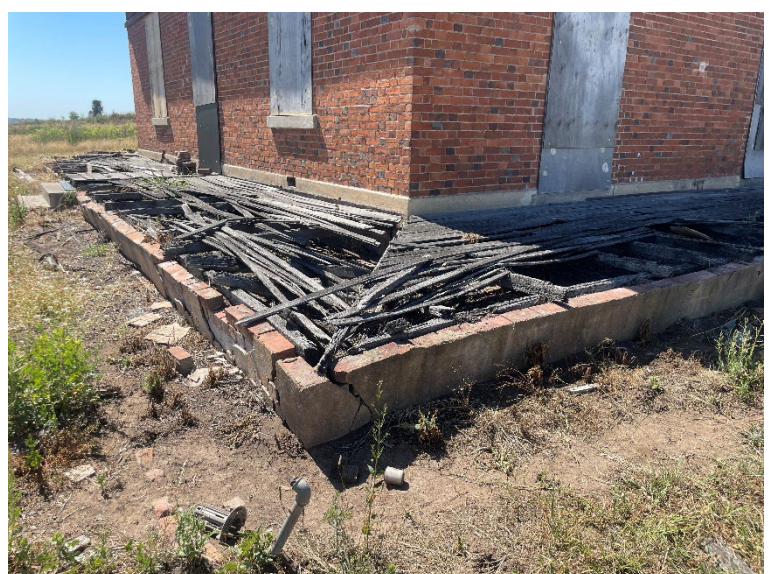
**View of south-east of building (focus on top of wall)**

**2015-8:** repointing requirements remain.

**2021-2022:** repointing and fascia repair requirements remain; white paint or similar has been daubed on wall.

**2022-2023:** brick fallen from chimney, some bowing to top of wall at veranda's end, repointing and fascia repair requirements remain.

**2023-2024:** brick fallen from chimney, bowing to top of wall at veranda's end with brick missing also, repointing and fascia repair requirements remain.

**2024-2025:** repointing and fascia/soffit repair requirements remain.

5. Repair fascias and soffits, and replace gutters around the house to match existing materials and ogee profile. Install new down-pipes and ensure they are discharging away from the building – particularly away from eastern back veranda;

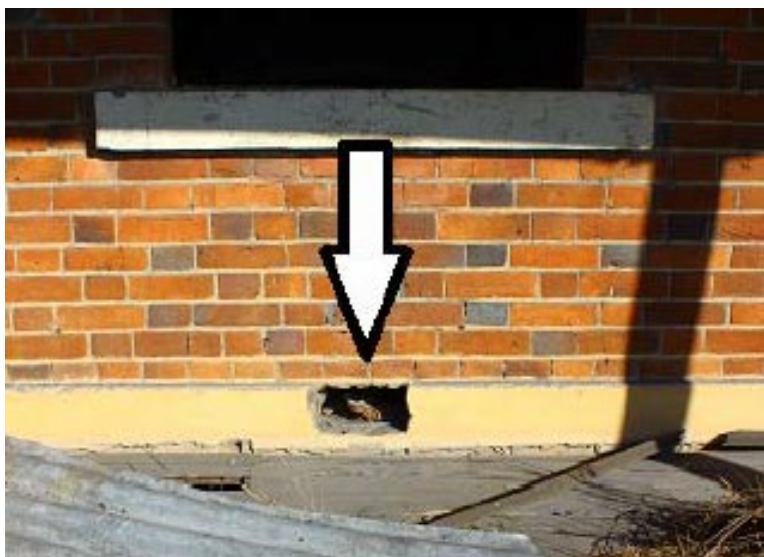
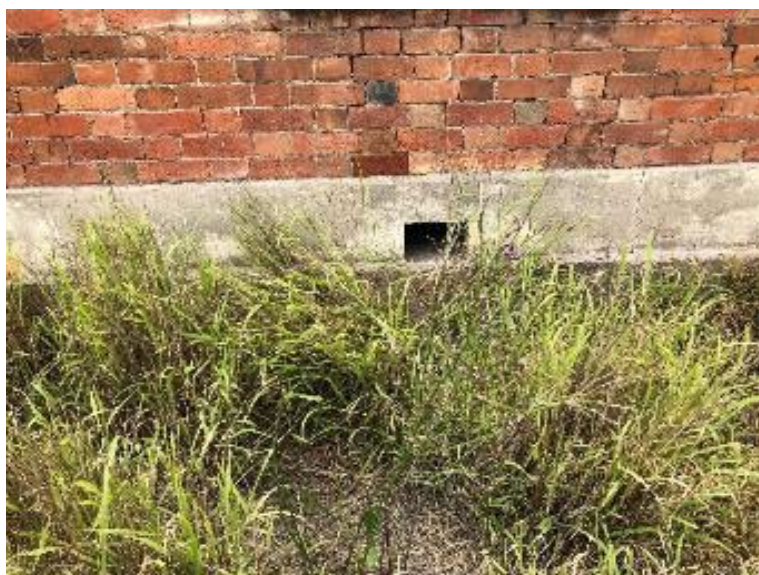
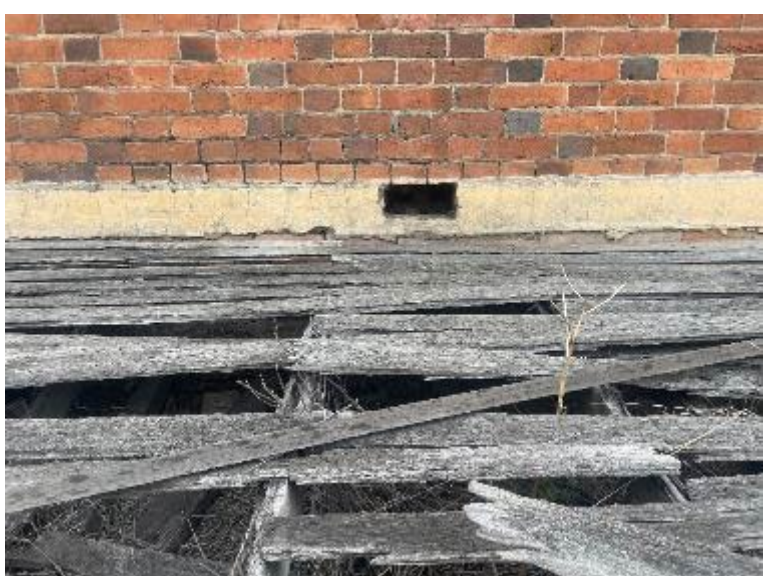
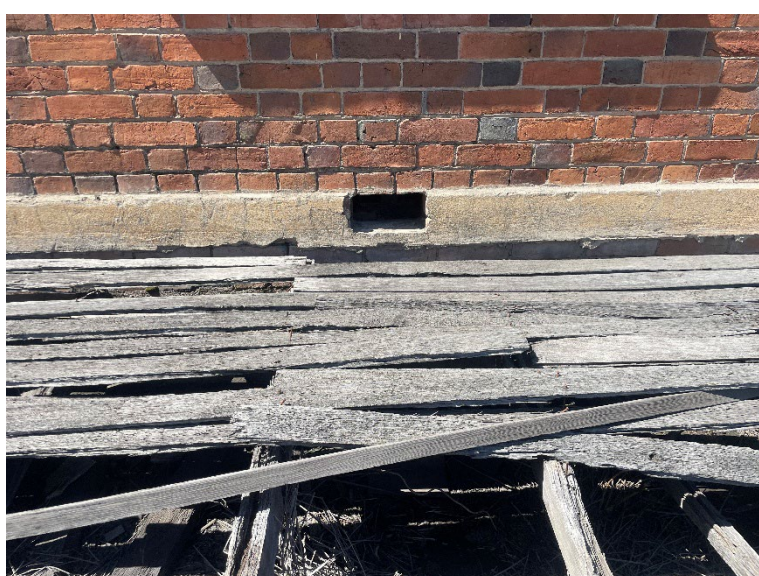
### View of eastern veranda (focus on dwarf wall wall)

2015-8: debris cleared from veranda, no change to dwarf wall.

Mar 2020-Dec 2020: cracking to wall evident.

2024-2025: veranda boards and dwarf wall noticeably deteriorated.

3. Reinstall veranda, including veranda decking and brick dwarf wall, re-using original material where possible, as per recommendations M5, M6 and L1 in the CMP conservation works schedule;

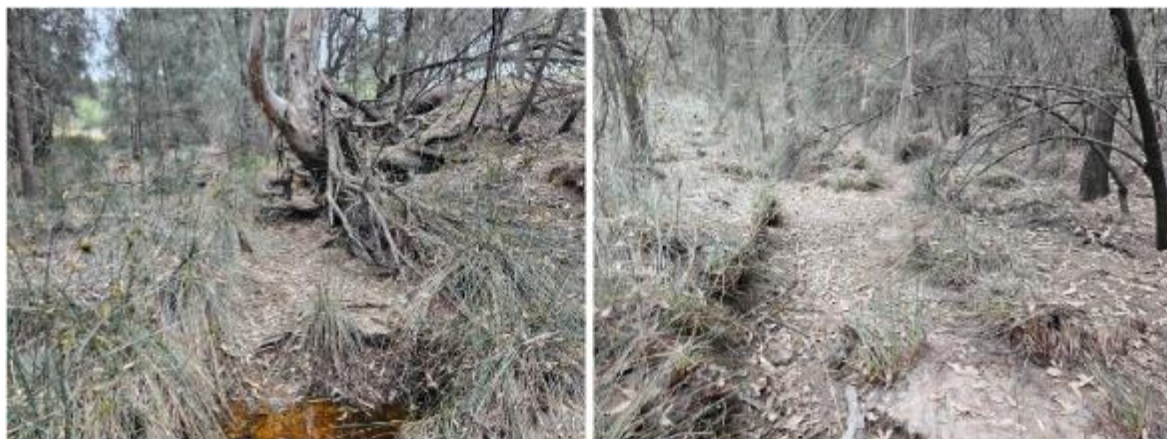
New monitoring site MTW LDP2 is located in the upper reaches of Loder creek, contained within a narrow section of drainage channel with mostly shallow sloped banks and a localised incision of the channel basin (**Figures 3 and 4**). There was very little surface water present with pooled water observed and with no surface flow through the site.

**Figure 3:** Looking upstream (left) and downstream (right) at Loder Creek site MTW LDP2.

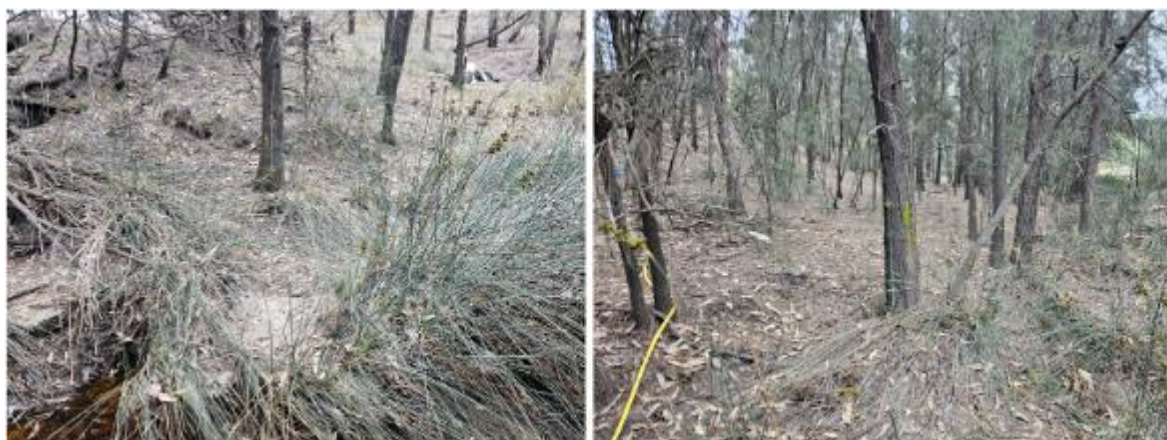
Most historical erosion features and potential sediment sources remained unchanged and appeared to be in a stabilising state. The most prominent feature, a large fallen eucalypt with an exposed root ball, continued to represent a potential sediment source; however, no new erosion, undercutting or destabilisation was evident, and accumulated canopy detritus covered sediments around the exposed roots. Minor localised erosion features were present within the Loder Creek channel bed which were generally less than 30-40 cm in height, and while stable at the time of survey, may deteriorate under sustained higher flow conditions. Exposed soils on the gently sloping northern bank continued to represent a potential sediment source, although the low gradient limits the likelihood of substantial sediment contribution to the channel.

**Figure 4:** Site MTW LDP2 left bank (left) and right bank (right).

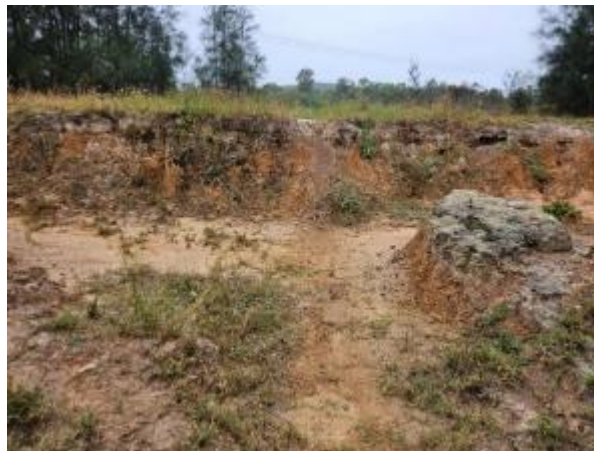
The exposed erosion scar along the upper southern (right hand) bank (**Figure 7**) is unchanged but continues to act as a source of active erosion. Along with animal tracks dissecting the site, this feature contributes fine sediment inputs to the creek line. The extent of settled colluvial sediments at the base of the channel valley walls and colonisation by couch grass noted in previous reports remained unchanged in 2025.

**Figure 7:** Erosion scar along the upper right-hand bank.

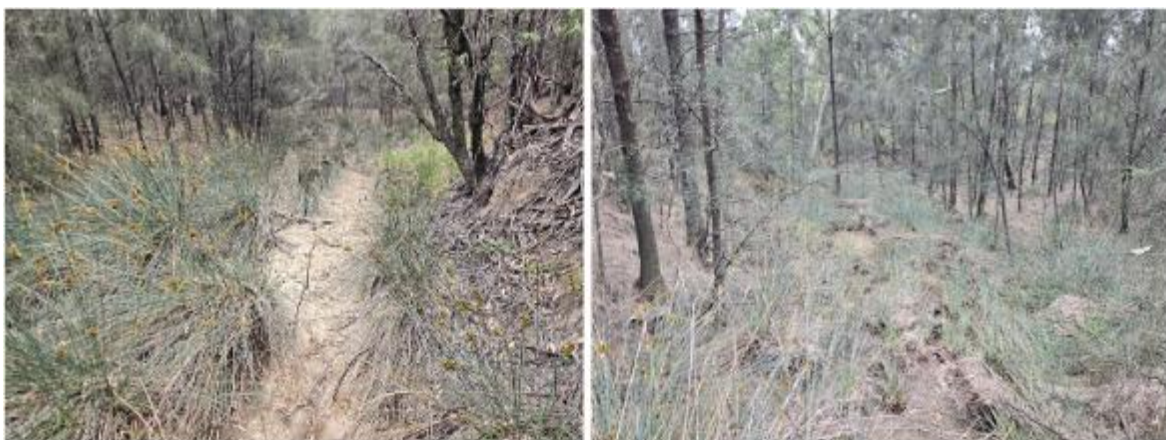
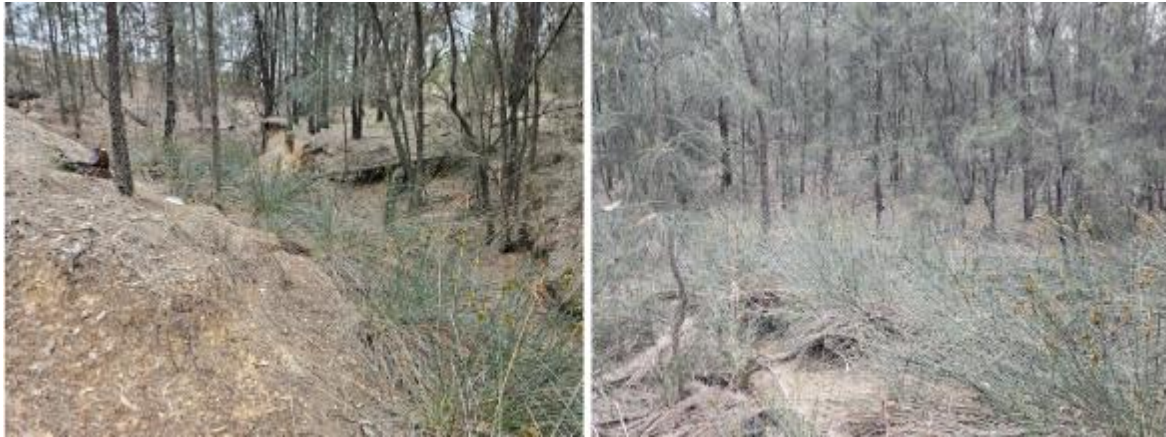
Loder Creek site is situated in a narrow section of drainage channel with moderately steep banks along both sides of the drainage channel (**Figures 17 and 18**). A small tributary drainage swale that enters the channel from the left-hand bank (north) contains some localised erosive features (gully erosion and bank undercutting), however the catchment area for the swale is small. No surface water was present within the site at the time of the survey, however dried mats of filamentous green alga in the upstream sections indicated that water had been present until recently.

The channel basin remained dominated by spiny rush, with no noticeable change in its distribution or abundance. The condition of the swamp-oak riparian corridor was largely unchanged for the 2025 survey. The coverage of the swamp-oak needle layer on the banks had increased since 2024, providing near complete ground coverage, and despite this, small patches of couch grass had showed signs of expansion along the right-hand bank. Weed occupation was very sparse, and a single prickly pear (*Opuntia sp.*) had colonised the site. Active sediment contribution to the channel basin remained negligible. Animal tracks and minor exposed banks continued to be the only notable areas of exposed soil, with the remainder covered by a dense layer of swamp-oak needles.

**Figure 17:** Site LC3 looking upstream (left) and looking downstream (right).

**Figure 18:** Site LC3 left hand bank (left) and right-hand bank (right).

The increased coverage provided swamp-oak needles since the previous survey led to a reassessment of the channel banks, resulting in the ‘Nature of lateral flow regulation into drainage line’ being reclassified to a ‘moderate flow rate’ contribution. This adjustment subsequently increased the LC3 site CSIRO ESA classification from *Very Active* to *Active*.

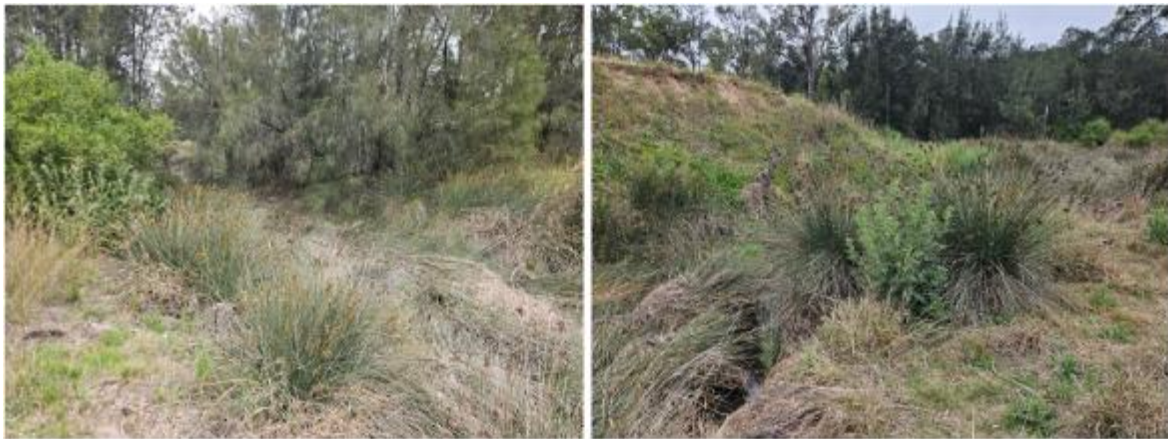
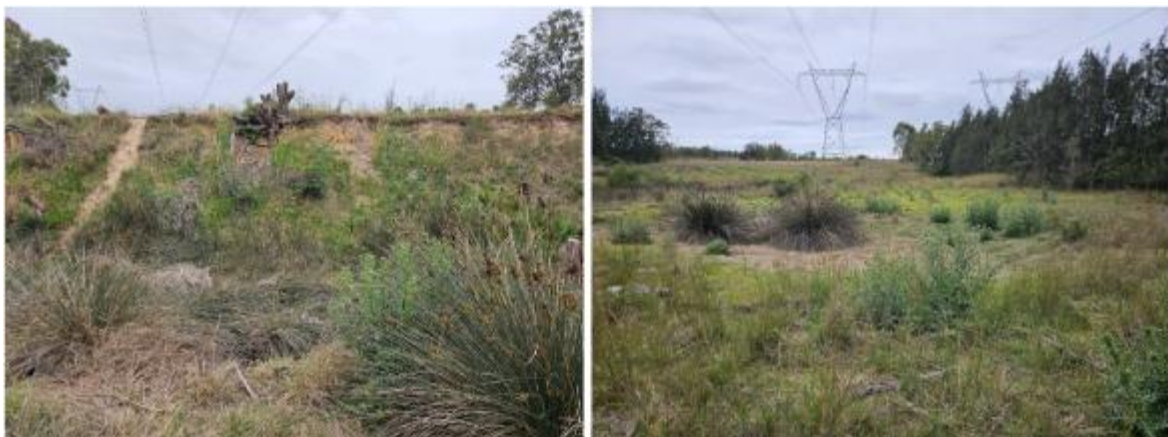
The LC4 site channel is relatively broad and flat-bottomed with a localised break in the riparian canopy corridor due to the powerline easement (**Figures 19 and 20**). The drainage channel is bordered by a near vertical, stepped bank along the left-hand side and shallow sloped bank along the right-hand side (**Figure 20**). There was no surface water observed throughout the site length for the 2025 survey.

Within the main channel, moderate accumulations of detritus (primarily spiny rush) were recorded, while the dense occupation of the channel bed by spiny rush likely stabilises (to some extent) new areas of erosion. A juvenile cumbungi plant was noted along the channel margins (**Figure 21**).

Riparian vegetation showed strong growth and vigour, maintaining a healthy and thriving conditions throughout the site. Pre-existing erosion features along the upper left bank remained stable, with compacted sands continuing to be the dominant exposed sediment type. There was no evidence of increased sediment loss from historical scars or any significant contribution of fine material to the channel bed. A small, recently formed erosion scar was observed along the left bank, contributing a minor amount of sediment (**Figure 21**).

**Figure 19:** Site LC4 looking upstream (left) and looking downstream (right).

**Figure 20:** Site LC4 left bank (left) and right bank (right).

Site conditions were consistent with those observed in 2024, and the CSIRO ESA classification for LC4 remained as *Potentially Stabilising*.

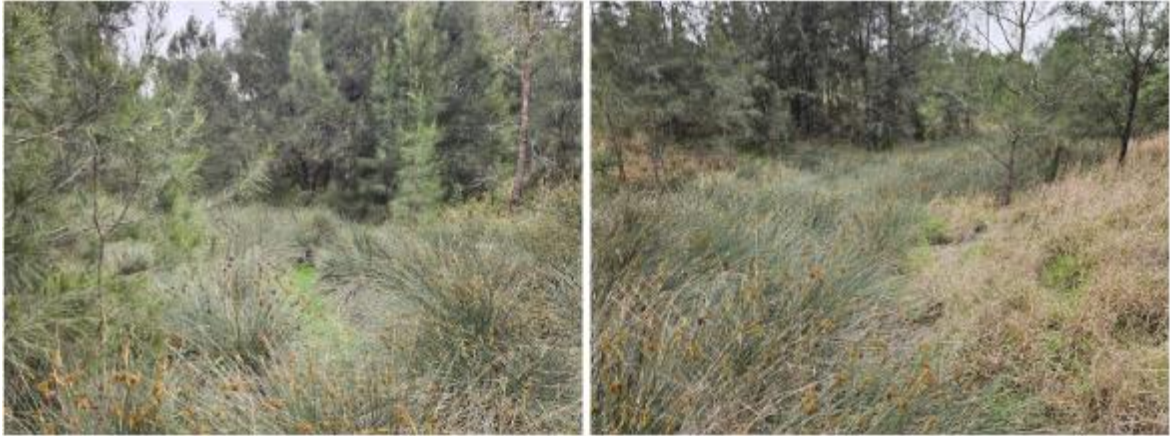
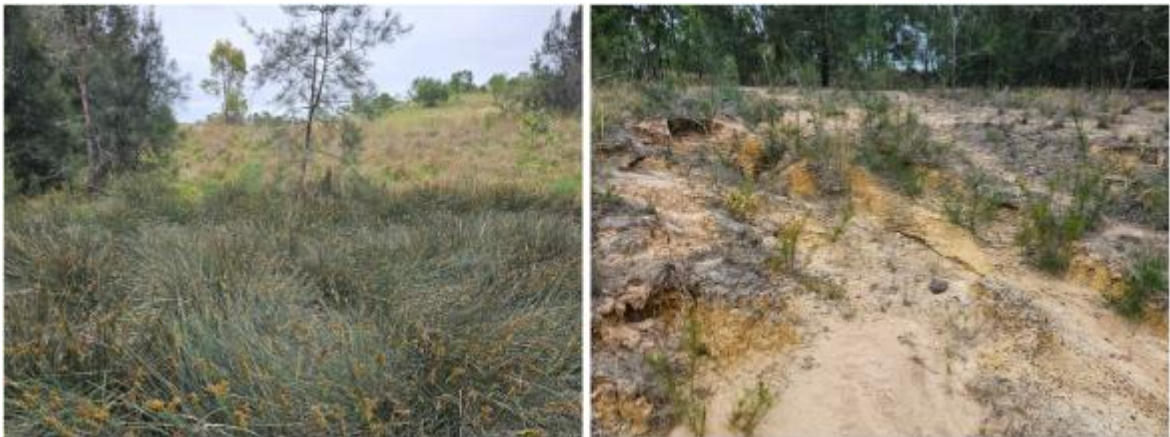
The channel basin at LC5 comprises a V-shaped channel with mostly shallow sloped banks. The riparian corridor remained somewhat fragmented but was bordered upstream by a dense, continuous stand of swamp-oak. Despite this fragmentation, the understory and groundcover vegetation were well established and densely vegetated, providing strong structural complexity and habitat continuity throughout the site (**Figures 22 and 23**).

**Figure 22:** Looking upstream (left) and downstream (right) at LC5.

**Figure 23:** Site LC5 left bank (left) and erosion scar (right).

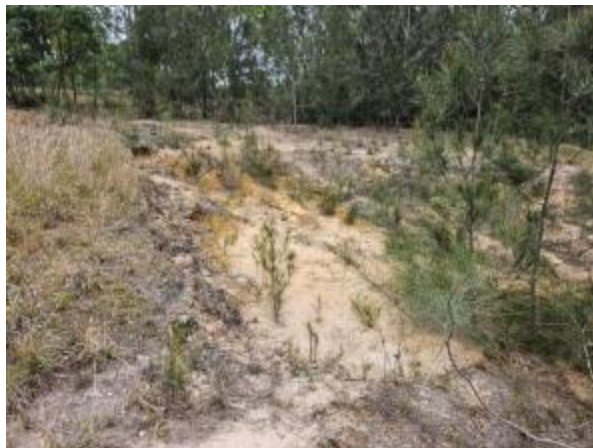
There was no surface water was present at LC5 for the 2025 survey. Evidence of a high flow event included accumulated spiny rush detrital deposits along the channel bank edges. Site channel and vegetation conditions remained largely consistent with previous assessments with dense spiny rush occurring throughout the length. Erosion scars noted in earlier surveys continued to act as minor sources of sediment input, although there was evidence of casuarina saplings establishing and slowly expanding within some of these eroded zones (**Figure 24**).

**Figure 24:** Site LC5 erosion scars with a proliferation of swamp-oak saplings.
