# Mount Thorley Warkworth

## 2025 Annual Review

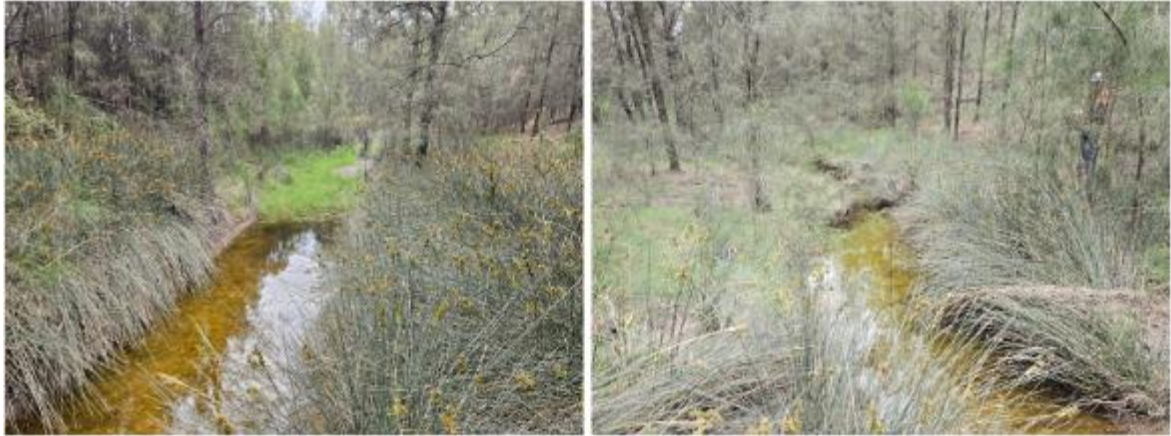
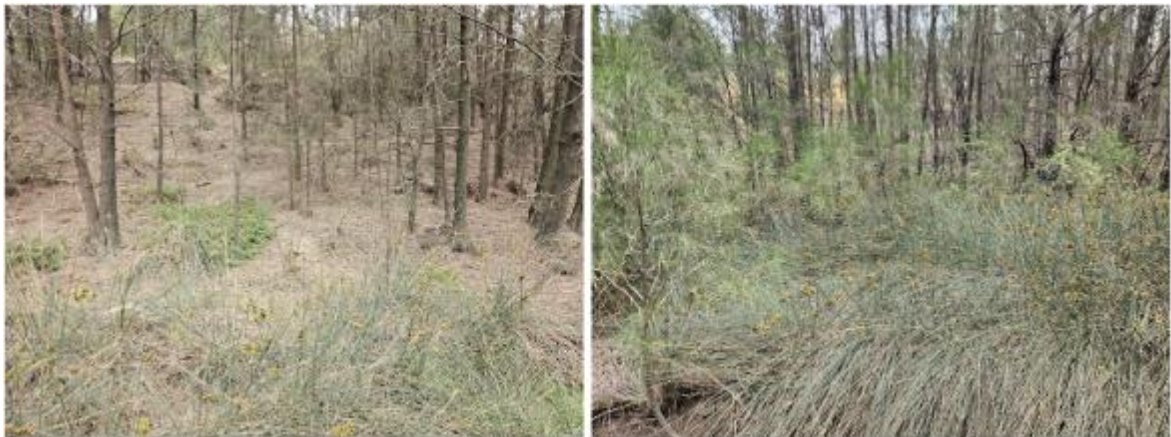
Site LC6 is situated in Loder Creek just upstream from the Nine Mile Creek confluence, in a V-shaped channel with moderately sloped channel walls and incised, box shaped channel. Surface water was present in 2025, with no observable flow. Water occurred throughout the channel but was confined to discrete pools separated by shallow breaks (**Figure 25**).

**Figure 25:** Looking upstream at site LC6 (left) and looking downstream (right).

**Figure 26:** Site LC6 left bank (left) and right bank (right).

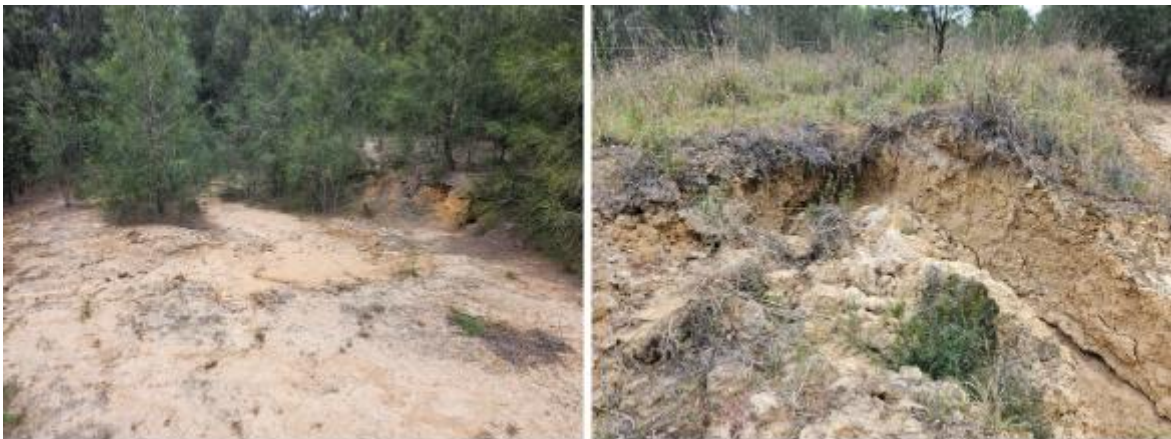
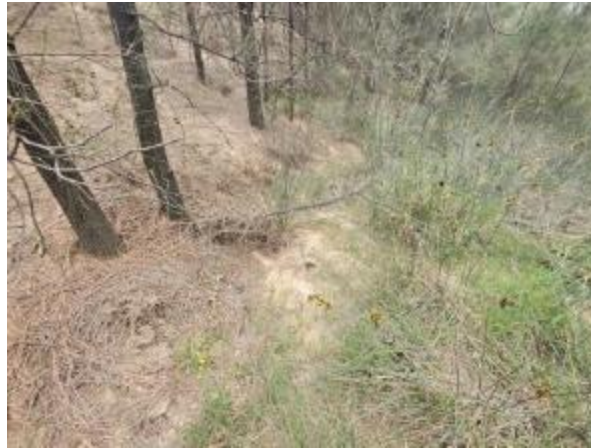
Active erosion persisted along the upper right-hand channel bank wall with further partial collapse of the erosion scar identified in previous annual reports (**Figure 27**). Animal tracks traversing the site continued to facilitate minor fine sediment input to the channel, however none of the existing erosion features dictated an increase in the CSIRO ESA category score. There were no indications of substantial or new sand deposition at the base of the right-hand bank wall with groundcover vegetation having occupied the settled sediments (**Figure 28**). The overall site conditions were mostly comparable to previous surveys, and the LC6 CSIRO ESA rating remained classified as *Active* in 2025.

**Figure 27:** Bank erosion along upper right-hand bank at LC6.

**Figure 28:** Downslope from recent bank collapse and occupation of the lower riparian banks by couch grass and casuarina needle detritus at LC6.

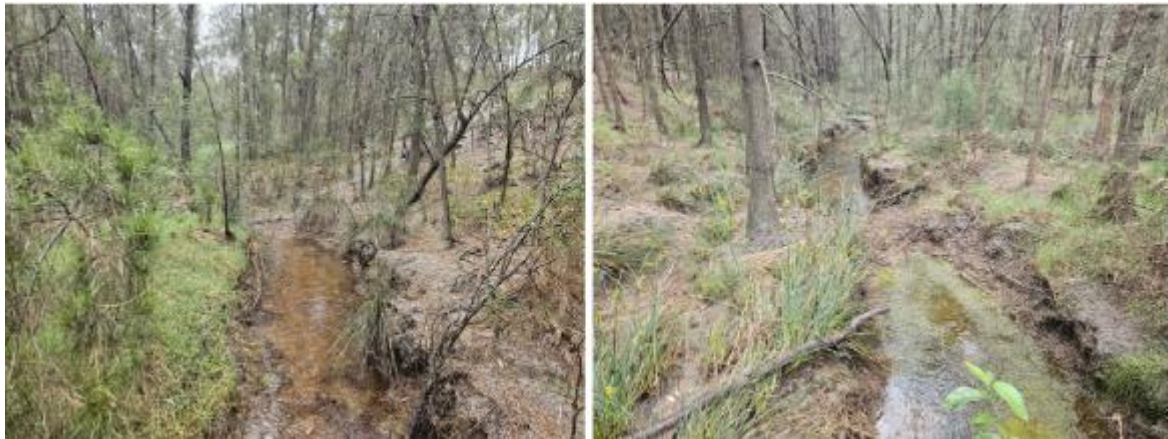
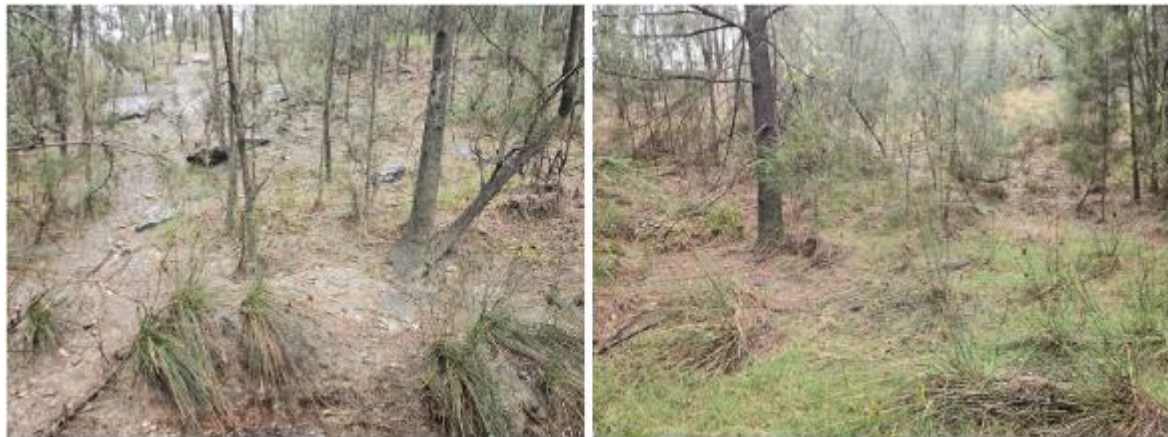
Site LC7 is located downstream of the confluence of Loder Creek and Nine Mile Creek. The channel is incised and box-shaped, meandering through a broader V-shaped valley containing some moderately sloped banks on both sides (**Figures 29** and **30**). Water was present and continuous throughout the site, though no active flow was observed.

**Figure 29:** Looking upstream in LC7 (left) and looking downstream (right).

**Figure 30:** Site LC7 left bank (left) and right bank (right).

No new erosion scars were recorded and existing areas remained stable, however, the animal track dissecting the site continued to act as a source of sediment input with loose material observed within pools similar to that along channel walls at the animal crossing site. The CSIRO ESA rating remained as *Active* in 2025, consistent with previous surveys.

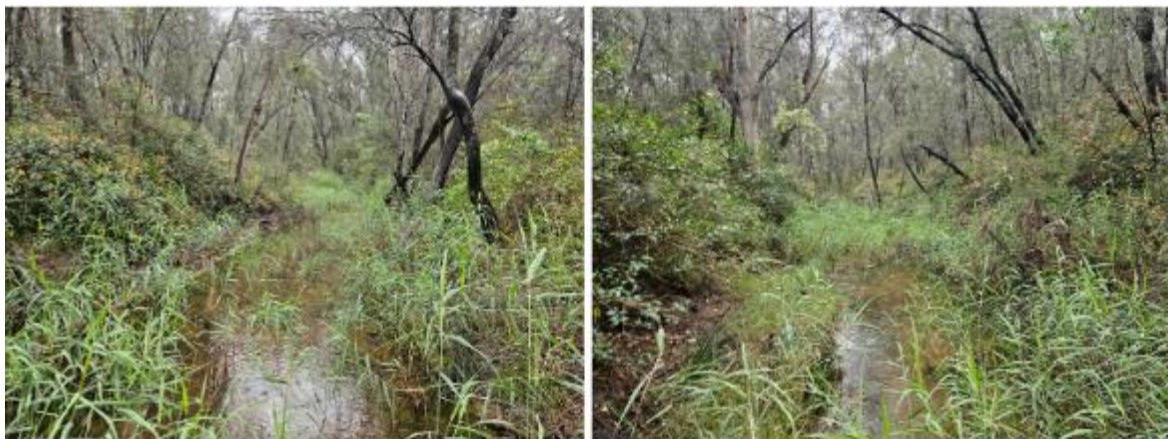
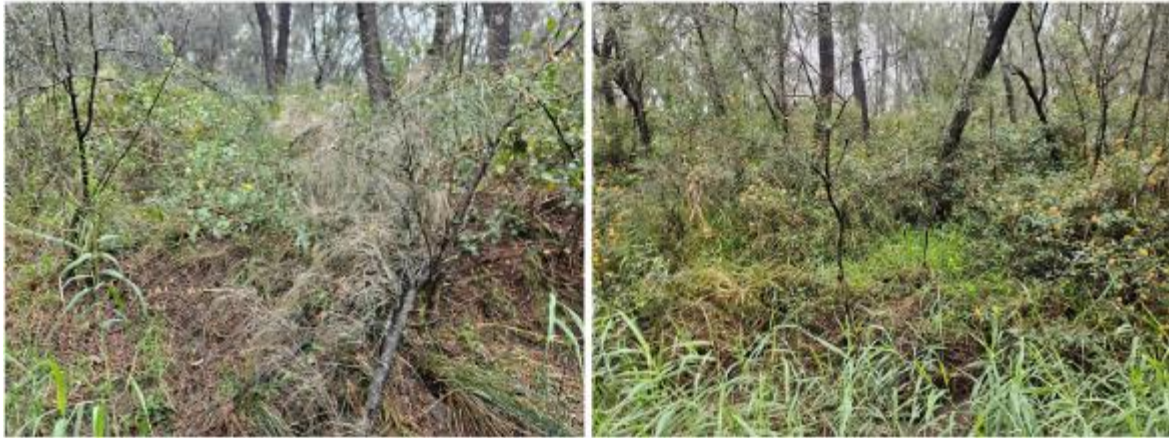
Compared to sites upstream in Loder Creek, the LC11 stream channel consists of a broad and flat-bottomed meandering channel, with intermittently occurring stepped bank edges intersected by shallow sloped (curved) banks (**Figures 31 and 32**).

Water was continuous throughout the site length however there was no observable surface flow at the time of survey. Vegetation within the LC11 drainage channel vegetation had flourished since 2024 (**Figure 31**). Aquatic vegetation was abundant within the channel, dominated by dense stands of common reed, with spiny rush and sago pondweed also present. Common reed density had increased within the site and upstream, while remaining comparable to 2024 conditions downstream, and couch grass was well established along the channel edges and had expanded compared to the previous survey (**Figure 31**).

**Figure 31:** Looking upstream in LC7 (left) and looking downstream (right).

**Figure 32:** Site LC11 left bank (left) and right bank (right).

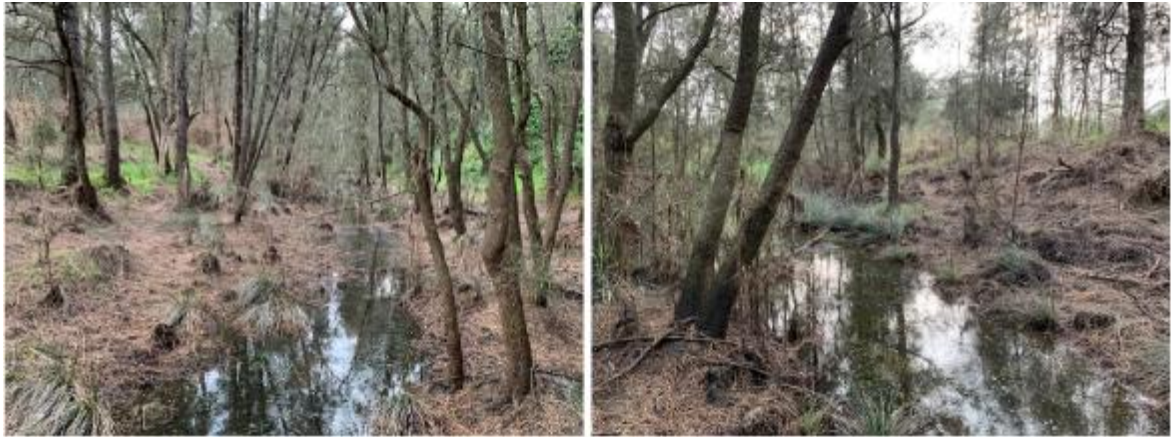
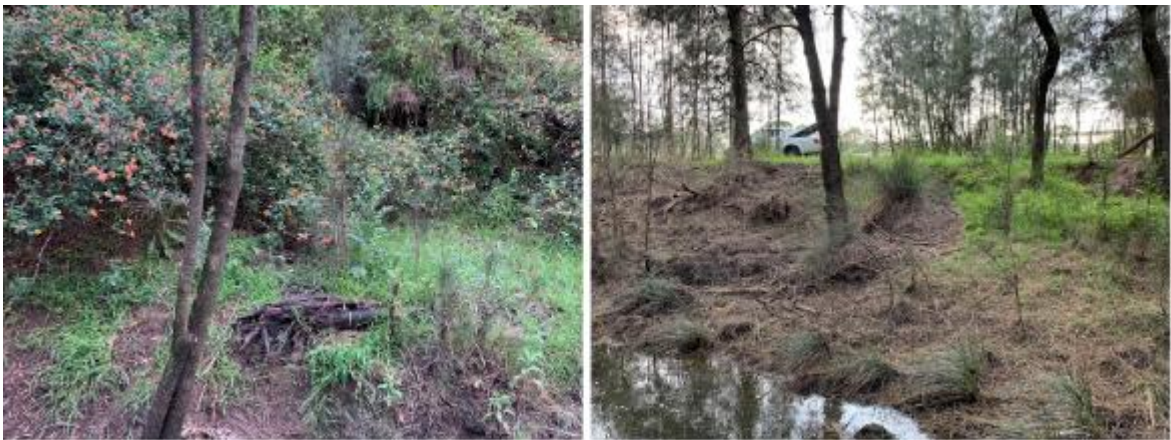
The channel at LC12 comprises a flat-bottomed meandering channel with moderate incision into the surrounding valley floor, which is bordered by moderately sloping and higher left-hand bank and shallow sloped bank along the right-hand side (**Figures 33 and 34**). Continuous shallow water present at the site with a low flow at the time of survey.

The swamp-oak woodland formed a continuous riparian corridor bordered by cleared pastures, with livestock access permissible to the channel area from adjoining paddocks on the right-hand bank. There were animal tracks in the mud alongside the pool edges with evidence of cattle, wild pigs and kangaroos. The channel macrophyte assemblages were composed of spiny rush, sago pondweed and common reed, with overall vegetation abundance in the channel basin low and comparable to conditions recorded over the past 2 years. The groundcover beneath the canopy consisted of dense swamp-oak needles, spiny rush and scattered weed growth, with scattered weeds along the channel bank edges and slopes including lantana (partially dead from spraying on the left bank), dead African boxthorn (sprayed), thistle, prairie grass, ribwort plantain (*Plantago lanceolata*) along pasture edges, and purple top. This reduction in vegetation cover led to a downgrade in the ‘Vegetation on drainage line floor’ category, with the CSIRO ESA score decreasing from *Potentially Stabilising* to *Active* in 2025, a return to the levels recorded in 2022 and 2023.

**Figure 33:** Looking upstream and downstream at LC12 in 2025.

**Figure 34:** Looking at the left and right bank at LC12 in 2025.

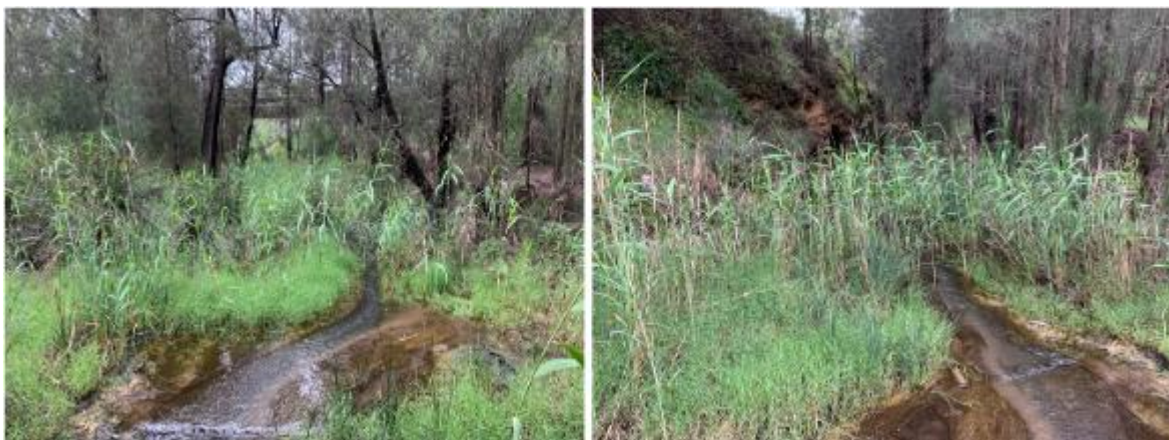
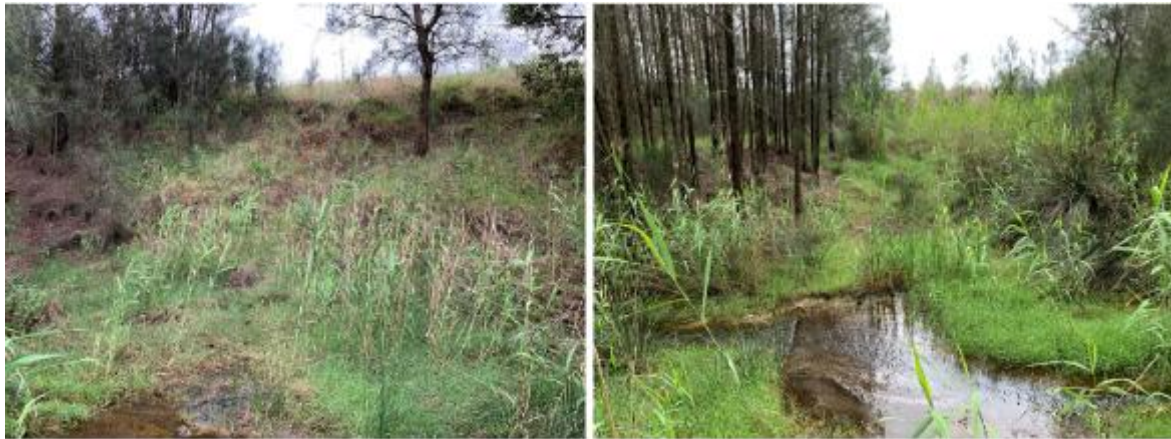
The Loder Creek channel at LC14 comprises a flat-bottomed meandering channel with variable incision into the surrounding valley floor, with a steep bank bordering the stream along the left-hand side and shallow profile bank to the right (**Figures 35 and 36**). Slightly turbid water was moving through the site at a low flow rate over the concrete crossing.

Active erosion remained largely confined to the prominent exposed left-hand bank along the downstream bend, where evidence of higher flows earlier in the year had resulted in additional bank undercutting and a modest increase in erosion extent relative to 2024. No signs of cattle or livestock disturbance were observed, and grass growth around the crossing appeared to be contributing to localised stabilisation of the channel margins.

**Figure 35:** Looking upstream at LC14 (left) and looking downstream (right) in 2025.

**Figure 36:** Site LC14 left bank (left) and right bank (right).

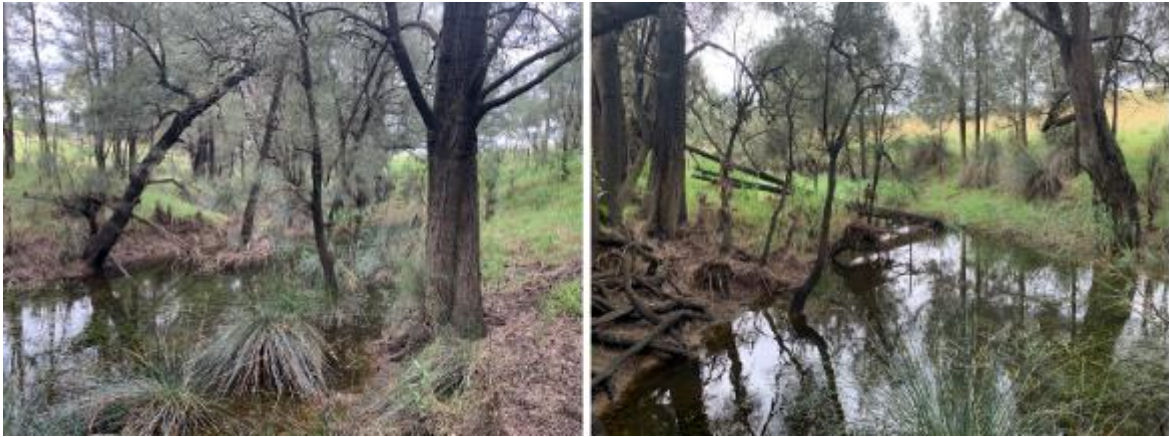
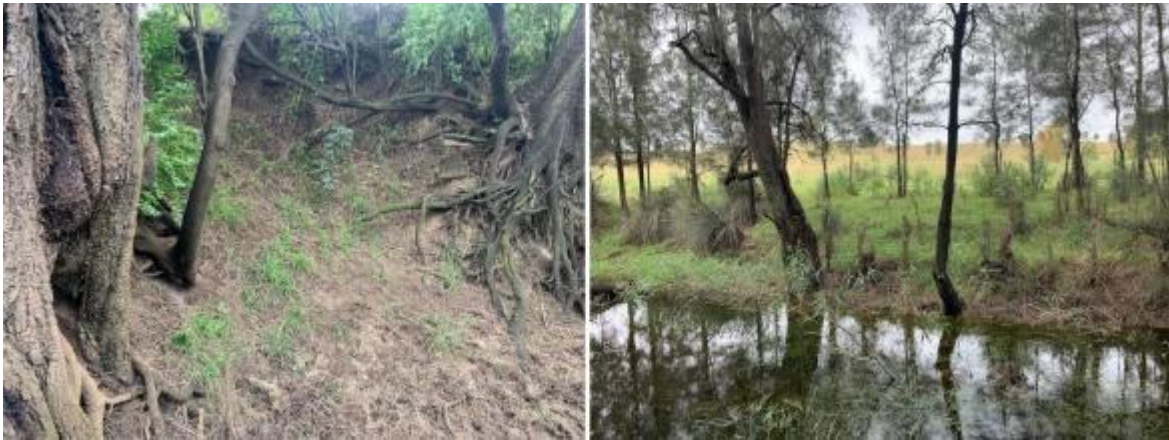
The drainage channel at LC8 comprises a steep, vertical bank along the western side and shallower sloped, stepped bank to the east, and both edges support a thin and continuous strip of riparian swamp-oak trees which are undercut in parts (**Figure 37** and **38**). Water remained continuous through the site with a gentle low flow, while indicators of previous high-flow events were evident up to approximately 1.5–2 m above current water levels.

Couch grass remained along the channel edges., and the overall vegetation structure and condition remained stable and consistent with 2024. Sago pondweed, arrowgrass and rushes (*Juncus spp.*) persisted at comparable densities to the previous survey, while spiny rush occurred along channel margins. The condition of the swamp-oak corridor showed little change, maintaining similar density and distribution to previous surveys. Beneath the swamp-oak canopy, the groundcover was comprised a mix of grasses and weeds, including fleabane, thistle, sow thistle, African boxthorn, and ribwort plantain. Some swamp-oak needles detritus had been removed or thinned in areas affected by high-flow events, but for the most part a thick layer occurred among the more heavily vegetation bank edges. Channel morphology remained stable with no new erosional features or changes to the existing erosion scars.

**Figure 37:** Looking upstream at LC8 (left) and looking downstream (right).

**Figure 38:** Site LC8 left bank (left) and right bank (right).

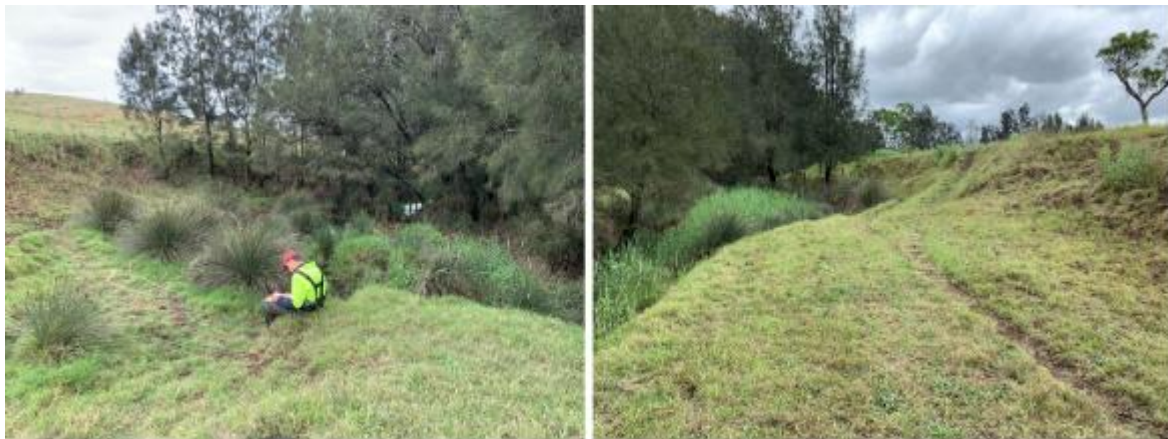
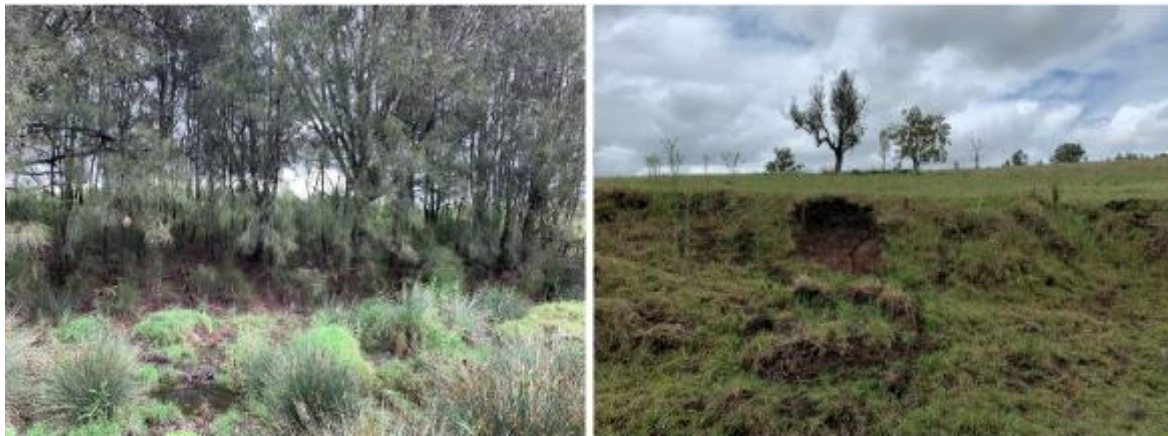
Loder Creek site LC9 channel is generally straight with low profile banks, with a dense and thin strip of swamp-oak riparian corridor up and downstream of the open channel area surrounding the middle of the site (**Figures 39 and 40**).

Slightly turbid water was slowly trickling through the site at a low flow. Evidence throughout the site suggested previous flows up to 2m above current level. Aquatic vegetation remained stable with spiny rush and dense stands of common reed present throughout the site. Notably, common reed had increased in density since 2024. Recent bank erosion spanning approximately 1m x 1m was observed on the right-hand bank (**Figure 40**), though it appeared to have contributed only a minor quantity of sediment to the channel. Cattle access continued to impact channel edges through trampling and disturbance.

**Figure 39:** Looking upstream (left) and downstream (right) at LC9.

**Figure 40:** Site LC9 left bank (left) and right bank (right).

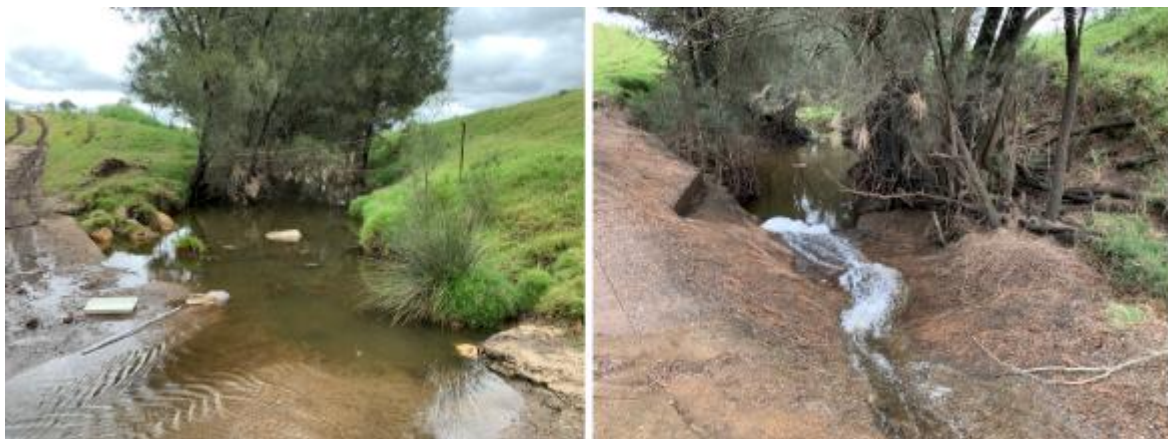
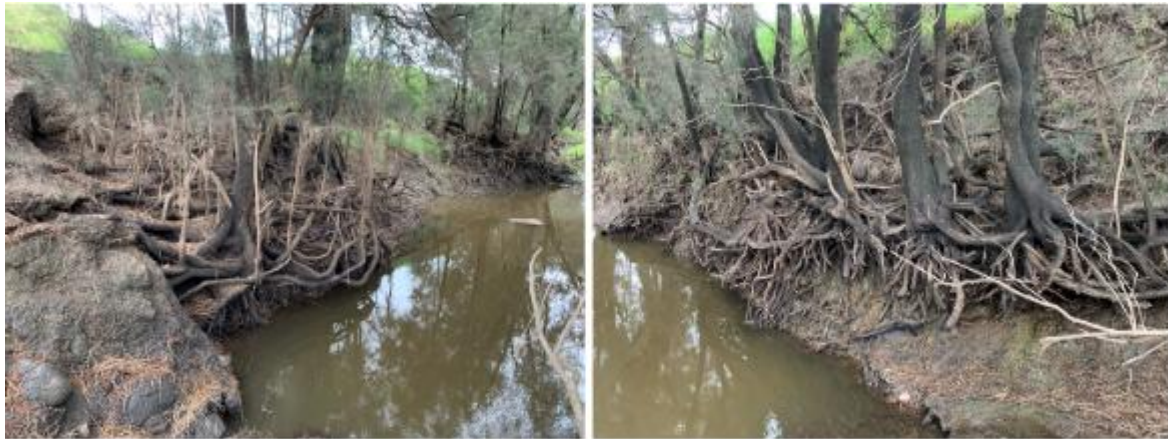
Site LC10 is located in the lower limits of Loder Creek at a concrete causeway with a narrow 100mm piped culvert (**Figures 41 and 42**). The channel is incised into the surrounding valley floor, and moderately steep V-shaped banks along both sides of the creek (reaching 5 to 8m above the channel floor), with bank undercutting prevalent throughout the section. Waters levels remained consistent, with slightly turbid water continuing to flow over the road crossing at a low flow.

**Figure 41:** Site LC10 looking upstream from causeway (left) and looking downstream (right).

**Figure 42:** LC10 left bank (left) and right bank (right).

Aside from a few minor new erosion scars (< 20 cm) formed along the left-hand bank downstream, the channel erosion features showed little variation to previous surveys and there were no changes made to the LC10 site CSIRO ESA rating of *Potentially Stabilising* between 2024 and 2025.

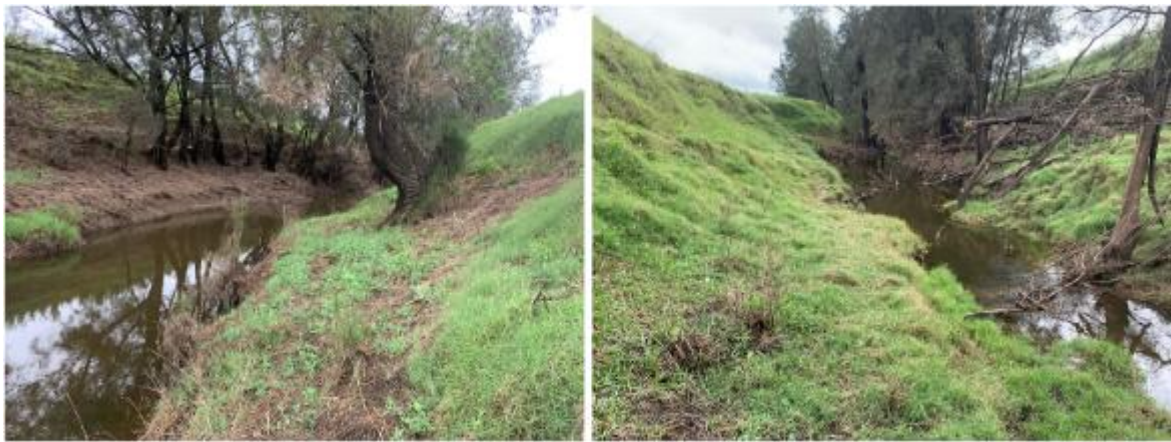
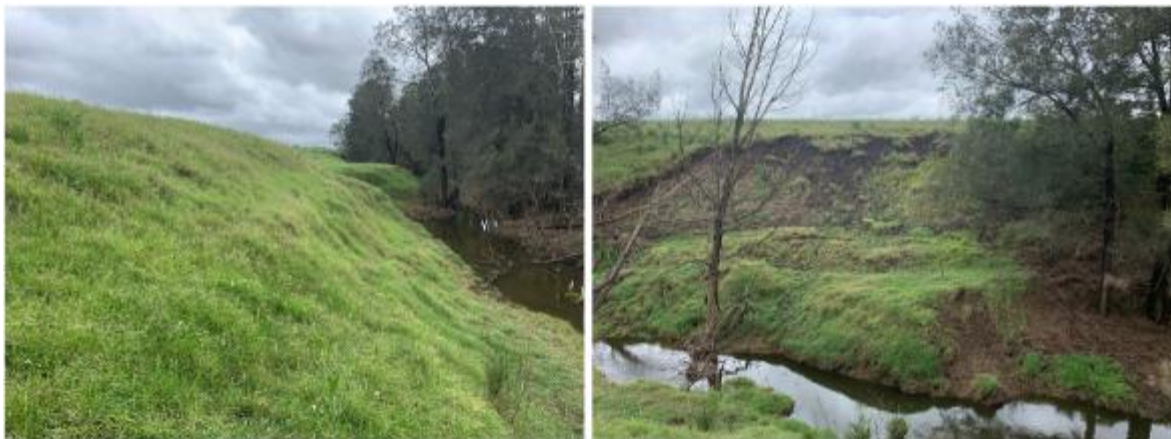
Site LC15 is contained in a generally straight section of drainage, within a V-shaped valley with stream channel incised into the surrounding valley floor at depths of 8 to 10m. The creekline contains moderately steep to near vertical sections of bank along both sides with bank undercutting and stepped bank walls prevalent throughout the section as a result of livestock access and fluvial processes (**Figures 43** and **44**). Surface waters were slightly turbid with a low trickle flow for the 2025 survey.

The active erosion scar previously identified on the right-hand bank showed further localised slumping (**Figure 44**), although much of the surrounding bank remained stabilised by grass cover. Minor cattle damage and exposed tracks were observed on the left-hand bank but did not appear to contribute substantially to sediment input. The overall site condition remained consistent with previous assessments, and the CSIRO ESA rating remained classified as *Stable* for the 2025 survey.

**Figure 43:** Site LC15 looking upstream (left) and looking downstream (right).

**Figure 44:** LC15 left bank (left) and right bank (right).

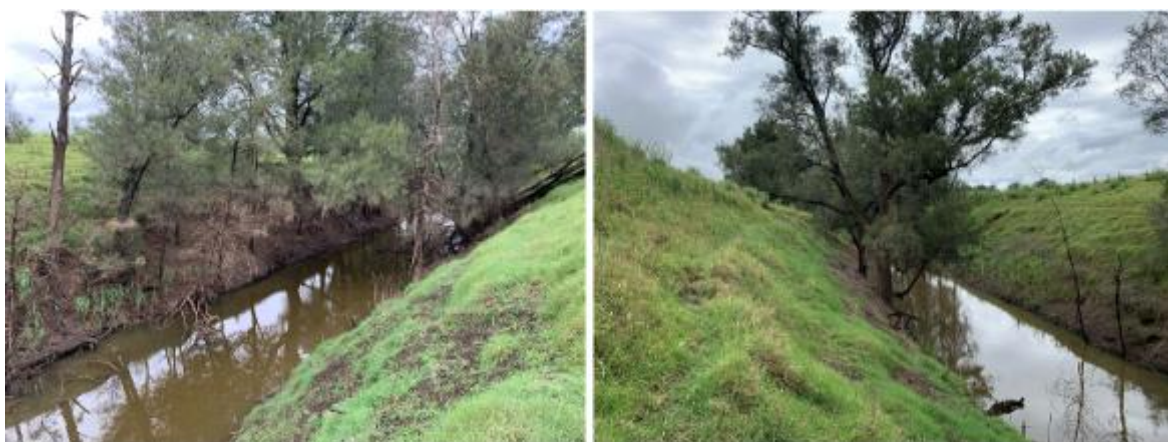
The channel form at LC13 is similar to that noted for LC10, and consists of a V-shaped channel, deeply incised (7 to 10m) into the surrounding catchment area with fragmented riparian corridor consisting of mature swamp-oak and eucalypts (**Figures 45 and 46**). Turbid water was slowly moving through the site at a low flow.

Several cattle access tracks along the banks exhibited partial recolonisation by grasses, indicating reduced trampling pressure. Woody debris was abundant throughout the site length, with numerous large logs and branches present both within the channel and along its margins (**Figures 45 and 46**).

**Figure 45:** Looking upstream (left) and downstream (right) at LC13.

Based on these observations, site condition remained consistent overall and the LC13 CSIRO ESA classification was unchanged, remaining *Potentially Stabilising* in 2025

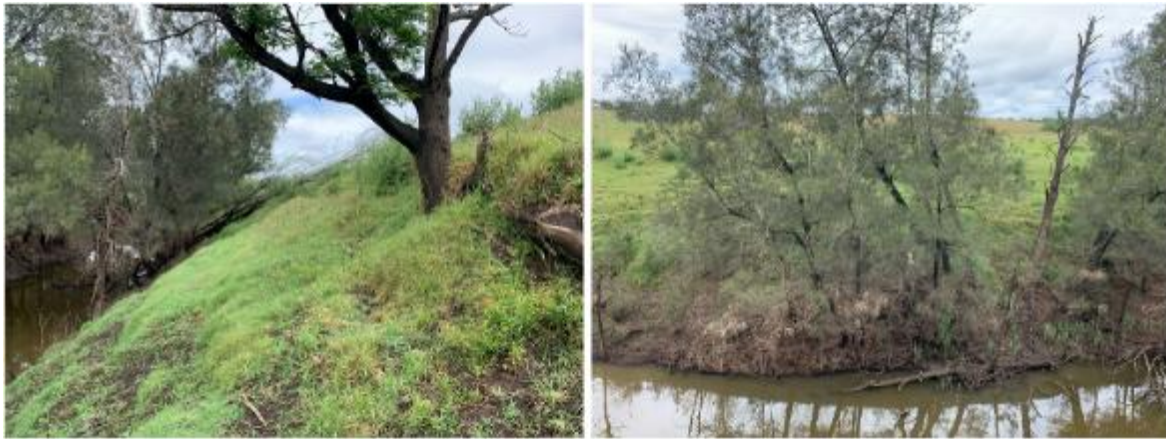
Swamp-oak canopy inputs continued to generate a substantial needle layer along portions of the right (eastern) bank, while the remainder of the site was largely characterised by grass dominated groundcover with intermittent weed occurrence. Weed density along the immediate bank slopes adjacent to the channel had decreased markedly since the previous survey, most notably for thistle which persisted in association with other common pasture and riparian weeds, including dock (*Rumex spp.*), fleabane, fireweed and rescue grass.

**Figure 46:** Looking at the left bank (left) and right bank (right) at LC13.

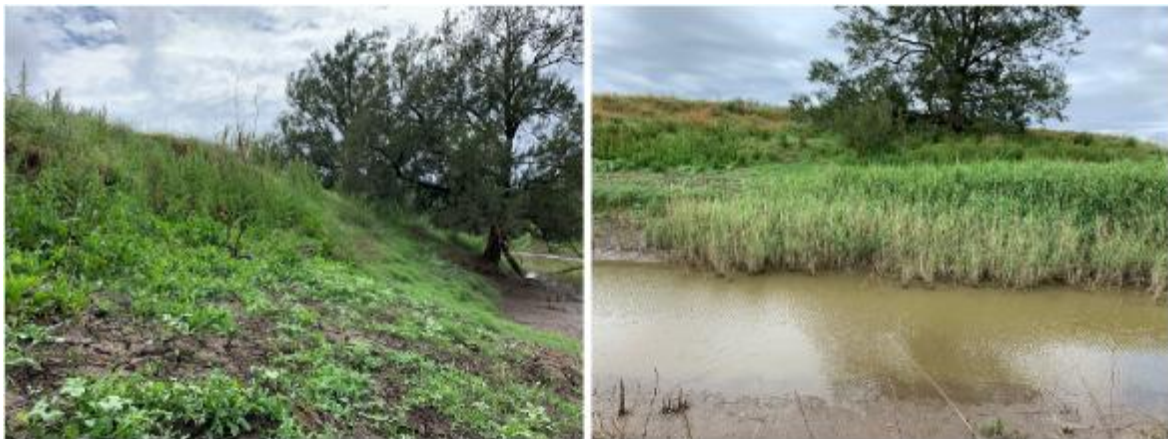
Site LC16 is located in the lower limits of Loder Creek, around 150m upstream from the confluence of the Hunter River. The channel banks are moderately sloped with very sparse occurrences of trees (gaps of 50m or more) (**Figures 47 and 48**). Water was turbid with a sluggish surface flow at the time of survey.

The LC16 channel is considered highly susceptible to flood-driven scouring and potential exacerbation of existing erosion, largely due to the absence of a well-developed wooded riparian corridor. Site conditions showed no substantial change in 2025, and accordingly, the CSIRO ESA rating for LC16 remained classified as *Active*.

**Figure 48:** Looking along the left-hand bank at LC16 (left) and right-hand bank (right).

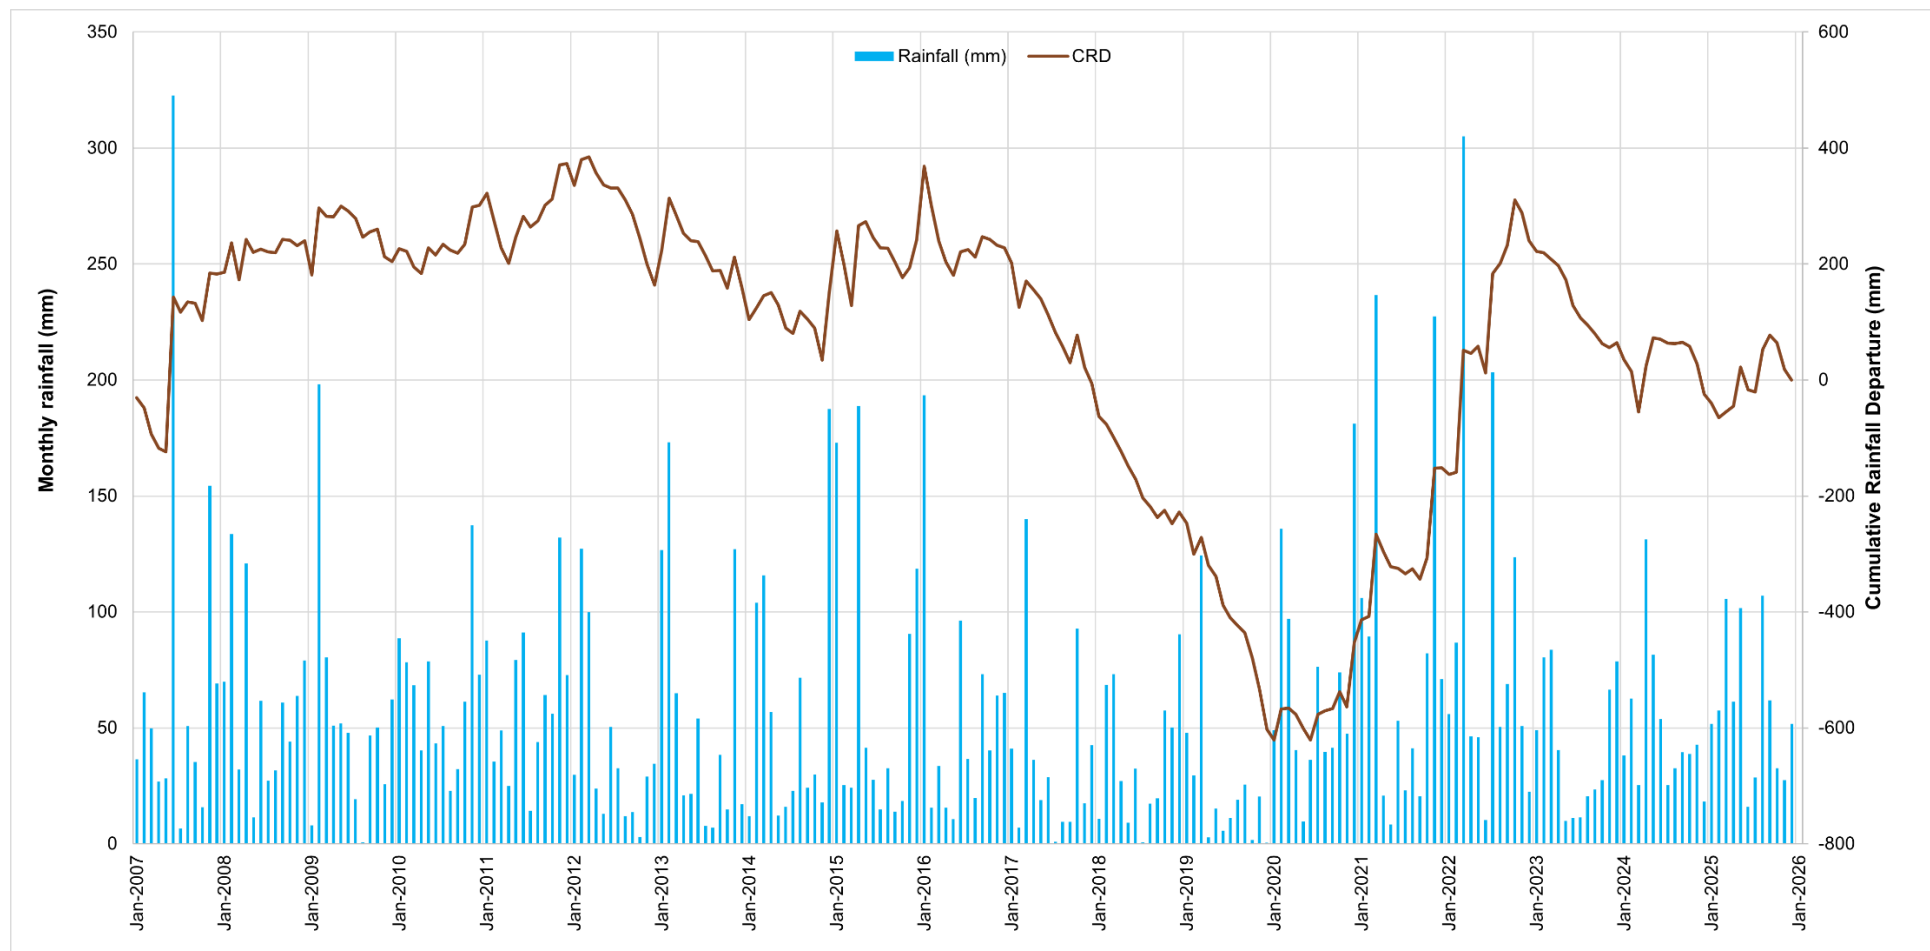
The CRD (Figure 2.1) displayed an increasing trend throughout 2020, 2021 and 2022, following drought conditions from early 2017 to late 2019. However, the CRD displayed a decreasing trend throughout 2023, reflective of the typically below-average rainfall experienced throughout the year. Average rainfall was recorded during 2024 and 2025, as indicated by the CRD curve, which exhibited minimal fluctuation during this timeframe (Table 2.1; Figure 2.1).

Figure 2.1 Cumulative rainfall departure (2007 to 2025) for MTW Charlton Ridge weather station

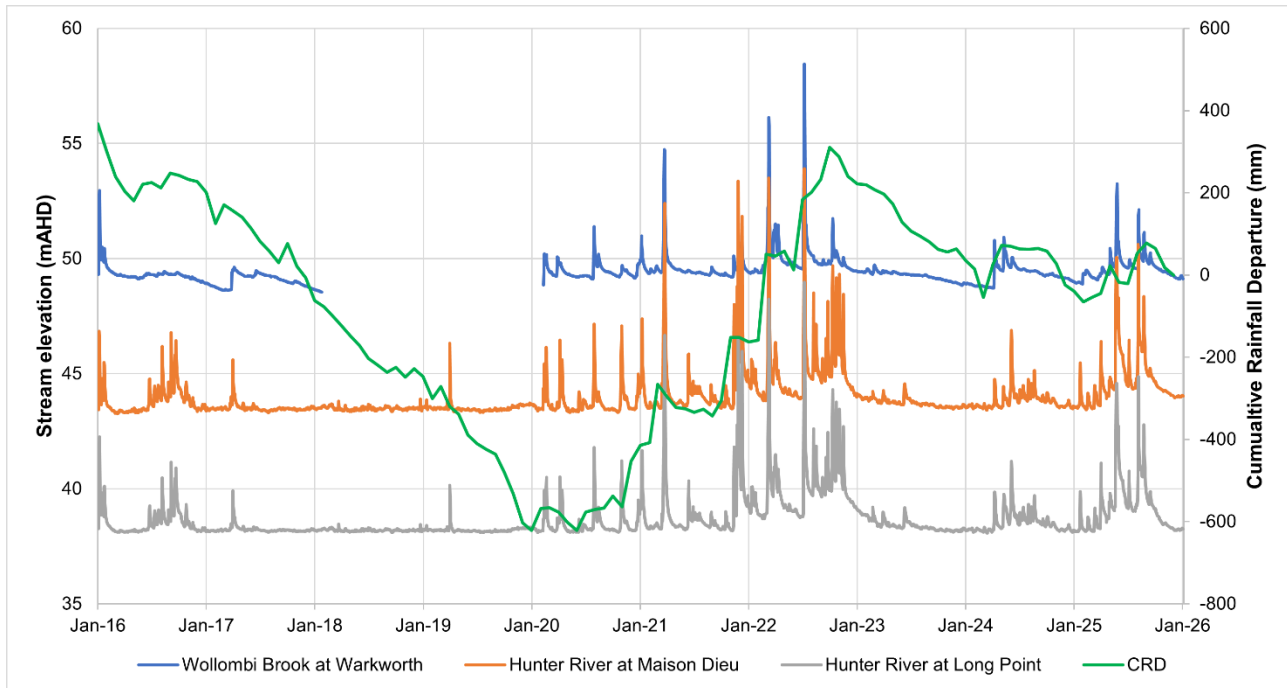
Excepting short term fluctuations following heavy rainfall events, surface water levels remained steady at surface water monitoring stations on the Hunter River at Long Point, Maison Dieu and also in the station located in Wollombi Brook at Warkworth. Hunter River is regulated at Glenbawn Dam with daily releases to maintain flow and environmental quality. Wollombi Brook has held water since January 2020, following an extended period with no flow (period with no data on chart; Figure 2.2). In 2024, river levels recorded a modest increase, aligning with the CRD following a period of decline throughout 2023. Significant rainfall events in mid-2025, followed by controlled dam releases, elevated stream levels to their highest point since 2022.

Figure 2.2 Surface water levels

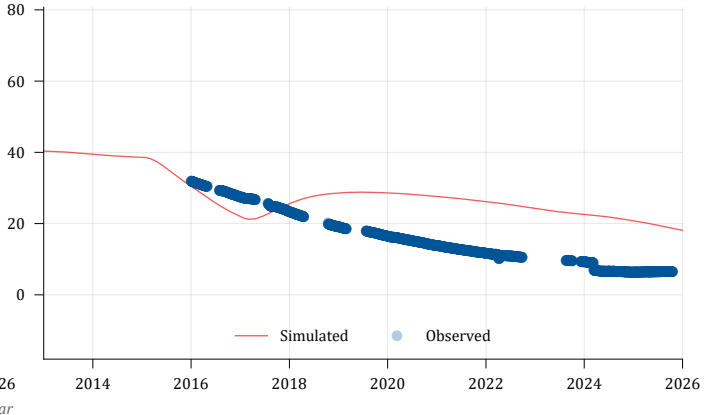
**MTD518\_P2**

- Pressure heads observed in VWP MTD518 sensors 2 (226.5 mBGL) and sensor 3 (142.5 mBGL) show a trend typically similar to modelled predictions, although observations are lower than those predicted. Observed pressure head data in sensor 1 (358 mBGL) appears to be the result of a faulty sensor, so comparison to modelled predictions cannot be determined.

- There were no VWP data available from sensors in the Wambo coal seam for 2025. Data from the sensor installed into the Wambo coal seam at VWP MTD518 indicates the sensor has likely failed.

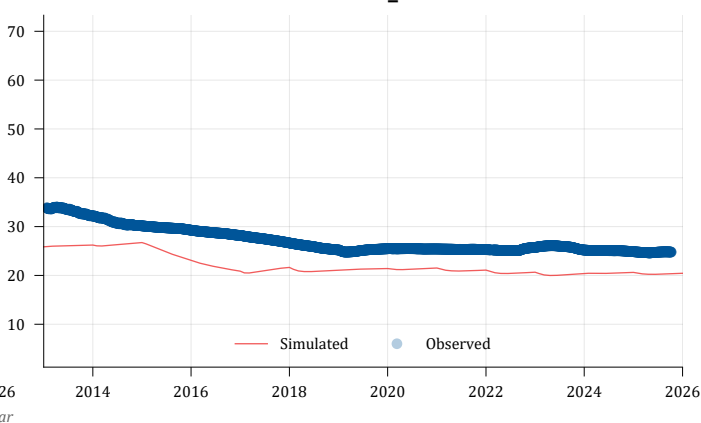
**WD615\_P1**

- The observed pressure head trend in VWP WD615 sensor 1 (133 mBGL) aligns closely with predictions. While predicted pressure heads in sensor 2 (225 mBGL) remained stable, actual values fell 120 m below predictions in 2018, recovered by 2024, and then declined again through 2025.
