# Mount Thorley Warkworth Historic Heritage Management Plan 2020 Compliance Audit Inspection

Report prepared for

Yancoal Australia, Mount Thorley Warkworth

January 2021

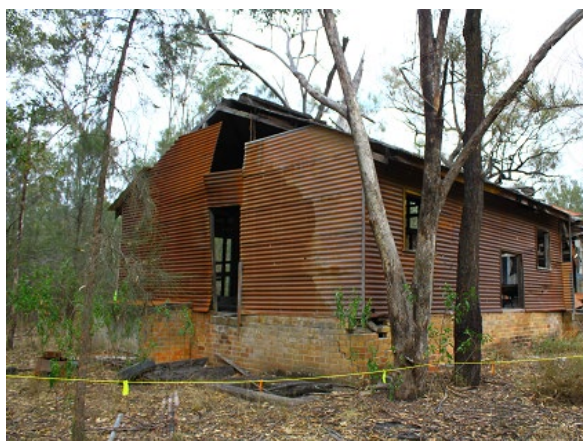
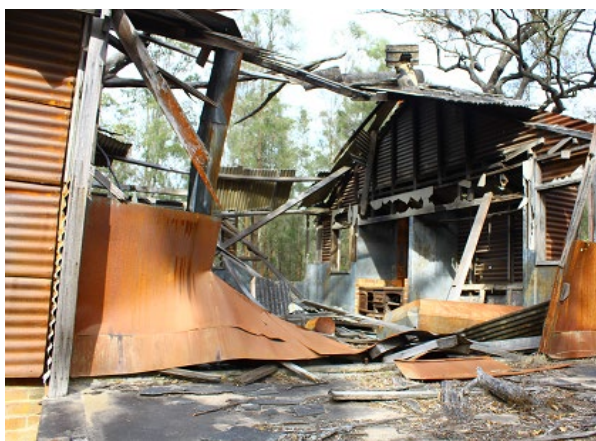
The building is currently structurally unsound, with a large tree impacting on the roof and a number of timber elements either missing or in a deteriorated state. Corrugated asbestos roof

sheeting is also missing in some places, and damaged and in poor condition where it remains. Much of the corrugated iron sheeting is corroded. Brickwork is also cracking in a number of locations resulting in significant movement outward, loss of mortar and loss of bricks along the southern and eastern elevations.

*View to mess from south-east (2012)*

*Remnant kitchen area (2012)*

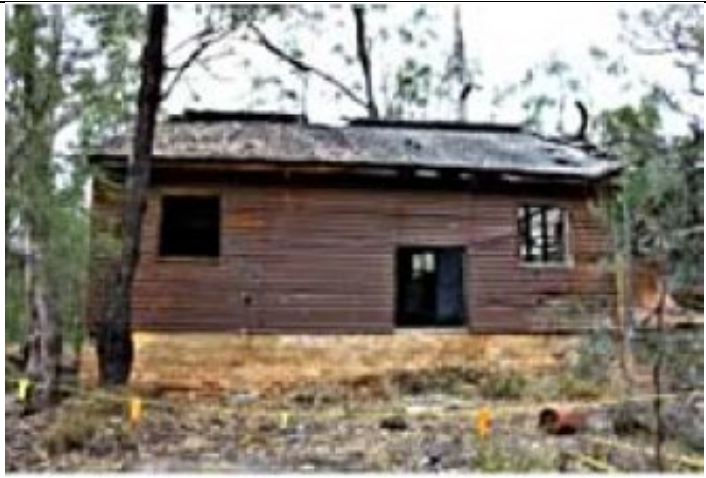
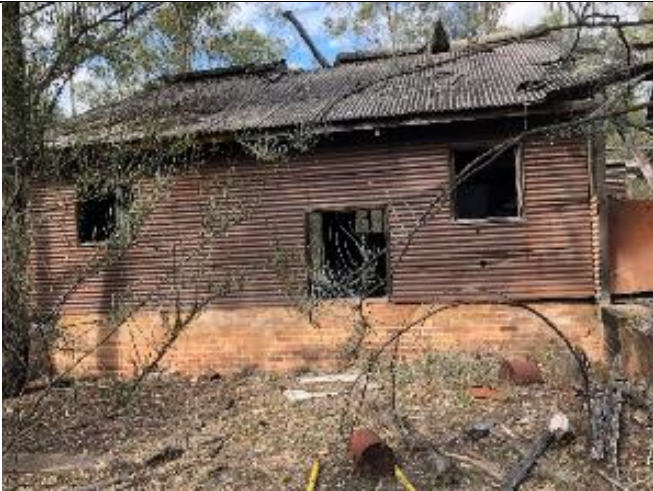
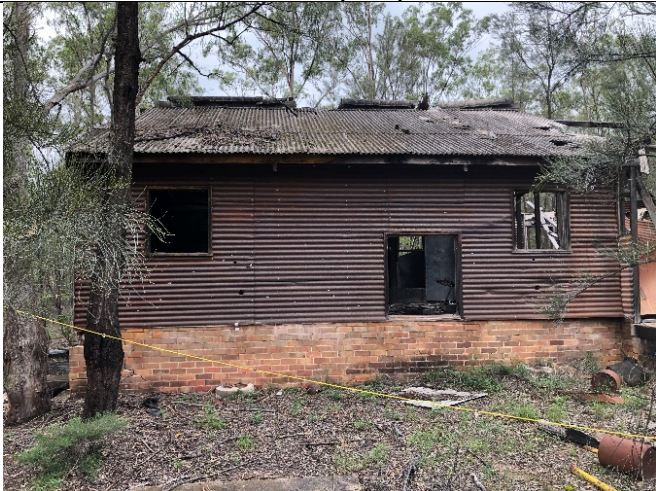
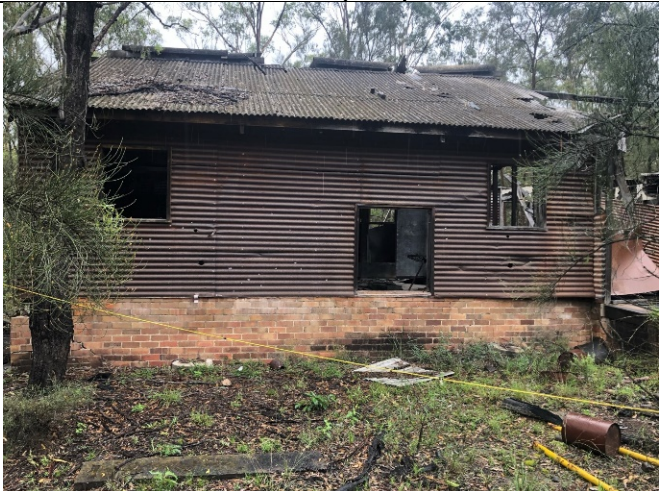
| 2012 | 2018 | 2020 (Mar) | 2020 (Dec) |
|---|---|---|---|
| <p><b>East elevation</b><br/><b>2012-18:</b> no discernible change – note fallen branch from tree on western side.<br/><b>2018-20 (Mar):</b> no discernible change – fallen branch has moved.<br/><b>Mar 2020 – Dec 2020:</b> no discernible change.</p> | | | |

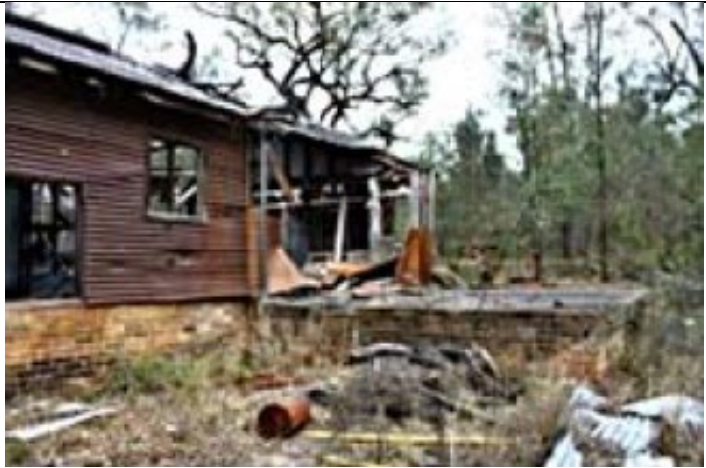
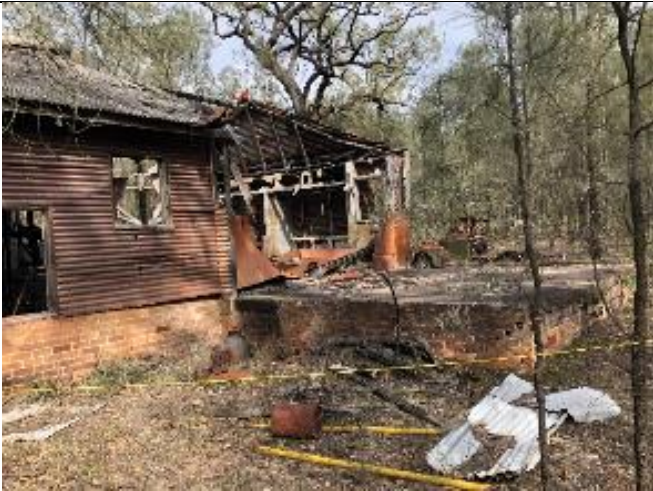
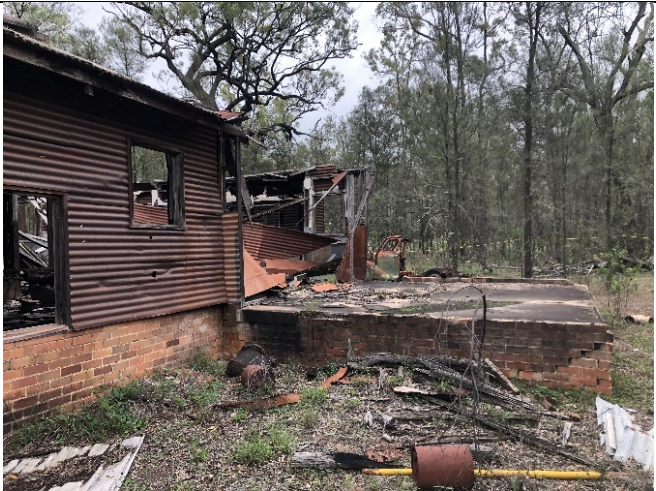
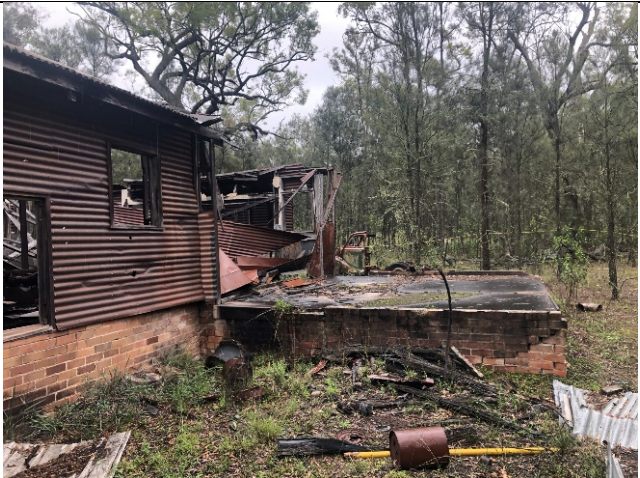
| 2012 | 2018 | 2020 (Mar) | 2020 (Dec) |
|---|---|---|---|
| <p><b>View to north-east elevation</b><br/><b>2012-18:</b> roof over open kitchen area has deteriorated, causing severe lean on far wall.<br/><b>2018-20 (Mar):</b> top of far wall now collapsed.<br/><b>Mar 2020 – Dec 2020:</b> no discernible change.</p> | | | |

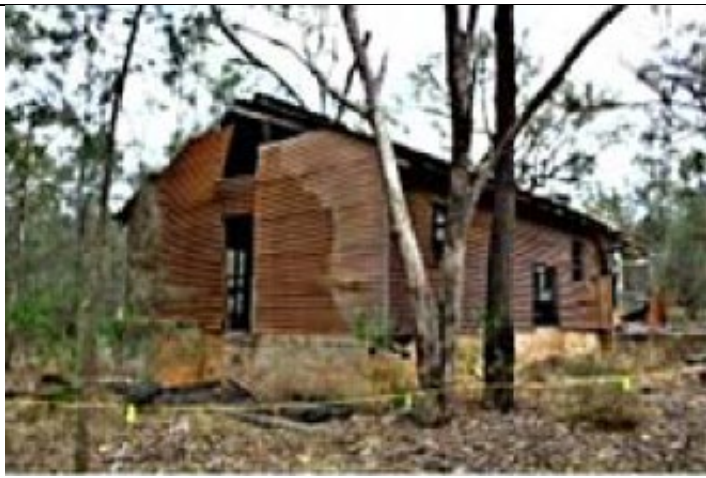
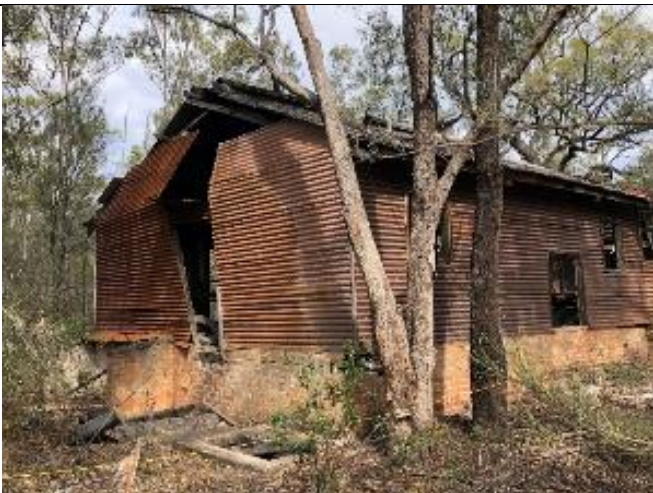
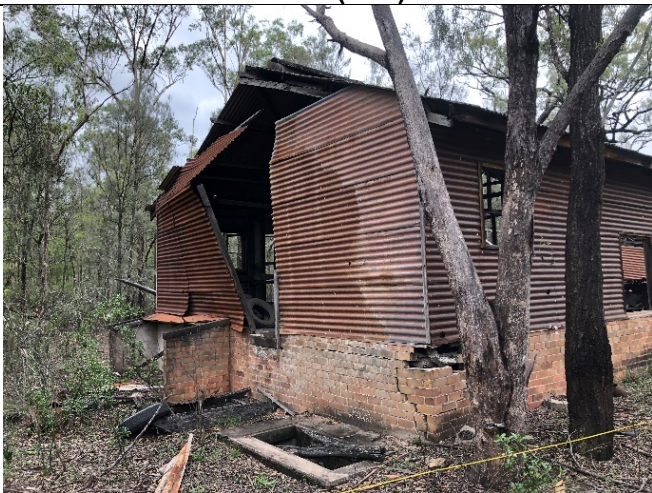
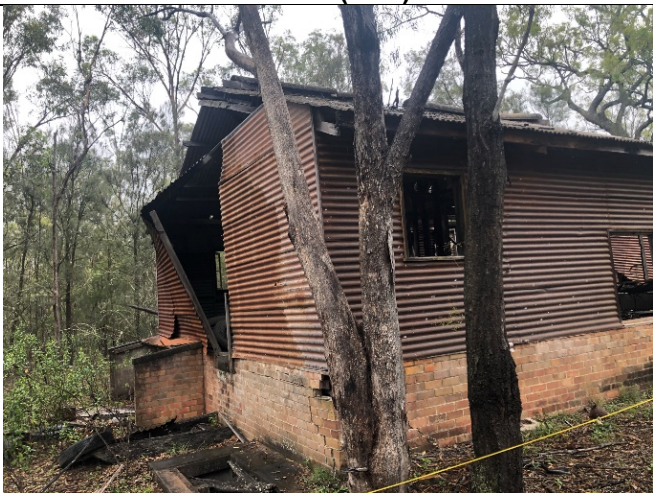
| 2012 | 2018 | 2020 (Mar) | 2020 (Dec) |
|---|---|---|---|
| <b>South-east elevation</b><br><b>2012-18:</b> evidence of increased bow to southern wall.<br><b>2018-20 (Mar):</b> bow in wall appears to have increased.<br><b>Mar 2020 – Dec 2020:</b> bow in wall continues to increase. | | | |

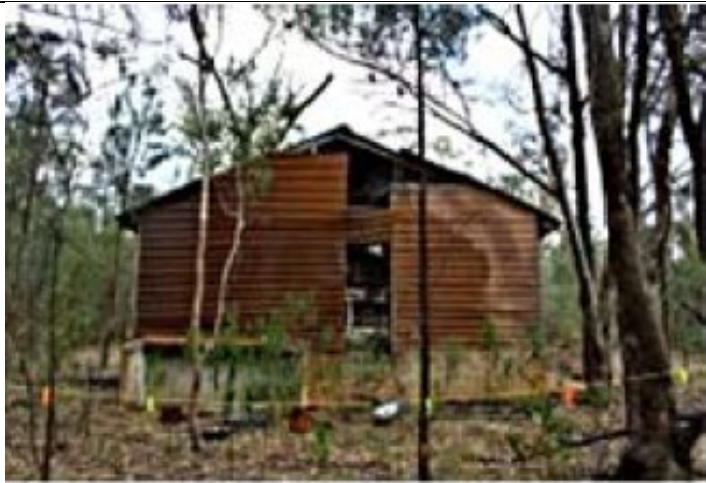
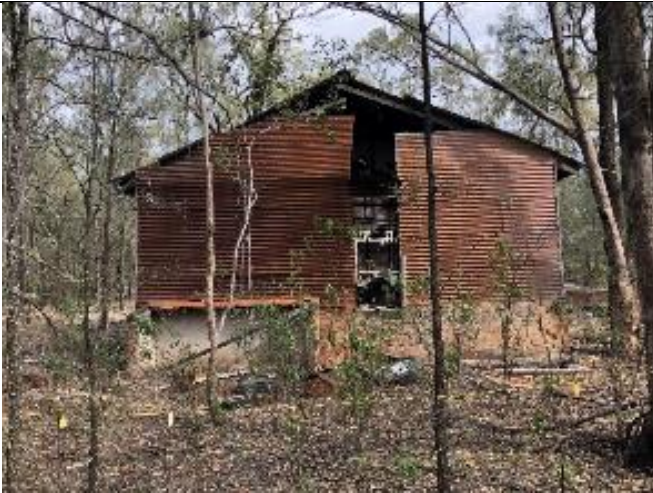
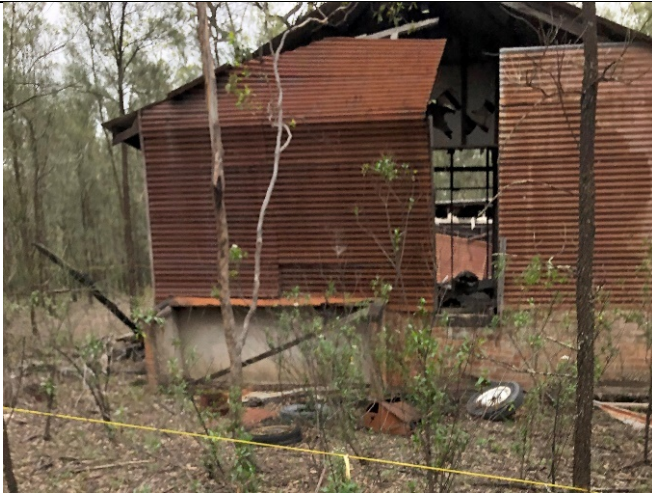
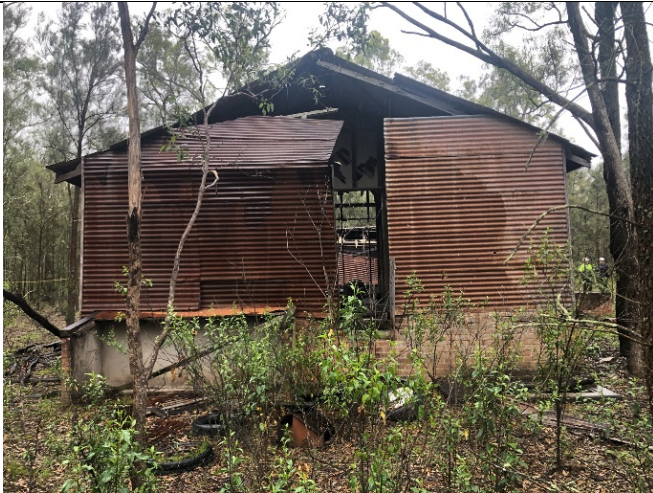
| 2012 | 2018 | 2020 (Mar) | 2020 (Dec) |
|---|---|---|---|
| <b>South elevation</b><br><b>2012-18:</b> evidence of increased bow to southern wall and missing panel above entry.<br><b>2018-20 (Mar):</b> increased bow to southern wall.<br><b>Mar 2020 – Dec 2020:</b> increased bowing on southern wall. | | | |

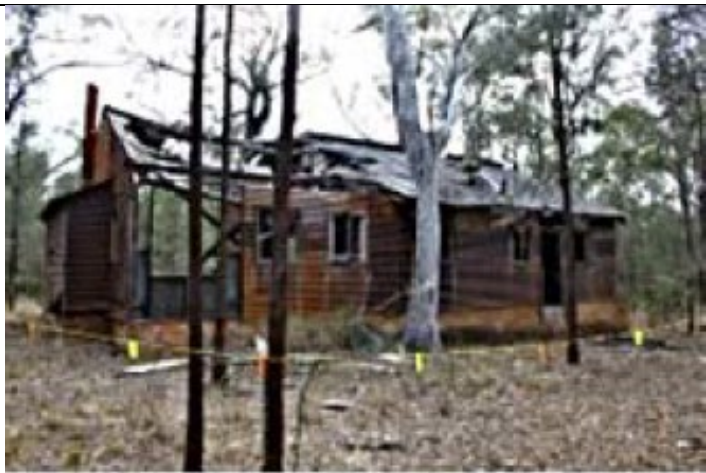
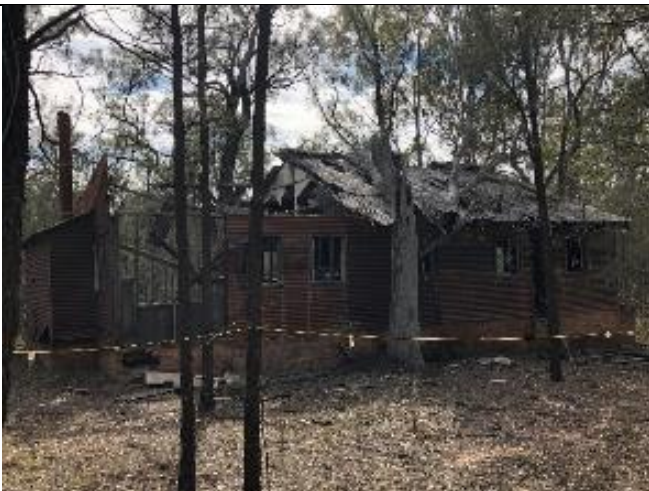
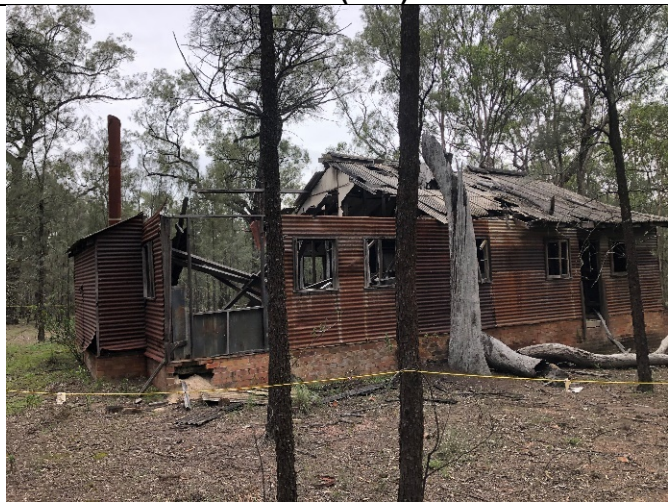
| 2012 | 2018 | 2020 (Mar) | 2020 (Dec) |
|---|---|---|---|
| <b>West elevation</b><br><b>2012-18:</b> shows deterioration of roofing members above open kitchen area and leaning north wall, and further collapse of asbestos roof due to fallen dead tree.<br><b>2018-20 (Mar):</b> top of north wall now collapsed, further damage to roof with branch now fallen to ground.<br><b>Mar 2020 – Dec 2020:</b> no discernible change. | | | |

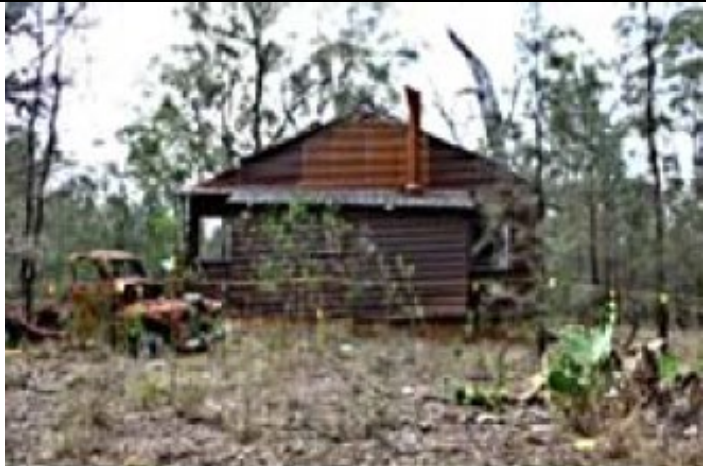
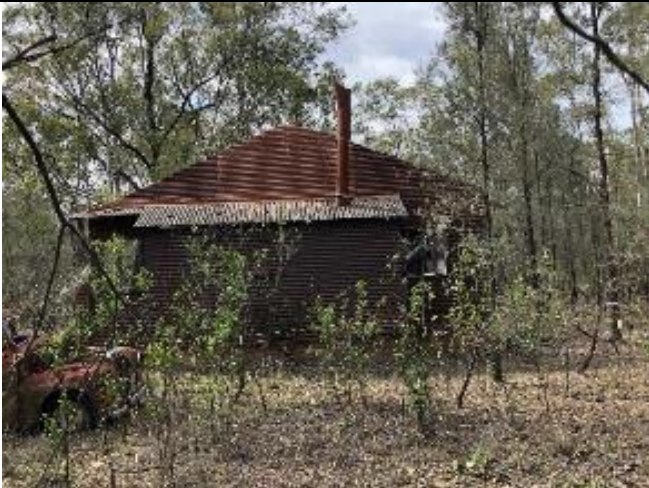
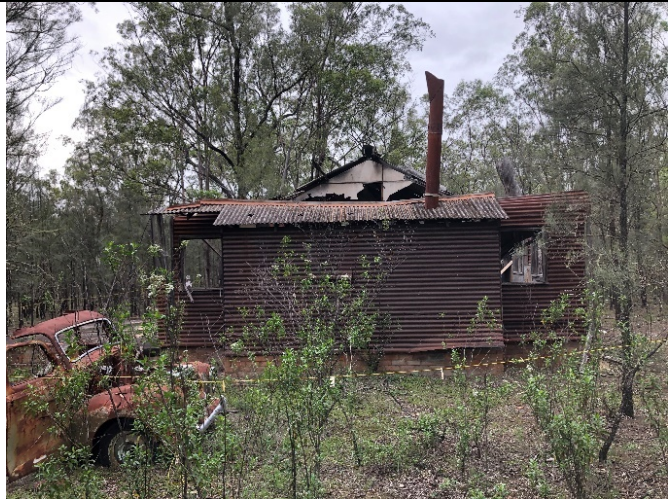
| 2012 | 2018 | 2020 (Mar) | 2020 (Dec) |
|---|---|---|---|
| <b>North elevation</b><br><b>2012-18:</b> no discernible change.<br><b>2018-20 (Mar):</b> top of north wall now collapsed.<br><b>Mar 2020 – Dec 2020:</b> no discernible change. | | | |

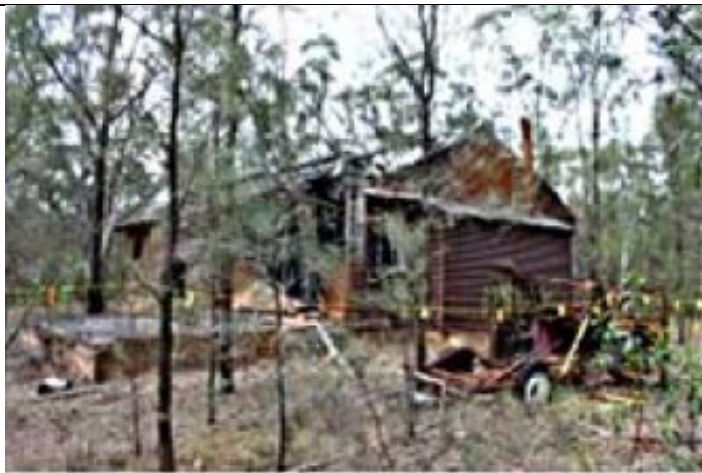
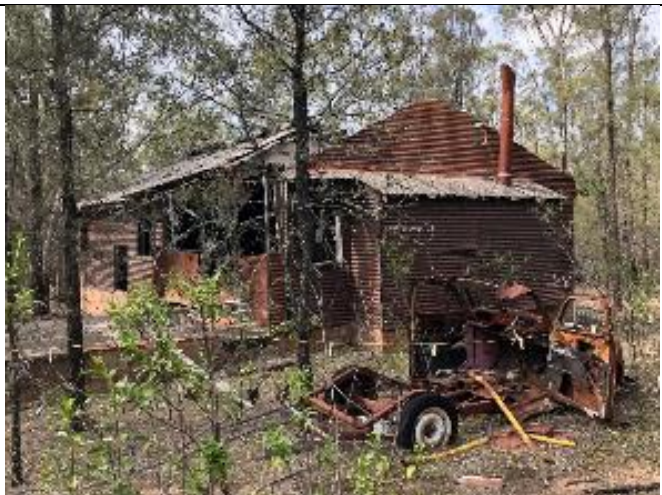
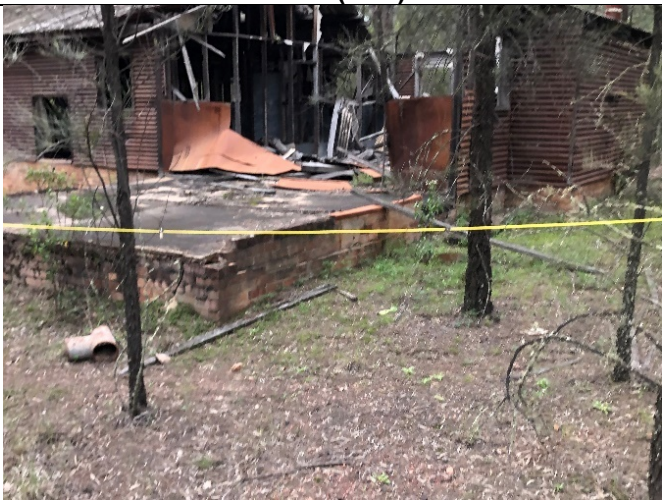
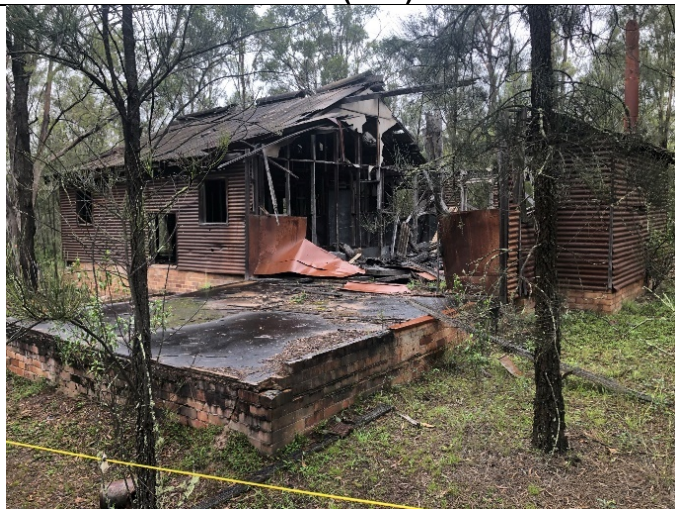
| 2012 | 2018 | 2020 (Mar) | 2020 (Dec) |
|---|---|---|---|
| <b>North-east elevation</b><br><b>2012-18:</b> difficult to discern change.<br><b>2018-20 (Mar):</b> difficult to discern change.<br><b>Mar 2020 – Dec 2020:</b> no discernible change. | | | |

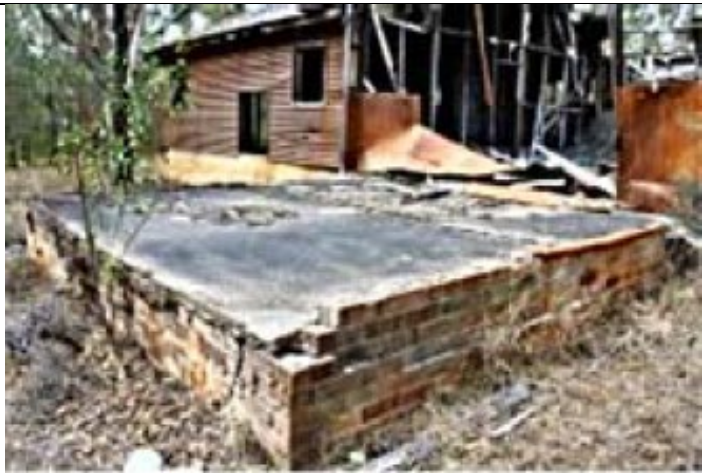
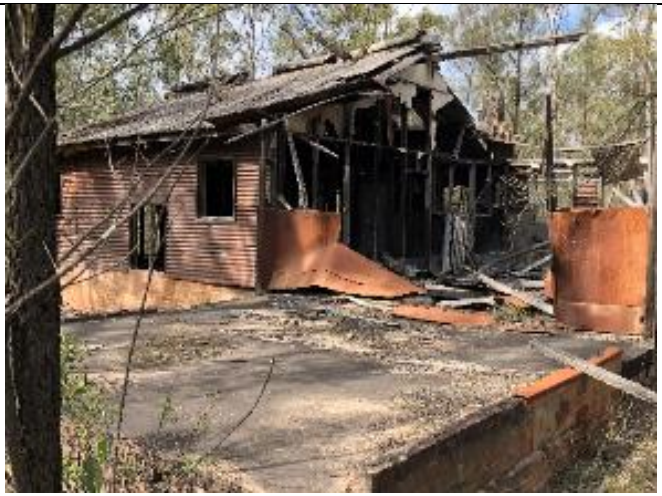
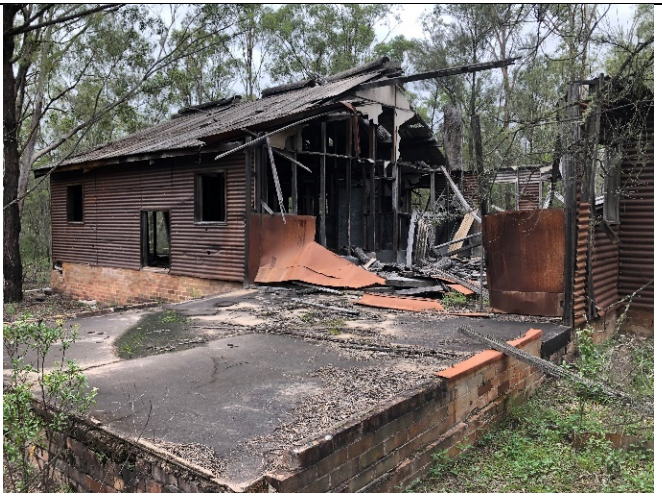
| 2012 | 2018 | 2020 (Mar) | 2020 (Dec) |
|---|---|---|---|
| <b>Concrete and brick foundation at east side of building</b><br><b>2012-18:</b> difficult to discern change.<br><b>2018-20 (Mar):</b> no discernible change.<br><b>Mar 2020 – Dec 2020:</b> no discernible change. | | | |

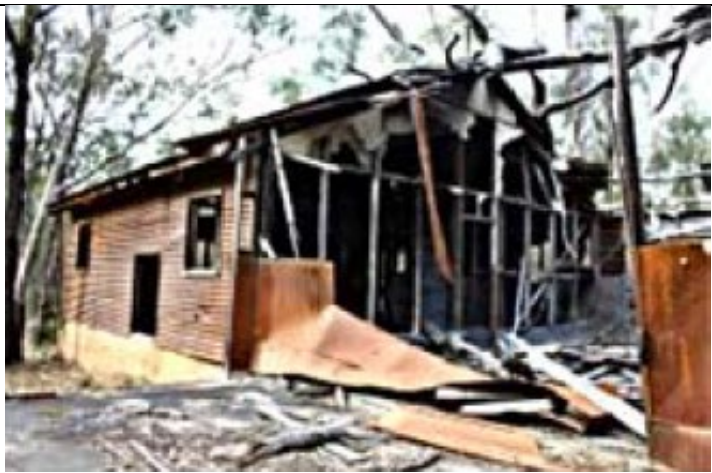
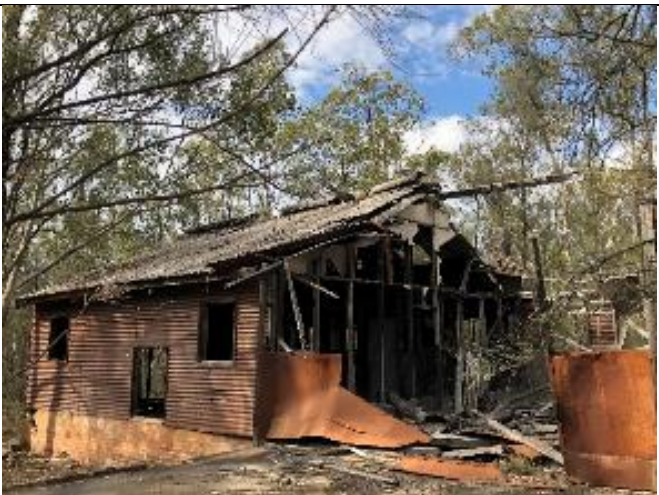
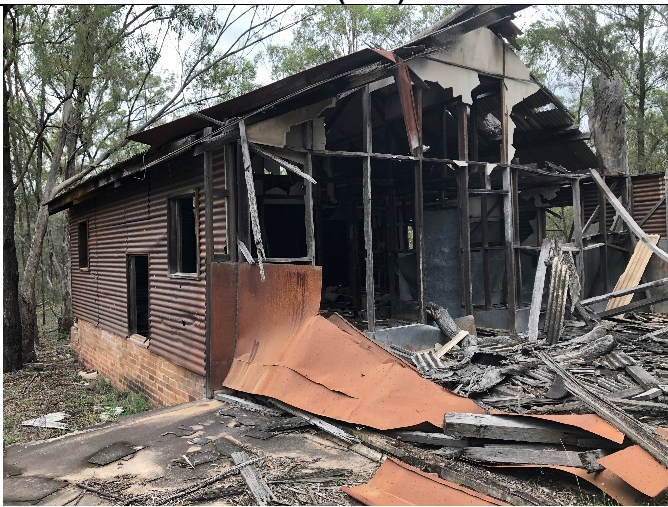
| 2012 | 2018 | 2020 (Mar) | 2020 (Dec) |
|---|---|---|---|
| <p><b>View to building interior from north-east</b><br/> <b>2012-18:</b> shows collapse of remnant roofing members above open kitchen area.<br/> <b>2018-20 (Mar):</b> further minor deterioration of asbestos sheeting panelling.<br/> <b>Mar 2020 – Dec 2020:</b> no discernible change.</p> | | | |

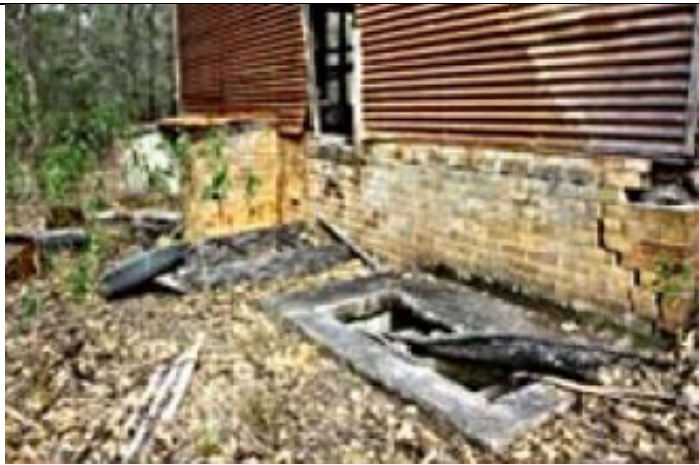
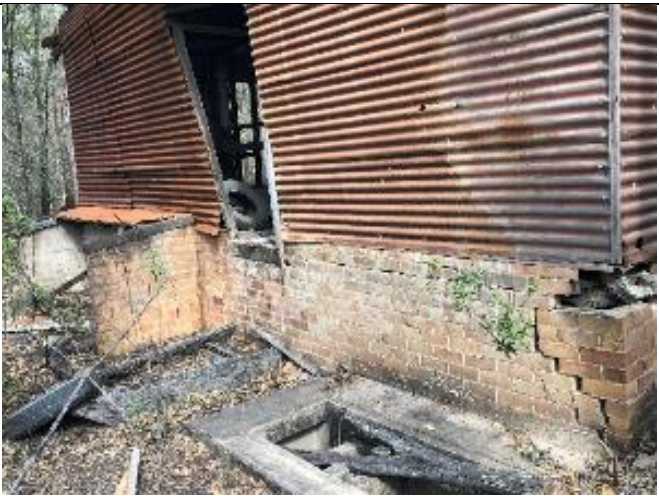
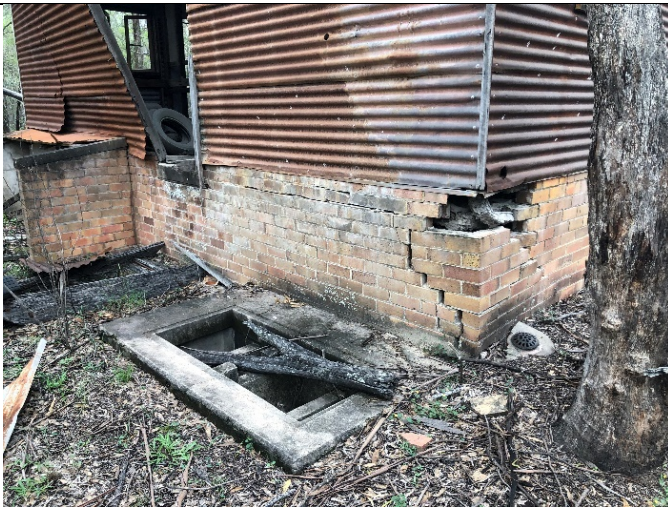
| 2012 | 2018 | 2020 (Mar) | 2020 (Dec) |
|---|---|---|---|
| <p><b>Grease trap at south end of building</b><br/> <b>2012-18:</b> shows bow to south wall.<br/> <b>2018-20 (Mar):</b> shows increased bow to south wall.<br/> <b>Mar 2020 – Dec 2020:</b> shows increasing bowing of south wall, and example of new termite monitoring system in bottom right of picture.</p> | | | |

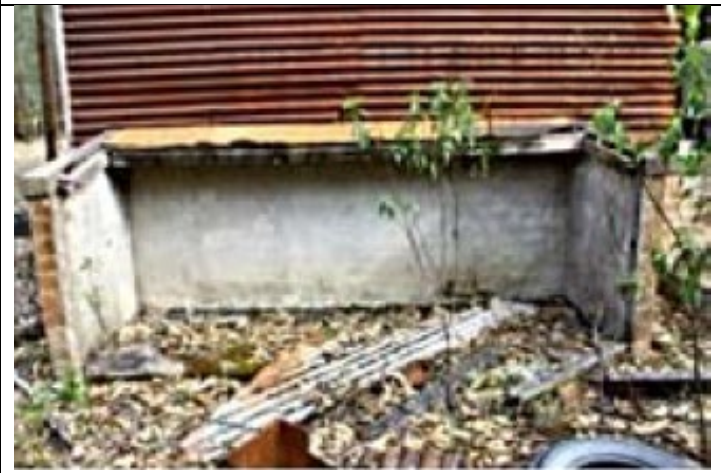
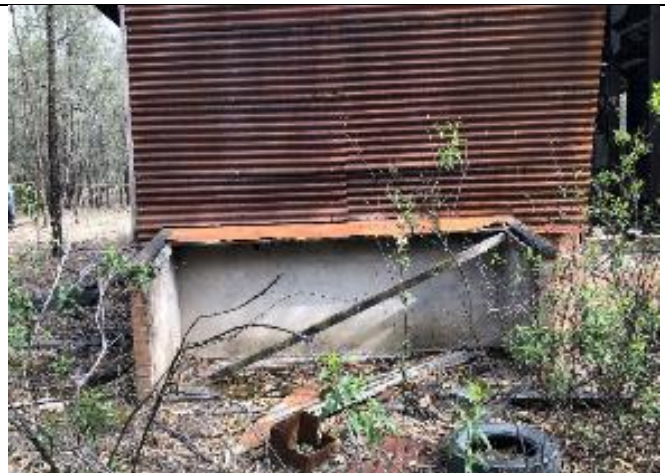
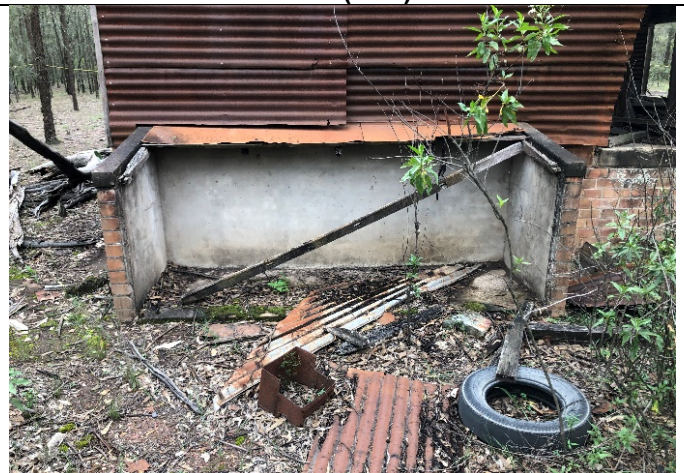
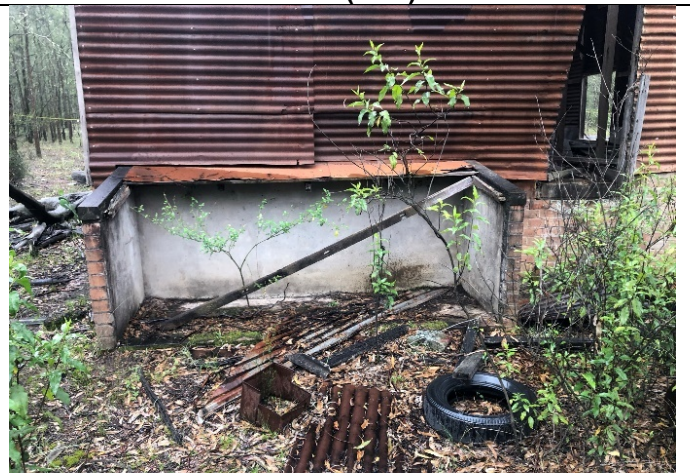
| 2012 | 2018 | 2020 (Mar) | 2020 (Dec) |
|---|---|---|---|
| <b>Storage area at south end of building</b><br><b>2012-18:</b> further slight collapse of storage area.<br><b>2018-20 (Mar):</b> shows loosening of corrugated iron wall sheeting due to bowing in wall.<br><b>Mar 2020 – Dec 2020:</b> no discernible change. | | | |

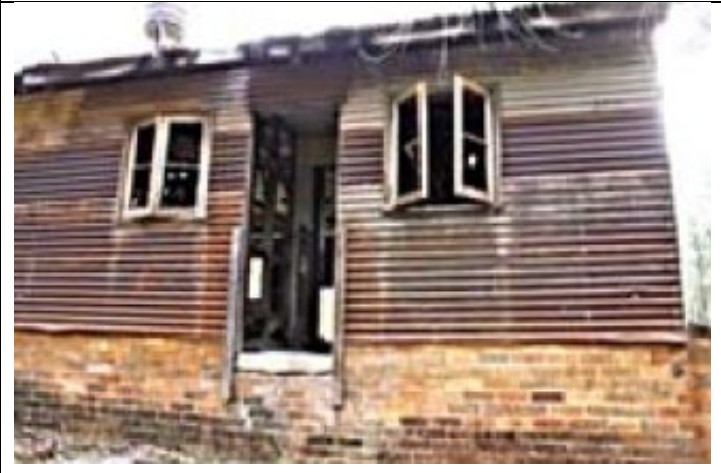
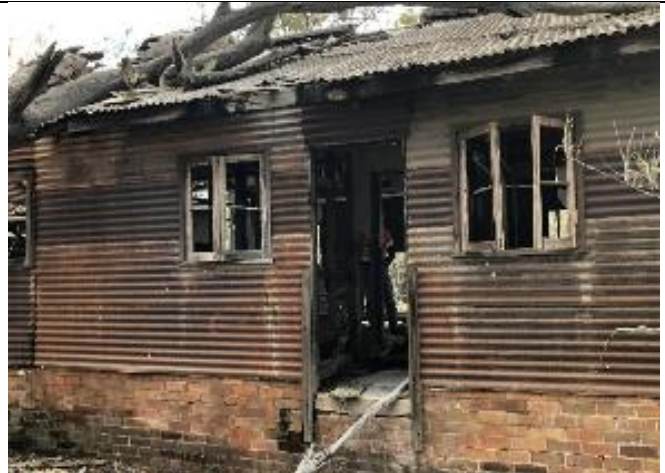
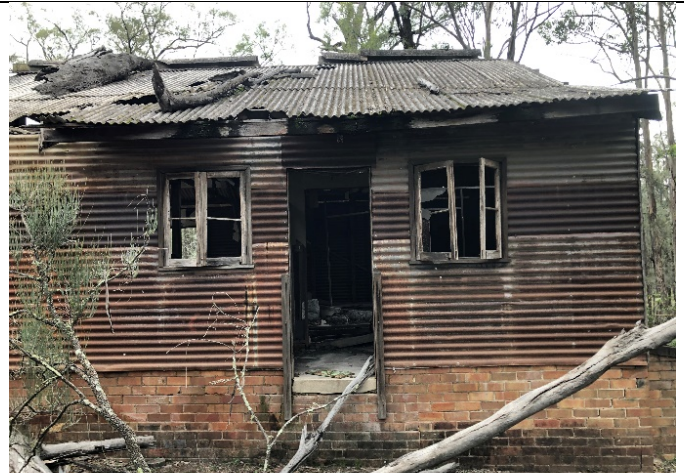
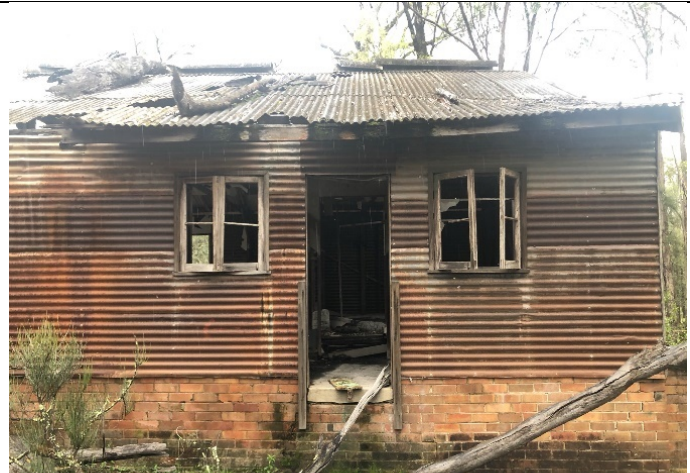
| 2012 | 2018 | 2020 (Mar) | 2020 (Dec) |
|---|---|---|---|
| <b>Windows and entry at west elevation</b><br><b>2012-18:</b> shows large trunk/branch portions of tree collapsed on roof, which has destroyed roof ventilator.<br><b>2018-20 (Mar):</b> shows majority of branches fallen from roof, leaving increased damage to sheeting.<br><b>Mar 2020 – Dec 2020:</b> no discernible change. | | | |

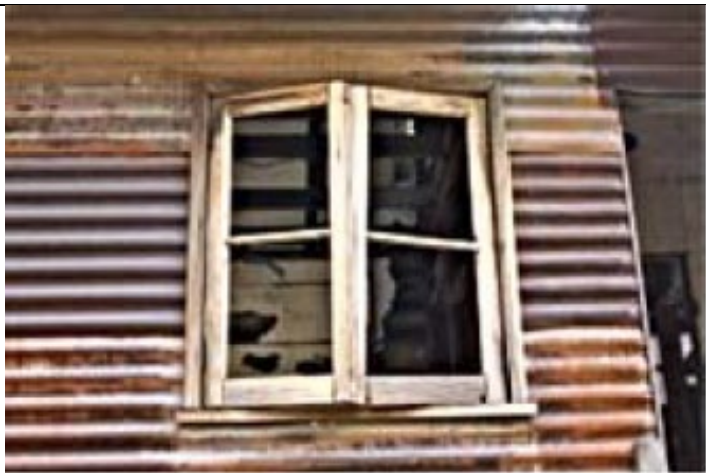
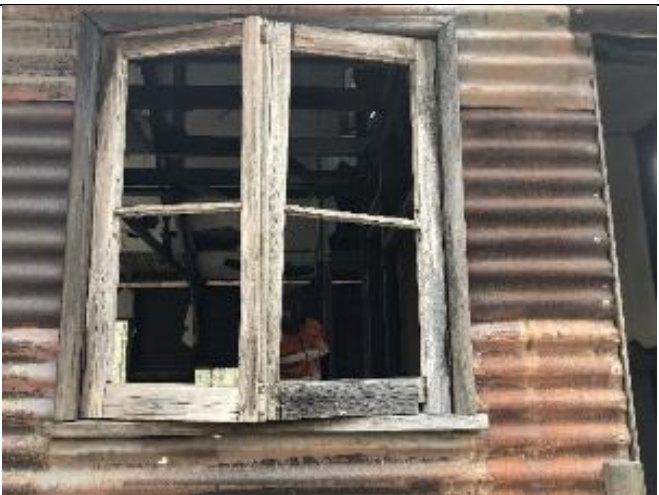
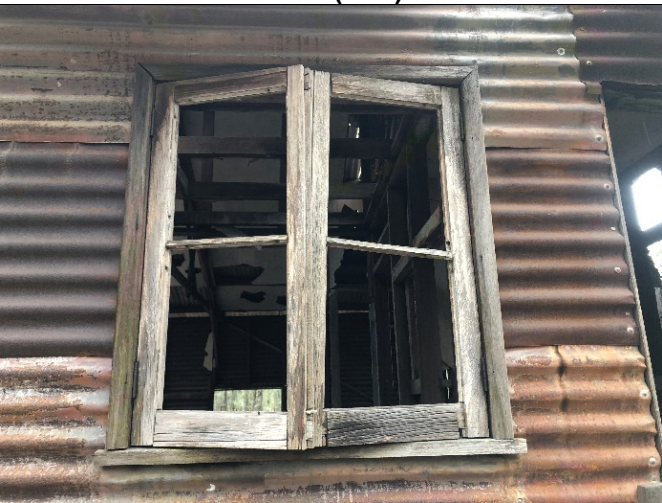
| 2012 | 2018 | 2020 (Mar) | 2020 (Dec) |
|---|---|---|---|
| <b>Timber window detail, west elevation</b><br><b>2012-18:</b> no discernible change.<br><b>2018-20 (Mar):</b> no discernible change.<br><b>Mar 2020 – Dec 2020:</b> no discernible change. | | | |

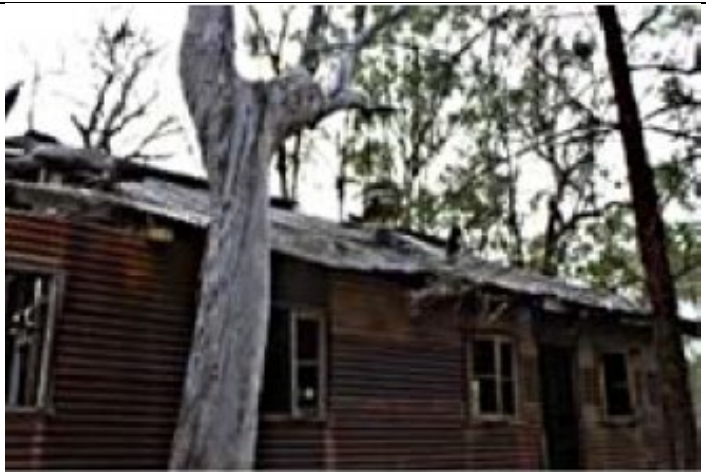
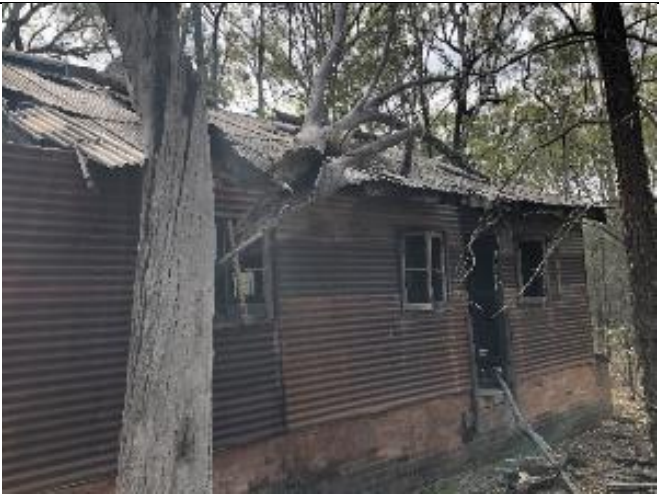
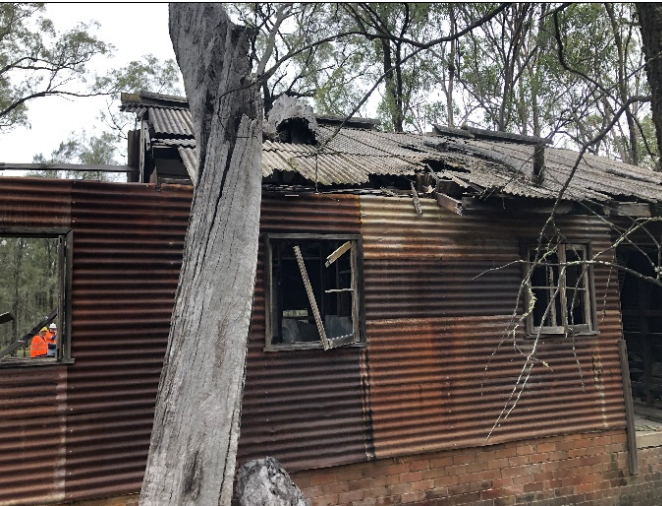
| 2012 | 2018 | 2020 (Mar) | 2020 (Dec) |
|---|---|---|---|
| <b>Showing cylindrical ventilator and damage to roof, view from west</b><br><b>2012-18:</b> shows significant roof damage from fallen dead tree, including to ventilator.<br><b>2018-20 (Mar):</b> shows increased damage to roof edge sheeting from fallen branch.<br><b>Mar 2020 – Dec 2020:</b> no discernible change. | | | |

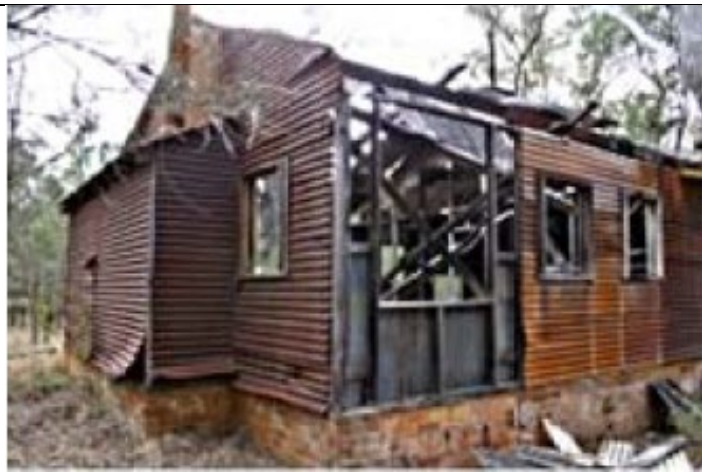
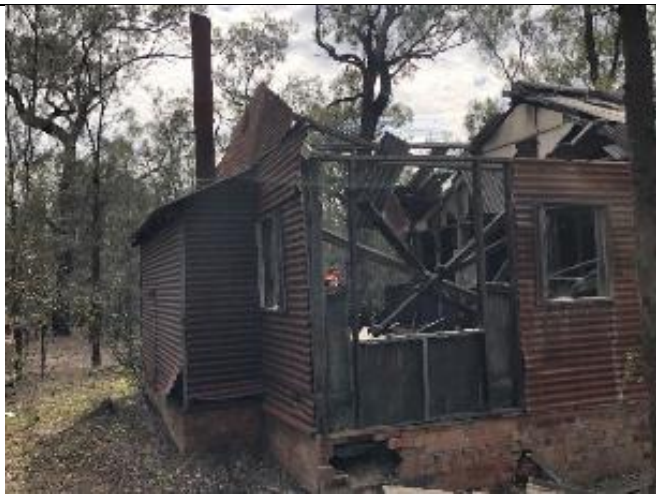
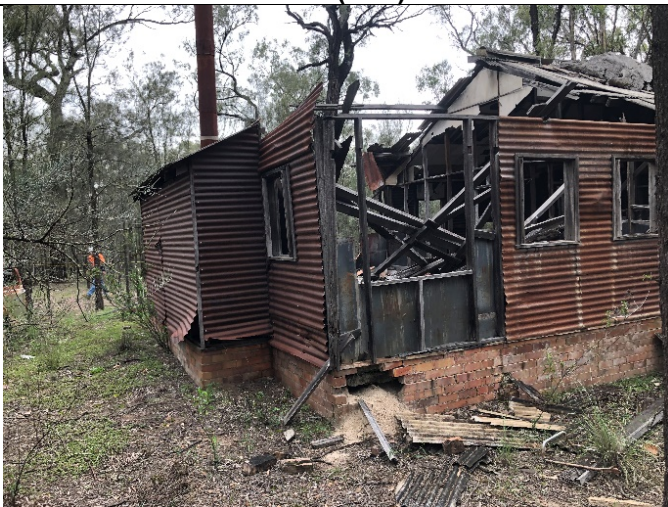
| 2012 | 2018 | 2020 (Mar) | 2020 (Dec) |
|---|---|---|---|
| <p><b>Detail of north-west elevation</b><br/> <b>2012-18:</b> shows increased collapse over open kitchen area, as well as new damage to brick foundation at north-west corner.<br/> <b>2018-20 (Mar):</b> shows fallen top of north wall plus increased (animal?) damage to brick foundation at north-western corner.<br/> <b>Mar 2020 – Dec 2020:</b> no discernible change.</p> | | | |

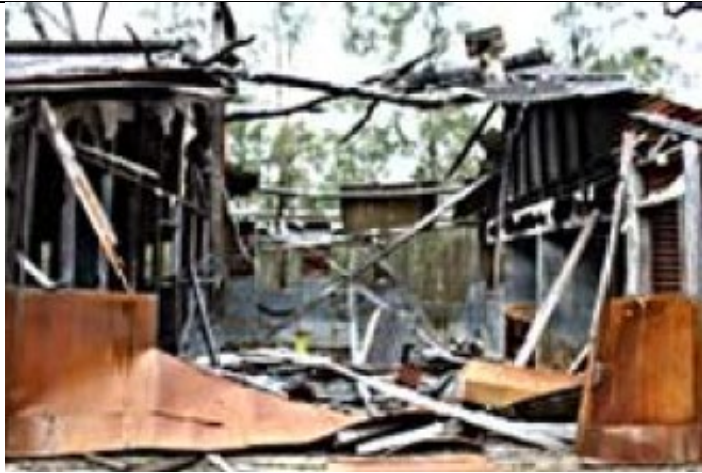
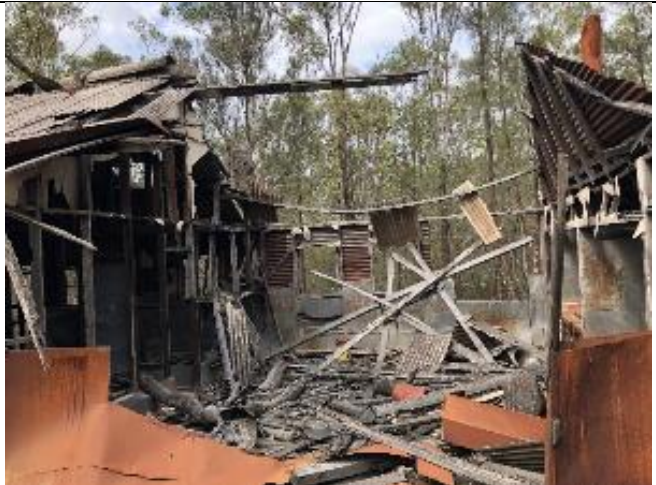
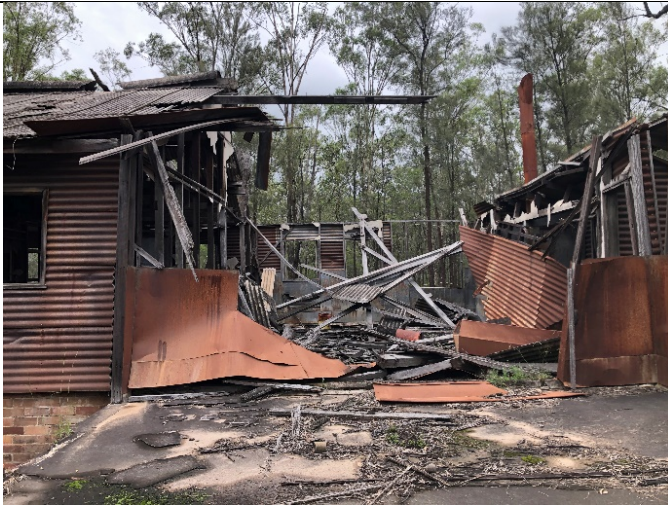
| 2012 | 2018 | 2020 (Mar) | 2020 (Dec) |
|---|---|---|---|
| <p><b>Showing interior damage at kitchen at north end of building</b><br/> <b>2012-18:</b> shows increased collapse over and accumulation of debris within open kitchen area. Note also severe lean to north wall.<br/> <b>2018-20 (Mar):</b> shows collapsed top of north wall and collapse of remaining full cross-beam.<br/> <b>Mar 2020 – Dec 2020:</b> no discernible change.</p> | | | |
