# Mount Thorley Warkworth Historic Heritage Management Plan 2020 Compliance Audit Inspection

Report prepared for

Yancoal Australia, Mount Thorley Warkworth

January 2021

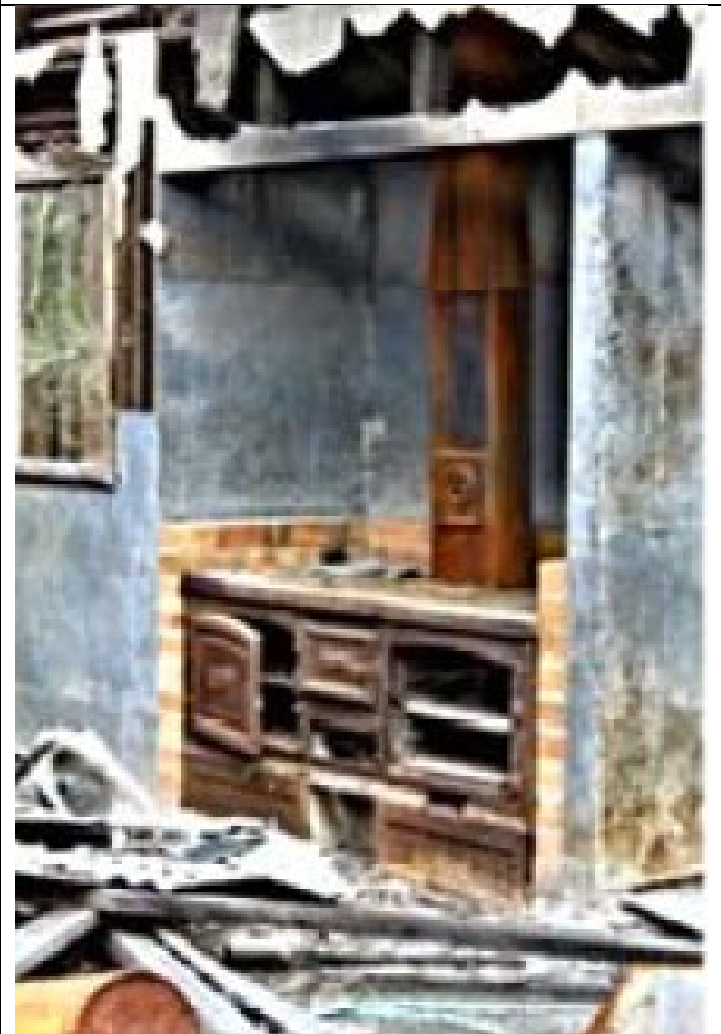
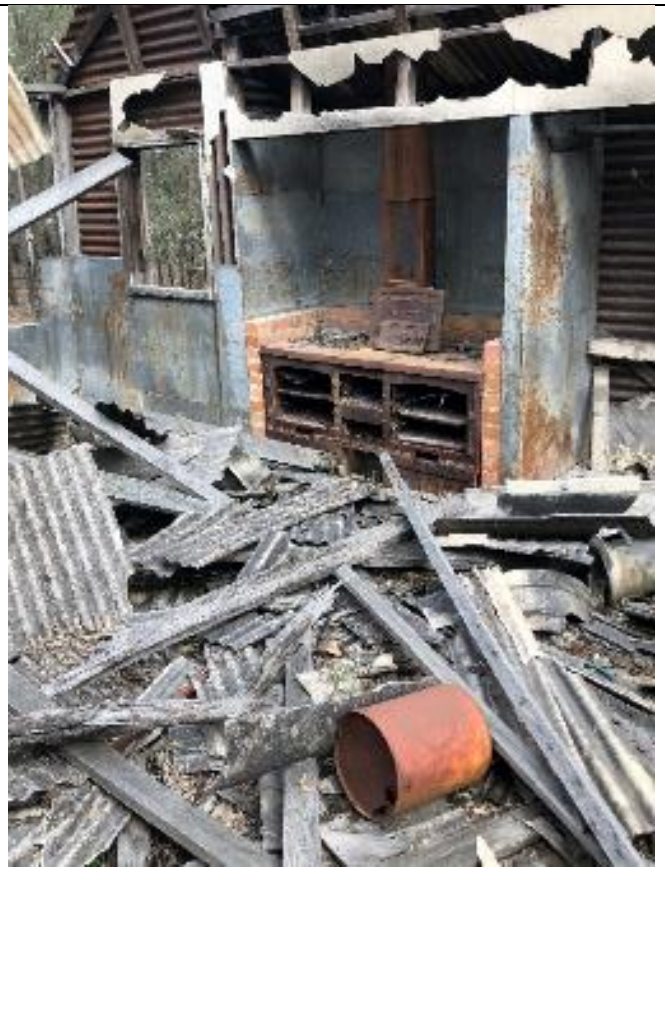
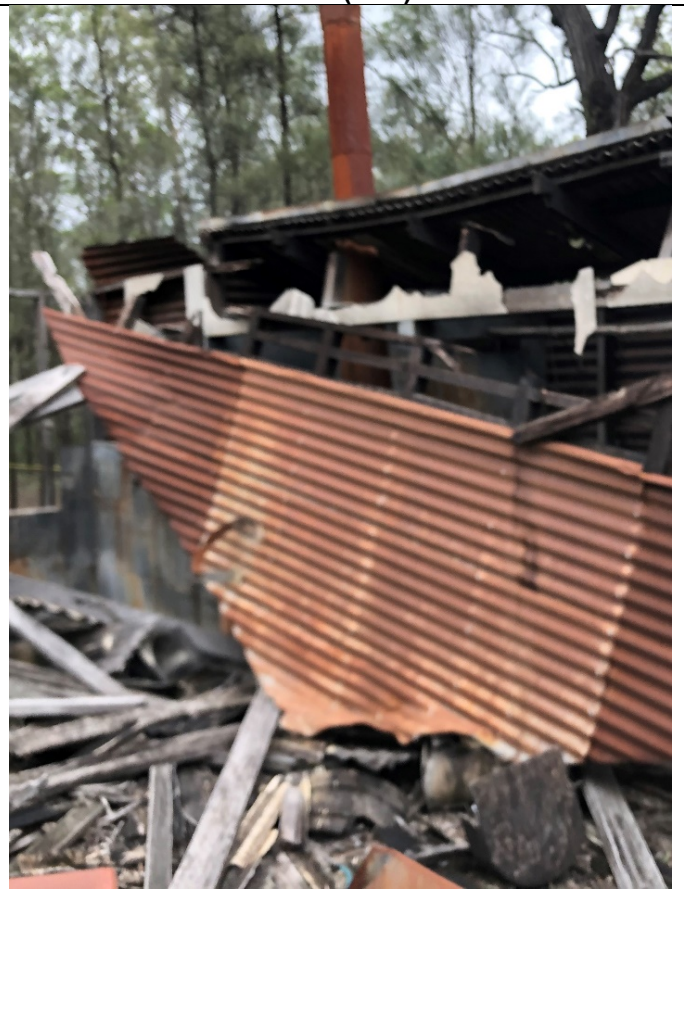
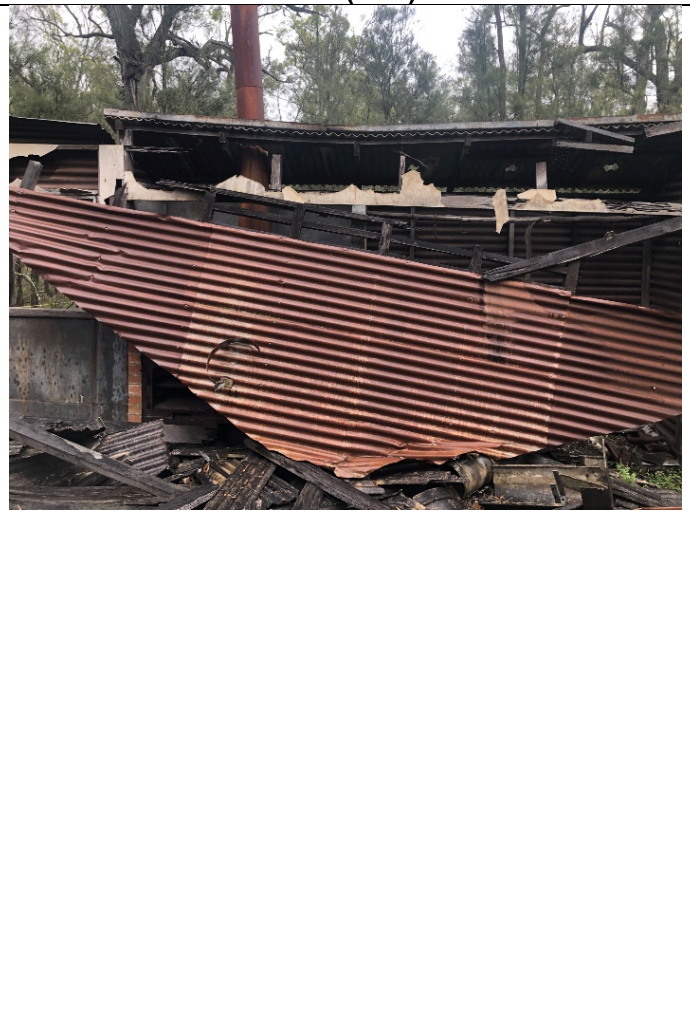
| 2012 | 2018 | 2020 (Mar) | 2020 (Dec) |
|---|---|---|---|
| <p><b>Showing stove at kitchen at north end</b><br/> <b>2012-18:</b> note the remaining two stove doors have become unhinged and build up of debris from collapsed roof.<br/> <b>2018-20 (Mar):</b> stove now obscured by collapsed north wall.<br/> <b>Mar 2020 – Dec 2020:</b> no discernible change.</p> | | | |

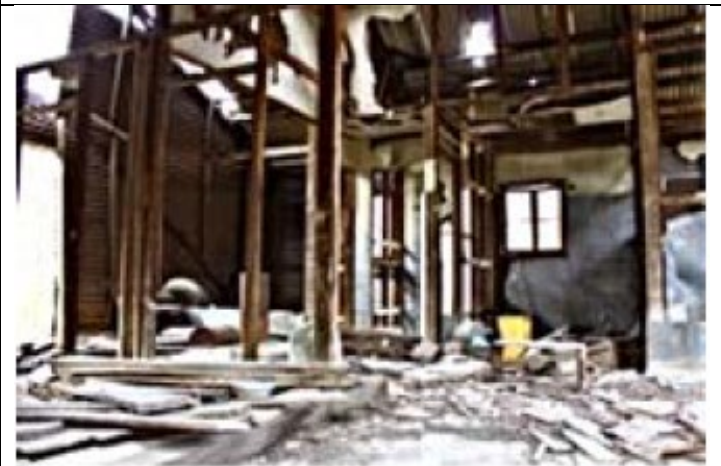
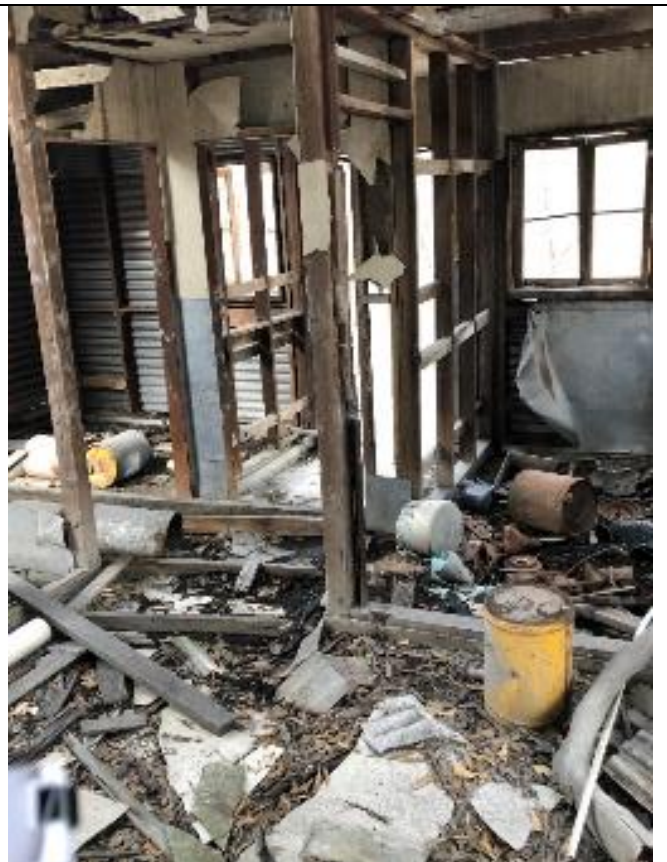
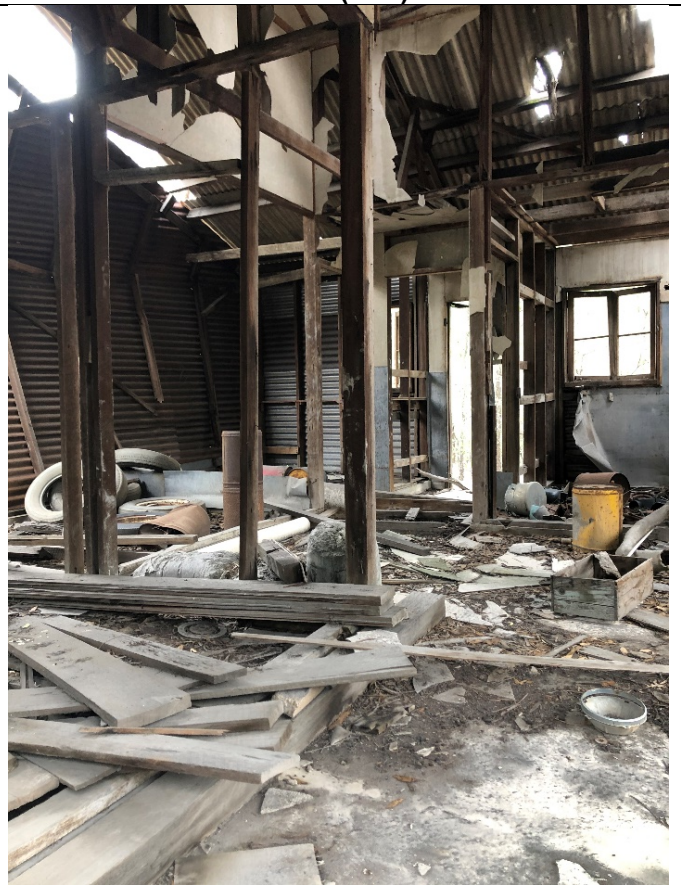
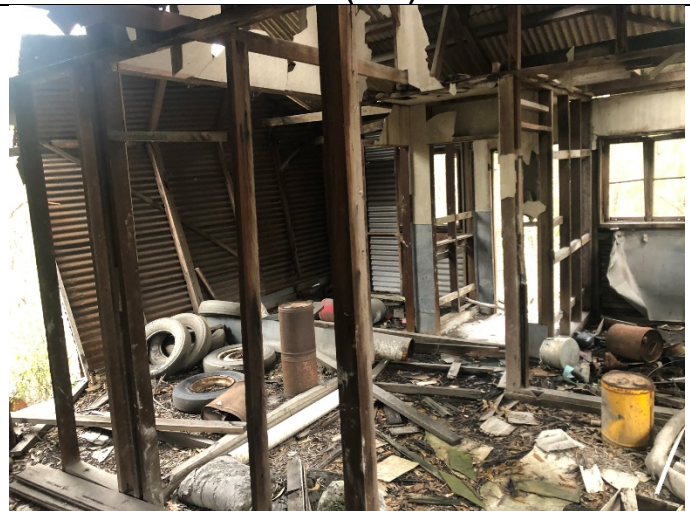
| 2012 | 2018 | 2020 (Mar) | 2020 (Dec) |
|---|---|---|---|
| <p><b>View to interior, showing west entry to building</b><br/> <b>2012-18:</b> no discernible change.<br/> <b>2018-20 (Mar):</b> no discernible change.<br/> <b>Mar 2020 – Dec 2020:</b> no discernible change.</p> | | | |

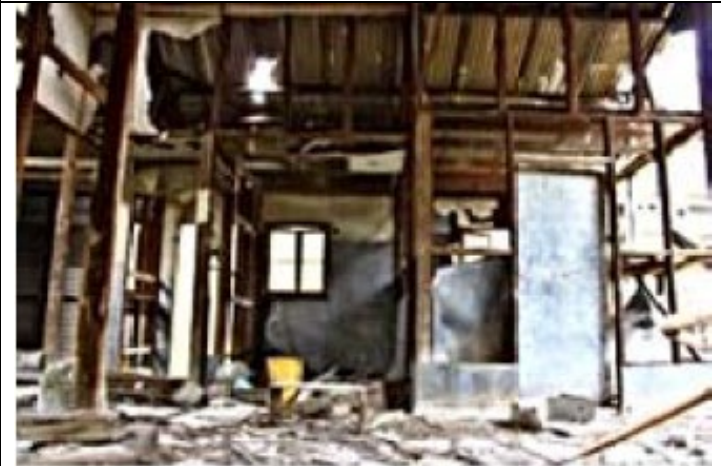
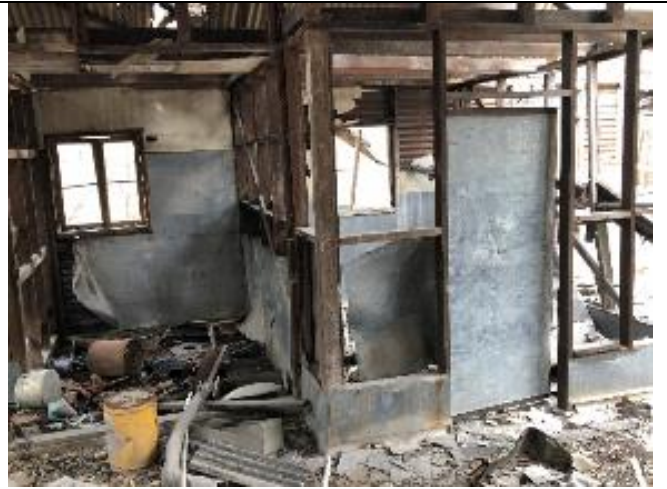
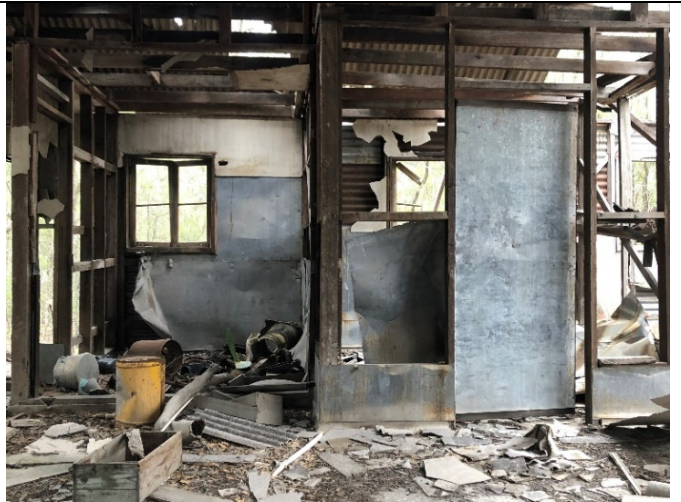
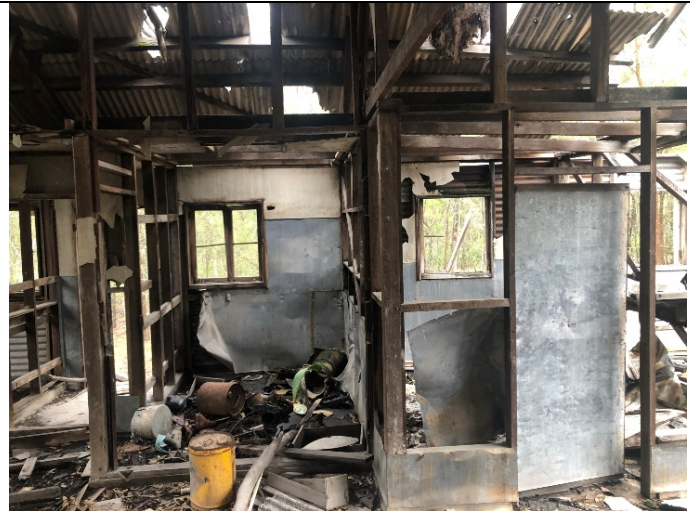
| 2012 | 2018 | 2020 (Mar) | 2020 (Dec) |
|---|---|---|---|
| <p><b>Showing west interior space</b><br/> <b>2012-18:</b> no discernible change.<br/> <b>2018-20 (Mar):</b> no discernible change.<br/> <b>Mar 2020 – Dec 2020:</b> no discernible change.</p> | | | |

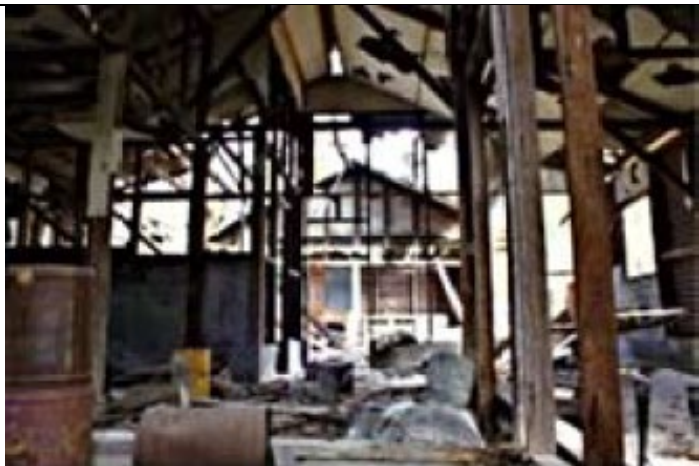
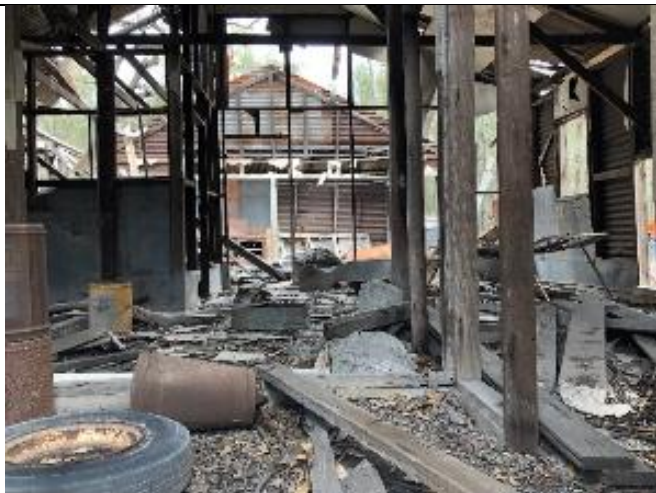
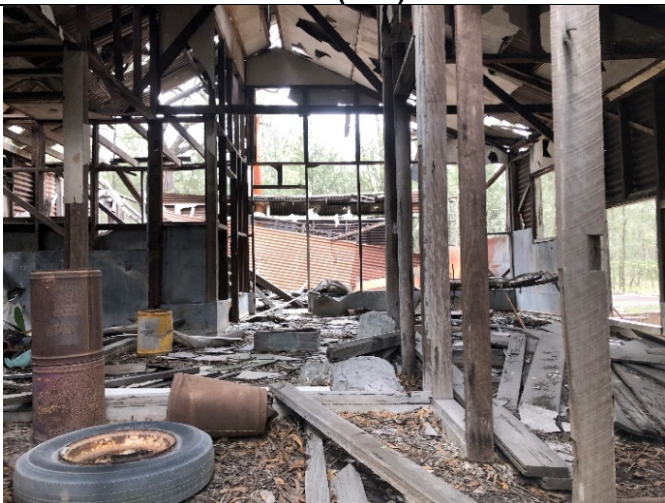
| 2012 | 2018 | 2020 (Mar) | 2020 (Dec) |
|---|---|---|---|
| <p><b>View to interior of building, looking north from south entry</b><br/> <b>2012-18:</b> no discernible change.<br/> <b>2018-20 (Mar):</b> no discernible interior change, but shows collapsed north wall.<br/> <b>Mar 2020 – Dec 2020:</b> no discernible change.</p> | | | |

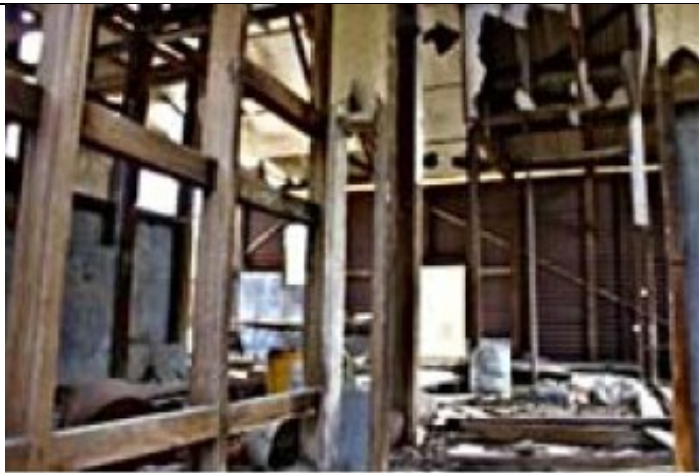
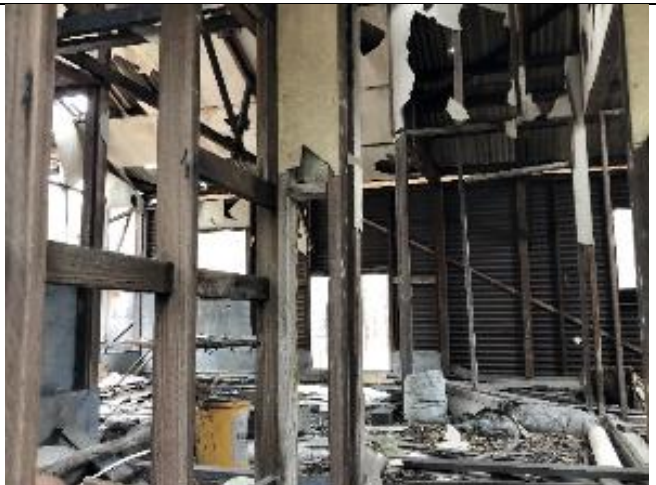
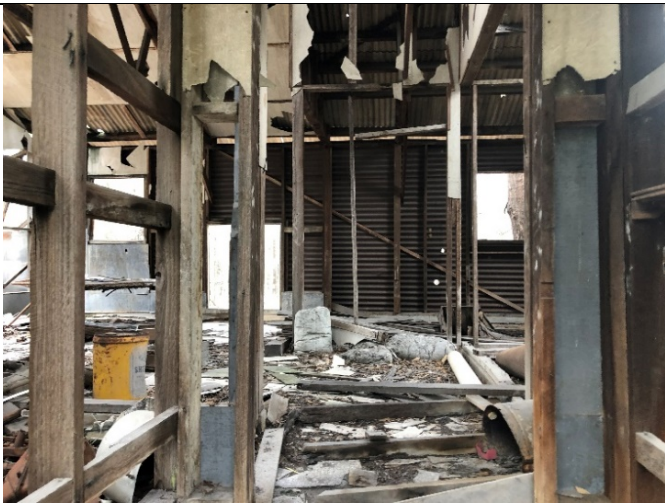
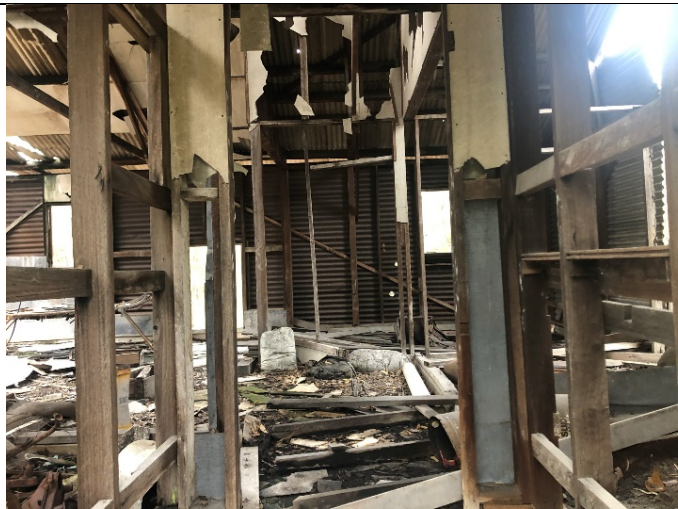
| 2012 | 2018 | 2020 (Mar) | 2020 (Dec) |
|---|---|---|---|
| <p><b>View to interior of building from entry at west</b><br/> <b>2012-18:</b> no discernible change.<br/> <b>2018-20 (Mar):</b> no discernible change.<br/> <b>Mar 2020 – Dec 2020:</b> no discernible change.</p> | | | |

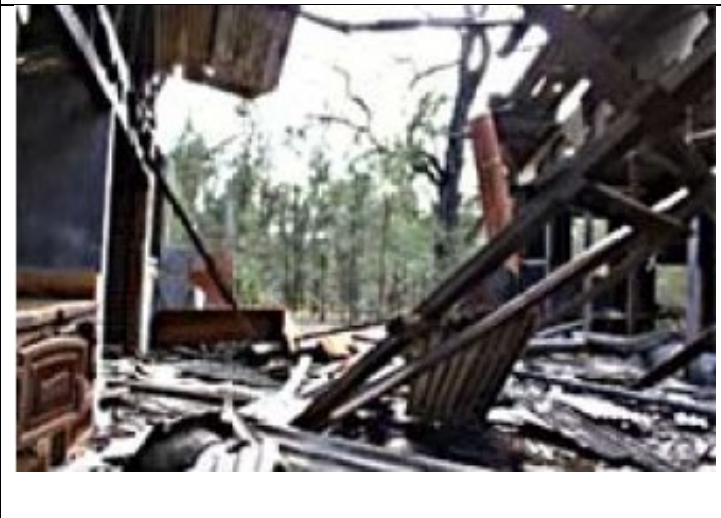
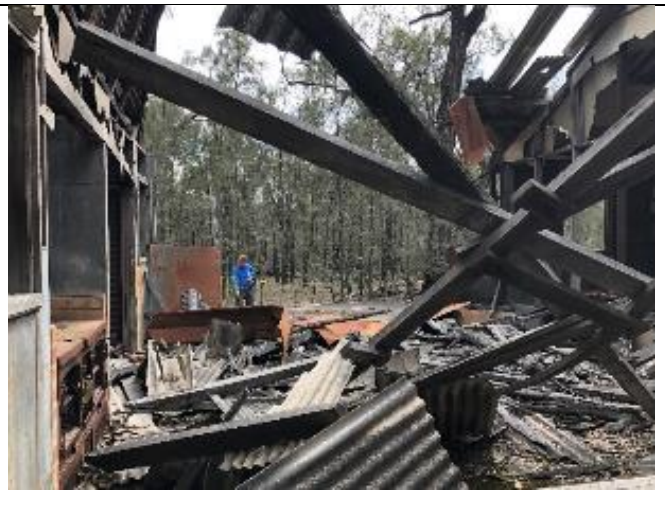
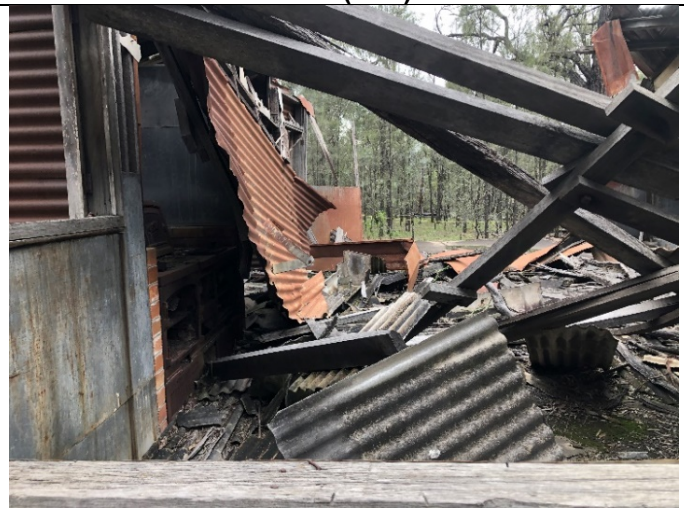
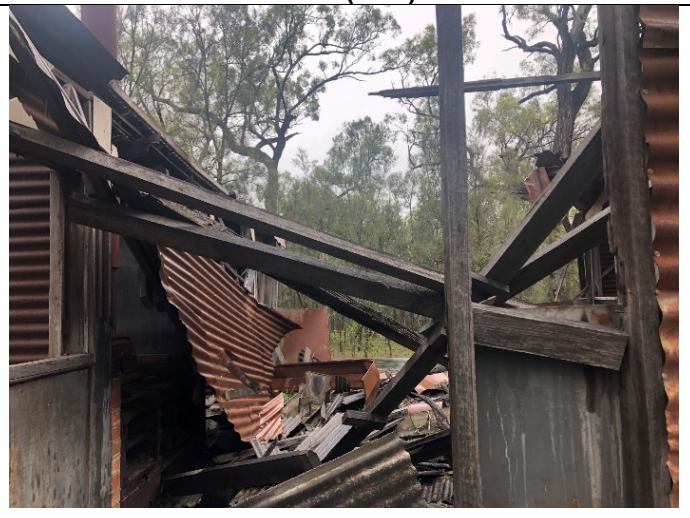
| 2012 | 2018 | 2020 (Mar) | 2020 (Dec) |
|---|---|---|---|
| <p><b>Showing interior of building, viewed from north-west corner</b><br/> <b>2012-18:</b> shows collapsed roofing members above open kitchen area and accumulation of debris.<br/> <b>2018-20 (Mar):</b> shows collapsed north wall across stove and additional fallen roof member.<br/> <b>Mar 2020 – Dec 2020:</b> no discernible change.</p> | | | |

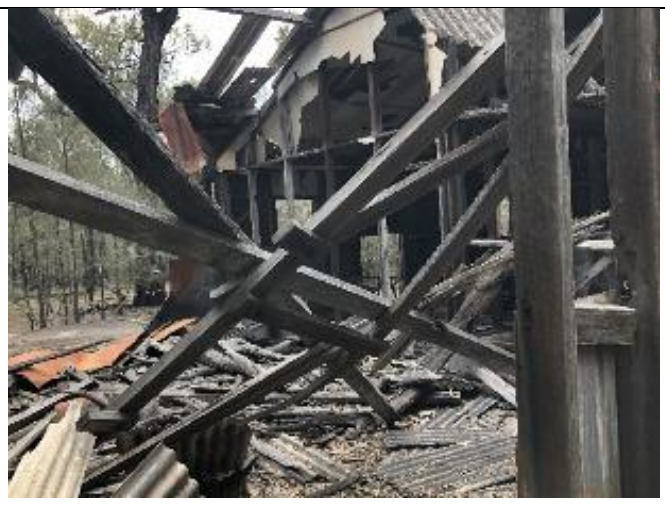
| 2012 | 2018 | 2020 (Mar) | 2020 (Dec) |
|---|---|---|---|
| <p><b>Showing interior of building, viewed from north-west corner</b><br/> <b>2012-18:</b> shows collapsed roofing members above open kitchen area and accumulation of debris.<br/> <b>2018-20 (Mar):</b> shows additional collapsed roofing member.<br/> <b>Mar 2020 – Dec 2020:</b> no discernible change.</p> | | | |

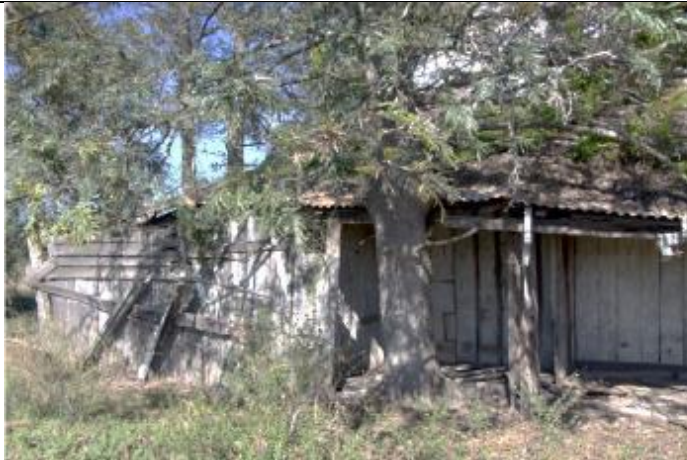
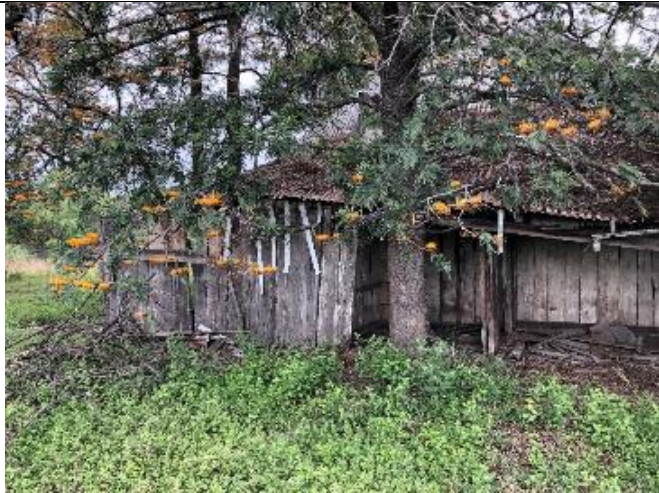
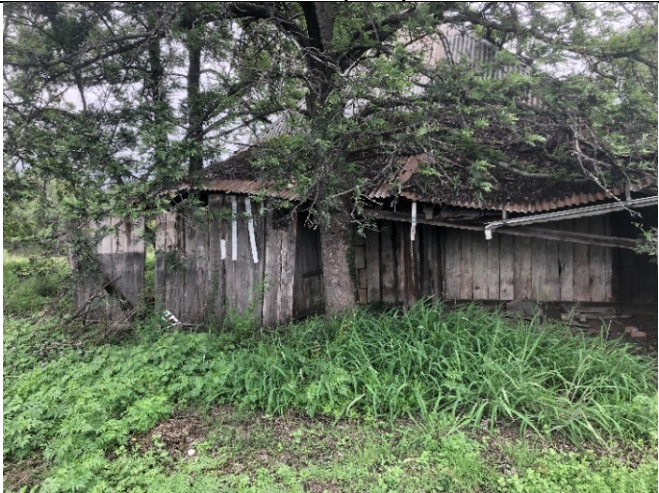
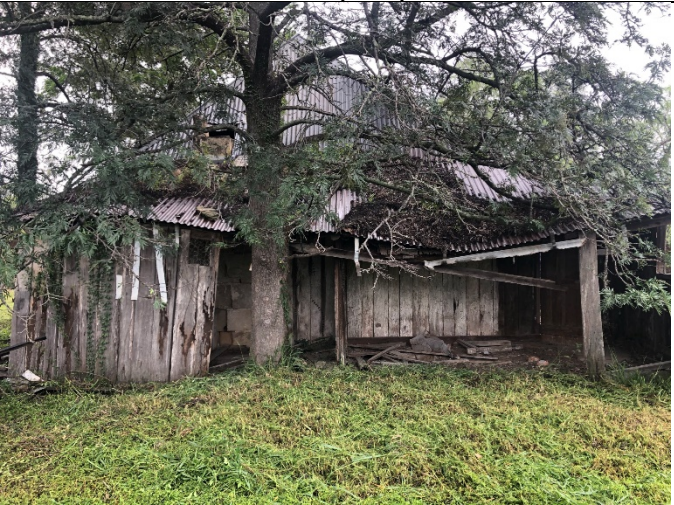
| 2014 | 2018 | 2020 (Mar) | 2020 (Dec) |
|---|---|---|---|
| <p><b>Eastern elevation</b><br/><b>2014-8:</b> no discernible change.<br/><b>2018-20 (Mar):</b> roof slumping appears to have increased.<br/><b>Mar 2020-Dec 2020:</b> heavy leaf litter on roof persists. Positively, vegetation surrounding the house is occurring regularly.</p> | | | |

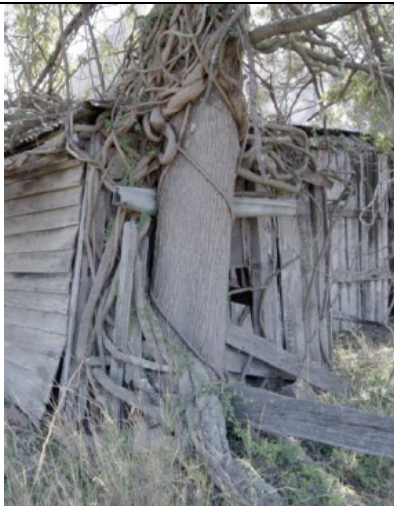
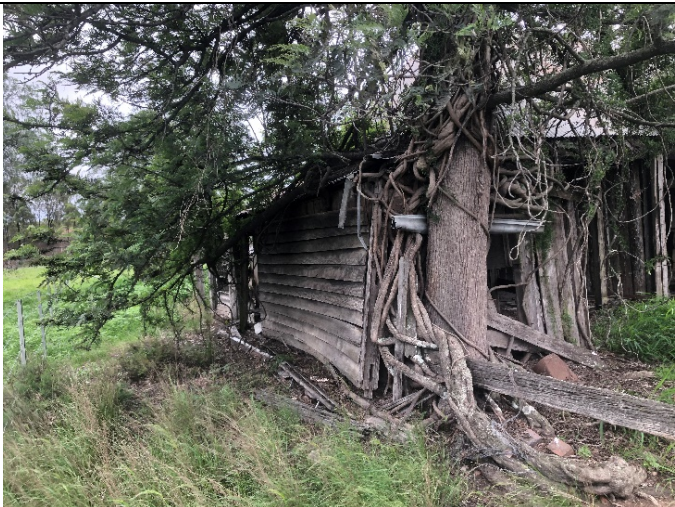
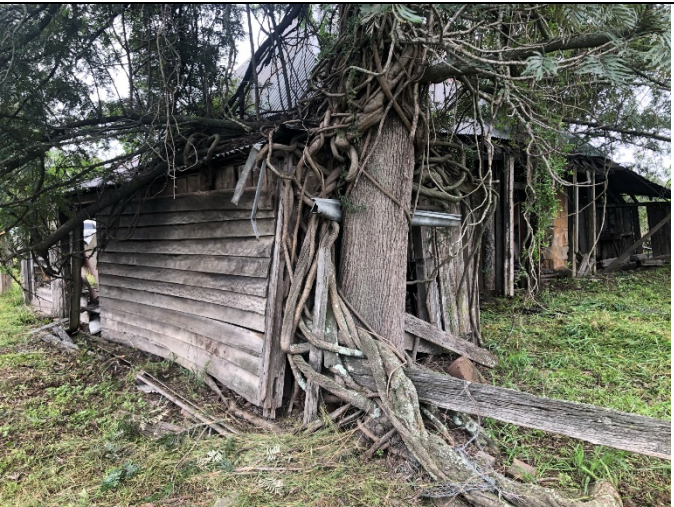
| 2014 | 2018 | 2020 (Mar) | 2020 (Dec) |
|---|---|---|---|
| <p><b>Looking towards south-west corner from south-west</b><br/><b>2014-8:</b> no discernible change to tree impact, but note missing vertical slabs from southern wall.<br/><b>2018-20 (Mar):</b> no discernible change, but vine still growing.<br/><b>Mar 2020-Dec 2020:</b> no discernible change.</p> | | | |

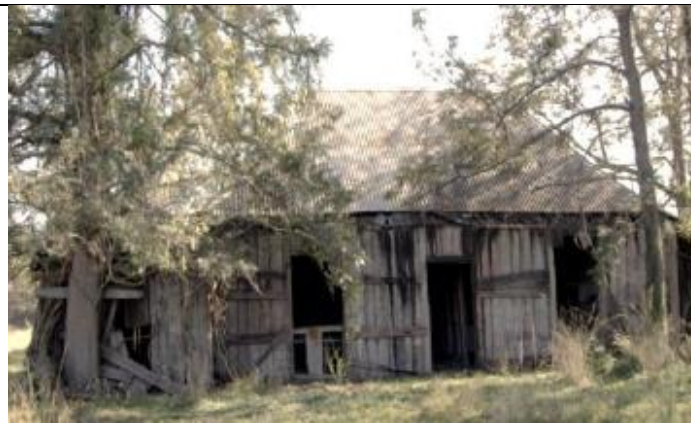
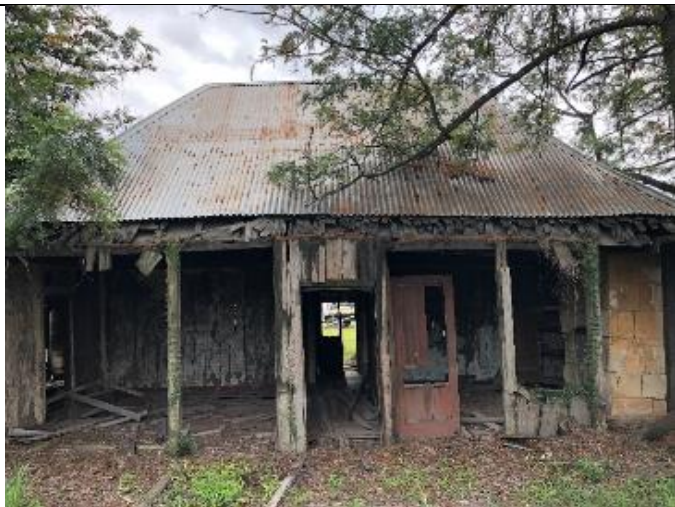
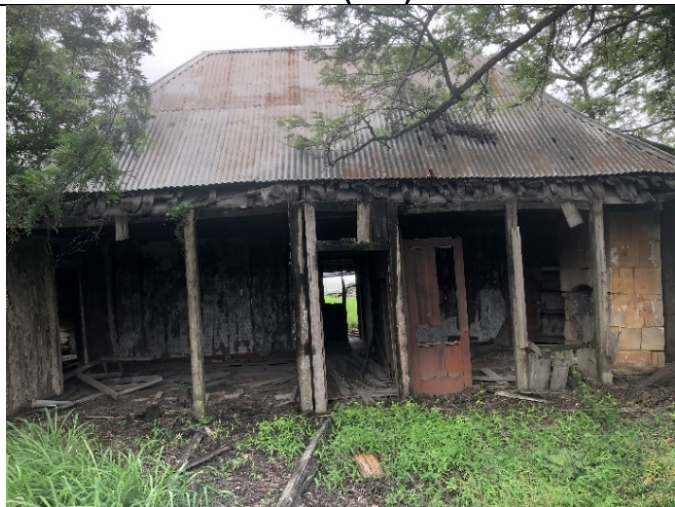
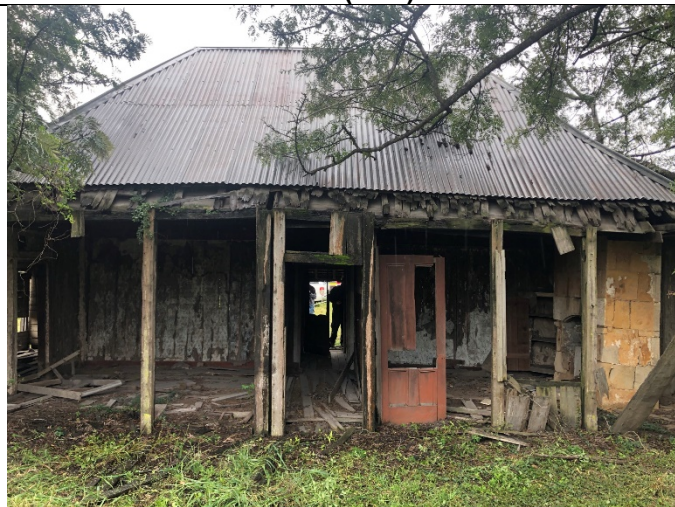
| 2014 | 2018 | 2020 (Mar) | 2020 (Dec) |
|---|---|---|---|
| <b>Southern elevation</b><br><b>2014-8:</b> vertical timber slabs have been removed from southern wall.<br><b>2018-20 (Mar):</b> possible deterioration of shingles at roof edge, and missing panels from above back door.<br><b>Mar 2020-Dec 2020:</b> no discernible change. | | | |

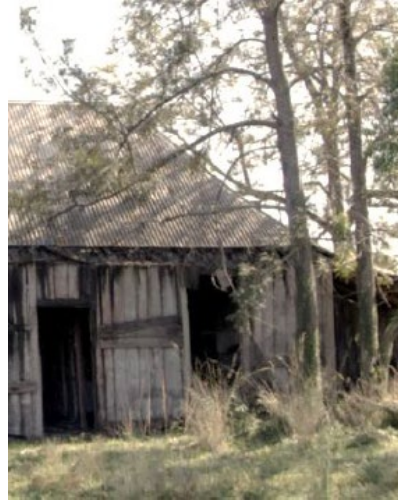
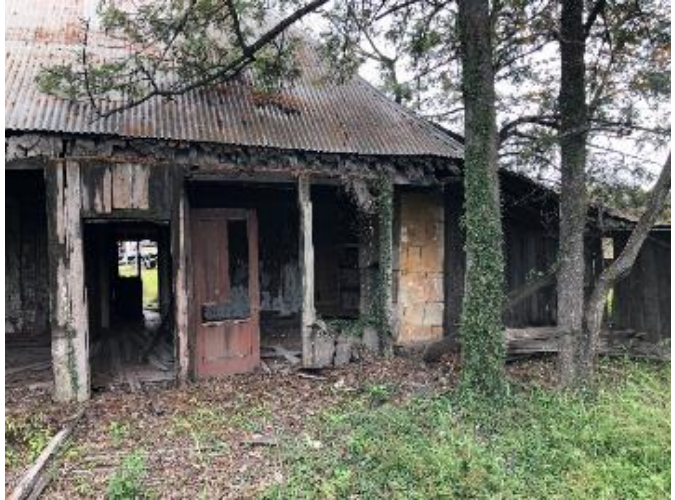
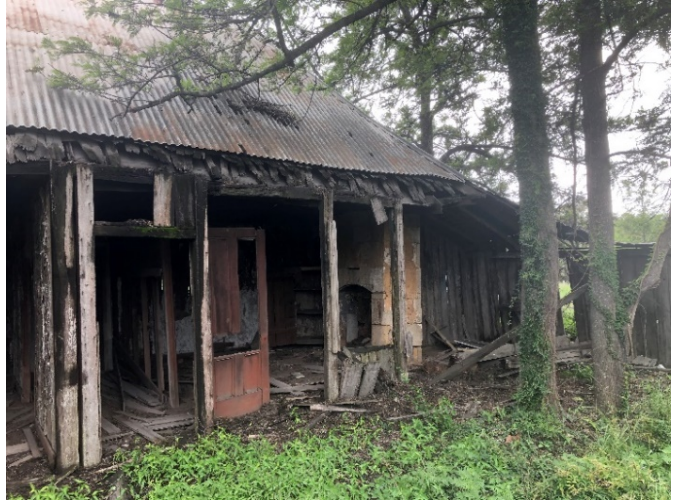
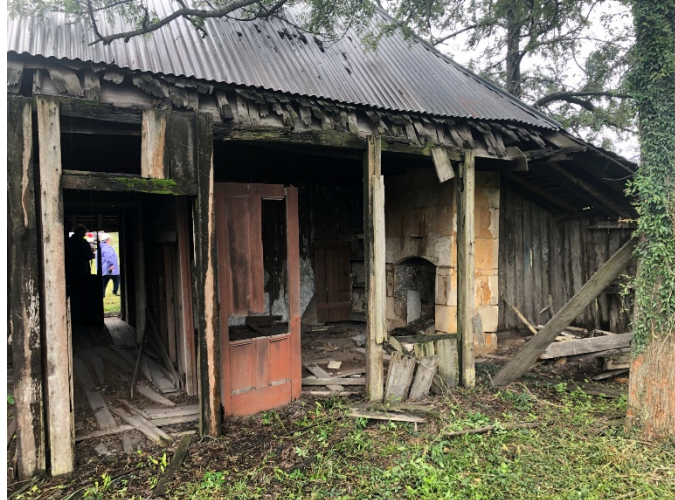
| 2014 | 2018 | 2020 (Mar) | 2020 (Dec) |
|---|---|---|---|
| <b>Southern elevation</b><br><b>2014-8:</b> vertical timber slabs have been removed from southern wall.<br><b>2018-20 (Mar):</b> possible deterioration of shingles at roof edge, and missing panels from above back door.<br><b>Mar 2020-Dec 2020:</b> no discernible change. | | | |

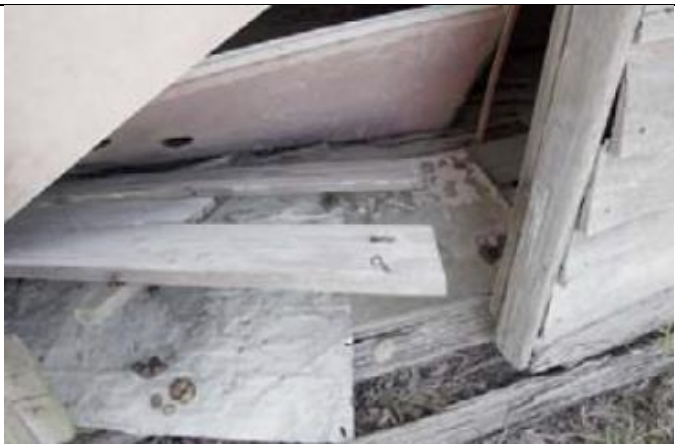
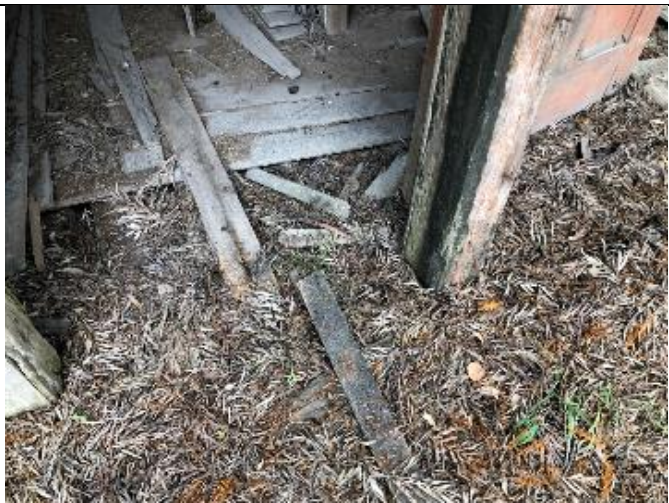
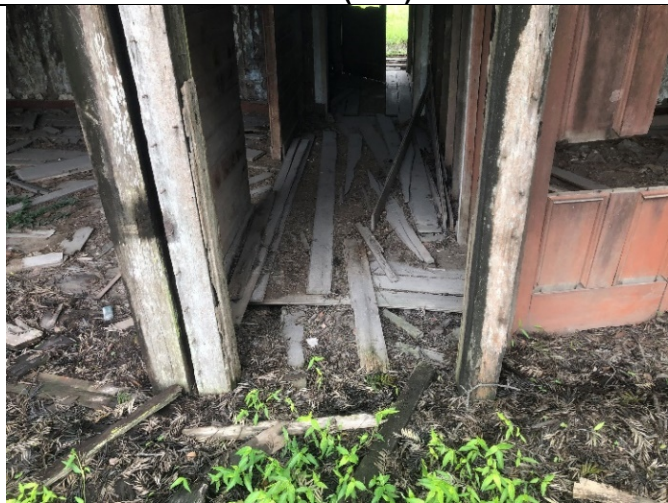
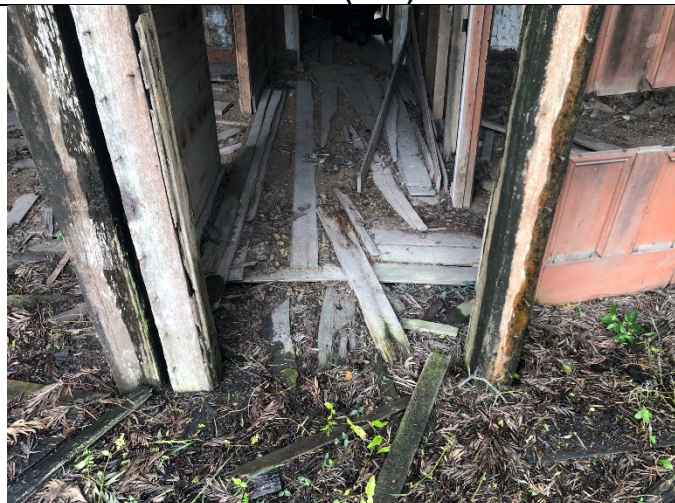
| 2014 | 2018 | 2020 (Mar) | 2020 (Dec) |
|---|---|---|---|
| <b>Southern elevation doorway</b><br><b>2014-8:</b> door has been removed.<br><b>2018-20 (Mar):</b> no discernible change.<br><b>Mar 2020-Dec 2020:</b> no discernible change. | | | |

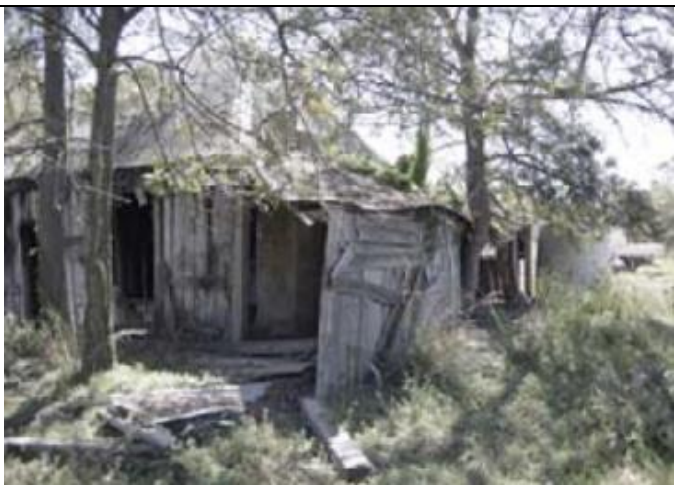
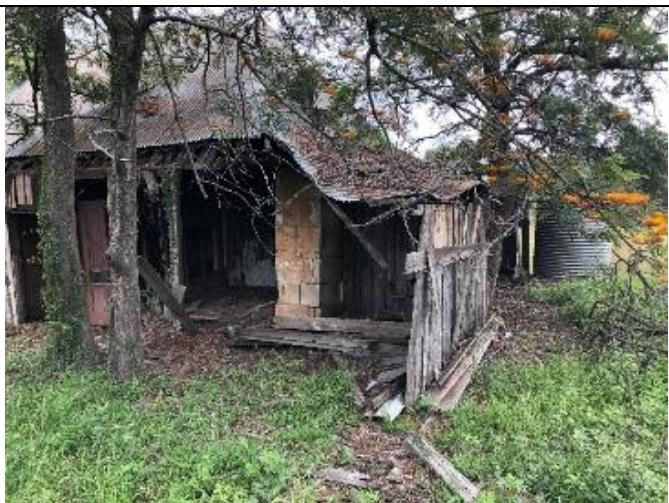
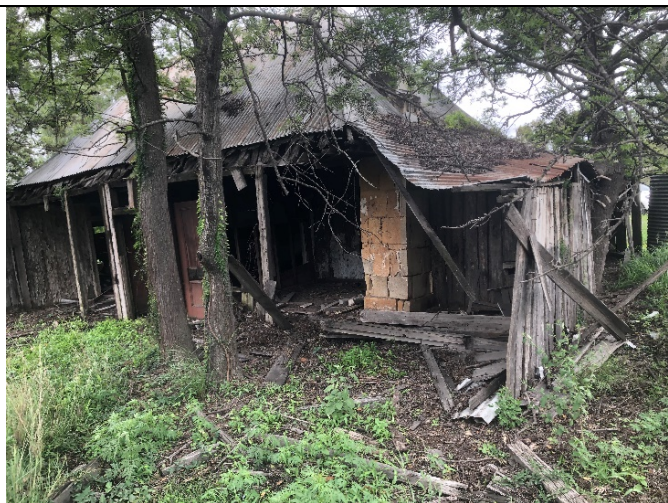
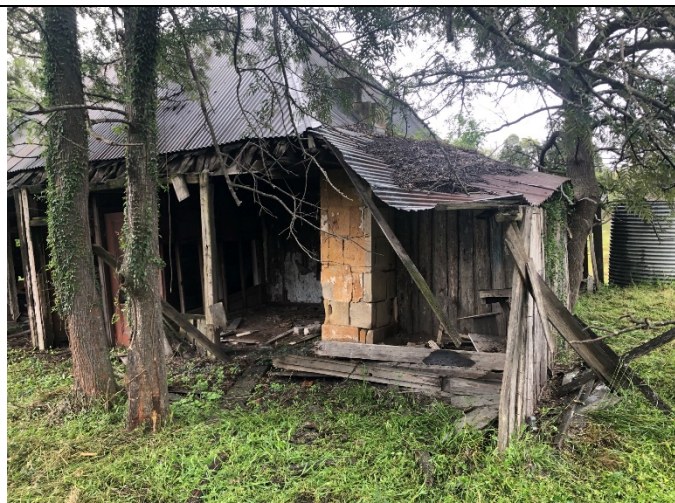
| 2014 | 2018 | 2020 (Mar) | 2020 (Dec) |
|---|---|---|---|
| <b>South-eastern corner</b><br><b>2014-8:</b> vertical slabs have been removed causing further collapse of roof.<br><b>2018-20 (Mar):</b> further deterioration of eastern wall.<br><b>Mar 2020-Dec 2020:</b> heavy leaf litter on roof persists. | | | |

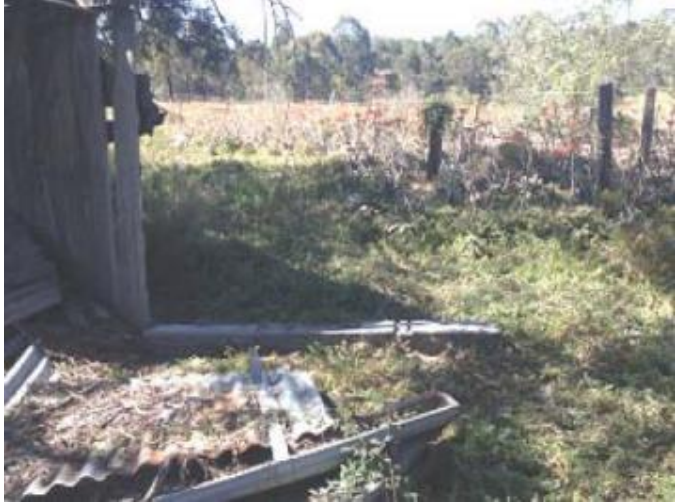
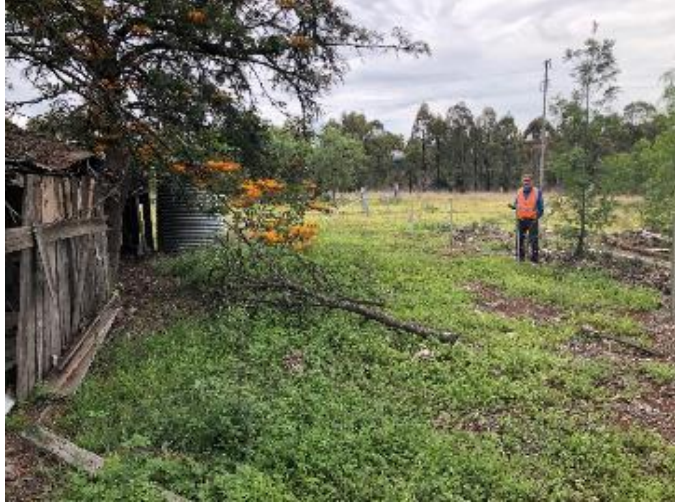
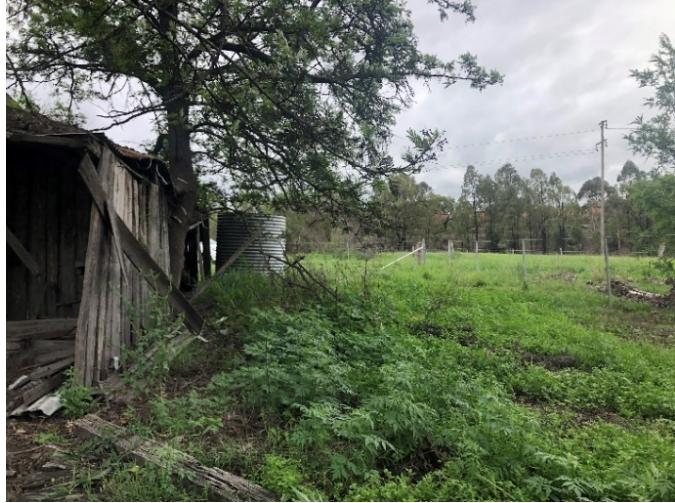
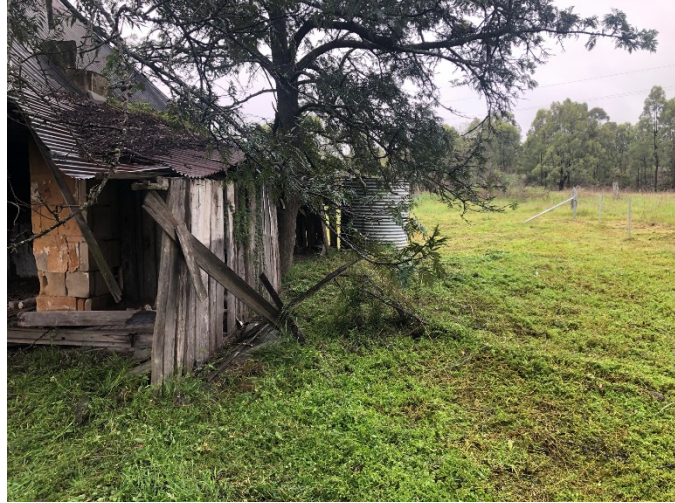
| 2014 | 2018 | 2020 (Mar) | 2020 (Dec) |
|---|---|---|---|
| <b>Eastern side</b><br><b>2014-8:</b> debris has been cleaned and stored and a weed removal program conducted. The house area has also been fenced.<br><b>2018-20 (Mar):</b> further deterioration of eastern wall and regrowth of weeds.<br><b>Mar 2020-Dec 2020:</b> no discernible change. | | | |

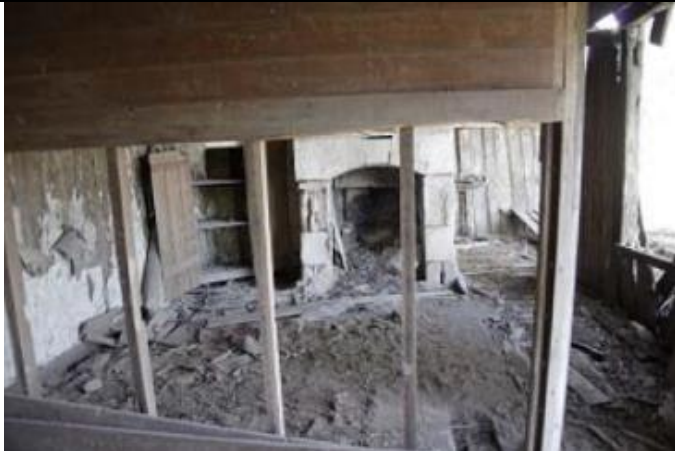
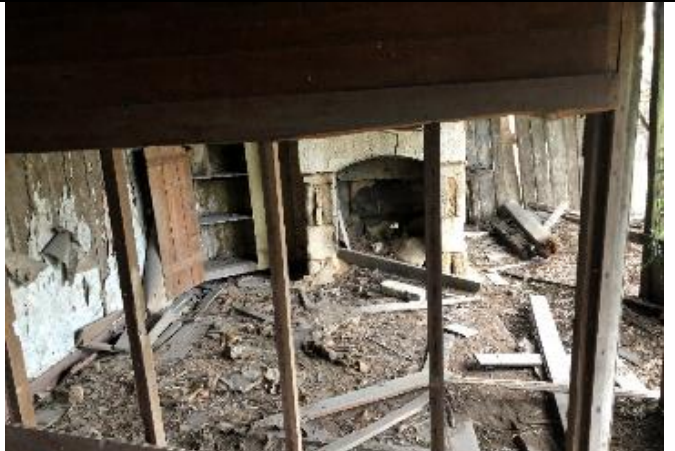
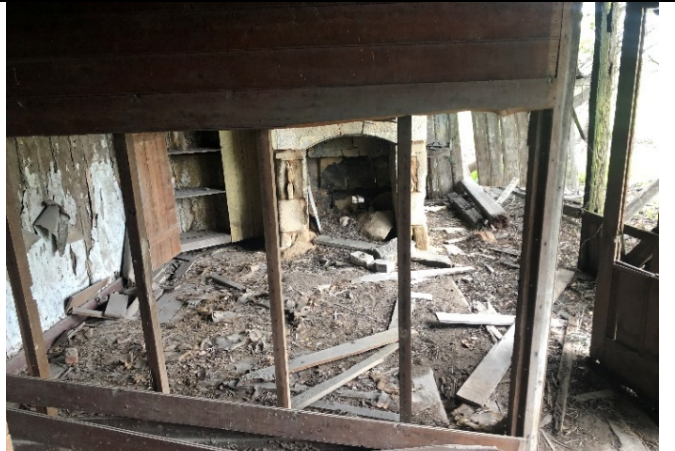
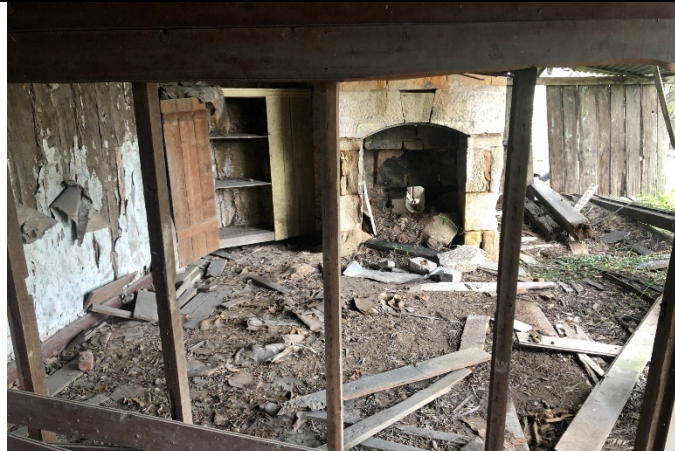
| 2014 | 2018 | 2020 (Mar) | 2020 (Dec) |
|---|---|---|---|
| <b>Room 2 interior</b><br><b>2014-8:</b> increased debris caused by removal of southern wall.<br><b>2018-20 (Mar):</b> no discernible change.<br><b>Mar 2020-Dec 2020:</b> no discernible change. | | | |

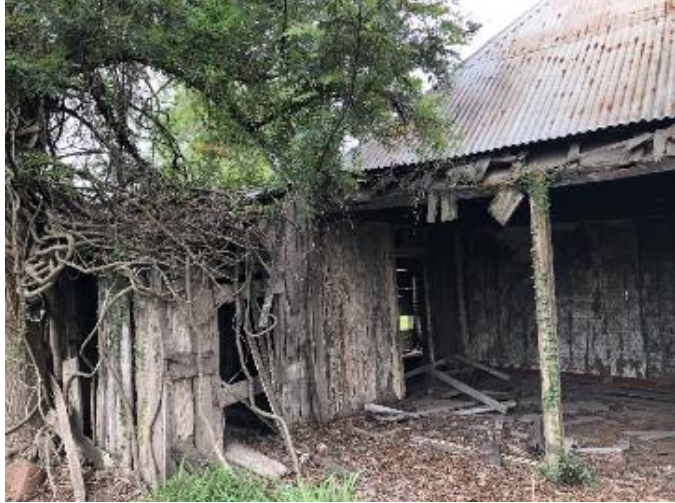
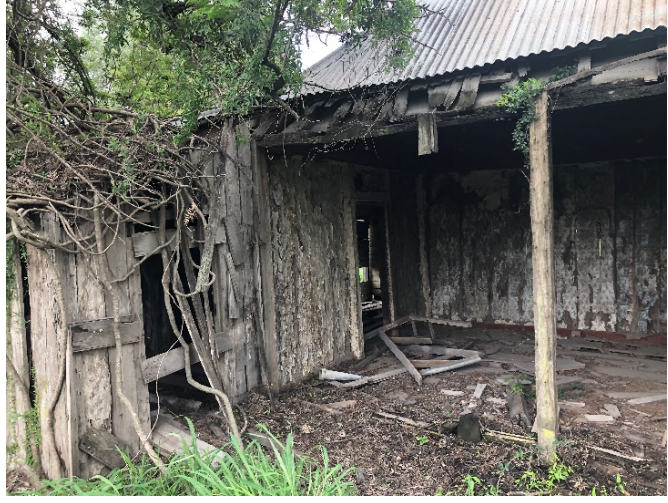
| 2014 | 2018 | 2020 (Mar) | 2020 (Dec) |
|---|---|---|---|
| <p><b>South-west corner</b><br/> <b>2014-8:</b> shows removal of vertical slabs from southern wall.<br/> <b>2018-20 (Mar):</b> no discernible change.<br/> <b>Mar 2020-Dec 2020:</b> no discernible change.</p> | | | |

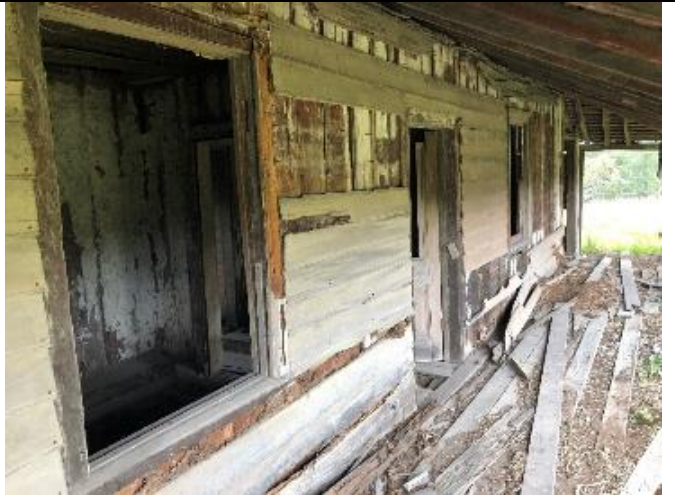
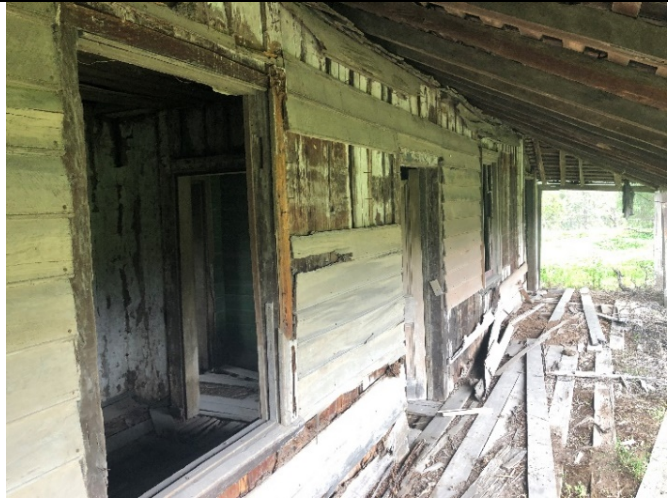
| 2014 | 2018 | 2020 (Mar) | 2020 (Dec) |
|---|---|---|---|
| <p><b>Northern elevation</b><br/> <b>2014-8:</b> further deterioration of weatherboard panelling.<br/> <b>2018-20 (Mar):</b> no discernible change, though termite activity present.<br/> <b>Mar 2020-Dec 2020:</b> grass/weed growth encroaching over verandah floor.</p> | | | |
