# Mount Thorley Warkworth Historic Heritage Management Plan 2020 Compliance Audit Inspection

Report prepared for

Yancoal Australia, Mount Thorley Warkworth

January 2021

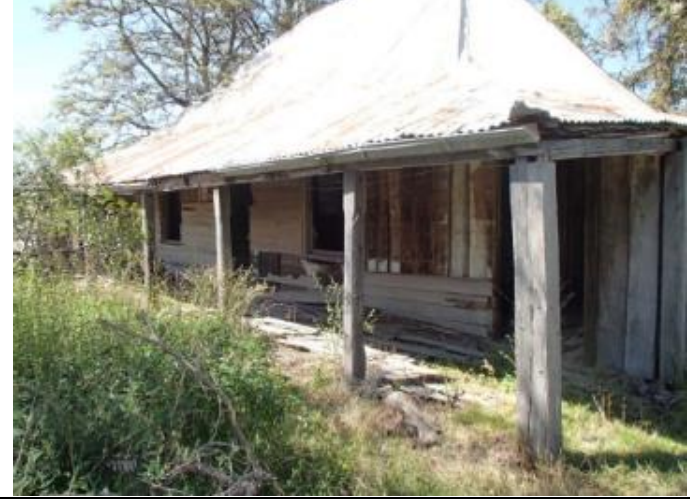
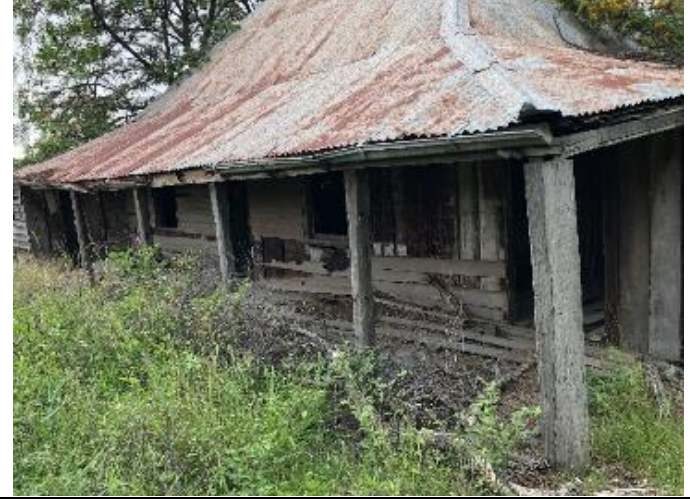
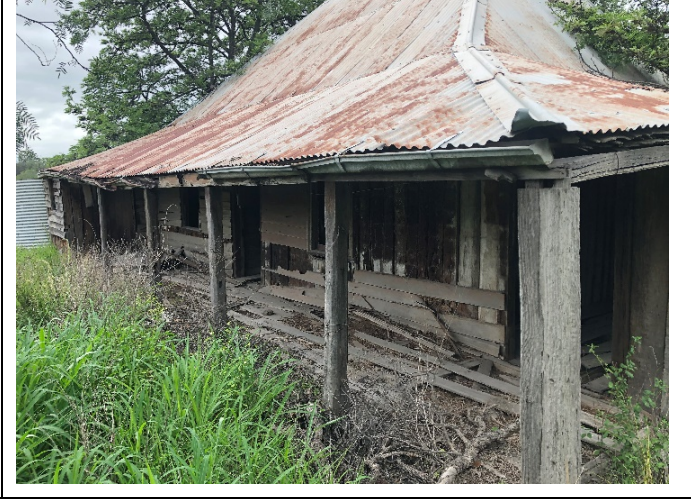
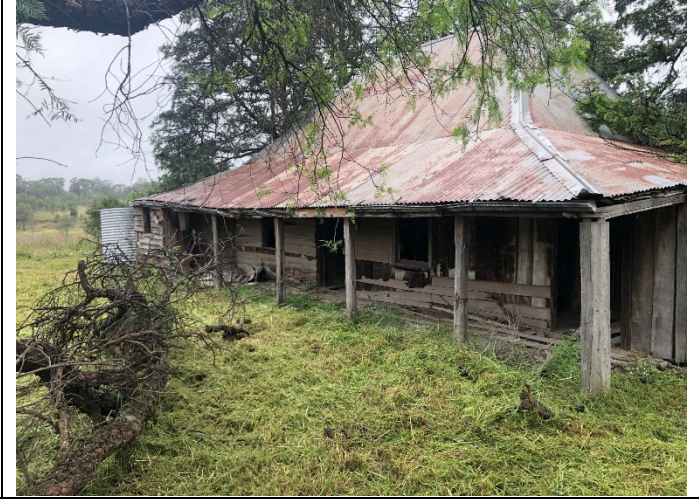
| 2014 | 2018 | 2020 (Mar) | 2020 (Dec) |
|---|---|---|---|
| <p><b>Northern elevation</b><br/> <b>2014-8:</b> slumping of verandah along edge beam.<br/> <b>2018-20 (Mar):</b> no discernible change.<br/> <b>Mar 2020-Dec 2020:</b> grass/weed growth encroaching over verandah floor.</p> | | | |

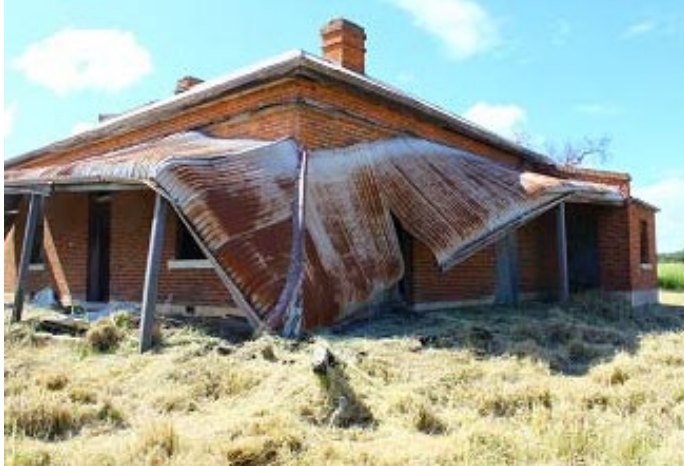
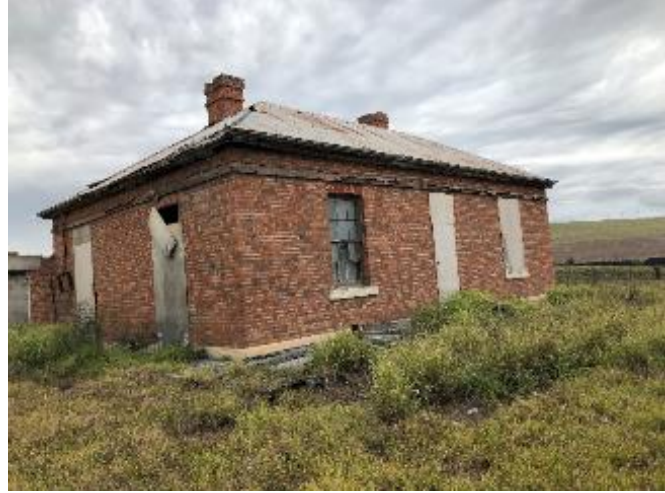
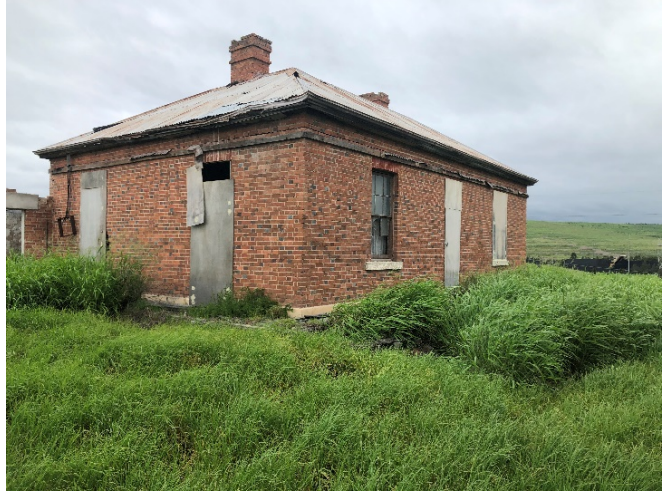
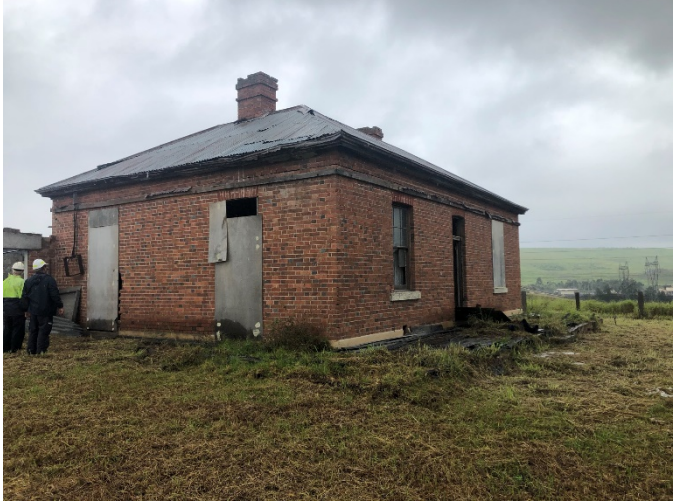
| 2015 | 2018 | 2020 (Mar) | 2020 (Dec) |
|---|---|---|---|
| <p><b>View of north-west side</b><br/><b>2015-8:</b> verandah removed and stored inside building, vegetation has been managed<br/><b>2018-20 (Mar):</b> vegetation has regrown around building<br/><b>Mar 2020-Dec 2020:</b> vegetation again under control, panel above boarded door requires refixing.</p> | | | |

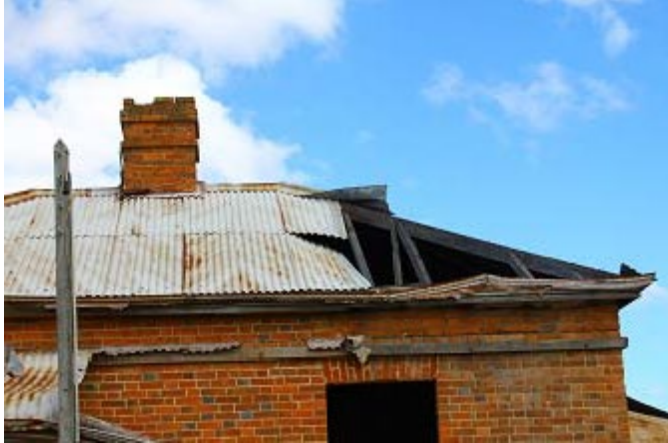
| 2015 | 2018 | 2020 (Mar) | 2020 (Dec) |
|---|---|---|---|
| <p><b>View of north-west roof corner (focus on damaged roof)</b><br/><b>2015-8:</b> roofing sheets have been replaced and holes patched<br/><b>2018-20 (Mar):</b> some minor roof holes and lifted sheeting noted<br/><b>Mar 2020-Dec 2020:</b> some verandah flashing fallen, panel above door requires refixing.</p> | | | |

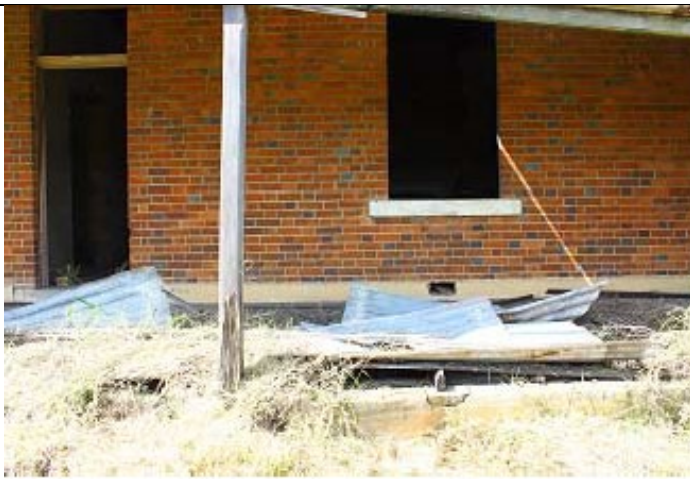
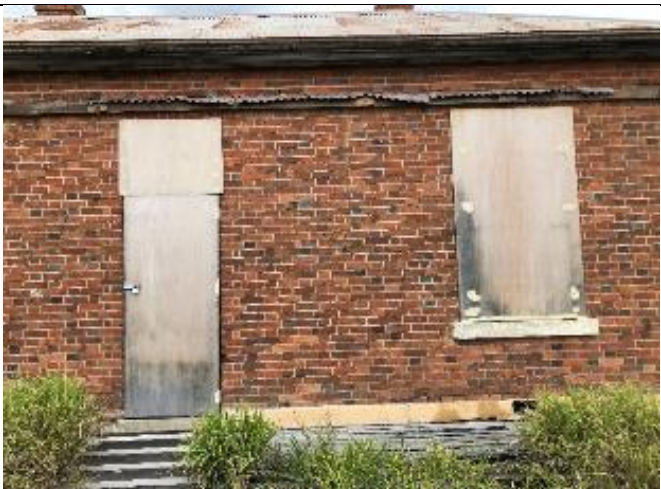
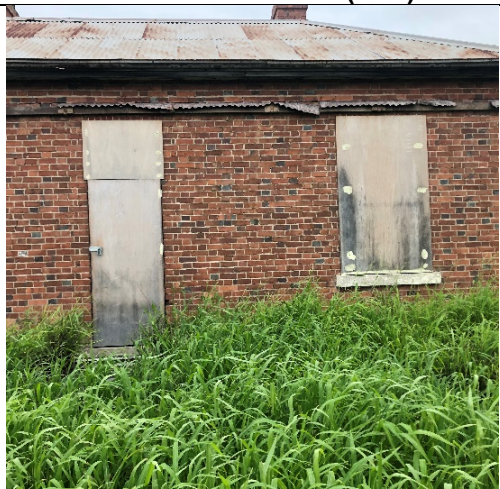
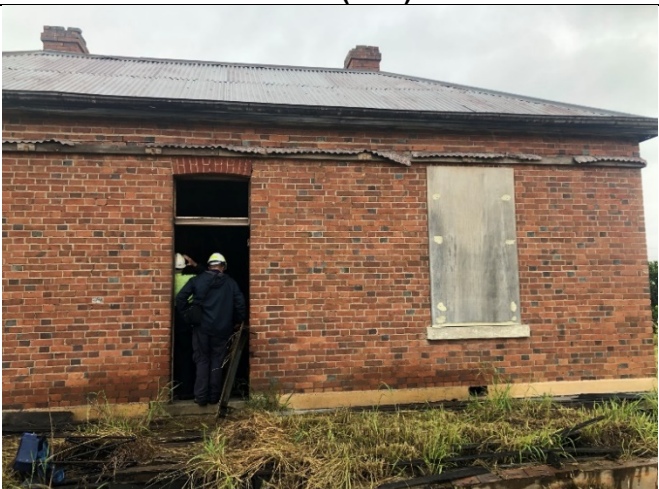
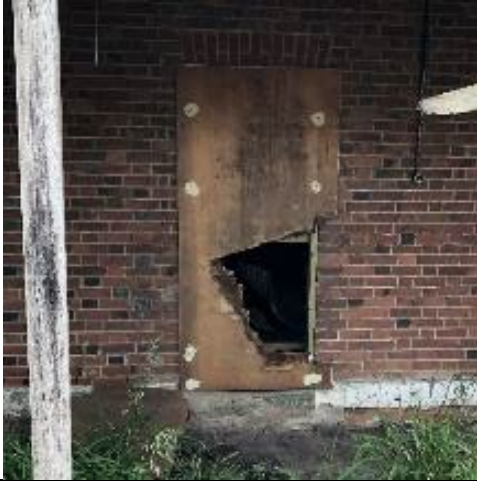
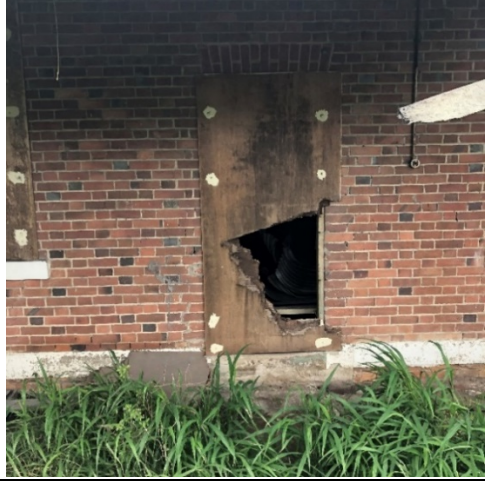
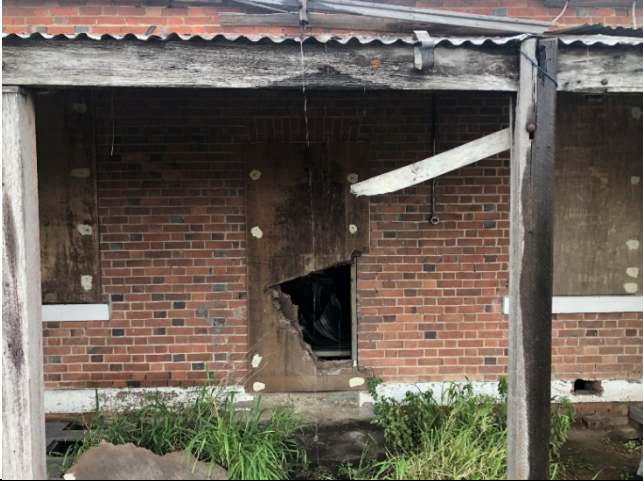
| 2015 | 2018 | 2020 (Mar) | 2020 (Dec) |
|---|---|---|---|
| <b>View of door and window panelling</b><br><b>2015-8:</b> sheeting installed on all openings, however some repair required<br><b>2018-20 (Mar):</b> some repair of panelling required<br><b>Mar 2020-Dec 2020:</b> Front door panel requires reinstallation. Broken panel remains unrepaired | | | |

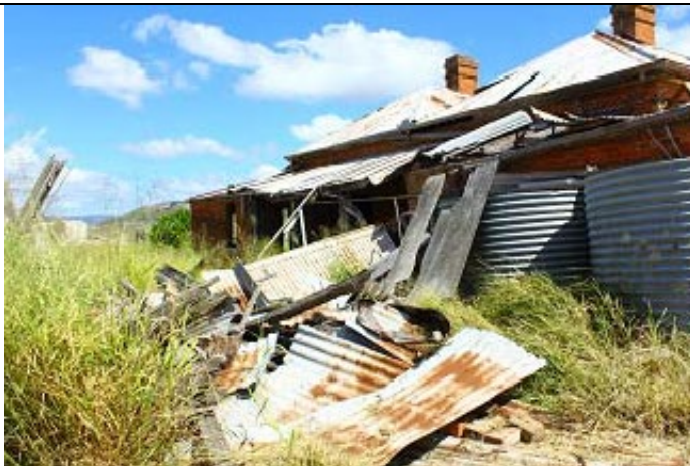
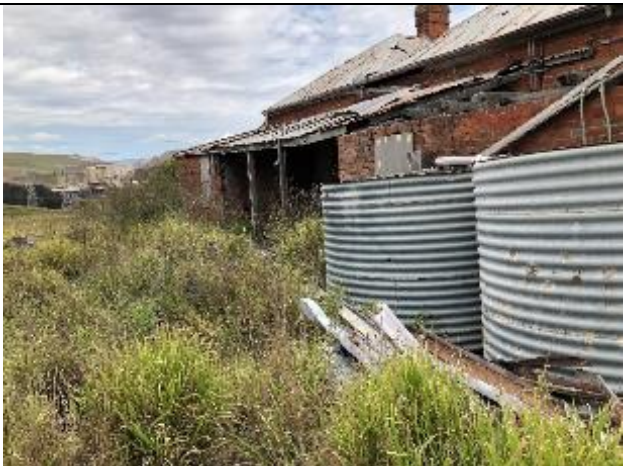
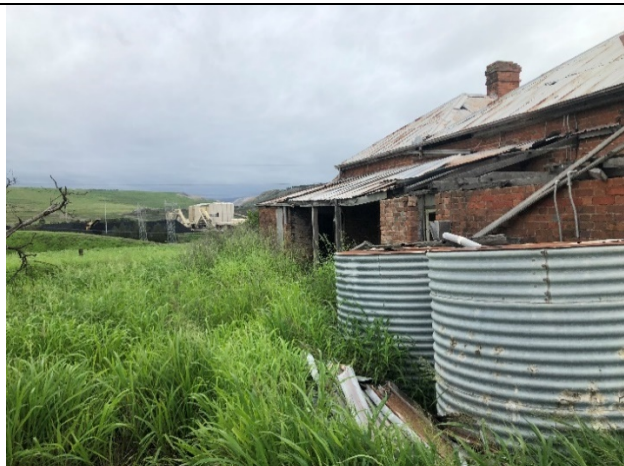
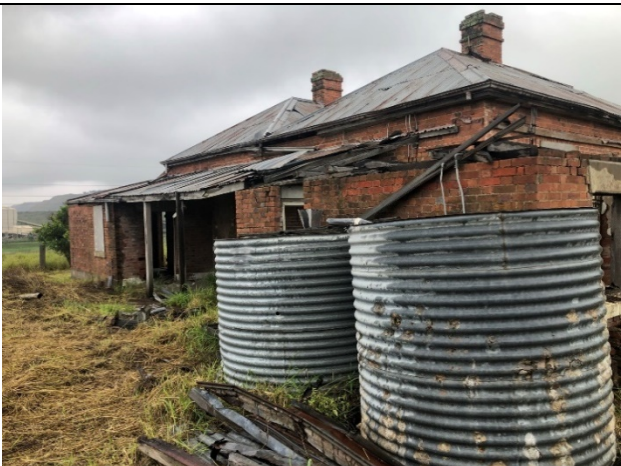
| 2015 | 2018 | 2020 (Mar) | 2020 (Dec) |
|---|---|---|---|
| <b>View of rear of building (view south)</b><br><b>2015-8:</b> debris has been cleared and stacked<br><b>2018-20 (Mar):</b> vegetation has regrown around building and stacked debris<br><b>Mar 2020-Dec 2020:</b> vegetation cleared and debris restacked | | | |

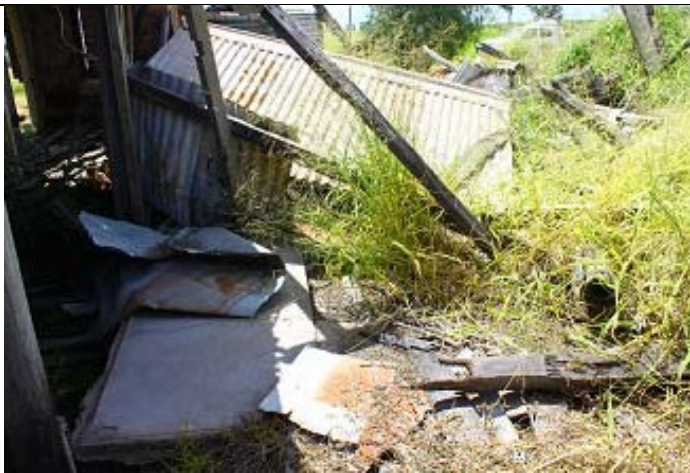
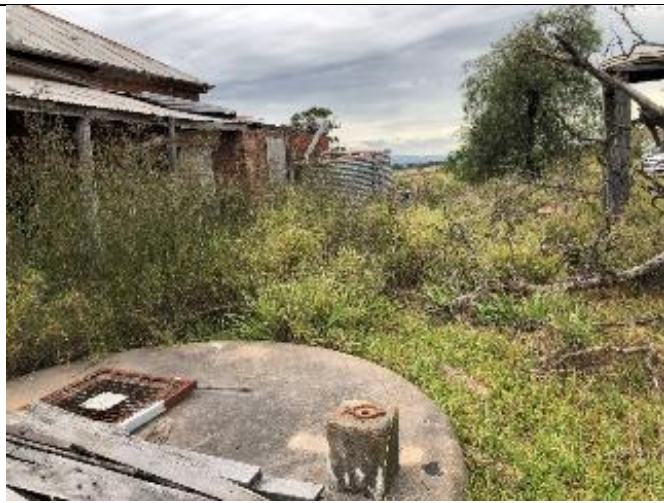
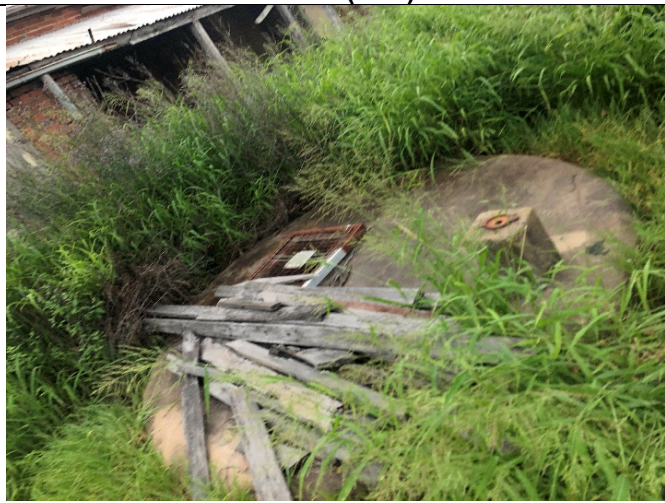
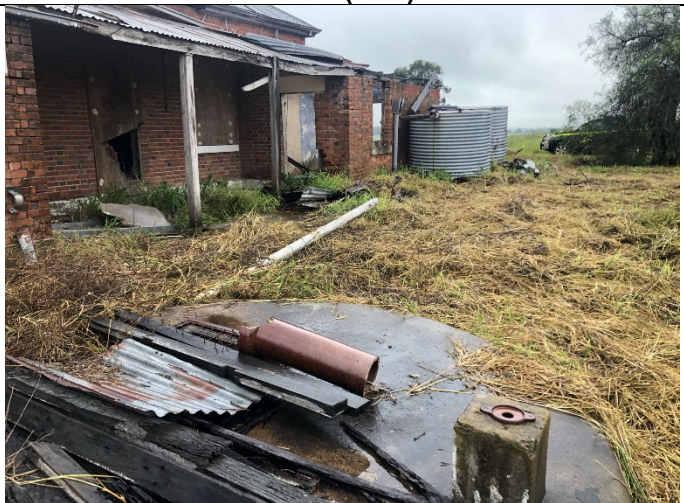
| 2015 | 2018 | 2020 (Mar) | 2020 (Dec) |
|---|---|---|---|
| <b>View of rear of building (view north)</b><br><b>2015-8:</b> debris has been cleared and stacked<br><b>2018-20 (Mar):</b> vegetation has regrown around building and stacked debris<br><b>Mar 2020-Dec 2020:</b> vegetation cleared and debris restacked | | | |

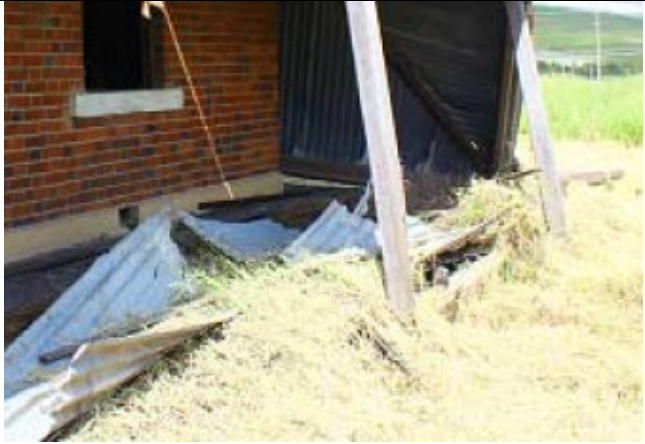
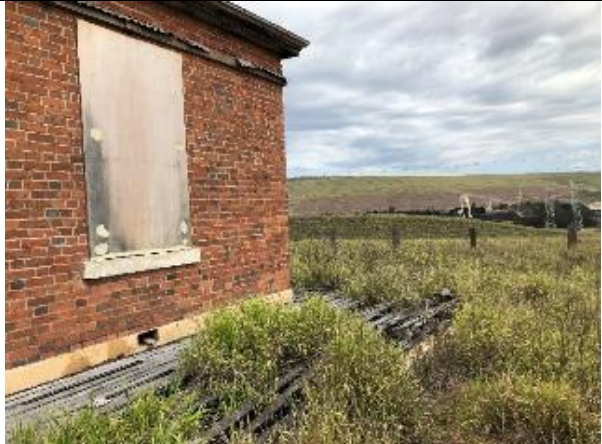
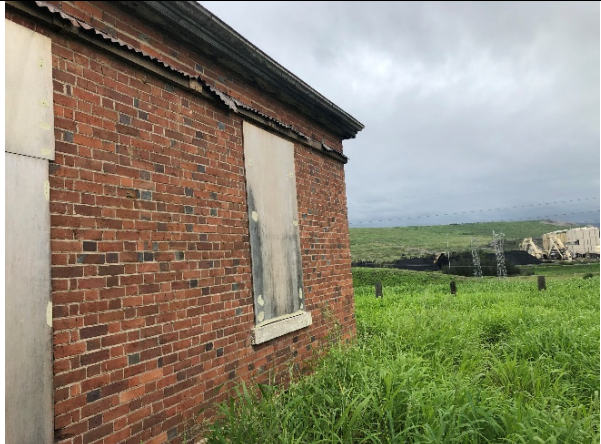
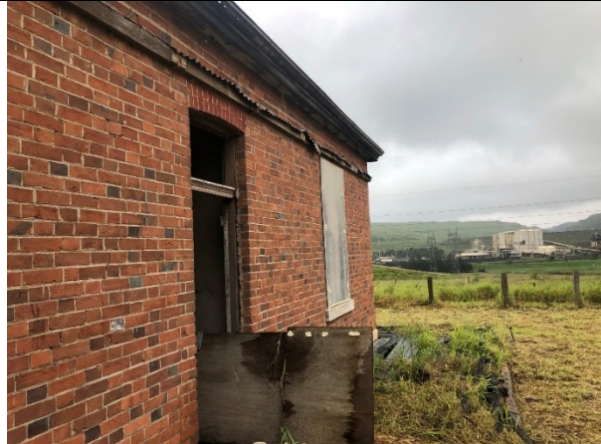
| 2015 | 2018 | 2020 (Mar) | 2020 (Dec) |
|---|---|---|---|
| <b>View of eastern verandah (focus on verandah floor)</b><br><b>2015-8:</b> posts and sheeting removed, damaged boards remain exposed<br><b>2018-20 (Mar):</b> damaged boards remain and vegetation growth throughout<br><b>Mar 2020-Dec 2020:</b> damaged boards remain and vegetation growth throughout | | | |

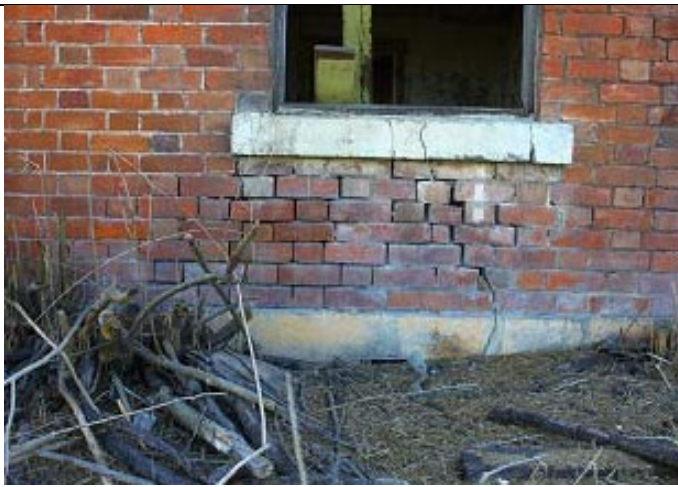
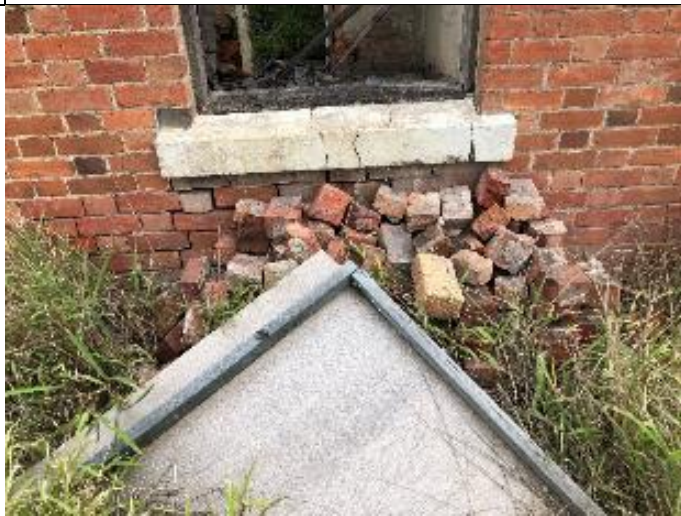
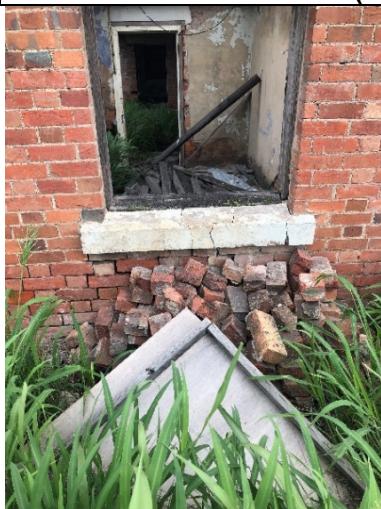
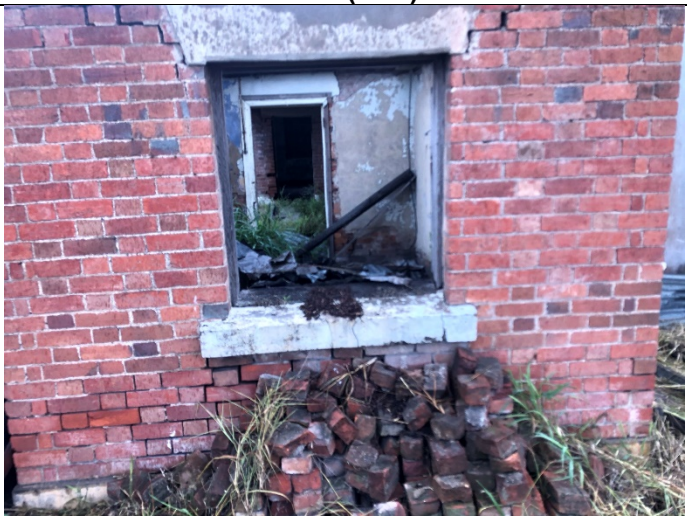
| 2015 | 2018 | 2020 (Mar) | 2020 (Dec) |
|---|---|---|---|
| <p><b>View of north-east corner of building (focus wall below window)</b><br/> <b>2015-8:</b> bricks from roof above stacked in front of required repointing, window sheeting removed<br/> <b>2018-20 (Mar):</b> no discernible change<br/> <b>Mar 2020-Dec 2020:</b> repointing requirements remain</p> | | | |

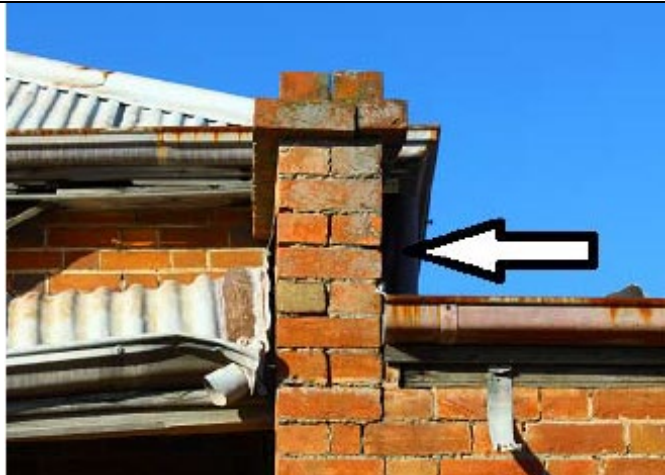
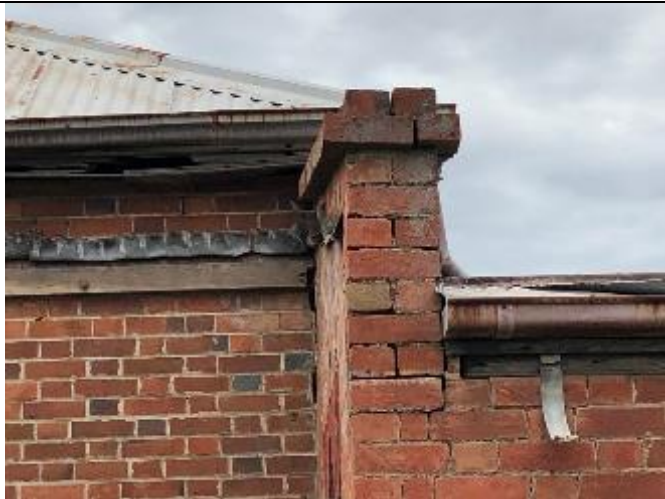
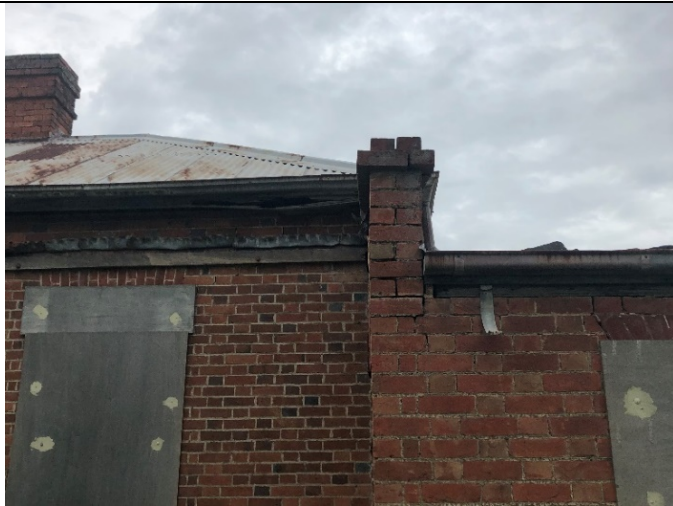
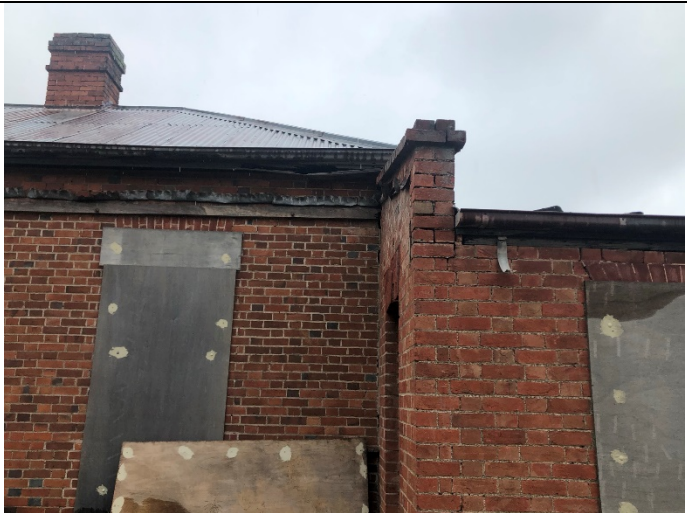
| 2015 | 2018 | 2020 (Mar) | 2020 (Dec) |
|---|---|---|---|
| <p><b>View of south-east of building (focus on top of wall)</b><br/> <b>2015-8:</b> no discernible change<br/> <b>2018-20 (Mar):</b> no discernible change<br/> <b>Mar 2020-Dec 2020:</b> no discernible change</p> | | | |

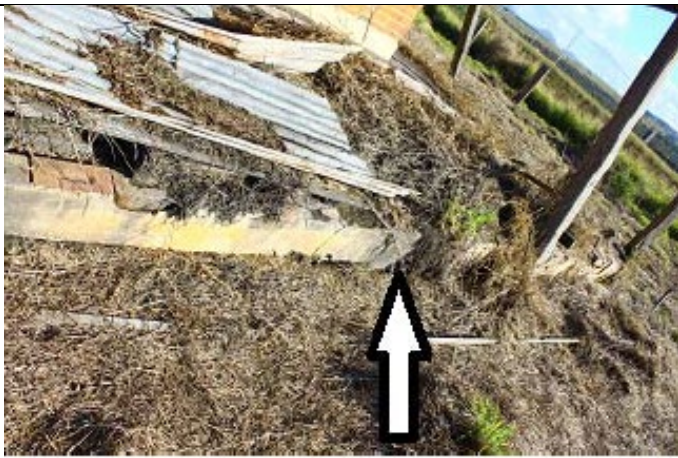
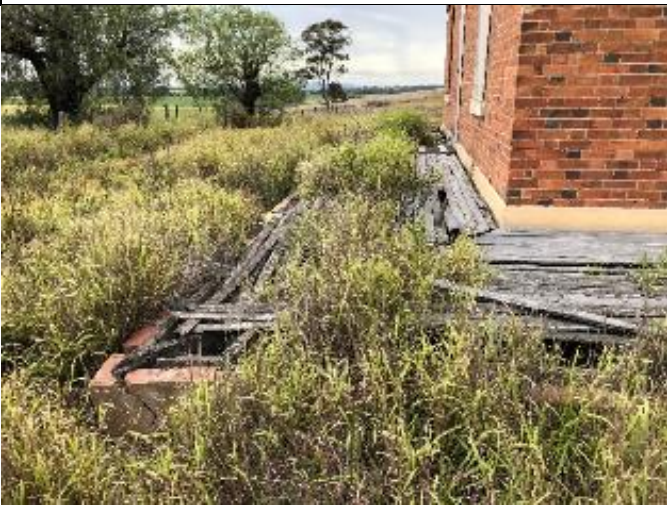
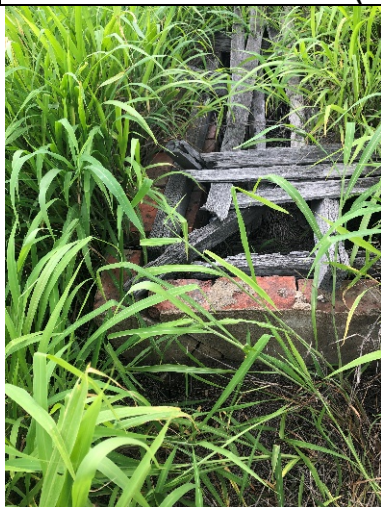
| 2015 | 2018 | 2020 (Mar) | 2020 (Dec) |
|---|---|---|---|
| <b>View of eastern verandah (focus on dwarf wall wall)</b><br><b>2015-8:</b> debris cleared from verandah, no change to dwarf wall<br><b>2018-20 (Mar):</b> no discernible change<br><b>Mar 2020-Dec 2020:</b> cracking to wall evident | | | |

5. Reinstall verandah, including verandah decking and northern brick dwarf wall, re-using original material where possible, as per recommendations M5, M6 and L1 in the CMP conservation works schedule;

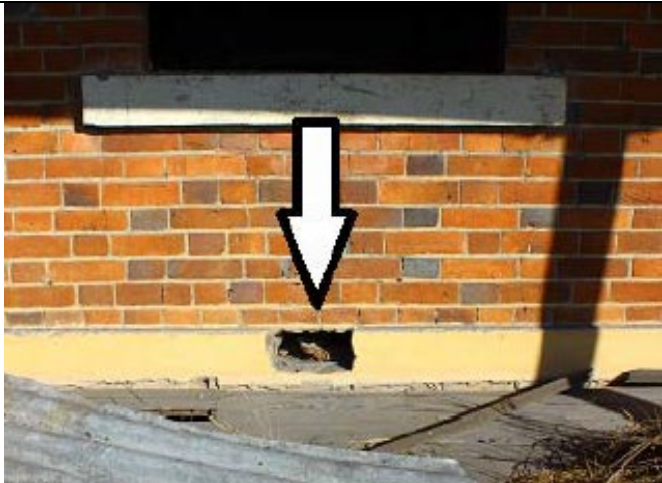
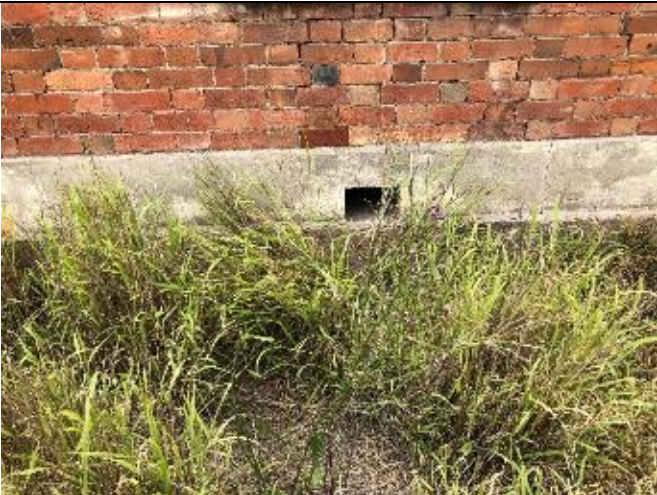
| 2015 | 2018 | 2020 (Mar) | 2020 (Dec) |
|---|---|---|---|
| <b>View of ventilation grilles</b><br><b>2015-8:</b> grilles not replaced<br><b>2018-20 (Mar):</b> no discernible change<br><b>Mar 2020-Dec 2020:</b> grilles remain open | | | |

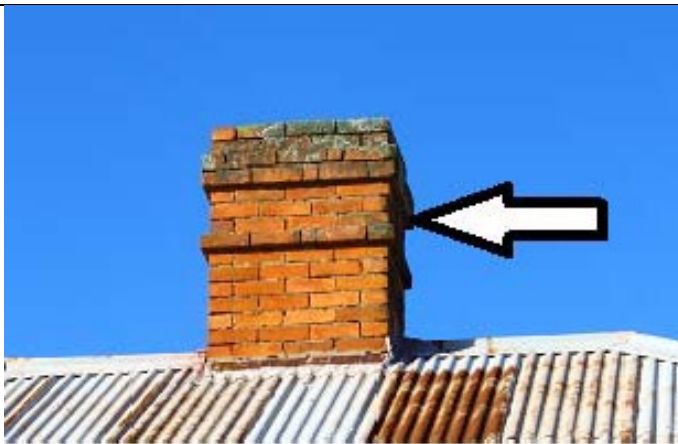
| 2015 | 2018 | 2020 (Mar) | 2020 (Dec) |
|---|---|---|---|
| <p><b>View of southern chimney</b><br/> <b>2015-8:</b> no discernible change<br/> <b>2018-20 (Mar):</b> no discernible change<br/> <b>Mar 2020-Dec 2020:</b> no discernible change</p> | | | |
