# 2020 STREAM HEALTH AND STABILITY REPORT

Mount Thorley Warkworth

SLR Ref: 630.30119-R01  
Version No: -v0.2  
February 2021

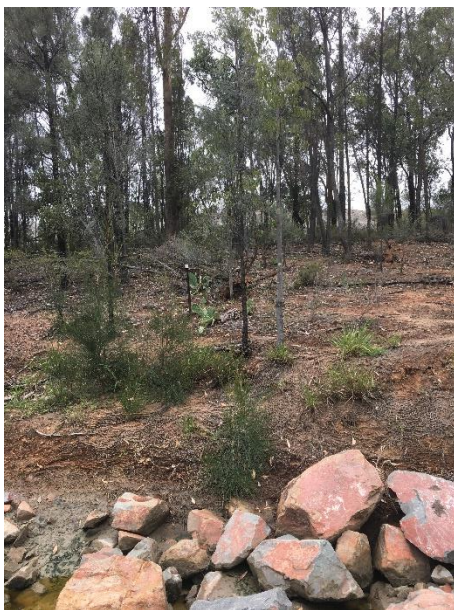
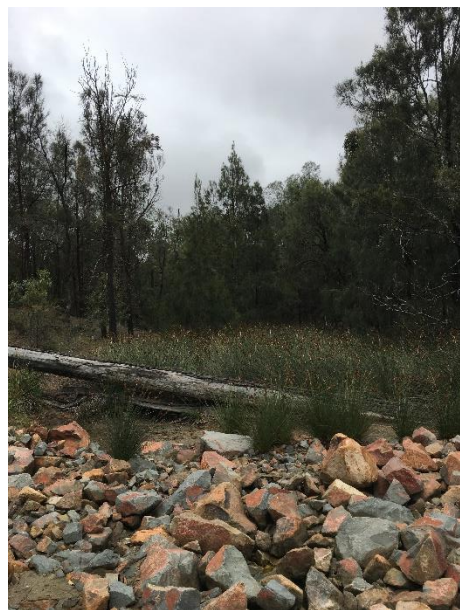
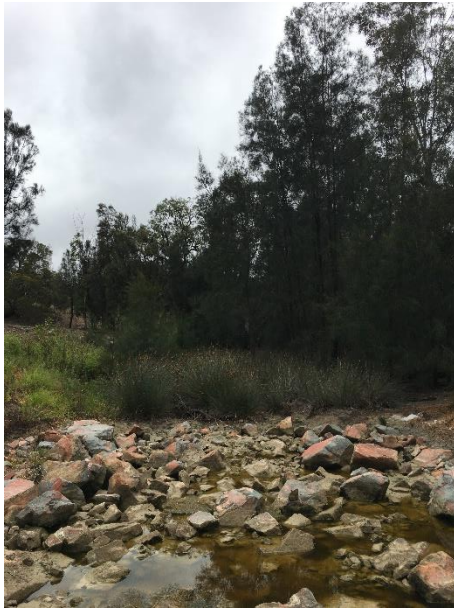
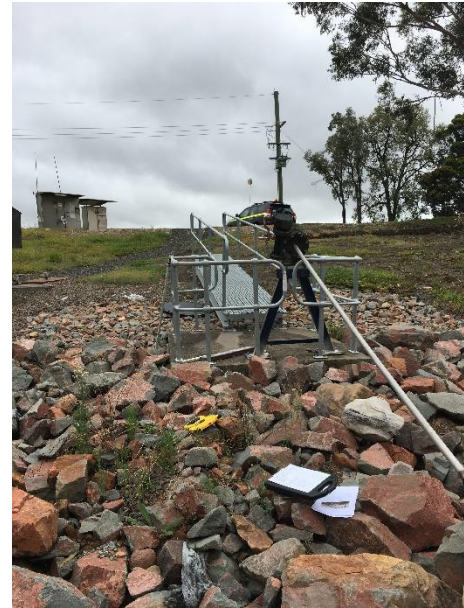
The banks are characterised by patches of scattered eucalypts with Bull Oak (*Allocasuarina luehmannii*) and Swamp Oak (*Casuarina glauca*) dominating the canopy. The understorey is sparse consisting mainly of Acacia shrubs scattered on the bank. An increase in groundcover was observed on either side of the rock armoured area likely due to recent rainfalls. While there was an increase in exotic grass (and some prickly pear), regeneration of canopy species was observed. It should be noted while there is still very little diversity in either canopy or groundcover species the diversity of canopy and groundcover species appears to be increasing. Both banks of the creek contain an almost continuous band of riparian vegetation in widths less than 40m wide, with the exception of the cleared area where the discharge construction works occurred. Exotic grass and bare soil (mine workings and vehicle tracks) surround riparian vegetation. Debris such as leaf litter and fallen logs are evident as well as standing dead trees. Linkage to larger areas of native vegetation is absent. The channel of the creek line contained dense native *Juncus* spp.

CSIRO Ephemeral Stream Assessment Classification – **Potentially Stabilising**

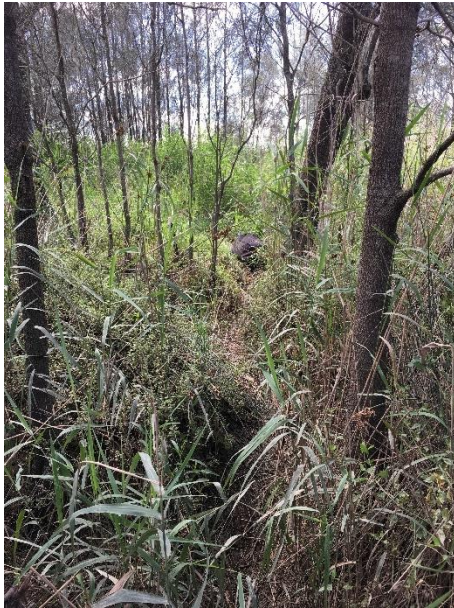
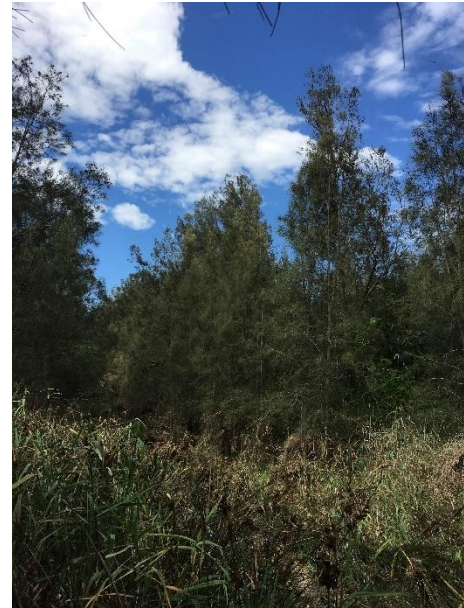
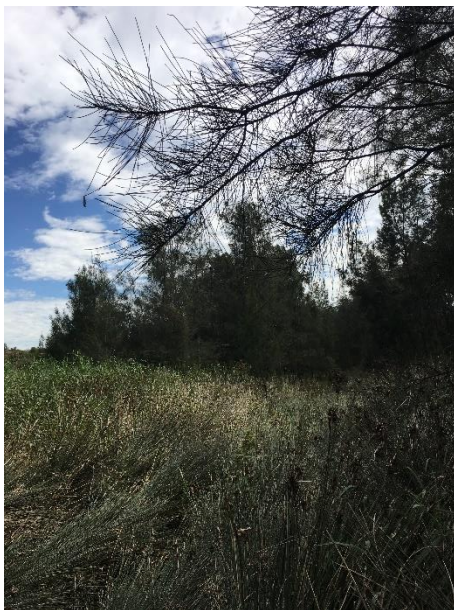
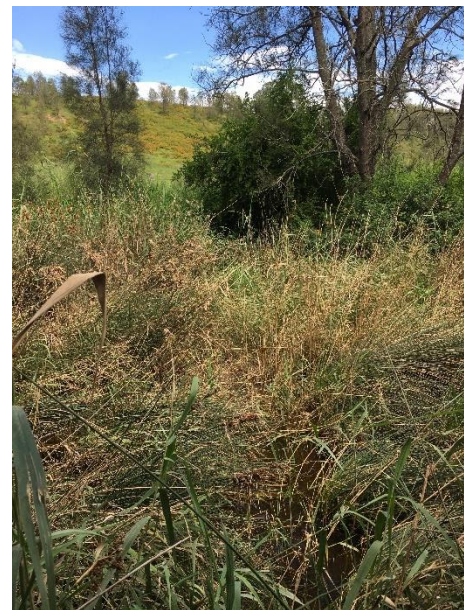
The creek bed at this monitoring point is covered by reeds and is stable. Both the left and right banks have good grass coverage and appear to be stable with gentle-moderate slopes. The creek upstream and downstream of the monitoring point also appears to be stable. The creek has a very slight meander at this monitoring point. Overall, this location has remained the same as the previous monitoring cycle conditions.

The banks were characterised by dense Swamp Oak (*Casuarina glauca*), tall River Oak (*Casuarina cunninghamia*) with scattered eucalypts. The creek is congested with *Juncus spp* and *Phragmites australis*. The understory contained high levels of weed infestation. Paddy's Lucerne and in particular African Boxthorn were abundant below the canopy particularly upstream of the monitoring point. An increase in blackberry nightshade was also observed on the upper slope of the banks. It should be noted that Lantana had been significantly reduced since the last monitoring period due to recent weed works. Native Weeping Grass (*Microlaena stipoides*) was present in small patches beneath the denser canopy areas. Both banks of the creek contained an almost continuous band of riparian vegetation in widths less than 30m wide. Exotic pastures surrounded riparian vegetation and linkage to other areas of native vegetation was absent. Regenerating canopy tree (mostly *Casuarina glauca*) species were abundant. The generally revealed vegetation growth since the last monitoring period especially in the stream bed where *Juncus spp* and *Phragmites australis* has continued to grow during favourable climatic conditions. However overall, there was very little observable change in vegetation structure.

CSIRO Ephemeral Stream Assessment Classification – **Stable**

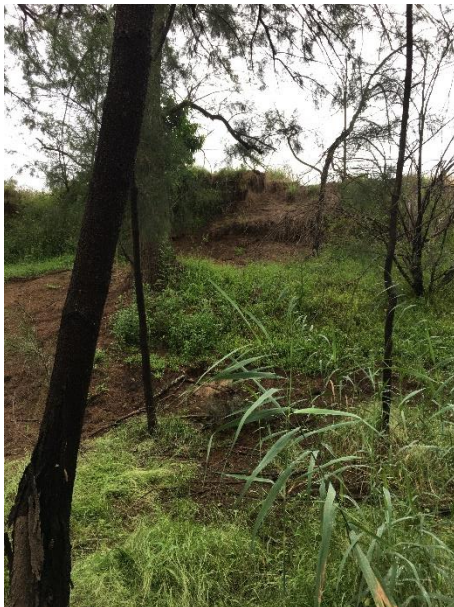
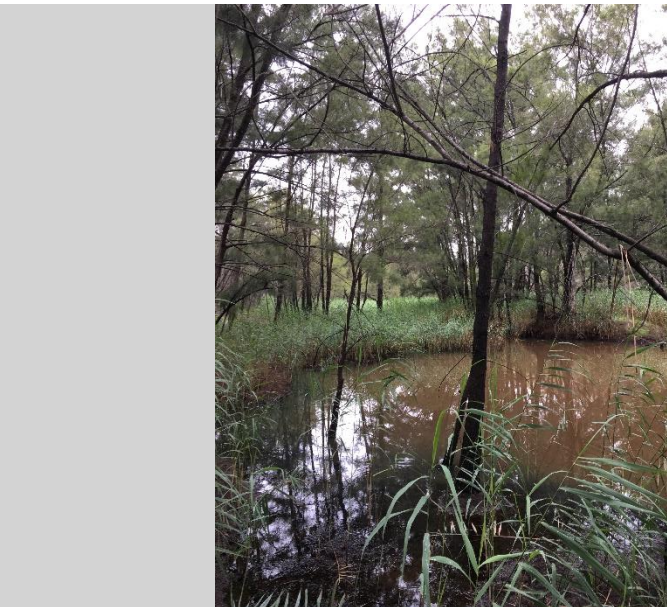
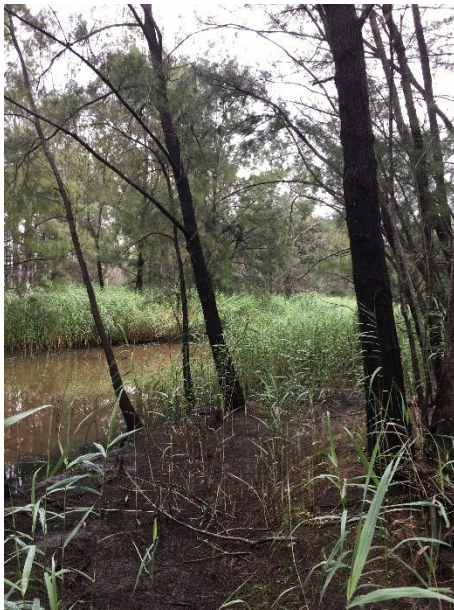
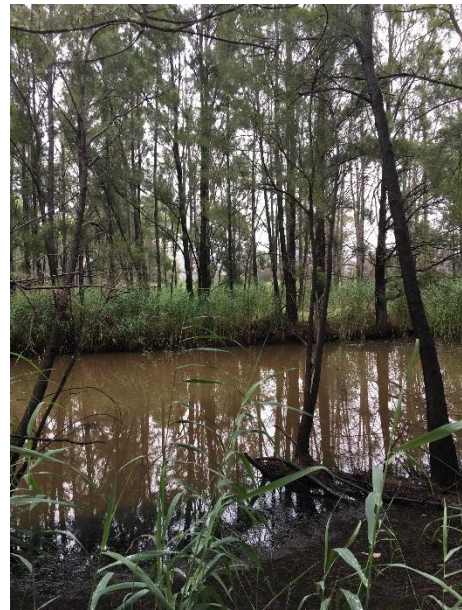
Monitoring point BM37 is the only monitoring point that is located on Wollombi Brook. Wollombi Brook is a large tributary of the Hunter River, with channel widths ranging from 10m to 60m. Generally, Wollombi Brook has flowing water in it except during extreme drought periods. Water was observed to be flowing at the time of the inspection. Both the left and right banks appeared to be generally stable with both banks containing trees. The right bank is steeper than the left bank with a moderate slope and a height of approximately 2m. A pipe outlet exists immediately downstream of the monitoring point on the eastern bank and has scoured out the bank slightly with some exposed moderately dispersive soils (approximately 0.3m high). Some wombat holes were also observed on the eastern bank. Overall, this location has remained the same as the previous monitoring cycle conditions.

Upslope of this vegetation, extending to the outer parts of the riparian zone, the forest canopy gives way to cleared land comprising with exotic pasture grass, supporting a range of common exotic grasses and herbs, including African Lovegrass *Eragrostis curvula*, Narrow-leafed Carpet Grass *Axonopus fissifolius*, Couch *Cynodon dactylon* and several other species. A dramatic increase in groundcover was observed on the flat sections of the bank including large blankets of ***Typha orientalis*** and patches of Sowthistle *Sonchus oleraceus*. The canopy layer appeared to be denser than the previous monitoring event which was likely due to the recent climatic conditions favourable for vegetation growth.

CSIRO Ephemeral Stream Assessment Classification – **Potentially Stabilising**

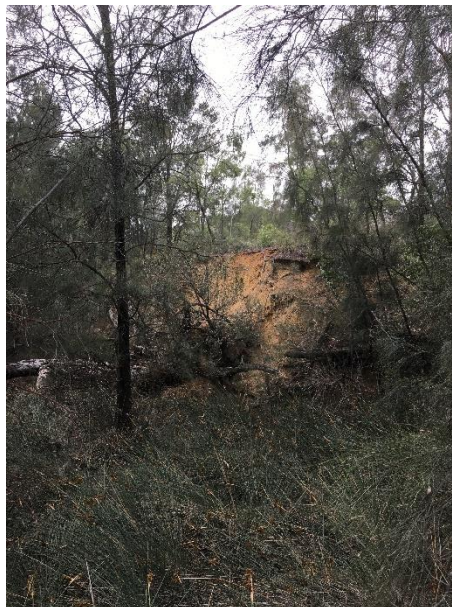
Plate 26 Erosion

The erosion observed at LC2 included a steep near vertical section of exposed dispersive material (approximately 2m high) on the right bank. This area appeared to be actively eroding including some areas immediately downstream. The erosion at this monitoring location appears to be similar to what was observed in the 2018 survey. A tree was observed to have fallen over at this section of the exposed creek bank. The creek bed and left bank appear to be stable at this location.

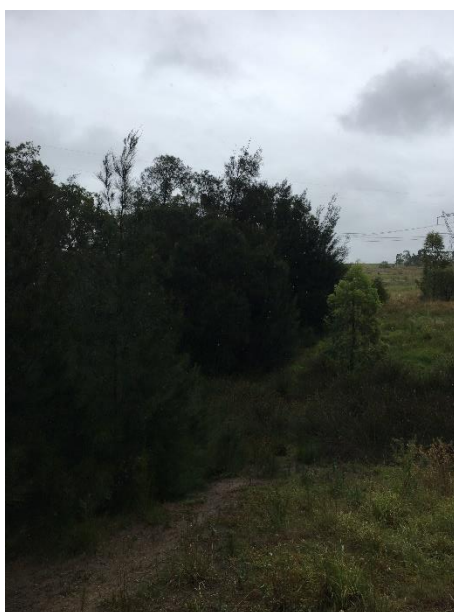
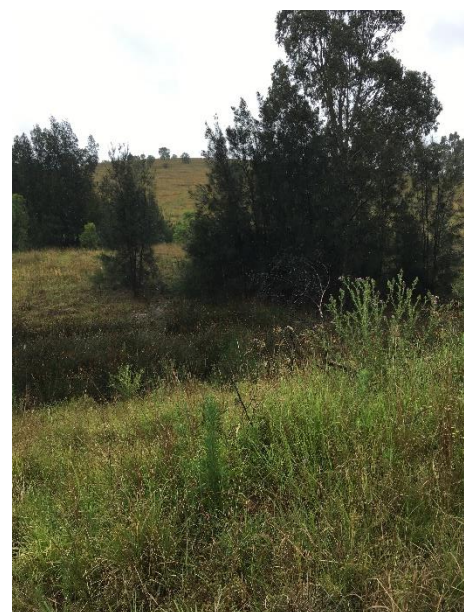
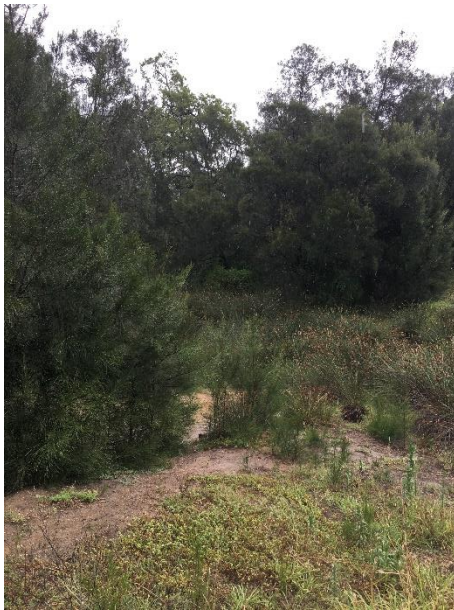
LC5 is located in a historic diversion of Loders Creek. The erosion observed at LC5 included erosion extending up the right bank approximately 20-30m. The area has 0.5-1.0m high steep exposed walls surrounding 5m of exposed soil. The creek bed and left bank appear to be stable. Overall, this monitoring location has shown similar conditions to the previous monitoring cycle.

CSIRO Ephemeral Stream Assessment Classification – **Active**

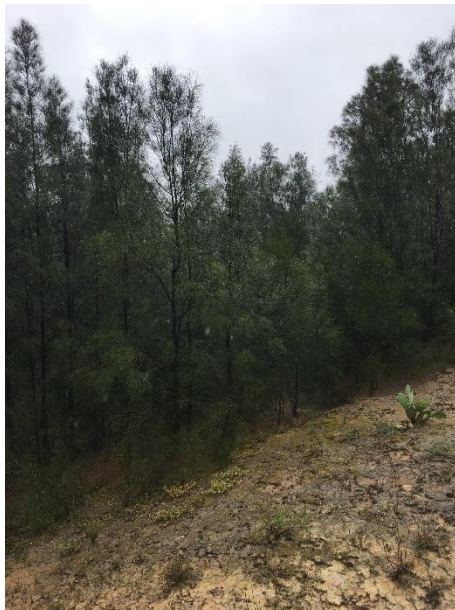
Plate 38 Right Bank

The erosion observed at LC6 included significant lateral erosion near the top of the right bank. This erosion was approximately 1m high with an alluvial fan extending approximately 2m from the near vertical bank. The rest of the right bank appears to be stable as does the creek bed and the left bank. Overall, this monitoring location appears similar to the previous monitoring cycle. The active erosion appears to be primarily the result of a historic disturbance of the top of the right bank which has exposed the highly dispersive soils at this location.

CSIRO Ephemeral Stream Assessment Classification – **Active**

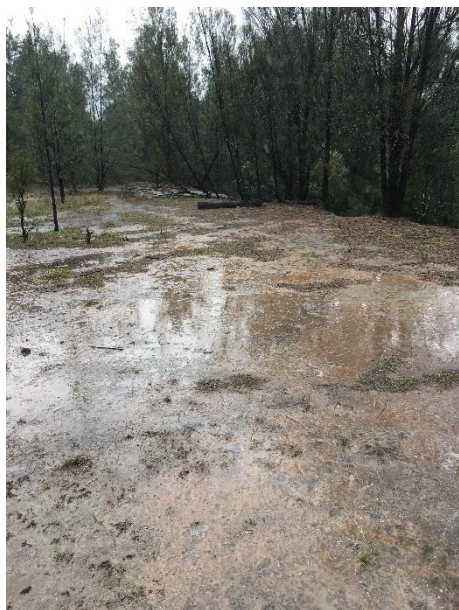
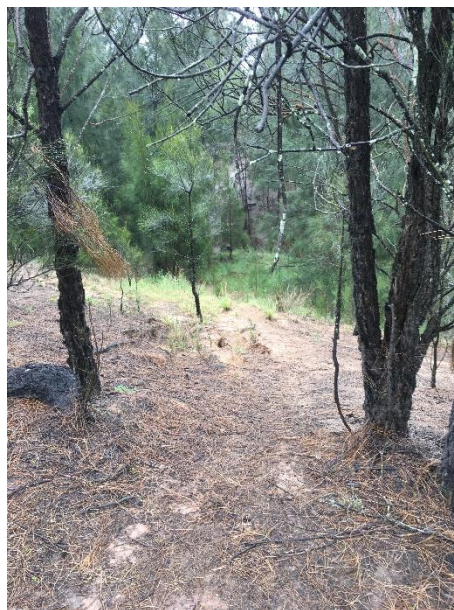
The erosion observed at LC7 included an area of active erosion of a steep comprising exposed dispersive clay material (approximately 0.8m high) on the right bank, however this erosion is not laterally extensive. The erosion appears to have been caused by lateral flow across the bare banks in the area. The right bank appears to be stable downslope of the eroded area, as does the creek bed and the left bank. Overall, this monitoring location has shown similar conditions to the previous monitoring cycle.

CSIRO Ephemeral Stream Assessment Classification – **Active**

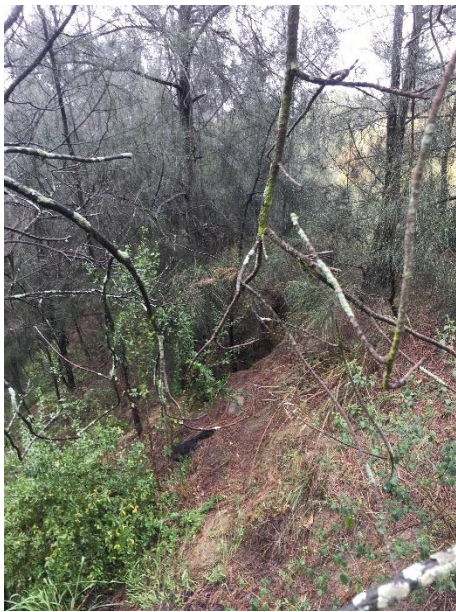
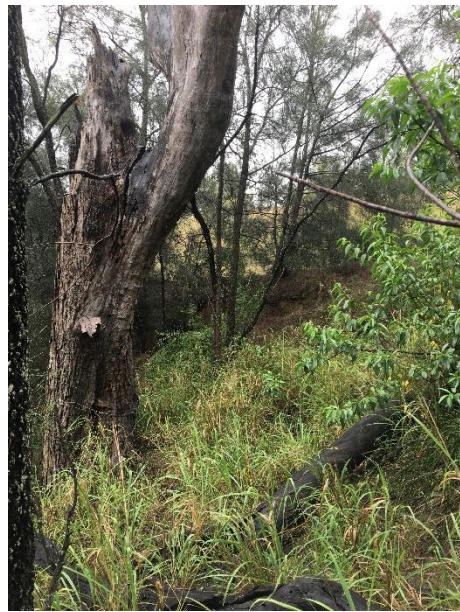
CSIRO Ephemeral Stream Assessment Classification – **Active**
