# Mount Thorley Warkworth

## 2023 Annual Review

| <b>Name of Operations</b> | Mount Thorley Warkworth |

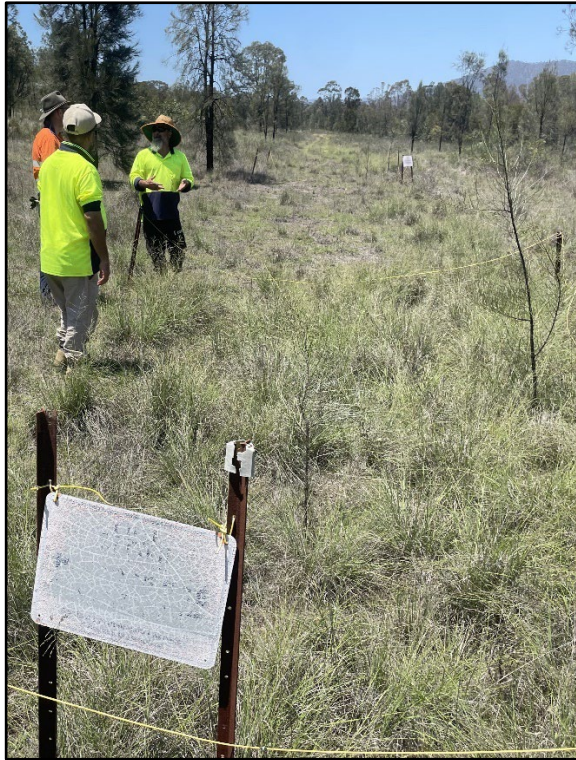
***Examples of barricading in need of repair (left) and newly reinstated (right)***

Several sites are recommended for barricading (or re-barricading) to protect them from current or future activities that have the potential to cause inadvertent disturbance. Such activities include the use of existing vehicle tracks on or near to sites, and current revegetation programs. There are a number of sites located on or adjacent to a disused track within the Wollombi Brook Aboriginal Cultural Heritage Conservation Area (WBACHCA). This track should be effectively barricaded to ensure it is closed for use.

Barricading should consist of hi-vis string line and signage delineating the area as an ACH site to be avoided. There are some areas, however, where hi-vis delineation posts minus string line are an appropriate demarcation method.

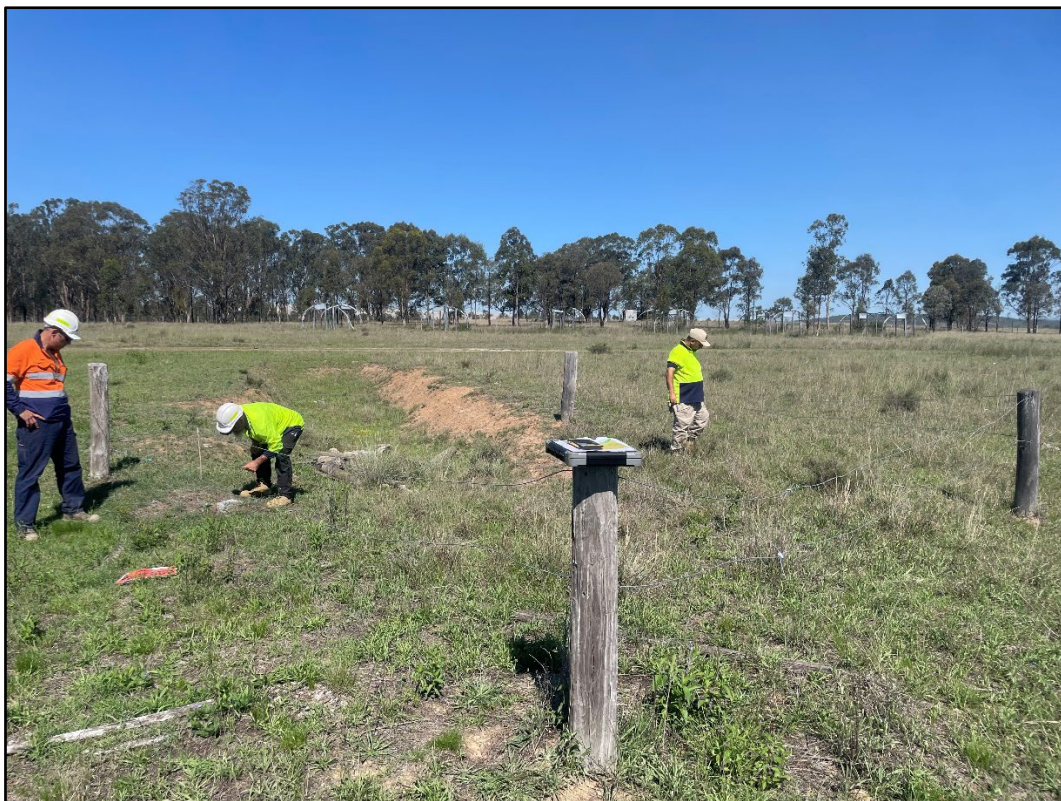
Site: MTW-178

***View across previously fenced MTW-178, located over rubbish-filled ditch***

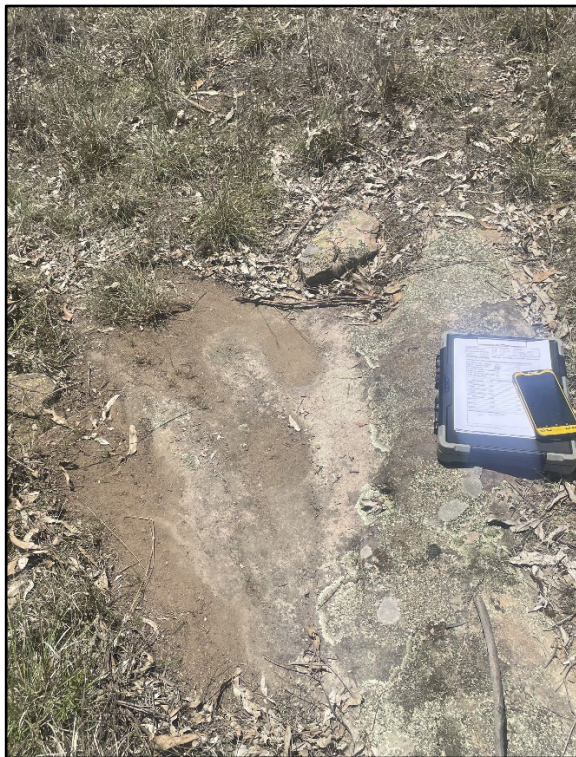
**Grooves on sandstone outcrop at MTW-267**

It is likely that more grooves are located in the vicinity of the grooves identified during this audit. It is recommended that each site is revisited and the soil/vegetative accumulation carefully removed from the immediate vicinity by hand and with brooms. This will aid in the preservation of the grooves by removing the possibility of moisture retention within the

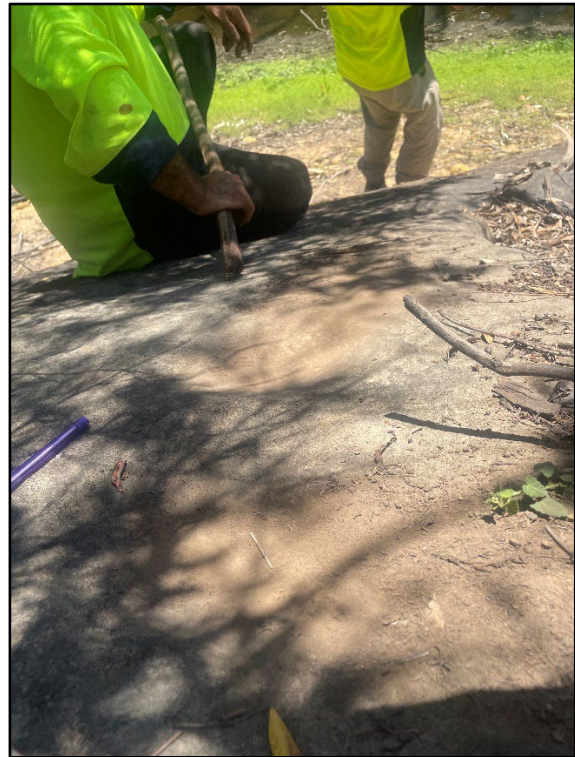
**Grooves on sandstone boulder at MTW-268**

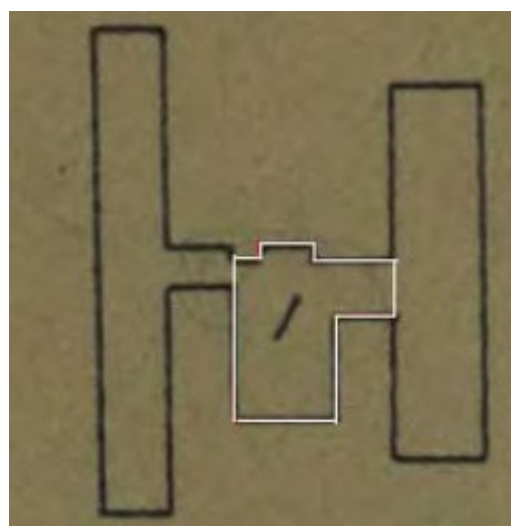
**Remaining structure**

The building is currently structurally unsound, with a number of timber elements either missing or in a deteriorated state. Corrugated asbestos roof sheeting is also missing in some places, and damaged and in poor condition where it remains. Much of the corrugated iron sheeting

is corroded. Brickwork is also cracking in a number of locations resulting in movement outward, loss of mortar and loss of bricks along the southern and eastern elevations.

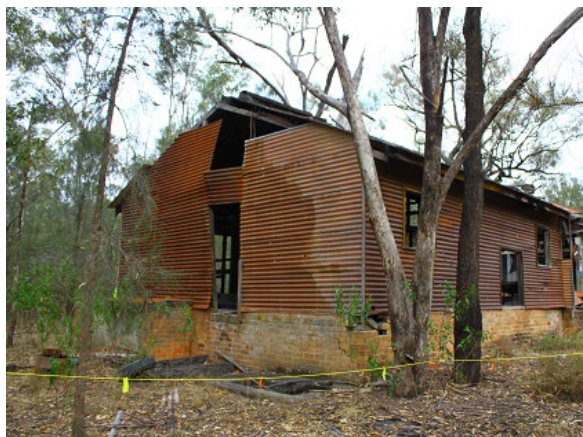
*View to mess from south-east (2012)*

As a result, a number of structural recommendations were outlined by ERM in the CMP developed for the site in 2012. These recommendations were not intended to return the building to a serviceable state, rather they sought to do the minimum required to allow safe access to the building to prevent significant damage, and also allow safe access for asbestos removal and internal inspection of the building in the short to medium term.

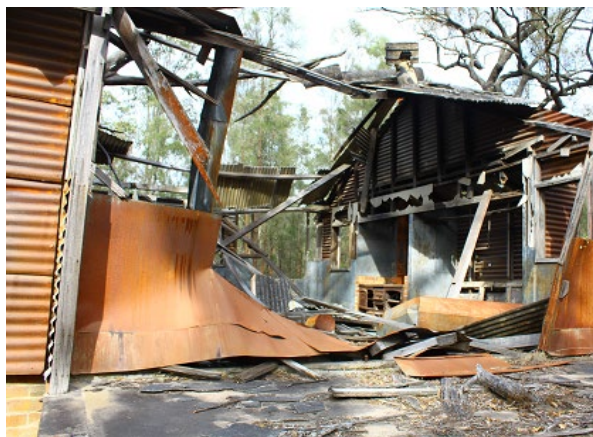
*Remnant kitchen area (2012)*

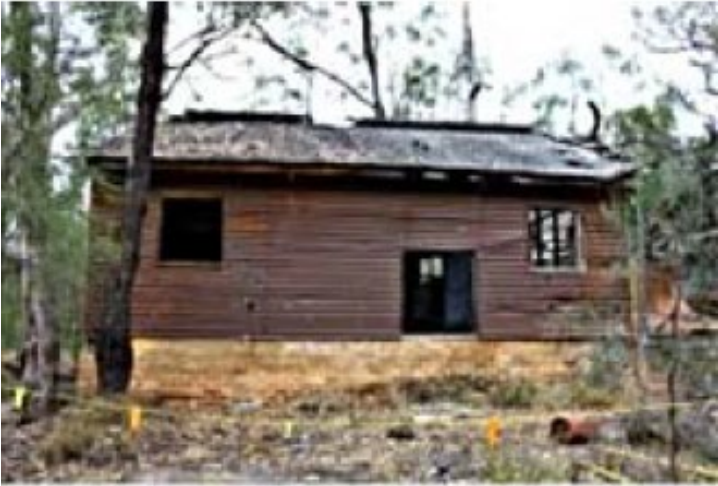
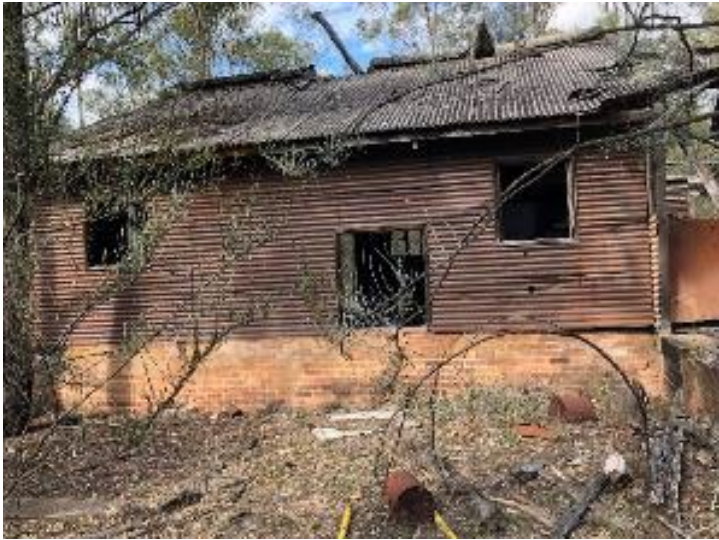
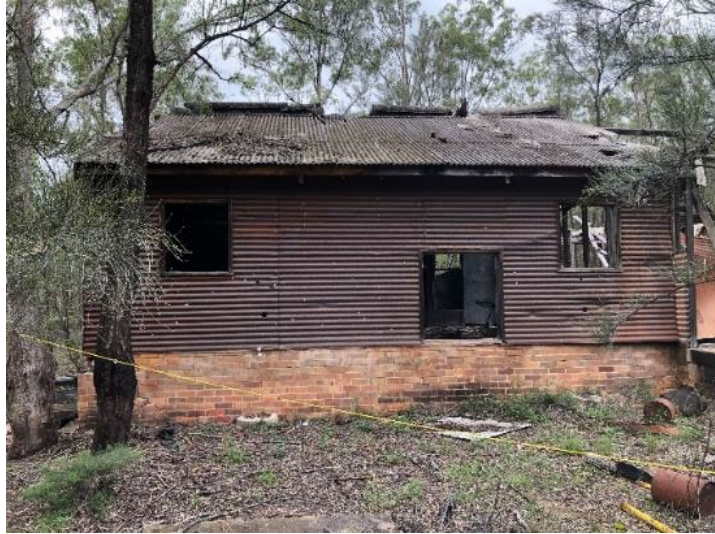
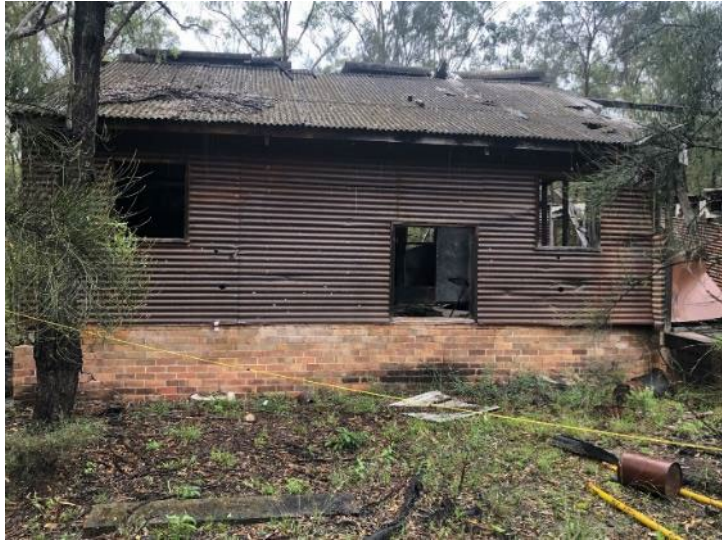
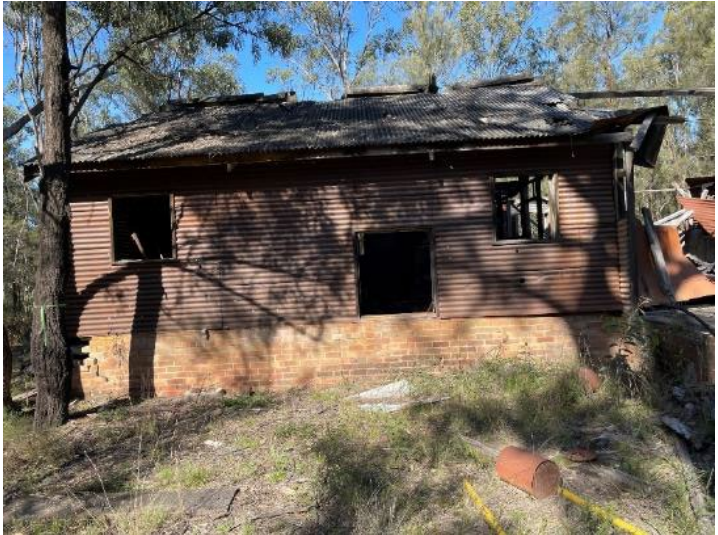
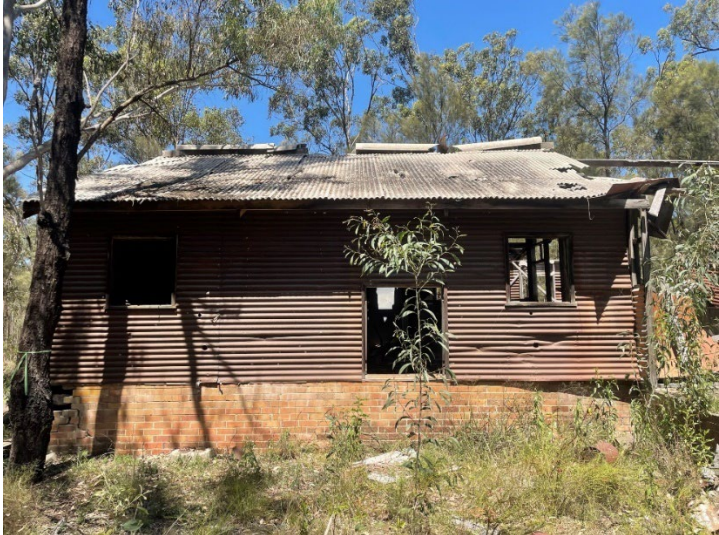
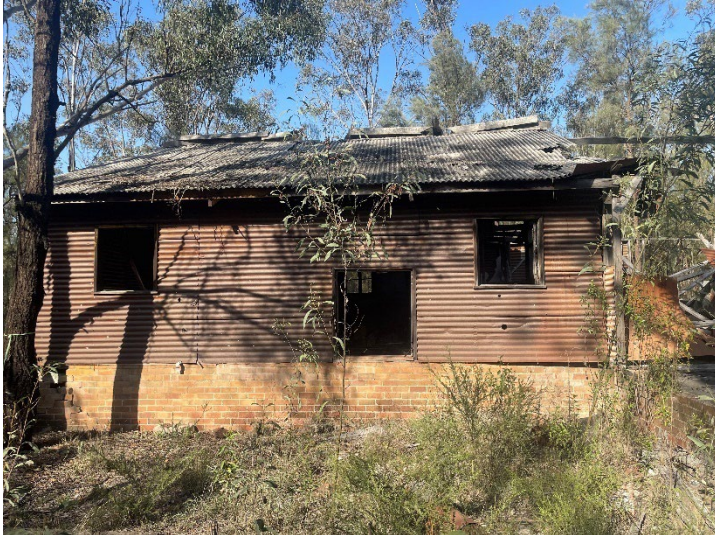
| 2012 | 2018 | 2020 (Mar) | 2020 (Dec) |
|---|---|---|---|
| | | | <p><b>2012-18:</b> no discernible change – note fallen branch from tree on western side.</p> <p><b>2018-20 (Mar):</b> no discernible change – fallen branch has moved.</p> <p><b>Mar 2020 – Dec 2020:</b> no discernible change.</p> <p><b>Dec 2020 – 2021:</b> no discernible change.</p> <p><b>2021-2022:</b> no discernible change.</p> <p><b>2022-2023:</b> no discernible change.</p> |

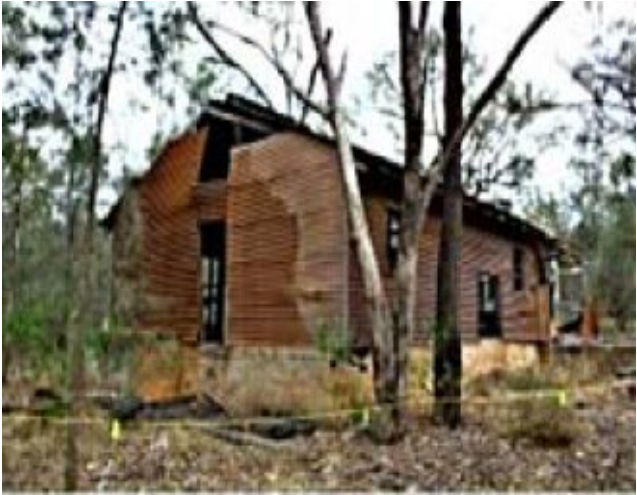
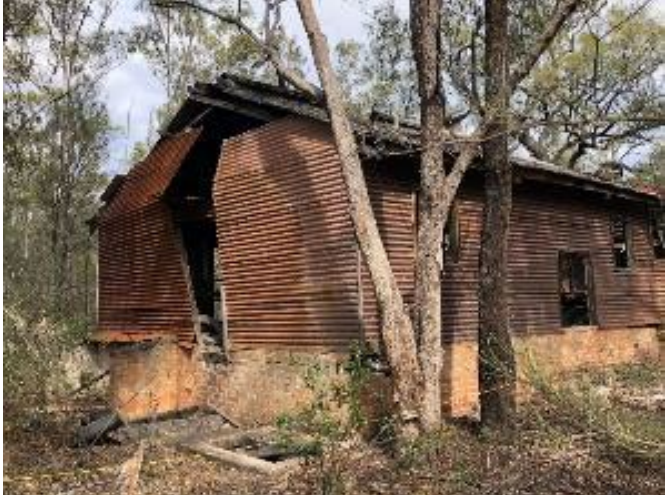
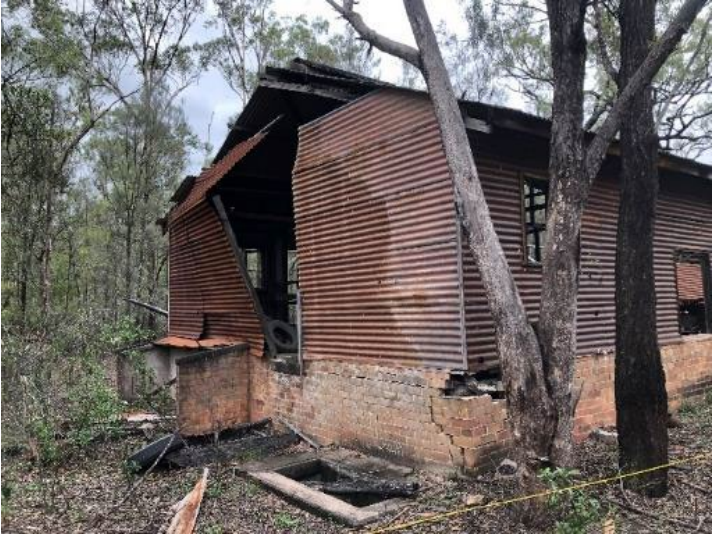
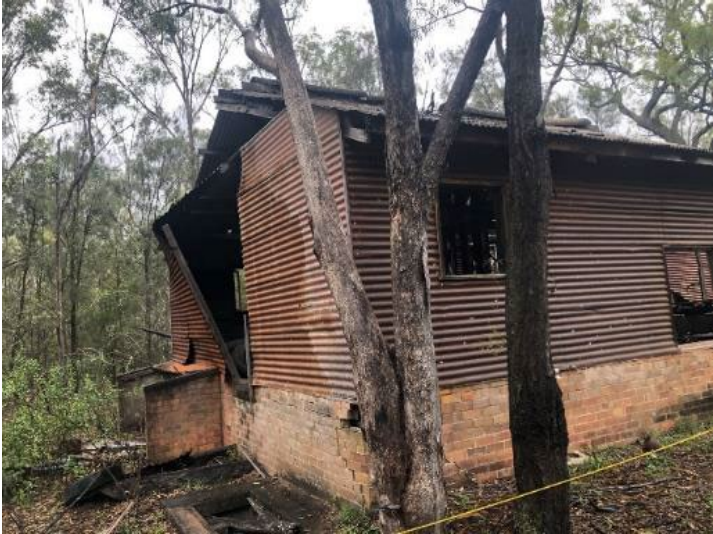
| 2012 | 2018 | 2020 (Mar) | 2020 (Dec) |
|---|---|---|---|
| | | | <p><b>2012-18:</b> evidence of increased bow to southern wall.</p> <p><b>2018-20 (Mar):</b> bow in wall appears to have increased.</p> <p><b>Mar 2020 – Dec 2020:</b> bow in wall continues to increase.</p> <p><b>Dec 2020 – 2021:</b> gap in bowing has increased.</p> <p><b>2021-2022:</b> no discernible change.</p> <p><b>2022-2023:</b> bow in wall continues to increase.</p> |

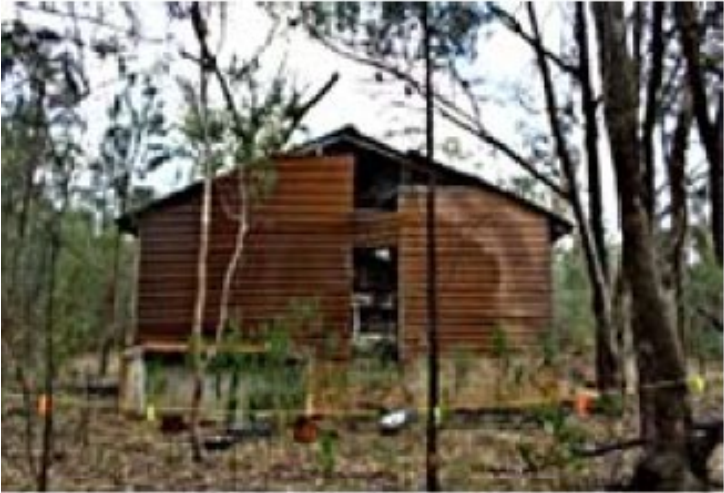
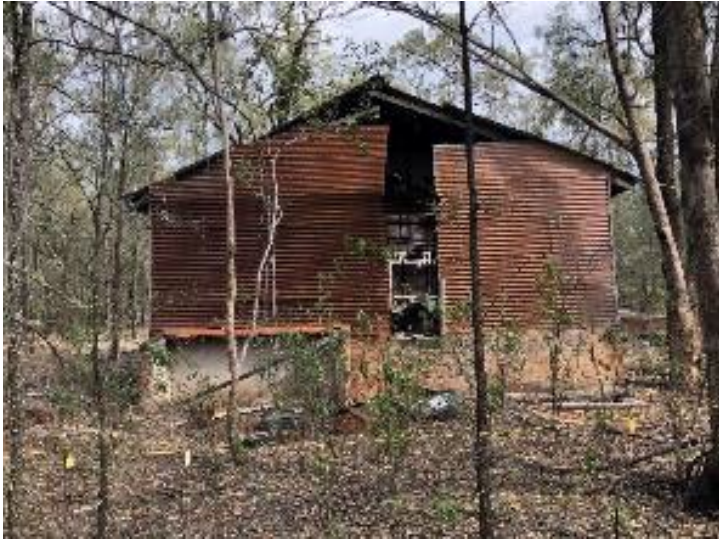
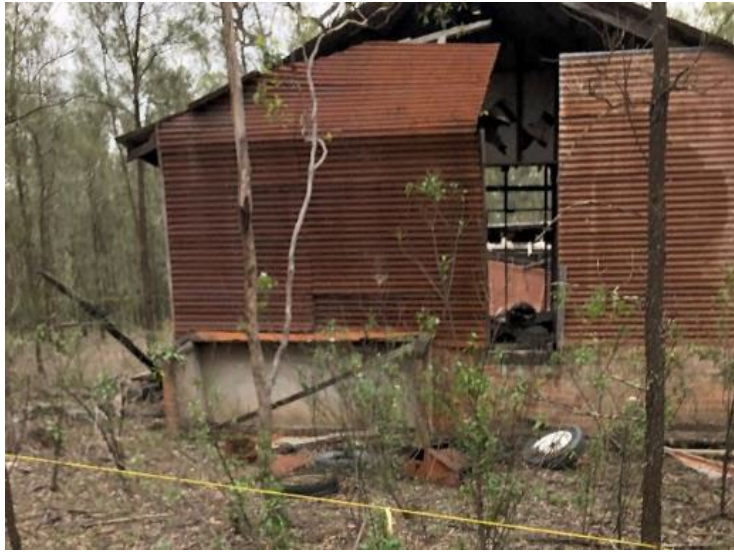
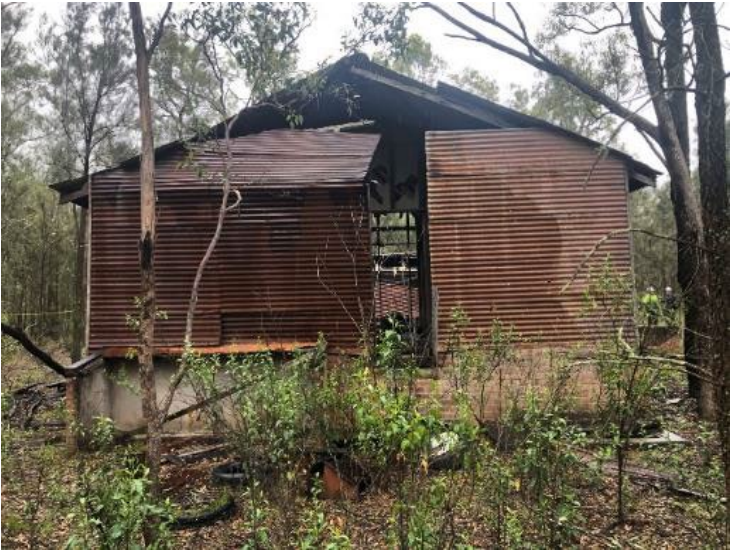
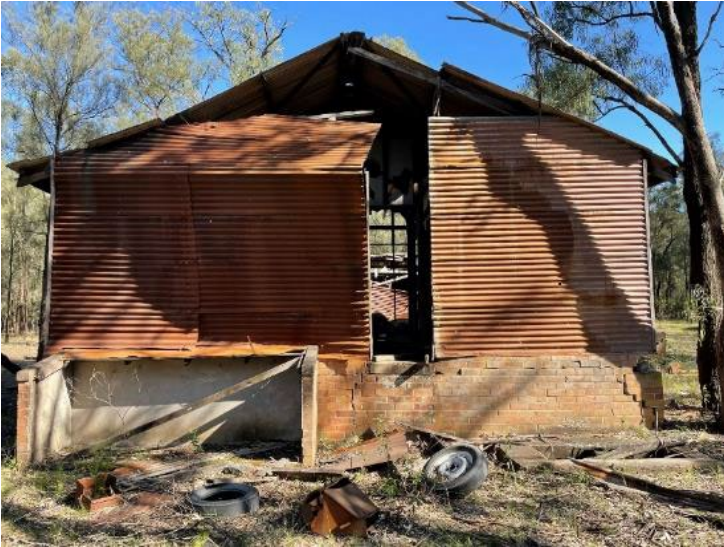
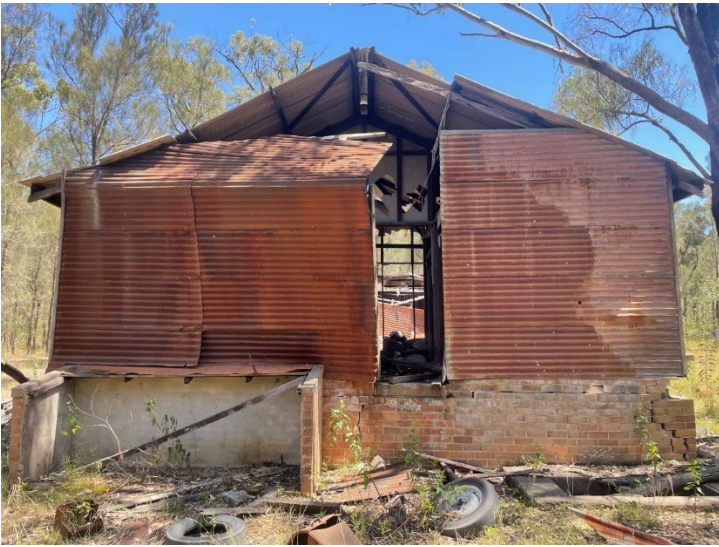
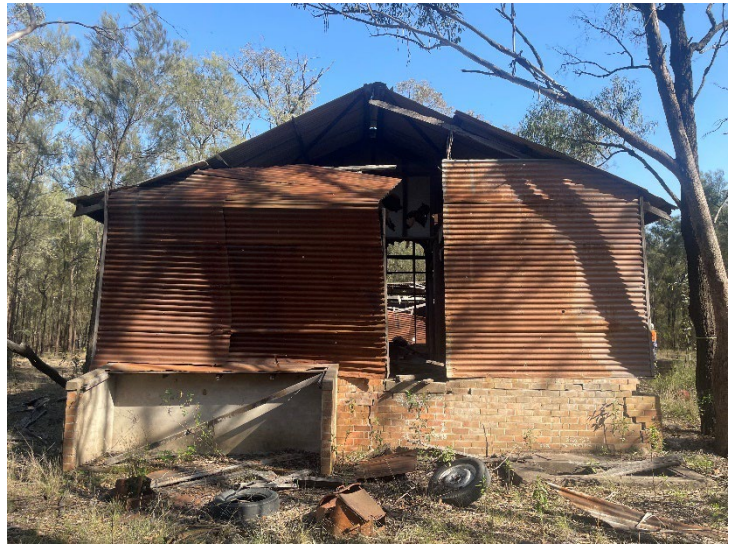
| 2012 | 2018 | 2020 (Mar) | 2020 (Dec) |
|---|---|---|---|
| | | | <p><b>2012-18:</b> evidence of increased bow to southern wall and missing panel above entry.</p> <p><b>2018-20 (Mar):</b> increased bow to southern wall.</p> <p><b>Mar 2020 – Dec 2020:</b> increased bowing on southern wall.</p> <p><b>Dec 2020-2021:</b> gap in bowing has increased.</p> <p><b>2021-2022:</b> potential subsidence bottom right corner.</p> <p><b>2022-2023:</b> increased bowing on southern wall.</p> |

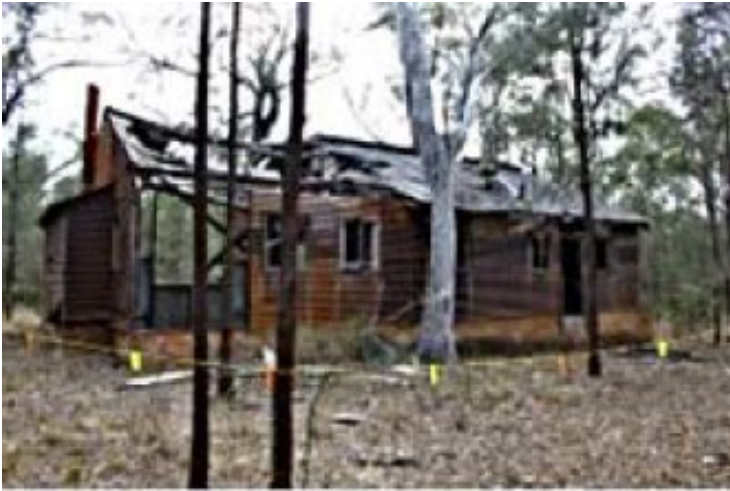
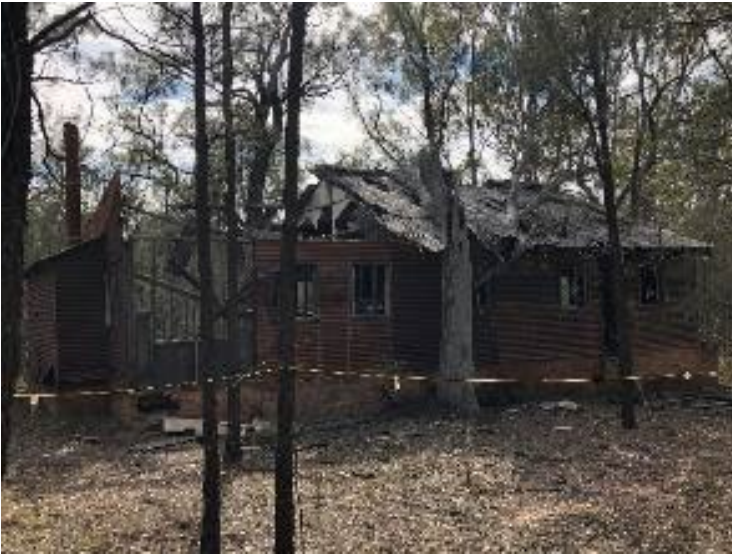
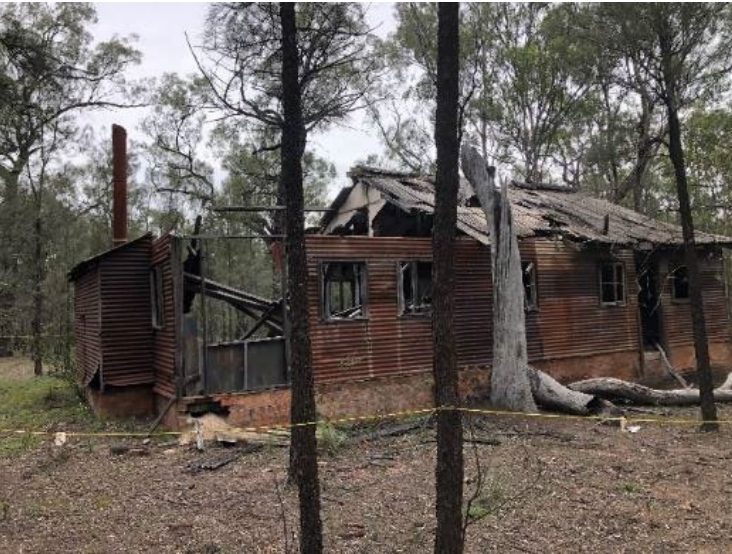
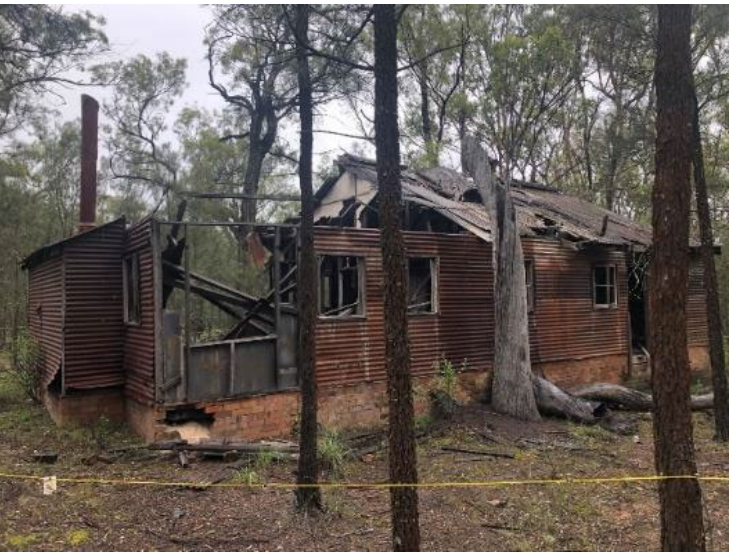
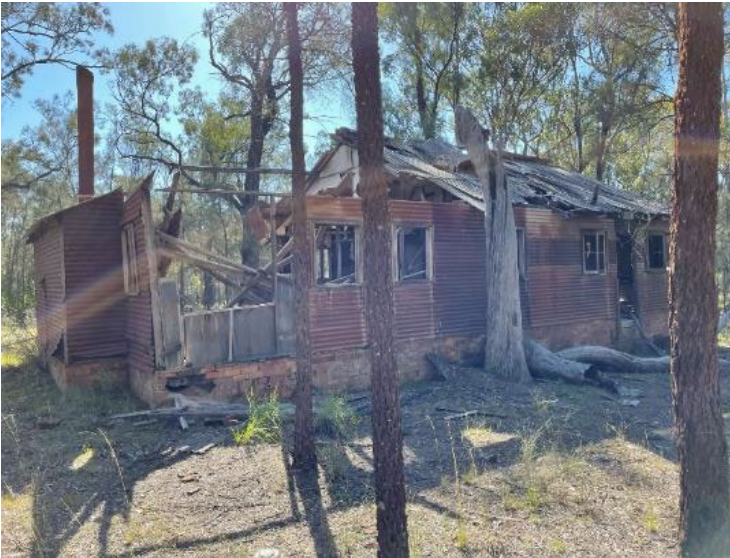
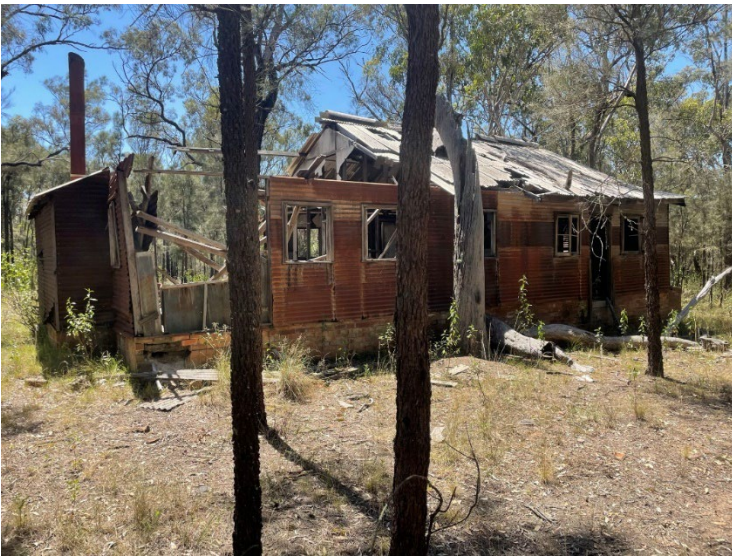
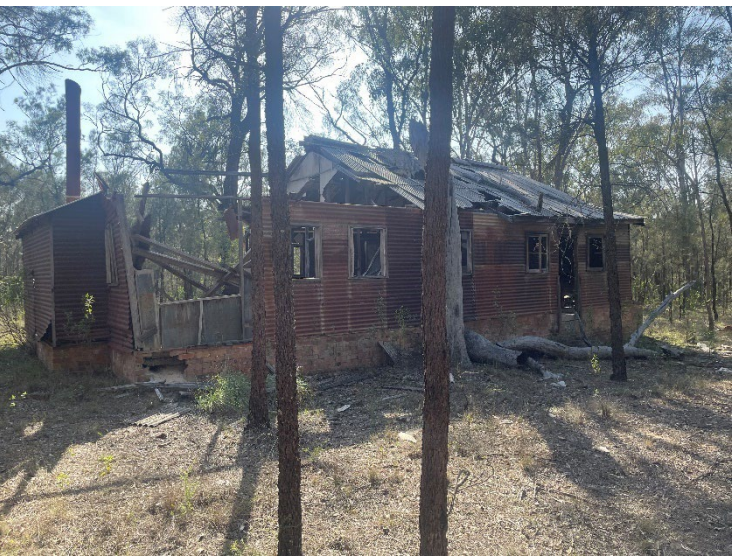
| 2012 | 2018 | 2020 (Mar) | 2020 (Dec) |
|---|---|---|---|
| | | | <p><b>2012-18:</b> shows deterioration of roofing members above open kitchen area and leaning north wall, and further collapse of asbestos roof due to fallen dead tree.</p> <p><b>2018-20 (Mar):</b> top of north wall now collapsed, further damage to roof with branch now fallen to ground.</p> <p><b>Mar 2020 – Dec 2020:</b> no discernible change.</p> <p><b>Dec 2020-2021:</b> northern wall on near side of chimney has detached from exposed western beam.</p> <p><b>2021-2022:</b> no discernible change</p> <p><b>2022-2023:</b> no discernible change</p> |

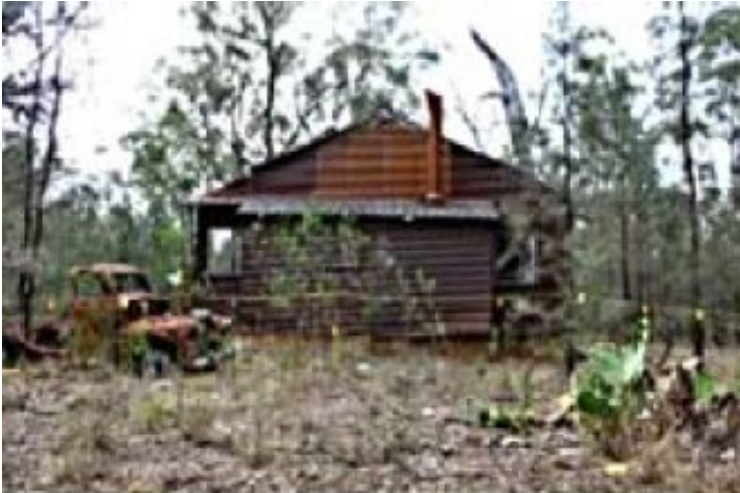
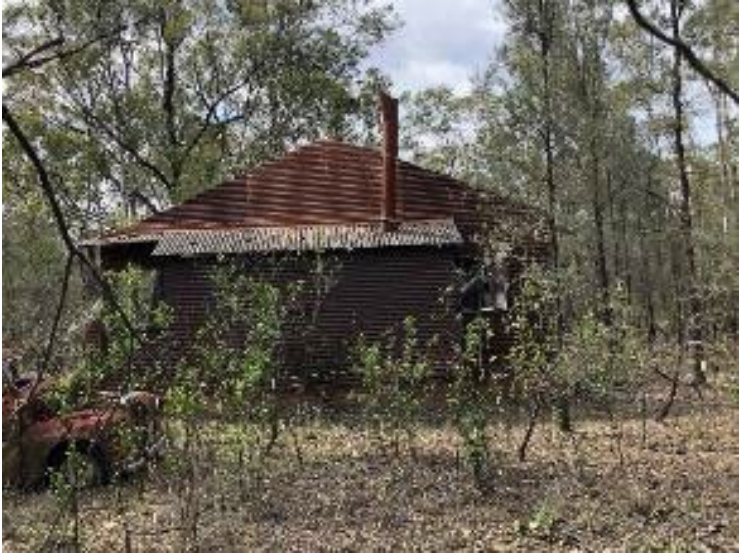
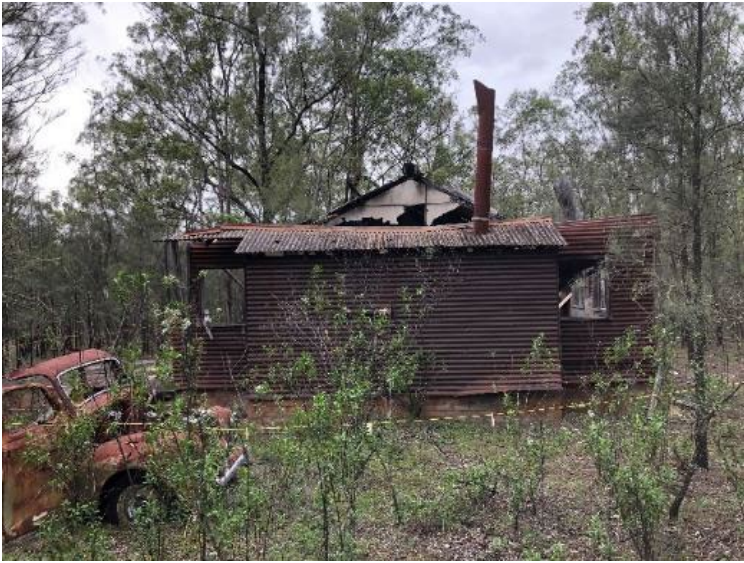
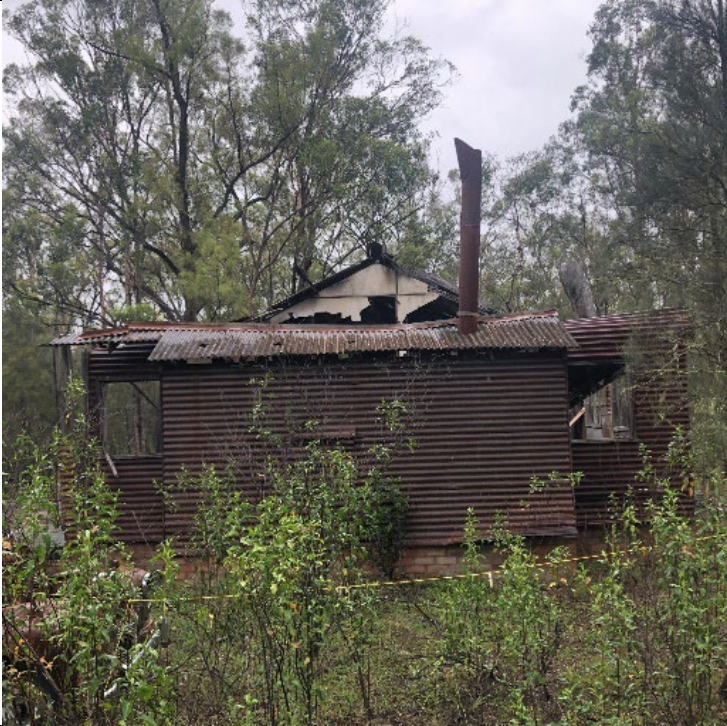
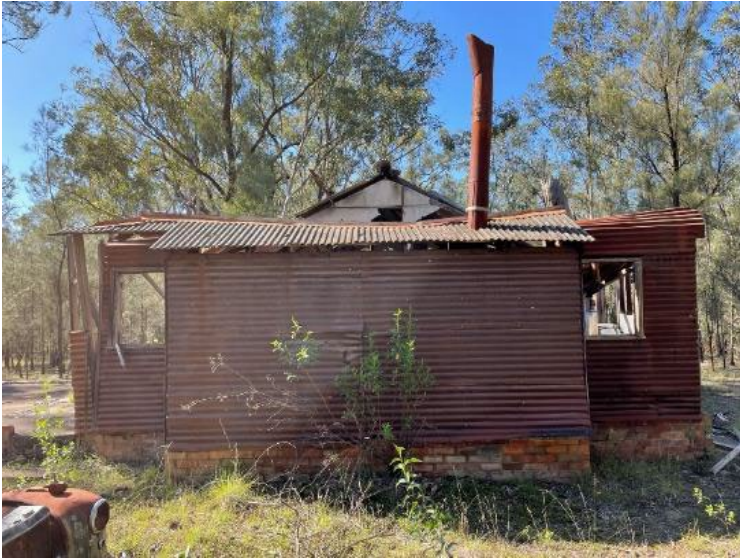
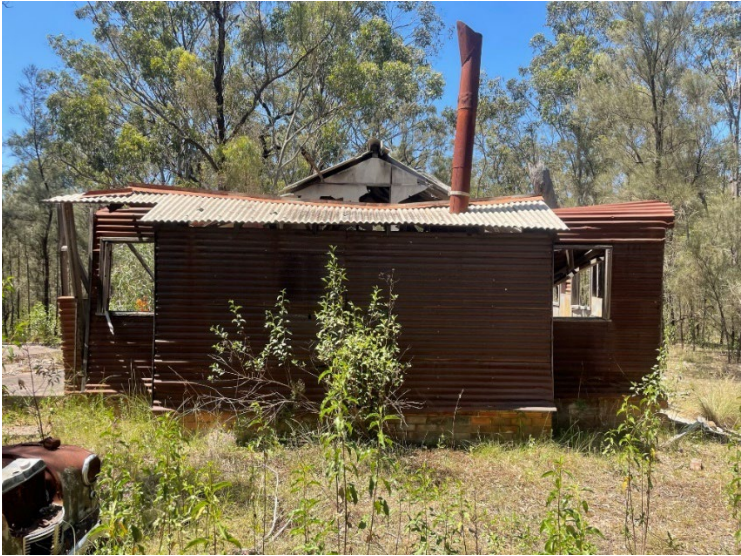
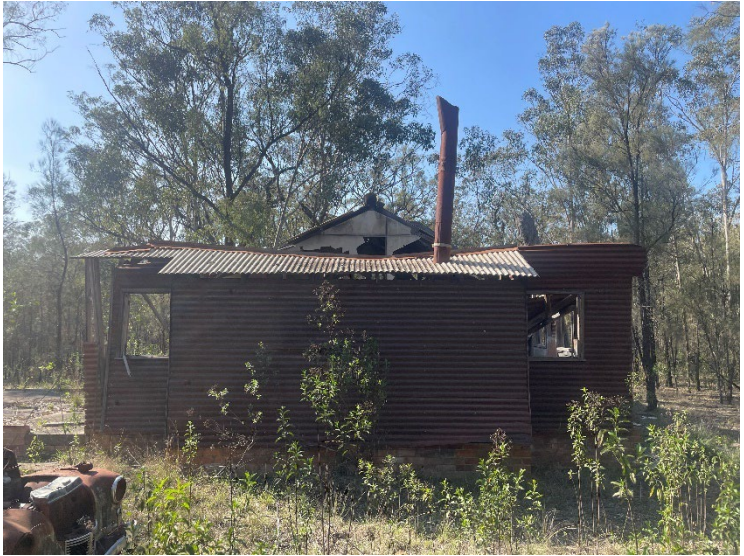
| 2012 | 2018 | 2020 (Mar) | 2020 (Dec) |
|---|---|---|---|
| | | | <p><b>2012-18:</b> no discernible change.</p> <p><b>2018-20 (Mar):</b> <a href="#">top of north wall now collapsed.</a></p> <p><b>Mar 2020 – Dec 2020:</b> no discernible change.</p> <p><b>Dec 2020-2021:</b> no discernible change.</p> <p><b>2021-2022:</b> no discernible change</p> <p><b>2022-2023:</b> no discernible change</p> |

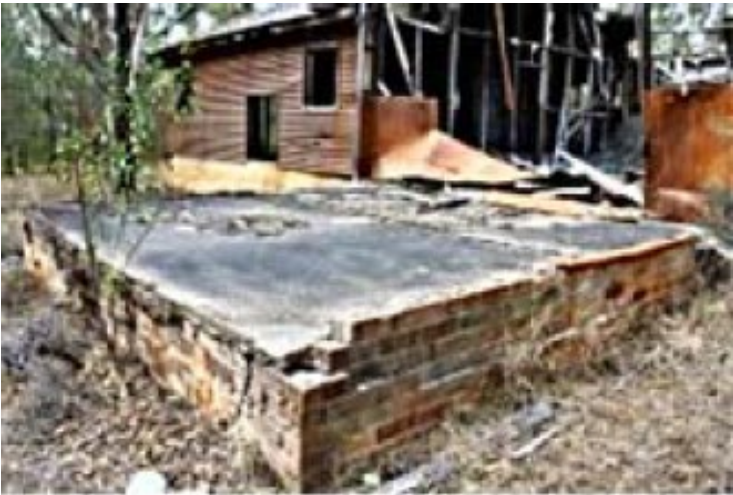
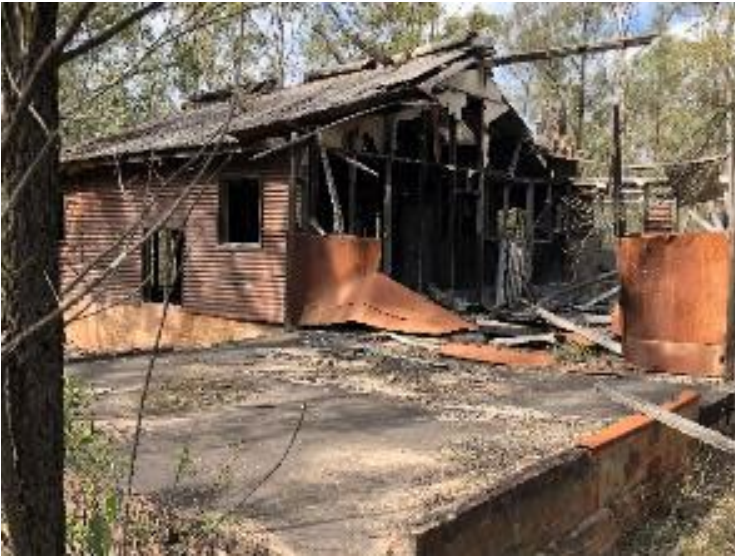
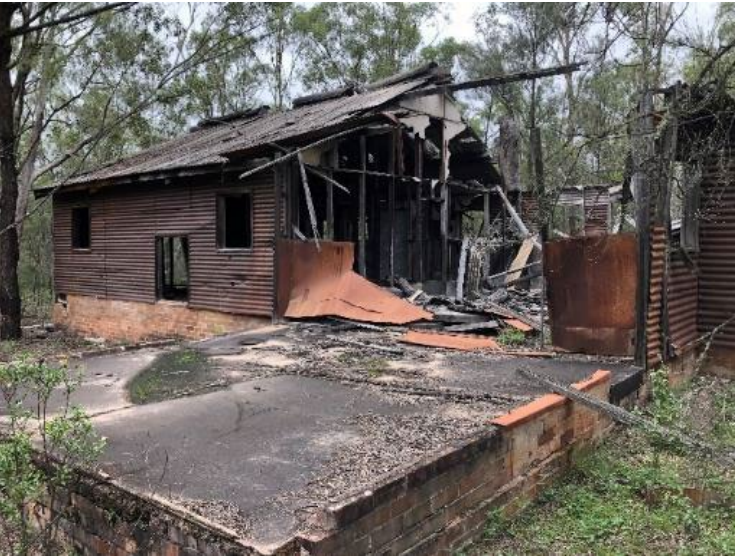
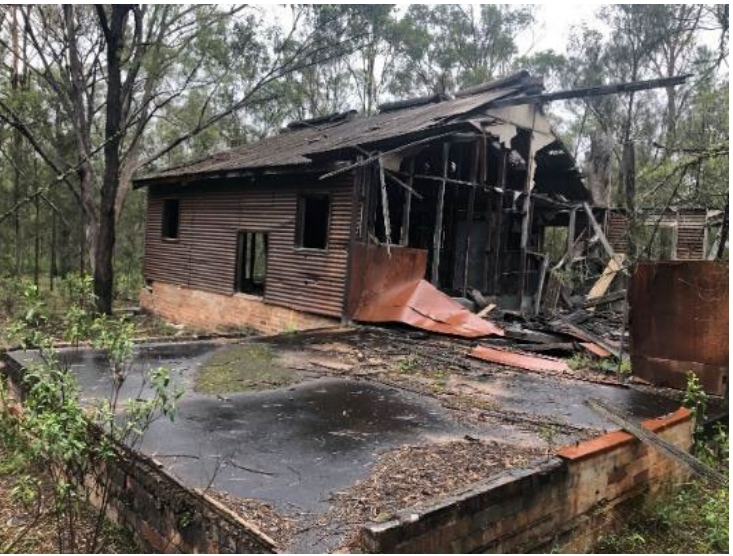
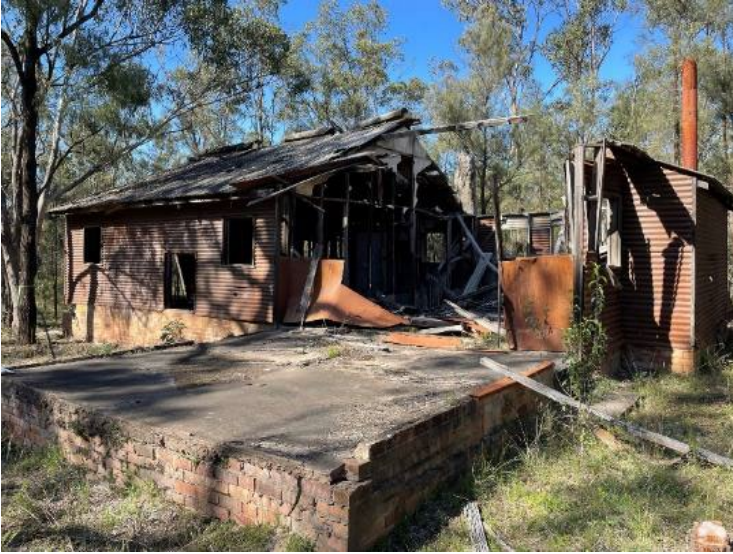
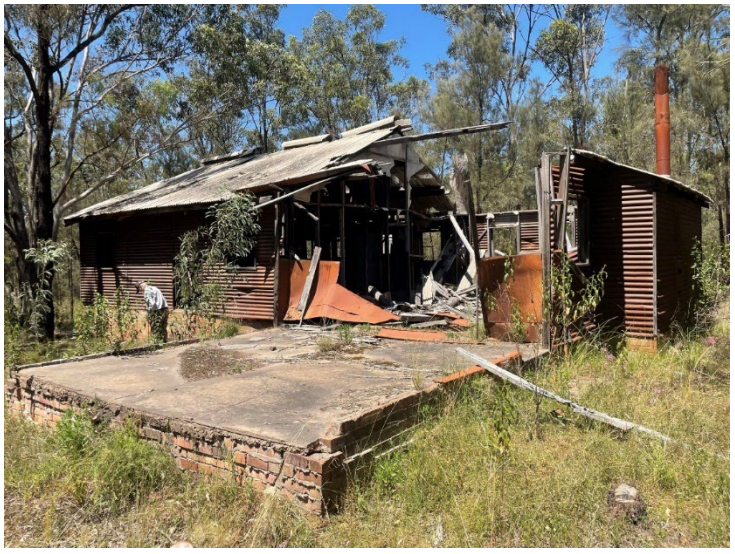
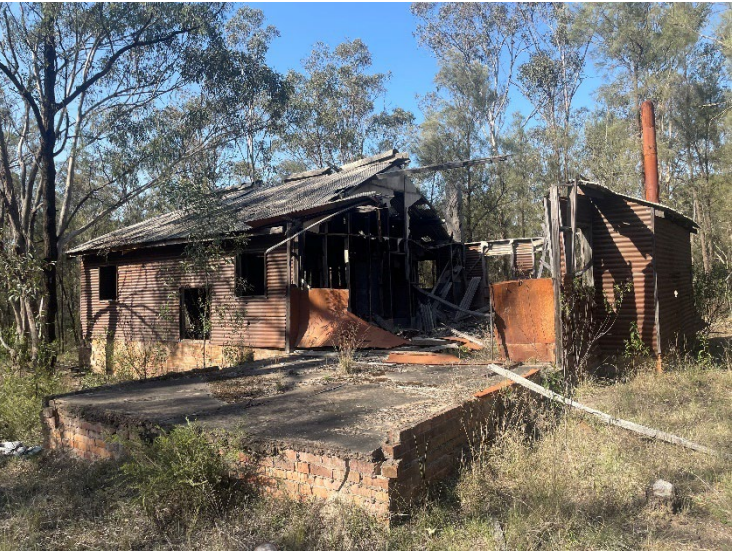
| 2012 | 2018 | 2020 (Mar) | 2020 (Dec) |
|---|---|---|---|
| | | | <p><b>2012-18:</b> difficult to discern change.</p> <p><b>2018-20 (Mar):</b> no discernible change.</p> <p><b>Mar 2020 – Dec 2020:</b> no discernible change.</p> <p><b>Dec 2020-2021:</b> difficult to discern change.</p> <p><b>2021-2022:</b> no discernible change</p> <p><b>2022-2023:</b> some collapse of internal timber members</p> |

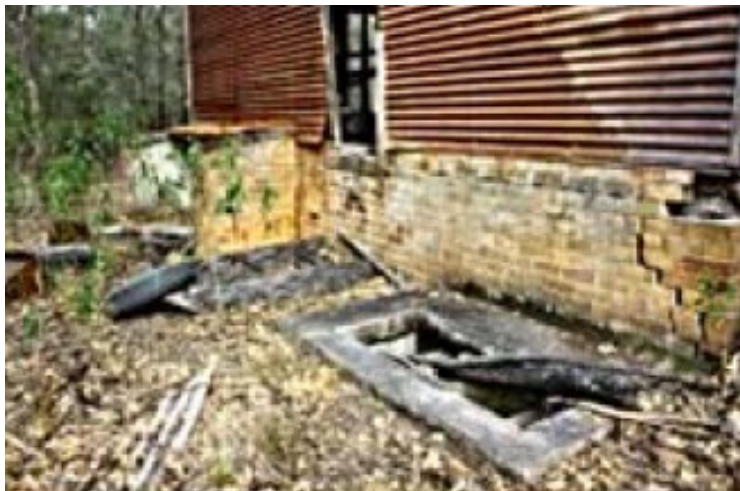
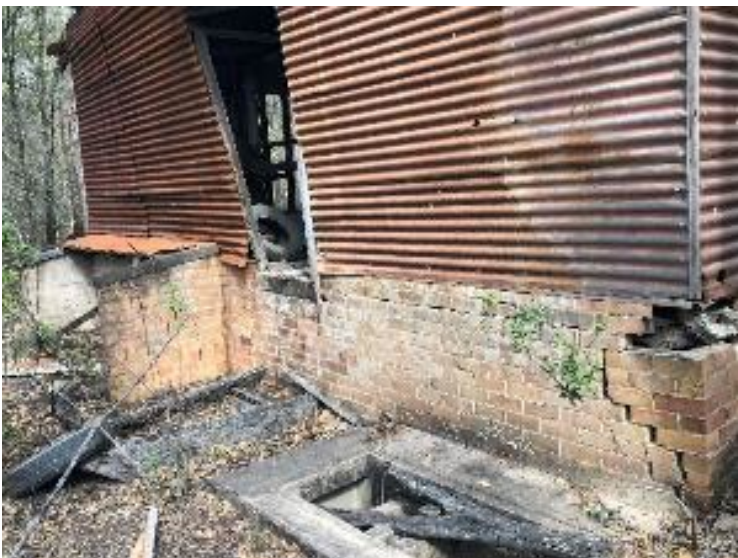
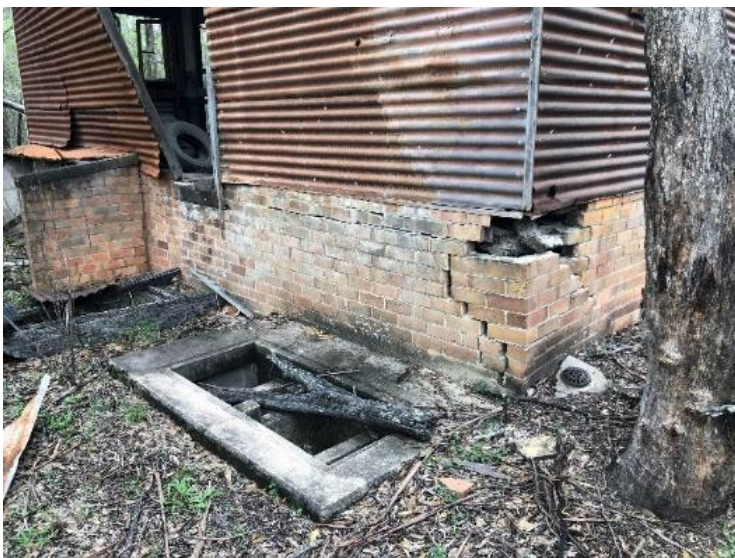
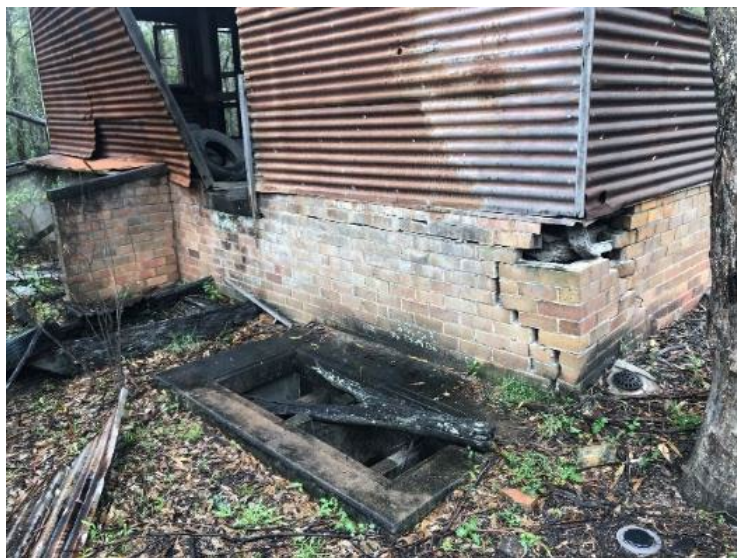
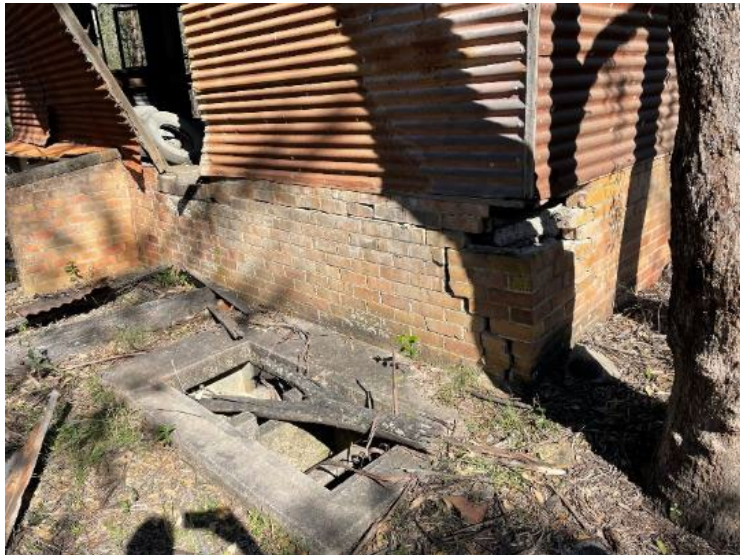
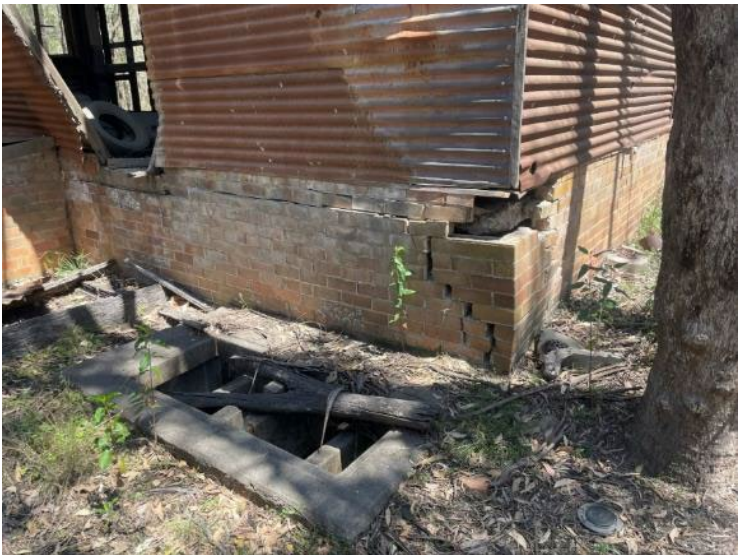
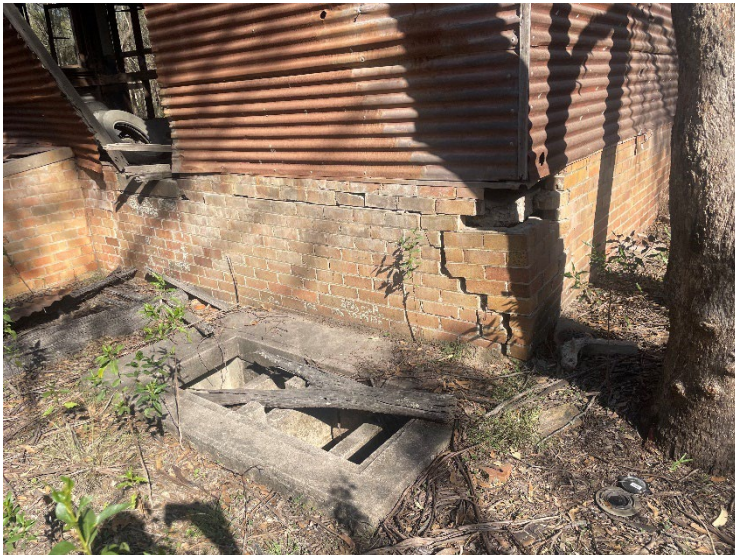
| 2012 | 2018 | 2020 (Mar) | 2020 (Dec) |
|---|---|---|---|
| 2021 | 2022 | 2023 | <p><b><u>Grease trap at south end of building</u></b></p> <p><b>2012-18:</b> shows bow to south wall.</p> <p><b>2018-20 (Mar):</b> shows increased bow to south wall.</p> <p><b>Mar 2020 – Dec 2020:</b> shows increasing bowing of south wall, and example of new termite monitoring system in bottom right of picture.</p> <p><b>Dec 2020-2021:</b> shows increasing bowing of south wall.</p> <p><b>2021-2022:</b> potential subsidence at broken brick corner.</p> <p><b>2022-2023:</b> some increased movement at cracked corner</p> |
