# Mount Thorley Warkworth

## 2023 Annual Review

| <b>Name of Operations</b> | Mount Thorley Warkworth |

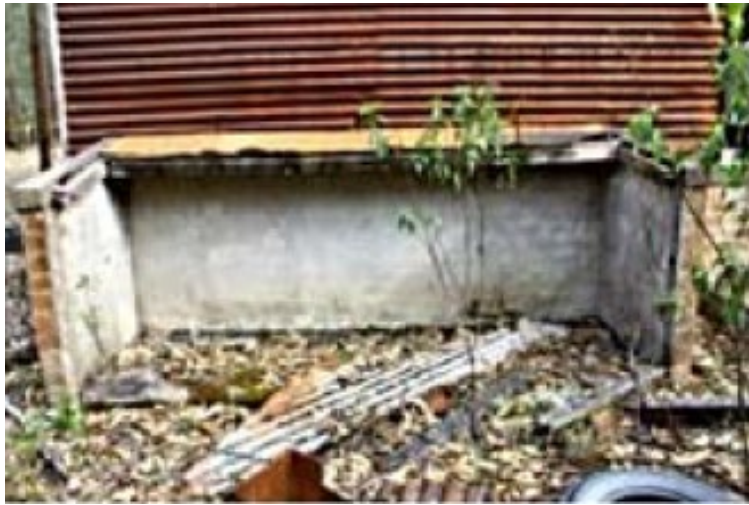
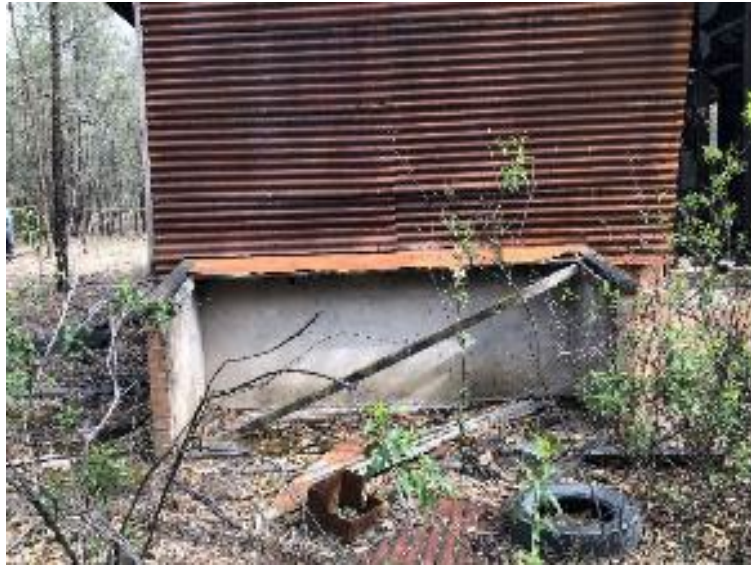
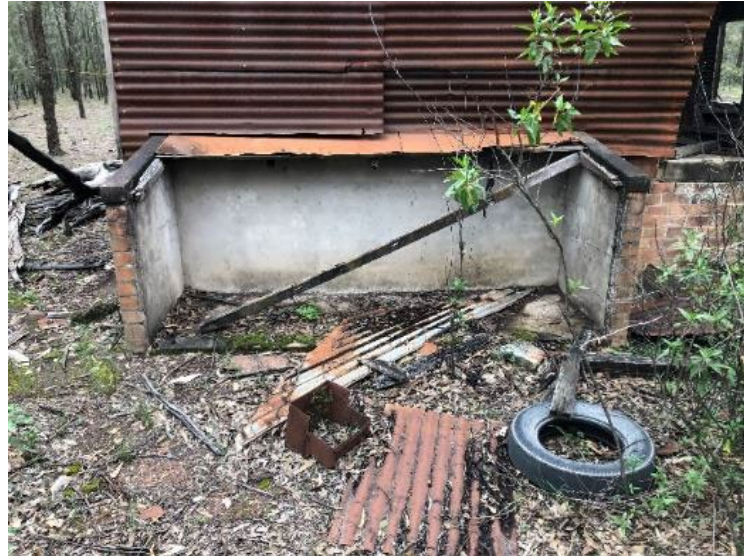
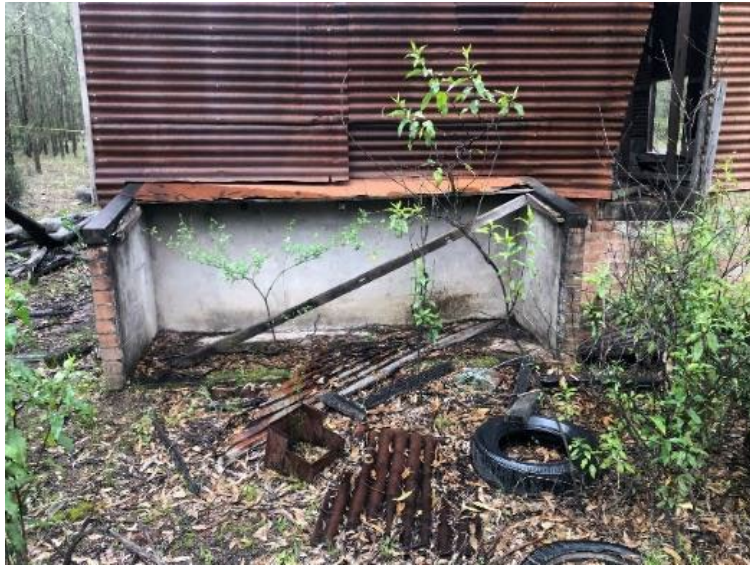
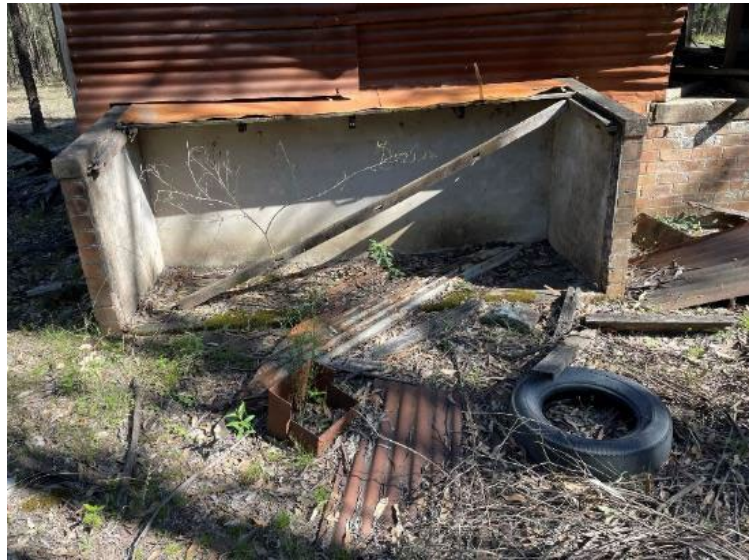
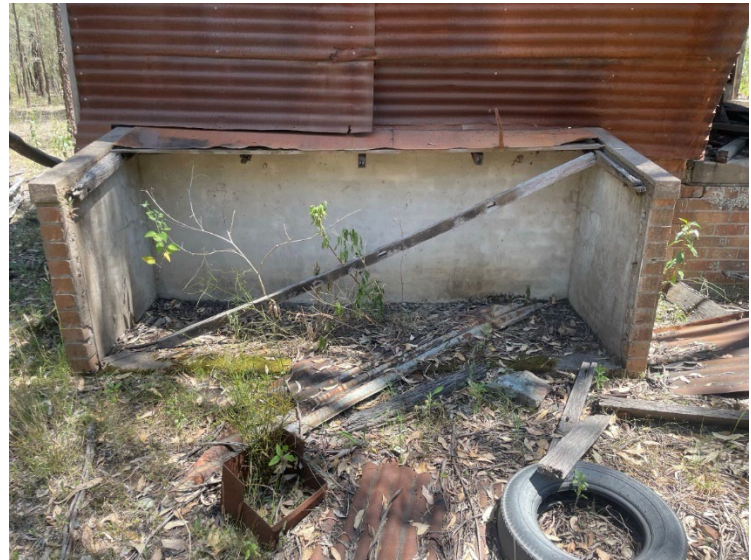
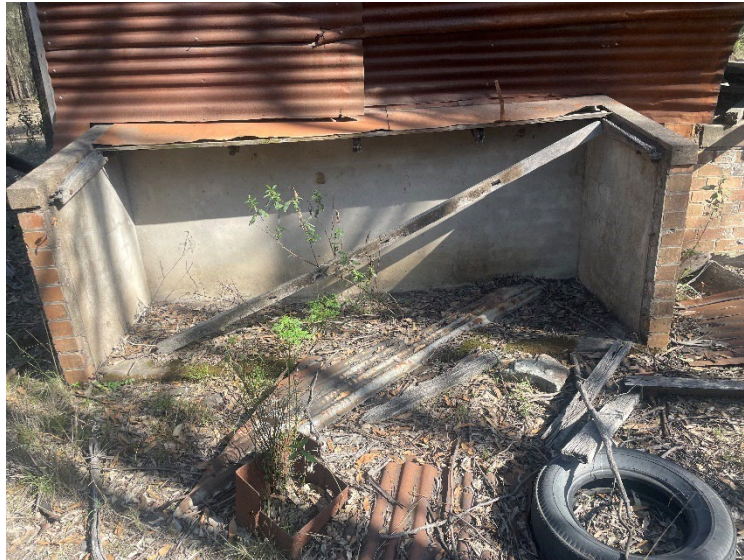
| 2012 | 2018 | 2020 (Mar) | 2020 (Dec) |
|---|---|---|---|
| 2021 | 2022 | 2023 | <p><b><u>Storage area at south end of building</u></b></p> <p><b>2012-18:</b> further slight collapse of storage area.</p> <p><b>2018-20 (Mar):</b> shows loosening of corrugated iron wall sheeting due to bowing in wall.</p> <p><b>Mar 2020 – Dec 2020:</b> no discernible change.</p> <p><b>Dec 2020-2021:</b> no discernible change.</p> <p><b>2021-2022:</b> no discernible change</p> <p><b>2022-2023:</b> further separation of corrugated iron wall sheeting due to bowing in wall.</p> |

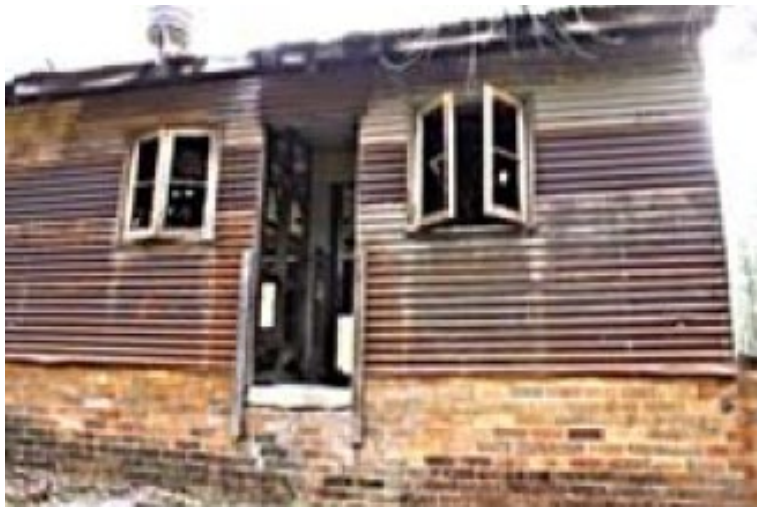
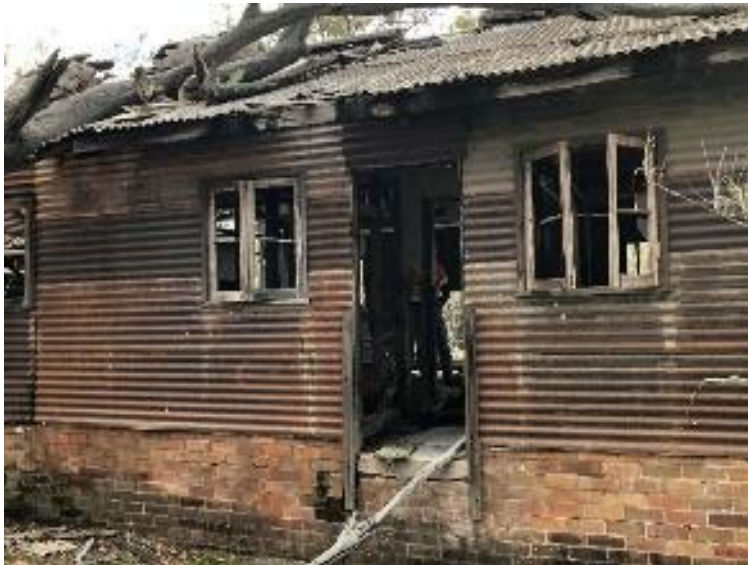
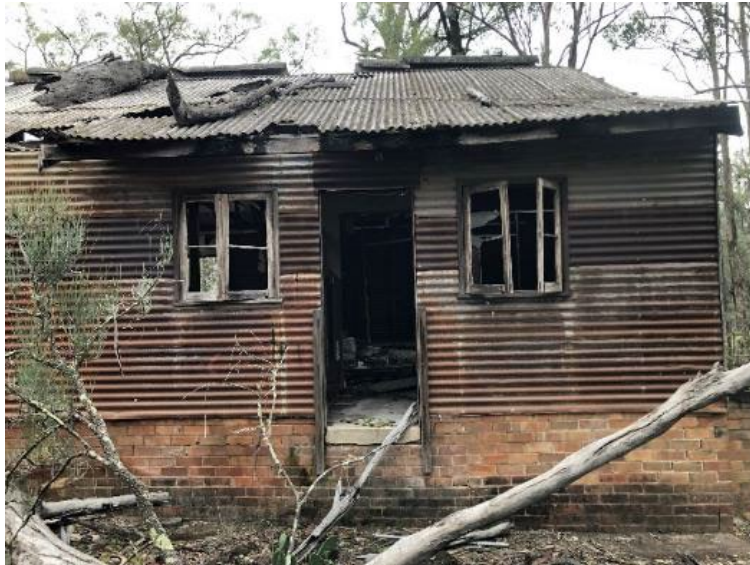
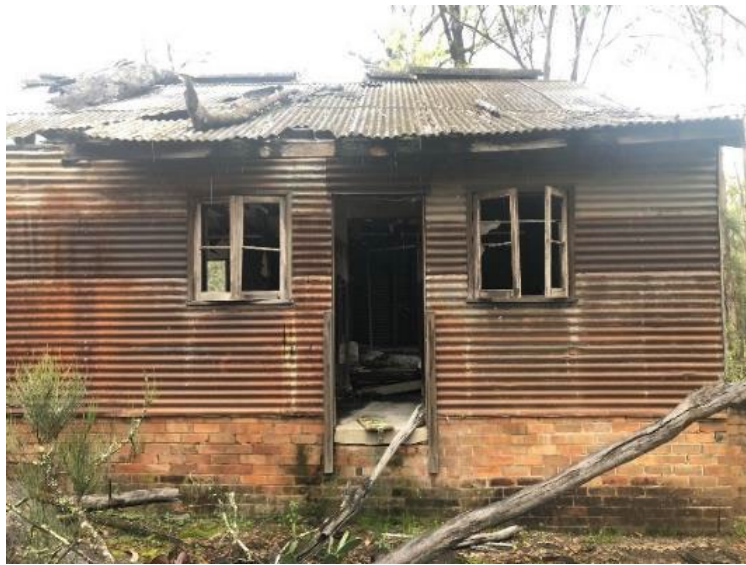
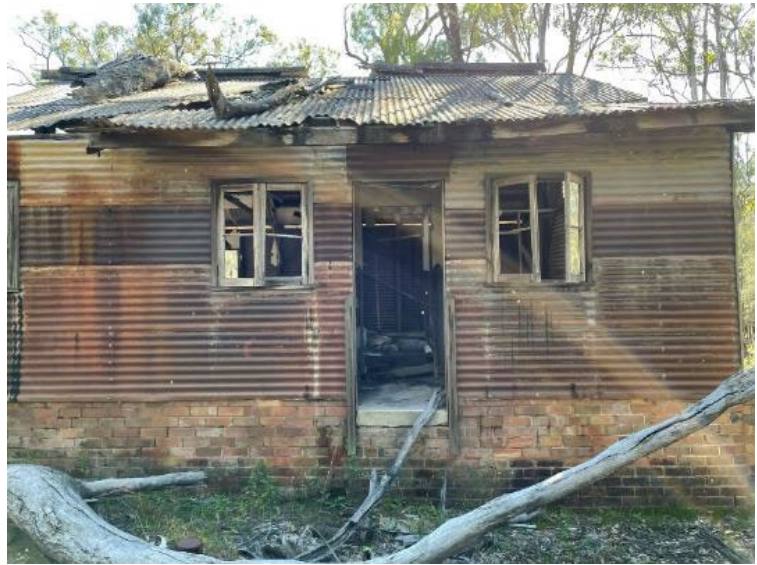
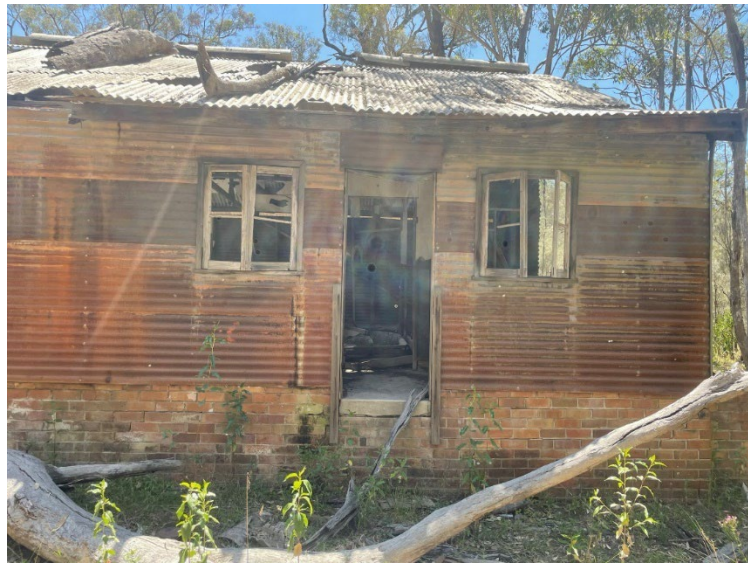
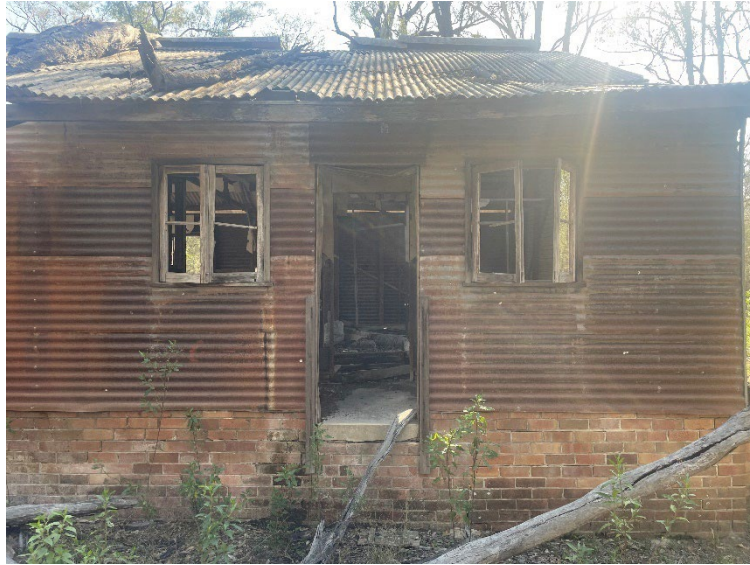
| 2012 | 2018 | 2020 (Mar) | 2020 (Dec) |
|---|---|---|---|
| 2021 | 2022 | 2023 | <p><b><u>Windows and entry at west elevation</u></b></p> <p><b>2012-18:</b> shows large trunk/branch portions of tree collapsed on roof, which has destroyed roof ventilator.</p> <p><b>2018-20 (Mar):</b> shows majority of branches fallen from roof, leaving increased damage to sheeting.</p> <p><b>Mar 2020 – Dec 2020:</b> no discernible change.</p> <p><b>Dec 2020-2021:</b> no discernible change.</p> <p><b>2021-2022:</b> no discernible change.</p> <p><b>2022-2023:</b> no discernible change</p> |

1. Engage an asbestos expert to assess and develop a clean-up and disposal plan to deal with both the broken fragments and intact asbestos sheeting;
2. Remove any remaining tree branches from the roof. In addition, to prevent similar damage in the future, serious consideration should be given to removing or lopping those trees that are located close enough to the building that they may cause damage if they fall or drop large branches.

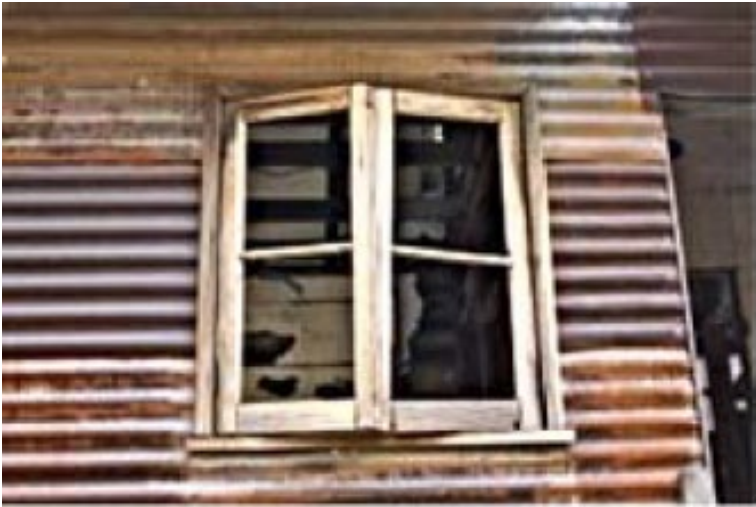
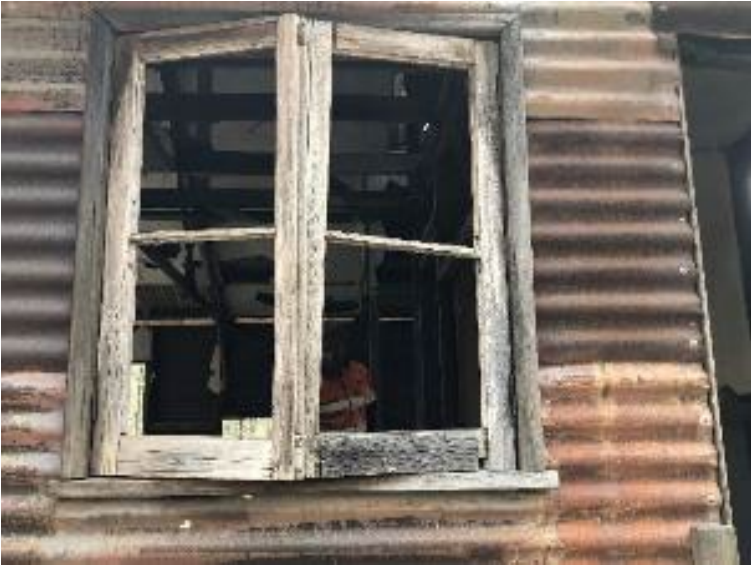
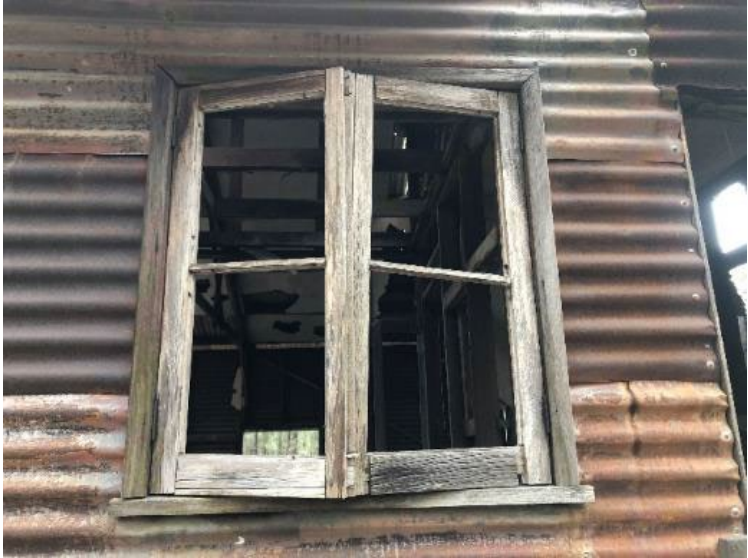
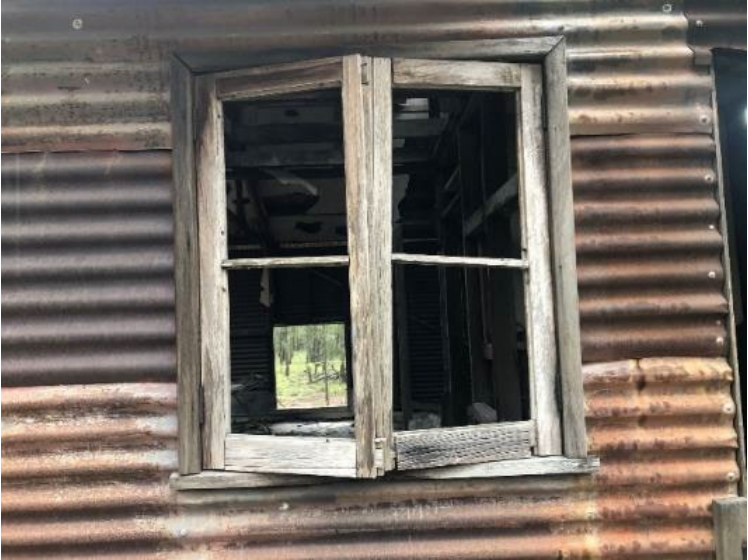
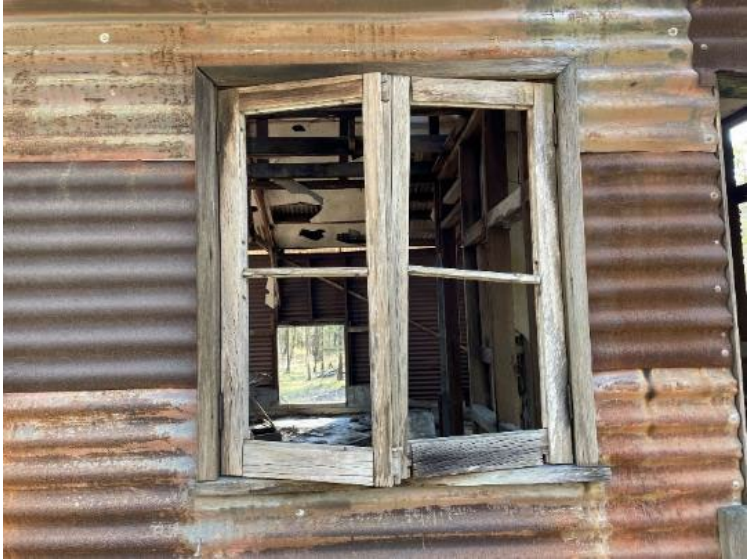
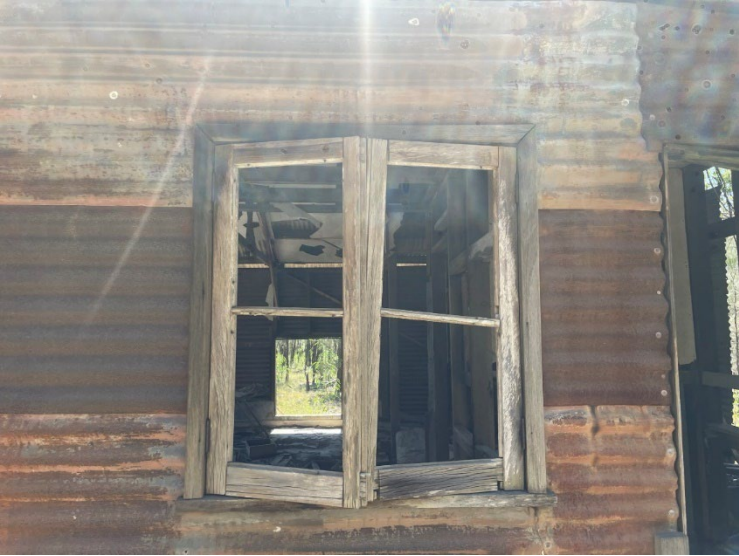
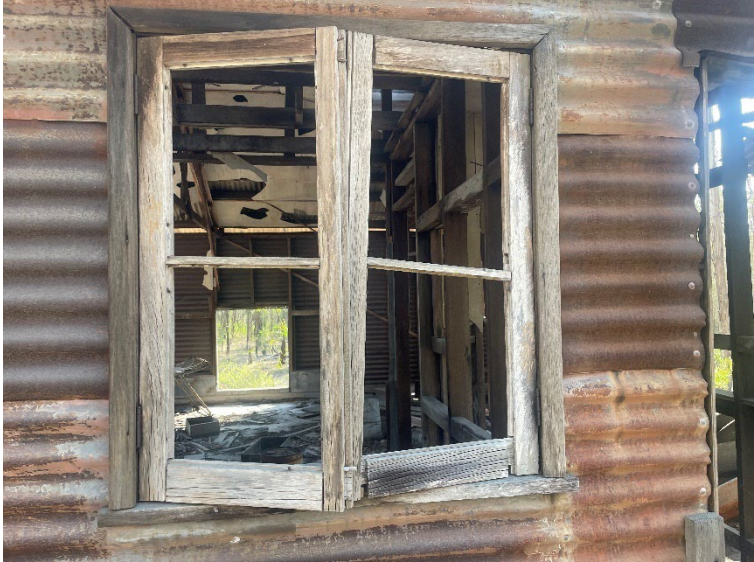
| 2012 | 2018 | 2020 (Mar) | 2020 (Dec) |
|---|---|---|---|
| | | | <p><b>2012-18:</b> no discernible change.</p> <p><b>2018-20 (Mar):</b> no discernible change.</p> <p><b>Mar 2020 – Dec 2020:</b> no discernible change.</p> <p><b>Dec 2020-2021:</b> no discernible change.</p> <p><b>2021-2022:</b> no discernible change</p> <p><b>2022-2023:</b> no discernible change</p> |

3. Pending the results of the asbestos assessment, the building and surrounds should be thoroughly cleaned of asbestos and other rubbish material. An archaeologist should be present to collect any items of historic importance or that relate to the original fabric of the building. This should also include the removal, repair and curation of items such

as window frames and panels before their total deterioration. All such items can be stored inside the building and potentially re-used during further stabilization programs;

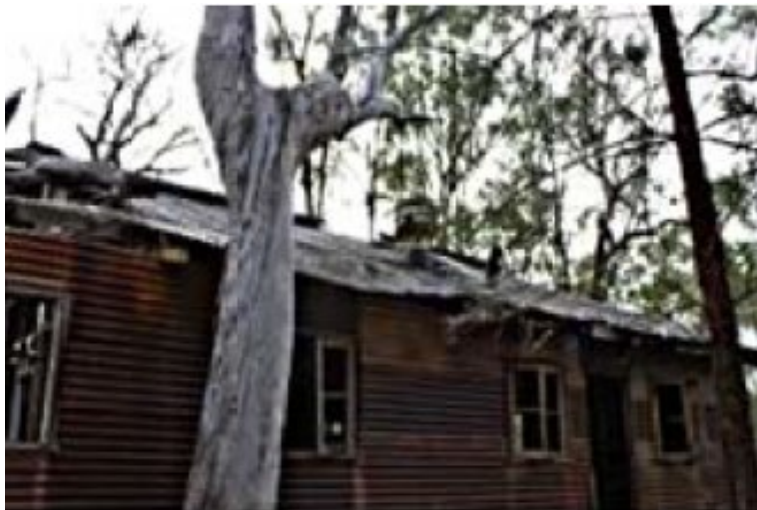
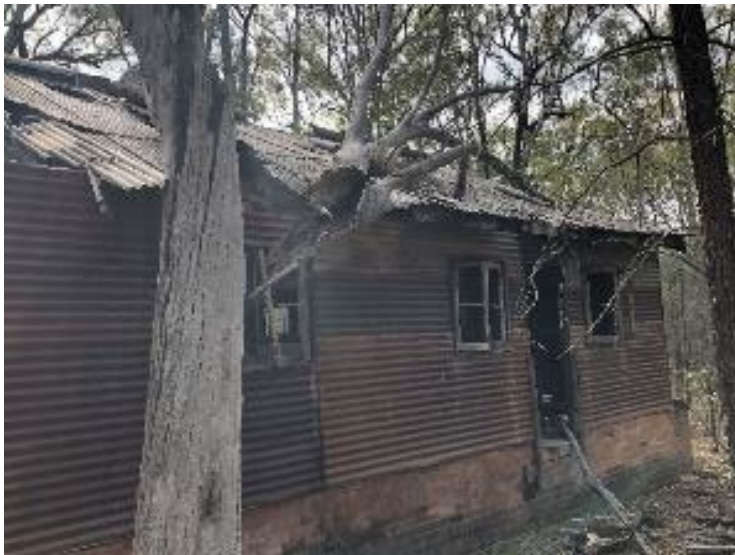
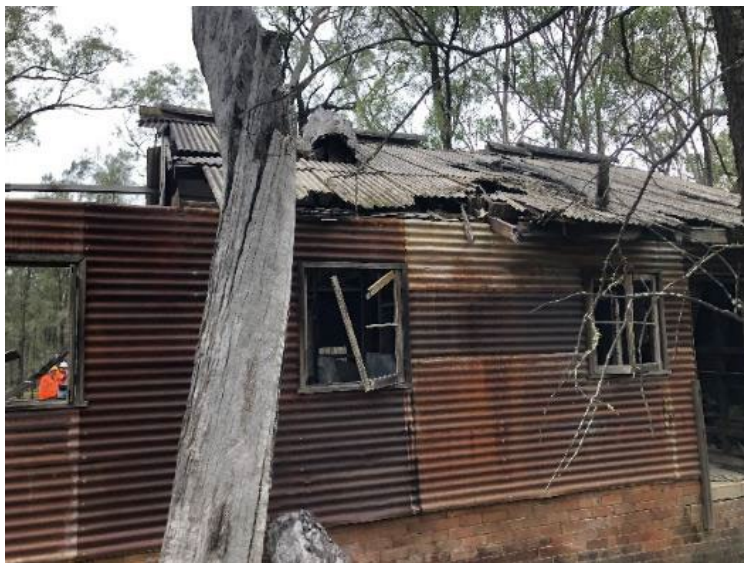
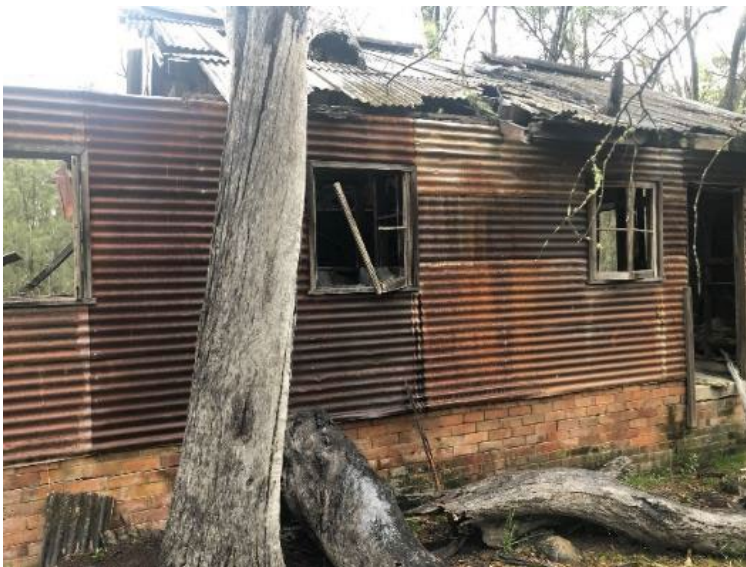
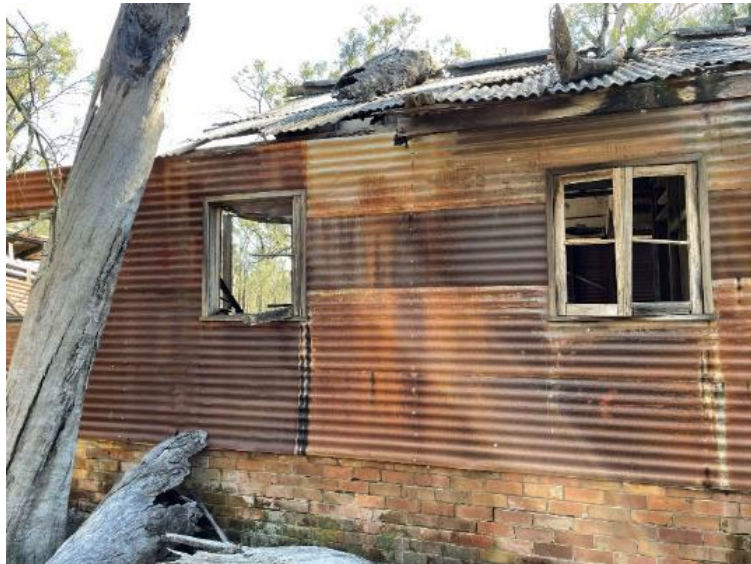
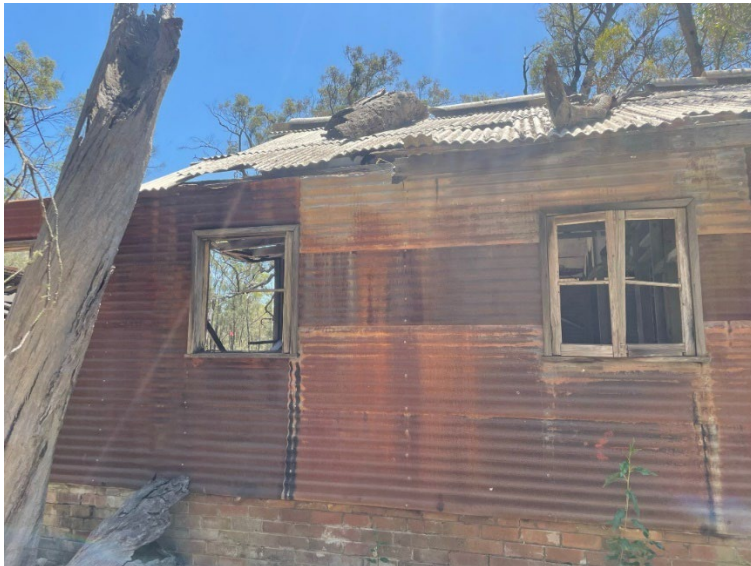
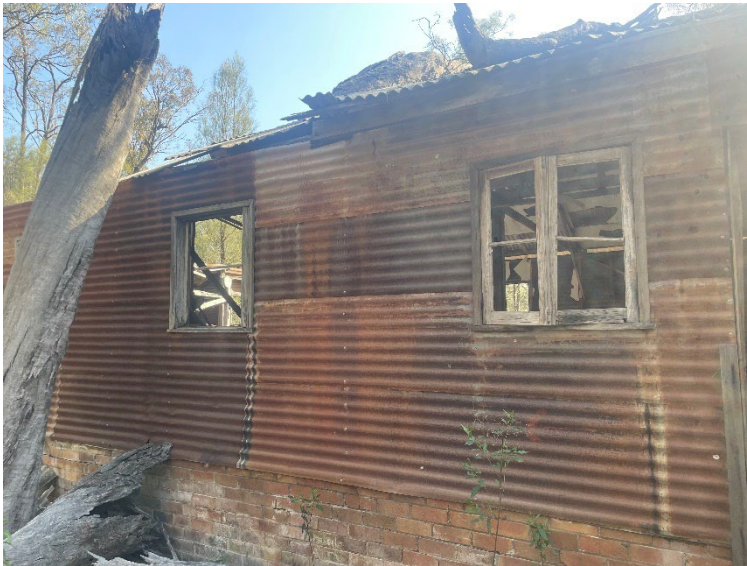
| 2012 | 2018 | 2020 (Mar) | 2020 (Dec) |
|---|---|---|---|
| 2021 | 2022 | 2023 | <p><b><u>Showing cylindrical ventilator and damage to roof, view from west</u></b></p> <p><b>2012-18:</b> shows significant roof damage from fallen dead tree, including to ventilator.</p> <p><b>2018-20 (Mar):</b> shows increased damage to roof edge sheeting from fallen branch.</p> <p><b>Mar 2020 – Dec 2020:</b> no discernible change.</p> <p><b>Dec 2020-2021:</b> deterioration of left window frame.</p> <p><b>2021-2022:</b> no discernible change</p> <p><b>2022-2023:</b> no discernible change</p> |

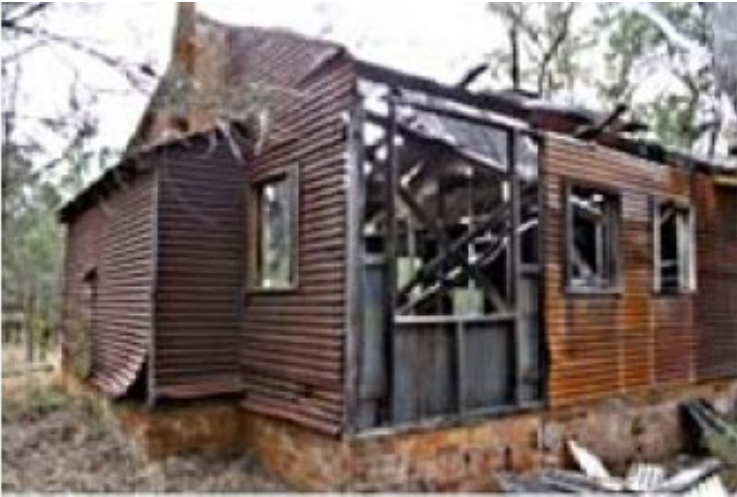
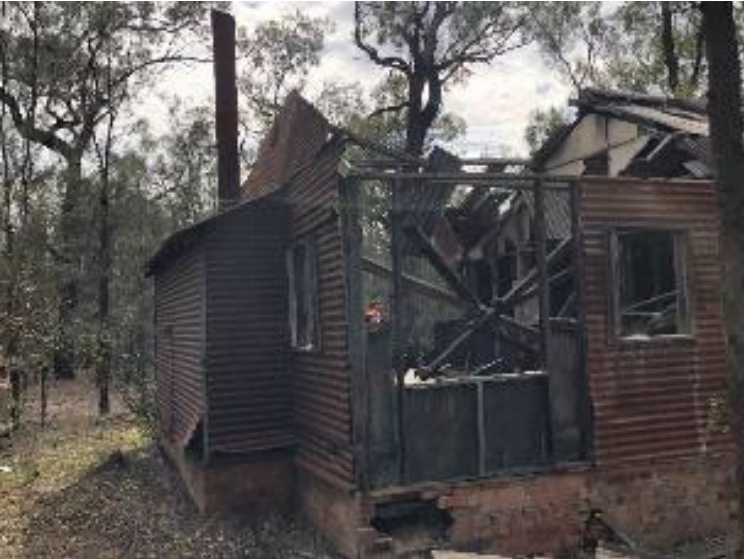
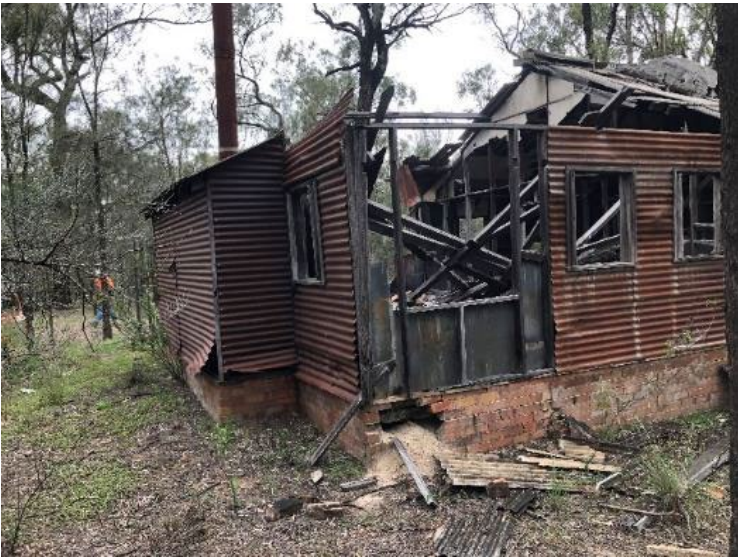
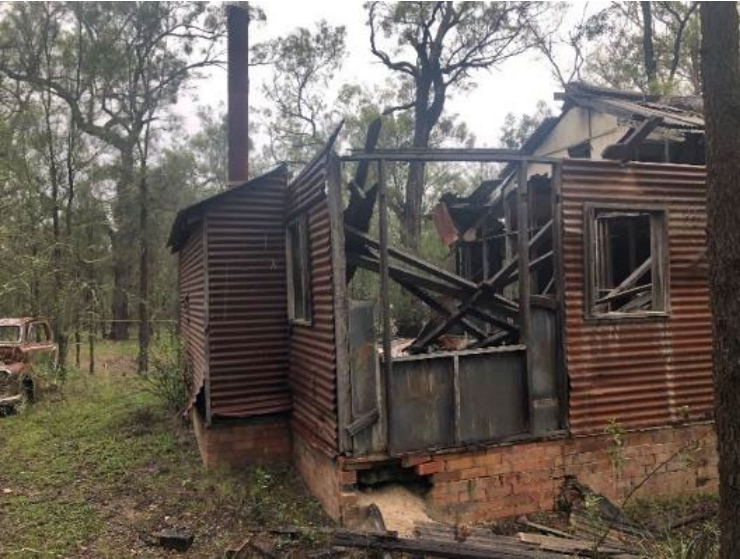
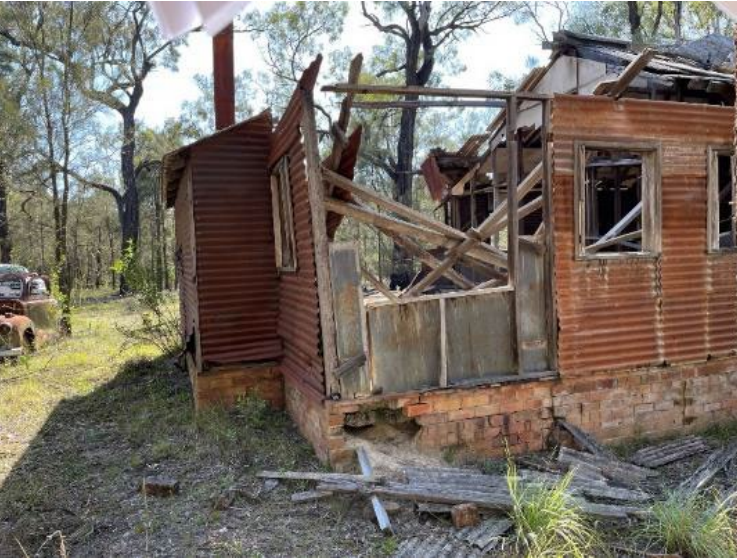
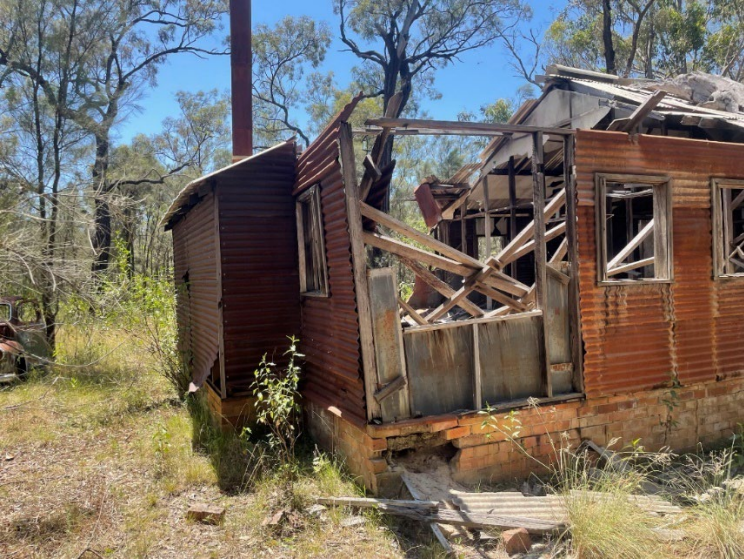
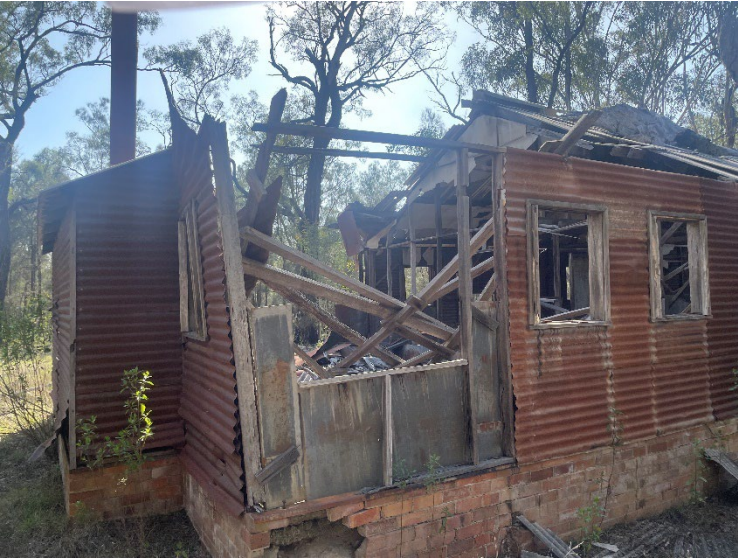
| 2012 | 2018 | 2020 (Mar) | 2020 (Dec) |
|---|---|---|---|
| | | | <p><b>2012-18:</b> shows increased collapse over open kitchen area, as well as new damage to brick foundation at north-west corner.</p> <p><b>2018-20 (Mar):</b> shows fallen top of north wall plus increased (animal?) damage to brick foundation at north-western corner.</p> <p><b>Mar 2020 – Dec 2020:</b> no discernible change.</p> <p><b>Dec 2020 – 2021:</b> detachment of north wall from western beam.</p> <p><b>2021-2022:</b> no discernible change</p> <p><b>2022-2023:</b> some internal timbers have fallen further.</p> |

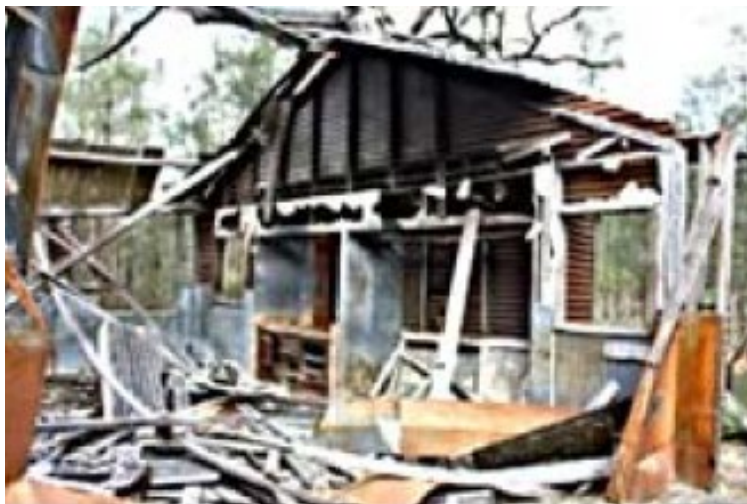
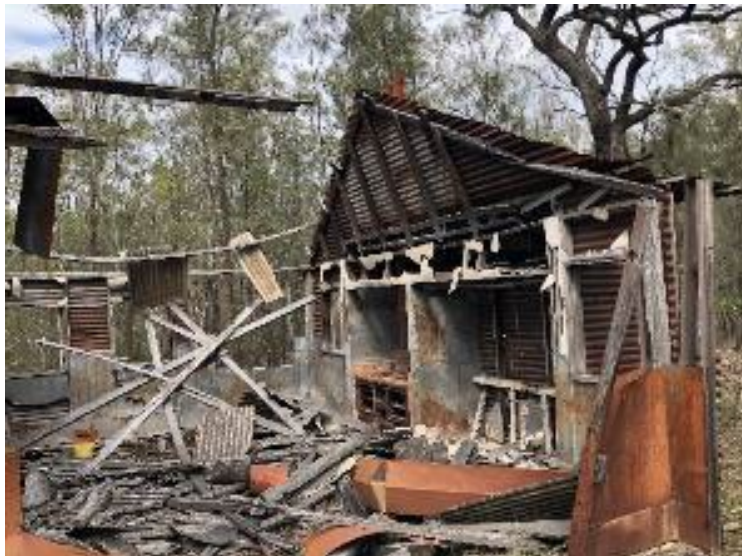
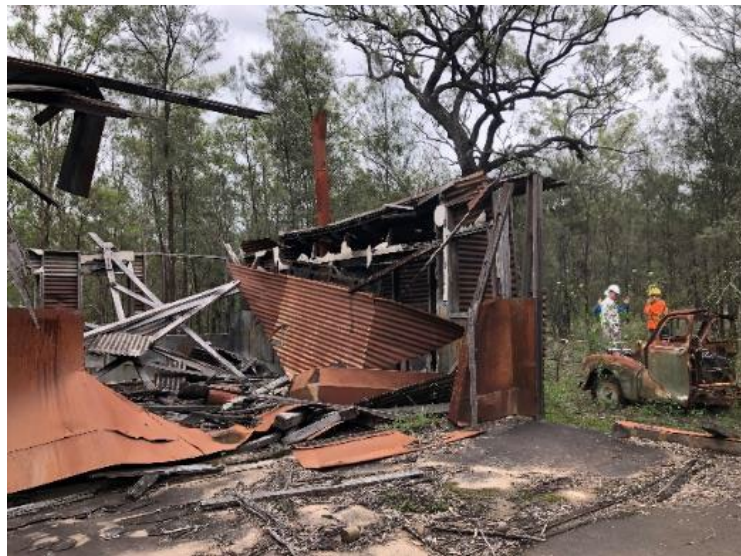
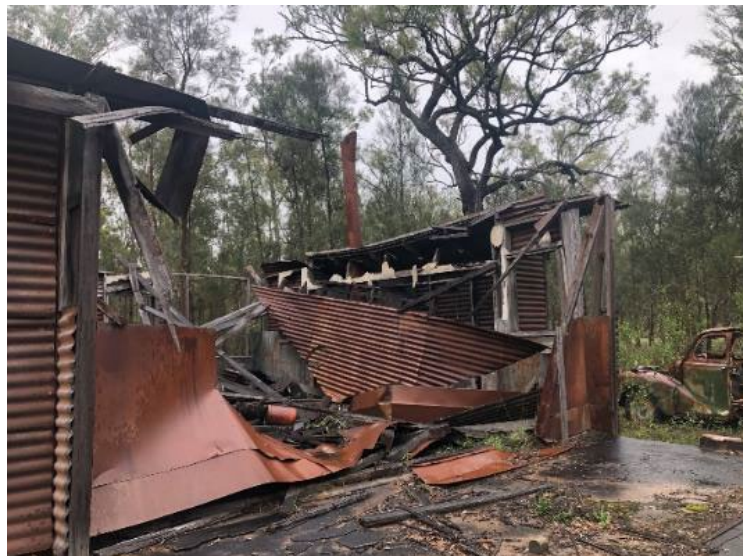
| 2012 | 2018 | 2020 (Mar) | 2020 (Dec) |
|---|---|---|---|
| 2021 | 2022 | 2023 | <p><b><u>Showing interior damage at kitchen at north end of building</u></b></p> <p><b>2012-18:</b> shows increased collapse over and accumulation of debris within open kitchen area. Note also severe lean to north wall. Stove doors have become unhinged.</p> <p><b>2018-20 (Mar):</b> shows collapsed top of north wall and collapse of remaining full crossbeam. Stove now obscured by collapsed north wall.</p> <p><b>Mar 2020 – Dec 2020:</b> no discernible change.</p> <p><b>Dec 2020 – 2021:</b> no discernible change.</p> <p><b>2021-2022:</b> no discernible change</p> <p><b>2022-2023:</b> some movement of fallen timbers</p> |

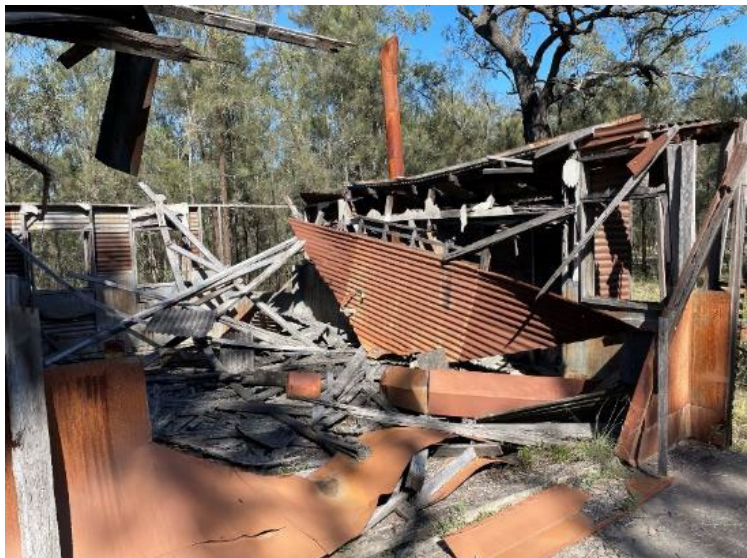
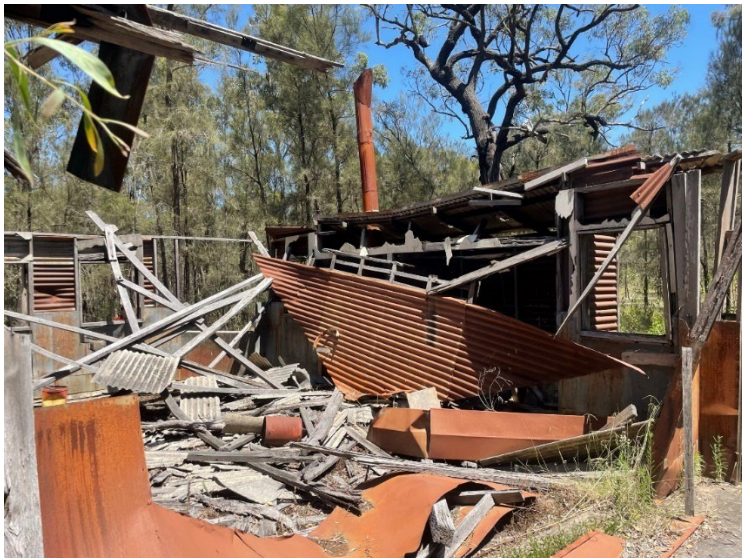
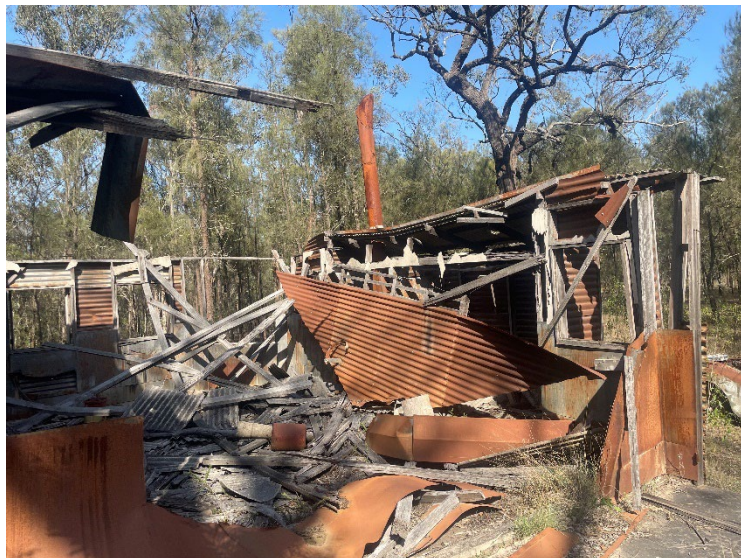
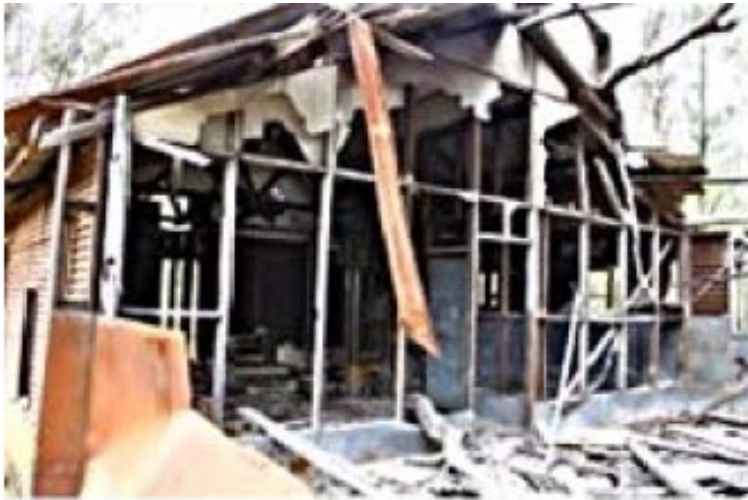
| 2012 | 2018 | 2020 (Mar) | 2020 (Dec) |
|---|---|---|---|
| 2021 | 2022 | 2023 | <p><b><u>View to interior of south end of building, view from east</u></b></p> <p><b>2012-18:</b> shows increased collapse over open kitchen area.</p> <p><b>2018-20 (Mar):</b> shows further minor deterioration of asbestos panelling.</p> <p><b>Mar 2020 – Dec 2020:</b> no discernible change.</p> <p><b>Dec 2020 – 2021:</b> no discernible change.</p> <p><b>2021-2022:</b> no discernible change</p> <p><b>2022-2023:</b> some movement of fallen timbers</p> |

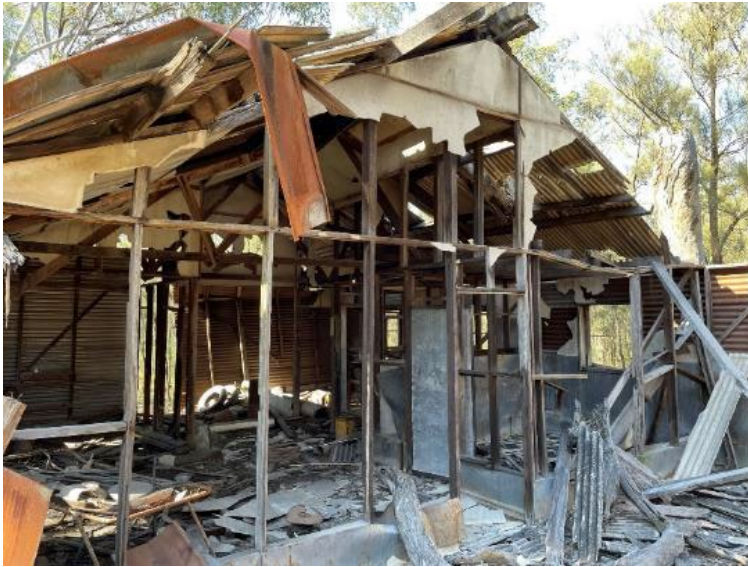
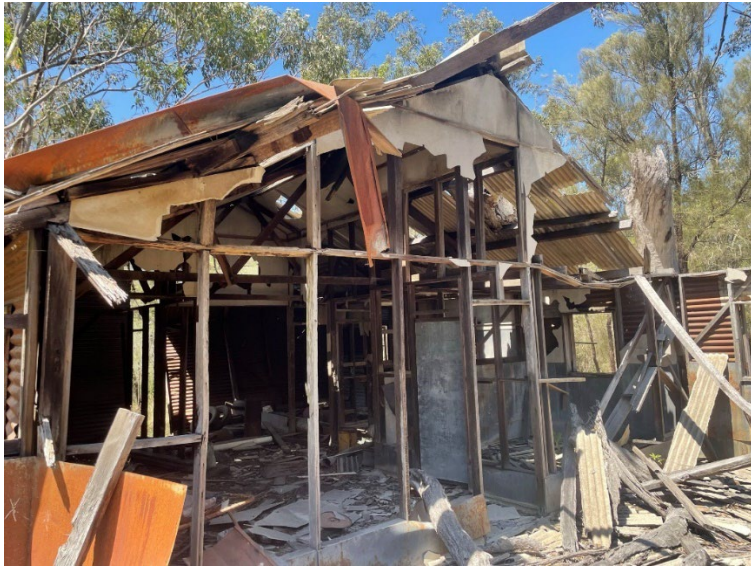
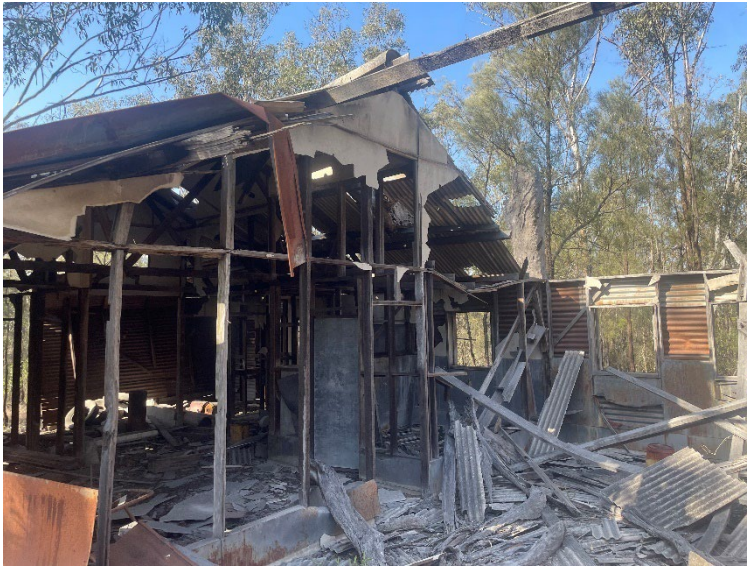
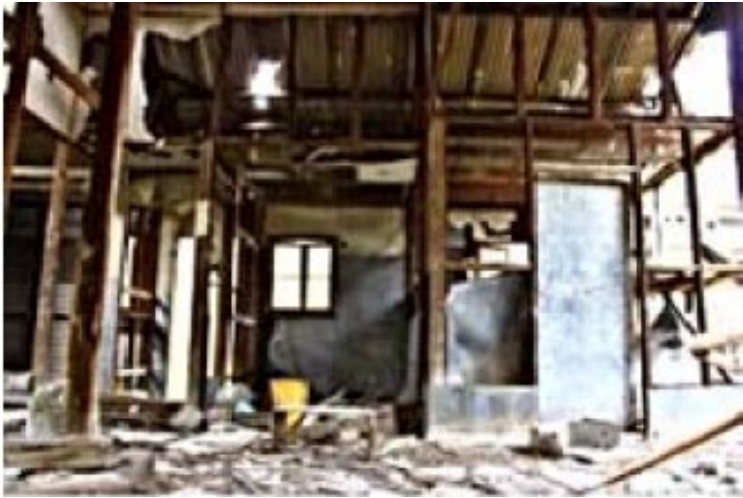
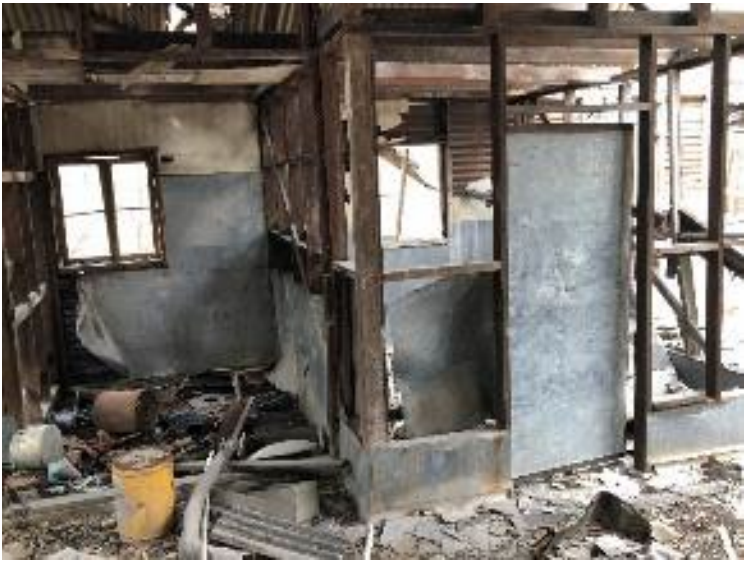
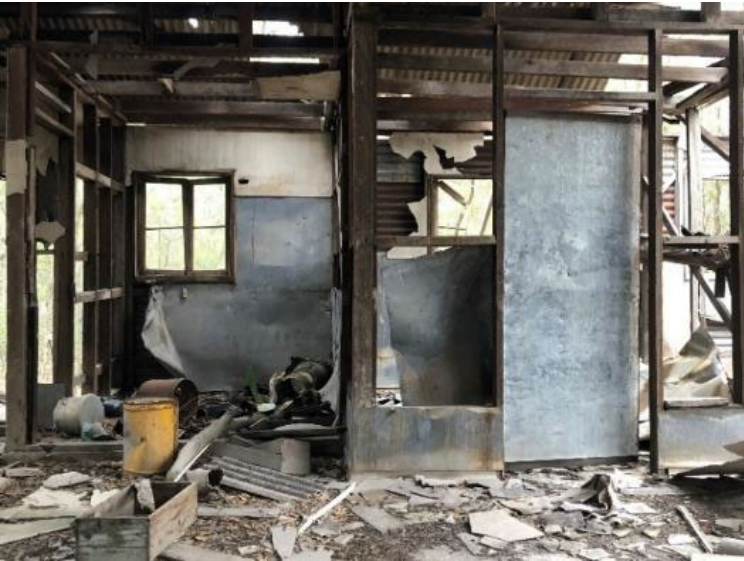
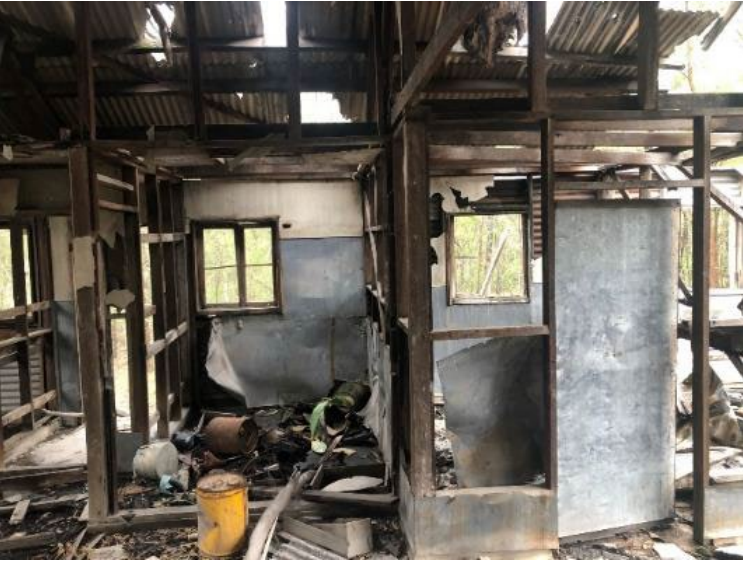
| 2012 | 2018 | 2020 (Mar) | 2020 (Dec) |
|---|---|---|---|
| 2021 | 2022 | 2023 | <u>Showing west interior space</u> |
| | | | <p><b>2012-18:</b> no discernible change.</p> <p><b>2018-20 (Mar):</b> no discernible change.</p> <p><b>Mar 2020 – Dec 2020:</b> no discernible change.</p> <p><b>Dec 2020 – 2021:</b> no discernible change.</p> <p><b>2021-2022:</b> no discernible change</p> <p><b>2022-2023:</b> no discernible change</p> |
