# Mount Thorley Warkworth

## 2023 Annual Review

| <b>Name of Operations</b> | Mount Thorley Warkworth |

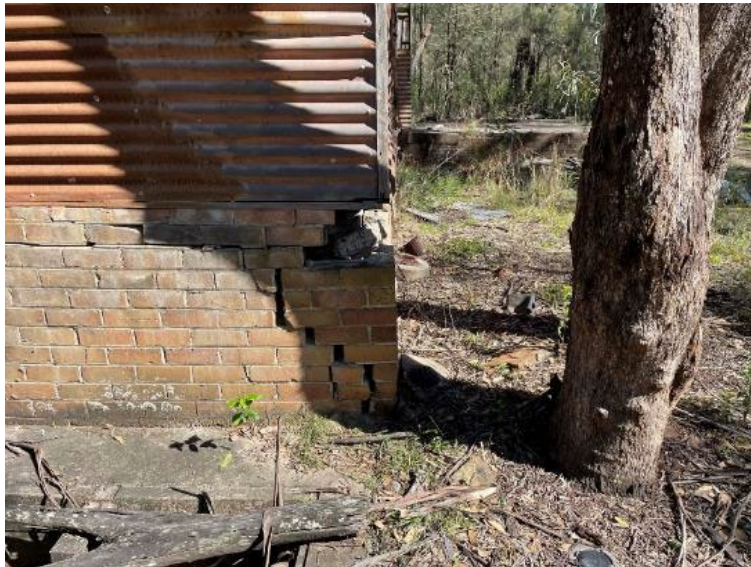
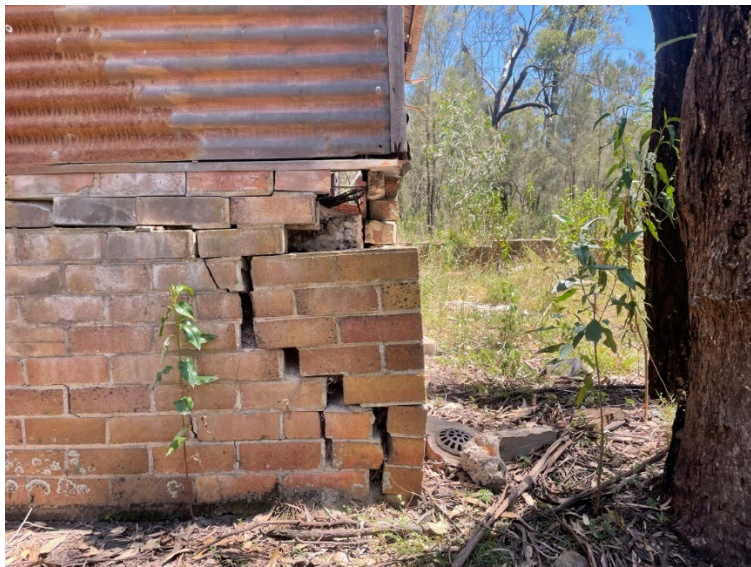
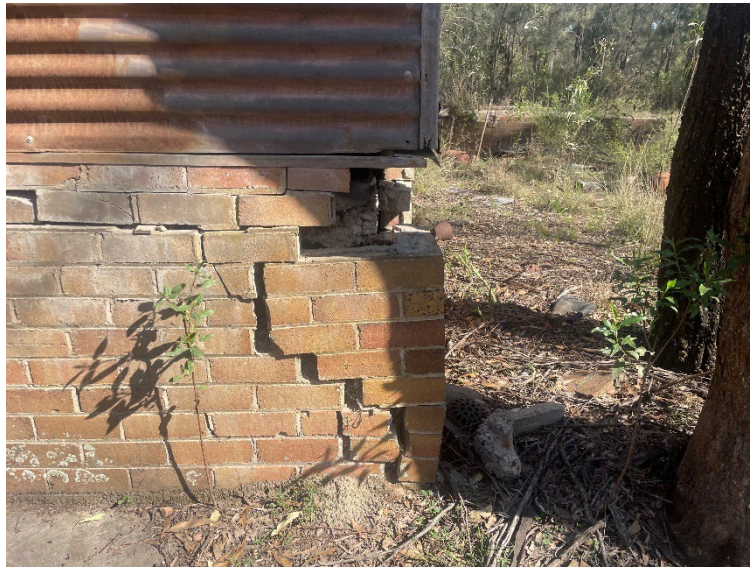
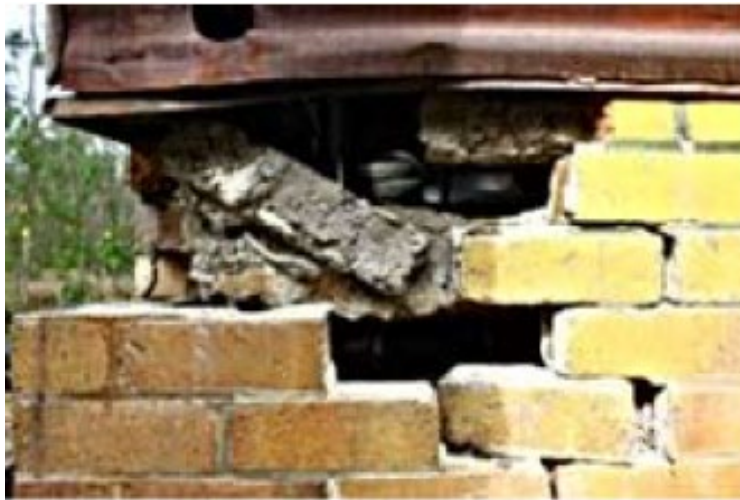
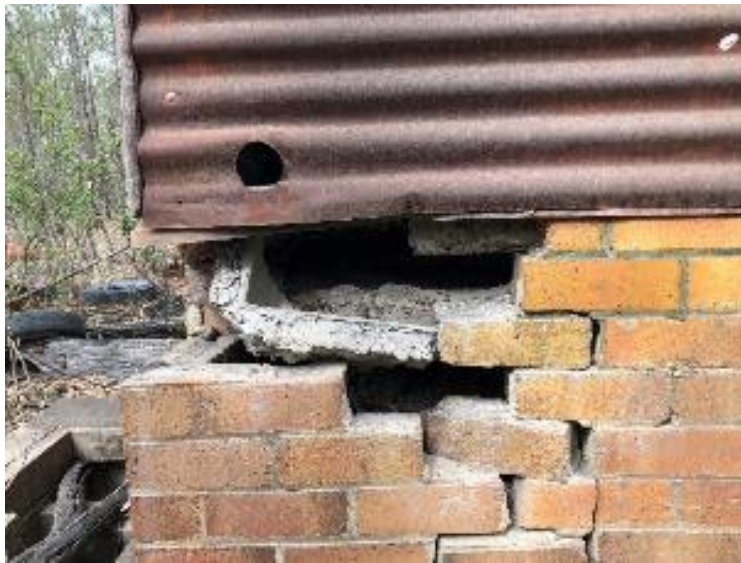
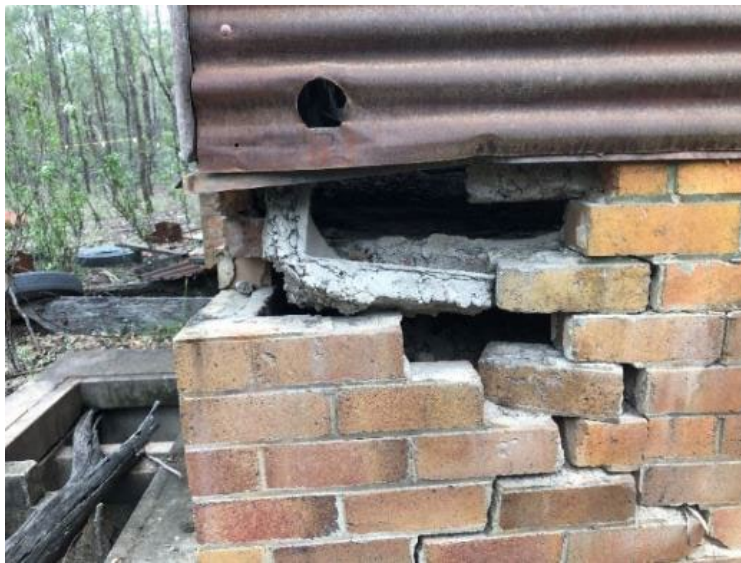
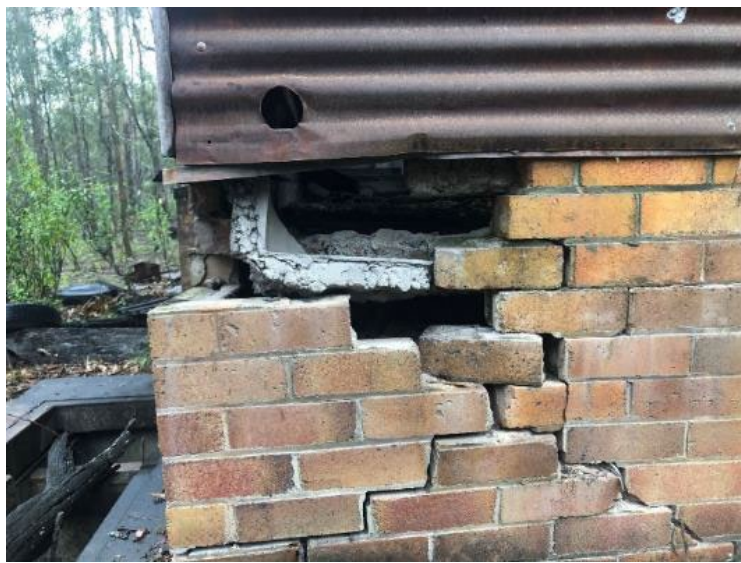
| 2012 | 2018 | 2020 (Mar) | 2020 (Dec) |
|---|---|---|---|
| 2021 | 2022 | 2023 | <p><b><u>Detail of damaged brick foundation (east view)</u></b></p> <p><b>2012-18:</b> some further collapse of concrete/cement above brick foundation.</p> <p><b>2018-20 (Mar):</b> some slumping outwards of corner brick foundation.</p> <p><b>Mar 2020 – Dec 2020:</b> no discernible change.</p> <p><b>Dec 2020 – 2021:</b> movement and setting of internal concrete piece.</p> <p><b>2021-2022:</b> increased cracking along mortar lines</p> <p><b>2022-2023:</b> no discernible change</p> |

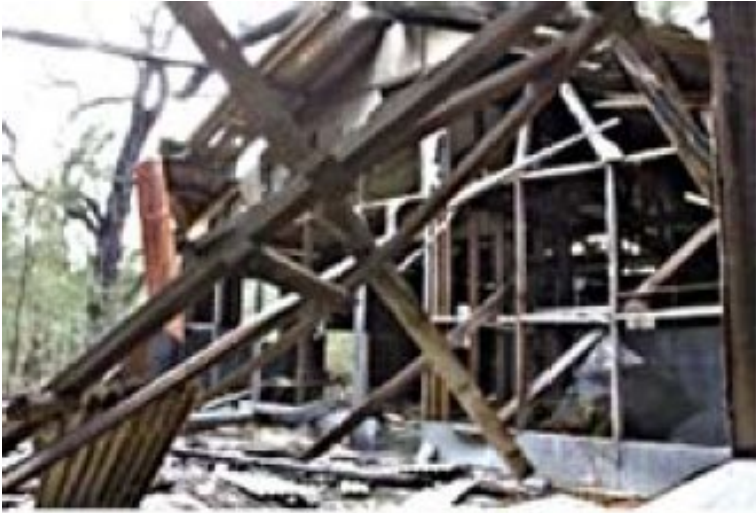
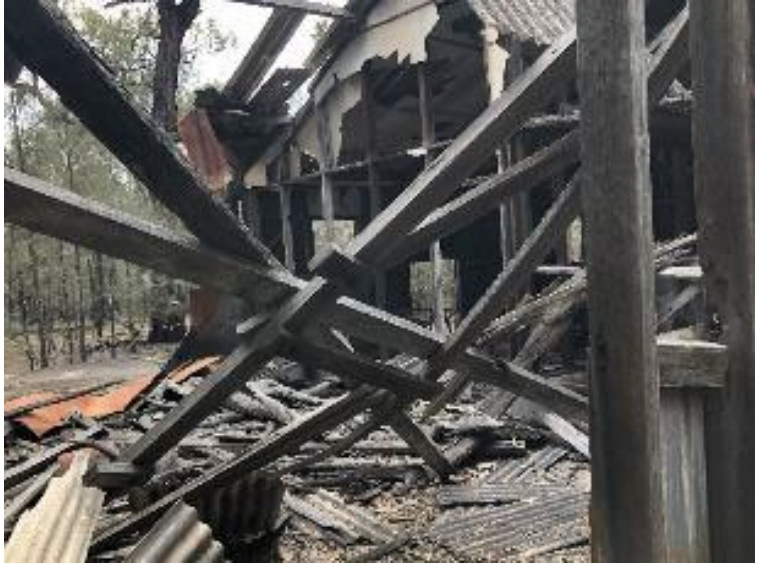
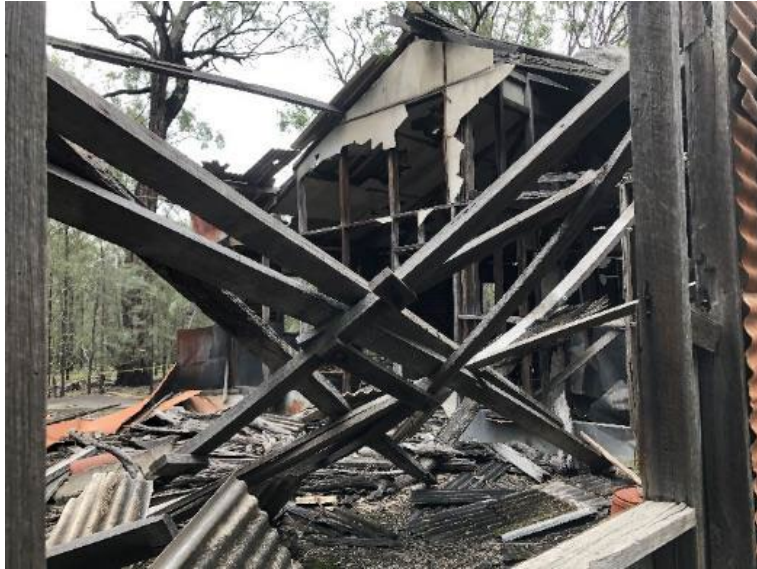
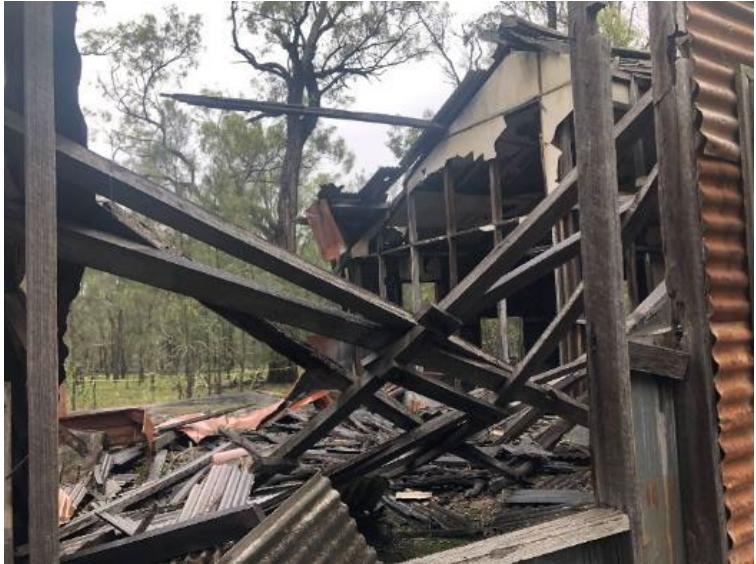
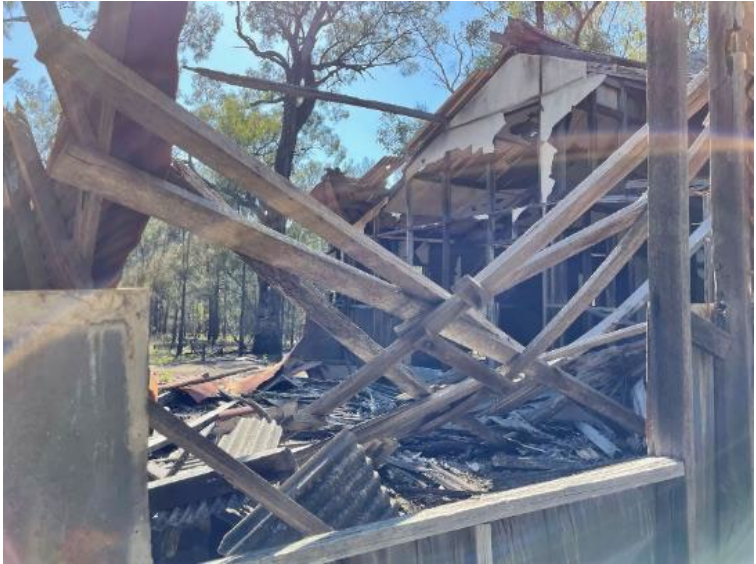
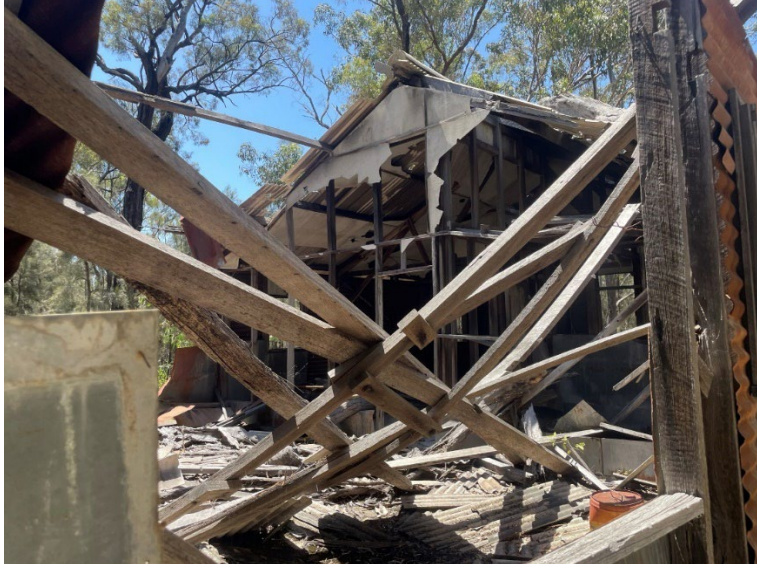
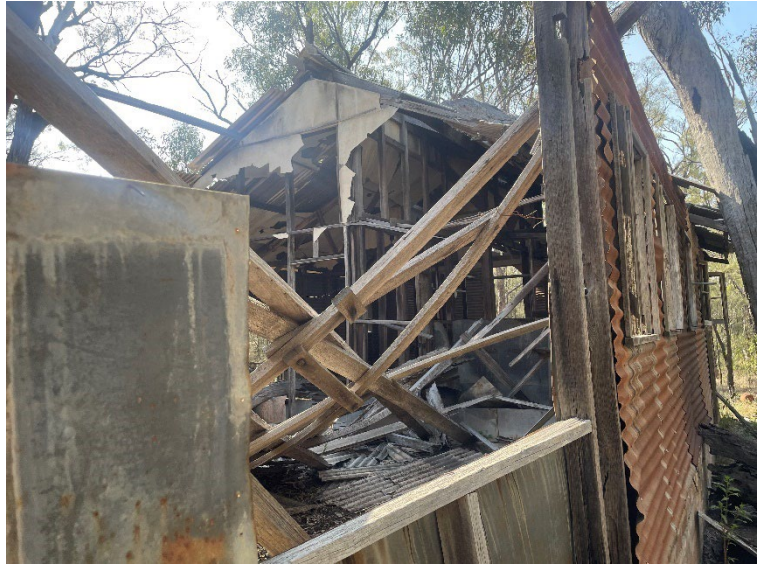
| 2012 | 2018 | 2020 (Mar) | 2020 (Dec) |
|---|---|---|---|
| 2021 | 2022 | 2023 | <p><b>Showing interior of building, viewed from north-west corner</b></p> <p><b>2012-18:</b> shows collapsed roofing members above open kitchen area and accumulation of debris.</p> <p><b>2018-20 (Mar):</b> shows additional collapsed roofing member.</p> <p><b>Mar 2020 – Dec 2020:</b> no discernible change.</p> <p><b>Dec 2020 – 2021:</b> no discernible change.</p> <p><b>2021-2022:</b> no discernible change</p> <p><b>2022-2023:</b> some movement of fallen timbers</p> |

The comparative photographs above show the changes at the building over the past ten years. Although no substantial changes were noted between the current and the last inspection, other than continuing instability along the southern face, no structural maintenance has occurred either. During this time, it can be expected that the underlying causes of deterioration, such as the degeneration of wooden framework and metal panelling, and animal burrowing underneath the structure has continued. Therefore, the more significant changes and priority actions identified during the last inspection remain of importance and, if anything, their need of remediation has increased in urgency. Previous recommendations remain valid and the key issues remain:

- Damaged roof sheeting and roofing members, as well as increasing structural instability of bowing southern wall;
- Due to the complete collapse of remaining roofing members over the open kitchen area the top portion of the northern wall has now failed and fallen inside the building footprint. This northern wall has now detached from remnant roofing and west wall members;
- Deterioration of window panelling; and
- Increased damage to brick foundation in north-west corner, and new slumping of south-east foundation corner.

1. Engage an asbestos expert to assess and develop a clean-up and disposal plan to deal with both the broken fragments and intact asbestos sheeting;
2. Remove any remaining tree branches from the roof. In addition, to prevent similar damage in the future, serious consideration should be given to removing or lopping those trees that are located close enough to the building that they may cause damage if they fall or drop large branches.

3. Pending the results of the asbestos assessment, the building and surrounds should be thoroughly cleaned of asbestos and other rubbish material. An archaeologist should be present to collect any items of historic importance or that relate to the original fabric of the building. This should also include the removal, repair and curation of items such

as window frames and panels before their total deterioration. All such items can be stored inside the building and potentially re-used during further stabilization programs;

4. Pending the results of the asbestos assessment, susceptible parts of the building framework, such as roofing members and walls should be stabilized and propped, using the CMP Bligh Tanner plans as a guide;
5. A structural engineer should then inspect the building before any further works are commenced to make further recommendations on stability requirements and structural repairs. These further works should aim to reduce the likelihood and extent of any further deterioration at the site rather than seek to rebuild or renovate as it is unlikely that there would be any valid or appropriate option to re-use the site; and

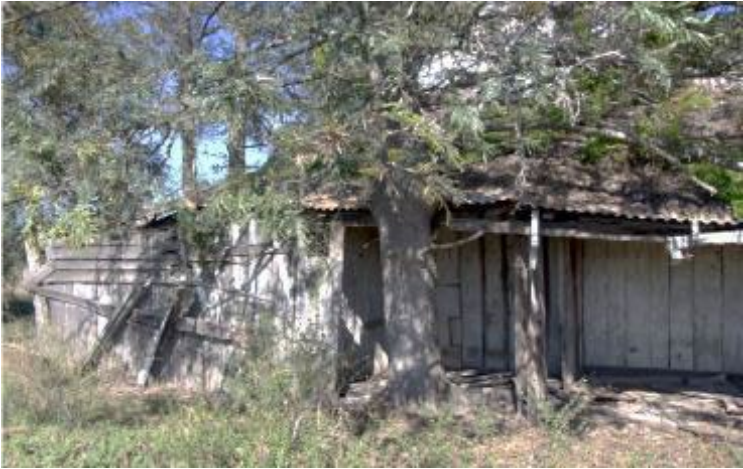
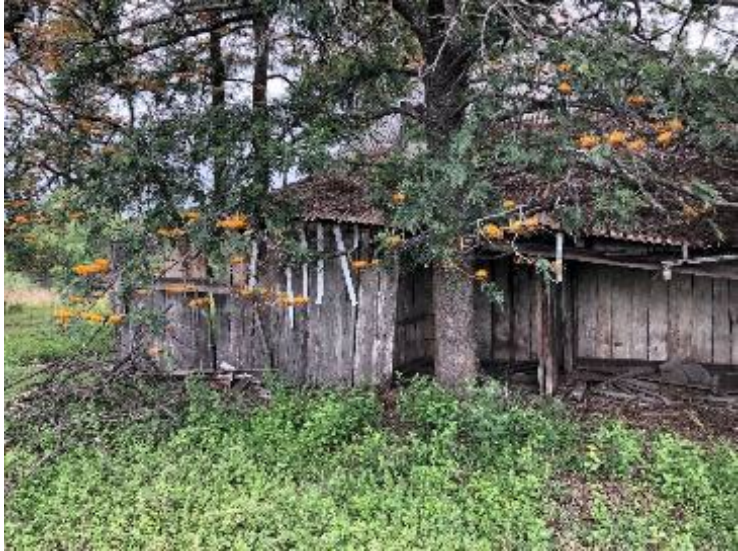
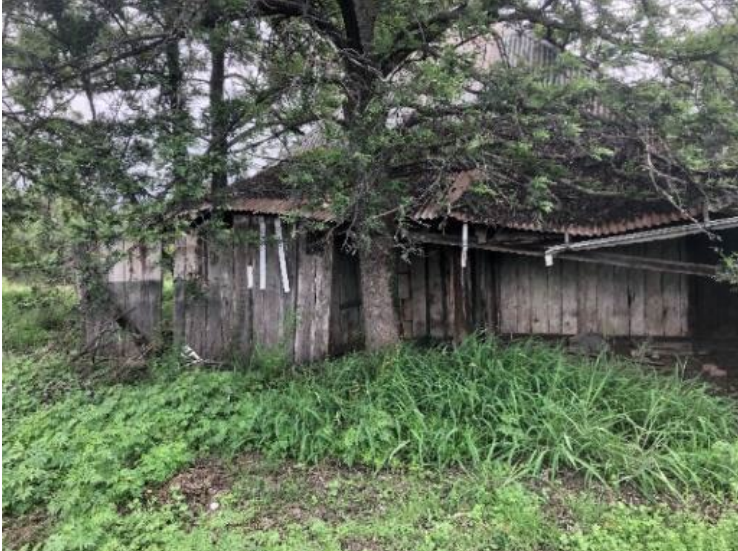
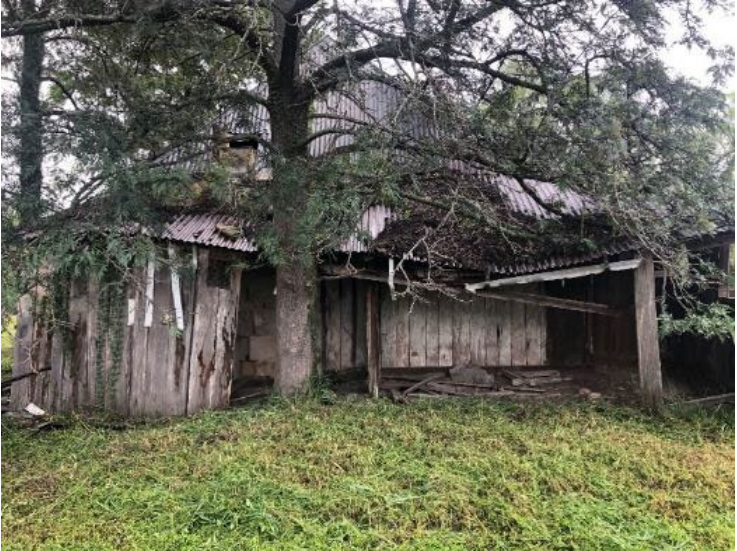
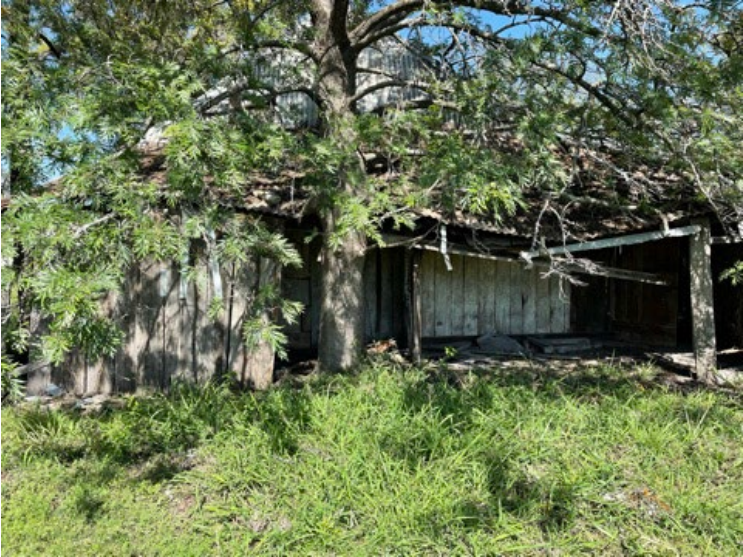
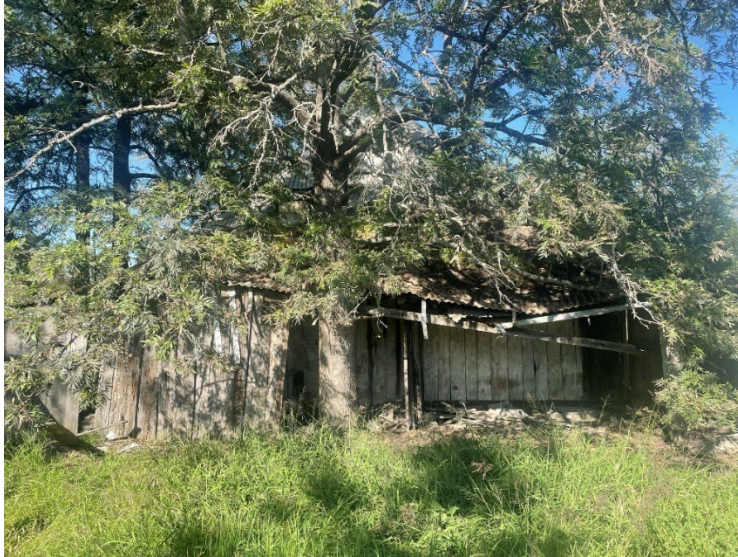
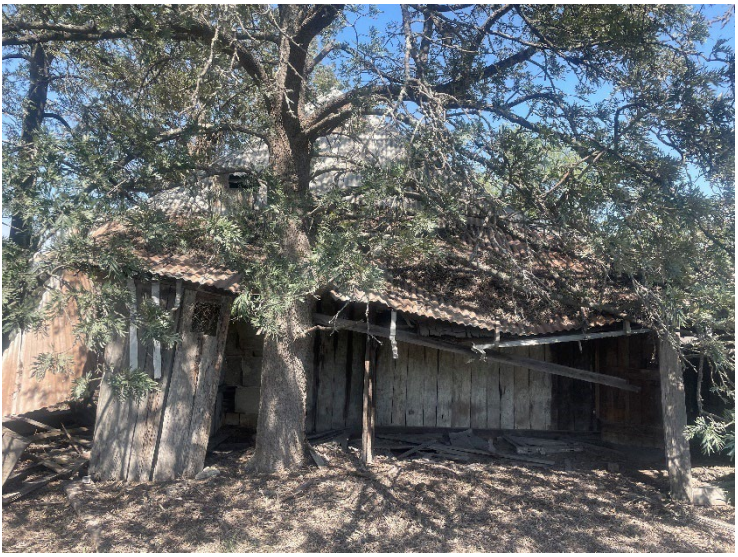
| 2014 | 2018 | 2020 (Mar) | 2020 (Dec) |
|---|---|---|---|
| | | | <p><b>2014-8:</b> no discernible change.</p> <p><b>2018-20 (Mar):</b> roof slumping appears to have increased.</p> <p><b>Mar 2020-Dec 2020:</b> heavy leaf litter on roof persists. Positively, vegetation clearing surrounding the house is occurring regularly.</p> <p><b>Dec 2020–2021:</b> tree growth and associated leaf litter/structural impacts increasing.</p> <p><b>2021-2022:</b> tree growth increasing with associated deterioration of roof integrity.</p> <p><b>2022-2023:</b> tree growth continues and southern section of timber wall/skillion has collapsed.</p> |

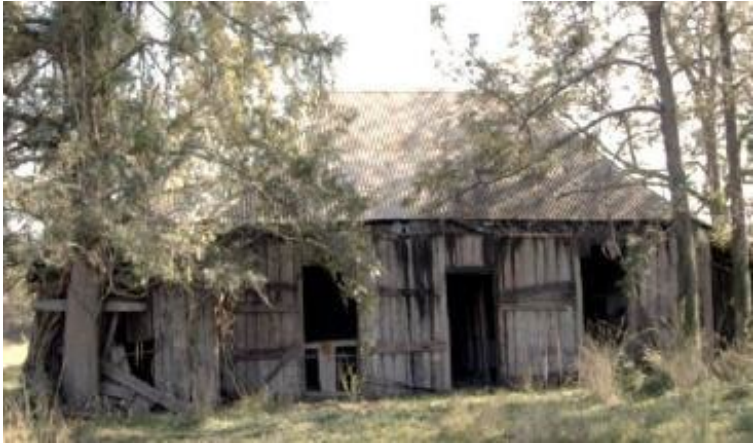
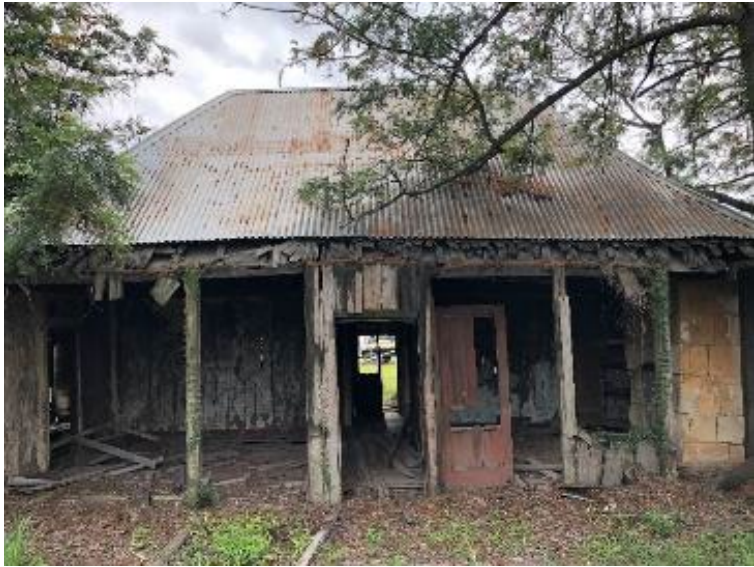
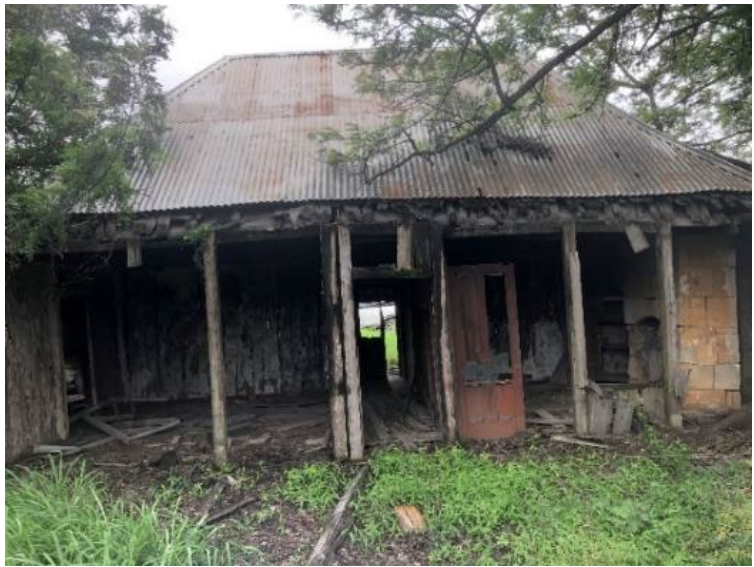
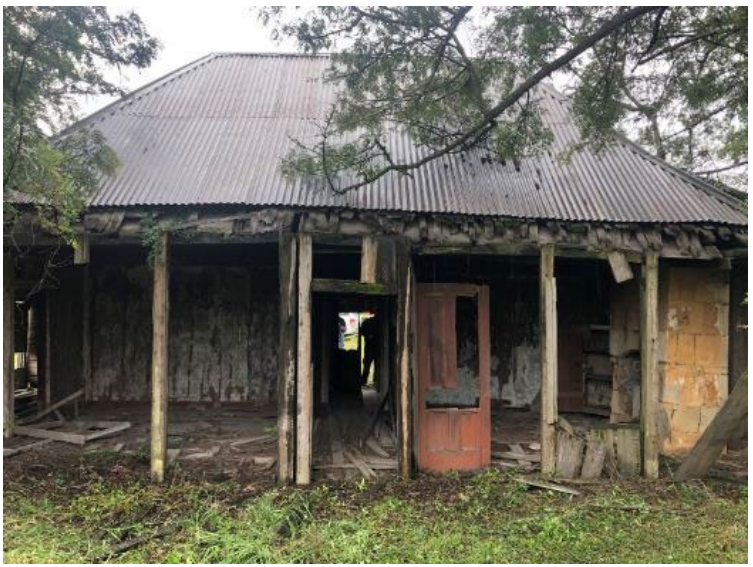
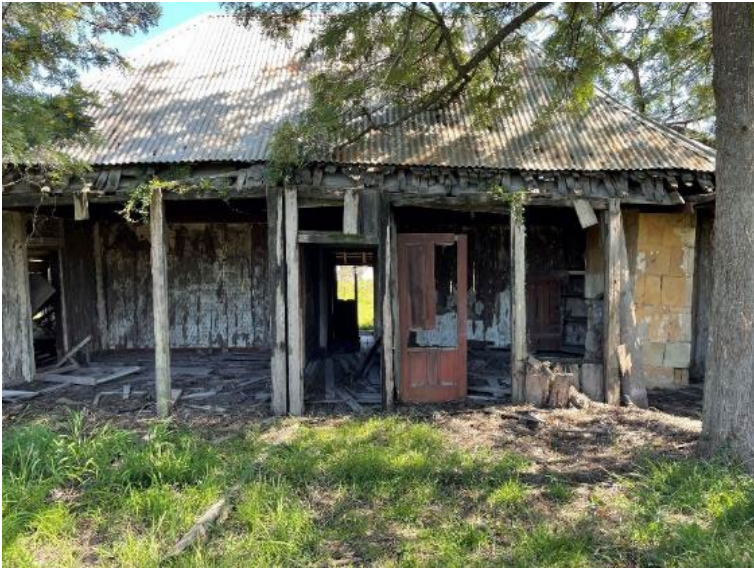
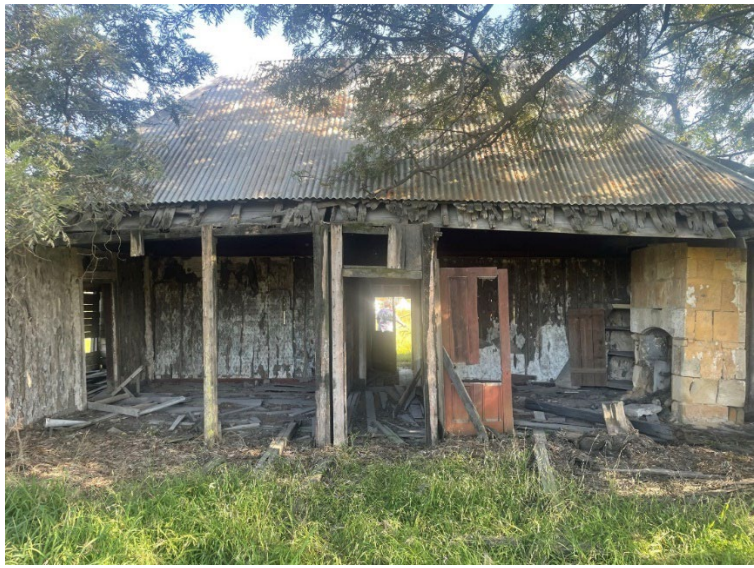
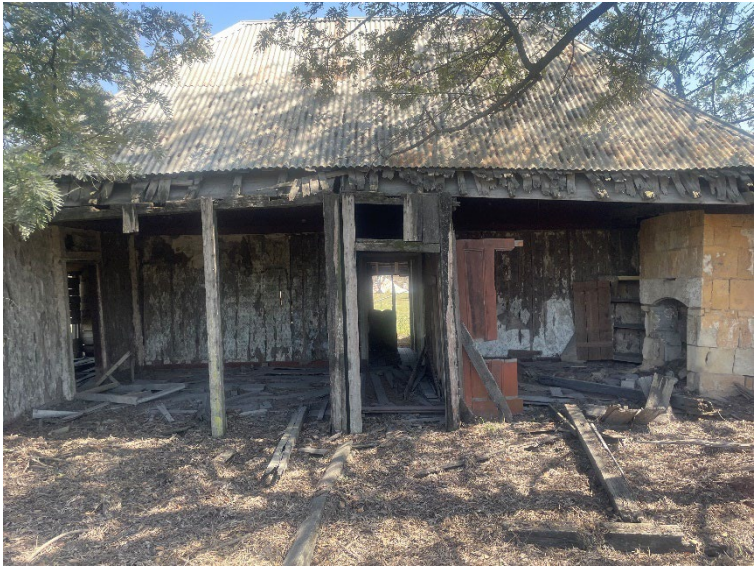
| 2014 | 2018 | 2020 (Mar) | 2020 (Dec) |
|---|---|---|---|
| | | | <p><b>2014-8:</b> vertical timber slabs have been removed from southern wall.</p> <p><b>2018-20 (Mar):</b> possible deterioration of shingles at roof edge, and missing panels from above back door.</p> <p><b>Mar 2020-Dec 2020:</b> no discernible change.</p> <p><b>Dec 2020 – 2021:</b> no discernible change.</p> <p><b>2021-2022:</b> uprights from chimney room wall fallen or vandalised, along with remaining wall elements. Associated roof line slumping. Chimney slumping to the east. Movement of remnant furniture/timbers evident through doorway in western room.</p> <p><b>2022-2023:</b> part of door has broken off</p> |

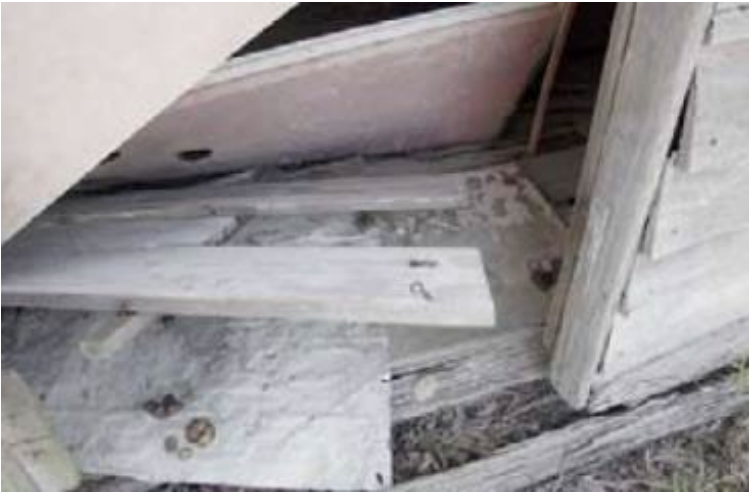
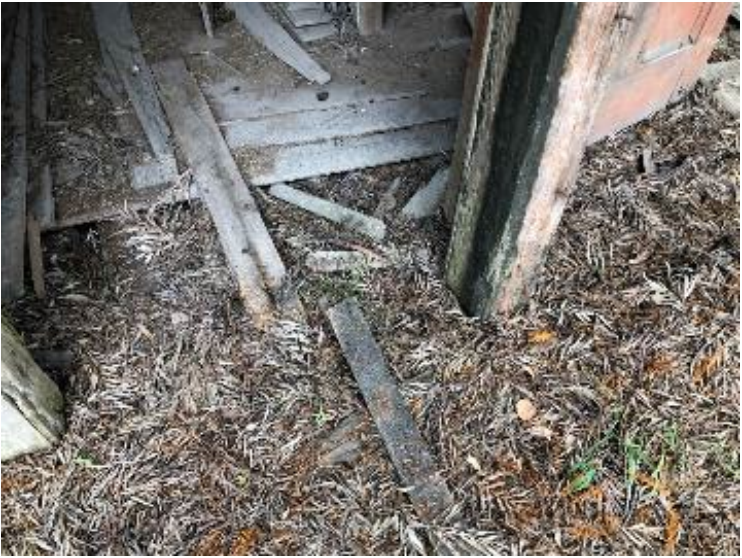
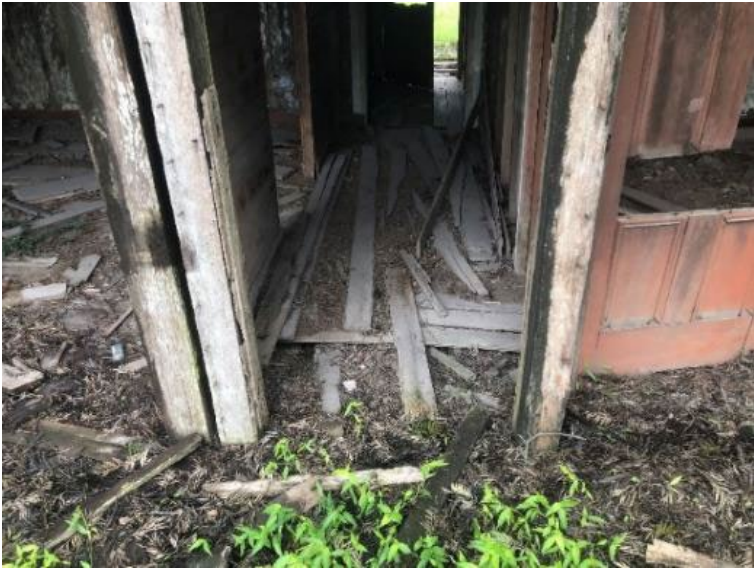
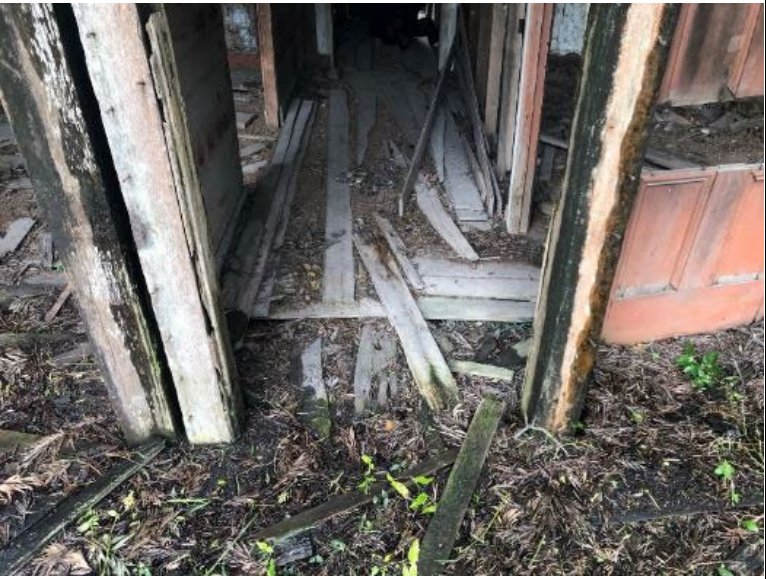
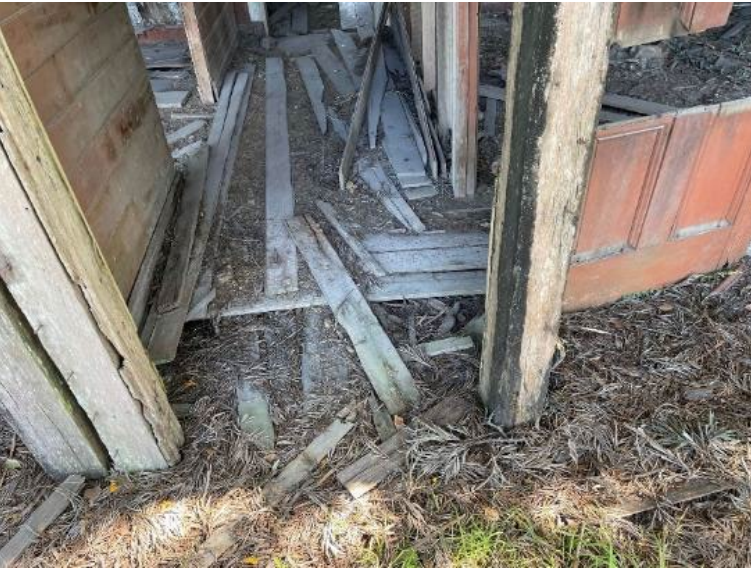
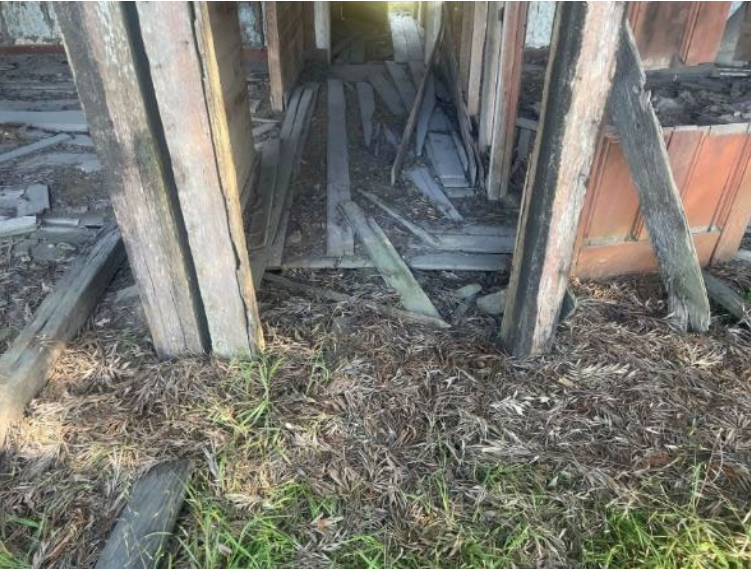
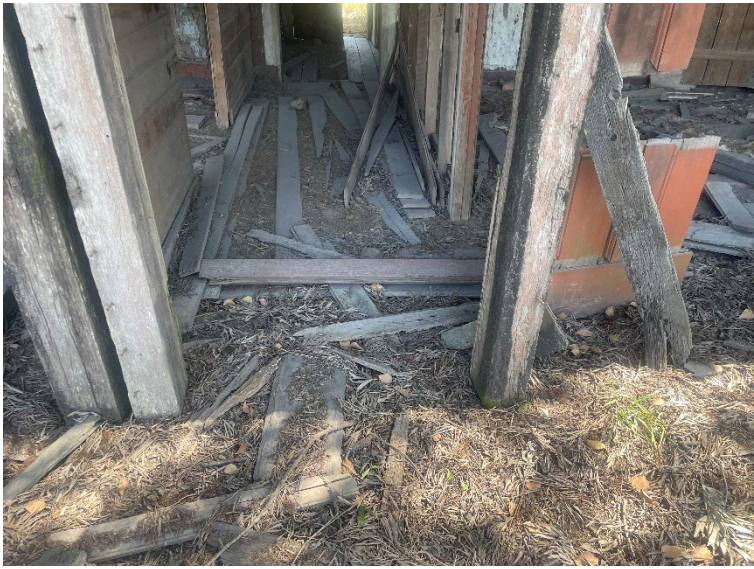
| 2014 | 2018 | 2020 (Mar) | 2020 (Dec) |
|---|---|---|---|
| | | | <p>2014-8: door has been removed.</p> <p>2018-20 (Mar): no discernible change.</p> <p>Mar 2020-Dec 2020: no discernible change.</p> <p>Dec 2020 – 2021: no discernible change.</p> <p>2021-2022: fallen timber to right of door jamb.</p> <p>2022-2023: door timber fallen across hallway.</p> |

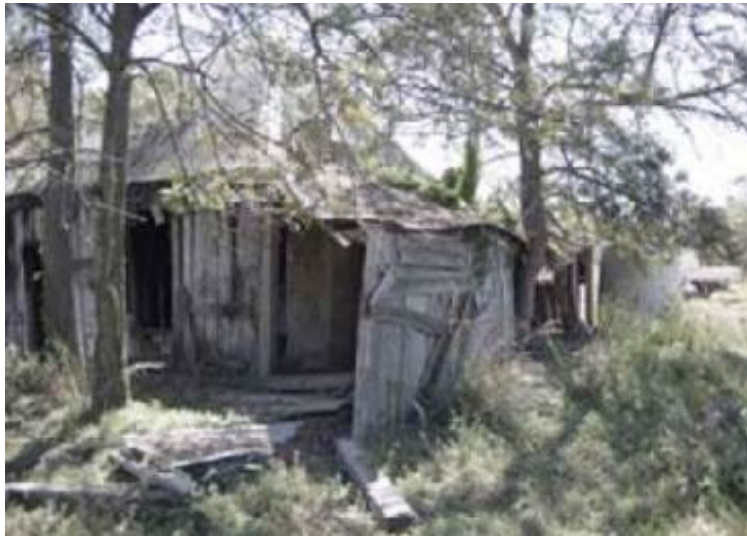
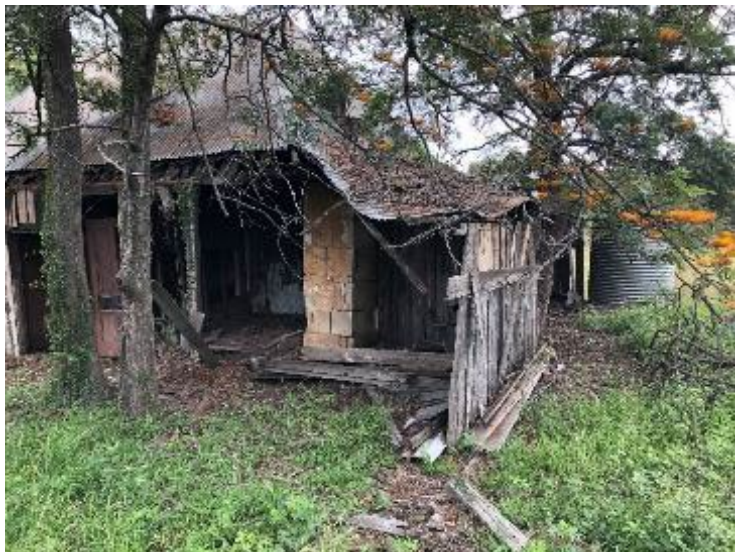
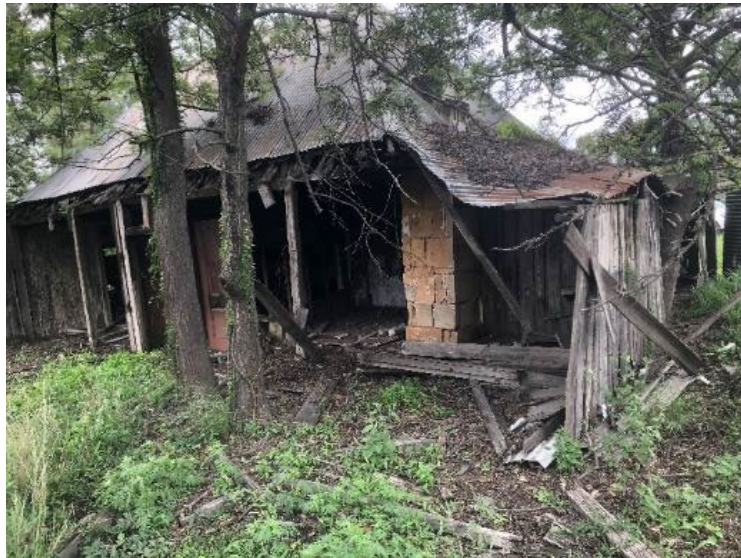
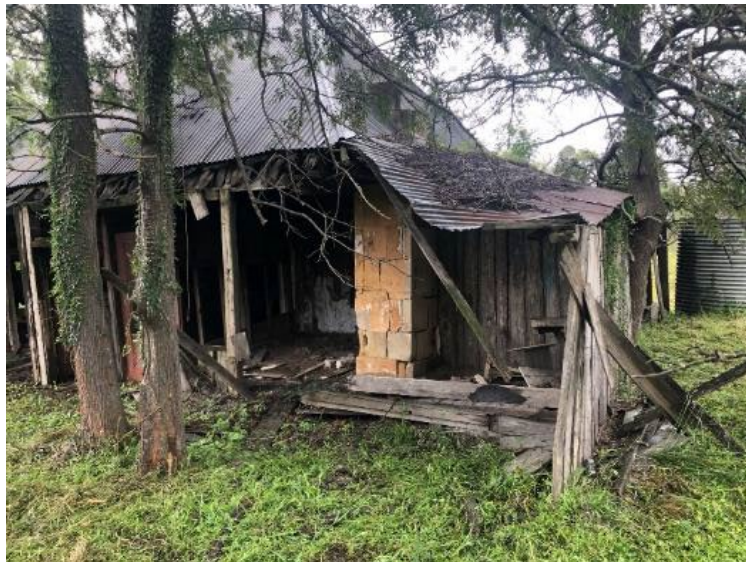
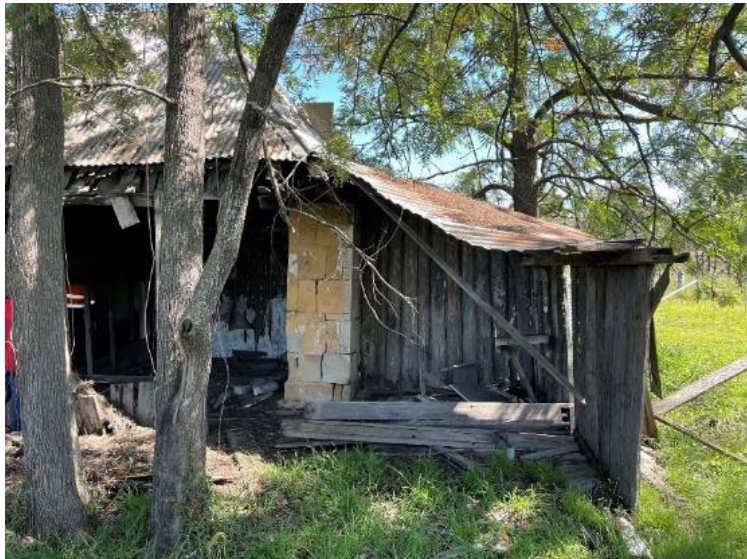
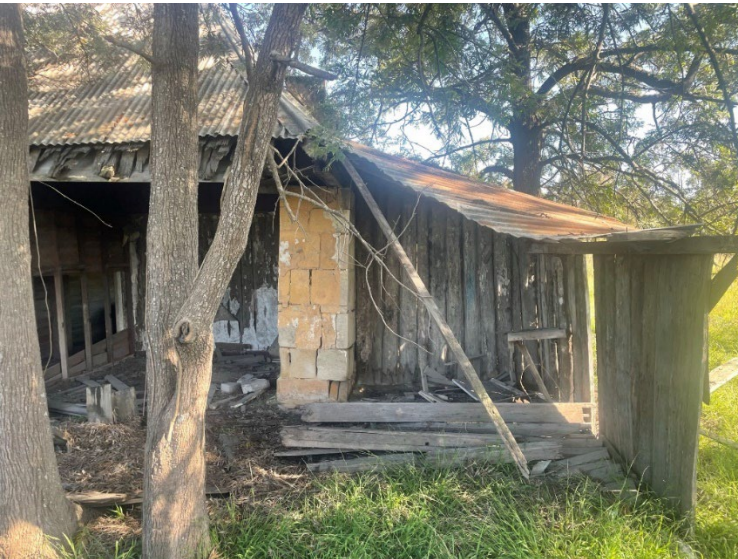
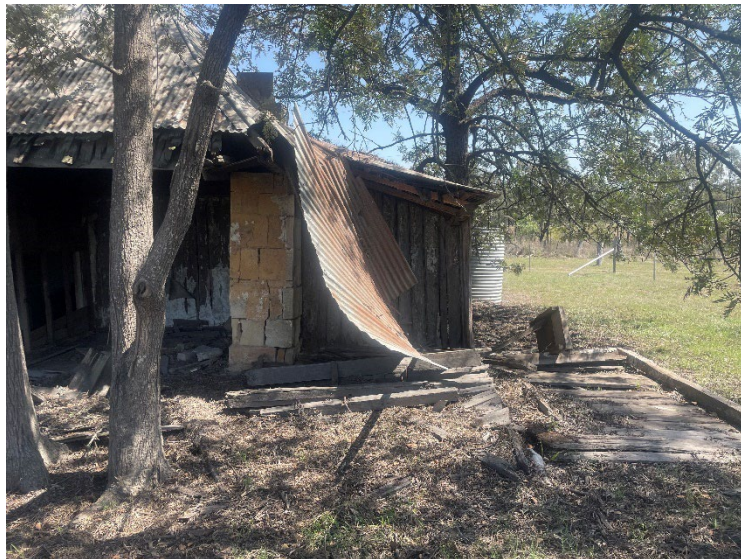
| 2014 | 2018 | 2020 (Mar) | 2020 (Dec) |
|---|---|---|---|
| 2021 | 2022 | 2023 | <p><b><u>South-eastern corner</u></b></p> <p><b>2014-8:</b> vertical slabs have been removed causing further collapse of roof.</p> <p><b>2018-20 (Mar):</b> further deterioration of eastern wall.</p> <p><b>Mar 2020-Dec 2020:</b> heavy leaf litter on roof persists.</p> <p><b>Dec 2020 – 2021:</b> heavy leaf litter on roof persists.</p> <p><b>2021-2022:</b> chimney slumping and separated from ceiling; back veranda roof also slipping.</p> <p><b>2022-2023:</b> south-east wall and skillion roof collapsed. 3° - 4.5° lean to the east on chimney.</p> |

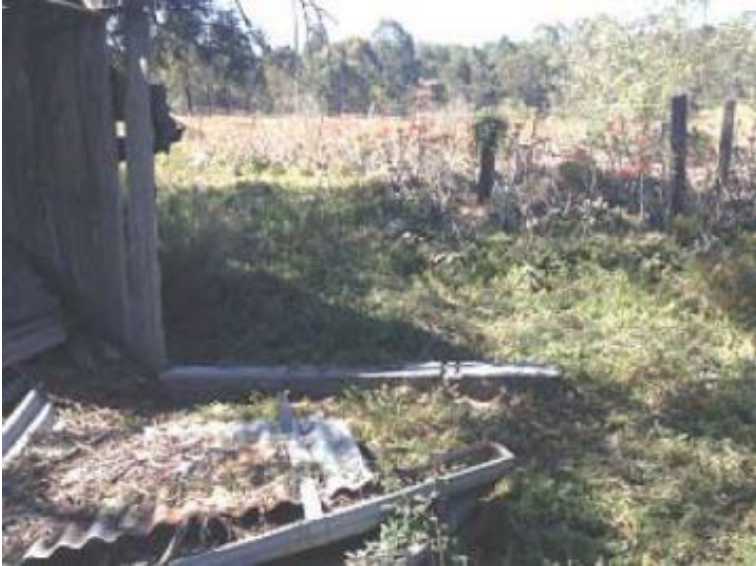
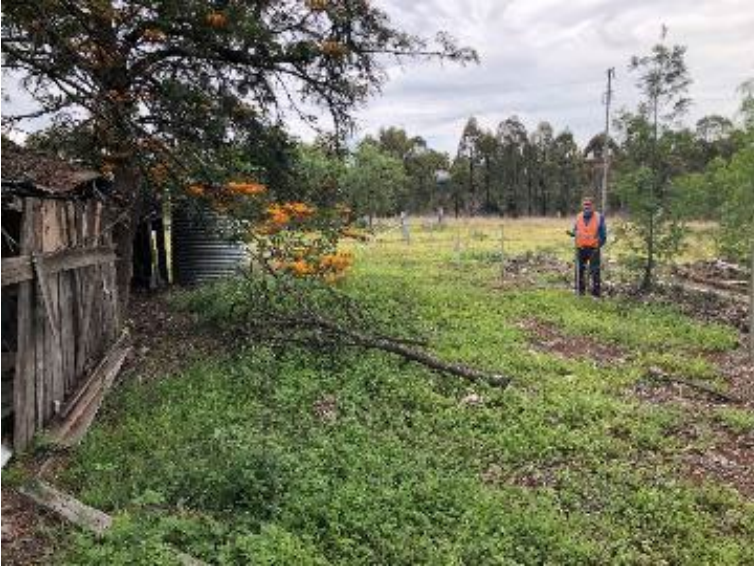
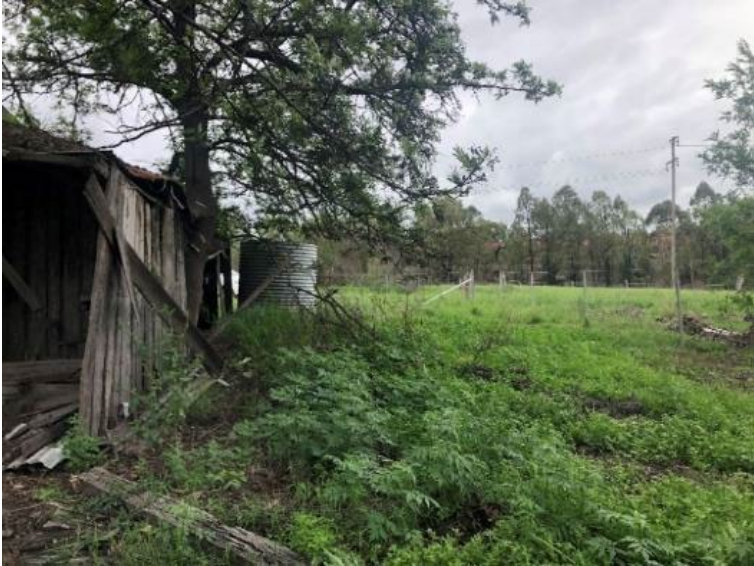
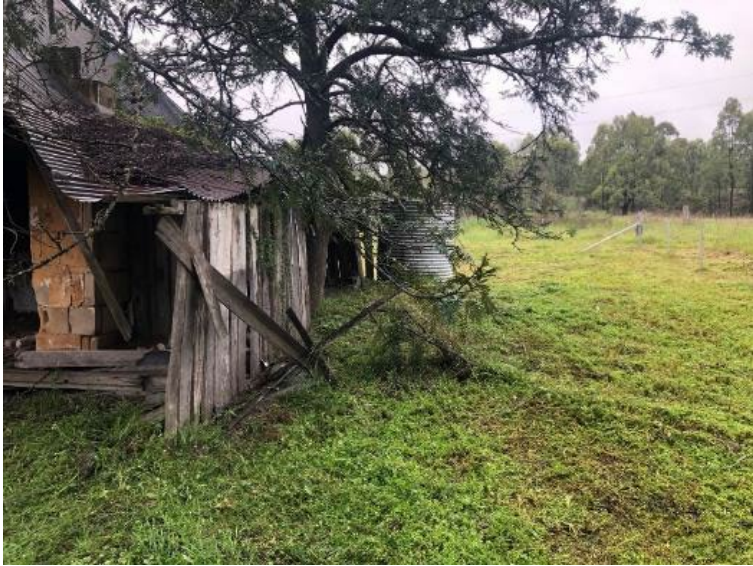
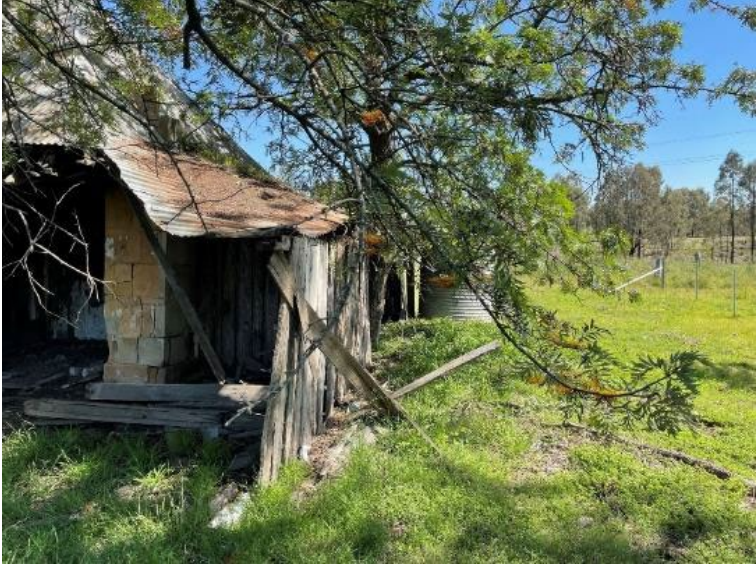
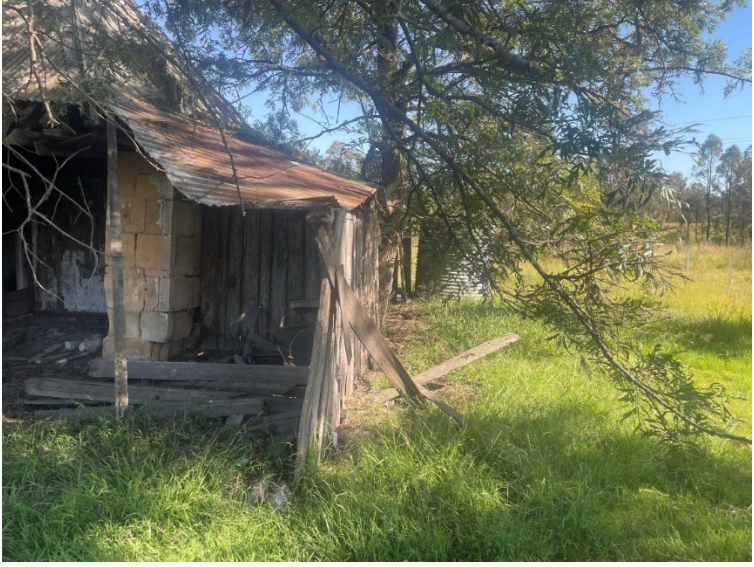
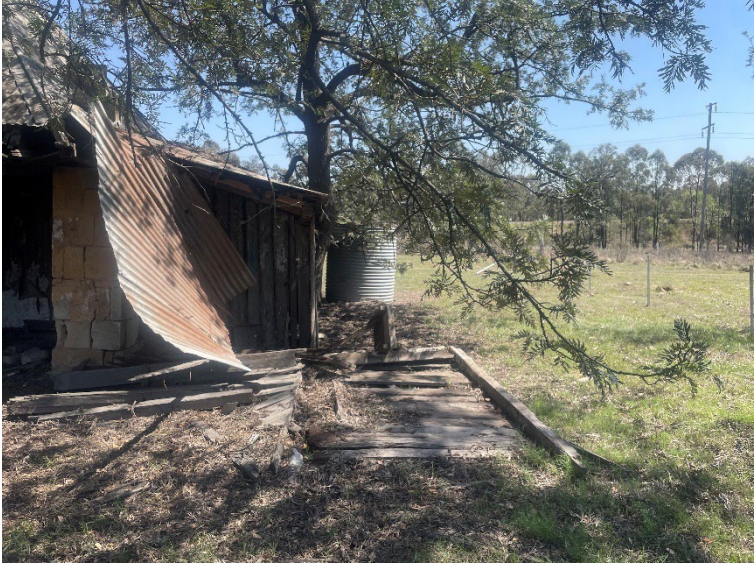
| 2014 | 2018 | 2020 (Mar) | 2020 (Dec) |
|---|---|---|---|
| 2021 | 2022 | 2023 | <p><b><u>Eastern side</u></b></p> <p><b>2014-8:</b> debris has been cleaned and stored and a weed removal program conducted. The house area has also been fenced.</p> <p><b>2018-20 (Mar):</b> further deterioration of eastern wall and regrowth of weeds.</p> <p><b>Mar 2020-Dec 2020:</b> no discernible change.</p> <p><b>Dec 2020 – 2021:</b> no discernible change.</p> <p><b>2021-2022:</b> apparent increased deformation of eastern roof line.</p> <p><b>2022-2023:</b> south-east wall and skillion roof collapsed</p> |
