# Mount Thorley Warkworth

## 2023 Annual Review

| <b>Name of Operations</b> | Mount Thorley Warkworth |

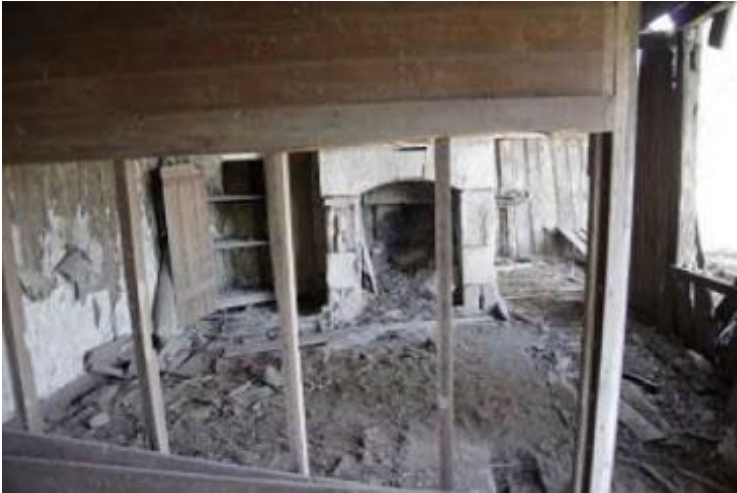
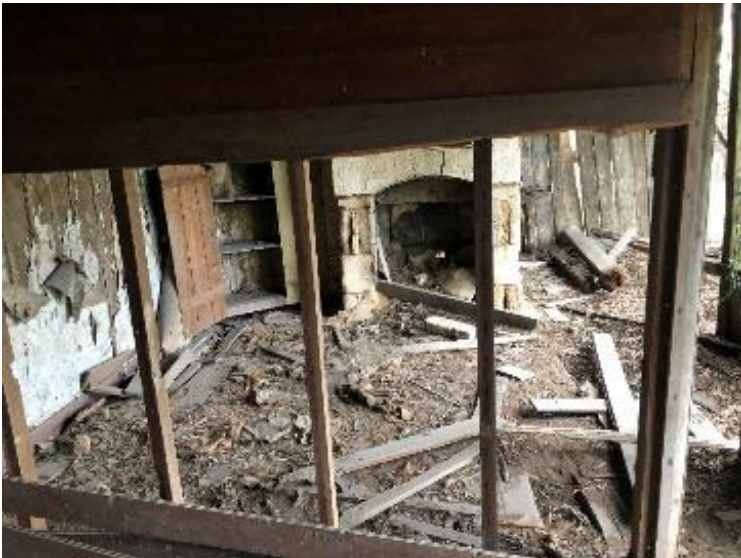
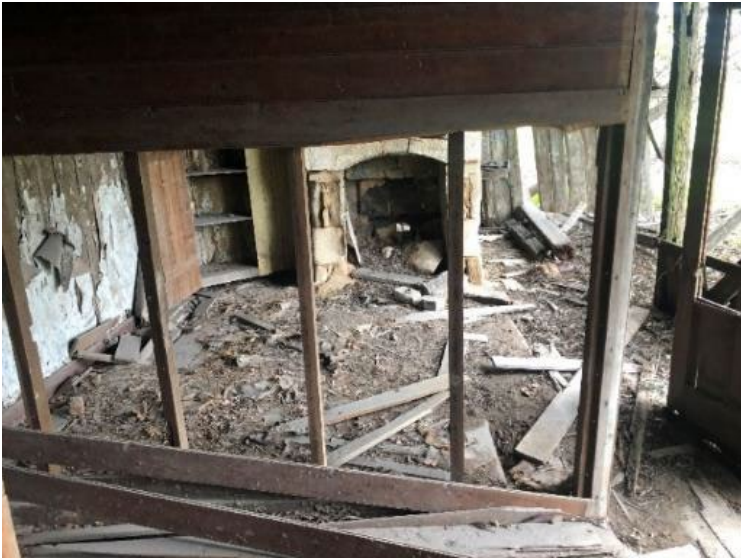
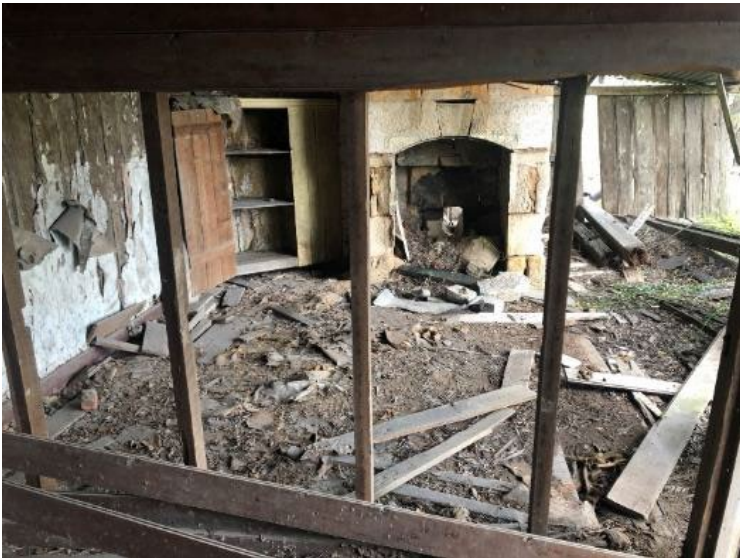
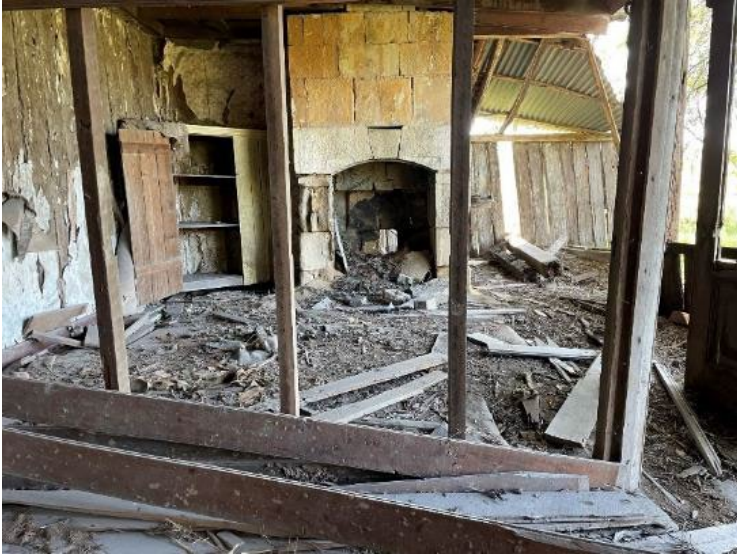
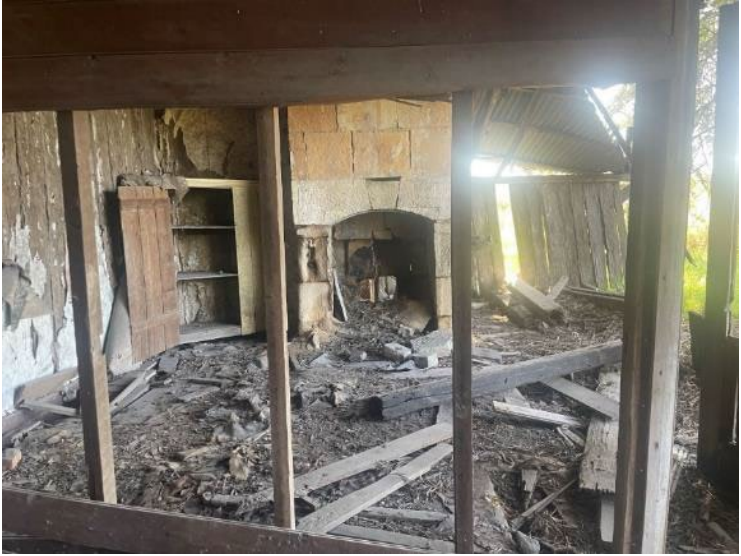
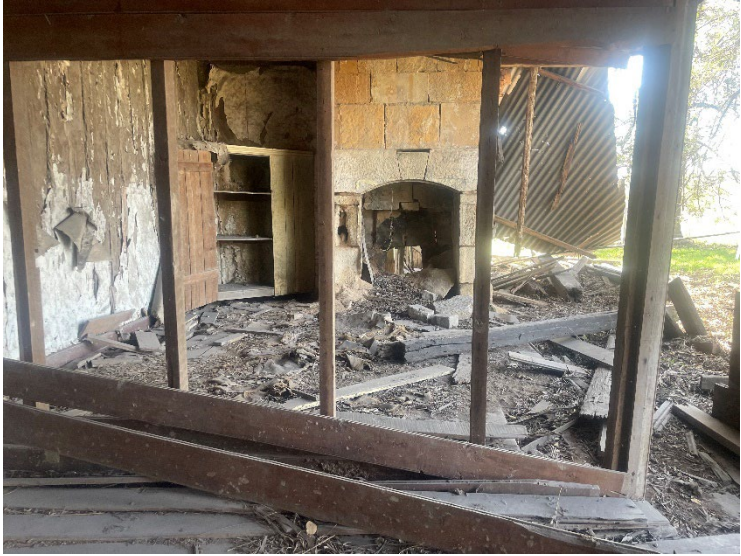
| 2014 | 2018 | 2020 (Mar) | 2020 (Dec) |
|---|---|---|---|
| 2021 | 2022 | 2023 | <u>Room 2 interior</u><br><b>2014-8:</b> increased debris caused by removal of southern wall.<br><br><b>2018-20 (Mar):</b> no discernible change.<br><br><b>Mar 2020-Dec 2020:</b> no discernible change.<br><br><b>Dec 2020 – 2021:</b> no discernible change.<br><br><b>2021-2022:</b> fallen timber upright; increased decay of chimney blocks.<br><br><b>2022-2023:</b> south-east wall and skillion roof collapsed, continued erosion of chimney sandstone blocks, movement of fallen timbers on floor suggests human or animal visitors. |

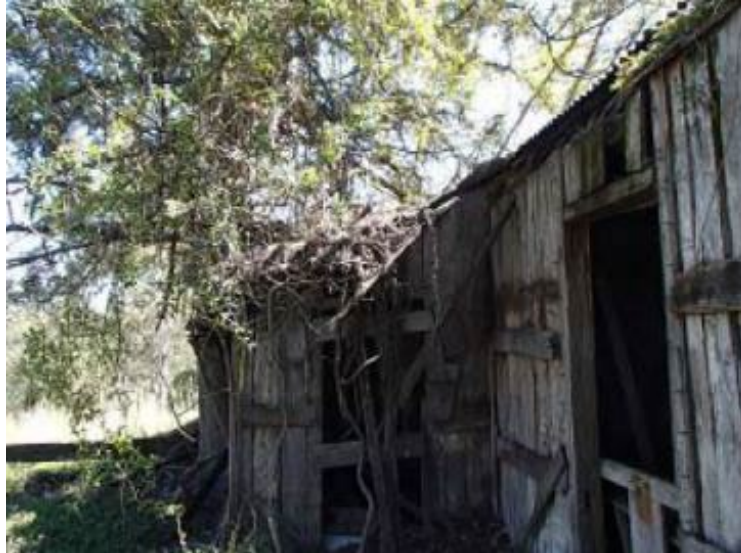
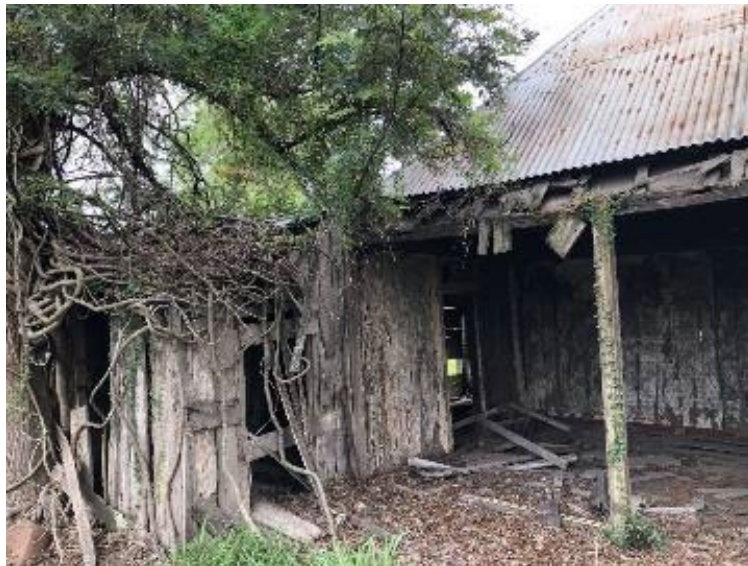
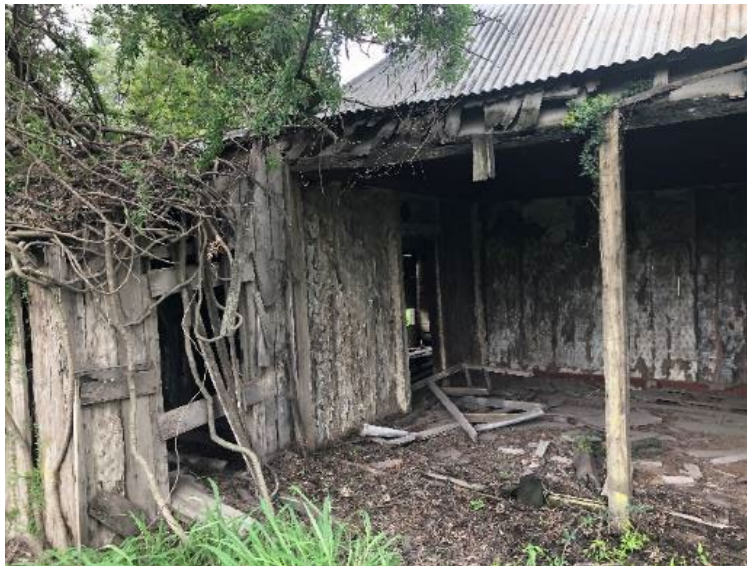
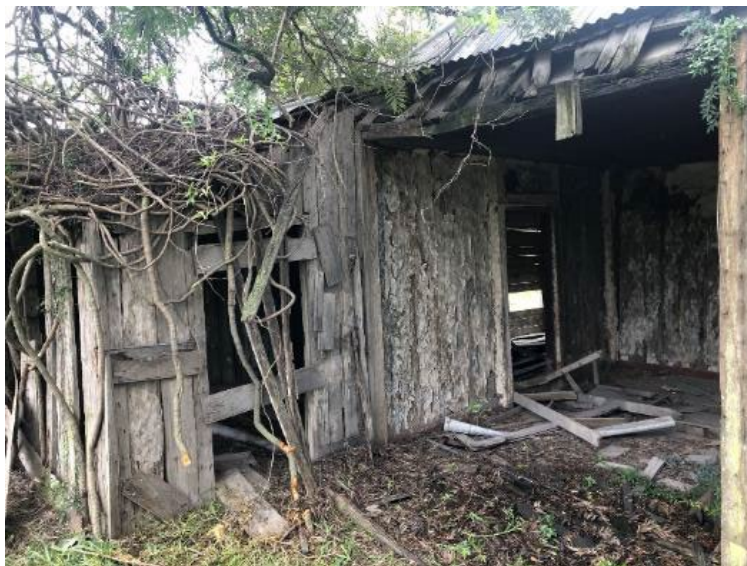
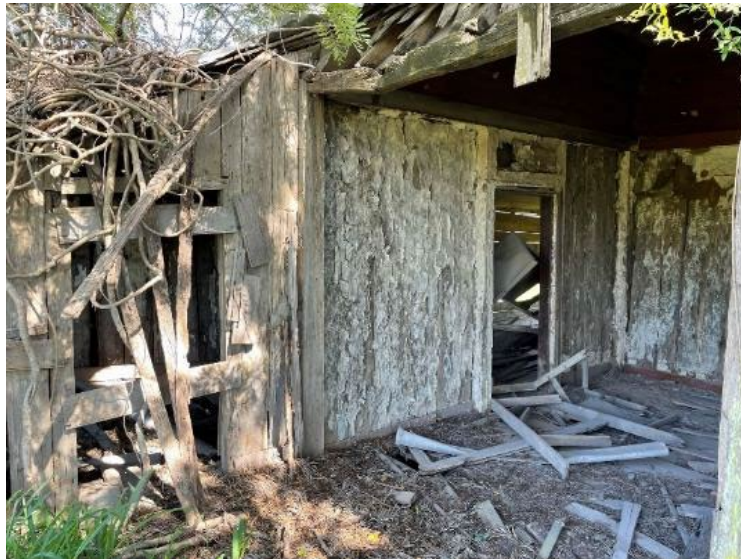
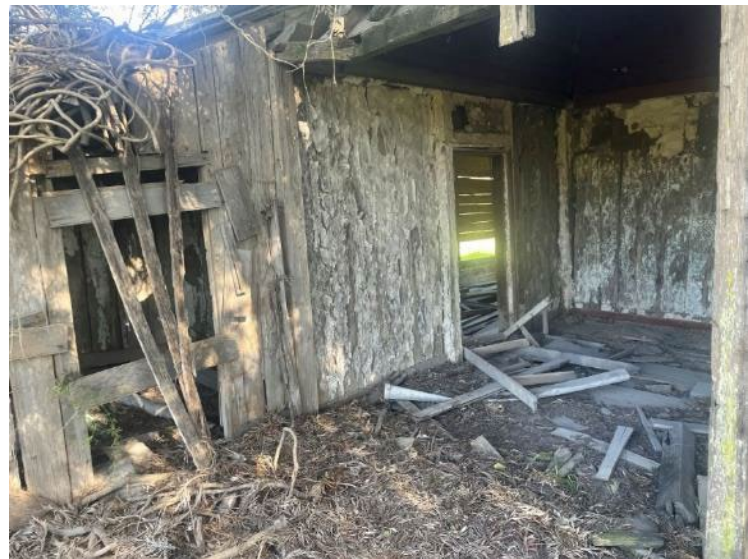
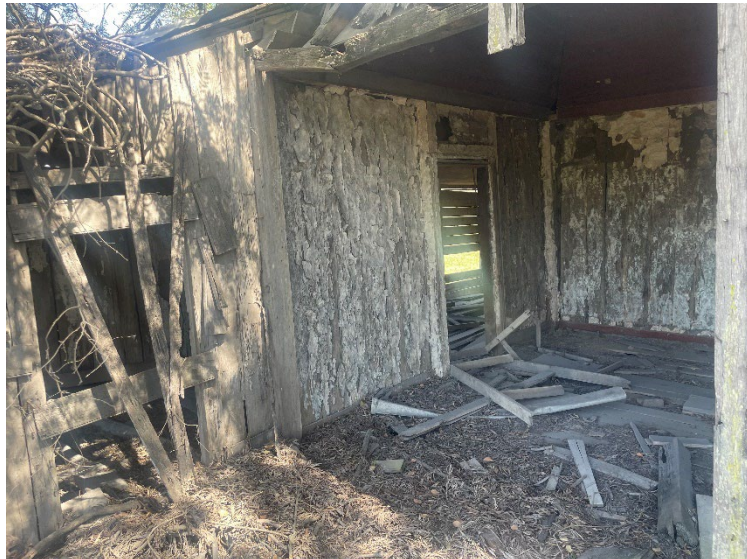
| 2014 | 2018 | 2020 (Mar) | 2020 (Dec) |
|---|---|---|---|
| 2021 | 2022 | 2023 | <p><b>South-west corner</b></p> <p><b>2014-8:</b> shows removal of vertical slabs from southern wall.</p> <p><b>2018-20 (Mar):</b> no discernible change.</p> <p><b>Mar 2020-Dec 2020:</b> no discernible change.</p> <p><b>Dec 2020 – 2021:</b> furniture in far room collapsed.</p> <p><b>2021-2022:</b> wall/ceiling separation within white room, furniture/timber disturbance in western room.</p> <p><b>2022-2023:</b> no discernible change</p> |

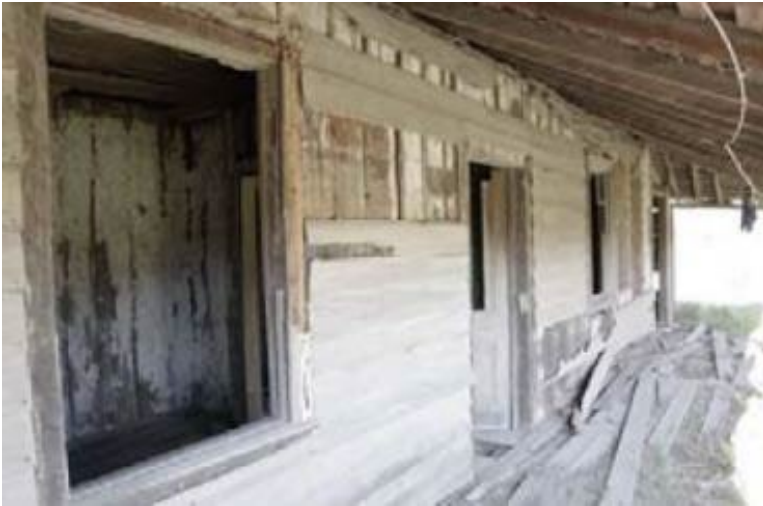
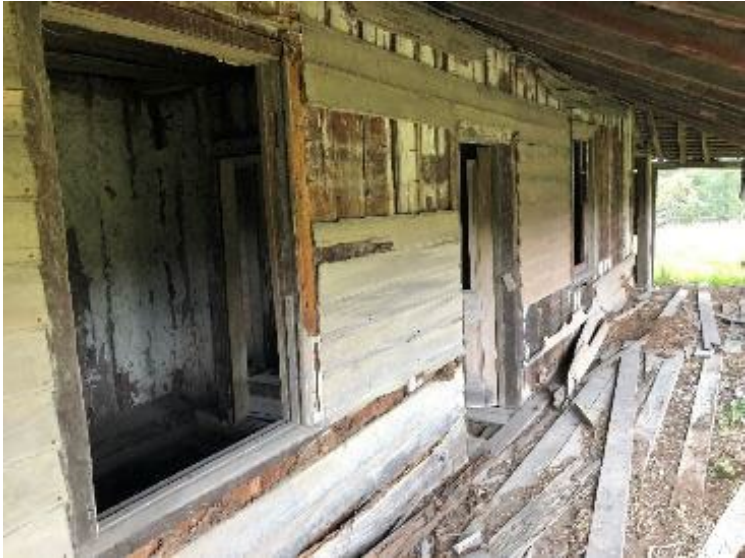
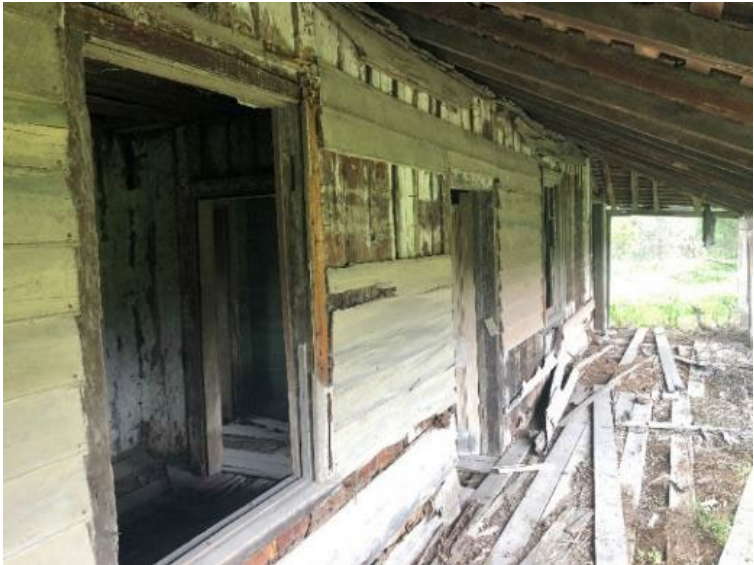
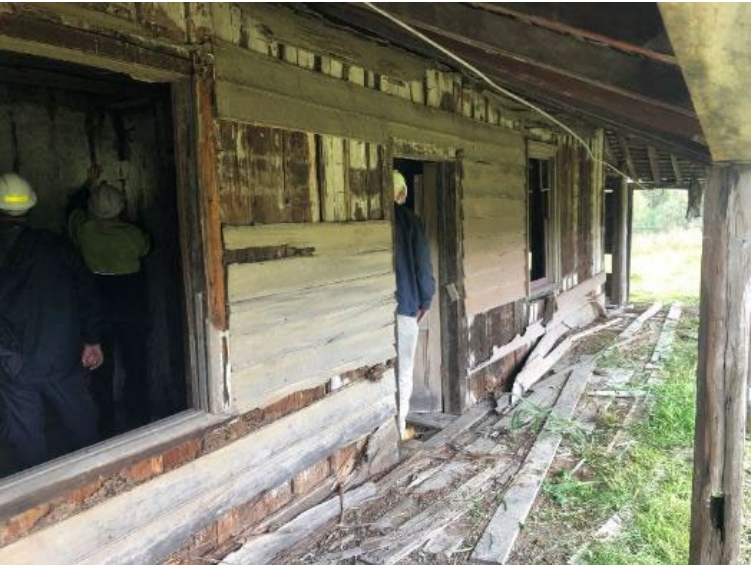
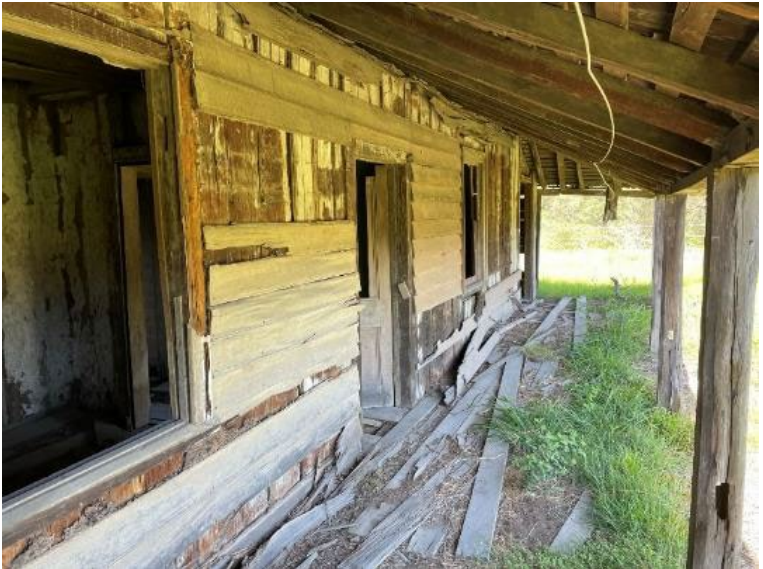
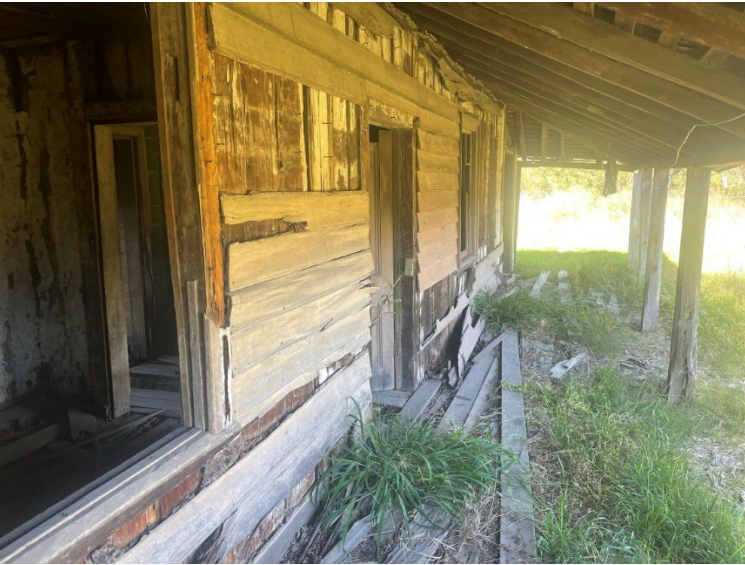
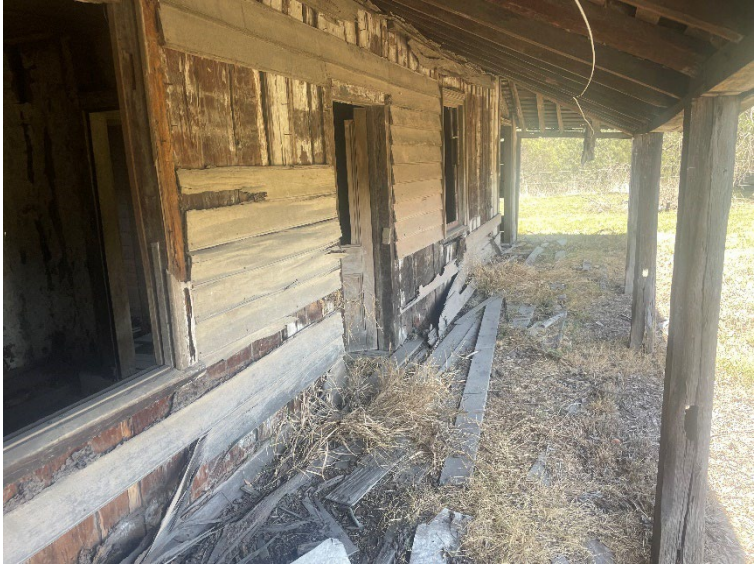
| 2014 | 2018 | 2020 (Mar) | 2020 (Dec) |
|---|---|---|---|
| | | | <p><b>2014-8:</b> further deterioration of weatherboard panelling.</p> <p><b>2018-20 (Mar):</b> no discernible change, though termite activity present.</p> <p><b>Mar 2020-Dec 2020:</b> grass/weed growth encroaching over veranda floor.</p> <p><b>Dec 2020 – 2021:</b> increased grass encroachment.</p> <p><b>2021-2022:</b> increased grass growth.</p> <p><b>2022-2023:</b> no discernible change</p> |

- The continued growth of trees also having impacts on structural stability in the south-western corner and along the eastern roof line; and
- Increasing instability to the front/northern verandah caused by severe damage to at least two supporting uprights caused by termite activity and wood rot.

The verandah uprights are all severely weakened through termite activity or rot and require bolstering to aid in support of the roof. This also the case along the eastern roofline, where slumping is continuing with the absence of any vertical support along this wall line.

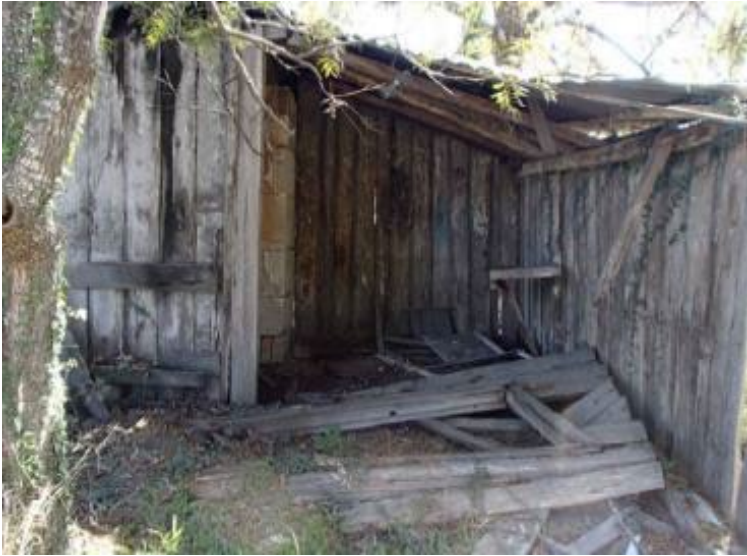
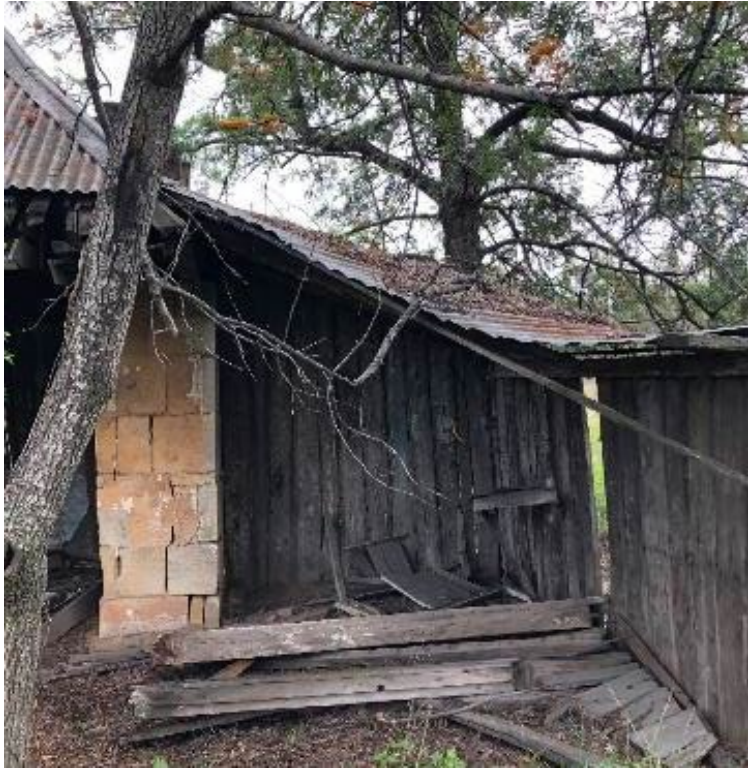
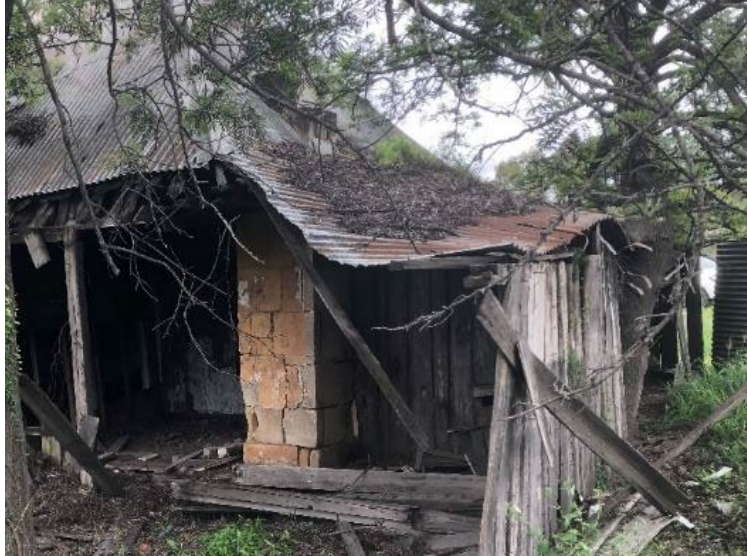
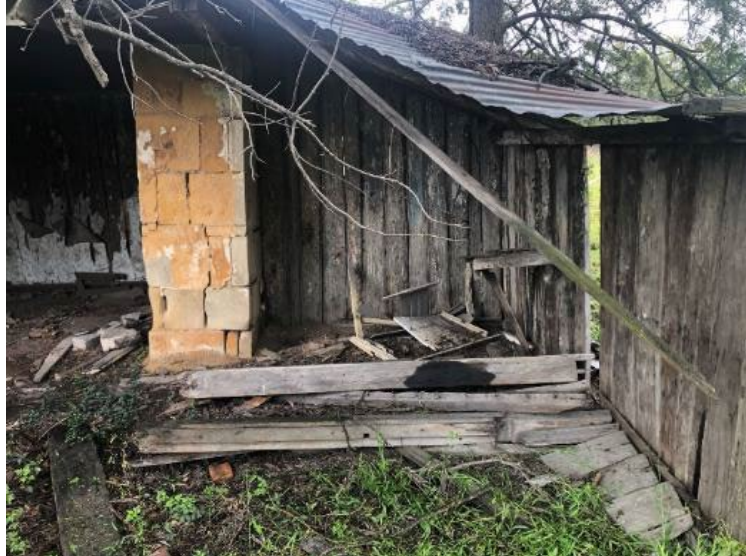
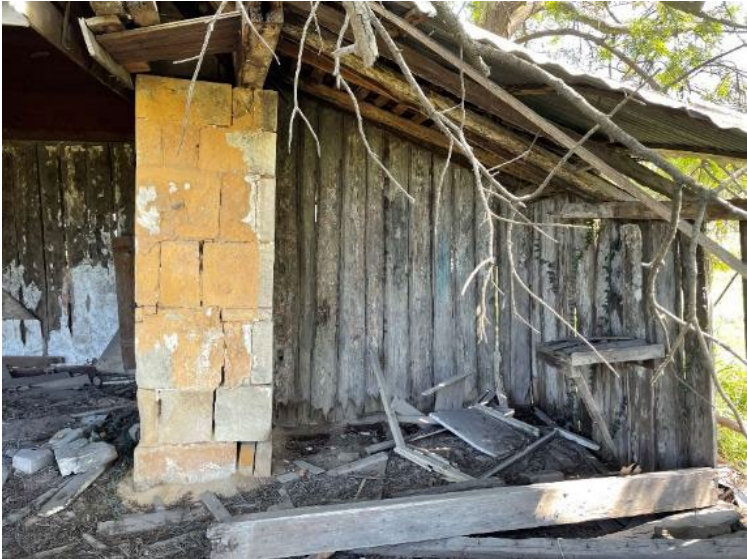
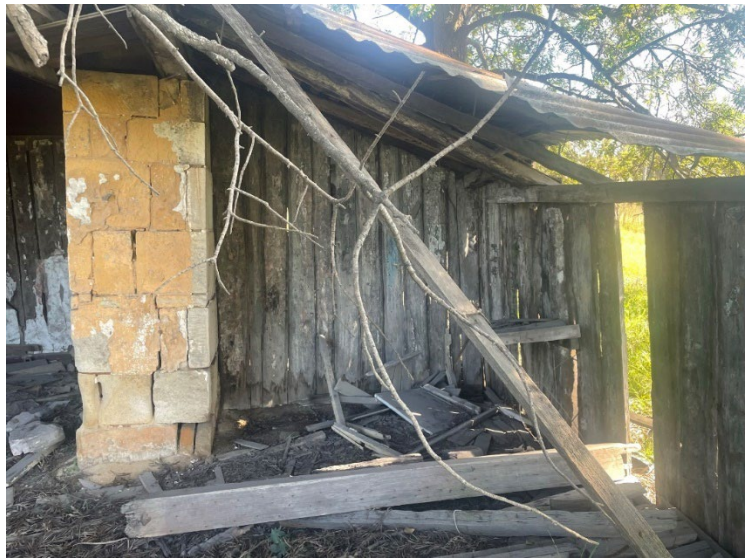
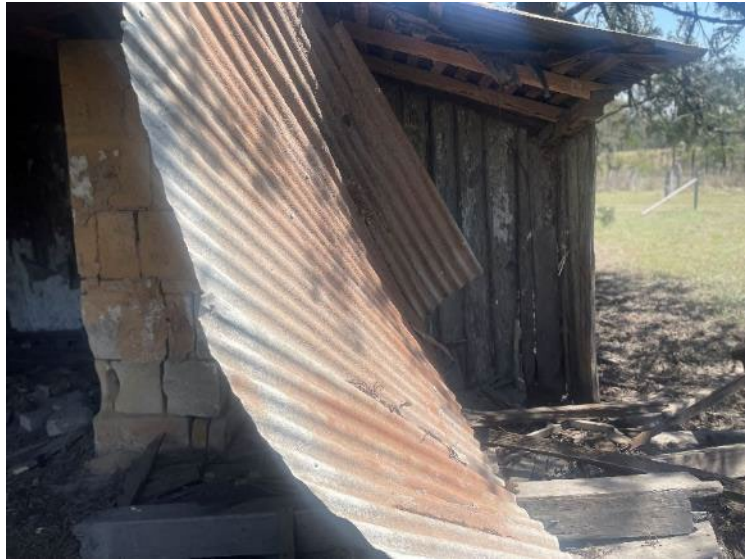
| 2014 | 2018 | 2020 (Mar) | 2020 (Dec) |
|---|---|---|---|
| | | | <p><b>2014-8:</b> shows removal of vertical slabs from southern wall, and some from eastern wall, and further collapse of roof.</p> <p><b>2018-20 (Mar):</b> further roof slumping and deterioration of eastern wall.</p> <p><b>Mar 2020-Dec 2020:</b> no discernible change.</p> <p><b>Dec 2020 – 2021:</b> further deterioration of eastern wall.</p> <p><b>2021-2022:</b> movement of roofing timbers, subsidence in chimney blocks, bottom left corner.</p> <p><b>2022-2023:</b> total collapse of side wall and roof</p> |

- The total collapse of the section of wall and roofline in the south-eastern corner of the house is a significant and detrimental change. The causes of this collapse are tied to the age and weathering to the materials themselves, with the structural integrity of the roofing and wall members likely further diminished by the previous collapse/removal of the southern wall of the house and associated increased weather impacts. This latest collapse will only serve to further exacerbate the impacts of weather to this section of the house, putting the integrity of the sandstone chimney at increased risk;

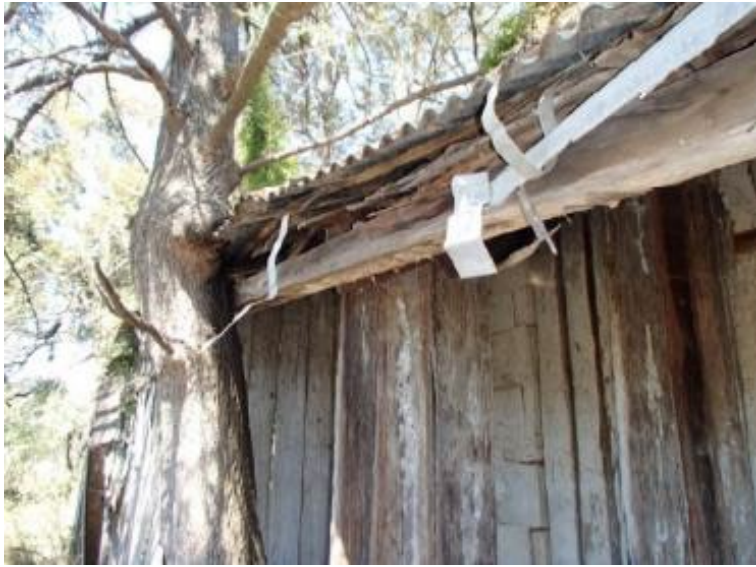
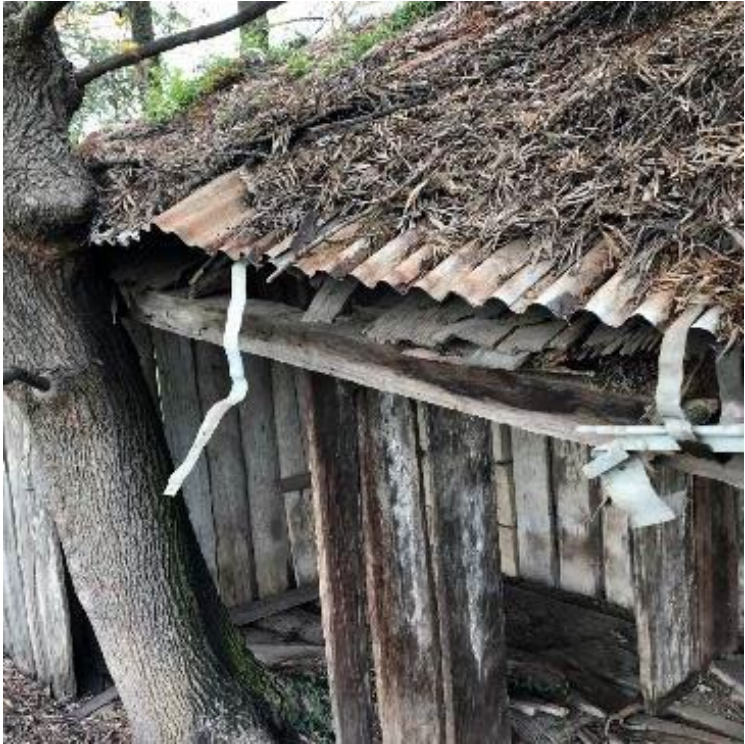
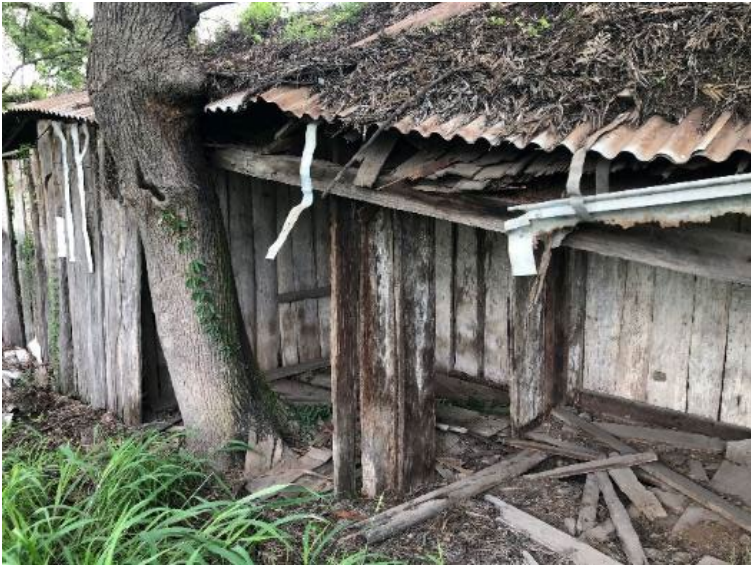
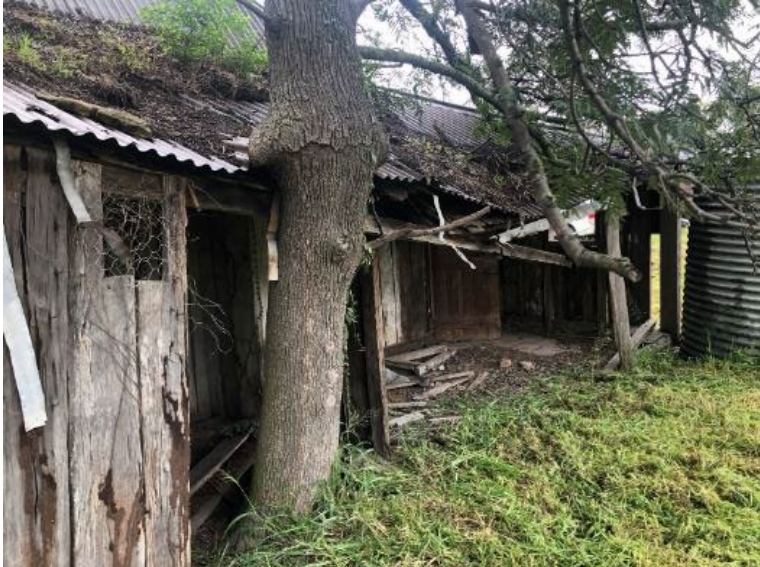
| 2014 | 2018 | 2020 (Mar) | 2020 (Dec) |
|---|---|---|---|
| | | | <p><b>2014-8:</b> possible further collapse of crossbeam and guttering.</p> <p><b>2018-20 (Mar):</b> tree continues to impact eastern roof line.</p> <p><b>Mar 2020-Dec 2020:</b> increased impact on roofline by tree branches.</p> <p><b>Dec 2020 – 2021:</b> tree continues to impact eastern side.</p> <p><b>2021-2022:</b> veranda roof now considerably buckled in middle, with separation of timber members occurring.</p> <p><b>2022-2023:</b> tree continues to impact eastern side, with wall collapse shown at near left.</p> |

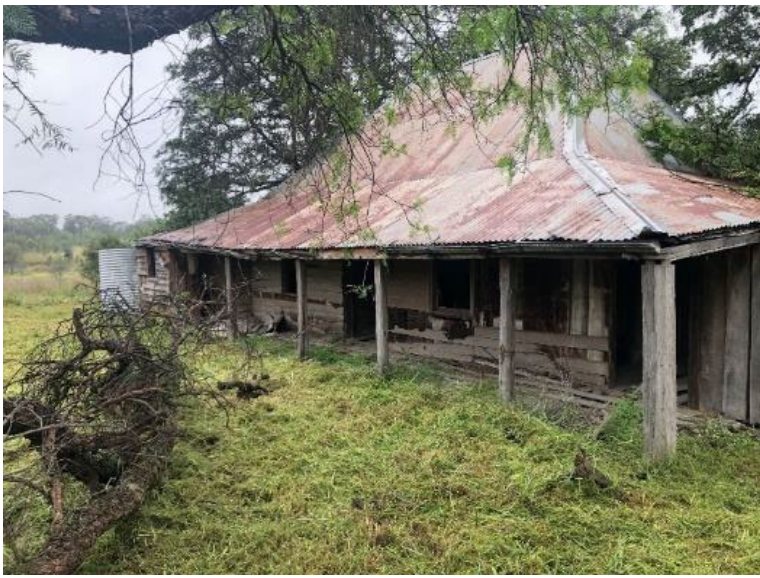
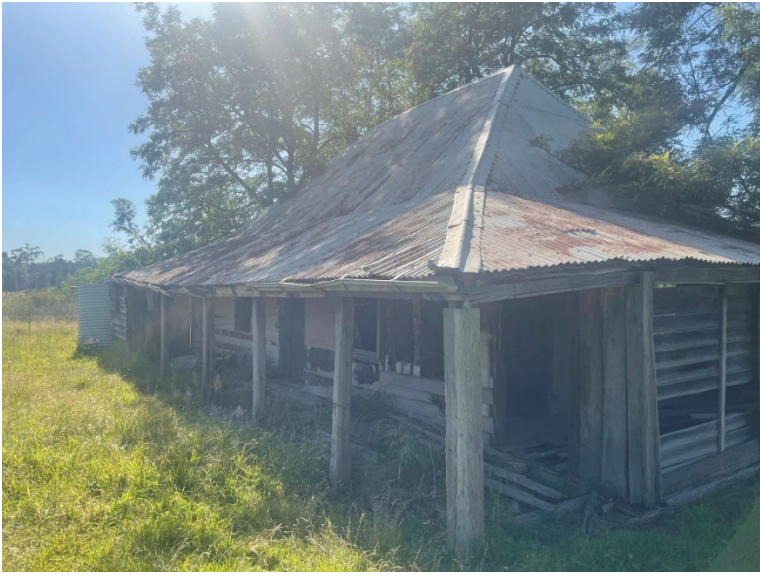
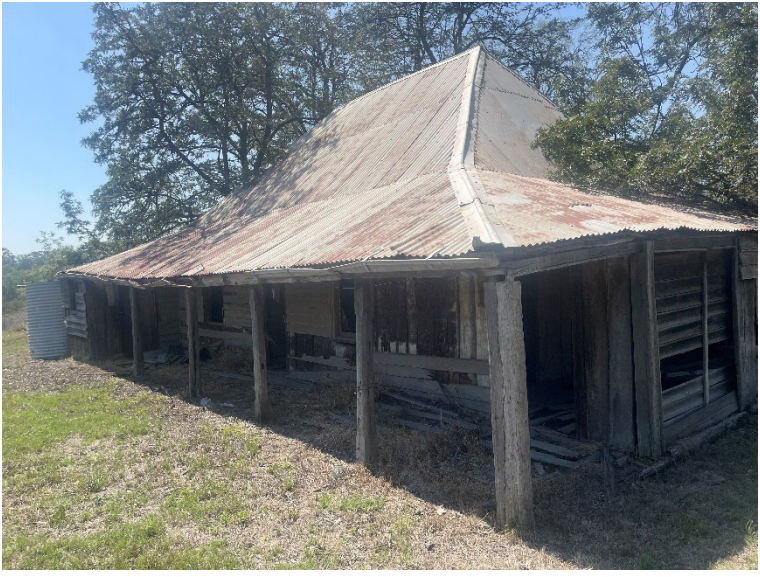
| 2014 | 2018 | 2020 (Mar) | 2020 (Dec) |
|---|---|---|---|
| | | | <p><b>2014-8:</b> <a href="#">slumping of veranda along edge beam.</a></p> <p><b>2018-20 (Mar):</b> no discernible change.</p> <p><b>Mar 2020-Dec 2020:</b> <a href="#">grass/weed growth encroaching over veranda floor.</a></p> <p><b>Dec 2020 – 2021:</b> no discernible change.</p> <p><b>2021-2022:</b> peppercorn has been pruned; <a href="#">termite damage is increased within veranda uprights.</a></p> <p><b>2022-2023:</b> <a href="#">increased splitting to fourth verandah post from right</a></p> |

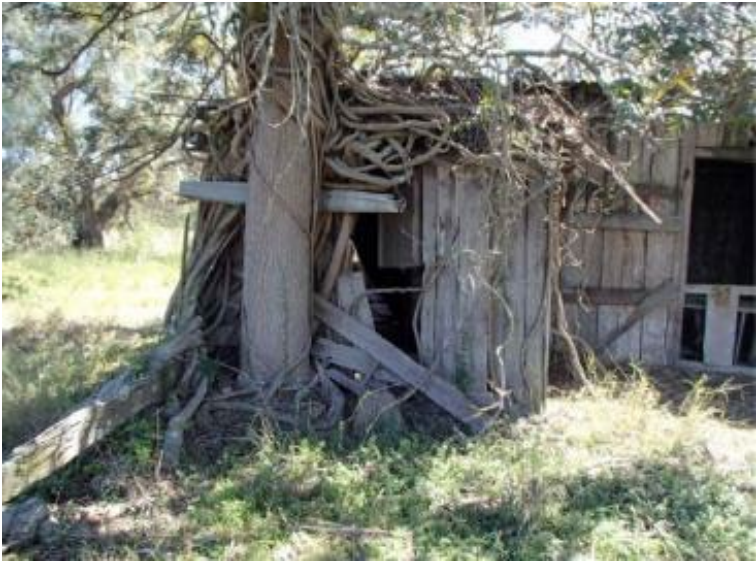
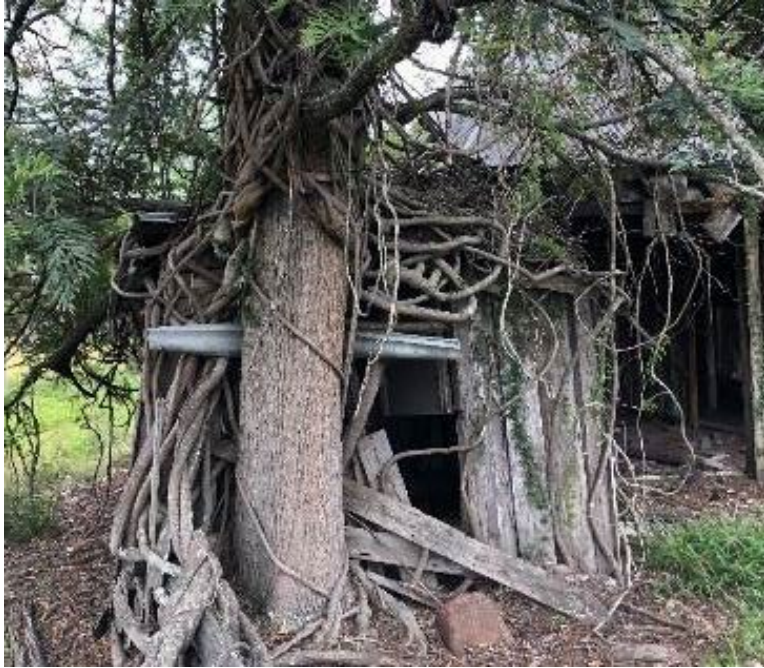
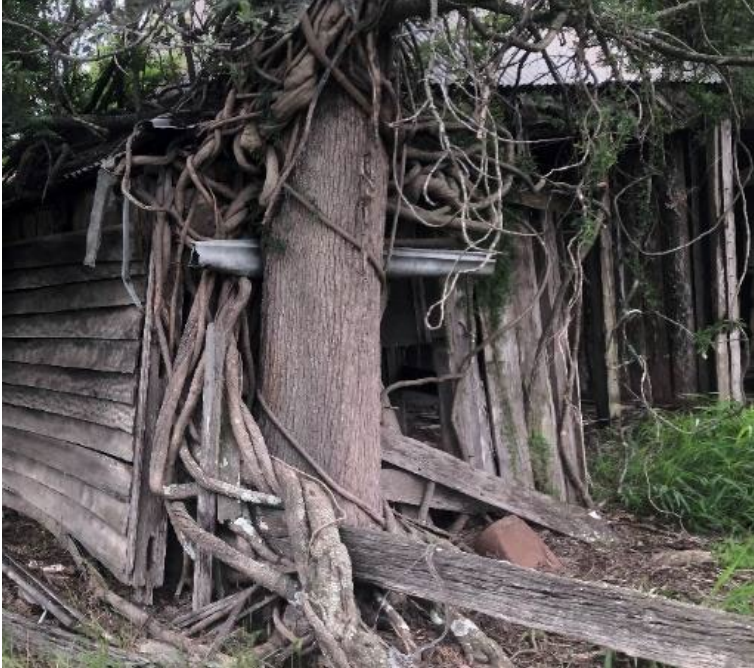
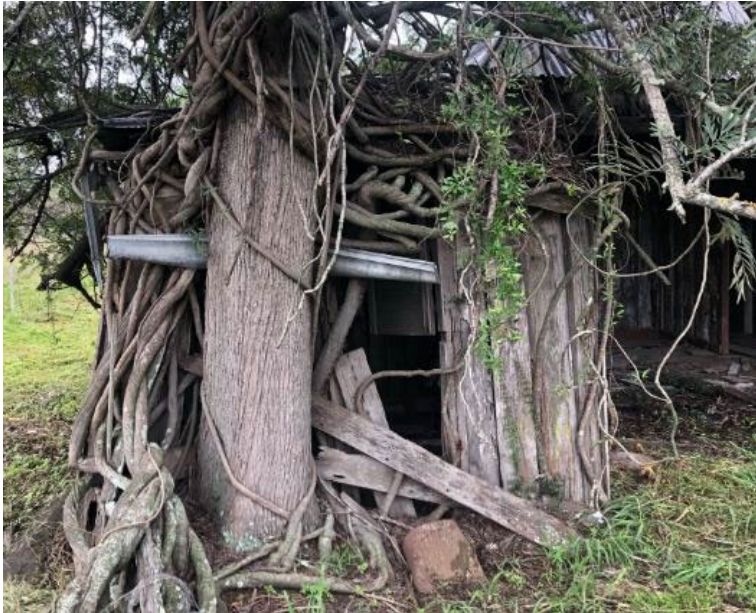
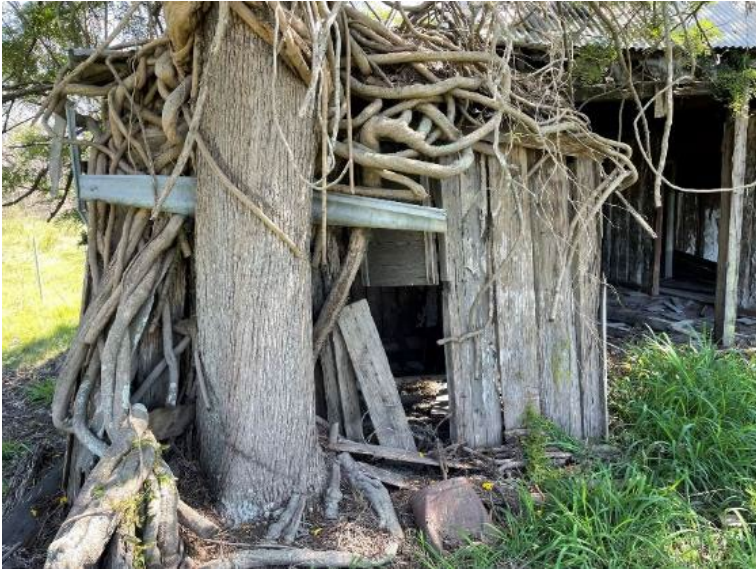
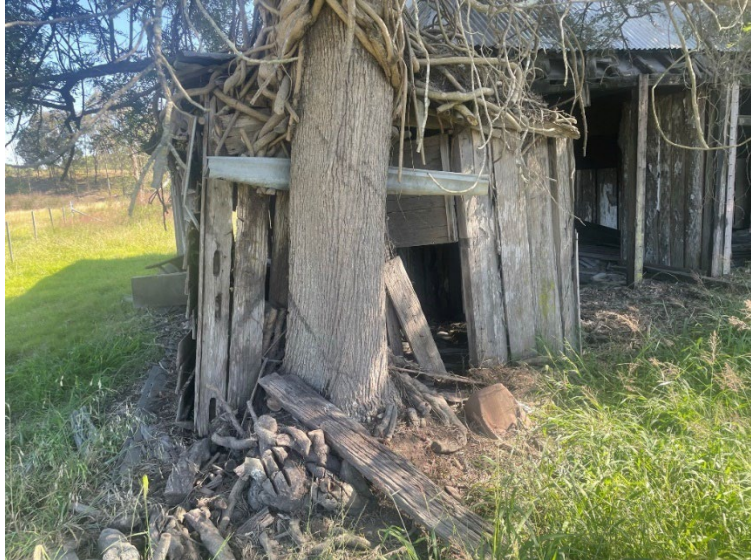
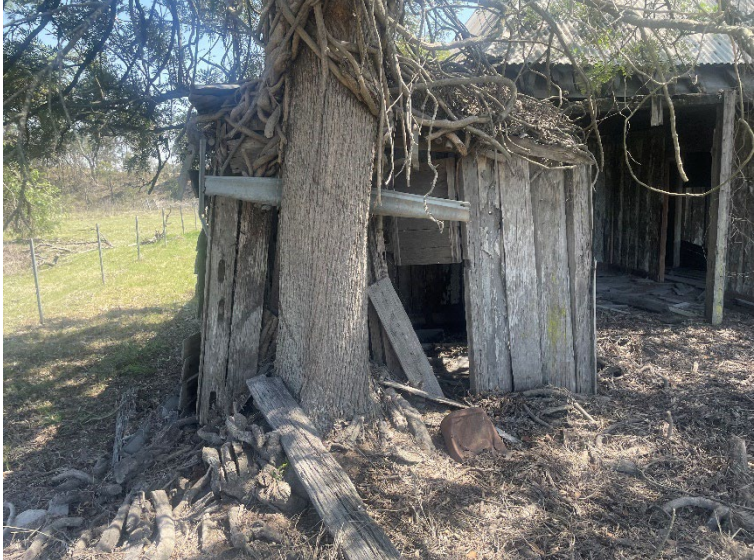
| 2014 | 2018 | 2020 (Mar) | 2020 (Dec) |
|---|---|---|---|
| | | | <p><b>2014-8:</b> shows removal of vertical slabs from southern wall as well as some increase in vegetation growth.</p> <p><b>2018-20 (Mar):</b> no discernible change but continuing vegetation impacts.</p> <p><b>Mar 2020-Dec 2020:</b> apparent increased vine growth.</p> <p><b>Dec 2020 – 2021:</b> continued impacts on south-west corner.</p> <p><b>2021-2022:</b> vine has been chopped near ground and killed, some resultant movement of timbers.</p> <p><b>2022-2023:</b> no discernible change but continuing vegetation impacts.</p> |

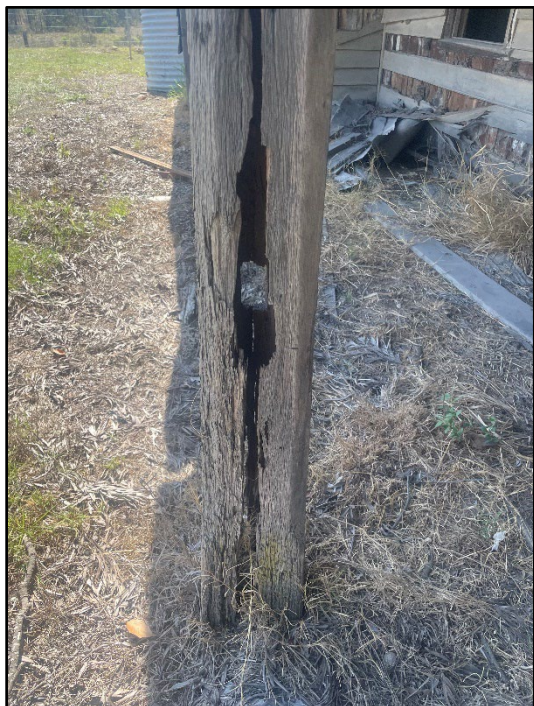
***Additional northern verandah upright affected by termites and/or rot***

4. Propping of the northern, eastern and southern roof lines should occur without delay to prevent any collapse caused by removed/damaged uprights; and

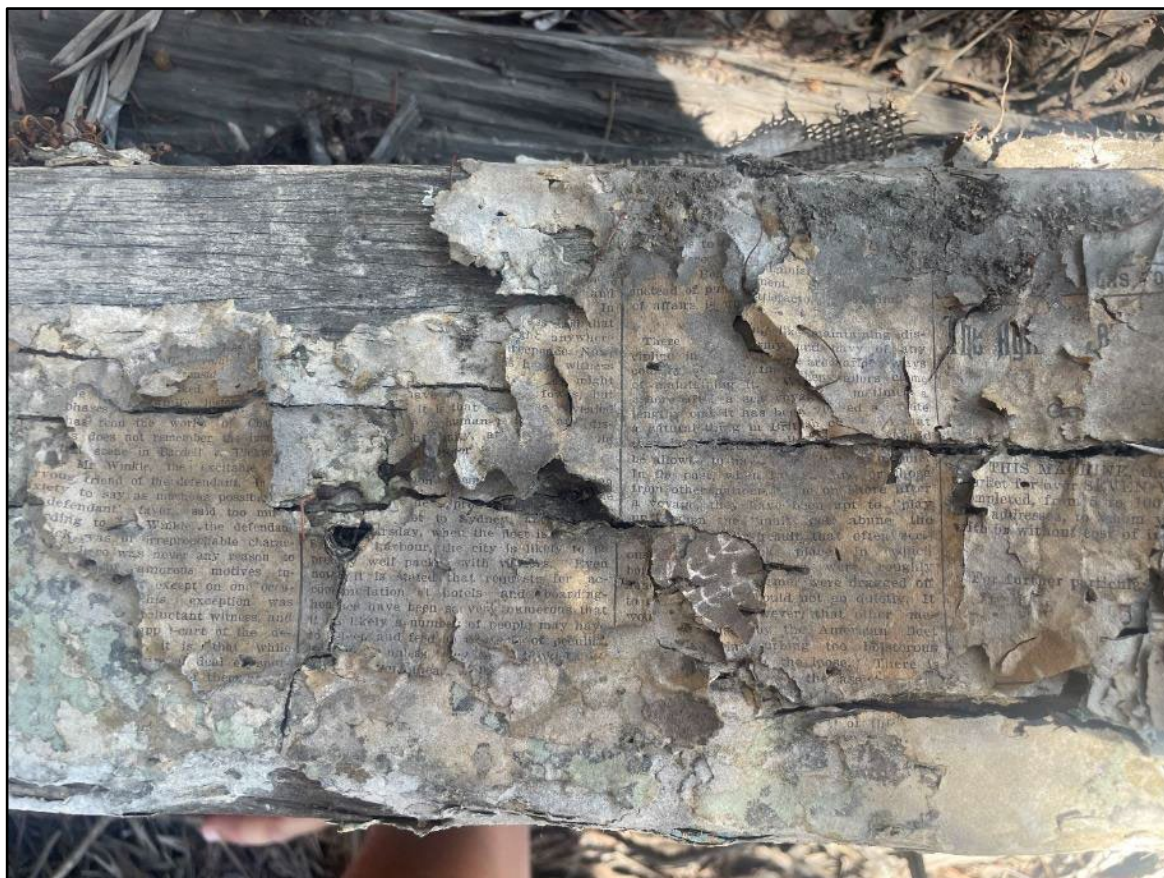
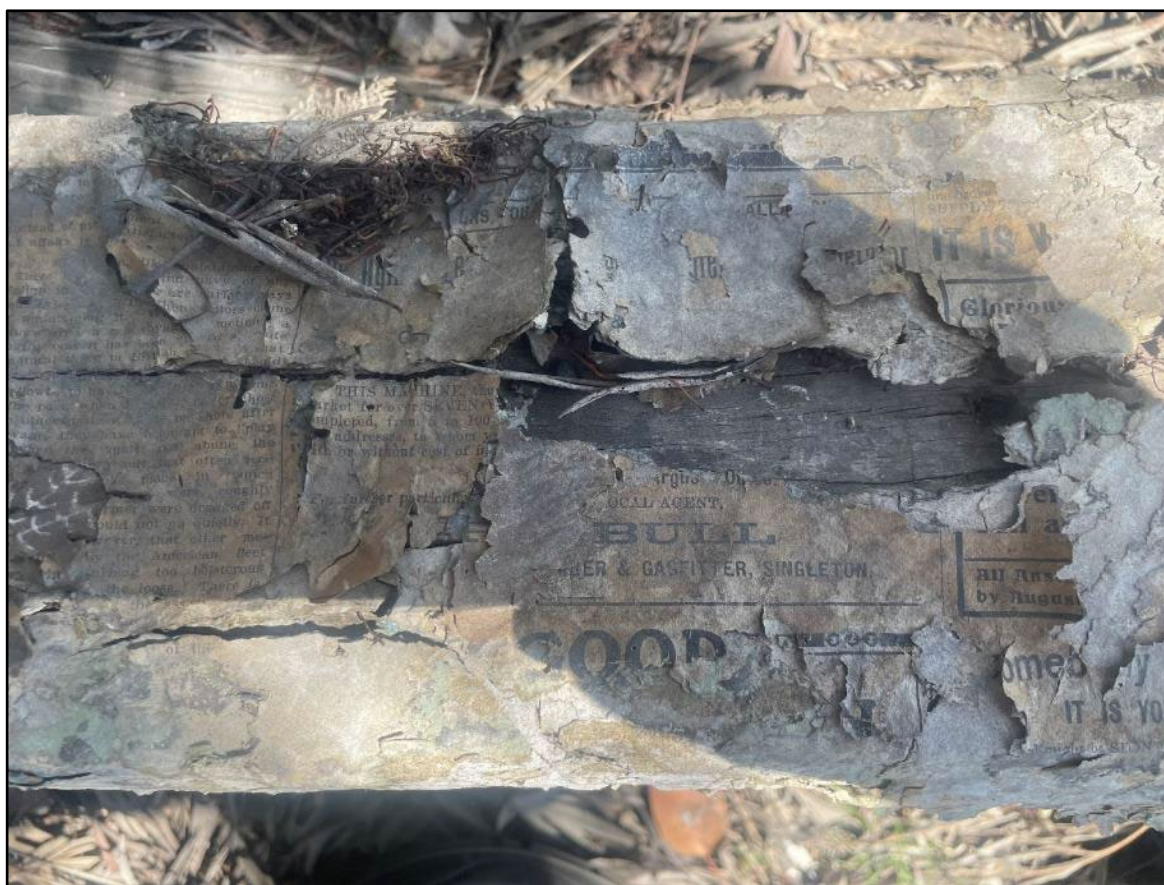
It should also be noted that the collapse of the south-eastern section of wall has also exposed some portions of old newspaper that had been adhered to one piece of wood that once served as shelving in this room. The newspaper appears to be one of several layers that have been used as coverings over the years. A search of the National Library of Australia's Trove newspaper database conducted by CHAG member Lyn MacBain revealed that the paper originated from p.7 of the August 15 1908 edition of the Singleton Argus, making these fragments 115 years old. Recommendations on their care and conservation are outlined below.

**Fragments of the August 15 1908 Singleton Argus recovered from the collapsed wall**

5. The wooden piece containing the remnant newspaper fragments should be removed from the site as soon as possible in order to preserve the remaining fabric. The piece should be stored inside and in constant temperature conditions at low humidity and in dark conditions. It should be stored so as to be protected from vermin and pests, and personnel involved should avoid touching the fragments, especially with bare hands. Prior to removal, in situ photographs should be taken of the piece and its relationship to the other fallen timbers in order to record its contextual provenance. These
