# Mount Thorley Warkworth

## 2023 Annual Review

| <b>Name of Operations</b> | Mount Thorley Warkworth |

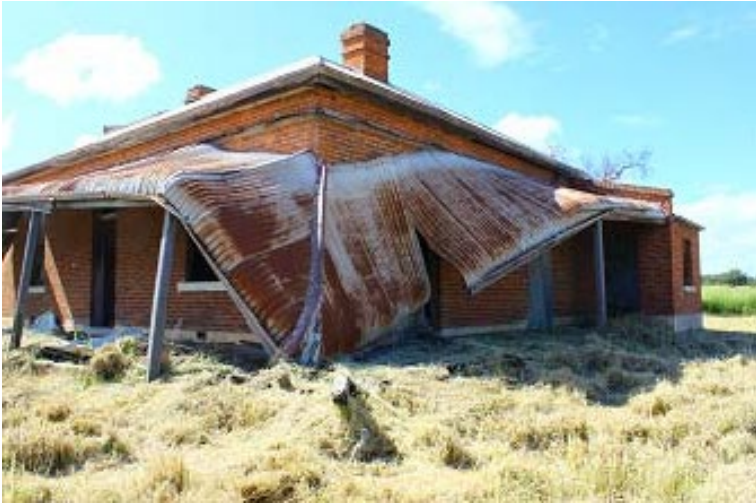
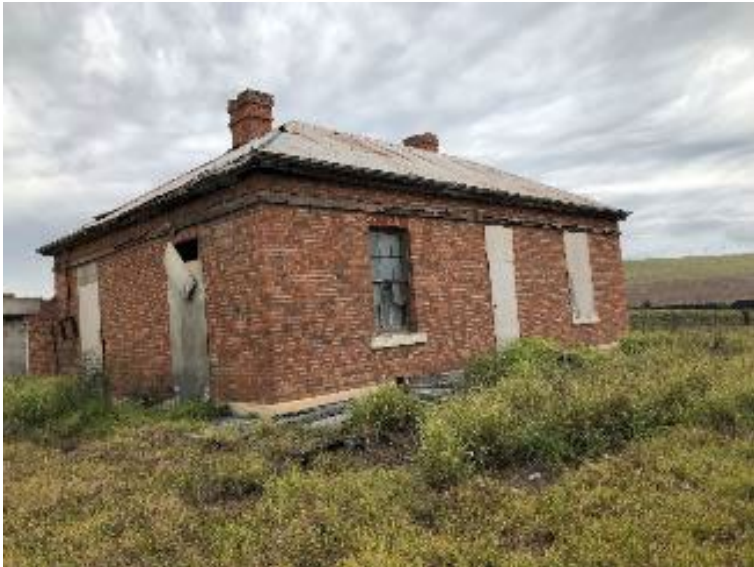
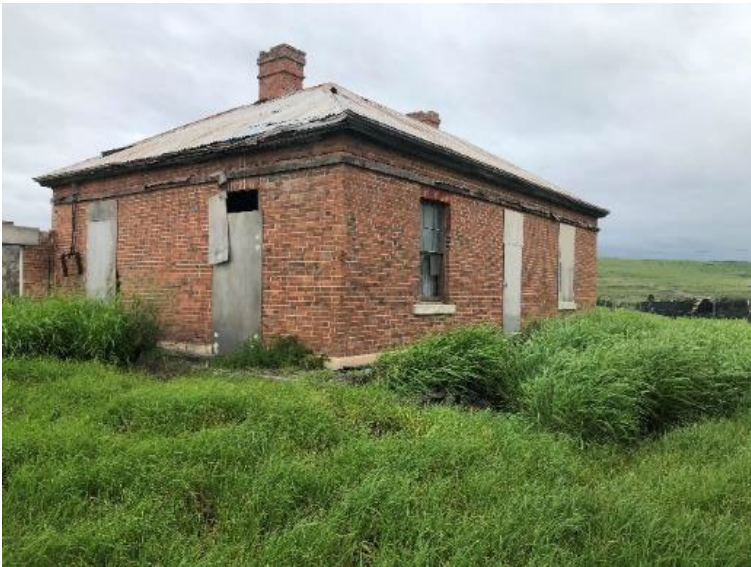
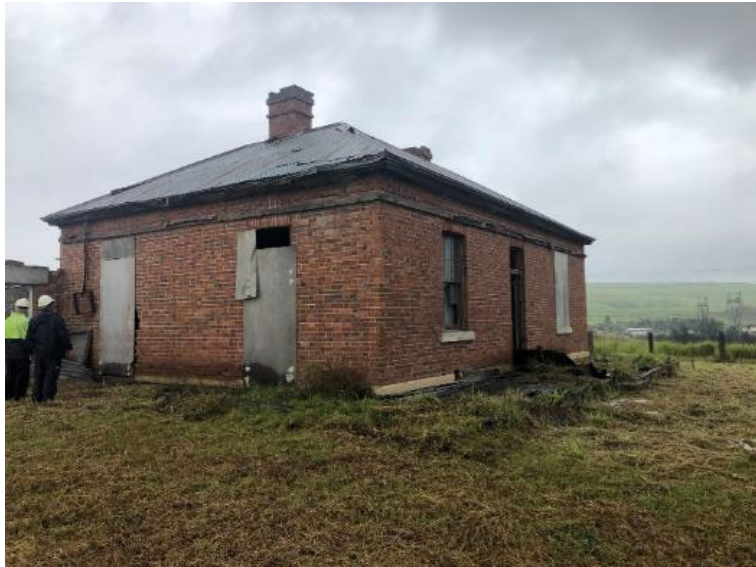
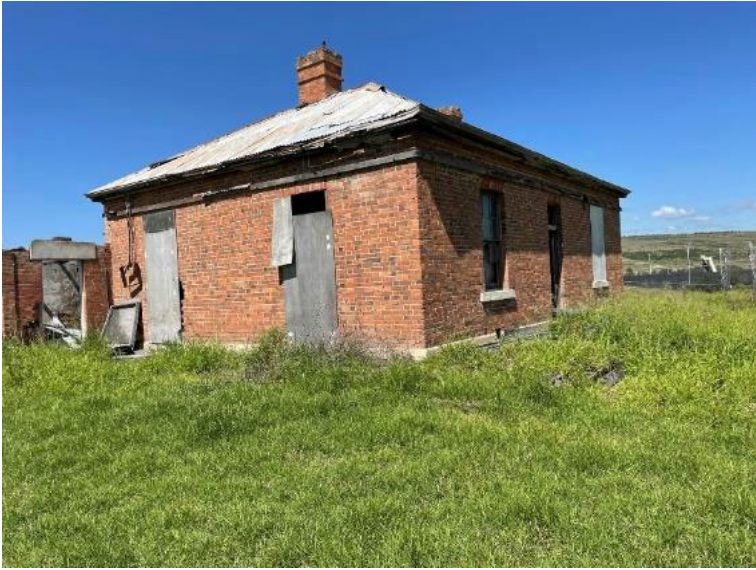
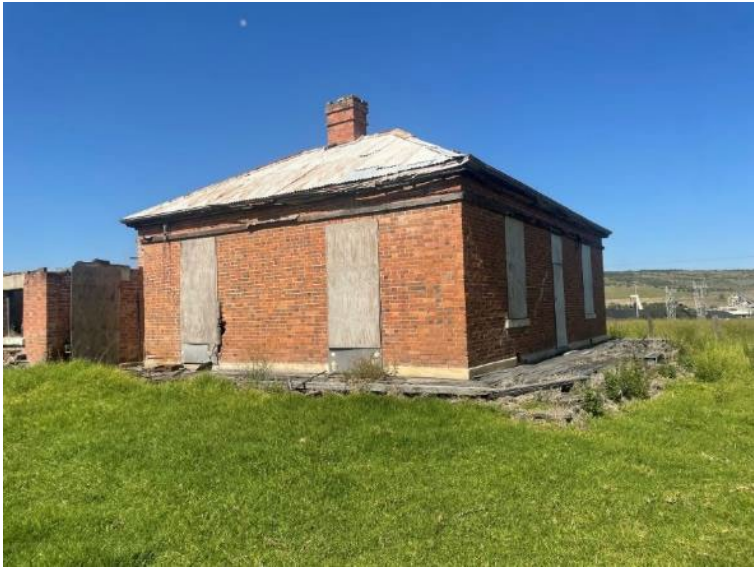
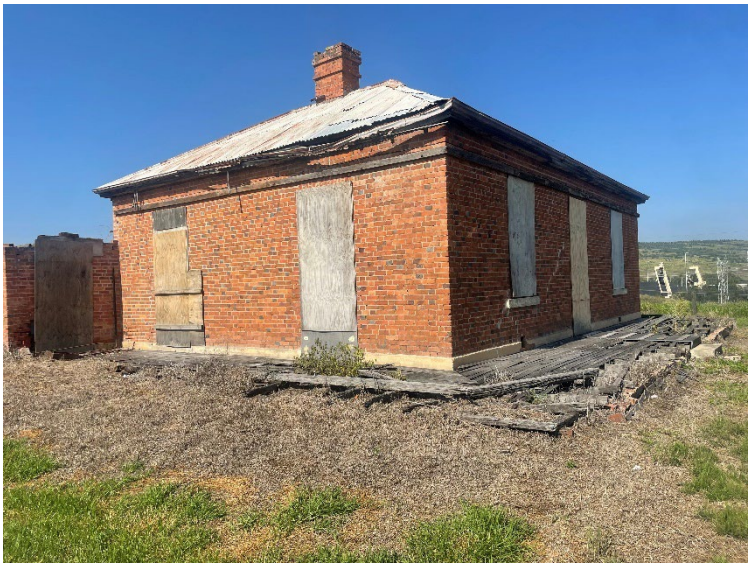
| 2015 | 2018 | 2020 (Mar) | 2020 (Dec) |
|---|---|---|---|
| | | | <p><b>2015-8:</b> veranda removed and stored inside building, vegetation has been managed.</p> <p><b>2018-20 (Mar):</b> vegetation has regrown around building.</p> <p><b>Mar 2020-Dec 2020:</b> vegetation again under control, panel above boarded door requires refixing.</p> <p><b>Dec 2020 – 2021:</b> vegetation requires management and loose boards re-affixing.</p> <p><b>2021-2022:</b> panelling fixed or reinstalled on all openings; <a href="#">ruinous electricity board fallen</a>; <a href="#">increased vandal activity at left-most door opening</a>; grass recently mowed.</p> <p><b>2022-2023:</b> recently mowed and left door barricading bolstered. <a href="#">Guttering deterioration and lifting of roof tin at near corner.</a></p> |

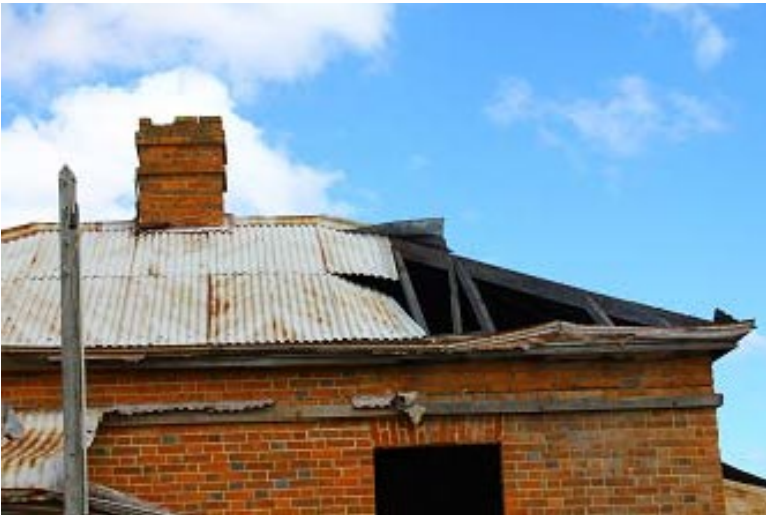
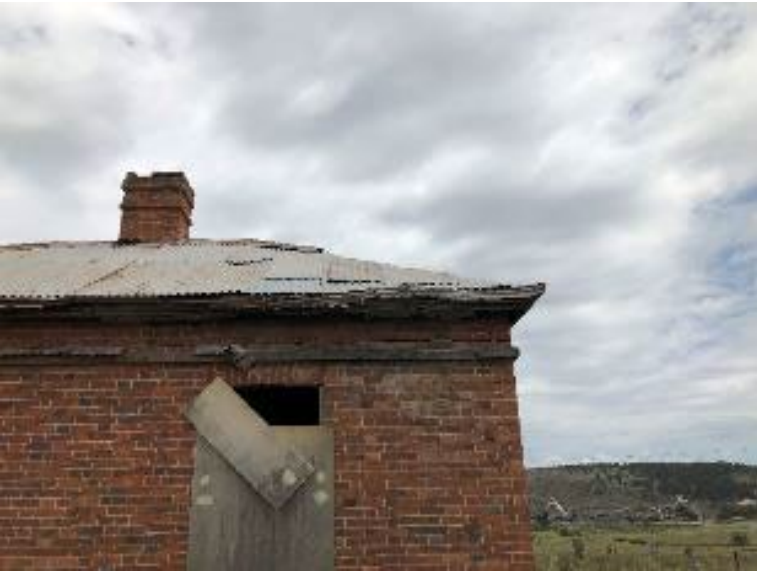
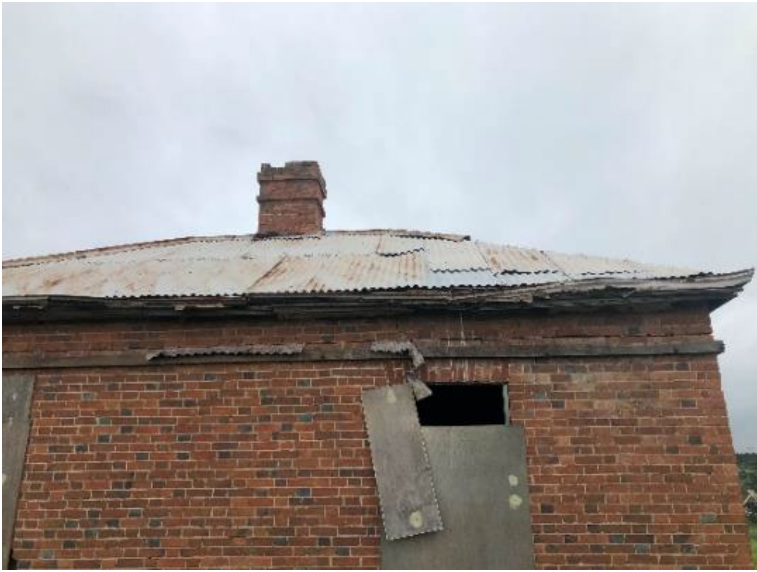
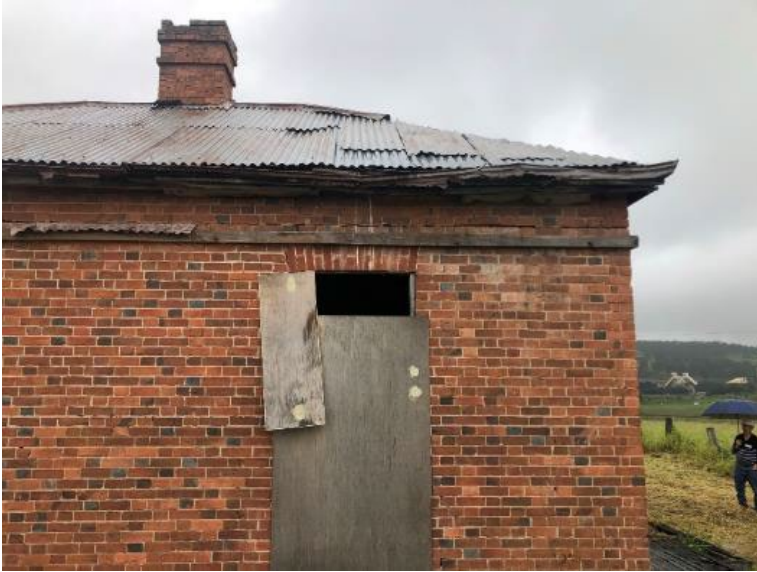
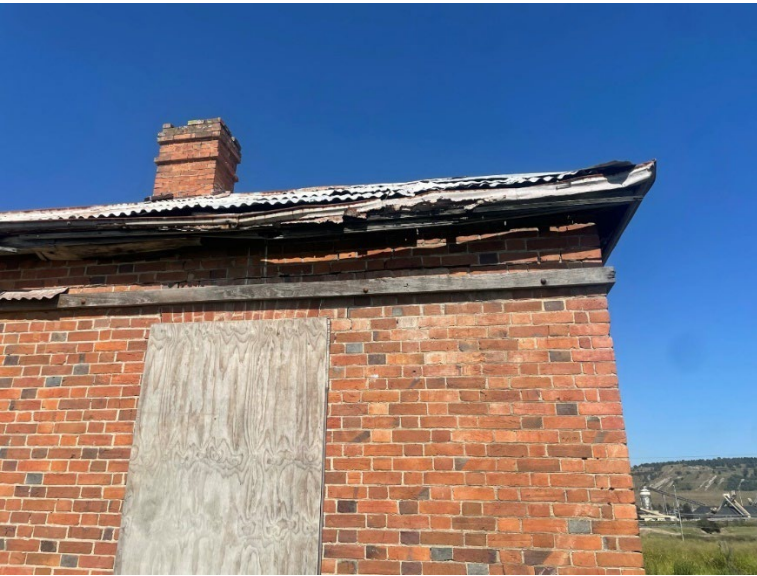
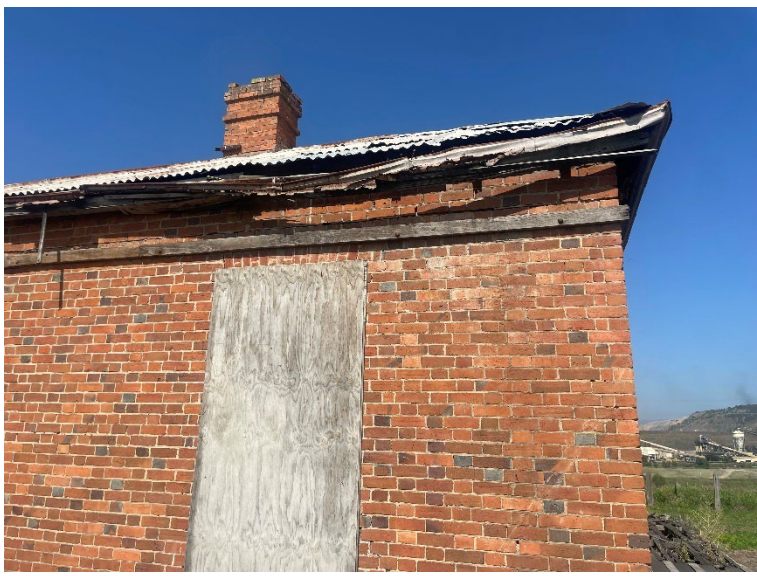
| 2015 | 2018 | 2020 (Mar) | 2020 (Dec) |
|---|---|---|---|
| | | | <p><b>2015-8:</b> roofing sheets have been replaced and holes patched.</p> <p><b>2018-20 (Mar):</b> some minor roof holes and lifted sheeting noted.</p> <p><b>Mar 2020-Dec 2020:</b> some veranda flashing fallen, panel above door requires refixing.</p> <p><b>Dec 2020 – 2021:</b> panel above door requires re-affixing and guttering remains in disrepair.</p> <p><b>2021-2022:</b> panel above door fixed, guttering in disrepair.</p> <p><b>2022-2023:</b> Deterioration of guttering and roof edge.</p> |

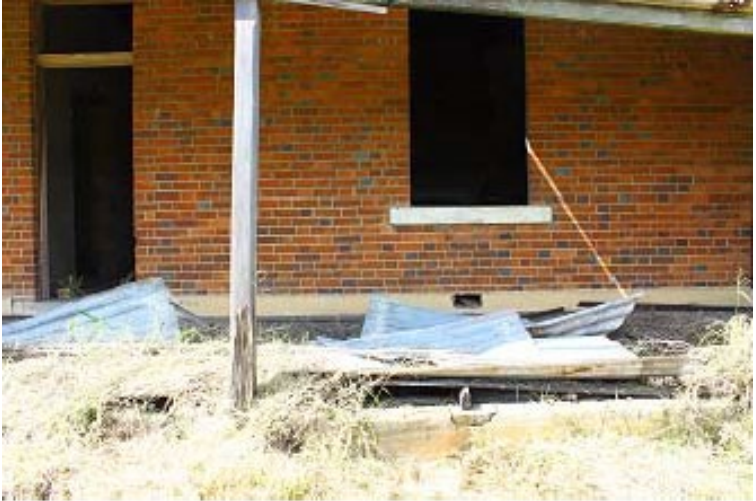
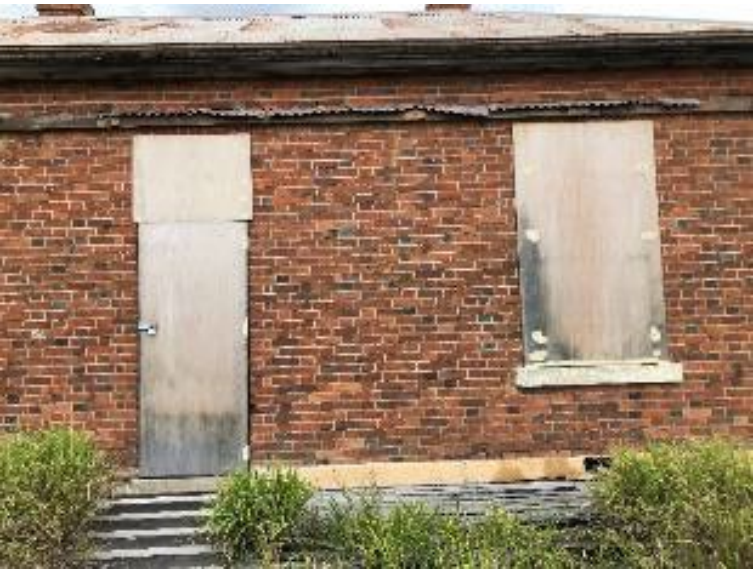
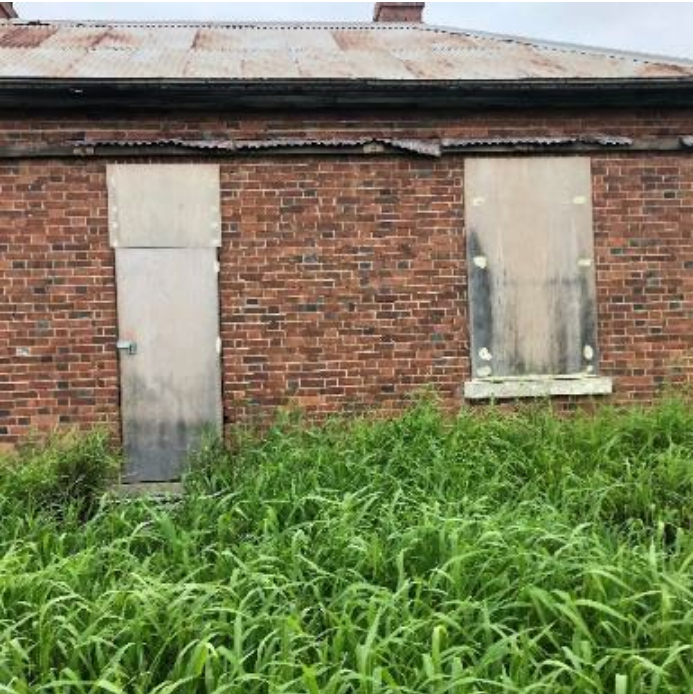
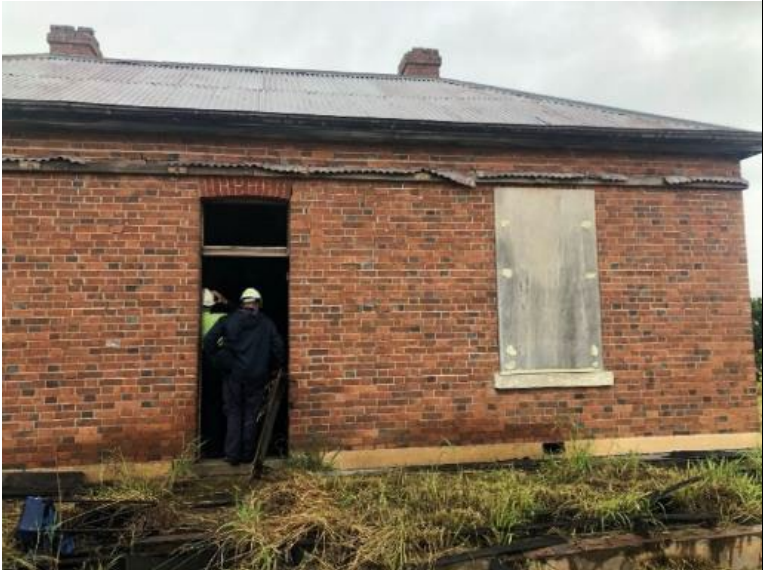
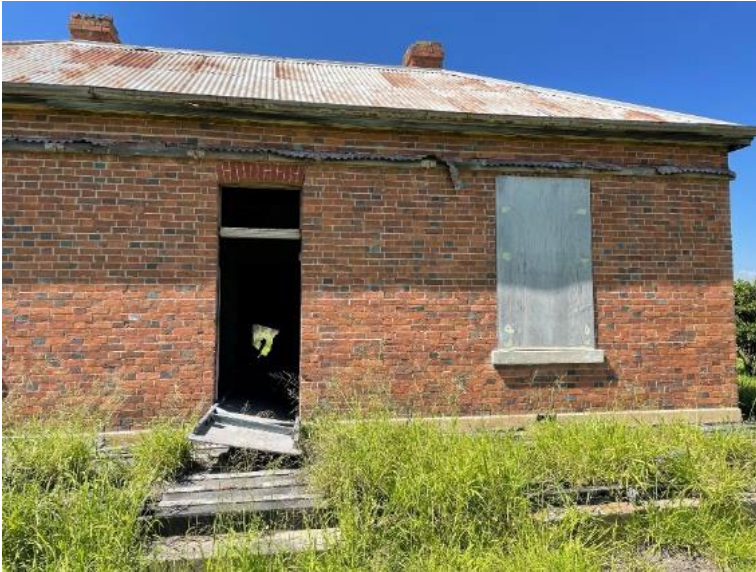
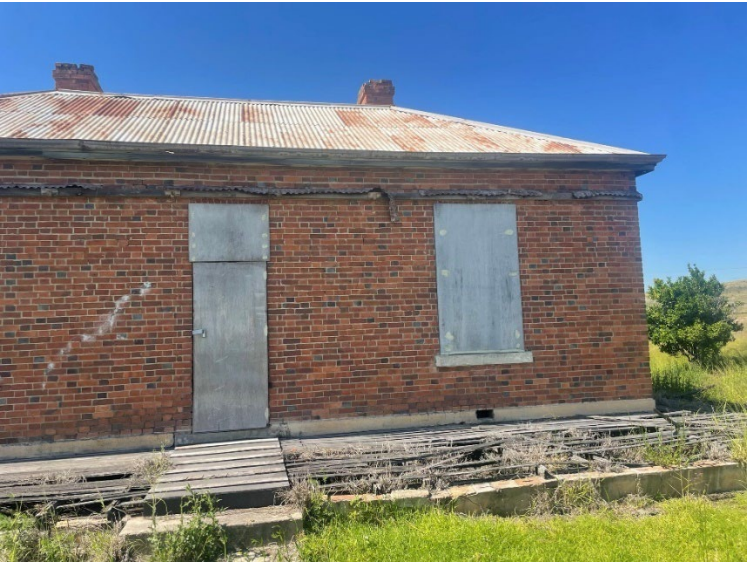
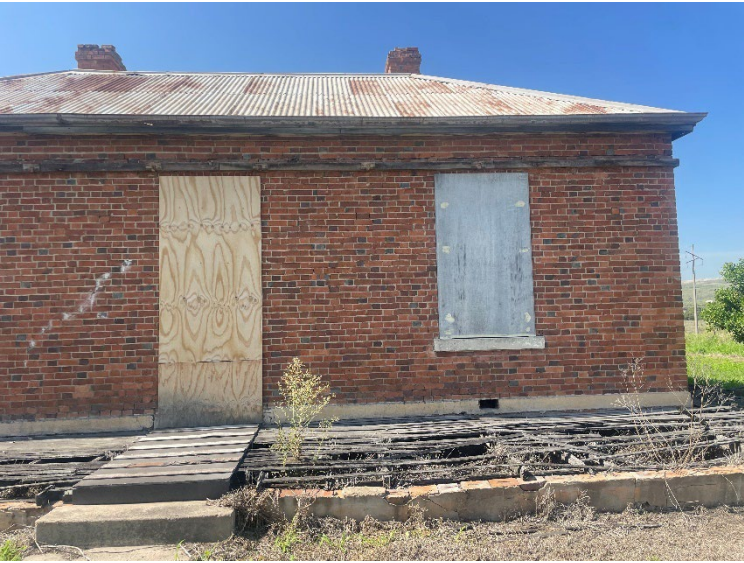
| 2015 | 2018 | 2020 (Mar) | 2020 (Dec) |
|---|---|---|---|
| | | | <p><b>2015-8:</b> sheeting installed on all openings, however some repair required.</p> <p><b>2018-20 (Mar):</b> no discernible change.</p> <p><b>Mar 2020-Dec 2020:</b> Front door panel requires reinstallation.</p> <p><b>Dec 2020 – 2021:</b> front door panel remains broken.</p> <p><b>2021-2022:</b> front door panel reaffixed; veranda grass poisoned.</p> <p><b>2022-2023:</b> new panelling installed on front door.</p> |

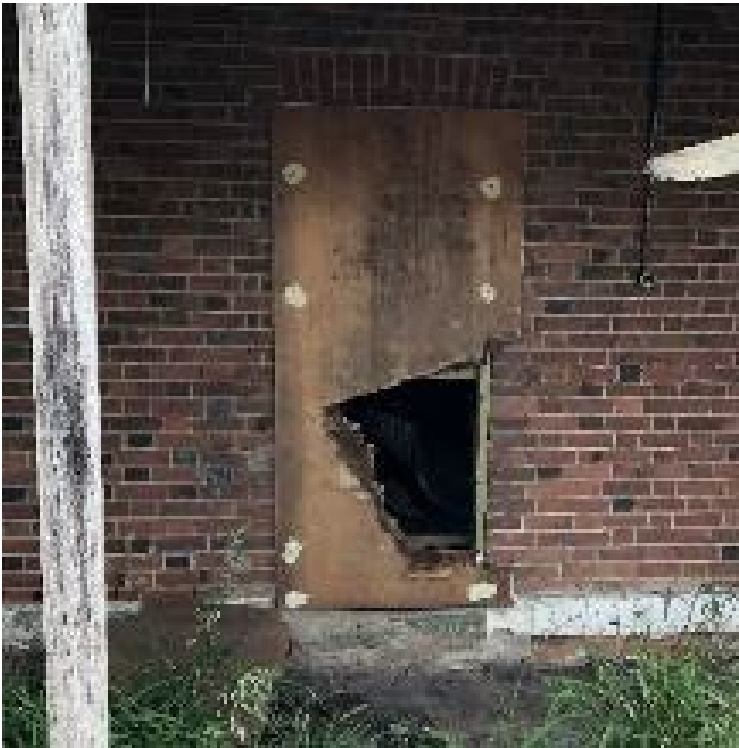
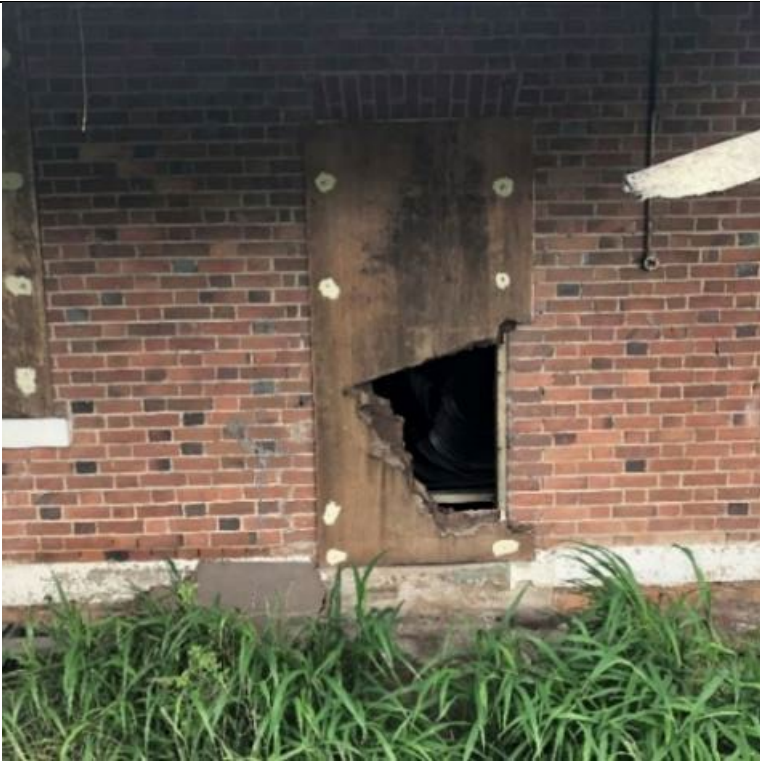
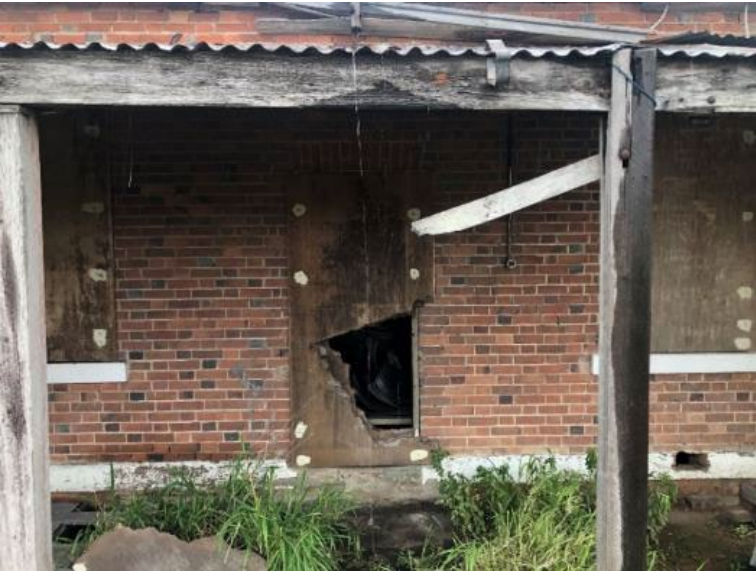
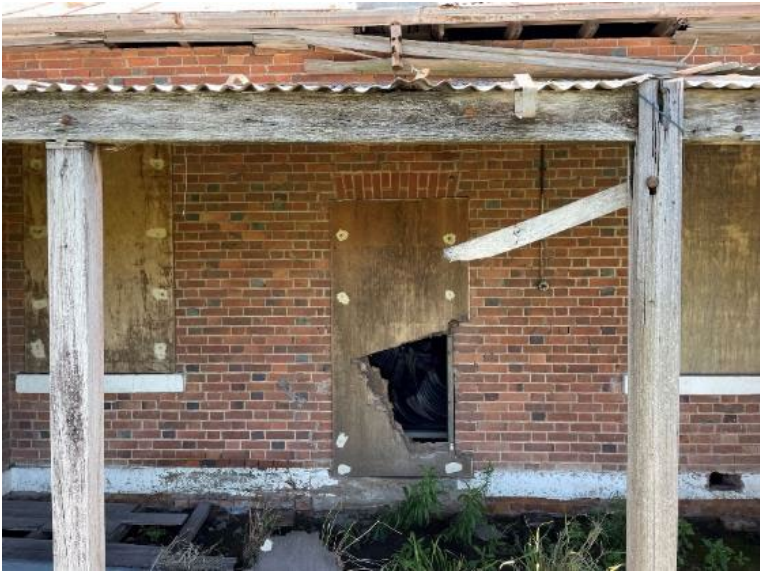
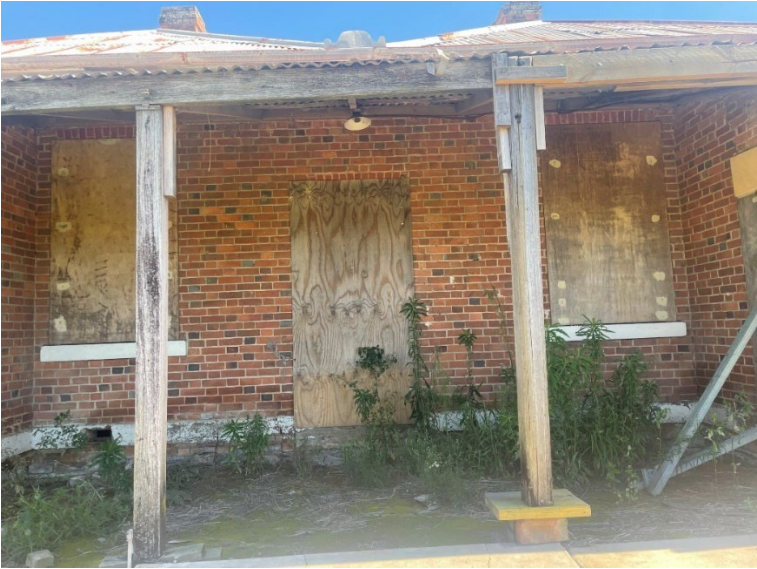
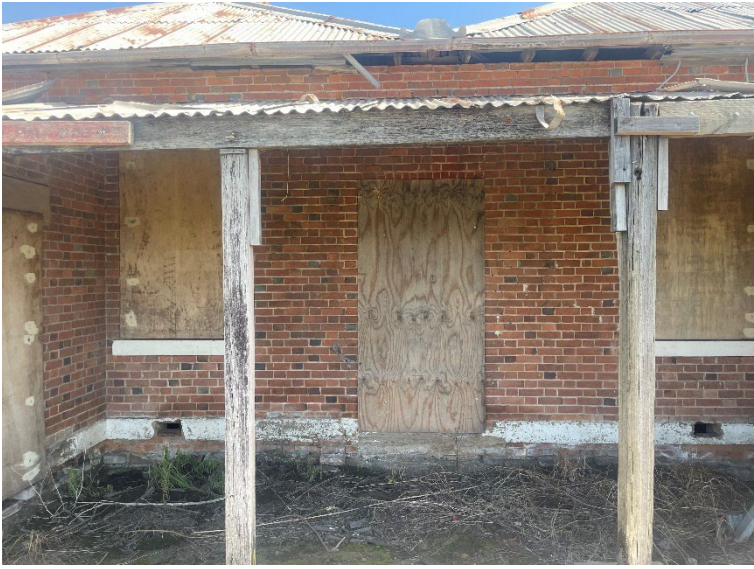
| 2015 | 2018 | 2020 (Mar) | 2020 (Dec) |
|---|---|---|---|
| | | | <p><b>2015-8:</b> sheeting installed on all openings, however some repair required.</p> <p><b>2018-20 (Mar):</b> some repair of panelling required.</p> <p><b>Mar 2020-Dec 2020:</b> Broken panel remains unrepaired.</p> <p><b>Dec 2020 – 2021:</b> broken panel remains unrepaired.</p> <p><b>2021-2022:</b> door panel fixed; uprights fixed and propped to support roof.</p> <p><b>2022-2023:</b> weeds sprayed, however <a href="#">water appears to be settling under back verandah, which may require attention.</a></p> |

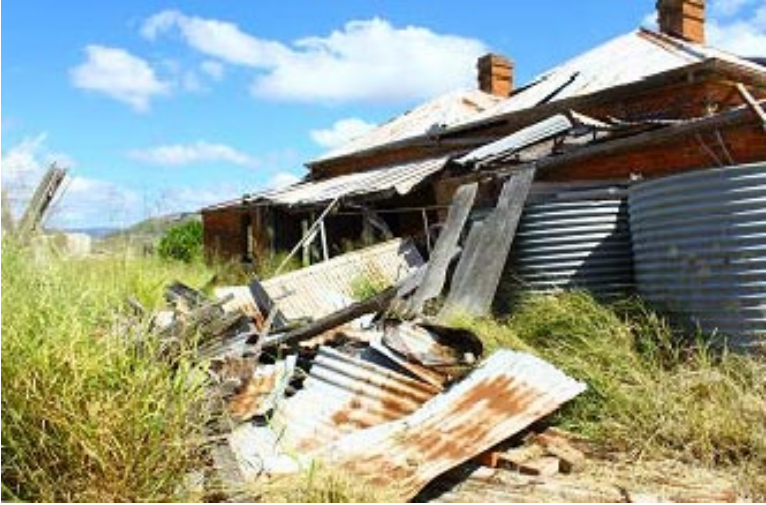
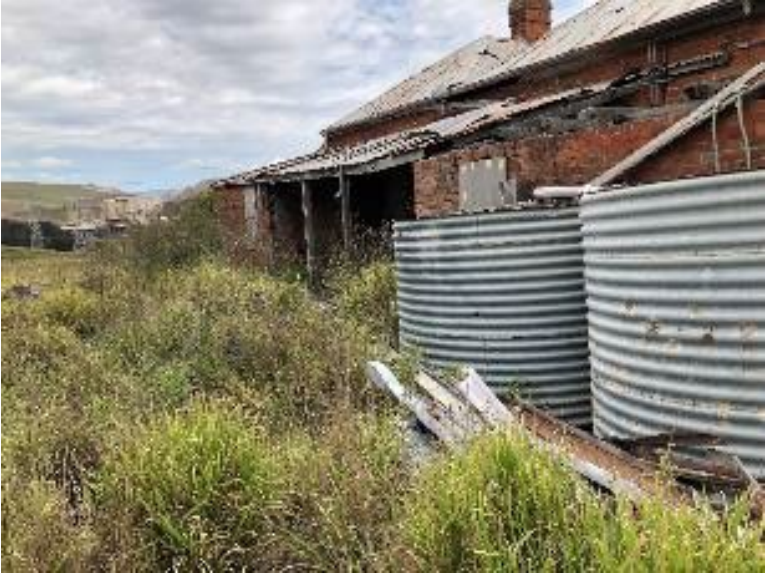
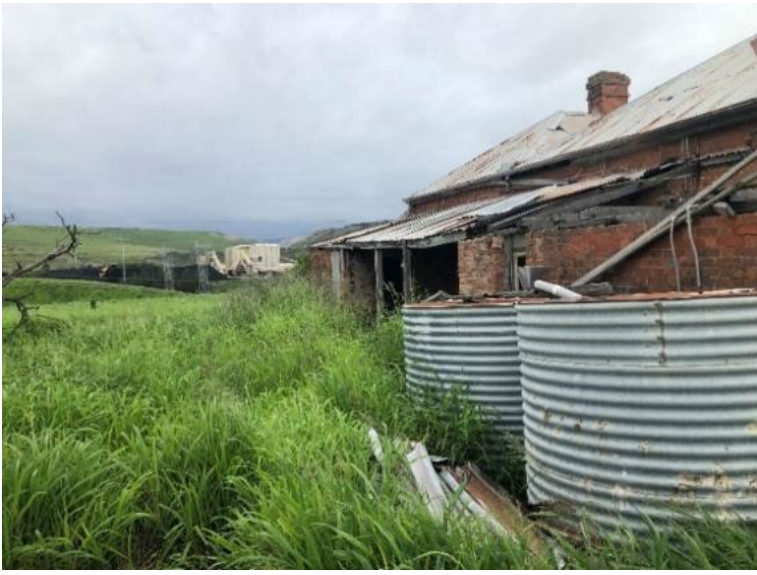
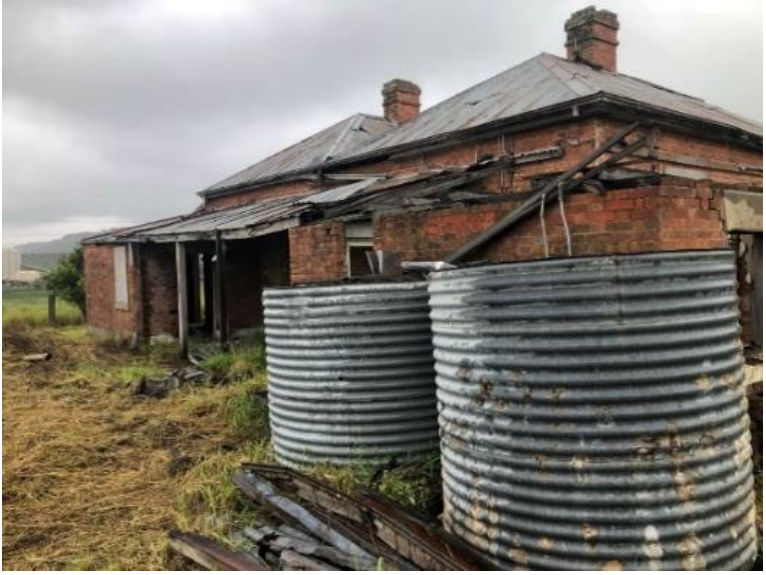
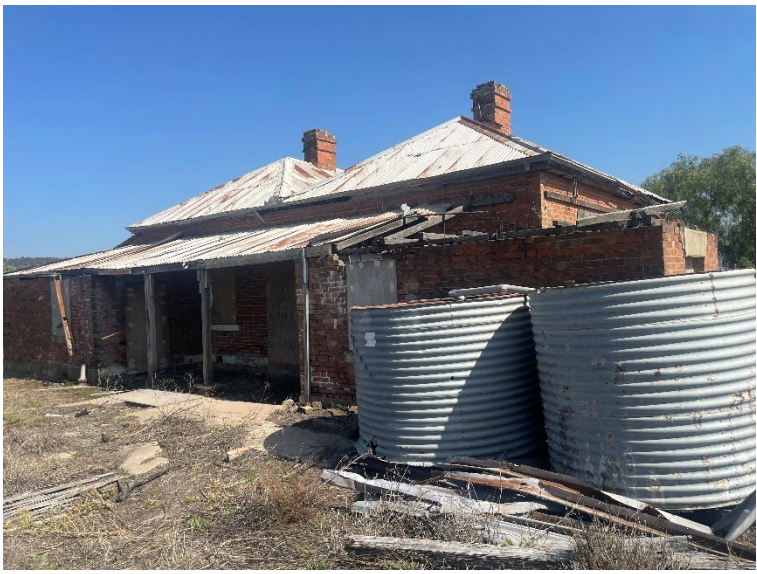
| 2015 | 2018 | 2020 (Mar) | 2020 (Dec) |
|---|---|---|---|
| | | | <p><b>2015-8:</b> debris has been cleared and stacked.</p> <p><b>2018-20 (Mar):</b> vegetation has regrown around building and stacked debris.</p> <p><b>Mar 2020-Dec 2020:</b> vegetation cleared and debris restacked.</p> <p><b>Dec 2020 – 2021:</b> vegetation management required.</p> <p><b>2021-2022:</b> vegetation managed; collapsed roofing members tidied and stacked inside building; <b>broken fascia removed but not repaired.</b></p> <p><b>2022-2023:</b> no discernible change.</p> |

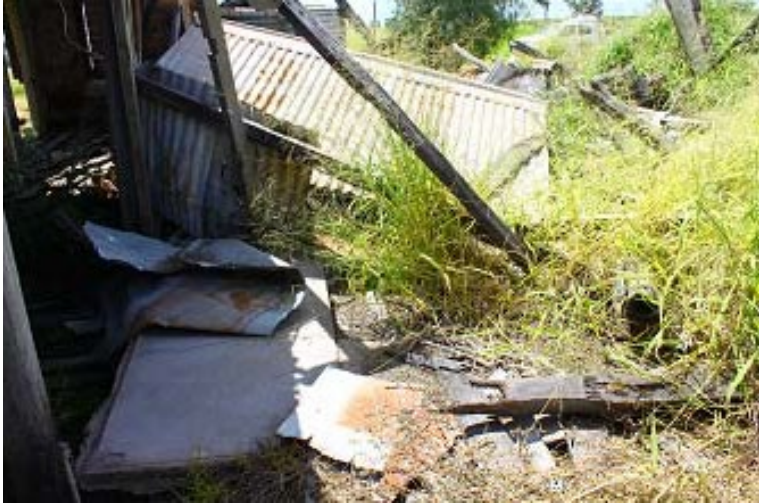
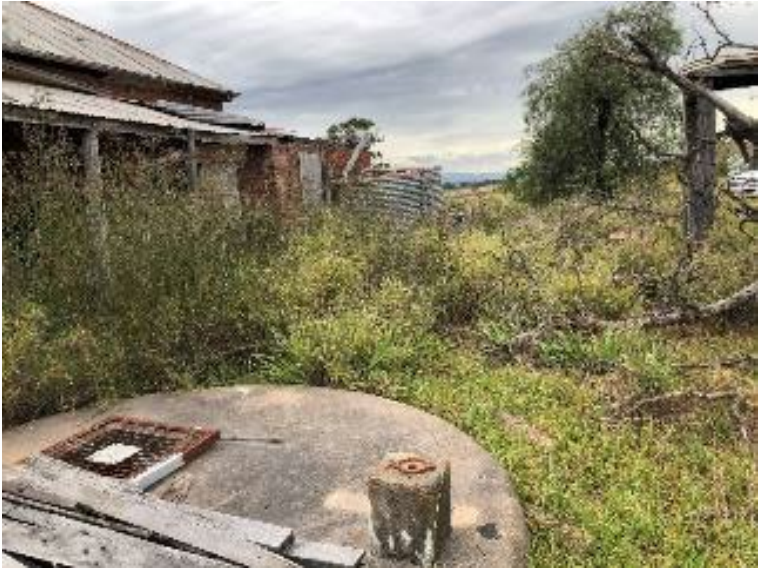
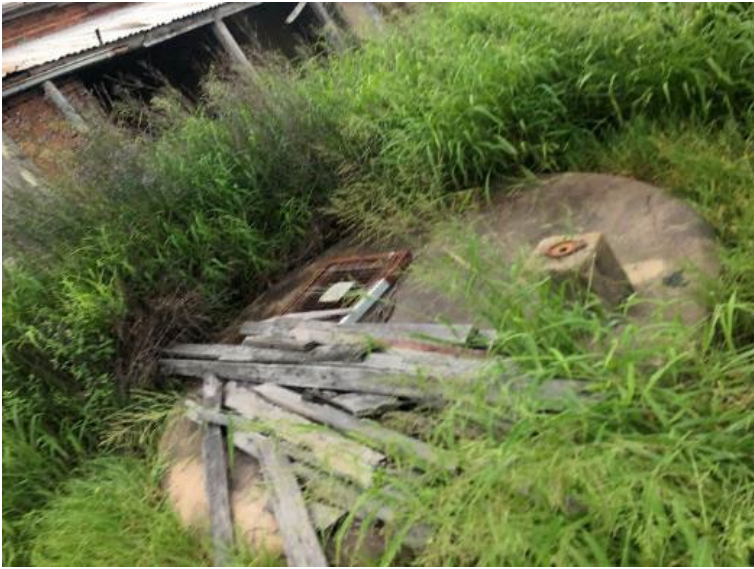
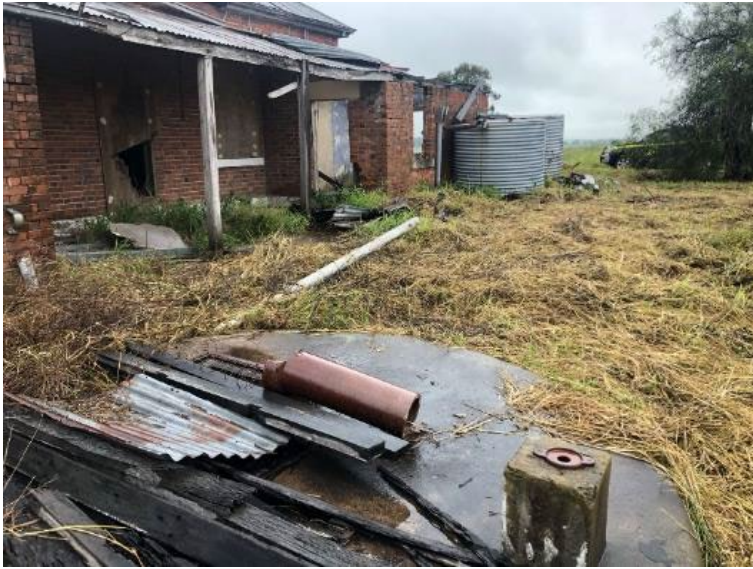
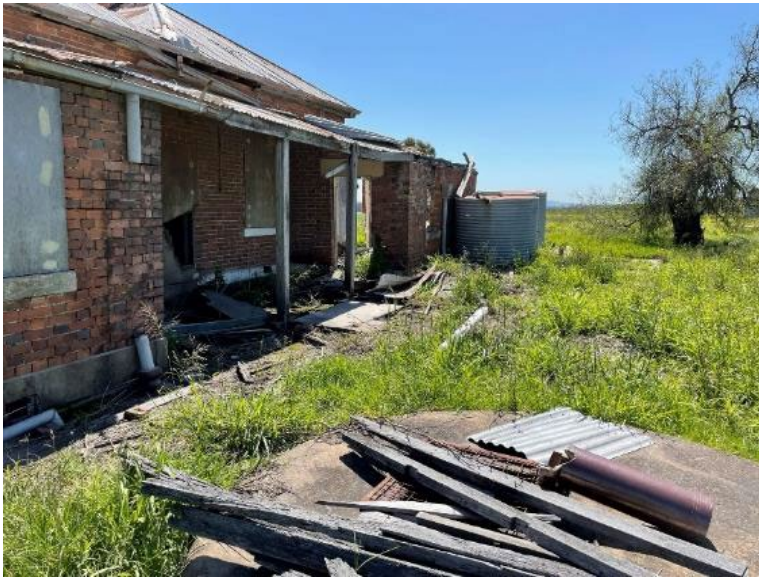
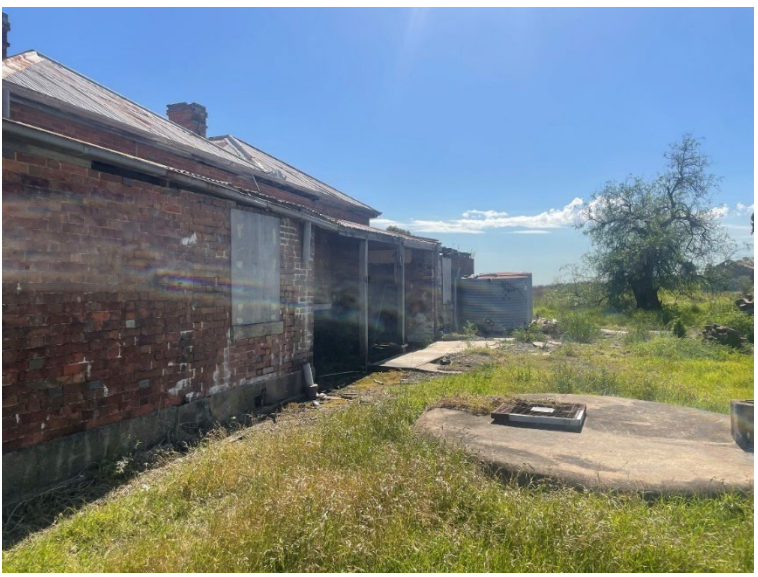
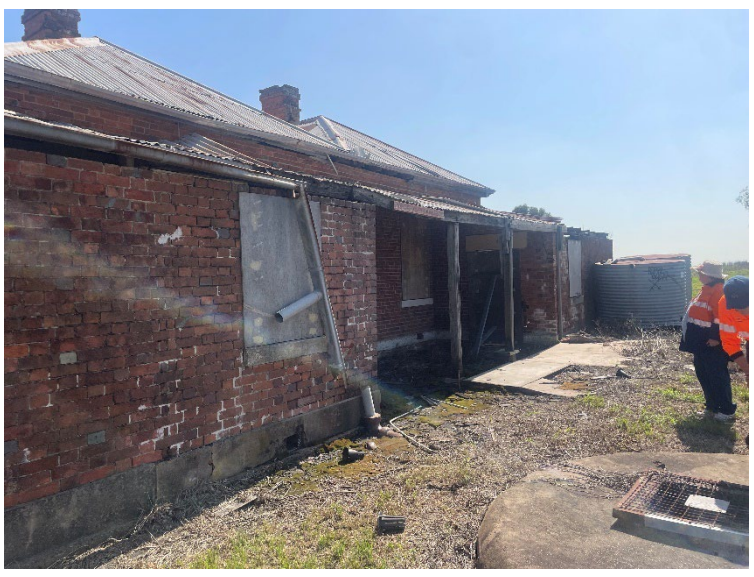
| 2015 | 2018 | 2020 (Mar) | 2020 (Dec) |
|---|---|---|---|
| | | | <p><b>2015-8:</b> debris has been cleared and stacked.</p> <p><b>2018-20 (Mar):</b> vegetation has regrown around building and stacked debris.</p> <p><b>Mar 2020-Dec 2020:</b> vegetation cleared and debris restacked.</p> <p><b>Dec 2020 – 2021:</b> vegetation regrown.</p> <p><b>2021-2022:</b> rear of building has been tidied and vegetation managed; building openings repanelled.</p> <p><b>2022-2023:</b> guttering has fallen with lifting of roof sheeting behind.</p> |

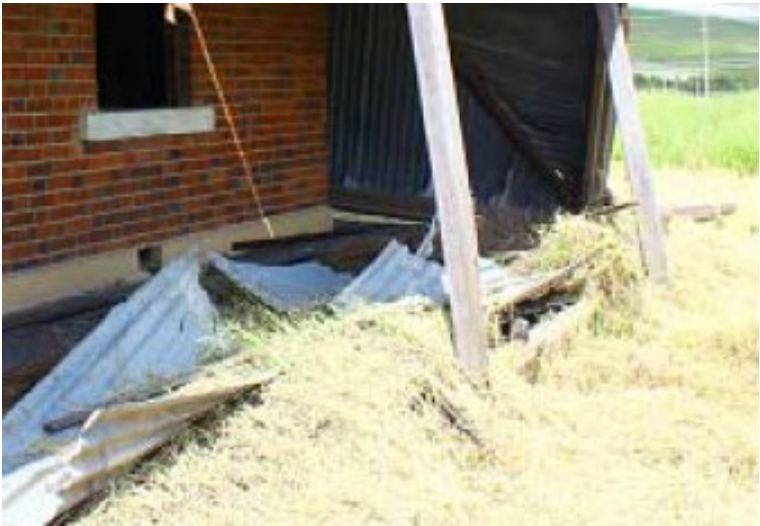
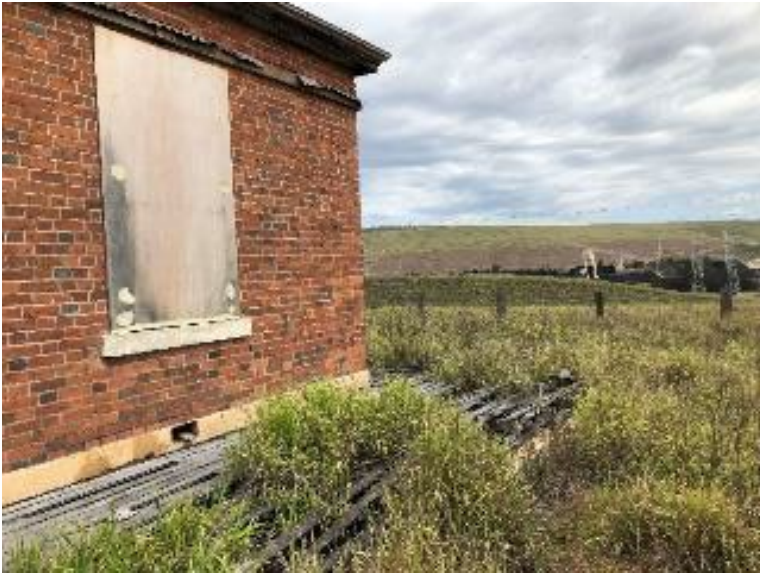
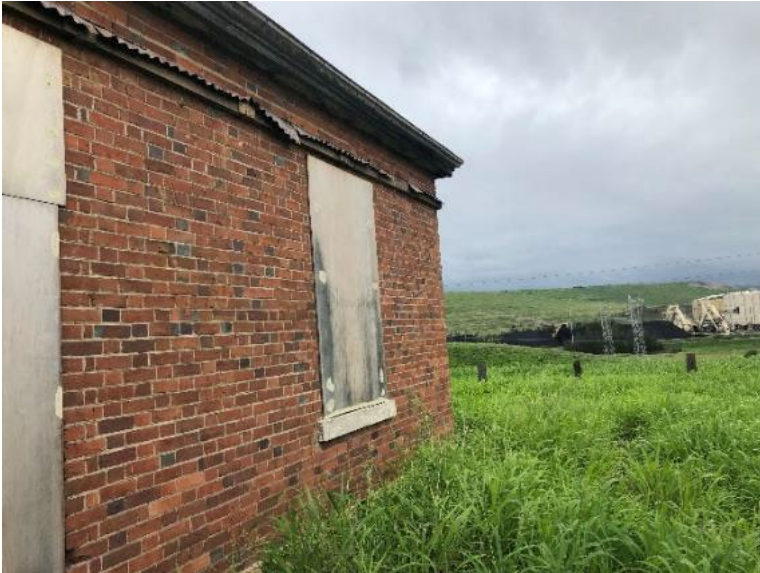
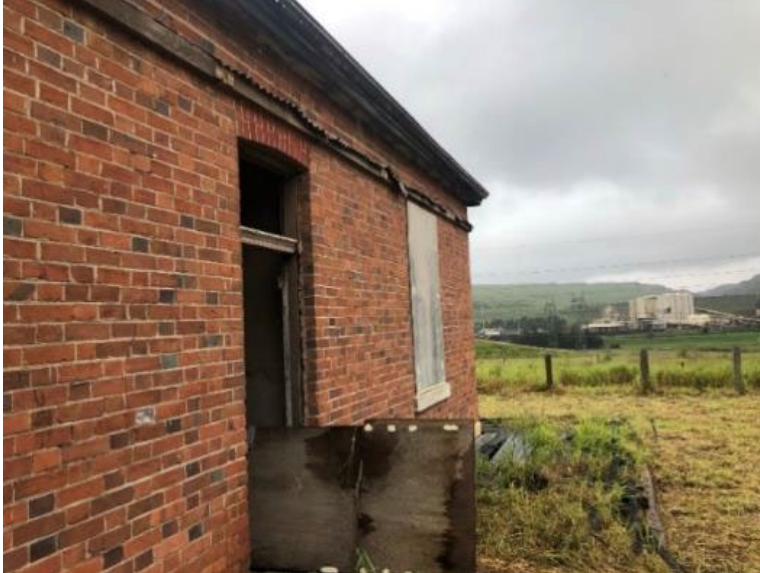
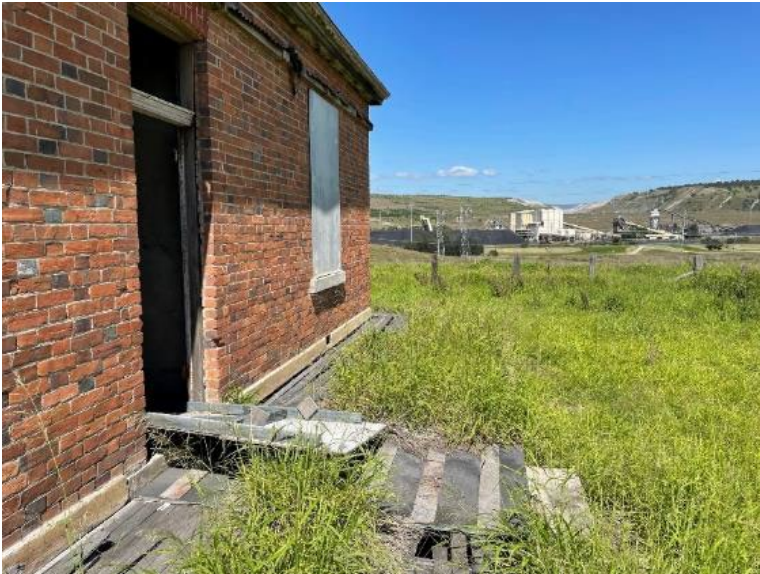
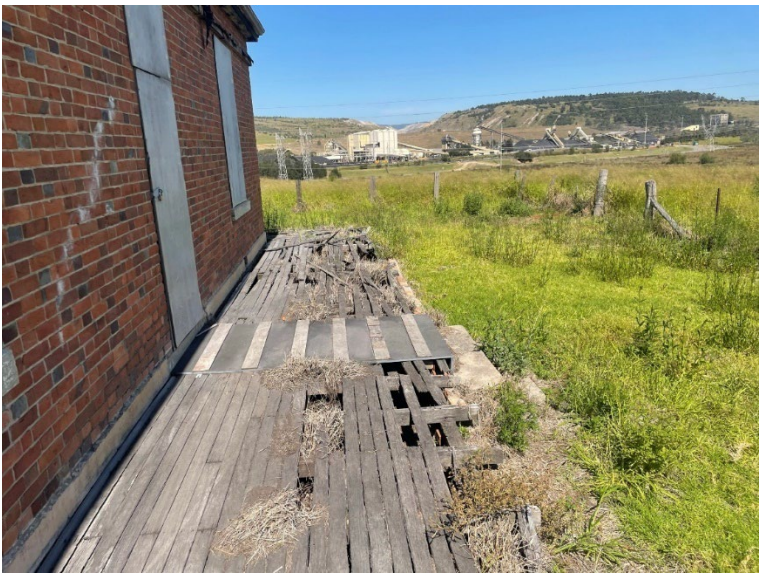
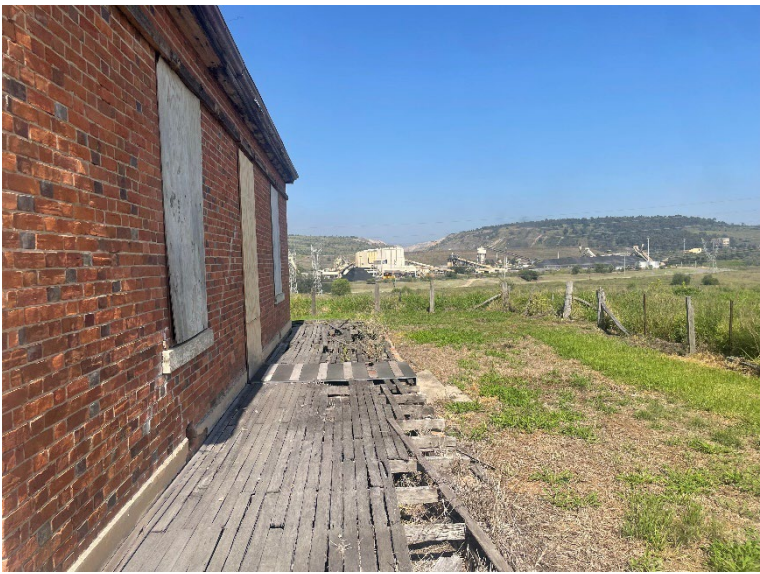
| 2015 | 2018 | 2020 (Mar) | 2020 (Dec) |
|---|---|---|---|
| | | | <p><b>2015-8:</b> posts and sheeting removed, <b>damaged boards remain exposed.</b></p> <p><b>2018-20 (Mar):</b> <b>damaged boards remain</b> and vegetation growth throughout.</p> <p><b>Mar 2020-Dec 2020:</b> <b>damaged boards remain</b> and vegetation growth throughout.</p> <p><b>Dec 2020 – 2021:</b> <b>veranda floor remains dilapidated</b> and grass growth throughout.</p> <p><b>2021-2022:</b> door panel fixed, vegetation managed but <b>veranda floor remains dilapidated.</b></p> <p><b>2022-2023:</b> no discernible change.</p> |

3. Reinstall veranda, including veranda decking and northern brick dwarf wall, re-using original material where possible, as per recommendations M5, M6 and L1 in the CMP conservation works schedule;

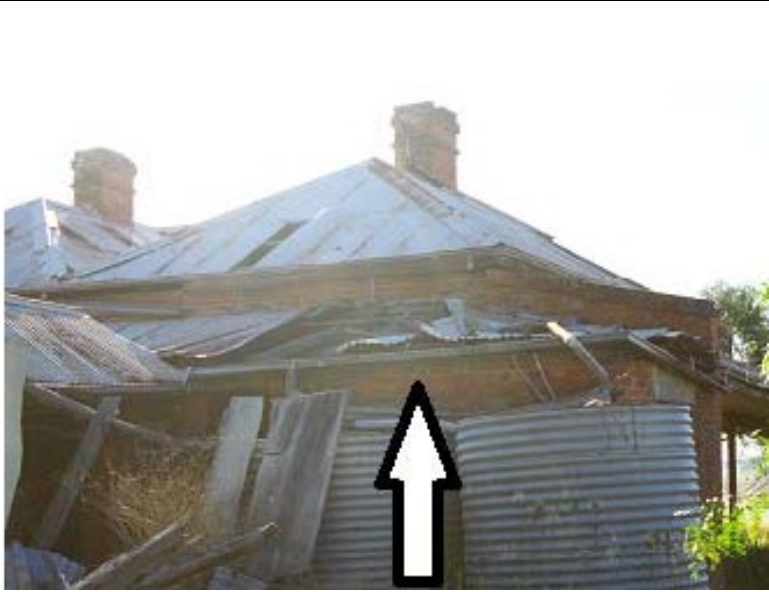
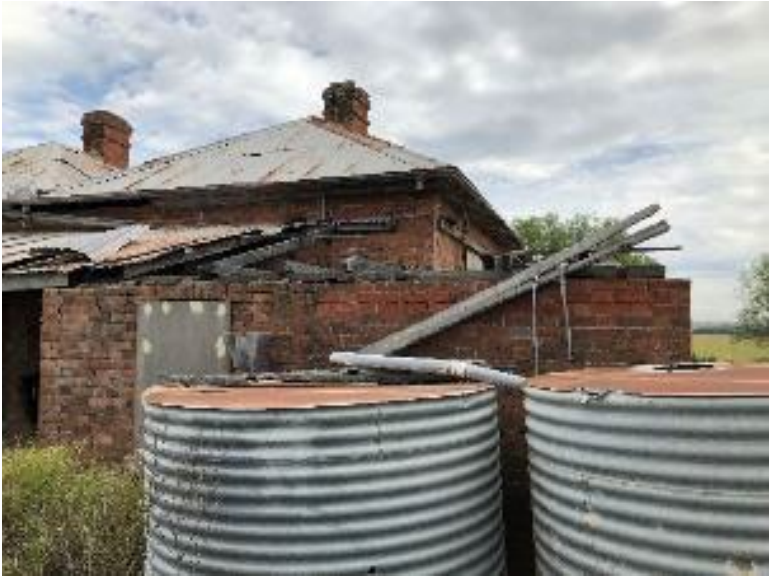
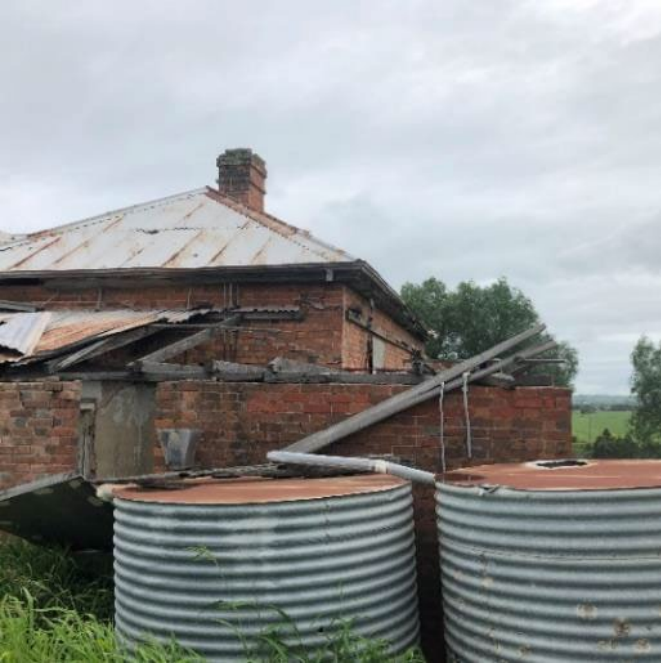
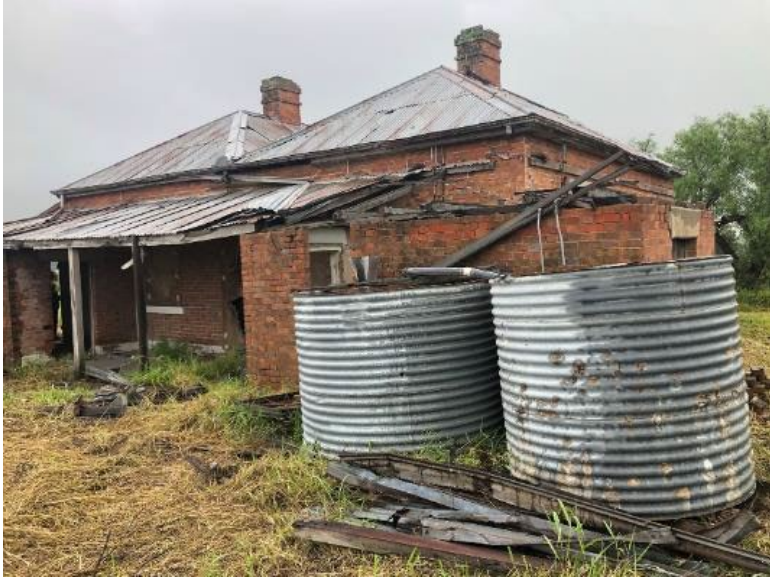
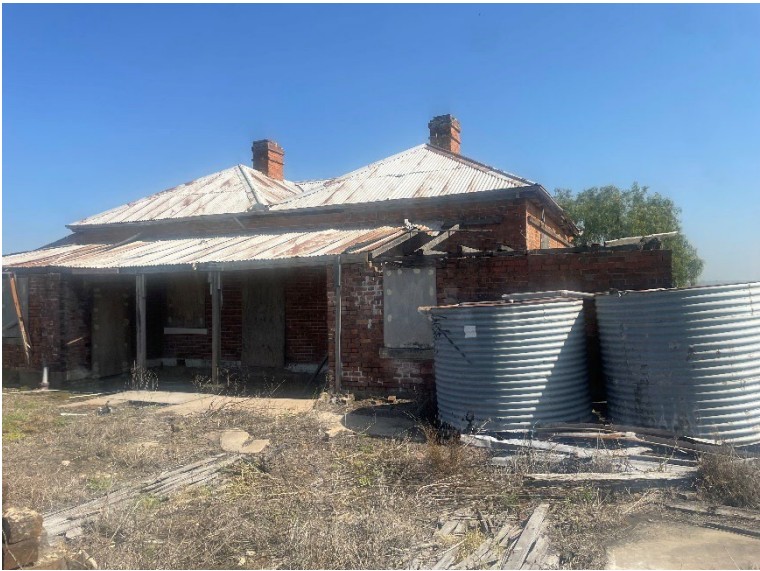
| 2015 | 2018 | 2020 (Mar) | 2020 (Dec) |
|---|---|---|---|
| | | | <p><b>2015-8:</b> skillion roof, guttering and rafters have collapsed; main roof holes repaired.</p> <p><b>2018-20 (Mar):</b> no discernible change.</p> <p><b>Mar 2020-Dec 2020:</b> some minor holes in roofing require repair.</p> <p><b>Dec 2020 – 2021:</b> minor roofing holes remain.</p> <p><b>2021-2022:</b> veranda uprights propped, loose members tidied; roofing appears patched.</p> <p><b>2022-2023:</b> shows fallen guttering with lifting of roof sheeting behind.</p> |
