# Mount Thorley Warkworth

## 2023 Annual Review

| <b>Name of Operations</b> | Mount Thorley Warkworth |

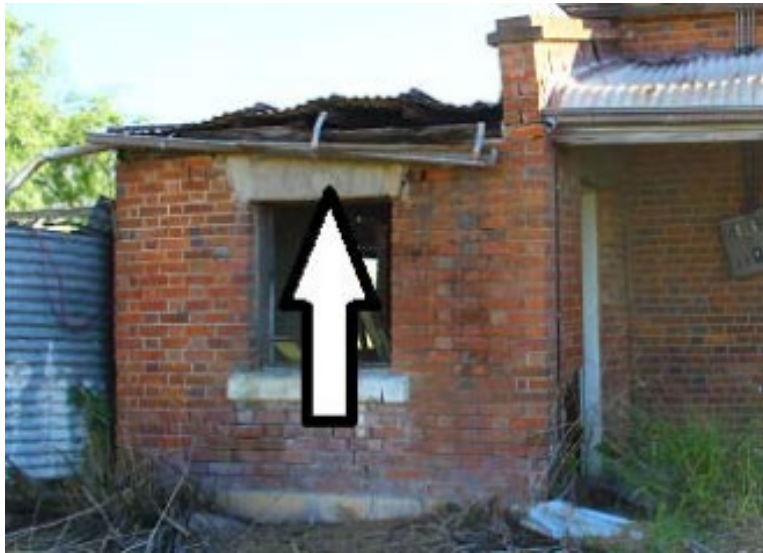
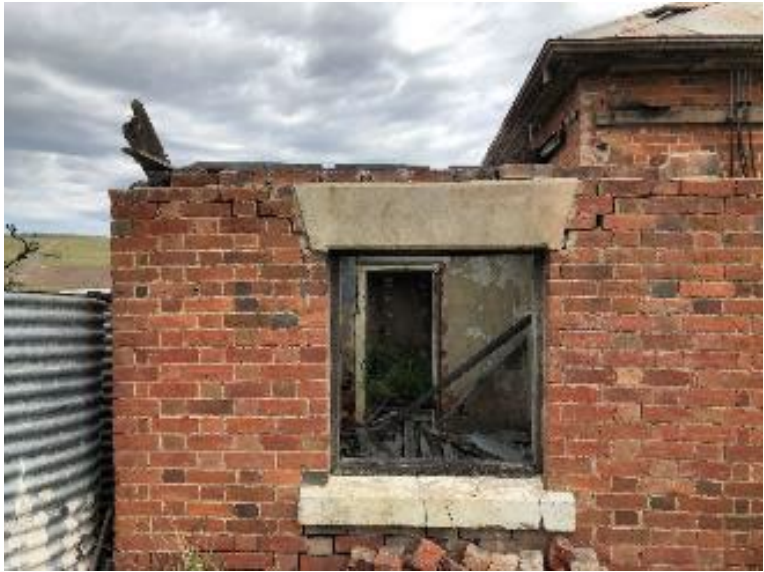
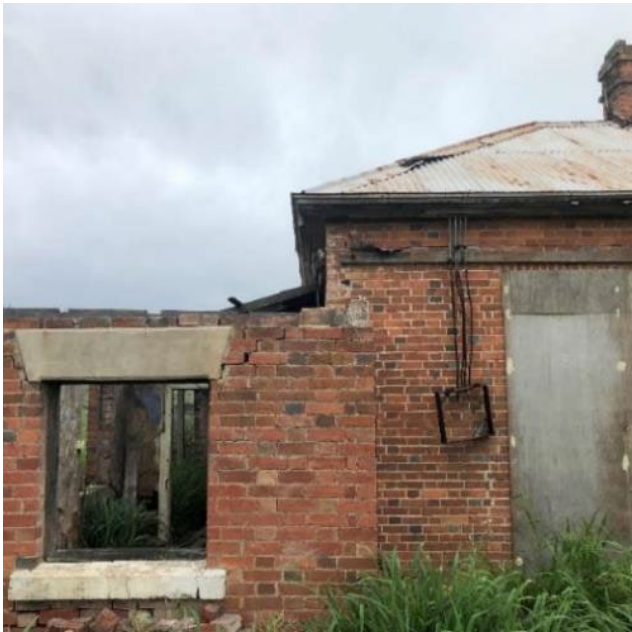
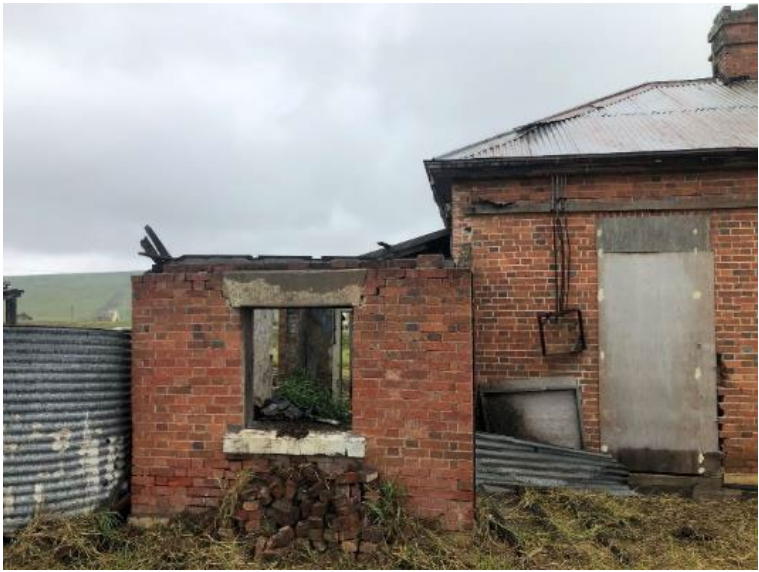
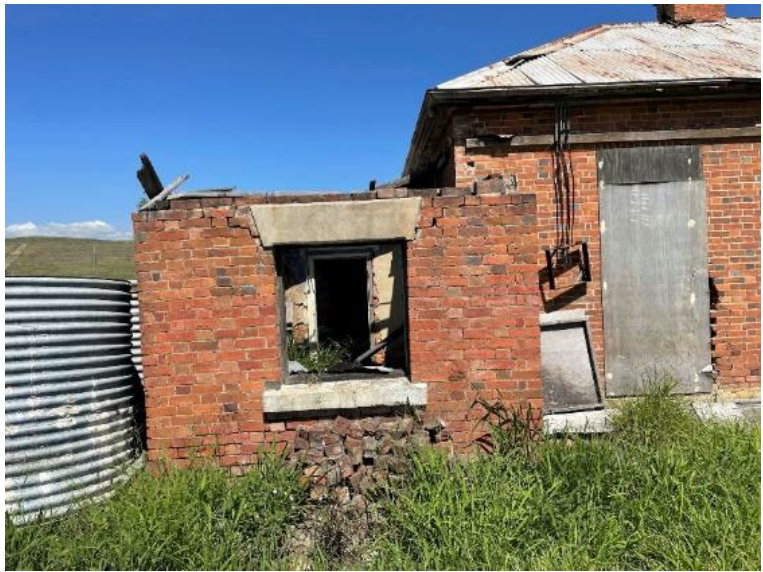
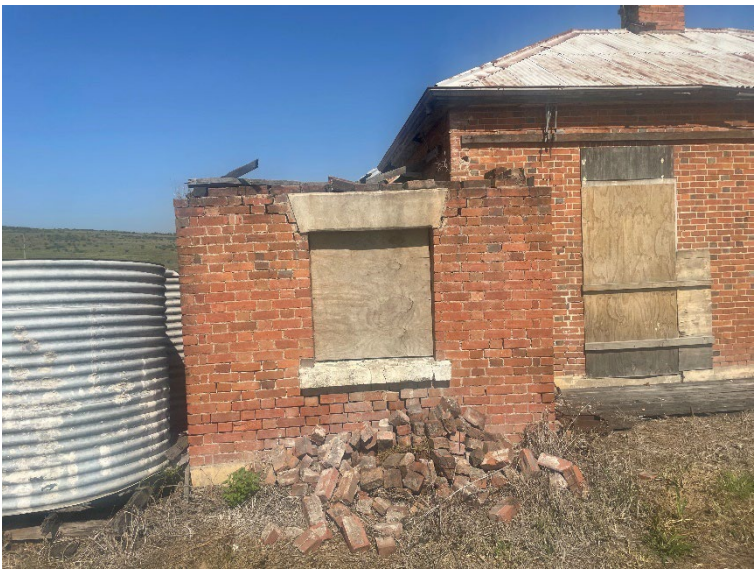
| 2015 | 2018 | 2020 (Mar) | 2020 (Dec) |
|---|---|---|---|
| | | | <p><b>2015-8:</b> wall element has collapsed (bricks stacked under window); roof framing, sheeting and guttering has collapsed.</p> <p><b>2018-20 (Mar):</b> no discernible change.</p> <p><b>Mar 2020-Dec 2020:</b> no discernible change.</p> <p><b>Dec 2020 – 2021:</b> rafter collapse from above window.</p> <p><b>2021-2022:</b> redundant electrical box fallen; increased vandal activity at doorway; roof capping repaired; redundant panel can be removed.</p> <p><b>2022-2023:</b> window opening cover replaced and door panel repaired.</p> |

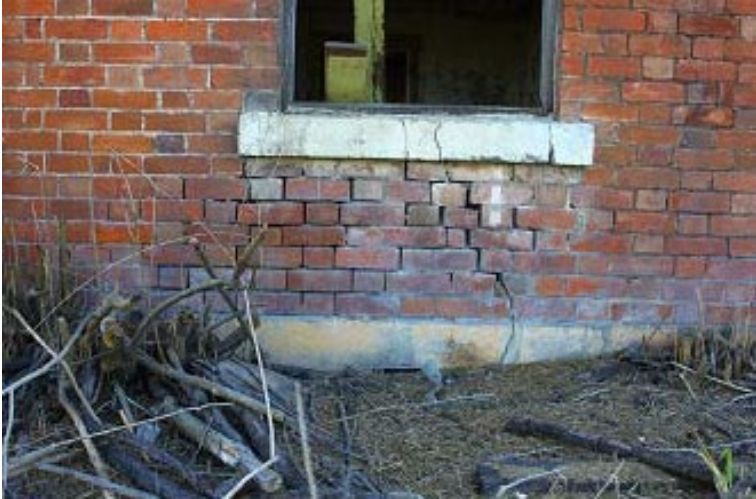
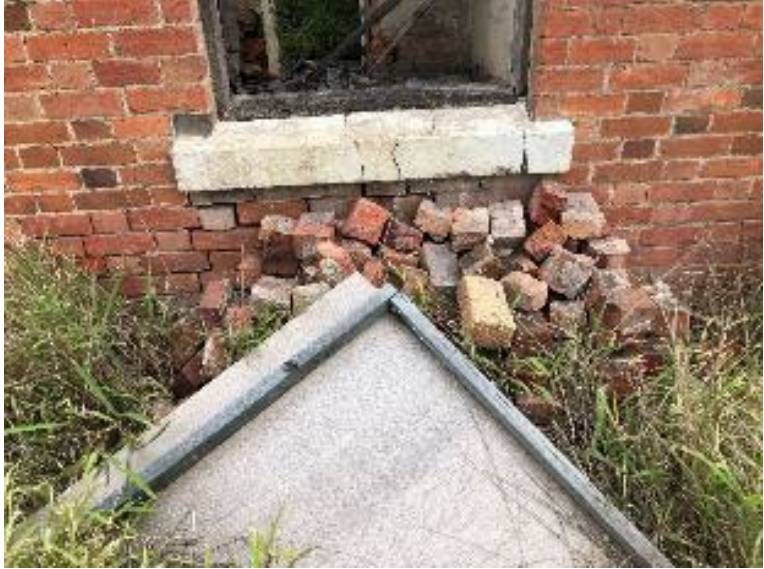
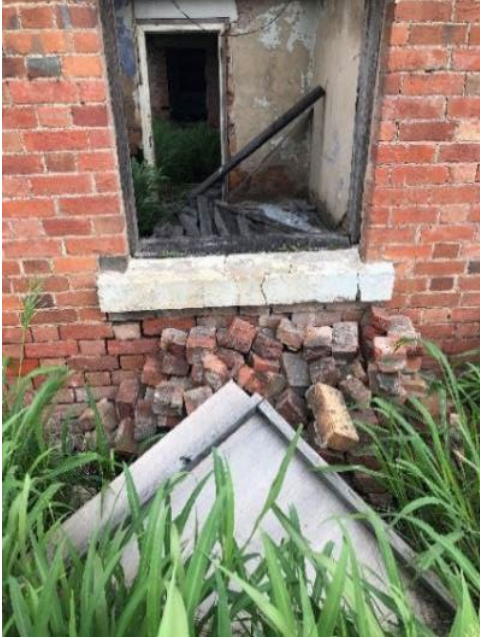
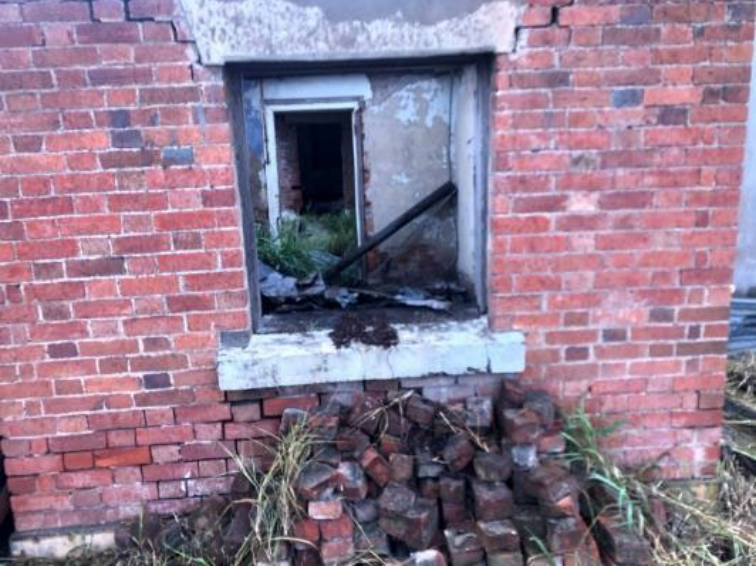
| 2015 | 2018 | 2020 (Mar) | 2020 (Dec) |
|---|---|---|---|
| | | | <p><b>2015-8:</b> bricks from roof above stacked in front of required repointing, window sheeting removed.</p> <p><b>2018-20 (Mar):</b> no discernible change.</p> <p><b>Mar 2020-Dec 2020:</b> repointing requirements remain.</p> <p><b>Dec 2020 – 2021:</b> repointing requirements remain.</p> <p><b>2021-2022:</b> collapsed roofing members stacked inside; far door panel reaffixed; redundant panel can be removed; repointing requirements remain.</p> <p><b>2022-2023:</b> window panel replaced, repointing requirements remain</p> |

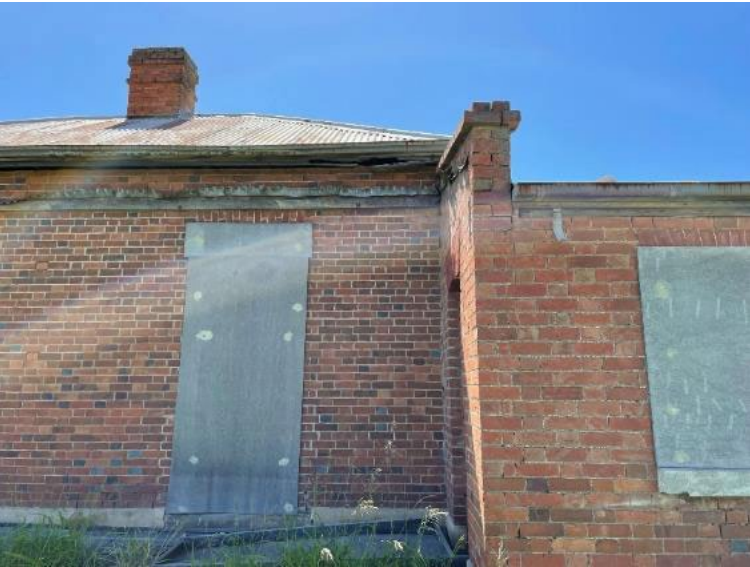
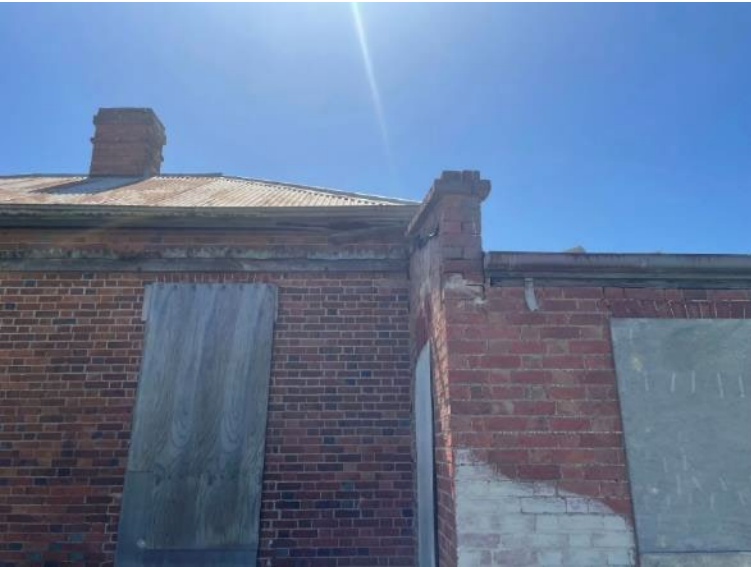
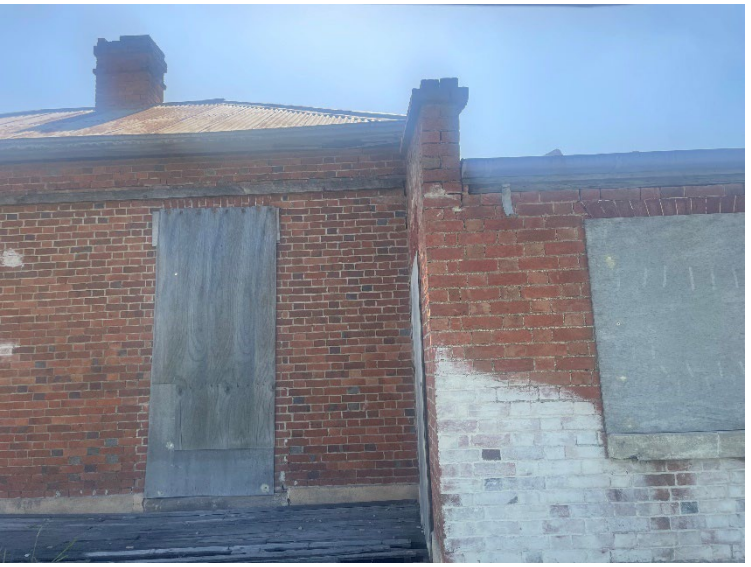
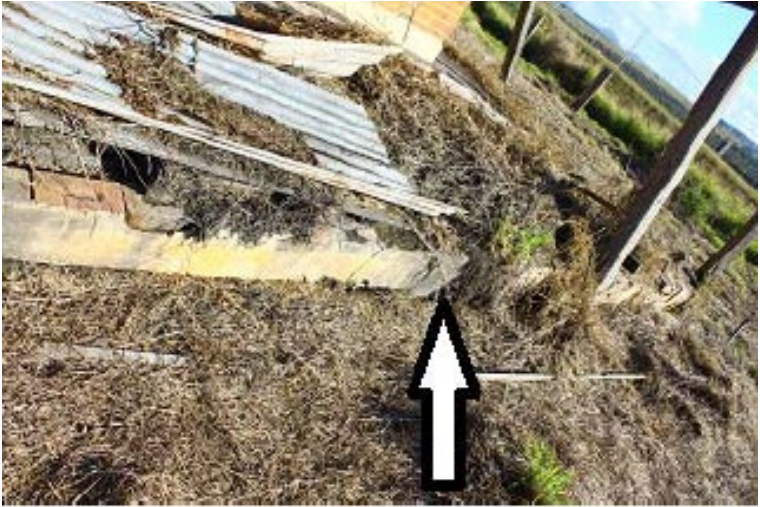
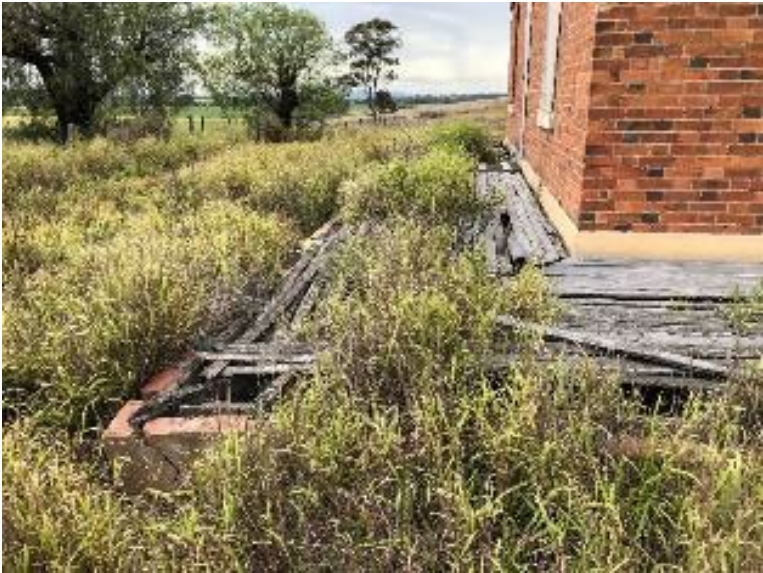
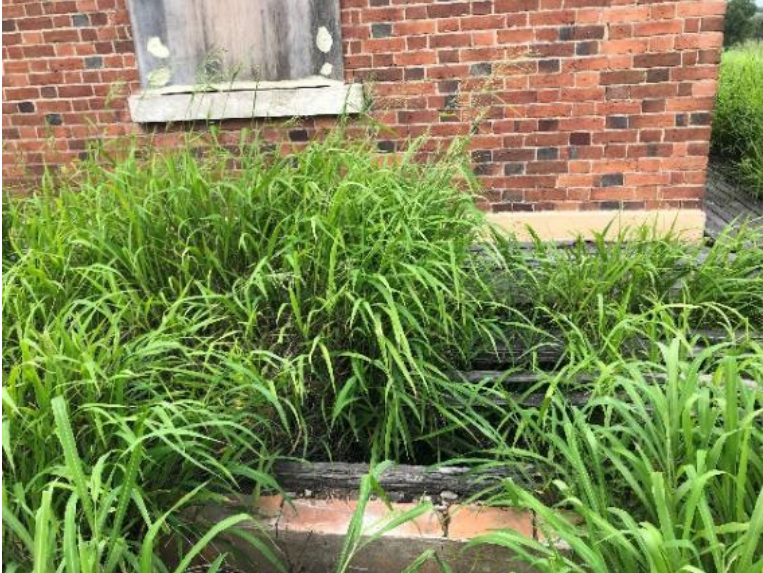
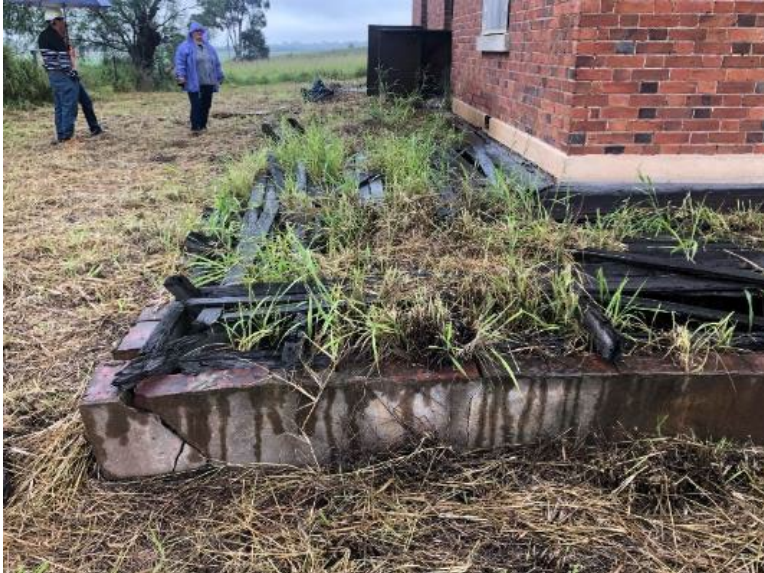
| 2015 | 2018 | 2020 (Mar) | 2020 (Dec) |
|---|---|---|---|
| | | | <p><b>2015-8:</b> <a href="#">repointing requirements remain.</a></p> <p><b>2018-20 (Mar):</b> <a href="#">repointing requirements remain.</a></p> <p><b>Mar 2020-Dec 2020:</b> <a href="#">repointing requirements remain.</a></p> <p><b>Dec 2020 – 2021:</b> <a href="#">repointing requirements remain.</a></p> <p><b>2021-2022:</b> <a href="#">repointing and fascia repair requirements remain; white paint or similar has been daubed on wall.</a></p> <p><b>2022-2023:</b> <a href="#">brick fallen from chimney, some bowing to top of wall at verandah’s end, repointing and fascia repair requirements remain.</a></p> |

A section of wall at the end of the verandah where it meets Room 5 on the house's south-east corner also requires attention (see picture below). The mortar between the brick work on this wall, particularly on the southern edge, has deteriorated, with fretting on some bricks also apparent. This has created some slight bowing/deformation to the top of the southern side of this wall, which poses a risk of collapse of this section. Repointing attention is required in this area, as it is in other sections of the building.

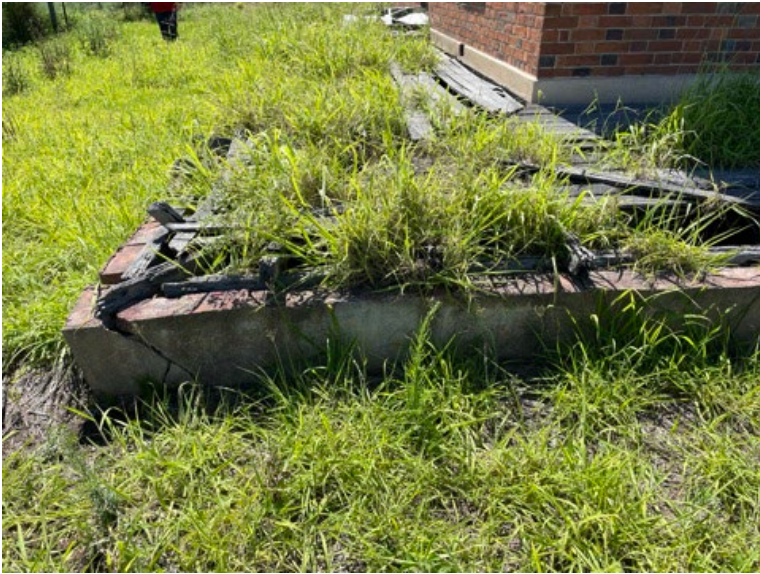
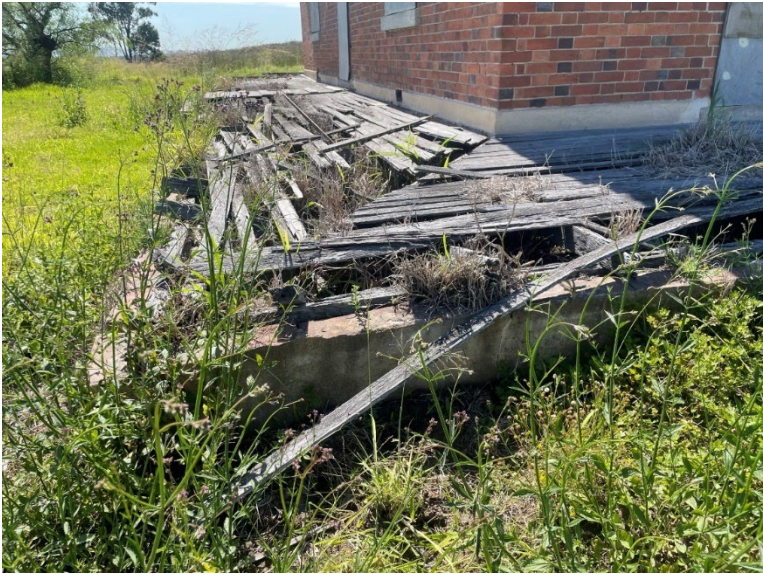
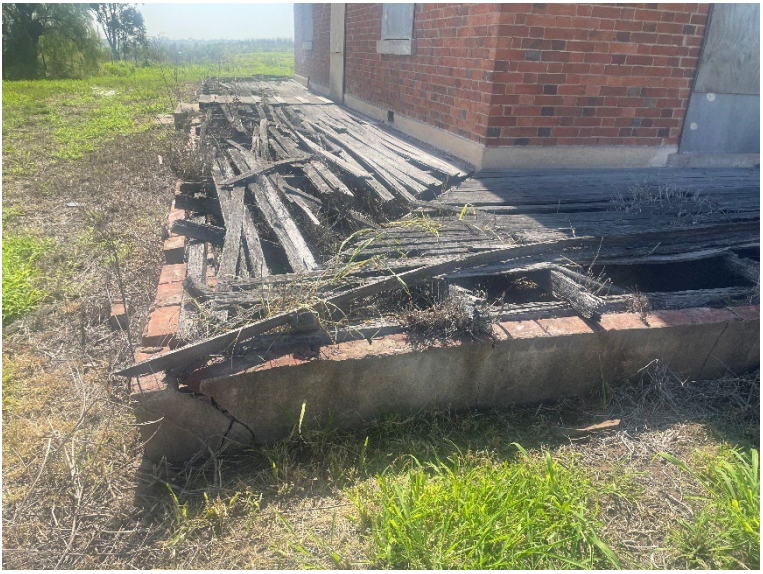
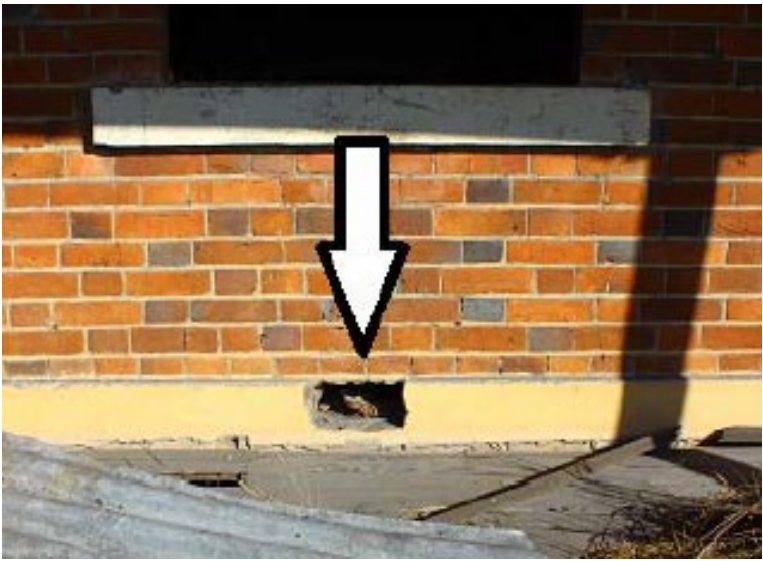
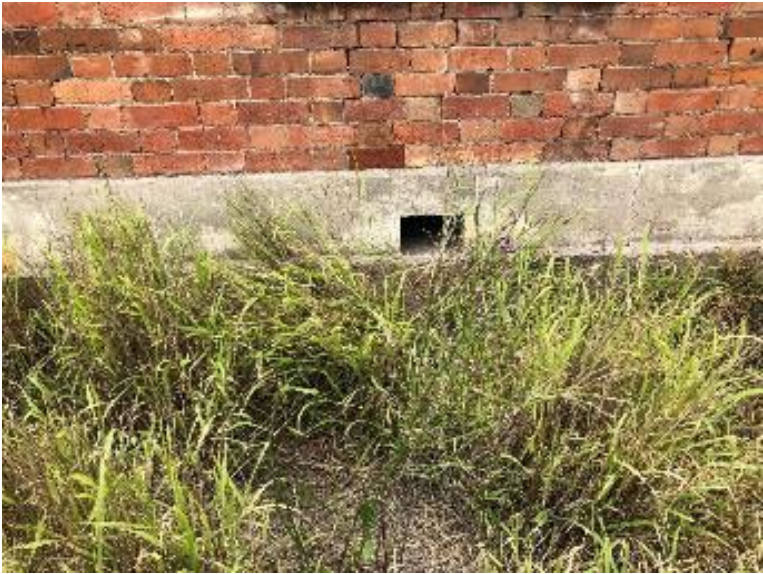
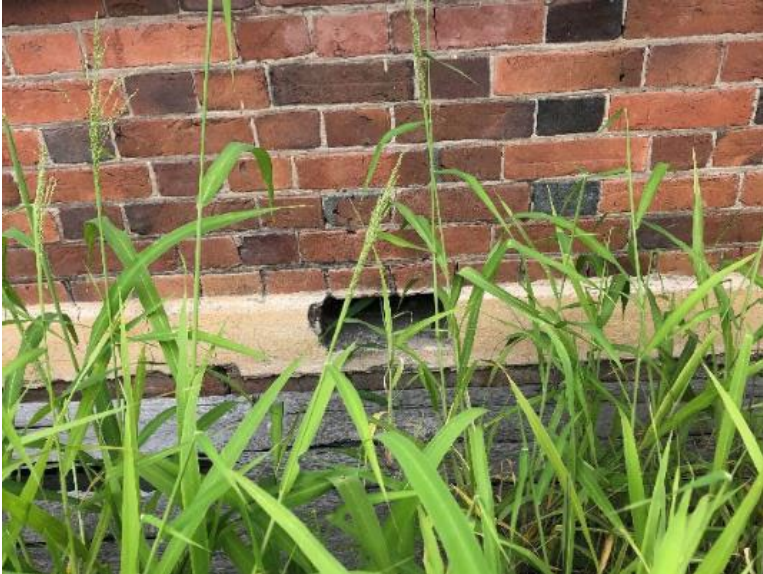
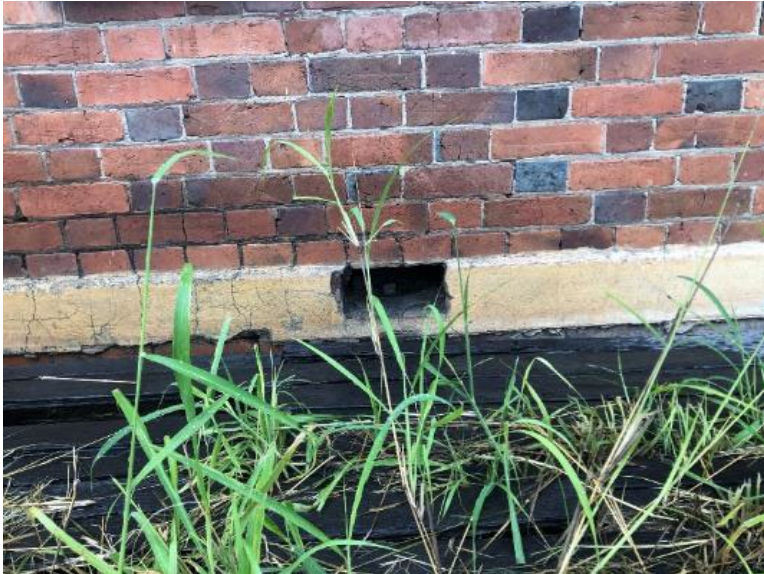
| 2015 | 2018 | 2020 (Mar) | 2020 (Dec) |
|---|---|---|---|
| | | | <p><b>2015-8:</b> debris cleared from veranda, no change to dwarf wall.</p> <p><b>2018-20 (Mar):</b> no discernible change.</p> <p><b>Mar 2020-Dec 2020:</b> <a href="#">cracking to wall evident</a>.</p> <p><b>Dec 2020 – 2021:</b> <a href="#">remains in disrepair</a>.</p> <p><b>2021-2022:</b> vegetation managed but <a href="#">remains in disrepair</a>.</p> <p><b>2022-2023:</b> vegetation managed but <a href="#">remains in disrepair</a>.</p> |

3. Reinstall veranda, including veranda decking and northern brick dwarf wall, re-using original material where possible, as per recommendations M5, M6 and L1 in the CMP conservation works schedule;

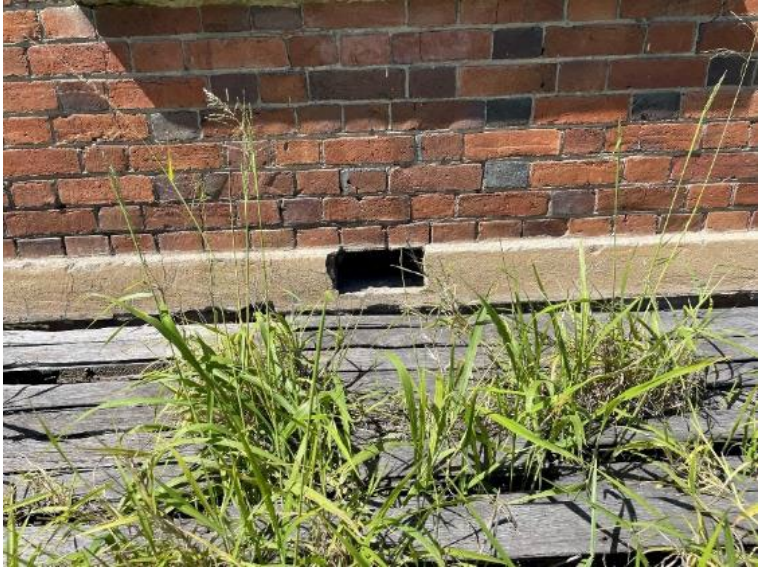
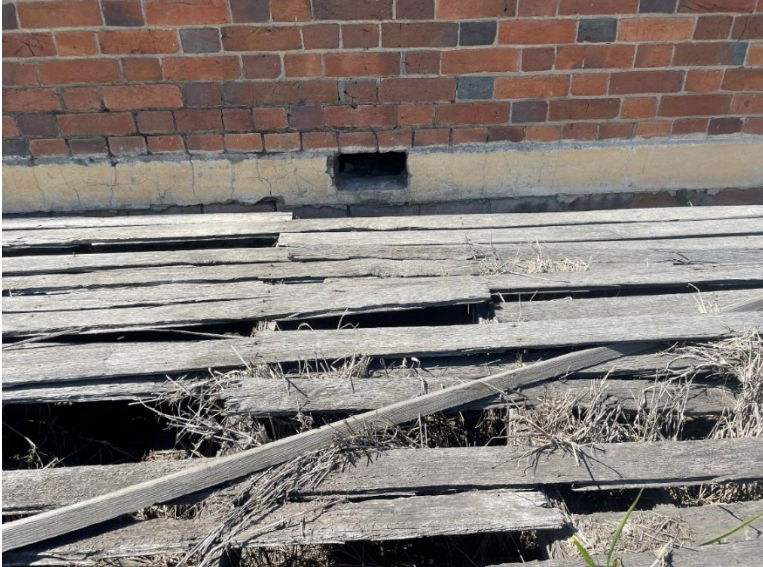
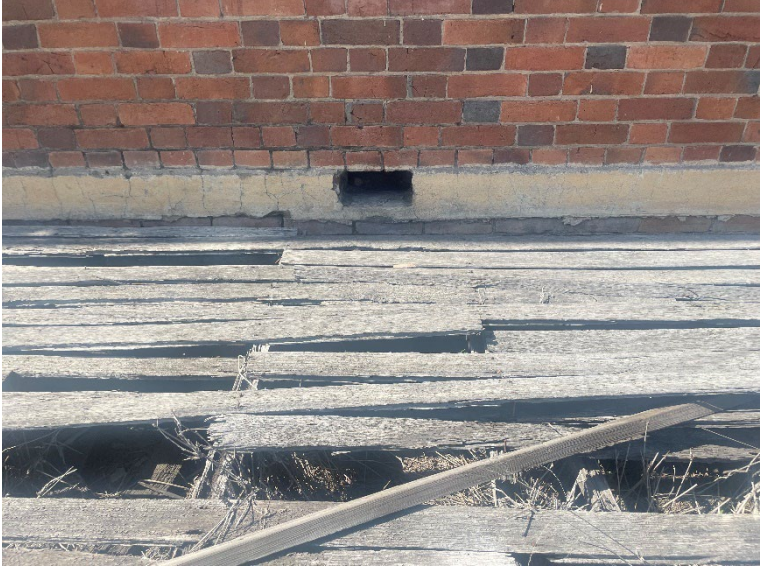
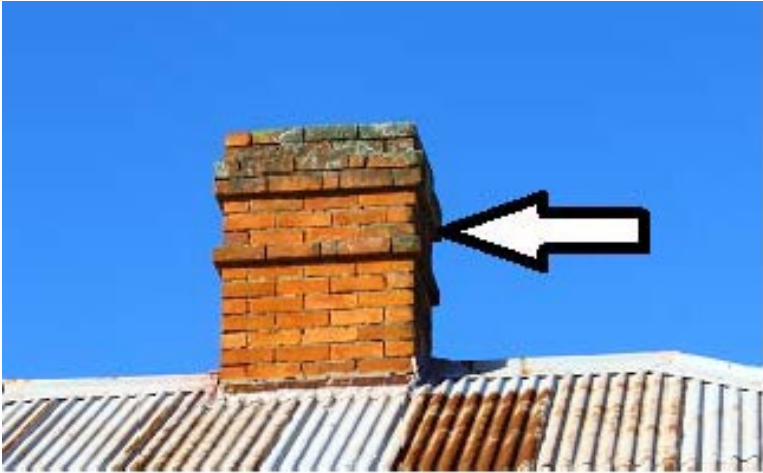
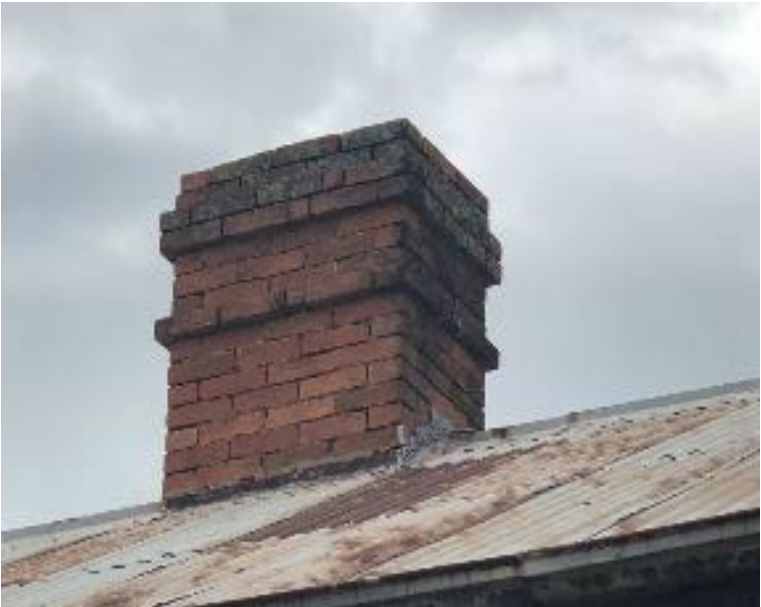
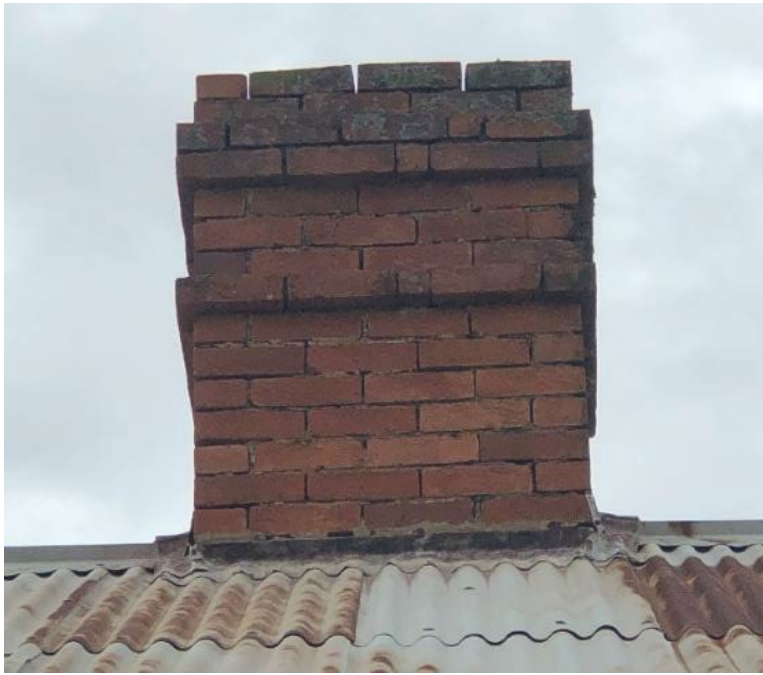
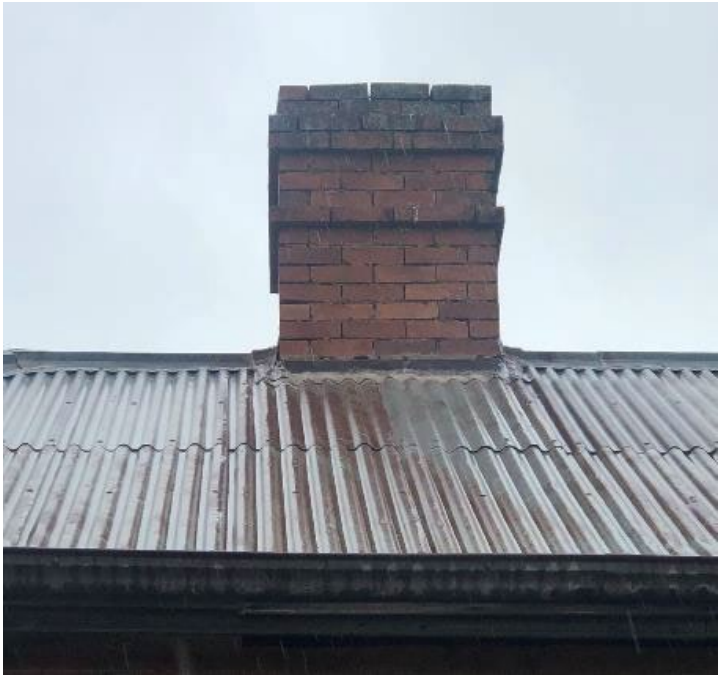
| 2015 | 2018 | 2020 (Mar) | 2020 (Dec) |
|---|---|---|---|
| | | | <p>2015-8: <a href="#">grilles not replaced.</a></p> <p>2018-20 (Mar): <a href="#">grilles remain missing.</a></p> <p>Mar 2020-Dec 2020: <a href="#">grilles remain missing.</a></p> <p>Dec 2020 – 2021: <a href="#">grilles remain missing.</a></p> <p>2021-2022: <a href="#">grilles remain missing.</a></p> <p>2022-2023: <a href="#">grilles remain missing.</a></p> |

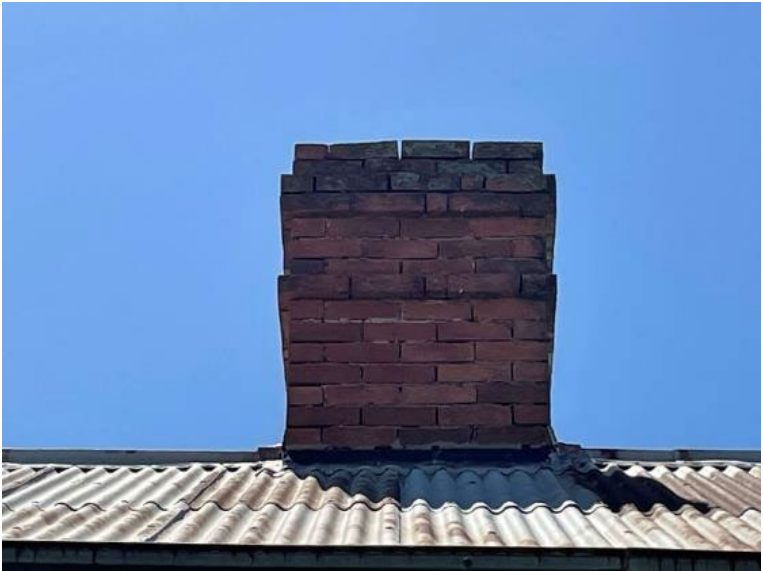
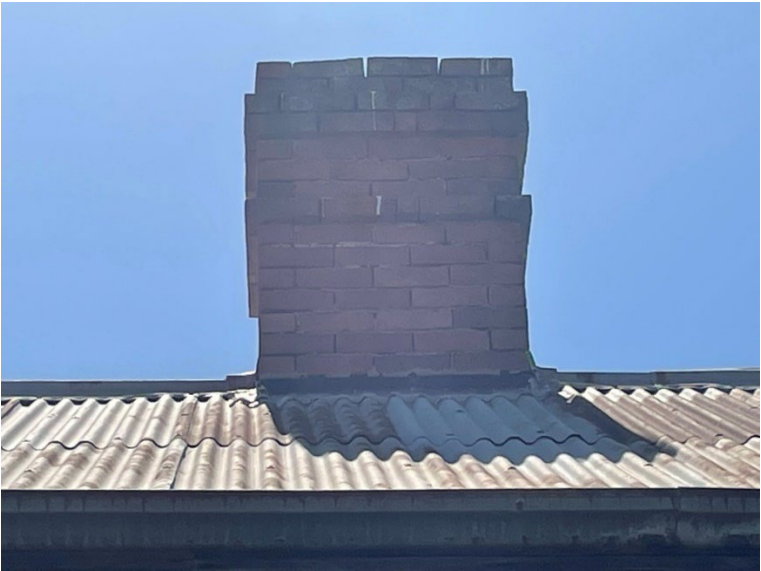
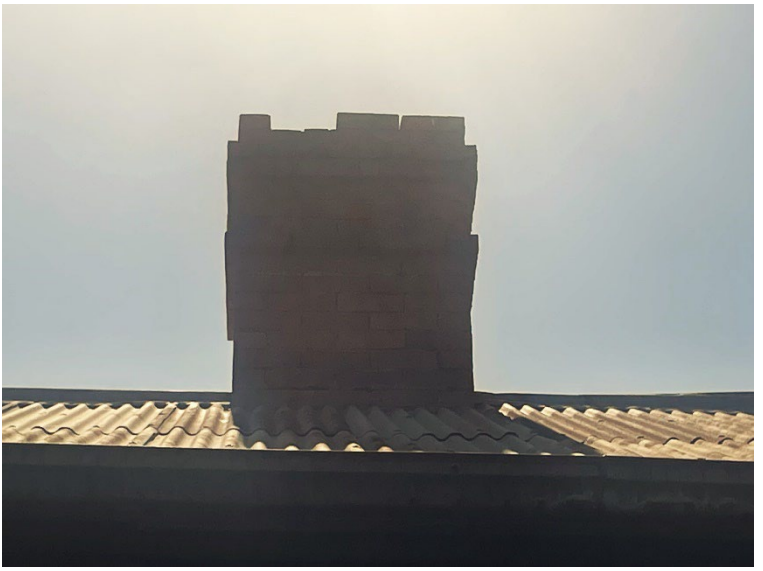
| 2015 | 2018 | 2020 (Mar) | 2020 (Dec) |
|---|---|---|---|
| | | | <p>2015-8: <a href="#">repointing requirements remain.</a></p> <p>2018-20 (Mar): <a href="#">repointing requirements remain.</a></p> <p>Mar 2020-Dec 2020: <a href="#">repointing requirements remain.</a></p> <p>Dec 2020 – 2021: <a href="#">repointing requirements remain.</a></p> <p>2021-2022: <a href="#">repointing requirements remain.</a></p> <p>2022-2023: <a href="#">brick missing</a> and <a href="#">repointing requirements remain.</a></p> |

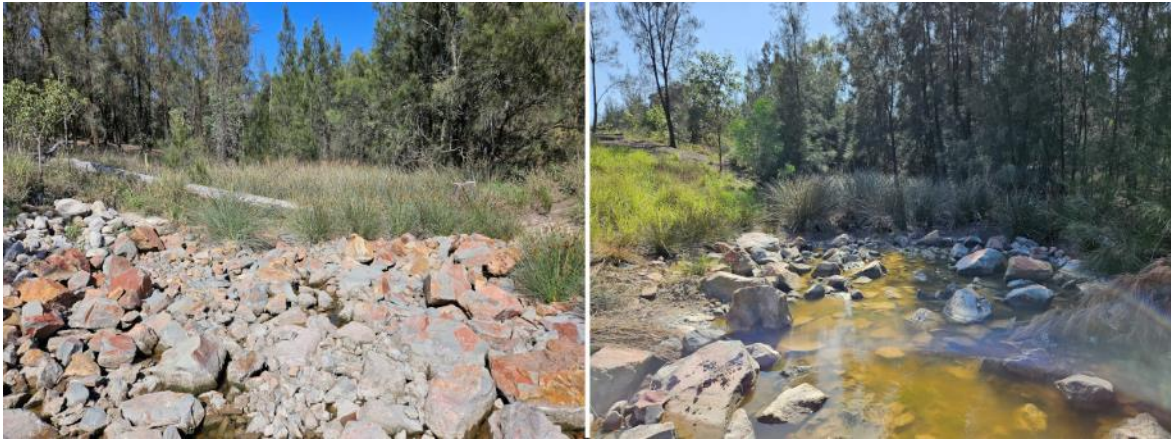
The creekline at MTW LDP accomodates a Mount Thorley Warkworth mine Licensed Discharge Point (LDP). The channel banks have been stabilised with logs and jute matting underlying a boulder and cobble embankment around the pipe outlet, and coir logs have been installed on the northern bank to contain potential sediment mobilisation from the LDP access track to the creekline (**Figures 3 and 4**).

**Figure 3:** Looking upstream (left) and downstream (right) at Loder Creek site MTW LDP.

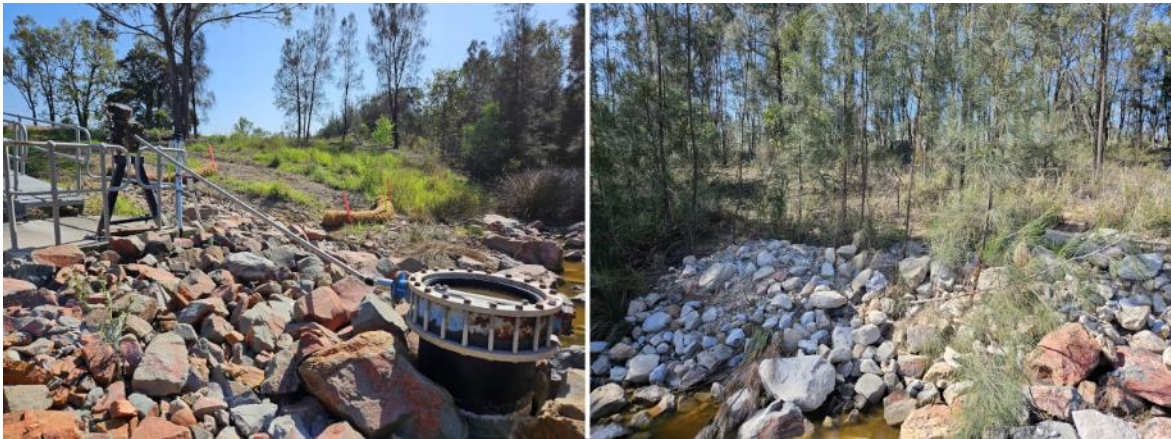
**Figure 4:** Site MTW LDP left bank (left) and right bank (right).

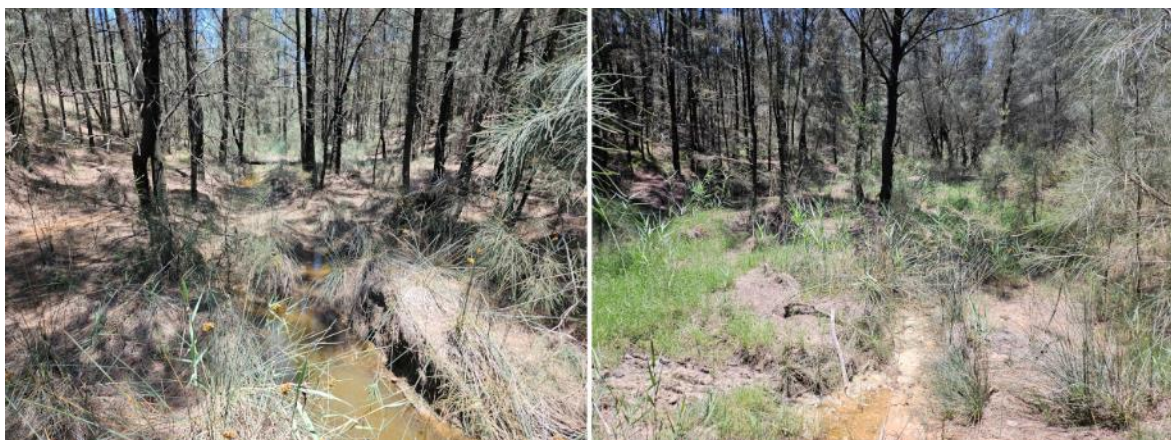
Site BM35 is located just downstream of the confluence of Loder Creek and Nine Mile Creek. The channel shape is V-shaped with shallow sloping banks, supporting a shallow (0.3m to 1m deep) and meandering box shaped stream flow channel in the middle (**Figure 5**). Surface water was present as isolated pools within the channel basin (no flow present).

**Figure 5:** Loder Creek site BM35 looking upstream (left) and downstream (right).

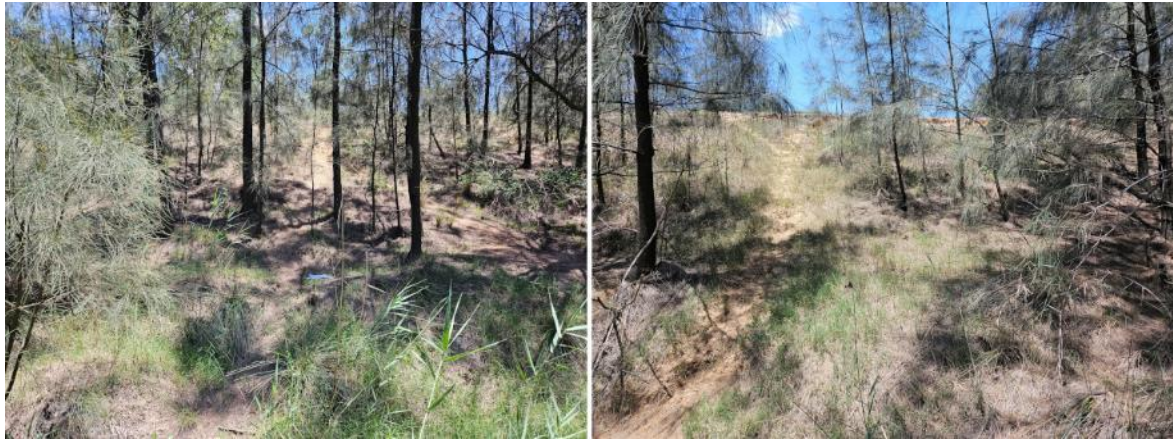
**Figure 6:** Site BM35 left bank (left) and right bank (right).

The animal track that crosses the site at BM35 (**Figure 6**) remains exposed and an active source of fine clayey silt to the creekline, as does the erosion scar along the upper right-hand bank (**Figure 7**). Couch grasses were noted to have colonised colluvial sediments at the base of the channel walls.

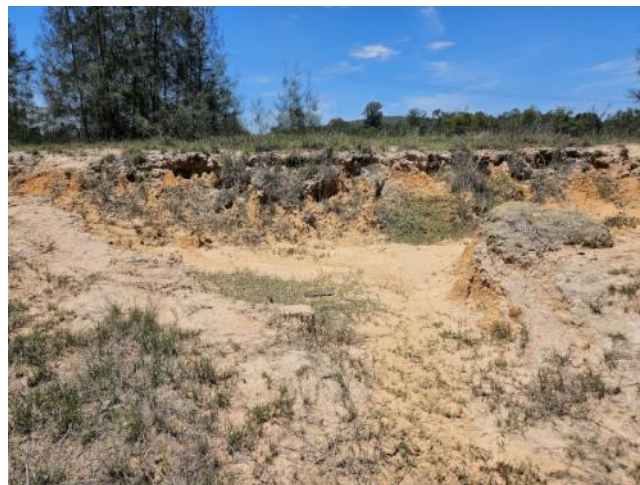
**Figure 7:** Erosion scar along the upper right-hand bank.

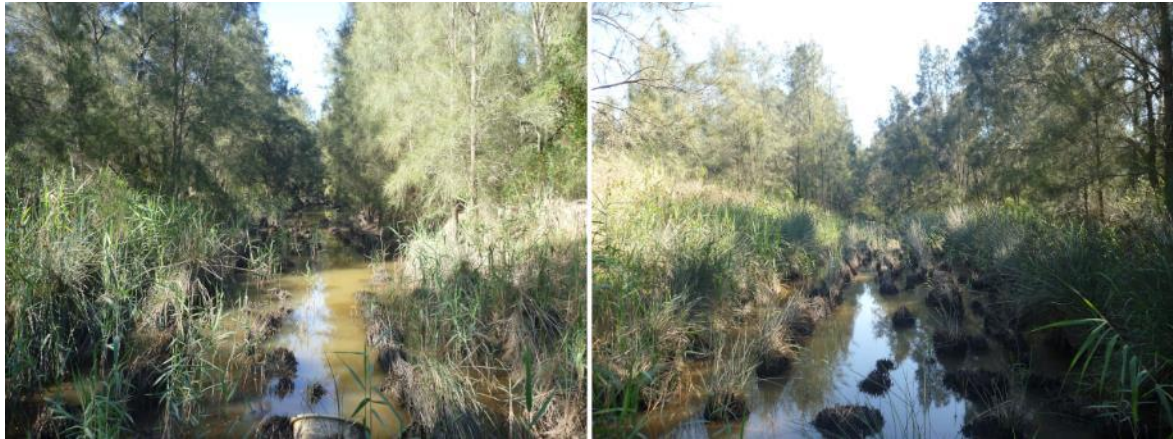
When compared to the previous survey in 2022, the instream and bank edge spiny rush and common reed stands at BM34 had proliferated in 2023 (**Figures 8 and 9**), however there was no change to the ‘Vegetation on drainage line floor’ category was already assigned to the highest category score. The channel pools supported other macrophytes (sago pondweed (*Stuckenia pectinata*), rushes *Juncus usitatus*), charophytes and regular occurrences of fat hen (*Chenopodium album*) along the waters edge.

**Figure 8:** Loder Creek site BM34 looking upstream (left) and downstream (right) in 2022.

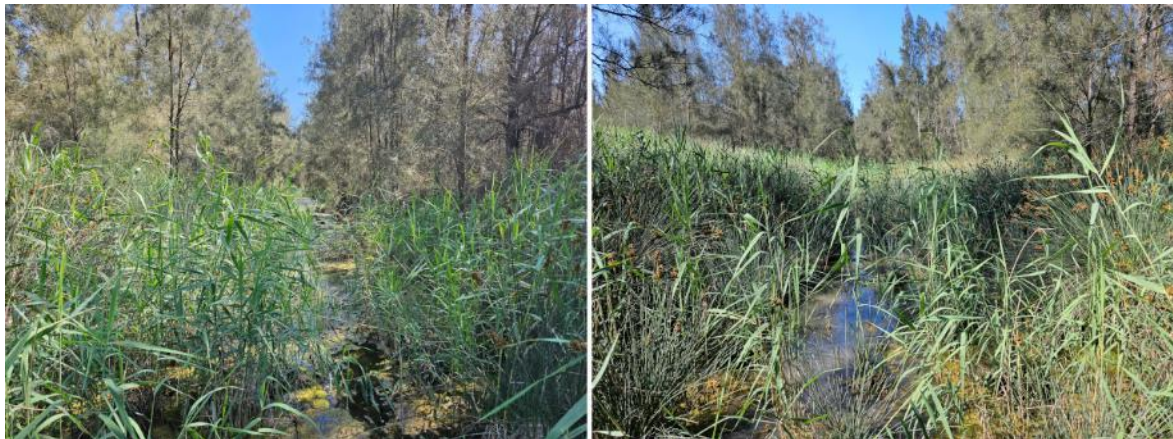
**Figure 9:** Looking upstream in site BM34 (left) and downstream (right) in 2023. Note the increase in macrophyte growth when compared to 2022 (**Figure 8**).

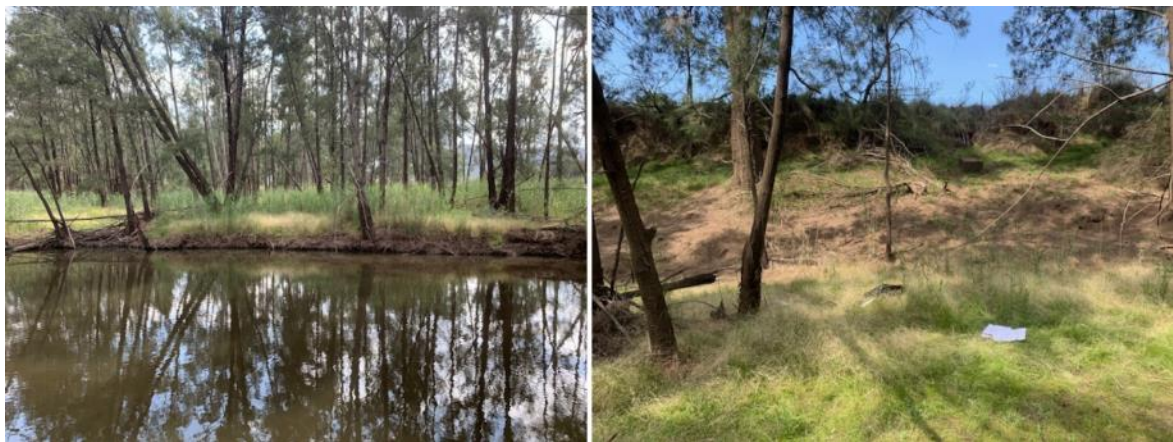
**Figure 12:** Site BM37 left bank (left) and right bank (right).

The upper channel bank walls and entry points for lateral runoff maintain some active erosional features (gully erosion, undercutting- see **Figure 12** right hand side), however many of the points are likely historical (from cattle access prior to fencing) or exacerbated from flood event scouring.

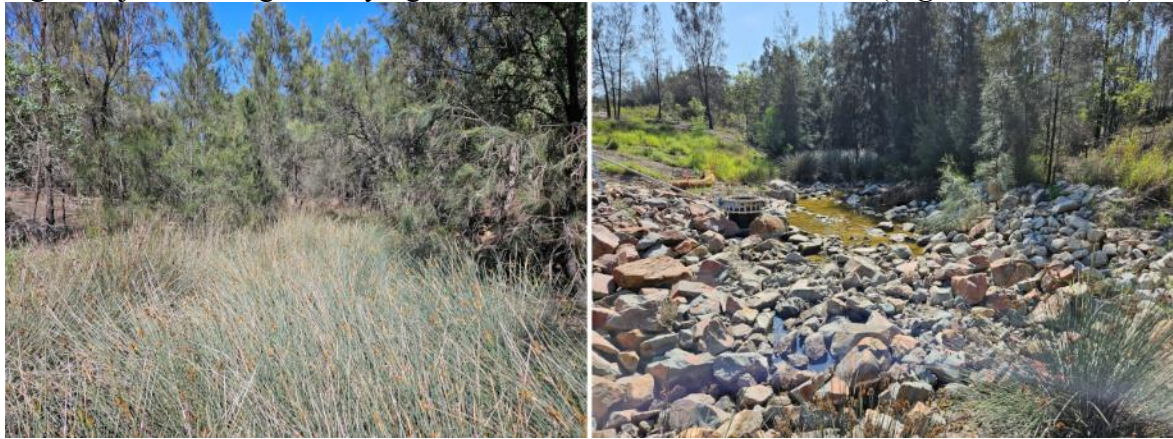
The creekline at LC1 accomodates a Mount Thorley Warkworth mine Licensed Discharge Point (LDP) immediately downstream and the channel banks have been stabilised with logs and jute matting underlying a boulder and cobble embankment (**Figures 13** and **14**).

**Figure 13:** Site LC1 looking upstream (left) and downstream (right).

There was no surface water observed in the channel upstream from the rock embankment, however there was ponded water around the LDP (see **Section 3.2.1** above). The channel upstream is densely occupied almost exclusively by spiny rush (**Figure 13**) bordered by a dense and continuous swamp-oak riparian corridor with scattered eucalypts. The site does contain some exposed soils along the drainage walls however for the most part, they are contained on low profile banks with grass coverage and coir logs had been installed on the

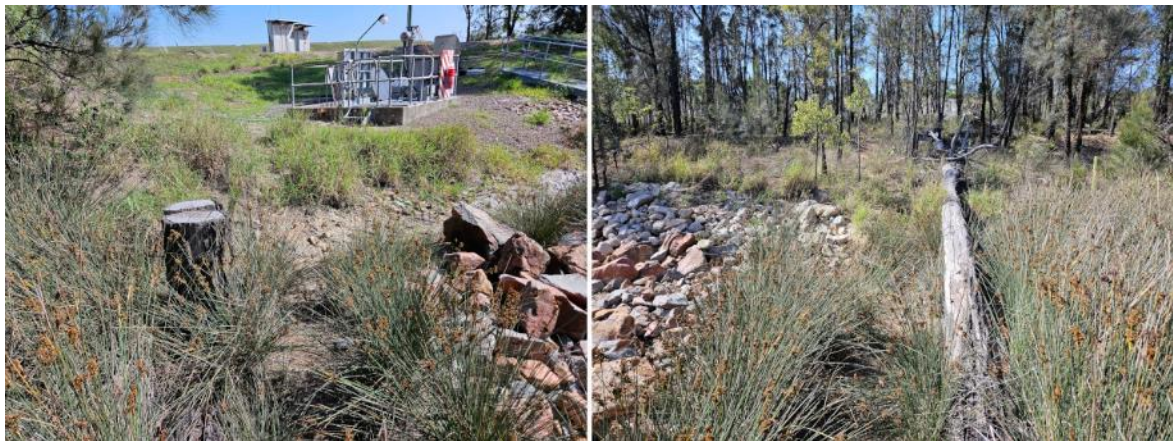
**Figure 14:** Site LC1 left bank (left) and right bank (right).

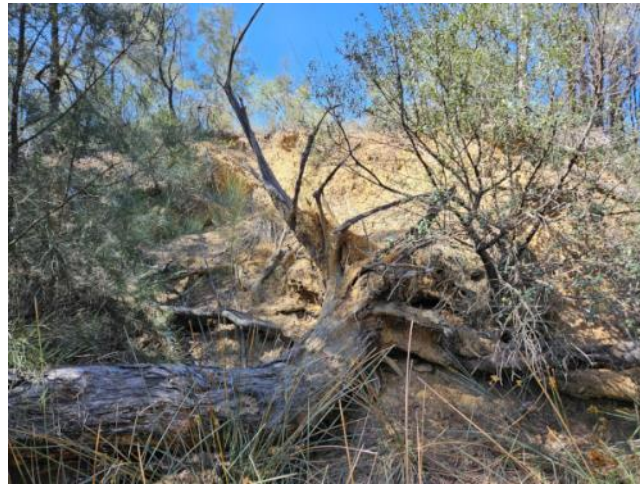
An erosion scar exists along the upper right-hand bank with a void created by a fallen tree stump (**Figure 17**). The scar remains exposed and active however there appears to be minimal contribution of channel wall sediments to the creek, and in 2023 there were new swamp-oak saplings that were noted to have colonised the void. Swamp-oak needles and other detrital reservoirs had accumulated along the drainage floor and walls which suggests that there had been no scouring flow events for some time.

**Figure 17:** Upper right-hand bank erosion exacerbated by a fallen tree.

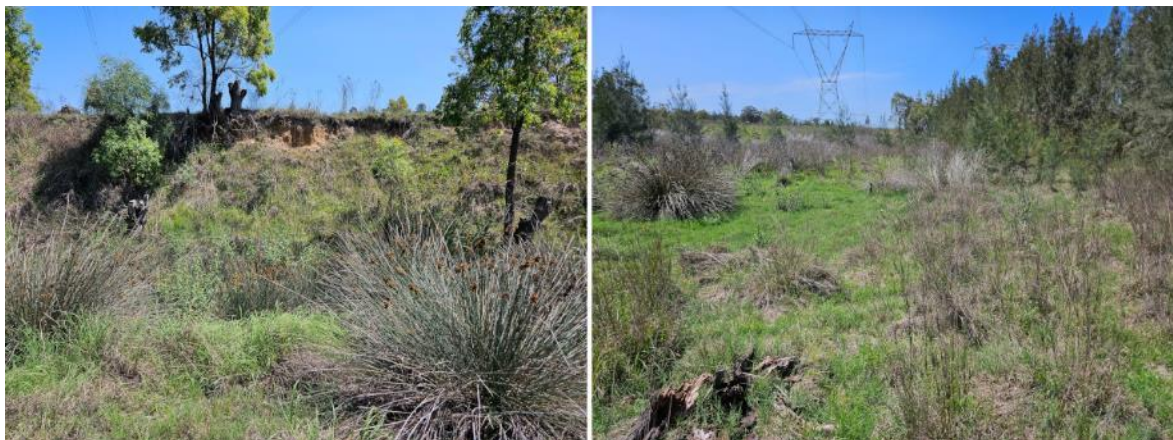
**Figure 21:** Site LC4 left bank (left) and right bank (right).

For the most part, a continuous assortment of groundcover species (grasses, shrubs and weeds) provide stabilisation for the channel floor and walls from stream flows or runoff. An exposed animal track traverses the channel from the left-hand bank which presents a localised source of erosion, which is bordered by an active erosion scar at the upper crest of the bank (**Figure 21** left-hand side).

The condition of both potential erosion sources appeared stable with groundcover having grown around their exposure perimeter, and throughout the broader channel area in general. The channel weeds (mainly spiny rush, fleabane and purple top), grasses (couch and slender bamboo grass) had showed signs of recent growth, likely in response to recent rainfall events, and there were new cumbungi plants shooting in the channel floor. The occurrences of thistle (*Cirsium vulgare*) had declined since the previous survey.
