# Mount Thorley Warkworth

## 2023 Annual Review

| <b>Name of Operations</b> | Mount Thorley Warkworth |

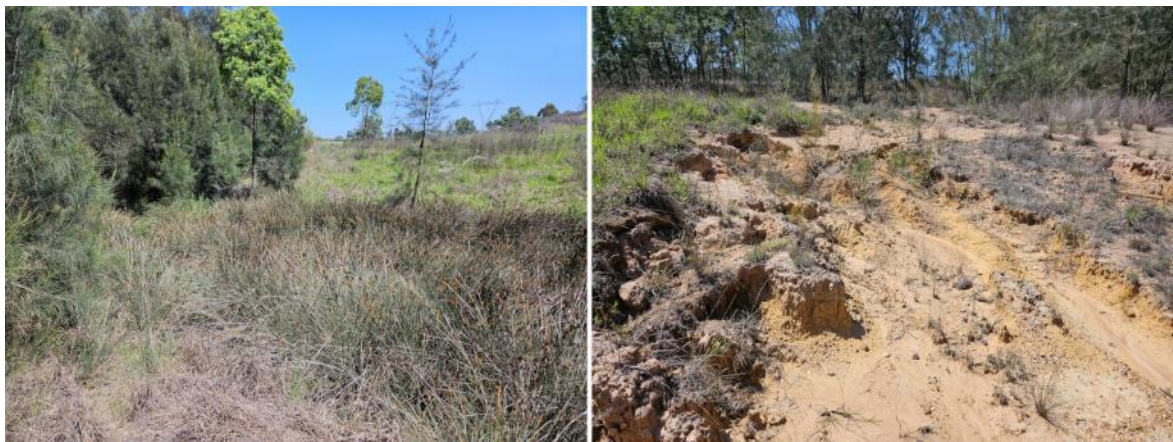
The upper right-hand bank contains an active erosion scar with rilling around its upper limits (**Figure 23**). While extent and condition of the exposure is consistent with the previous monitoring round, the accumulation of soft, fine sediments at the base of the slope and its colonisation by grasses and rushes does indicate that it's an active source of erosive material during wet weather events (**Figure 24**). There were some new swamp-oak saplings observed along the channel bank walls, and the instream and edge bank vegetation (grasses and rushes) had showed signs of minor growth since 2022.

**Figure 23:** Site LC5 left bank (left) and erosion scar (right).

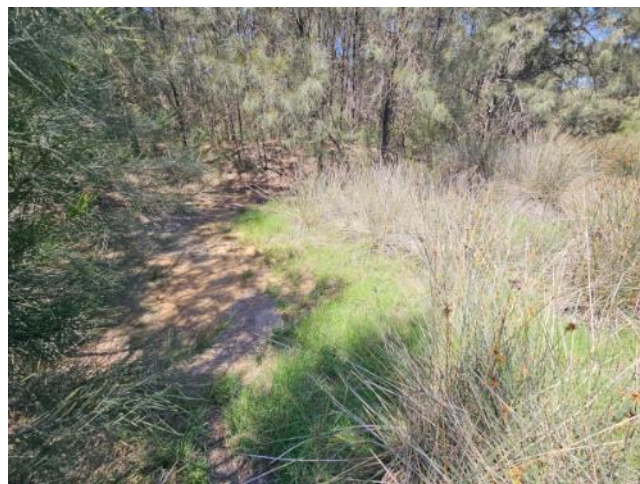
**Figure 24:** Couch grass colonising colluvial deposits (fine clayey sand) at the base of the right-hand bank, sourced from the erosion scar shown in **Figure 23**.

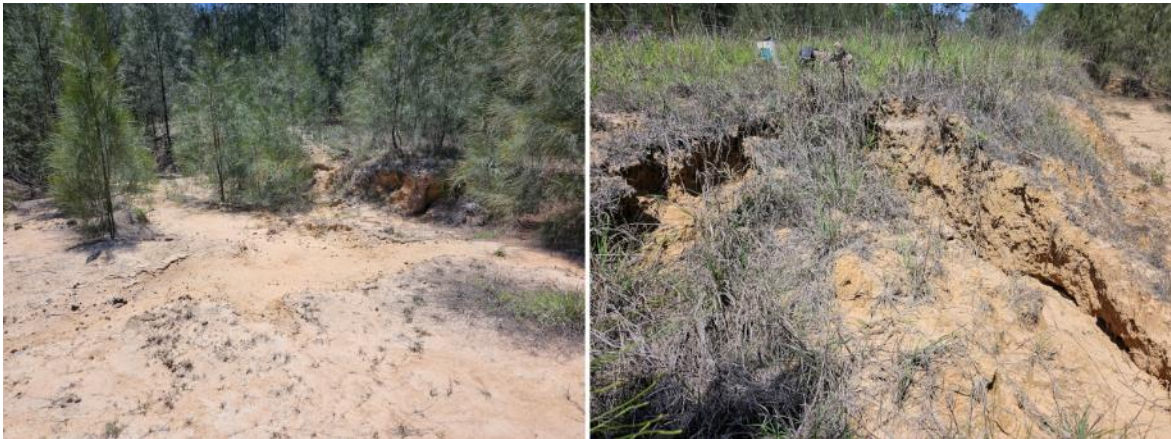
The swamp-oak riparian corridor is generally narrow, relatively dense and continuous and throughout the width of the channel with cleared pastures and rehabilitated mining land beyond the riparian strip (**Figure 26**). The upper right-hand bank contains a considerable erosion scar which remains an active source of fine sediment to the creekline (**Figure 27**). As noted at LC5, accumulated fine sediments at the base of the slopes have been colonised by couch grass which show signs of recent growth, as had spiny rushes which occupy the channel floor, however there are still bare patches with no vegetation (only swamp-oak needles) occupying much of the channel area, which limit the category score for ‘Vegetation on drainage line floor’ to 2, and resulted in a decrease in the overall CSIRO ESA score from 53 in 2022 to 50 in 2023.

**Figure 27:** Bank erosion along upper right-hand bank at LC6.

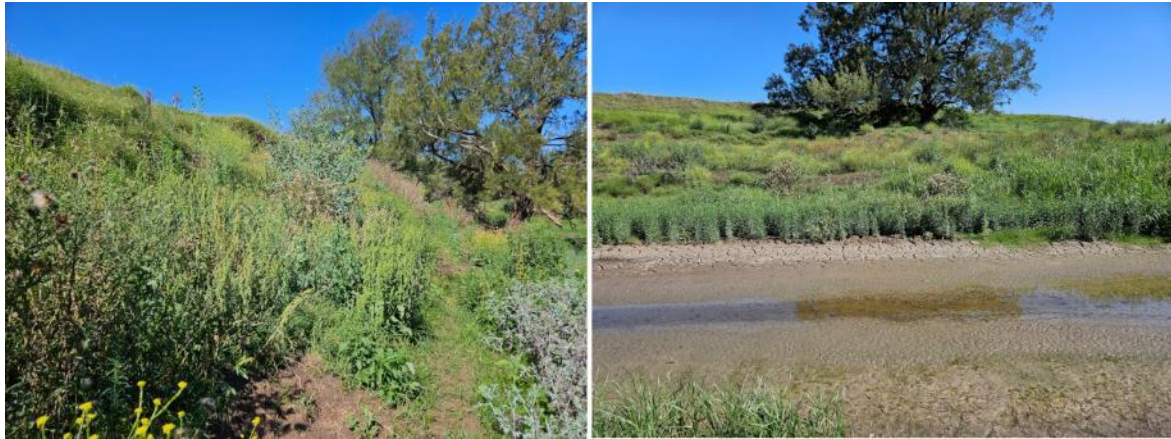
**Figure 45:** Looking along the left-hand bank at LC16 (left) and right-hand bank (right).

Mass failure occurs along the upper right-hand bank with an exposed soil profile and active erosional features (most likely a scour hole left from a tree root mass), and the left bank contains stepped banks with infrequent undercutting isolated to heights of less than 1m. A re-evaluation of the 'Shape of drainage line cross-section' resulted in an improved category score and overall CSIRO ESA score in 2023, however the CSIRO rating within the limits of *Active* in 2023.

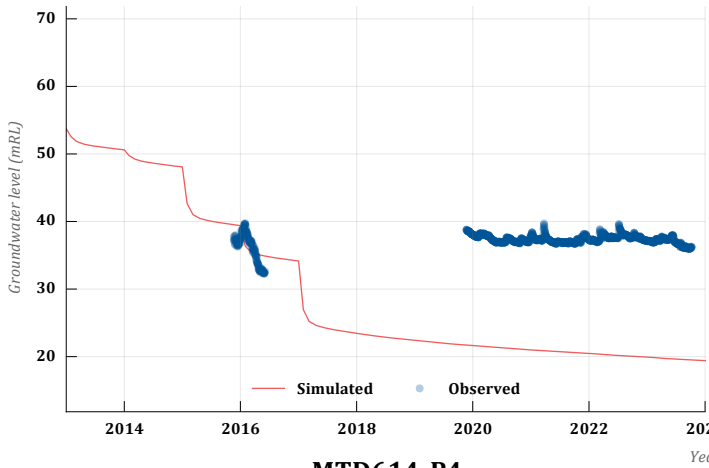
**MTD614\_P1**

- observed pressure heads in VWP MTD614 vary considerably to modelled predictions. Observed pressure head in sensor 1 (64 mBGL) is higher than predictions (approximately 20 m), whilst sensor 2 (191 mBGL) is lower (approximately 20 m). No data is available for the remaining sensors likely due to faults in the sensors;

- calibration factors for VWP PZ1 should be determined so that pressure head trends can be discussed in future annual reviews;
- Mount Arthur, Bowfield and Vaux seam VWP sensor cables should be inspected in MTD614 for damage to determine if erroneous data is due to a poor connection to the logger;
