**WOOLLOOMOOLOO BAY SSD 6471  
SYDNEY MODERN -  
ART GALLERY OF NEW SOUTH WALES  
EXPANSION PROJECT**

DAVID NUTLEY  
GML HERITAGE  
C.2018  
AUGUST 2018

PROJECT NO.: GM333      STATUS: DRAFT

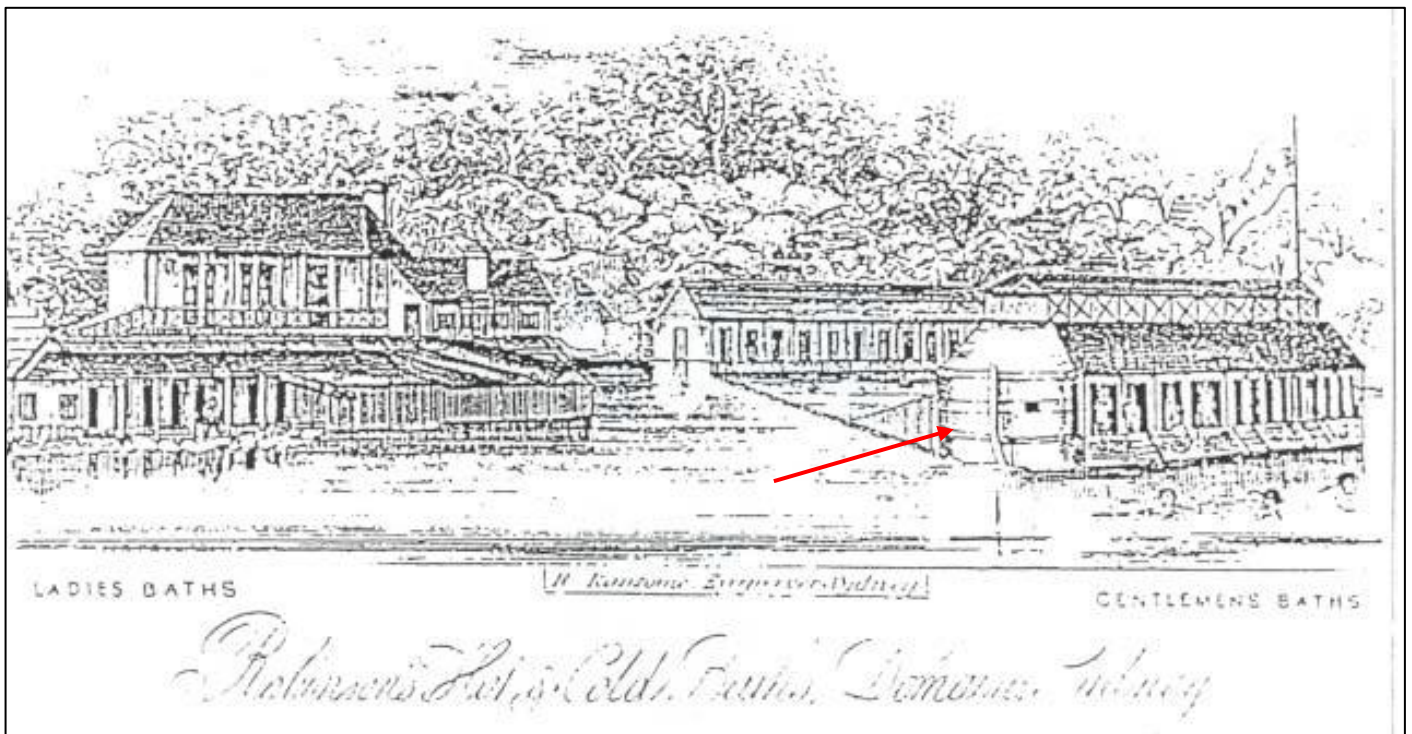
**Figure 4:** Ransome's c1855 sketch of 'Robinson's Hot & Cold Baths, Domain, Sydney'  
With arrow to the bluff bowed hulk (Coroneos 2004:34)

While Josephson may well have been surprised to find the hulk no longer at the baths, it is unlikely that the vessel actually did sink at its moorings. The depth of water is only 3m and, as noted by Coroneos, the superstructure of the hulk would remain visible. If it did sink at its moorings, the hull would have been refloated and, most likely taken to be broken up. Alternatively, if the hulk had broken its moorings, moved off-shore and foundered in deeper water in or near the bay, such an obstacle within navigable waters of Woolloomooloo Bay, or Sydney Harbour would attract media attention. This would be particularly so during any recovery and removal of the shipwreck. In the absence of such documentation, or evidence to date of shipwreck remains in Woolloomooloo Bay, it is more likely that the hulk was actually purposefully removed and taken to a ship breaking yard for disposal.

This review supports the 2004 assessment that neither the *Ben Bolt* nor the *Sir William Wallace* are located in the study area.

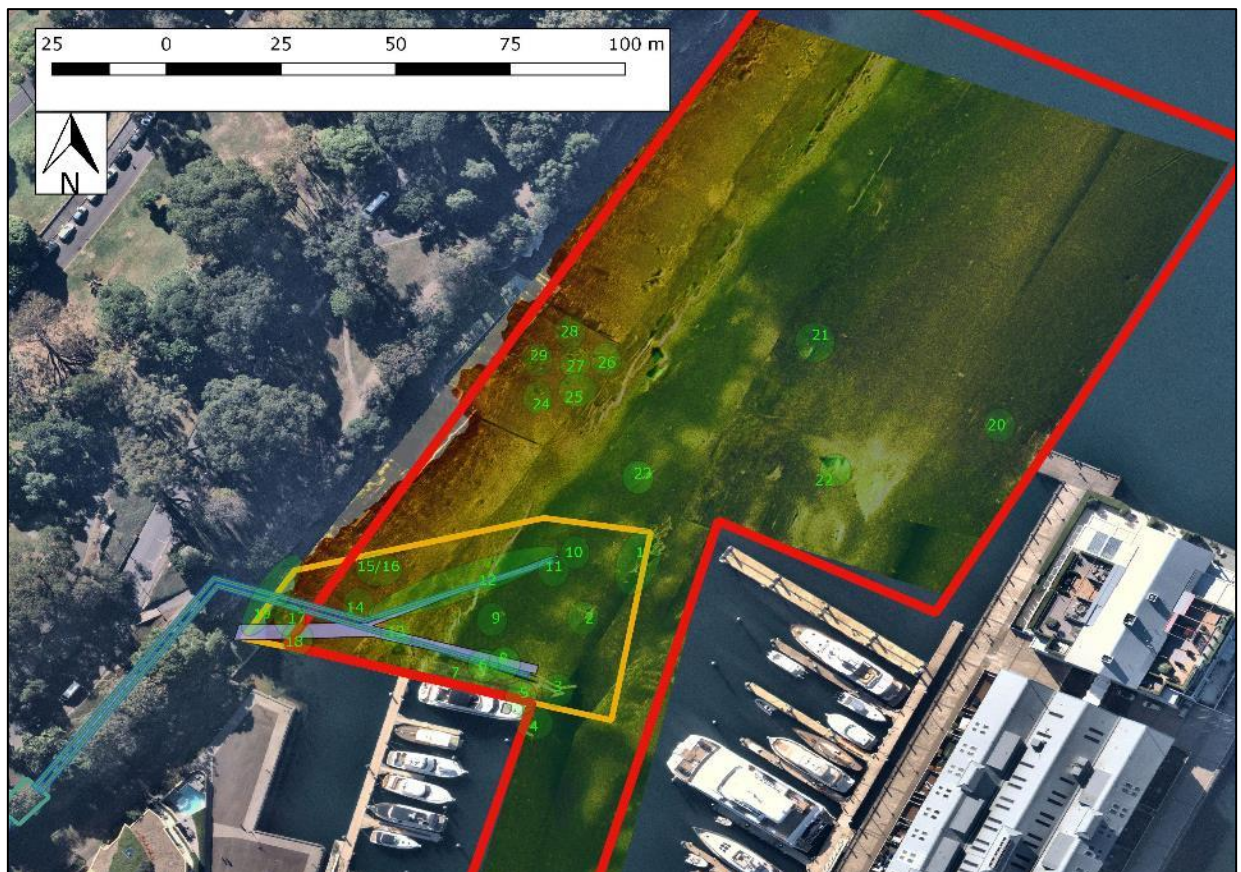
**Figure 7:** Overlay of MBES and SSS imagery with distribution of targets identified for dive inspection

### 4.2 Dive inspection results

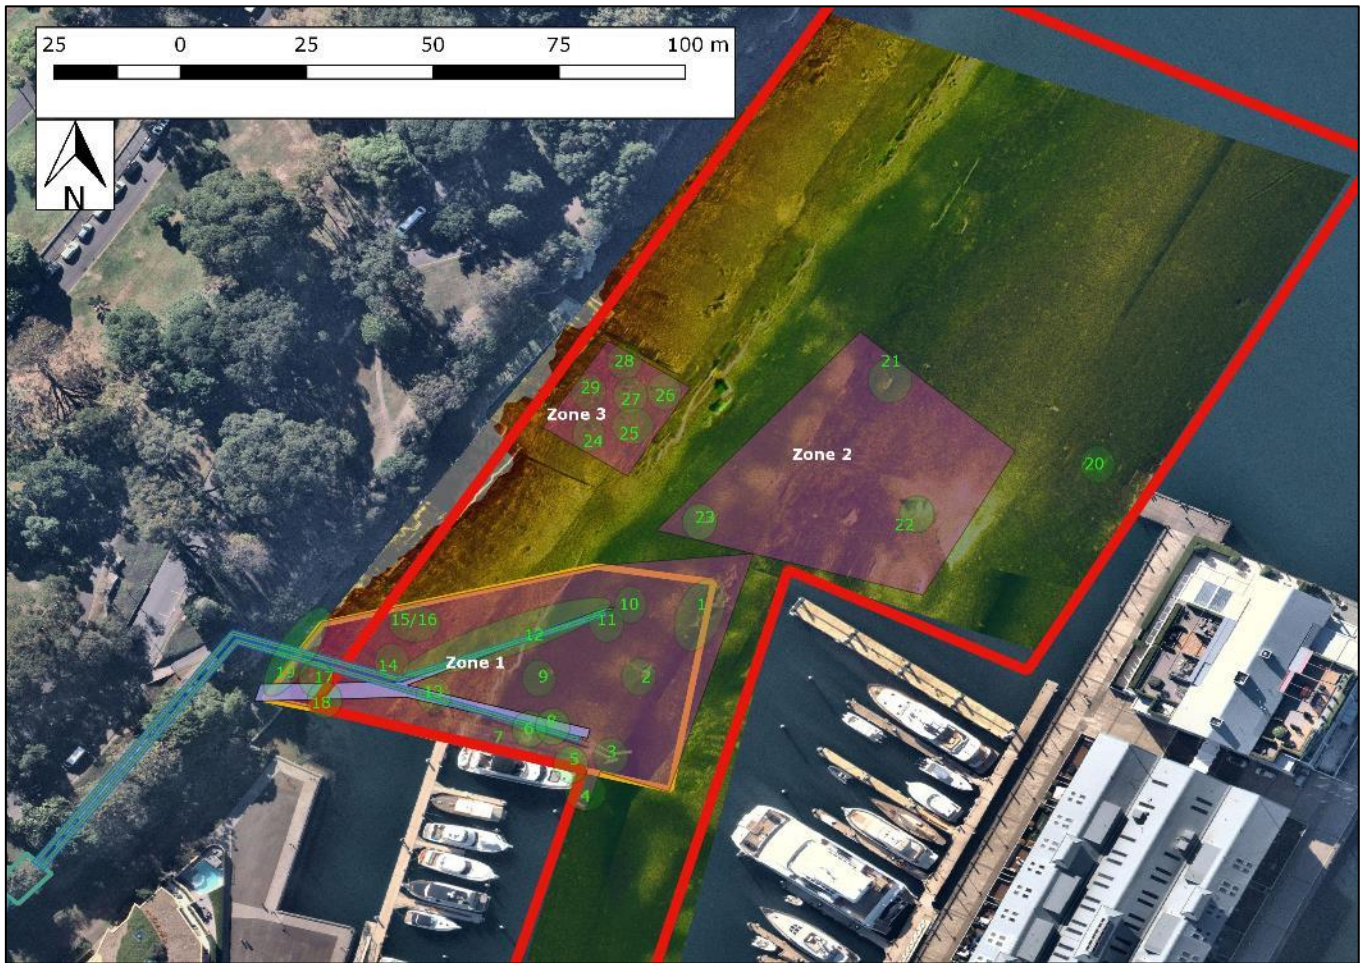
**Figure 7:** Combined overlay of MBES and SSS imagery with the dive Zones (shaded purple) showing coverage and relationship to identified targets

Visual coverage was 100% within Zone 1, (Figure 7 & Table 1). The dive inspection within Zone 1 (Figure 7 & Table 1) identified sandstone bedrock shelving across the zone. The bedrock was covered with a thin layer of fine sediment. Within this zone, there were no areas of significant sedimentation over the bedrock where cultural deposits could remain buried.

In Zone 2, (Figure 7 & Table 2), the identified targets were isolated within an otherwise barren sea bed. No attempt was made to extend coverage beyond those targets and their immediate surroundings. Both targets were identified. While there was additional sedimentation within Zone 3, the remote survey and dive inspection did not identify any evidence of potentially significant cultural deposits within that sediment.

In Zone 3, (Figure 7, Table 3), the identified targets were identical mooring blocks in shallow, clear water – each within 10-15m of the nearest mooring block. All targets were identified as being concrete mooring blocks, each approximately 1cu metre and with a short length of attached chain. The dive inspection identified sandstone bedrock shelving across the length and breadth of this Zone. The bedrock was covered with a thin layer of fine sediment. There was no indication of areas where cultural deposits could remain buried beneath that sediment.
