**Addendum 2 to Arboricultural Impact Assessment Report  
Art Gallery of NSW Expansion Project – Sydney Modern [SSD 14\_6471]  
Consistency with the objectives of the *Royal Botanic Gardens and Domain Trust Act 1980*.**

# PICUS SONIC TOMOGRAPH REPORT

### **Re – Arborist Inspection - Picus Sonic Tomograph Testing**

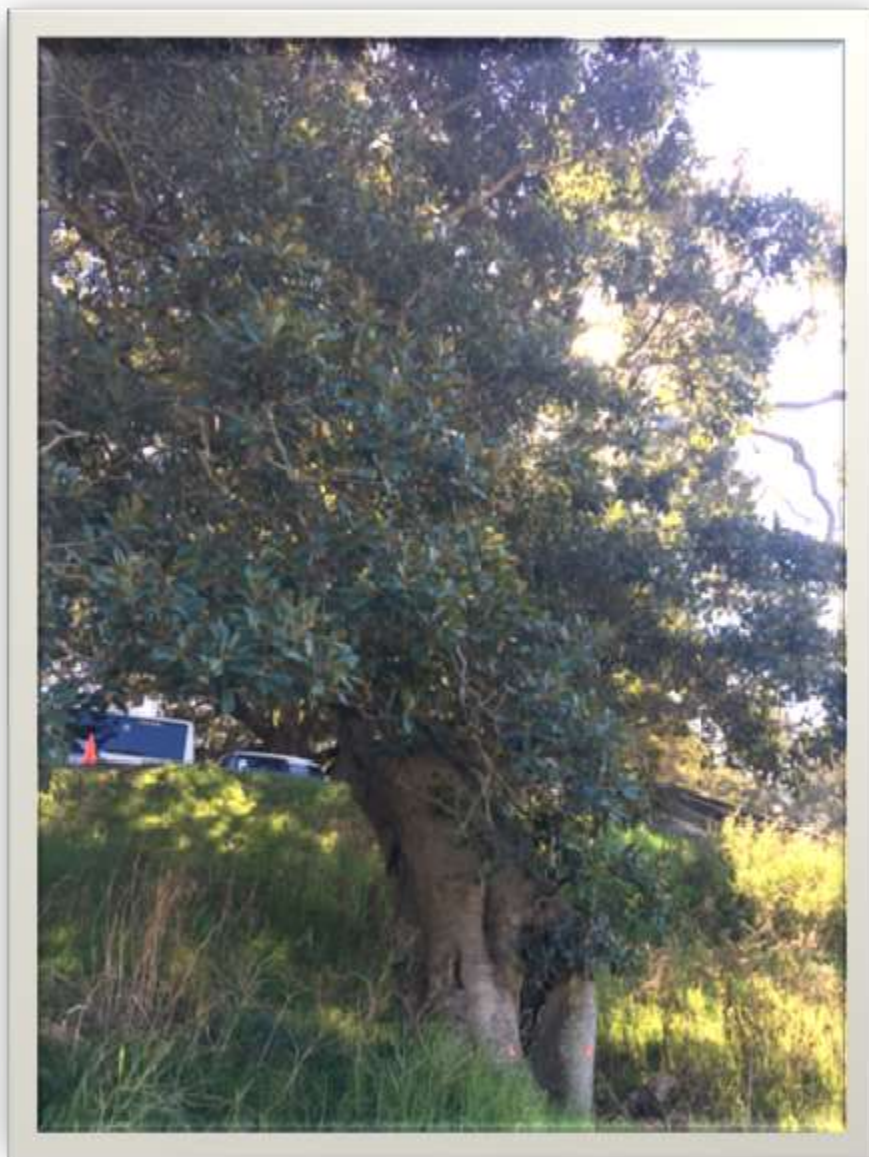
Subject tree. *Ficus macrophylla*

The Picus test was undertaken on a *Ficus macrophylla* (Moreton Bay Fig) identified as requiring further investigation to determine the structural condition of the tree at the site of a large lower trunk cavity.

Based on the findings from this Picus test the structural integrity at the base of the tree has been compromised by extensive decay and the tree should be only considered for retention if the area can be isolated from the public.
