Hazardous Materials Survey

Prepared for:	Pariter
Prepared by:	Alex Tam Licensed Asbestos Assessor 001241 Trinitas Group
Site	Cumberland Country Golf Club
Address:	248 Old Prospect Road, Greystanes NSW 2145
Date:	04/02/2024
Version:	3

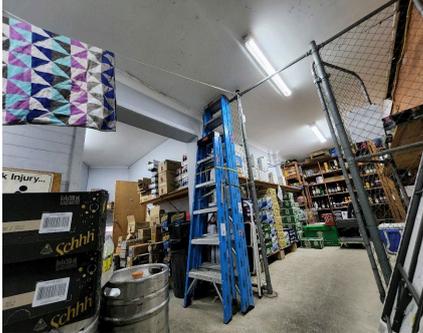
Photo No: 231218-092301
 Result: Asbestos - Negative
 Location-Level: Interior - Ground Floor
 Room-Location: Loading dock - ceiling
 Feature-Material: Plaster-like material

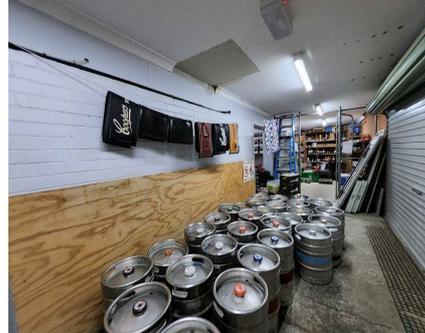
Photo No: 231218-092517
 Result: Lead in Paint - Negative
 Location-Level: Interior - Ground Floor
 Room-Location: Loading dock - internal walls
 Feature-Material: Lower colour paint system

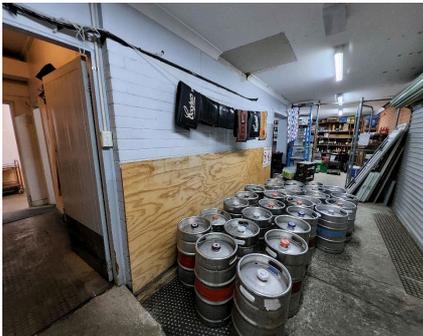
Photo No: 231218-093246
 Result: Asbestos - Negative
 Location-Level: Interior - Ground Floor
 Room-Location: Loading dock - internal walls
 Feature-Material: Brick

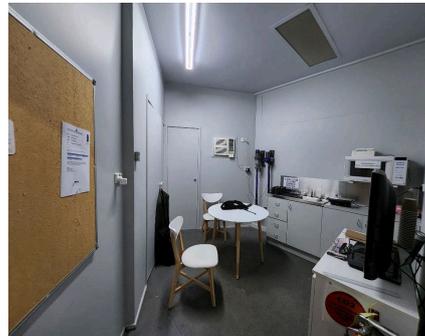
Photo No: 231218-093408
 Result: Asbestos - Presumed Negative
 Location-Level: Interior and Exterior - Ground Floor
 Room-Location: Staff room - internal walls and ceiling
 Feature-Material: Plaster-like material

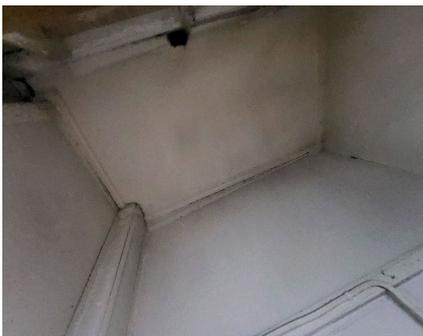
Photo No: 231218-095449
 Result: Asbestos - Presumed Negative
 Location-Level: Interior - Ground Floor
 Room-Location: Staff room - original ceiling
 Feature-Material: Plaster-like material

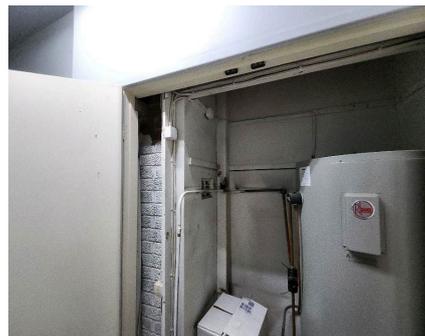
Photo No: 231218-095936
 Result: Lead in Dust - Negative
 Location-Level: Interior - Ground Floor
 Room-Location: Staff room original walls - elevated horizontal surfaces
 Feature-Material: Settled dust

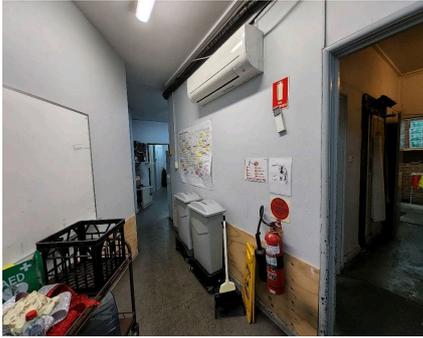
Photo No: 231218-100102
 Result: Asbestos - Presumed Negative
 Location-Level: Interior - Ground Floor
 Room-Location: Loading dock - division walls
 Feature-Material: Plaster-like material

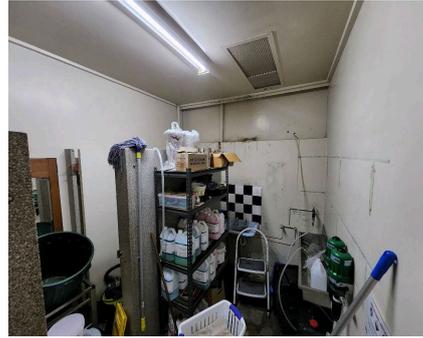
Photo No: 231218-100834
 Result: Lead in Paint - Negative
 Location-Level: Interior - Ground Floor
 Room-Location: Existed disable toilet - internal walls
 Feature-Material: Lower colour paint system

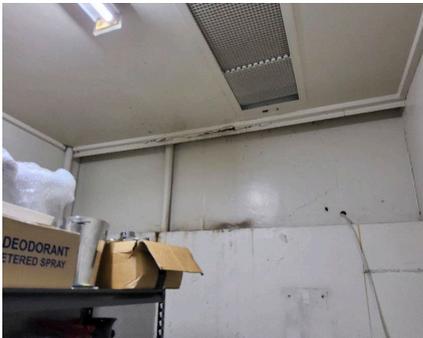
Photo No: 231218-100555
 Result: Asbestos - Negative
 Location-Level: Interior - Ground Floor
 Room-Location: Exited disable toilet - infill
 Feature-Material: FC sheeting

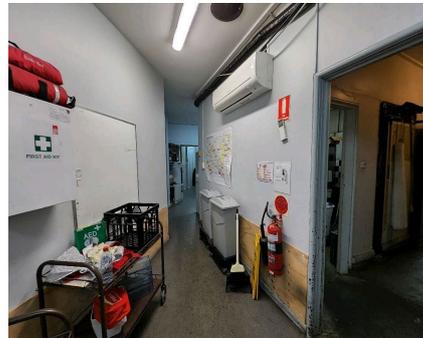
Photo No: 231218-100854
 Result: Lead in Paint - Presumed Negative
 Location-Level: Interior - Ground Floor
 Room-Location: Loading dock - division walls
 Feature-Material: Lower colour paint system

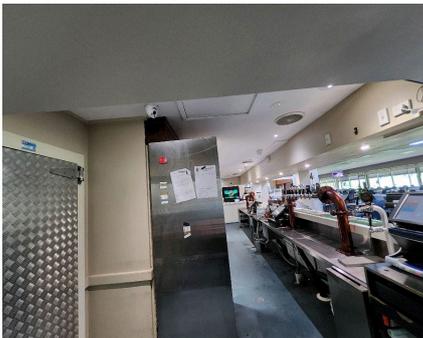
Photo No: 231218-101032
 Result: Asbestos - Presumed Negative
 Location-Level: Interior - Ground Floor
 Room-Location: Bar - division walls and ceilings
 Feature-Material: Plaster-like material

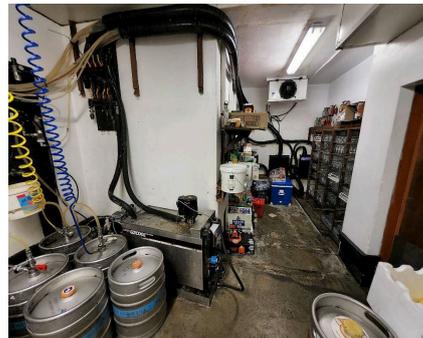
Photo No: 231218-101127
 Result: Asbestos - Presumed Negative
 Location-Level: Interior - Ground Floor
 Room-Location: Bar storage area - internal walls and ceiling
 Feature-Material: Plaster-like material

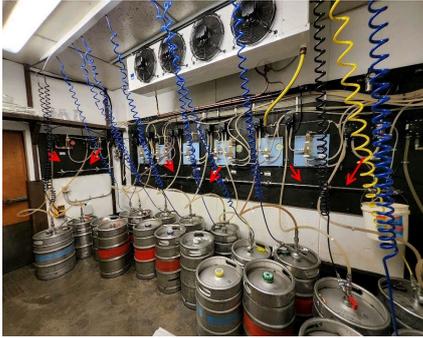
Photo No: 231218-101118
 Result: Asbestos - Negative
 Location-Level: Interior - Ground Floor
 Room-Location: Bar store area - backing material to drink dispenser
 Feature-Material: Timber

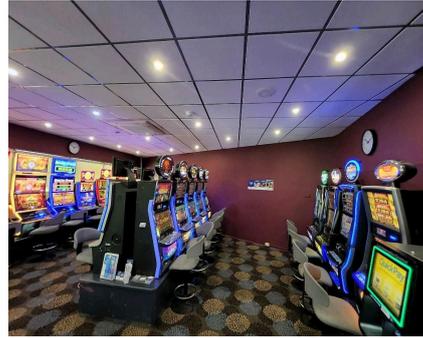
Photo No: 231218-101222
 Result: Asbestos - Presumed Negative
 Location-Level: Interior - Ground Floor
 Room-Location: Gaming area - internal walls
 Feature-Material: Plaster-like material

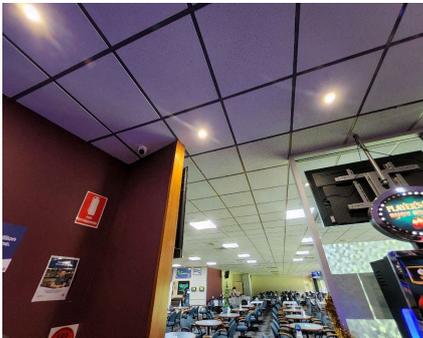
Photo No: 231218-101242
 Result: Asbestos - Presumed Negative
 Location-Level: Interior - Ground Floor
 Room-Location: Dining area and gaming area - ceiling
 Feature-Material: Acoustic tiles

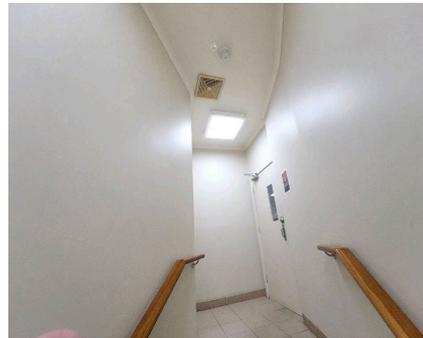
Photo No: 231218-101540
 Result: Asbestos - Presumed Negative
 Location-Level: Interior - Basement
 Room-Location: Corridor to male toilet - internal walls and ceiling
 Feature-Material: Plaster-like material

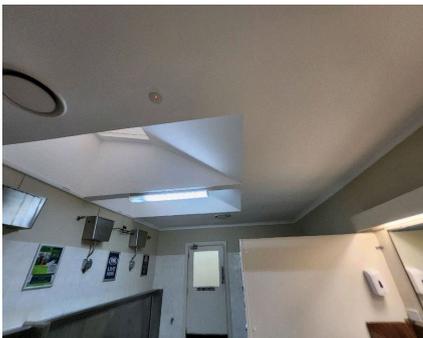
Photo No: 231218-101642
 Result: Asbestos - Presumed Negative
 Location-Level: Interior - Basement
 Room-Location: Male toilet - internal walls and ceiling
 Feature-Material: Plaster-like material

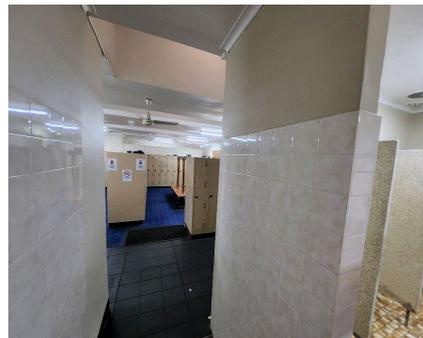
Photo No: 231218-101749
 Result: Asbestos - Negative
 Location-Level: Interior - Basement
 Room-Location: Male shower and changing room - internal walls
 Feature-Material: Brick

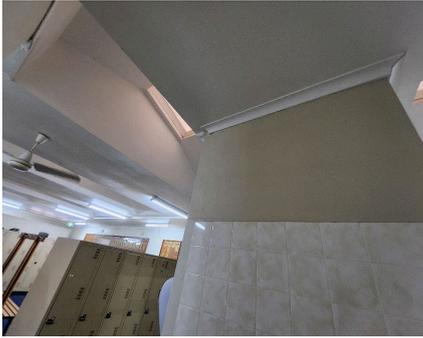
Photo No: 231218-101759
 Result: Asbestos - Presumed Negative
 Location-Level: Interior - Basement
 Room-Location: Male shower and changing room - internal ceilings
 Feature-Material: Plaster-like material

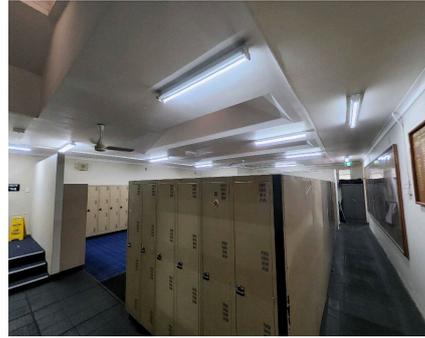
Photo No: 231218-101936
 Result: Lead in Paint - Negative
 Location-Level: Interior - Basement
 Room-Location: Male shower and changing room - walls, door frame and window frames
 Feature-Material: Lower colour paint system

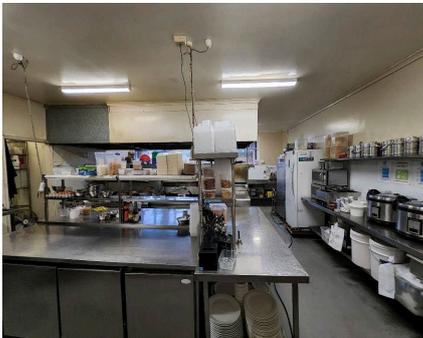
Photo No: 231219-205628
 Result: Asbestos - Negative
 Location-Level: Interior - Ground Floor
 Room-Location: Kitchen - internal walls and ceiling
 Feature-Material: Brick

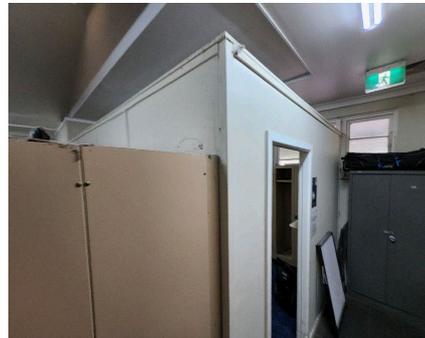
Photo No: 231218-102449
 Result: Asbestos - Presumed Negative
 Location-Level: Interior - Basement
 Room-Location: Male changing room - division walls
 Feature-Material: Plaster-like material

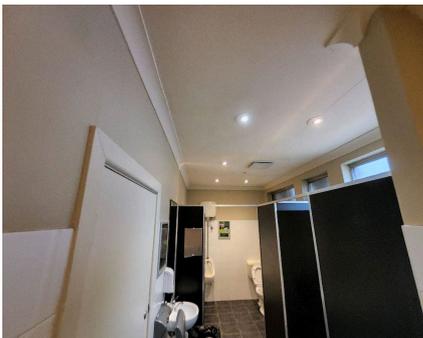
Photo No: 231218-102648
 Result: Asbestos - Presumed Negative
 Location-Level: Interior - Ground Floor
 Room-Location: Unisex toilet - internal walls and ceiling
 Feature-Material: Plaster-like material

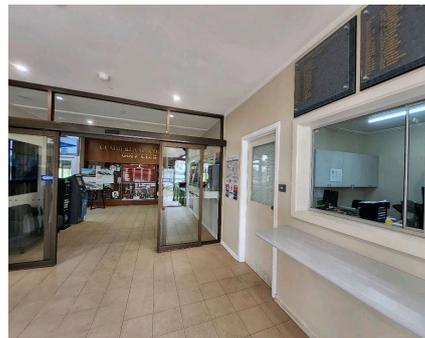
Photo No: 231218-103626
 Result: Asbestos - Presumed Negative
 Location-Level: Interior - Ground Floor
 Room-Location: Lobby and reception - internal walls and ceiling
 Feature-Material: Plaster-like material

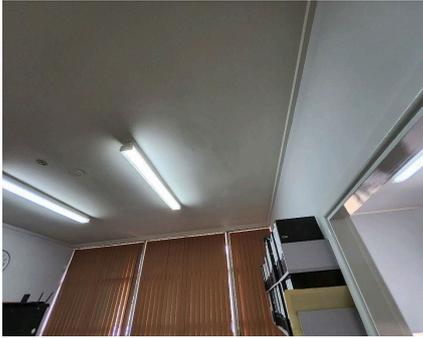
Photo No: 231218-103704
 Result: Asbestos - Presumed Negative
 Location-Level: Interior - Ground Floor
 Room-Location: Office - internal walls and ceiling
 Feature-Material: Plaster-like material

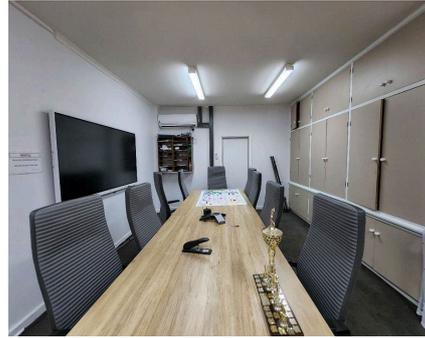
Photo No: 231218-103710
 Result: Asbestos - Presumed Negative
 Location-Level: Interior - Ground Floor
 Room-Location: Meeting room - internal walls and ceiling
 Feature-Material: Plaster-like material

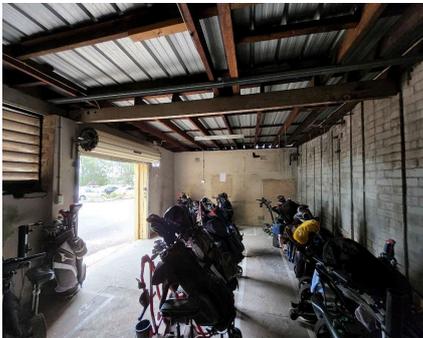
Photo No: 231218-103959
 Result: Asbestos - Negative
 Location-Level: Interior - Ground Floor
 Room-Location: Garage - internal walls
 Feature-Material: Brick

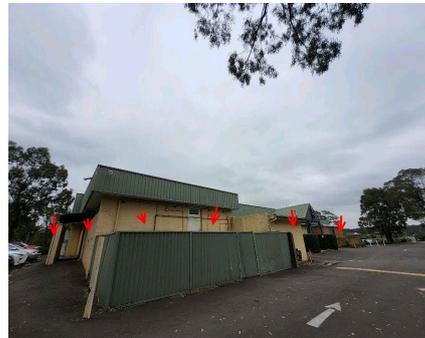
Photo No: 231219-210216
 Result: Lead in Paint - Negative
 Location-Level: Interior - Ground Floor
 Room-Location: All elevation of the building and garage - walls
 Feature-Material: Lower colour paint system

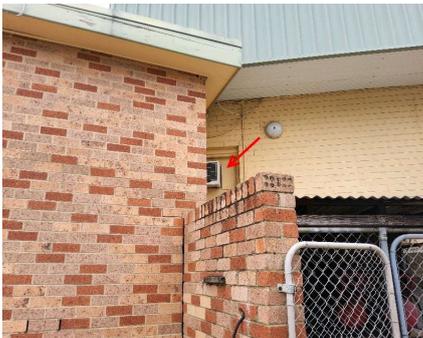
Photo No: 231218-112709
 Result: Asbestos - Negative
 Location-Level: Exterior - Ground Floor
 Room-Location: Northern elevation of the building (above external toilet) - infill panel
 Feature-Material: FC sheeting

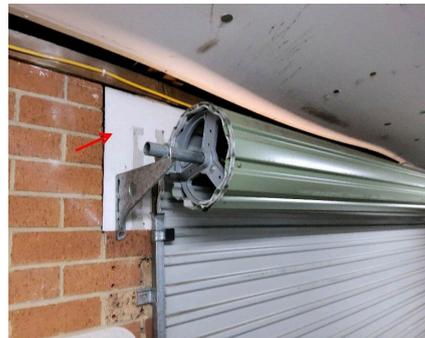
Photo No: 231219-101457
 Result: Asbestos - Negative
 Location-Level: Interior - Ground Floor
 Room-Location: Above loading dock entrance - infill panels
 Feature-Material: FC sheeting

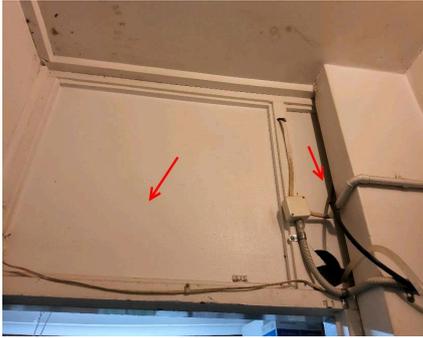
Photo No: 231219-101952
Result: Asbestos - Negative
Location-Level: Interior and Exterior - Ground Floor
Room-Location: Next to cool room - infill panels above entrance
Feature-Material: FC sheeting

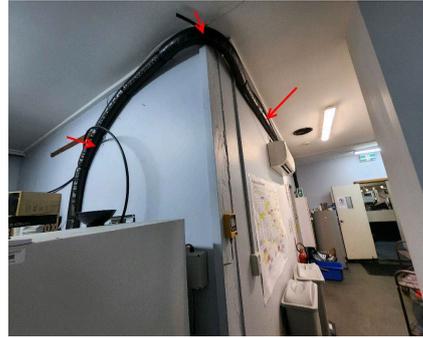
Photo No: 231219-102354
Result: Asbestos - Negative
Location-Level: Interior - Ground Floor
Room-Location: Bar - conducting
Feature-Material: Form-like material

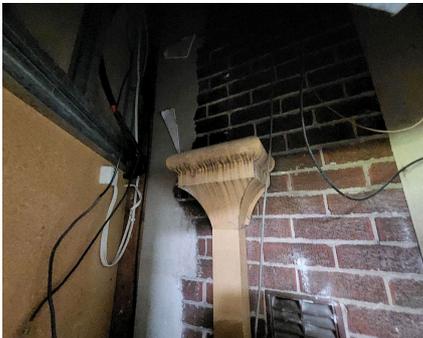
Photo No: 231219-102550
Result: Lead in Dust - Negative
Location-Level: Exterior - Ground Floor
Room-Location: Hydrate (next to Male toilet entrance) - elevated horizontal surfaces
Feature-Material: Settled dust

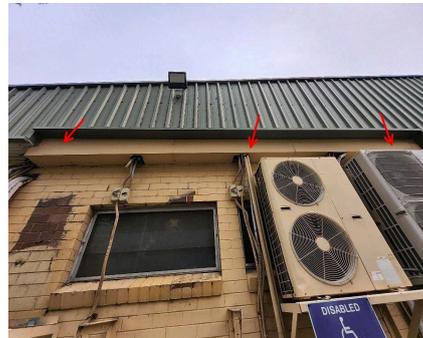
Photo No: 231219-104429
Result: Asbestos - Negative
Location-Level: Exterior - Ground Floor
Room-Location: Southern elevation of the building - infill panels above AC units
Feature-Material: Metal

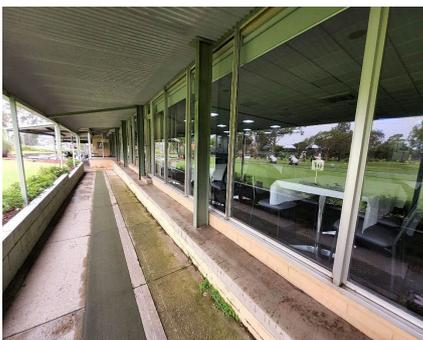
Photo No: 231219-104554
Result: Asbestos - Negative
Location-Level: Exterior - Ground Floor
Room-Location: Western elevation of the building - window frame sealant
Feature-Material: Mastic-like material

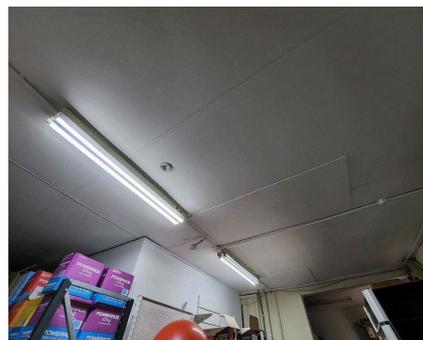
Photo No: 231218-110349
Result: Asbestos - Negative
Location-Level: Interior - Ground Floor
Room-Location: Worship - internal ceiling
Feature-Material: FC sheeting
