HUNTER INDOOR SPORTS CENTRE (HISC)

ARBORICULTURAL IMPACT ASSESSMENT

MAY 2024

Arboricultural Impact Assessment

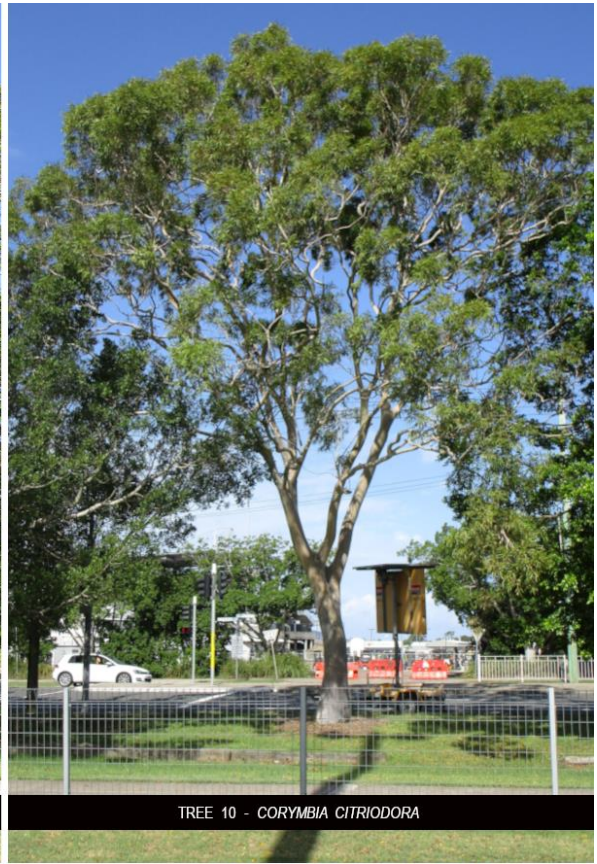
9	<i>Ficus microcarpa var. hillii</i>	Hills Weeping Fig	M	14	820	9.84	720	2.88	+40	AV	AV	A1	A3A	9. [CoN TREE ID 67117] TREE CONTAINS ONE NEST AND BRUSH-TAILED POSSUM. LARGE SURFACE ROOTS MANY RUNNING PARALLEL TO ROAD DUE TO THE PRESENCE OF TIMBER EDGING TO THE WEST AND FOOTPATH TO THE EAST. TREE ROOTS NOW RUNNING BEYOND EDGING AND INTO NEARBY TURF. PREVIOUS FOOTPATH DAMAGE AND REPAIRS NOTED. THIS TREE WILL NEED TO BE REMOVED.
10	<i>Corymbia citriodora</i>	Lemon-scented Gum	M	17	510	6.12	720	2.88	+40	AV	AV	A1	A3B	10. [CoN TREE ID 67116] PAST PRUNING OF LOWER CANOPY WITH UPPER BRANCHES CLEAR OF WIRES. PRUNING TO ROADSIDE CANOPY RESULTING IN AN ASYMMETRIC CANOPY. MINOR ENCROACHMENT. TO BE RETAINED
11	<i>Ficus microcarpa var. hillii</i>	Hills Weeping Fig	M	14	680	8.16	650	2.76	+40	AV	AV	A1	A3C	11. [CoN TREE ID 67115] SEWER MANHOLE NOTED NEARBY INDICATING PRESENCE OF SEWER. MECHANICAL DAMAGE TO SURFACE ROOTS. PRUNING TO ROADSIDE CANOPY RESULTING IN AN ASYMMETRIC CANOPY. THIS TREE WILL NEED TO BE REMOVED.

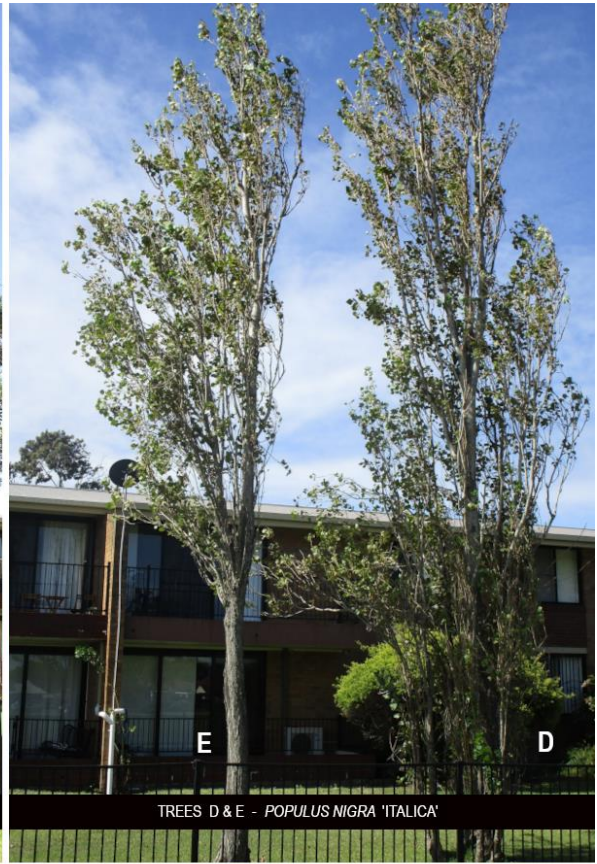
E*	<i>Populus nigra Italica'</i>	Lombardy Poplar	M	9	230	2.76	300	2.00	+40	F	AV	A1	A6B	E. SLIGHT MECHANICAL DAMAGE AT THE BASE OF THE TREE. IT APPEARS THAT THE TREE MAY HAVE BEEN LOPPED AT 3M AGL SOME TIME AGO AS SECONDARY GROWTH NOW WELL ESTABLISHED. TO BE RETAINED
F	<i>Melaleuca quinquenervia</i>	Swamp Paperbark	M	12	930	11.16	970	3.27	+40	AV	AV	A1	A7C	F. MULTI-TRUNKED TREE WITH 6 MAJOR LEADERS FORMING AT 800MM AGL. PAST PRUNING HAS BEEN DONE POORLY, RESULTING IN THE EXISTENCE OF BRANCH STUBS - SOME WITH WOOD ROT. GROUND AROUND THE BASE OF THE TREE HEAVILY COMPACTED BY STUDENTS GATHERING UNDER THE TREE. NEARBY DISH DRAIN AFFECTED BY TREE ROOT. THREATENED TREE. DETAILED DESIGN OF SUSPENDED ROADWAY AND SUPPLY OF MOISTURE TO UNDERLYING ROOTS WILL BE NEEDED. IMPLEMENTATION OF TREE PROTECTION PLAN REQUIRED.
G*	<i>Eucalyptus robusta</i>	Swamp Mahogany	M	14	720	8.64	800	3.01	+40	AV	AV	A1	A7D	G. CO-DOMINANT TRUNK @ 1.3M AGL. SPREADING CANOPY. MINOR DEADWOOD AND EPICORMIC GROWTH THROUGHOUT. SURROUNDING GROUND MILDLY COMPACTED. MEDIUM CROWN DENSITY. TREE REQUIRES DETAILED DESIGN TO ENSURE LEVELS AND INSTALLATION OF DECOMPOSED GRANITE TRACK DO NOT SIGNIFICANTLY IMPACT ON THE TREE'S ROOT PLATE. CONSIDERATION SHOULD BE GIVEN TO USING A CELLULAR PLASTIC GRID LAID OVER A GEOTEXTILE LINER TO AVOID EXCAVATION AND COMPACTION ISSUES FOR THE GRAVEL TRACK.

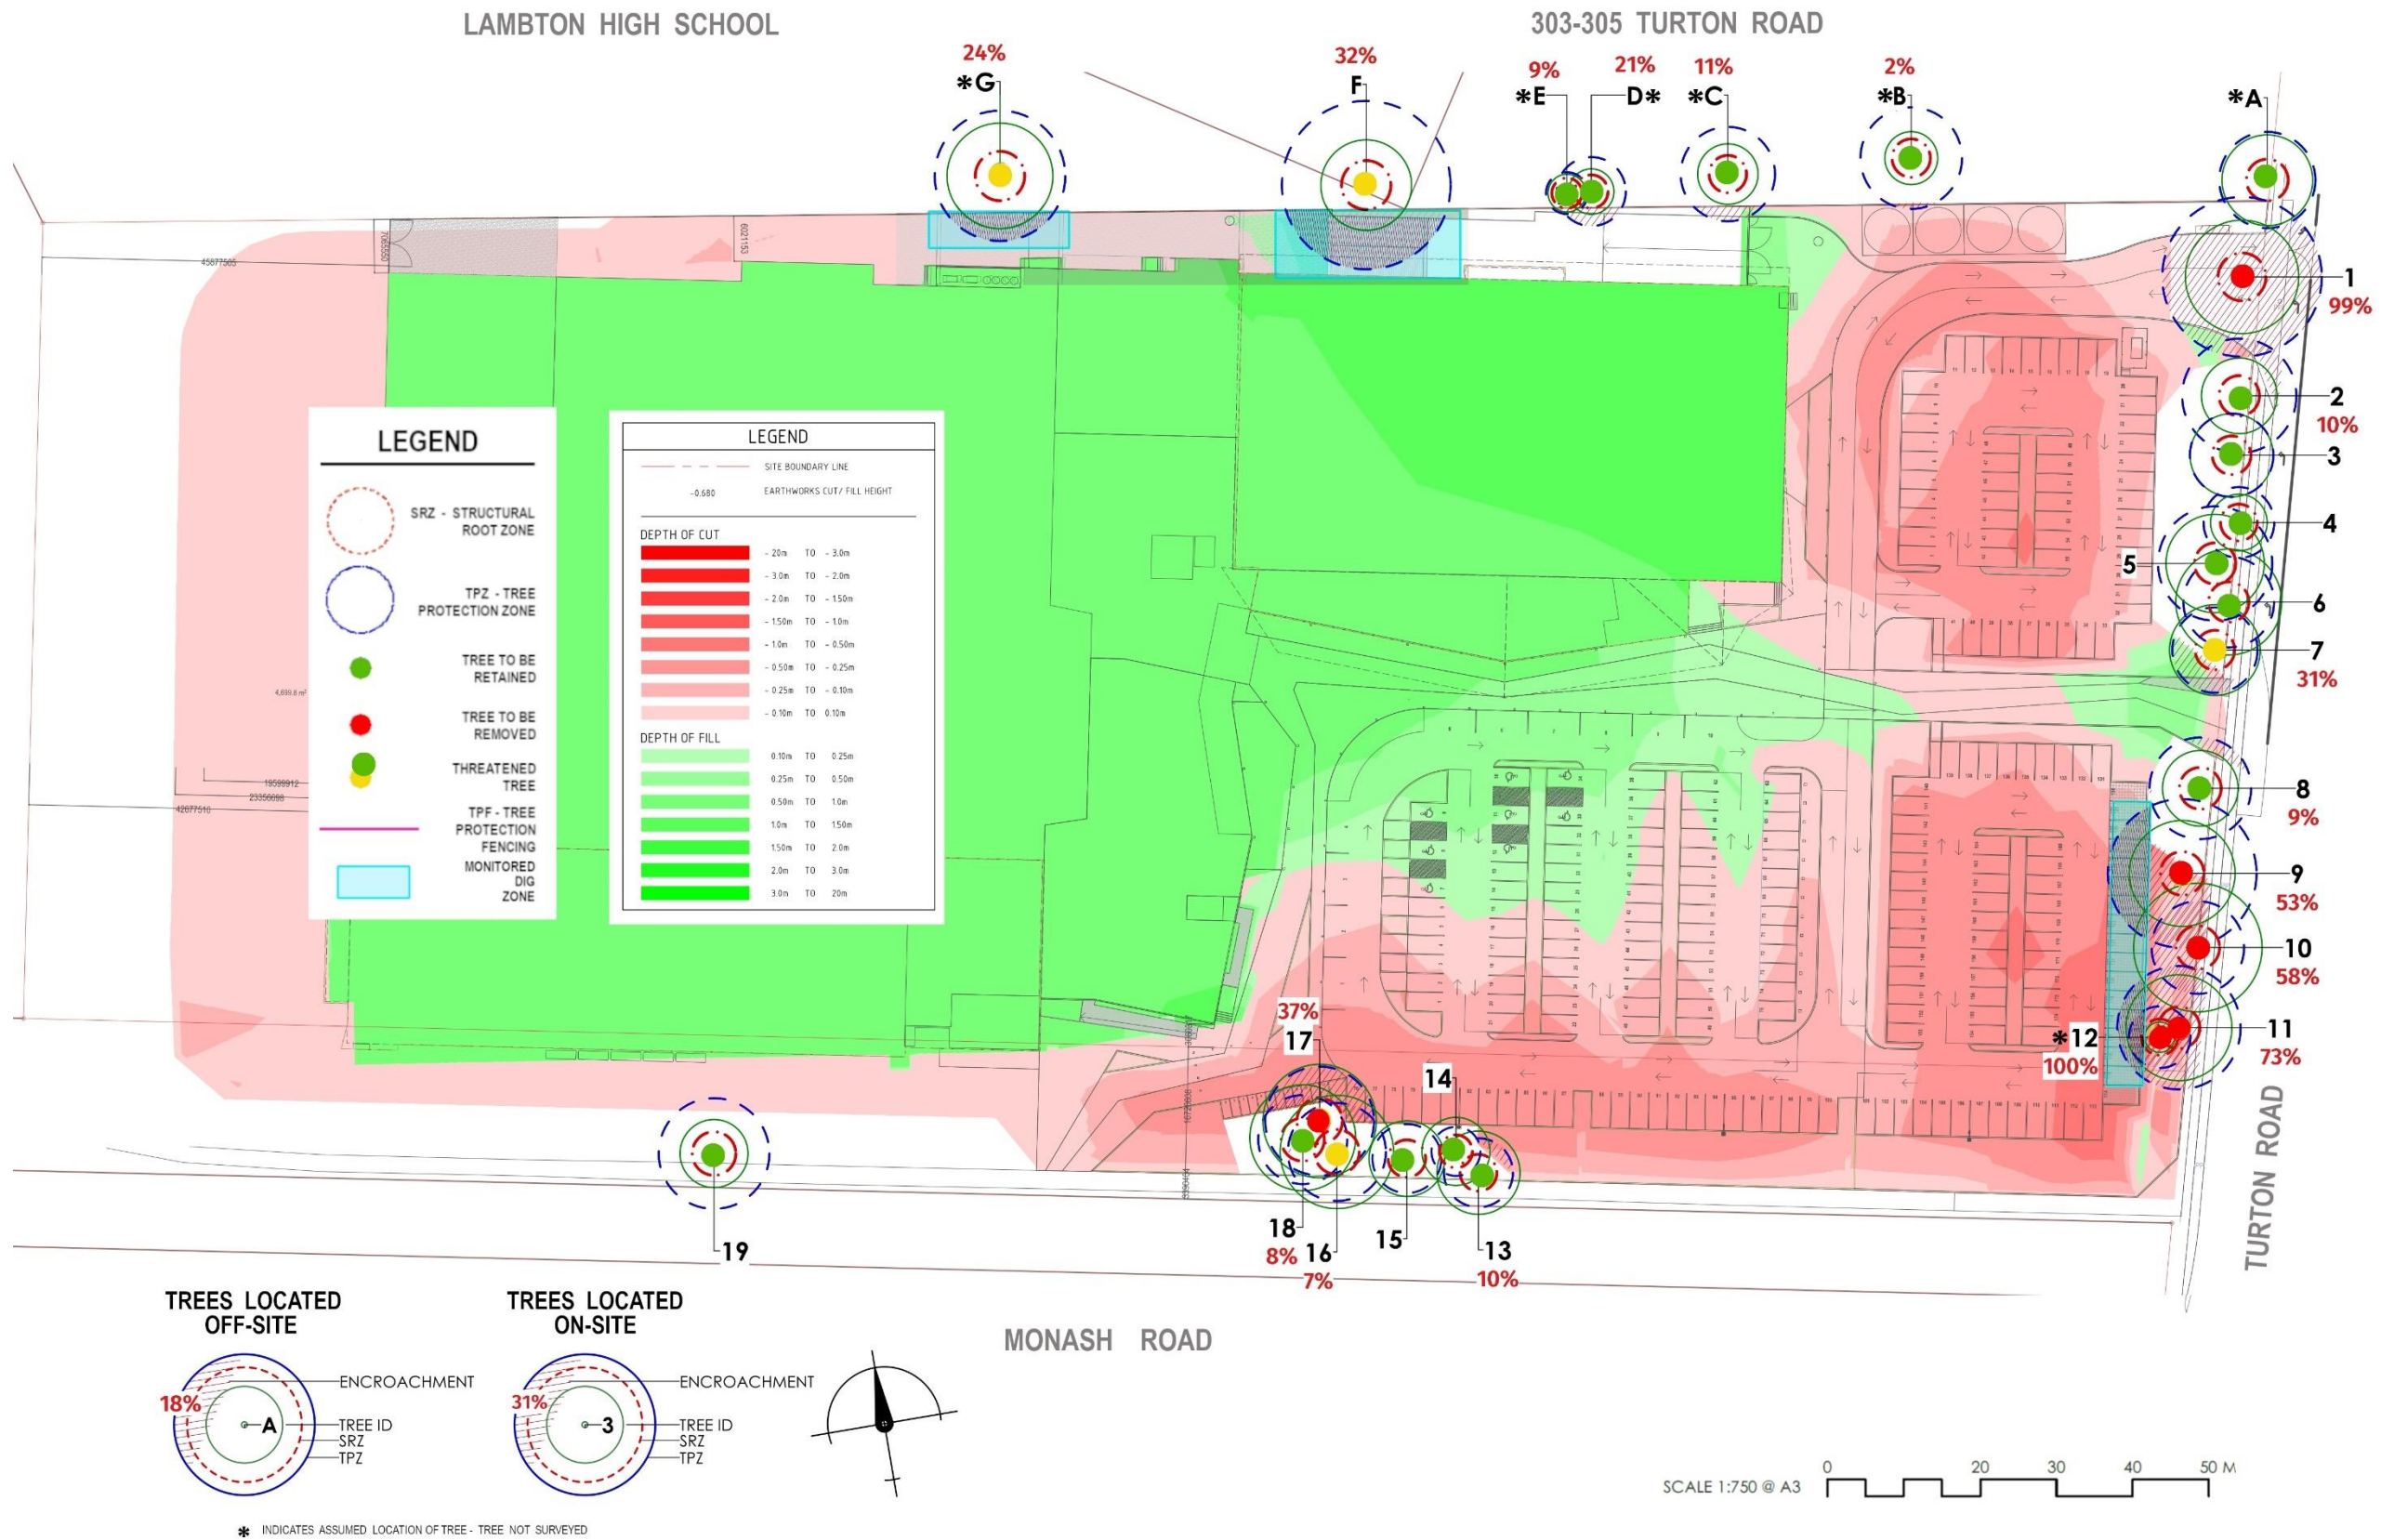
FIGURE C2 – TREE IMPACT ASSESSMENT DIAGRAM [BASE DRAWING SOURCE: EJE ARCHITECTURE & NORTHROP]

On-site, Trees 2, 3, 4, 5, 6, 8, 13, 14, 15, 18 and 19 will not be impacted by the the proposed works as the TPZs of these trees will be subjected to minor encroachments only, if at all. Off-site Trees A, B, C, D, and E will also be retained as encroachments are within acceptable limits of encroachment having regard to their locations, type of tree and condition. It should be noted that Tree D has an encroachment of 21% which is the upper tolerance for this species having average health. Nevertheless routine monitoring will be required.

Tree 16 has also been noted as being "Threatened". This tree is in decline and even if left undisturbed, it is likely to fail. By removing the existing containers and making changes nearby, it is likely that its decline will be hastened although not directly affected by the construction works. It would be possible to minimise the decline by removing grass from around the base of the tree and covering the exposed area with an organic mulch.

- that Trees 1, 9, 10, 11, 12 & 17 be removed;
- that Trees 2, 3, 4, 5, 6, 8, 13, 14, 15, 18, 19, A, B, C, D, and E be retained; and,
- that Trees 7, 16, F and G be retained by following the requirements of the Tree Protection Plan (refe Appendix D) subject to careful detailing during the detailed design and documentation phases and further investigations occurring at the commencement of construction to ensure major roots are not damaged and/or further action taken.
