# **PRE-CONSTRUCTION CONDITION SURVEY (DILAPIDATION REPORT)**

**REPORT NUMBER:** S26211301 - 001

**PROJECT:** 6 Halifax Street, Macquarie Park NSW 2113

**INSPECTION DATE:** 17<sup>th</sup> April 2026

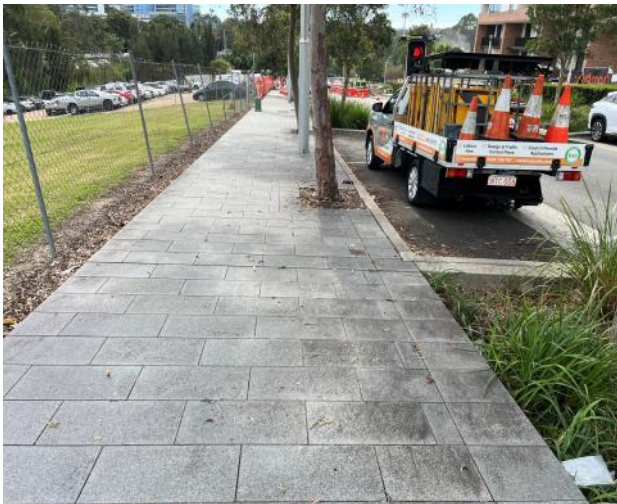
Figure 1 – General view of council footpath.

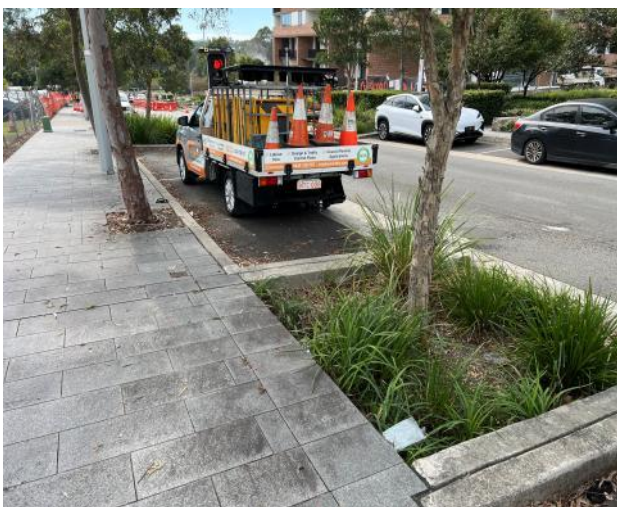
Figure 3 – General view of council footpath and tree pit.

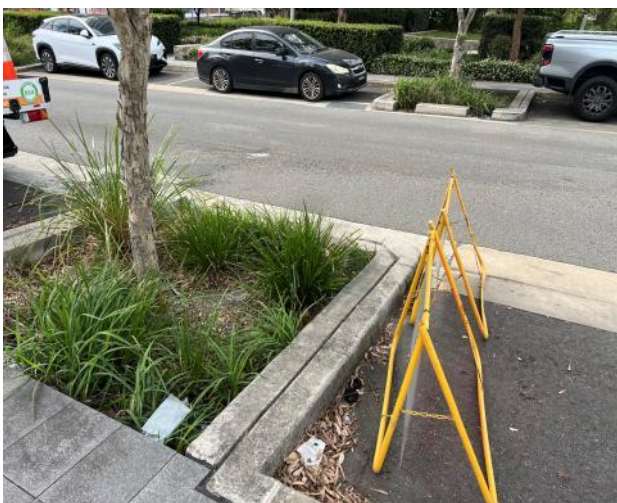
Figure 5 – General view of kerb and council tree pit.

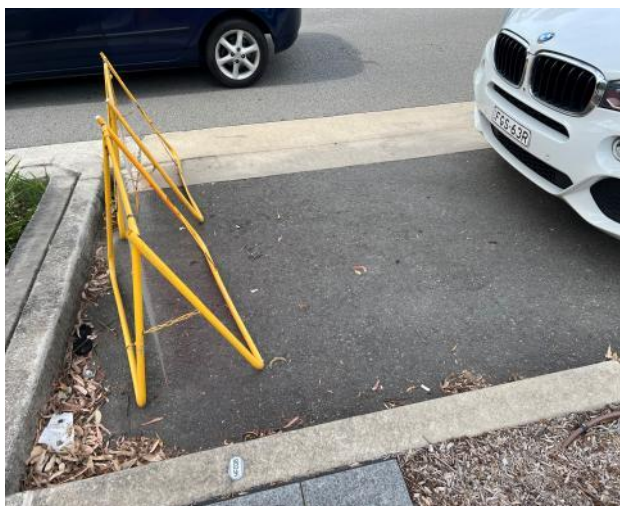
Figure 7 – General view of road pavement at parking bay.

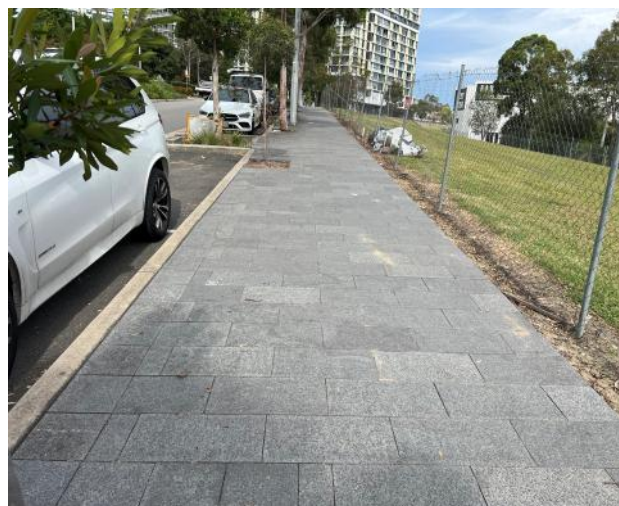
Figure 8 – General view of council footpath.

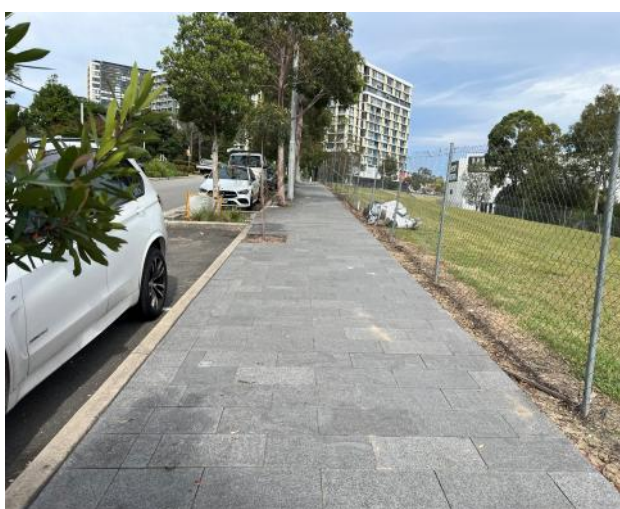
Figure 9 – General view of council footpath, kerb and gutter.

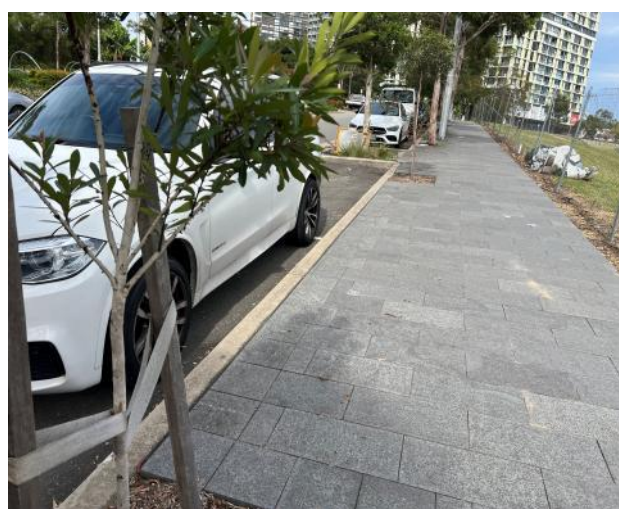
Figure 10 – General view of footpath and kerb.

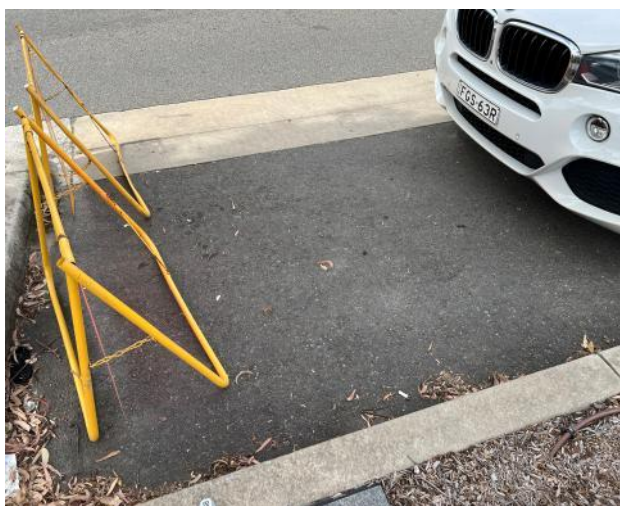
Figure 11 – General view of road pavement at parking bay.

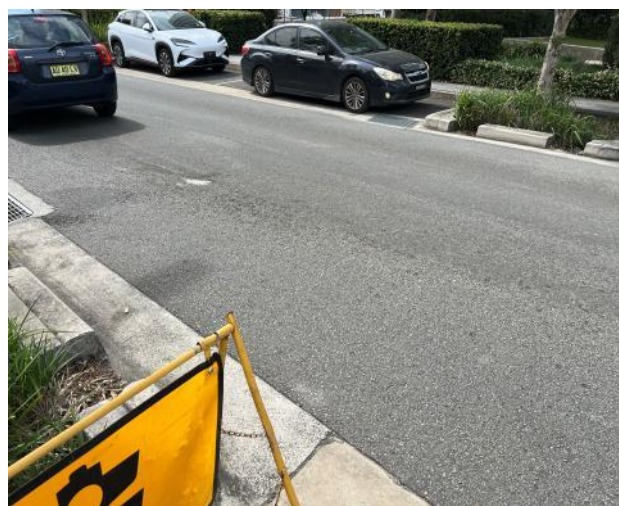
Figure 12 – General view of road pavement.

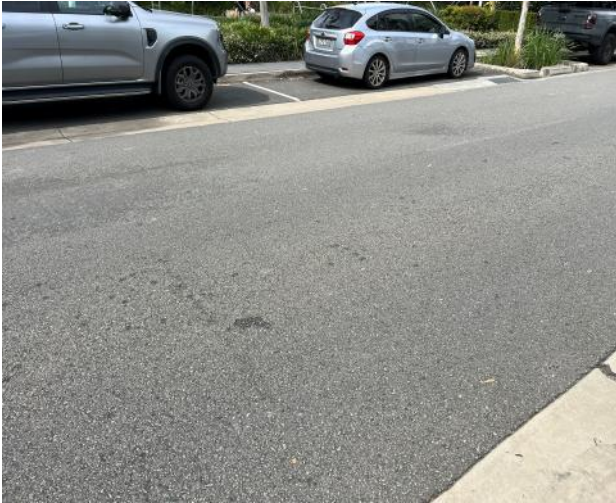
Figure 13 – General view of road pavement.

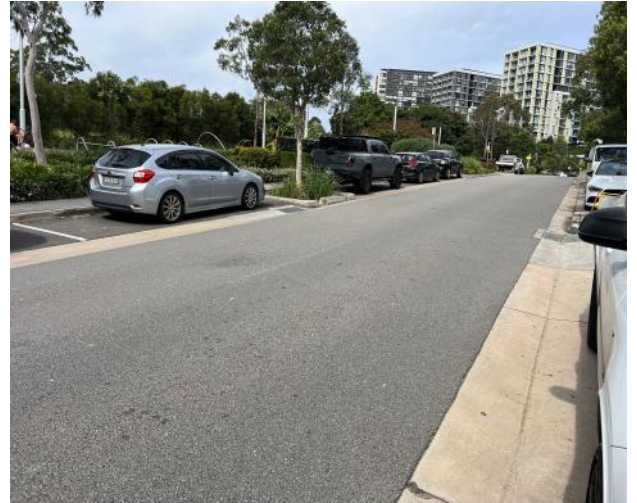
Figure 14 – General view of road pavement.

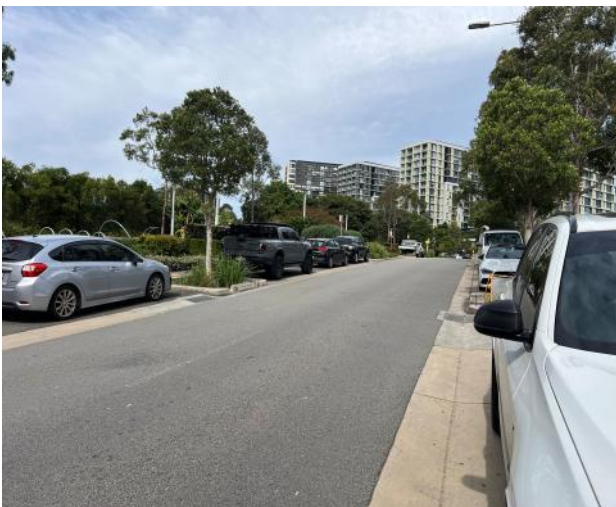
Figure 15 – General view of road pavement.

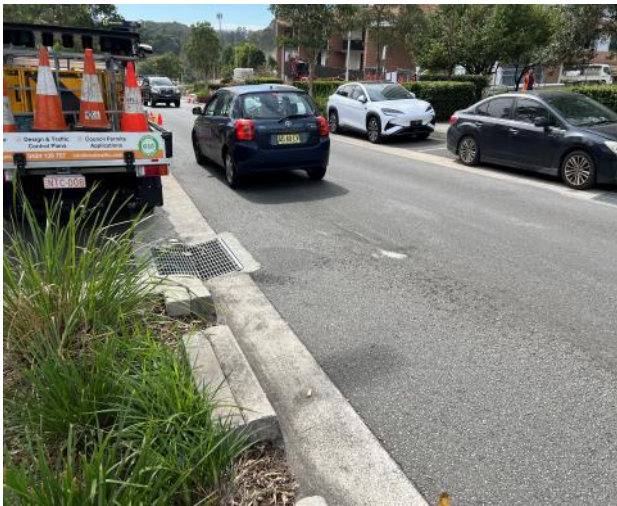
Figure 19 – General view of road pavement.

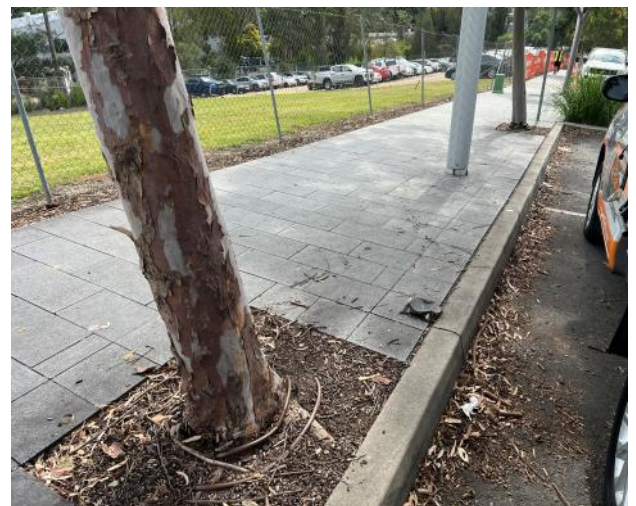
Figure 24 – General view of tree and kerb on council land.

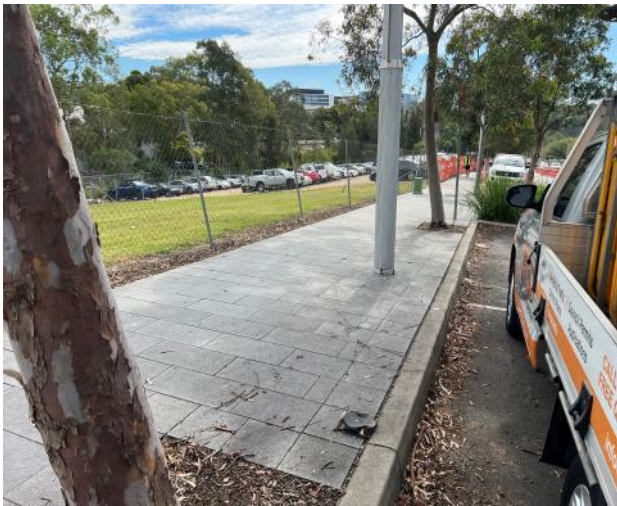
Figure 25 – General view of footpath and power pole.

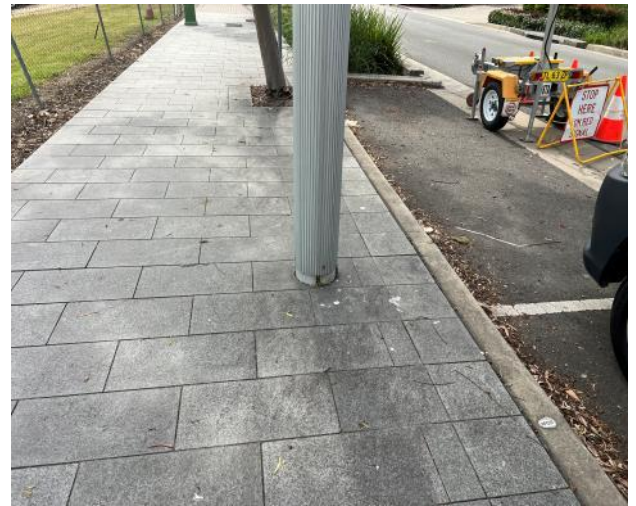
Figure 26 – General view of base of power pole.

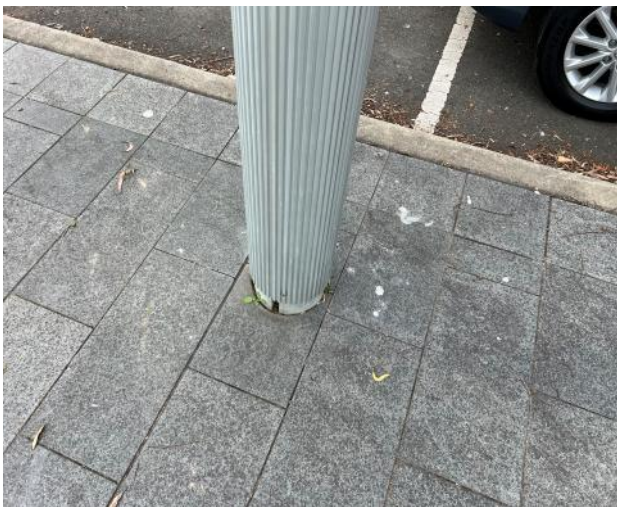
Figure 27 – General view of base of power pole.

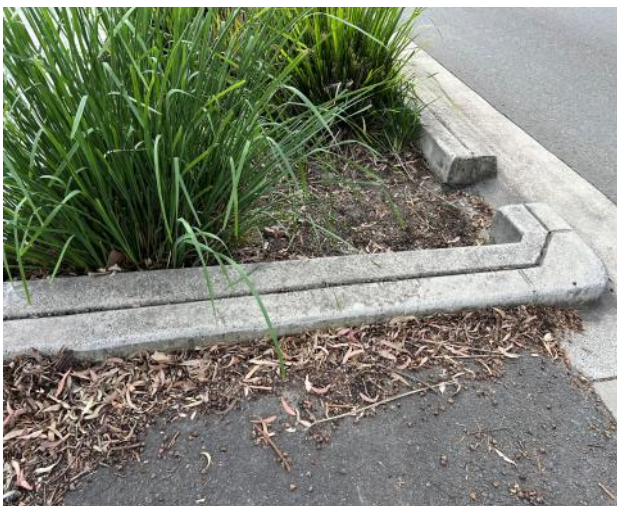
Figure 29 – Current condition of kerb around tree/shrub pit.

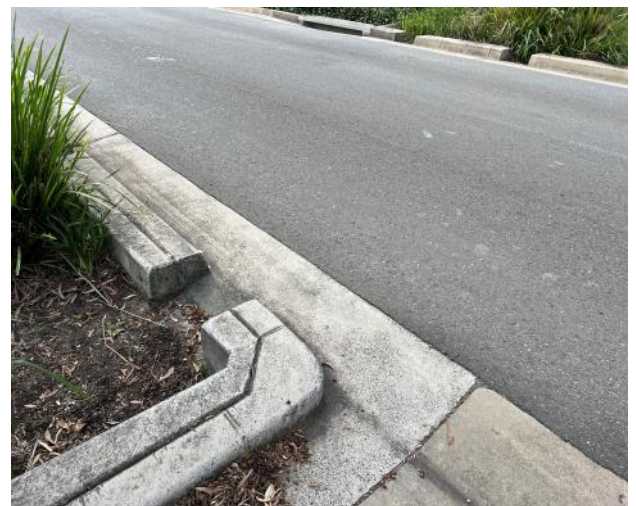
Figure 30 – Current condition of kerb and gutter.

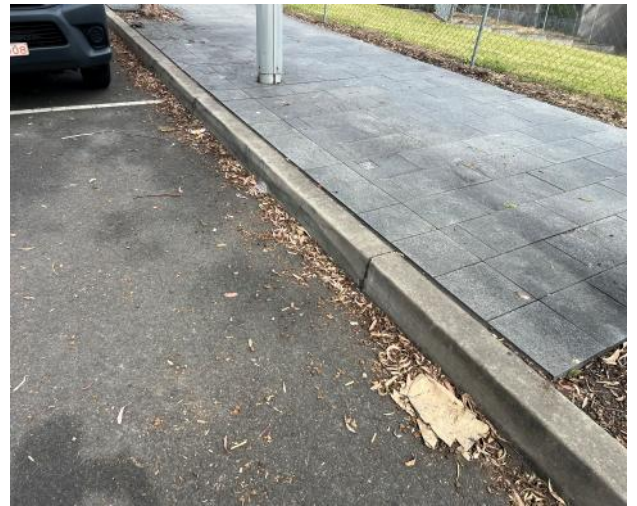
Figure 32 – kerb and council road pavement.

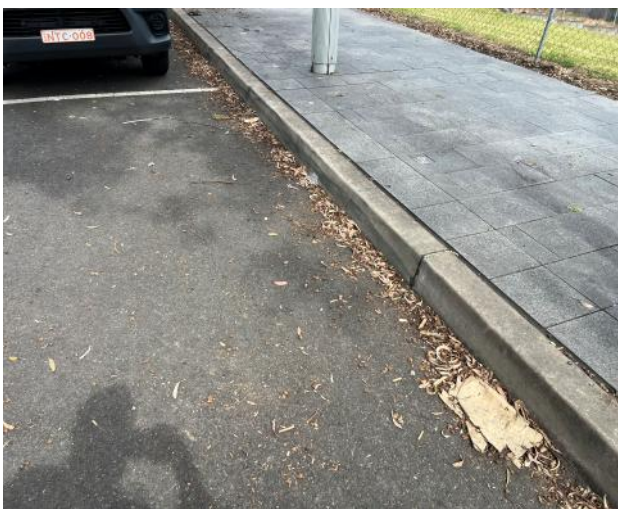
Figure 33 – General view of kerb.

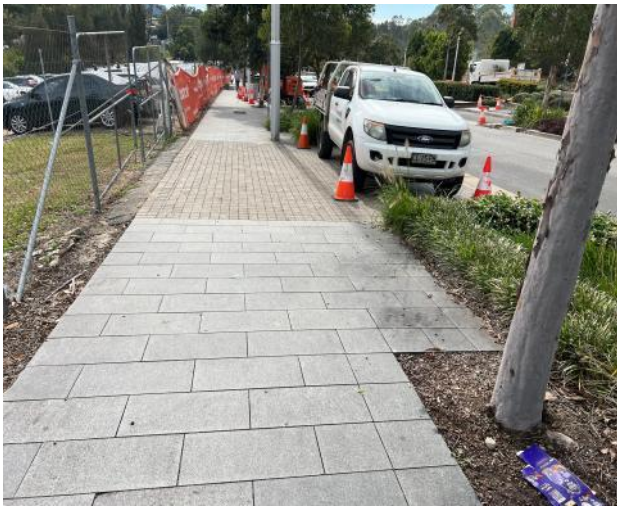
Figure 43 – General view of council footpath.

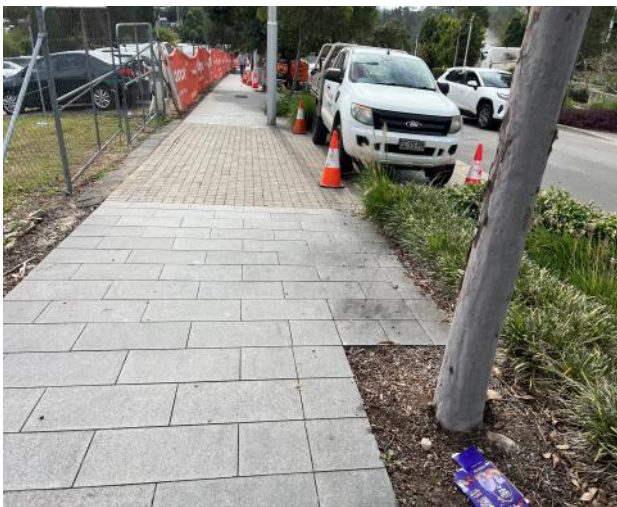
Figure 45 – General view of council footpath.

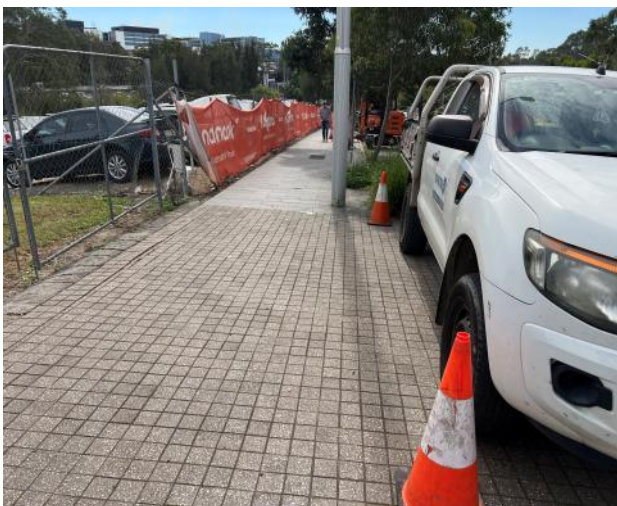
Figure 47 – General view of council footpath.

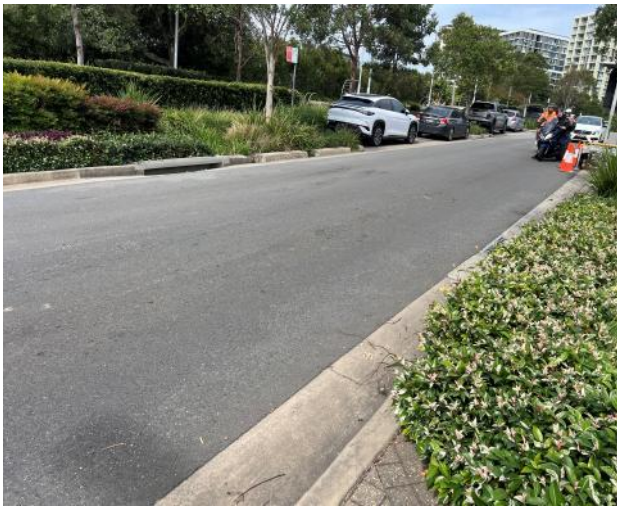
Figure 50 – General view of road pavement.

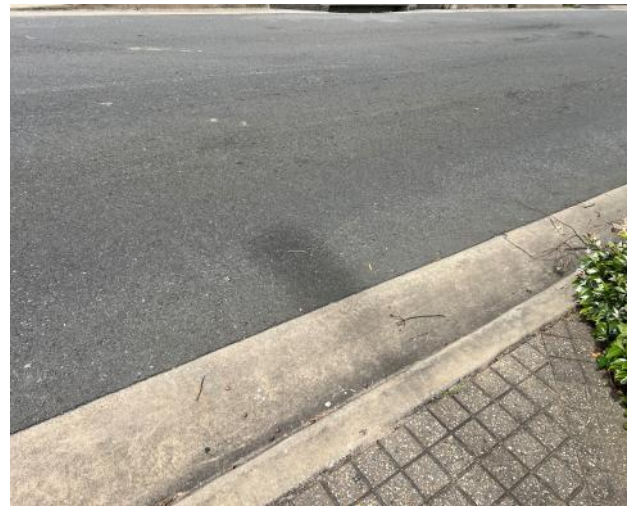
Figure 51 – General view of road pavement. Cracking to gutter.

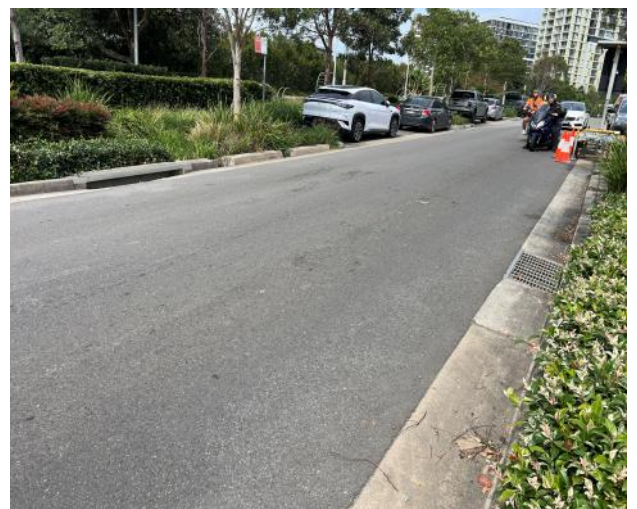
Figure 53 – General view of road pavement.

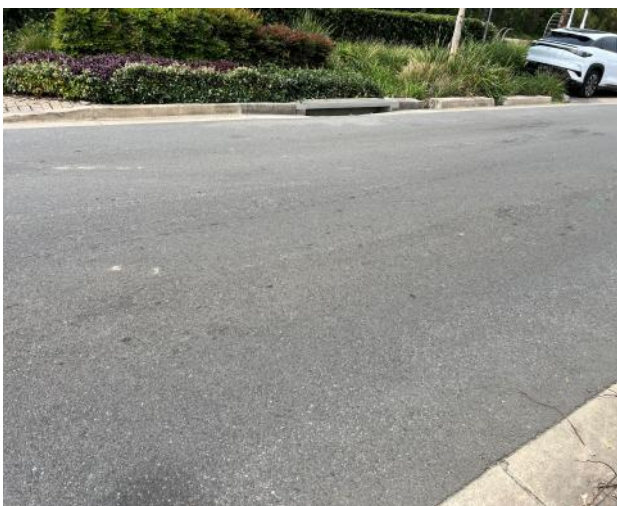
Figure 54 – General view of road pavement.

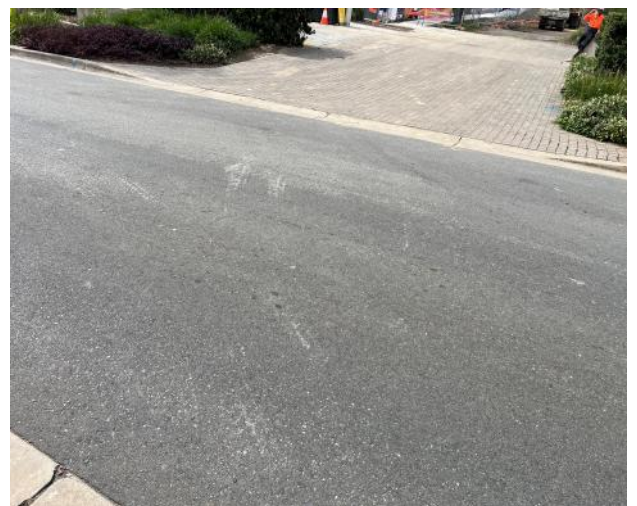
Figure 55 – General view of road pavement. Cracking to gutter.

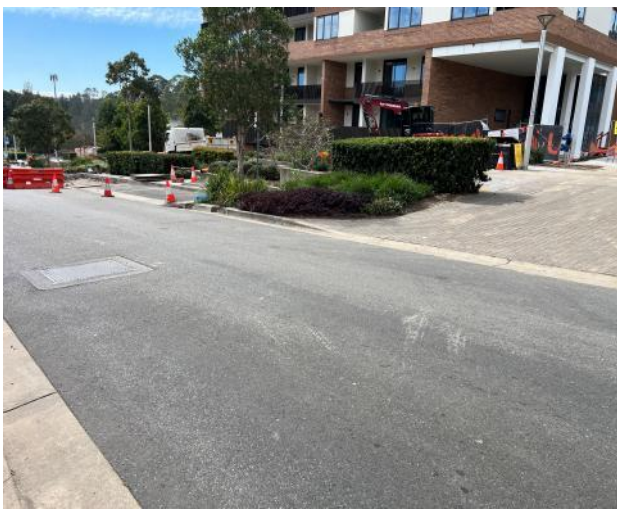
Figure 57 – General view of road pavement.

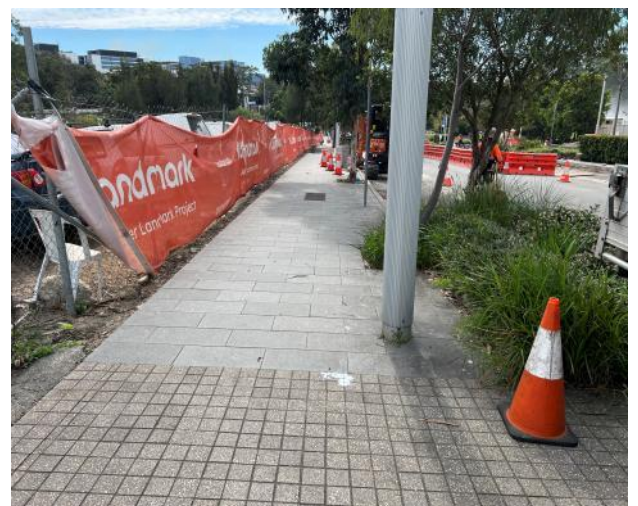
Figure 60 – General view of council footpath.

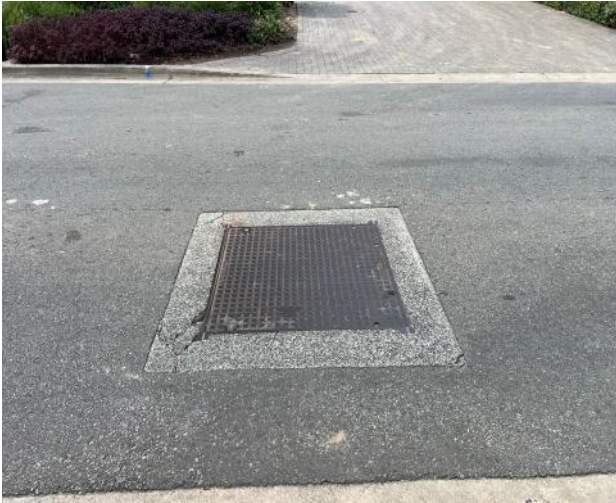
Figure 61 – General view of service pit.

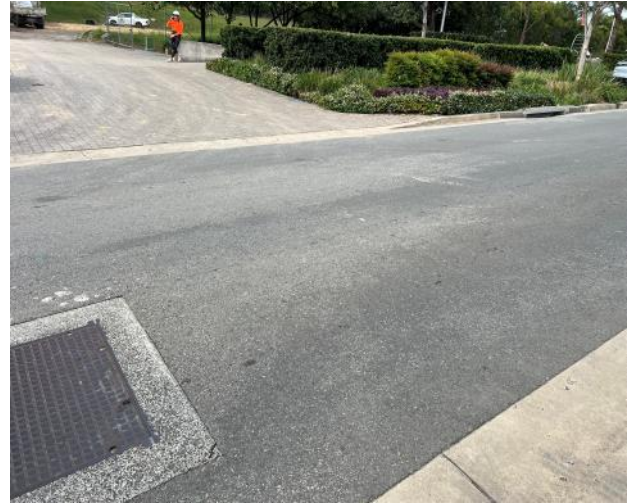
Figure 62 – General view of road pavement.

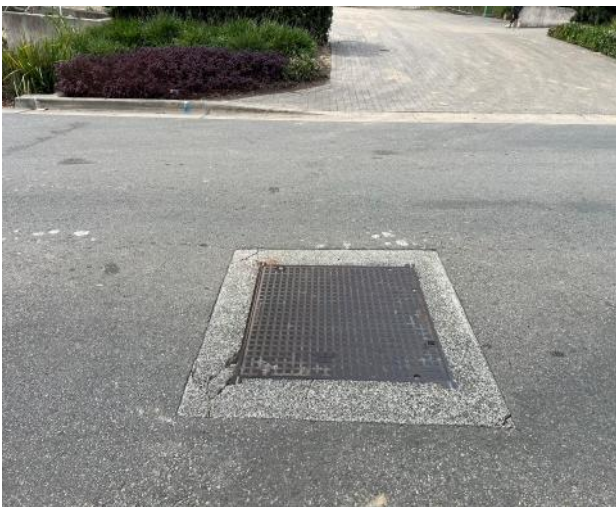
Figure 63 – General view of service pit.

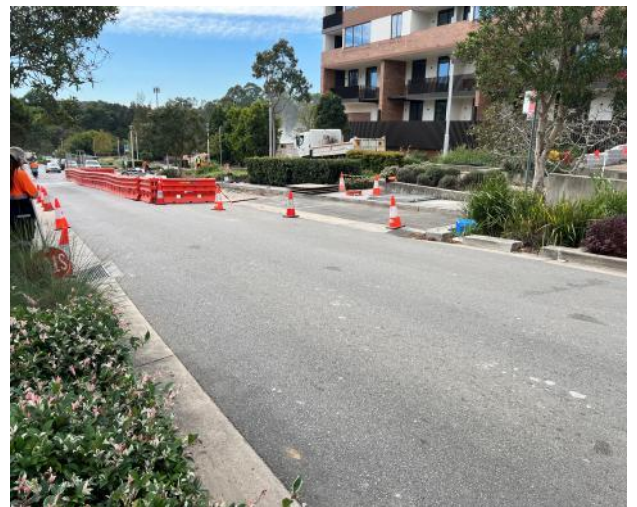
Figure 64 – General view of road pavement.

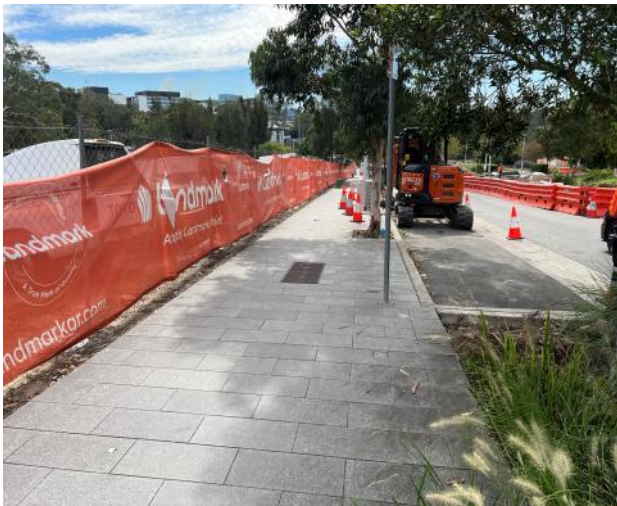
Figure 67 – General view of council footpath.

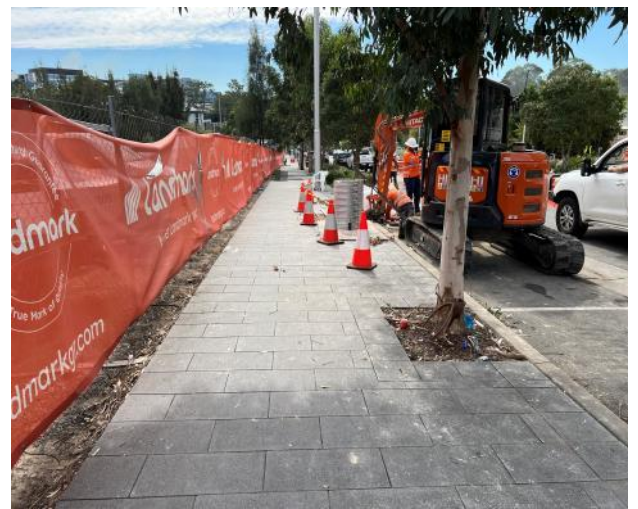
Figure 70 – General view of council footpath.

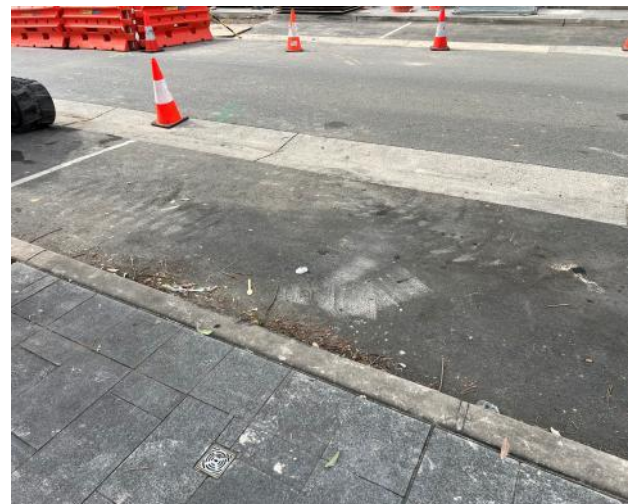
Figure 72 – General view of road pavement.

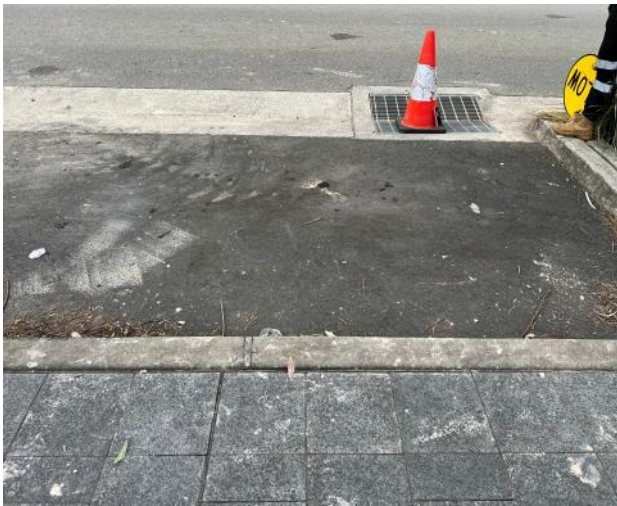
Figure 73 – General view of parking bay.

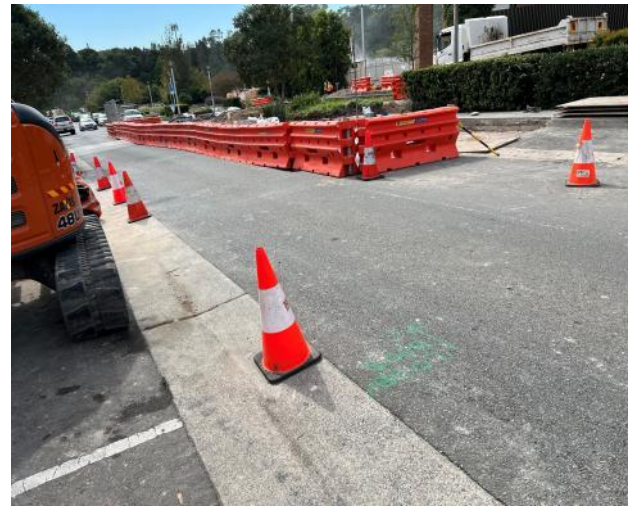
Figure 74 – General view of road pavement.

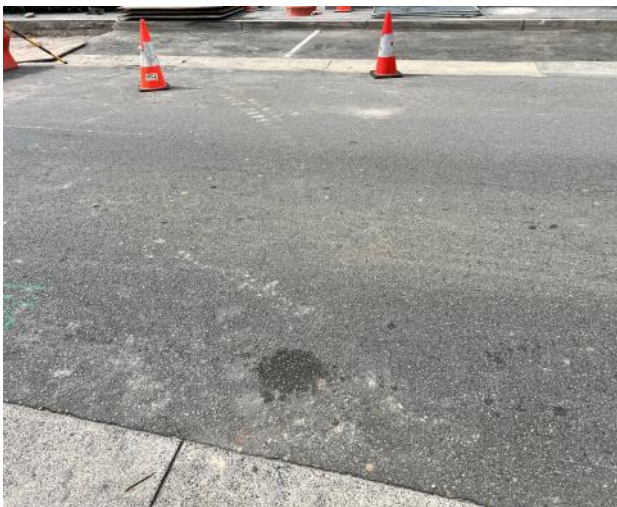
Figure 75 – General view of road pavement.

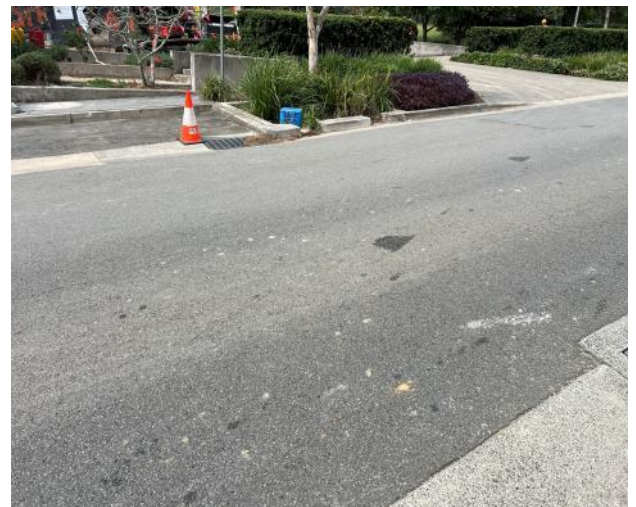
Figure 76 – General view of road pavement.

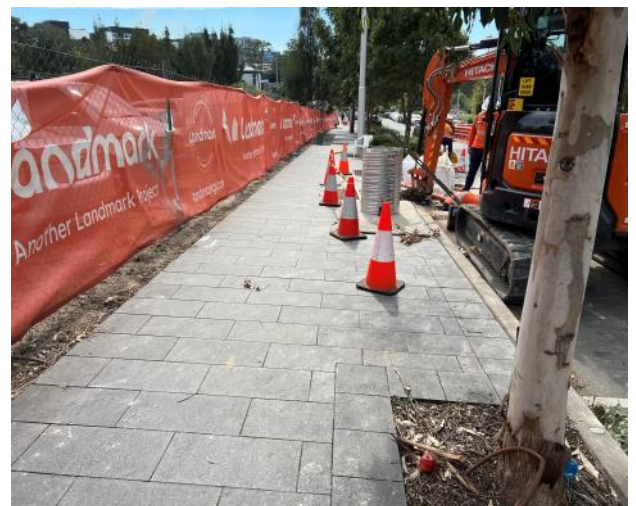
Figure 78 – General view of council footpath.

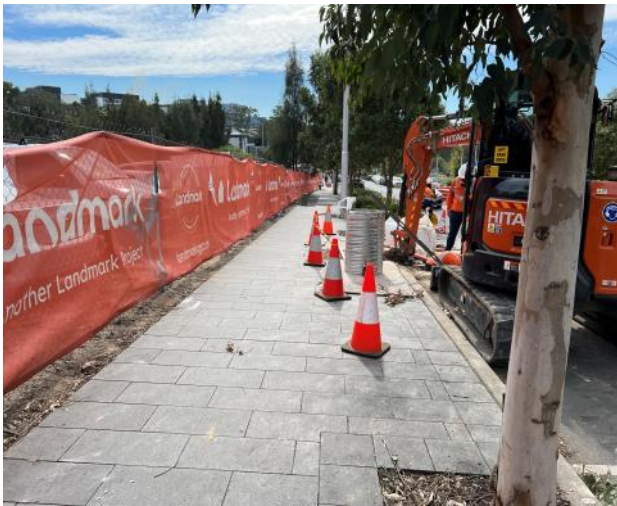
Figure 79 – General view of council footpath.

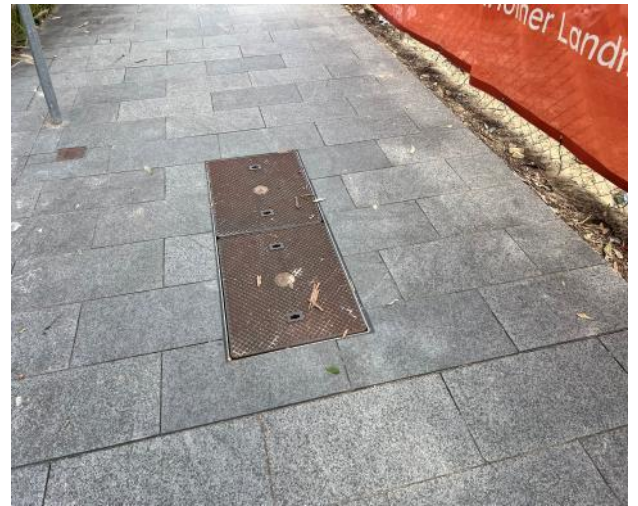
Figure 80 – General view of service pit.

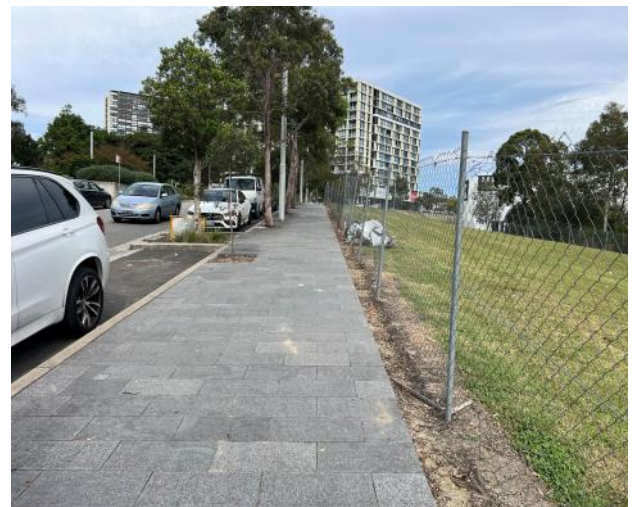
Figure 82 – General view of council footpath.

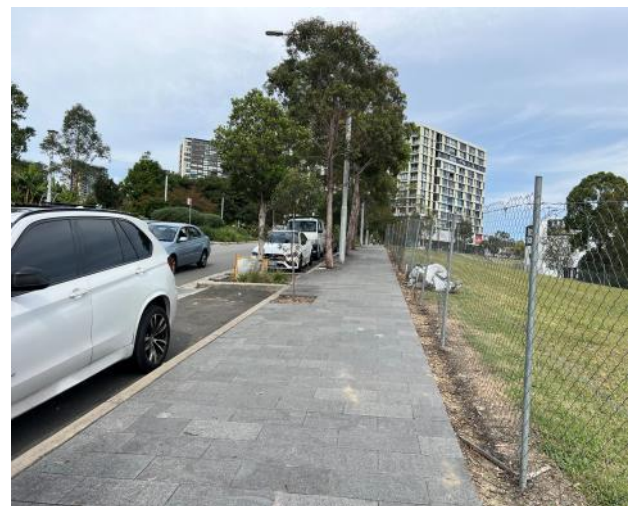
Figure 84 – General view of council footpath.

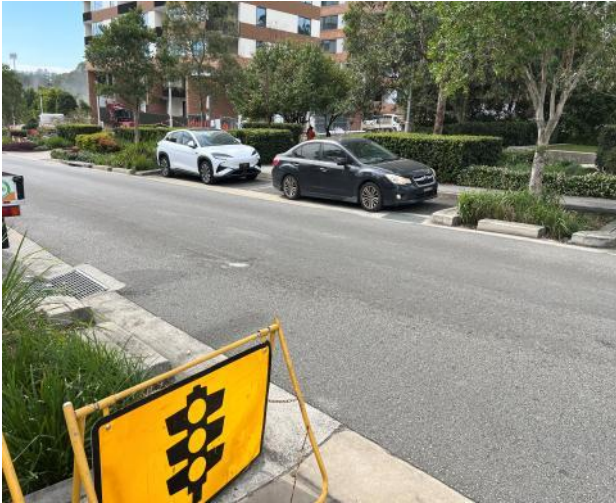
Figure 85 – General view of road pavement.

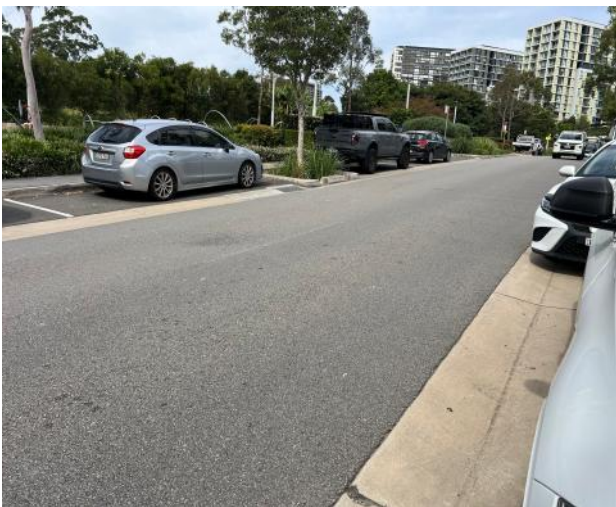
Figure 87 – General view of road pavement.

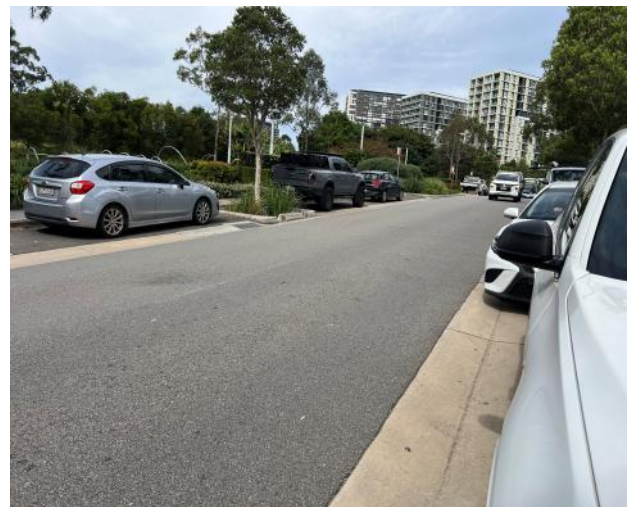
Figure 88 – General view of road pavement.

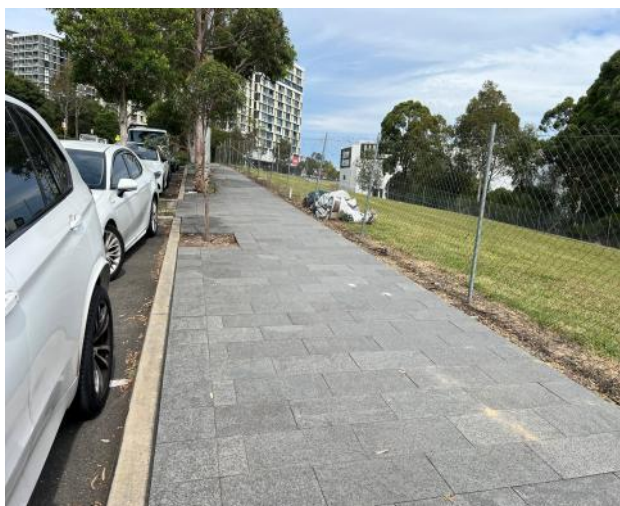
Figure 91 – General view of council footpath.

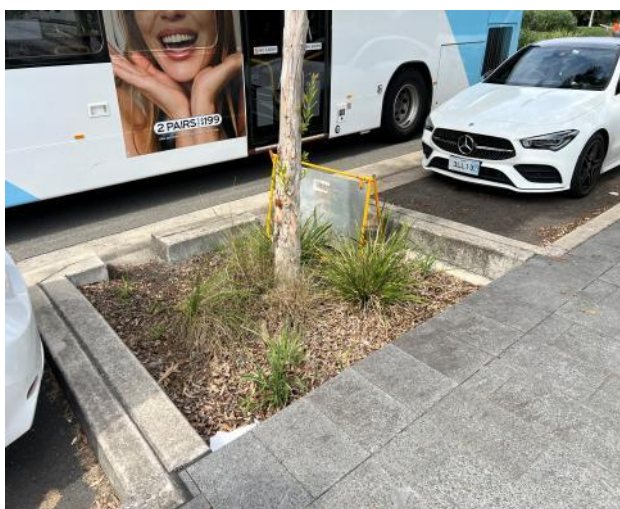
Figure 93 – General view of council tree pit.

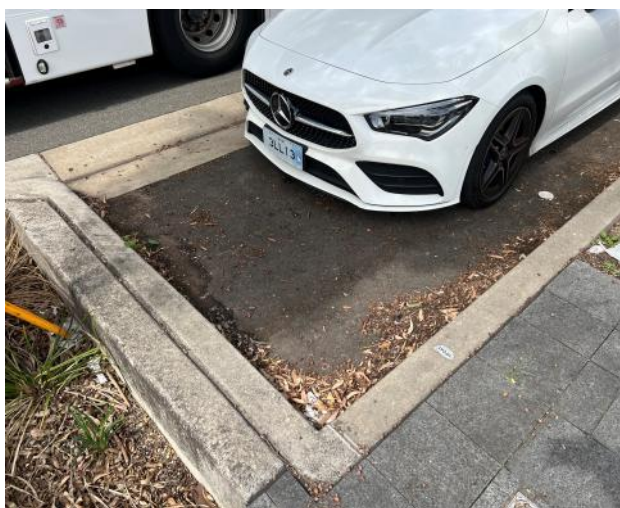
Figure 95 – Kerb and road pavement at parking bay.

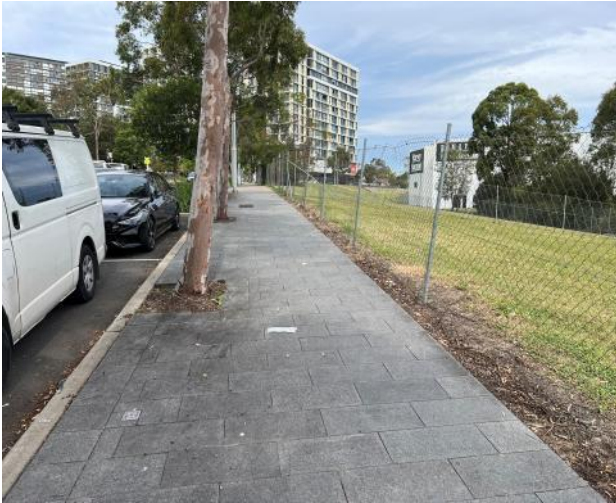
Figure 97 – General view of council footpath.

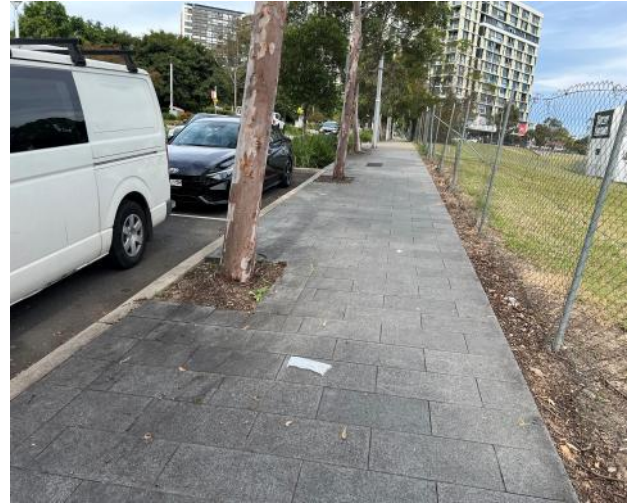
Figure 98 – General view of council footpath.

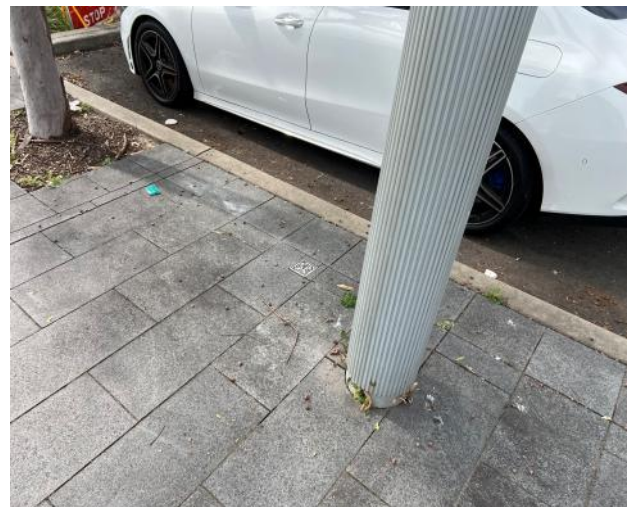
Figure 100 – Power pole on council land.

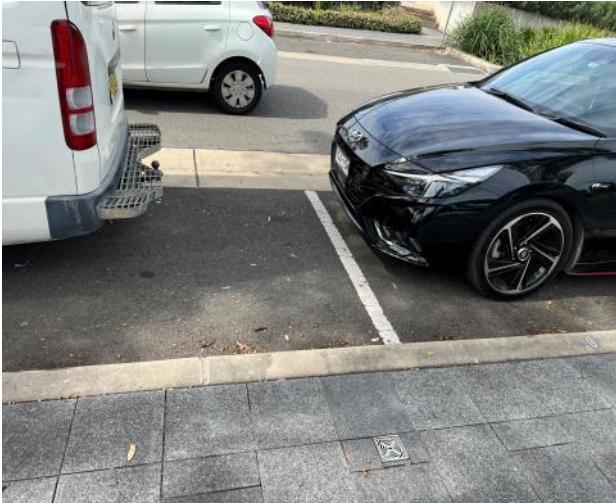
Figure 103 – Parking bay road pavement.

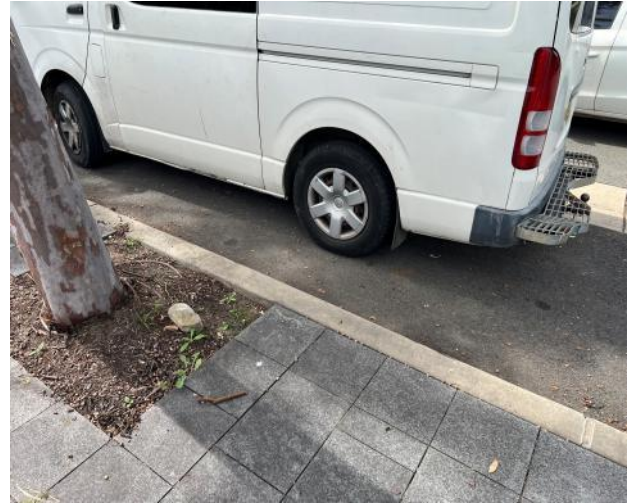
Figure 104 – kerb and road pavement.

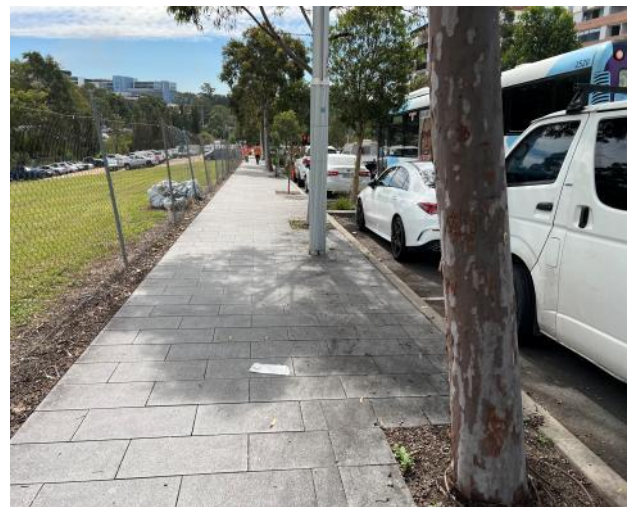
Figure 106 – General view of council footpath.

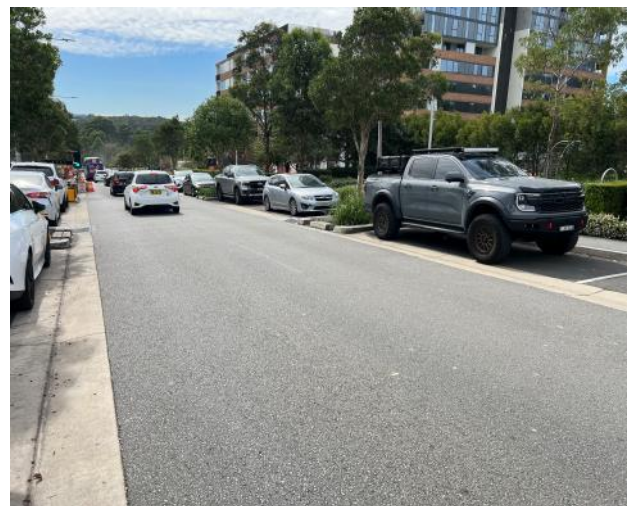
Figure 108 – General view of road pavement.

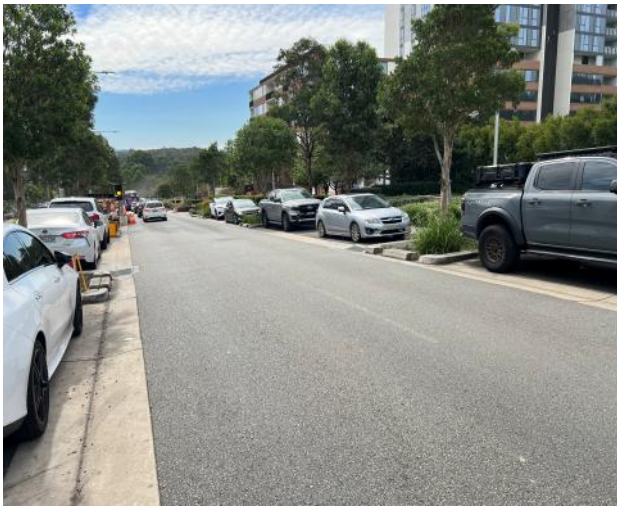
Figure 109 – General view of road pavement.

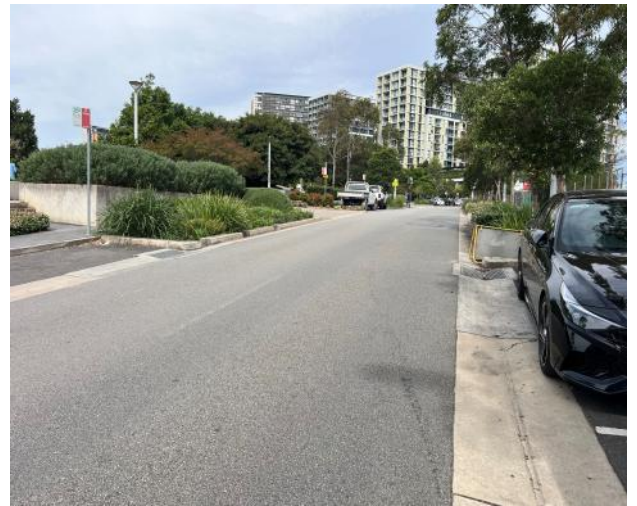
Figure 110 – General view of road pavement.

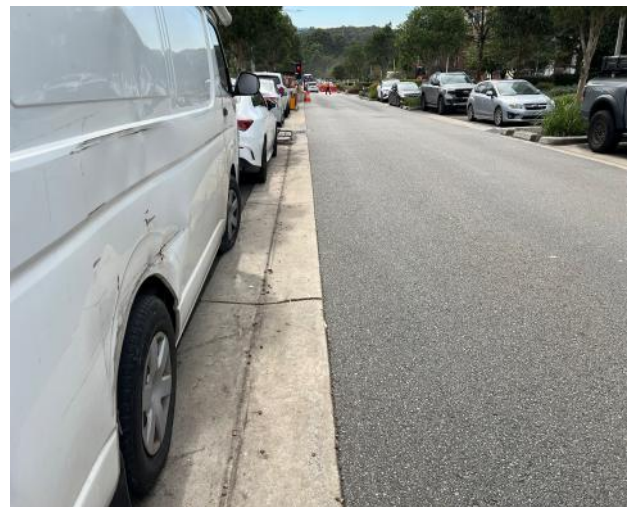
Figure 112 – General view of road gutter.

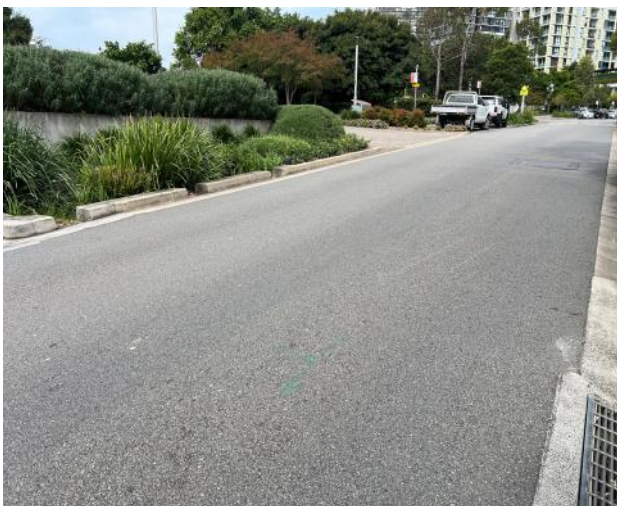
Figure 113 – General view of road pavement.

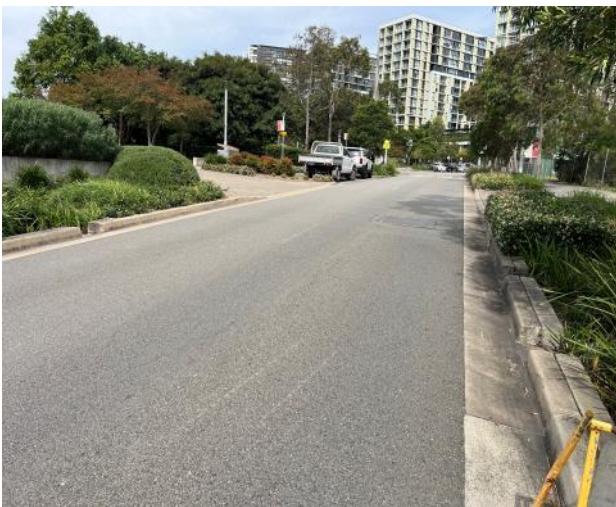
Figure 117 – General view of road pavement.

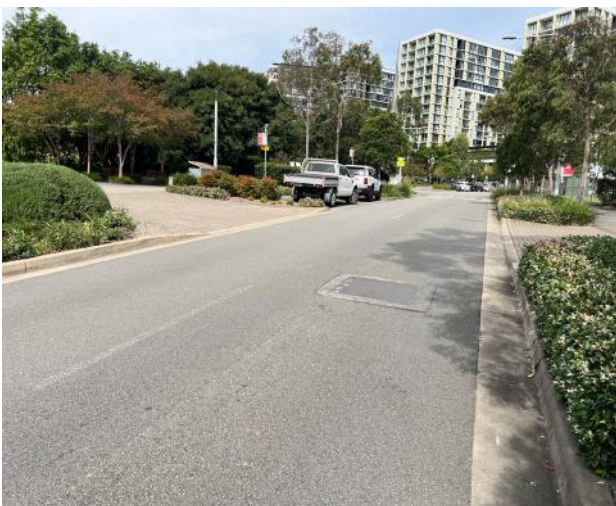
Figure 119 – General view of road pavement.

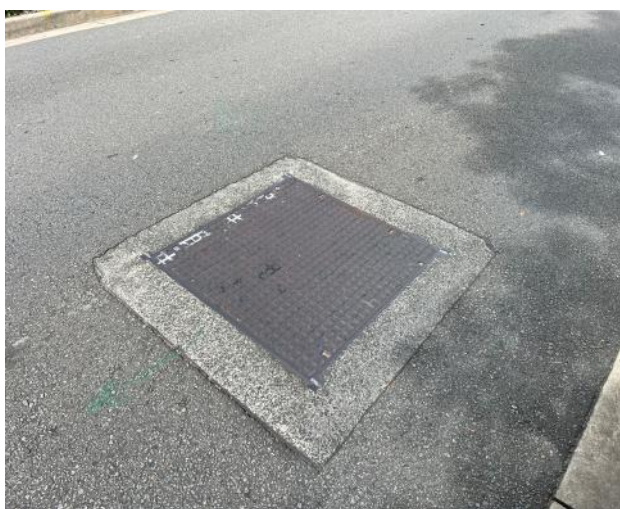
Figure 123 – Service pit in road pavement.

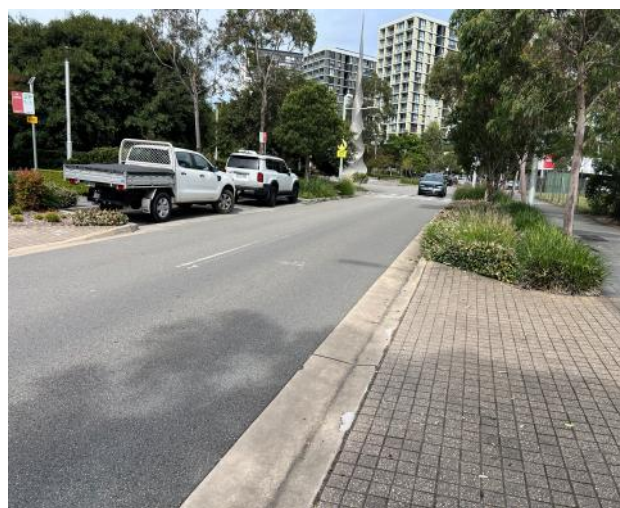
Figure 126 – General view of road pavement.

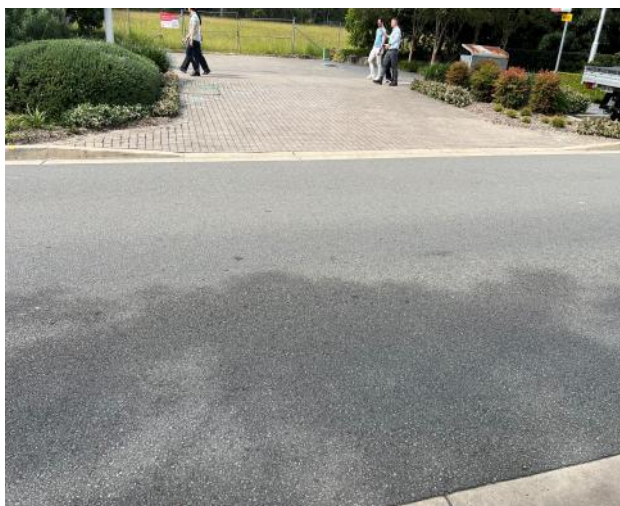
Figure 127 – General view of road pavement.

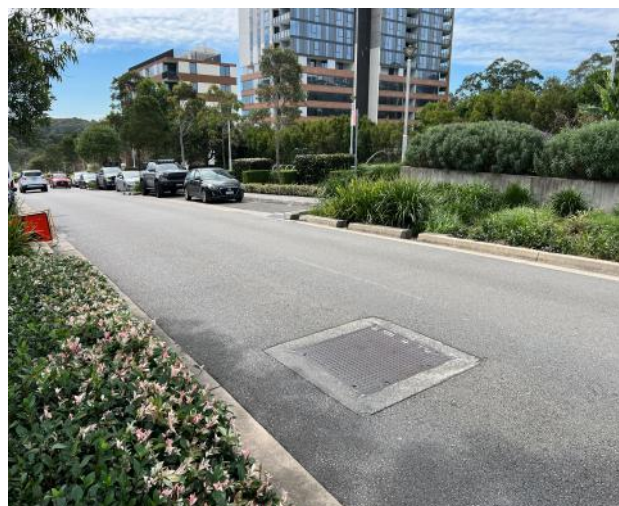
Figure 128 – General view of road pavement and service pit.
