# **PRE-CONSTRUCTION CONDITION SURVEY (DILAPIDATION REPORT)**

**REPORT NUMBER:** S26211301 - 001

**PROJECT:** 6 Halifax Street, Macquarie Park NSW 2113

**INSPECTION DATE:** 17<sup>th</sup> April 2026

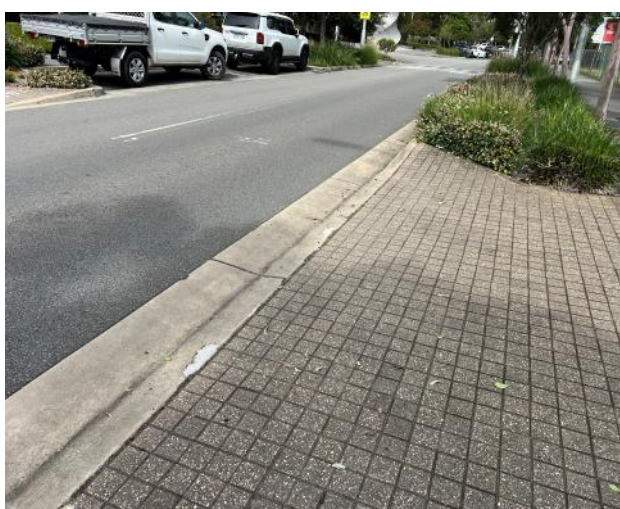
Figure 129 – General view of road pavement, kerb and gutter.

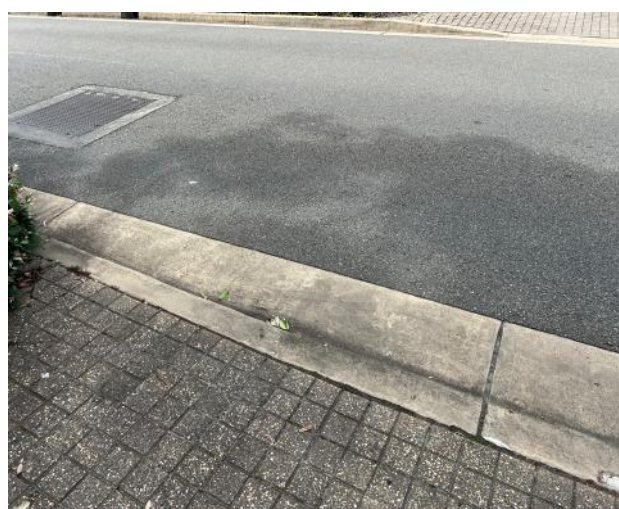
Figure 130 – General view of road pavement, kerb and gutter.

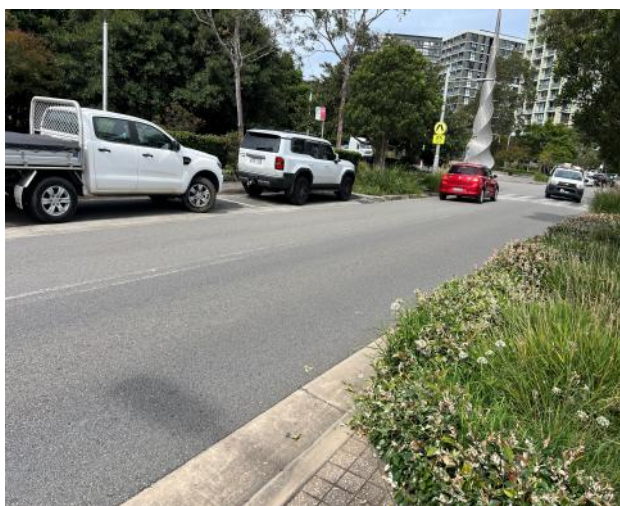
Figure 131 – General view of road pavement.

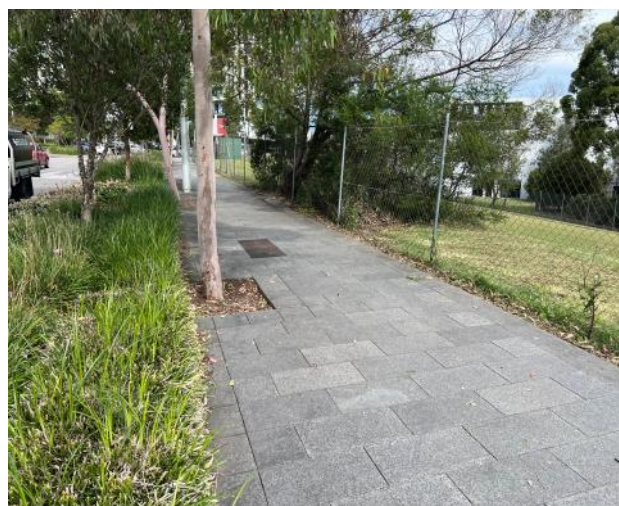
Figure 132 – General view of council footpath.

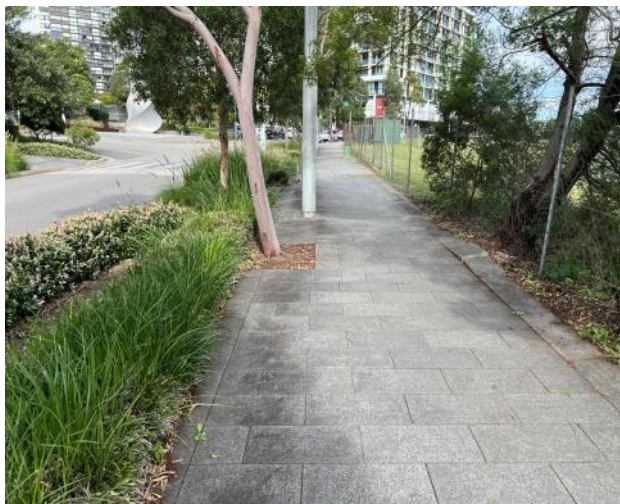
Figure 133 – General view of council footpath.

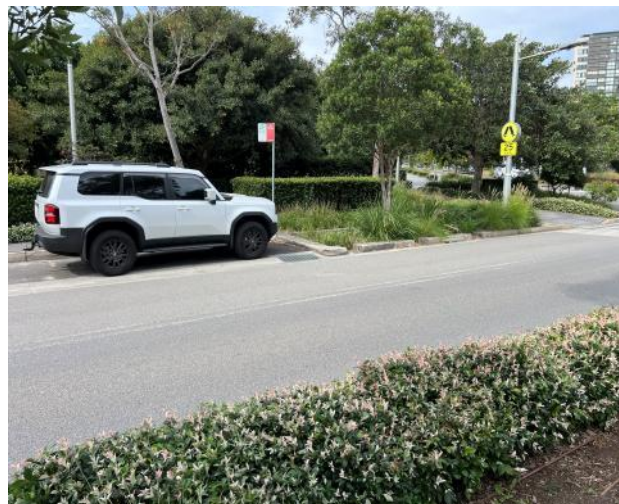
Figure 134 – General view of road pavement.

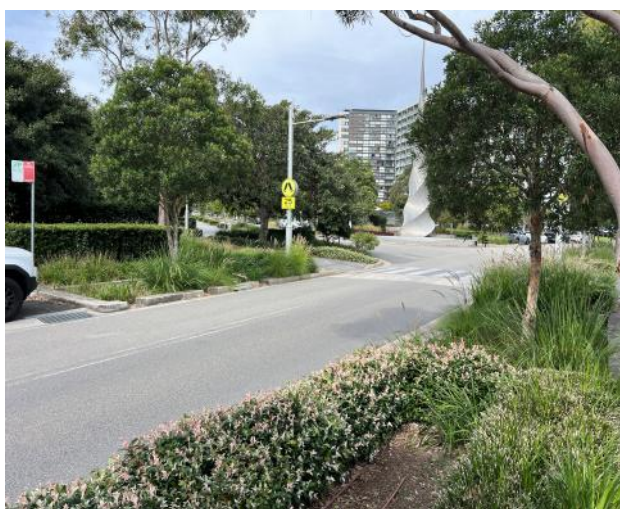
Figure 135 – General view of road pavement.

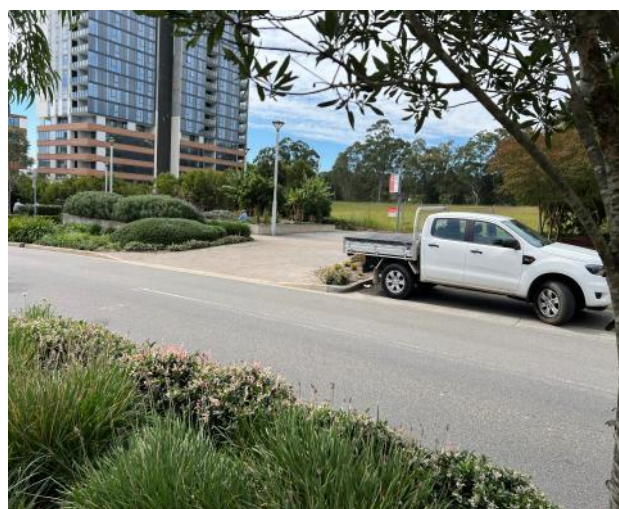
Figure 136 – General view of road pavement.

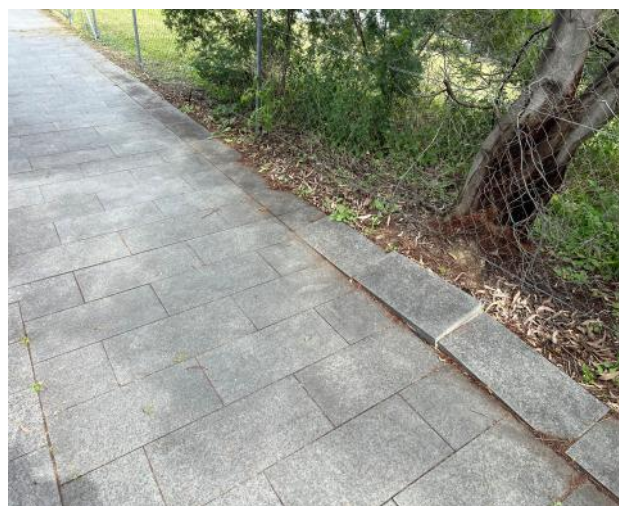
Figure 138 – General view of council footpath.

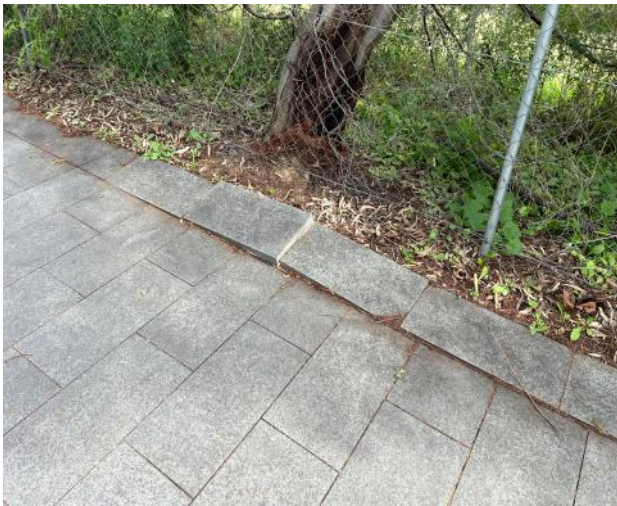
Figure 139 – General view of council footpath.

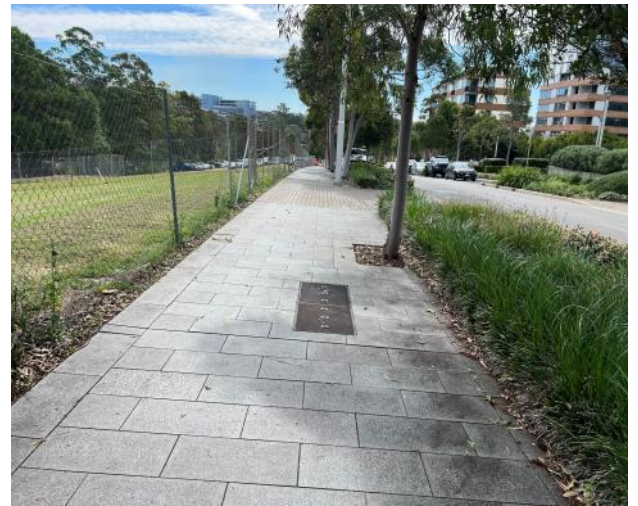
Figure 140 – General view of council footpath.

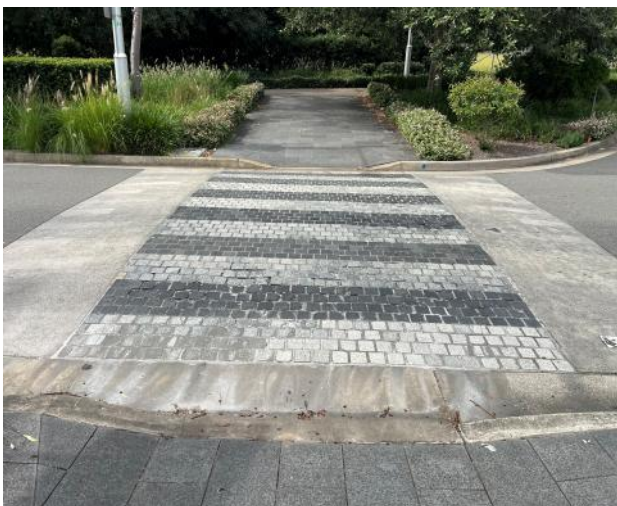
Figure 143 – General view of road crossing.

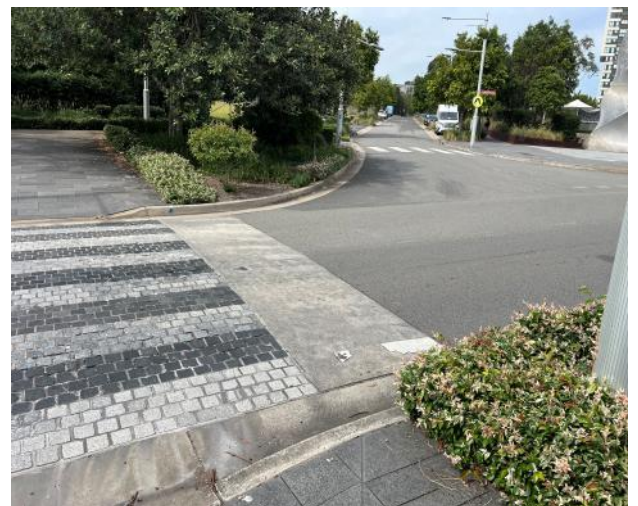
Figure 144 – General view of road crossing.

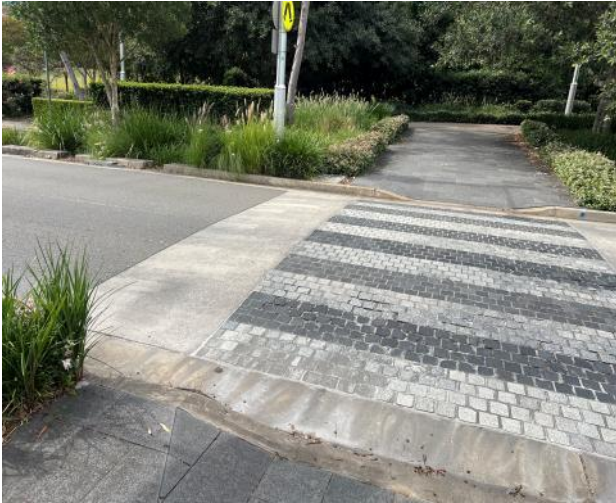
Figure 145 – General view of road crossing.

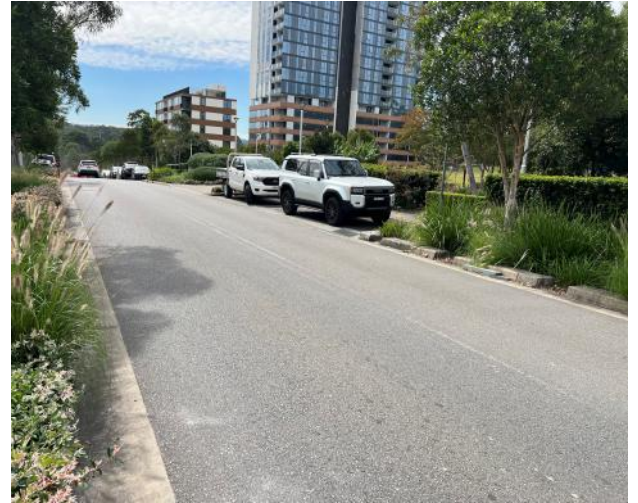
Figure 146 – General view of road pavement.

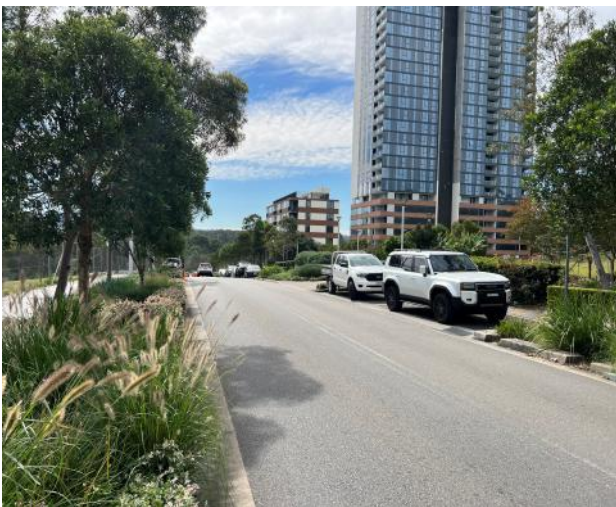
Figure 147 – General view of road pavement.

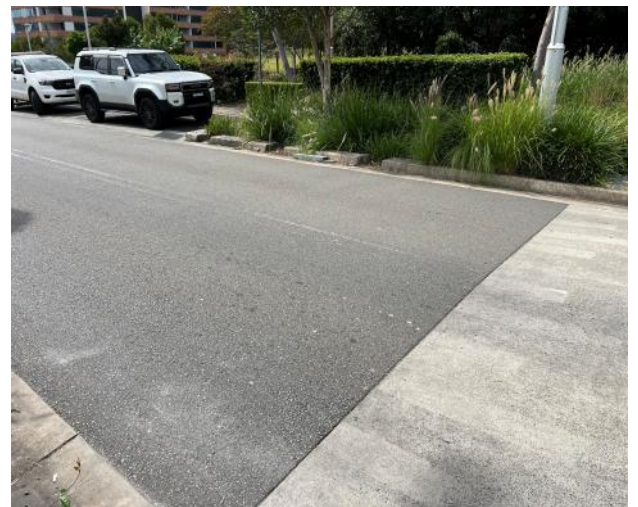
Figure 148 – General view of road pavement.

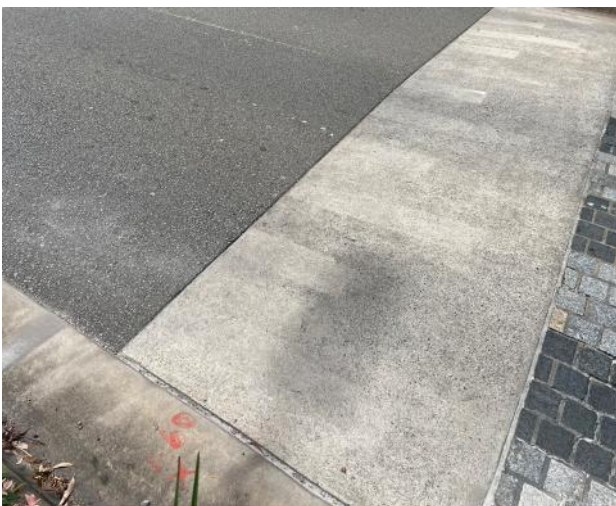
Figure 149 – General view of road pavement.

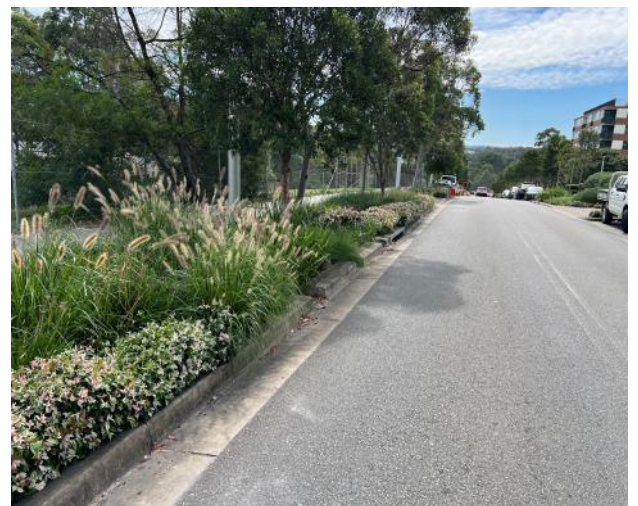
Figure 150 – General view of road pavement, kerb and gutter.

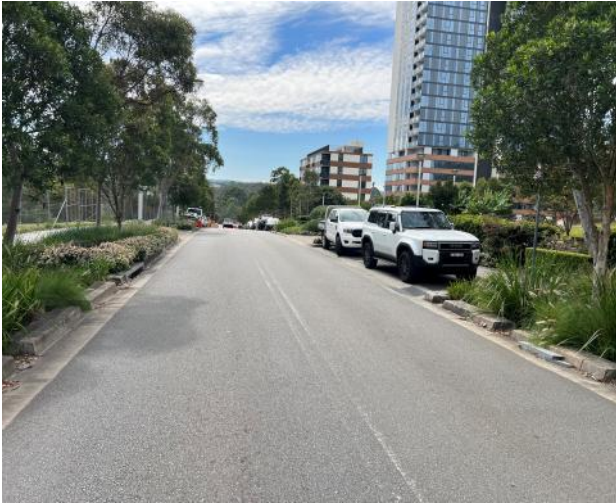
Figure 151 – General view of road pavement.

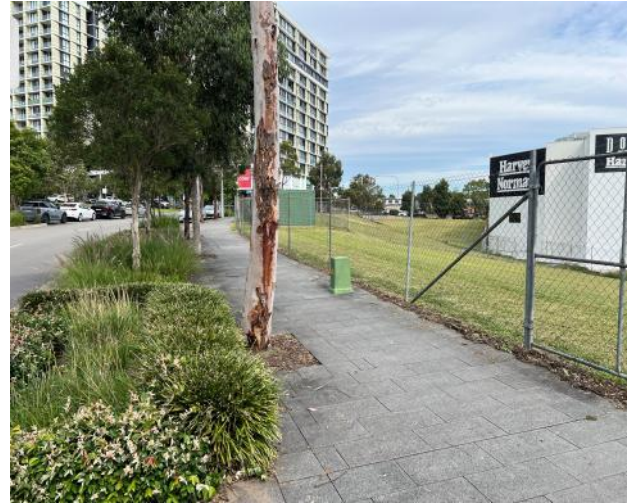
Figure 152 – General view of road pavement.
