APPENDIX M
Gostwyck Bridge Report

Daracon Group
Gostwyck Bridge BN1461
Summary Strategic Report

Revision 1

November 2020

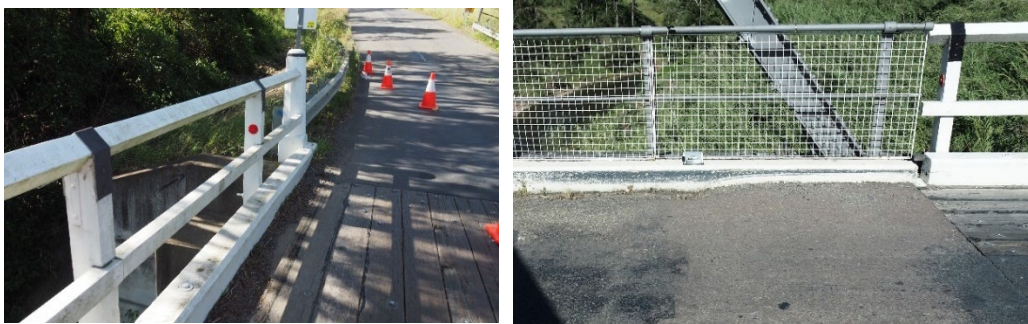
Figure 4-1 Gostwyck bridge timber and steel barriers (Source: FBE)

The steel barrier was rated as being in “good” condition and the timber barrier as being in “as-built” condition in the TfNSW 17 July 2017 Level 2 (L2) inspection.

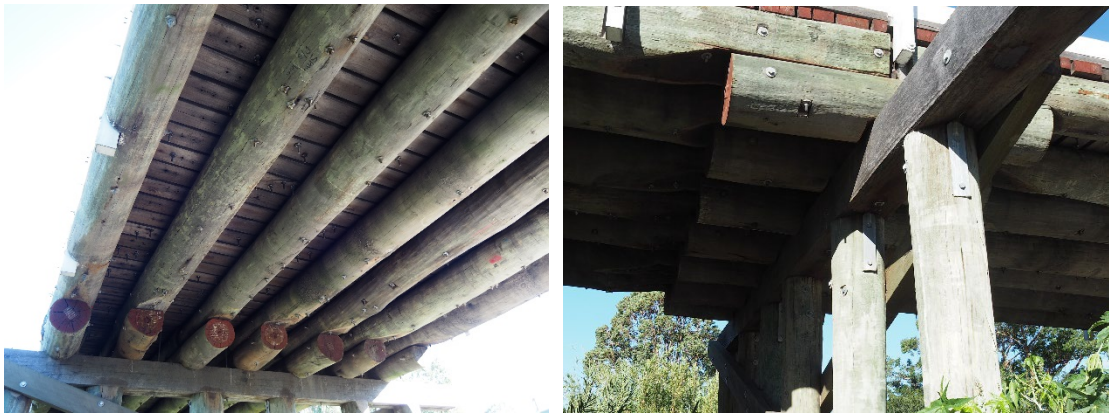
Figure 4-11 Typical condition of timber girders (Source: FBE)

TfNSW has rated the timber girders as being in “as-built” condition.

The timber corbels, seen in the right image in Figure 4-11, have been rated as being in “good” condition by TfNSW.

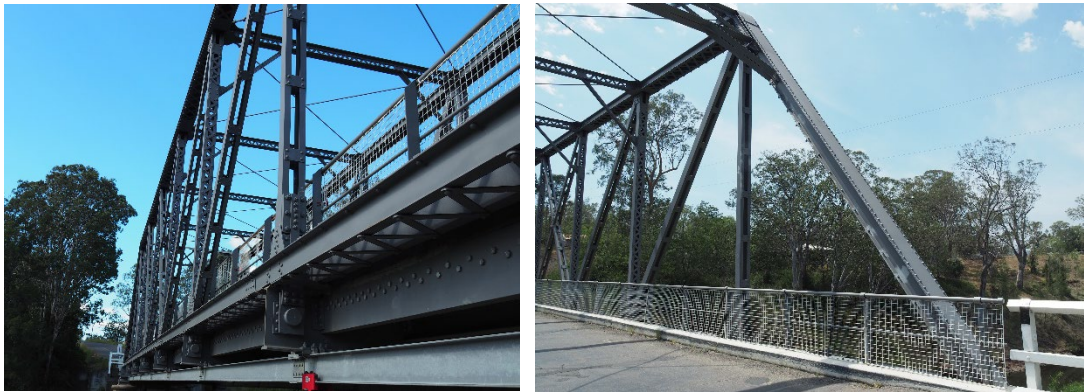
Figure 4-13 Steel Pratt truss span (Source: FBE)

The steel truss has been recently painted and has been rated by TfNSW in the July 2017 L2 inspection as being in “as-built” condition. There were no observed areas of damage or corrosion on the truss.

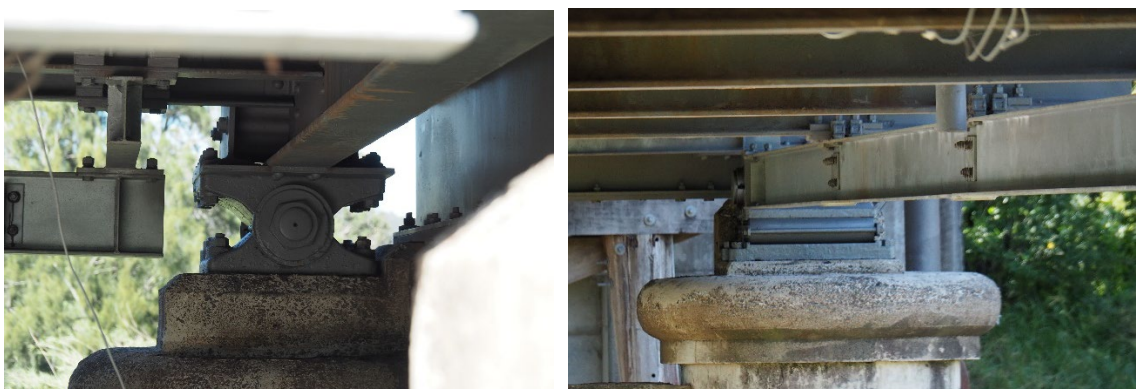
Figure 4-18 Typical condition of steel span bearings (Source: FBE)

The steel truss span has fixed bearings at Pier 4 and expansion bearings at Pier 5. These are shown as the left and right images respectively in Figure 4-18.

Both sets of bearings were listed as being in “good” condition in the July 2017 L2 inspection report.

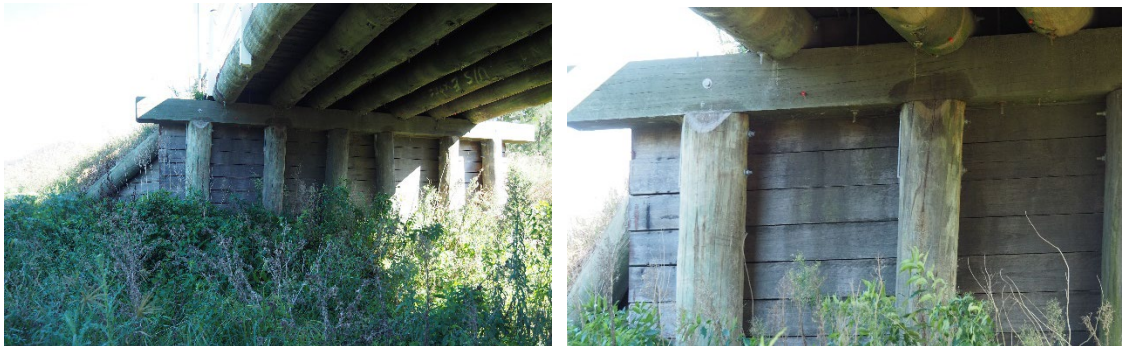
Figure 4-19 Timber abutment (Source: FBE)

The timber abutment, headstock and sheeting are identified as being in “as-built” condition by the July 2017 L2 inspection. These elements are shown in Figure 4-19.

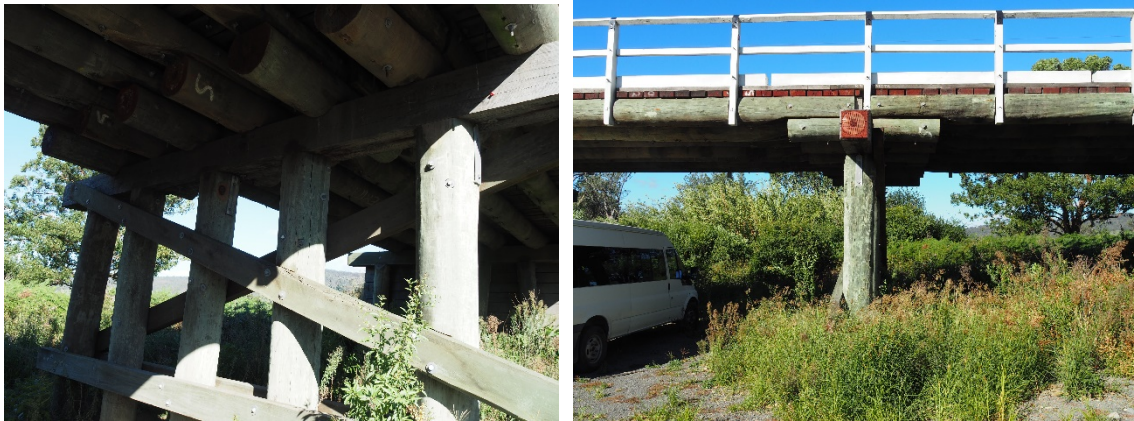
Figure 4-21 Typical condition of Piers 1 to 3 (Source: FBE)

The timber piers on the Paterson side of the bridge are observed as being in “as-built” condition in the 2017 L2 inspections. Typical pier conditions are shown in Figure 4-21.

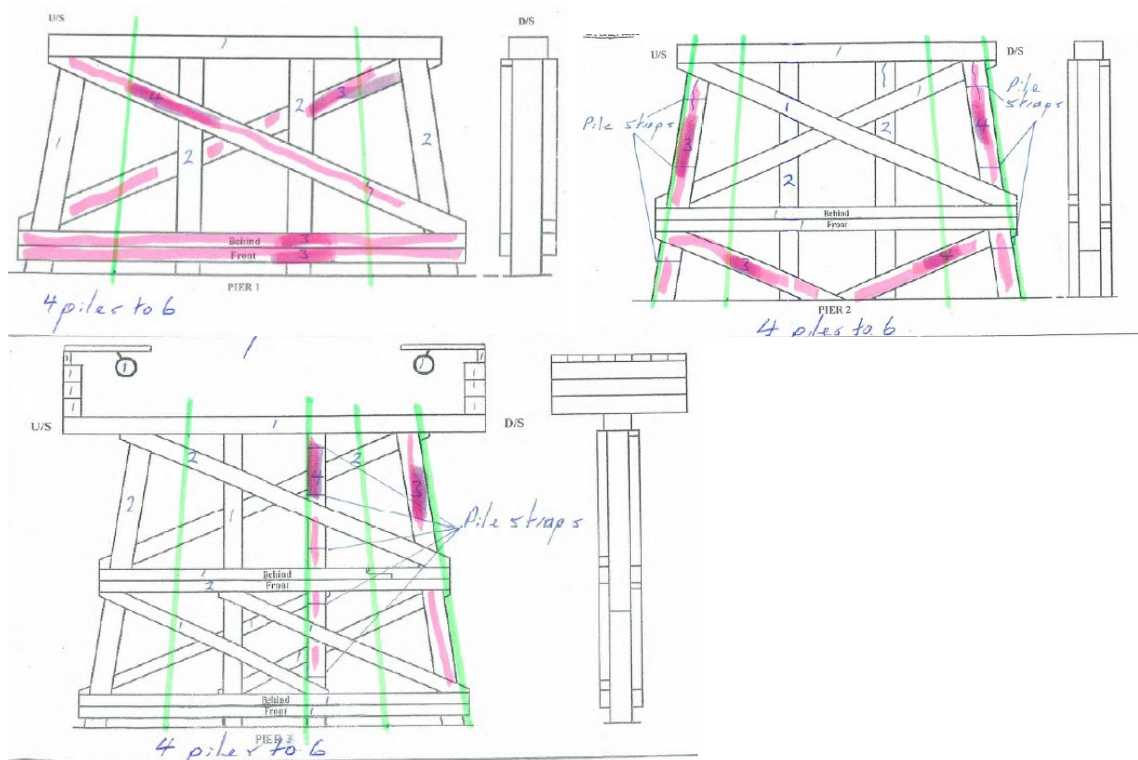
Figure 4-22 Timber pier rehabilitation for Pier 1 to 3 excerpt (Source: TfNSW)

The number of piles per pier on the Paterson side of the bridge has been increased from 4 to 6 for each pier. This is shown in Figure 4-22 which is an extract from the Supplementary Review of Environment Factors February 2014 supplied to FBE by TfNSW.

Figure 4-22 shows in green where the new timber piles have been installed on these piers, and where deteriorated timber has been replaced.

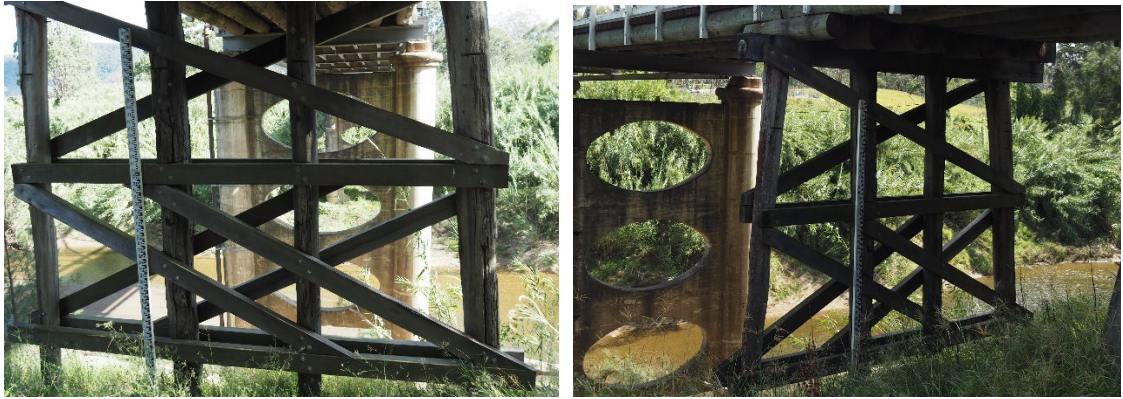
Figure 4-23 **Typical condition of Pier 6 (Source: FBE)**

The timber piles on the Dungog side of the bridge have not been rehabilitated. This was either due to the poor access on this side of the bridge or these piles were not considered as badly deteriorated as those on the Paterson side of the bridge.

The piles on this pier are not specifically identified in the L2 inspection report as being deteriorated, however two timber piles are listed as being in condition state 2 and two timber piles are listed as being in condition state 3. It can be assumed that this refers to the deteriorated piles on Pier 6.

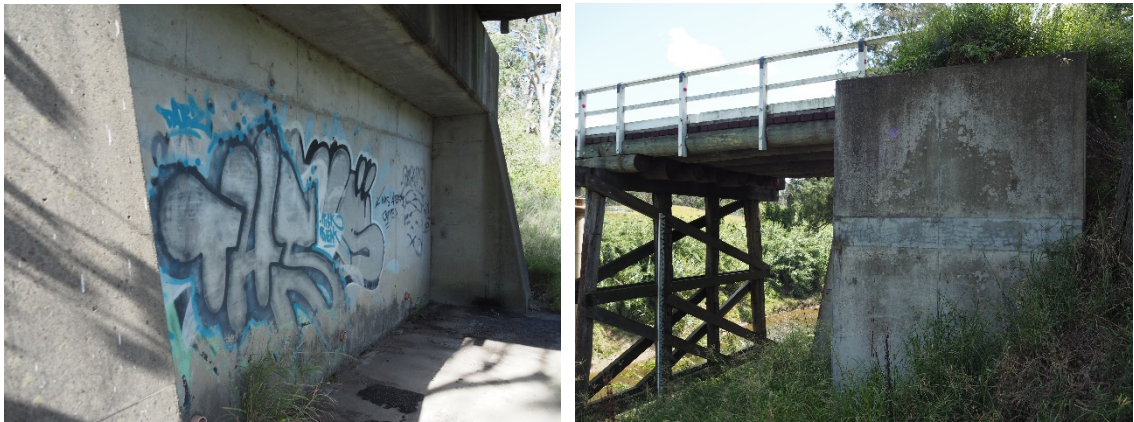
Figure 4-29 Typical condition of Abutment B (Source: FBE)

Abutment B has been replaced with a reinforced concrete structure. The 2017 L2 inspection lists both the concrete abutment and wingwalls as being in “as-built” condition. Figure 4-29 shows the general condition of the abutment.

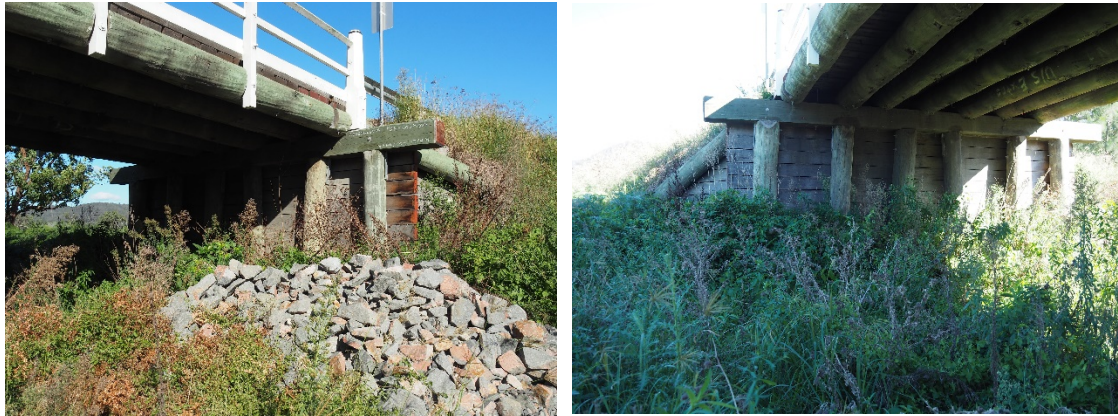
Figure 2-1 Abutment A (Source: FBE)

Abutment A has been modified by the introduction of two additional piles, new headstock, replacement sheeting and repaired wing walls (see Figure 2-1).

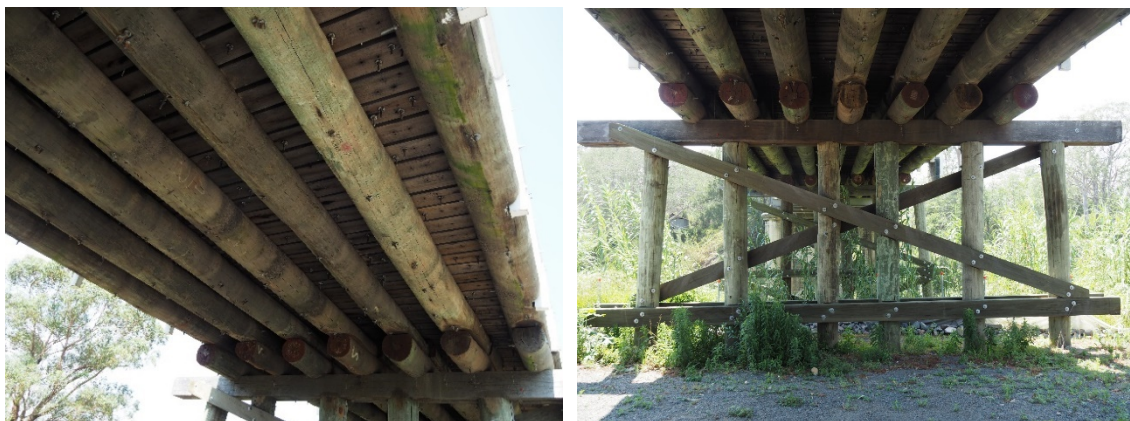
Figure 2-2 Approach spans typical (Source: FBE)

The approach spans have been modified by changing from five girders to seven girders and the piers have been changed from four piles to six piles, the capwales have also been changed to a square headstock (see Figure 2-2).

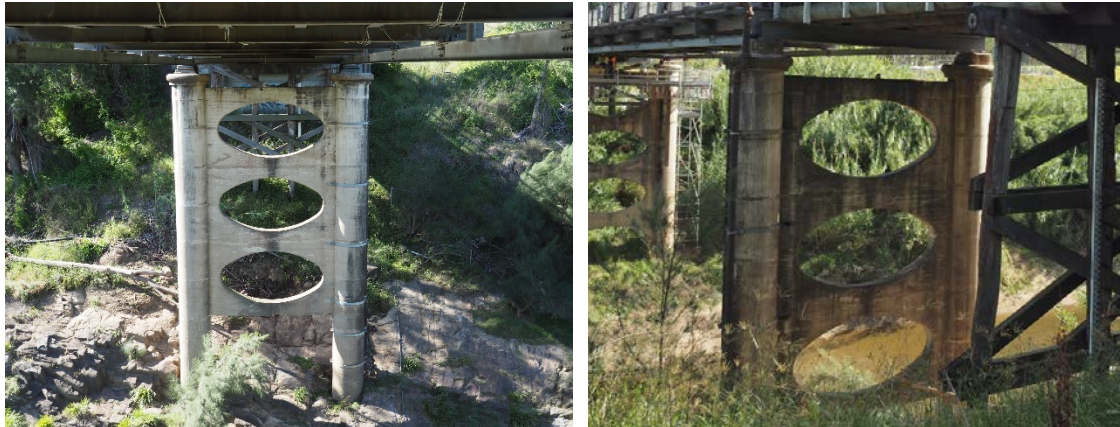
Figure 2-5 Main piers typical views (Source: FBE)

The twin piers are tied together by an oval shaped diaphragm which is relatively uncommon and more complex construction than a simple deep tie beam (see Figure 2-5).

The reinforced concrete piers have technical and aesthetic significance.
