391-423 PACIFIC HIGHWAY, CROWSNEST NSW 2065

PRE-DILAPIDATION REPORT

DEICORP PTY LTD

Job No. 240325.4

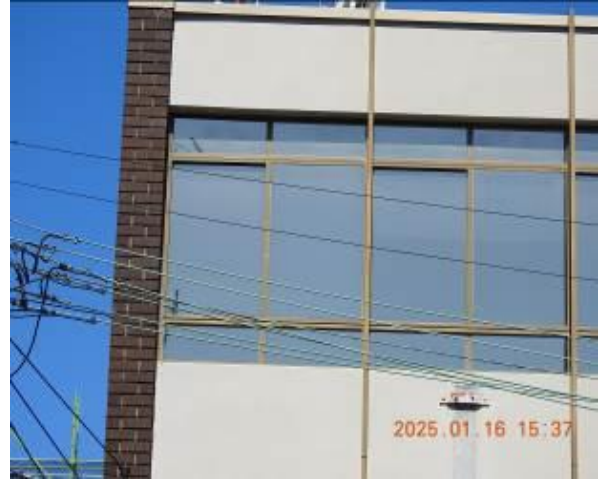
Figure 2 - General condition of external wall

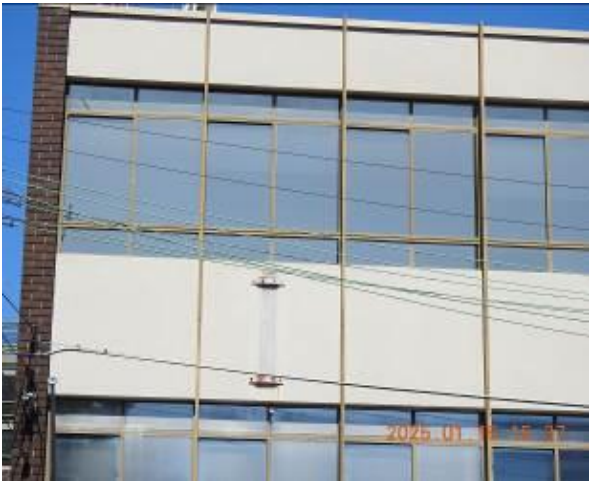
Figure 3 - General condition of external wall

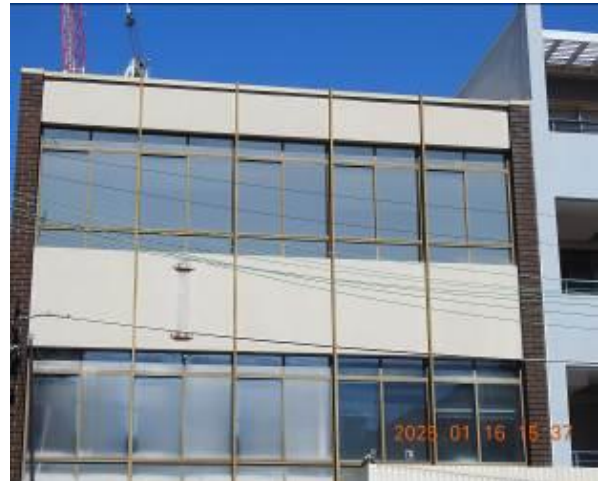
Figure 4 - General condition of external wall

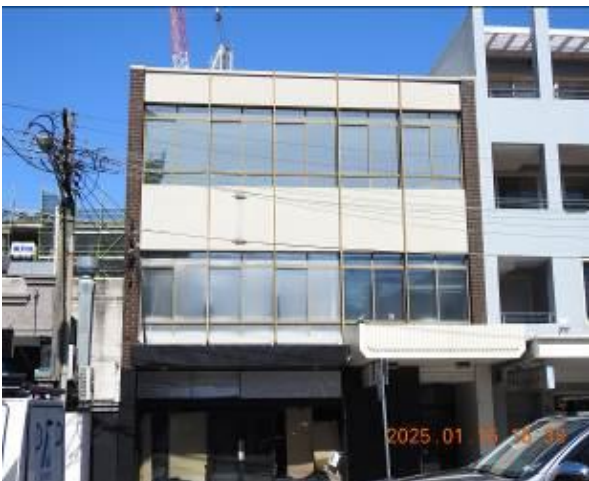
Figure 5 - General condition of external wall

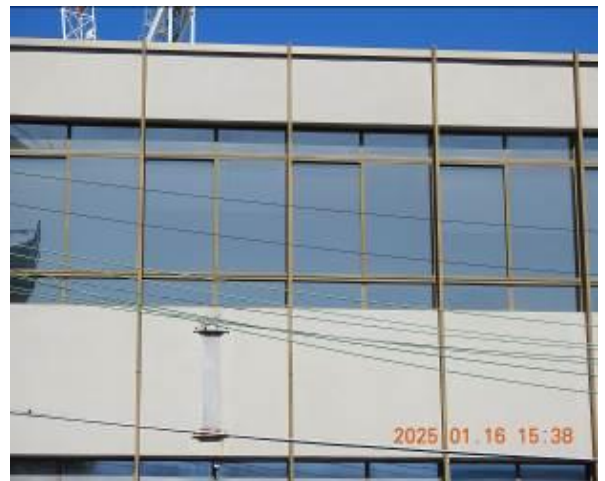
Figure 6 - General condition of external wall

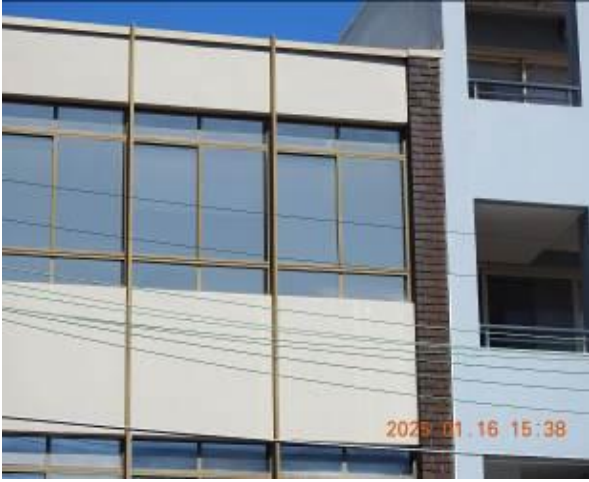
Figure 7 - General condition of external wall

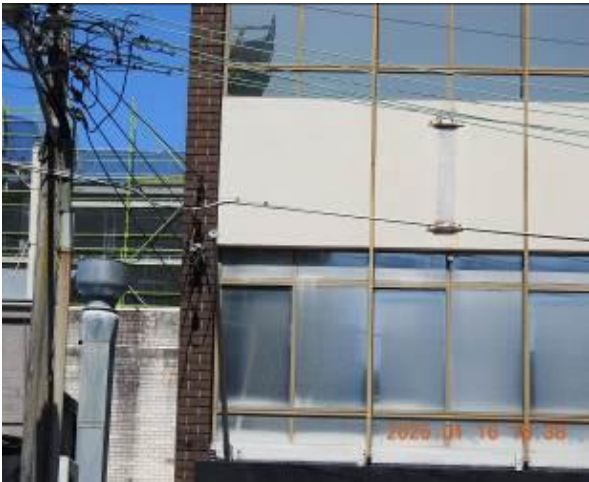
Figure 9 - General condition of external wall

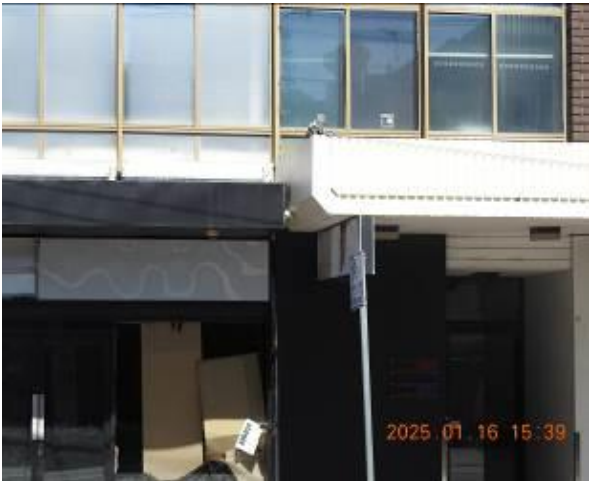
Figure 11 - General condition of external wall

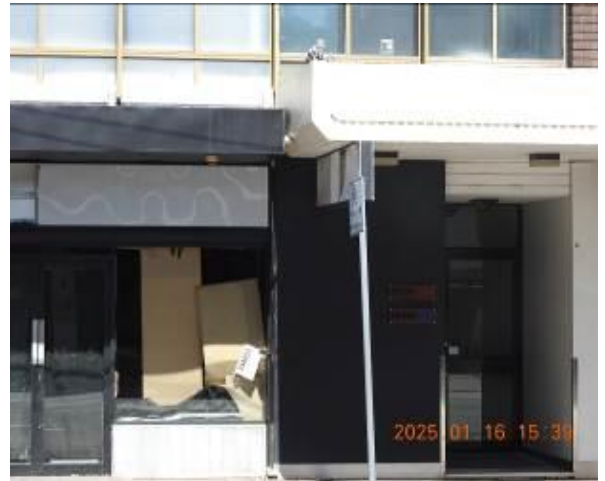
Figure 12 - General condition of external wall

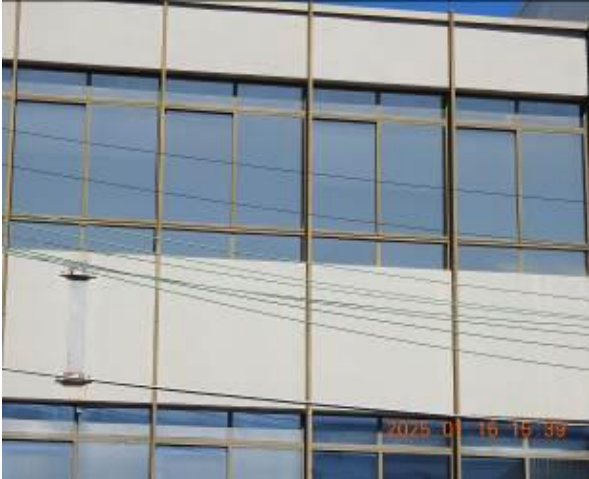
Figure 13 - General condition of external wall

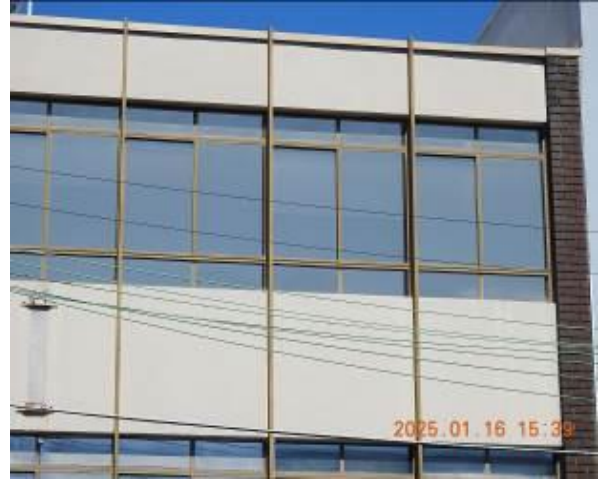
Figure 14 - General condition of external wall

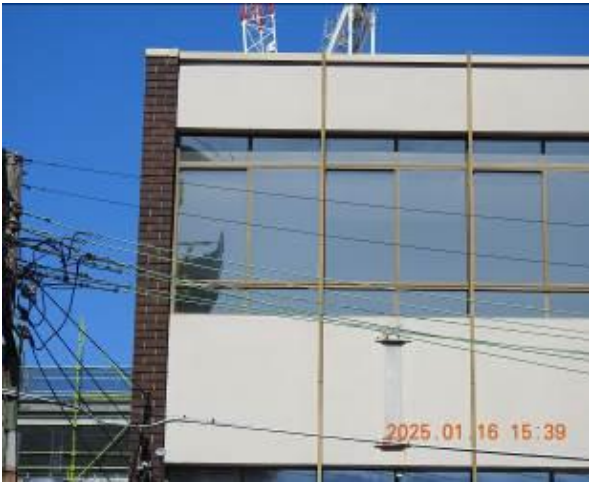
Figure 15 - General condition of external wall

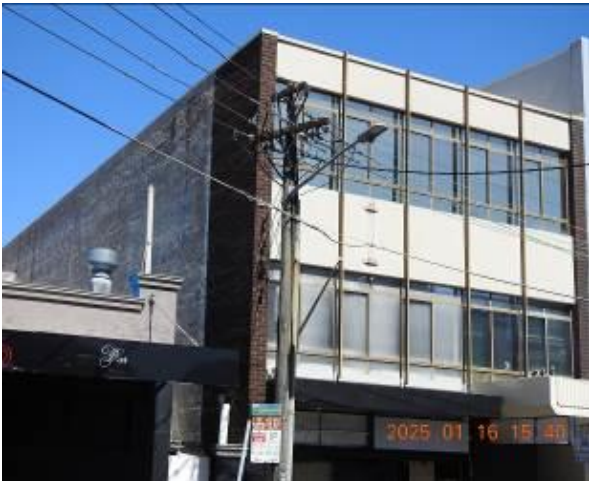
Figure 17 - General condition of external wall

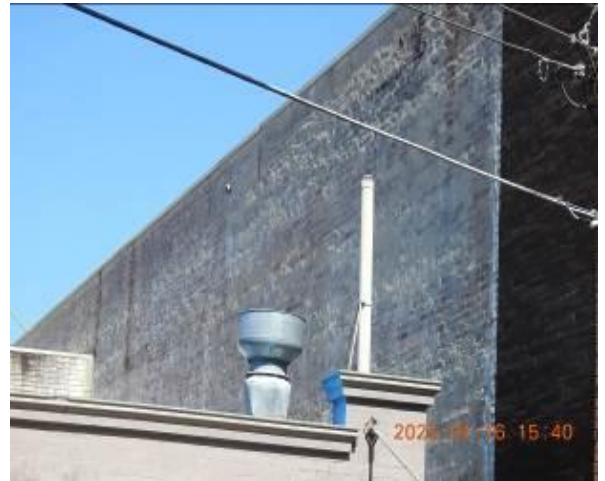
Figure 18 - General condition of external wall

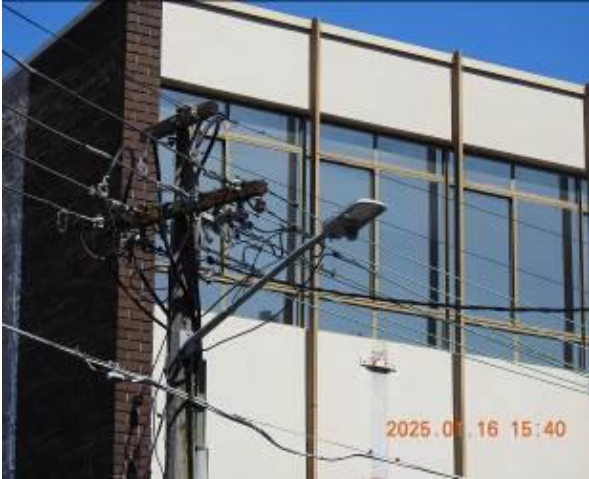
Figure 19 - General condition of external wall

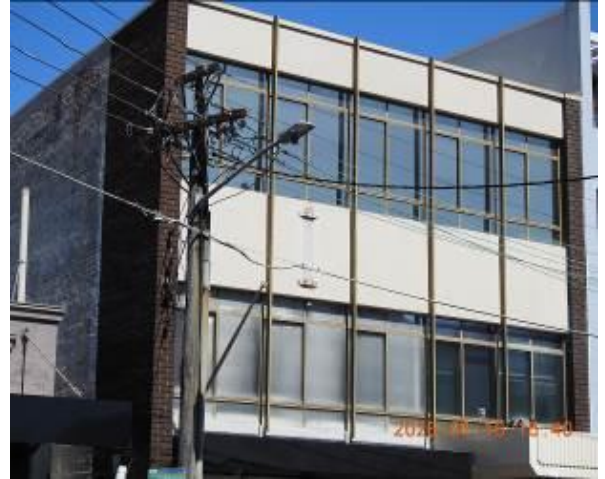
Figure 20 - General condition of external wall

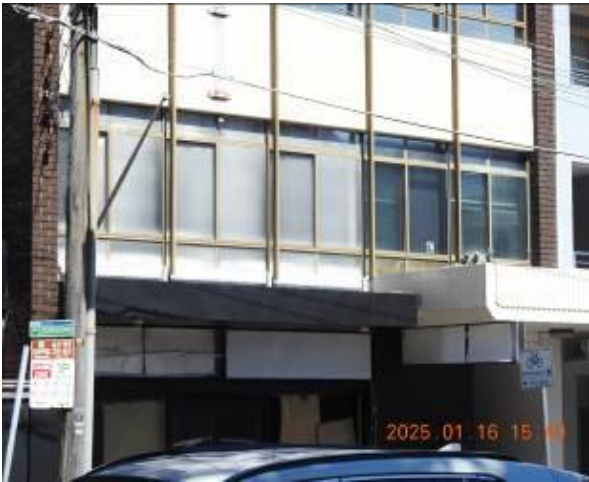
Figure 21 - General condition of external wall

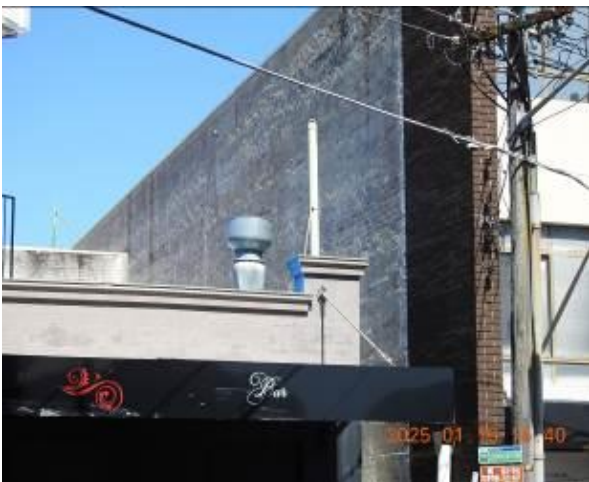
Figure 23 - General condition of external wall

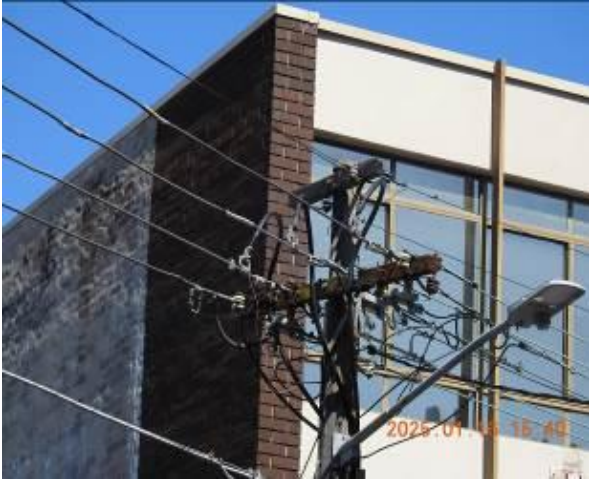
Figure 25 - General condition of external wall

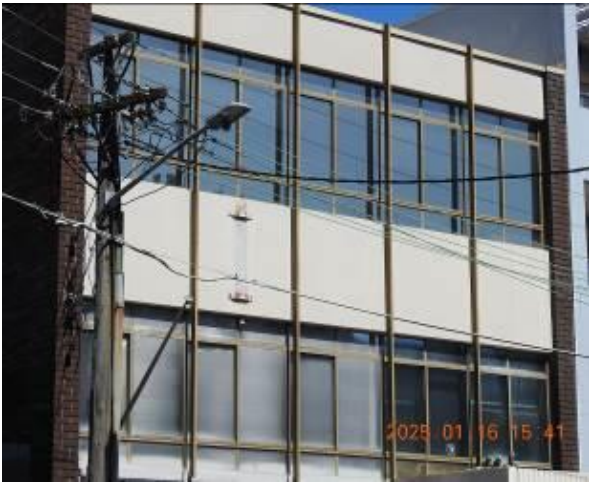
Figure 27 - General condition of external wall

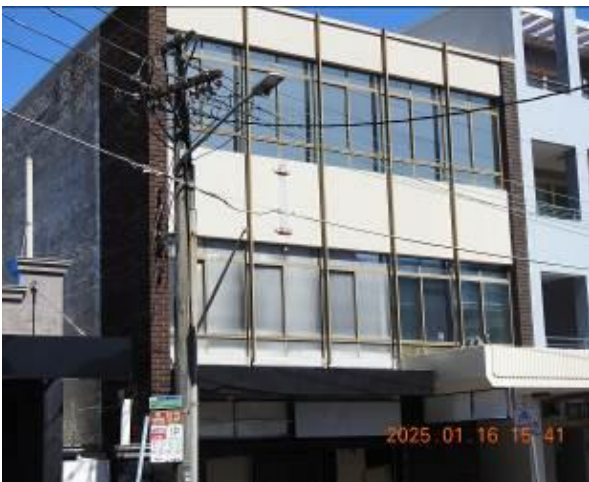
Figure 29 - General condition of external wall

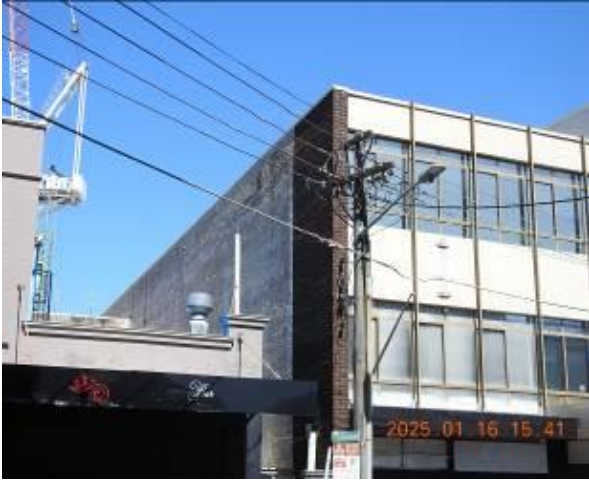
Figure 31 - General condition of external wall

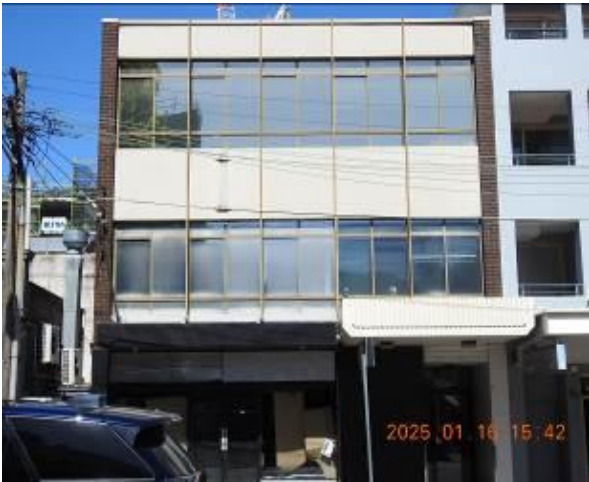
Figure 33 - General condition of external wall

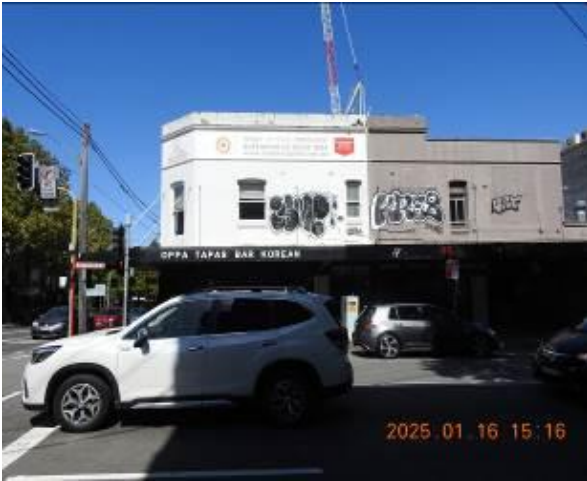
Figure 35 – The Following images displays the general condition of 17 Alexander Street

The property located at 17 Alexander Street, is the neighbouring property to our client's site. It was photographed and visually inspected prior to any construction works on the subject site and was found to be in a reasonable condition. The building serves as a Restaurant.

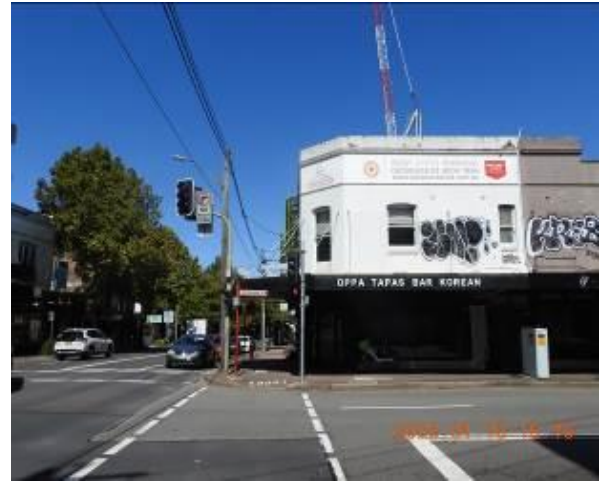
Figure 36 - General condition of external wall

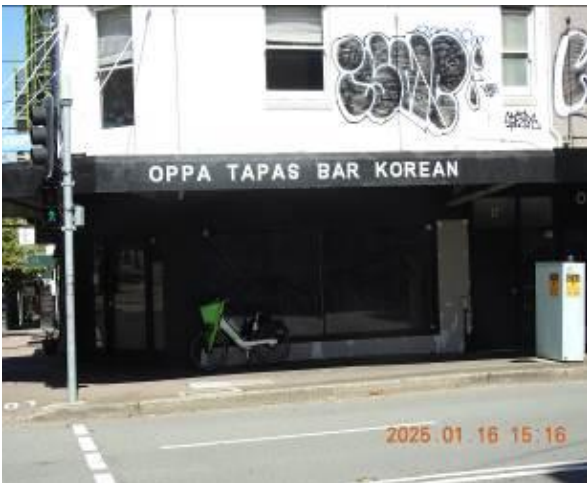
Figure 37 - General condition of external wall

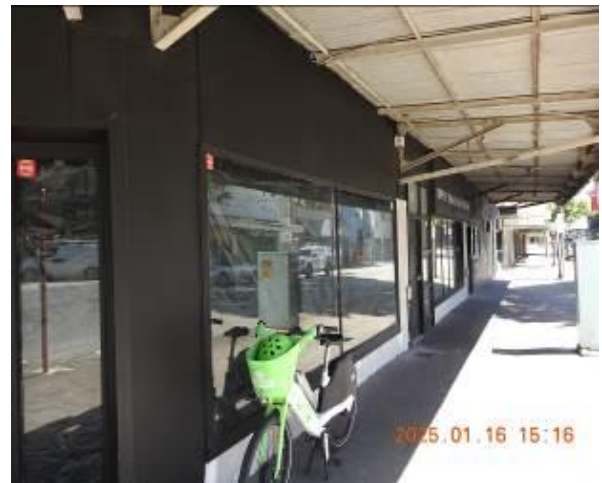
Figure 38 - General condition of external wall

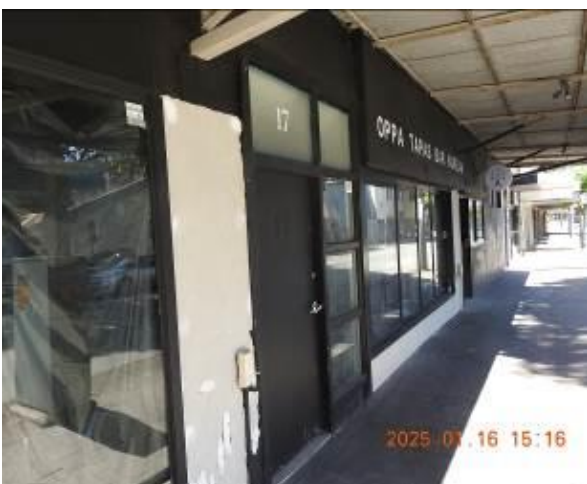
Figure 39 - General condition of external wall

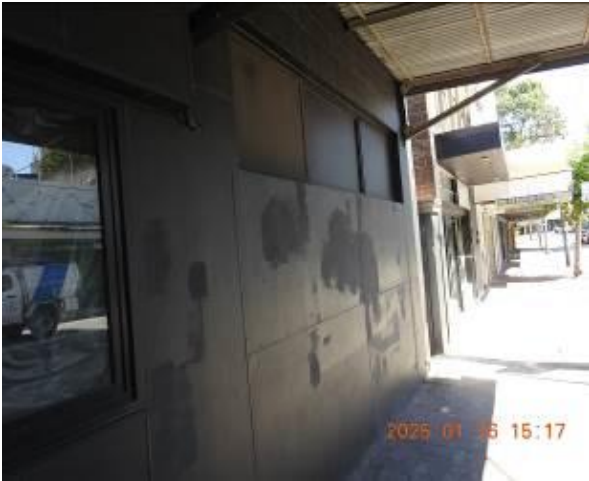
Figure 41 - General condition of external wall

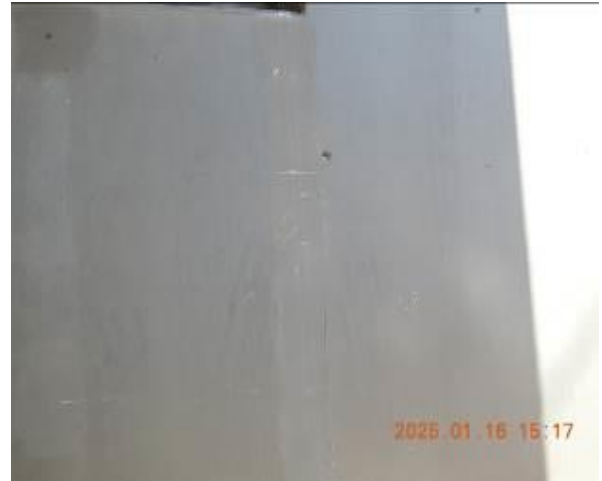
Figure 42 - General condition of external wall

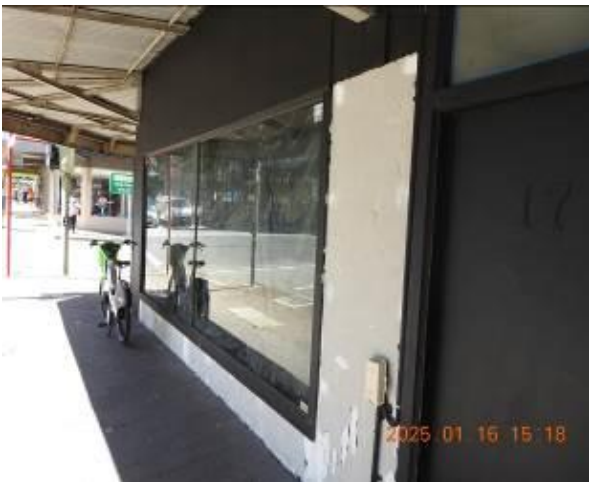
Figure 43 - General condition of external wall

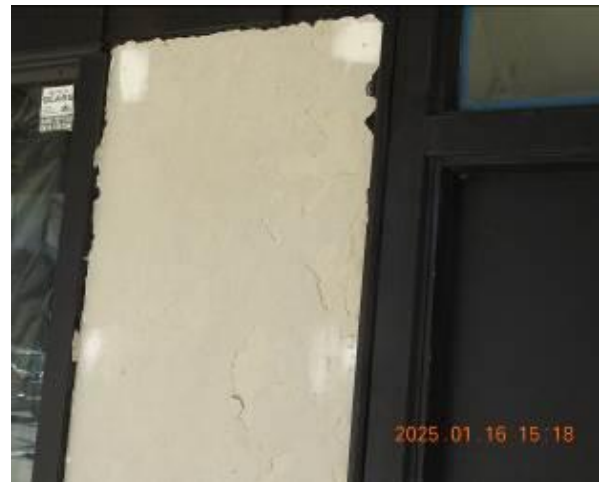
Figure 44 - Crack propagation through external wall

The exterior of the building was in a reasonable condition with evidence of cracking, material loss, through the external walls.

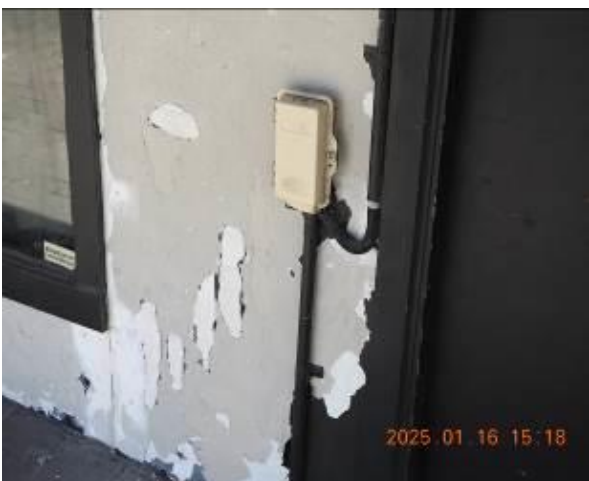
Figure 45 - Loss of material through external wall

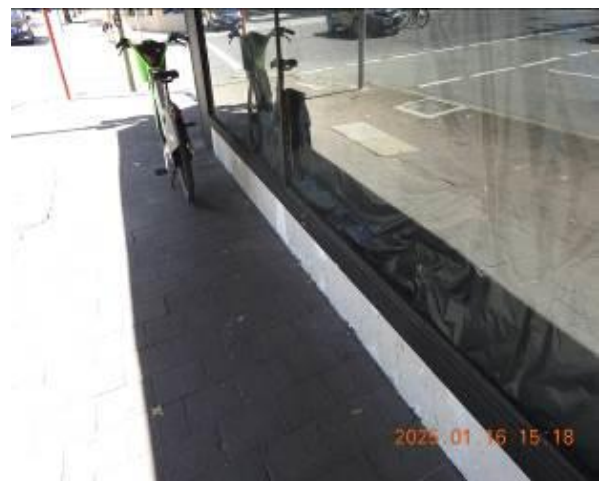
Figure 46 - General condition of external wall

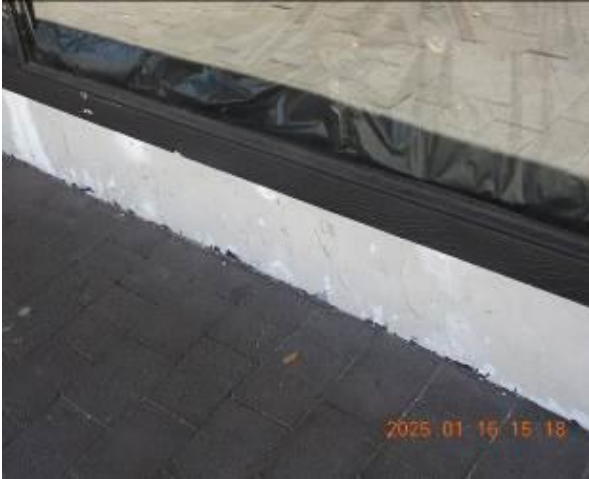
Figure 47 - General condition of external wall

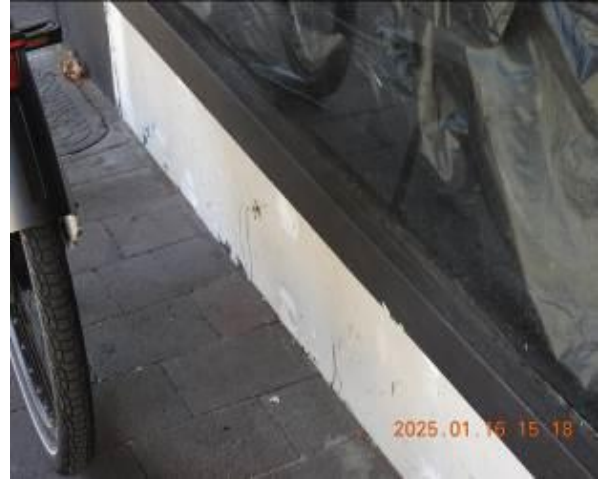
Figure 48 - General condition of external wall

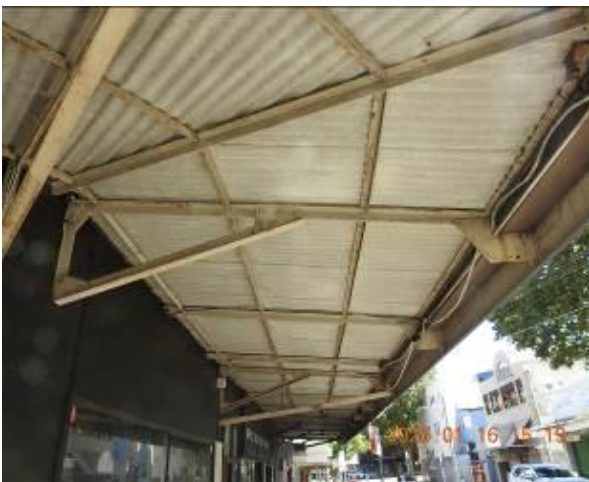
Figure 51 - General condition of awning

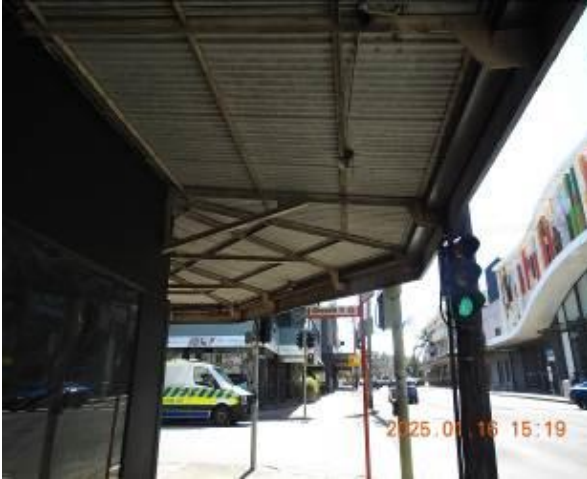
Figure 53 - General condition of awning

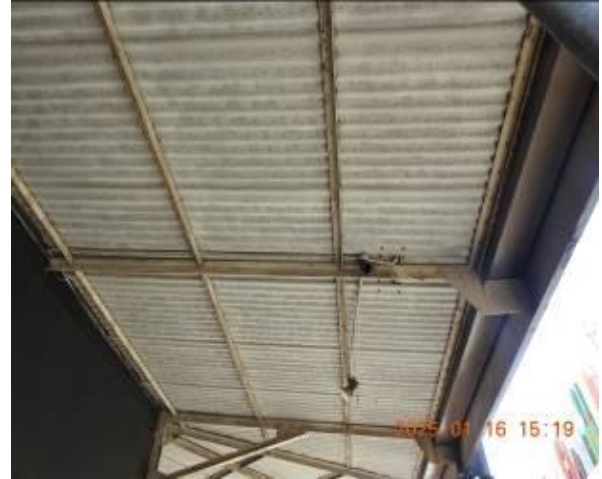
Figure 54 - General condition of awning

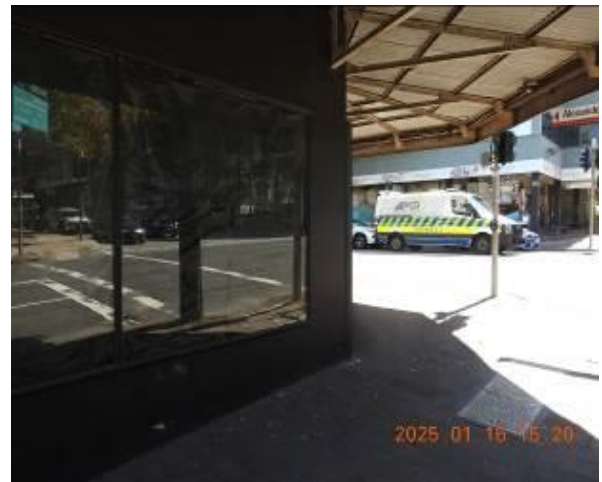
Figure 56 - General condition of external wall

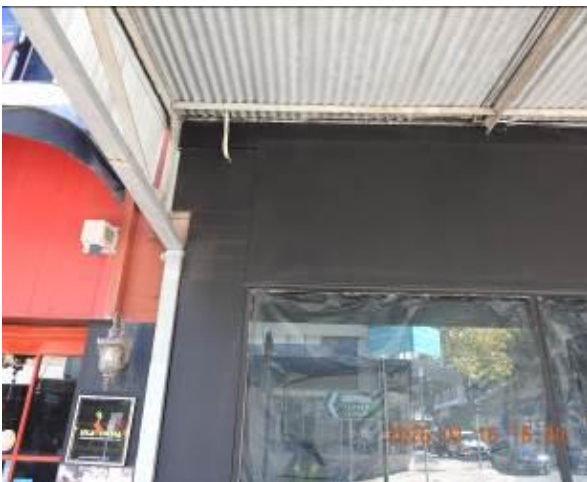
Figure 57 - General condition of awning

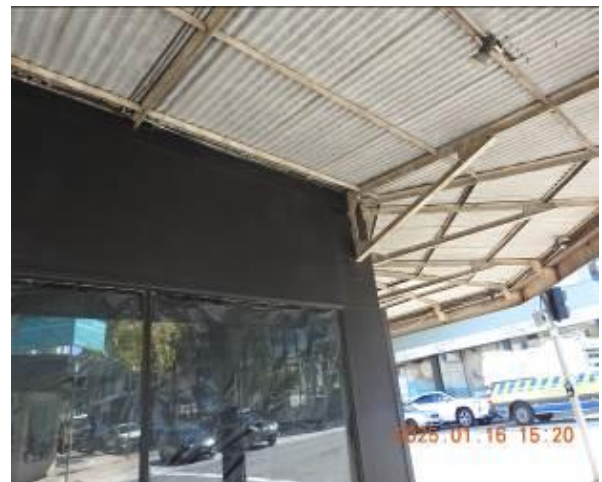
Figure 58 - General condition of awning

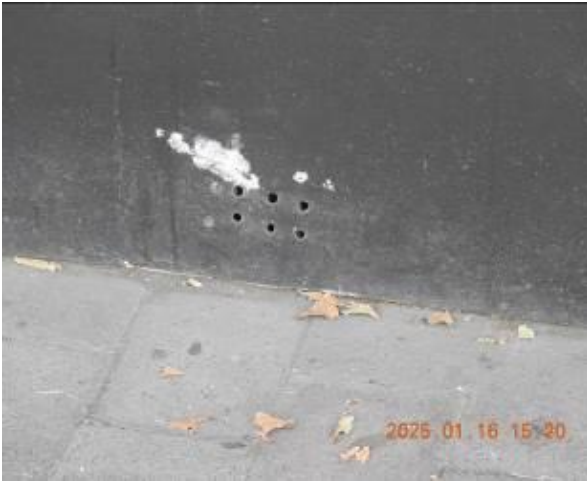
Figure 59 – Loss of material through external wall

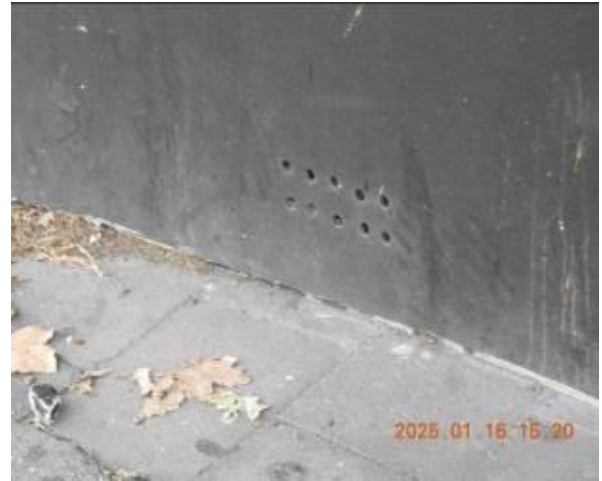
Figure 60 - Loss of material through external wall

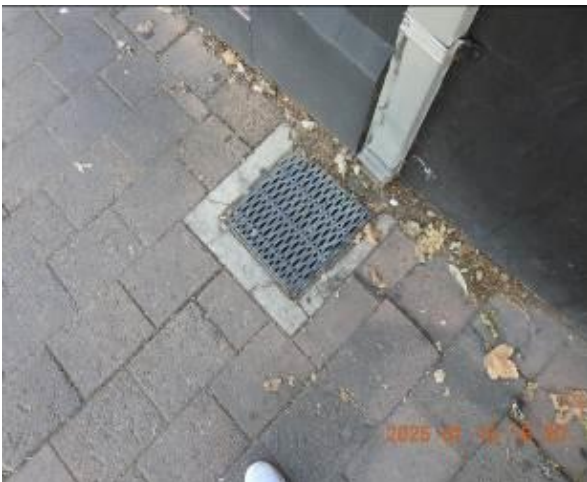
Figure 61 - General condition of service pit

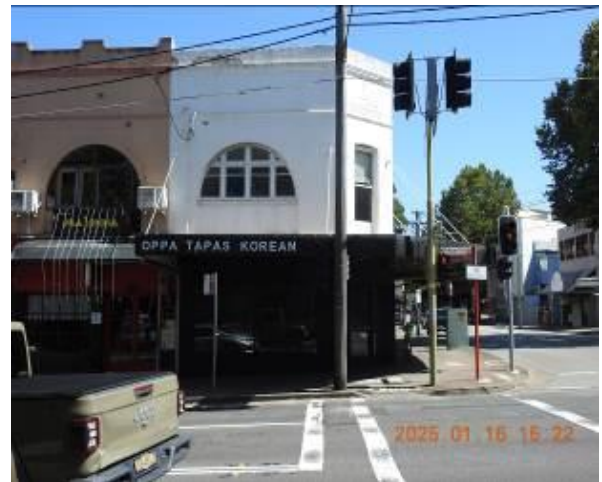
Figure 62 - General condition of external wall

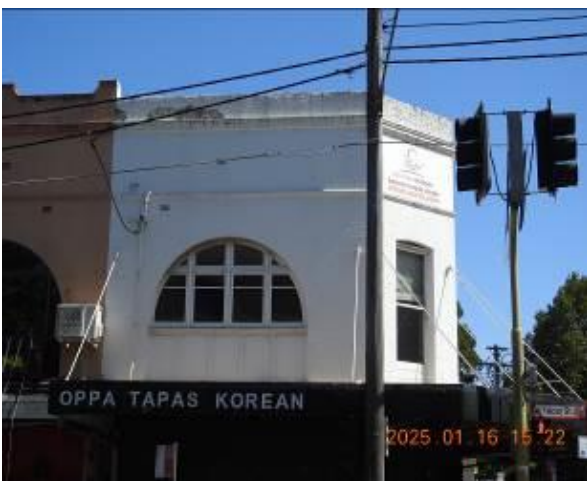
Figure 63 - - General condition of external wall

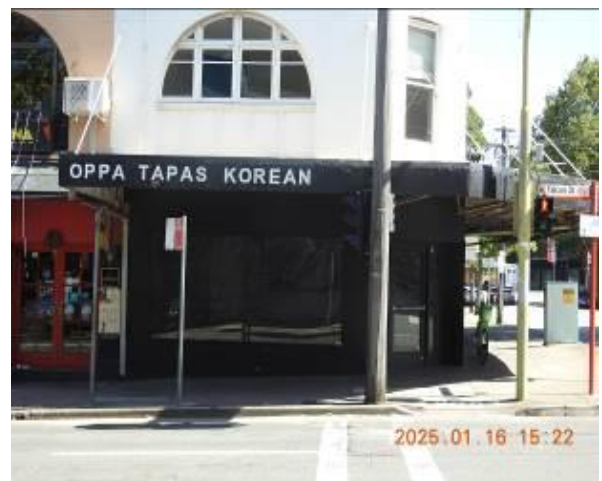
Figure 64 - - General condition of external wall

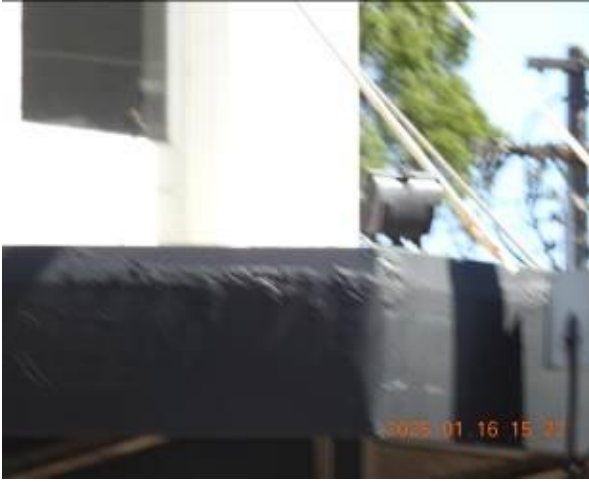
Figure 65 - - General condition of external wall

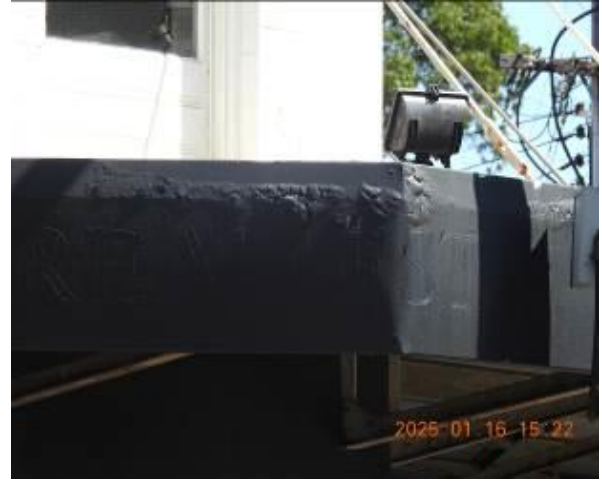
Figure 66 - - General condition of external wall

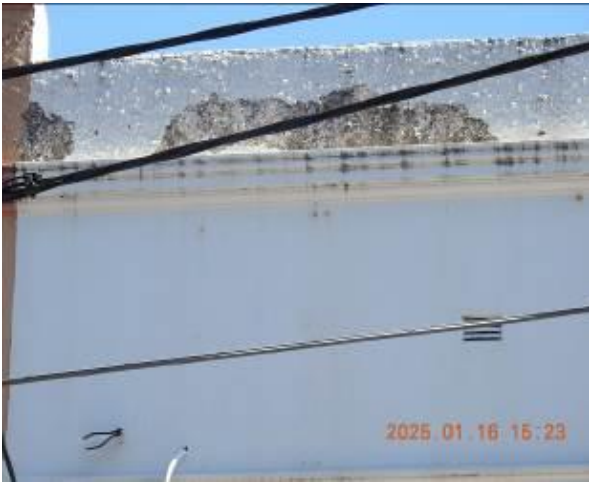
Figure 67 - - General condition of external wall

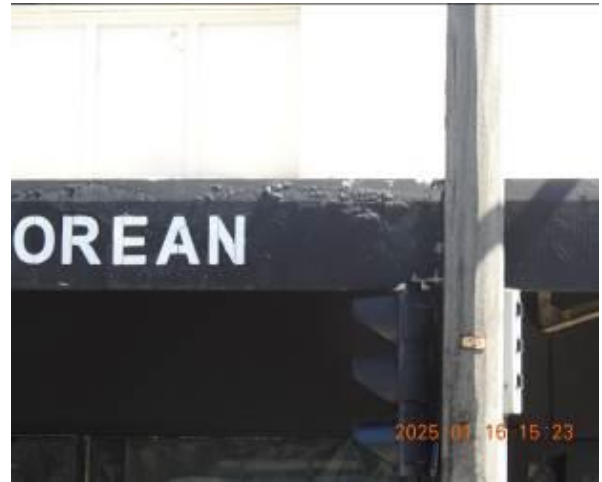
Figure 68 - - General condition of external wall

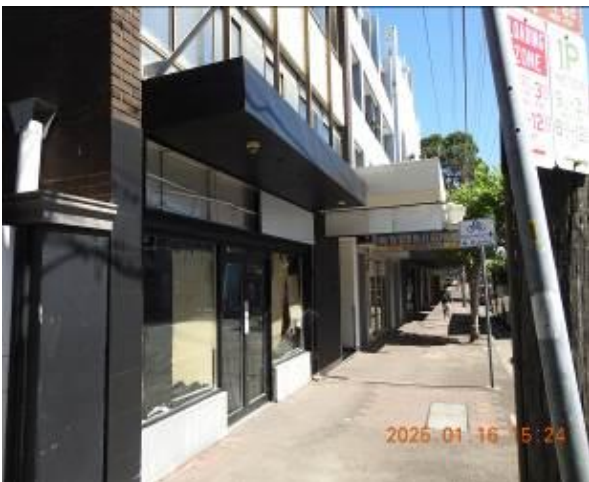
Figure 69 - - General condition of external wall

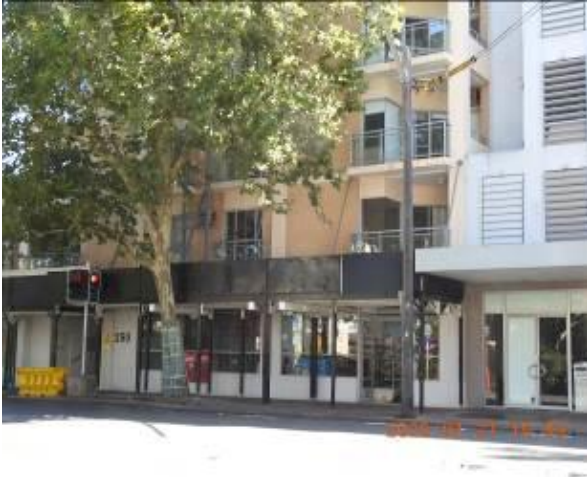
Figure 70 - General condition of external wall

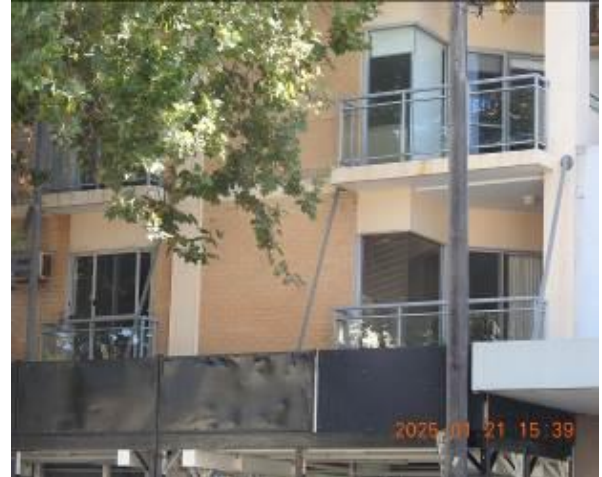
Figure 71 - General condition of external wall

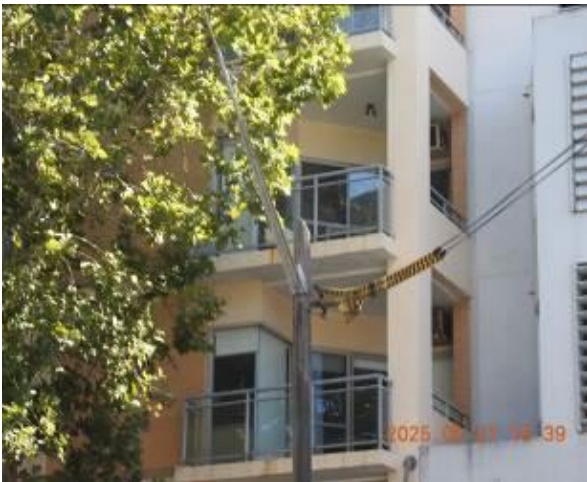
Figure 72 - General condition of external wall

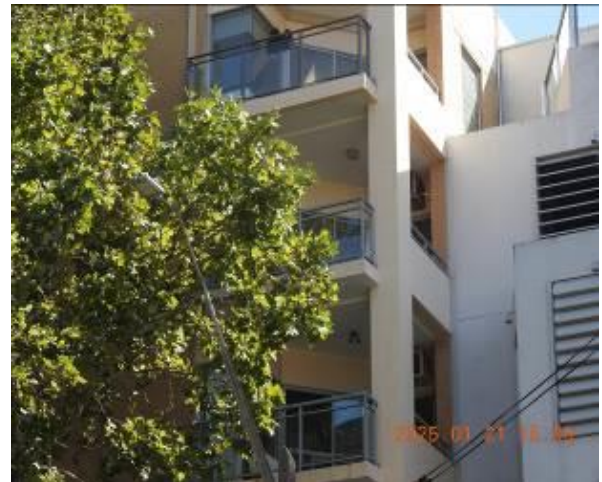
Figure 73 - General condition of external wall

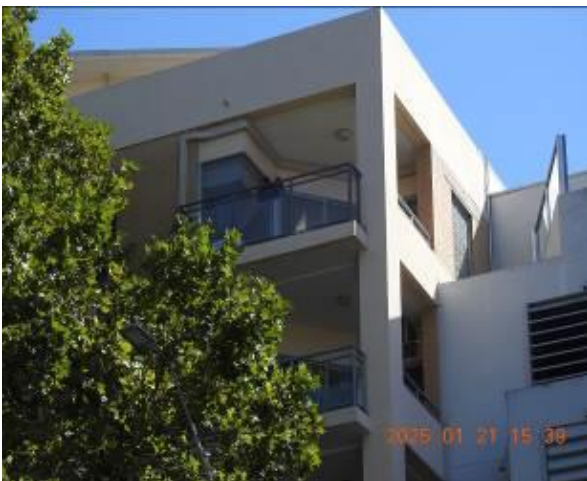
Figure 74 - General condition of external wall

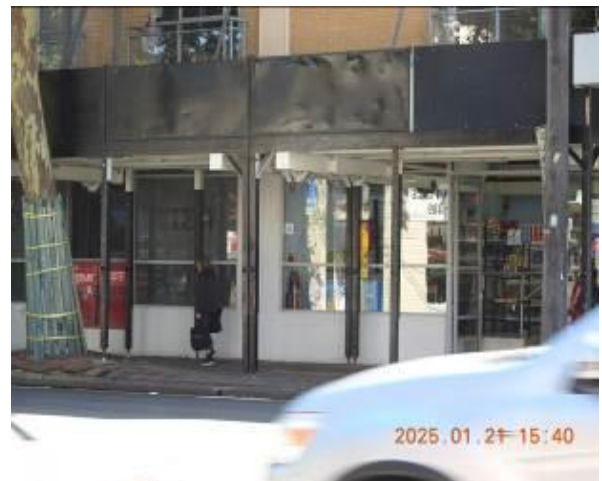
Figure 75 - General condition of external wall

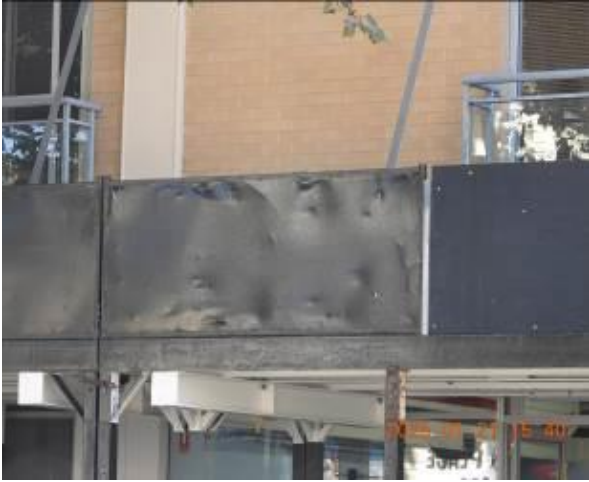
Figure 76 - General condition of external wall

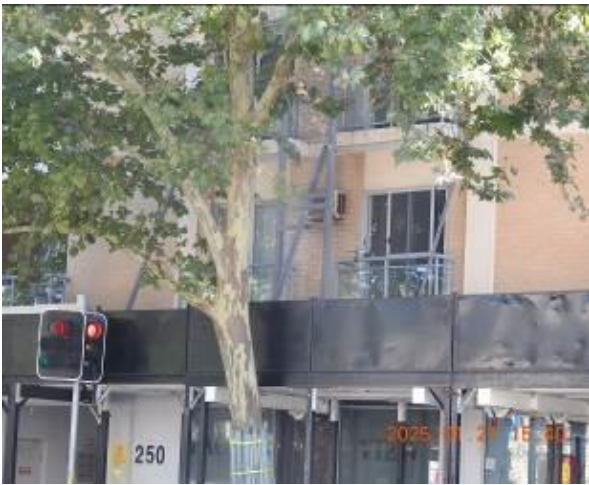
Figure 78 - General condition of external wall

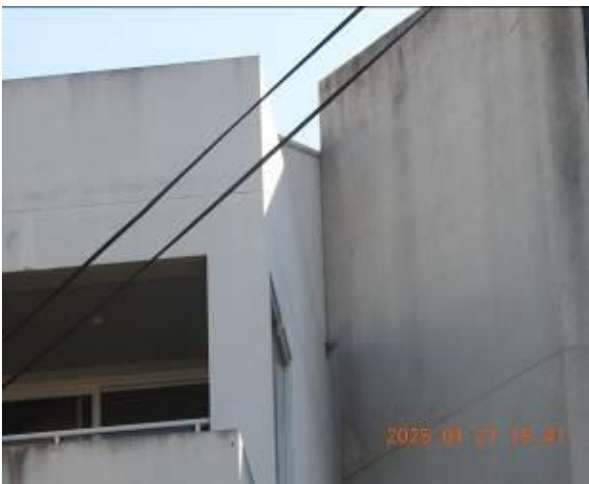
Figure 80 - General condition of external wall

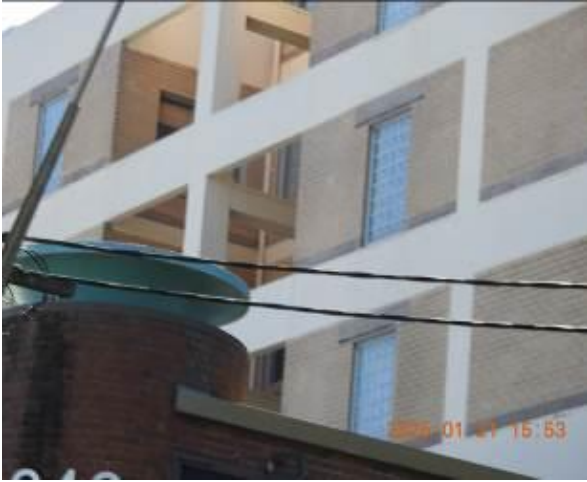
Figure 82 - General condition of external wall

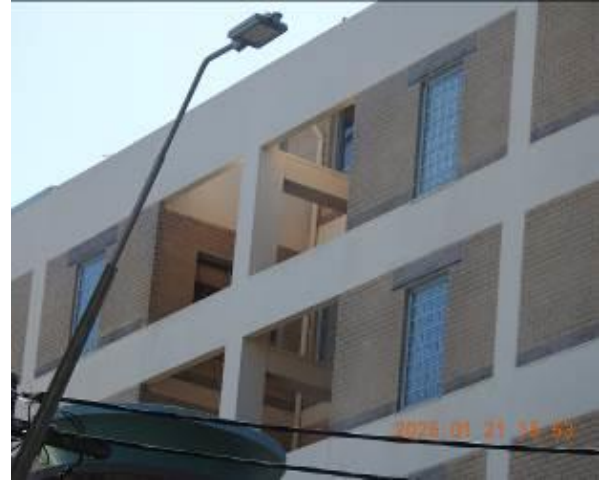
Figure 83 - General condition of external wall

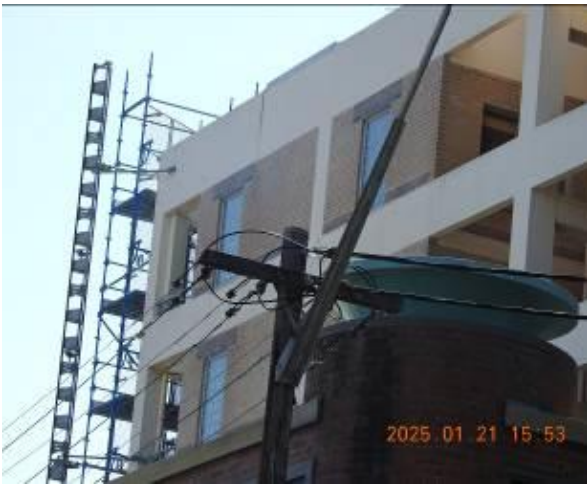
Figure 84 - General condition of external wall

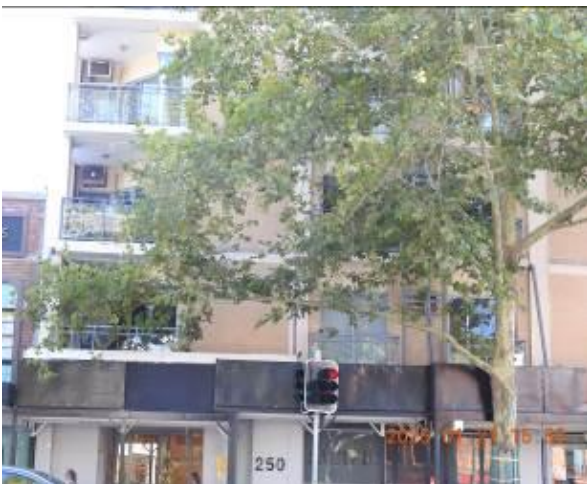
Figure 86 - General condition of external wall

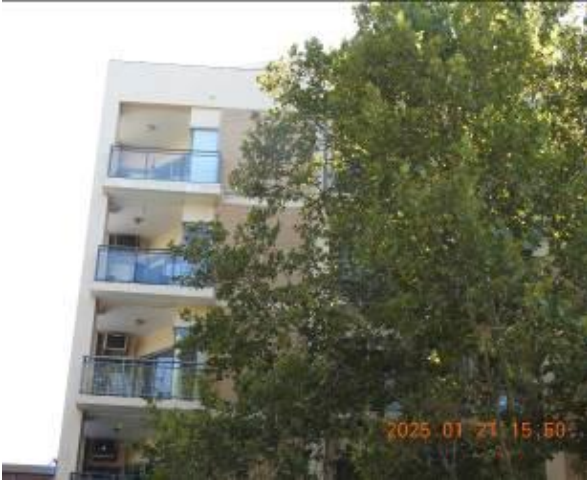
Figure 88 - General condition of external wall

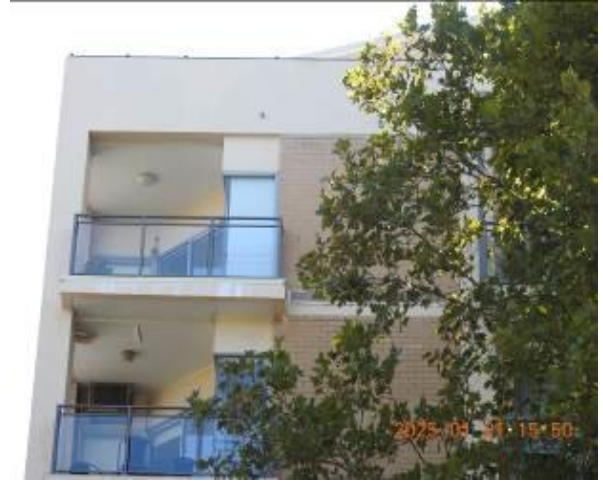
Figure 89 - General condition of external wall

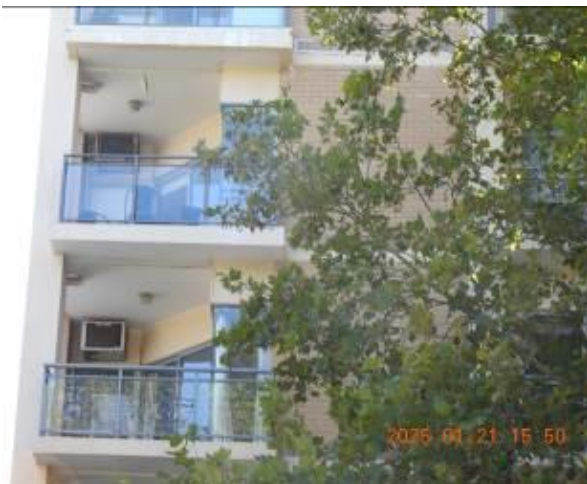
Figure 90 - General condition of external wall

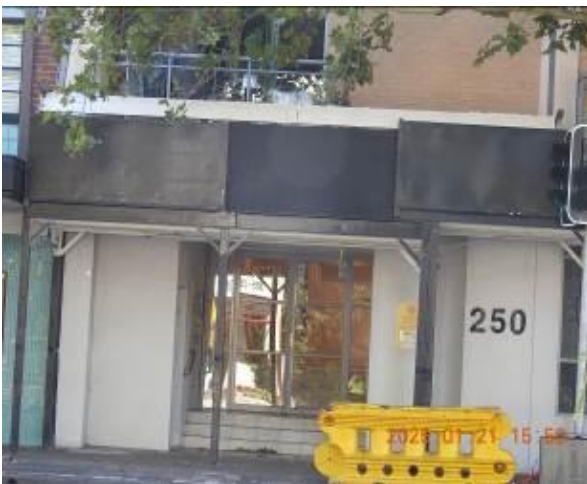
Figure 92 - General condition of external wall

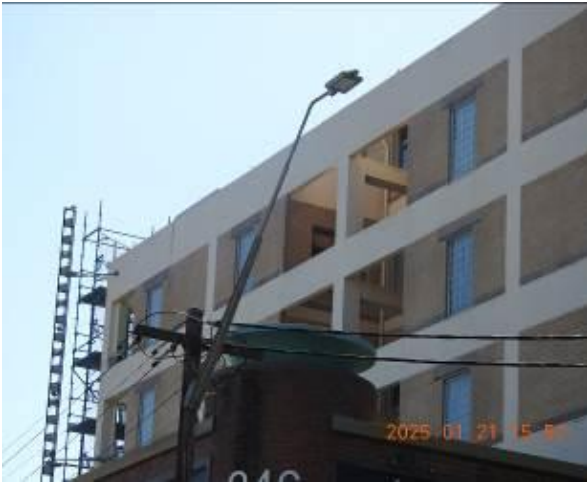
Figure 94 - General condition of external wall

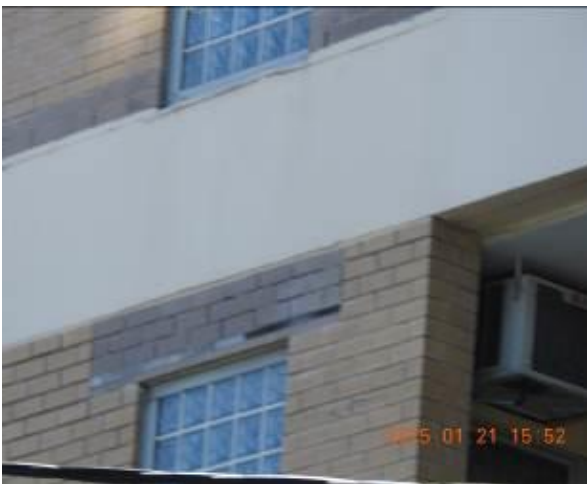
Figure 96 - General condition of external wall

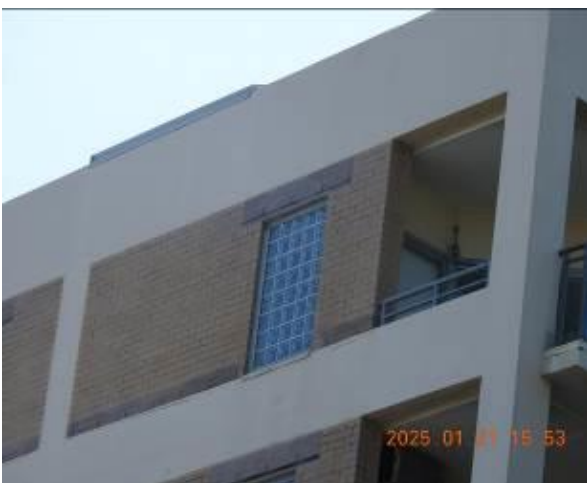
Figure 98 - General condition of external wall

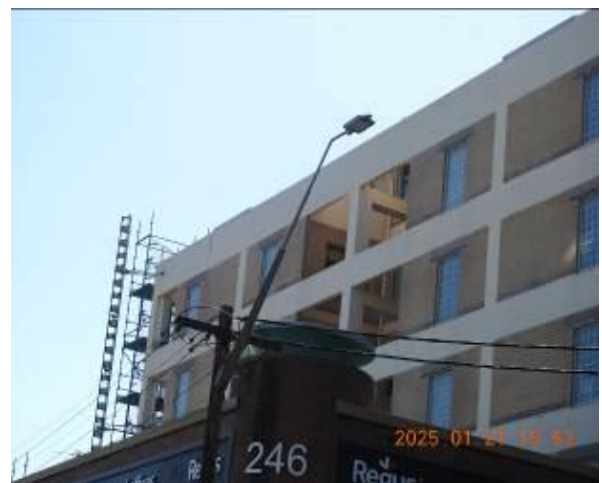
Figure 99 - General condition of external wall

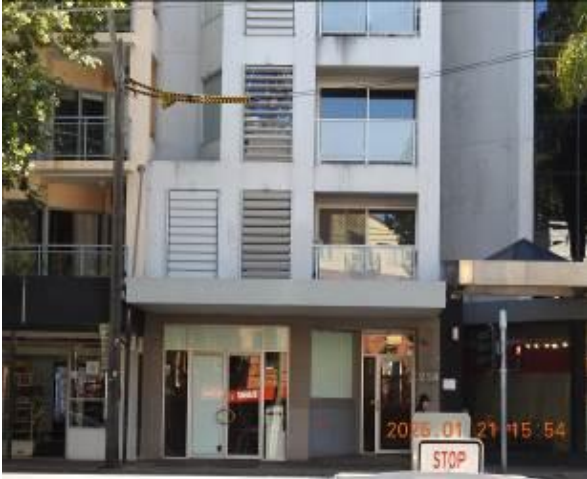
Figure 100 - General condition of external wall

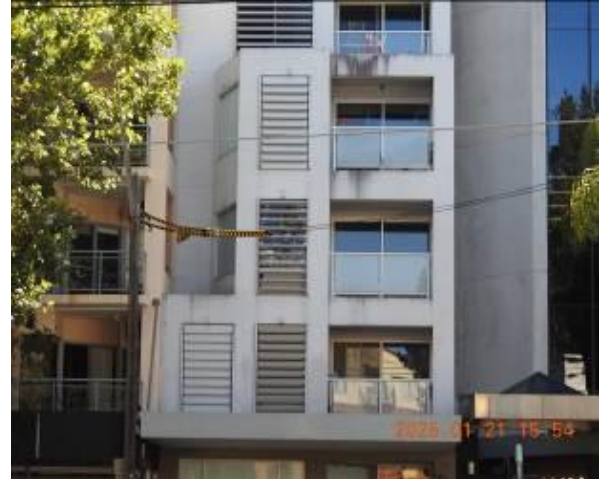
Figure 101 - General condition of external wall

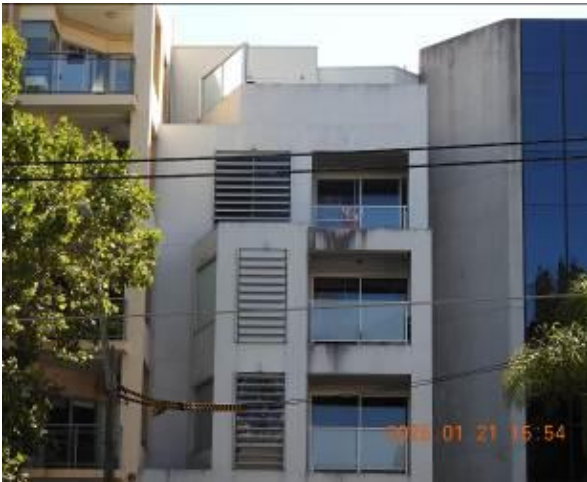
Figure 102 - General condition of external wall
