391-423 PACIFIC HIGHWAY, CROWSNEST NSW 2065

PRE-DILAPIDATION REPORT

DEICORP PTY LTD

Job No. 240325.4

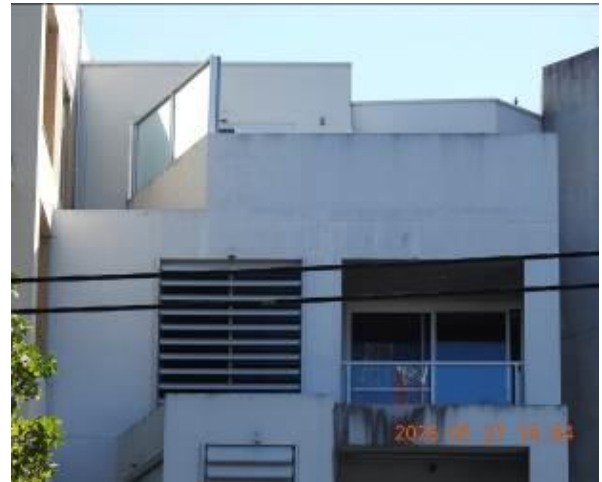
Figure 103 - General condition of external wall

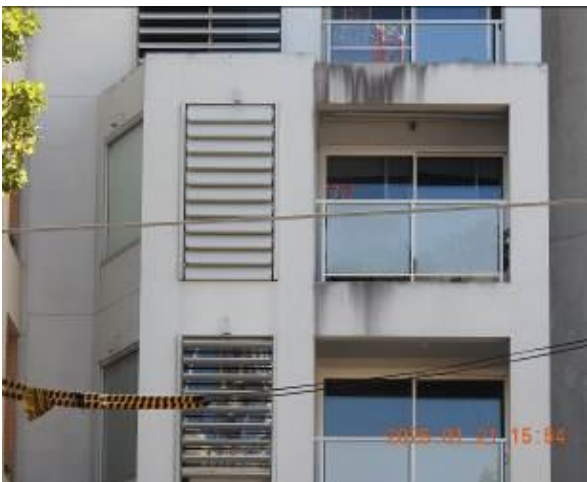
Figure 104 - General condition of external wall

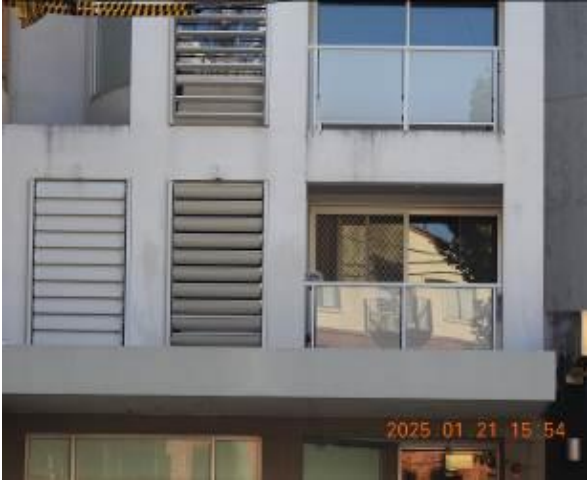
Figure 106 - General condition of external wall

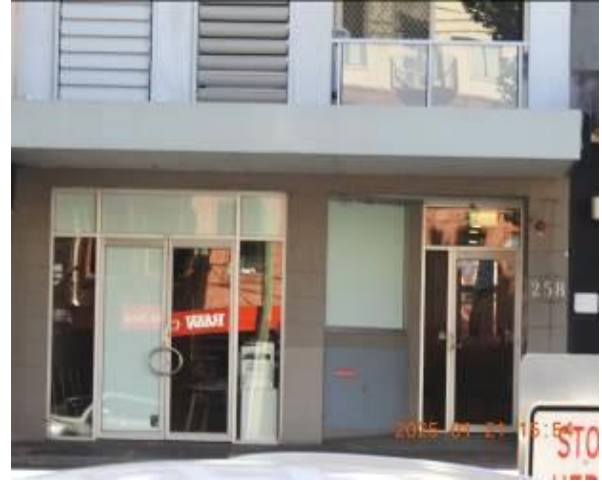
Figure 107 - General condition of external wall

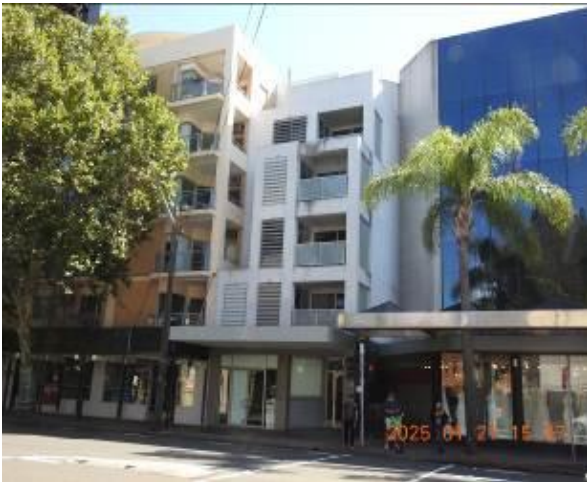
Figure 108 - General condition of external wall

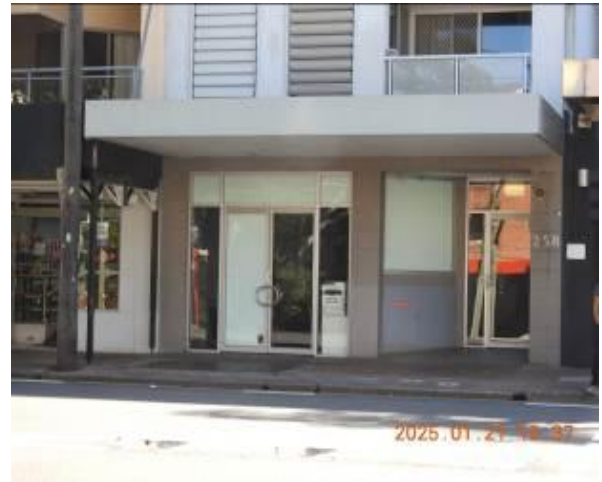
Figure 109 - General condition of external wall

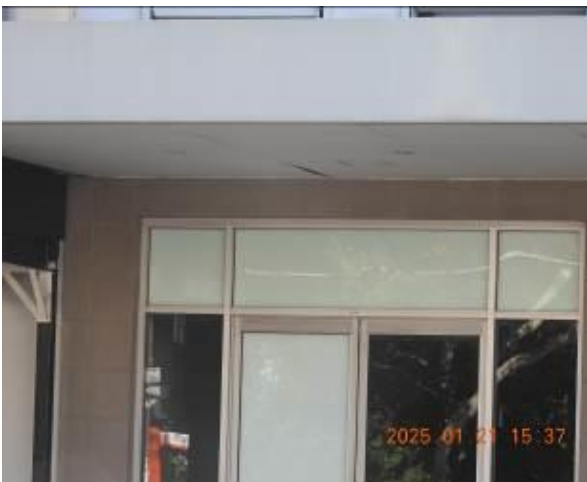
Figure 110 - General condition of external wall

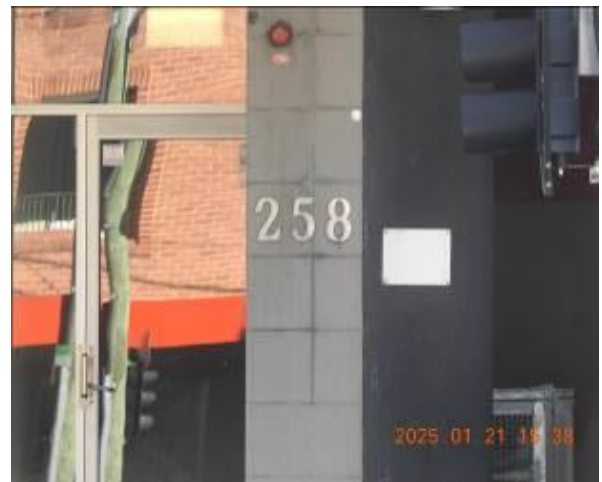
Figure 111 - General condition of external wall

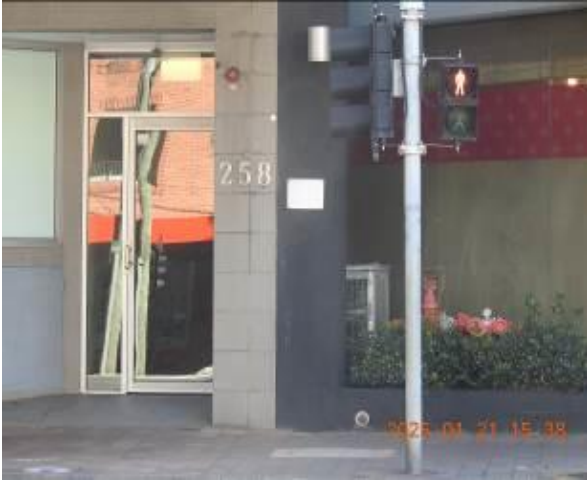
Figure 112 - General condition of external wall

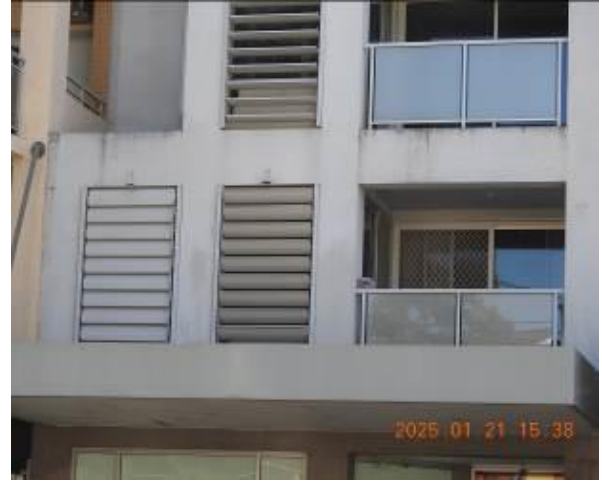
Figure 113 - General condition of external wall

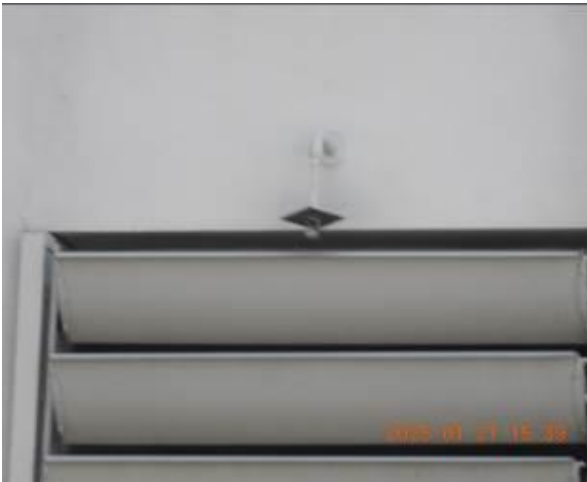
Figure 114 - General condition of external wall

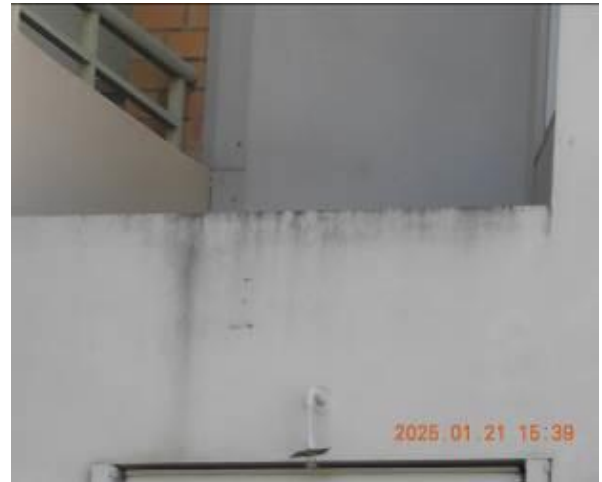
Figure 115 - General condition of external wall

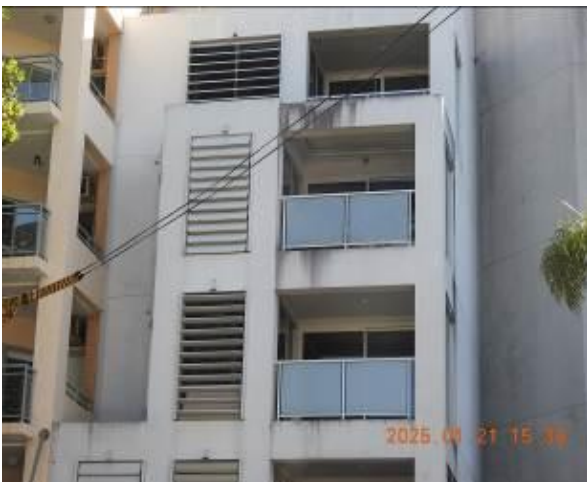
Figure 116 - General condition of external wall

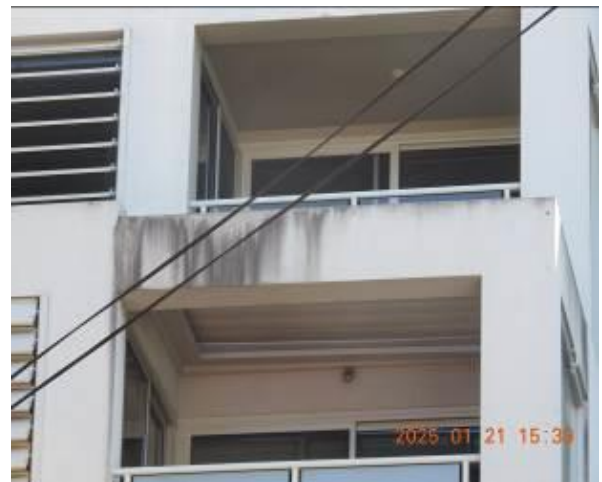
Figure 117 - General condition of external wall

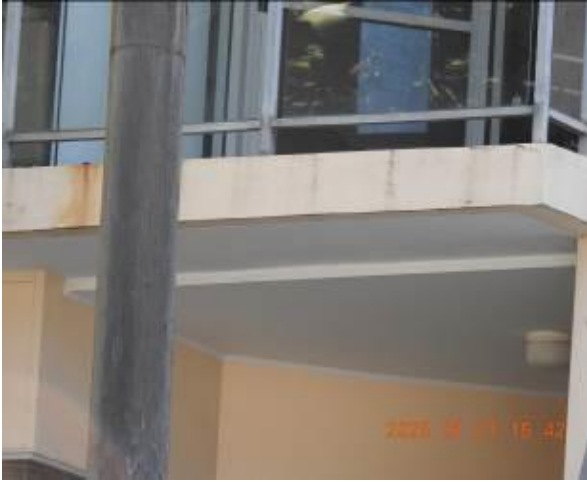
Figure 118 - General condition of external wall

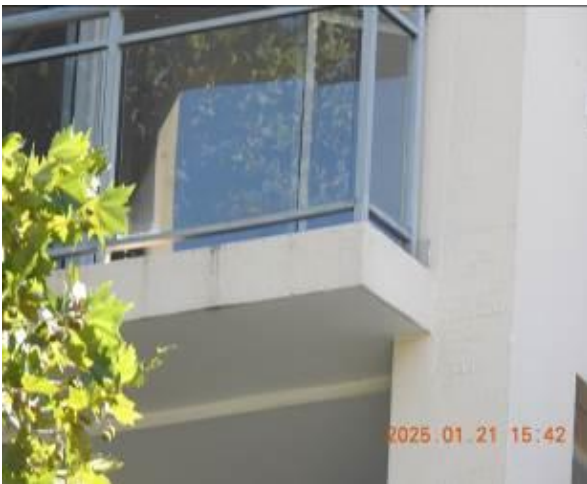
Figure 120 - General condition of external wall

The exterior of the building was in a reasonable condition with evidence of cracking, material loss, through the external walls.

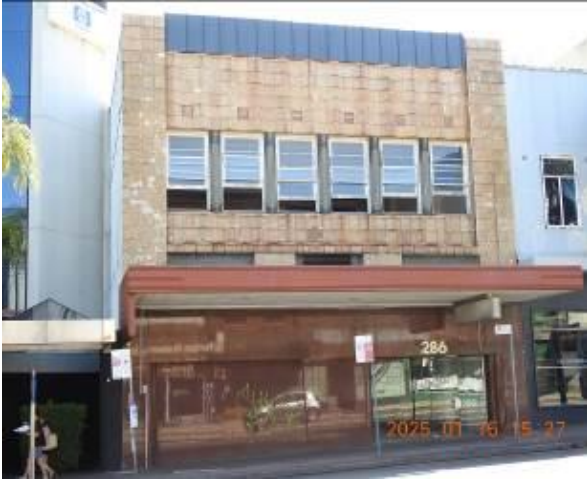
Figure 121 – The following images displays the general condition of 286 Pacific Highway

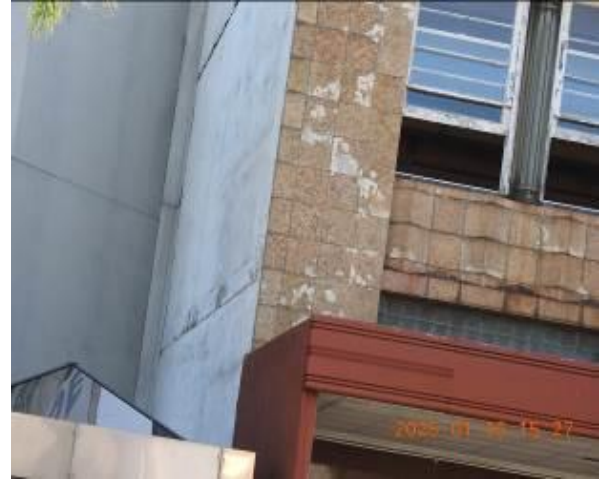
Figure 122 - General condition of external wall

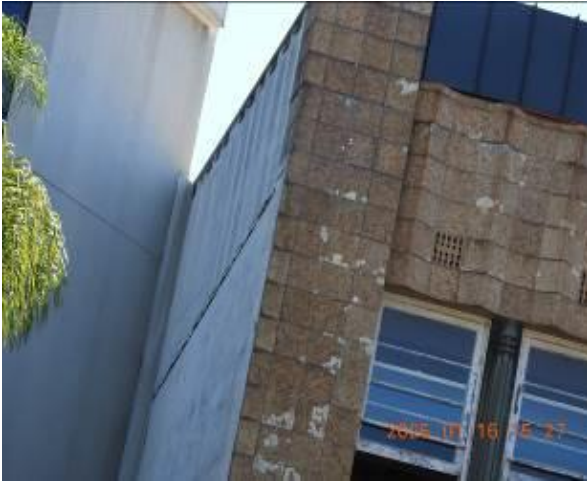
Figure 123 - General condition of external wall

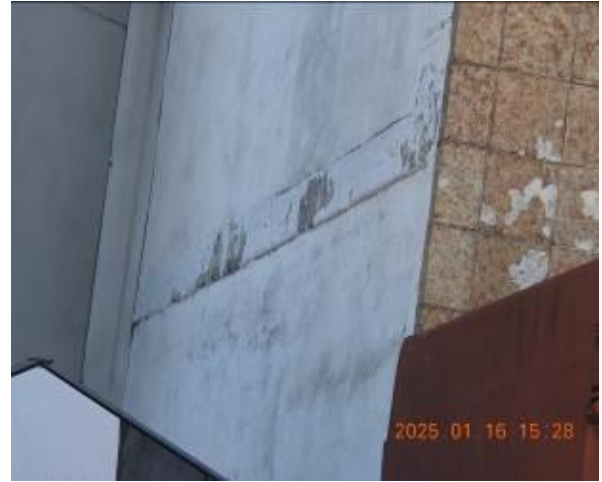
Figure 124 - General condition of external wall

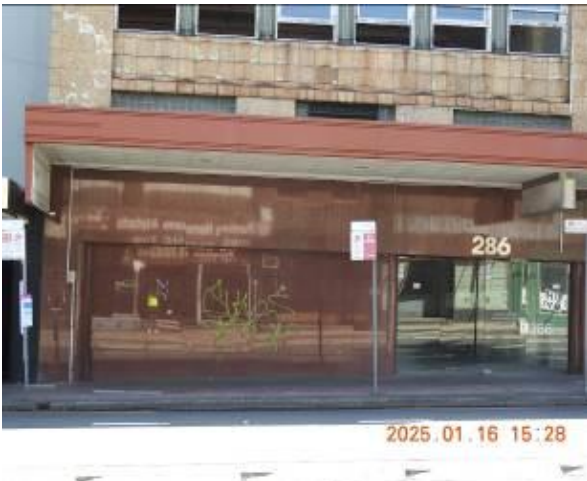
Figure 125 - General condition of external wall

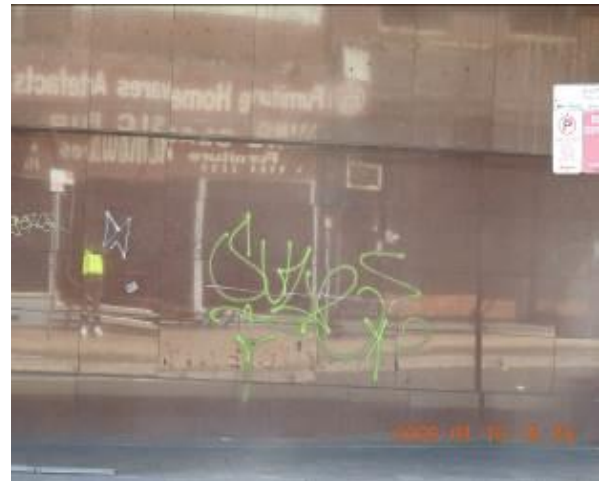
Figure 126 - General condition of external wall

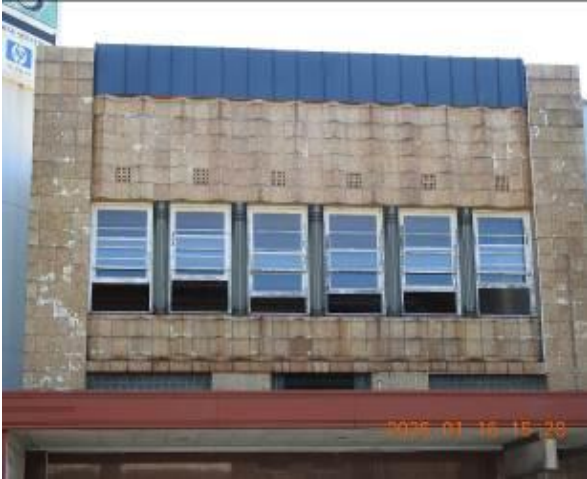
Figure 127 - General condition of external wall

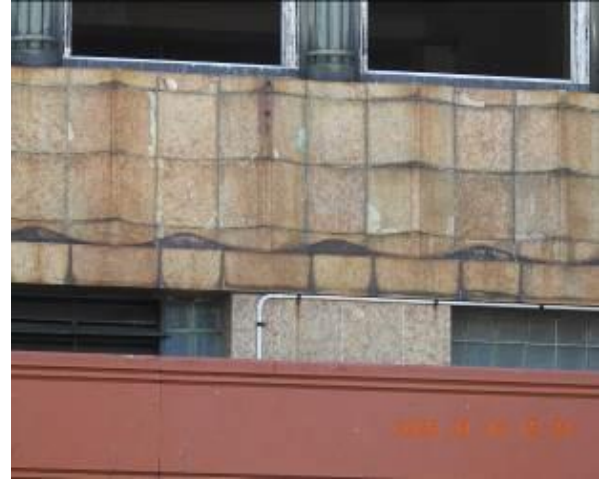
Figure 128 - General condition of external wall

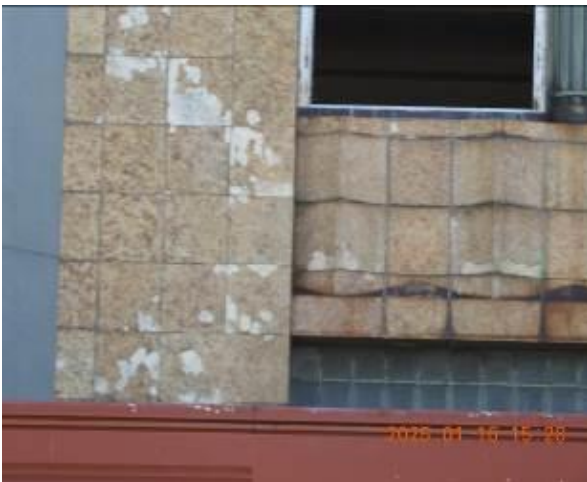
Figure 129 - General condition of external wall

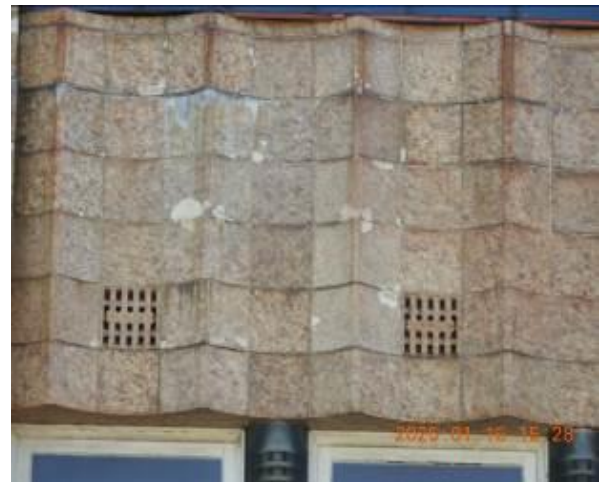
Figure 130 - General condition of external wall

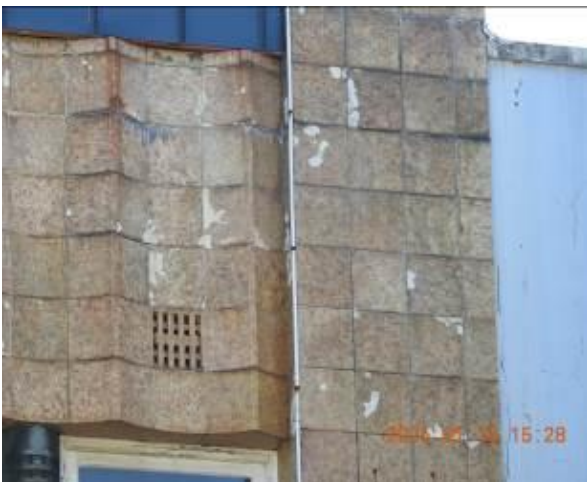
Figure 131 - General condition of external wall

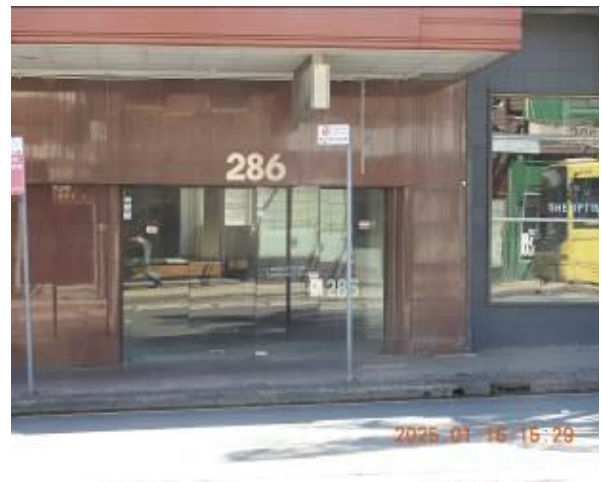
Figure 132 - General condition of external wall

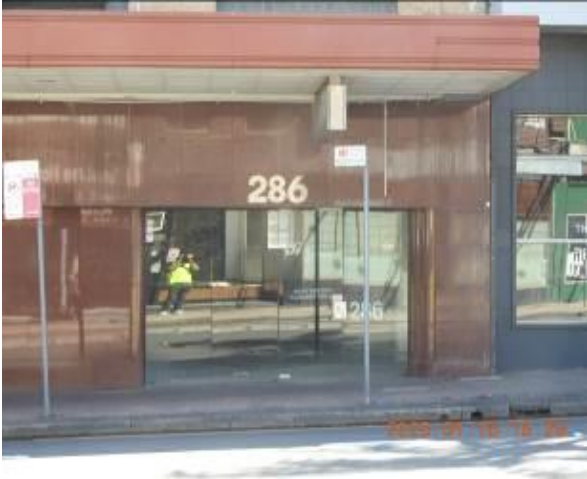
Figure 133 - General condition of external wall

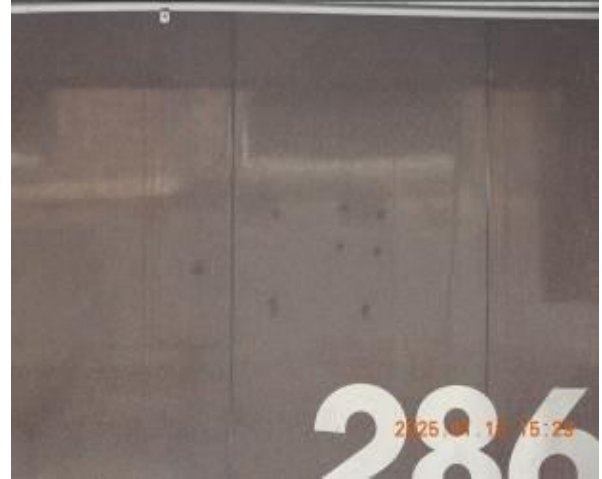
Figure 134 - General condition of external wall

The exterior of the building was in a reasonable condition. The building was inspected externally only as visible from footpath since the building was Abandoned during the time of inspection.

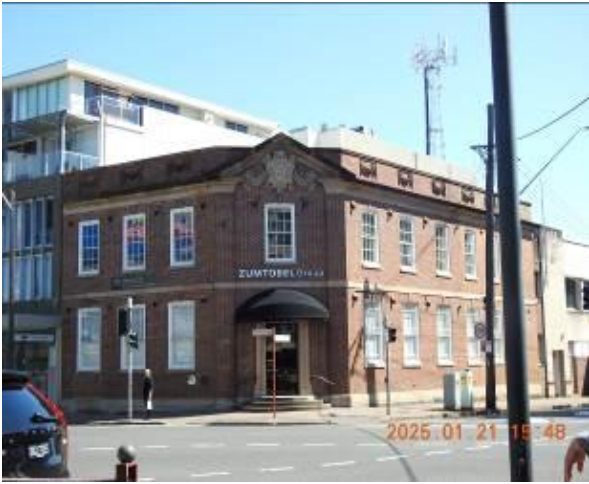
Figure 135 - General condition of external wall

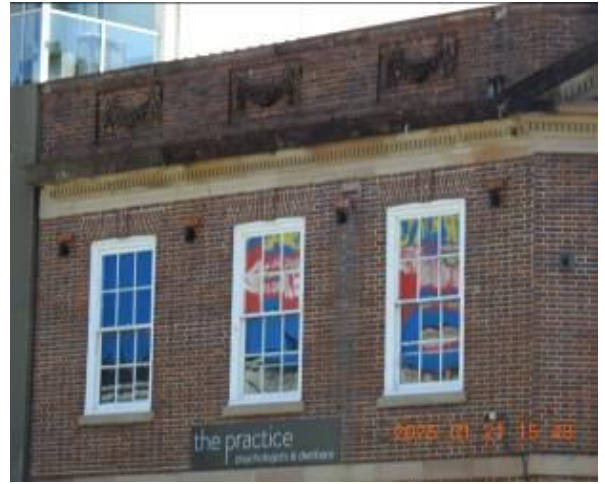
Figure 136 - General condition of external wall

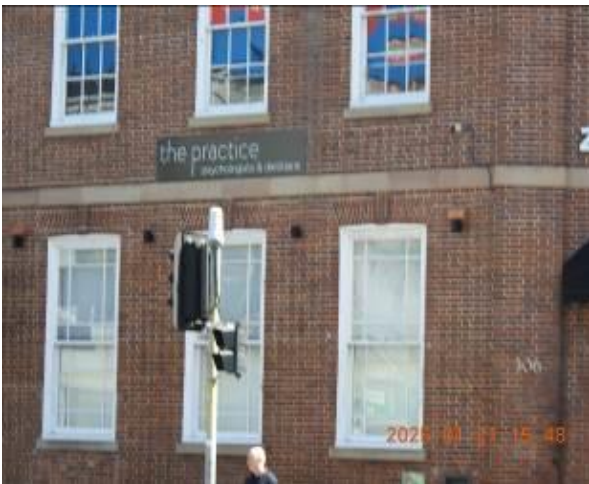
Figure 137 - General condition of external wall

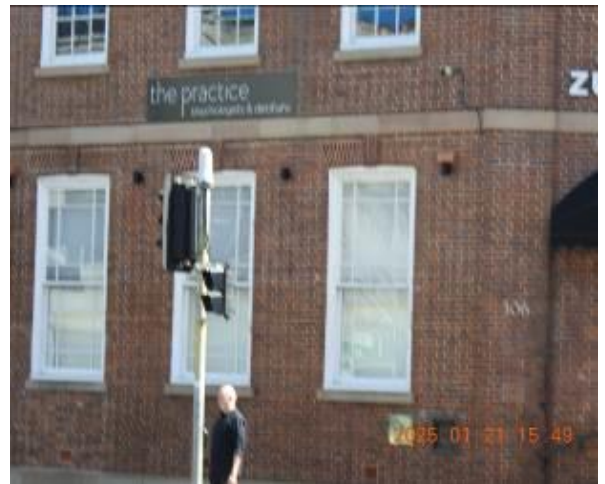
Figure 138 - General condition of external wall

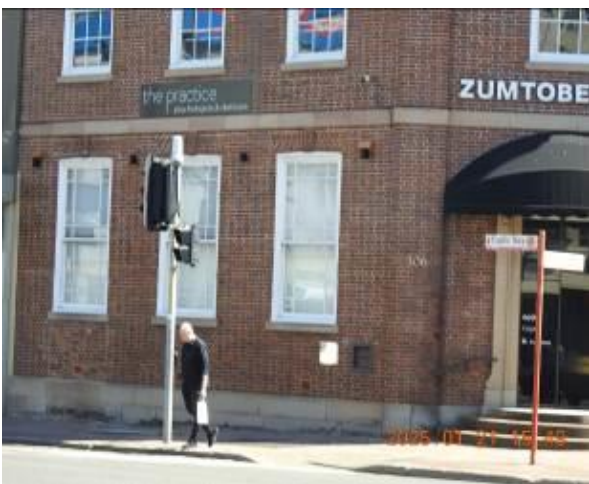
Figure 139 - General condition of external wall

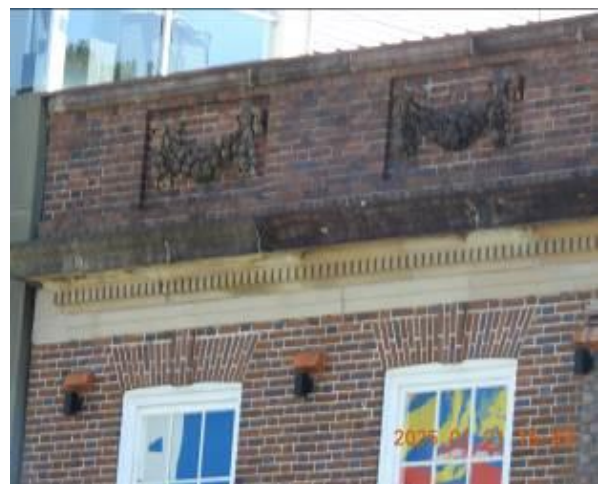
Figure 140 - General condition of external wall

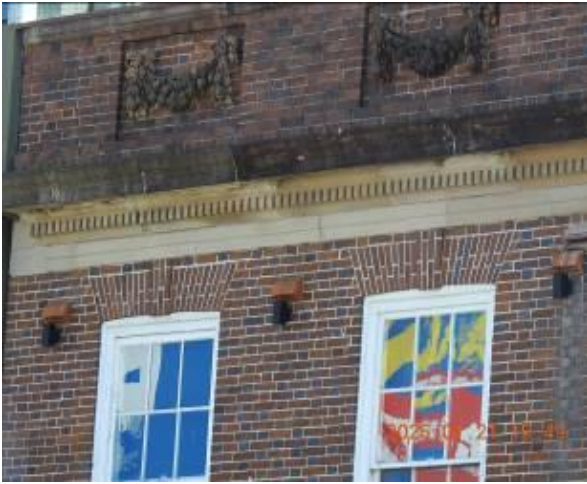
Figure 141 - General condition of external wall

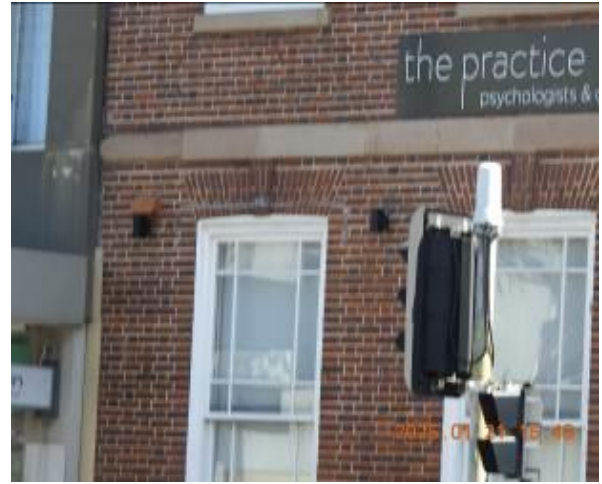
Figure 142 - General condition of external wall

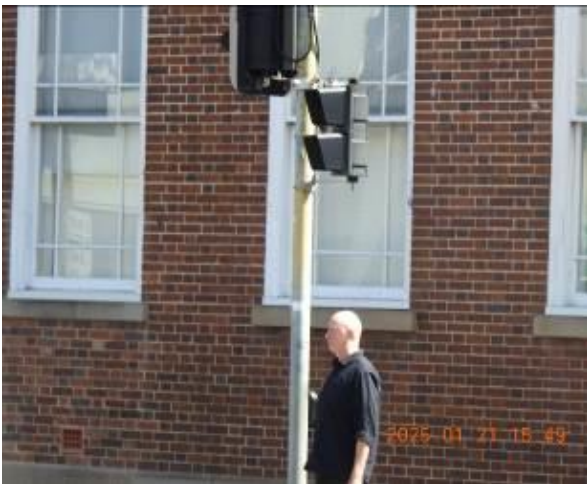
Figure 143 - General condition of external wall

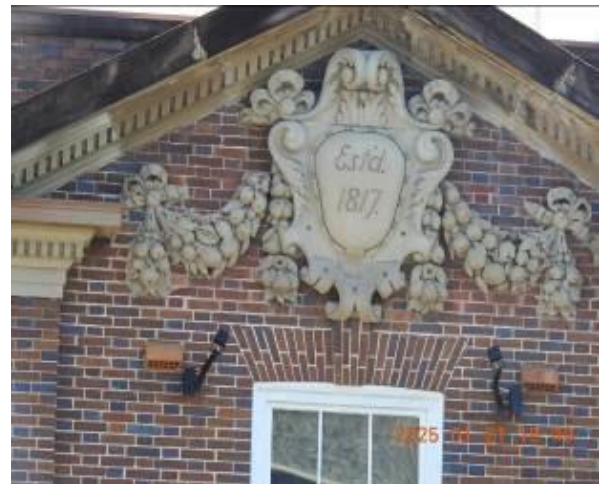
Figure 144 - General condition of external wall

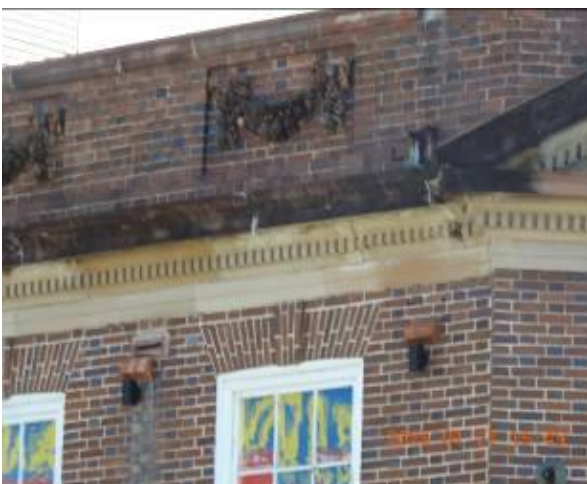
Figure 145 - General condition of external wall

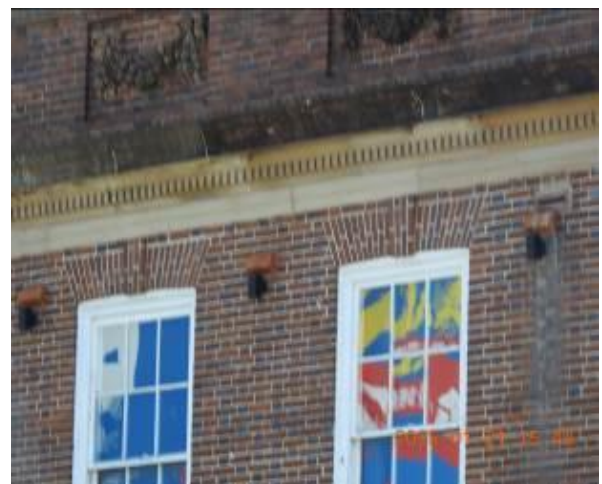
Figure 146 - General condition of external wall

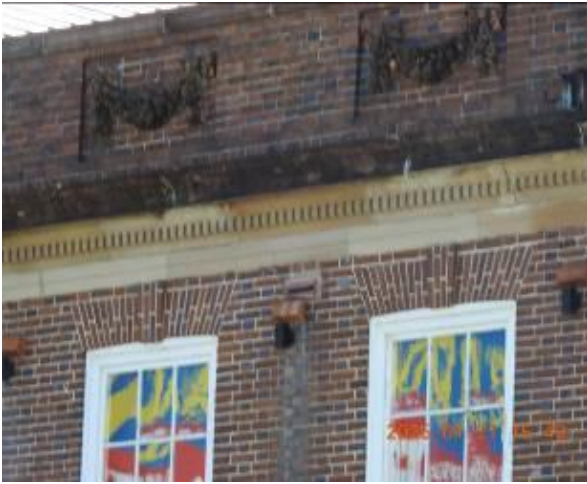
Figure 147 - General condition of external wall

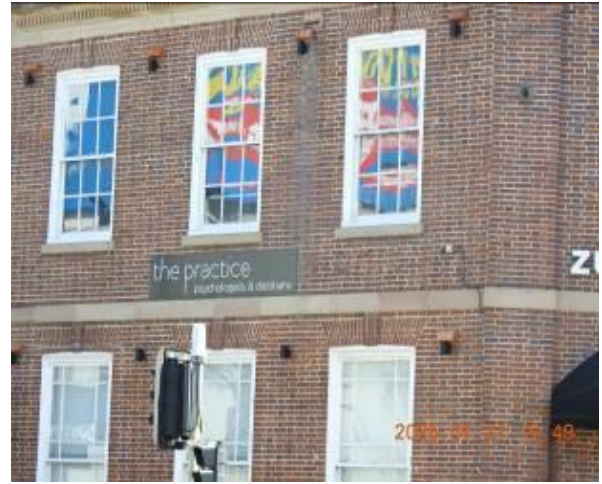
Figure 148 - General condition of external wall

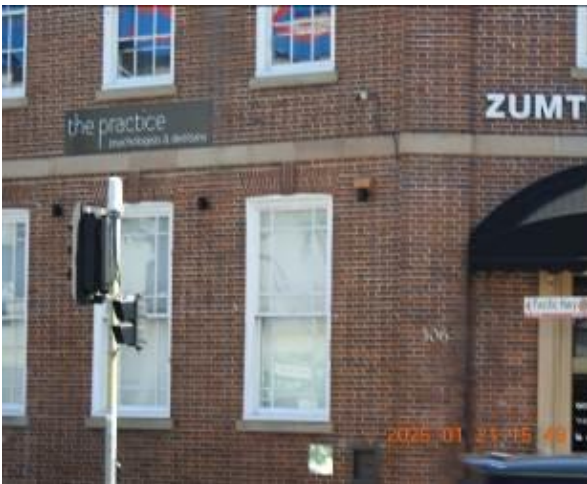
Figure 149 - General condition of external wall

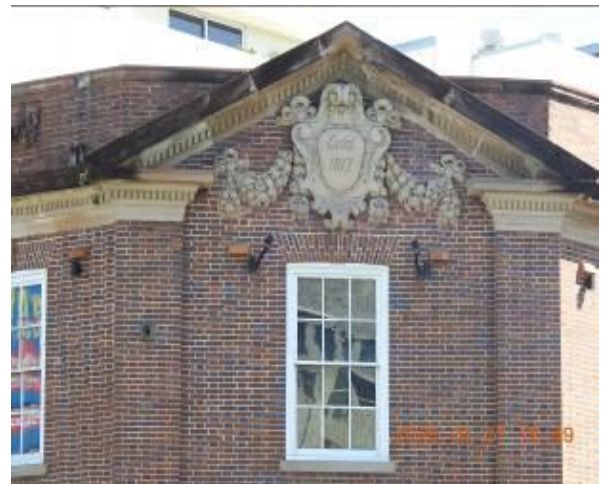
Figure 150 - General condition of external wall

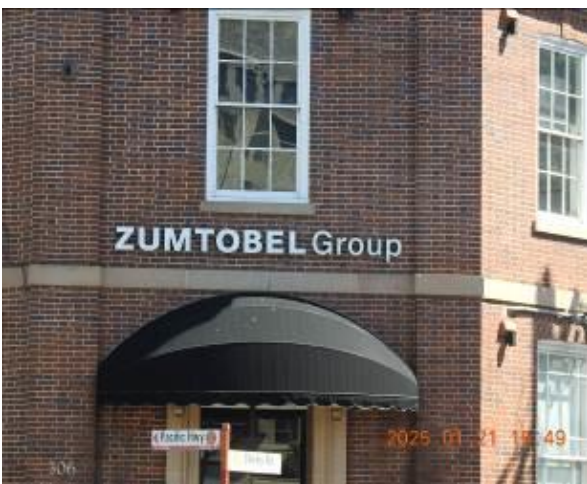
Figure 151 - General condition of external wall

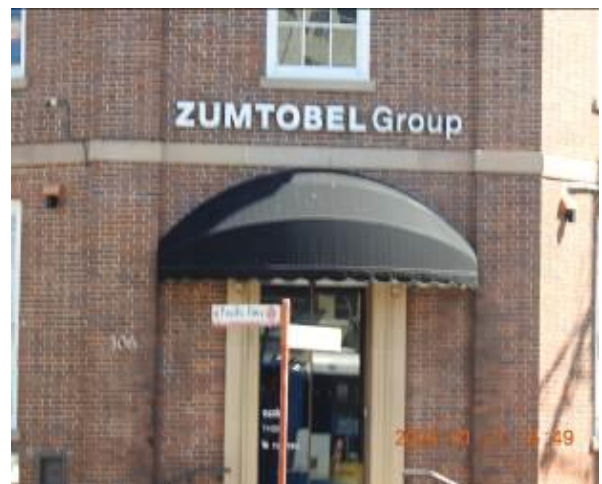
Figure 152 - General condition of external wall

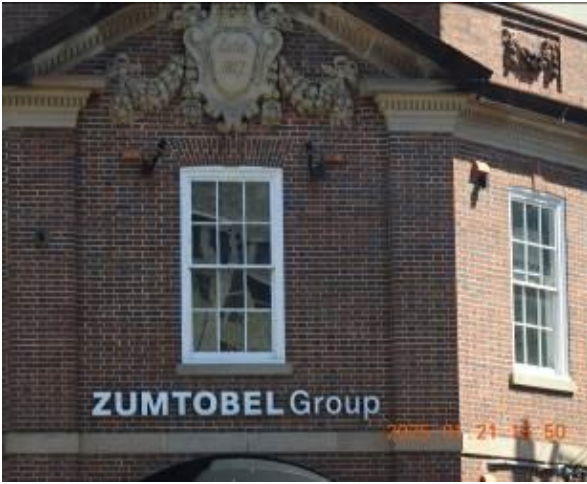
Figure 153 - General condition of external wall

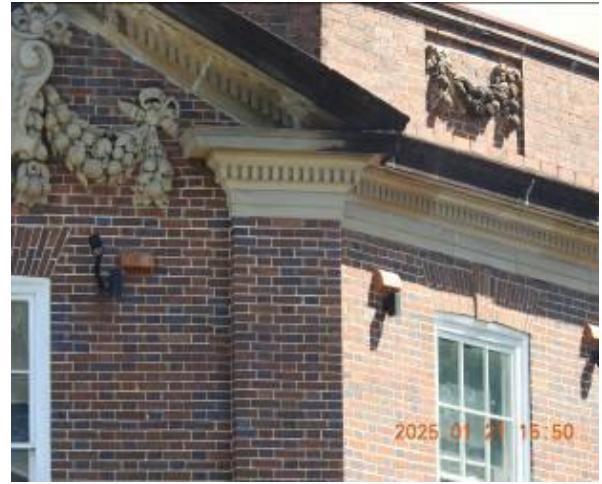
Figure 154 - General condition of external wall

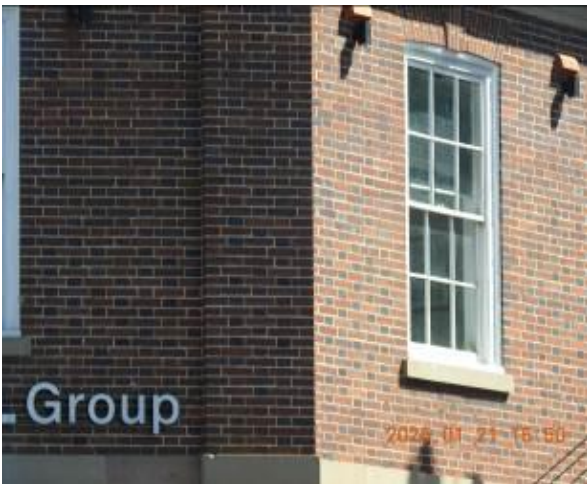
Figure 155 - General condition of external wall

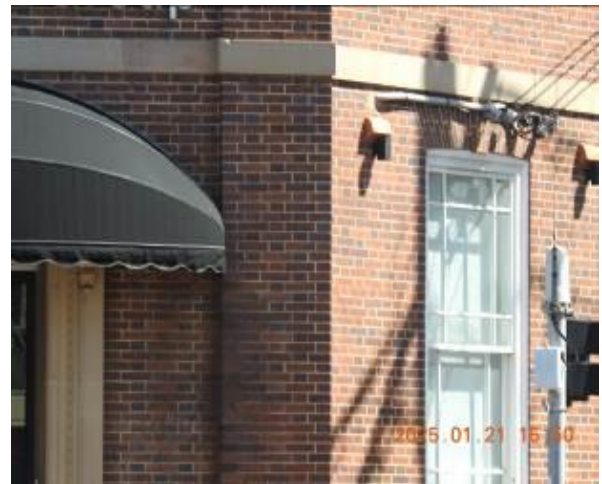
Figure 156 - General condition of external wall

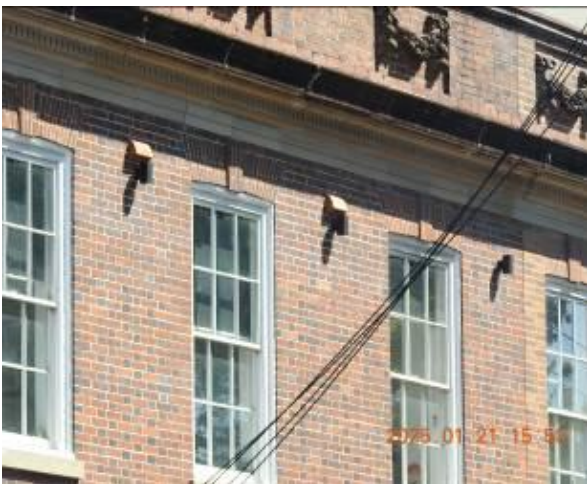
Figure 157 - General condition of external wall

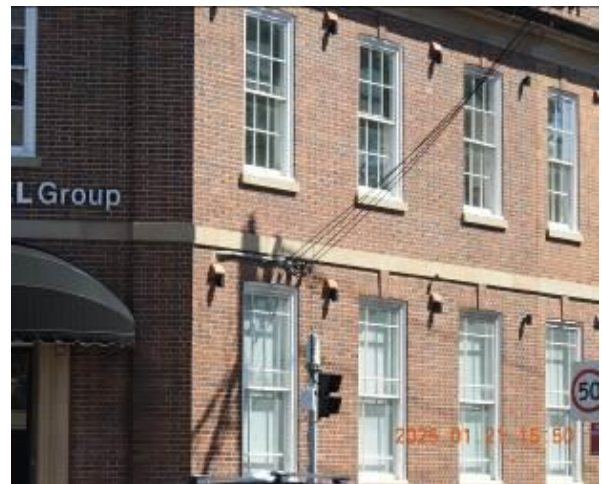
Figure 158 - General condition of external wall

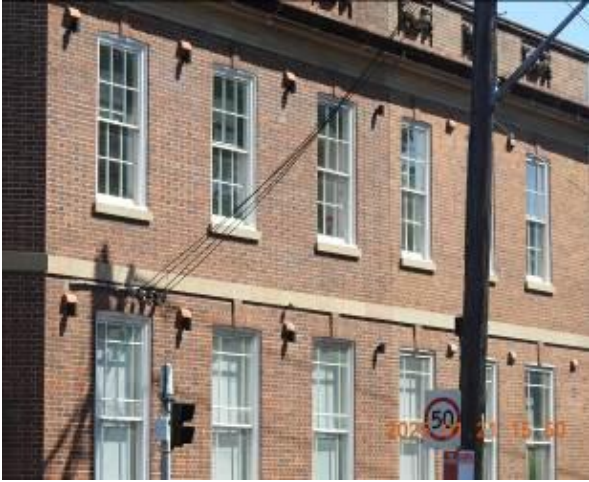
Figure 159 - General condition of external wall

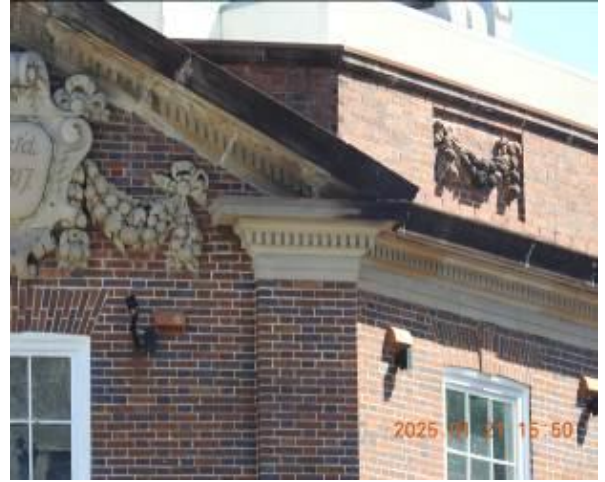
Figure 160 - General condition of external wall

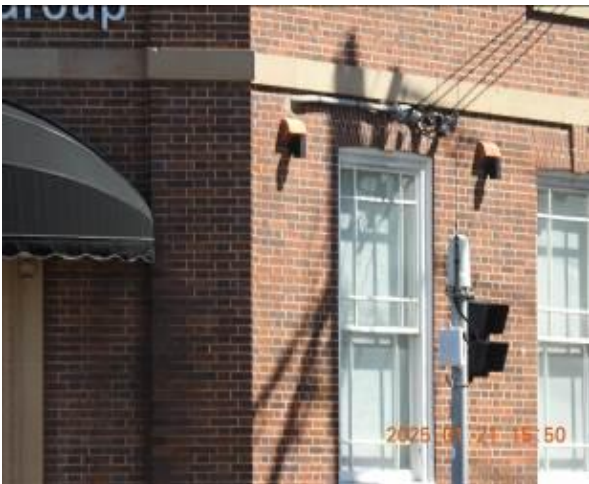
Figure 161 - General condition of external wall

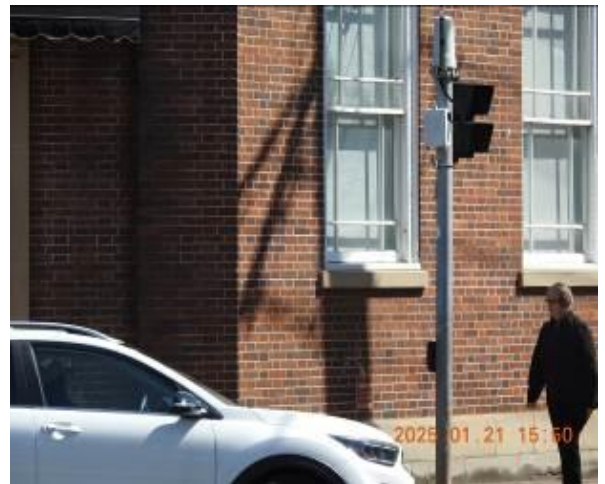
Figure 162 - General condition of external wall

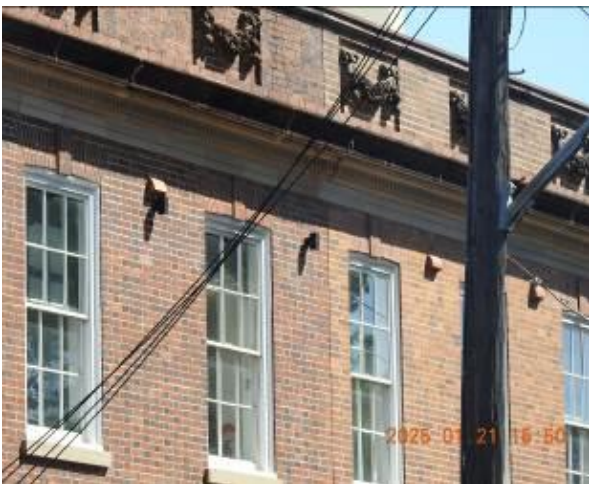
Figure 163 - General condition of external wall

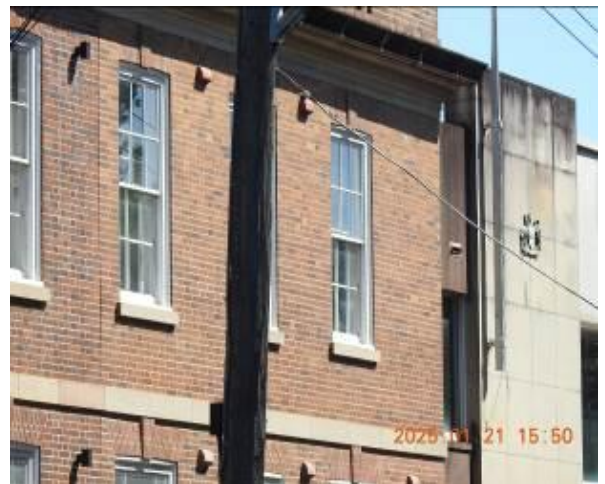
Figure 164 - General condition of external wall

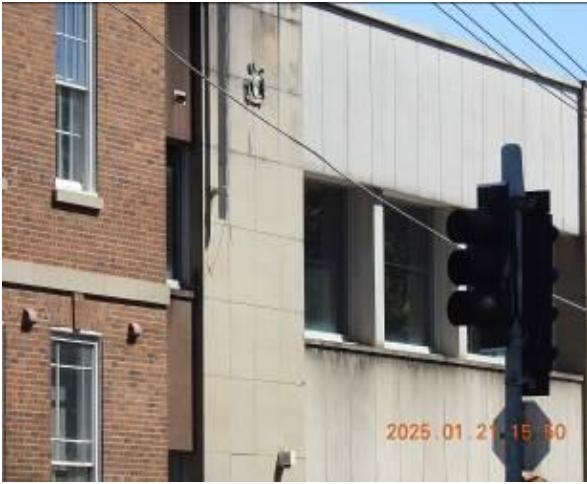
Figure 165 - General condition of external wall

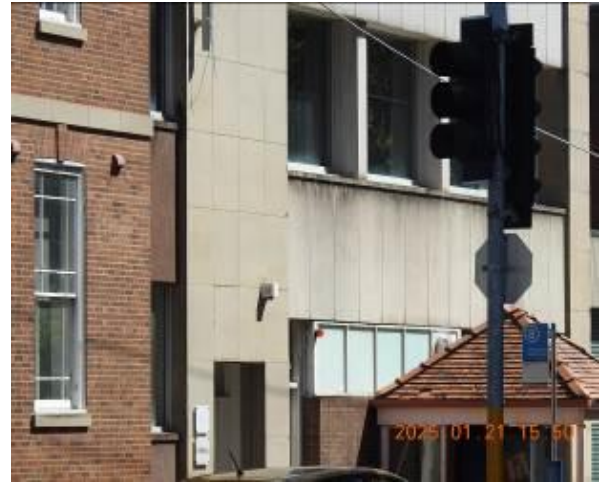
Figure 166 - General condition of external wall

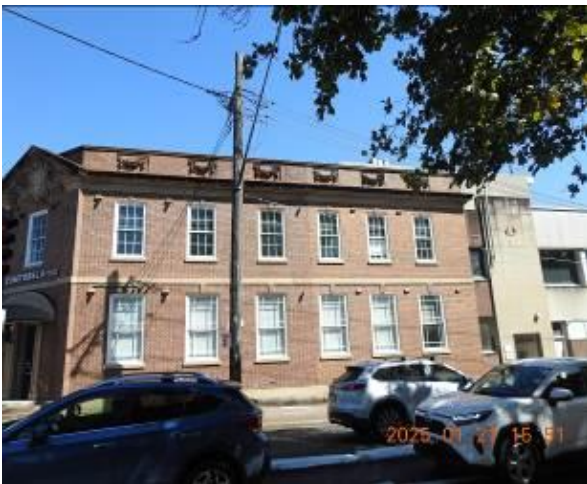
Figure 167 - General condition of external wall

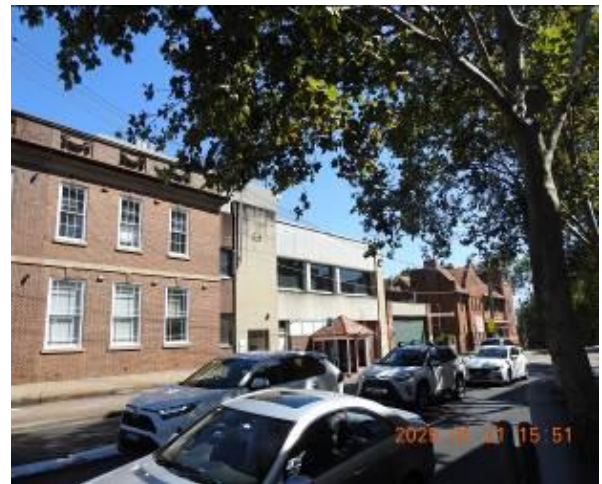
Figure 168 - General condition of external wall

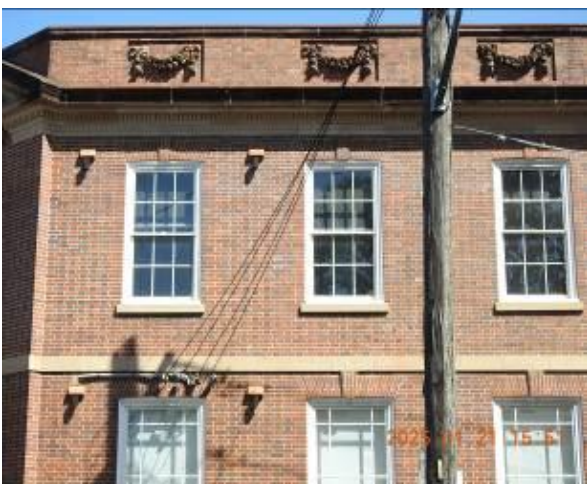
Figure 169 - General condition of external wall

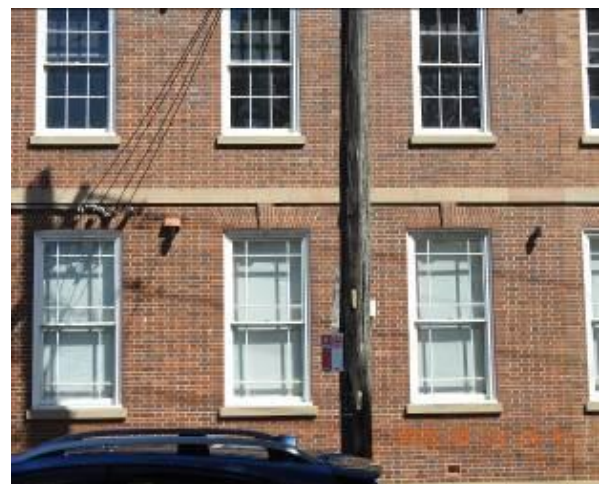
Figure 170 - General condition of external wall

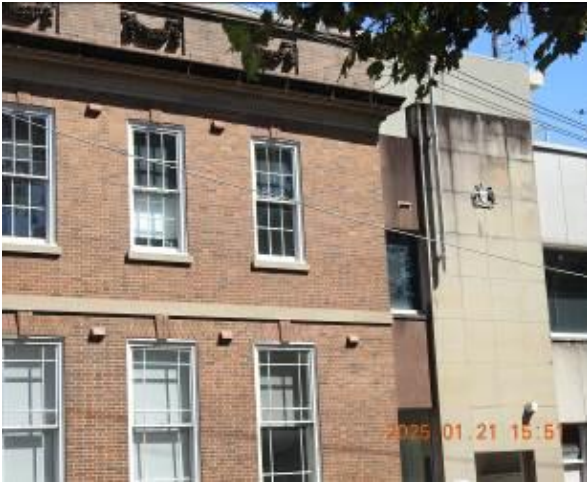
Figure 171 - General condition of external wall

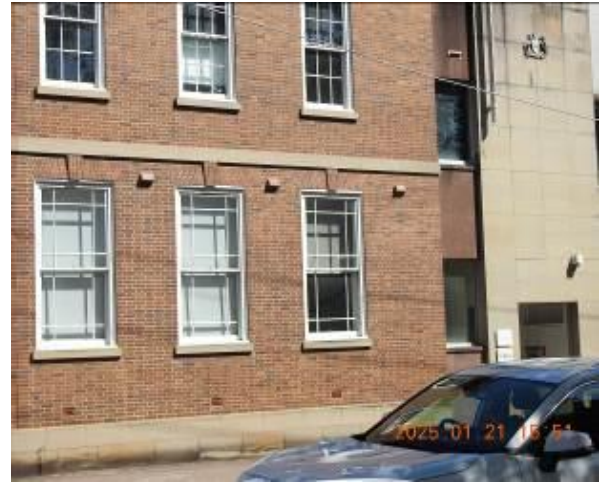
Figure 172 - General condition of external wall

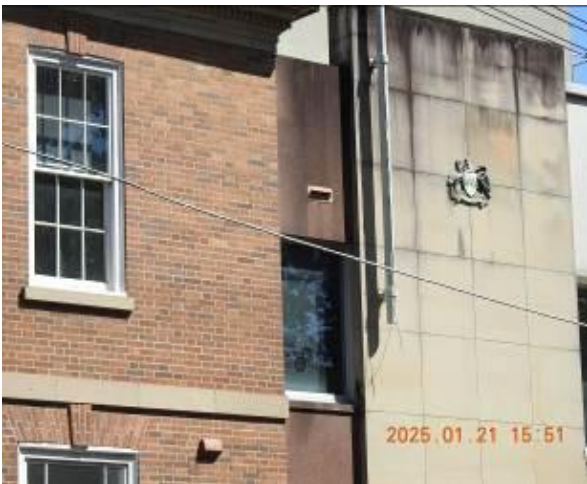
Figure 173 - General condition of external wall

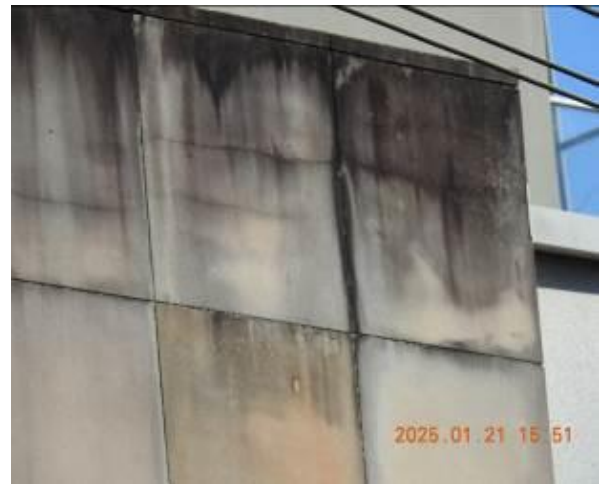
Figure 174 - Crack propagation through external wall

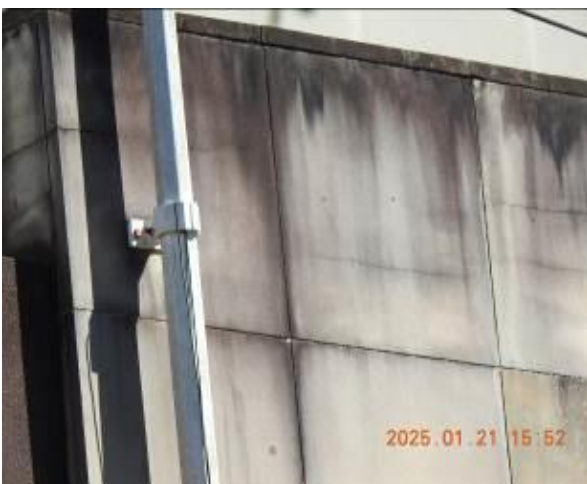
Figure 175 - Crack propagation through external wall

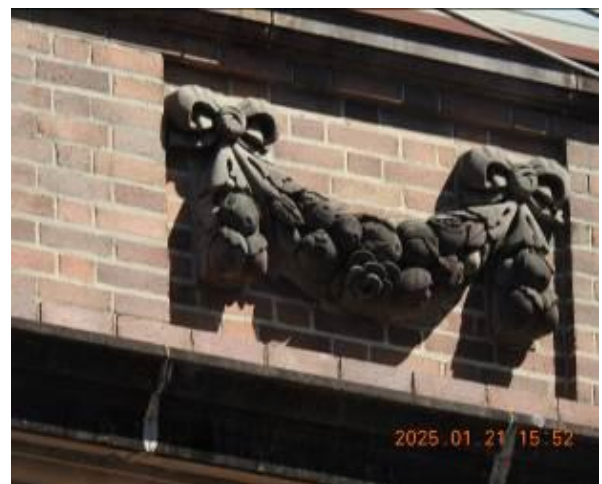
Figure 176 - General condition of external wall

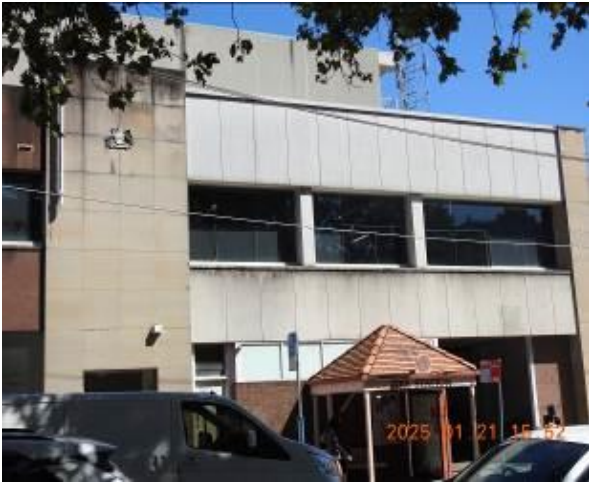
Figure 177 - General condition of external wall

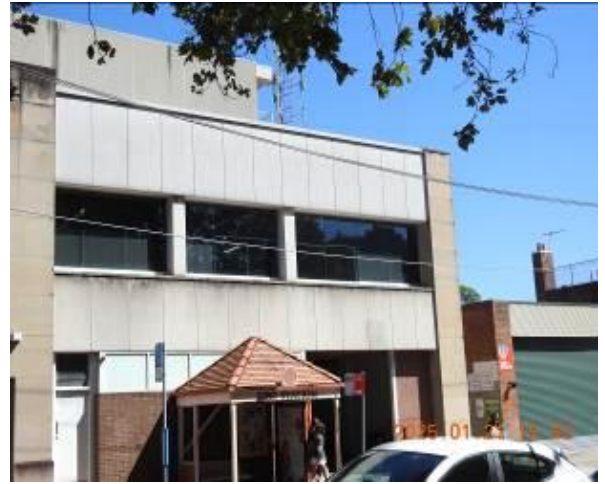
Figure 178 - General condition of external wall

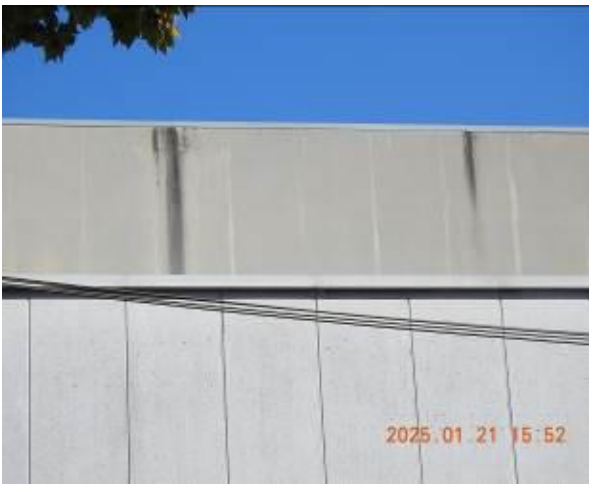
Figure 179 - Crack propagation through external wall

The exterior of the building was in a reasonable condition with evidence of cracking, material loss, through the external walls.

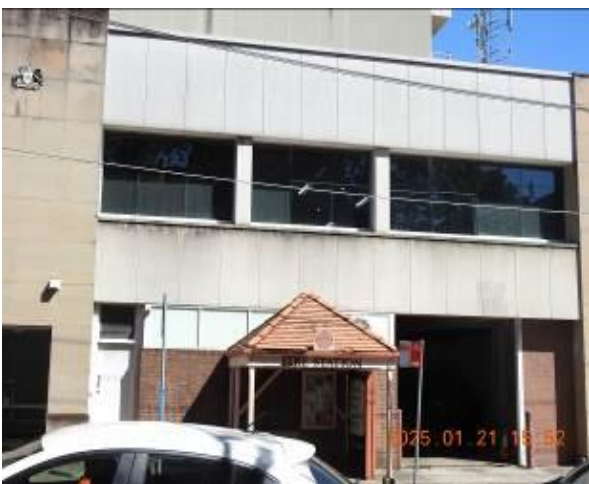
Figure 181 - General condition of external wall

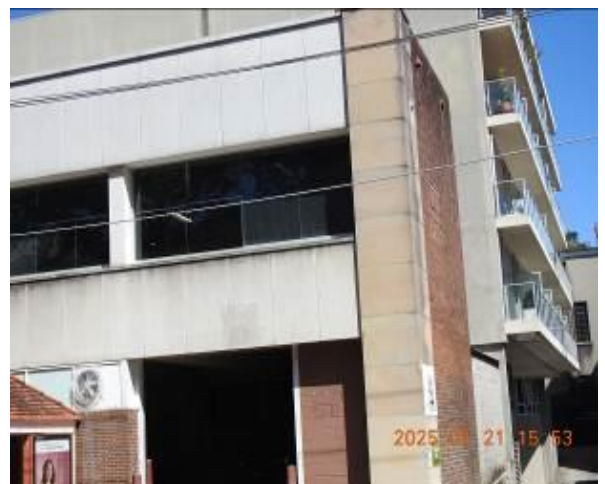
Figure 182 - General condition of external wall
