391-423 PACIFIC HIGHWAY, CROWSNEST NSW 2065

PRE-DILAPIDATION REPORT

DEICORP PTY LTD

Job No. 240325.4

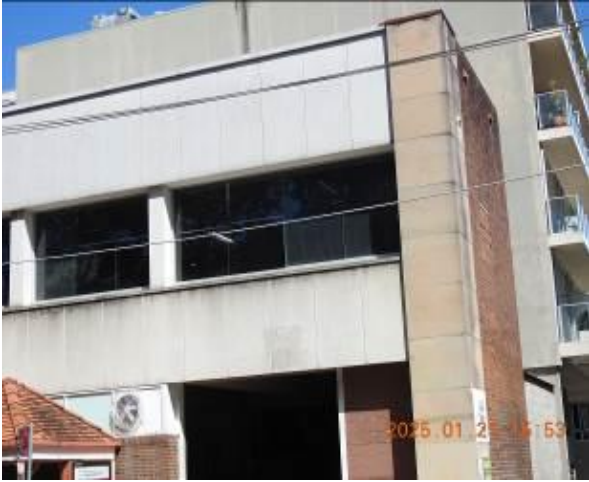
Figure 183 - General condition of external wall

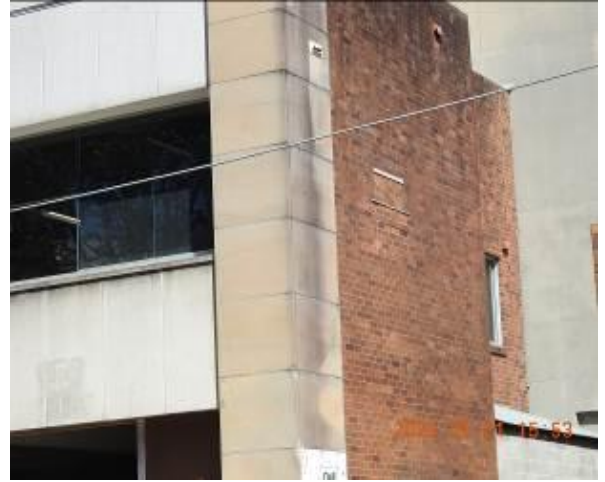
Figure 184 - General condition of external wall

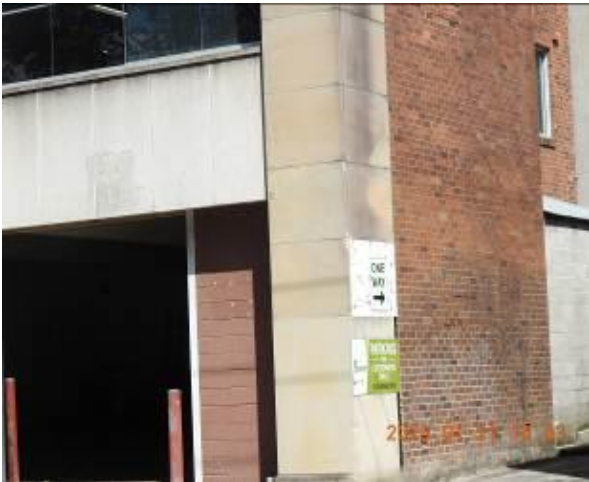
Figure 185 - General condition of external wall

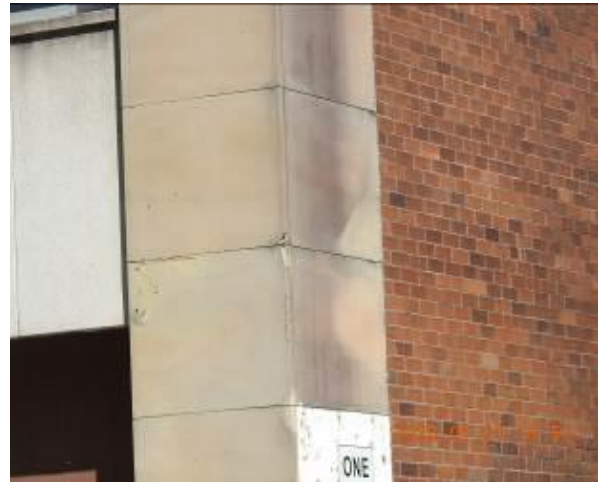
Figure 186 - General condition of external wall

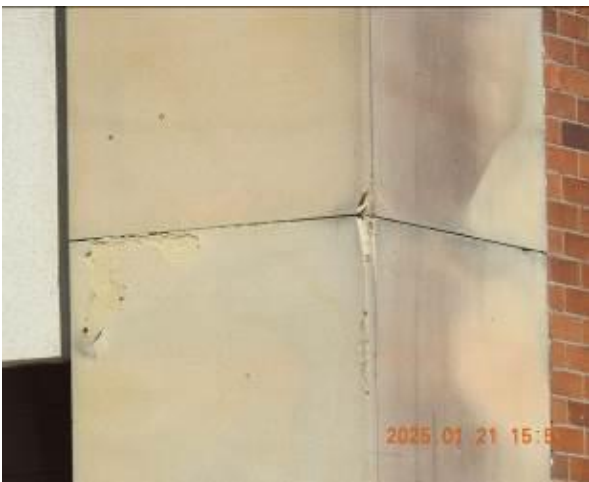
Figure 187 - Loss of material through external wall

The exterior of the building was in a reasonable condition with evidence of cracking, material loss, through the external walls.

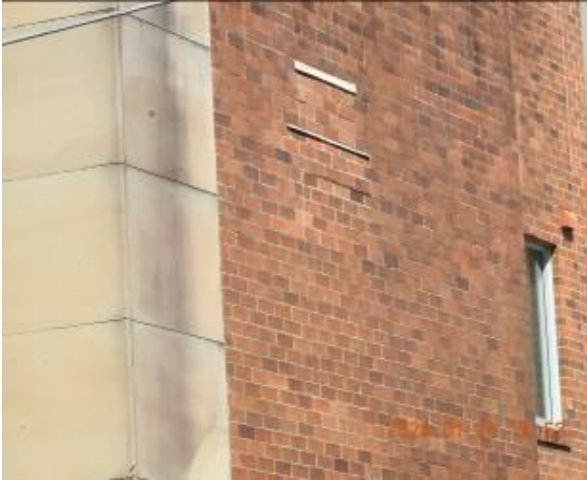
Figure 189 - General condition of external wall

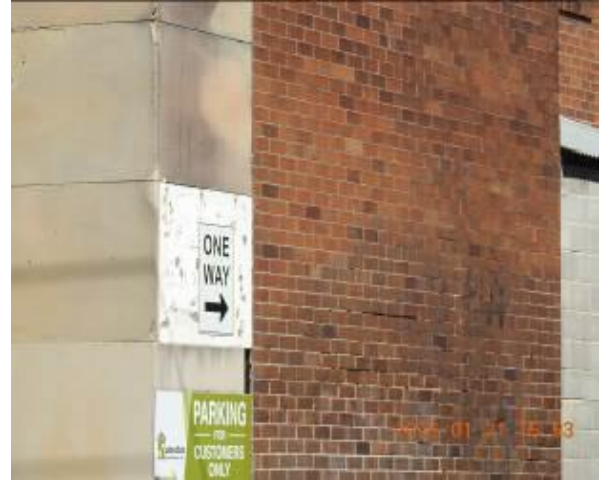
Figure 190 - General condition of external wall

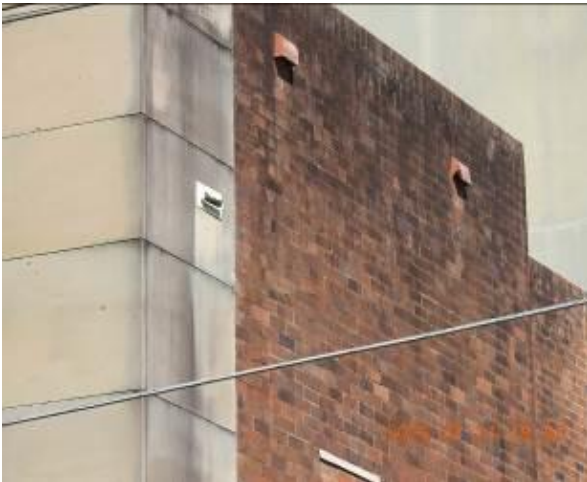
Figure 191 - General condition of external wall

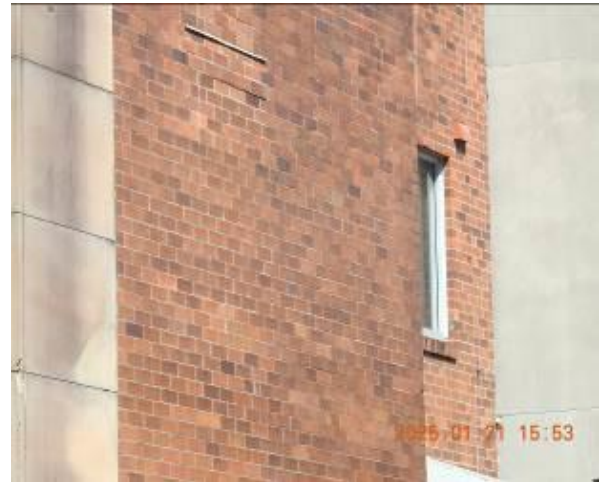
Figure 192 - General condition of external wall

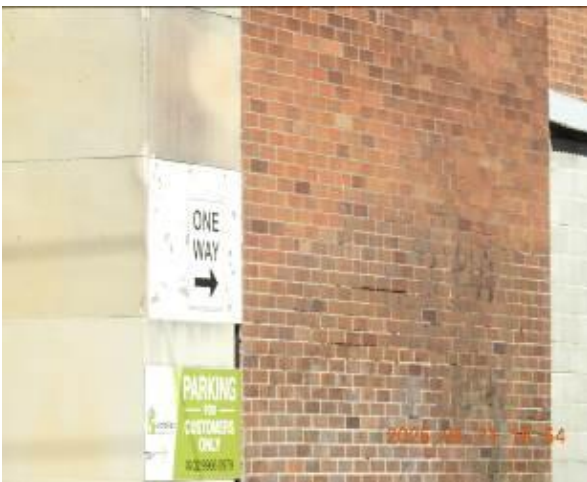
Figure 193 - General condition of external wall

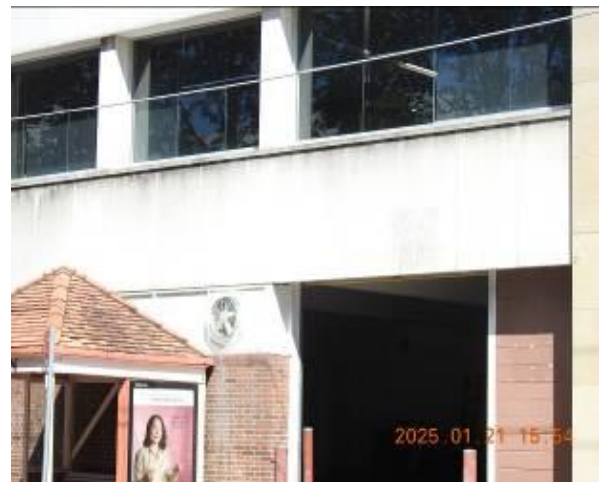
Figure 194 - General condition of external wall

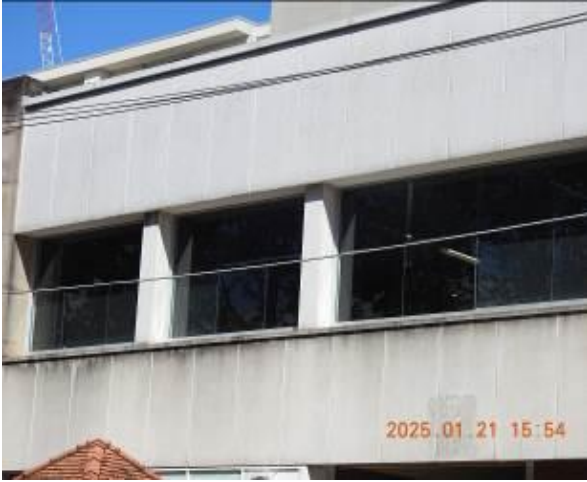
Figure 195 - General condition of external wall

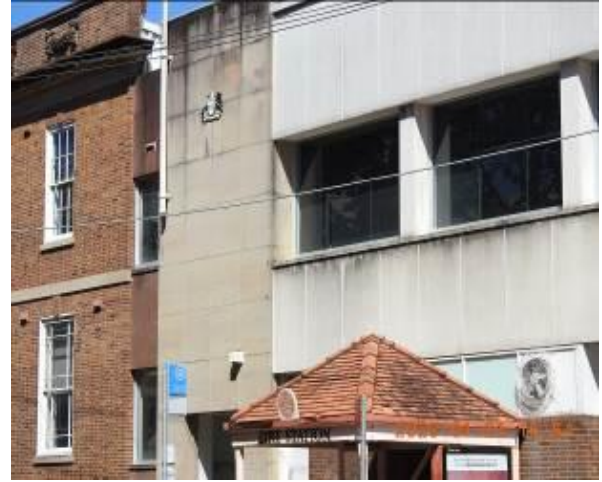
Figure 196 - General condition of external wall

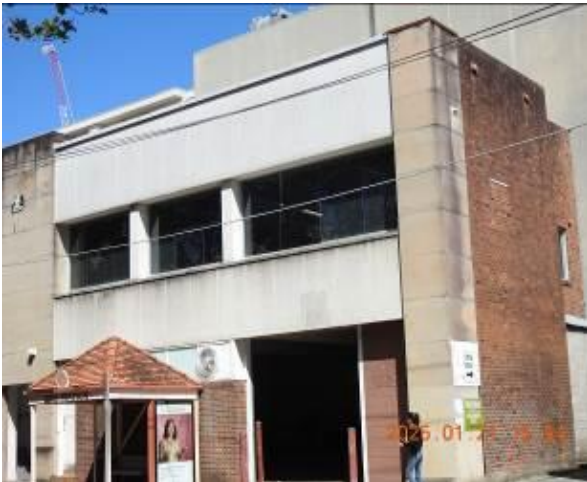
Figure 197 - General condition of external wall

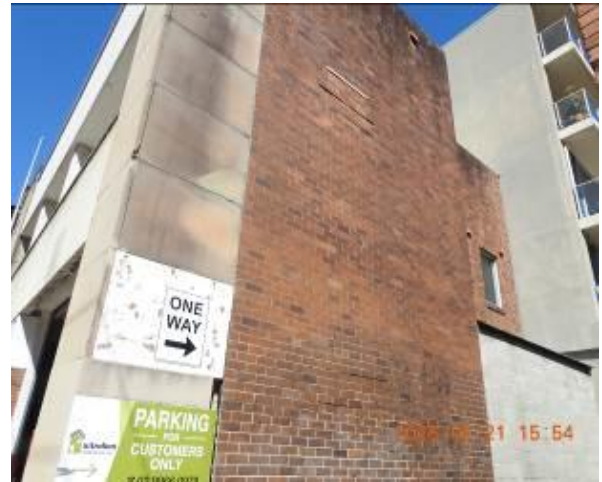
Figure 198 - General condition of external wall

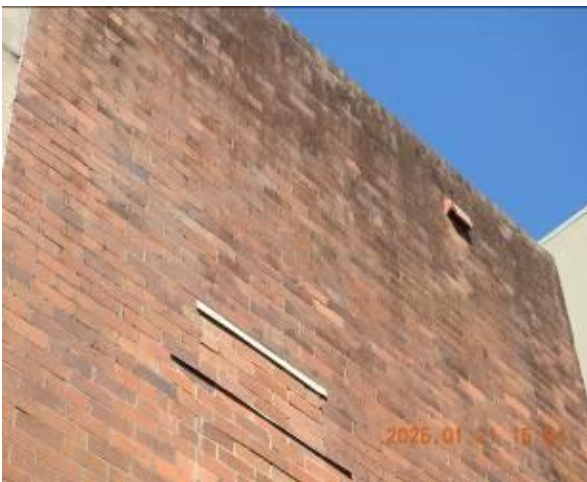
Figure 199 - General condition of external wall

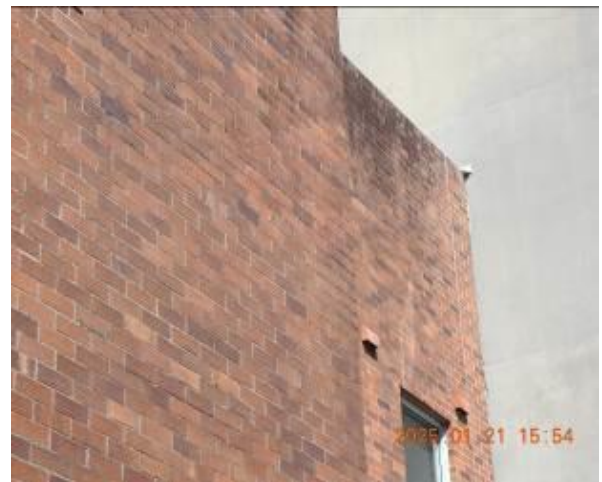
Figure 200 - General condition of external wall

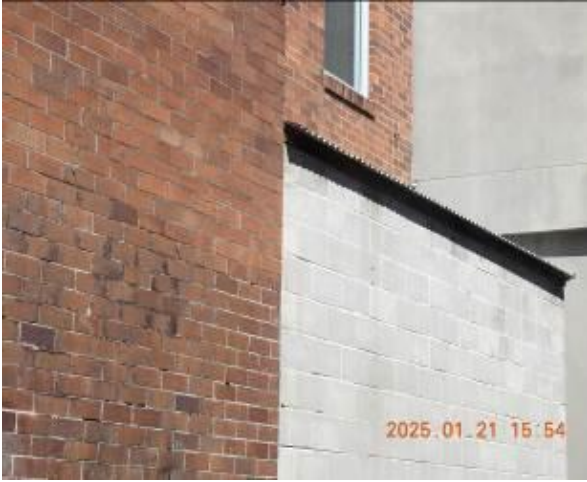
Figure 201 - General condition of external wall

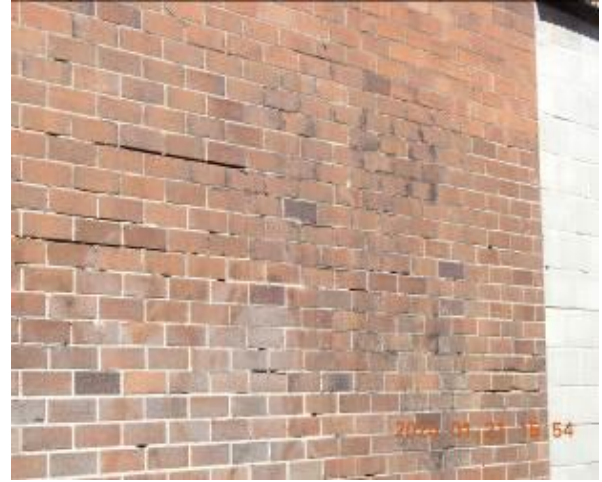
Figure 202 - General condition of external wall

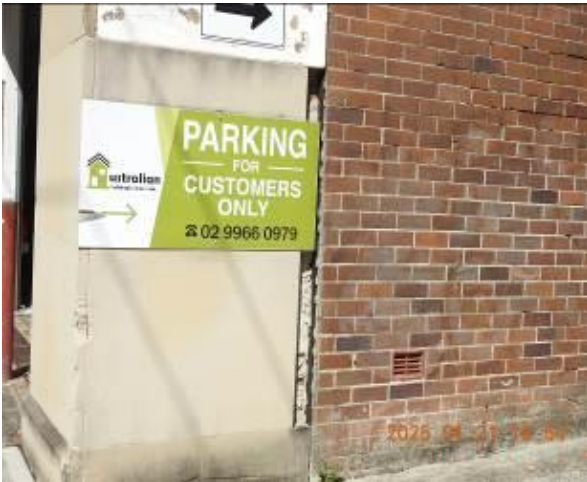
Figure 203 - General condition of external wall

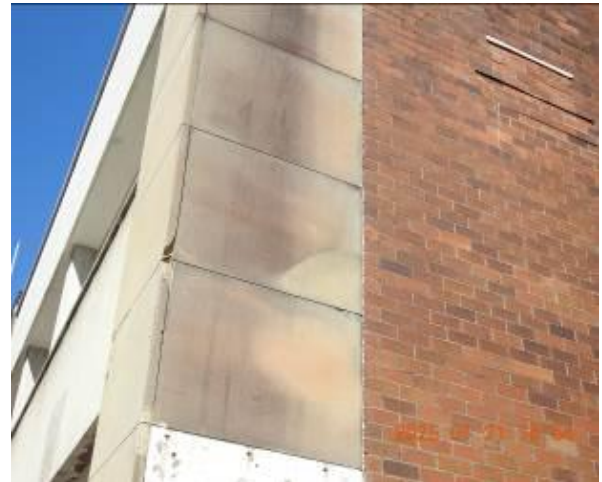
Figure 204 - General condition of external wall

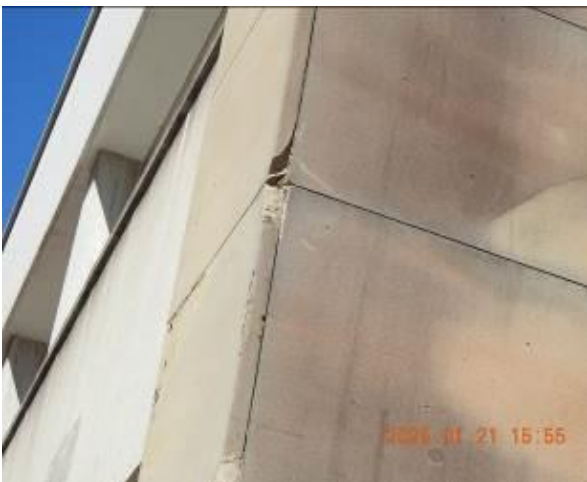
Figure 205 - Crack propagation and loss of material through external wall

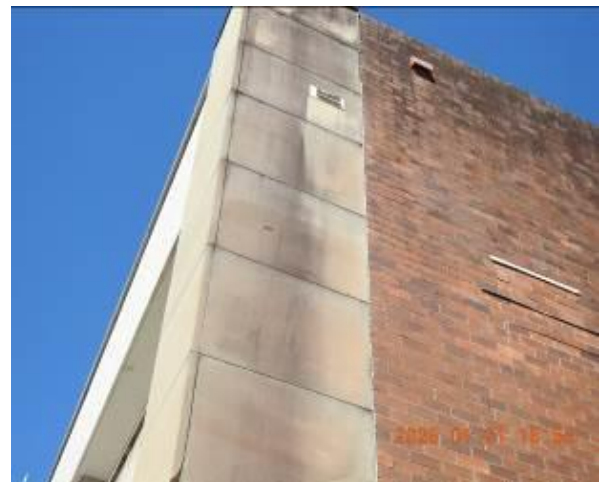
Figure 206 - General condition of external wall

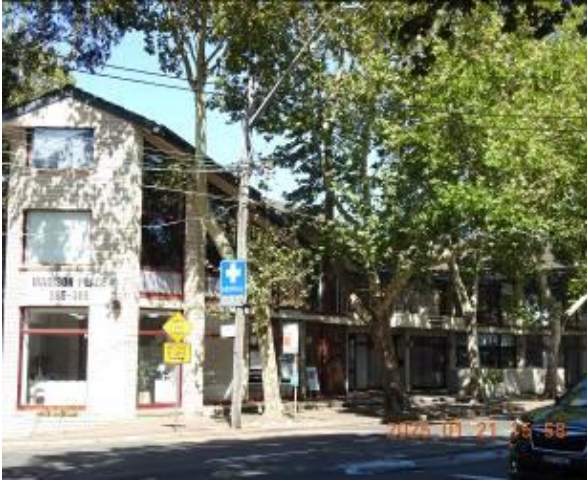
Figure 207 - General condition of external wall

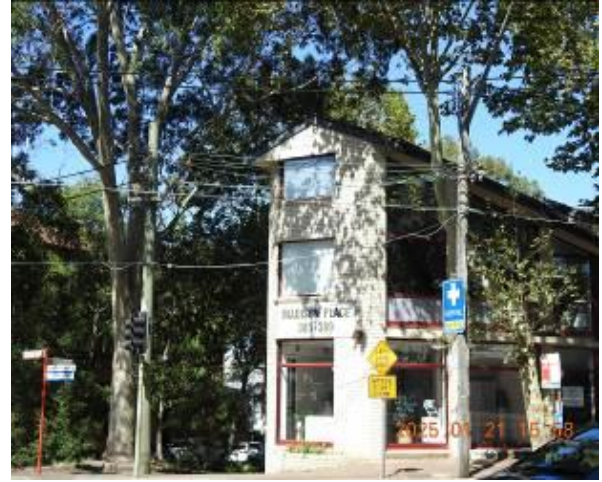
Figure 208 - General condition of external wall

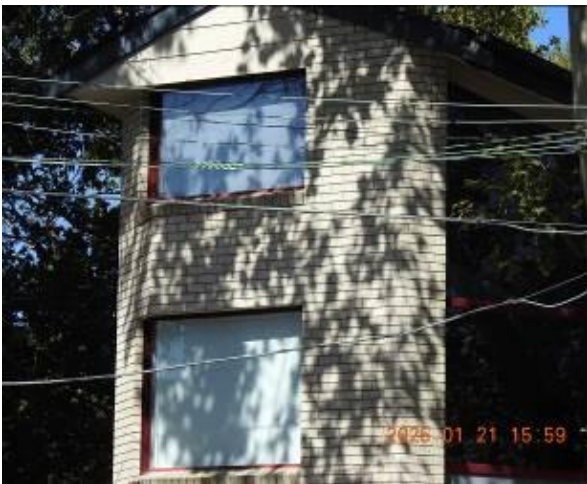
Figure 209 - General condition of external wall

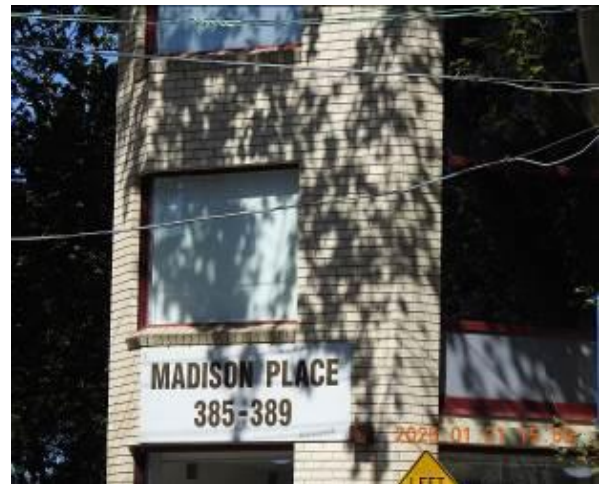
Figure 210 - General condition of external wall

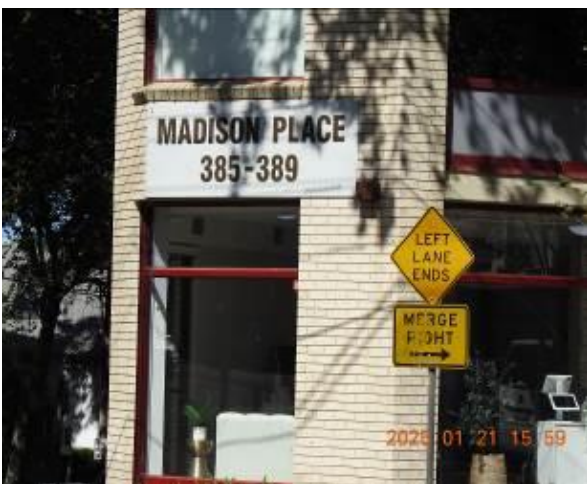
Figure 211 - General condition of external wall

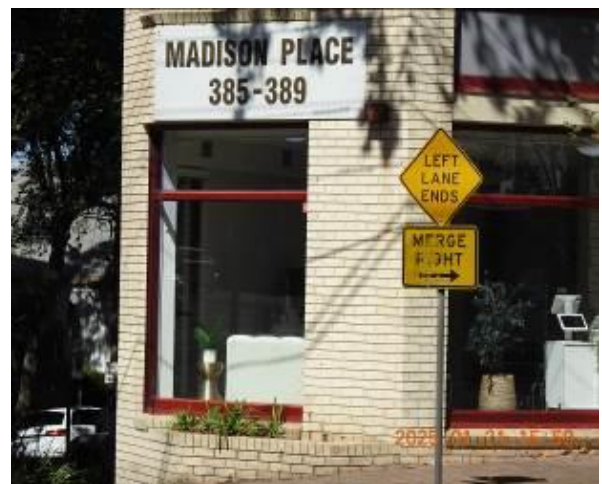
Figure 212 - General condition of external wall

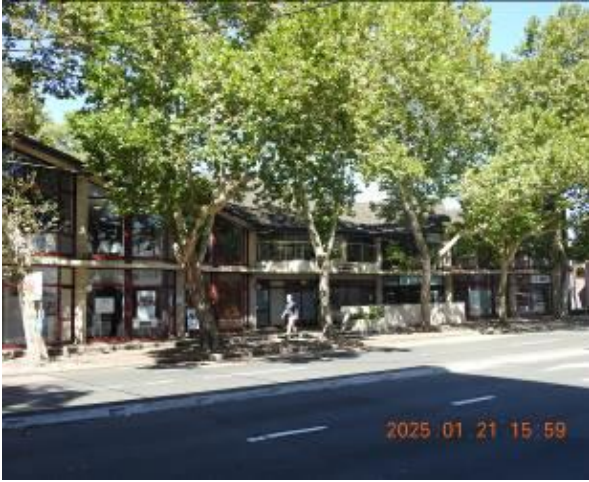
Figure 213 - General condition of external wall

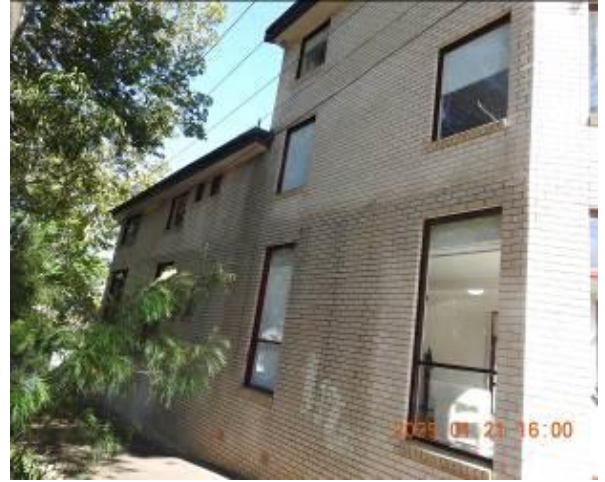
Figure 214 - General condition of external wall

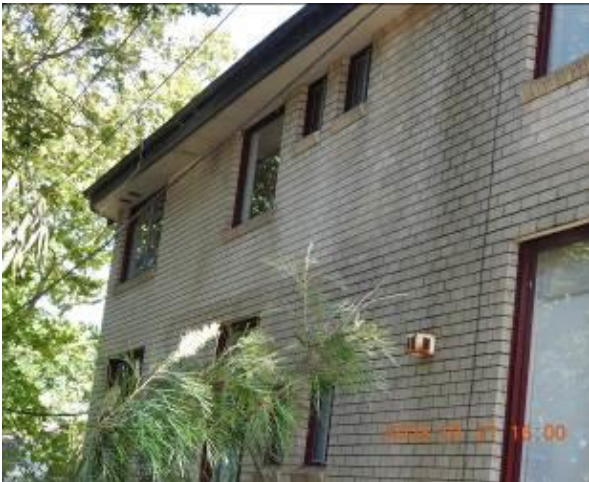
Figure 215 - General condition of external wall

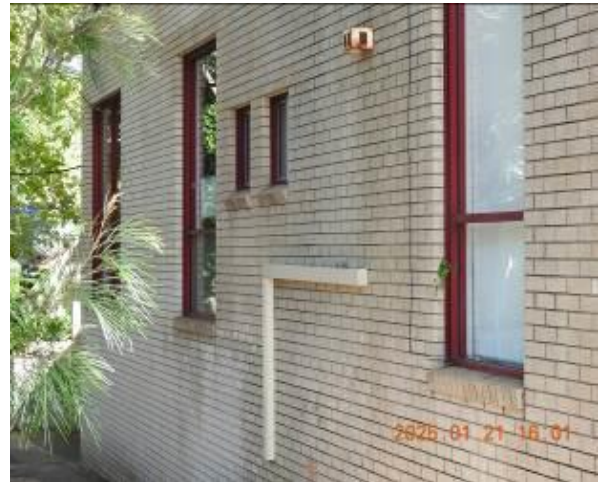
Figure 216 - General condition of external wall

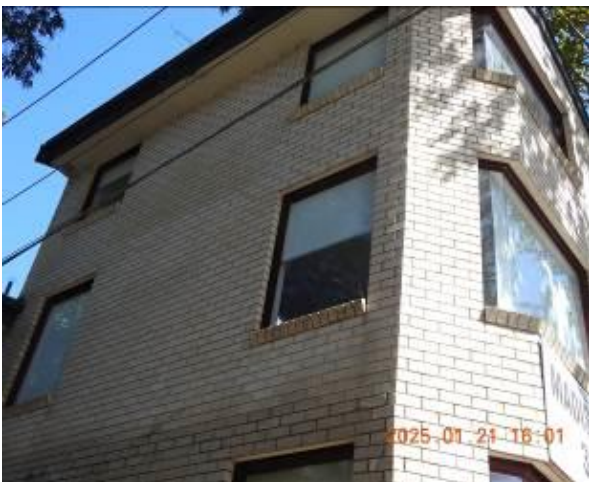
Figure 217 - General condition of external wall

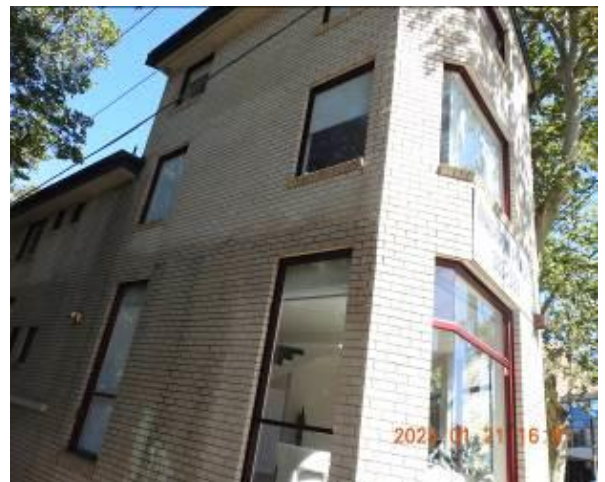
Figure 218 - General condition of external wall

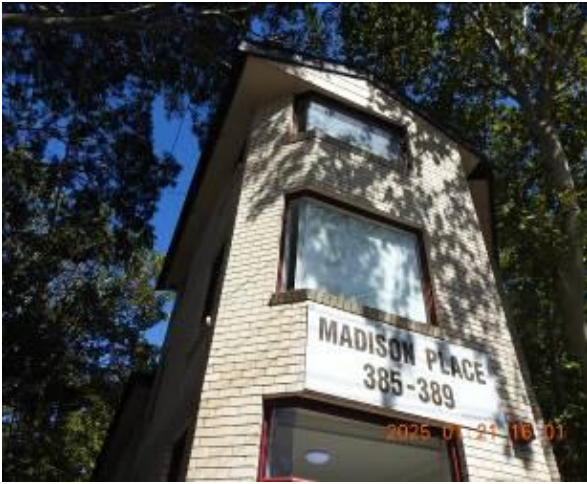
Figure 219 - General condition of external wall

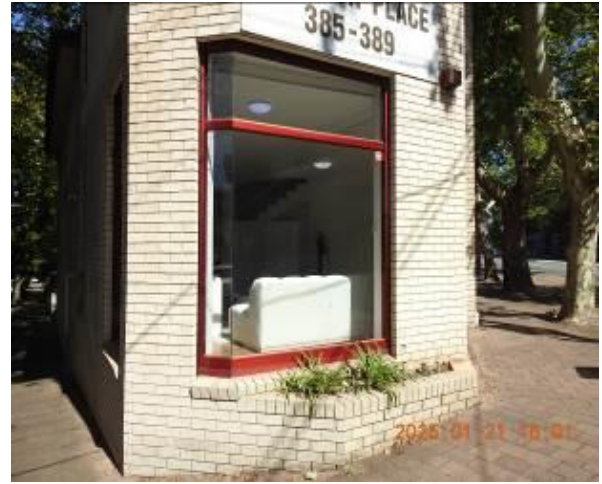
Figure 220 - General condition of external wall

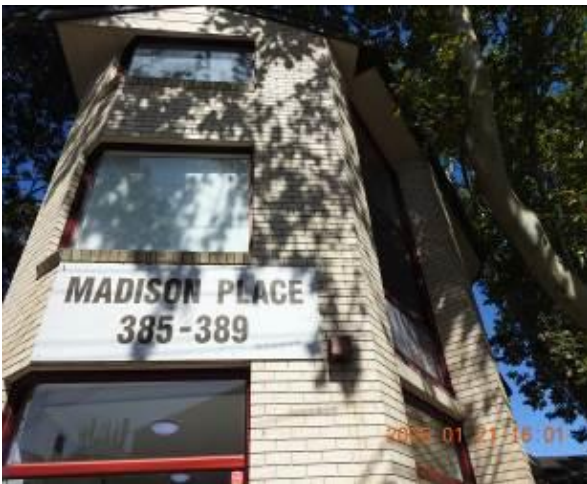
Figure 221 - General condition of external wall

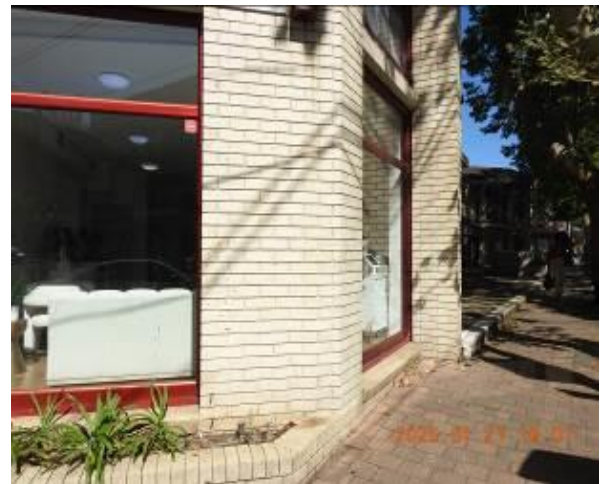
Figure 222 - General condition of external wall

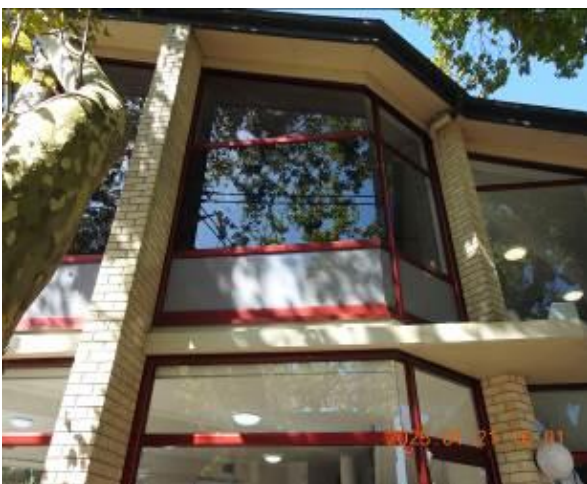
Figure 223 - General condition of external wall

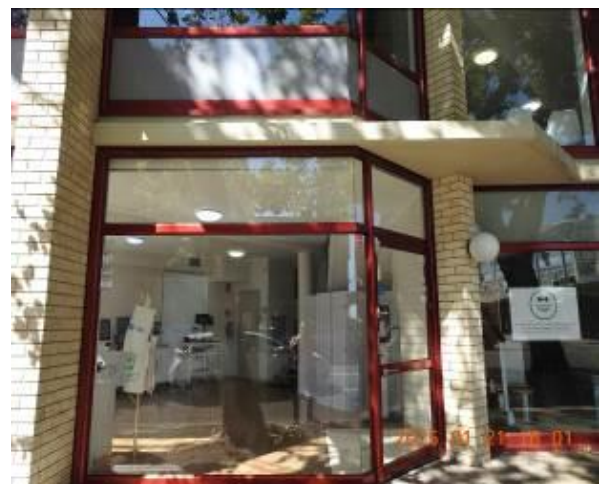
Figure 224 - General condition of external wall

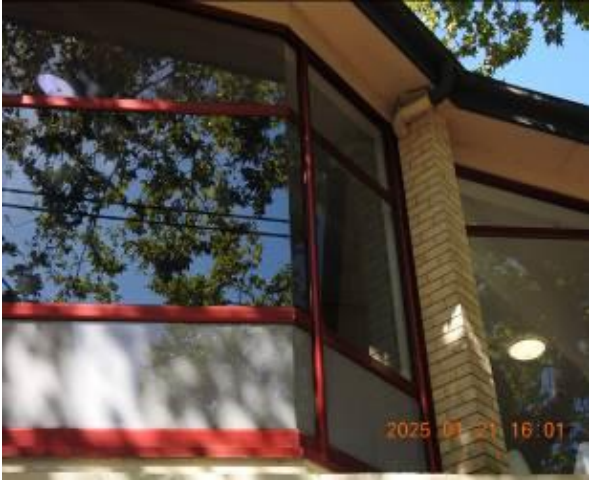
Figure 225 - General condition of external wall

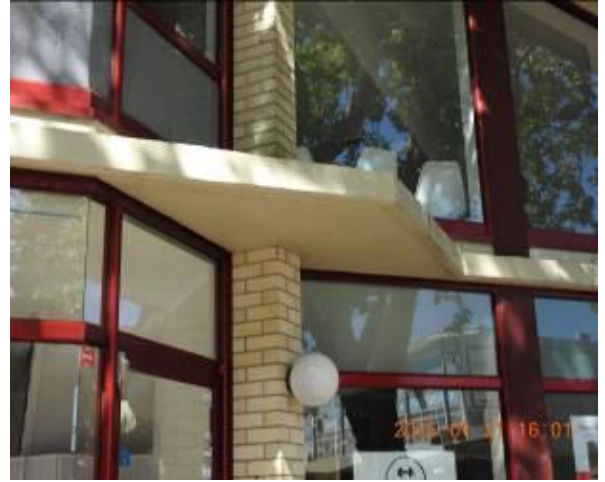
Figure 226 - General condition of external wall

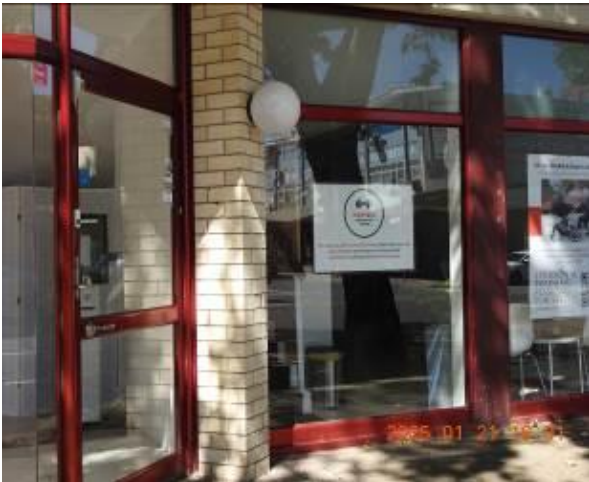
Figure 227 - General condition of external wall

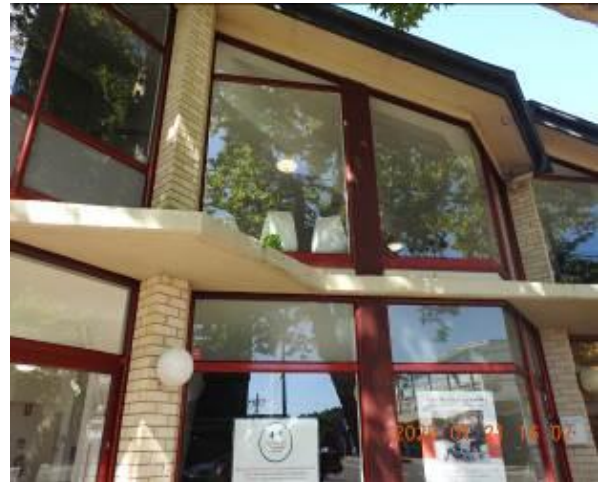
Figure 228 - General condition of external wall

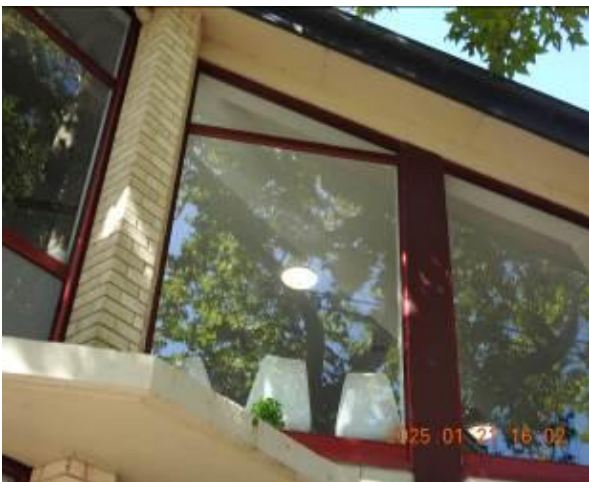
Figure 229 - General condition of external wall

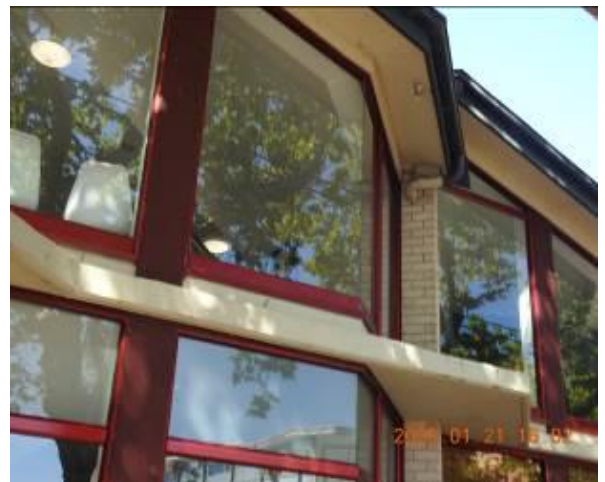
Figure 230 - General condition of external wall

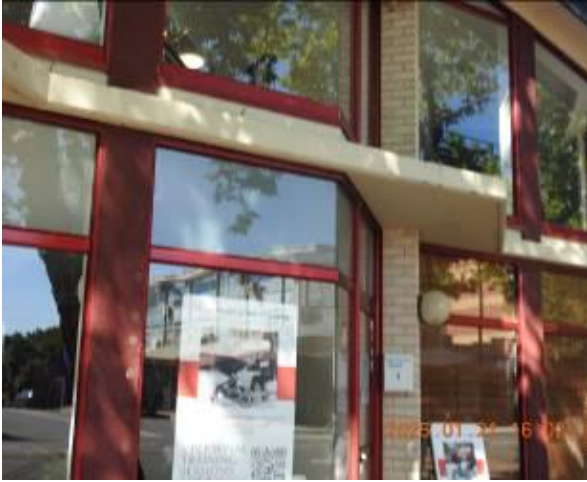
Figure 231 - General condition of external wall

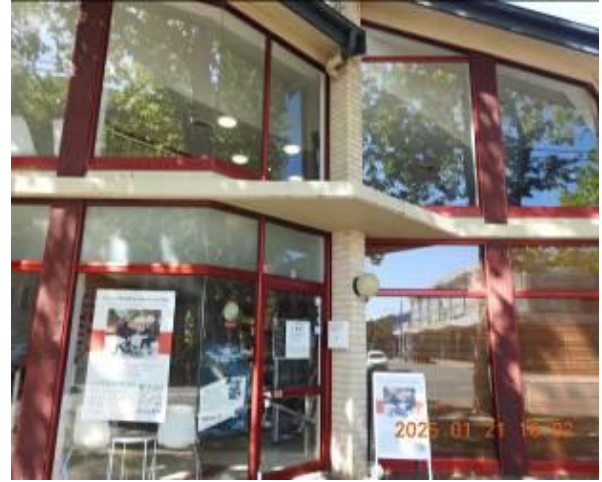
Figure 232 - General condition of external wall

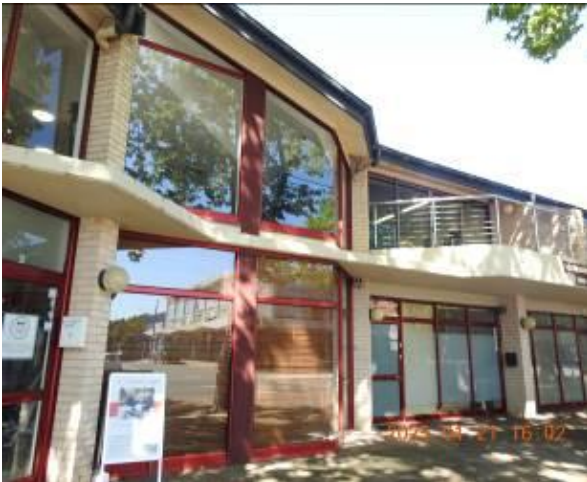
Figure 233 - General condition of external wall

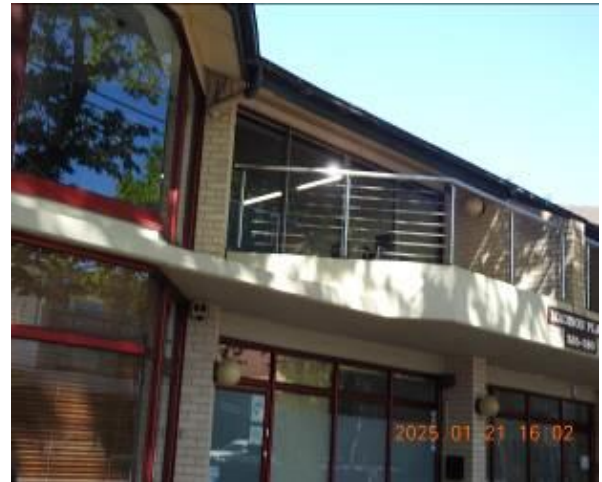
Figure 234 - General condition of external wall

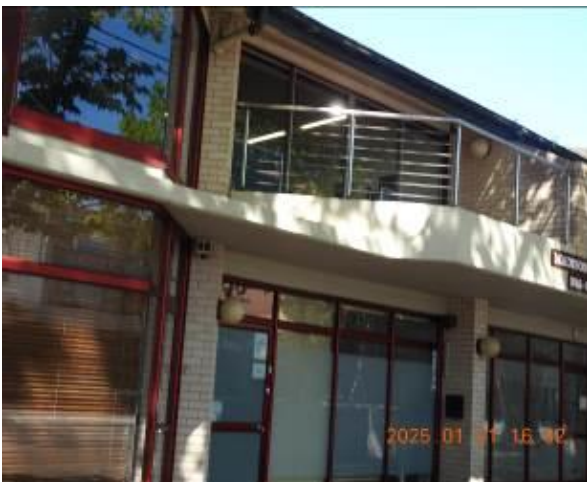
Figure 235 - General condition of external wall

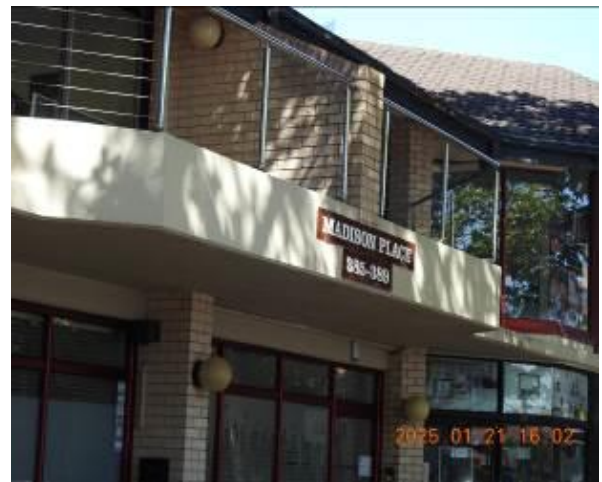
Figure 236 - General condition of external wall

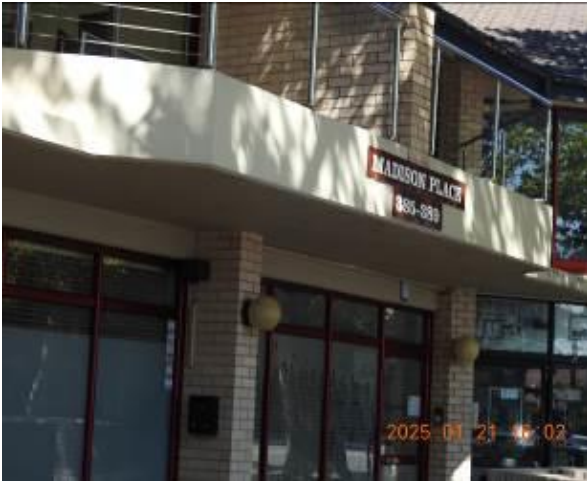
Figure 237 - General condition of external wall

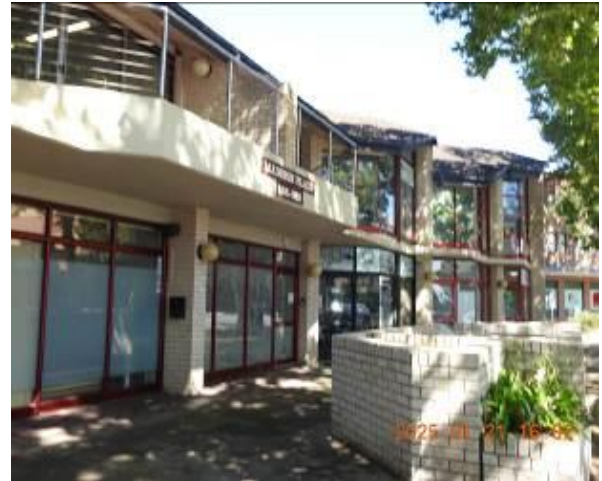
Figure 238 - General condition of external wall

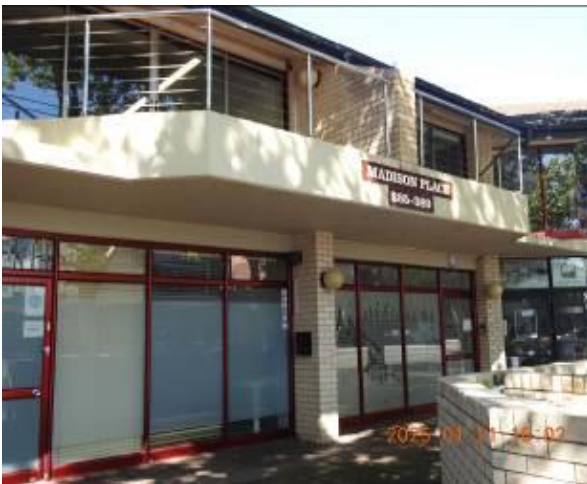
Figure 239 - General condition of external wall

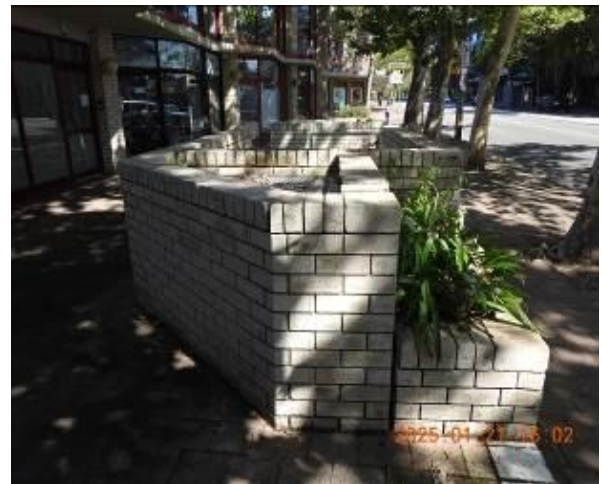
Figure 240 - General condition of external wall

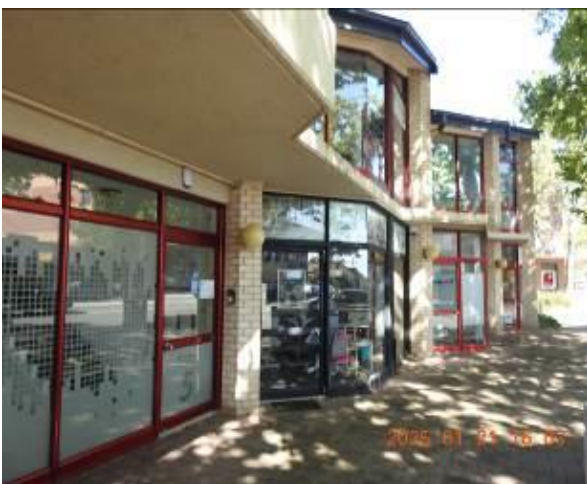
Figure 241 - General condition of external wall

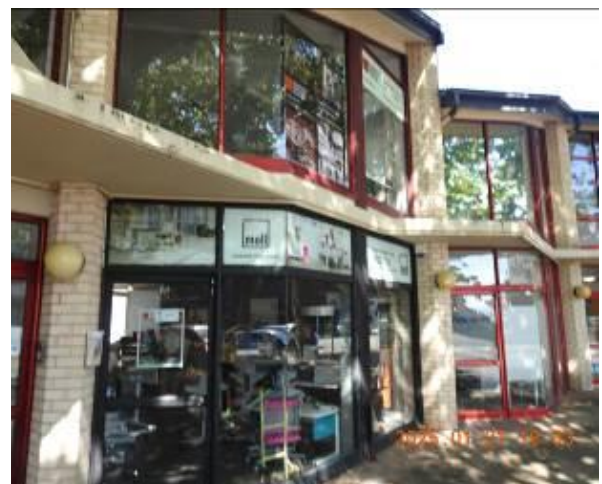
Figure 242 - General condition of external wall

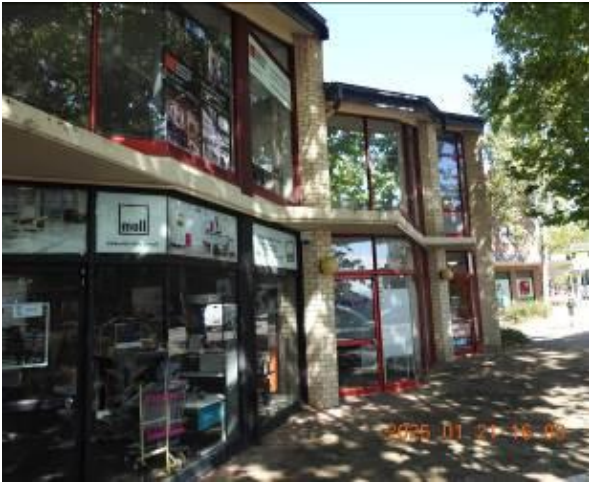
Figure 243 - General condition of external wall

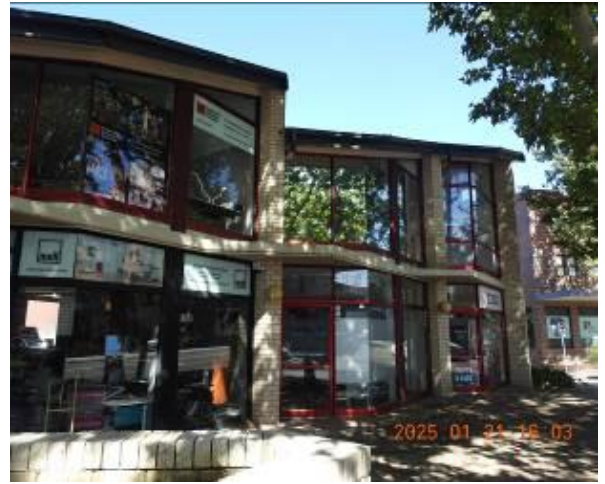
Figure 244 - General condition of external wall

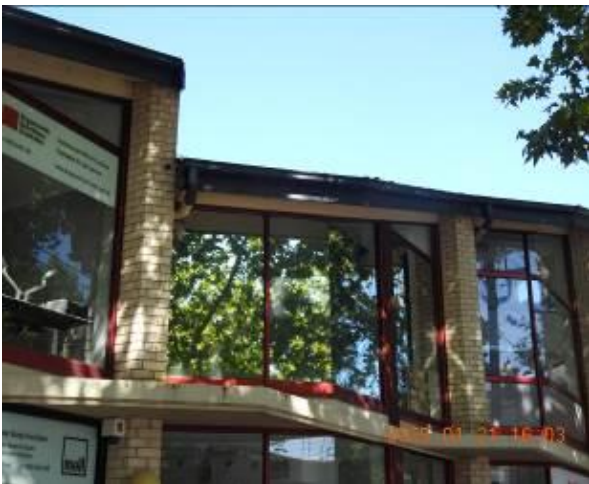
Figure 245 - General condition of external wall

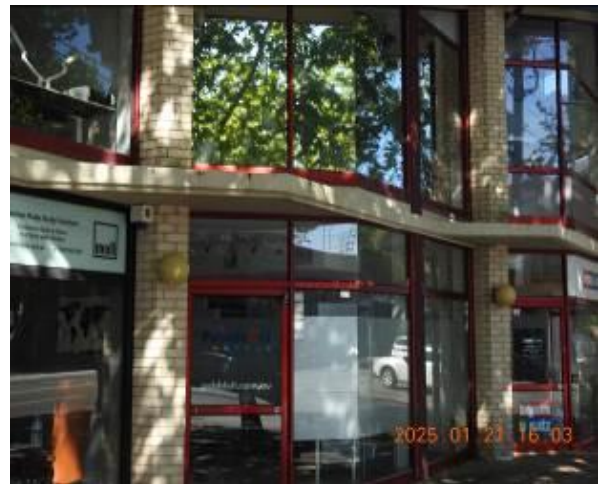
Figure 246 - General condition of external wall

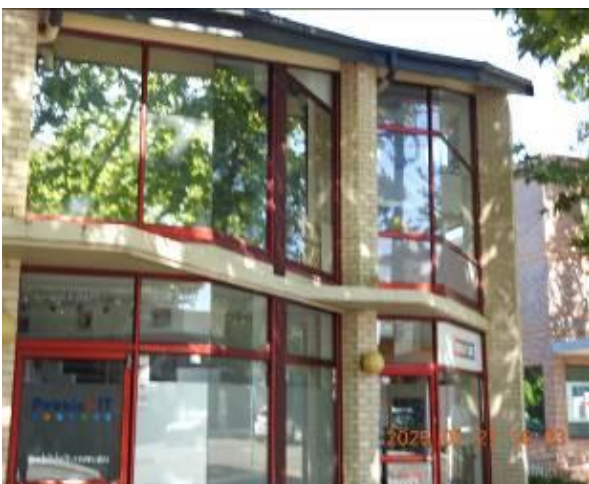
Figure 247 - General condition of external wall

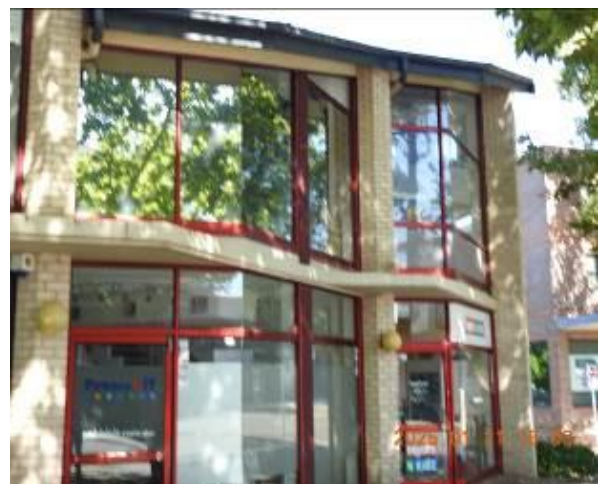
Figure 248 - General condition of external wall

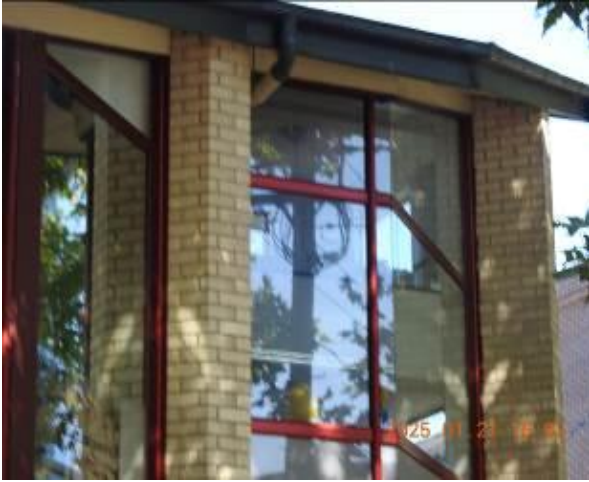
Figure 249 - General condition of external wall

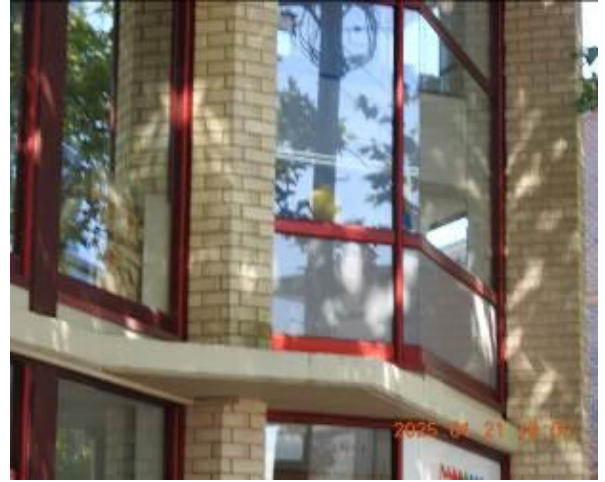
Figure 250 - General condition of external wall

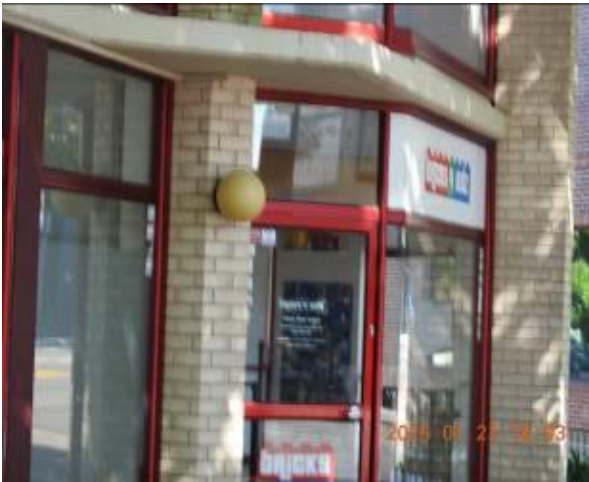
Figure 251 - General condition of external wall

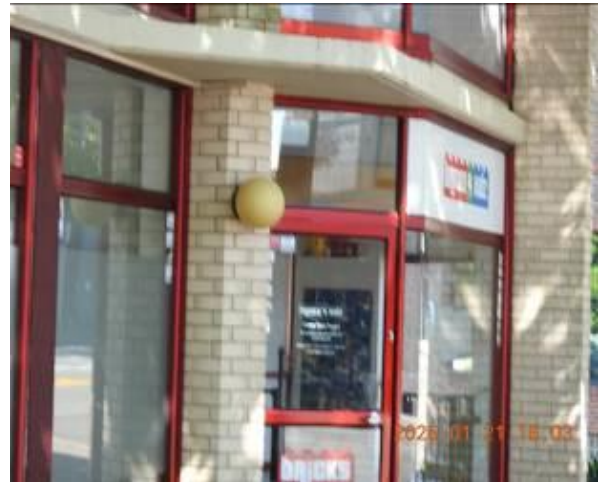
Figure 252 - General condition of external wall

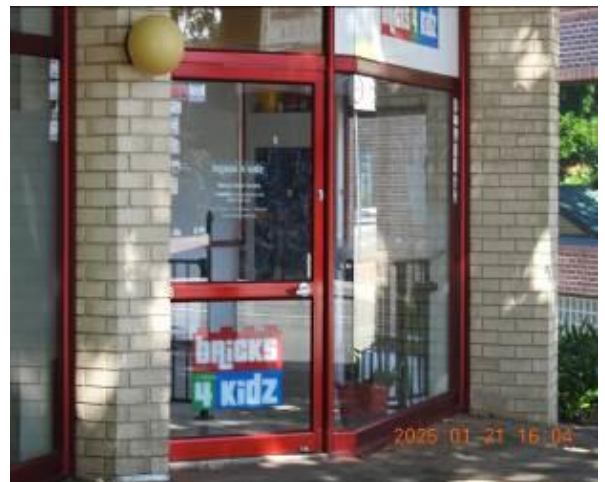
Figure 254 - General condition of external wall

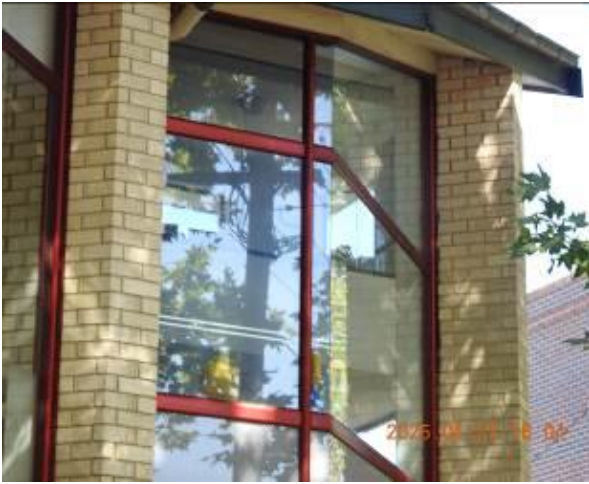
Figure 255 - General condition of external wall

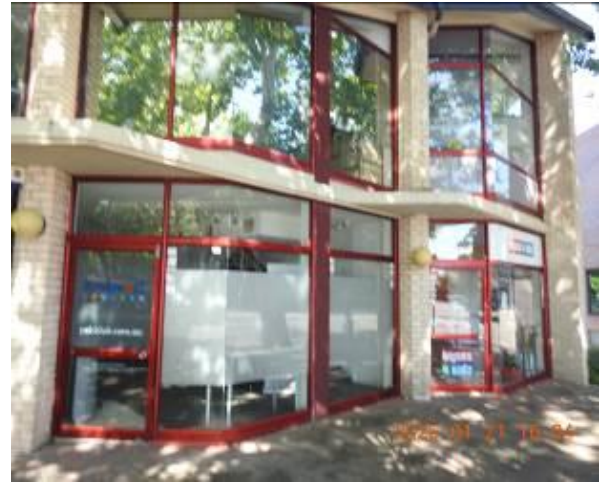
Figure 256 - General condition of external wall

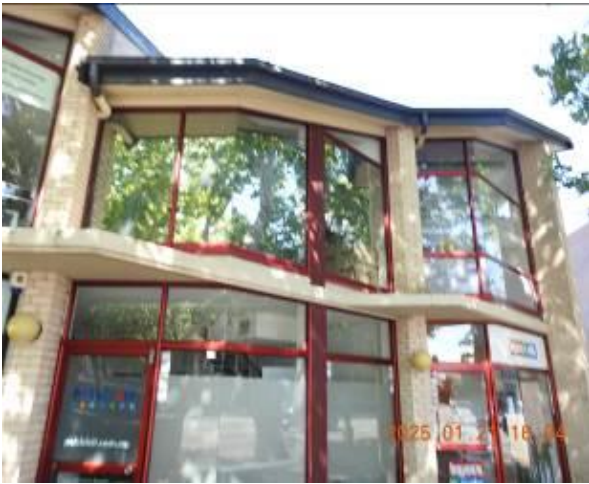
Figure 257 - General condition of external wall

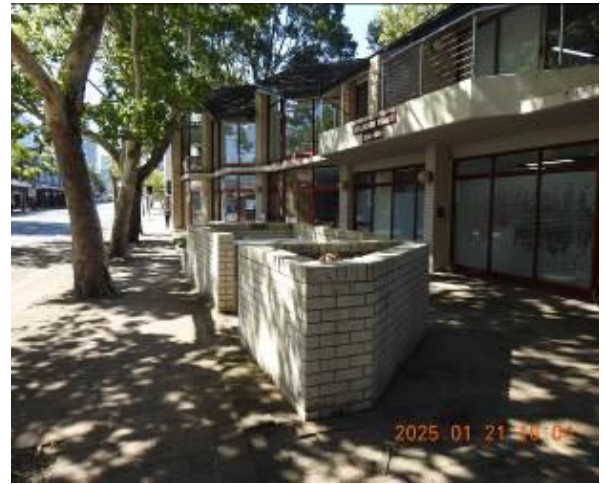
Figure 258 - General condition of external wall

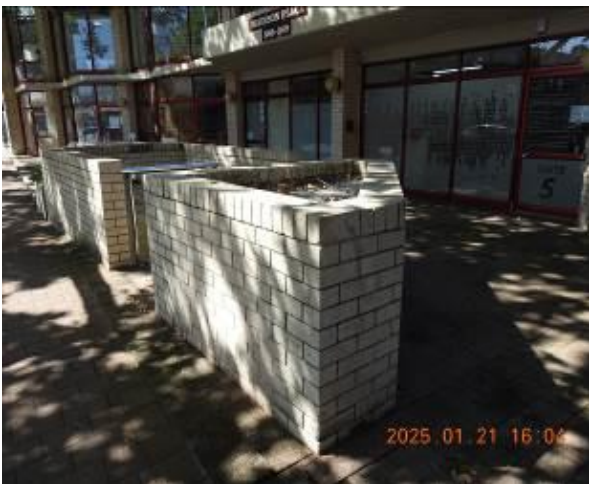
Figure 259 - General condition of retaining wall

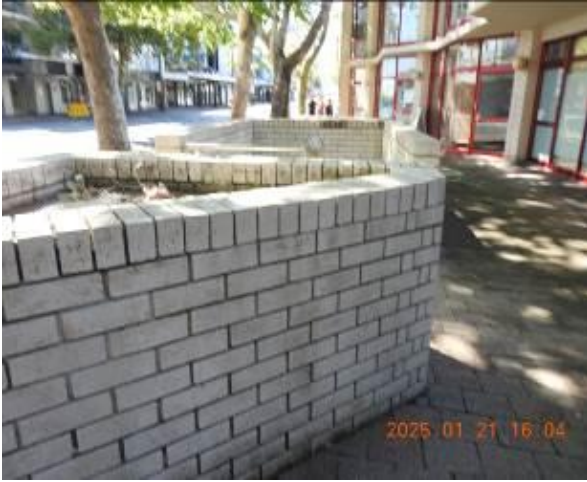
Figure 261 - General condition of retaining wall

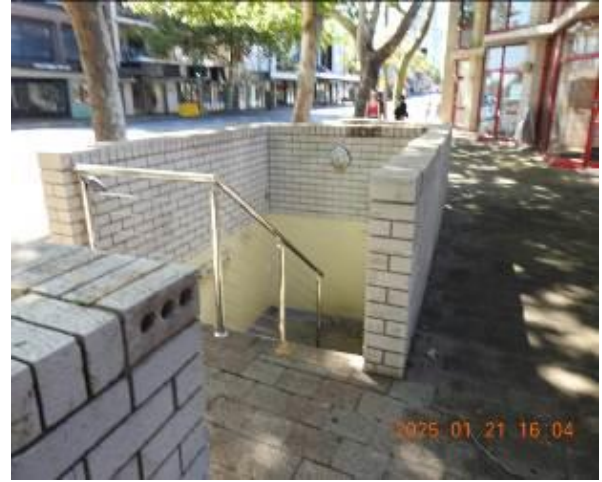
Figure 262 - General condition of external wall
