391-423 PACIFIC HIGHWAY, CROWSNEST NSW 2065

PRE-DILAPIDATION REPORT

DEICORP PTY LTD

Job No. 240325.4

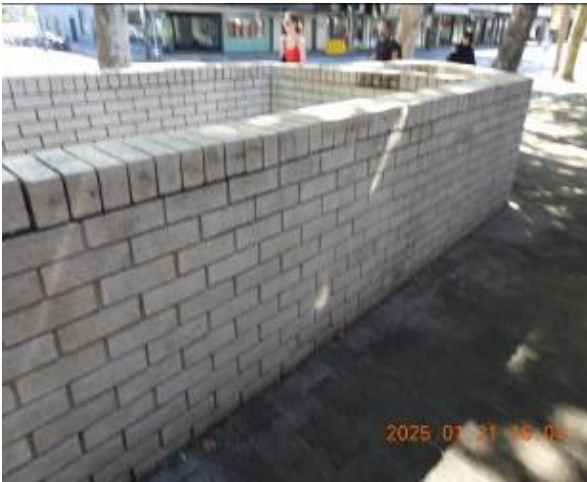
Figure 263 - General condition of external wall

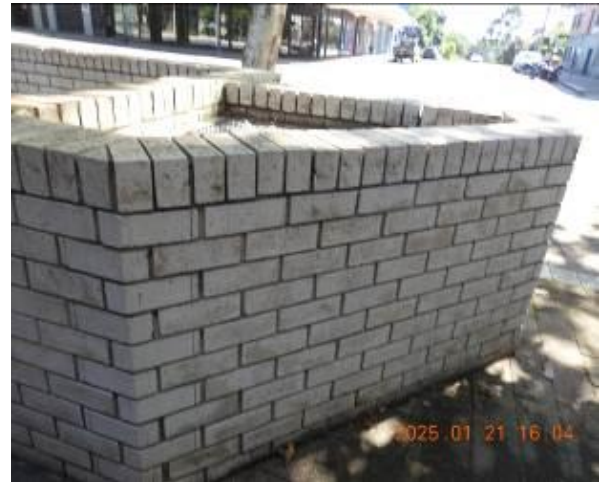
Figure 264 - General condition of external wall

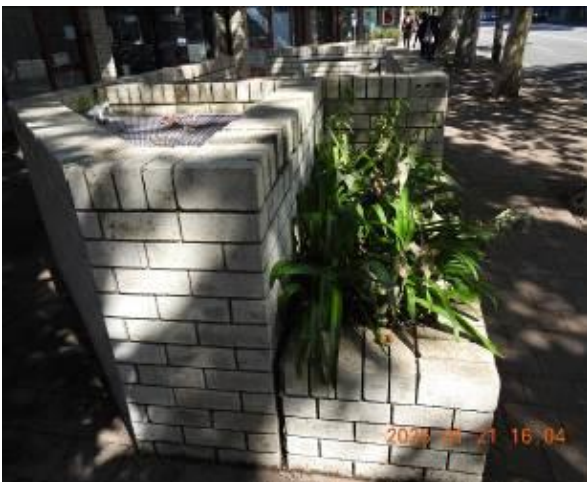
Figure 265 - General condition of retaining wall

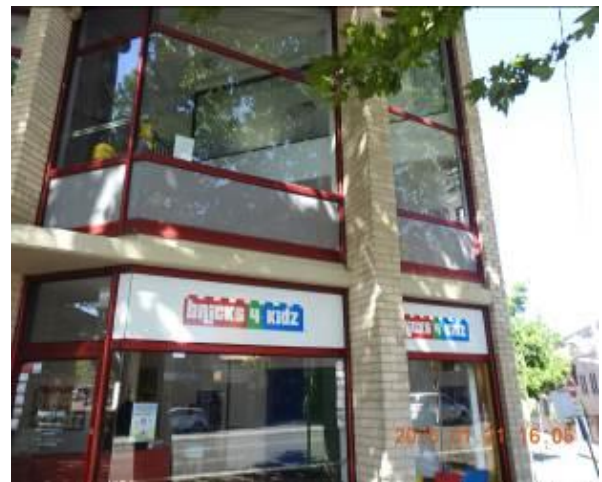
Figure 266 - General condition of external wall

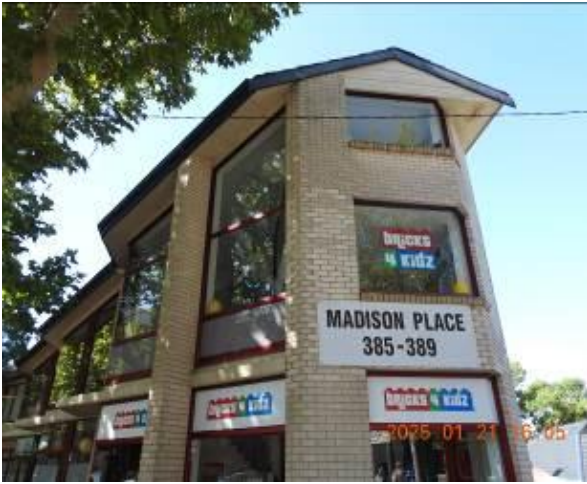
Figure 267 - General condition of external wall

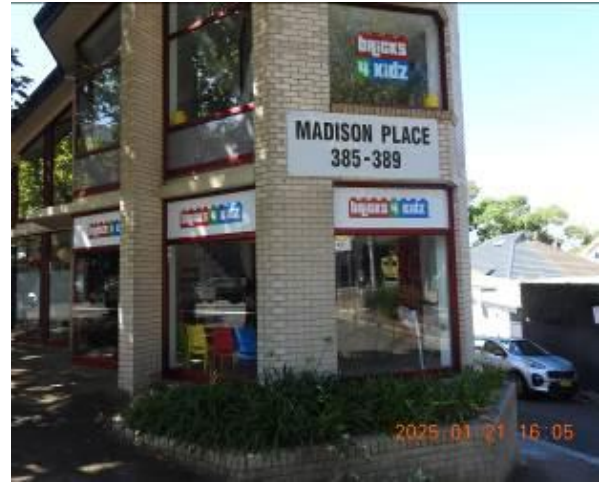
Figure 268 - General condition of external wall

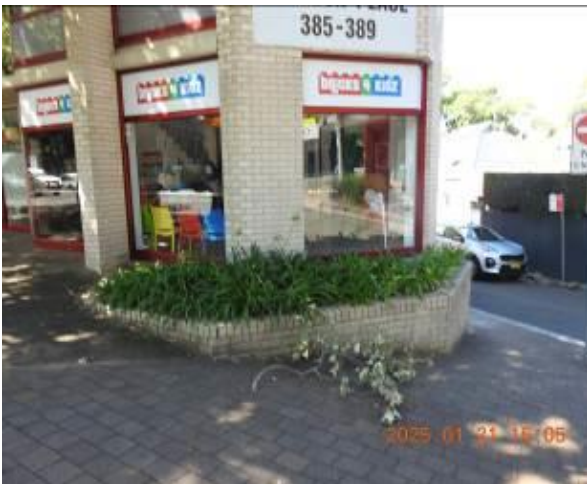
Figure 269 - General condition of retaining wall

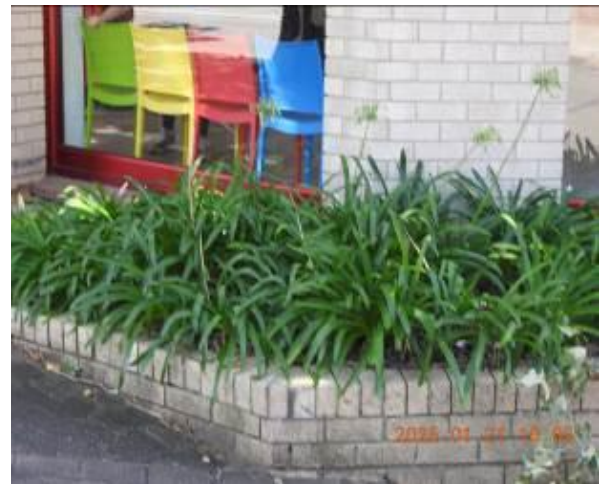
Figure 270 - General condition of retaining wall

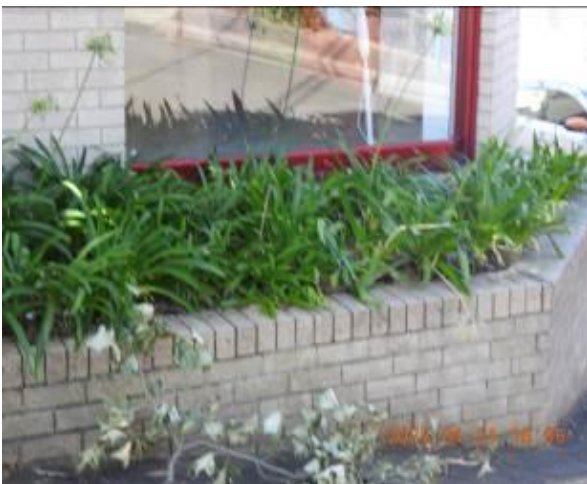
Figure 271 - General condition of retaining wall

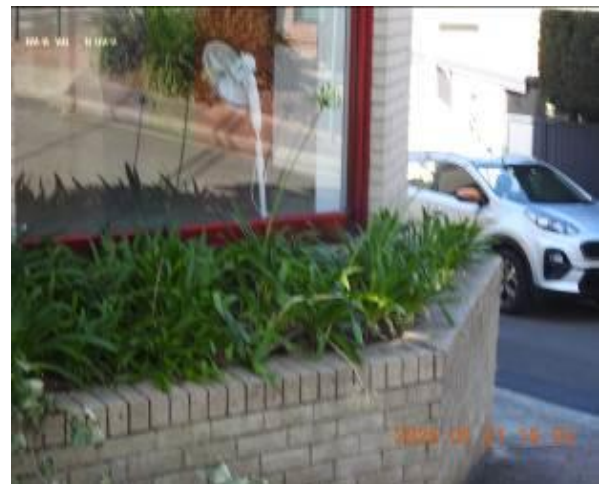
Figure 272 - General condition of retaining wall

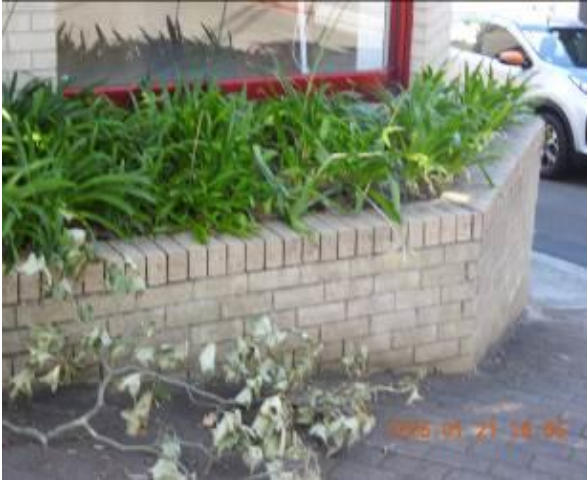
Figure 273 - General condition of retaining wall

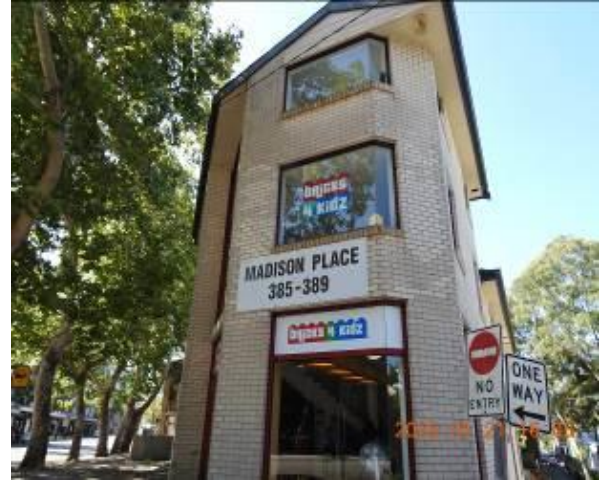
Figure 274 - General condition of external wall

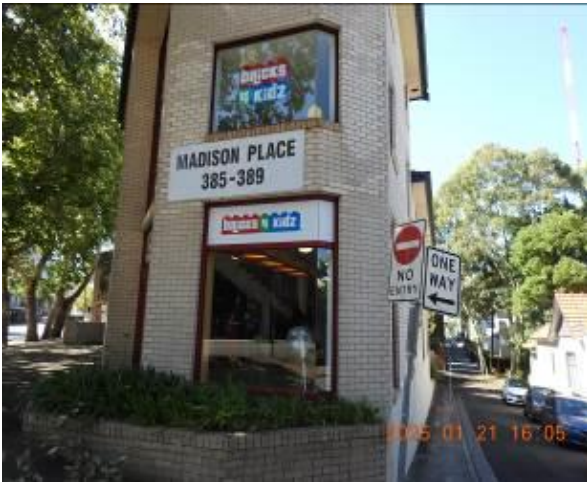
Figure 275 - General condition of external wall

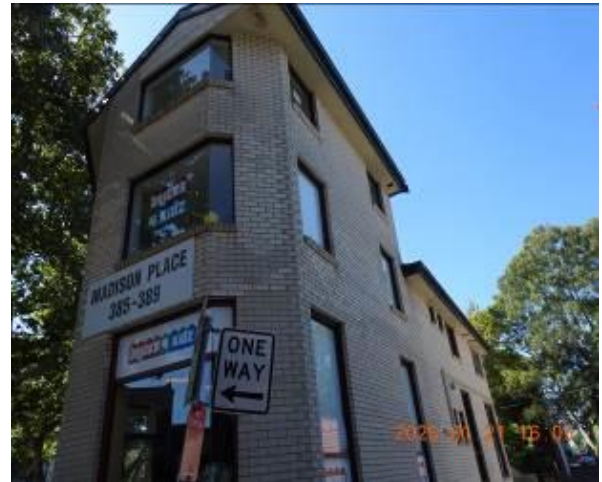
Figure 276 - General condition of external wall

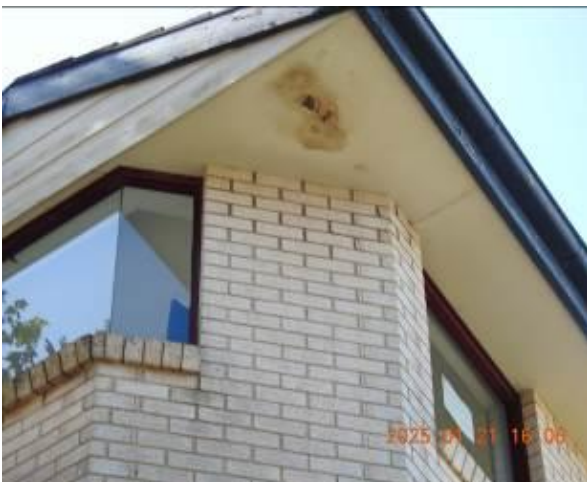
Figure 277 - General condition of external wall

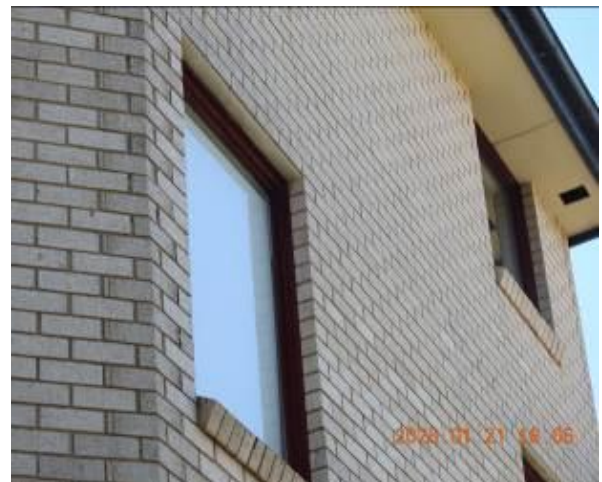
Figure 278 - General condition of external wall

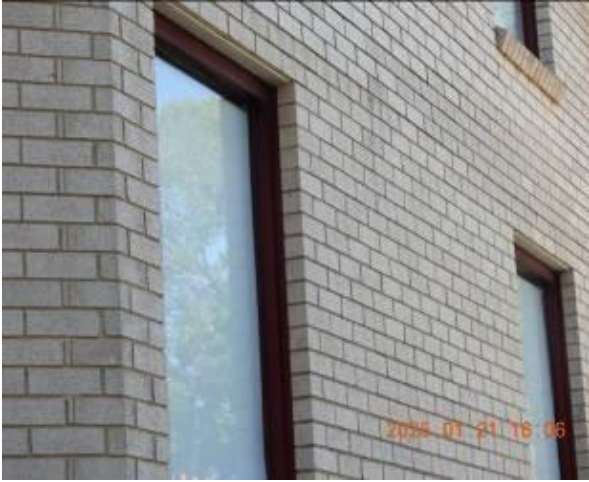
Figure 279 - General condition of external wall

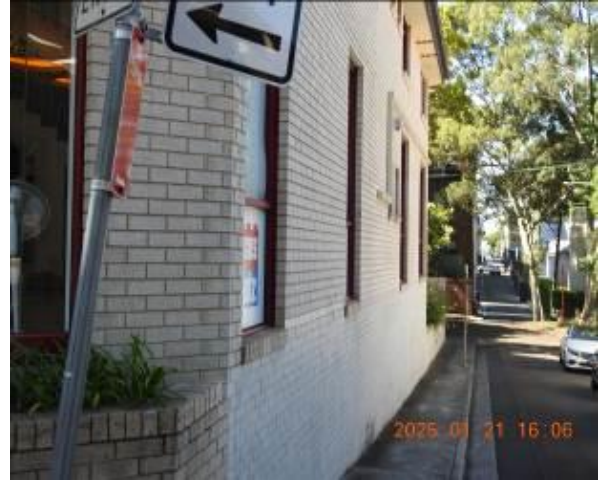
Figure 280 - General condition of external wall

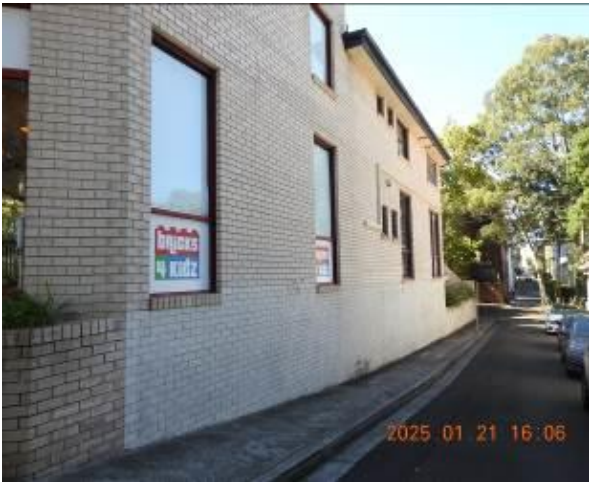
Figure 281 - General condition of external wall

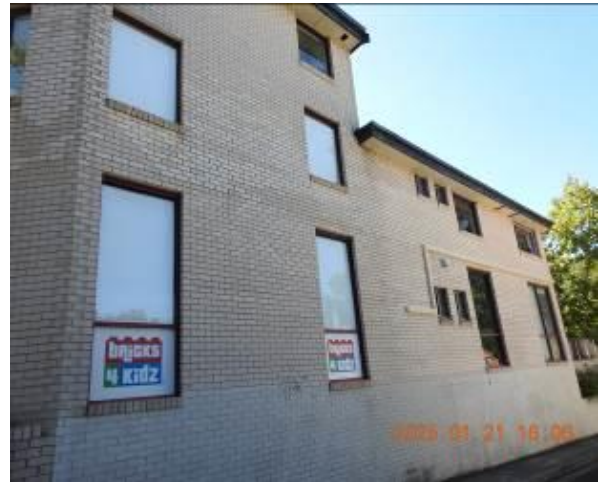
Figure 282 - General condition of external wall

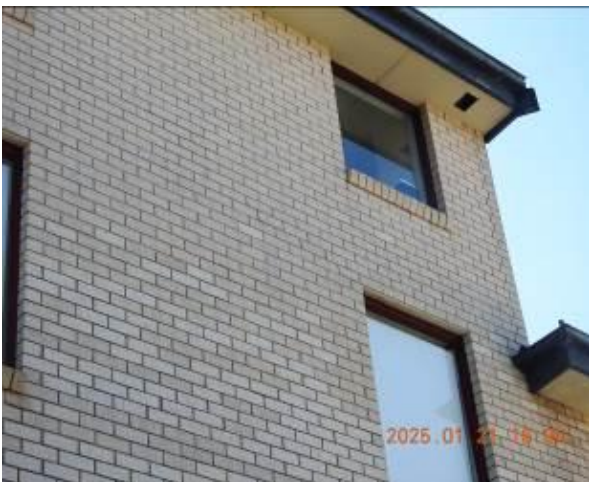
Figure 283 - General condition of external wall

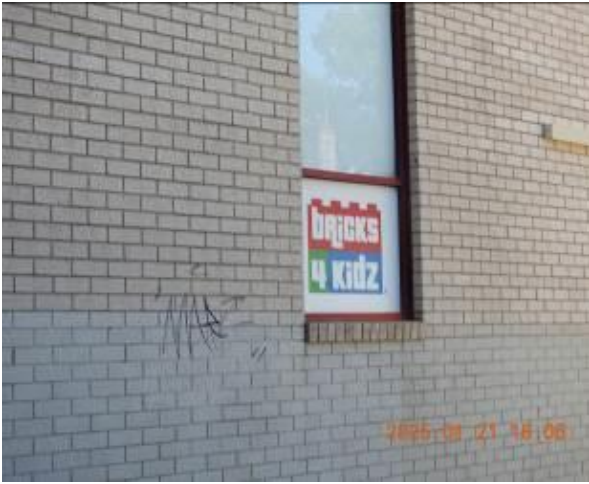
Figure 285 - General condition of external wall

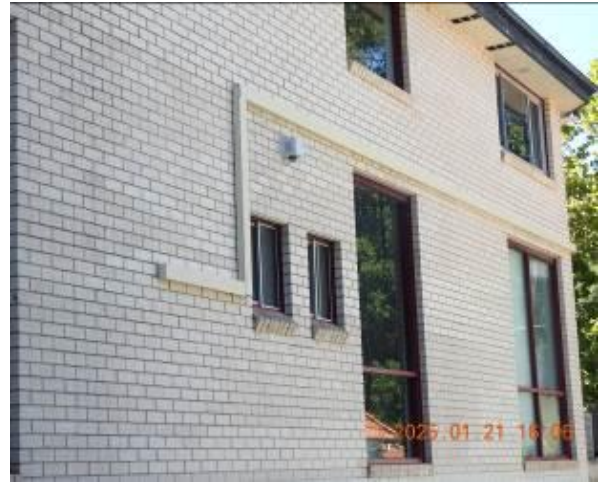
Figure 286 - General condition of external wall

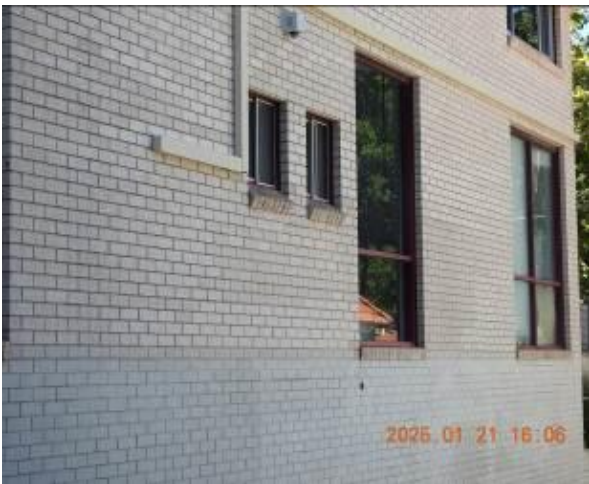
Figure 287 - General condition of external wall

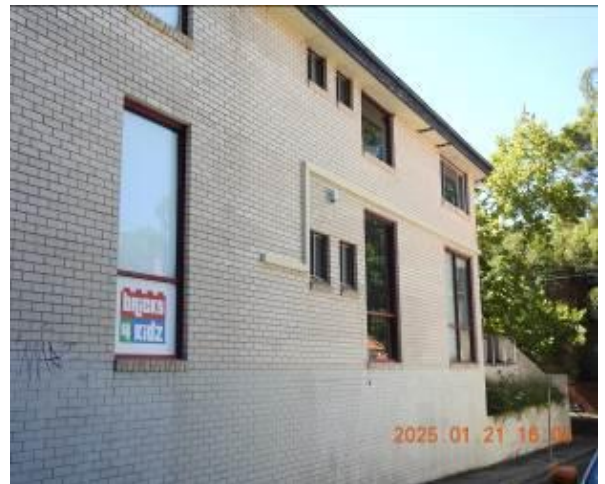
Figure 288 - General condition of external wall

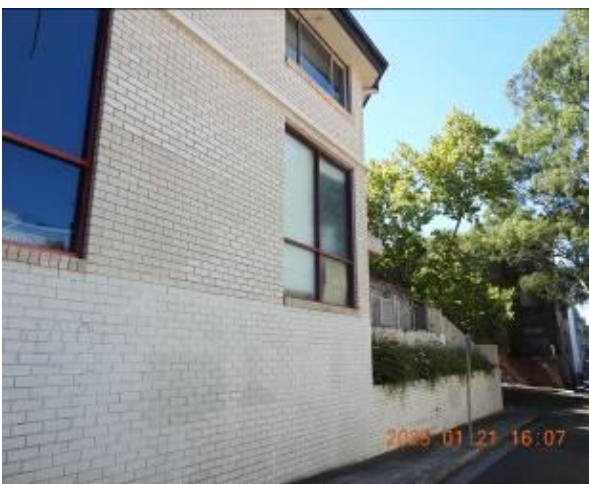
Figure 289 - General condition of external wall

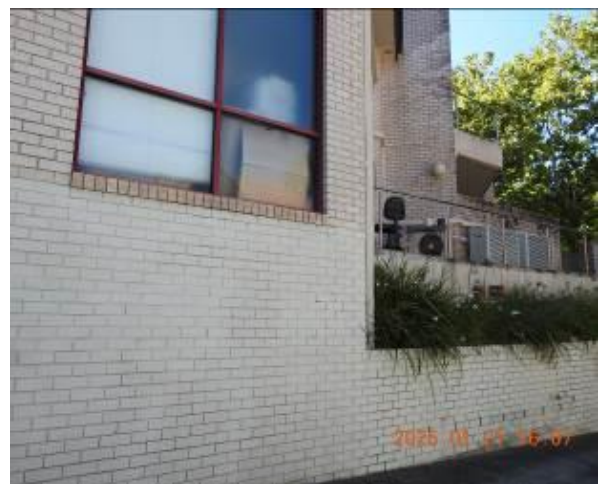
Figure 290 - General condition of external wall

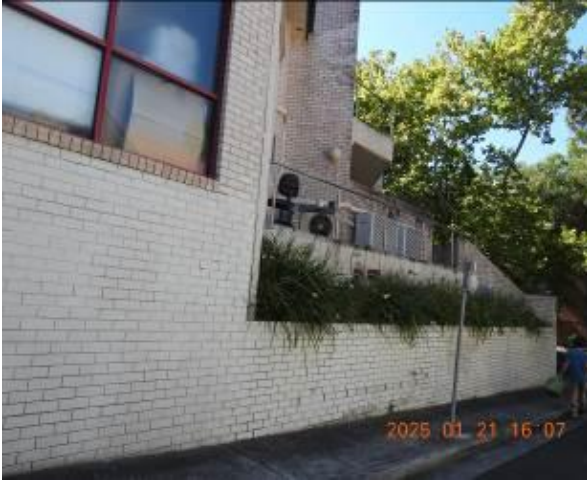
Figure 291 - General condition of external wall

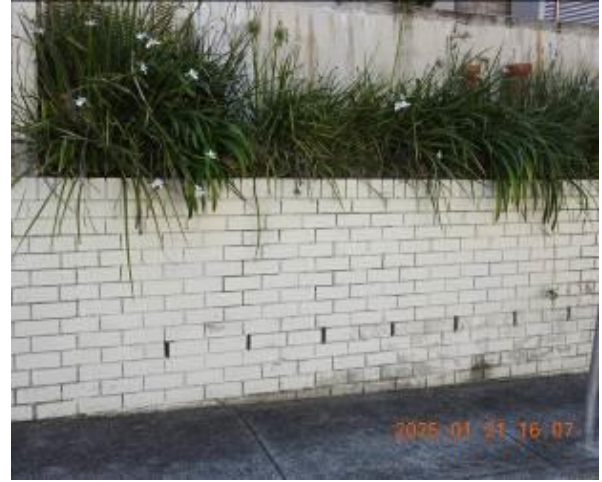
Figure 292 - General condition of retaining wall

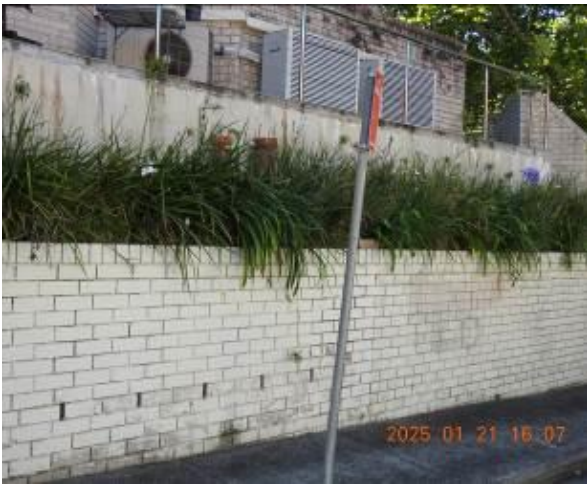
Figure 293 - General condition of external wall

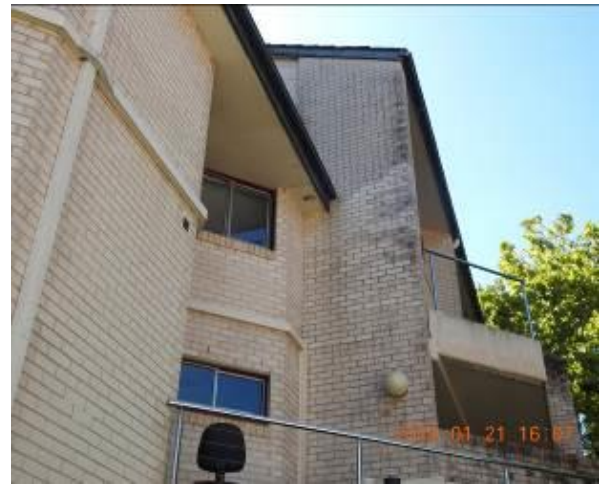
Figure 294 - General condition of external wall

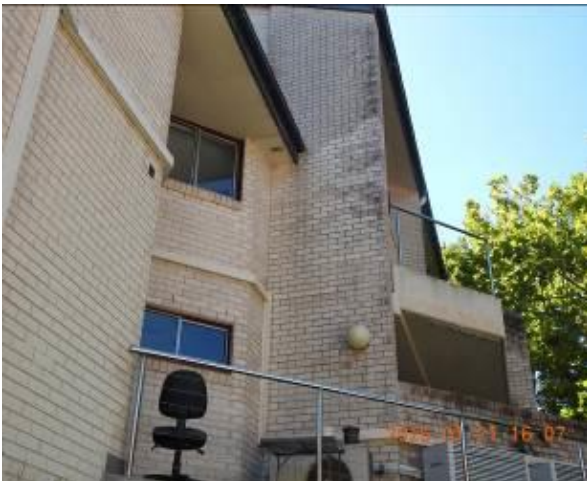
Figure 295 - General condition of external wall

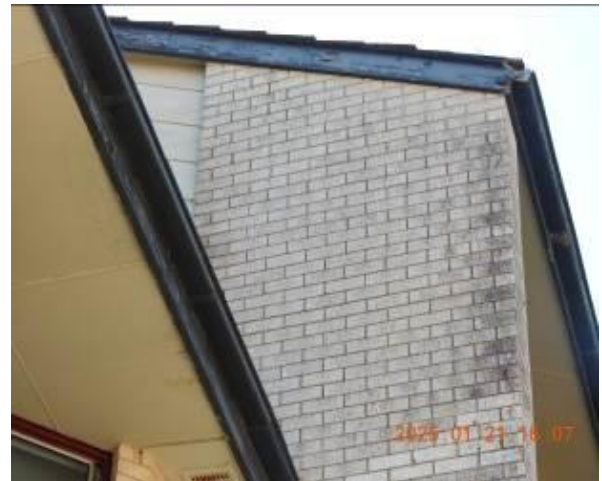
Figure 296 - General condition of external wall

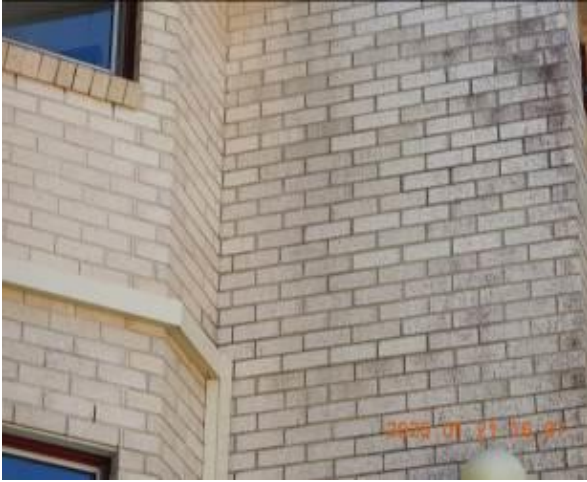
Figure 297 - General condition of external wall

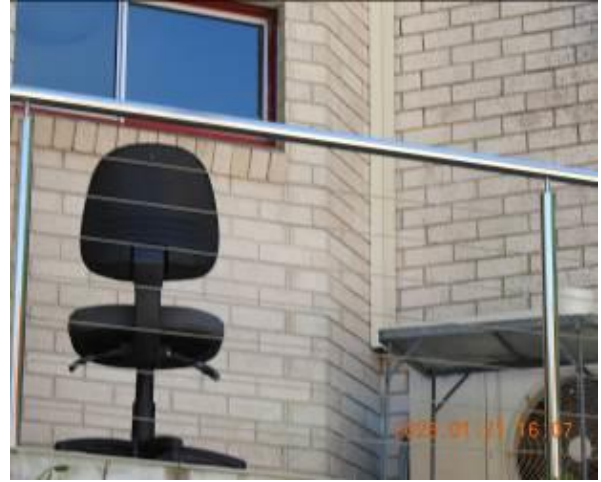
Figure 298 - General condition of external wall

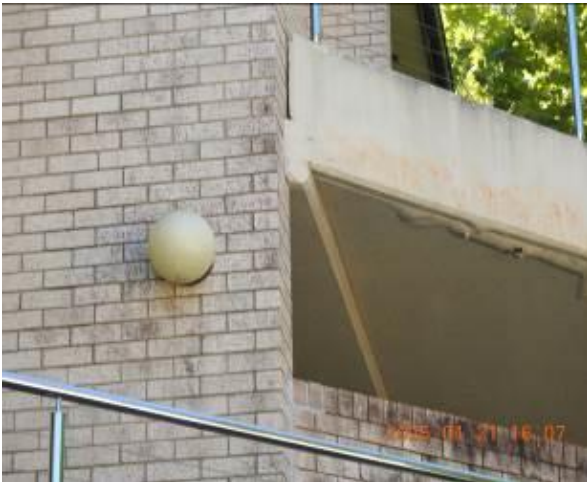
Figure 299 - General condition of external wall

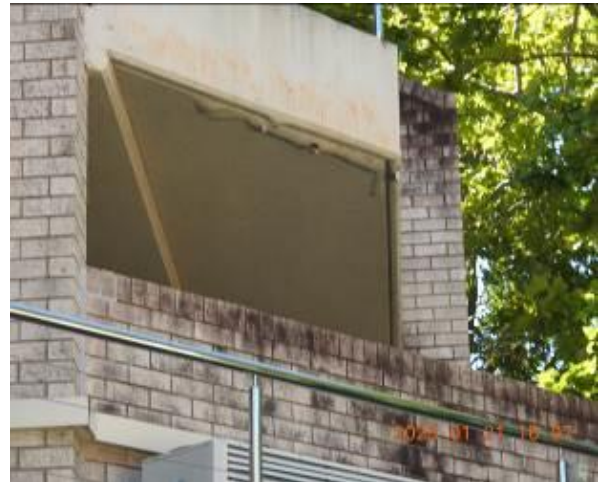
Figure 300 - General condition of external wall

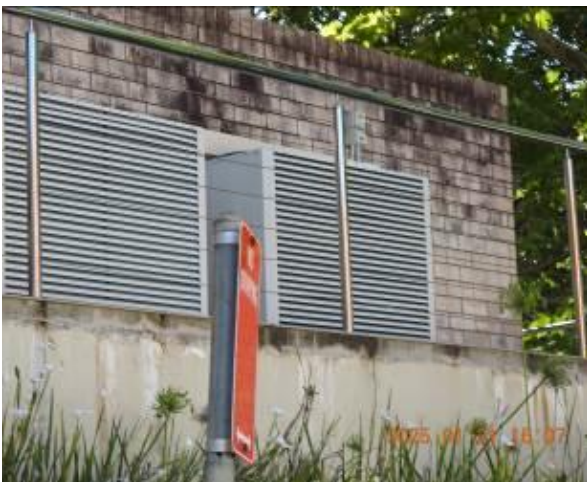
Figure 301 - General condition of external wall

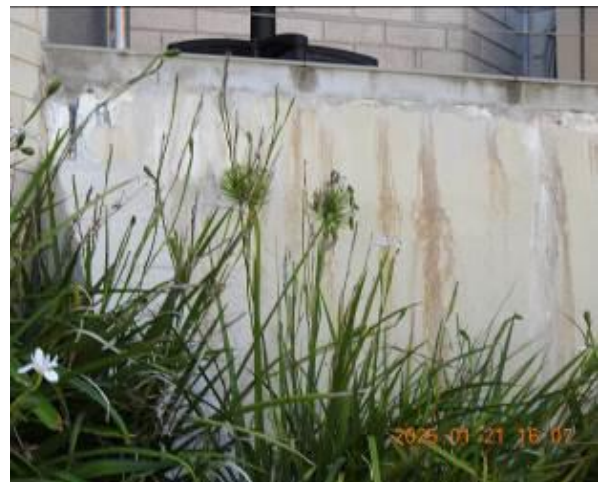
Figure 302 - Crack propagation through external wall

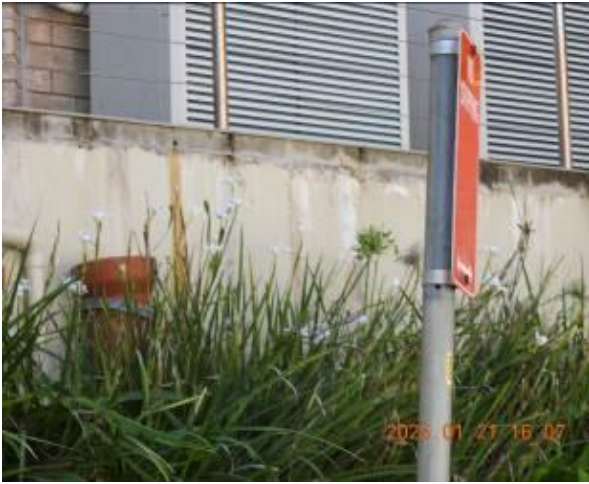
Figure 303 - Crack propagation through external wall

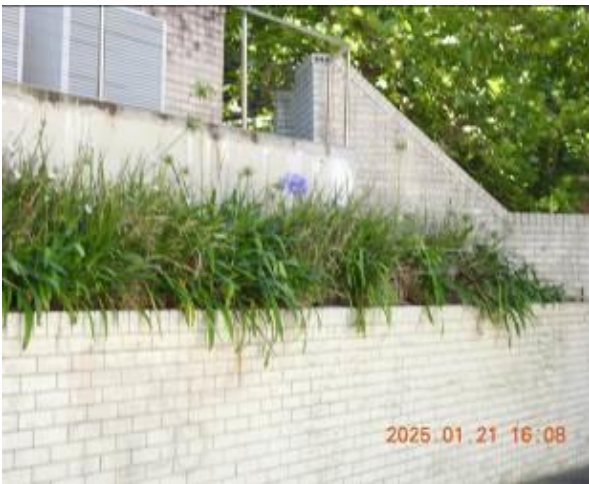
Figure 305 - General condition of external wall

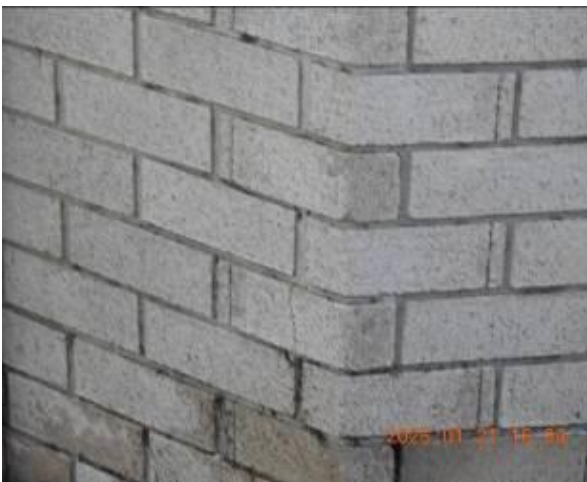
Figure 319 - Crack propagation through external wall

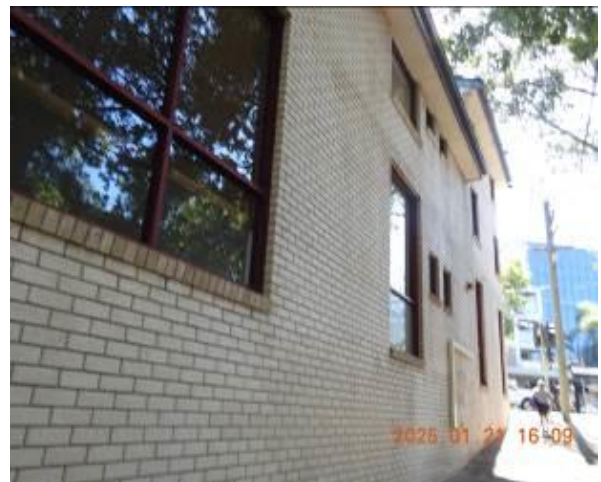
Figure 320 - General condition of external wall
