# External Road Dilapidation Report – Existing Condition

## Uungula Wind Farm

*Prepared for: Uungula Wind Farm Pty Ltd*

| <b>Job Number</b> | 19-142 |

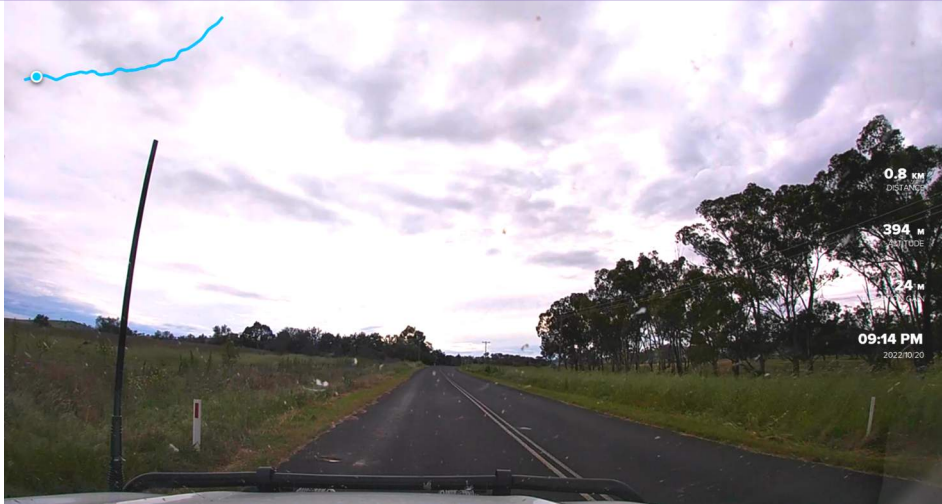
| Defect ID | Start Ch | End Ch | Defect Type (and side of road) | Image |
|---|---|---|---|---|
| 1.0 | 0 | 600 | Edge Break (BS)<br>Pothole (LHS)<br>Flushing (LHS) | |

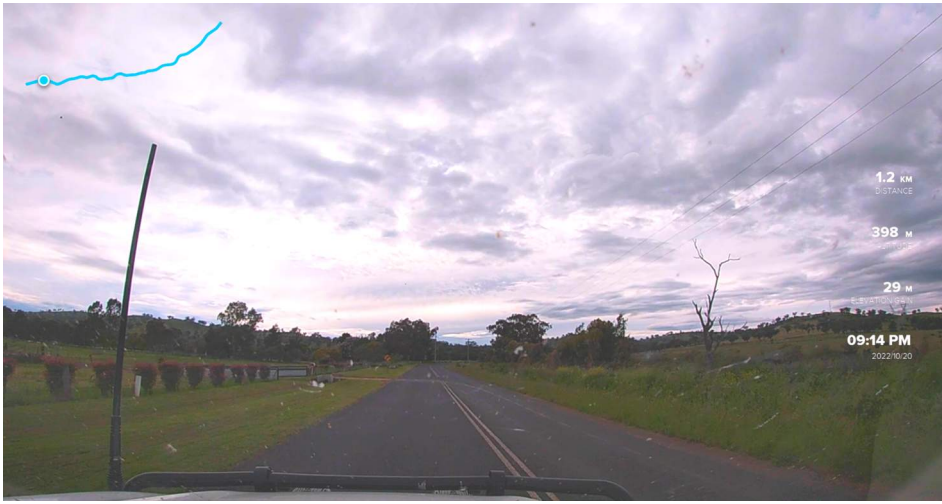
| Defect ID | Start Ch | End Ch | Defect Type (and side of road) | Image |
|---|---|---|---|---|
| 2.0 | 600 | 1000 | Minor seal defects. | |

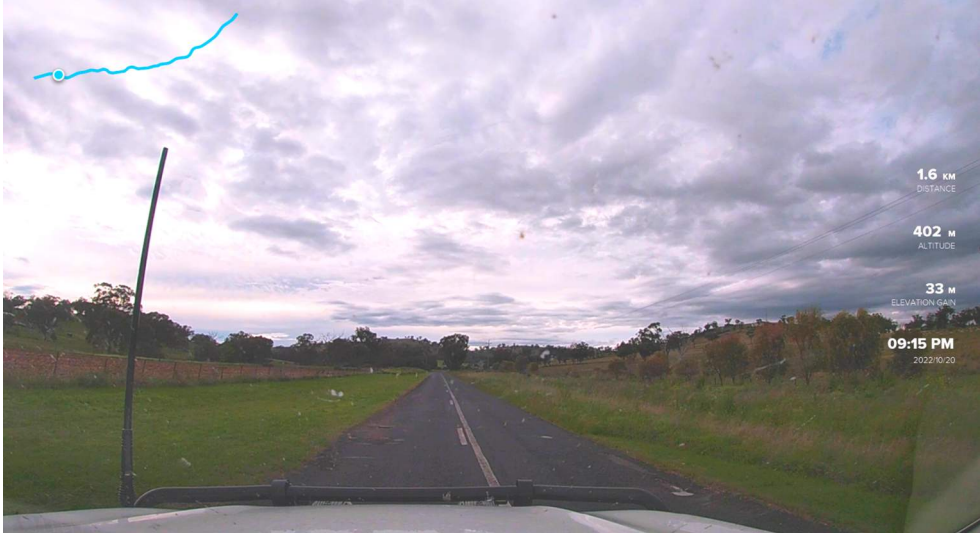
| Defect ID | Start Ch | End Ch | Defect Type (and side of road) | Image |
|---|---|---|---|---|
| 3.0 | 1000 | 1400 | Edge Break (BS)<br>Potholes (BS)<br>Potholes Patched (BS)<br>Ravelling/Fretting (RHS) | <p>1.6 KM<br/>DISTANCE<br/>402 M<br/>ALTITUDE<br/>33 M<br/>ELEVATION GAIN<br/>09:15 PM<br/>2022/10/20</p> |

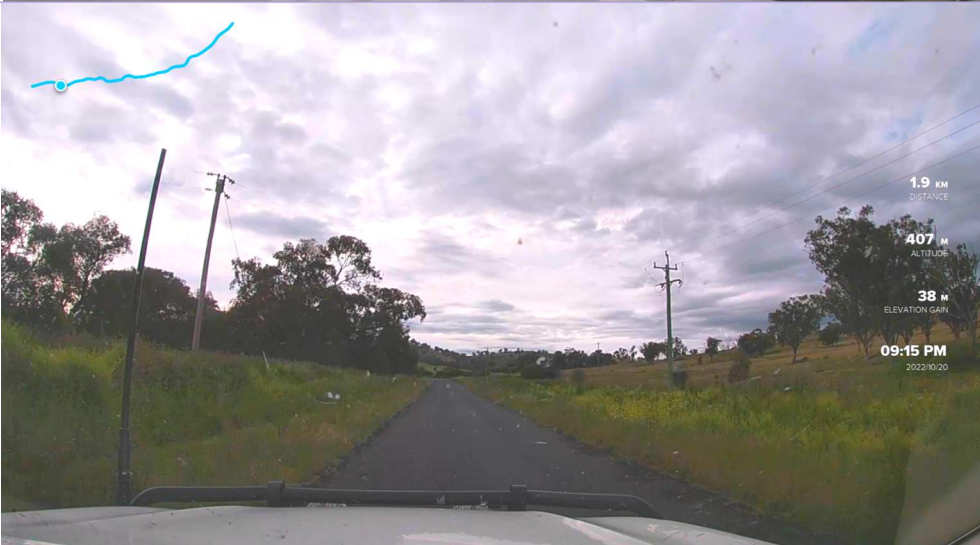
| Defect ID | Start Ch | End Ch | Defect Type (and side of road) | Image |
|---|---|---|---|---|
| 4.0 | 1400 | 1700 | Edge break (BS)<br>Transverse Crack (RHS)<br>Pothole (RHS)<br>Ravelling/Fretting (LHS)<br>Stripping (BS) | <p>1.9 KM<br/>DISTANCE<br/>407 M<br/>ALTITUDE<br/>38 M<br/>ELEVATION GAIN<br/>09:15 PM<br/>2022/10/20</p> |

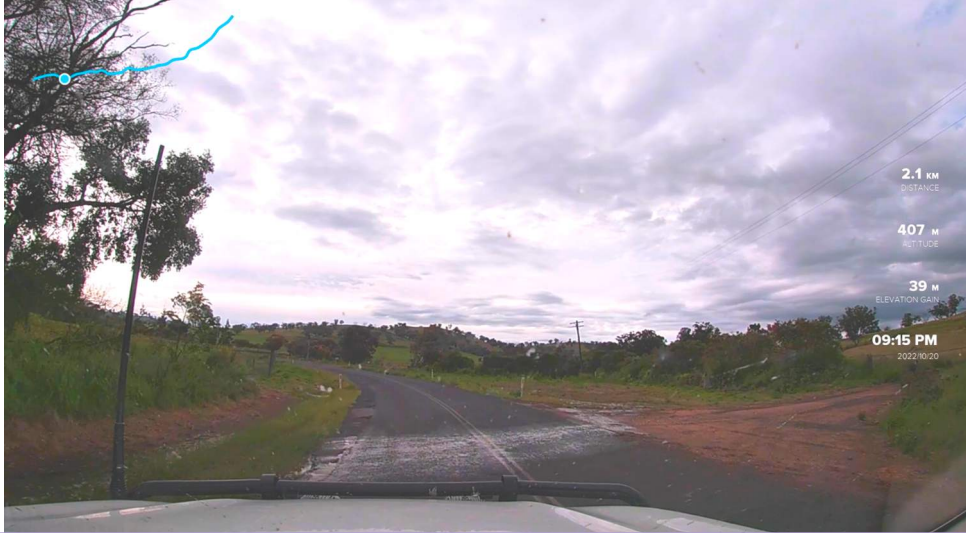
| Defect ID | Start Ch | End Ch | Defect Type (and side of road) | Image |
|---|---|---|---|---|
| 5.0 | 1700 | 1800 | Pothole (LHS)<br>Pothole Patched (BS)<br>Ravelling/Fretting (LHS)<br>Edge break (LHS)<br>Drainage Issue | |

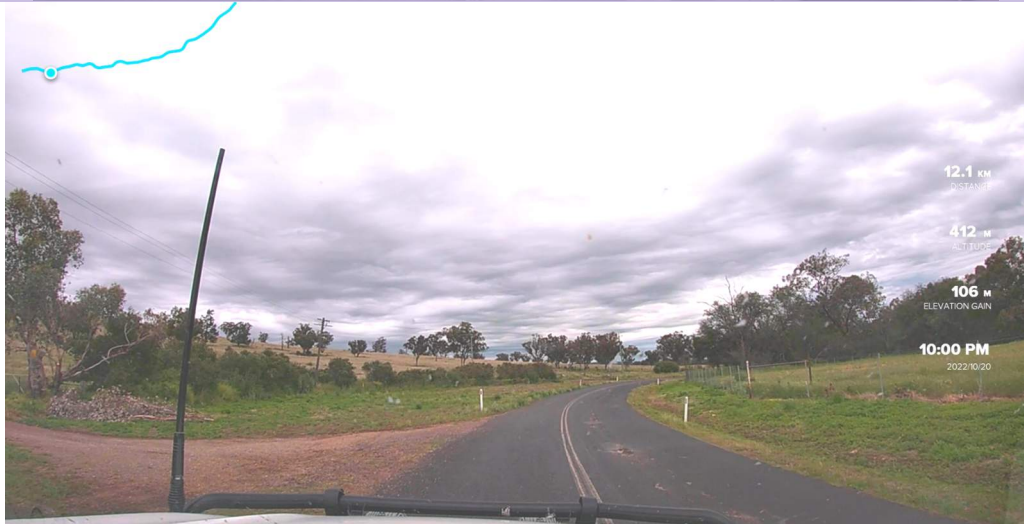
| Defect ID | Start Ch | End Ch | Defect Type (and side of road) | Image |
|---|---|---|---|---|
| 6.0<br>(Image looking west) | 1800 | 2000 | Pothole (LHS)<br>Ravelling/Fretting (LHS)<br>Longitudinal Cracking (LHS) | |

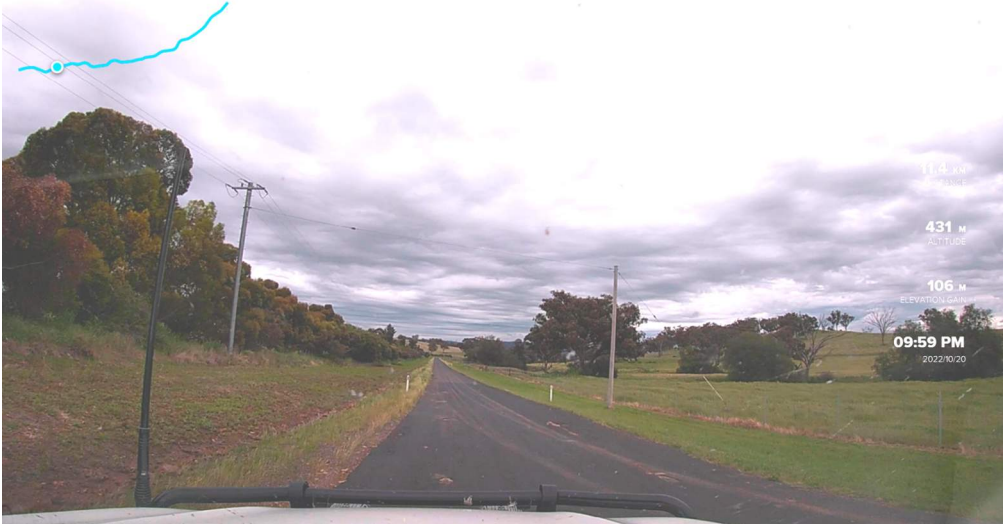
| Defect ID | Start Ch | End Ch | Defect Type (and side of road) | Image |
|---|---|---|---|---|
| 7.0<br><br>(Image looking west) | 2000 | 2600 | Edge break (BS)<br>Ravelling/Fretting (BS)<br>Pothole (RHS)<br>Pothole (CR)<br>Pothole Patched (BS) | |

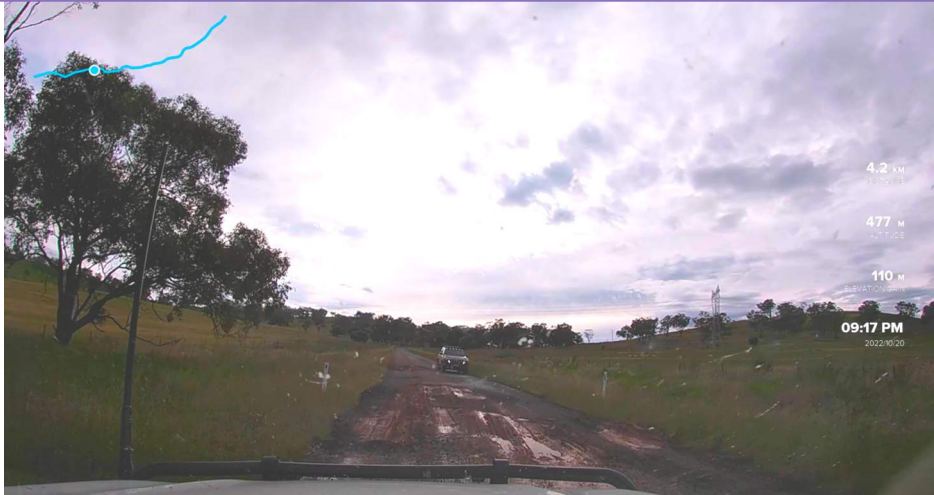
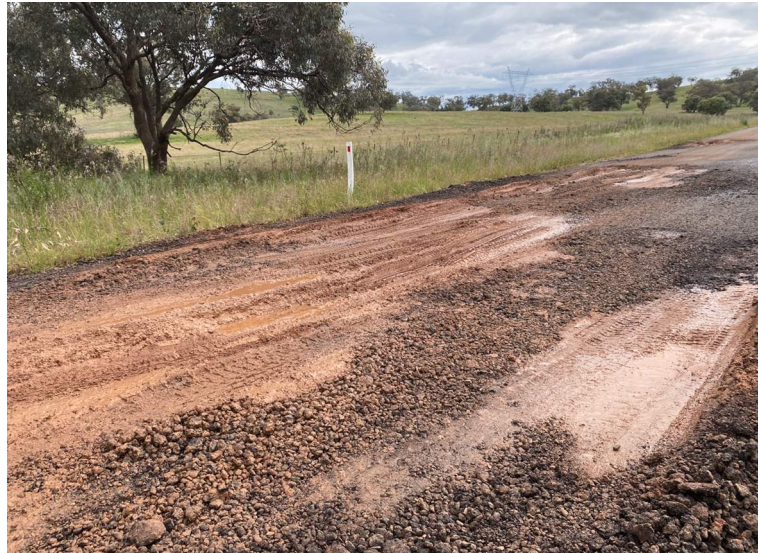
| Defect ID | Start Ch | End Ch | Defect Type (and side of road) | Image |
|---|---|---|---|---|
| 9.0 | 3400 | 4200 | Ravelling/Fretting (BS)<br>Delamination (RHS)<br>Pothole (LHS)<br>Depression (CR)<br>Ponding issue<br>Crocodile Cracking (LHS) | <br> |

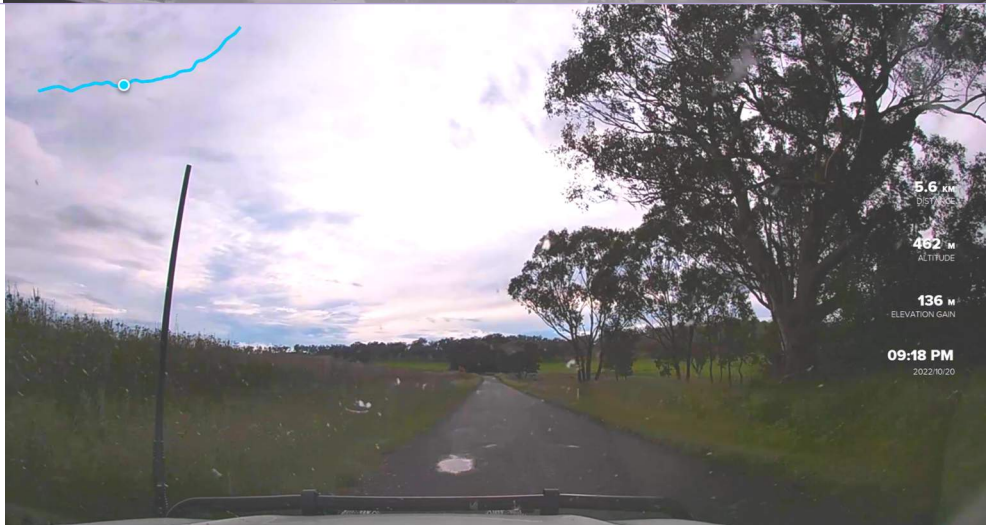
| Defect ID | Start Ch | End Ch | Defect Type (and side of road) | Image |
|---|---|---|---|---|
| 11.0 | 4800 | 5200 | Pothole (BS)<br>Stripping (RHS) | |

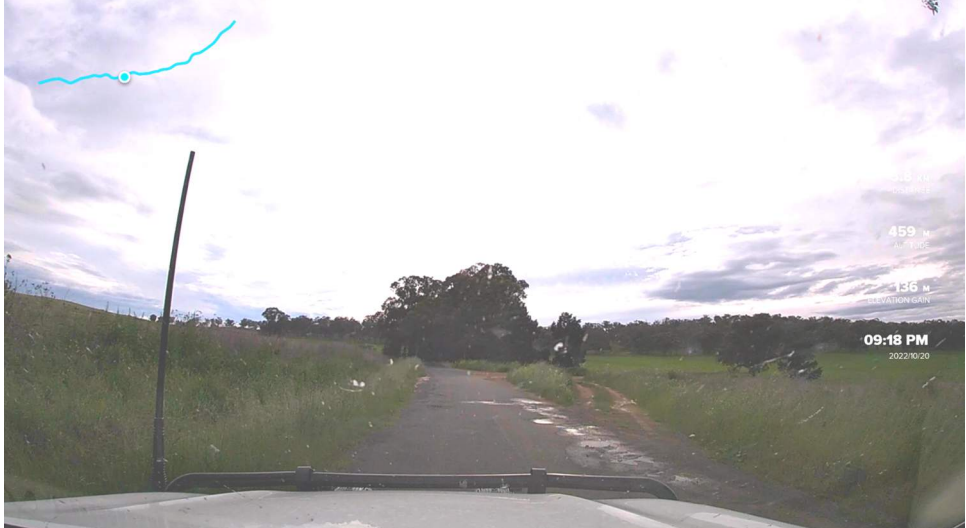
| Defect ID | Start Ch | End Ch | Defect Type (and side of road) | Image |
|---|---|---|---|---|
| 12.0 | 5200 | 5300 | Ravelling/Fretting (RHS)<br>Pothole (RHS)<br>Drainage Issue | |

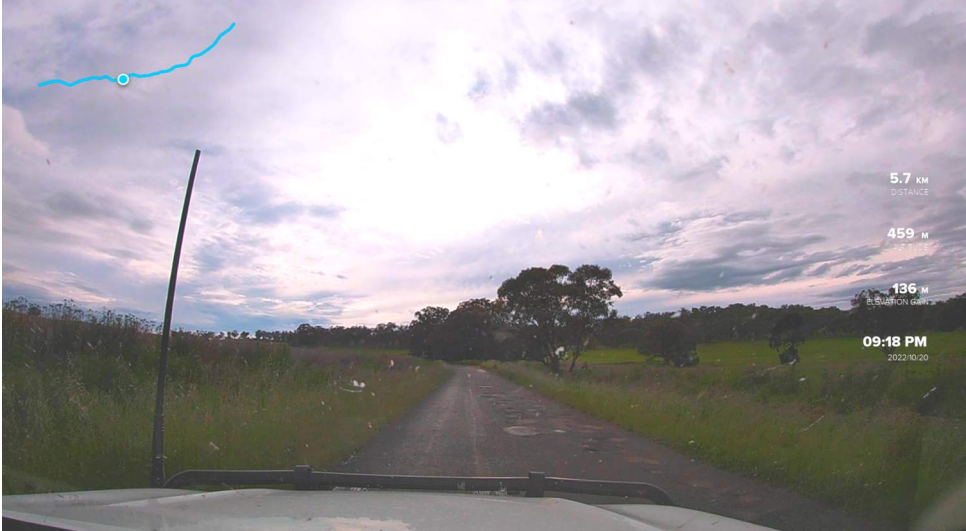
| Defect ID | Start Ch | End Ch | Defect Type (and side of road) | Image |
|---|---|---|---|---|
| 13.0 | 5300 | 5500 | Ravelling/Fretting (RHS)<br>Pothole (RHS)<br>Pothole Patched (CR)<br>Corrugation (RHS)<br>Edge break (LHS)<br>Stripping (CR) | |

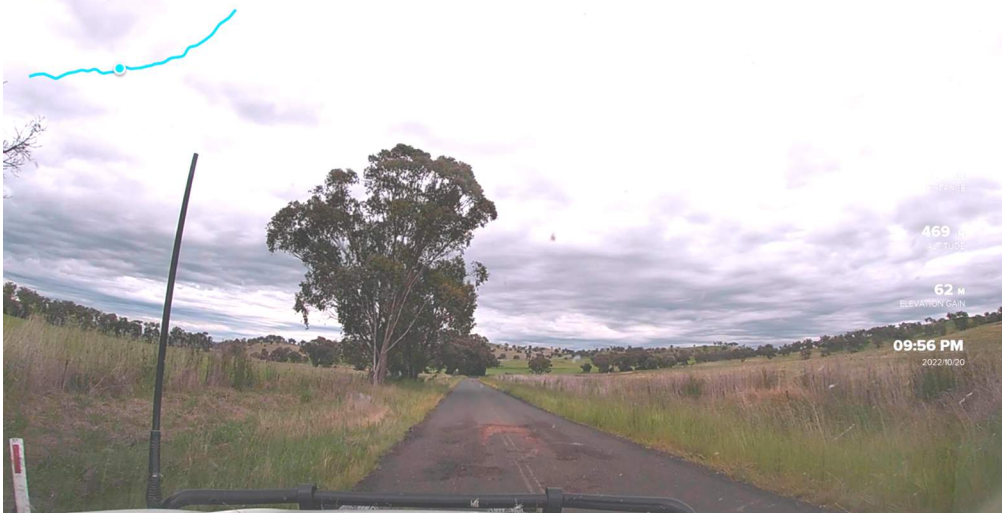
| Defect ID | Start Ch | End Ch | Defect Type (and side of road) | Image |
|---|---|---|---|---|
| 14.0<br><br>(Image looking west) | 5500 | 5600 | Pothole (CR)<br>Ravelling/Fretting (CR) | |

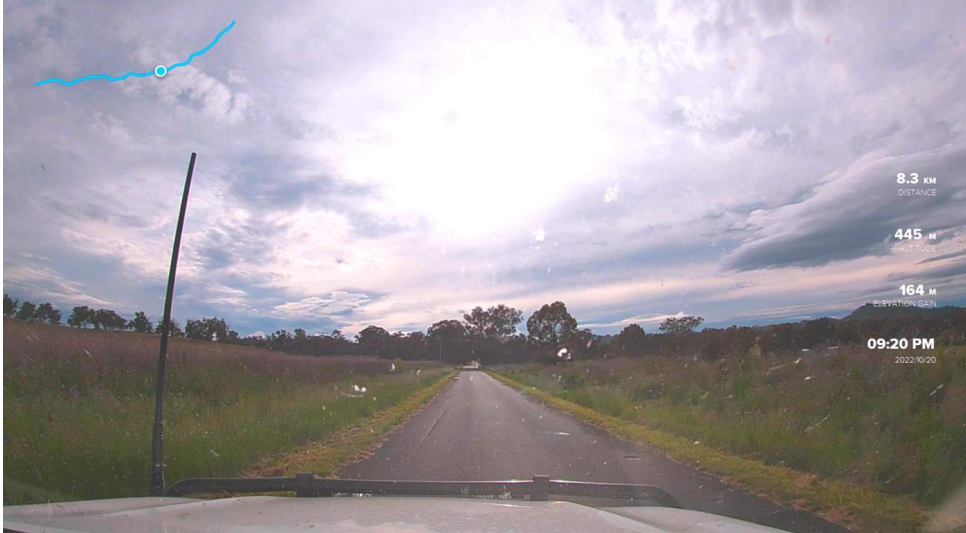
| Defect ID | Start Ch | End Ch | Defect Type (and side of road) | Image |
|---|---|---|---|---|
| 18.0 | 7400 | 8000 | Pothole (RHS)<br>Stripping (RHS)<br>Longitudinal Crack (LHS)<br>Edge break (LHS)<br>Delamination (RHS) | |

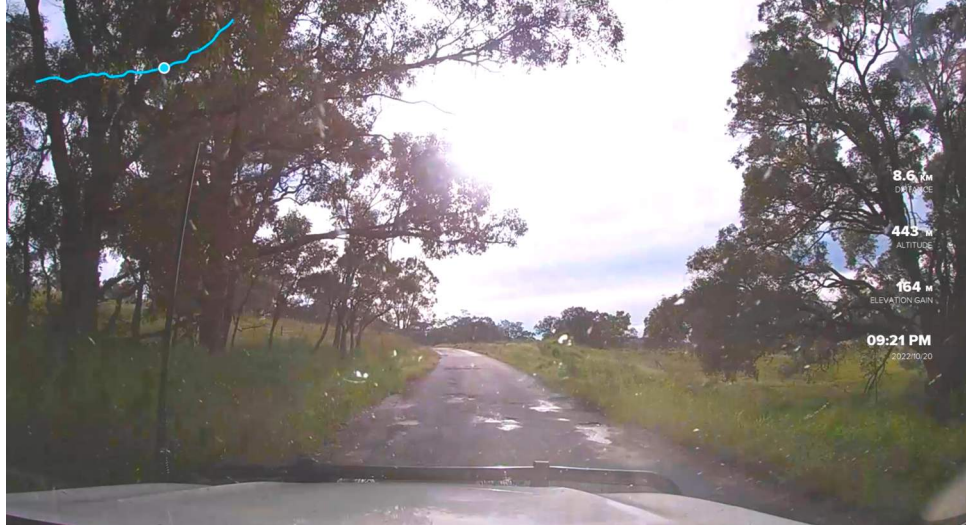
| Defect ID | Start Ch | End Ch | Defect Type (and side of road) | Image |
|---|---|---|---|---|
| 19.0 | 8000 | 8200 | Potholes (BS)<br>Potholes (CR)<br>Ravelling/Fretting (LHS) | |

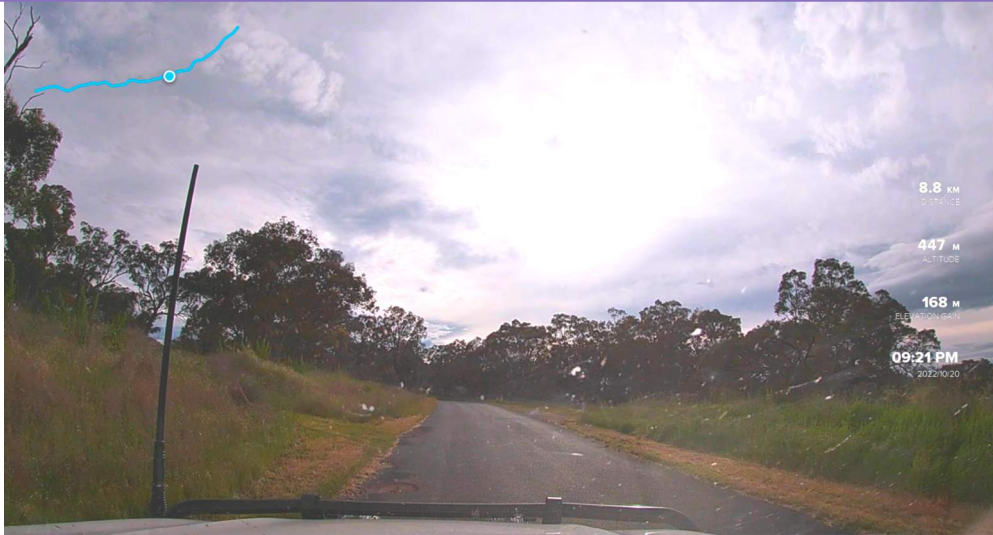
| Defect ID | Start Ch | End Ch | Defect Type (and side of road) | Image |
|---|---|---|---|---|
| 20.0 | 8200 | 9000 | Stripping (RHS)<br>Pothole (LHS)<br>Pothole Patched (RHS)<br>Ravelling/Fretting Patched (RHS) | |

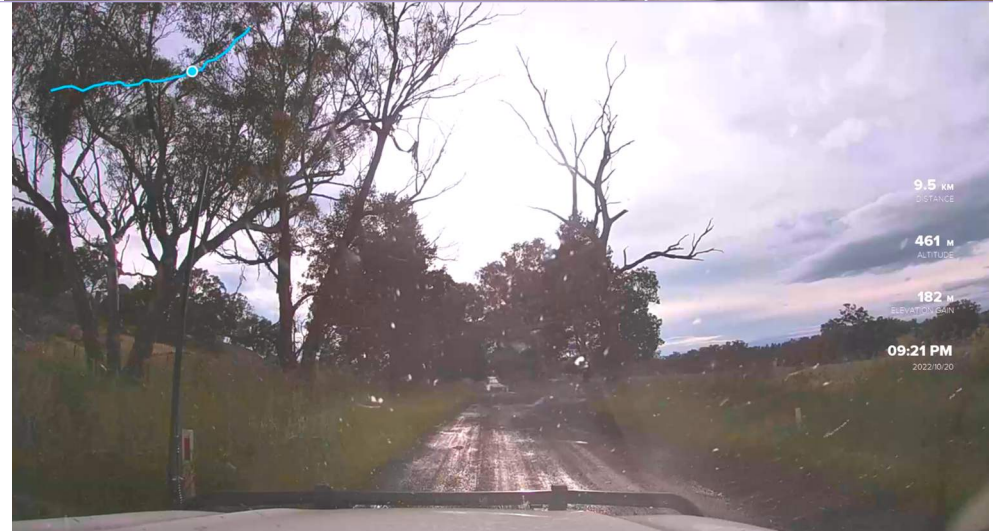
| Defect ID | Start Ch | End Ch | Defect Type (and side of road) | Image |
|---|---|---|---|---|
| 21.0 | 9000 | 9300 | Pothole (CR)<br>Pothole (RHS)<br>Ravelling/Fretting Patched (LHS)<br>Stripping (CR)<br>Stripping (RHS) | |

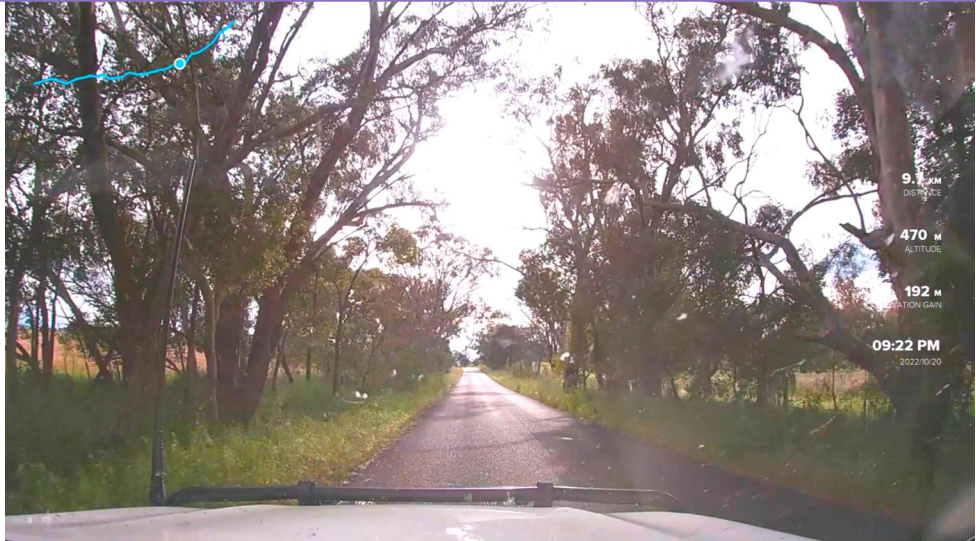
| Defect ID | Start Ch | End Ch | Defect Type (and side of road) | Image |
|---|---|---|---|---|
| 22.0 | 9300 | 9500 | Longitudinal Cracking (RHS)<br>Longitudinal Cracking (CR)<br>Pothole (CR) | |

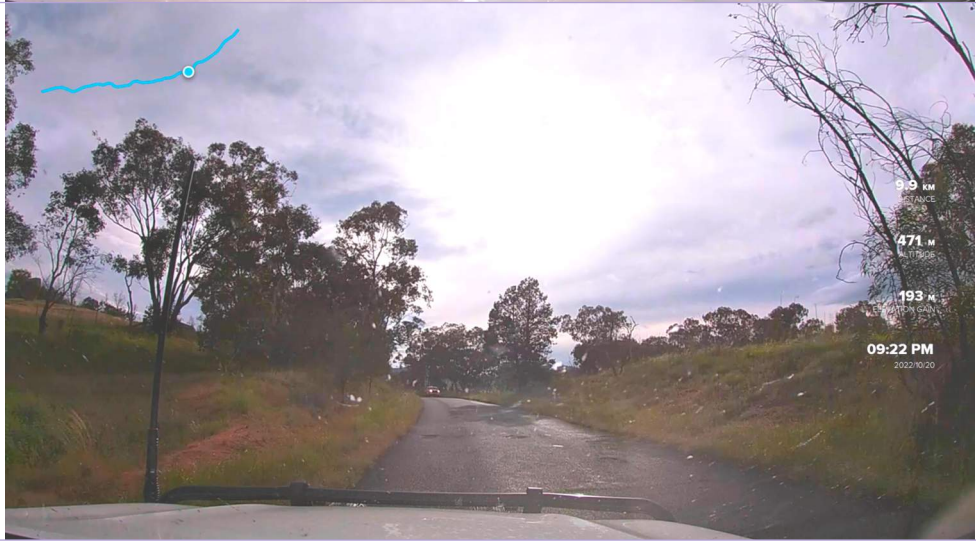
| Defect ID | Start Ch | End Ch | Defect Type (and side of road) | Image |
|---|---|---|---|---|
| 23.0 | 9500 | 9900 | Longitudinal Cracking (RHS)<br>Delamination (CR)<br>Delamination (RHS) | |

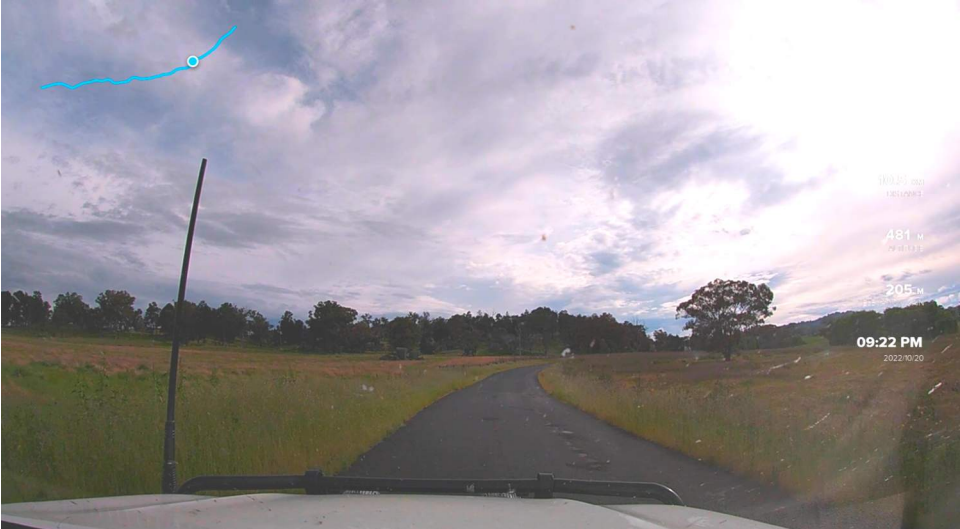
| Defect ID | Start Ch | End Ch | Defect Type (and side of road) | Image |
|---|---|---|---|---|
| 24.0 | 9900 | 10400 | Ravelling/Fretting Patched (RHS)<br>Longitudinal Cracking (RHS)<br>Longitudinal Cracking (CR) | |

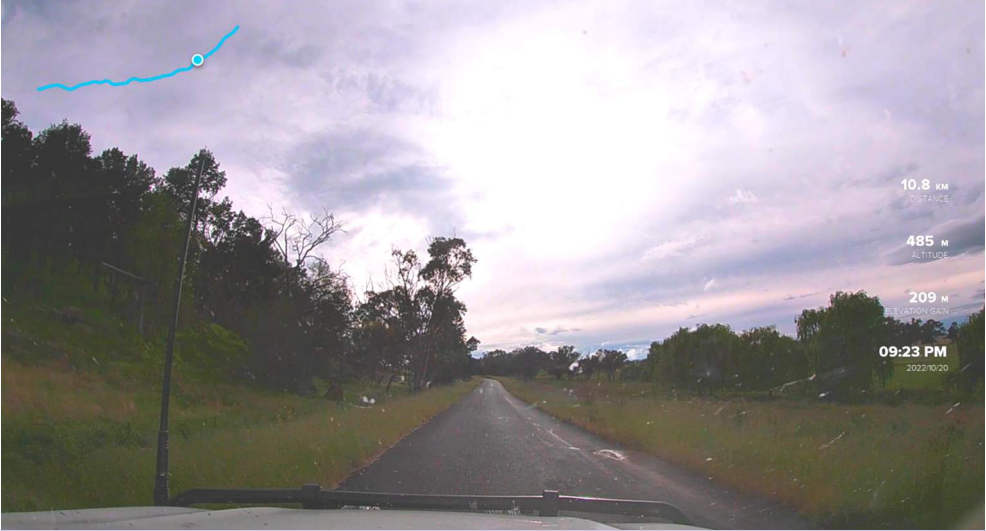
| Defect ID | Start Ch | End Ch | Defect Type (and side of road) | Image |
|---|---|---|---|---|
| 25.0 | 10400 | 10600 | Ravelling/Fretting Patched (RHS)<br>Ravelling/Fretting Patched (CR)<br>Pothole (RHS) | |

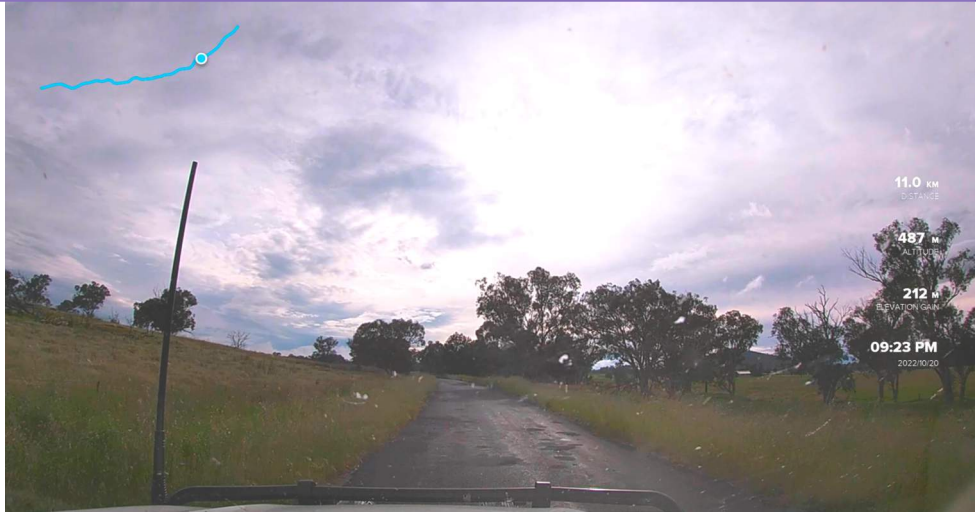
| Defect ID | Start Ch | End Ch | Defect Type (and side of road) | Image |
|---|---|---|---|---|
| 26.0 | 10600 | 10700 | Pothole Patched (BS)<br>Pothole Patched (CR)<br>Ravelling/Fretting Patched (RHS) | |

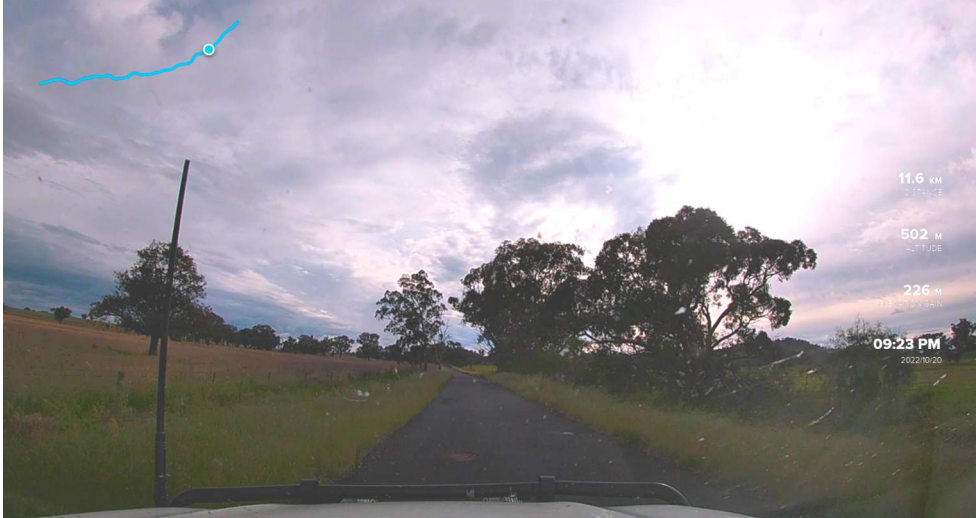
| Defect ID | Start Ch | End Ch | Defect Type (and side of road) | Image |
|---|---|---|---|---|
| 27.0 | 10700 | 11300 | Ravelling/Fretting Patched (LHS)<br>Pothole Patched (RHS)<br>Pothole (LHS) | |

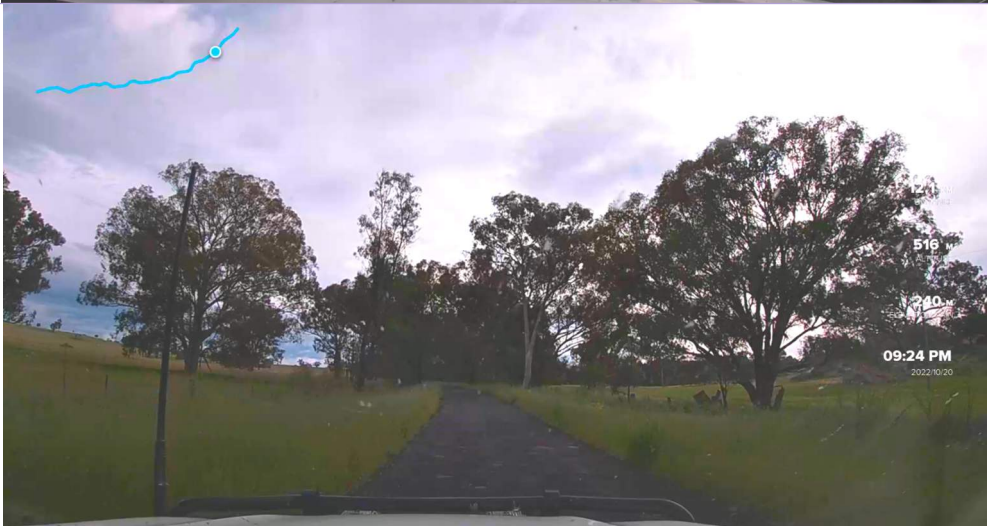
| Defect ID | Start Ch | End Ch | Defect Type (and side of road) | Image |
|---|---|---|---|---|
| 29.0 | 11600 | 12000 | Edge break (LHS)<br>Pothole Patched (BS)<br>Delamination Patched (BS)<br>Delamination (CR)<br>Pothole (BS)<br>Ravelling/Fretting (RHS) | |

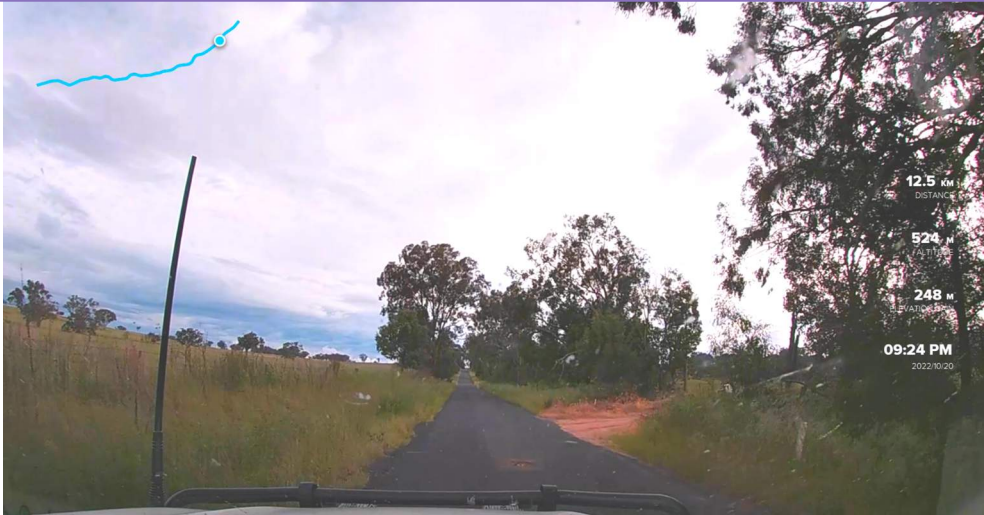
| Defect ID | Start Ch | End Ch | Defect Type (and side of road) | Image |
|---|---|---|---|---|
| 30.0 | 12000 | 12200 | Pothole (CR)<br>Pothole Patched (CR)<br>Pothole Patched (LHS)<br>Ravelling/Fretting Patched (RHS)<br>Ravelling/Fretting Patched (CR) | |

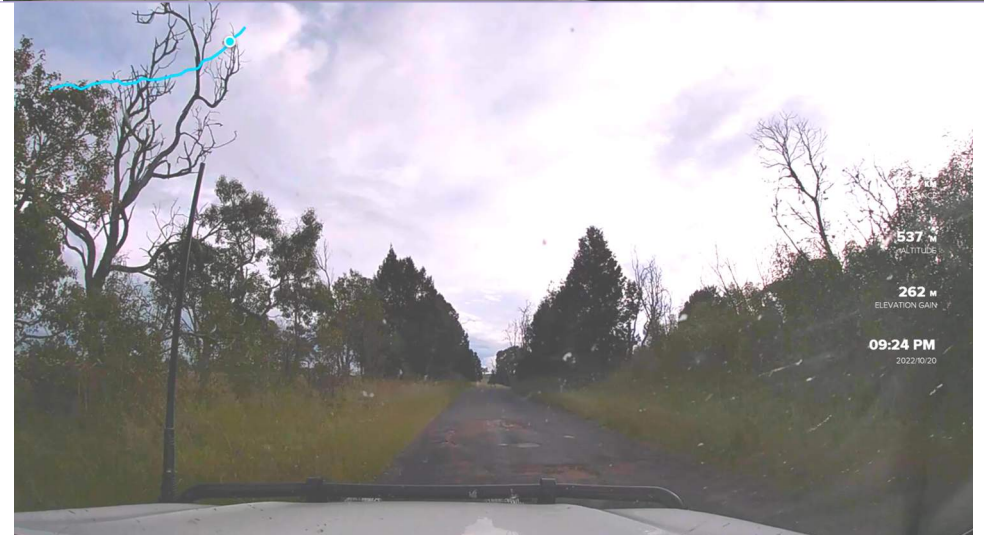
| Defect ID | Start Ch | End Ch | Defect Type (and side of road) | Image |
|---|---|---|---|---|
| 31.0 | 12200 | 12500 | Delamination (LHS)<br>Pothole (CR)<br>Ravelling/Fretting (LHS)<br>Ravelling/Fretting (CR) | |

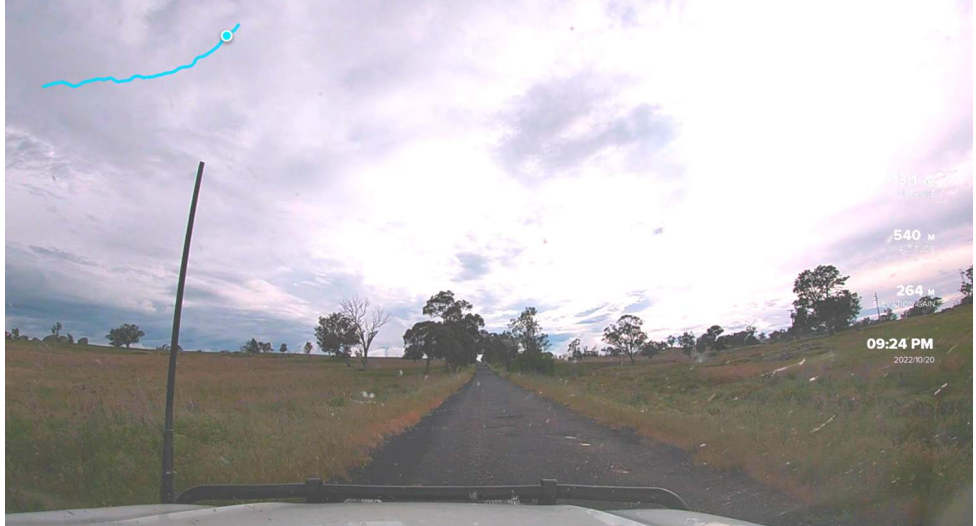
| Defect ID | Start Ch | End Ch | Defect Type (and side of road) | Image |
|---|---|---|---|---|
| 32.0 | 12500 | 13000 | Delamination (LHS)<br>Pothole (RHS)<br>Pothole (CR)<br>Ravelling/Fretting Patched (CR) | |

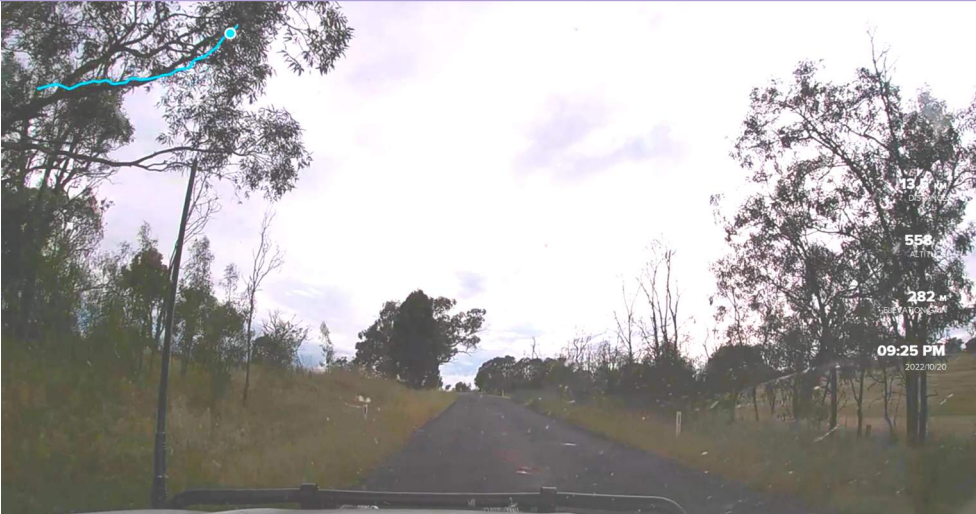
| Defect ID | Start Ch | End Ch | Defect Type (and side of road) | Image |
|---|---|---|---|---|
| 33.0 | 13000 | 13300 | Delamination (CR)<br>Delamination Patched (CR)<br>Edge break (LHS) | |

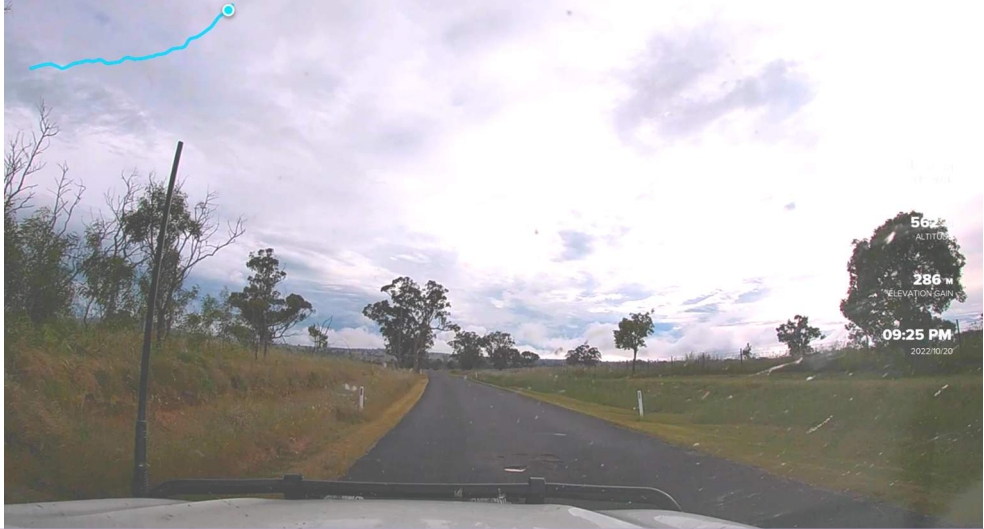
| Defect ID | Start Ch | End Ch | Defect Type (and side of road) | Image |
|---|---|---|---|---|
| 34.0 | 13300 | 13400 | Pothole (CR)<br>Ravelling/Fretting (CR) | |

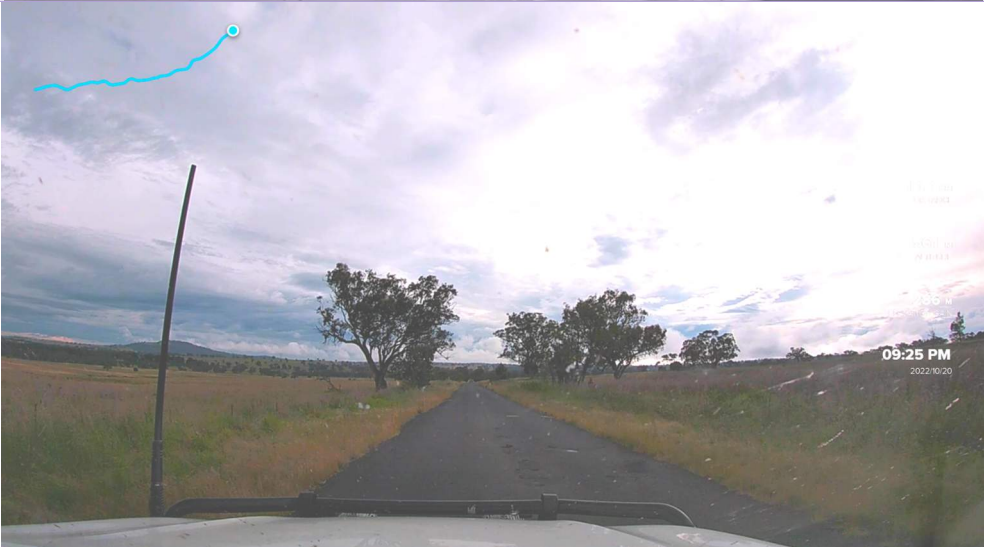
| Defect ID | Start Ch | End Ch | Defect Type (and side of road) | Image |
|---|---|---|---|---|
| 35.0 | 13400 | 13700 | Ravelling/Fretting (CR)<br>Stripping (RHS) | |

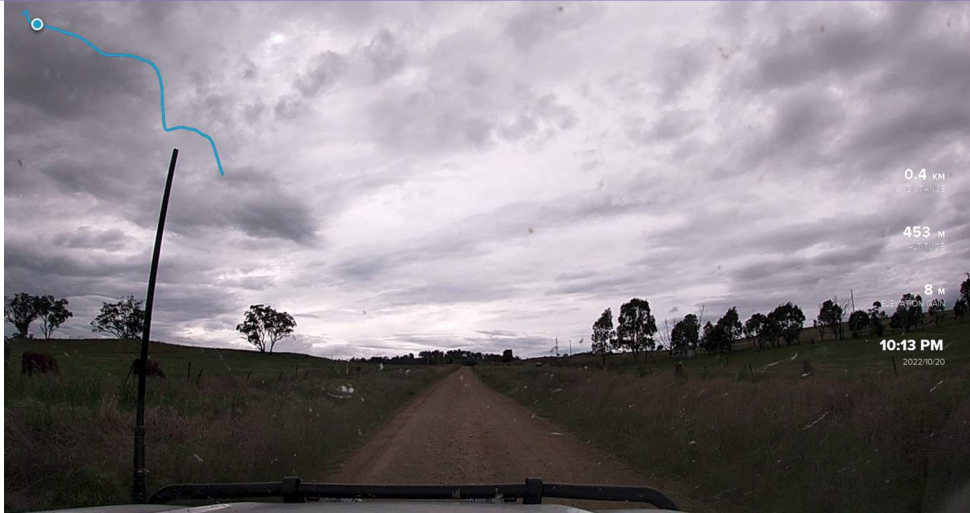
| Defect ID | Start Ch | End Ch | Defect Type (and side of road) | Image |
|---|---|---|---|---|
| 1.0 | 0 | 500 | Minor Defects | |

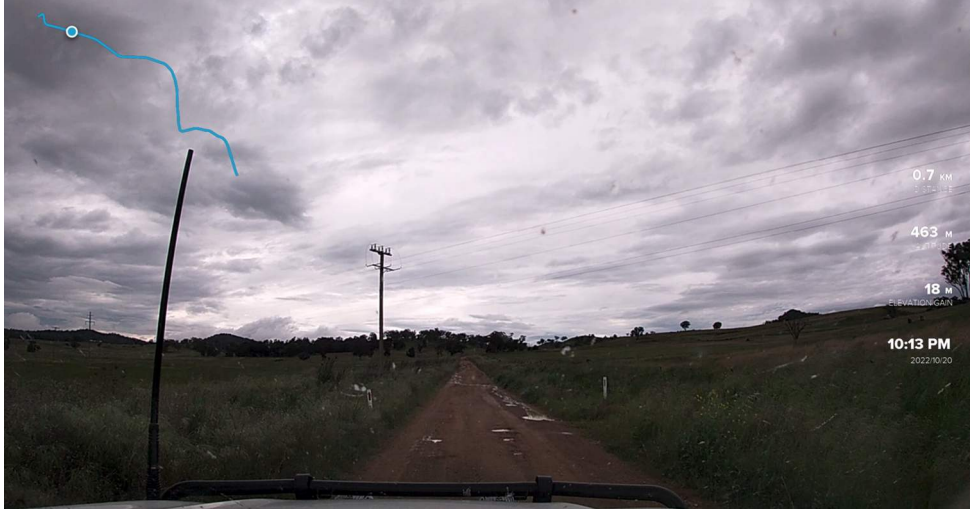
| Defect ID | Start Ch | End Ch | Defect Type (and side of road) | Image |
|---|---|---|---|---|
| 2.0 | 500 | 700 | Surface Scour (BS)<br>Potholes (BS)<br>Rutting (RHS)<br>Drainage Issue | |

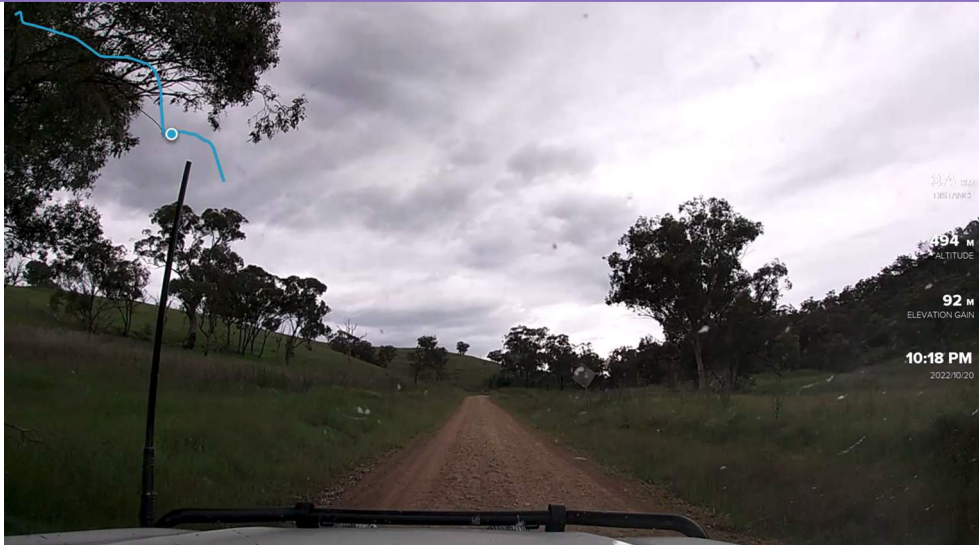
| Defect ID | Start Ch | End Ch | Defect Type (and side of road) | Image |
|---|---|---|---|---|
| 14.0 | 3300 | 3400 | Rough Surface (CR) | |

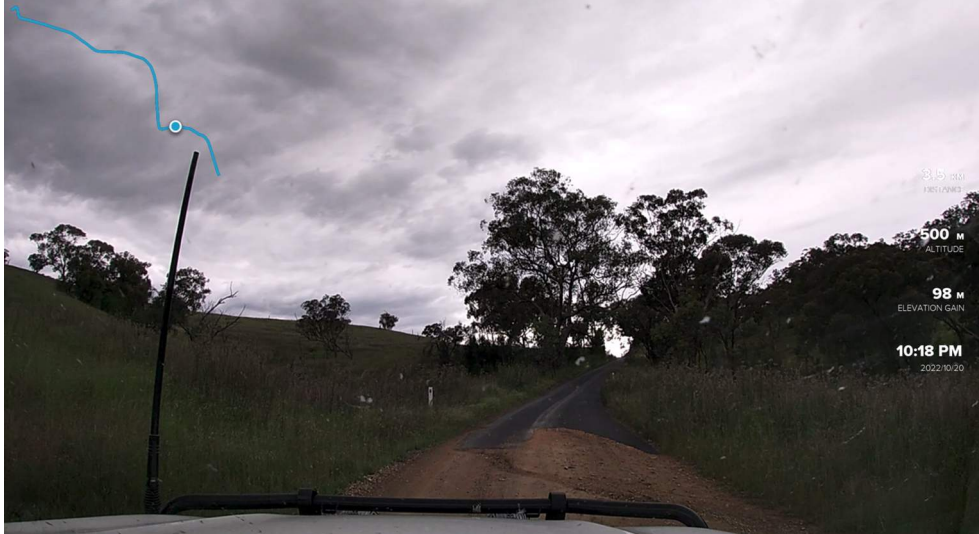
| Defect ID | Start Ch | End Ch | Defect Type (and side of road) | Image |
|---|---|---|---|---|
| 15.0 | 3400 | 3800 | Unsealed to sealed pavement<br>Pothole (RHS)<br>Delamination (RHS) | |

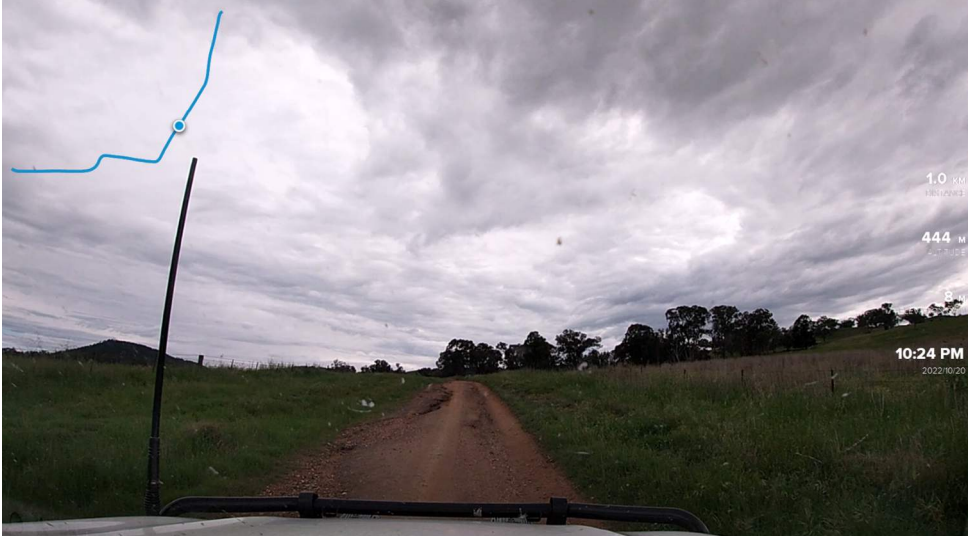
| Defect ID | Start Ch | End Ch | Defect Type (and side of road) | Image |
|---|---|---|---|---|
| 22.0 | 5400 | 5700 | Rough surface | |

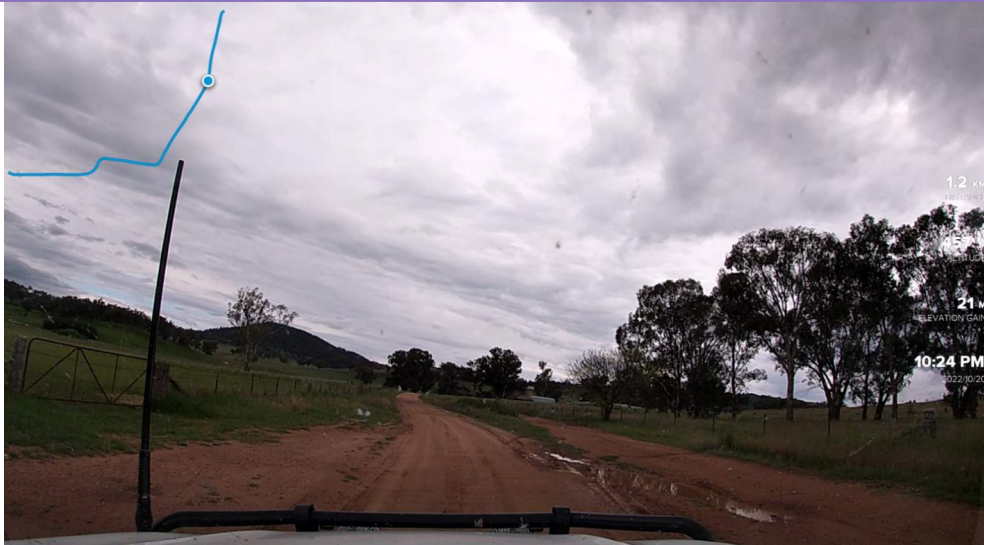
| Defect ID | Start Ch | End Ch | Defect Type (and side of road) | Image |
|---|---|---|---|---|
| 23.0 | 5700 | 6000 | Corrugation (CR)<br>Surface scour (RHS)<br>Potholes (BS) | |

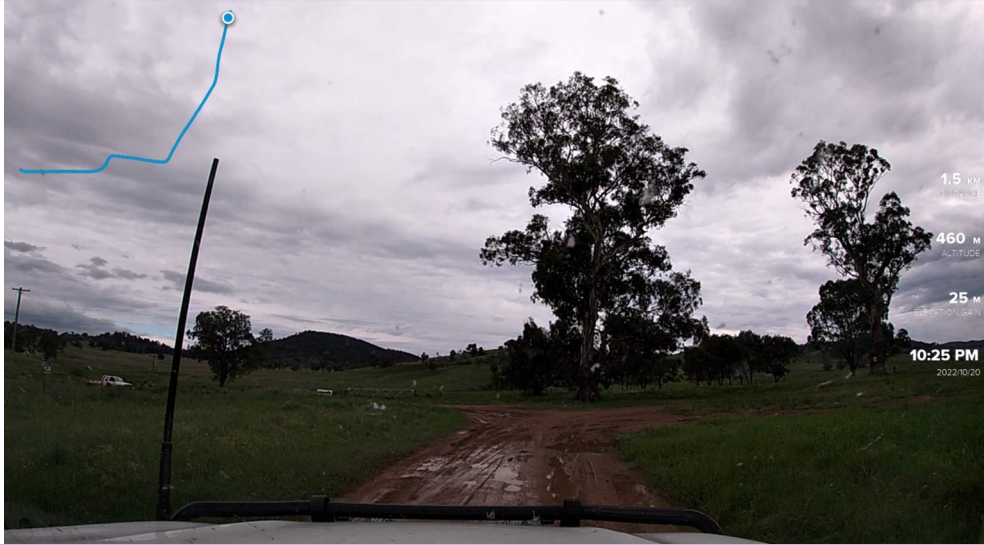
| Defect ID | Start Ch | End Ch | Defect Type (and side of road) | Image |
|---|---|---|---|---|
| 24.0 | 6000 | 6100 | Slippery Surface<br>Pothole (RHS)<br>Pothole (CR)<br>Rutting (BS)<br>Drainage issue | |

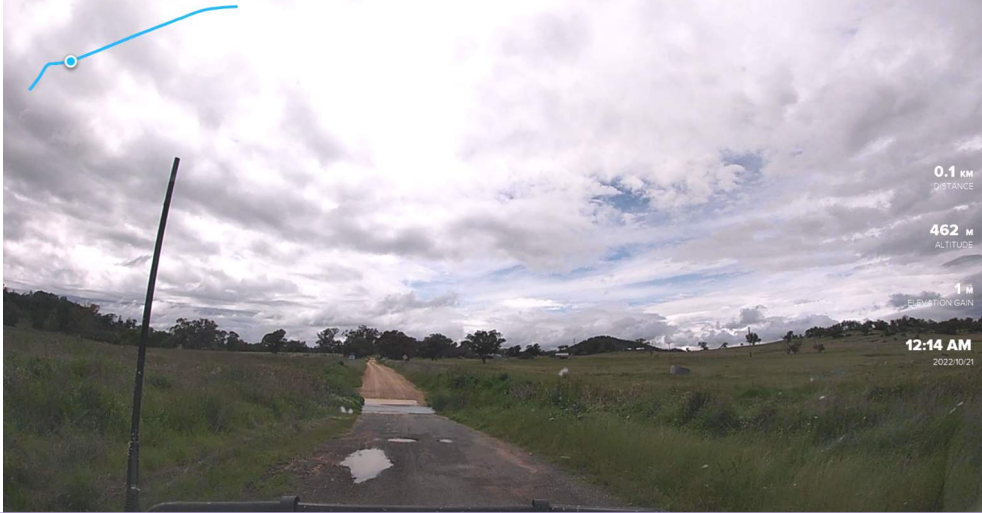
| Defect ID | Start Ch | End Ch | Defect Type (and side of road) | |
|---|---|---|---|---|
| 1.0 | 0 | 100 | Sealed to unsealed pavement with concrete causeway transition.<br><br>Pothole (LHS)<br>Pothole (CR)<br>Depression (RHS)<br>Drainage issue | |

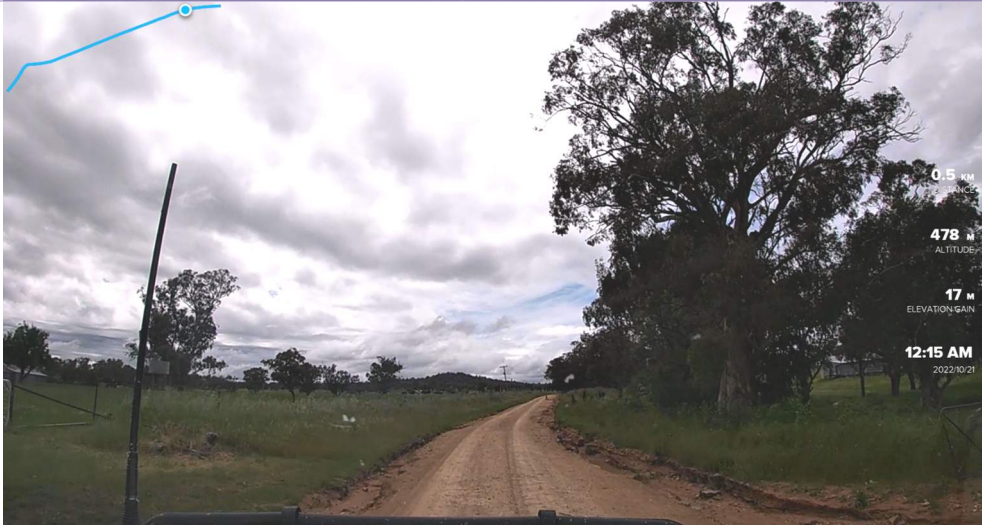
| Defect ID | Start Ch | End Ch | Defect Type (and side of road) | |
|---|---|---|---|---|
| 2.0 | 100 | 550 | Surface Scour (BS)<br>Edge break (BS) | |

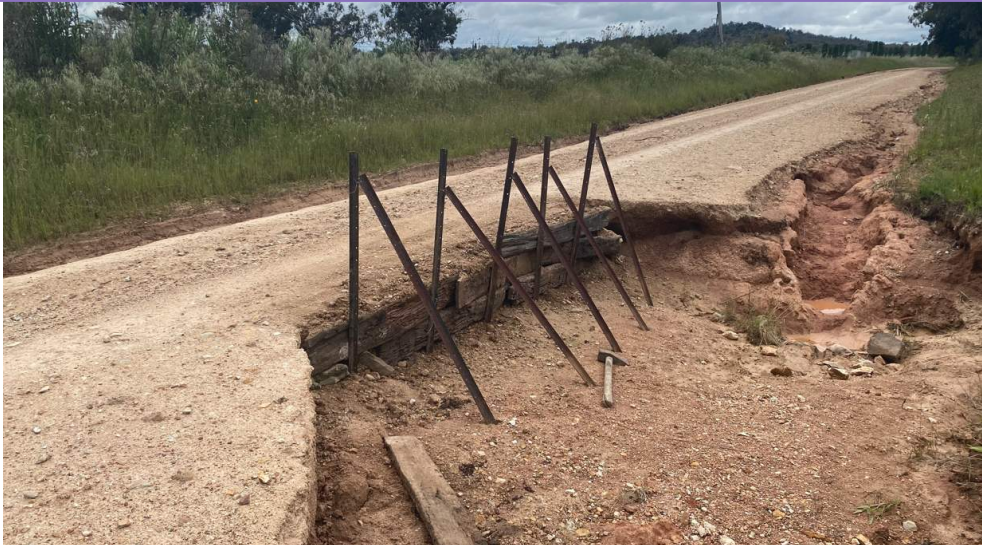
| Defect ID | Start Ch | End Ch | Defect Type (and side of road) | |
|---|---|---|---|---|
| 3.0 | 550 | 550 | <p>Erosion (RHS)</p> <p>Surface scour (RHS)</p> <p>Edge break (LHS)</p> <p>Local attempt to prevent further erosion.</p> | |
