# External Road Dilapidation Report – Existing Condition

## Uungula Wind Farm

*Prepared for: Uungula Wind Farm Pty Ltd*

| <b>Job Number</b> | 19-142 |

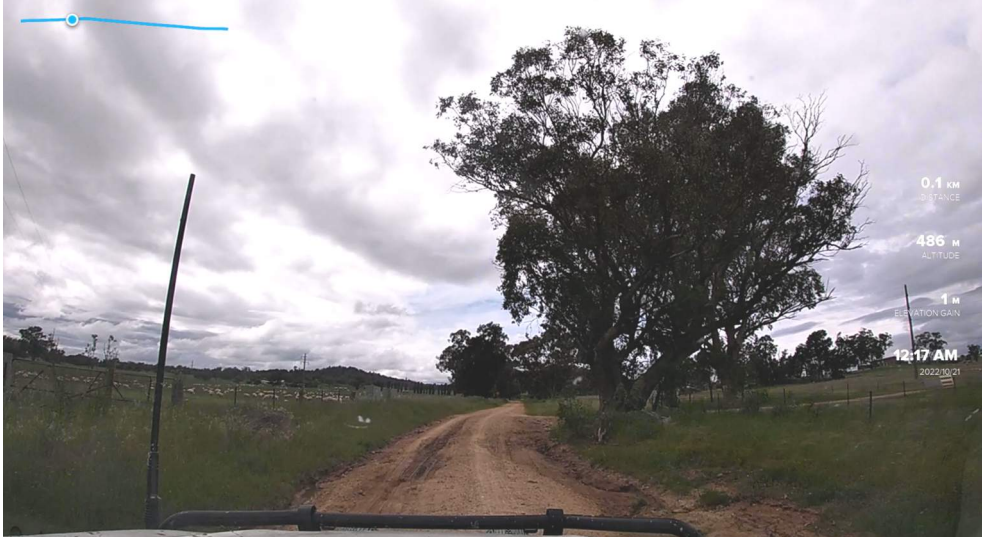
| Defect ID | Start Ch | End Ch | Defect Type (and side of road) | |
|---|---|---|---|---|
| 4.0 | 550 | 750 | Rutting (BS) | |

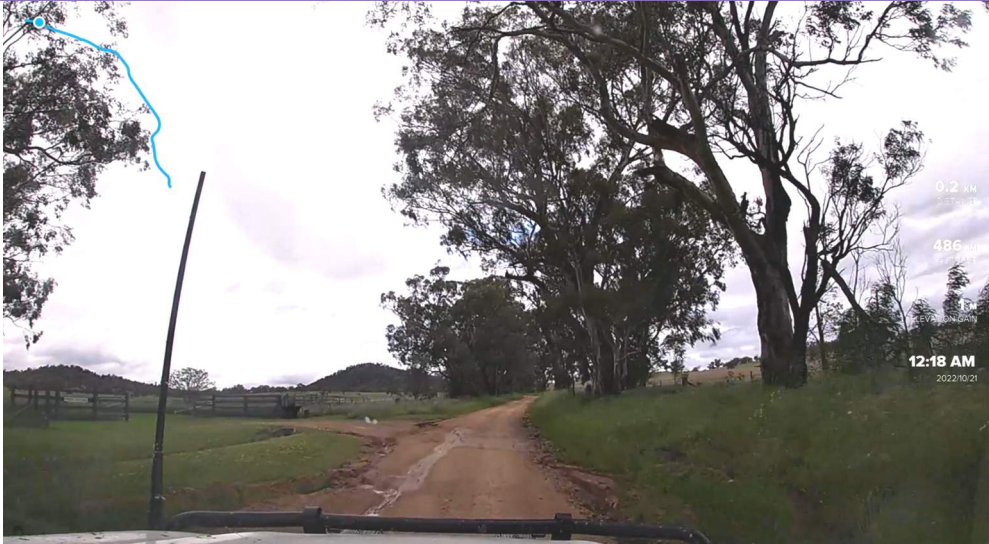
| Defect ID | Start Ch | End Ch | Defect Type (and side of road) | |
|---|---|---|---|---|
| 6.0 | 800 | 1000 | Surface Scour (LHS) | |

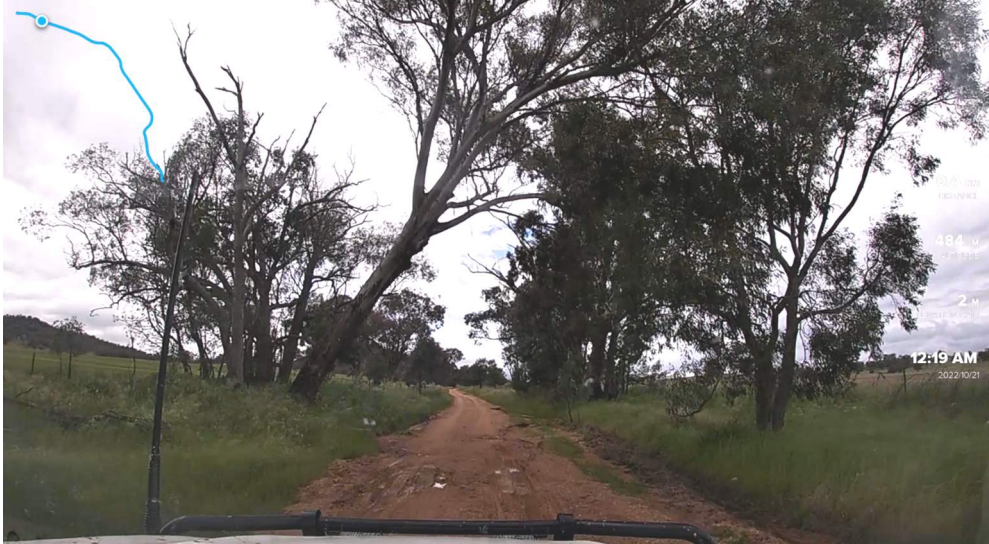
| Defect ID | Start Ch | End Ch | Defect Type (and side of road) | |
|---|---|---|---|---|
| 7.0 | 1000 | 1200 | Rutting (BS)<br>Surface Scour (RHS)<br>Soft Surface | |

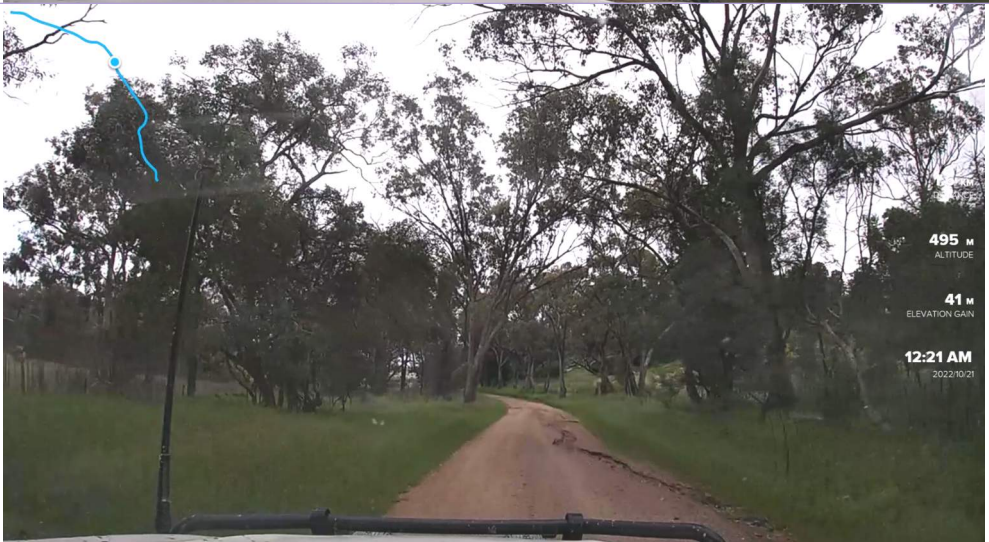
| Defect ID | Start Ch | End Ch | Defect Type (and side of road) | |
|---|---|---|---|---|
| 11.0 | 2400 | 2500 | Surface Scour (RHS) | |

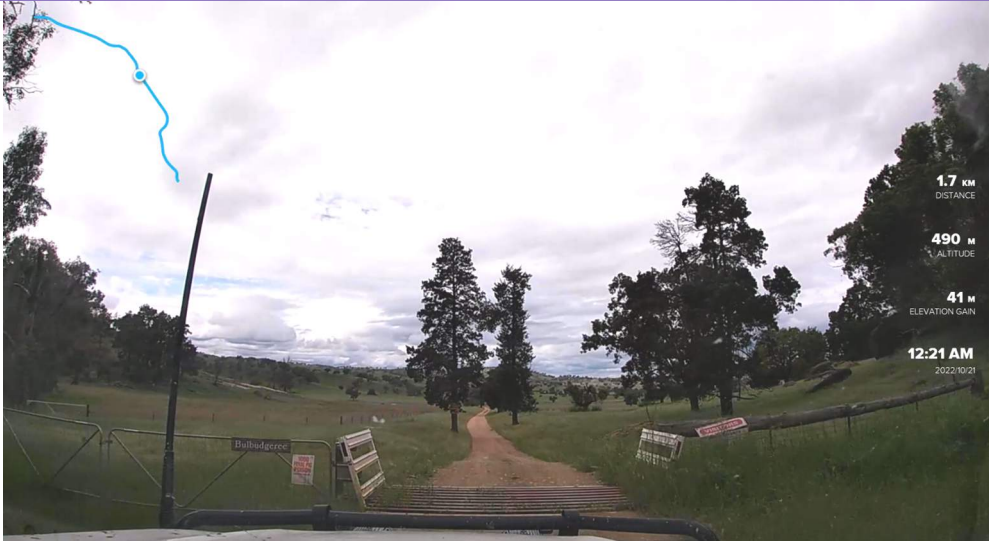
| Defect ID | Start Ch | End Ch | Defect Type (and side of road) | |
|---|---|---|---|---|
| 12.0 | 2500 | 3500 | Cattle grid<br>Rutting minor (CR)<br>Rutting (RHS) | <p>1.7 KM<br/>DISTANCE</p> <p>490 M<br/>ALTITUDE</p> <p>41 M<br/>ELEVATION GAIN</p> <p>12:21 AM<br/>2022/10/21</p> |

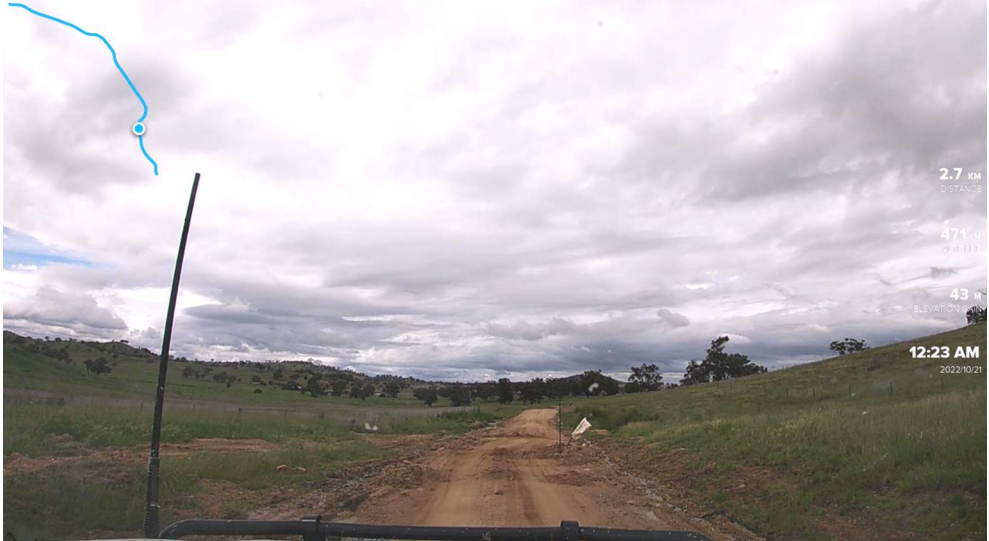
| Defect ID | Start Ch | End Ch | Defect Type (and side of road) | |
|---|---|---|---|---|
| 13.0 | 3500 | 3600 | Rutting major (BS)<br>Rocks in pavement<br>Soft surface (LHS)<br>Drainage issue. | <p>2.7 KM<br/>DISTANCE</p> <p>471 M<br/>ALTITUDE</p> <p>43 M<br/>ELEVATION GAIN</p> <p>12:23 AM<br/>2022/10/21</p> |

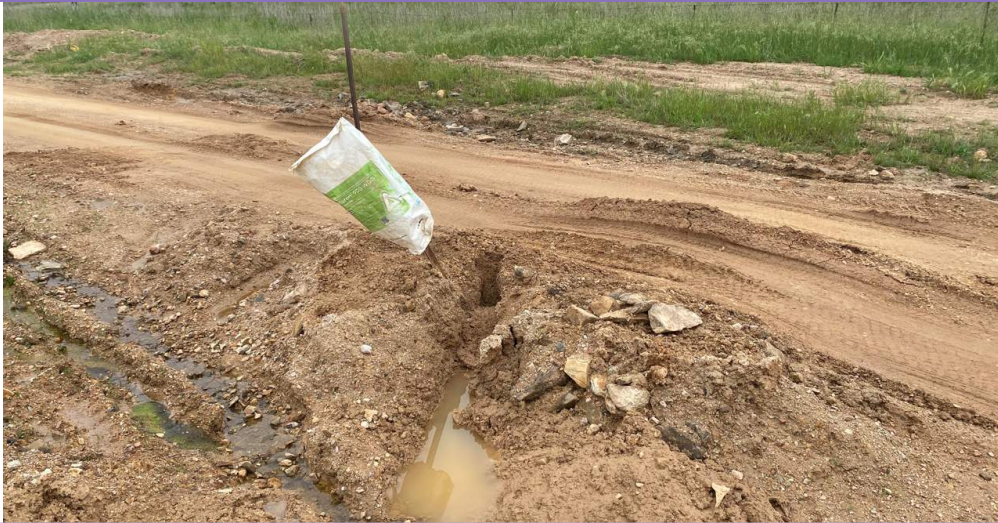
| Defect ID | Start Ch | End Ch | Defect Type (and side of road) | |
|---|---|---|---|---|
| 14.0 | 3600 | 4300 | Edge break (RHS) | |

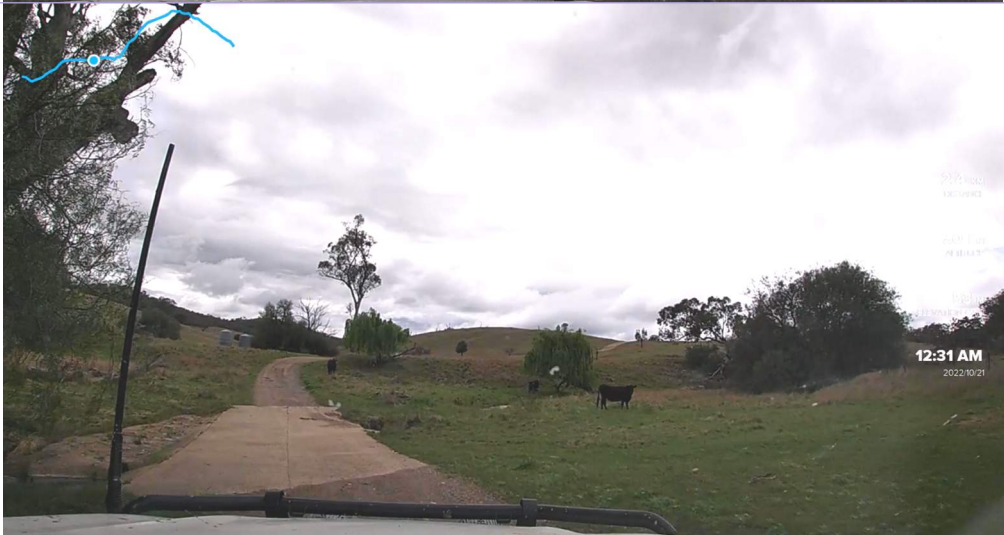
| Defect ID | Start Ch | End Ch | Defect Type (and side of road) | |
|---|---|---|---|---|
| 24.0 | 6500 | 6600 | Causeway | |

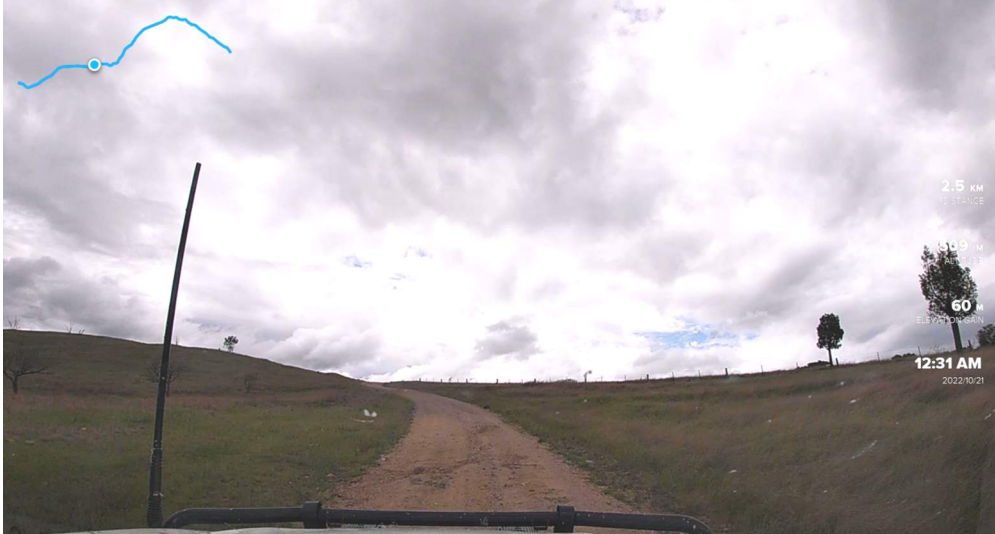
| Defect ID | Start Ch | End Ch | Defect Type (and side of road) | |
|---|---|---|---|---|
| 26.0 | 6700 | 7000 | Surface scour (CR)<br>Corrugation (LHS) | |

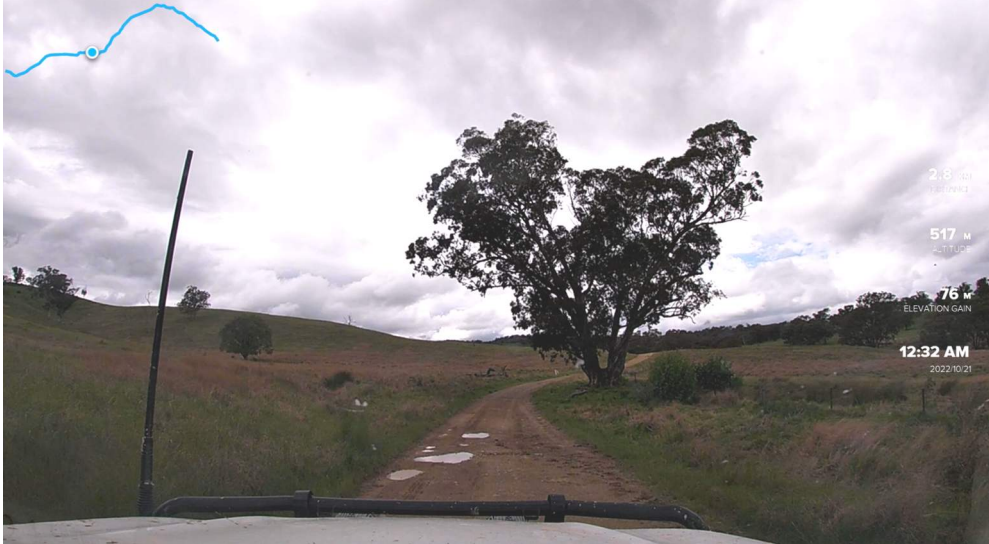
| Defect ID | Start Ch | End Ch | Defect Type (and side of road) | |
|---|---|---|---|---|
| 27.0 | 7000 | 7600 | Potholes (BS)<br>Potholes (RHS)<br>Rutting (RHS) | |

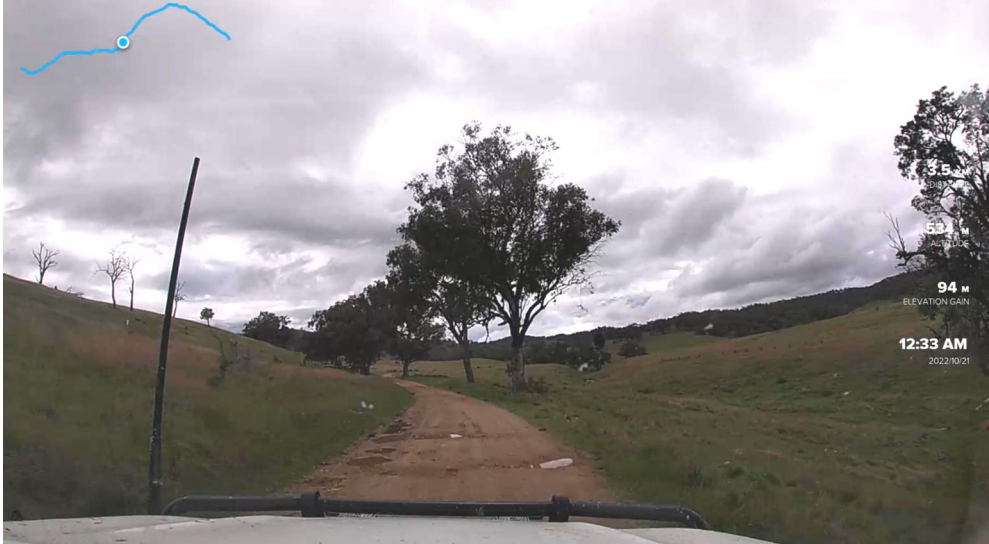
| Defect ID | Start Ch | End Ch | Defect Type (and side of road) | |
|---|---|---|---|---|
| 28.0 | 7600 | 7700 | Depression (CR)<br>Rutting (LHS) | |

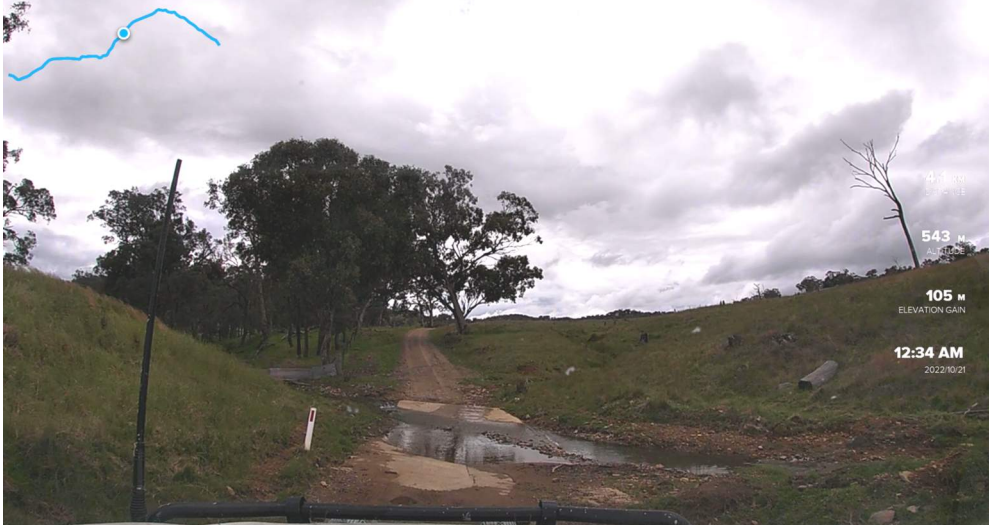
| Defect ID | Start Ch | End Ch | Defect Type (and side of road) | |
|---|---|---|---|---|
| 30.0 | 8200 | 8300 | Causeway<br>Surface scour around concrete transition<br>Drainage issue<br>Loose material on causeway | |

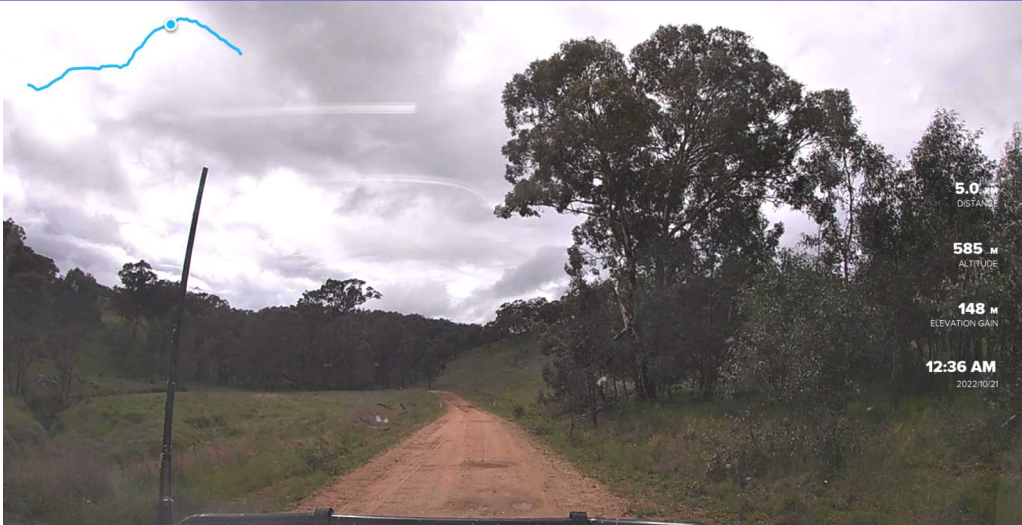
| Defect ID | Start Ch | End Ch | Defect Type (and side of road) | |
|---|---|---|---|---|
| 34.0 | 8900 | 9500 | Pothole (CR)<br>Rutting (BS) | |

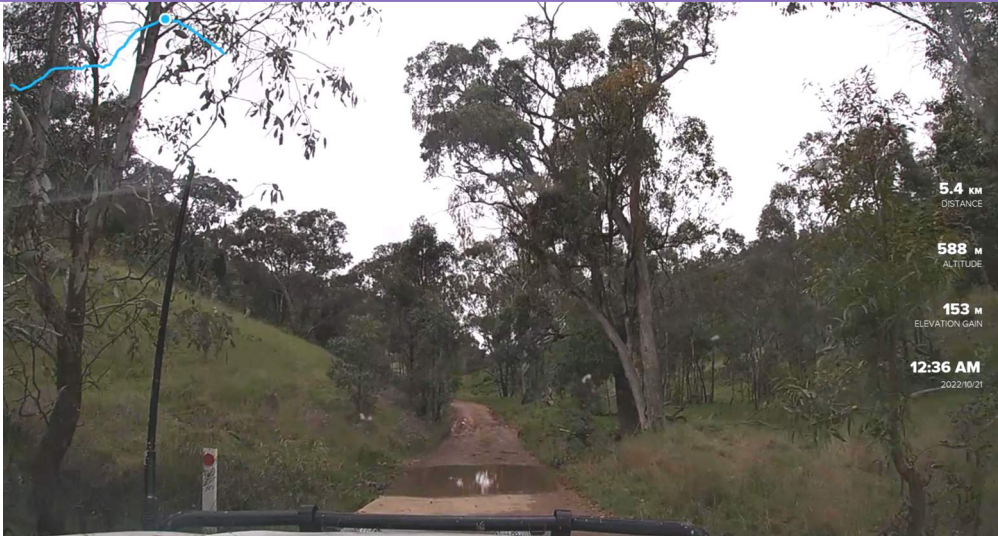
| Defect ID | Start Ch | End Ch | Defect Type (and side of road) | |
|---|---|---|---|---|
| 36.0 | 9600 | 9700 | Causeway<br>Soft Surface<br>Rutting (BS)<br>Drainage issue | |

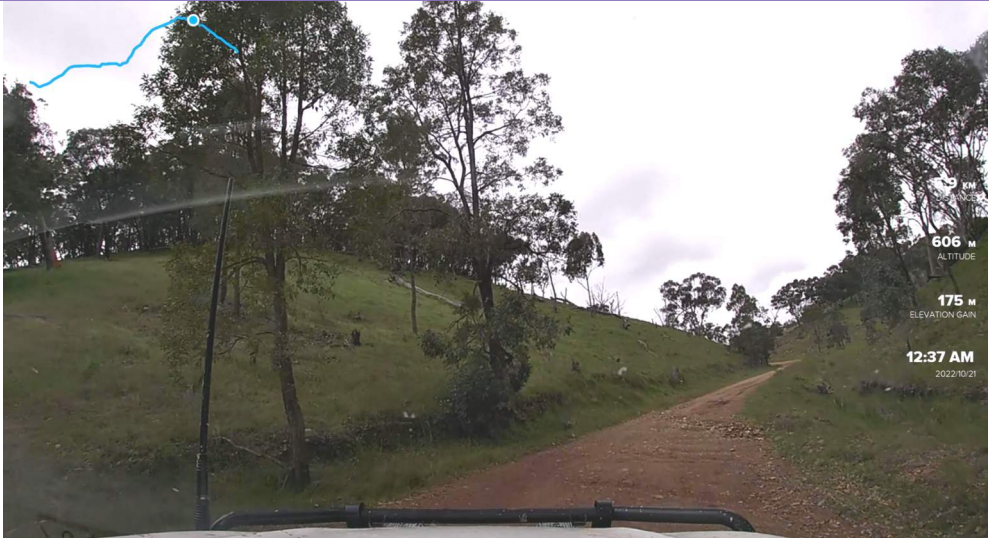
| Defect ID | Start Ch | End Ch | Defect Type (and side of road) | |
|---|---|---|---|---|
| 38.0 | 9800 | 10300 | Corrugation (RHS)<br>Corrugation (CR)<br>Surface scour (BS) | |

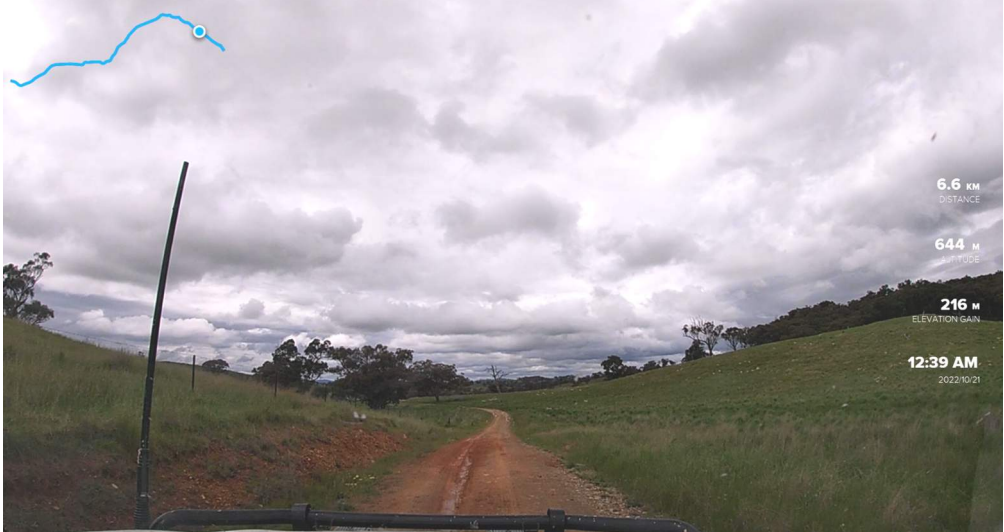
| Defect ID | Start Ch | End Ch | Defect Type (and side of road) | |
|---|---|---|---|---|
| 40.0 | 10500 | 10800 | Rutting (LHS) | |

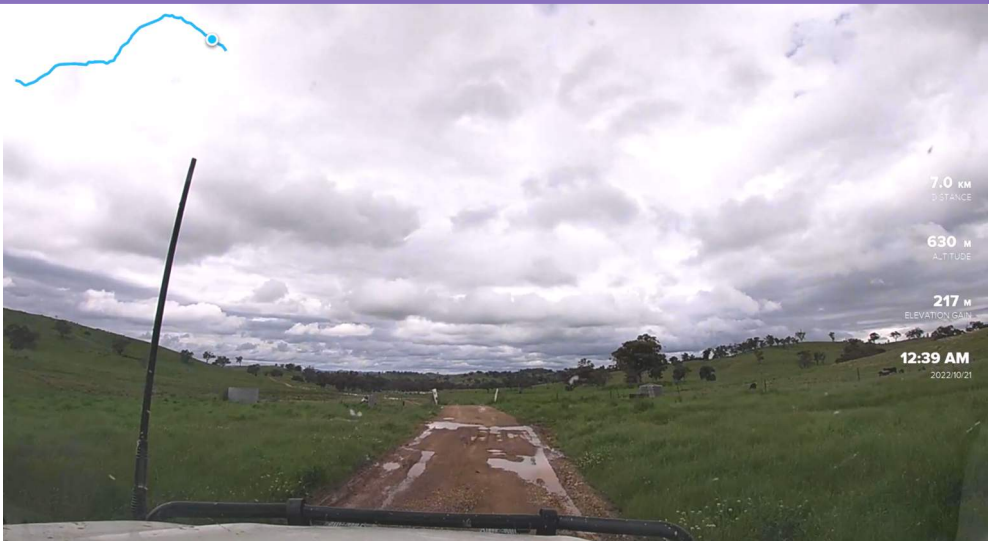
| Defect ID | Start Ch | End Ch | Defect Type (and side of road) | |
|---|---|---|---|---|
| 42.0 | 11100 | 11200 | Rutting (BS)<br>Pothole (BS)<br>Drainage issue<br>Cattle grid | |

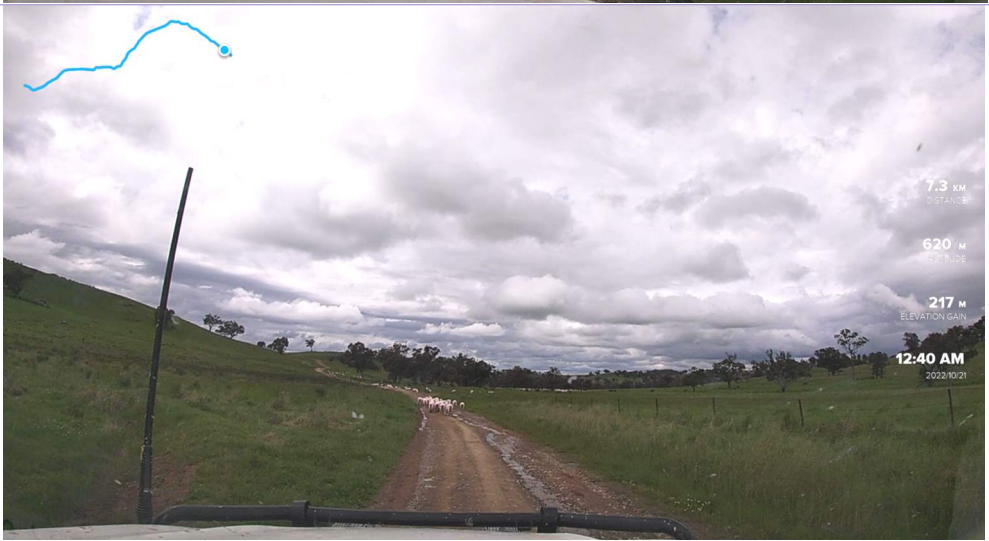
| Defect ID | Start Ch | End Ch | Defect Type (and side of road) | |
|---|---|---|---|---|
| 43.0 | 11200 | 11500 | Surface scour (RHS) | |

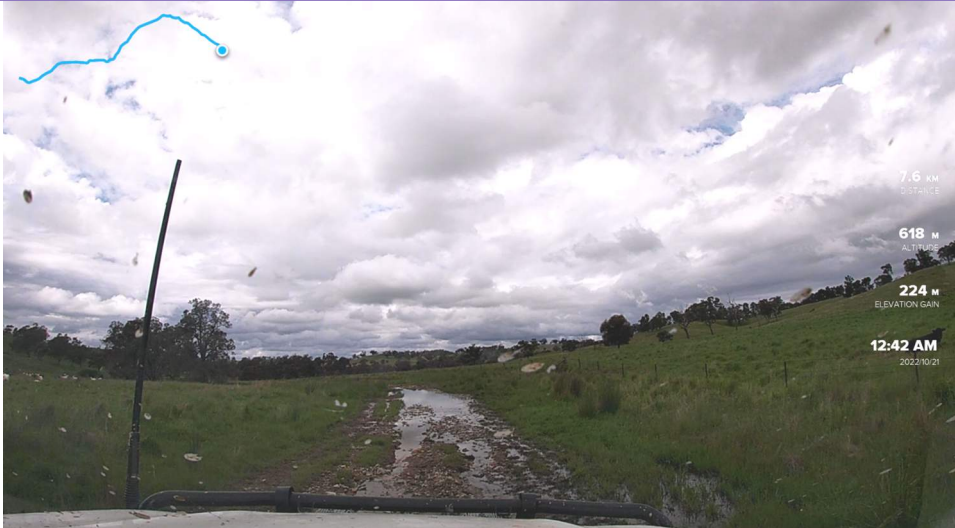
| Defect ID | Start Ch | End Ch | Defect Type (and side of road) | |
|---|---|---|---|---|
| 44.0 | 11500 | 11800 | Soft surface<br>Drainage issue | |

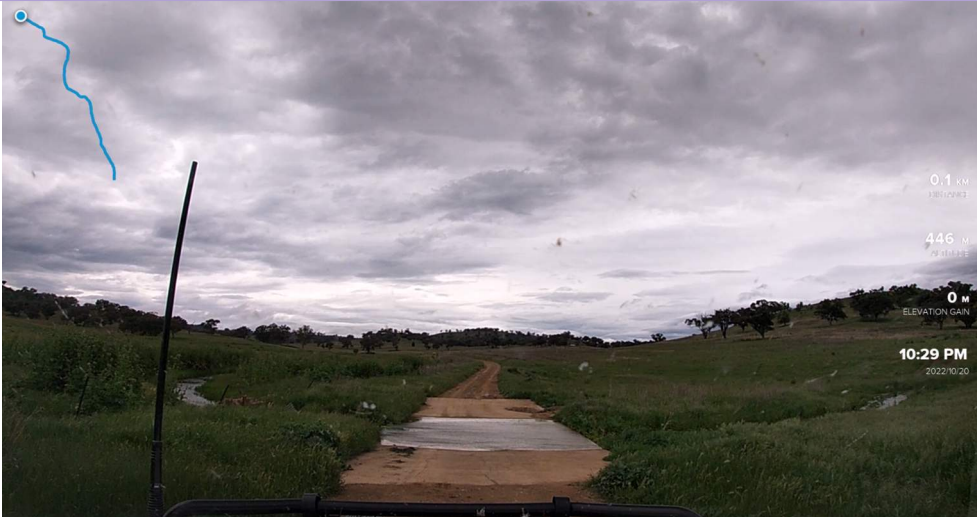
| Defect ID | Start Ch | End Ch | Defect Type (and side of road) | |
|---|---|---|---|---|
| 2.0 | 100 | 200 | Concrete causeway<br>Pothole (LHS)<br>Drainage issue | |

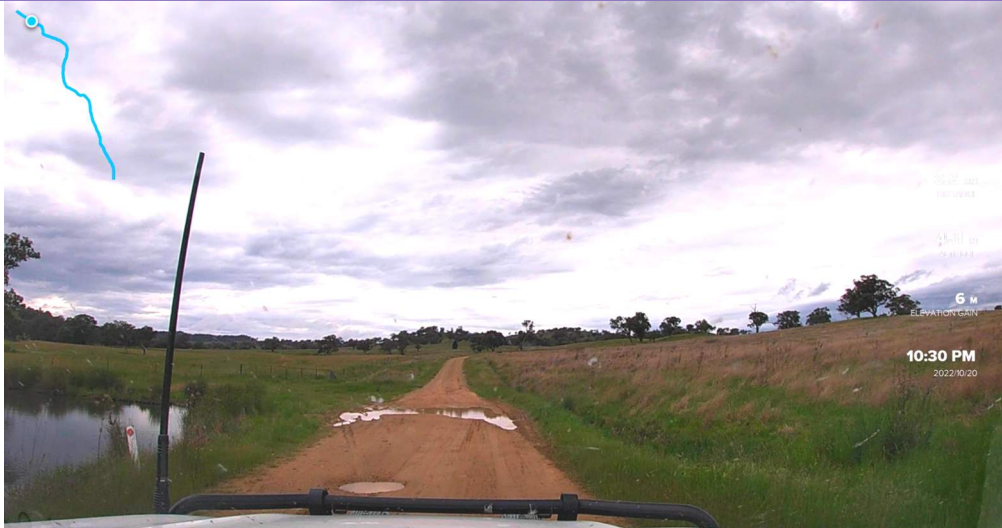
| Defect ID | Start Ch | End Ch | Defect Type (and side of road) | |
|---|---|---|---|---|
| 5.0 | 600 | 700 | Pothole (LHS)<br>Depression<br>Drainage issue | |

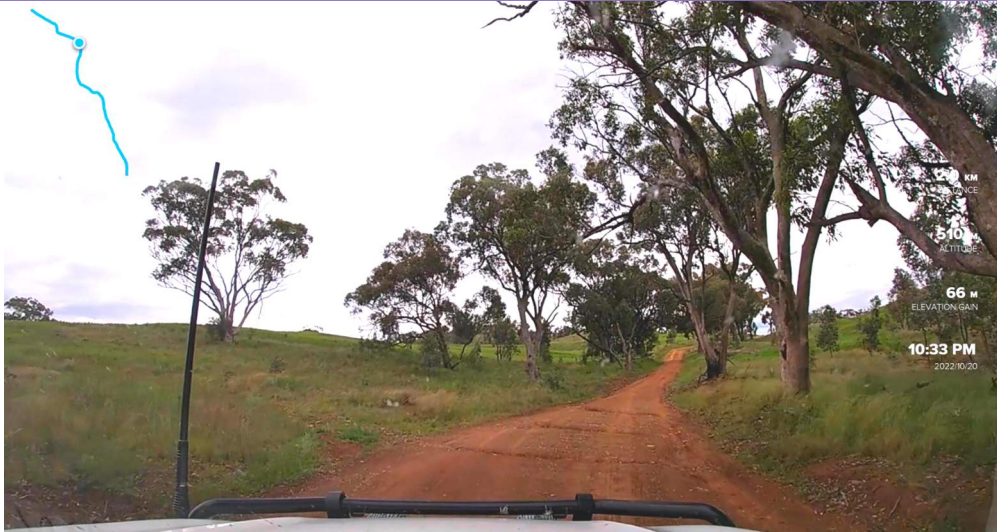
| Defect ID | Start Ch | End Ch | Defect Type (and side of road) | |
|---|---|---|---|---|
| 11.0 | 2000 | 2300 | Corrugation (BS)<br>Surface scour (BS) | |

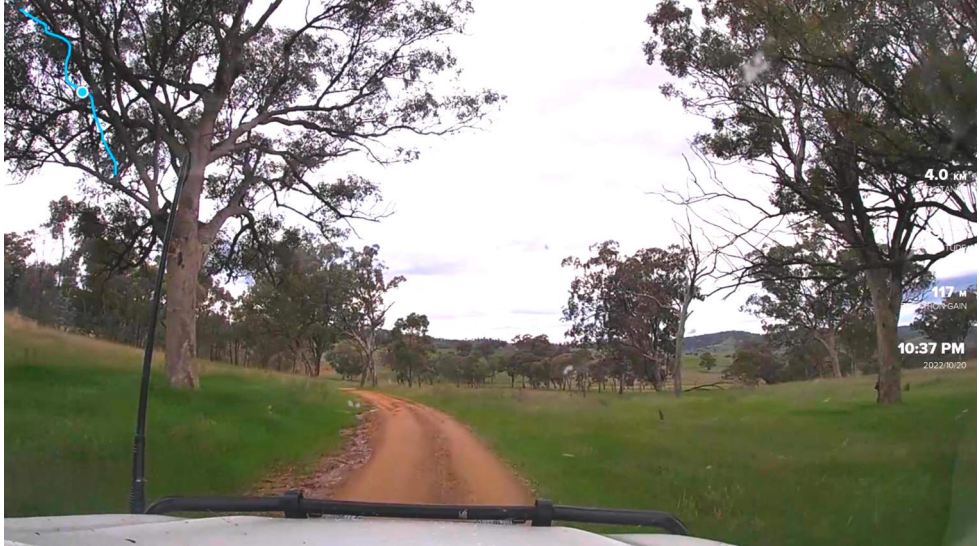
| Defect ID | Start Ch | End Ch | Defect Type (and side of road) | |
|---|---|---|---|---|
| 20.0 | 3900 | 4200 | Edge break (RHS) | |

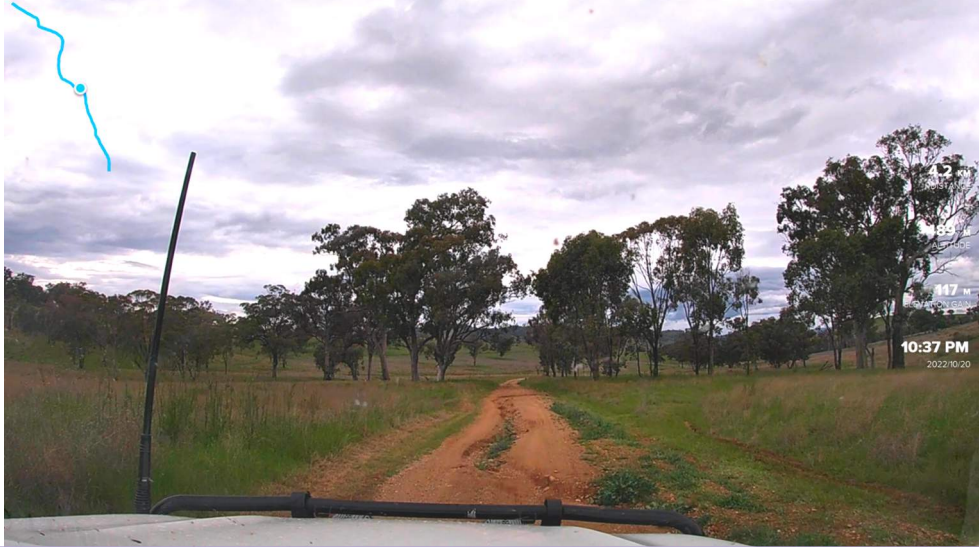
| Defect ID | Start Ch | End Ch | Defect Type (and side of road) | |
|---|---|---|---|---|
| 21.0 | 4200 | 4400 | Surface scour (CR) | |

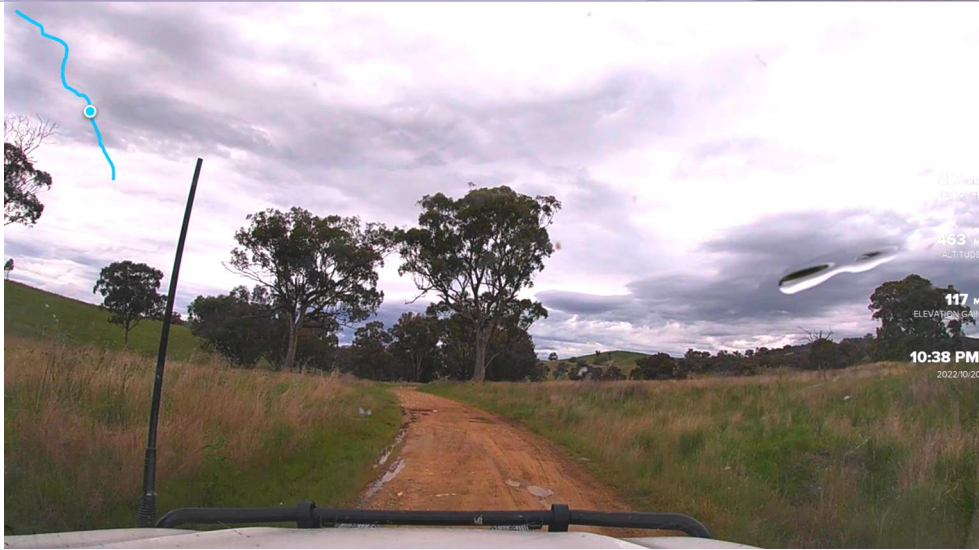
| Defect ID | Start Ch | End Ch | Defect Type (and side of road) | |
|---|---|---|---|---|
| 22.0 | 4400 | 4700 | Rutting (RHS)<br>Pothole (BS) | |

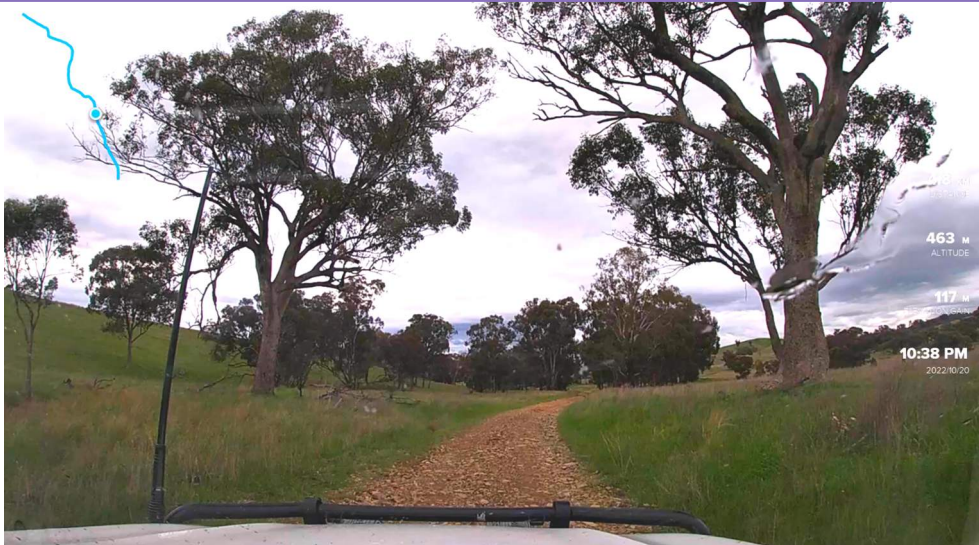
| Defect ID | Start Ch | End Ch | Defect Type (and side of road) | |
|---|---|---|---|---|
| 23.0 | 4700 | 4800 | Poorly graded pavement material | |

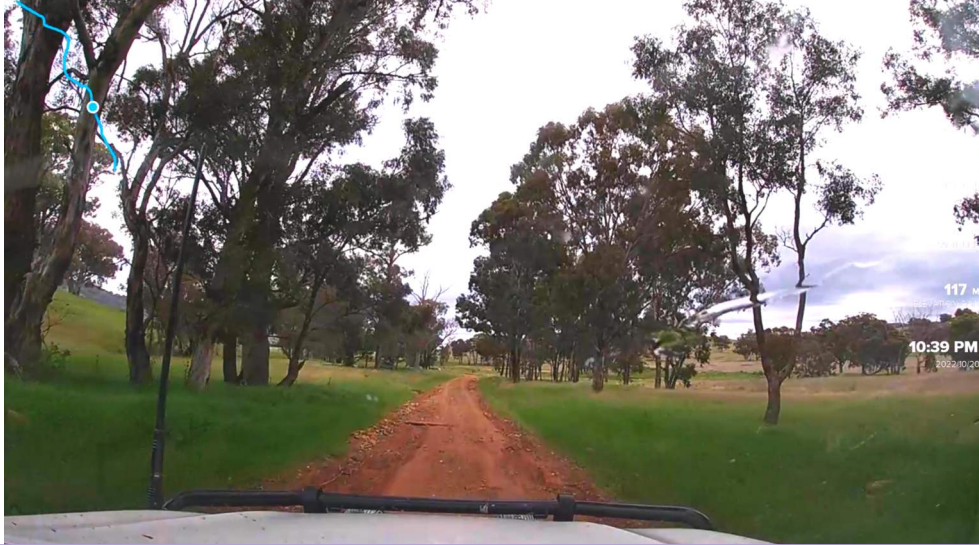
| Defect ID | Start Ch | End Ch | Defect Type (and side of road) | |
|---|---|---|---|---|
| 24.0 | 4800 | 4900 | Rutting (BS) | |

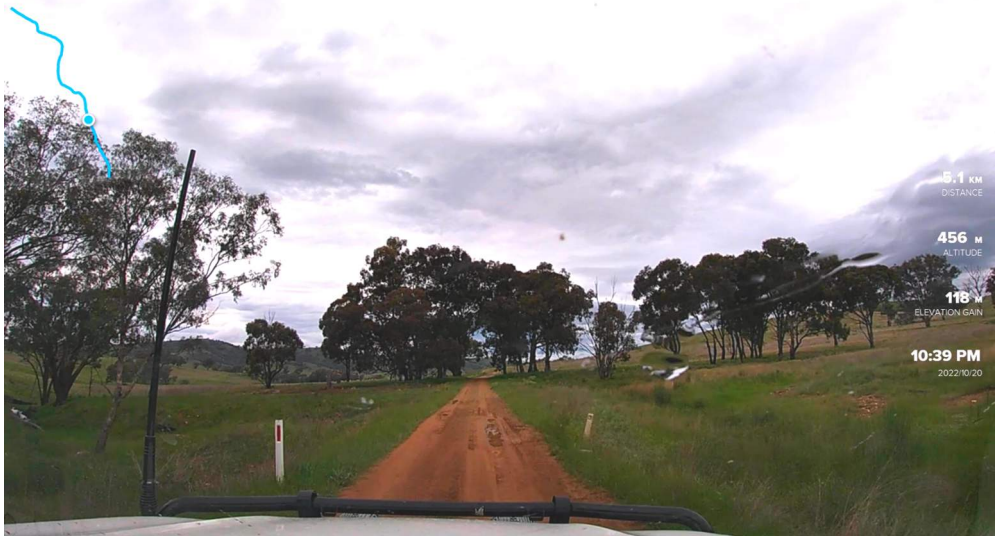
| Defect ID | Start Ch | End Ch | Defect Type (and side of road) | |
|---|---|---|---|---|
| 26.0 | 5000 | 5100 | Rutting (RHS) | |

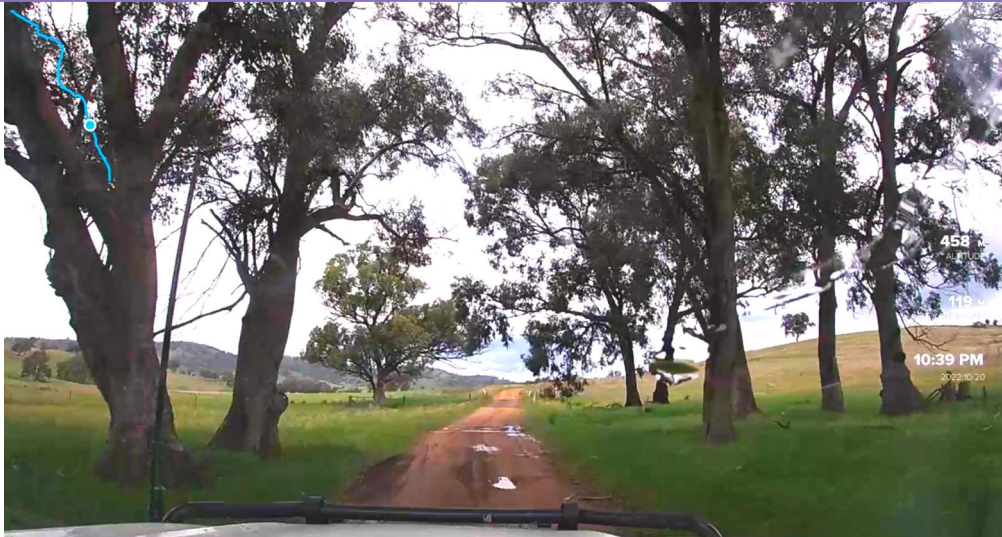
| Defect ID | Start Ch | End Ch | Defect Type (and side of road) | |
|---|---|---|---|---|
| 27.0 | 5100 | 5200 | Pothole (CR)<br>Rutting (RHS) | |

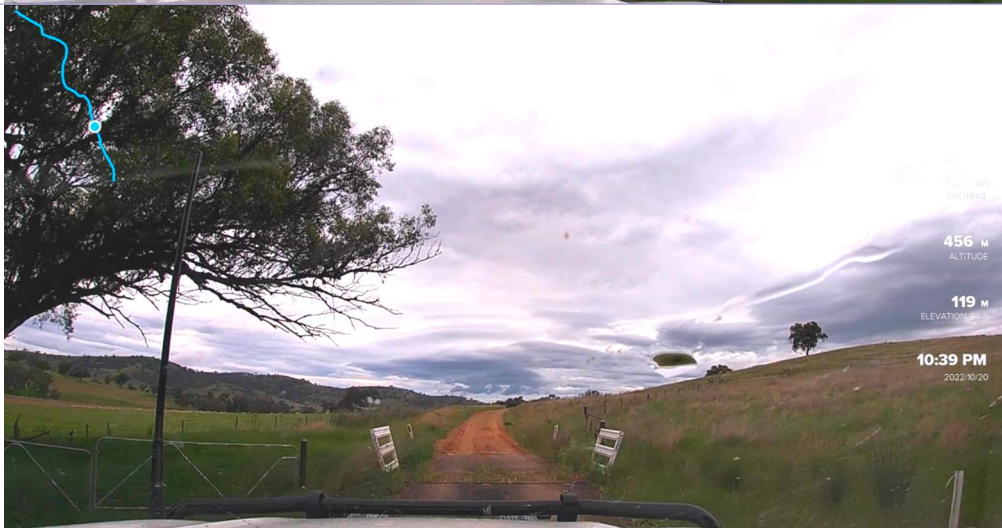
| Defect ID | Start Ch | End Ch | Defect Type (and side of road) | |
|---|---|---|---|---|
| 28.0 | 5200 | 5200 | Pothole (RHS)<br>Cattle grid | |

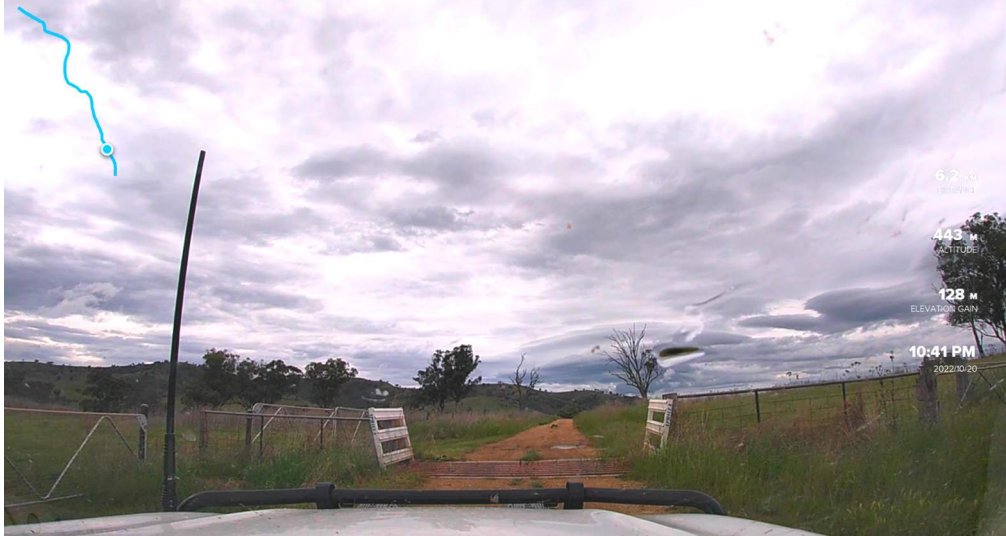
| Defect ID | Start Ch | End Ch | Defect Type (and side of road) | |
|---|---|---|---|---|
| 33.0 | 6200 | 6500 | Pothole (BS)<br>Cattle grid | |

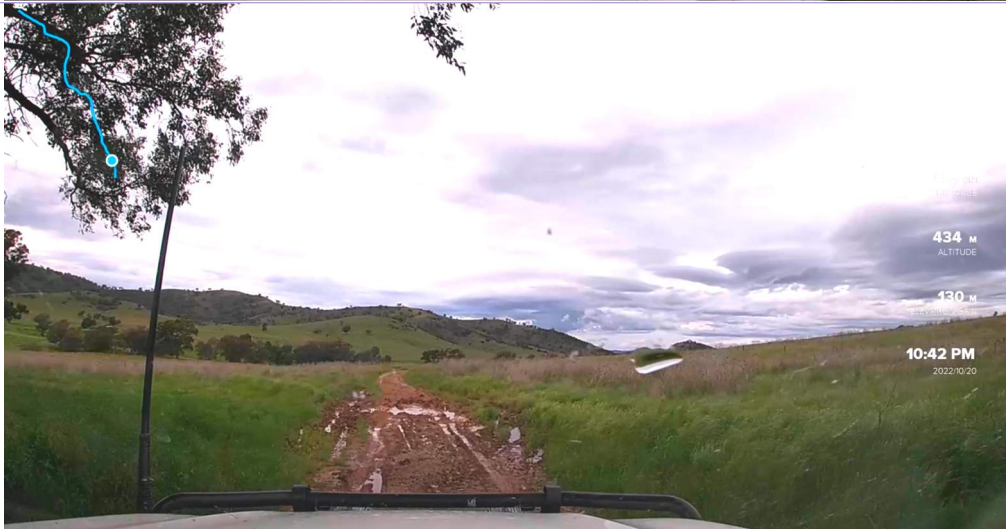
| Defect ID | Start Ch | End Ch | Defect Type (and side of road) | |
|---|---|---|---|---|
| 34.0 | 6500 | 6600 | Rutting (BS)<br>Rutting (CR)<br>Soft surface<br>Drainage issue | |

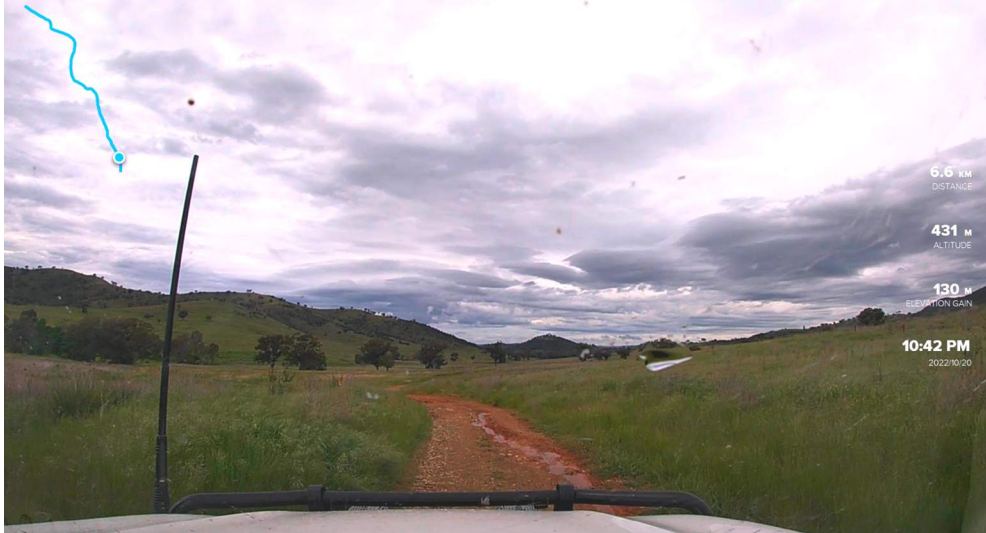
| Defect ID | Start Ch | End Ch | Defect Type (and side of road) | |
|---|---|---|---|---|
| 35.0 | 6600 | 6700 | Drainage issue | |

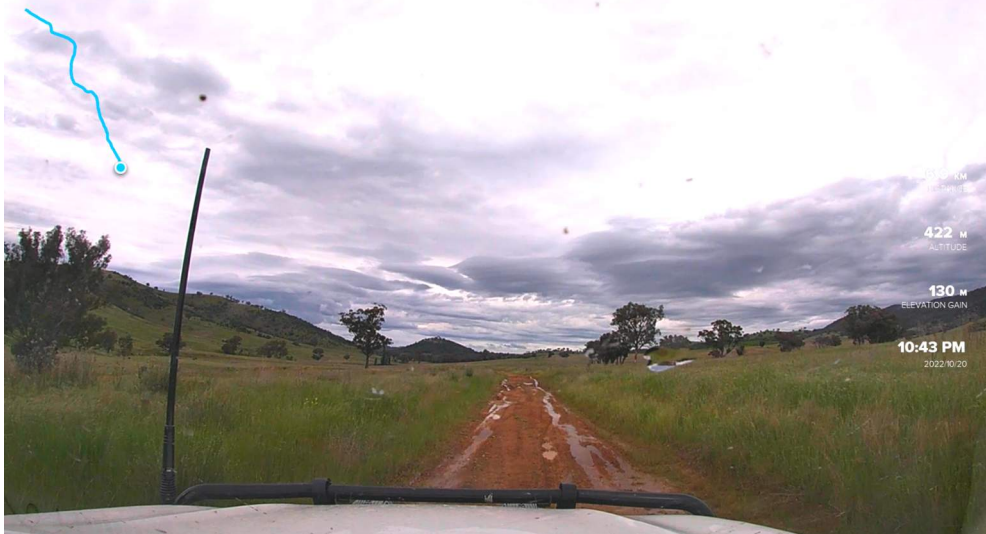
| Defect ID | Start Ch | End Ch | Defect Type (and side of road) | |
|---|---|---|---|---|
| 36.0 | 6700 | 7100 | Rutting (BS)<br>Drainage issue | |

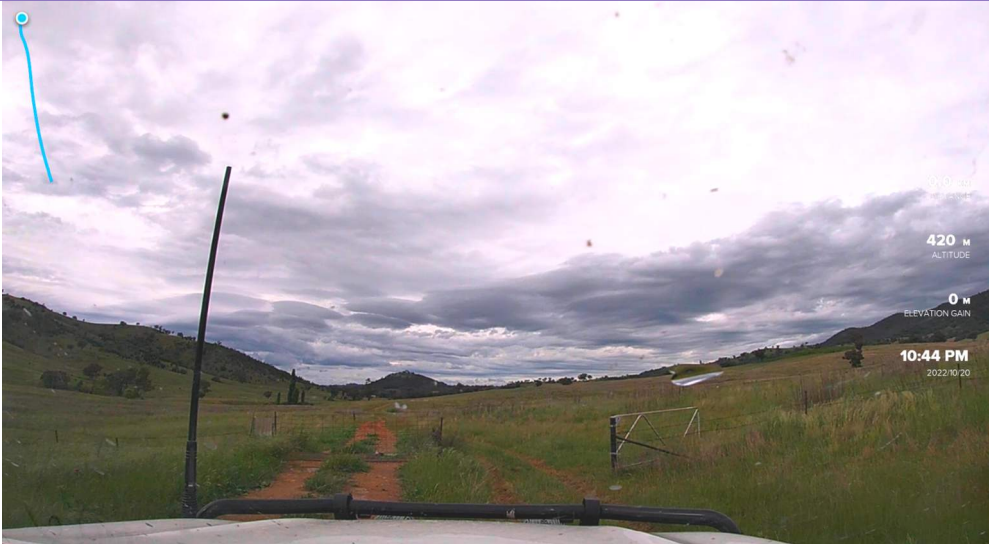
| Defect ID | Start Ch | End Ch | Defect Type (and side of road) | |
|---|---|---|---|---|
| 37.0 | 7100 | 7100 | Cattle grid (LHS)<br>Grass in the middle of the road | |
