**Hazardous Materials Risk Assessment**  
**Joss Group**  
**Berrima Correctional Centre**  
Argyle Street, Berrima NSW 2577

**Site Reference: BCC001**

**Our Reference: C106543 : J145125**

**Date: June 2016**

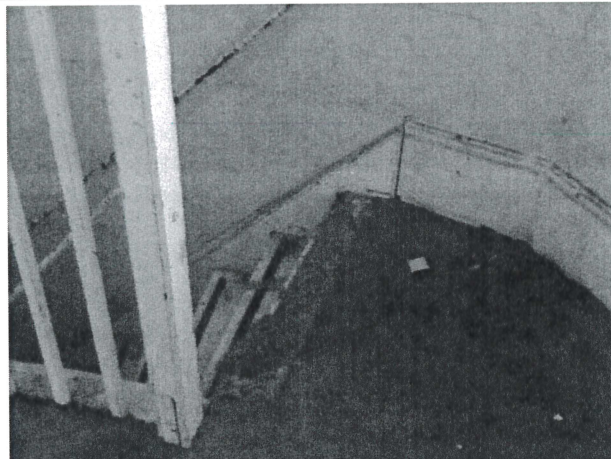
Photo No: J145125-BCC001-Photo002  
Result: Lead (Paint) - Previously Sampled Positive  
Building/Level: 001 Gatehouse -All Levels  
Room/Location: All rooms-Throughout  
Feature/Material: Timber Work-Lower Paint System/s

| Site Details | | | | Building Details | | | | | Audit Details | | | | | | | | |
|---|---|--|--|---|---|---|---|---|---|---|---|---|---|---|---|---|---|
| All rooms - Throughout Timber Work - Lower Paint System/s - White | | | | Lead (Paint) | Previously Sampled Envirolab<br>74021-001-LP02 | Previously Sampled Positive | J145125-BCC 001-Photo002 | 100 m² | Fair | | | | | | | Maintain in good condition and incorporate into a HMMP. Remove under controlled conditions prior to demolition or refurbishment. | |

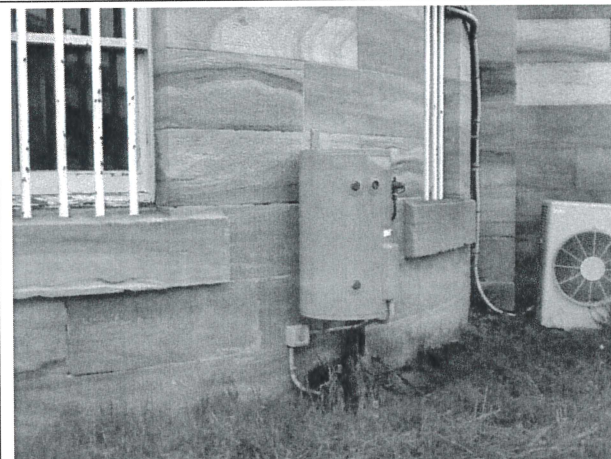
Photo No: J145125-BCC001-Photo005  
Result: SMF - Presumed Positive  
Building/Level: 001 Gatehouse -Ground Level  
Room/Location: Exterior-Southwest  
Feature/Material: Hot Water Heater-Insulation Material

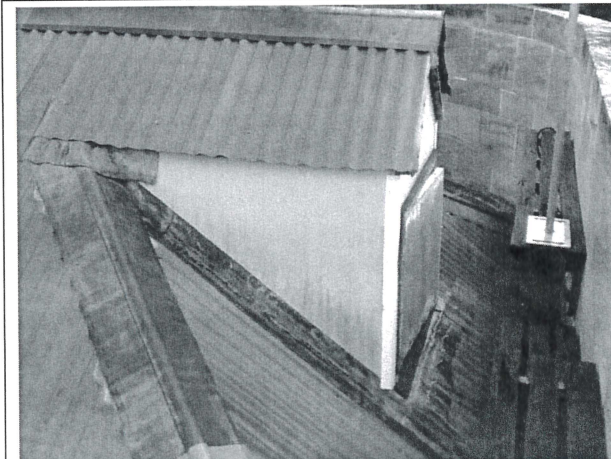
Photo No: J145125-BCC001-Photo001  
Result: Asbestos - Previously Sampled Positive  
Building/Level: 001 Gatehouse -Level Two  
Room/Location: Dormer Windows-Surrounding  
Feature/Material: Wall Covering-Fibre Cement Sheetting

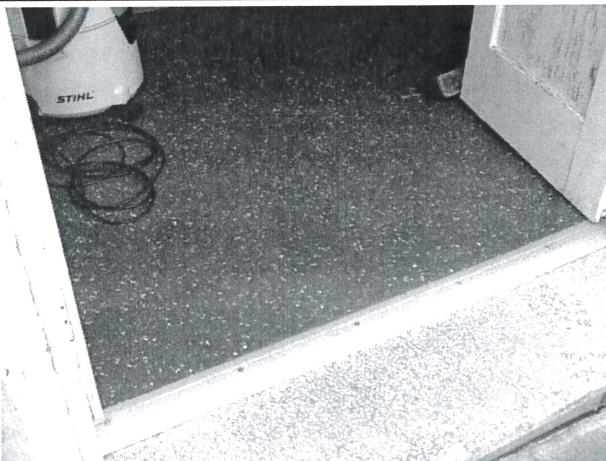
Photo No: J145125-BCC001-Photo022  
Result: Asbestos - Previously Sampled Positive  
Building/Level: 003 MDI/DEP GOV/BOX VISITS-Ground Level  
Room/Location: Entrance to Staff Room-Floor under carpet & linoleum  
Feature/Material: Floor-Fibre Cement Sheetting

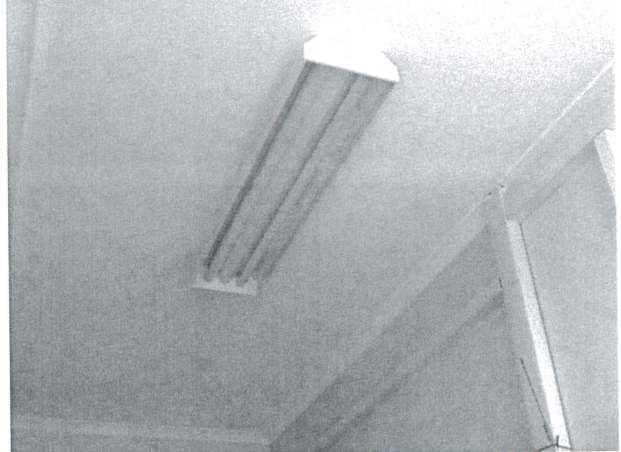
Photo No: J145125-BCC001-Photo018  
Result: PCB - Presumed Positive  
Building/Level: 003 MDI/DEP GOV/BOX VISITS-Ground Level  
Room/Location: Main Switchroom-Throughout  
Feature/Material: Fluorescent Light Fitting - Double Tube-Capacitor

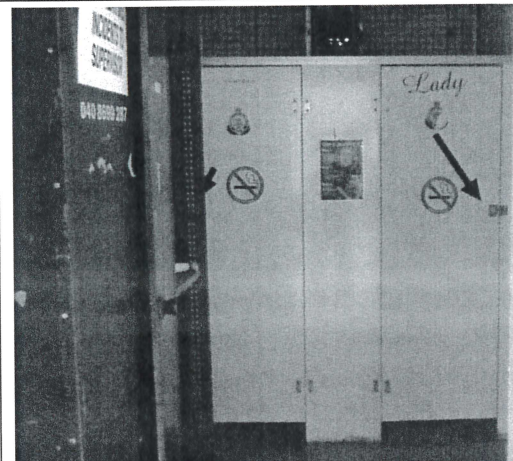
| Site Details | | | | Building Details | | | | Audit Details | | | |
|---|---|---|---|---|---|---|---|---|---|---|---|
| Inmate Toilet - Throughout Cubicle Partitions - Compressed Cement Sheeting | Previously Sampled NAA 74021-016-01 | Previously Sampled Positive | J145125-BCC 001-Photo037 | 6 m² | Good | Non Friable | Low | Low | Not Labelled | 02-06-2017 | P4 |

Photo No: J145125-BCC001-Photo037  
Result: Asbestos - Previously Sampled Positive  
Building/Level: 016 Industries Building-Ground Level  
Room/Location: Inmate Toilet-Throughout  
Feature/Material: Cubicle Partitions-Compressed Cement Sheetting

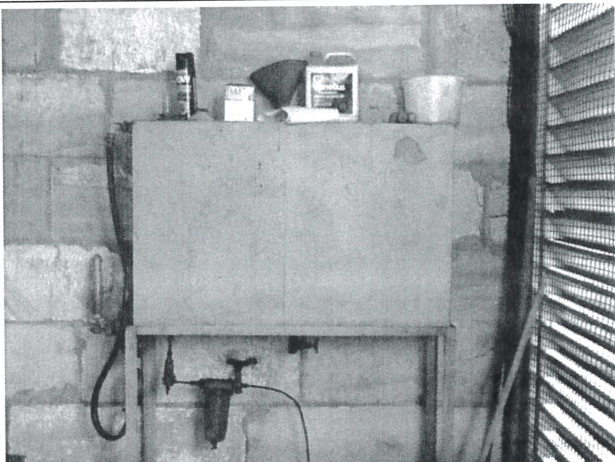
| Site Details | | | | Building Details | | | | | | Audit Details | | | | | |
|---|---|---|---|---|---|---|---|---|---|---|---|---|---|---|---|
| Diesel Room - Fuel Tank | Storage Tanks | Not Sampled | Presumed Positive | J145125-BCC 001-Photo042 | 1 Unit/s | Good | | | | | | | | | |

Photo No: J145125-BCC001-Photo042  
Result: Storage Tanks - Presumed Positive  
Building/Level: 031 Diesel Generator Room-Ground Level  
Room/Location: Diesel Room-Fuel Tank  
Feature/Material: Non-Hazardous Feature-Non-Hazardous Material

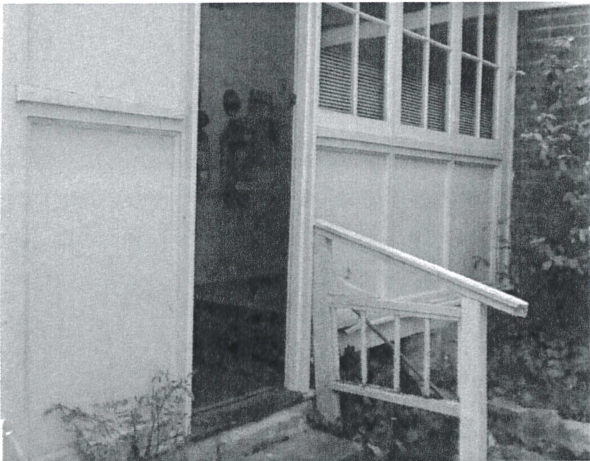
Photo No: J145125-BCC001-Photo105  
Result: Asbestos - Previously Sampled Positive  
Building/Level: 038 Admin/Governor-Ground Level  
Room/Location: West Side-Under Windows  
Feature/Material: Infill Panels - Low Level-Fibre Cement Sheetting

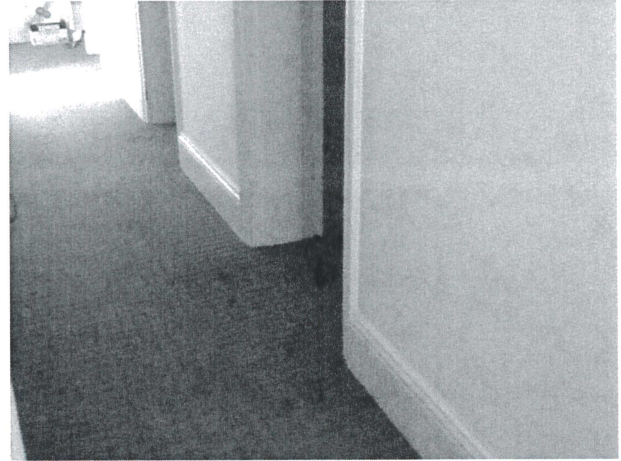
Photo No: J145125-BCC001-Photo088  
Result: Lead (Paint) - Previously Sampled Positive  
Building/Level: 038 Admin/Governor-Ground Level  
Room/Location: All rooms-Throughout  
Feature/Material: Timber Work-Lower Paint System/s

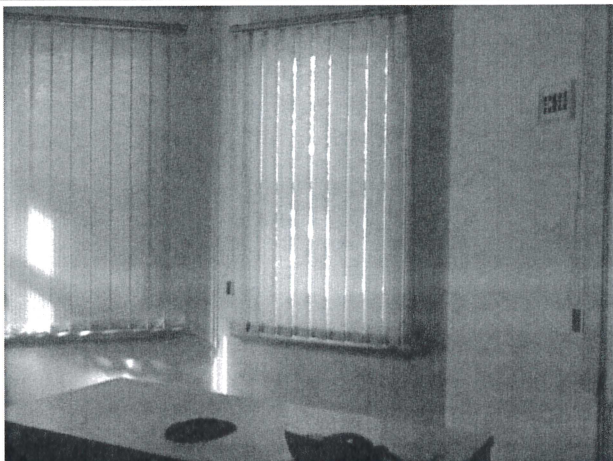
Photo No: J145125-BCC001-Photo090  
Result: Lead (Paint) - Previously Sampled Positive  
Building/Level: 038 Admin/Governor-Ground Level  
Room/Location: All rooms-Throughout  
Feature/Material: Window Frame-Lower Paint System/s

| Site Details | | | | Building Details | | | | Audit Details | | | | | | | | | | | | | |
|---|---|---|---|---|---|---|---|---|---|---|---|---|---|---|---|---|---|---|---|---|---|
| All rooms - Throughout | | Lead (Paint) | Previously Sampled 74021-038-LP03 | Previously Sampled Positive | J145125-BCC 001-Photo090 | 10 m² | Good | | | | | | | | | | | | | Maintain in good condition and incorporate into a HMMP. Remove under controlled conditions prior to demolition or refurbishment. | |

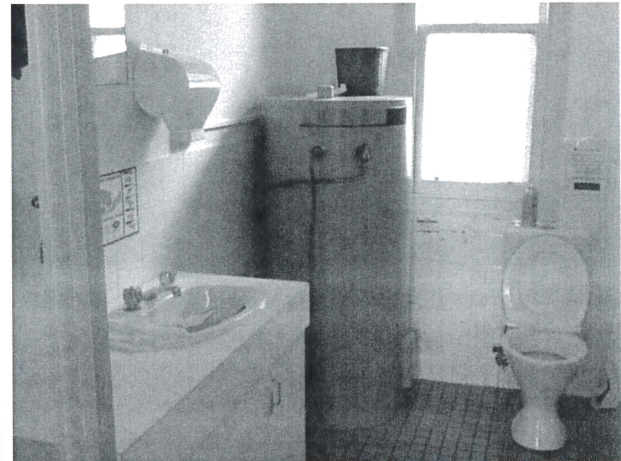
Photo No: J145125-BCC001-Photo093  
Result: SMF - Presumed Positive  
Building/Level: 038 Admin/Governor-Ground Level  
Room/Location: Bathroom-North  
Feature/Material: Hot Water Heater-Insulation Material

| Site Details | | | | Building Details | | | | Audit Details | | | | | | | | | | | | | |
|---|---|---|---|---|---|---|---|---|---|---|---|---|---|---|---|---|---|---|---|---|---|
| Bathroom - North | | SMF | | Presumed Positive | J145125-BCC 001-Photo093 | 1 Units | Good | Bonded (SMF) | | | | | | | | | | | | Maintain in good condition and incorporate into a HMMP. Remove under controlled conditions prior to demolition or refurbishment. | |

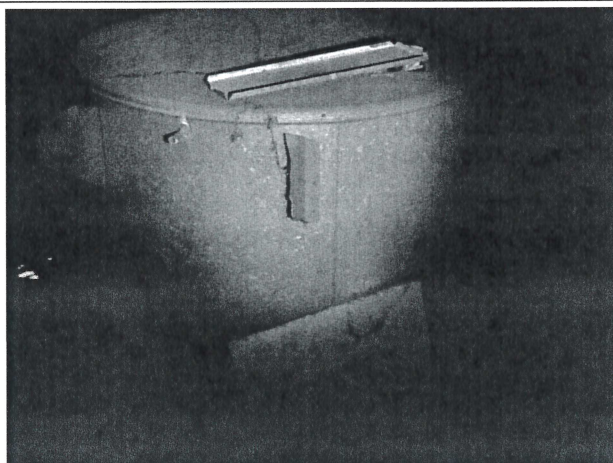
Photo No: J145125-BCC001-Photo099  
Result: SMF - Presumed Positive  
Building/Level: 038 Admin/Governor-Ground Level  
Room/Location: Ceiling Space-Old Water Heater  
Feature/Material: Hot Water Heater-Insulation Material

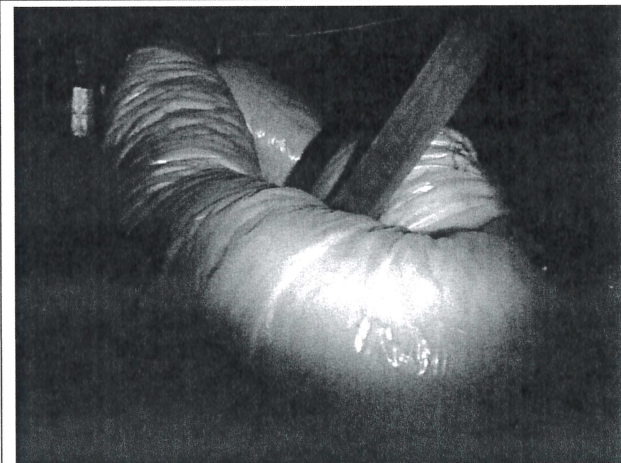
Photo No: J145125-BCC001-Photo096  
Result: SMF - Positive  
Building/Level: 038 Admin/Governor-Ground Level  
Room/Location: Ceiling Space-Throughout  
Feature/Material: Ductwork Insulation-Insulation Material

| Site Details | | | | Building Details | | | | Audit Details | | | | | | | | | | | | | |
|---|---|---|---|---|---|---|---|---|---|---|---|---|---|---|---|---|---|---|---|---|---|
| Ceiling Space - Throughout | | SMF | | Positive | J145125-BCC 001-Photo096 | 100 m | Good | Bonded (SMF) | | | | | | | | | | | | Maintain in good condition and incorporate into a HMMP. Remove under controlled conditions prior to demolition or refurbishment. | |

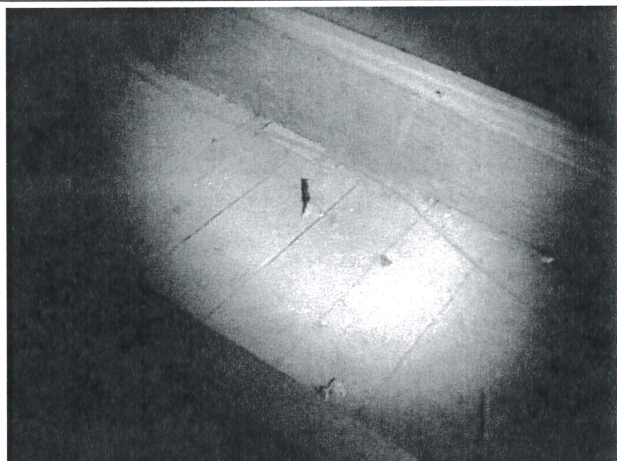
| Site Details | | | | | Building Details | | | | | Audit Details | | | | | |
|---|---|---|---|---|---|---|---|---|---|---|---|---|---|---|---|
| Ceiling Space - Throughout<br>On Top of Ceiling - Dust - Lead | Lead (Dust) | Previously Sampled<br>Envirolab<br>74021-038-LD02 | Previously Sampled<br>Positive | J145125-BCC<br>001-Photo098 | 200 m² | Poor | | | | | | | | All dust, dirt and sediment material with lead levels above the adopted standard (i.e. above 300mg/kg) should be removed under controlled conditions. | |

Photo No: J145125-BCC001-Photo098  
Result: Lead (Dust) - Previously Sampled Positive  
Building/Level: 038 Admin/Governor-Ground Level  
Room/Location: Ceiling Space-Throughout  
Feature/Material: On Top of Ceiling-Dust - Lead

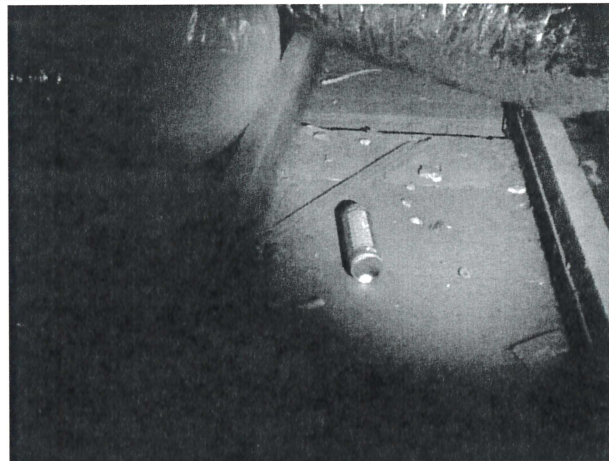
| Site Details | | | | | Building Details | | | | | Audit Details | | | | | |
|---|---|---|---|---|---|---|---|---|---|---|---|---|---|---|---|
| | | Previously Sampled<br>Envirolab<br>74021-038-LD01 | Previously Sampled<br>Positive | J145125-BCC<br>001-Photo097 | 100 m² | Poor | | | | | | | | All dust, dirt and sediment material with lead levels above the adopted standard (i.e. above 300mg/kg) should be removed under controlled conditions. | |

Photo No: J145125-BCC001-Photo097  
Result: Lead (Dust) - Previously Sampled Positive  
Building/Level: 038 Admin/Governor-Ground Level  
Room/Location: Ceiling Space-Throughout  
Feature/Material: On Top of Ceiling-Dust - Lead

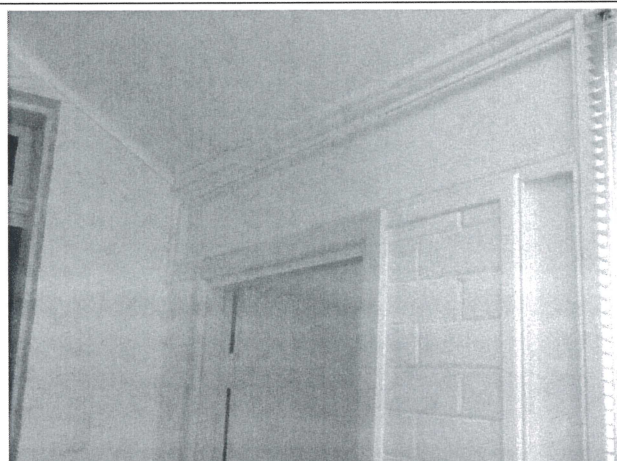
| Site Details | | | | | Building Details | | | | | Audit Details | | | | | |
|---|---|---|---|---|---|---|---|---|---|---|---|---|---|---|---|
| | | Previously Sampled<br>NAA<br>74021-038-07 | Previously Sampled<br>Positive | J145125-BCC<br>001-Photo102 | 6 m² | Good | Non Friable | Low | Low | Not Labelled | 02-06-2017 | P4 | Maintain in current condition, label and incorporate into a HMMP. Remove by licensed asbestos removal contractor prior to demolition or refurbishment. | | |

Photo No: J145125-BCC001-Photo102  
Result: Asbestos - Previously Sampled Positive  
Building/Level: 038 Admin/Governor-Ground Level  
Room/Location: South-west Corridor-South Wall  
Feature/Material: Wall Covering-Fibre Cement Sheetting

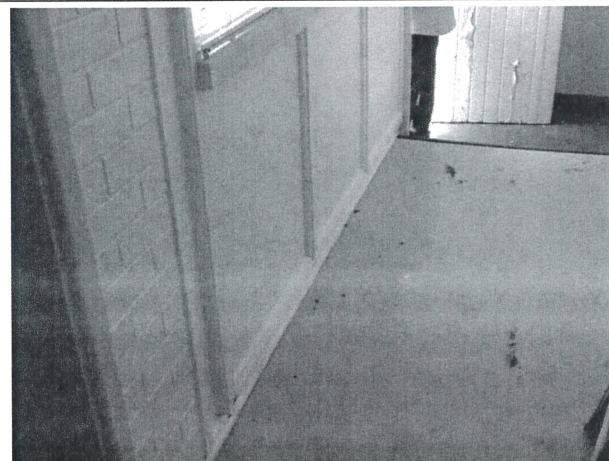
| Site Details | | | | | Building Details | | | | | Audit Details | | | | | |
|---|---|---|---|---|---|---|---|---|---|---|---|---|---|---|---|
| South-west Corridor - Under Windows<br>Infill Panels - Low Level - Fibre Cement Sheeting | Asbestos | Previously Sampled<br>NAA<br>74021-038-06 | Previously Sampled<br>Positive | J145125-BCC<br>001-Photo101 | 12 m² | Good | Non Friable | Low | Low | Low | Not Labelled | 02-06-2017 | P4 | Maintain in current condition, label and incorporate into a HMMP. Remove by licensed asbestos removal contractor prior to demolition or refurbishment. | |

Photo No: J145125-BCC001-Photo101  
Result: Asbestos - Previously Sampled Positive  
Building/Level: 038 Admin/Governor-Ground Level  
Room/Location: South-west Corridor-Under Windows  
Feature/Material: Infill Panels - Low Level-Fibre Cement Sheetting

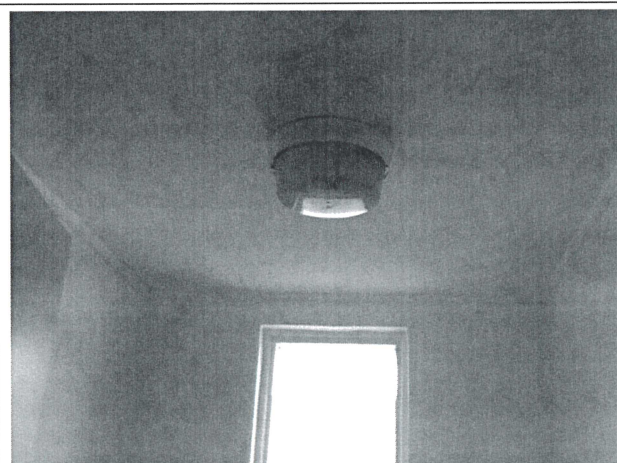
| Site Details | | | | | Building Details | | | | | Audit Details | | | | | |
|---|---|---|---|---|---|---|---|---|---|---|---|---|---|---|---|
| Toilet - South<br>Ceiling - Fibre Cement Sheeting | Asbestos | Previously Sampled<br>NAA<br>74021-038-02 | Previously Sampled<br>Positive | J145125-BCC<br>001-Photo103 | 6 m² | Good | Non Friable | Low | Low | Low | Not Labelled | 02-06-2017 | P4 | Maintain in current condition, label and incorporate into a HMMP. Remove by licensed asbestos removal contractor prior to demolition or refurbishment. | |

Photo No: J145125-BCC001-Photo103  
Result: Asbestos - Previously Sampled Positive  
Building/Level: 038 Admin/Governor-Ground Level  
Room/Location: Toilet-South  
Feature/Material: Ceiling-Fibre Cement Sheetting

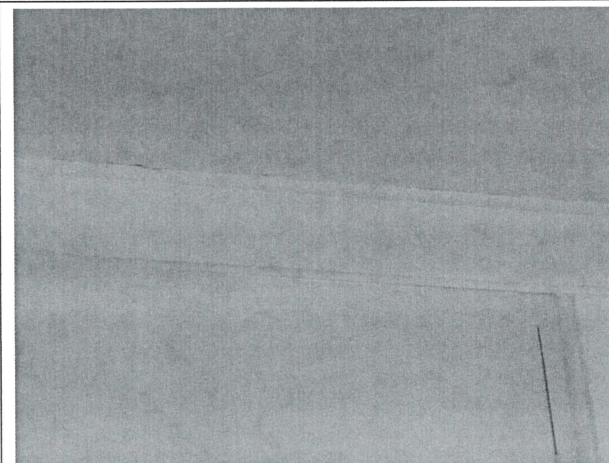
| Site Details | | | | | Building Details | | | | | Audit Details | | | | | |
|---|---|---|---|---|---|---|---|---|---|---|---|---|---|---|---|
| Toilet - South<br>Infill Panels - High Level - Fibre Cement Sheeting - Above door | Asbestos | Previously Sampled<br>NAA<br>74021-038-03 | Previously Sampled<br>Positive | J145125-BCC<br>001-Photo104 | 1 m² | Good | Non Friable | Low | Low | Low | Not Labelled | 02-06-2017 | P4 | Maintain in current condition, label and incorporate into a HMMP. Remove by licensed asbestos removal contractor prior to demolition or refurbishment. | |

Photo No: J145125-BCC001-Photo104  
Result: Asbestos - Previously Sampled Positive  
Building/Level: 038 Admin/Governor-Ground Level  
Room/Location: Toilet-South  
Feature/Material: Infill Panels - High Level-Fibre Cement Sheetting

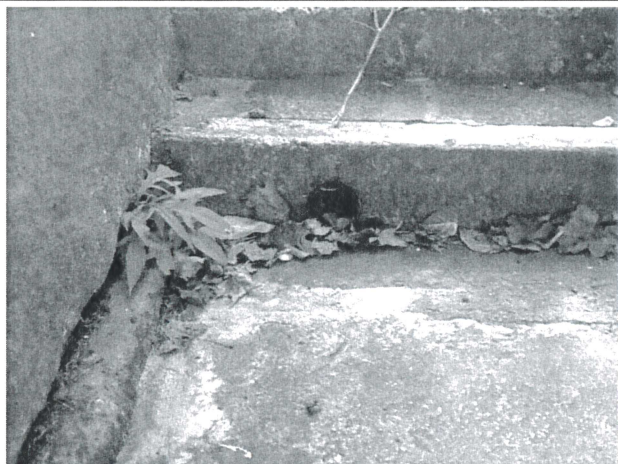
Photo No: J145125-BCC001-Photo068  
Result: Asbestos - Previously Sampled Positive  
Building/Level: 800 Outer Grounds-Ground Level  
Room/Location: Adjacent Main Entry-Buired under both sides of steps  
Feature/Material: Pipe-Moulded Fibre Cement

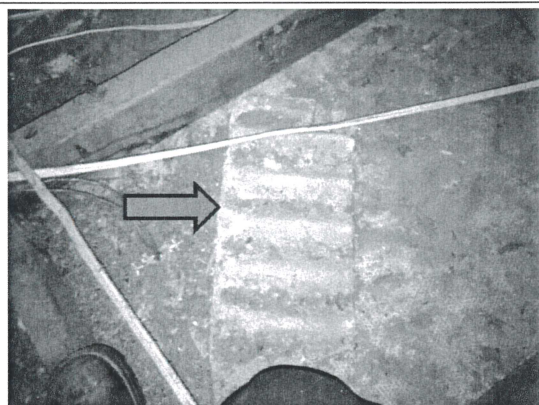
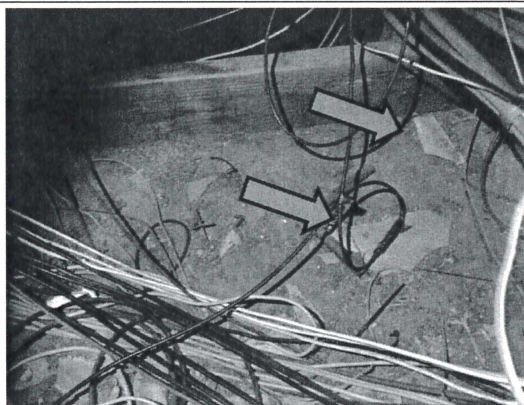
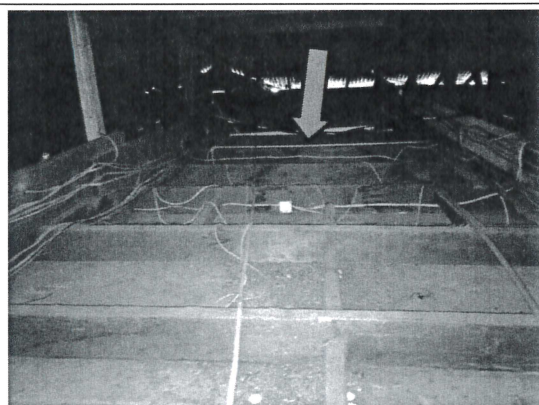
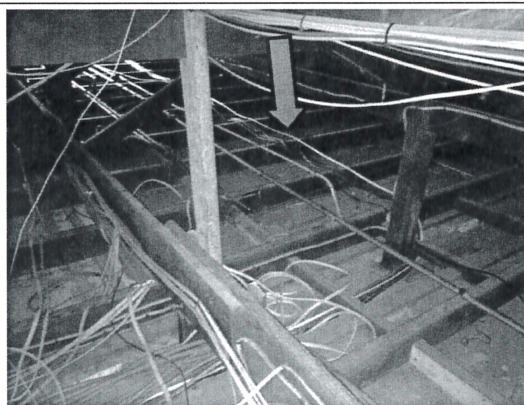
**Photo 1.** Block D, C & Sally Port, Fibre cement sheeting prior to removal works.

**Photo 2.** Block D, C & Sally Port, Fibre cement sheeting prior to removal works.

**Photo 3.** Block D, C & Sally Port, Fibre cement sheeting prior to removal works.

**Photo 4.** Block D, C & Sally Port, Fibre cement sheeting prior to removal works.

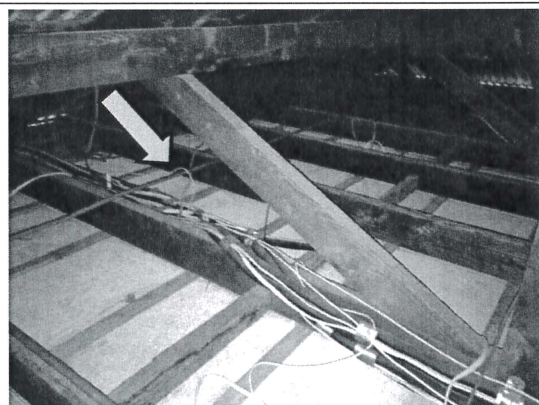
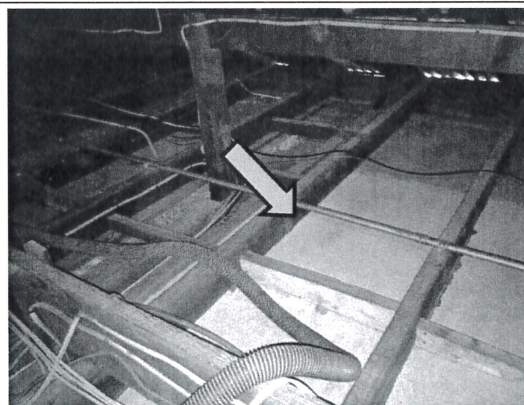
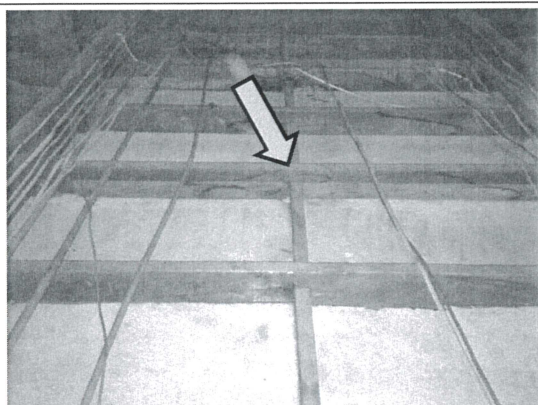
**Photo 5.** Block D, C & Sally Port, Ceiling space following removal works.

**Photo 6.** Block D, C & Sally Port, Ceiling space following removal works.

**Photo 7.** Block D, C & Sally Port, Ceiling space following removal works.

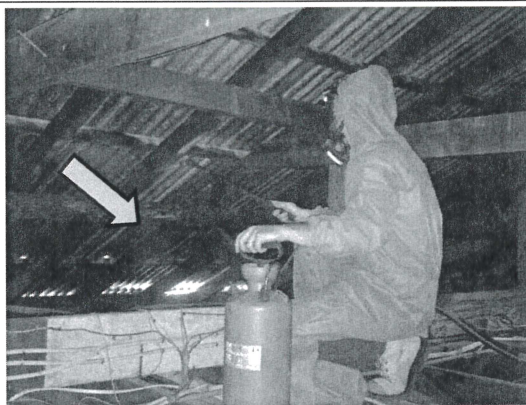
**Photo 8.** Block D, C & Sally Port, Ceiling space, Diluted PVA solution been applied following removal works.

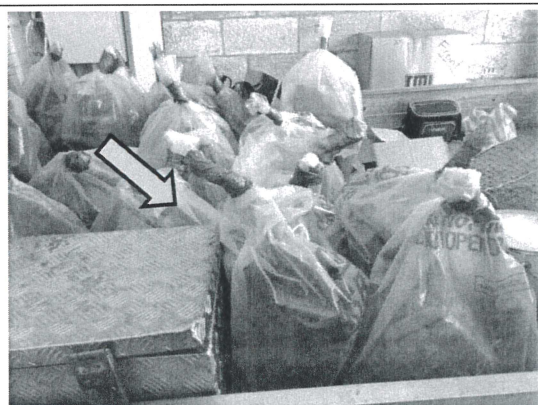
**Photo 9.** Asbestos waste material bagged in 200 µm thick plastic waste bags for removal from site.

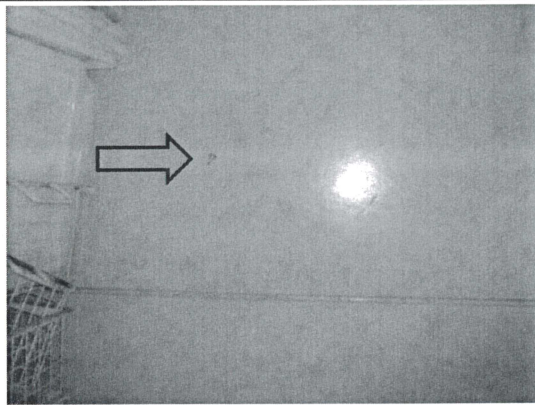
**Photo 1.** Building 012, Fibre cement sheeting prior to encapsulation works.

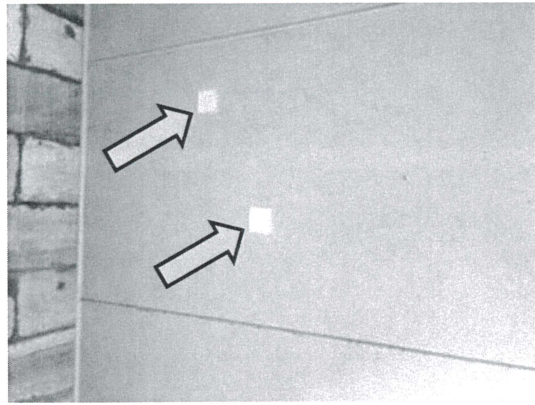
**Photo 2.** Building 012, Fibre cement sheeting following encapsulation works.

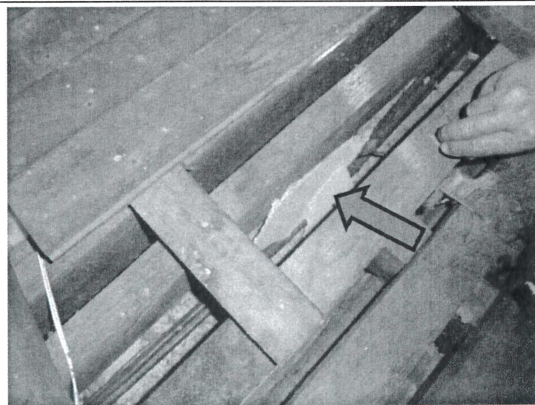
**Photo 3.** Building 013, Ceiling space, Debris, Prior to removal works.

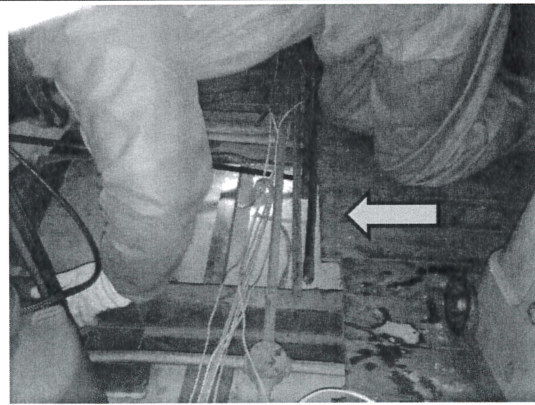
**Photo 4.** Building 013, Ceiling space, Asbestos removalist encapsulating exposed edges with paint during removal works.

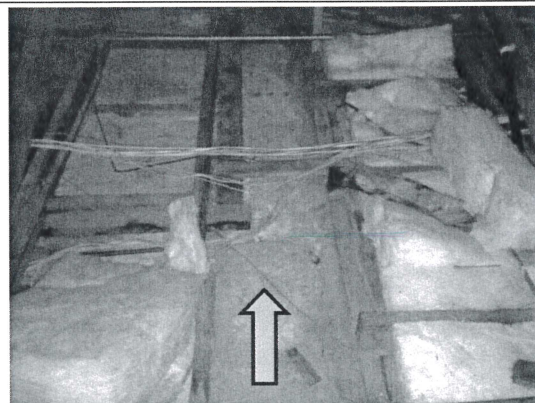
**Photo 5.** Building 013, Ceiling space, Following removal works.

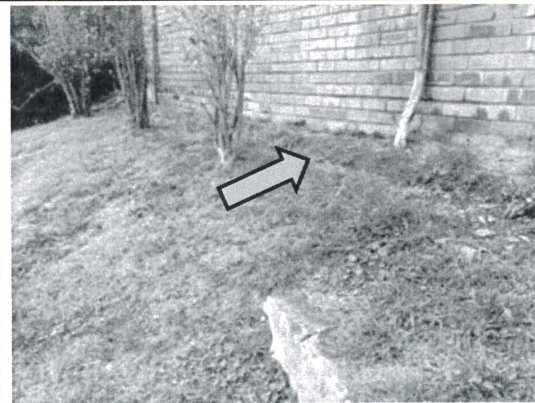
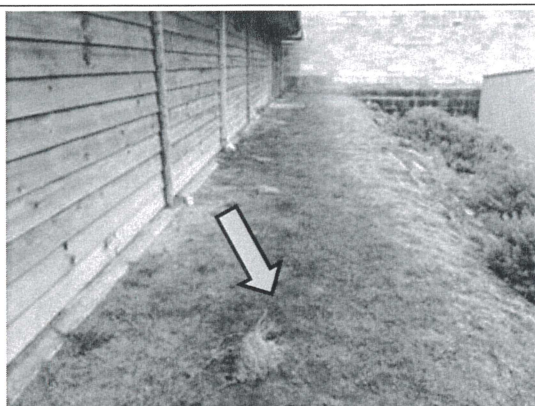
**Photo 6.** Building 016, Exterior, Western side, on ground, Debris prior to removal works.

**Photo 7.** Building 016, Exterior, Western side, on ground, Debris prior to removal works.

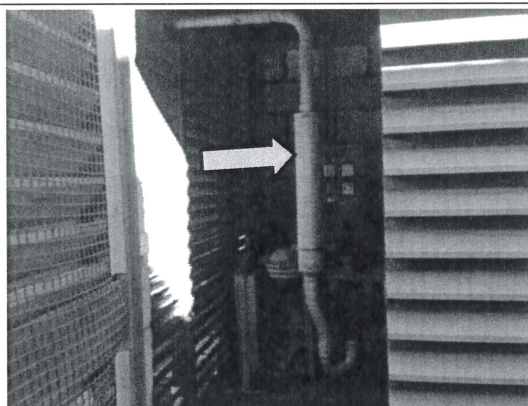
**Photo 8.** Building 031, Diesel generator exhaust pipe following encapsulation of woven rope.
