## JONES LANG LASALLE

# HAZARDOUS MATERIALS REINSPECTION 155 GEORGE STREET, SYDNEY, NSW 2000

**REFERENCE No. S6184**

**APRIL 2010**

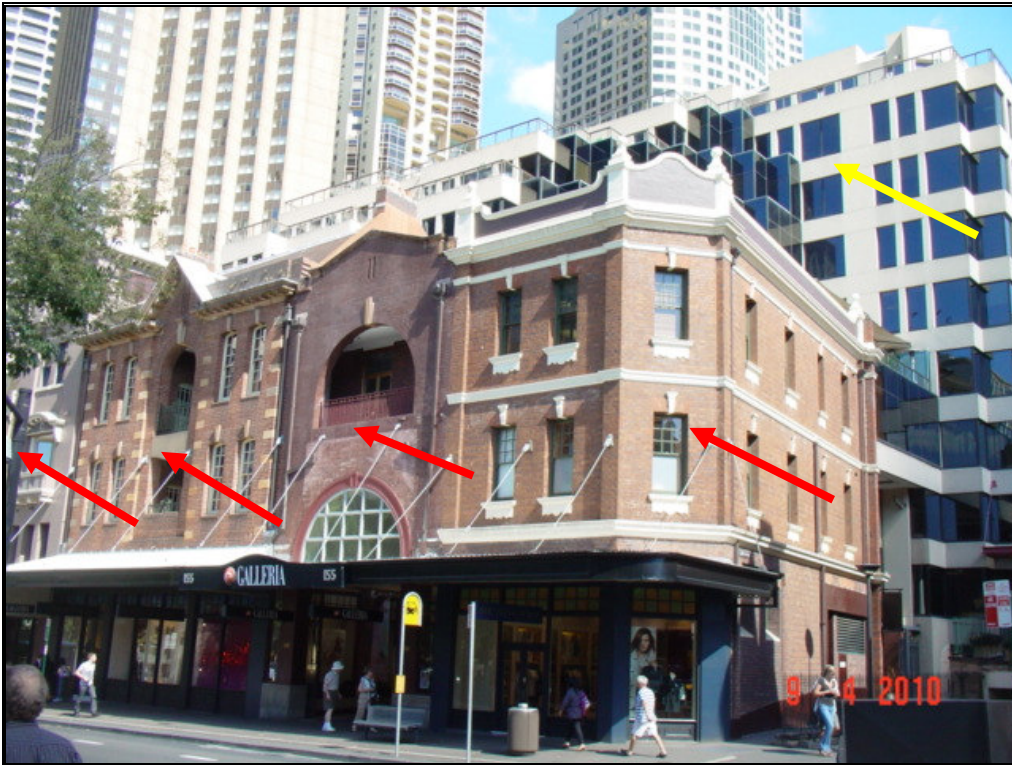
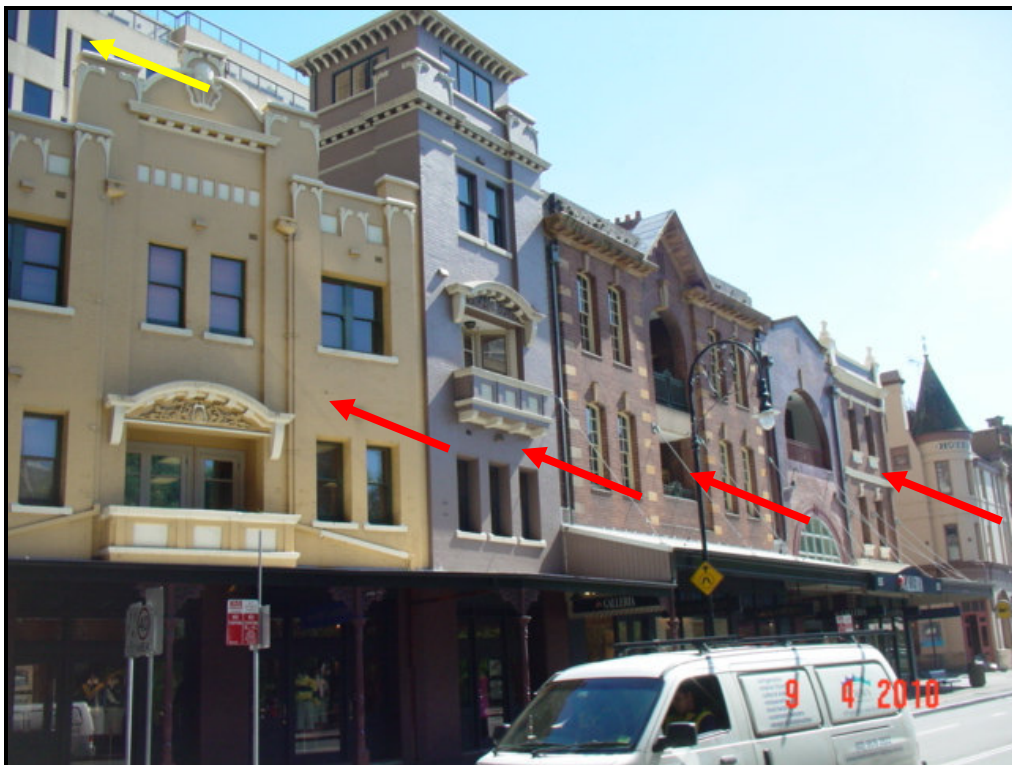
**Photographs 13 and 13.1**

Red arrows point to 'Terraces' building in foreground and yellow arrow points to ten-storey building in background.
