Asbestos Materials Survey

Prepared for:	Catholic Schools Broken Bay
Prepared by:	Alex Tam Senior Occupational Hygienist Trinitas Group
Site	St Peter's Catholic College, Tuggerah
Address:	84 Gavenlock Road, Tuggerah NSW 2259
Date:	Tuesday, 20 June 2023

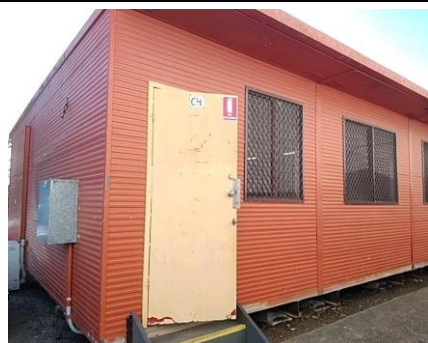
Client Name:	Catholic Schools Broken Bay	Property Number:	NA	Survey Date:	20/06/2023
Site Name:	St Peter's Catholic College, Tuggerah	Building Age:	N/A	Inspected By:	Alex Tam
Site Address:	84 Gavenlock Road, Tuggerah NSW 2259	Construction Type:	Metal	Building Size (m2):	30
Building Name:	Building C4	Roof Type:	Metal	No. Levels:	1

Item	Location	Level	Room-Specific Location	Hazard Type	Item description	Sample Reference	Sample Status	Photo No	Extent	Condition	Friability	Disturbance Potential	Risk Rating	Current Label	Control Priority	Control Recommendation
1	Interior	Ground Floor	Classroom - internal walls	Asbestos	Timber	NA	Negative	230620-095355								
2	Interior	Ground Floor	Classroom - ceiling	Asbestos	Plaster-like material	NA	Negative	230620-095403								
3	Exterior	Sub-floor	All elevation of the floor - packer to support column	Asbestos	FC sheeting	4221.01	Negative	230620-095652								
4	Exterior	Ground Floor	Western elevation of the building - electrical distribution board	Asbestos	Bituminous-like material	Nil - electrical hazards	Presumed Positive	230620-095900	1 unit	Good	Non-Friable	Low	Low	No	P4	P4 - No short term remediation works required. Review periodically and manage as part of an AMP
5	Exterior	Ground Floor	All elevation of the building - eaves	Asbestos	FC sheeting	Nil - safety concerns (uneven ground surface)	Presumed Positive	230620-095916	Through out	Good	Non-Friable	Low	Low	No	P4	P4 - No short term remediation works required. Review periodically and manage as part of an AMP

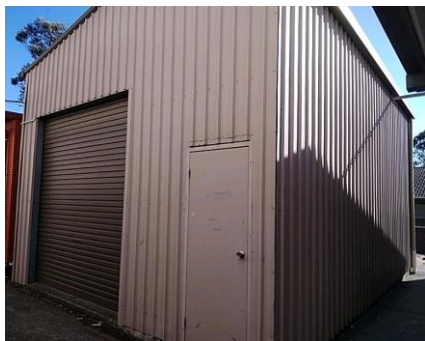
Client Name:	Catholic Schools Broken Bay	Property Number:	NA	Survey Date:	20/06/2023
Site Name:	St Peter's Catholic College, Tuggerah	Building Age:	N/A	Inspected By:	Alex Tam
Site Address:	84 Gavenlock Road, Tuggerah NSW 2259	Construction Type:	Metal	Building Size (m2):	45
Building Name:	Storage shed	Roof Type:	Metal	No. Levels:	1

Item	Location	Level	Room-Specific Location	Hazard Type	Item description	Sample Reference	Sample Status	Photo No	Extent	Condition	Friability	Disturbance Potential	Risk Rating	Current Label	Control Priority	Control Recommendation
nil asbestos identified.

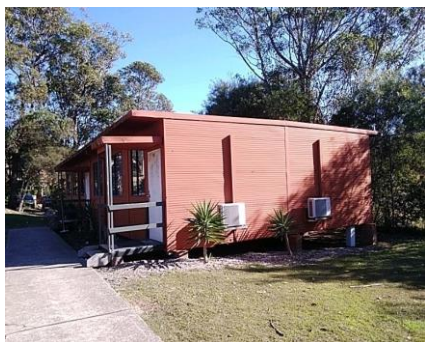
Client Name:	Catholic Schools Broken Bay	Property Number:	NA	Survey Date:	20/06/2023
Site Name:	St Peter's Catholic College, Tuggerah	Building Age:	N/A	Inspected By:	Alex Tam
Site Address:	84 Gavenlock Road, Tuggerah NSW 2259	Construction Type:	Metal	Building Size (m2):	170
Building Name:	Block D15	Roof Type:	Metal	No. Levels:	1

Item	Location	Level	Room-Specific Location	Hazard Type	Item description	Sample Reference	Sample Status	Photo No	Extent	Condition	Friability	Disturbance Potential	Risk Rating	Current Label	Control Priority	Control Recommendation
1	Interior	Ground Floor	All elevation of the floor - internal walls	Asbestos	Timber	NA	Negative	230620-100423								
2	Interior	Ground Floor	All elevation of the floor - ceilings	Asbestos	Plaster-like material	NA	Negative	230620-100435

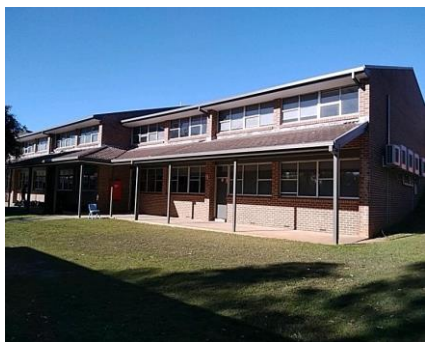
Client Name:	Catholic Schools Broken Bay	Property Number:	NA	Survey Date:	20/06/2023
Site Name:	St Peter's Catholic College, Tuggerah	Building Age:	N/A	Inspected By:	Alex Tam
Site Address:	84 Gavenlock Road, Tuggerah NSW 2259	Construction Type:	Brick	Building Size (m2):	850
Building Name:	Block D	Roof Type:	Tile	No. Levels:	2

Item	Location	Level	Room-Specific Location	Hazard Type	Item description	Sample Reference	Sample Status	Photo No	Extent	Condition	Friability	Disturbance Potential	Risk Rating	Current Label	Control Priority	Control Recommendation
1	Interior	Ground Floor	All elevation of the floor: classrooms - internal walls	Asbestos	Brick	NA	Presumed Positive	230620-100809	Through out	Good	Non-Friable	Low	Low	No	P4	P4 - No short term remediation works required. Review periodically and manage as part of an AMP
2	Interior	1st Floor	All elevation of the floor classroom - ceiling	Asbestos	Plaster-like material	NA	Negative	230620-100935								
3	Interior	1st Floor	All elevation of the floor - ceilings	Asbestos	Plaster-like material	NA	Presumed Positive	230620-100947	Through out	Good	Non-Friable	Low	Low	No	P4	P4 - No short term remediation works required. Review periodically and manage as part of an AMP
4	Interior	1st Floor	All elevation of the floor - division walls	Asbestos	Plaster-like material	NA	Negative	230620-101152

5	Interior	1st Floor	All elevation of the floor - infill panels to walls	Asbestos	Plaster-like material	NA	Negative	230620-102755								
6	Exterior	1st Floor	Corridor to courtyard	Asbestos	FC sheeting	4221.02	Negative	230620-102828								
7	Interior	Ground Floor	All elevation of the floor - internal walls	Asbestos	Brick	NA	Negative	230620-103050								
8	Interior	Ground Floor	All elevation of the floor - ceilings	Asbestos	Plaster-like material	NA	Negative	230620-103057

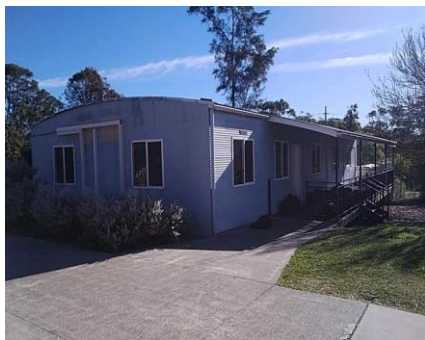
Client Name:	Catholic Schools Broken Bay	Property Number:	NA	Survey Date:	20/06/2023
Site Name:	St Peter's Catholic College, Tuggerah	Building Age:	N/A	Inspected By:	Alex Tam
Site Address:	84 Gavenlock Road, Tuggerah NSW 2259	Construction Type:	Metal	Building Size (m2):	190
Building Name:	House of Drama	Roof Type:	Metal	No. Levels:	1

Item	Location	Level	Room-Specific Location	Hazard Type	Item description	Sample Reference	Sample Status	Photo No	Extent	Condition	Friability	Disturbance Potential	Risk Rating	Current Label	Control Priority	Control Recommendation
1	Exterior	Ground Floor	Landing - flooring	Asbestos	FC sheeting	4221.03	Negative	230620-103753								
2	Interior	Ground Floor	All elevation of the floor - internal walls and ceiling	Asbestos	Timber	NA	Negative	230620-111633								
3	Interior	Ground Floor	Storage room - internal walls and ceiling	Asbestos	Timber	NA	Negative	230620-111753

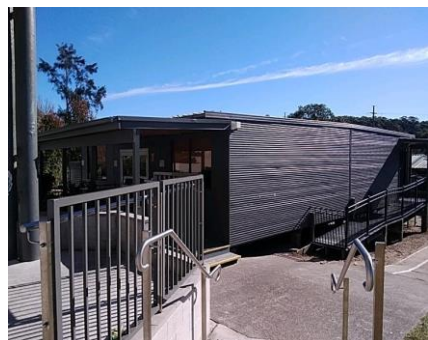
Client Name:	Catholic Schools Broken Bay	Property Number:	NA	Survey Date:	20/06/2023
Site Name:	St Peter's Catholic College, Tuggerah	Building Age:	N/A	Inspected By:	Alex Tam
Site Address:	84 Gavenlock Road, Tuggerah NSW 2259	Construction Type:	Metal	Building Size (m2):	120
Building Name:	Block F	Roof Type:	Metal	No. Levels:	1

Item	Location	Level	Room-Specific Location	Hazard Type	Item description	Sample Reference	Sample Status	Photo No	Extent	Condition	Friability	Disturbance Potential	Risk Rating	Current Label	Control Priority	Control Recommendation
1	Interior	Ground Floor	All elevation of the floor - internal walls and ceiling	Asbestos	Plaster-like material	NA	Negative	230620-104331								
2	Exterior	Ground Floor	All elevation of the building - eaves	Asbestos	FC sheeting	Nil - height restrictions	Presumed Positive	230620-104559	Through out	Good	Non-Friable	Low	Low	No	P4	P4 - No short term remediation works required. Review periodically and manage as part of an AMP

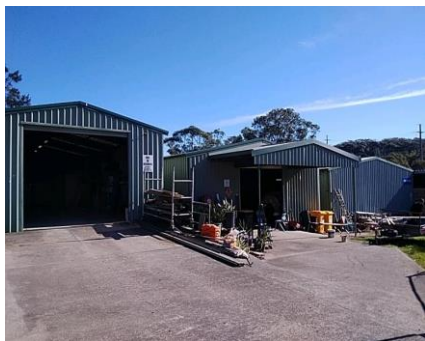
Client Name:	Catholic Schools Broken Bay	Property Number:	NA	Survey Date:	20/06/2023
Site Name:	St Peter's Catholic College, Tuggerah	Building Age:	N/A	Inspected By:	Alex Tam
Site Address:	84 Gavenlock Road, Tuggerah NSW 2259	Construction Type:	Metal	Building Size (m2):	500
Building Name:	Maintenance sheds	Roof Type:	Metal	No. Levels:	1

Item	Location	Level	Room-Specific Location	Hazard Type	Item description	Sample Reference	Sample Status	Photo No	Extent	Condition	Friability	Disturbance Potential	Risk Rating	Current Label	Control Priority	Control Recommendation
1	Interior	Ground Floor	All elevation of the floor - division walls	Asbestos	Plaster-like material	NA	Negative	230620-104750								
2	Interior	Ground Floor	All elevation of the floor - walls	Asbestos	Plaster-like material	NA	Negative	230620-104931

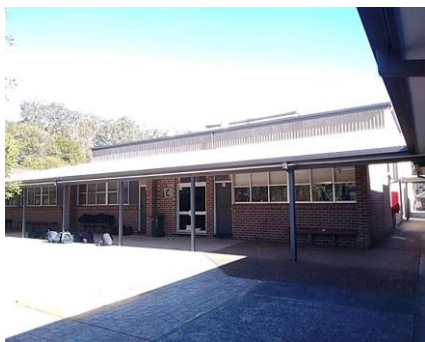
Client Name:	Catholic Schools Broken Bay	Property Number:	NA	Survey Date:	20/06/2023
Site Name:	St Peter's Catholic College, Tuggerah	Building Age:	N/A	Inspected By:	Alex Tam
Site Address:	84 Gavenlock Road, Tuggerah NSW 2259	Construction Type:	Brick	Building Size (m2):	1200
Building Name:	Block C / Hall	Roof Type:	Metal	No. Levels:	2

Item	Location	Level	Room-Specific Location	Hazard Type	Item description	Sample Reference	Sample Status	Photo No	Extent	Condition	Friability	Disturbance Potential	Risk Rating	Current Label	Control Priority	Control Recommendation
1	Interior	Ground Floor	Hall - internal walls	Asbestos	FC sheeting	4221.04	Negative	230620-105529								
2	Interior	Ground Floor	Hall - internal ceilings	Asbestos	FC sheeting	Nil - height restrictions	Presumed Positive	230620-105805	Through out	Good	Non-Friable	Low	Low	No	P4	P4 - No short term remediation works required. Review periodically and manage as part of an AMP
3	Interior	1st Floor	All elevation of the floor - external walls	Asbestos	Plaster-like material	NA	Negative	230620-110003								
4	Interior	1st Floor	All elevation of the floor - internal walls and ceiling	Asbestos	Plaster-like material	NA	Negative	230620-110138								
5	Interior	Ground Floor	Electrical distribution cupboard - internal walls and ceiling	Asbestos	Brick	NA	Negative	230620-110332

6	Interior	Ground Floor	All elevation of the floor: classrooms - internal walls	Asbestos	Brick	NA	Negative	230620-110409								
7	Interior	Ground Floor	All elevation of the floor: classrooms - ceilings	Asbestos	Plaster-like material	NA	Negative	230626-003710

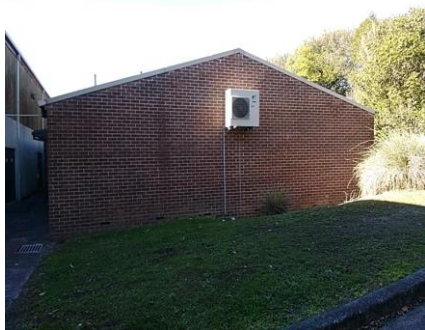
Client Name:	Catholic Schools Broken Bay	Property Number:	NA	Survey Date:	20/06/2023
Site Name:	St Peter's Catholic College, Tuggerah	Building Age:	N/A	Inspected By:	Alex Tam
Site Address:	84 Gavenlock Road, Tuggerah NSW 2259	Construction Type:	Brick	Building Size (m2):	840
Building Name:	Block B	Roof Type:	Tile	No. Levels:	1

Item	Location	Level	Room-Specific Location	Hazard Type	Item description	Sample Reference	Sample Status	Photo No	Extent	Condition	Friability	Disturbance Potential	Risk Rating	Current Label	Control Priority	Control Recommendation
1	Interior	Ground Floor	Walls	Asbestos	Plaster material	Nil	Negative	230620-110808								
2	Interior	Ground Floor	Ceilings	Asbestos	Plaster like material	Nil	Negative	230620-110822								
3	Interior	Ground Floor	Electrical box	Asbestos	Backing board, no access	Nil - encapsulated	Presumed Positive	230620-111158	1 unit	Good	Non-Friable	Low	Low	No	P4	P4 - No short term remediation works required. Review periodically and manage as part of an AMP

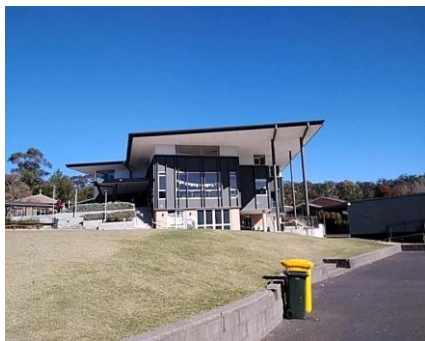
Client Name:	Catholic Schools Broken Bay	Property Number:	NA	Survey Date:	20/06/2023
Site Name:	St Peter's Catholic College, Tuggerah	Building Age:	N/A	Inspected By:	Alex Tam
Site Address:	84 Gavenlock Road, Tuggerah NSW 2259	Construction Type:	Brick	Building Size (m2):	1000
Building Name:	Library	Roof Type:	Metal	No. Levels:	3

Item	Location	Level	Room-Specific Location	Hazard Type	Item description	Sample Reference	Sample Status	Photo No	Extent	Condition	Friability	Disturbance Potential	Risk Rating	Current Label	Control Priority	Control Recommendation
1	Interior	Ground Floor	All elevation of the floor - division walls	Asbestos	Glass	NA	Negative	230620-112043								
2	Interior	Ground Floor	Storage area - walls	Asbestos	Concrete	NA	Negative	230620-112441								
3	Interior	Ground Floor	Storage area - ceilings	Asbestos	Concrete	NA	Negative	230620-112447								
4	Exterior	Ground Floor	All elevation of the floor - eaves	Asbestos	FC sheeting		Negative	230620-112646								
5	Interior	Roof	All elevation of 1st and roof - eaves	Asbestos	FC sheeting		Negative	230620-112721								
6	Interior	1st Floor	All elevation of the floor - internal walls and ceilings	Asbestos	Plaster-like material	NA	Negative	230620-112929								
7	Interior	1st Floor	All elevation of the floor - division walls and walls	Asbestos	Plaster-like material	NA	Negative	230620-113155

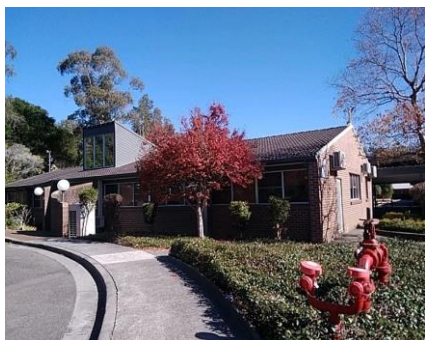
Client Name:	Catholic Schools Broken Bay	Property Number:	N/A	Survey Date:	20/06/2023
Site Name:	St Peter's Catholic College, Tuggerah	Building Age:	N/A	Inspected By:	Alex Tam
Site Address:	84 Gavenlock Road, Tuggerah NSW 2259	Construction Type:	Brick	Building Size (m2):	200
Building Name:	Reception	Roof Type:	Tile	No. Levels:	1

Item	Location	Level	Room-Specific Location	Hazard Type	Item description	Sample Reference	Sample Status	Photo No	Extent	Condition	Friability	Disturbance Potential	Risk Rating	Current Label	Control Priority	Control Recommendation
1	Interior	Ground Floor	All elevation of the floor: classrooms - internal walls	Asbestos	Brick	NA	Negative	230620-113529								
2	Interior	Ground Floor	All elevation of the floor - division walls	Asbestos	Plaster-like material	NA	Negative	230620-113538								
3	Interior	Ground Floor	Northern kitchen - internal walls	Asbestos	Plaster-like material	NA	Negative	230620-113613								
5	Interior	Ground Floor	Male toilet - urinal	Asbestos	Internal insulation	Nil - encapsulated	Presumed Positive	230620-113804	1 unit	Good	Non-Friable	Low	Low	No	P4	P4 - No short term remediation works required. Review periodically and manage as part of an AMP
6	Interior	Ground Floor	Staff male toilet - internal walls	Asbestos	FC sheeting	4221.05	Negative	230620-114124

7	Interior	Ground Floor	Disabled toilet - internal walls	Asbestos	FC sheeting	Similar to 4221.05	Presumed Negative	230620-114225								
8	Interior	Ground Floor	Staff female toilet - internal walls	Asbestos	FC sheeting	Similar to 4221.05	Presumed Negative	230620-114419								
9	Interior	Ground Floor	Electrical distribution cupboard - internal walls	Asbestos	FC sheeting	4221.06	Negative	230620-114519								
10	Interior	Ground Floor	Staff kitchen - internal walls	Asbestos	FC sheeting	Similar to 4221.05	Presumed Negative	230620-114834

Item	Location	Level	Room-Specific Location	Hazard Type	Item description	Sample Reference	Sample Status	Photo No	Extent	Condition	Friability	Disturbance Potential	Risk Rating	Current Label	Control Priority	Control Recommendation
11	Exterior	Ground Floor	All elevation of the building - eaves	Asbestos	FC sheeting	NA	Negative	230620-115055

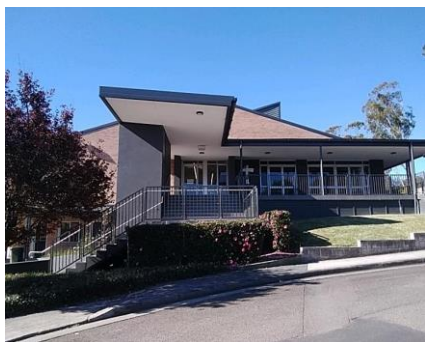
Client Name:	Catholic Schools Broken Bay	Property Number:	NA	Survey Date:	20/06/2023
Site Name:	St Peter's Catholic College, Tuggerah	Building Age:	N/A	Inspected By:	Alex Tam
Site Address:	84 Gavenlock Road, Tuggerah NSW 2259	Construction Type:	Brick	Building Size (m2):	1050
Building Name:	Theatre / Chapel	Roof Type:	Tile	No. Levels:	2

Item	Location	Level	Room-Specific Location	Hazard Type	Item description	Sample Reference	Sample Status	Photo No	Extent	Condition	Friability	Disturbance Potential	Risk Rating	Current Label	Control Priority	Control Recommendation
1	Interior	Ground Floor	All elevation of the floor - internal walls	Asbestos	Brick	NA	Negative	230620-115321								
3	Interior	Ground Floor	Male toilet - urinal	Asbestos	Internal insulation	Nil - encapsulated	Presumed Positive	230620-115548	1 unit	Good	Non-Friable	Low	Low	No	P4	P4 - No short term remediation works required. Review periodically and manage as part of an AMP
4	Interior	1st Floor	Canteen storage area - internal walls	Asbestos	FC sheeting	4221.07	Negative	230620-120214								
5	Interior	Ground Floor	All elevation of the floor - internal walls	Asbestos	Plaster-like material	NA	Negative	230620-120450								
6	Interior	Ground Floor	All elevation of the floor - ceilings	Asbestos	Plaster-like material	NA	Negative	230620-120518

7	Interior	Ground Floor	Canteen - internal walls	Asbestos	Brick	NA	Negative	230620-120542								
9	Interior	1st Floor	All elevation of the floor - internal walls and ceilings	Asbestos	Plaster-like material	NA	Negative	230621-093859								
10	Interior	1st Floor	Scarcity - safe	Asbestos	Internal insulation	Nil - encapsulated	Presumed Positive	230621-093922	1 unit	Good	Non-Friable	Low	Low	No	P4	P4 - No short term remediation works required. Review periodically and manage as part of an AMP

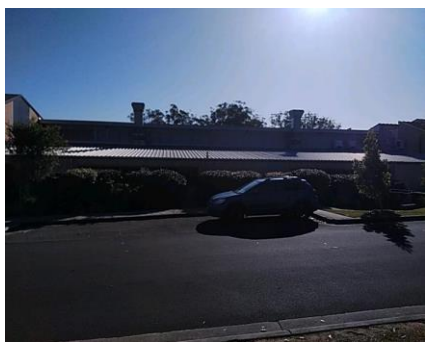
Client Name:	Catholic Schools Broken Bay	Property Number:	NA	Survey Date:	20/06/2023
Site Name:	St Peter's Catholic College, Tuggerah	Building Age:	N/A	Inspected By:	Alex Tam
Site Address:	84 Gavenlock Road, Tuggerah NSW 2259	Construction Type:	Brick	Building Size (m2):	680
Building Name:	Trade training centre	Roof Type:	Tile	No. Levels:	2

Item	Location	Level	Room-Specific Location	Hazard Type	Item description	Sample Reference	Sample Status	Photo No	Extent	Condition	Friability	Disturbance Potential	Risk Rating	Current Label	Control Priority	Control Recommendation
1	Interior	1st Floor	All elevation of the floor - division walls	Asbestos	Plaster-like material	NA	Negative	230620-121101								
2	Exterior	1st Floor	Deck - internal walls and ceiling	Asbestos	Plaster-like material	NA	Negative	230620-121137								
3	Interior	1st Floor	All elevation of the floor: offices - internal walls and ceiling	Asbestos	Plaster-like material	NA	Negative	230620-121230								
4	Interior	1st Floor	Electrical distribution cupboard - internal walls	Asbestos	Plaster-like material	NA	Negative	230620-121337								
5	Interior	1st Floor	Laundry - internal walls and ceiling	Asbestos	Plaster-like material	NA	Negative	230620-121421

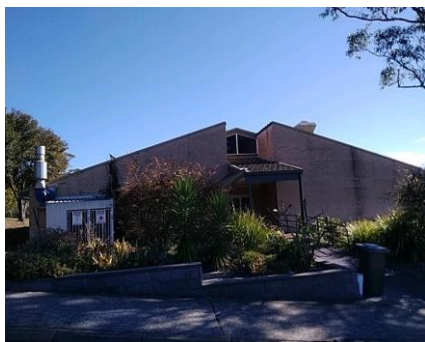
Client Name:	Catholic Schools Broken Bay	Property Number:	NA	Survey Date:	20/06/2023
Site Name:	St Peter's Catholic College, Tuggerah	Building Age:	N/A	Inspected By:	Alex Tam
Site Address:	84 Gavenlock Road, Tuggerah NSW 2259	Construction Type:	Brick	Building Size (m2):	680
Building Name:	Block M	Roof Type:	Tile	No. Levels:	3

Item	Location	Level	Room-Specific Location	Hazard Type	Item description	Sample Reference	Sample Status	Photo No	Extent	Condition	Friability	Disturbance Potential	Risk Rating	Current Label	Control Priority	Control Recommendation
1	Interior	1st Floor	All elevation of the floor - walls	Asbestos	Brick	NA	Negative	230620-121824								
2	Interior	2nd Floor	All elevation of the floor - internal walls	Asbestos	Timber	NA	Negative	230620-121941								
3	Interior	2nd Floor	All elevation of the floor - ceilings	Asbestos	Plaster-like material	NA	Negative	230620-122029								
4	Exterior	1st Floor	Southern entrance - eaves	Asbestos	FC sheeting	Nil - safety concerns	Presumed Positive	230620-122229	Through out	Good	Non-Friable	Low	Low	No	P4	P4 - No short term remediation works required. Review periodically and manage as part of an AMP
5	Interior	Ground Floor	All elevation of the floor: offices - internal walls	Asbestos	Brick	NA	Negative	230620-122402

6	Interior	Ground Floor	All elevation of the floor - ceilings	Asbestos	Plaster-like material	NA	Negative	230620-122523

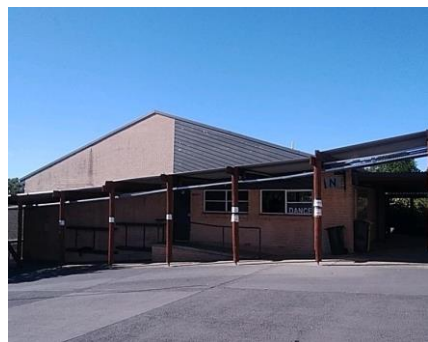
Client Name:	Catholic Schools Broken Bay	Property Number:	NA	Survey Date:	20/06/2023
Site Name:	St Peter's Catholic College, Tuggerah	Building Age:	N/A	Inspected By:	Alex Tam
Site Address:	84 Gavenlock Road, Tuggerah NSW 2259	Construction Type:	Brick	Building Size (m2):	560
Building Name:	Block N	Roof Type:	Tile	No. Levels:	1

Item	Location	Level	Room-Specific Location	Hazard Type	Item description	Sample Reference	Sample Status	Photo No	Extent	Condition	Friability	Disturbance Potential	Risk Rating	Current Label	Control Priority	Control Recommendation
1	Interior	Ground Floor	roof gables	Asbestos	FC sheeting	4221.08	Negative	230620-122759

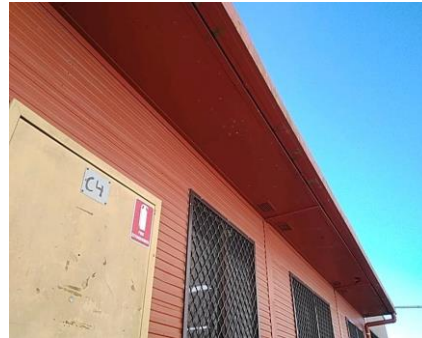
Photo No: 230620-095916
Result: Asbestos - Presumed Positive
Location-Level: Exterior - Ground Floor
Room-Location: All elevation of the building - eaves
Feature-Material: FC sheeting
Item No - Risk Rating: 5 - Low

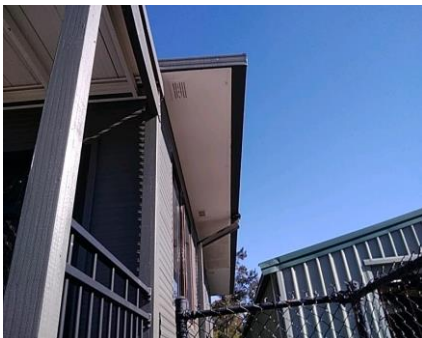
Photo No: 230620-104559
Result: Asbestos - Presumed Positive
Location-Level: Exterior - Ground Floor
Room-Location: All elevation of the building - eaves
Feature-Material: FC sheeting
Item No - Risk Rating: 2 - Low

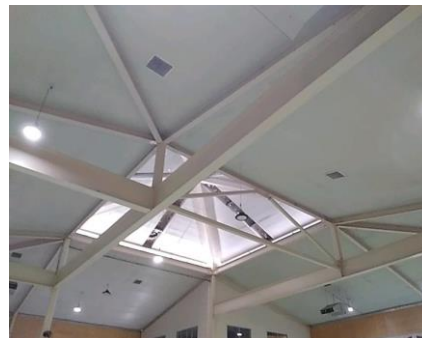
Photo No: 230620-105805
Result: Asbestos - Presumed Positive
Location-Level: Interior - Ground Floor
Room-Location: Hall - internal ceilings
Feature-Material: FC sheeting
Item No - Risk Rating: 2 - Low

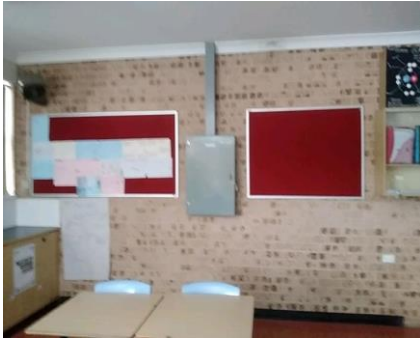
Photo No: 230620-111158
Result: Asbestos - Presumed Positive
Location-Level: Interior - Ground Floor
Room-Location: Electrical box
Feature-Material: Backing board, no access
Item No - Risk Rating: 3 - Low

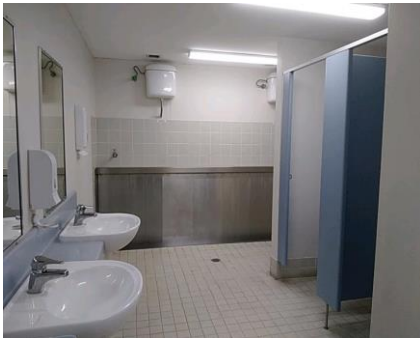
Photo No: 230620-115548
Result: Asbestos - Presumed Positive
Location-Level: Interior - Ground Floor
Room-Location: Male toilet - urinal
Feature-Material: Internal insulation
Item No - Risk Rating: 3 - Low

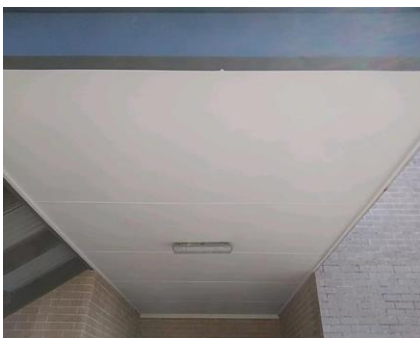
Photo No: 230620-122229
Result: Asbestos - Presumed Positive
Location-Level: Exterior - 1st Floor
Room-Location: Southern entrance - eaves
Feature-Material: FC sheeting
Item No - Risk Rating: 4 - Low

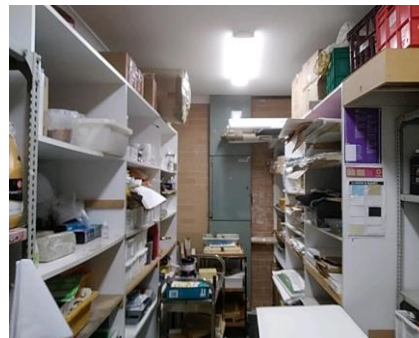
Photo No: 230620-125406
Result: Asbestos - Presumed Positive
Location-Level: Interior - 1st Floor
Room-Location: Electrical distribution cupboard
Feature-Material: Internal insulation
Item No - Risk Rating: 3 - Low

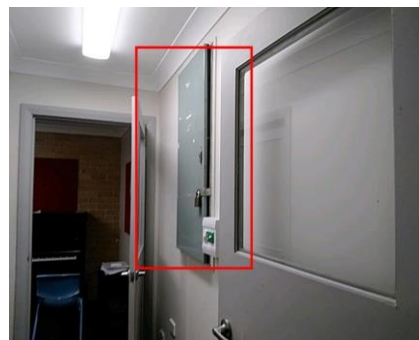
Photo No: 230621-102730
Result: Asbestos - Presumed Positive
Location-Level: Interior - Ground Floor
Room-Location: Electrical distribution cupboard
Feature-Material: Internal insulation
Item No - Risk Rating: 2 - Low

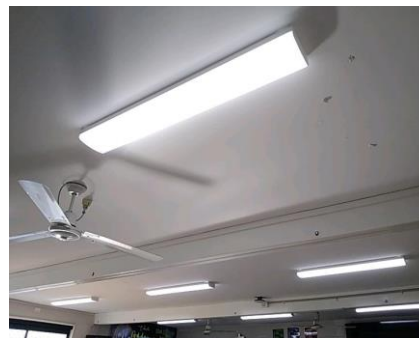
Photo No: 230620-095403
Result: Asbestos - Negative
Location-Level: Interior - Ground Floor
Room-Location: Classroom - ceiling
Feature-Material: Plaster-like material

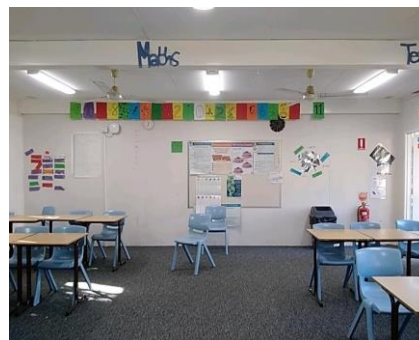
Photo No: 230620-100423
Result: Asbestos - Negative
Location-Level: Interior - Ground Floor
Room-Location: All elevation of the floor - internal walls
Feature-Material: Timber

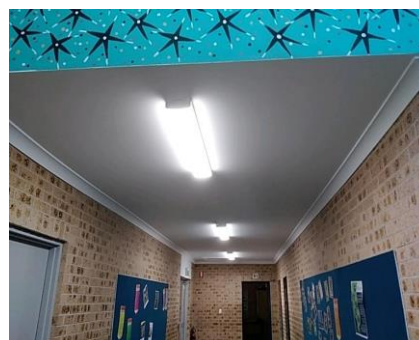
Photo No: 230620-100935
Result: Asbestos - Negative
Location-Level: Interior - 1st Floor
Room-Location: All elevation of the floor classroom - ceiling
Feature-Material: Plaster-like material

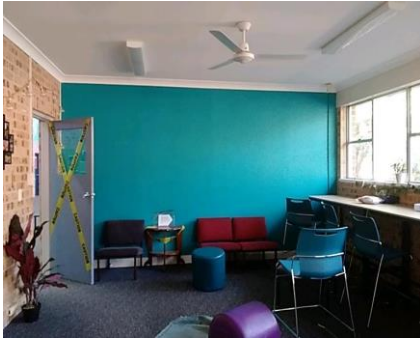
Photo No: 230620-101152
Result: Asbestos - Negative
Location-Level: Interior - 1st Floor
Room-Location: All elevation of the floor - division walls
Feature-Material: Plaster-like material

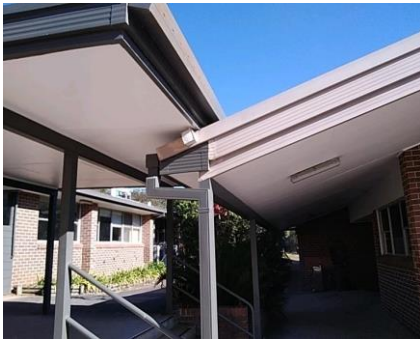
Photo No: 230620-102828
Result: Asbestos - Negative
Location-Level: Exterior - 1st Floor
Room-Location: Corridor to courtyard
Feature-Material: FC sheeting

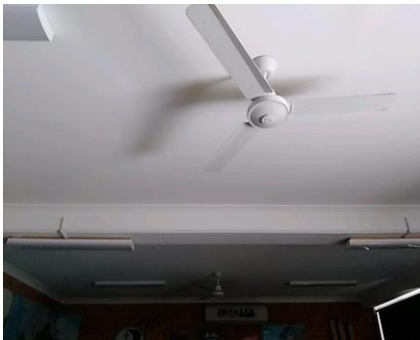
Photo No: 230620-103057
Result: Asbestos - Negative
Location-Level: Interior - Ground Floor
Room-Location: All elevation of the floor - ceilings
Feature-Material: Plaster-like material

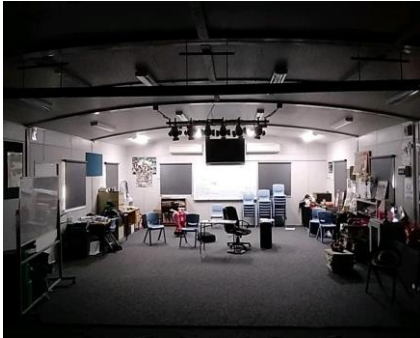
Photo No: 230620-111633
Result: Asbestos - Negative
Location-Level: Interior - Ground Floor
Room-Location: All elevation of the floor - internal walls and ceiling
Feature-Material: Timber

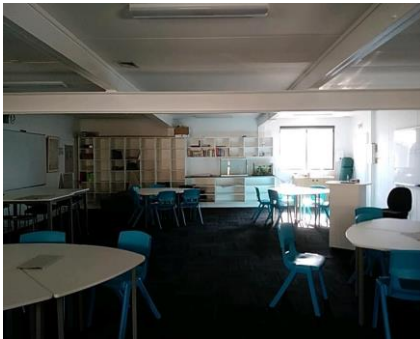
Photo No: 230620-104331
Result: Asbestos - Negative
Location-Level: Interior - Ground Floor
Room-Location: All elevation of the floor - internal walls and ceiling
Feature-Material: Plaster-like material

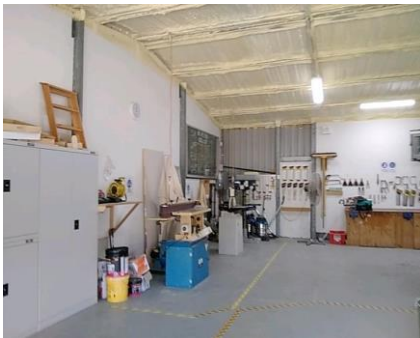
Photo No: 230620-104931
Result: Asbestos - Negative
Location-Level: Interior - Ground Floor
Room-Location: All elevation of the floor - walls
Feature-Material: Plaster-like material

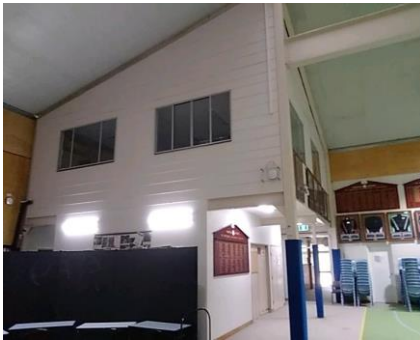
Photo No: 230620-110003
Result: Asbestos - Negative
Location-Level: Interior - 1st Floor
Room-Location: All elevation of the floor - external walls
Feature-Material: Plaster-like material

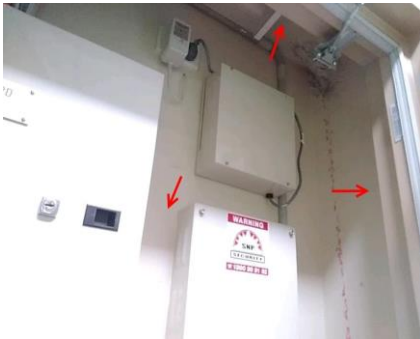
Photo No: 230620-110332
Result: Asbestos - Negative
Location-Level: Interior - Ground Floor
Room-Location: Electrical distribution cupboard - internal walls and ceiling
Feature-Material: Brick

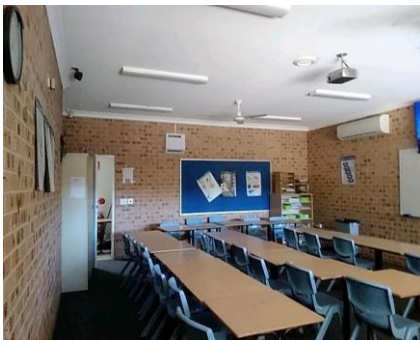
Photo No: 230626-003710
Result: Asbestos - Negative
Location-Level: Interior - Ground Floor
Room-Location: All elevation of the floor: classrooms - ceilings
Feature-Material: Plaster-like material

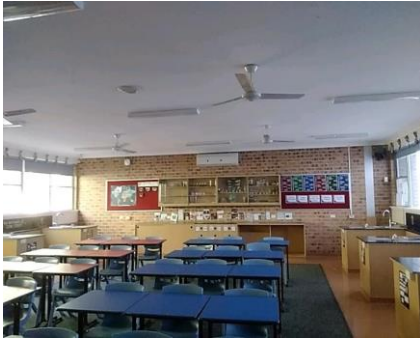
Photo No: 230620-110822
Result: Asbestos - Negative
Location-Level: Interior - Ground Floor
Room-Location: Ceilings
Feature-Material: Plaster like material

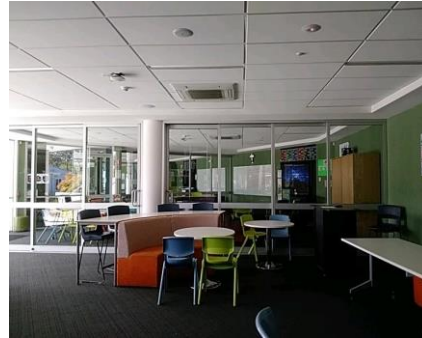
Photo No: 230620-112043
Result: Asbestos - Negative
Location-Level: Interior - Ground Floor
Room-Location: All elevation of the floor - division walls
Feature-Material: Glass

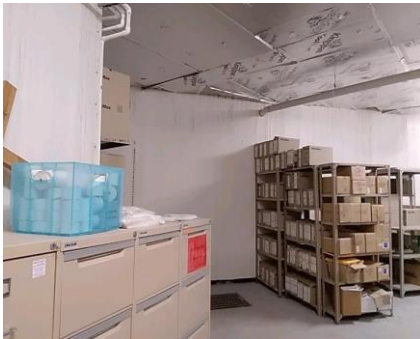
Photo No: 230620-112441
Result: Asbestos - Negative
Location-Level: Interior - Ground Floor
Room-Location: Storage area - walls
Feature-Material: Concrete

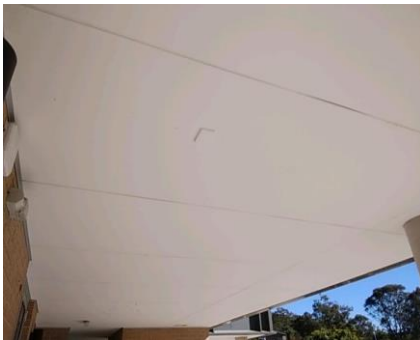
Photo No: 230620-112646
Result: Asbestos - Negative
Location-Level: Exterior - Ground Floor
Room-Location: All elevation of the floor - eaves
Feature-Material: FC sheeting

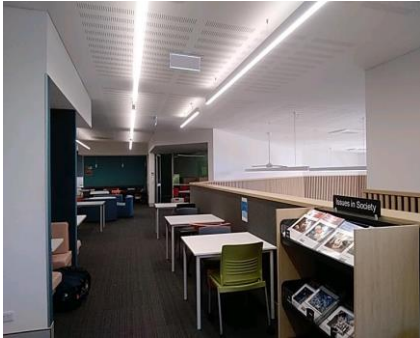
Photo No: 230620-112929
Result: Asbestos - Negative
Location-Level: Interior - 1st Floor
Room-Location: All elevation of the floor - internal walls and ceilings
Feature-Material: Plaster-like material

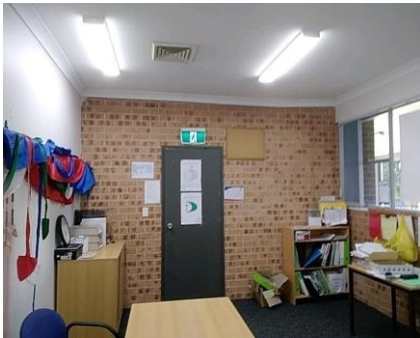
Photo No: 230620-113529
Result: Asbestos - Negative
Location-Level: Interior - Ground Floor
Room-Location: All elevation of the floor: classrooms - internal walls
Feature-Material: Brick

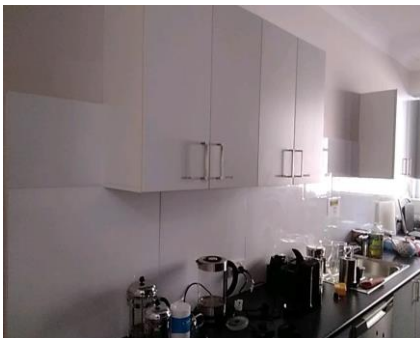
Photo No: 230620-113613
Result: Asbestos - Negative
Location-Level: Interior - Ground Floor
Room-Location: Northern kitchen - internal walls
Feature-Material: Plaster-like material

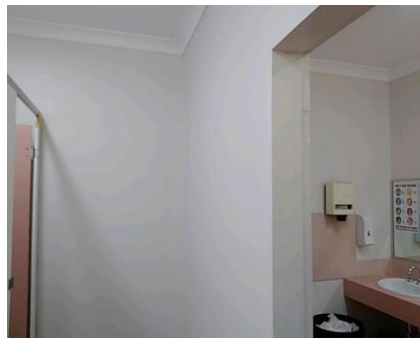
Photo No: 230620-114419
Result: Asbestos - Presumed Negative
Location-Level: Interior - Ground Floor
Room-Location: Staff female toilet - internal walls
Feature-Material: FC sheeting

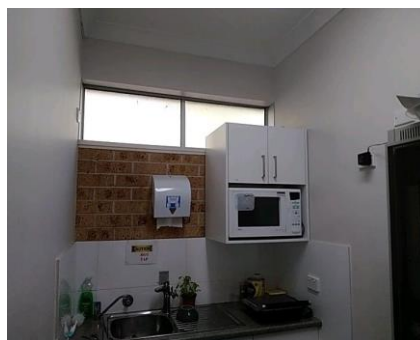
Photo No: 230620-114834
Result: Asbestos - Presumed Negative
Location-Level: Interior - Ground Floor
Room-Location: Staff kitchen - internal walls
Feature-Material: FC sheeting

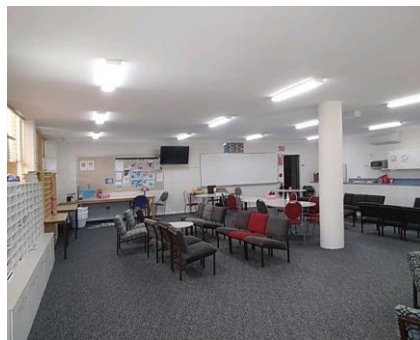
Photo No: 230620-115321
Result: Asbestos - Negative
Location-Level: Interior - Ground Floor
Room-Location: All elevation of the floor - internal walls
Feature-Material: Brick

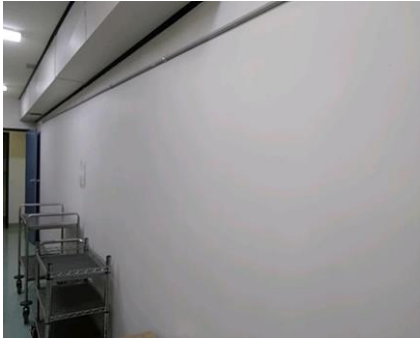
Photo No: 230620-120214
Result: Asbestos - Negative
Location-Level: Interior - 1st Floor
Room-Location: Canteen storage area - internal walls
Feature-Material: FC sheeting

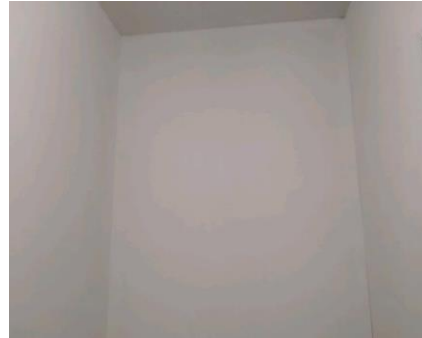
Photo No: 230620-120450
Result: Asbestos - Negative
Location-Level: Interior - Ground Floor
Room-Location: All elevation of the floor - internal walls
Feature-Material: Plaster-like material

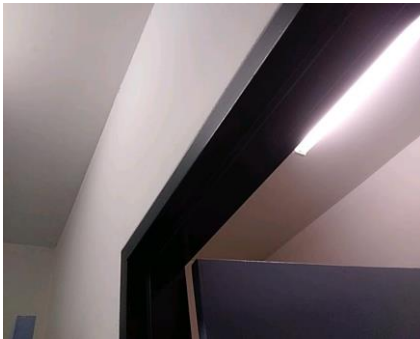
Photo No: 230620-120518
Result: Asbestos - Negative
Location-Level: Interior - Ground Floor
Room-Location: All elevation of the floor - ceilings
Feature-Material: Plaster-like material

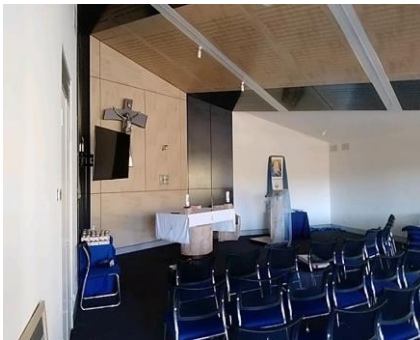
Photo No: 230621-093859
Result: Asbestos - Negative
Location-Level: Interior - 1st Floor
Room-Location: All elevation of the floor - internal walls and ceilings
Feature-Material: Plaster-like material

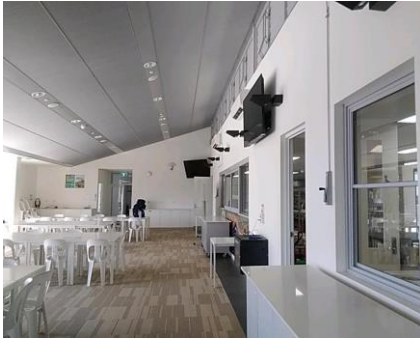
Photo No: 230620-121137
Result: Asbestos - Negative
Location-Level: Exterior - 1st Floor
Room-Location: Deck - internal walls and ceiling
Feature-Material: Plaster-like material

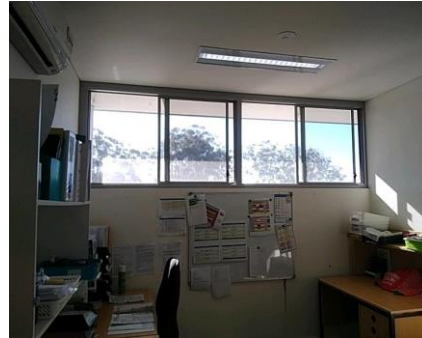
Photo No: 230620-121230
Result: Asbestos - Negative
Location-Level: Interior - 1st Floor
Room-Location: All elevation of the floor: offices - internal walls and ceiling
Feature-Material: Plaster-like material

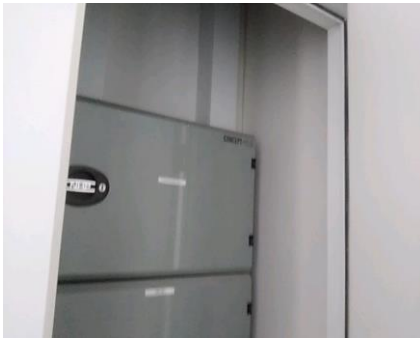
Photo No: 230620-121337
Result: Asbestos - Negative
Location-Level: Interior - 1st Floor
Room-Location: Electrical distribution cupboard - internal walls
Feature-Material: Plaster-like material

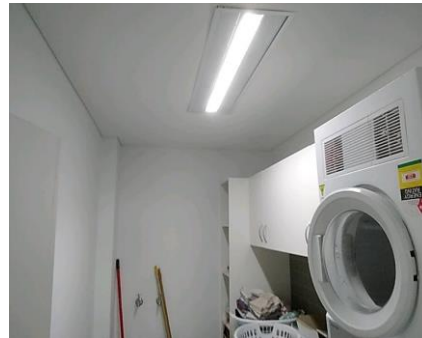
Photo No: 230620-121421
Result: Asbestos - Negative
Location-Level: Interior - 1st Floor
Room-Location: Laundry - internal walls and ceiling
Feature-Material: Plaster-like material

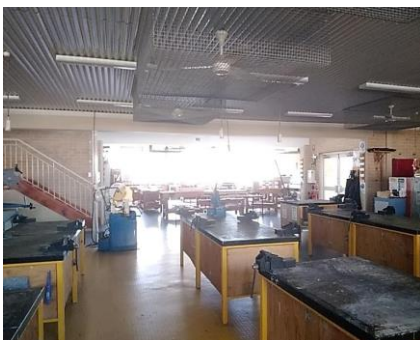
Photo No: 230620-121824
Result: Asbestos - Negative
Location-Level: Interior - 1st Floor
Room-Location: All elevation of the floor - walls
Feature-Material: Brick

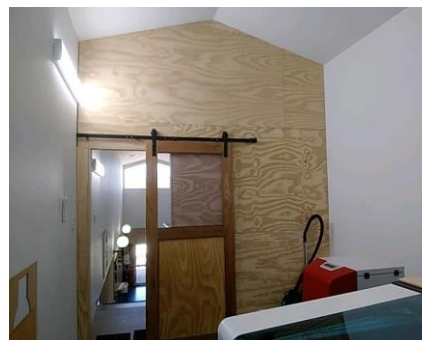
Photo No: 230620-121941
Result: Asbestos - Negative
Location-Level: Interior - 2nd Floor
Room-Location: All elevation of the floor - internal walls
Feature-Material: Timber

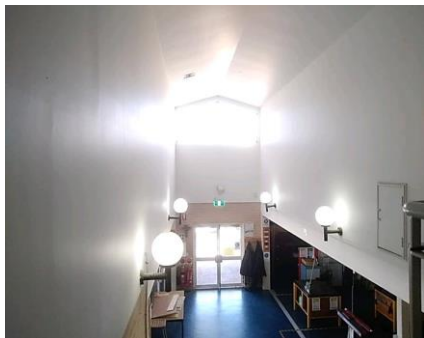
Photo No: 230620-122029
Result: Asbestos - Negative
Location-Level: Interior - 2nd Floor
Room-Location: All elevation of the floor - ceilings
Feature-Material: Plaster-like material

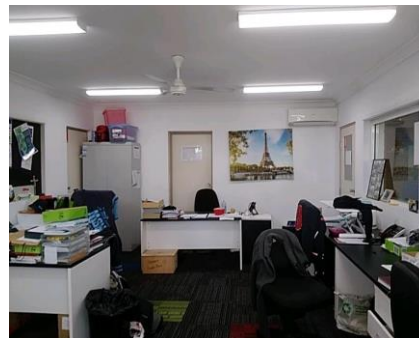
Photo No: 230620-122402
Result: Asbestos - Negative
Location-Level: Interior - Ground Floor
Room-Location: All elevation of the floor: offices - internal walls
Feature-Material: Brick

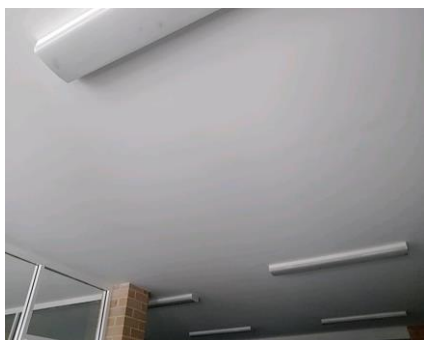
Photo No: 230620-122523
Result: Asbestos - Negative
Location-Level: Interior - Ground Floor
Room-Location: All elevation of the floor - ceilings
Feature-Material: Plaster-like material

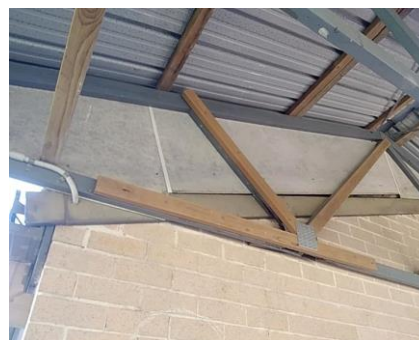
Photo No: 230620-122759
Result: Asbestos - Negative
Location-Level: Interior - Ground Floor
Room-Location: roof gables
Feature-Material: FC sheeting

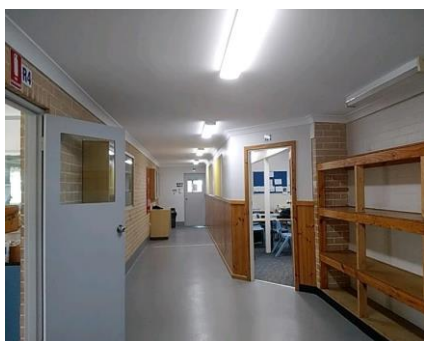
Photo No: 230620-124915
Result: Asbestos - Negative
Location-Level: Interior - Ground Floor
Room-Location: All elevation of the floor - division walls
Feature-Material: Plaster-like material

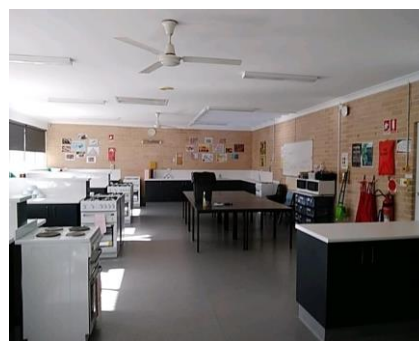
Photo No: 230621-100527
Result: Asbestos - Negative
Location-Level: Interior - Ground Floor
Room-Location: All elevation of the floor: classrooms - internal walls
Feature-Material: Brick

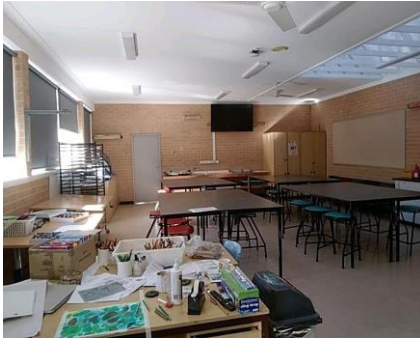
Photo No: 230620-125144
Result: Asbestos - Negative
Location-Level: Interior - 1st Floor
Room-Location: All elevation of the floor: classrooms - internal walls
Feature-Material: Brick

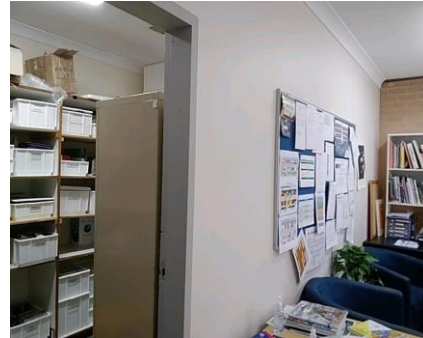
Photo No: 230620-125314
Result: Asbestos - Negative
Location-Level: Interior - 1st Floor
Room-Location: All elevation of the floor - division walls
Feature-Material: Plaster-like material

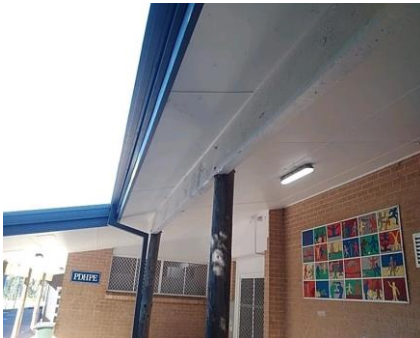
Photo No: 230620-125531
Result: Asbestos - Negative
Location-Level: Exterior - Ground Floor
Room-Location: All elevation of the building - eaves
Feature-Material: FC sheeting

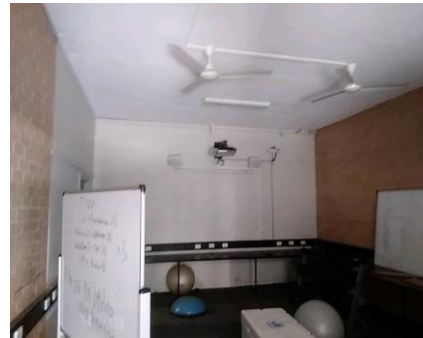
Photo No: 230620-125604
Result: Asbestos - Negative
Location-Level: Interior - Ground Floor
Room-Location: All elevation of the floor - division walls
Feature-Material: Timber

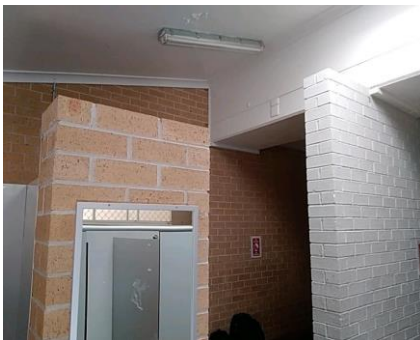
Photo No: 230621-094818
Result: Asbestos - Negative
Location-Level: Interior - Ground Floor
Room-Location: Amenities - internal walls
Feature-Material: Brick

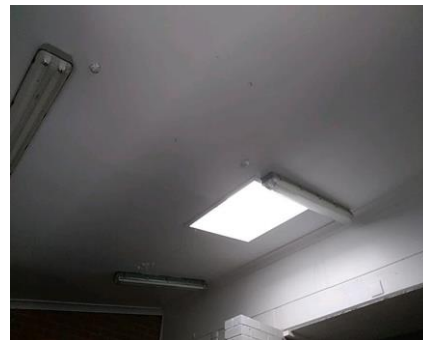
Photo No: 230621-094823
Result: Asbestos - Negative
Location-Level: Interior - Ground Floor
Room-Location: All elevation of the floor - ceilings
Feature-Material: FC sheeting

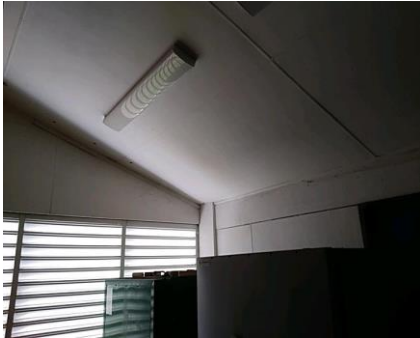
Photo No: 230621-095839
Result: Asbestos - Negative
Location-Level: Interior - 1st Floor
Room-Location: Northern elevation of the floor - internal walls to extension
Feature-Material: Timber

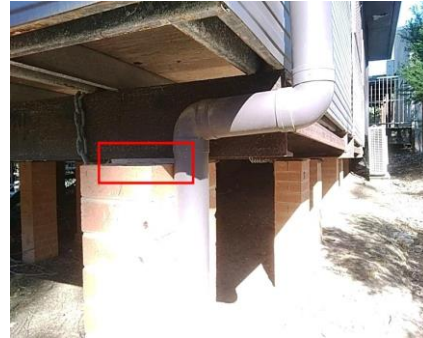
Photo No: 230620-130123
Result: Asbestos - Negative
Location-Level: Exterior - Sub-floor
Room-Location: All elevation of the floor - packer to support column
Feature-Material: FC sheeting

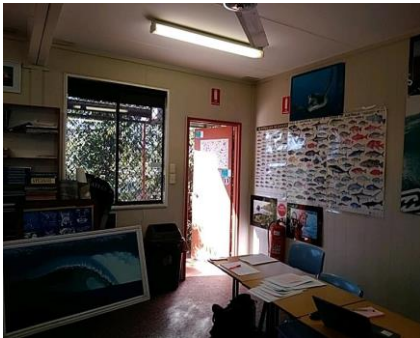
Photo No: 230621-100946
Result: Asbestos - Negative
Location-Level: Interior - Ground Floor
Room-Location: All elevation of the floor - internal walls and ceiling
Feature-Material: Timber

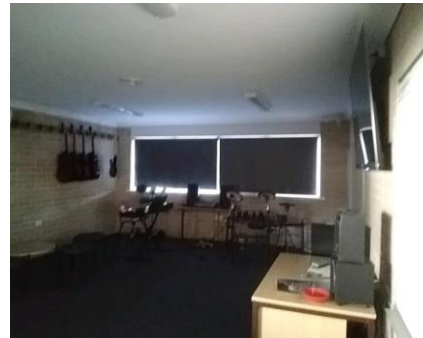
Photo No: 230621-094451
Result: Asbestos - Negative
Location-Level: Interior - Ground Floor
Room-Location: All elevation of the floor: classrooms - internal walls
Feature-Material: Brick

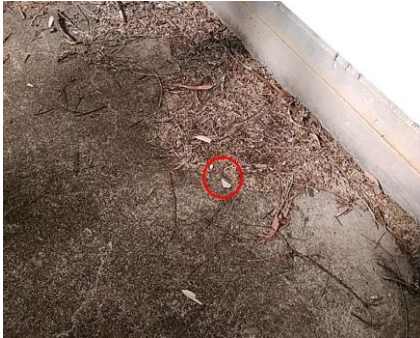
Photo No: 230621-101520
Result: Asbestos - Negative
Location-Level: Interior and Exterior - Ground Floor
Room-Location: All elevation of the building - walls and eaves
Feature-Material: FC sheeting

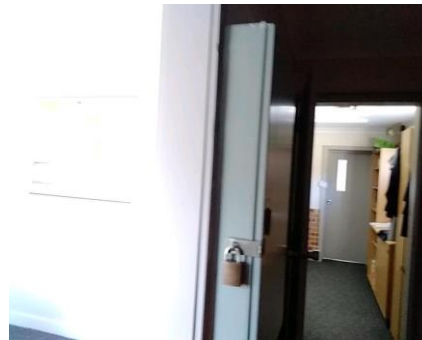
Photo No: 230620-131500
Result: Asbestos - Negative
Location-Level: Interior - Ground Floor
Room-Location: All elevation of the floor: classrooms - internal walls
Feature-Material: Brick

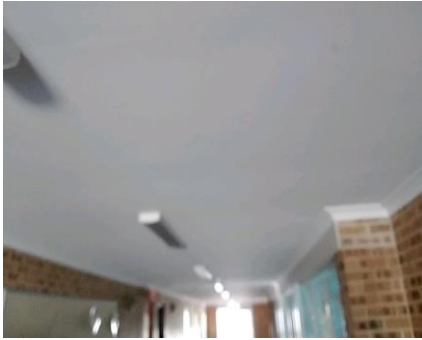
Photo No: 230621-105132
Result: Asbestos - Negative
Location-Level: Interior - Ground Floor
Room-Location: All elevation of the floor - division walls
Feature-Material: Plaster-like material
