Hazardous Materials Management Survey and Register 1 Apollo Place, Lane Cove West, NSW 2066

JOB NUMBER: JN04987
ISSUED DATE: 9 April 2024
PREPARED FOR: EMKC AUSTRALIA PTY LTD
CLIENT ADDRESS: Level 11, 37 York Street Sydney NSW 2000 Australia
INSPECTED BY: Faz Jalali, Occupational Hygienist
REPORT BY: Faz Jalali, Occupational Hygienist
APPROVED BY: Alex Clark, Senior Hazmat Consultant
ISSUE NUMBER: Rev_0

Hazardous Materials Management Survey and Register 2 Apollo Place, Lane Cove West, NSW 2066

JOB NUMBER: JN04987
ISSUED DATE: 21 March 2024
PREPARED FOR: EMKC AUSTRALIA PTY LTD
CLIENT ADDRESS: Level 11, 37 York Street Sydney NSW 2000 Australia
INSPECTED BY: Faz Jalali, Occupational Hygienist
REPORT BY: Faz Jalali, Occupational Hygienist
APPROVED BY: Alex Clark, Senior Hazmat Consultant
ISSUE NUMBER: Rev_0

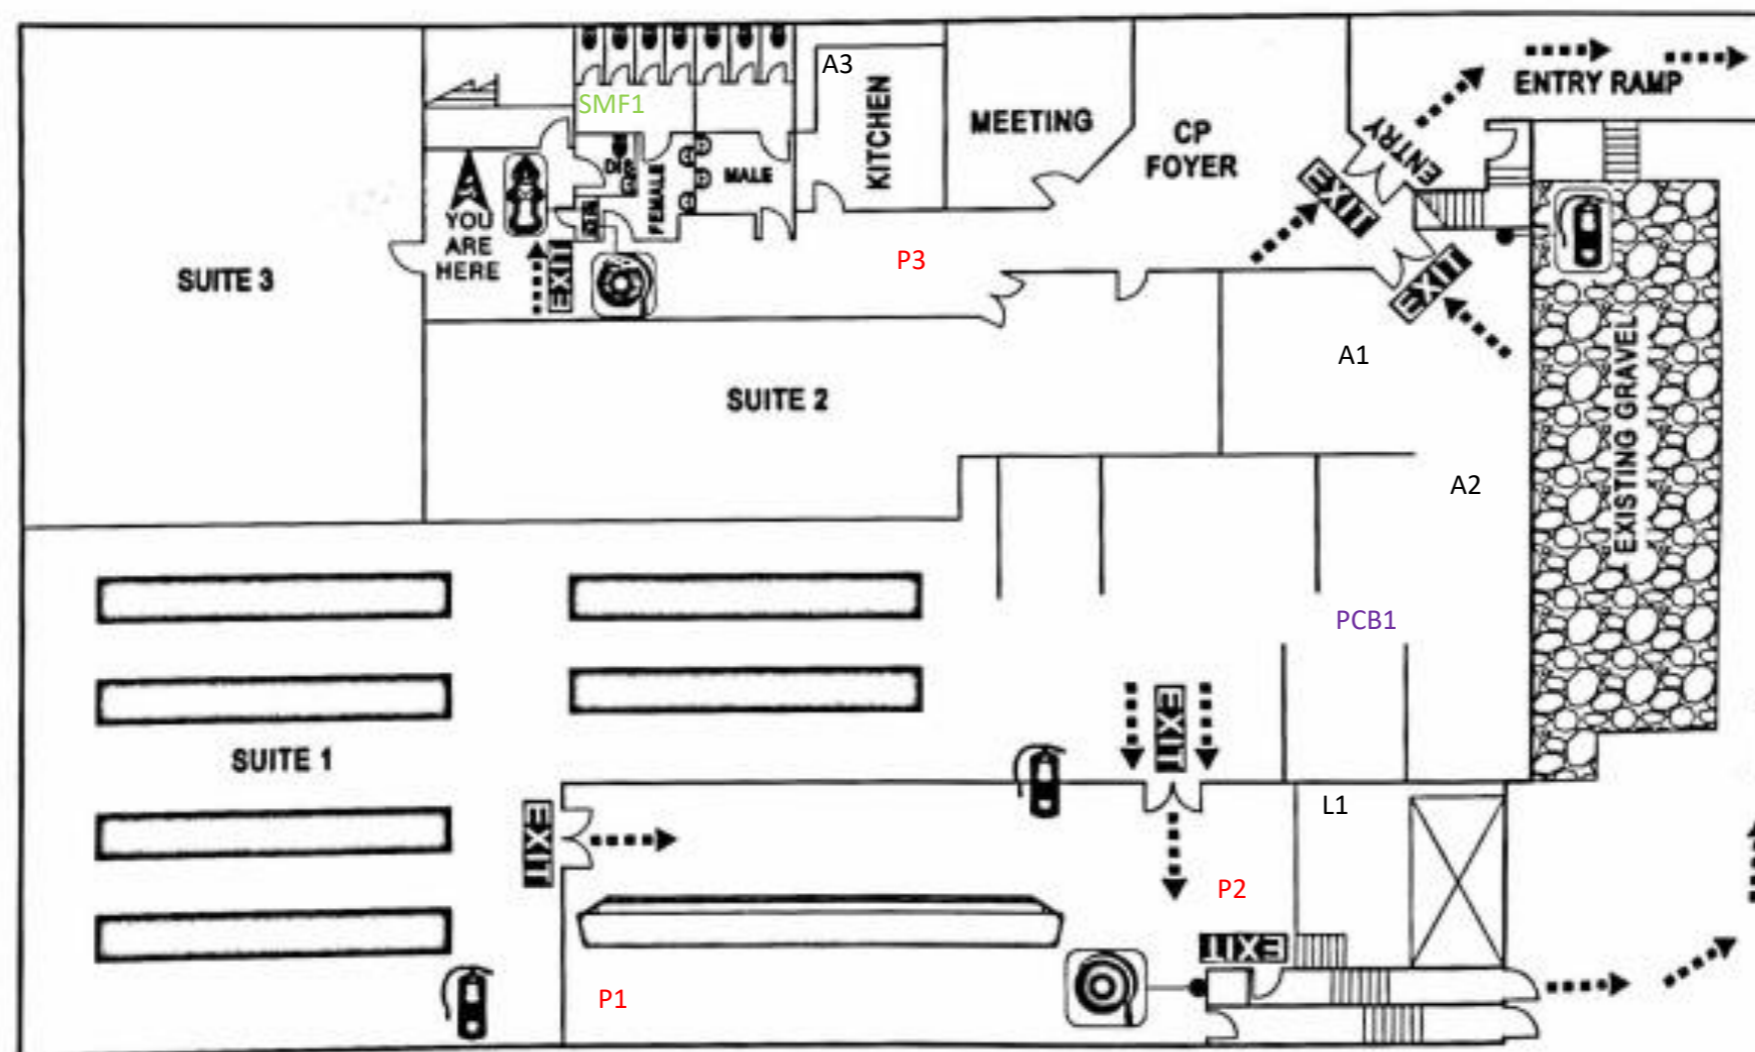
Figure 2 - Depicts site plan and sample location lower ground

Lower ground level	Flexible insulation ducts above suspended ceiling in toilets	SMF1	SMF	TH	F	Negligible	Remove under controlled conditions during or before demolition works by competent persons

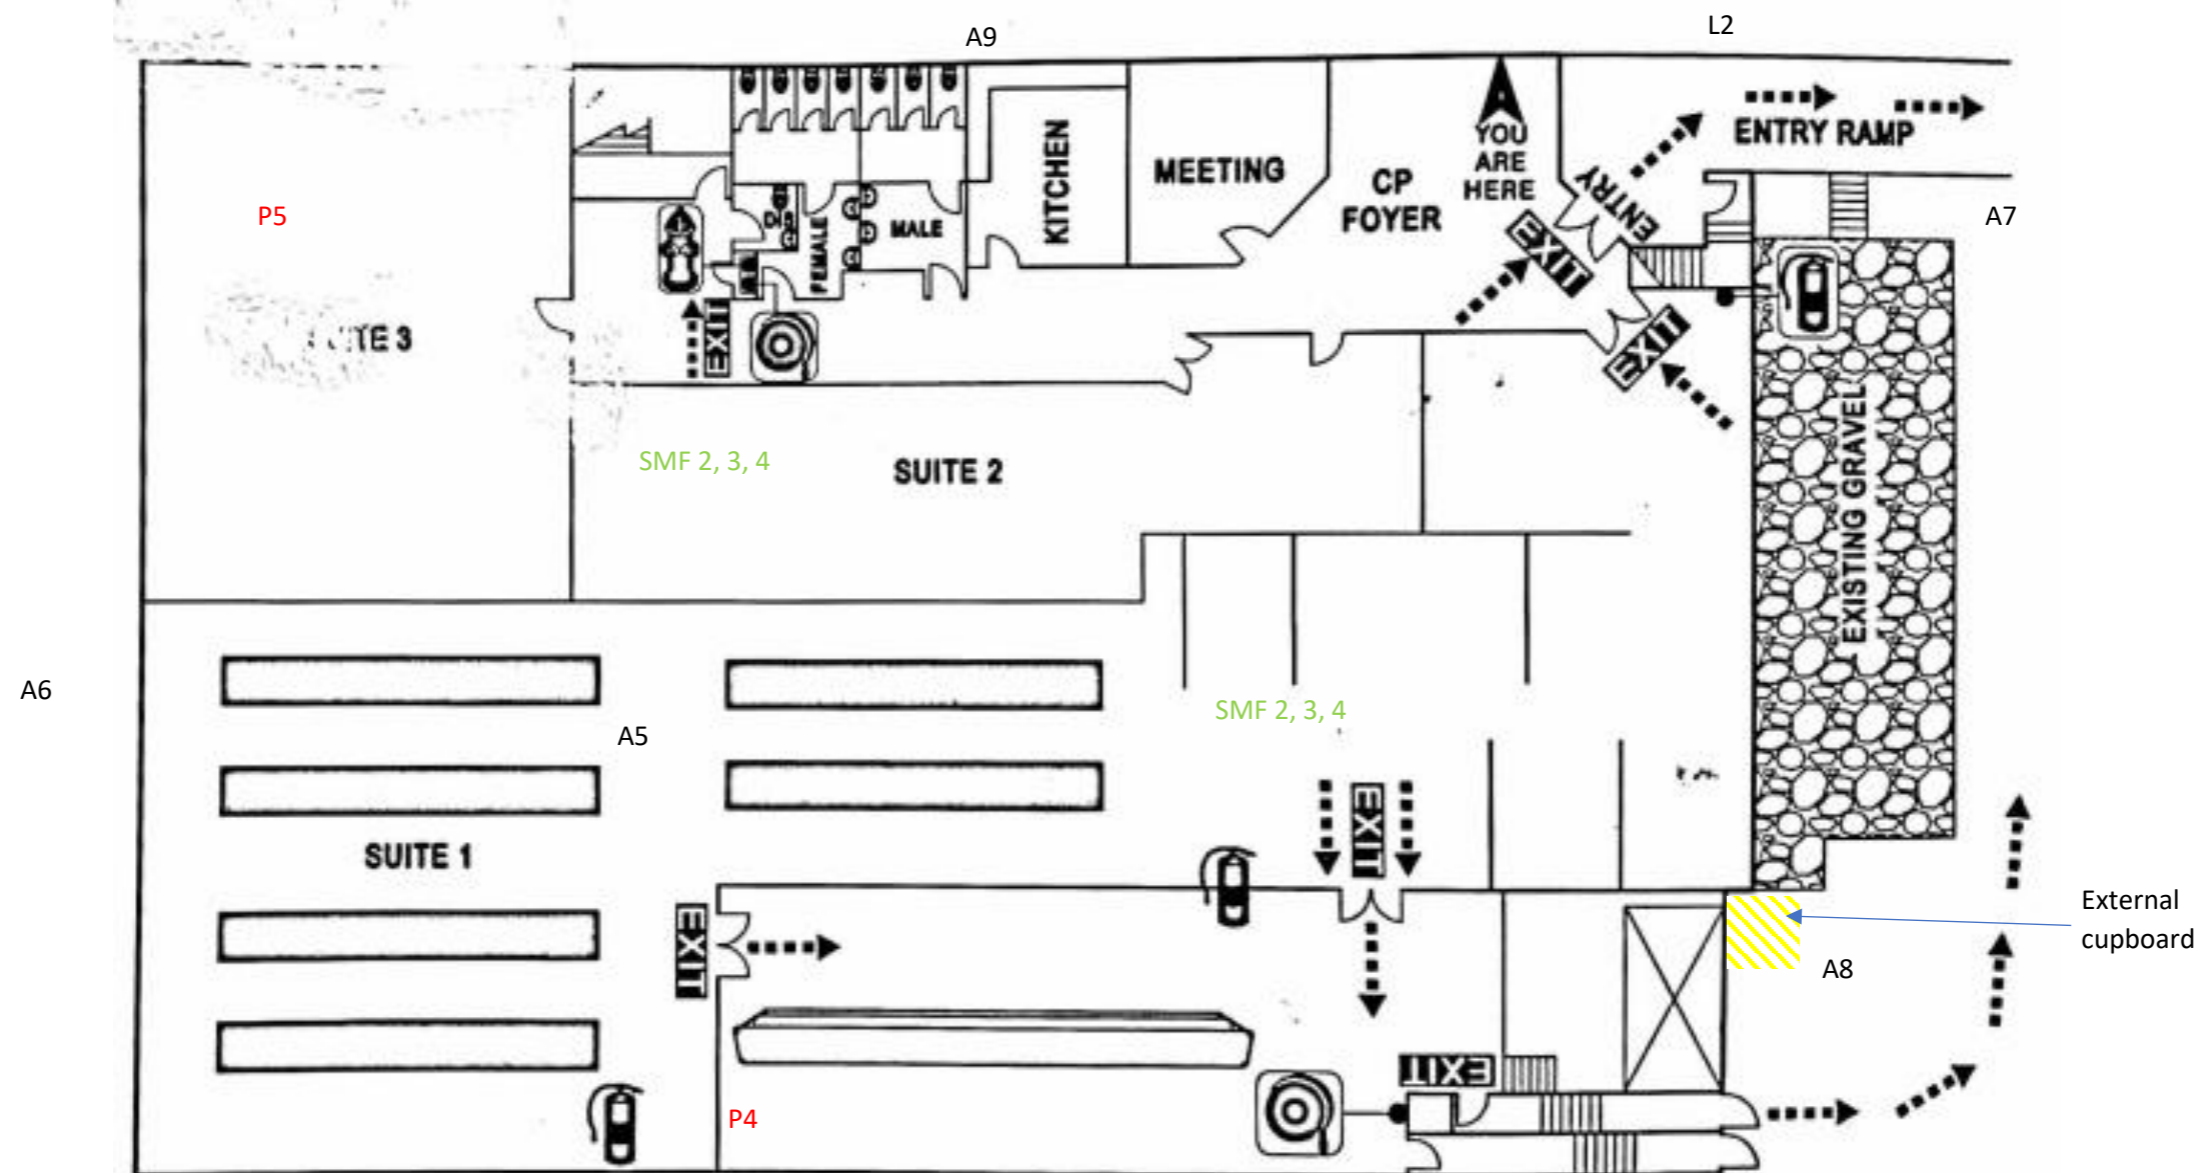
Figure 3 - Depicts site plan and sample location ground

Garage	Floor movement joint	A4	NAD	NA	NA	NA	No further action required.	
Ground floor	Vinyl sheeting throughout	A5	NAD	NA	NA	NA	No further action required.	
Ground floor	Suspended ceiling tiles in office areas	SMF2	SMF	TH	F	Low	Remove under controlled conditions during or before demolition works by competent persons	
Ground floor	Sarking to roof panels above suspended ceiling	SMF3	SMF	TH	F	Low	Remove under controlled conditions during or before demolition works by competent persons
