## Pre-Construction Dilapidation Survey of 25-27 Leeds St, Rhodes - Roads and Council Assets – Blaxland Road

MAJ-20240111-DS-REP-001-1A-R01

RE: 25-27 LEEDS STREET, RHODES  
PRE-CONSTRUCTION DILAPIDATION SURVEY OF ROADS AND COUNCIL ASSETS – BLAXLAND ROAD

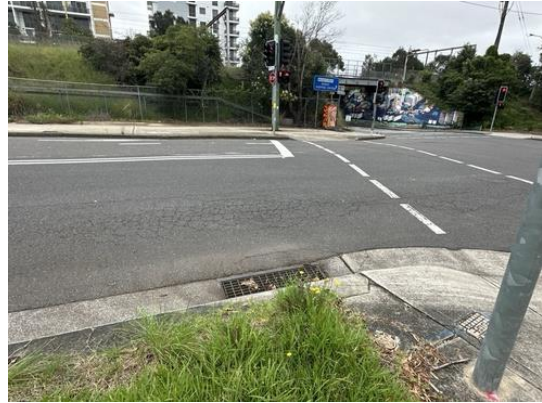
Photo 2

- A. Cracks to road (example Photo 2, category 4; Photo 96-97, category 3)
- B. Map cracking (example Photo 5-7, category 3)
- C. Cracks to kerb and gutter (example Photo 15-16, category 4)
- D. Cracks to service cover (example Photo 19-20, category 3; Photo 133, category 3)
- E. Cracks to footpath (example Photo 49-50, 60-61, 69-70; category 3)
- F. Cracks to concrete spoon drain (example Photo 224-225, 232-233, 240-241; category 2-4)

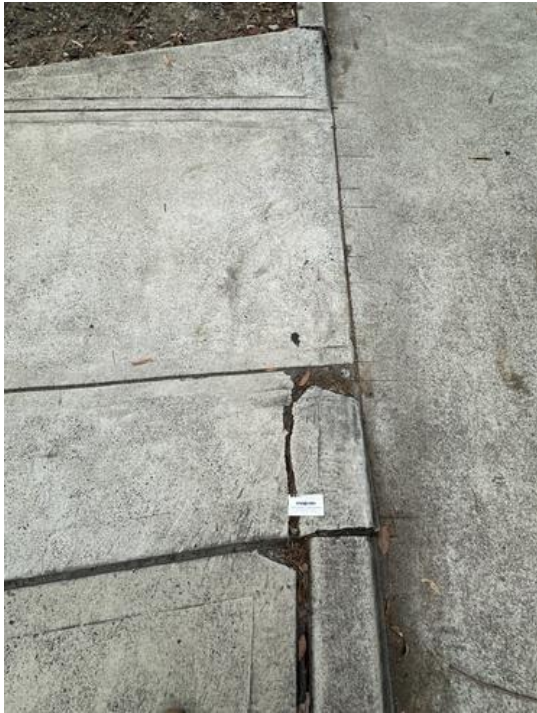
Photo 188

| Width of Crack | Category 2; $1.0 < \alpha < 2.0$ mm |

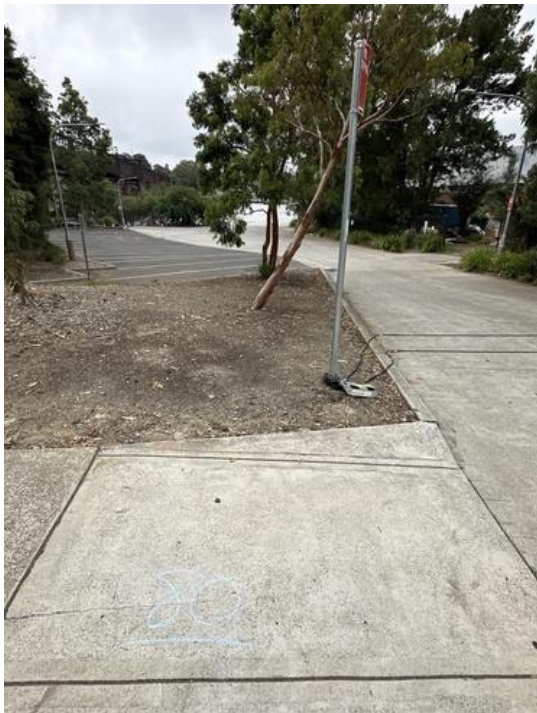
Photo 190

| Number of cracks | 1 |
| Average length of crack (mm) | 500 |
| Width of Crack | Category 5; $\alpha > 10.0$ mm |

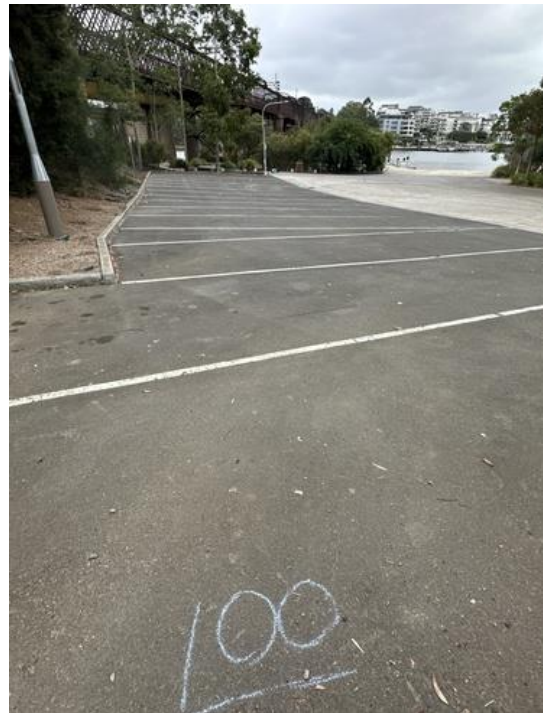
Photo 199

Number of cracks 1

Average length of crack (mm) 1000

Width of Crack Category 2;  $1.0 < \alpha < 2.0$  mm

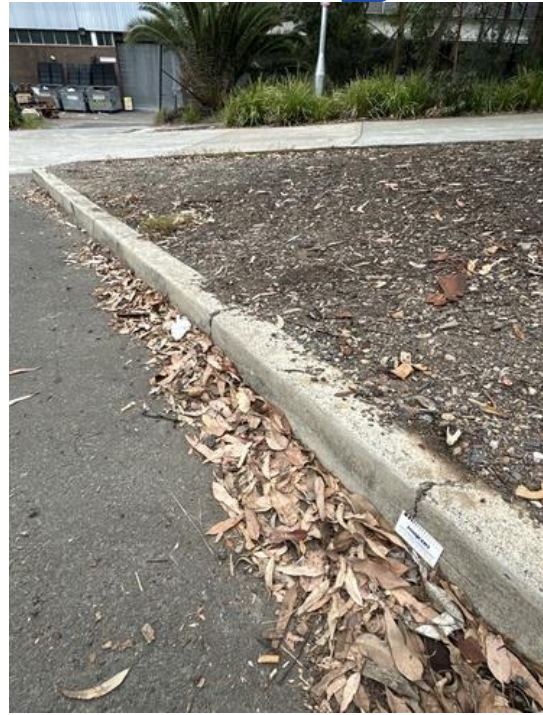
Photo 205

General views/conditions

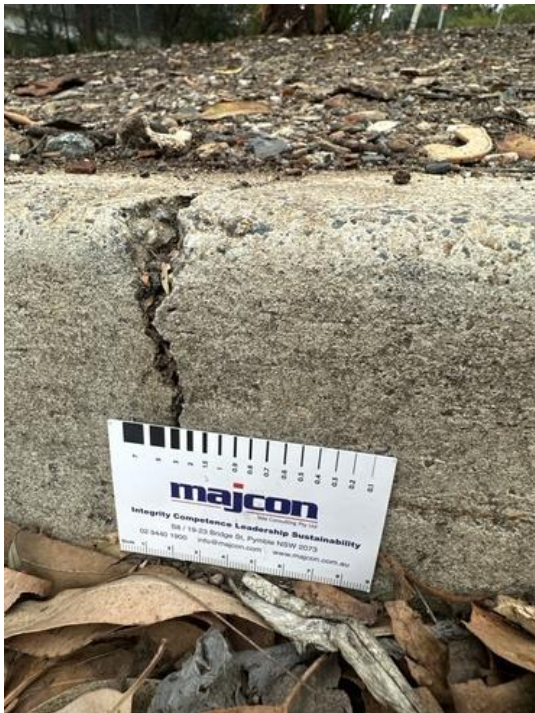
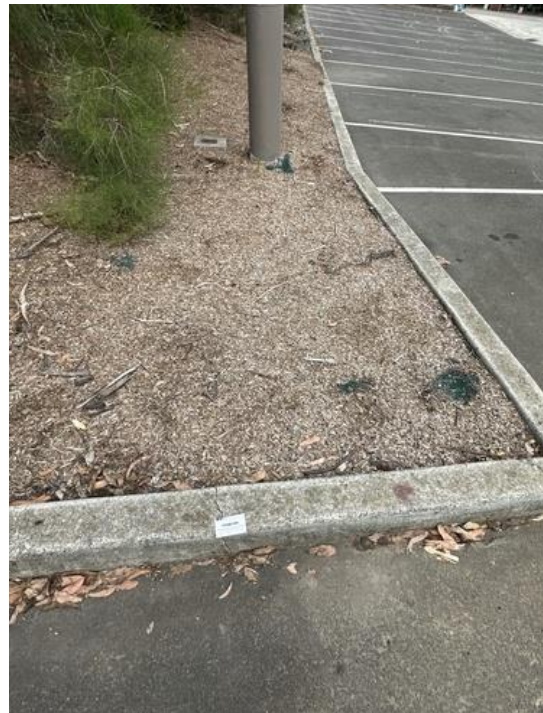
Photo 206

Crack

Number of cracks

Average length of crack (mm)

Width of crack

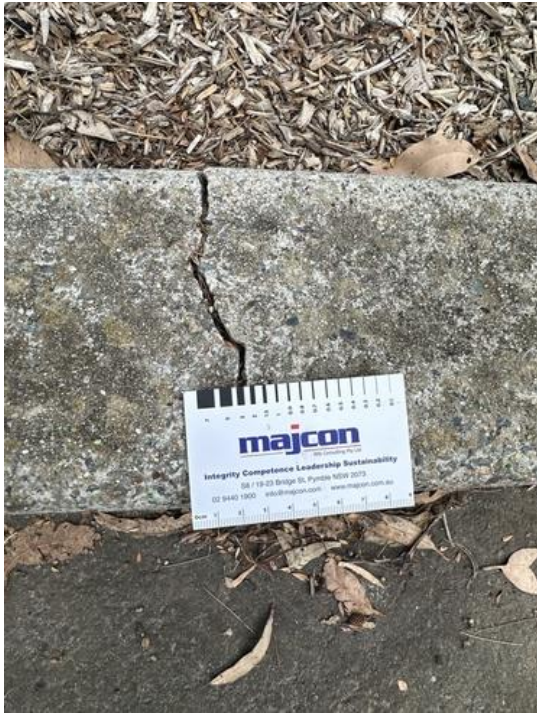
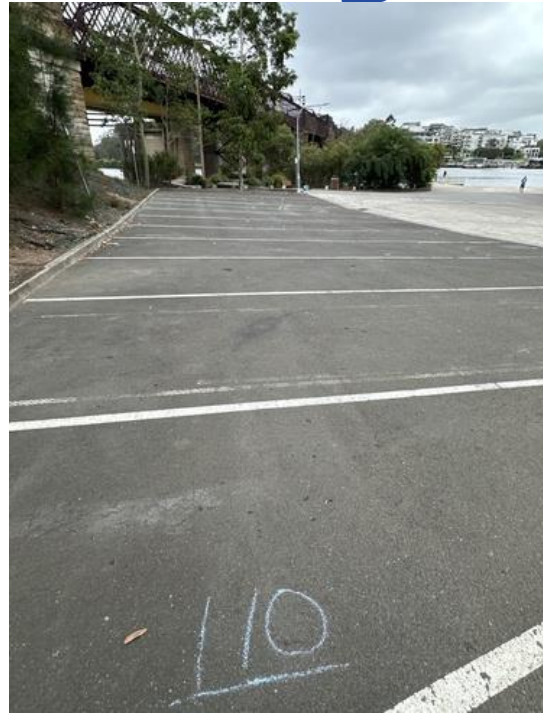
Photo 208

Crack

Number of cracks

Average length of crack (mm)

Width of Crack

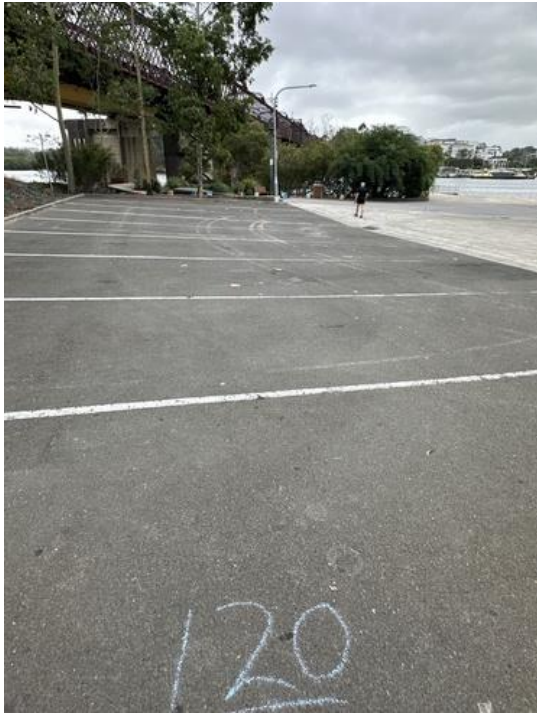
Photo 216

Crack

### Number of cracks

Map Cracking

Average length of cracks (mm)

Width of Cracks

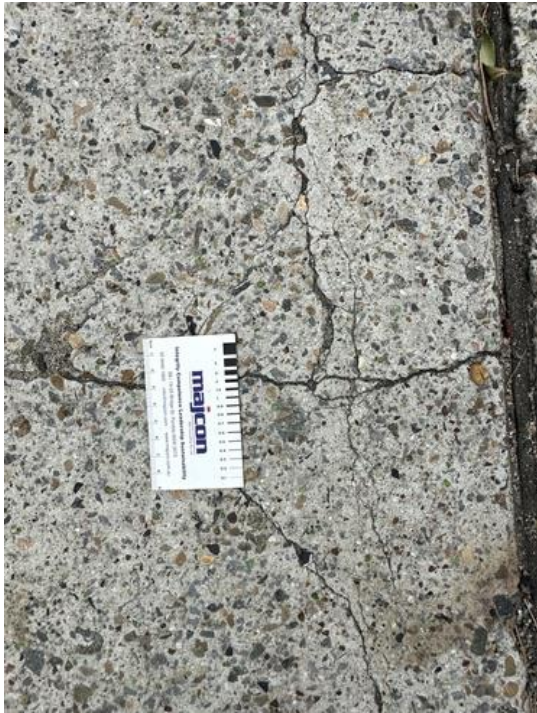
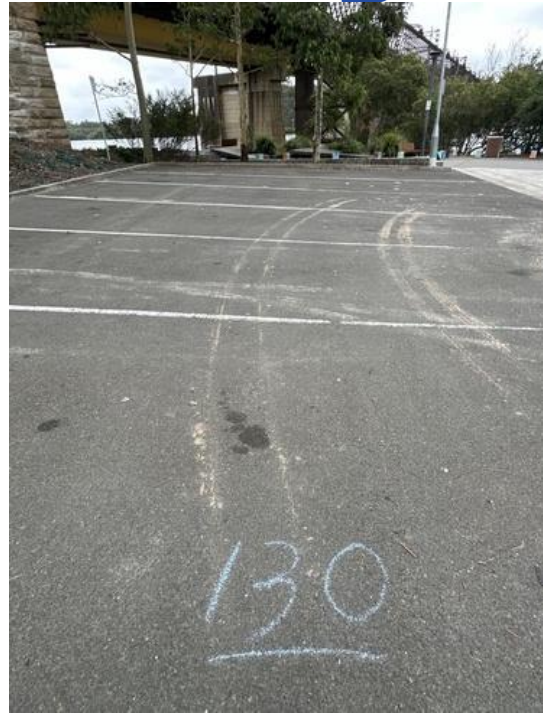
Photo 224

Crack

Number of cracks

Map Cracking

Average length of cracks (mm)

Width of Cracks

Crack on concrete spoon drain

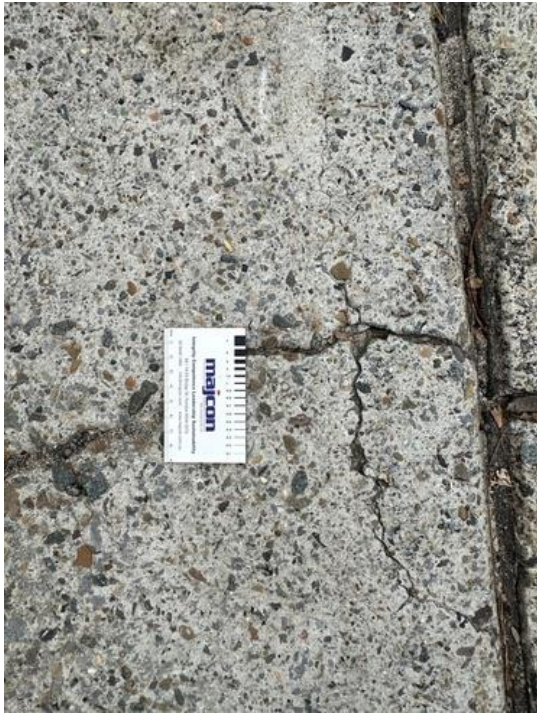
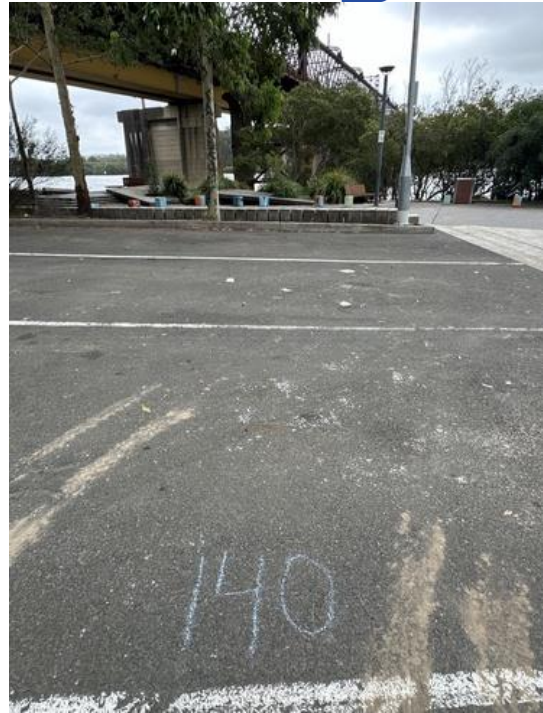
Photo 232

Crack

Number of cracks

Average length of crack (mm)

Width of crack

Crack on concrete spoon drain

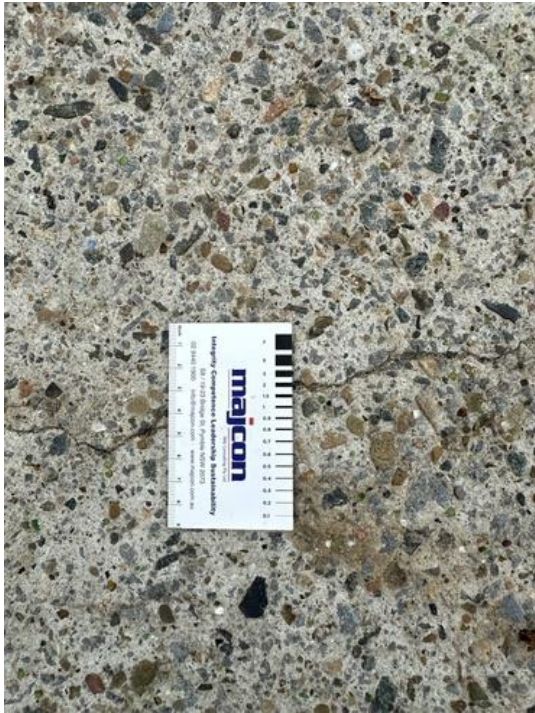
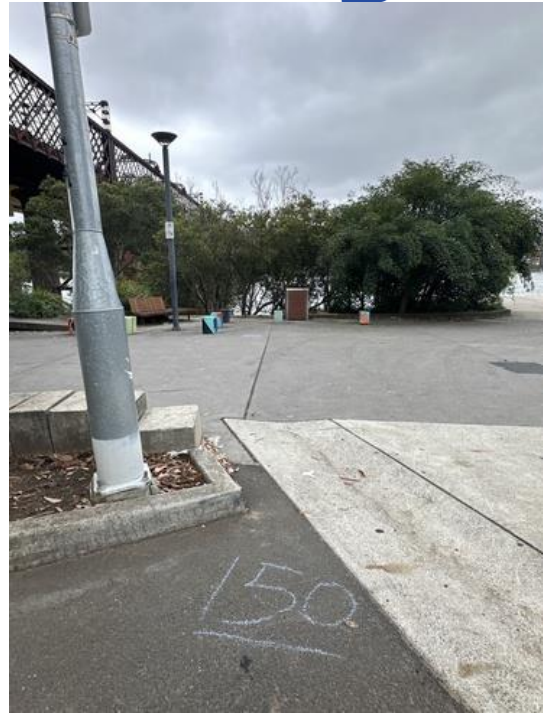
Photo 240

Crack

Number of cracks

| Average length of crack (mm) | 600 |
| Width of Crack | Category 2; $1.0 < \alpha < 2.0$ mm |
| Other Details | Crack on concrete spoon drain |

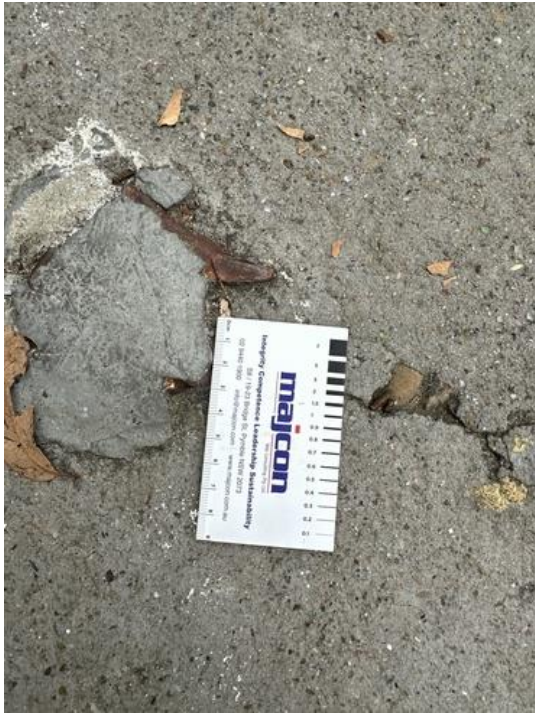
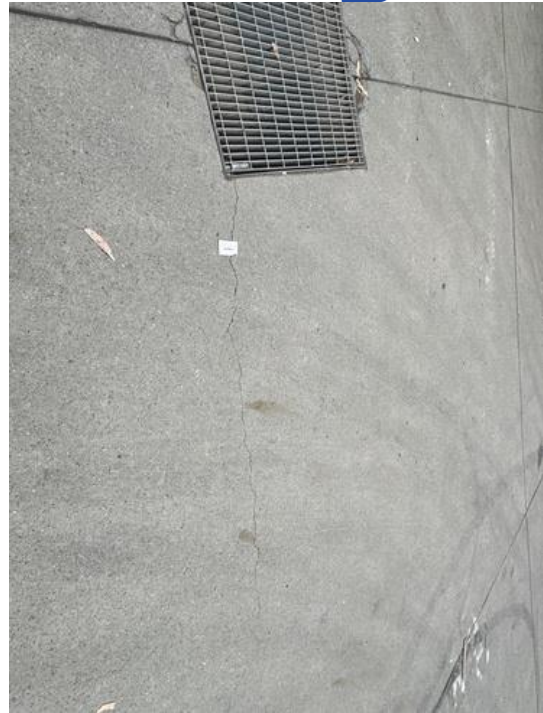
| Type of Photo | Crack |
| Number of cracks | 1 |
| Average length of crack (mm) | 500 |
| Width of Crack | Category 2; $1.0 < \alpha < 2.0$ mm |

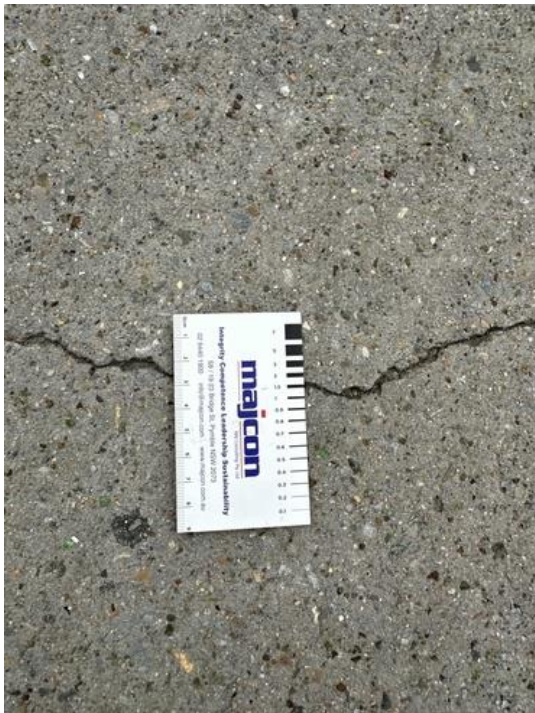
Photo 250

| Type of Photo | Crack |

| Number of cracks | 1 |
| Average length of crack (mm) | 2500 |
| Width of Crack | Category 2; $1.0 < \alpha < 2.0$ mm |

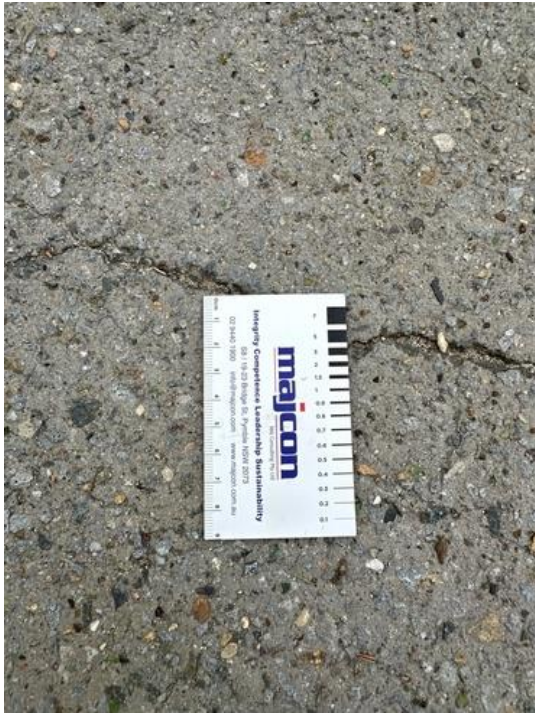
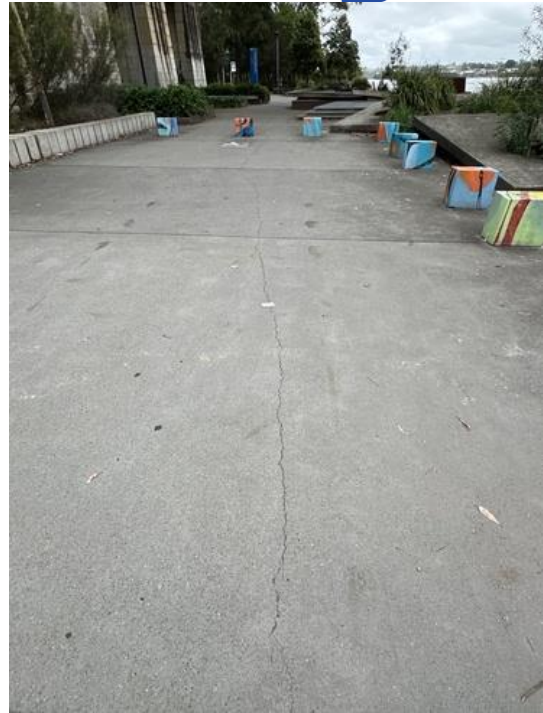
Type of Photo Crack

| Number of cracks | 1 |
| Average length of crack (mm) | 4000 |
| Width of Crack | Category 3; $2.0 < \alpha < 4.0$ mm |

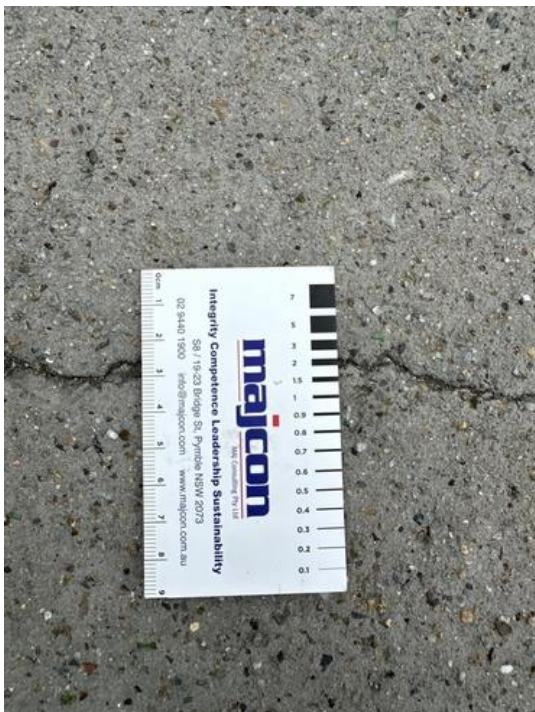
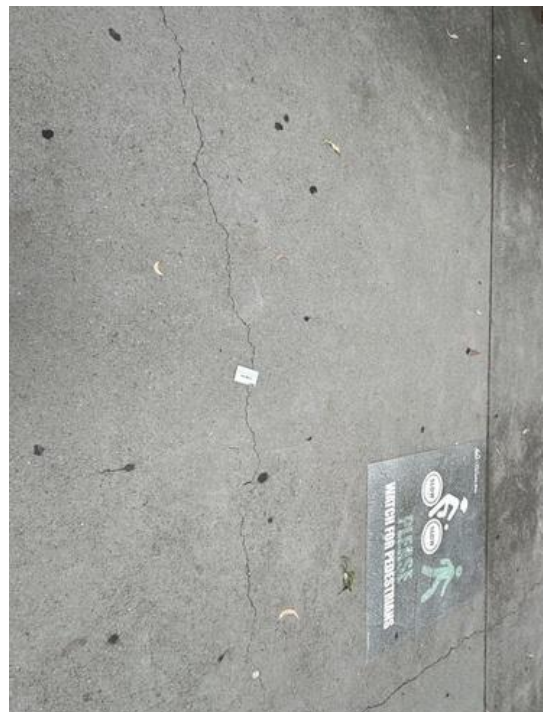
Type of Photo Crack

| Number of cracks | 1 |

| Average length of crack (mm) | 10000 | | | | |
| Width of Crack | Category 3; $2.0 < \alpha < 4.0$ mm | | | | |

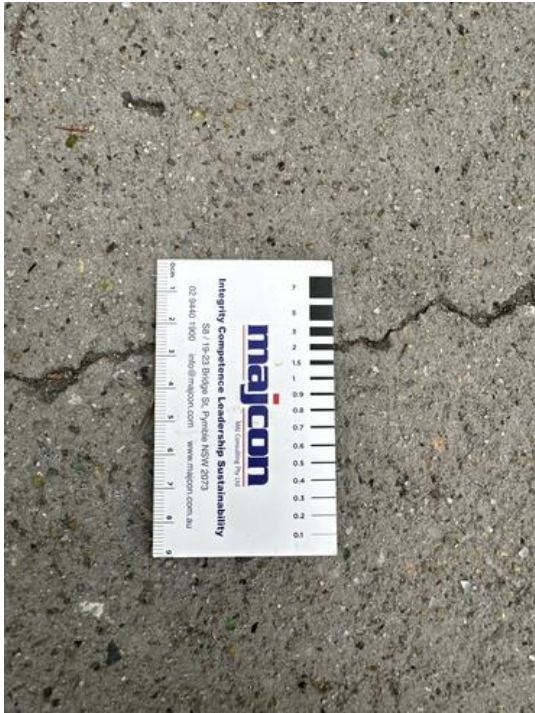
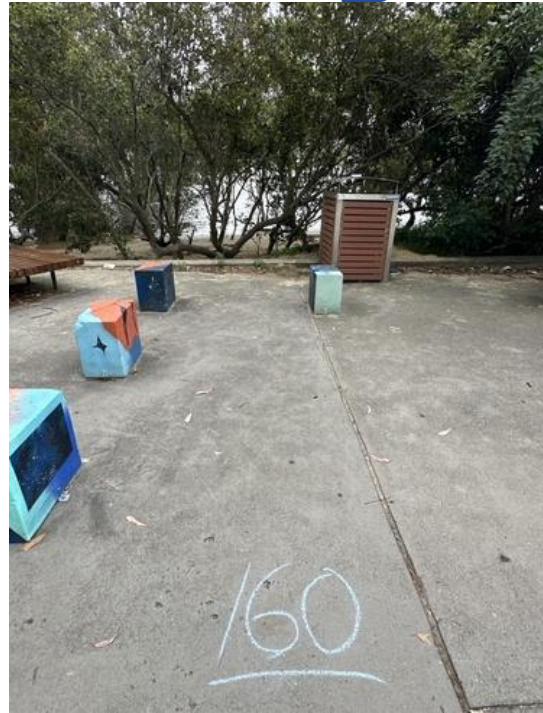
| Type of Photo | Crack | | | | |
| Number of cracks | 1 | | | | |
| Average length of crack (mm) | 4000 | | | | |
| Width of Crack | Category 3; $2.0 < \alpha < 4.0$ mm | | | | |
