ELEMENT / ZONE	DESCRIPTION / BACKGROUND	SIGNIFICANCE	CONDITION	RECOMMENDATIONS
----------------	--------------------------	--------------	-----------	-----------------

For room numbers see 2013 floor plans in Section 7.34 pp.193-200.

(See also Section 5: Heritage Management Policies & Guidelines)

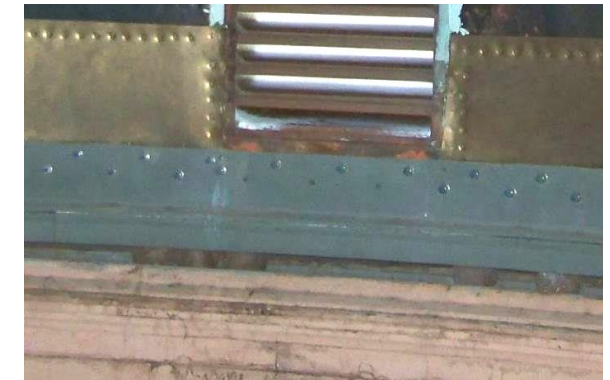
The copper observatory dome atop the northern tower is a riveted copper sheet dome with a telescope opening slot. The dome is able to be rotated on an original cannon ball track. The dome was repaired in 1995. The slot has been louvered to exclude water entry.

Copper dome track with cannon balls

Cyclic repair of the dome and track as required.

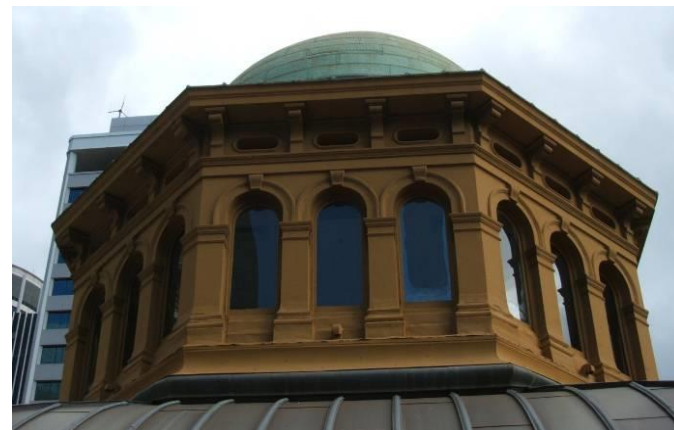
The room is located between the observatory dome and the main northern dome. It is octagonal in plan with fixed timber arched windows with 360° views over the harbour and city.

The existing timber flooring shows evidence of large openings in the floor. These have since been covered. The octagonal lantern still retains the early, (if not original), colour scheme. Of interest is the method used for ventilation, i.e. the portholes and their flaps.

Exceptional
Rot in windows
Very Poor
Windows generally
Fair

Cyclic painting and timber repair required in the short term. The last repair and painting was in 1995.

The sashes and sills need immediate repair with extensive rot in some elements. Repairs to be undertaken to retain the remaining intact portions of the windows.

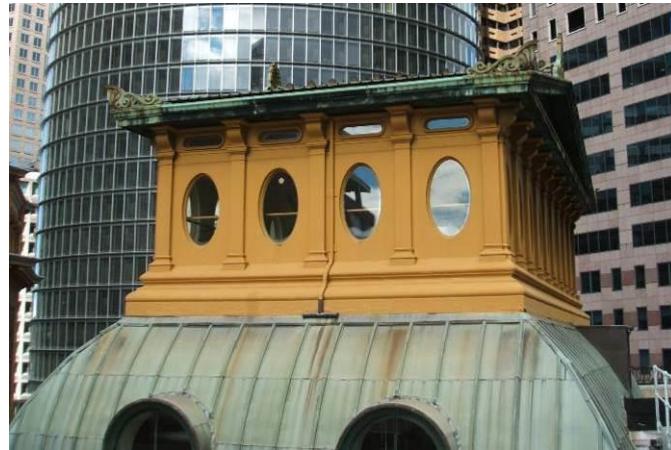
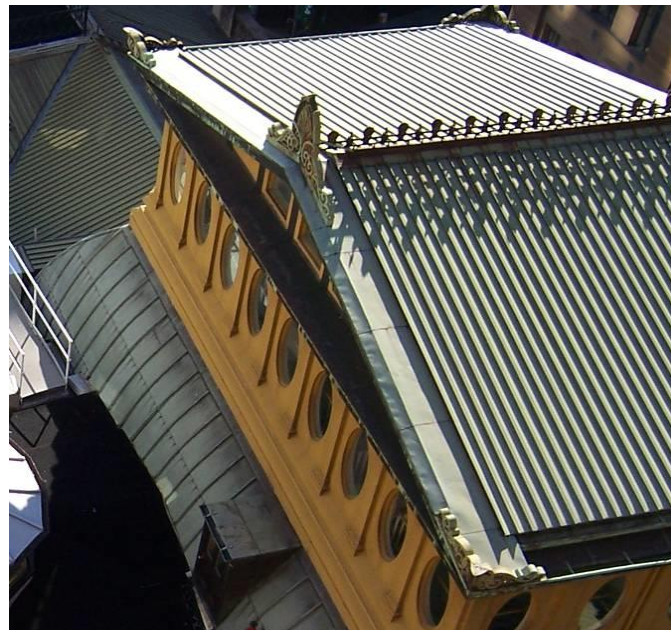
EASTERN PAVILION

The dome structure is steel framed and externally clad in copper batten roll detail. Internally the dome has one level of office space. The floors are timber and wall linings are sheeted. The dome has not undergone any recent external repair. Windows are located on the dome to the internal office level. One door exits the dome at roof level on the western face.

Due to access limitations a detailed assessment of the copper roof and pavilion elements is required to fully assess condition and cyclic repair. Recommend inspection when next assessing this area.

Cart iron cresting requires treatment and repainting

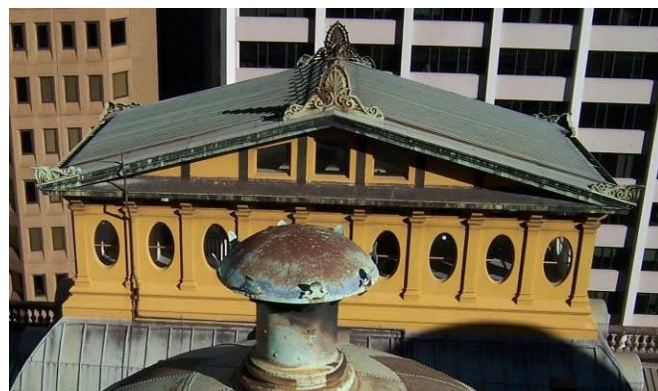
Eastern face of western pavilion

Due to access limitations a detailed assessment of the copper roof and pavilion elements is required to fully assess condition and cyclic repair. Recommend inspection when next assessing this area.

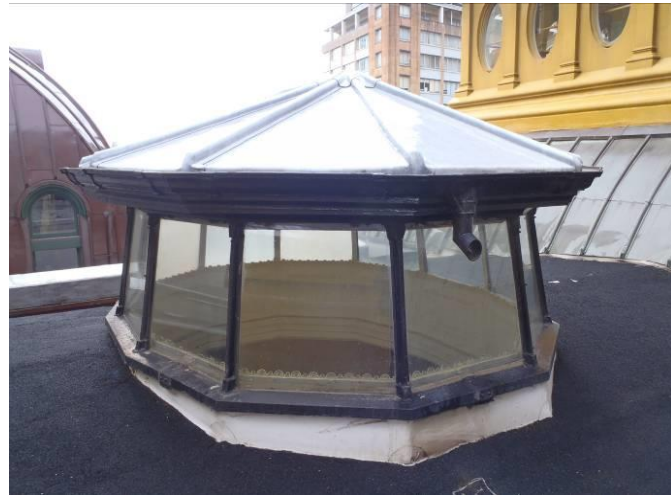
Viewed from south

Re-paint with cyclic maintenance in the short term

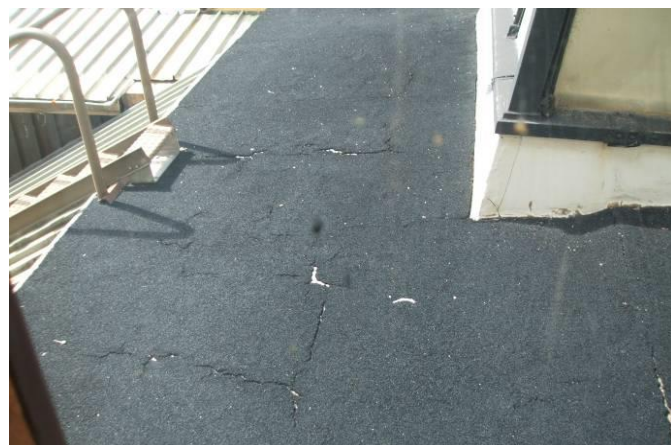
Membrane west of central dome

The membranes are of varying age condition and product. Some are nearing the end of their expectancy. Generally They all appear to be watertight at the time of inspection to the areas we were able to access. The top trafficable coating is breaking down and is unsightly to some of the membranes. The membrane over room G28 is a recent installation and has only biological growth on the surface due to the location within the internal lightwell.

Replace old deteriorated membranes at roof level in the short term. Repair and clean membranes still with a serviceable life in light wells.

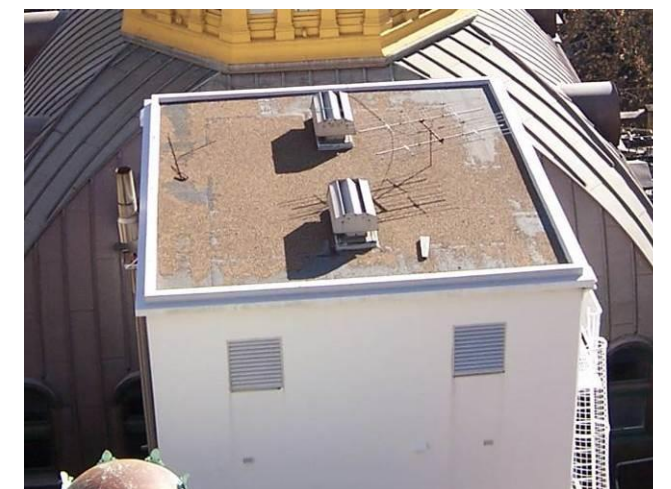
Lift motor room membrane

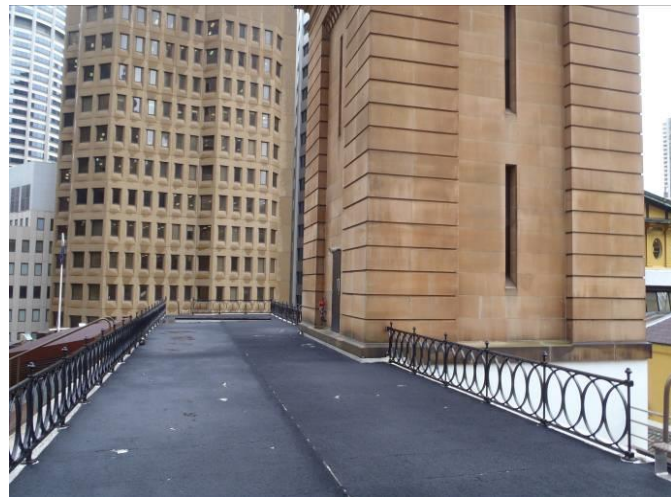
Southern membrane roof adjacent tower

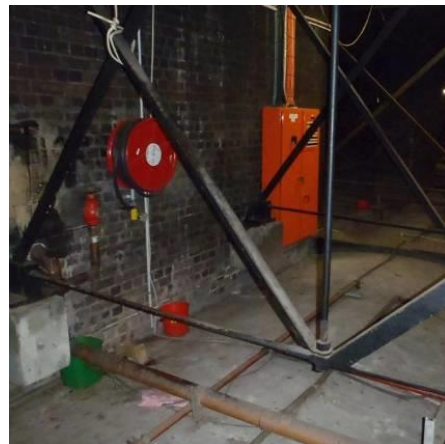
Steel Truss

The trusses appear to be in good condition with minor corrosion on some elements. Some bracing elements need repair.

To prevent water ingress and ensure the longevity of the timber members, the roofing/ membrane should be repaired/ replaced where leaking.

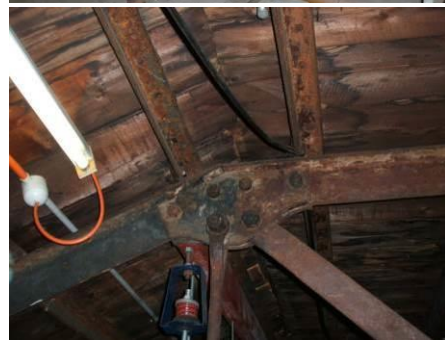
Timber boarded underlay

The roof leaks in various areas, and a number of buckets were in place in various areas (it was raining during the site visit). Some timber roofing boards appear to have been replaced in the past.

There are signs of minor timber decay where roof leakage has occurred in the past, however, no major timber decay was noticed during the visit. The timber members were generally in a serviceable condition and structurally acceptable.

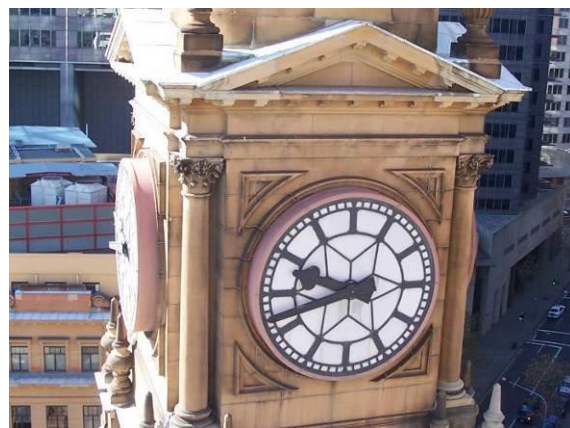
Clock face

In 2007 during an inspection of the tower by GAO it was observed that the clock faces were corroding with light corrosion externally and required repair and re-

Clock faces requires repair and re-painting in the short term

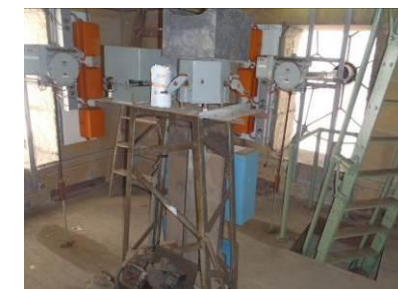
Clock mechanism

The clock mechanism requires regular cyclic maintenance in the short term, medium term and long term.

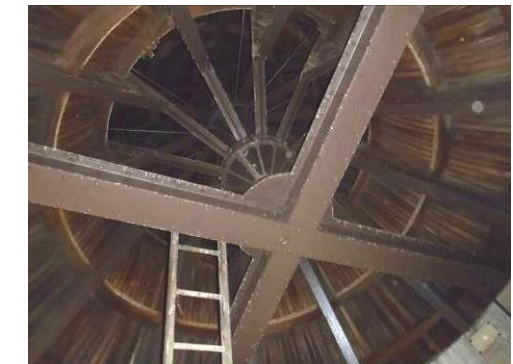
At the top of the tower is an elegant onion shaped dome, which is copper clad with a ring of ornate copper acrotera at the base.
The dome structure consists of numerous timber brackets radiating out from a vertical cast iron centering pin.
Work was completed on the tower in 1891. The then Minister for Lands, Hon. James N. Brunner, laid a stone at the top of the tower bearing an inscribed plaque on January 5th 1891.
In 2007 during an inspection of the tower by Government Architect's Office (GAO) observed that the copper sheeting required minor repair, many copper screws attaching the copper cladding to the timber frame were missing allowing water ingress into the tower and potentially causing the sheeting to become loose. No work has been undertaken since this inspection.

Exceptional Fair / poor

Inside tower dome

Repair to the tower copper sheeting is required in the short term to prevent water damage to timber frame and to secure the sheeting.
Use traditional methods of repair when repairing copperwork.

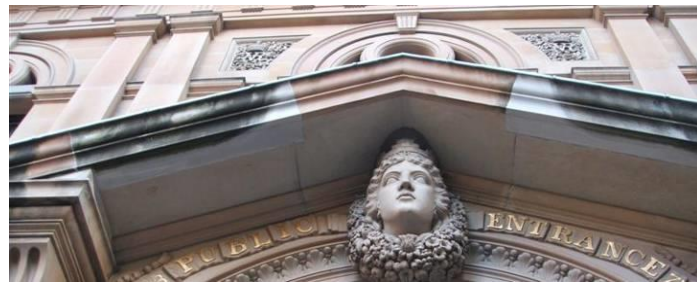
view of bridge street entrance stonework with past stone replacement

now degraded to a point where it now requires replacement.

Refer to Lands Building Façade Condition Report September 2007 Public Works Report HG 07/49
Stonework safety inspections to remove potentially dangerous stonework required immediately.
Repair of stonework required in the short term

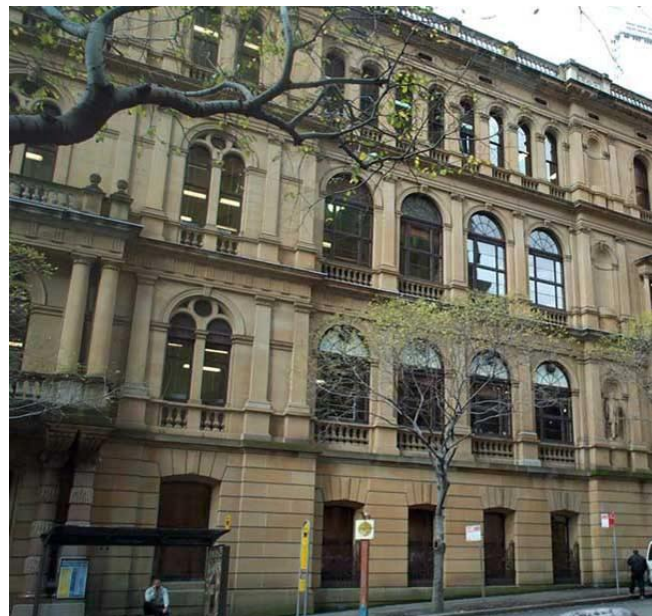
Gresham street elevation

The stonework requires repair due to salt activity, cracking and general weathering exposure.

Refer to Lands Building Façade Condition Report September 2007 Public Works Report HG 07/49

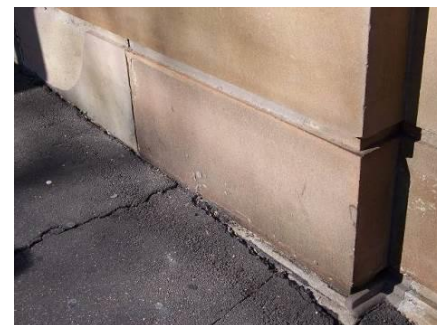
Typical stonework condition at footpath

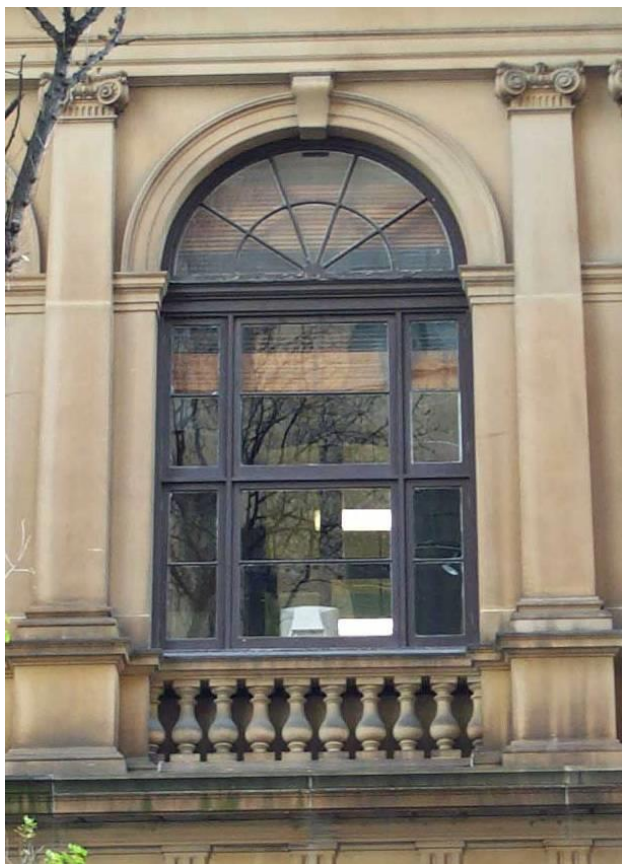
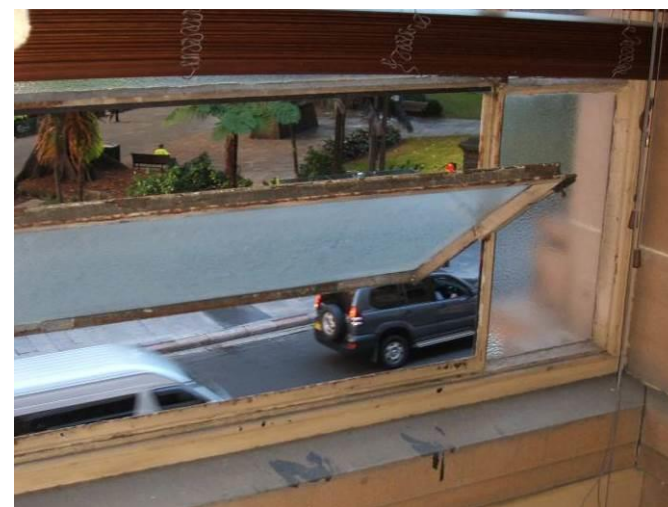
The metal windows are generally in fair condition the paint is in poor condition. Where internal floors have been raised for concealing plumbing, the floor to opening height is below acceptable heights for child safety.

Metal Windows enclosing original verandahs detract from the significance of the façade
Intrusive

Poor / Fair

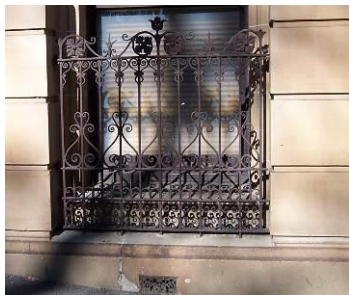
These are generally in good condition but require treatment and painting to prevent expansive corrosion from jacking and cracking the stone in the short term.

Bridge Street stage 1 Window grilles

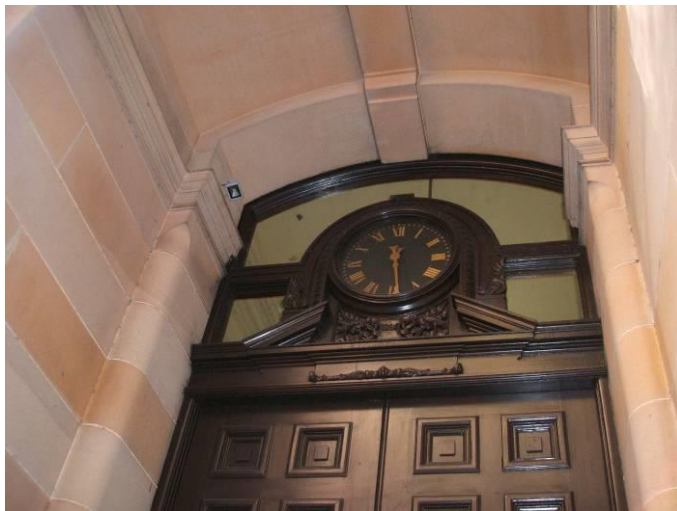
Clock and doors at Loftus Street entrance

Repair clock and make operable retain and conserve original mechanism

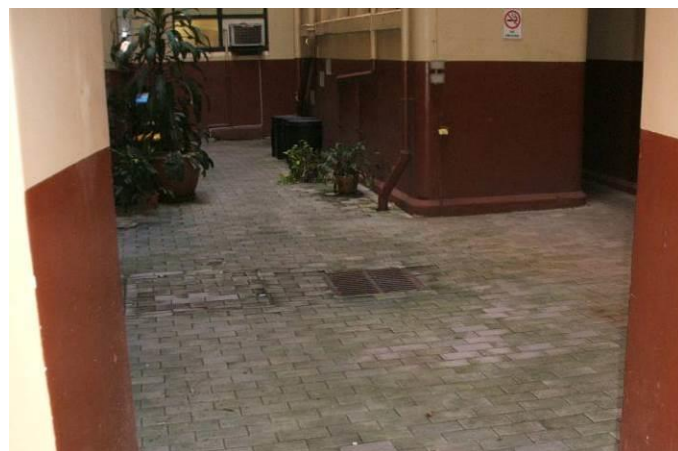
Southern courtyard

Some of these new pavers need replacement and relaying.
Paving is mossy / mouldy in part.

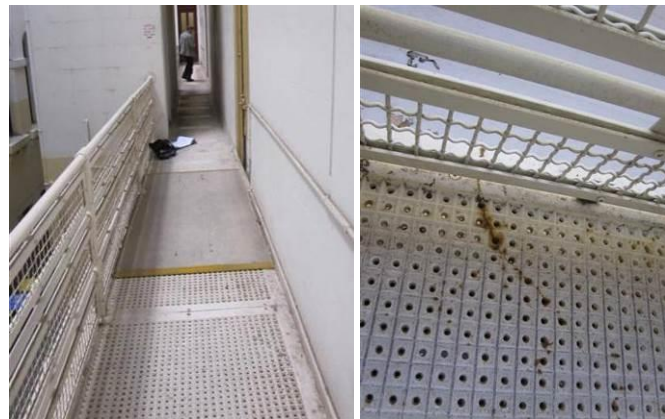
Cast iron catwalks

A number of cracks have developed in the cast-iron floor panels, progressing from one hole to the next, some of which are significant. Most of the cracks progress to/near bolt-hole fixings; some cracks are straight in plan, spanning either parallel to, or perpendicular to, the floor panel's span; some cracks are diagonal in plan. Some of the cracked panels are currently covered by CFC flooring due to safety concerns.

Initiation of the cracks is considered to have developed at the bolted connection points. The steel beams deflect/curve relative to stiffer brittle cast-iron panels which results in the panels losing their continuous support along the beams, becoming locally supported at the bolted connections leading to overstress and cracking - steel packers (below the panels) at bolted connections confirm this relative deflection. The cracks extend over time due to the repeated deflection of the panels from pedestrian traffic.

panels are permanently redressed. Two options for a long-term solution to the significantly cracked panels are:

1. Replace the panels with cast-iron panels to match existing (including panels currently covered by flooring); or
2. Install new corrosion-protected perforated structural steel flooring below the panels. For either of the above options, to ensure continuous support of the panels along the steel beams, any gap between panels and supporting beams needs to be tightly packed. Moreover, as a preventative measure, all remaining catwalk panels (even if uncracked) should be checked for gaps between the panel and supporting beam and any gaps tightly packed.

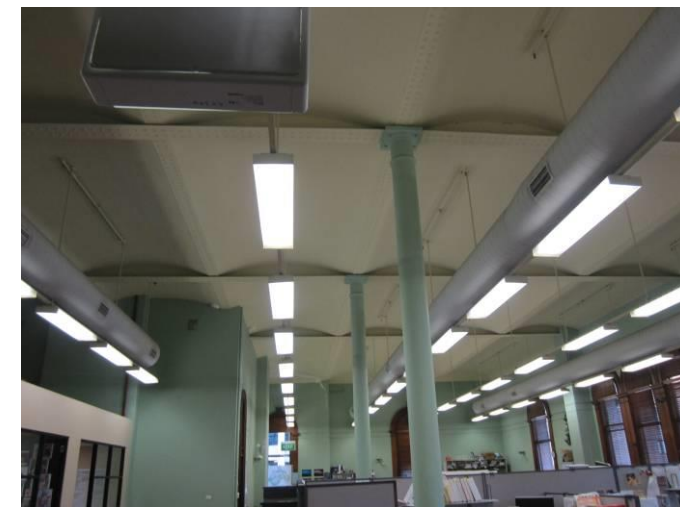
Room 302: Vaulted ceilings: High Significance.

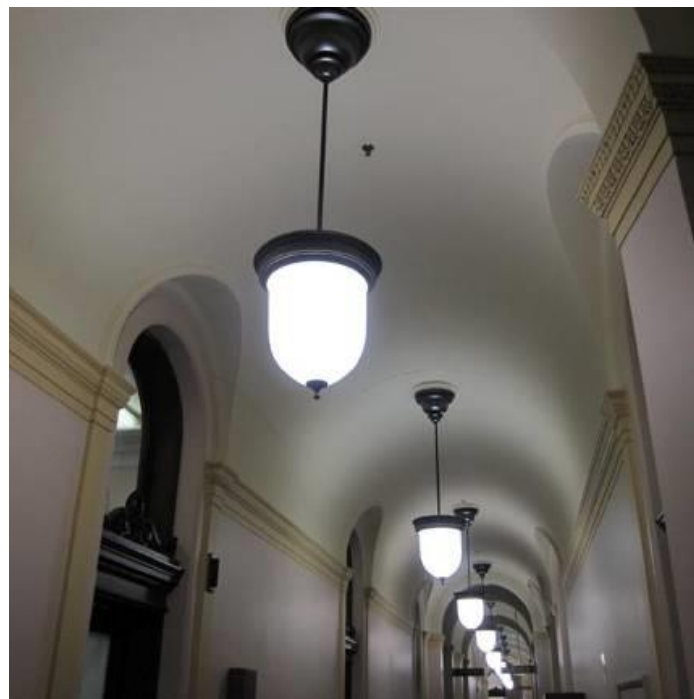
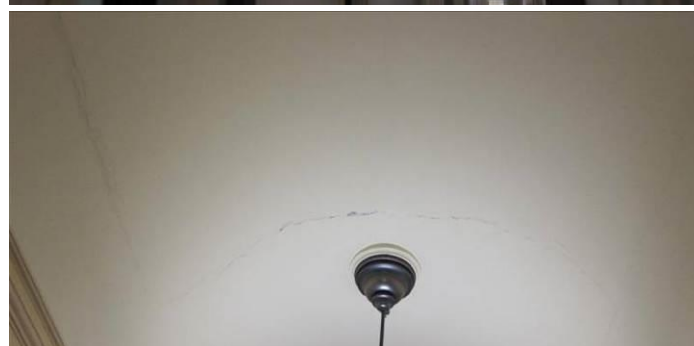
A number of cracks were seen in the soffit of concrete vault ceilings of the main corridors on all floors – the concrete is most likely unreinforced. Most cracks span across the ceiling, occurring mainly at/near door openings and cross walls/steel beams; crack widths vary in size with some being hairline and barely visible while others are larger and more prominent. There are longitudinal cracks in some areas which run along the apex of the vault ceiling and some occur near the junction of the concrete ceiling and supporting masonry corridor walls.

The cracks are not currently considered to be structurally significant. They are believed to have developed over time from repeated thermal and moisture induced expansion/contraction movements of the building structure's various walls and ceiling/floor elements, exacerbated by the building's size and shape. The cracks that span across the ceiling may have initially developed due to

concrete shrinkage in the early life of the building, subsequently returning due to on-going thermal/moisture movements.

Some cracking in concrete arched ceilings generally in good condition
 Monitor cracking, if cracking increases investigate cause and implement rectification with competent heritage engineer and heritage architect.

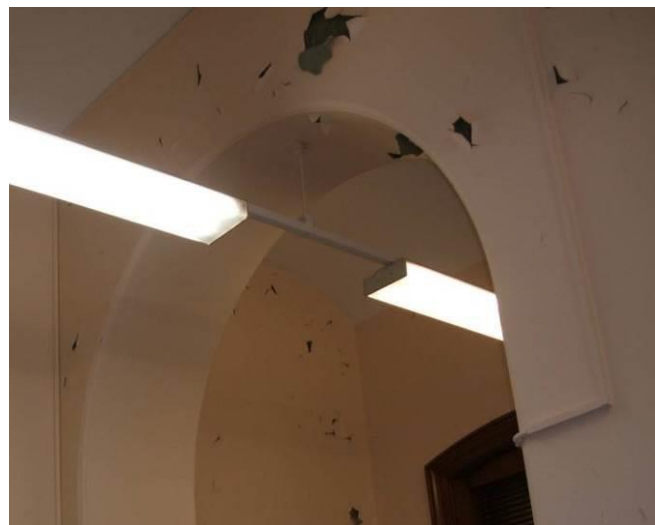
Room G12

The ground floor on the Western side has blistering paint on the walls and ceiling as seen in room G12. The failure may be more than a moisture issue and could relate to the underlying paint and substrate.

approximately 1 year for the walls and ceiling to fully dry before the paint can be applied without failing.

Investigate the cause of paint failure in each location and repair and eliminate the cause prior to painting.

Analyse degraded paint layers for lead content in each area immediately and assess potential lead contamination in building. If lead is detected prepare surface for painting in accordance with appropriate Australian Standards.

Repaint failing paint systems in the short term. Cyclic painting in the medium term.

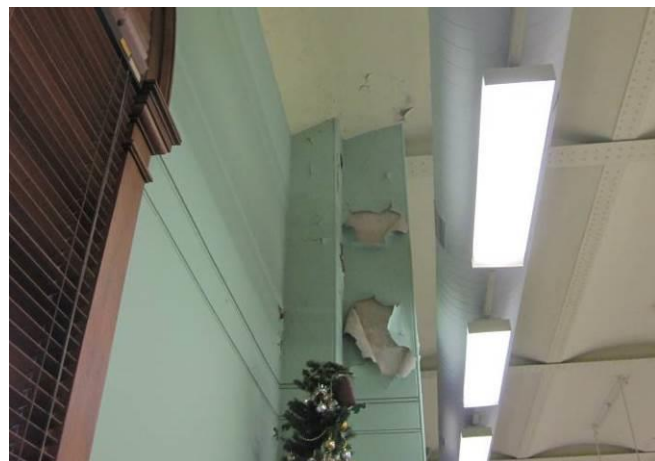
Room 302

The upper floor walls and ceilings on Level 3 (see room 302) have paint failure in ceilings and upper wall areas. This is most likely from falling damp from leaking flashings, membranes and roof sheeting above. These ceilings are concrete and although durable and less likely to fail from water ingress when damp cause the ceiling paints to fail. Even after the leaks have been repaired it will take

Repaint ceilings that have defective or peeling paint in the immediate term. These defective paint finishes may contain lead. Retain original colour schemes.

Repair concrete ceilings to engineer's requirements.

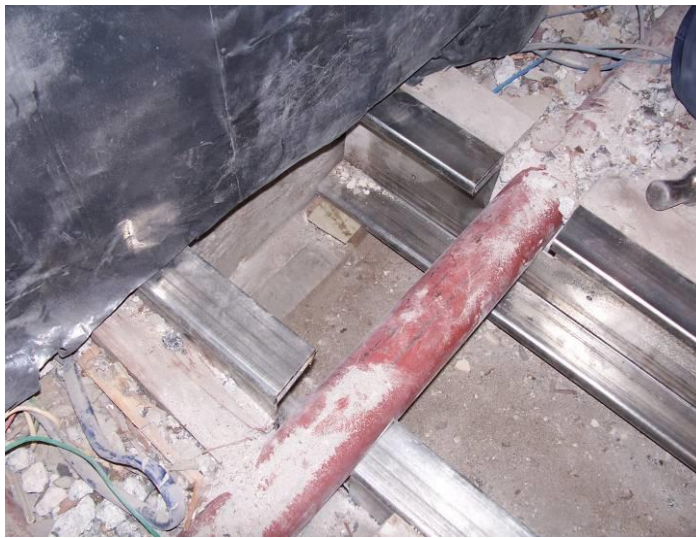
Room 219 stabilisation of timber floor

joists in this room thought to be an original detail to reduce fire and sound transfer. This is likely to be damaged to varying degrees where services have been inserted into the floors.

Investigate for structural stability and general damage when carpet is removed to each area in the short term. Potential damage has occurred during past services installations.

Protect and retain original timber floor construction and floors where coke breeze has been placed. Use previously disturbed zones if new services are required in floors.
