ELEMENT / ZONE	DESCRIPTION / BACKGROUND	SIGNIFICANCE	CONDITION	RECOMMENDATIONS
For room numbers see 2013 floor plans in Section 7.34 pp.193-200.				(See also Section 5: Heritage Management Policies & Guidelines)

7.18 FIREPLACES

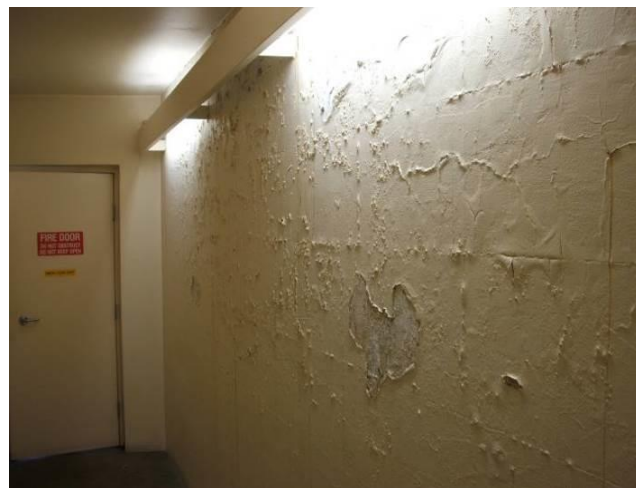
Service corridor at Level 4

Some spaces are poorly finished with holes and voids compromising fire ratings and degrading heritage fabric.

Repaint deteriorated wall in the short term.

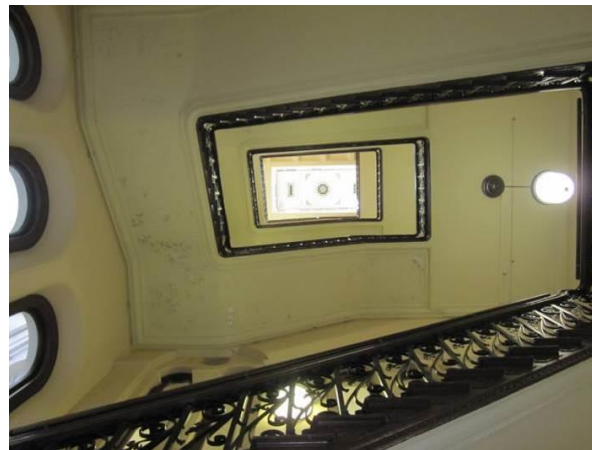
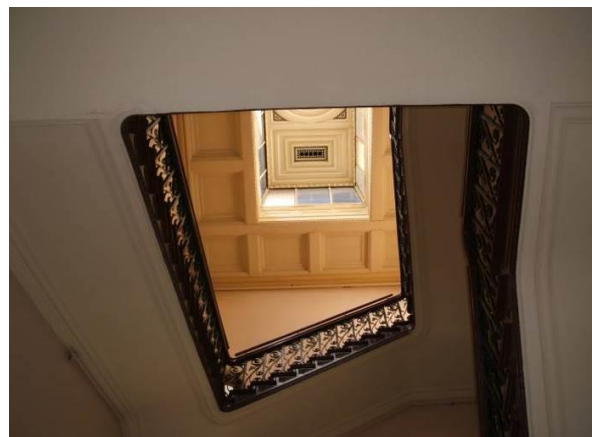
Western stair

There were no lifts located in this well.

Repaint walls and underside of stair landings and flights in the short term. Undertake a fire engineered assessment of the stairs within the context of the future building use. Determine and implement appropriate and sympathetic methods of upgrading the stair / stair shaft without causing loss of significance.

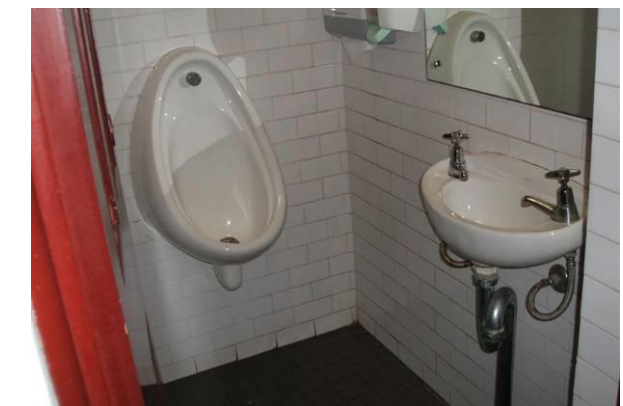
Generally toilets, change room, kitchenettes and their services are now approx. 20 years old. In some locations the cabinets have deteriorated surfaces, loose doors, lifting and stained sheeting. Taps and services are not compliant with current codes.

Typical male toilet cubical to lightwells.

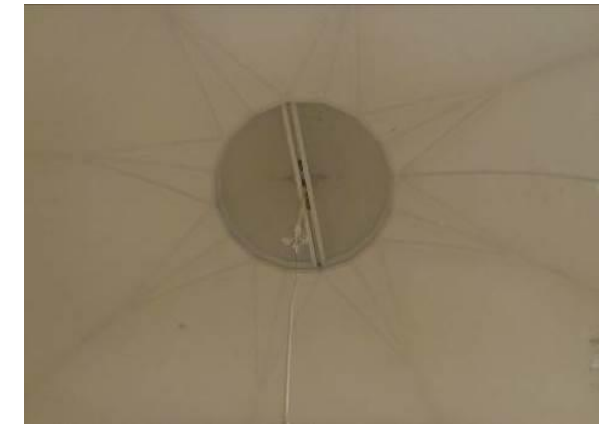
Room316 internal view of top of dome

Some minor cracking in masonry / concrete dome, paint finishes generally in fair condition.

Some minor cracking has occurred in the upper concrete dome which has been assessed as requiring minor patching and monitoring at this stage. Refer to structural engineers report.

- Consider the removal of intrusive fabric within the space.
- Consider repairing the roof light umbrella and window shutters and make operable.
- Repaint the dome and repair minor cracking in the short term

- Monitor the cracks with "tell-tale" indicators (or similar) once every 2 years (short term).
- New lighting and services must be installed in a reversible and sympathetic manner with as little damage to significant fabric as possible.

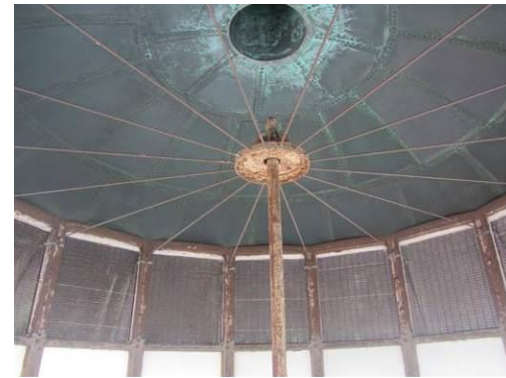
Adjustable steel umbrella at top of dome in domed roof light. View between steel dome and copper roof dome.

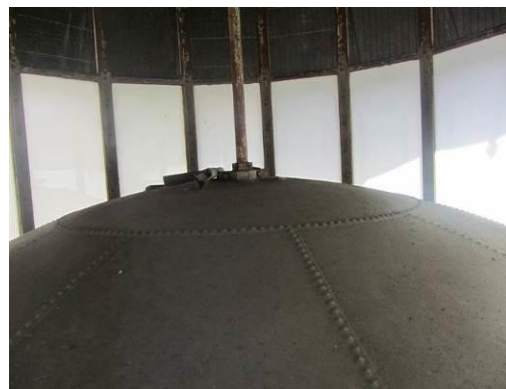
Adjustable steel umbrella at top of dome in domed roof light

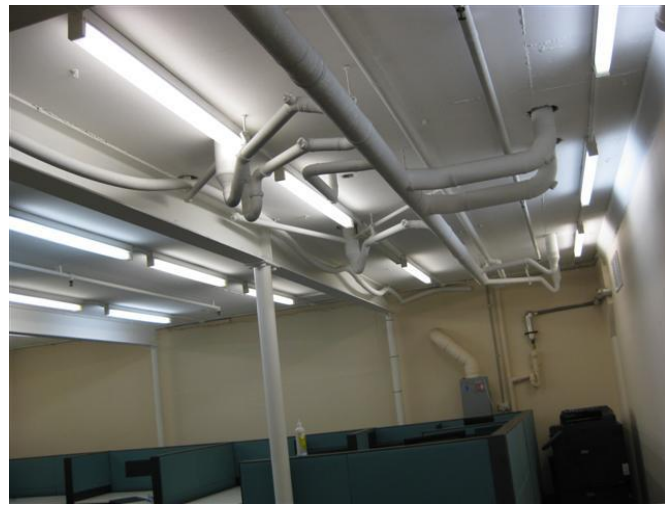
PLUMBING IN CELING OF ROOM G.16

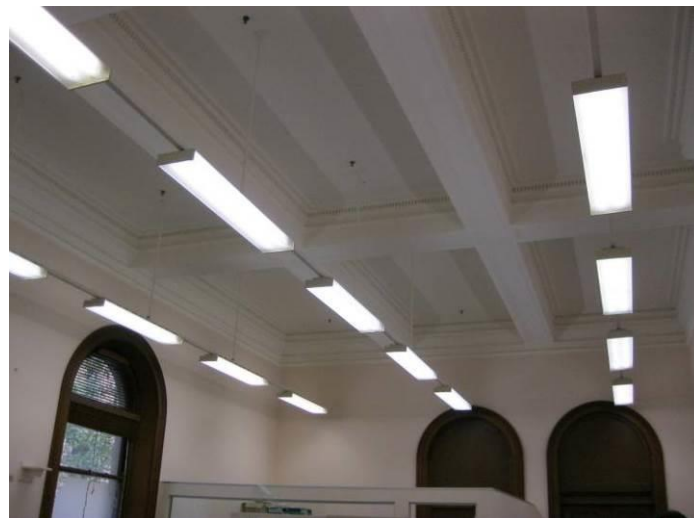
Uni strut / chain Suspended 2x65W T12 luminaires with prismatic diffusers.

The general lighting varies slightly throughout the building. The majority of lighting is by twin 65watt T12 linear fluorescent lamps, with different mounting types in each area. The T12 linear fluorescent lamps are at the end of economic life and should be replaced with the more efficient T5, 28w linear fluorescent fittings in the short term, Period style lighting in the general areas, walk ways and stair ways require a clean a re-lamp, but otherwise are in good general working order, and provide sufficient light output levels.
