# 2024 Channel Stability Monitoring Report

Wilpinjong Coal Mine

Wilpinjong Coal Pty Ltd

Project Name: 2024 WCPL Channel Stability Monitoring Report

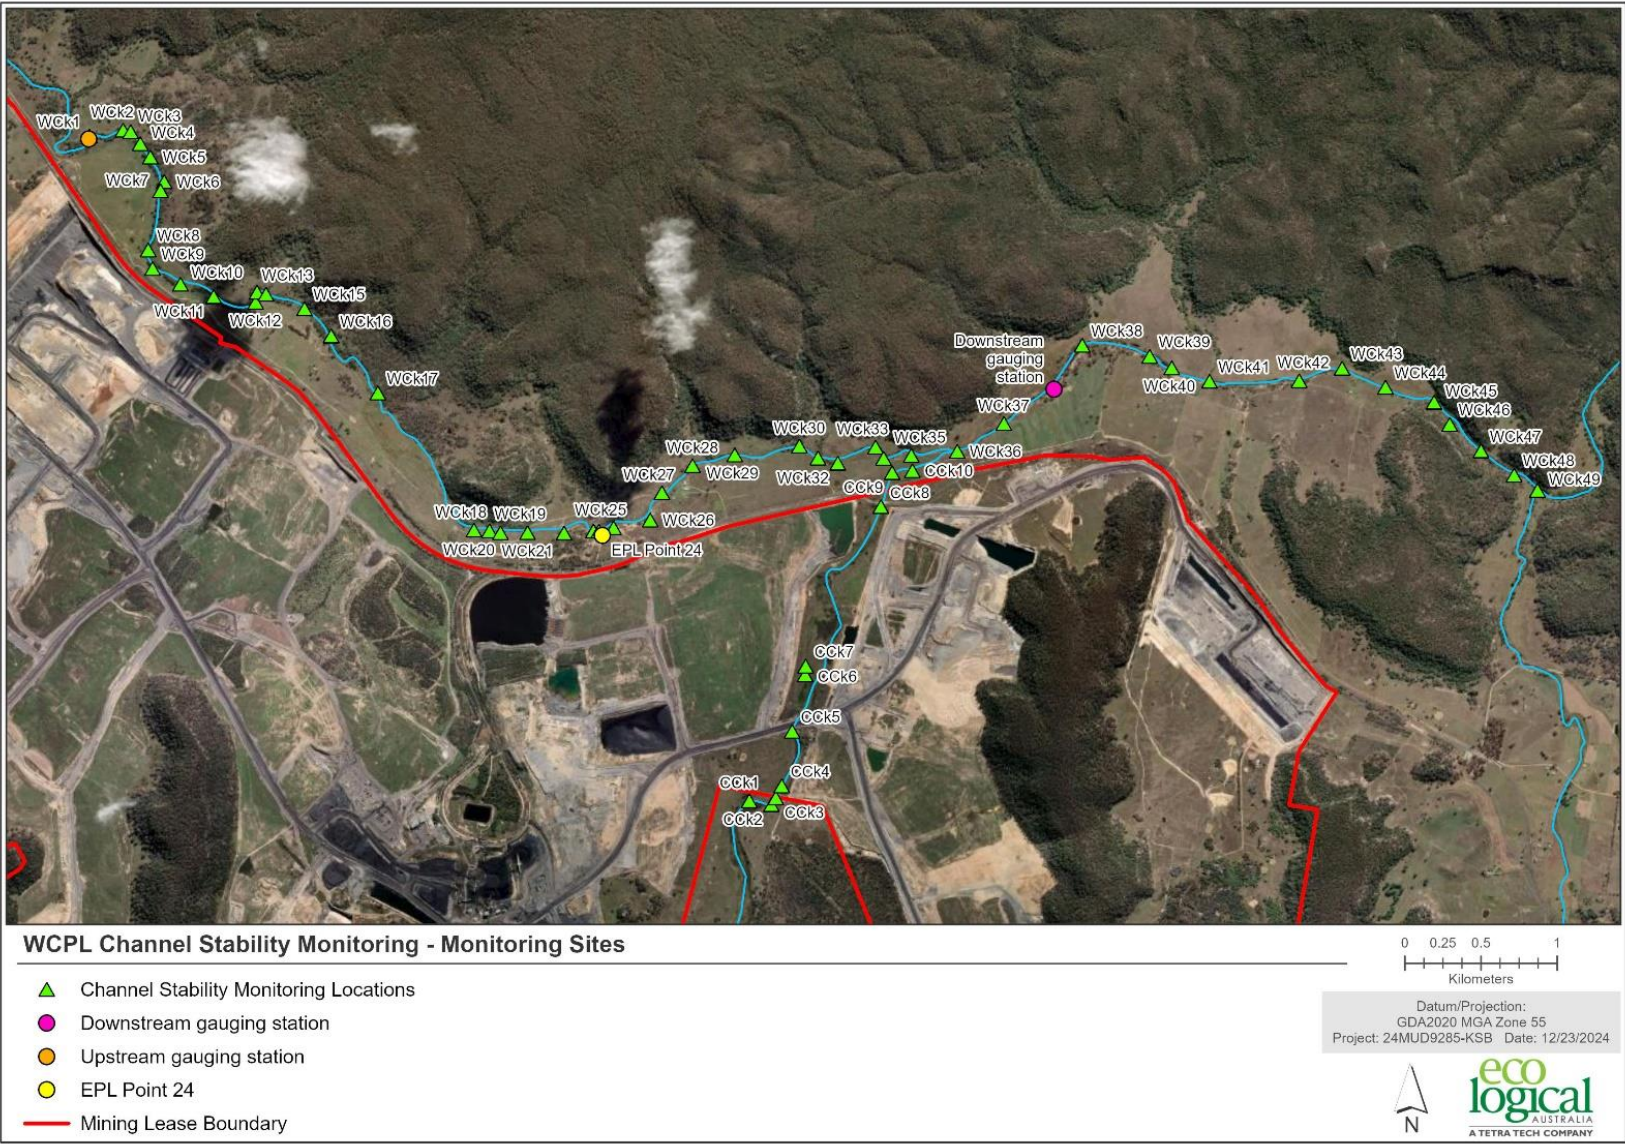
Figure 1: Channel Stability monitoring locations along Wilpinjong Creek and Cumbo Creek

A total of 59 permanent monitoring locations were surveyed (49 on Wilpinjong Creek and 10 on Cumbo Creek; Figure 1). Consistent with previous monitoring, surveys involved surveying the designated reach of each site (approximately 100 m) and completing the Bank Erosion Hazard Index (BEHI) assessment. BEHI assessment involves scoring a site on eight quantitative categories outlined below and in Appendix A.

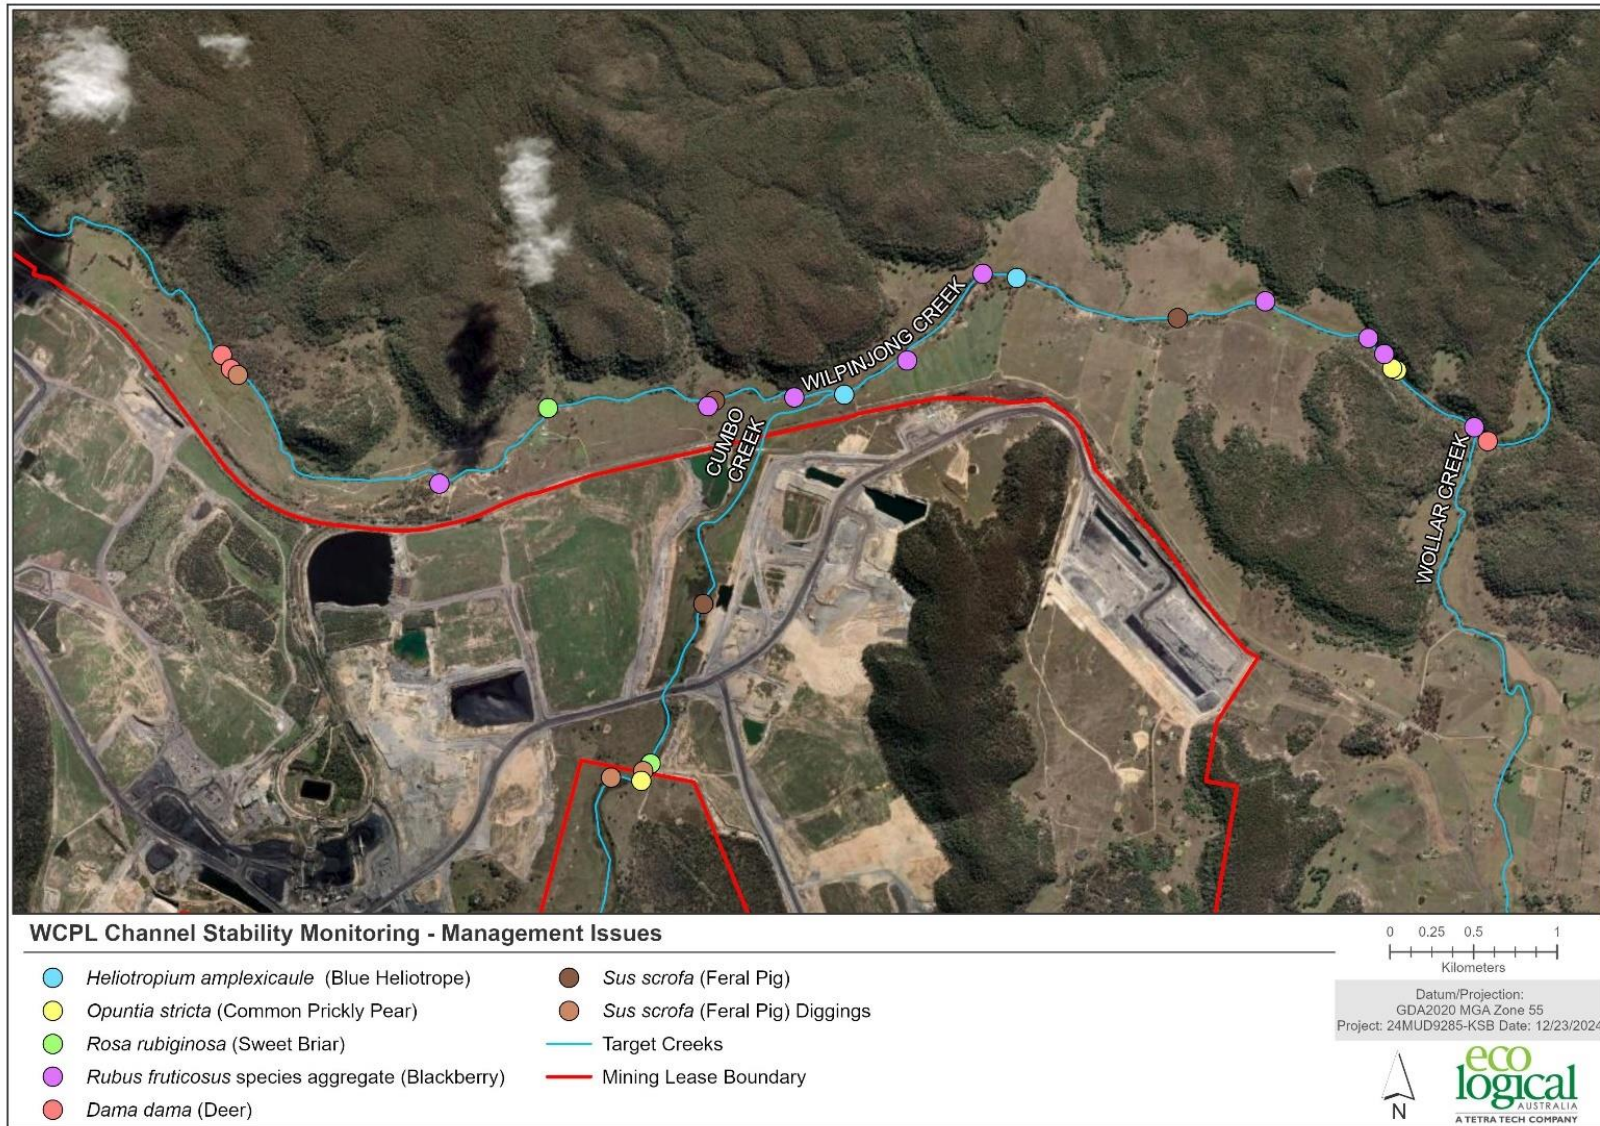
Figure 6: Weed species and feral species along Wilpinjong and Cumbo Creek

The results of the BEHI assessments completed at sites along Wilpinjong Creek and Cumbo Creek are presented below in Appendix B:. Site descriptions and comparison notes can be found in Appendix C:. A range of priority weed species listed within the Central Tablelands Regional Strategic Weed Management Plan 2023-2027 (LLS 2023) were recorded, as well as priority pest animal species listed within the Central Tablelands Regional Strategic Pest Animal Management Plan 2018-2023 (LLS 2018), the locations of which are shown in **Error! Reference source not found.**

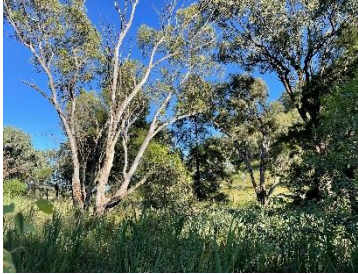
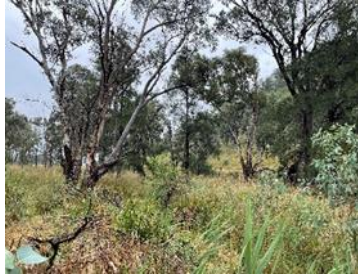
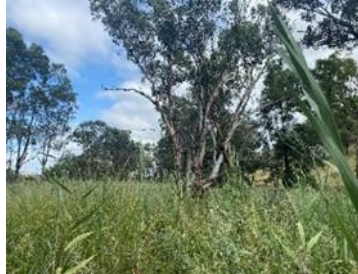
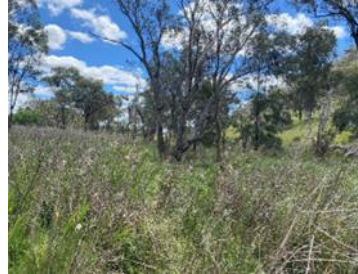
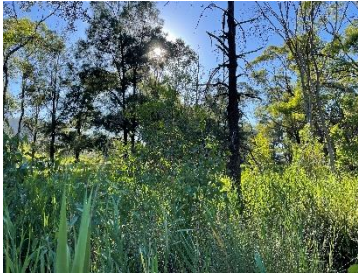
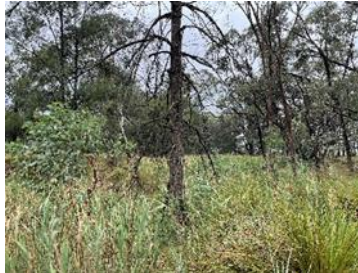
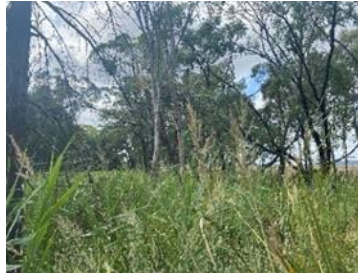
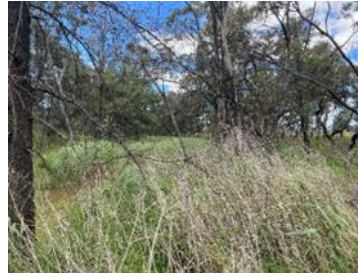
**WCK 11**

Wck11	<ul style="list-style-type: none"> <li>● High vegetation cover in channel and on banks with <i>Phragmites australis</i>, <i>Arundinella nepalensis</i> (Reedgrass), and <i>Austrostipa verticillata</i> (Slender bamboo grass) present</li> <li>● <i>Cyperaceae</i> sp. in channel</li> <li>● High woody vegetation cover on LHB</li> <li>● Young <i>E. camaldulensis</i> and <i>E. blakelyi</i> on RHB</li> <li>● No water within channel</li> </ul>	<ul style="list-style-type: none"> <li>● High cover of <i>Phragmites australis</i> in channel</li> <li>● High vegetation cover on both banks</li> <li>● Regeneration of <i>Eucalyptus blakelyi</i> in channel</li> <li>● No water in channel</li> </ul>
